THE  
ONTARIO WATER RESOURCES  
COMMISSION  
WATER POLLUTION SURVEY  
of the  
VILLAGE OF THORNLOE  
DISTRICT OF TIMISKAMING

WATER POLLUTION SURVEY

VILLAGE OF THORNLOE

September 1966

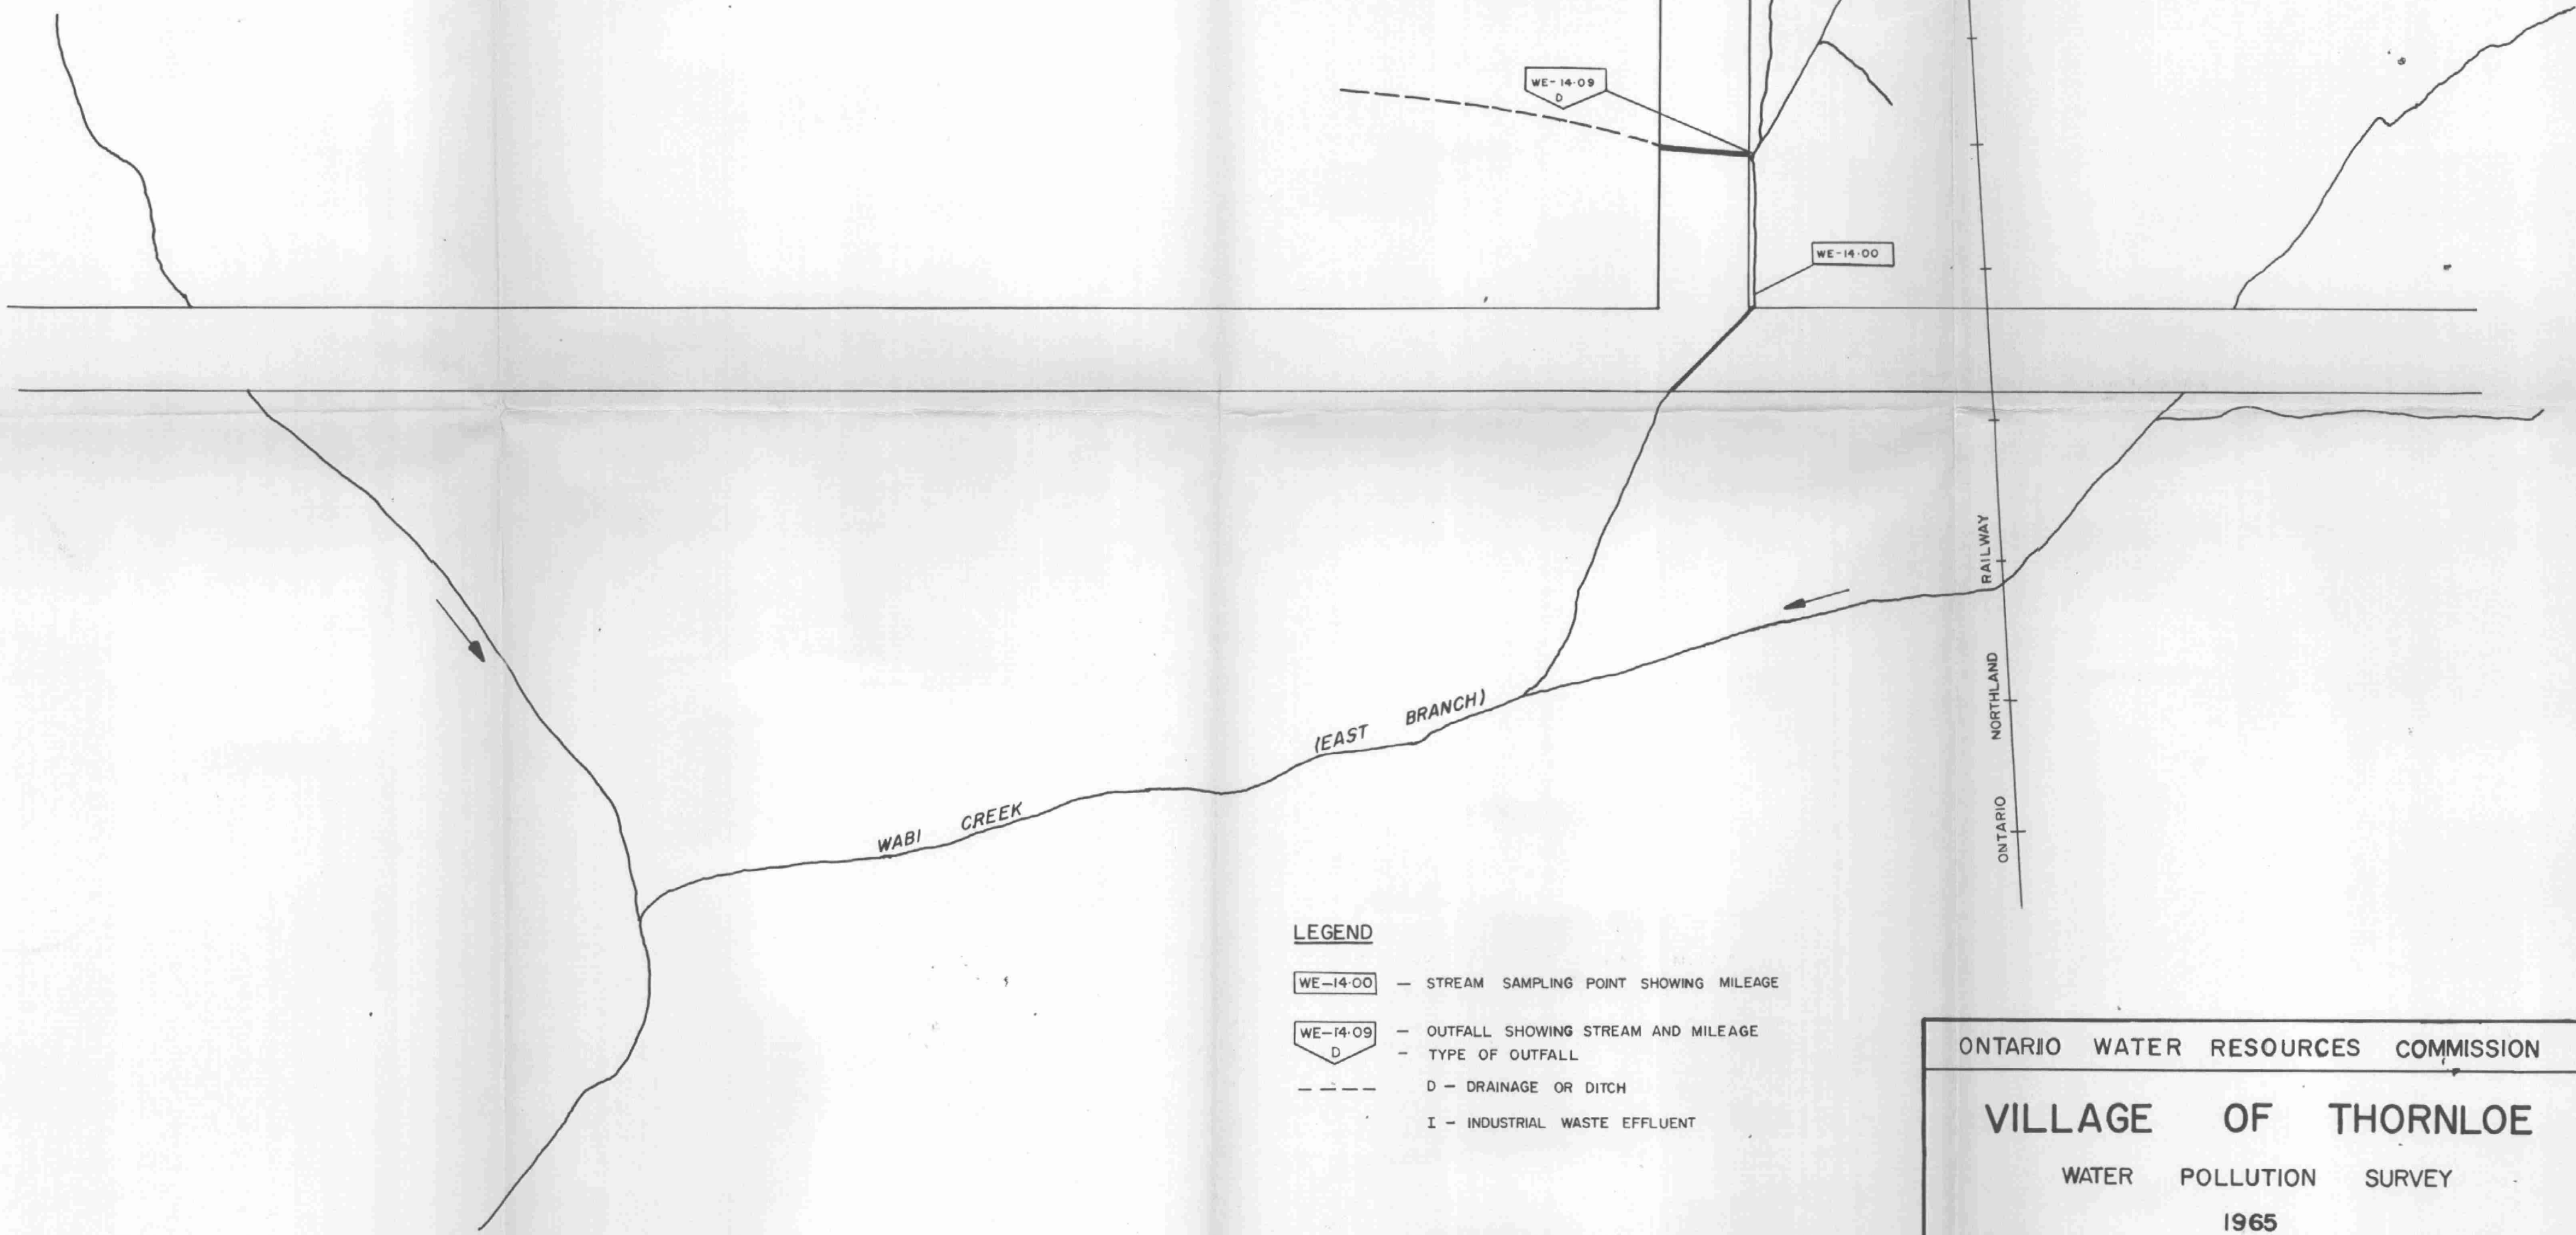
DRAWING No. 66-55

Samples, collected from the open ditch on the east side of Young Street downstream from the Thornloe Cheese Factory and the residences discharging septic-tank effluent to the ditch, revealed

The samples, collected from the open ditches receiving septic-tank effluents from residences on Main Street, showed excessive BOD and coliform counts.

The open ditches behind the residences on Main Street flow in a westerly direction and finally discharge into one drainage ditch east of the Ontario Northland Railway tracks. This drainage ditch has been constructed to a six-foot width and approximately four feet in depth. Flow is in a southerly direction and water in the ditch is ponded by a blocked culvert under the ONR tracks. At the time of the investigation the water in the ditch was a milky colour. It is suspected that wastes from the cheese factory has access to this ditch. A sample, collected from the ditch downstream from the ponded area, revealed a high coliform count.

The sample, collected from the tributary of the Wabi Creek downstream from the Village of Thornloe and from the confluences with the drainage ditches, showed an excessive coliform density and a high 5-Day BOD.

As indicated by the laboratory results the water quality of the open ditches and the tributary of Wabi Creek has been adversely affected by the discharging of septic-tank effluent and milk wastes

Consideration should be given to the establishment of a sanitary sewerage system for the Village of Thornloe in order to eliminate the discharges of polluting material into open ditches.

Allowance should be made in the system to treat the waste discharges from the Thornloe Cheese Factory.
