# NAVAL POSTGRADUATE SCHOOL

USE OF IMPLANT TESTING TO EVALUATE  
THE SUSCEPTIBILITY OF HY-130 STEEL  
WELDMENTS TO HYDROGEN EMBRITTLEMENT

Bradley J. Mason

December 1981

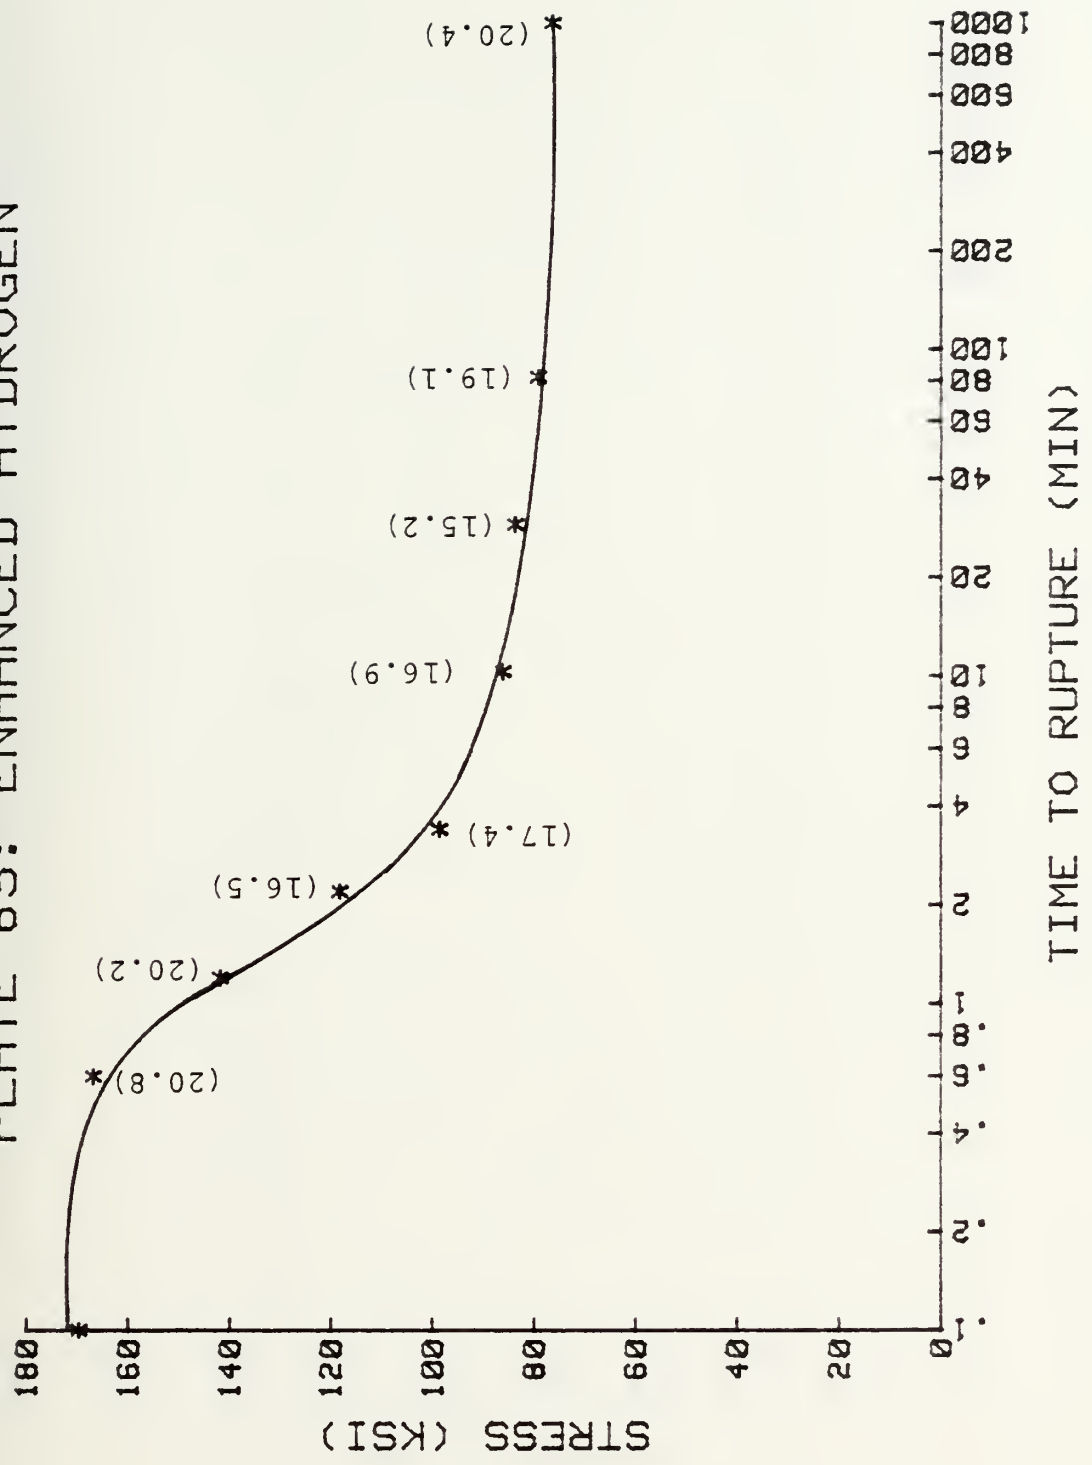
Figure 18. Stress vs. Time-to-Rupture for Plate 6 Short Transverse Direction, Enhanced Hydrogen Welding Conditions

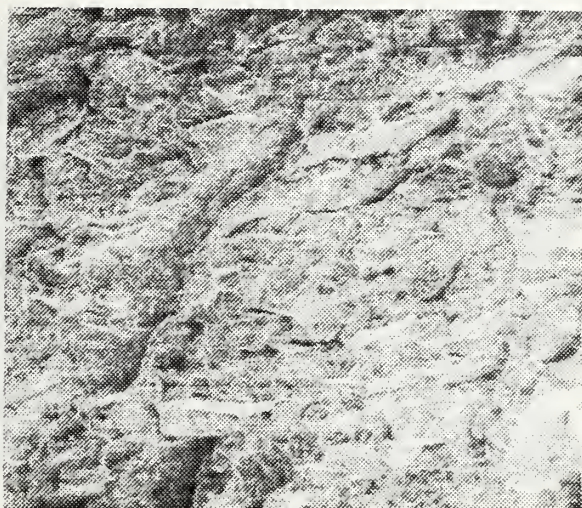
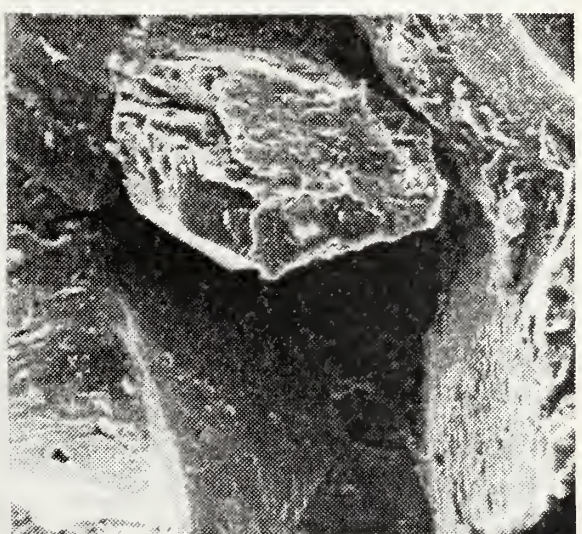
a) 50X, 2.4 ppm H<sub>2</sub>, (70% Ductile)

b) 50X, 20.2 ppm H<sub>2</sub>, (10% Ductile)

c) 500X - Dimpled Fracture

d) 500X - Dimpled Fracture

e) 500X - I.G. Fracture

f) 500X - I.G. Fracture

Figure 23. Plate 2, Short Transverse Direction, Normal (Left) and Enhanced Hydrogen (Right) Welding Conditions

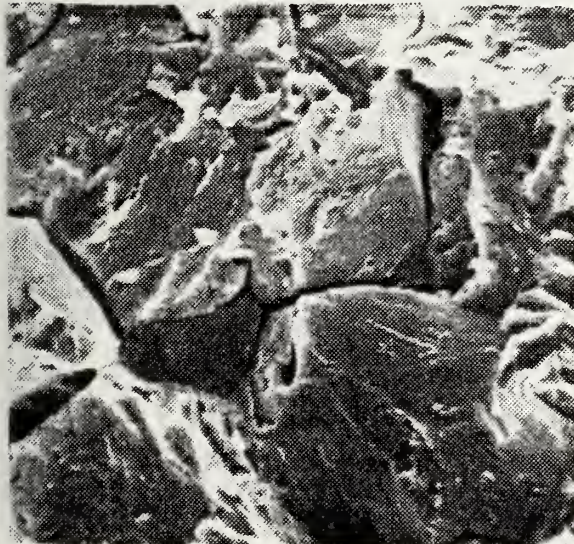
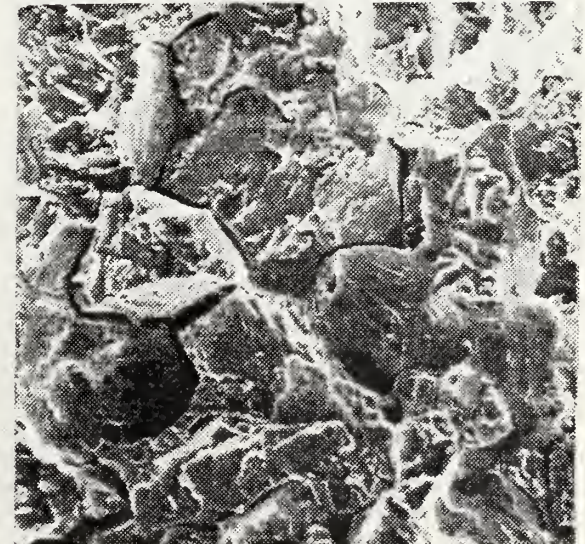
a) 50X, 1.1 ppm H<sub>2</sub>, (80% Ductile)

b) 50X, 18.3 ppm H<sub>2</sub> (25% Ductile)

c) 500X - Dimpled Fracture

d) 500X - Dimpled Fracture

e) 500X - I.G. Fracture

f) 500X - I.G. Fracture

Figure 25. Plate 4, Short Transverse Direction, Normal (Left) and Enhanced Hydrogen (Right) Welding Conditions

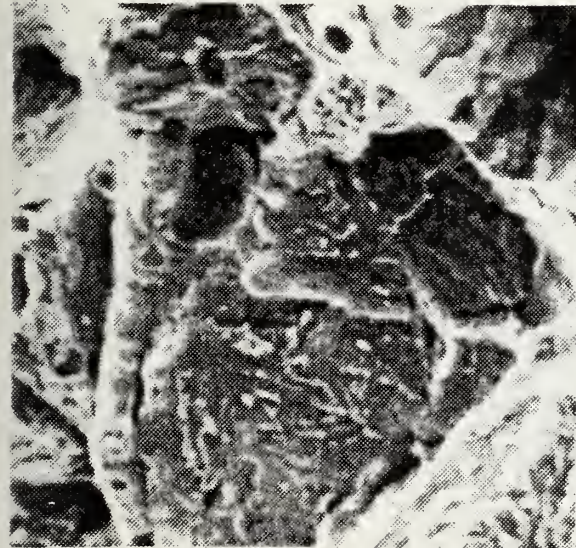
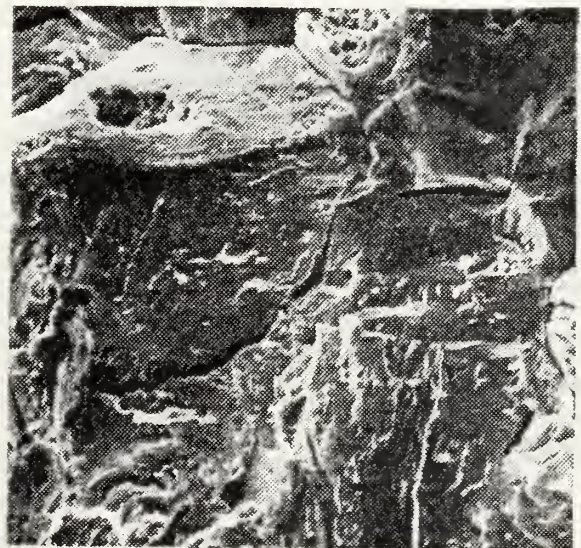
a) 50X, 4.2 ppm H<sub>2</sub> (85% Ductile)

b) 50X, 19.5 ppm H<sub>2</sub> (20% Ductile)

b) 500X - Dimpled Fracture

d) 500X - Dimpled Fracture

e) 500X - I.G. Fracture

f) 500X - I.G. Fracture

Figure 26. Plate 4 Longitudinal Direction Normal (Left) and Enhanced Hydrogen (Right) Welding Conditions

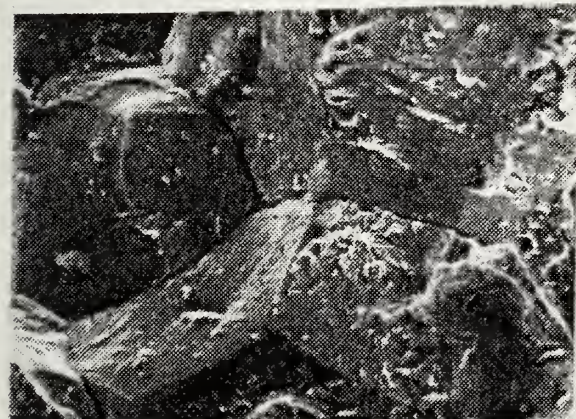
a) 50X, 0.7 ppm H<sub>2</sub> (80% Ductile)

b) 50X, 19.1 ppm H<sub>2</sub> (25% Ductile)

c) 500X - Dimpled Fracture

d) 500X - Dimpled Fracture

e) 500X - I.G. Fracture

f) 500X - I.G. Fracture

Figure 27. Plate 6, Short Transverse Direction, Normal (Left) and Enhanced Hydrogen (Right) Welding Conditions

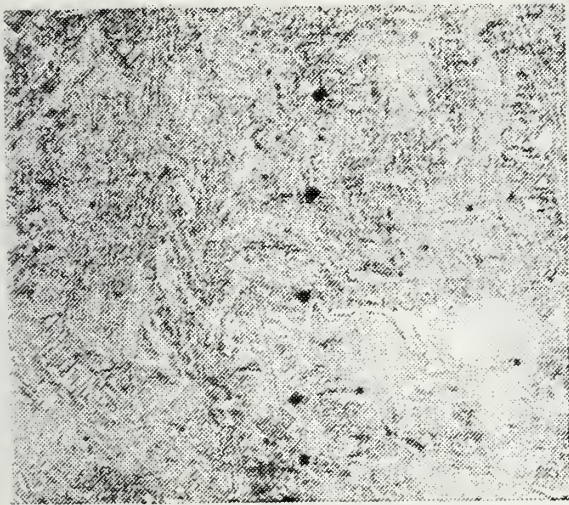
a) 64X - Weld Fusion Line

f) 450X - 1.0 mm Below Fusion Line

Figure 36. Microstructure of Cast Plate Weldment  
(Plate 6)

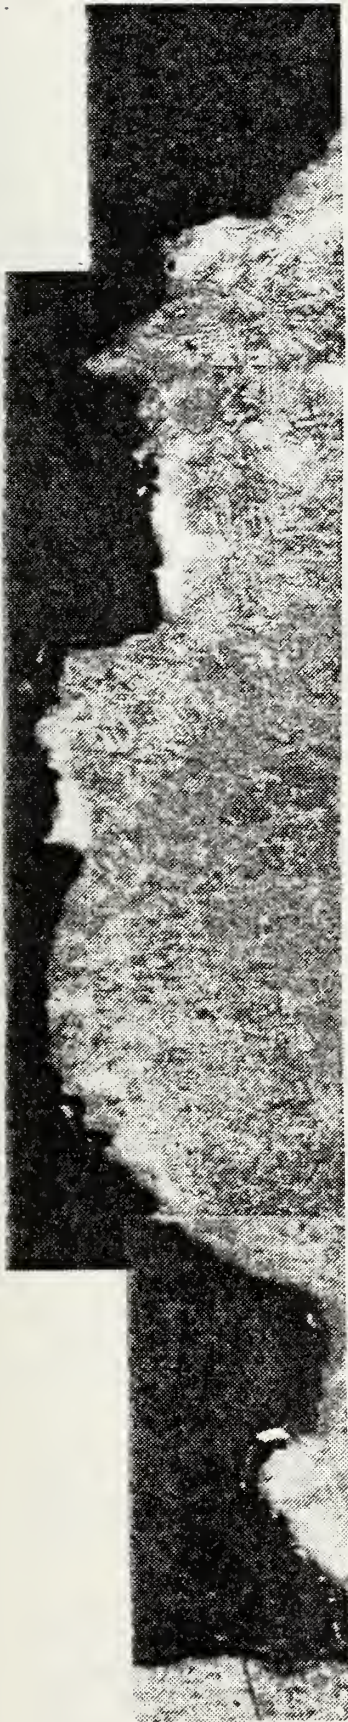
a) 64X - View of Fracture Surface, Enhanced Hydrogen Welding Conditions, 1% Nital Etch. Fracture Occurred Through Base Metal Heat-Affected Zone (Reduced 40%)

b) 64X - View of Fracture Surface, Normal Welding Conditions, 1% Nital Etch. Fracture Occurred Primarily Through the Base Metal Heat-Affected Zone (Reduced 40%)

Figure 40. Microstructure of Fractured Implant Specimens from Plate 6
