1981 C.B. ANNUAL REPORT

SUMMARY OF DEVELOPMENT ACTIVITIES,
COSTS AND ENVIRONMENTAL MONITORING

CATHEDRAL BLUFFS SHALE OIL COMPANY

APRIL 30, 1982

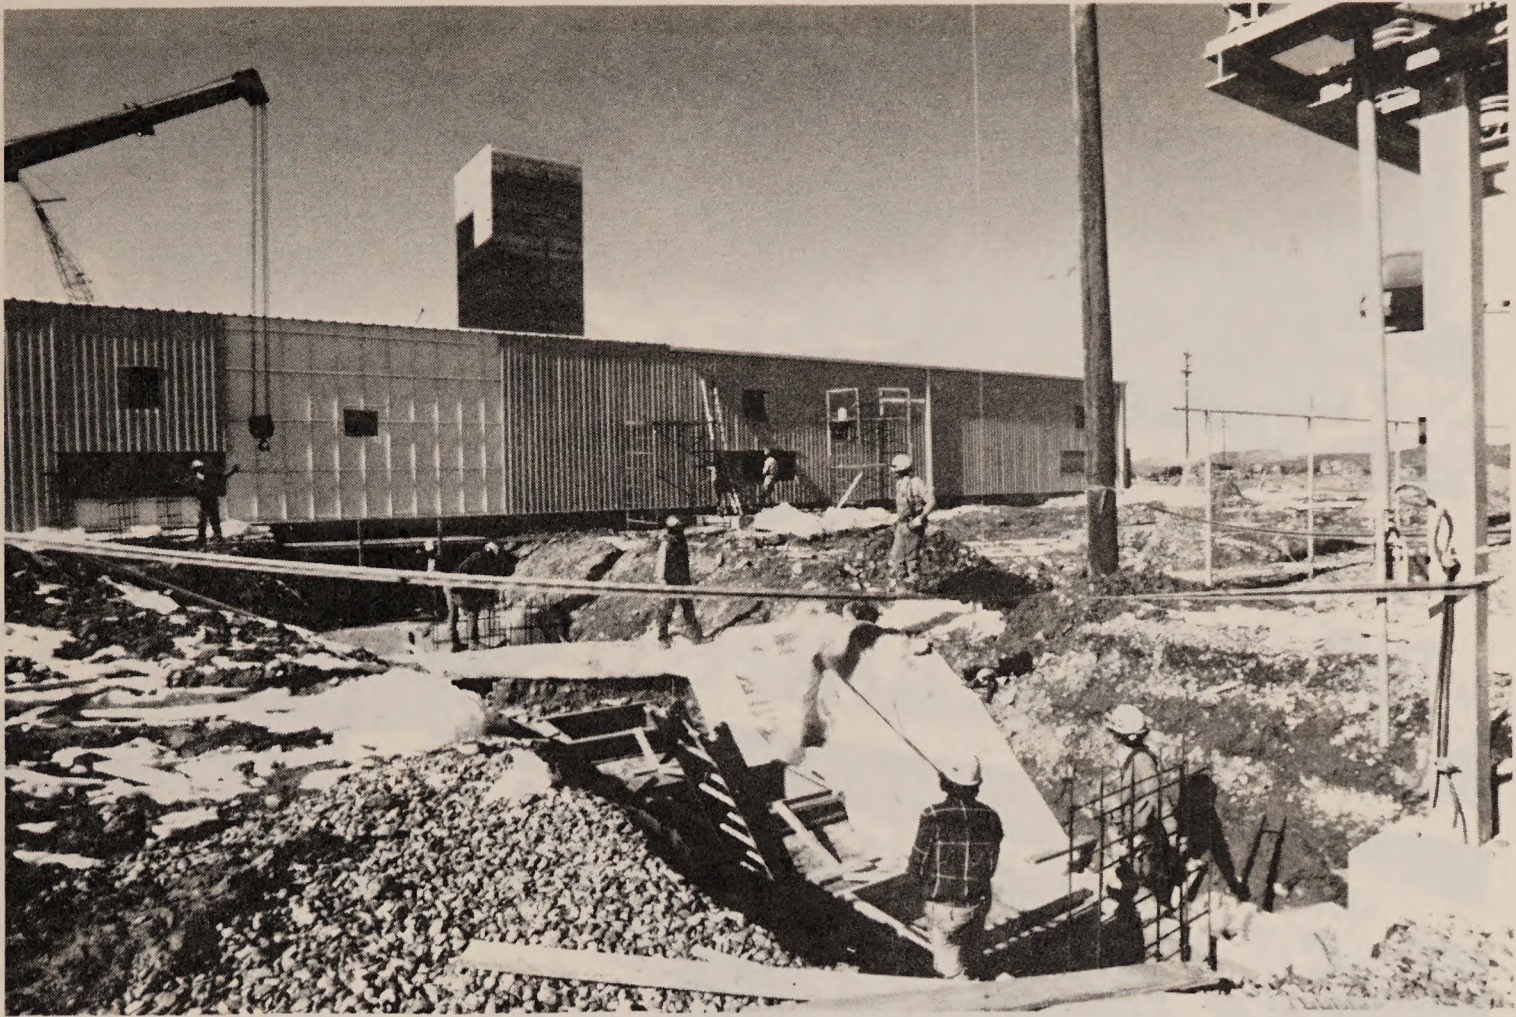
Figure 4-20. Excavation for the bus ducts from the switchyard to the power substation. (October 1981)

The first stage of the electric power supply system for the project was completed in late 1981. This consists of a single 138,000 volt, 22-mile transmission line from Meeker to the C.B. site. The routing was discussed in last year's report. The power line attaches to a 30,000 KVA transformer in a Substation at the Mine Support Area. Power was applied to the power line/Substation in late December for testing purposes. This equipment is now ready to connect to the C.B. Mine Support Area switchgear. This is expected to take place in early 1982.

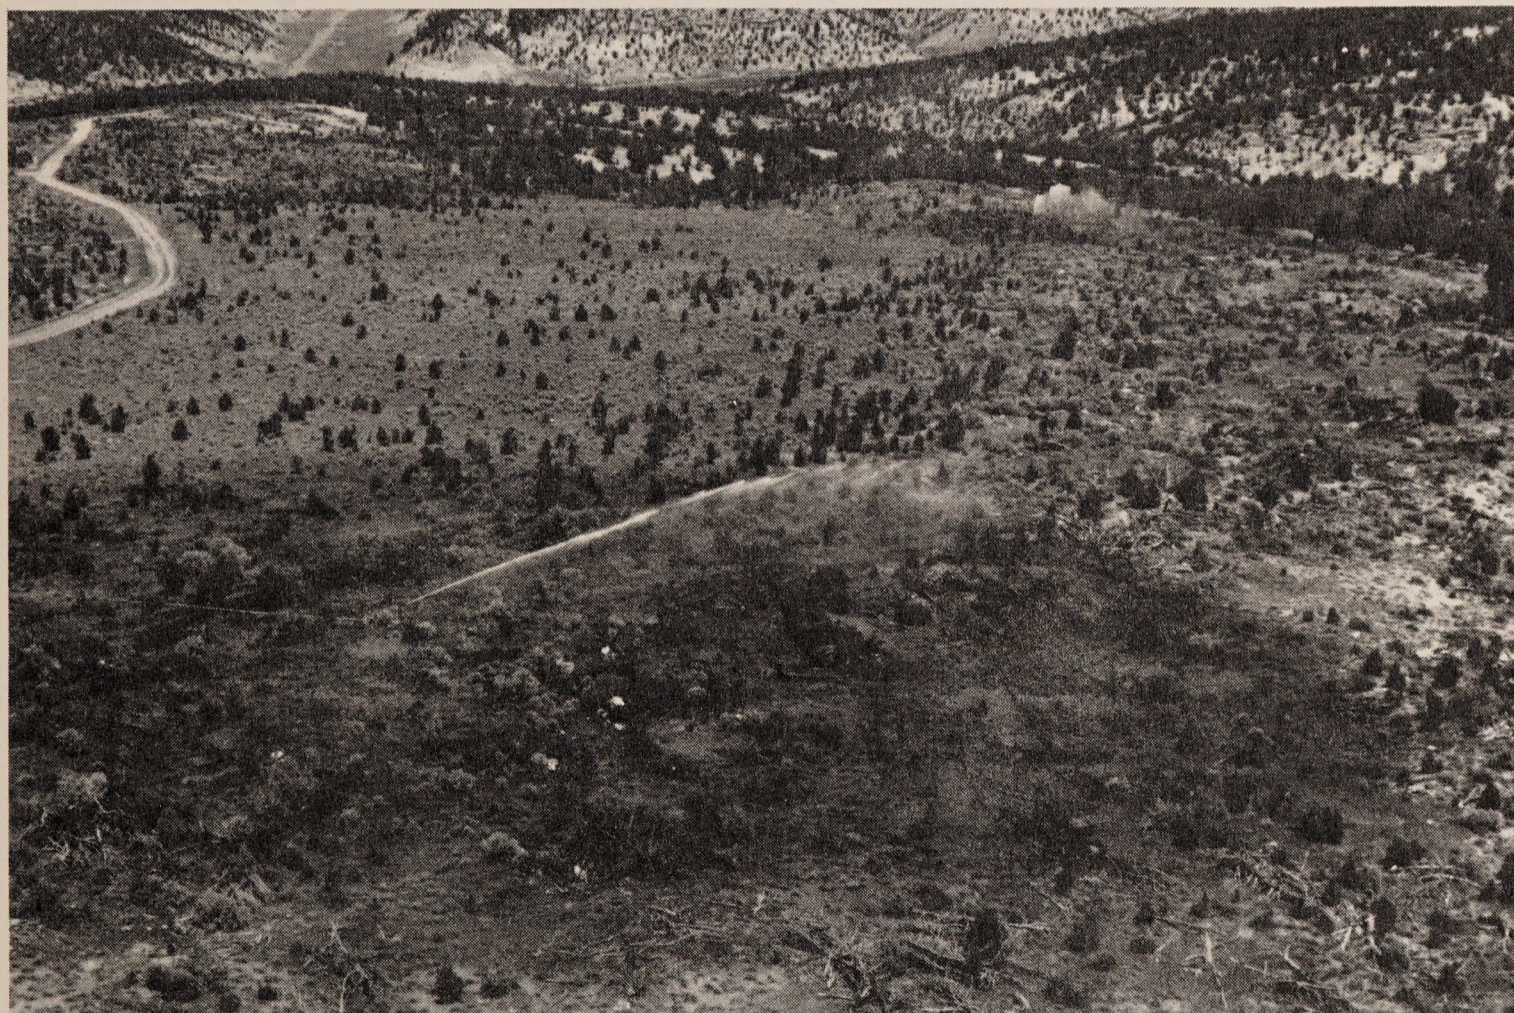
Figure 4-25. Aerial view of the land application system. (August 1981)

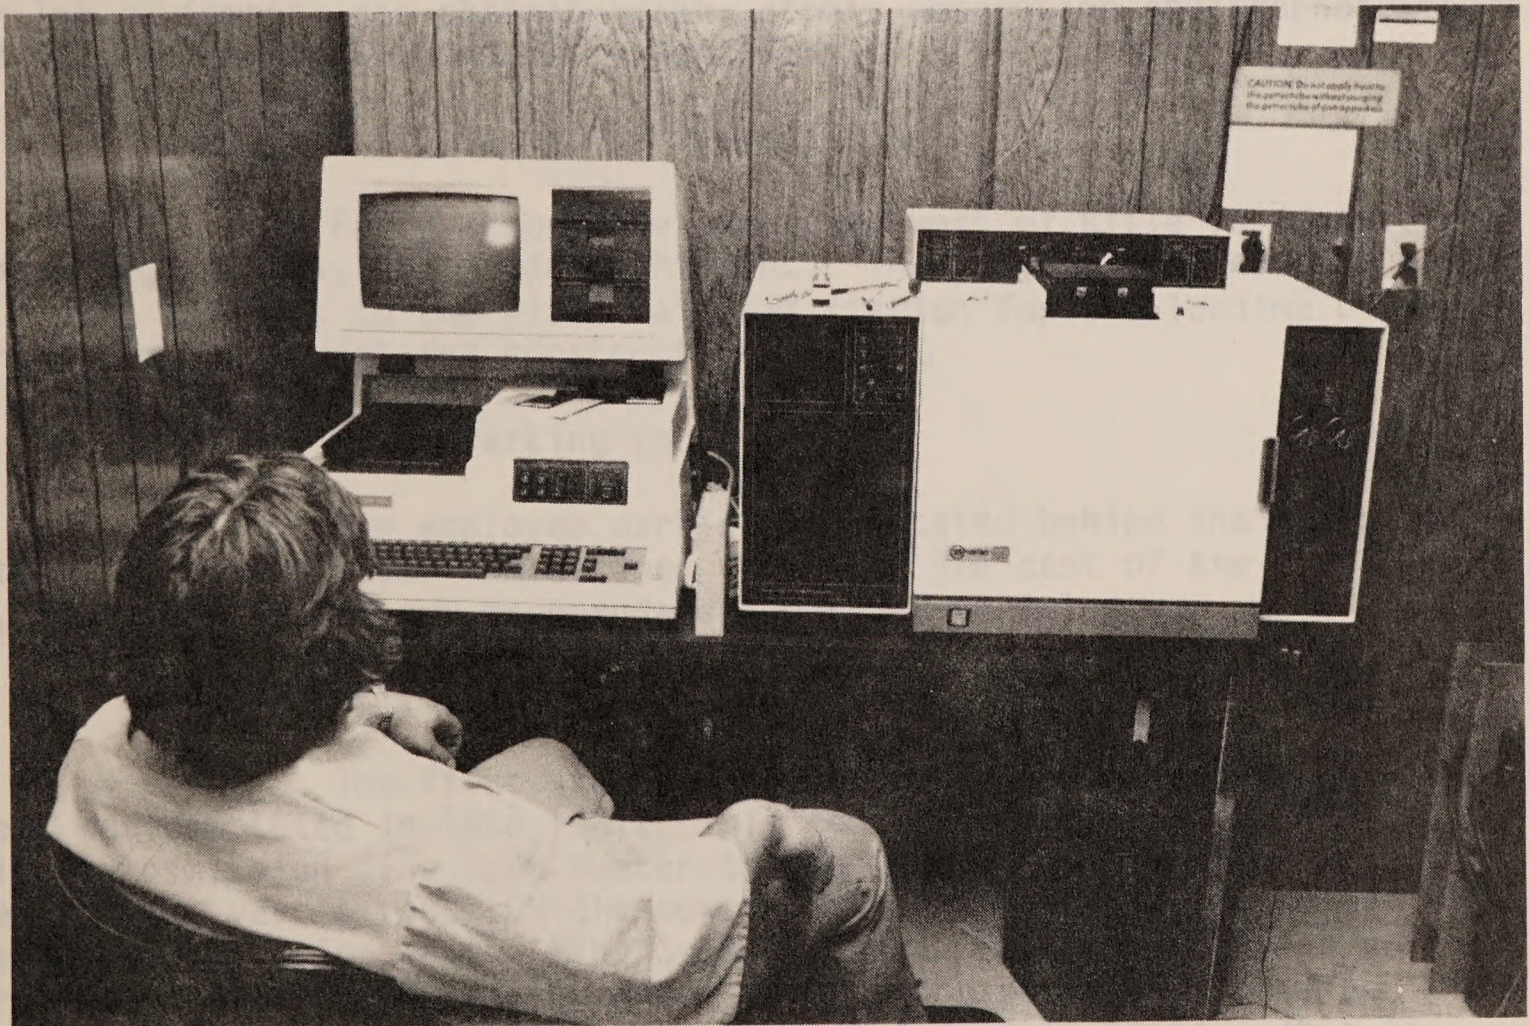
Figure 4-31. Gas chromatograph, processor and display - Grand Junction Laboratory.
