CONSOLIDATED MISSION REPORT

FIELD ORDER NUMBER 29  
MISSION NUMBER 12  
DATE OF MISSION  
13 DECEMBER 1944

HEADQUARTERS  
73RD BOMBARDMENT WING  
APO #237, % POSTMASTER  
SAN FRANCISCO, CALIFORNIA

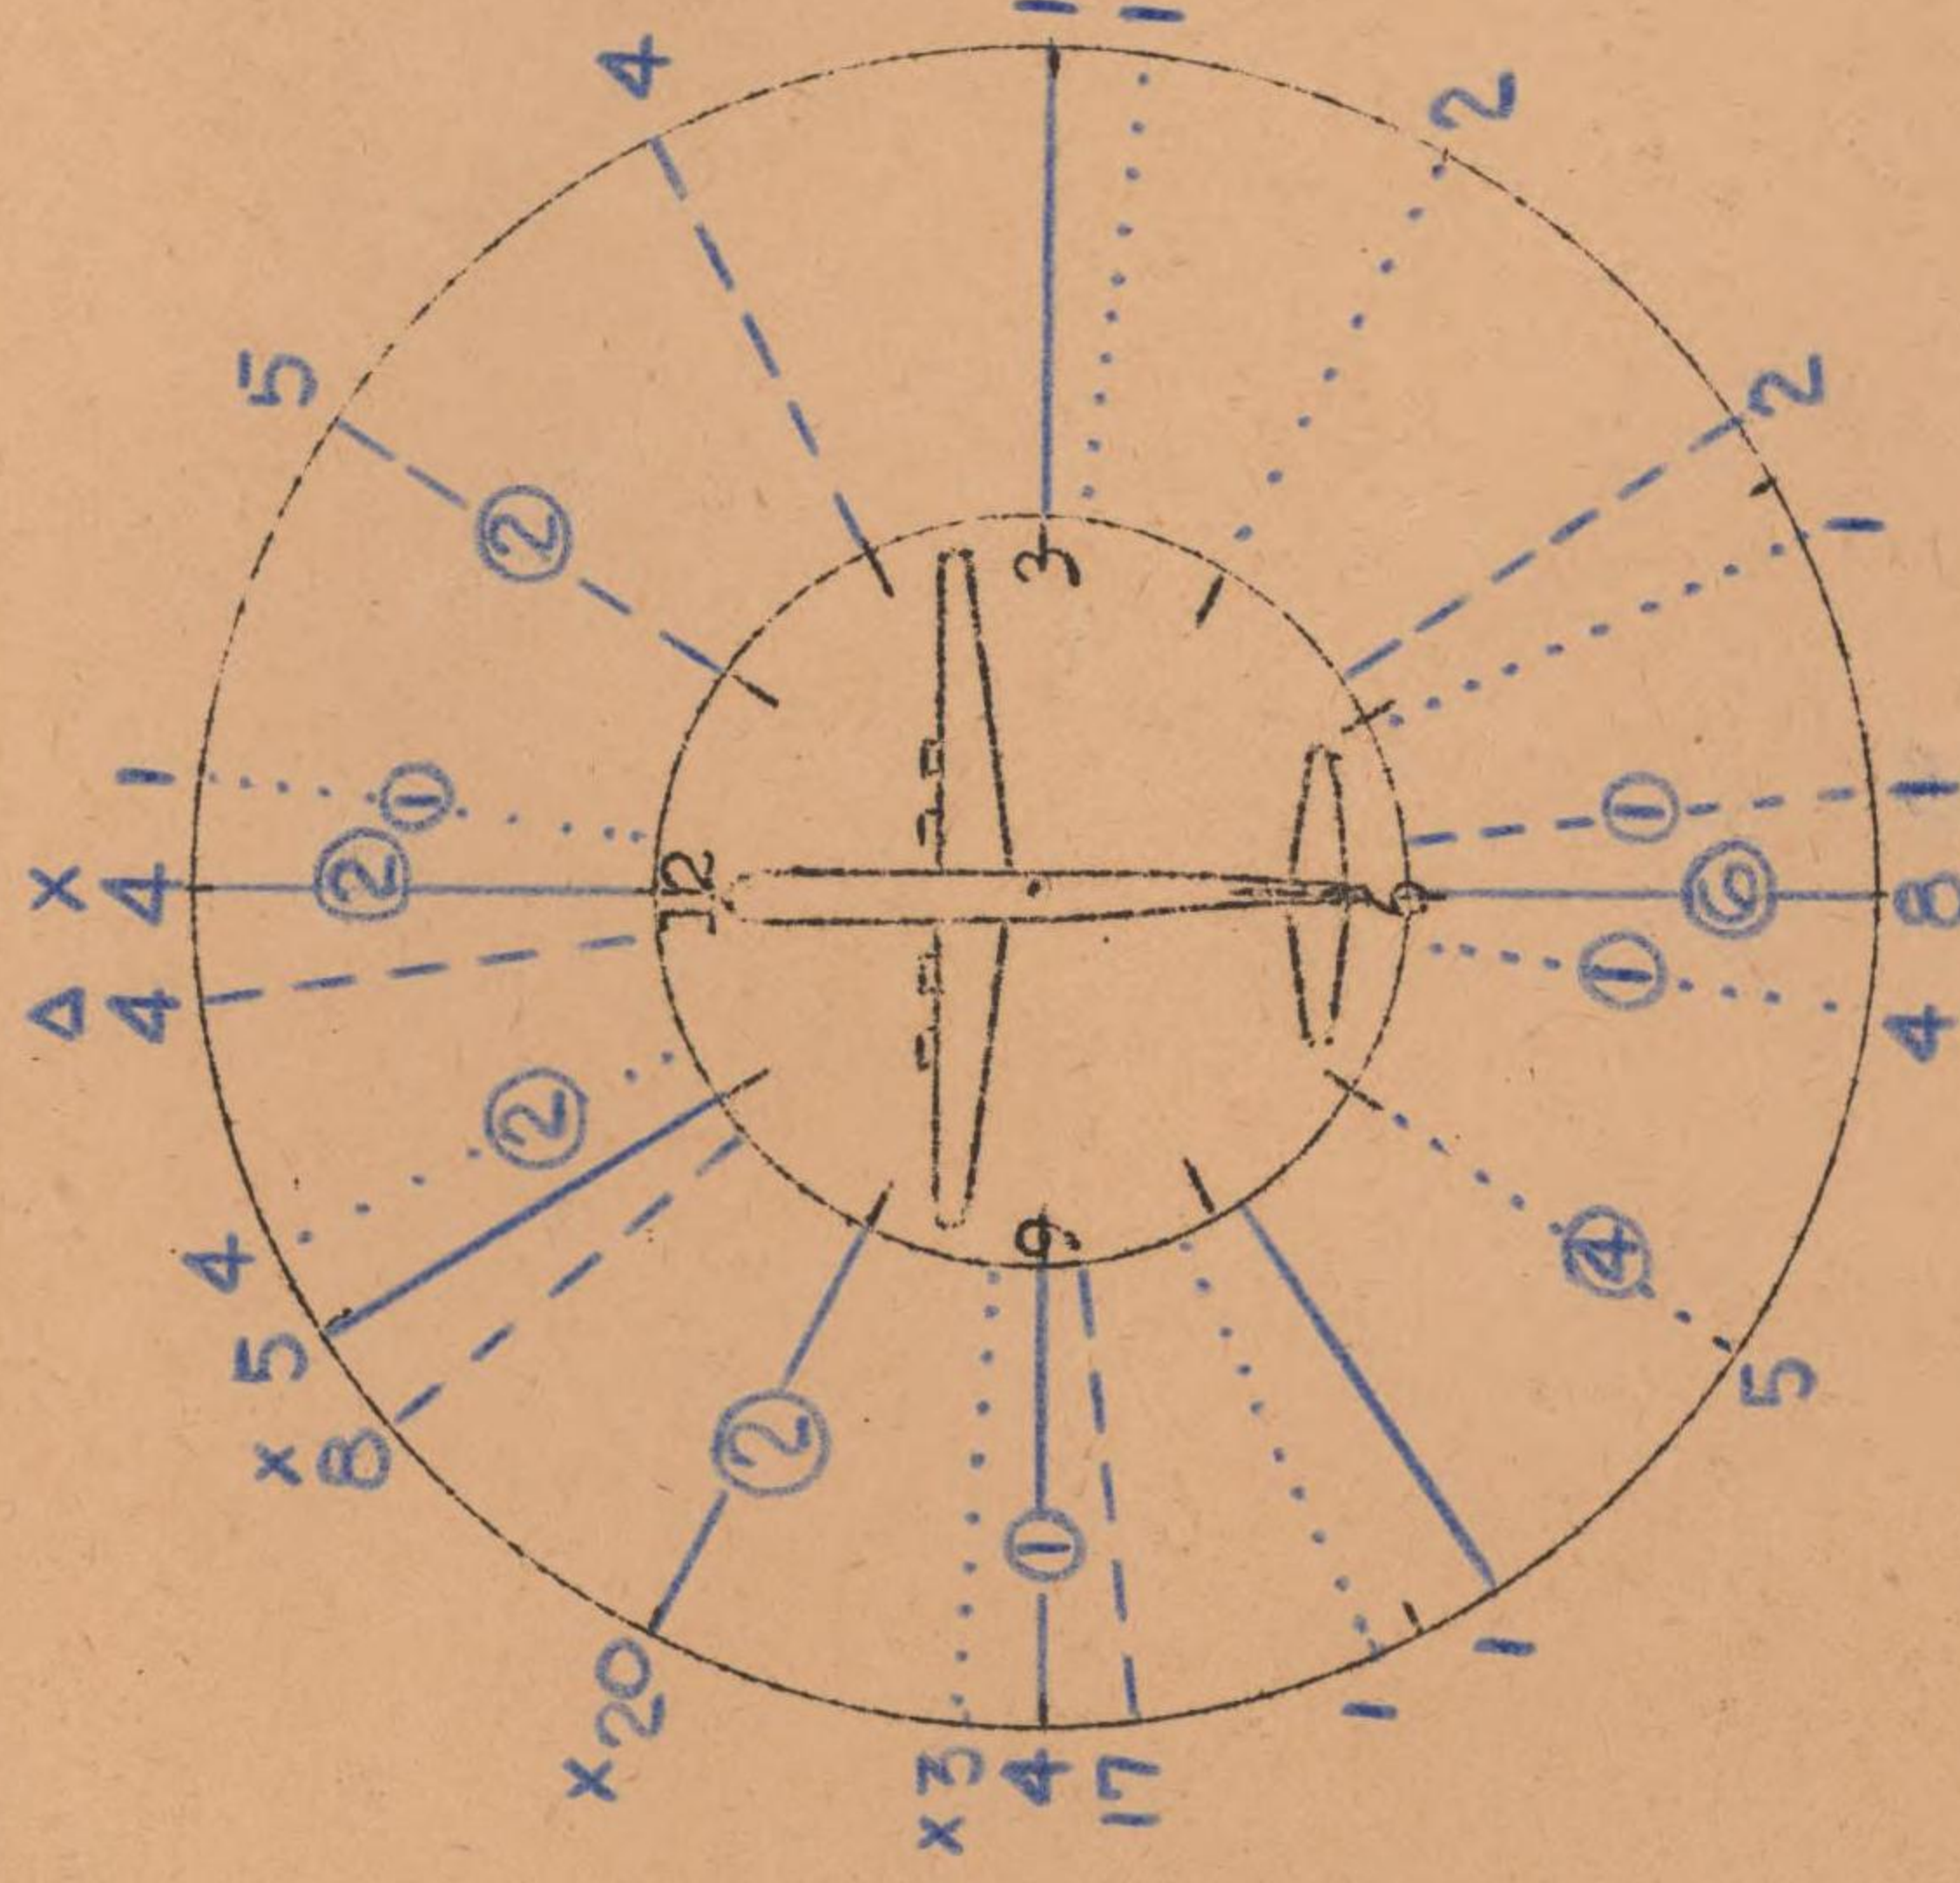
<u>TOTALS</u>	106
<u>ATTACKS</u>	
Level	43
From Above	41
High From	22
Below	
Low	
<u>E/A</u>	
Destr'd	4
E/A Prob	1
Dest'd	
E/A	0
Damaged	0

Note: The number of E/A attacking is shown at the outside end of each line. Attacks made by twin-engine enemy aircraft are indicated by "o" interruption in attack line, and when more than one T/E attack is made, the total is shown inside the "o".

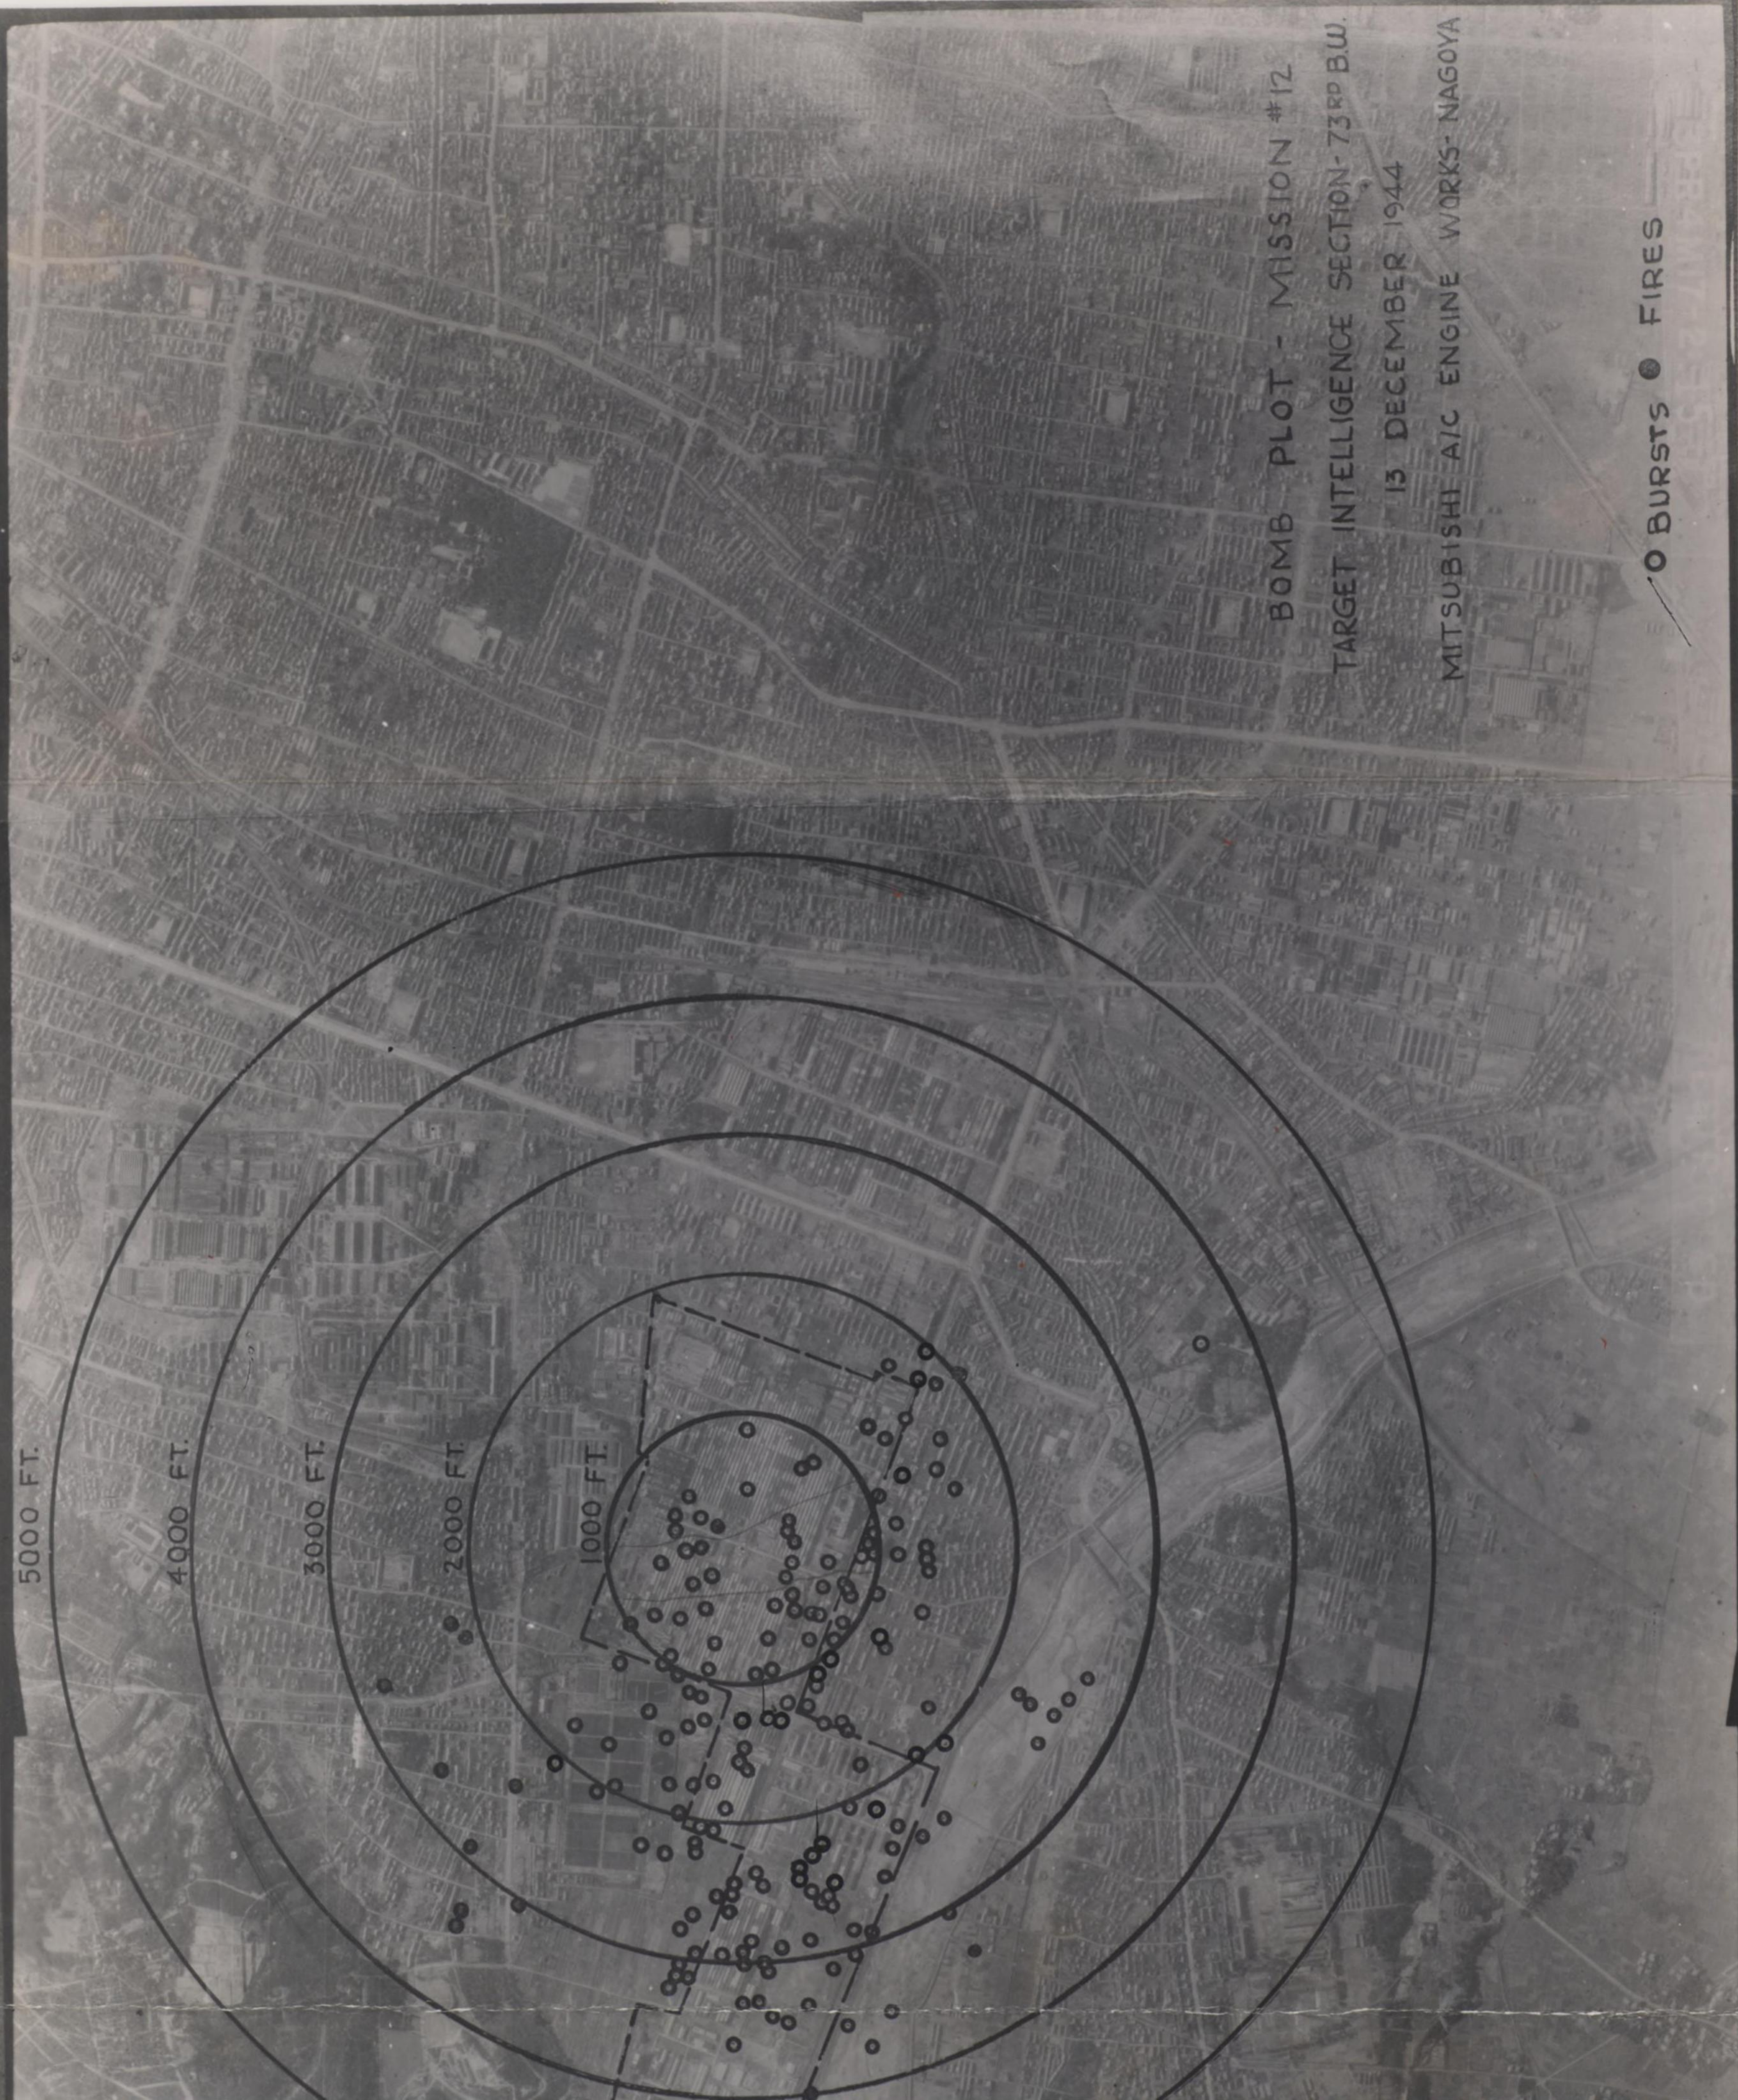
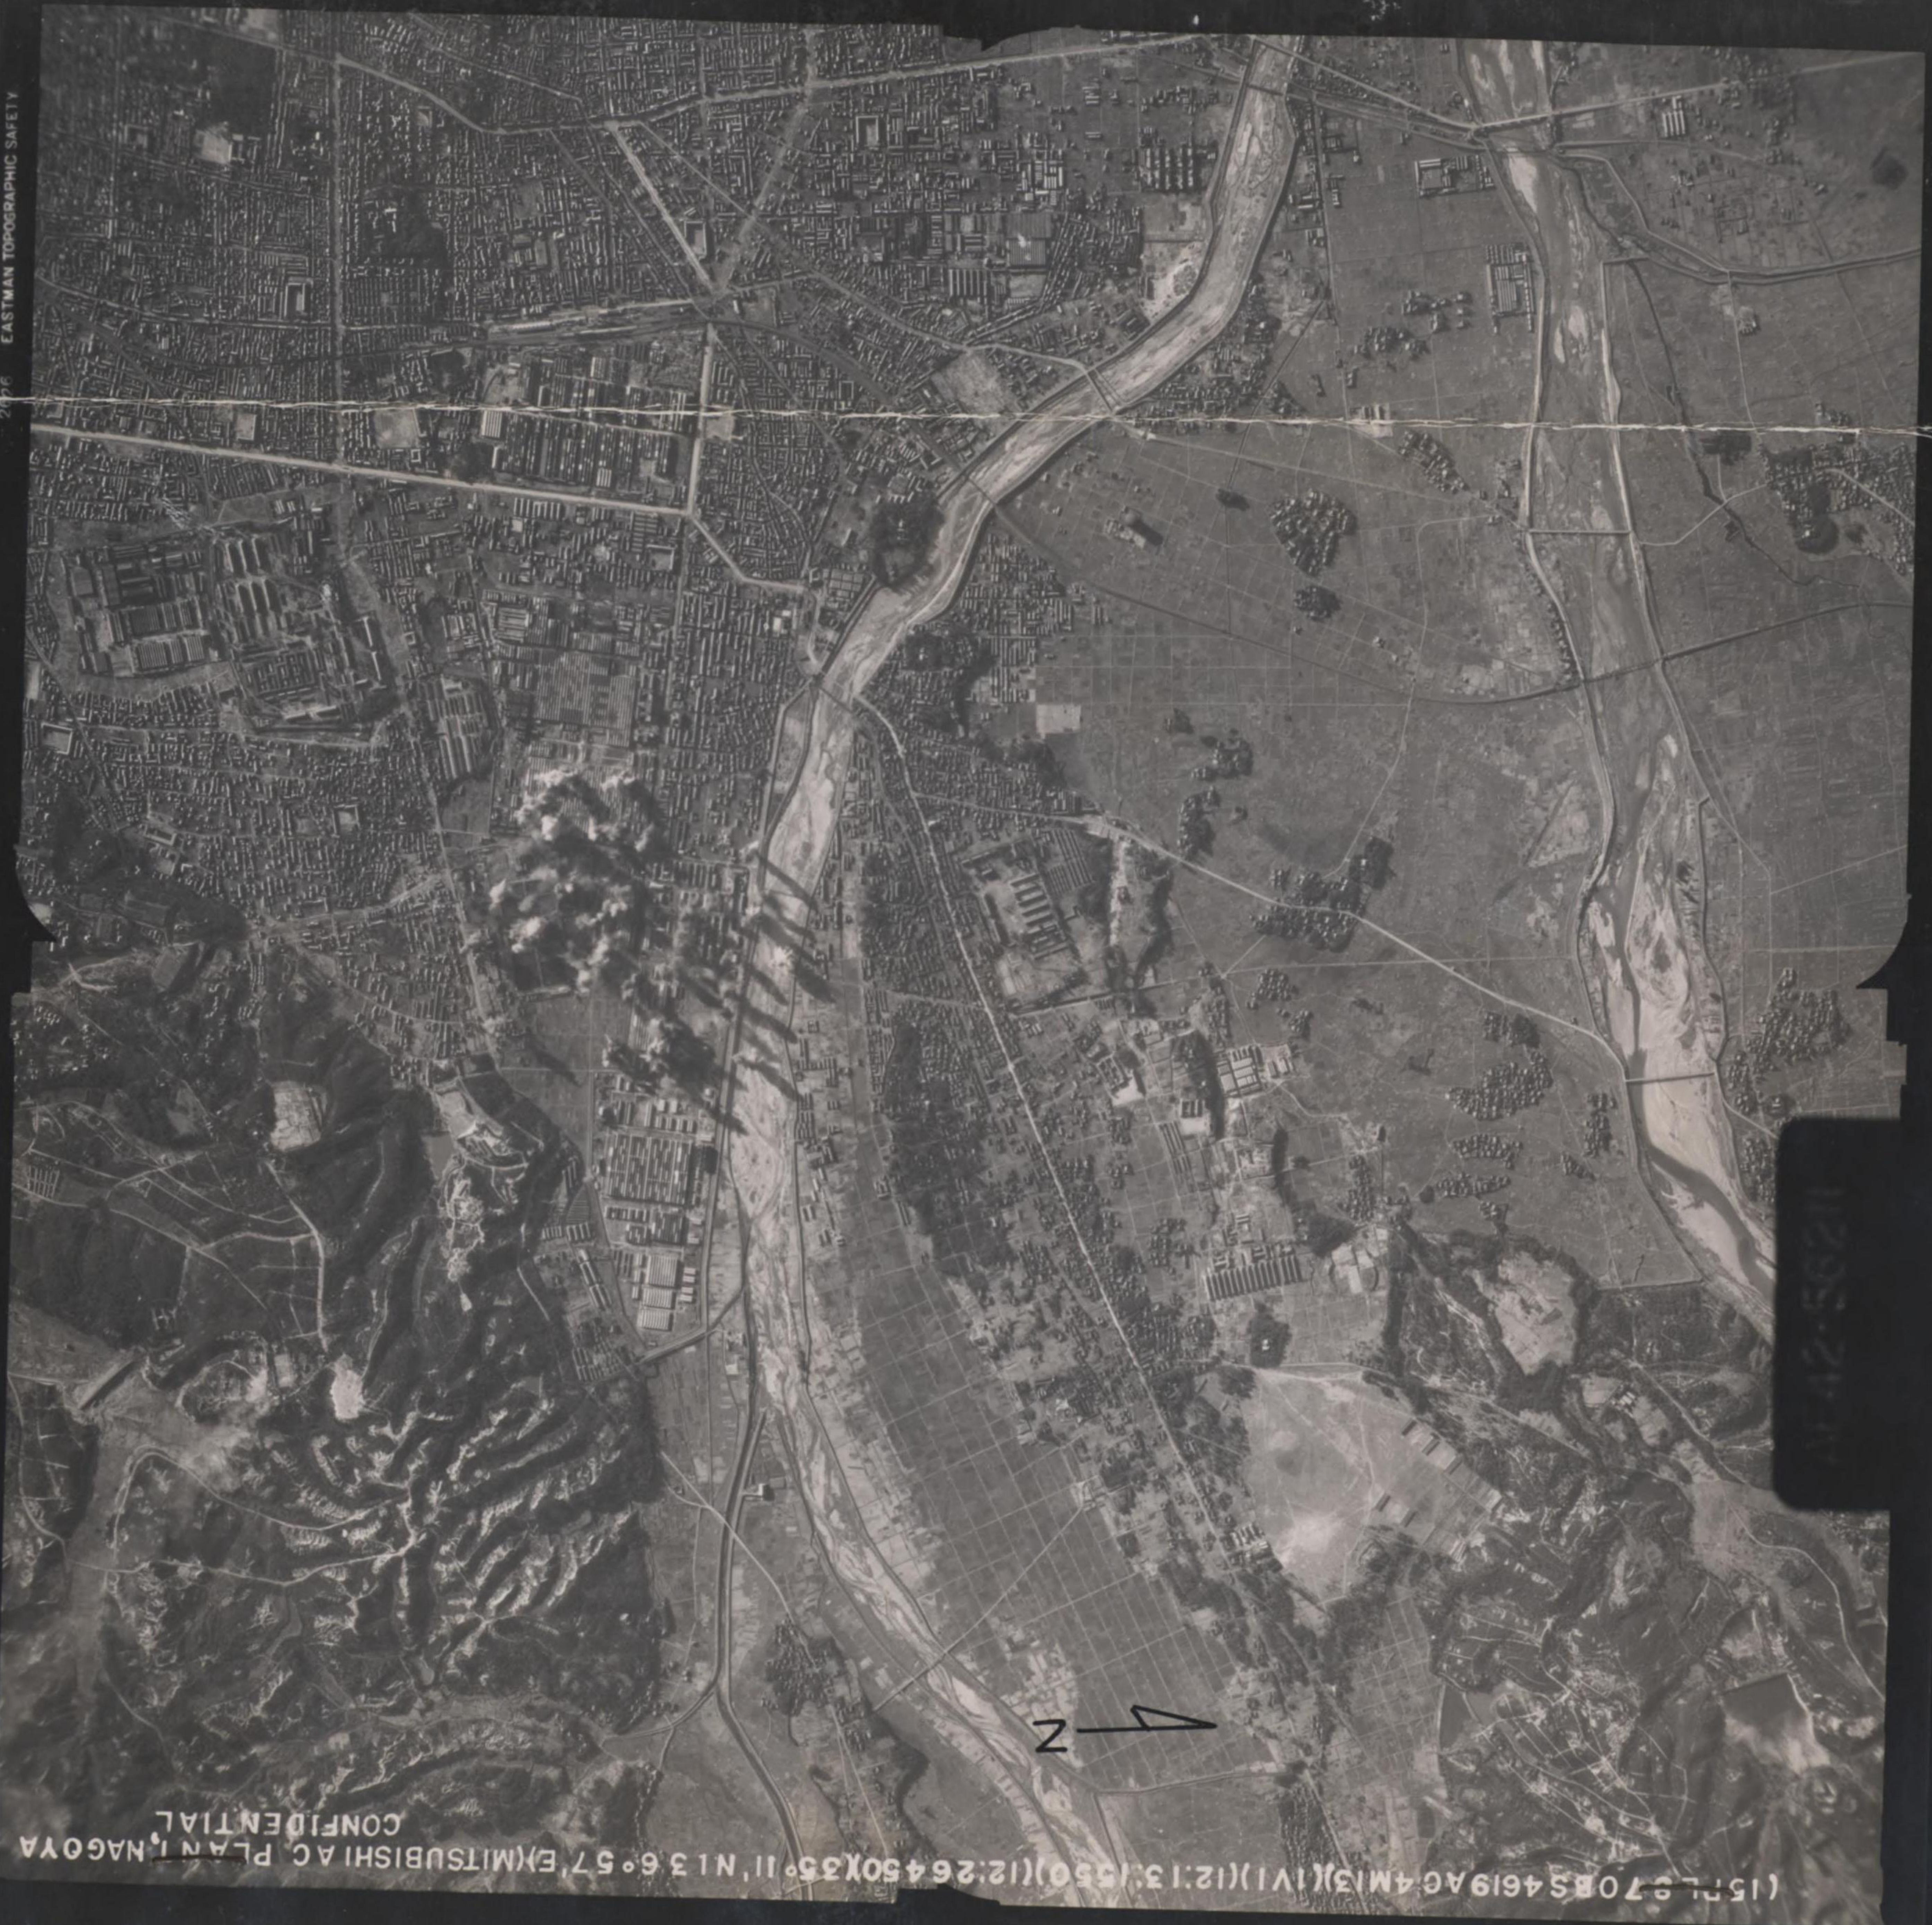
BOMB PLOT - MISSION #12  
TARGET INTELLIGENCE SECTION - 73<sup>RD</sup> BW.  
13 DECEMBER 1944  
MITSUBISHI A/C ENGINE WORKS - NAGOYA

Approximately 230 bomb bursts and 43 fires are visible on the photographs of these approximately 60 bursts can be seen in the target area, 58 having hit the buildings. 13 of these are along the narrow strip of small buildings located north of the two assembly buildings of the old plant. 9 bursts can be seen in the large assembly building at the western edge of the target. These caused large holes in the roof at the north eastern corner and one large hole in the south east corner of the building. There are 7 bursts showing on the small buildings and on the open ground between the two major assembly buildings. 14 bursts can be seen on the first assembly building at the eastern edge of the older area. The roof of this building has a gabled appearance in the north west and south east corners as well as in the center of the western side. In the newer section of the plant the large rectangular final assembly building adjacent to the old area has 7 bursts. The somewhat larger assembly building to the northeast has 6 bursts. 8 bursts are visible in the warehouse area of the new addition. 18 bursts can be seen in the open area of the warehouse.

44. Results of bombing observed: The results of bombing were fair as photographs show approximately 50% destruction of the plant.
45. Possible sources of error in Bombing: In one lead A/C, IV531, trouble was encountered in the last few seconds of the run. Because of the accurate AA fire, the A/C was put into evasive action which made sighting very difficult and the formation missed the target. The O-1 autopilot was not employed. Bombs were dropped through the formation led by A/C No. 24V531 a moment before bombs away, making it necessary to toggle immediately. This formation did an excellent job in spite of this fact. In lead A/C 24V531, the bombsight was found to process excessively on a check made after landing. Bombing was accomplished with a caged gyro but due to the fact that the A/C was on O-1 autopilot the results were good anyway. One Squadron out short of the I.P. which resulted in this Squadron arriving at the bomb release line with the previous Squadron below it.
