0-0  
FLOOD PLAIN MANAGEMENT STUDY

# CITY OF CHEWELAH

STEVENS COUNTY, WASHINGTON

SOIL CONSERVATION SERVICE  
U.S. DEPARTMENT OF AGRICULTURE

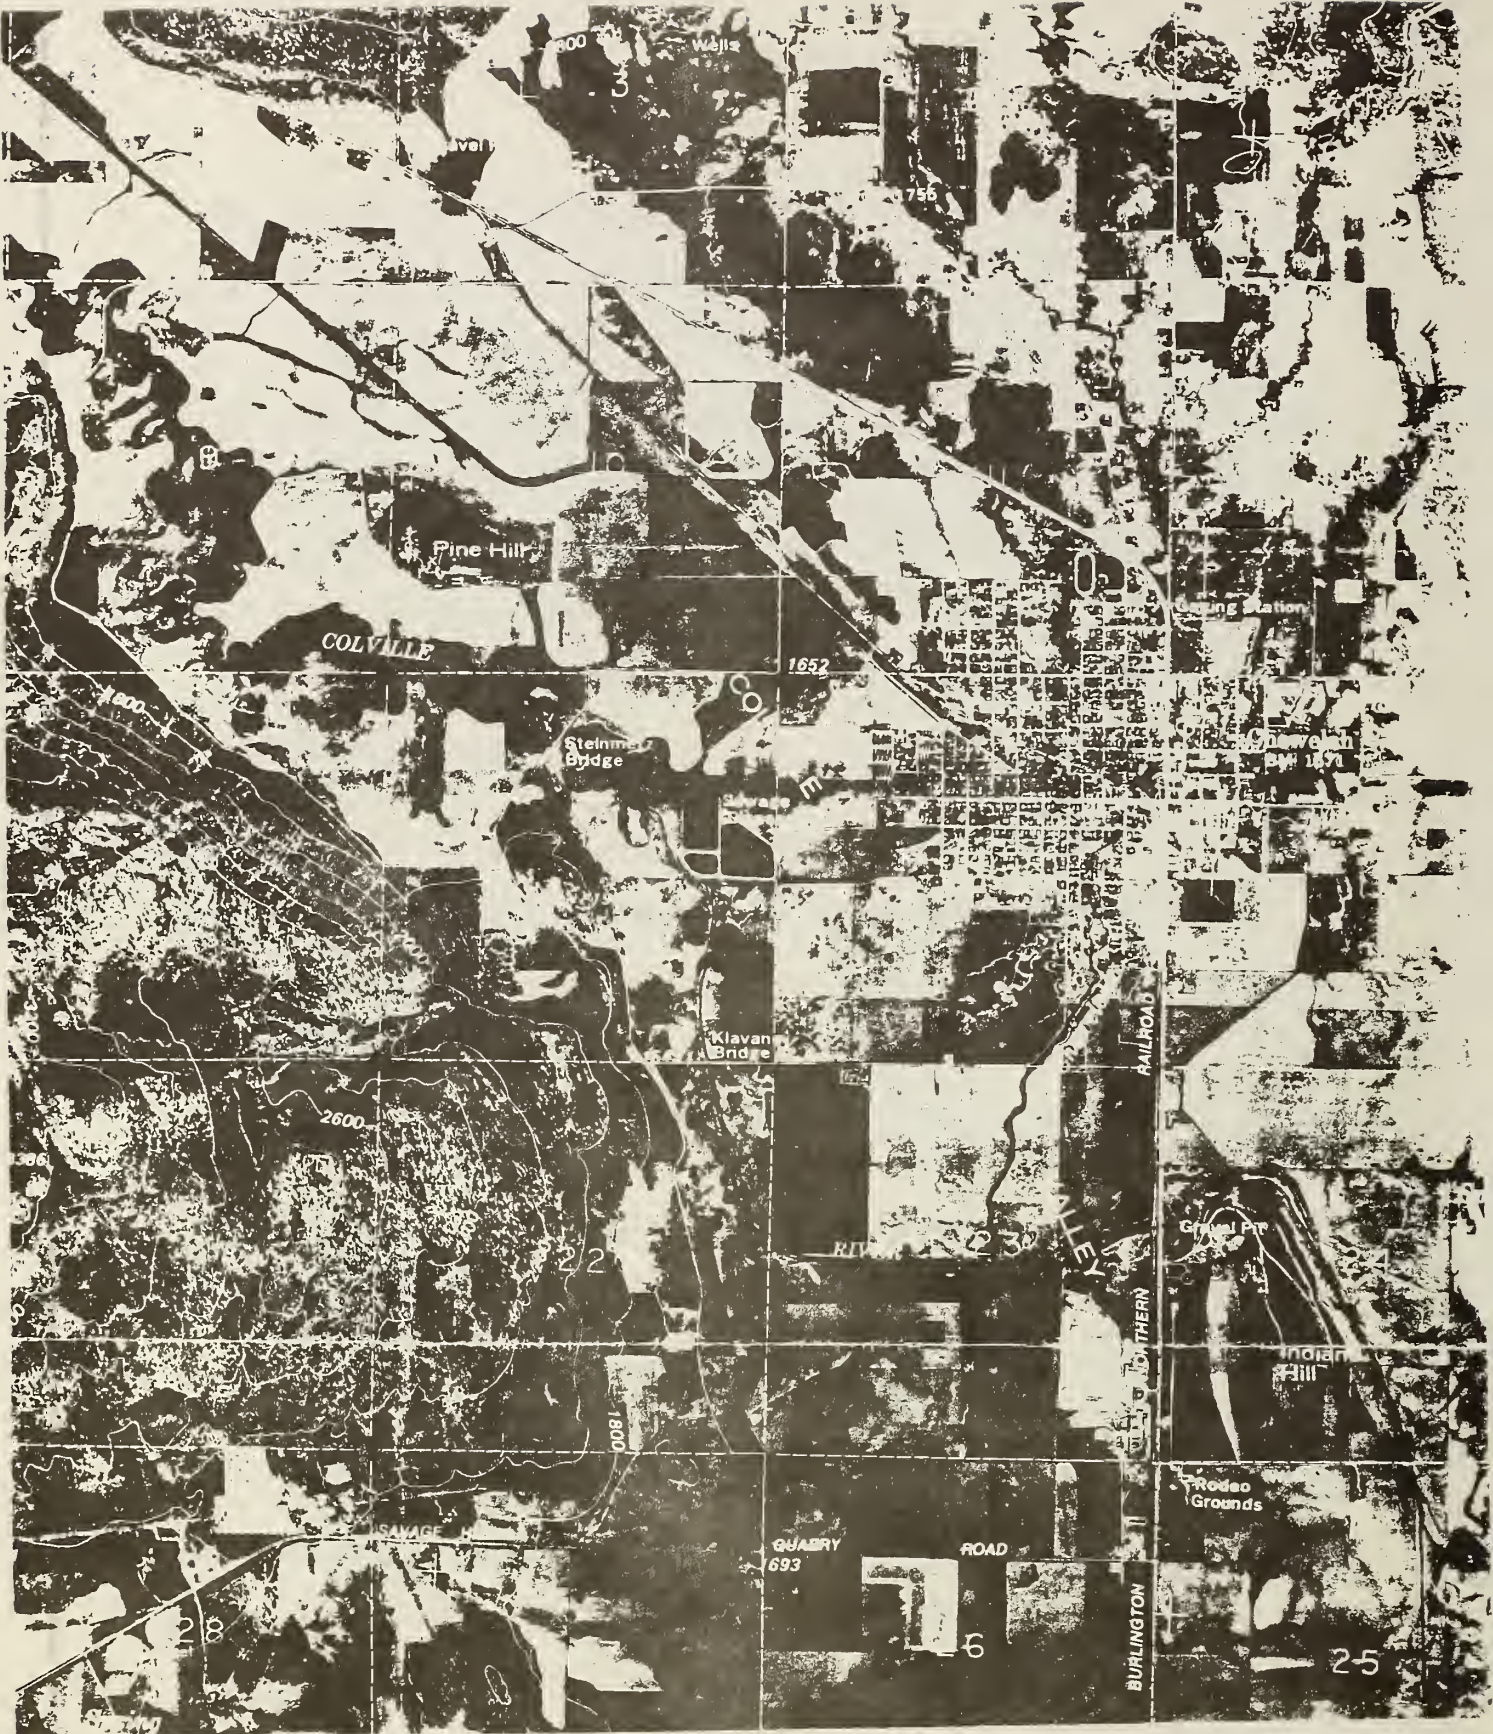
STUDY AREA MAP  
 FLOOD PLAIN MANAGEMENT STUDY  
 CITY OF CHEWELAH  
 STEVENS COUNTY, WASHINGTON

The study area includes the corporate boundary of the City of Chewelah. It is in the Stevens County Conservation District. The area studied, shown on the study area map on page 4, is in Hydrologic Unit 17020003. Chewelah Creek, Paye Creek and Thomason Creek are tributaries to the Colville River. Approximately 5.2 miles of stream were studied in detail to determine flood potential.

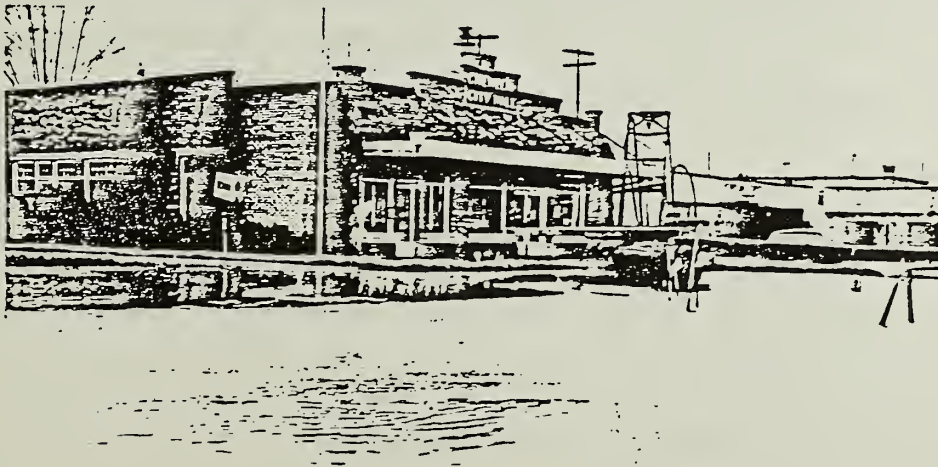
Photo showing flooding near city hall at the corner of Highway 395 and Webster Avenue.

"The January 24, 1974, edition of the paper indicates that early in the week heavy snows, followed by chinook winds caused flooding. The Wrights Valley road washed out and the water came up over 395 at City Hall and traveled down the adjacent streets. By January 23, the city park was entirely underwater and water was over the bridges on East Lincoln, Webster and 395. There was flooding at the intersections of Main Avenue and Second Street and at King and Second. Some flooding in basements was reported." <sup>/1.</sup>
