# A case study on pile relaxation in dilative silts

A CASE STUDY ON PILE RELAXATION IN DILATIVE SILTS

A THESIS SUBMITTED IN PARTIAL FULFILLMENT OF THE  
REQUIREMENTS FOR THE DEGREE OF

OCEAN ENGINEERING

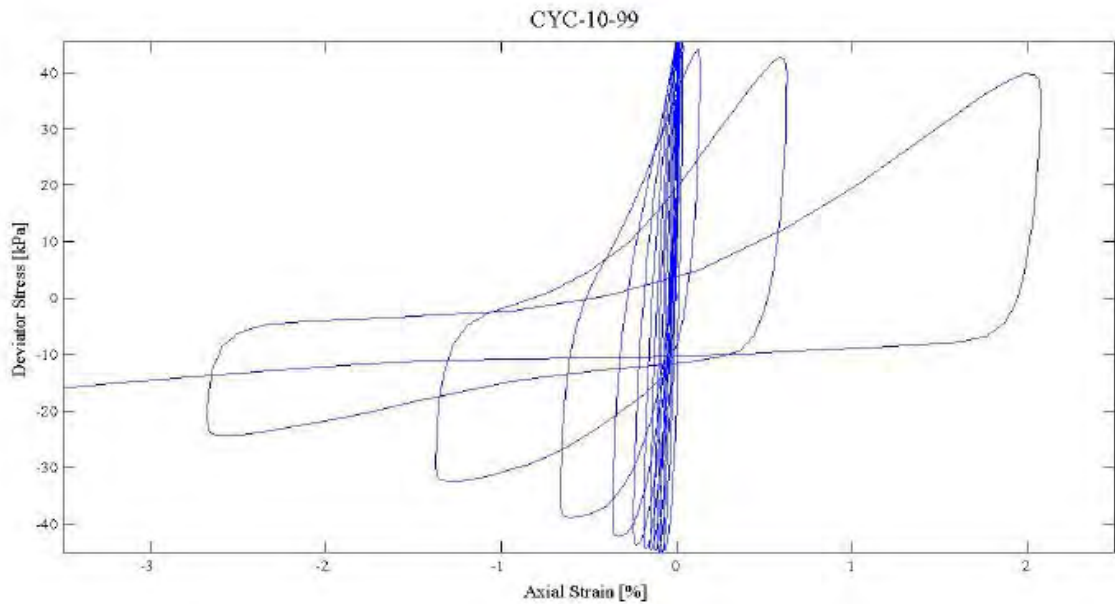
**Figure 2-7 Deviator stress (kPa) with axial strain (%) hysteresis loop from a stress controlled cyclic triaxial test for a Rhode Island silt, Taylor (2011).**

The behavior displayed by the Rhode Island silt in regards to the hysteresis loop indicates a decrease in stiffness and therefore an increase of energy dissipated into the system. The results shown in Figure 2.7 indicate an accumulation of excess pore water pressures and an increase in strain as the number of cycles increase.

It can be derived from Figures 2.7 and 2.8 that as the material is cyclically loaded under undrained conditions in the field, there exists the potential for liquefaction due to the decreased stiffness and increased excess pore water pressures. Though it can be assumed the soil liquefies during pile driving, it is unclear whether or not the soil retains the same friction angle after it transitions from the liquefied state.

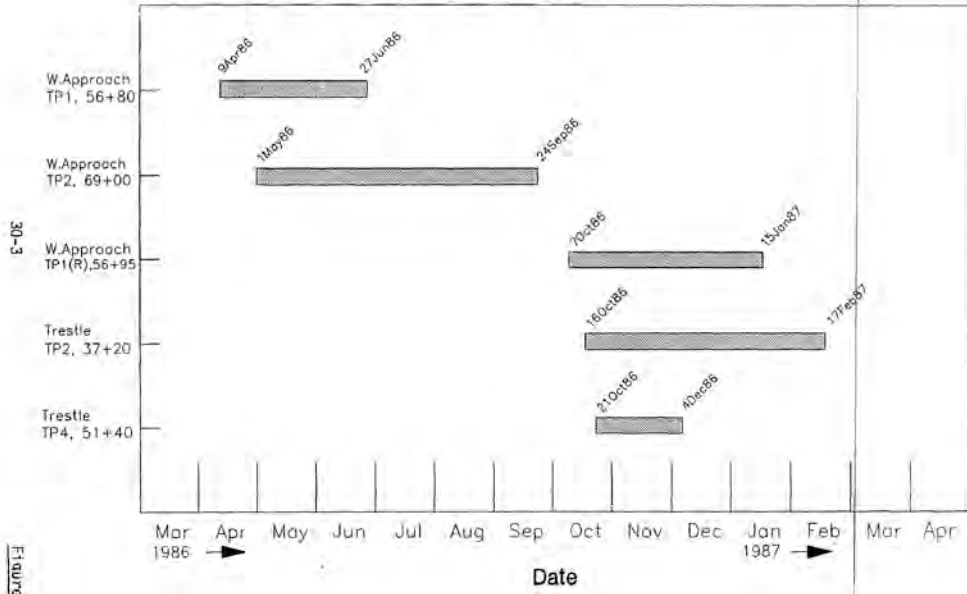
Figure 2

Progress - Test Pile Program  
Jamestown Bridge
