CONSOLIDATED MISSION REPORT

FIELD ORDER NUMBER 21)
MISSION NUMBER 10
DATE OF MISSION
3 DECEMBER 1944

HEADQUARTERS
73RD BOMBARDMENT WING
APO #237, % POSTMASTER
SAN FRANCISCO, CALIFORNIA

Field Order Number 21 of the 73rd Bombardment Wing directed that four Combat Groups form a Task Force to bomb as its primary target the Musashino A/C Engine Factory (Target No. 90.17-357), west of Tokyo, or, as its secondary and last resort target, the dock and industrial area of Tokyo proper.

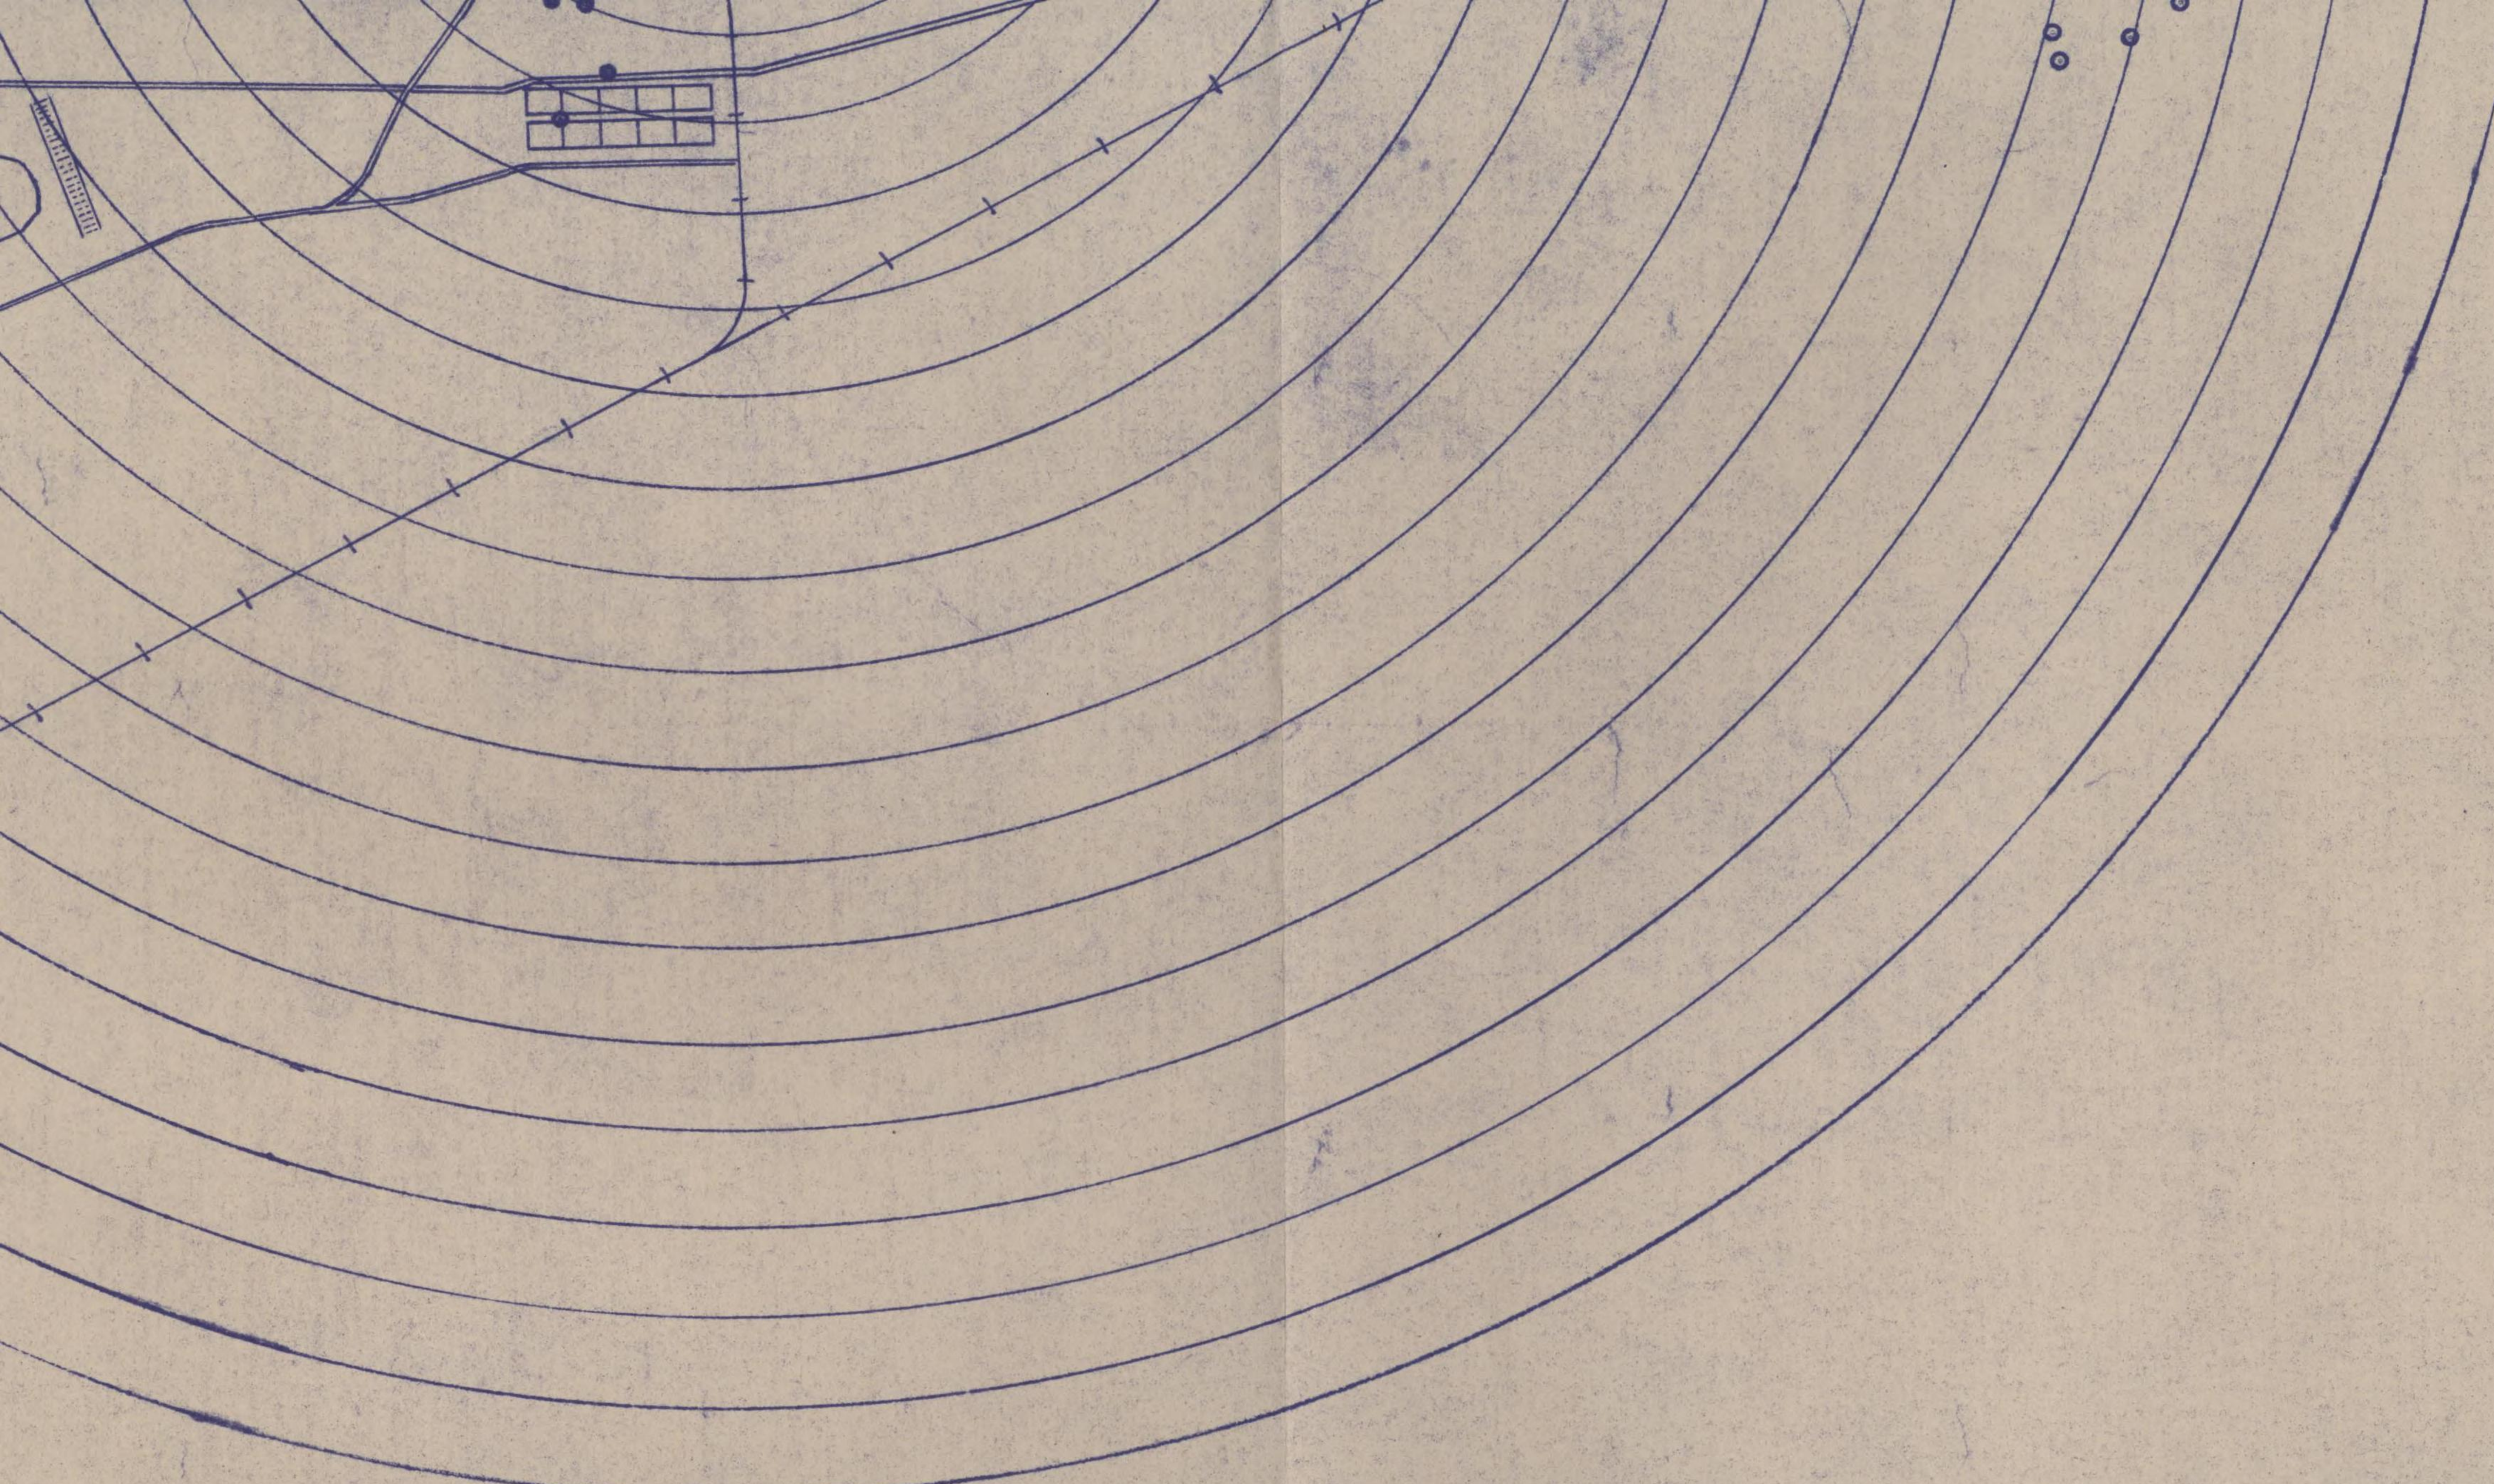
BOMB PLOT - MISSION # 10
TARGET INTELLIGENCE SECTION
73RD B.W. - 4 DEC. 1944
MUSASHINO A/C PLANT - TOKYO

Approximately 235 bomb bursts can be seen on the photographs. In the target area 12 bursts are visible, 6 of which are seen on the buildings. 1 burst is observed on the NE corner of the new rectangular building in the old plant area. On the SW corner of the cylinder works near the center of the target area, 1 burst can be seen. 600 feet to the SE, 1 burst can be seen on the new assembly building. 1 burst is observed on the administration building of the new plant. 1 direct hit and a near miss set fire to the building at the SE edge of the plant. This building was apparently destroyed by fire. 5 bursts can be seen in the area immediately to the west of the plant.

Outside the target area, approximately 54 bursts are observed 3000 feet N and slightly W of the AP. 15,000 feet W of the AP, 29 bursts can be seen with direct hits on the road and railroad. 18,000 feet N of the AP 17 craters are visible. These could possibly have been caused by Mission #7. Between the two railroads NE of the AP, 46 bursts and 4 fires are visible. 35 bursts can be seen 4400 feet N of target 356 and 12 bursts can be seen in the small village to the south. 18 bursts can be seen immediately to the S of the target.

The holes in the sawtooth roof of the large building at the N end of the new area have been partially repaired. Two holes in the large sawtooth building at the N end of the old area have been partially repaired also. No attempt has been made to repair the outer buildings of the plant or the barracks-warehouse area to the North.

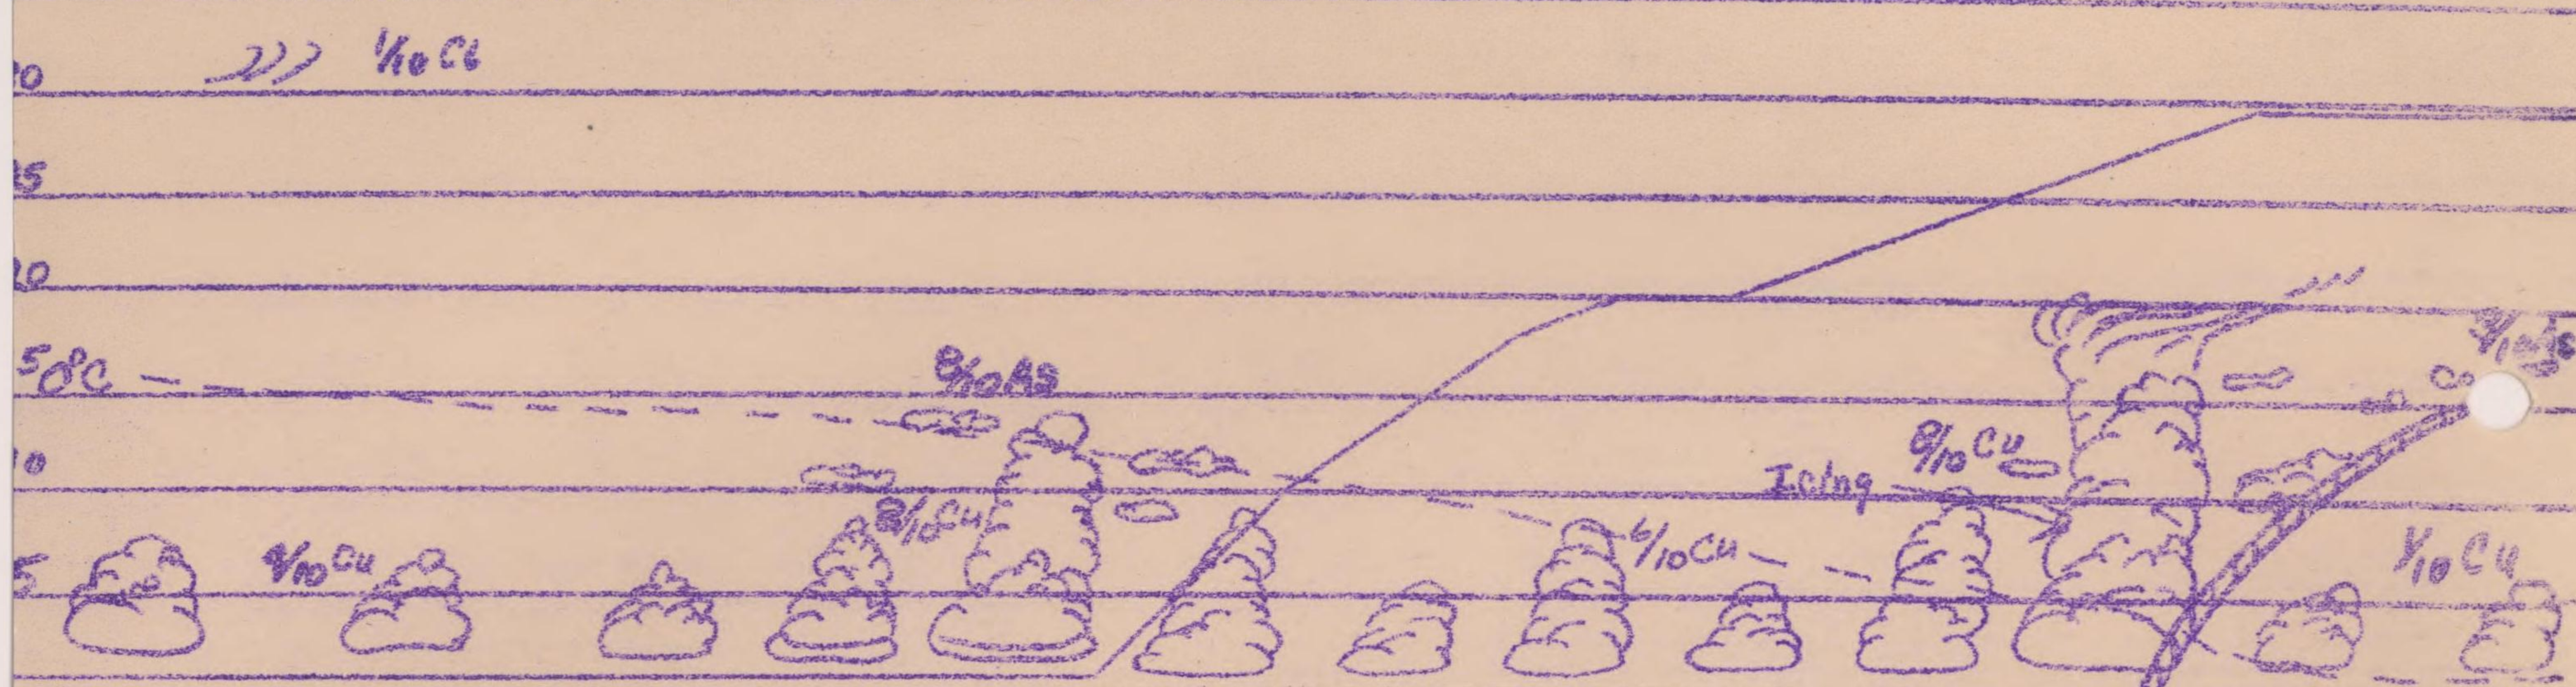
Pilots and Navigators Forecast 07-215Z Dec 44
Outgoing

Time	20°N	25°N	30°N	Target
Base				29.97
Wt Stg	29.85			
Dirb	Nil	Mod in Clds	Light in Clds	Mod in clds Nil
Vis	15 Miles	15 Miles	15 miles	12 miles
5				270° 160K -53
10	220° 30K	-32°C 260° 45K	-34° 270° 105K	-35° 270° 145K -41
15	180° 25	-24°C 260° 35	-23° 260° 85	-25° 270° 125K -30
20	80° 15	-10°C 240° 25	-12° 255° 70	-13° 270° 110K -19
25	80° 15	0° 220° 20	2° 250° 50	-4° 260° 90K -11
30	80° 15	9° 180° 10	8° 240° 30	0° 250° 70K -4
35	80° 20	15° 110° 10K	16° 310° 25	12°
01	90° 18	24° 120° 10	22° 330° 20	20°
Surf	90° 18	28° 120° 10	26° 340° 14	24°

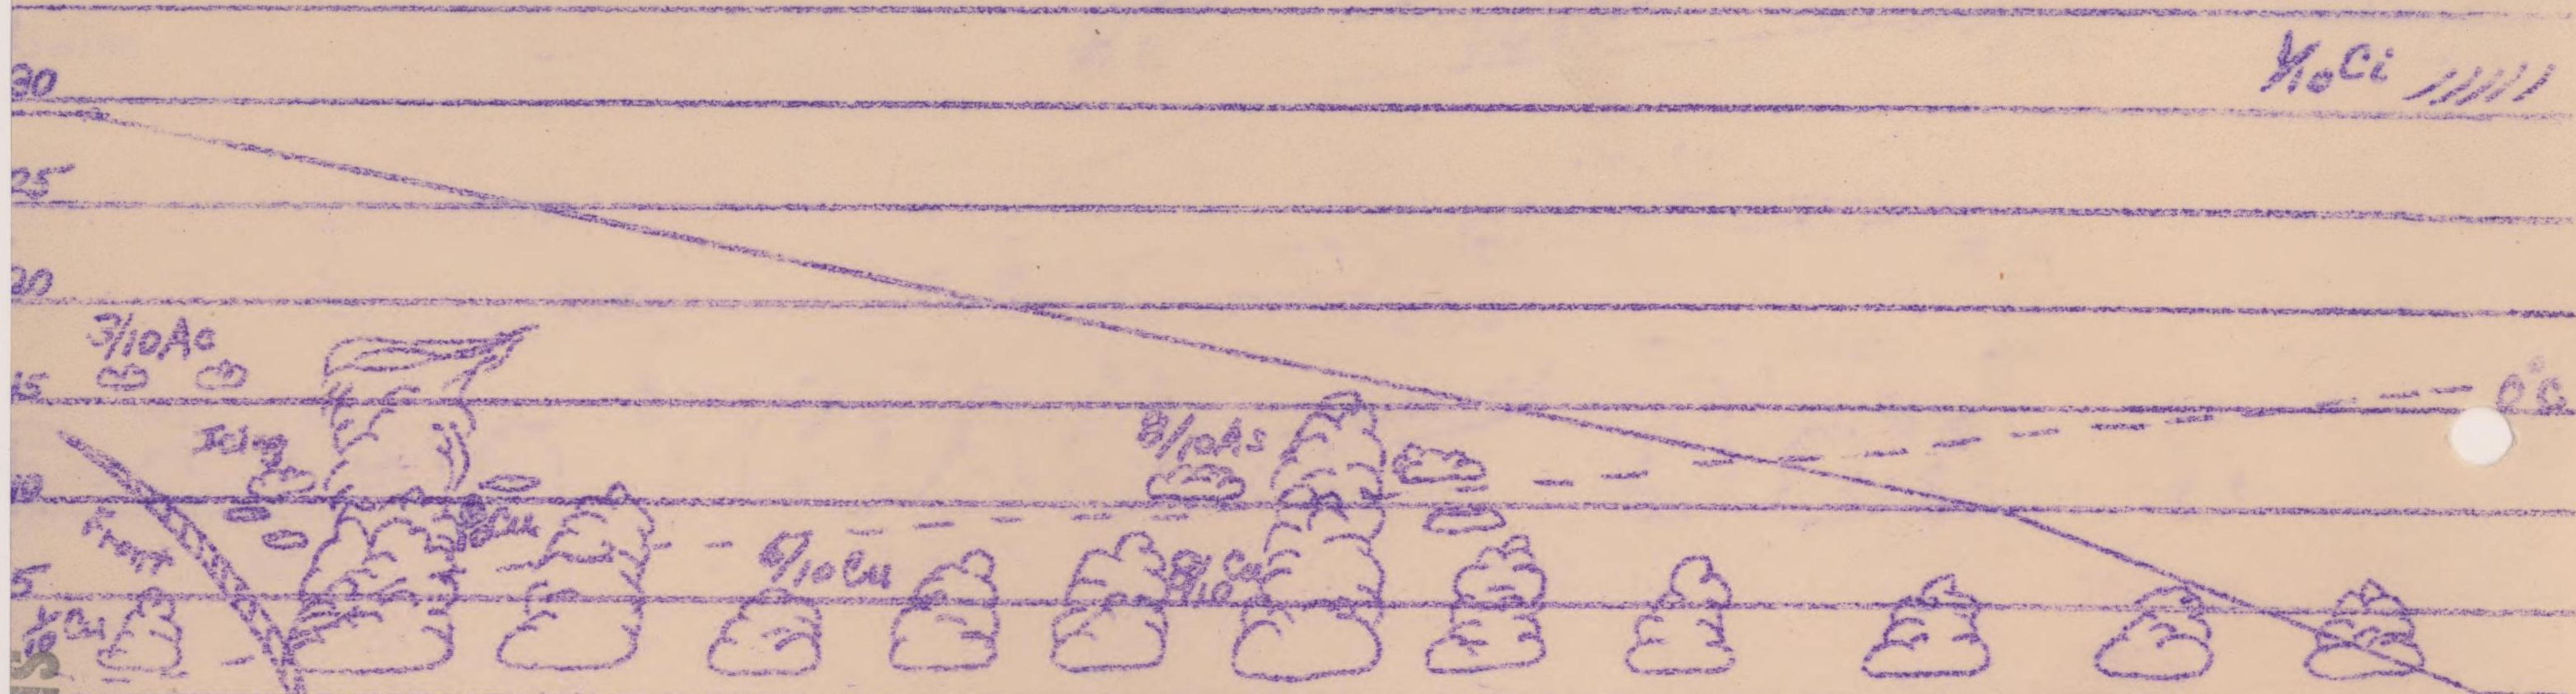
Pilots and Navigators Forecast 07-223, 2 Dec 44
Returning

Target	36N	25N	20N	BASE
29.97				29.88
Turb Nil	Mod in Cld	Lgt in Cld	Mod in Cloud	NIL
Vis 15 mi	12 mi	15 mi	15 mi	15 mi
35 270 170K -53°	270 160K -53°	270 140K -49°		
30 270 165 -44	270 145 -41	270 135 -36	270 85K -35°	260 45K -34°
25 270 155 -34	270 125 -30	270 100 -26	260 75 -25	260 35 -23
20 270 140 -23	270 110 -19	260 80 -14	250 60 -13	240 35 -12
15 270 110 -16	260 90 -11	250 60 -6	250 45 -4	220 20 2
10 270 85 -11	250 70 -4	240 30 -2	240 30 9	130 10 8
05		300 25 10	310 20 13	110 10 16
04		330 17 20	330 15 21	120 10 23
03		340 14 23	340 12 24	120 10 26
