MISSION #20

BANGKOK

Tactical Mission Report

TARGET: RAMA VI RAILROAD BRIDGE
Bangkok, Thailand

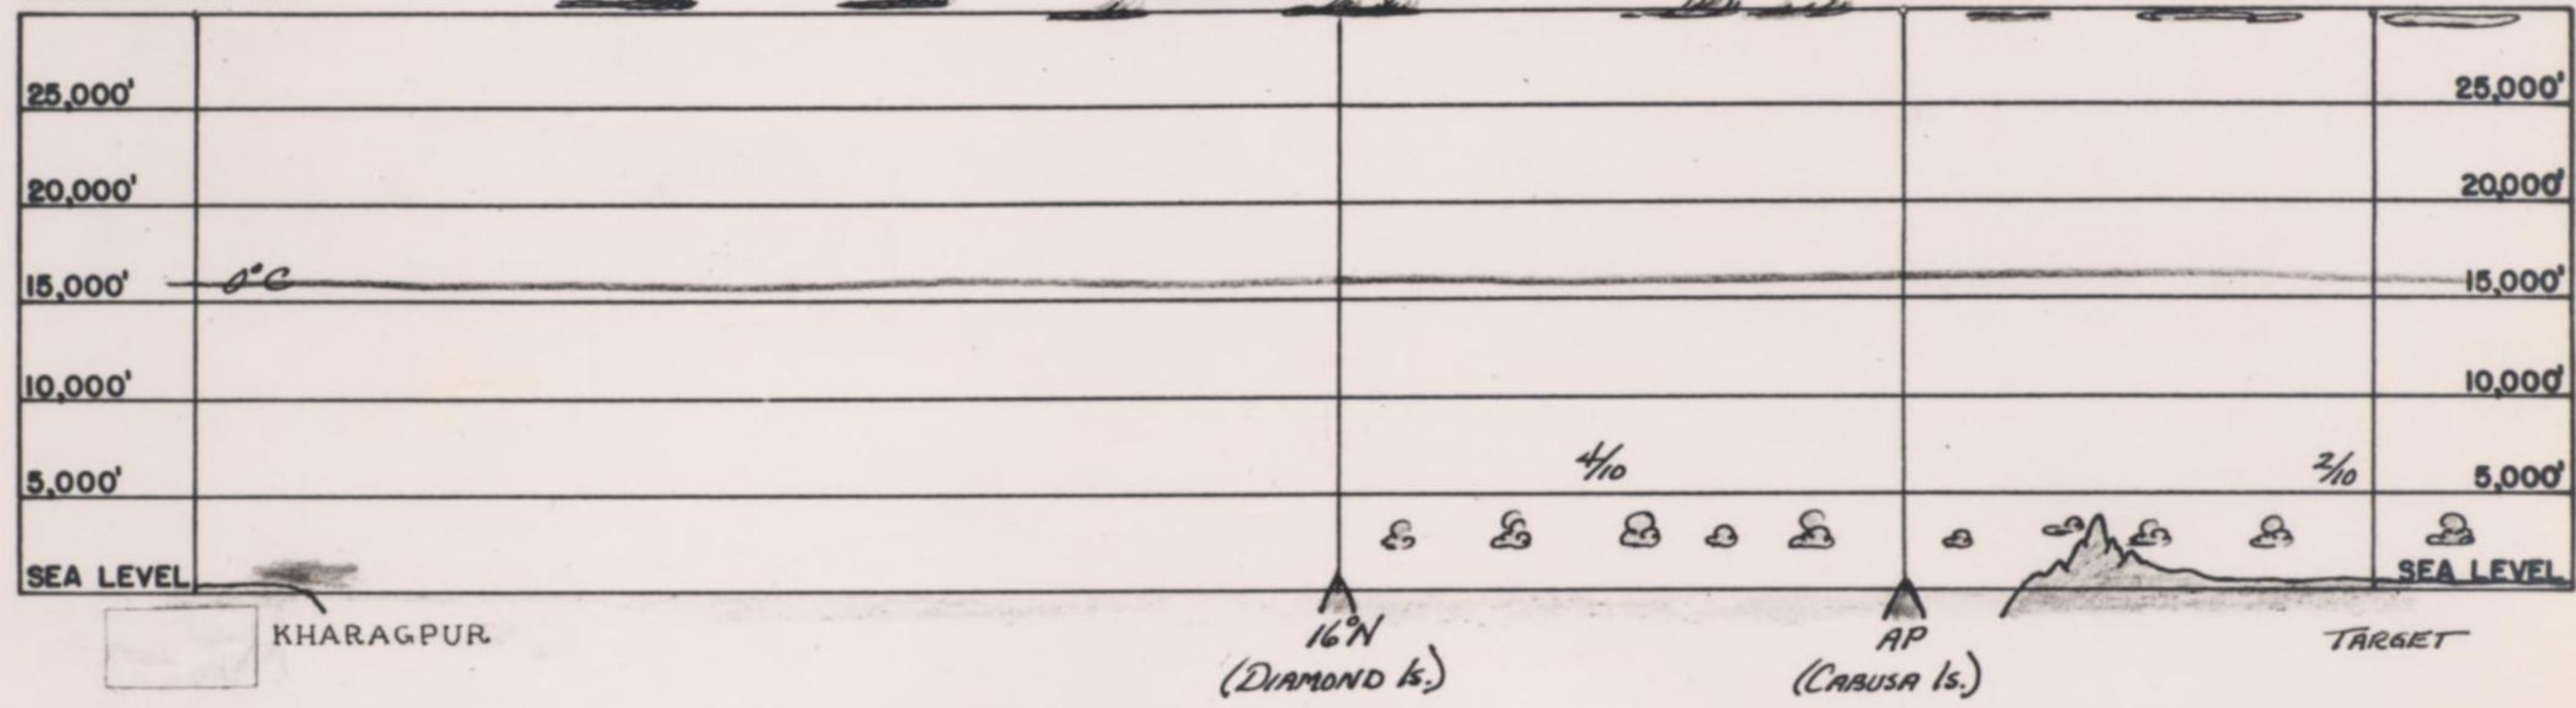
MISSION NO. 20

XX BOMBER COMMAND
WEATHER AS FORECAST

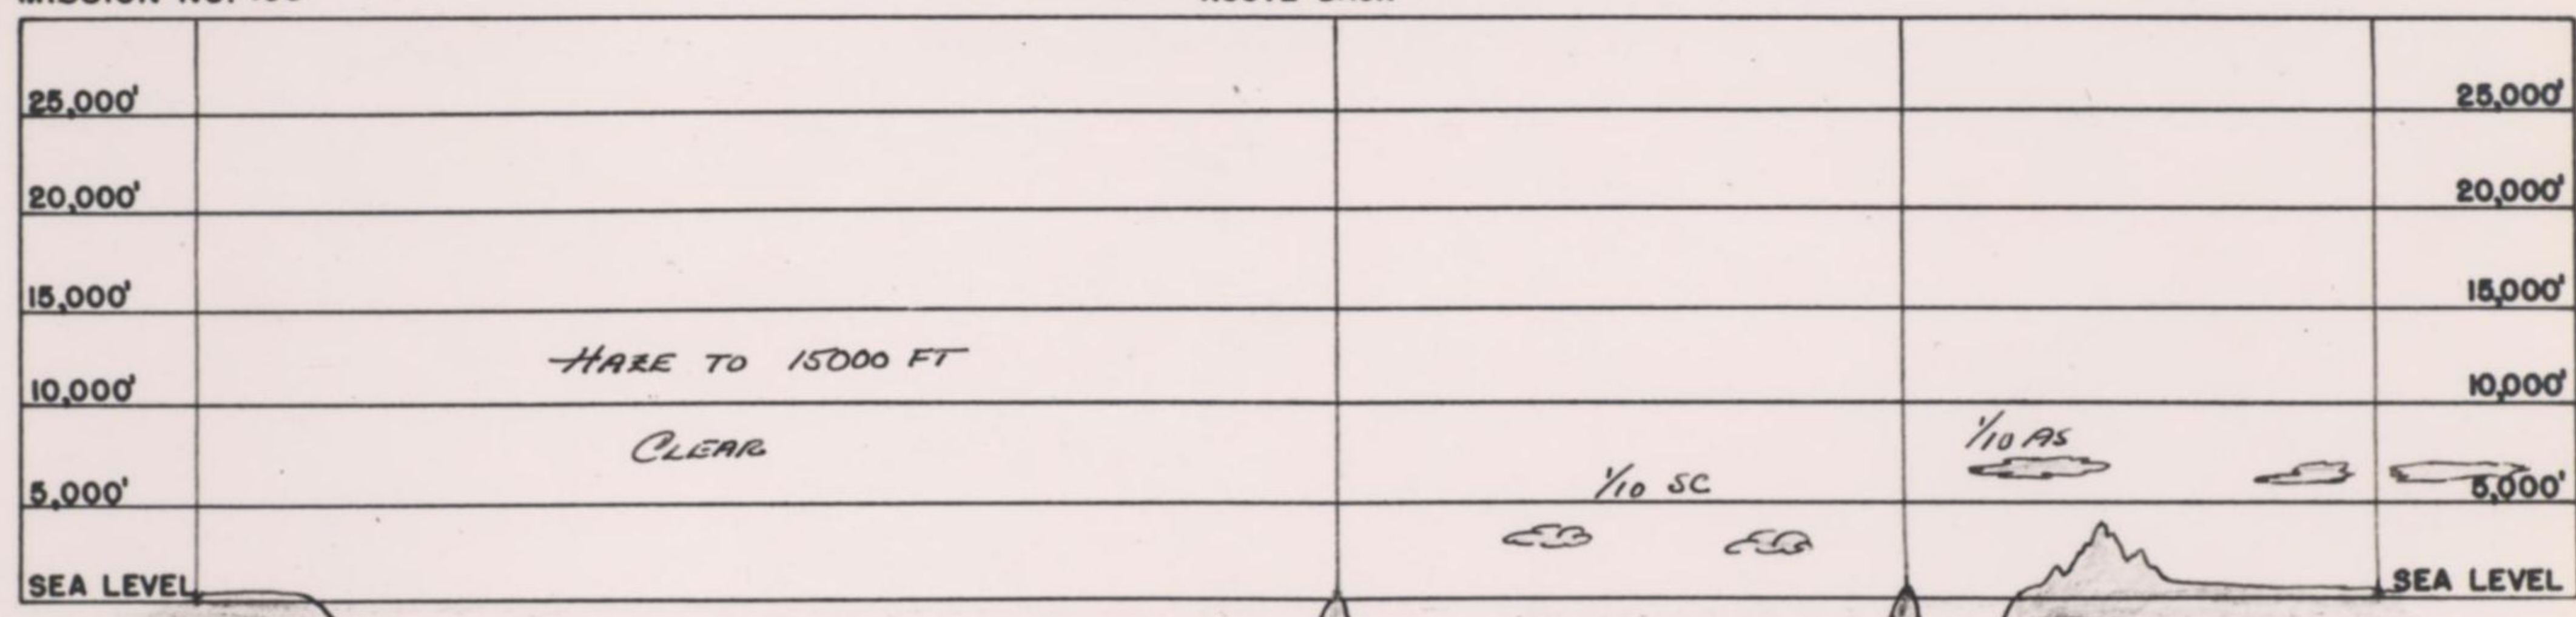
MISSION NO. 20

WEATHER AS ENCOUNTERED
ROUTE BACK

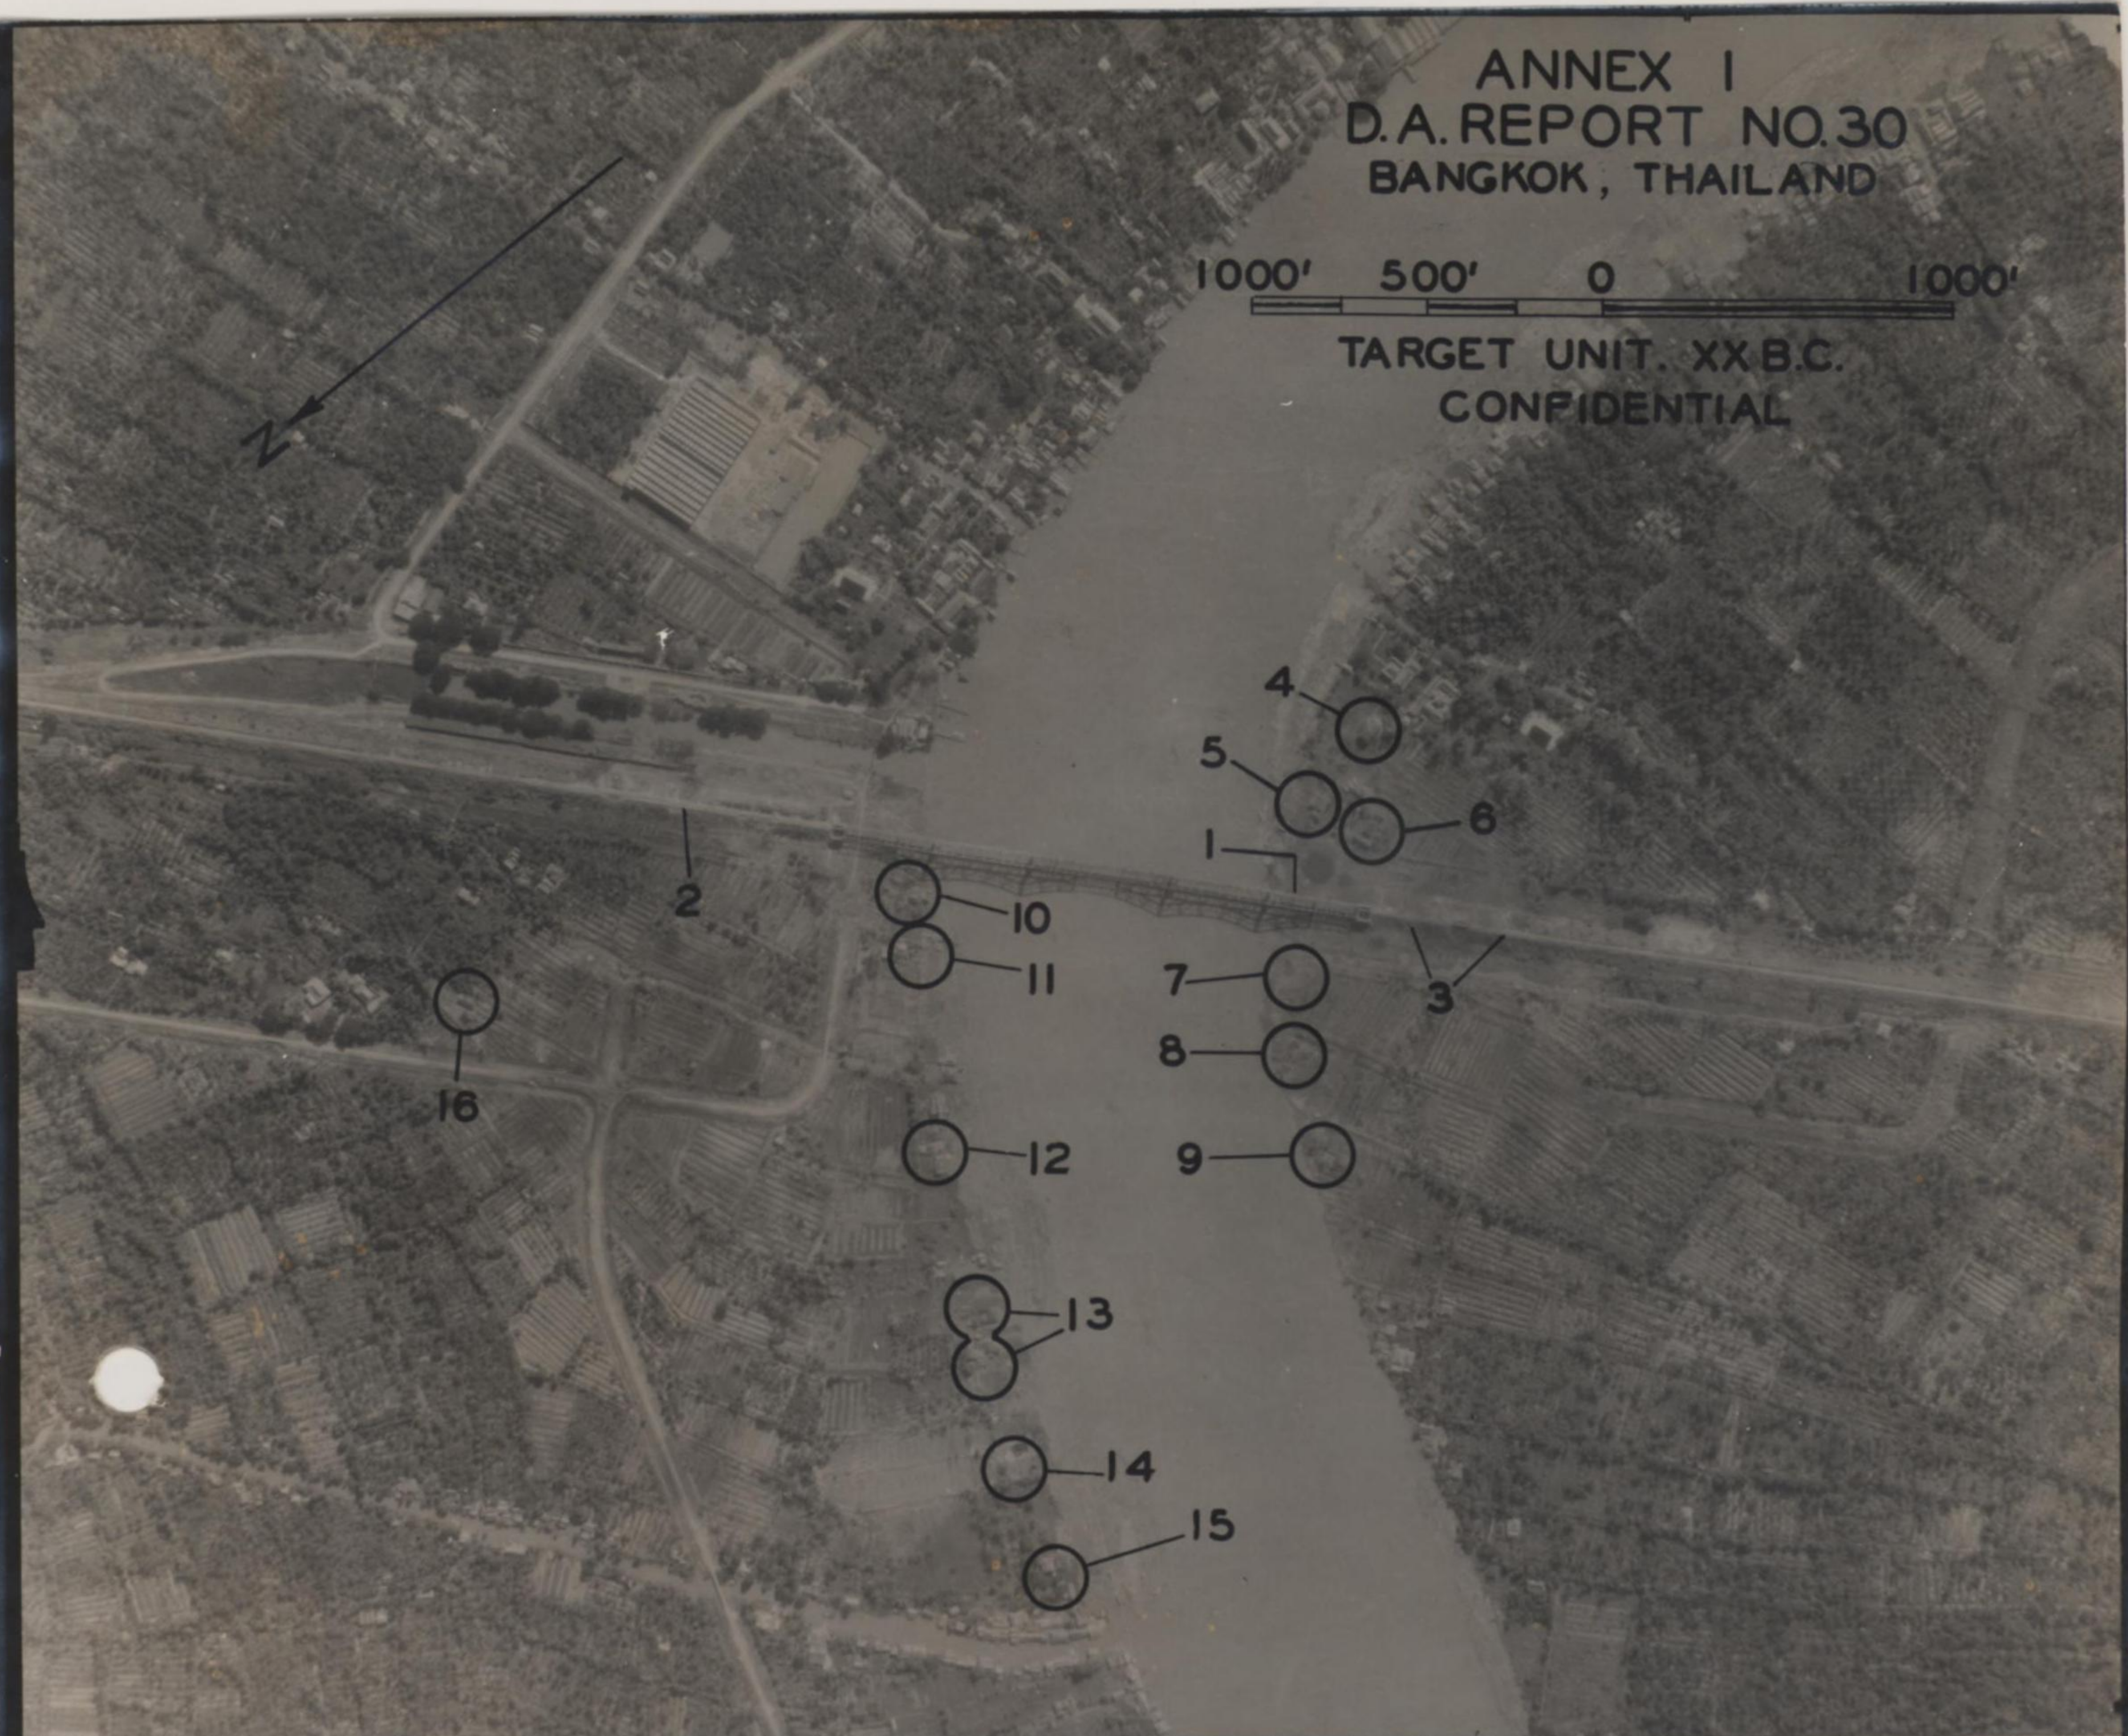
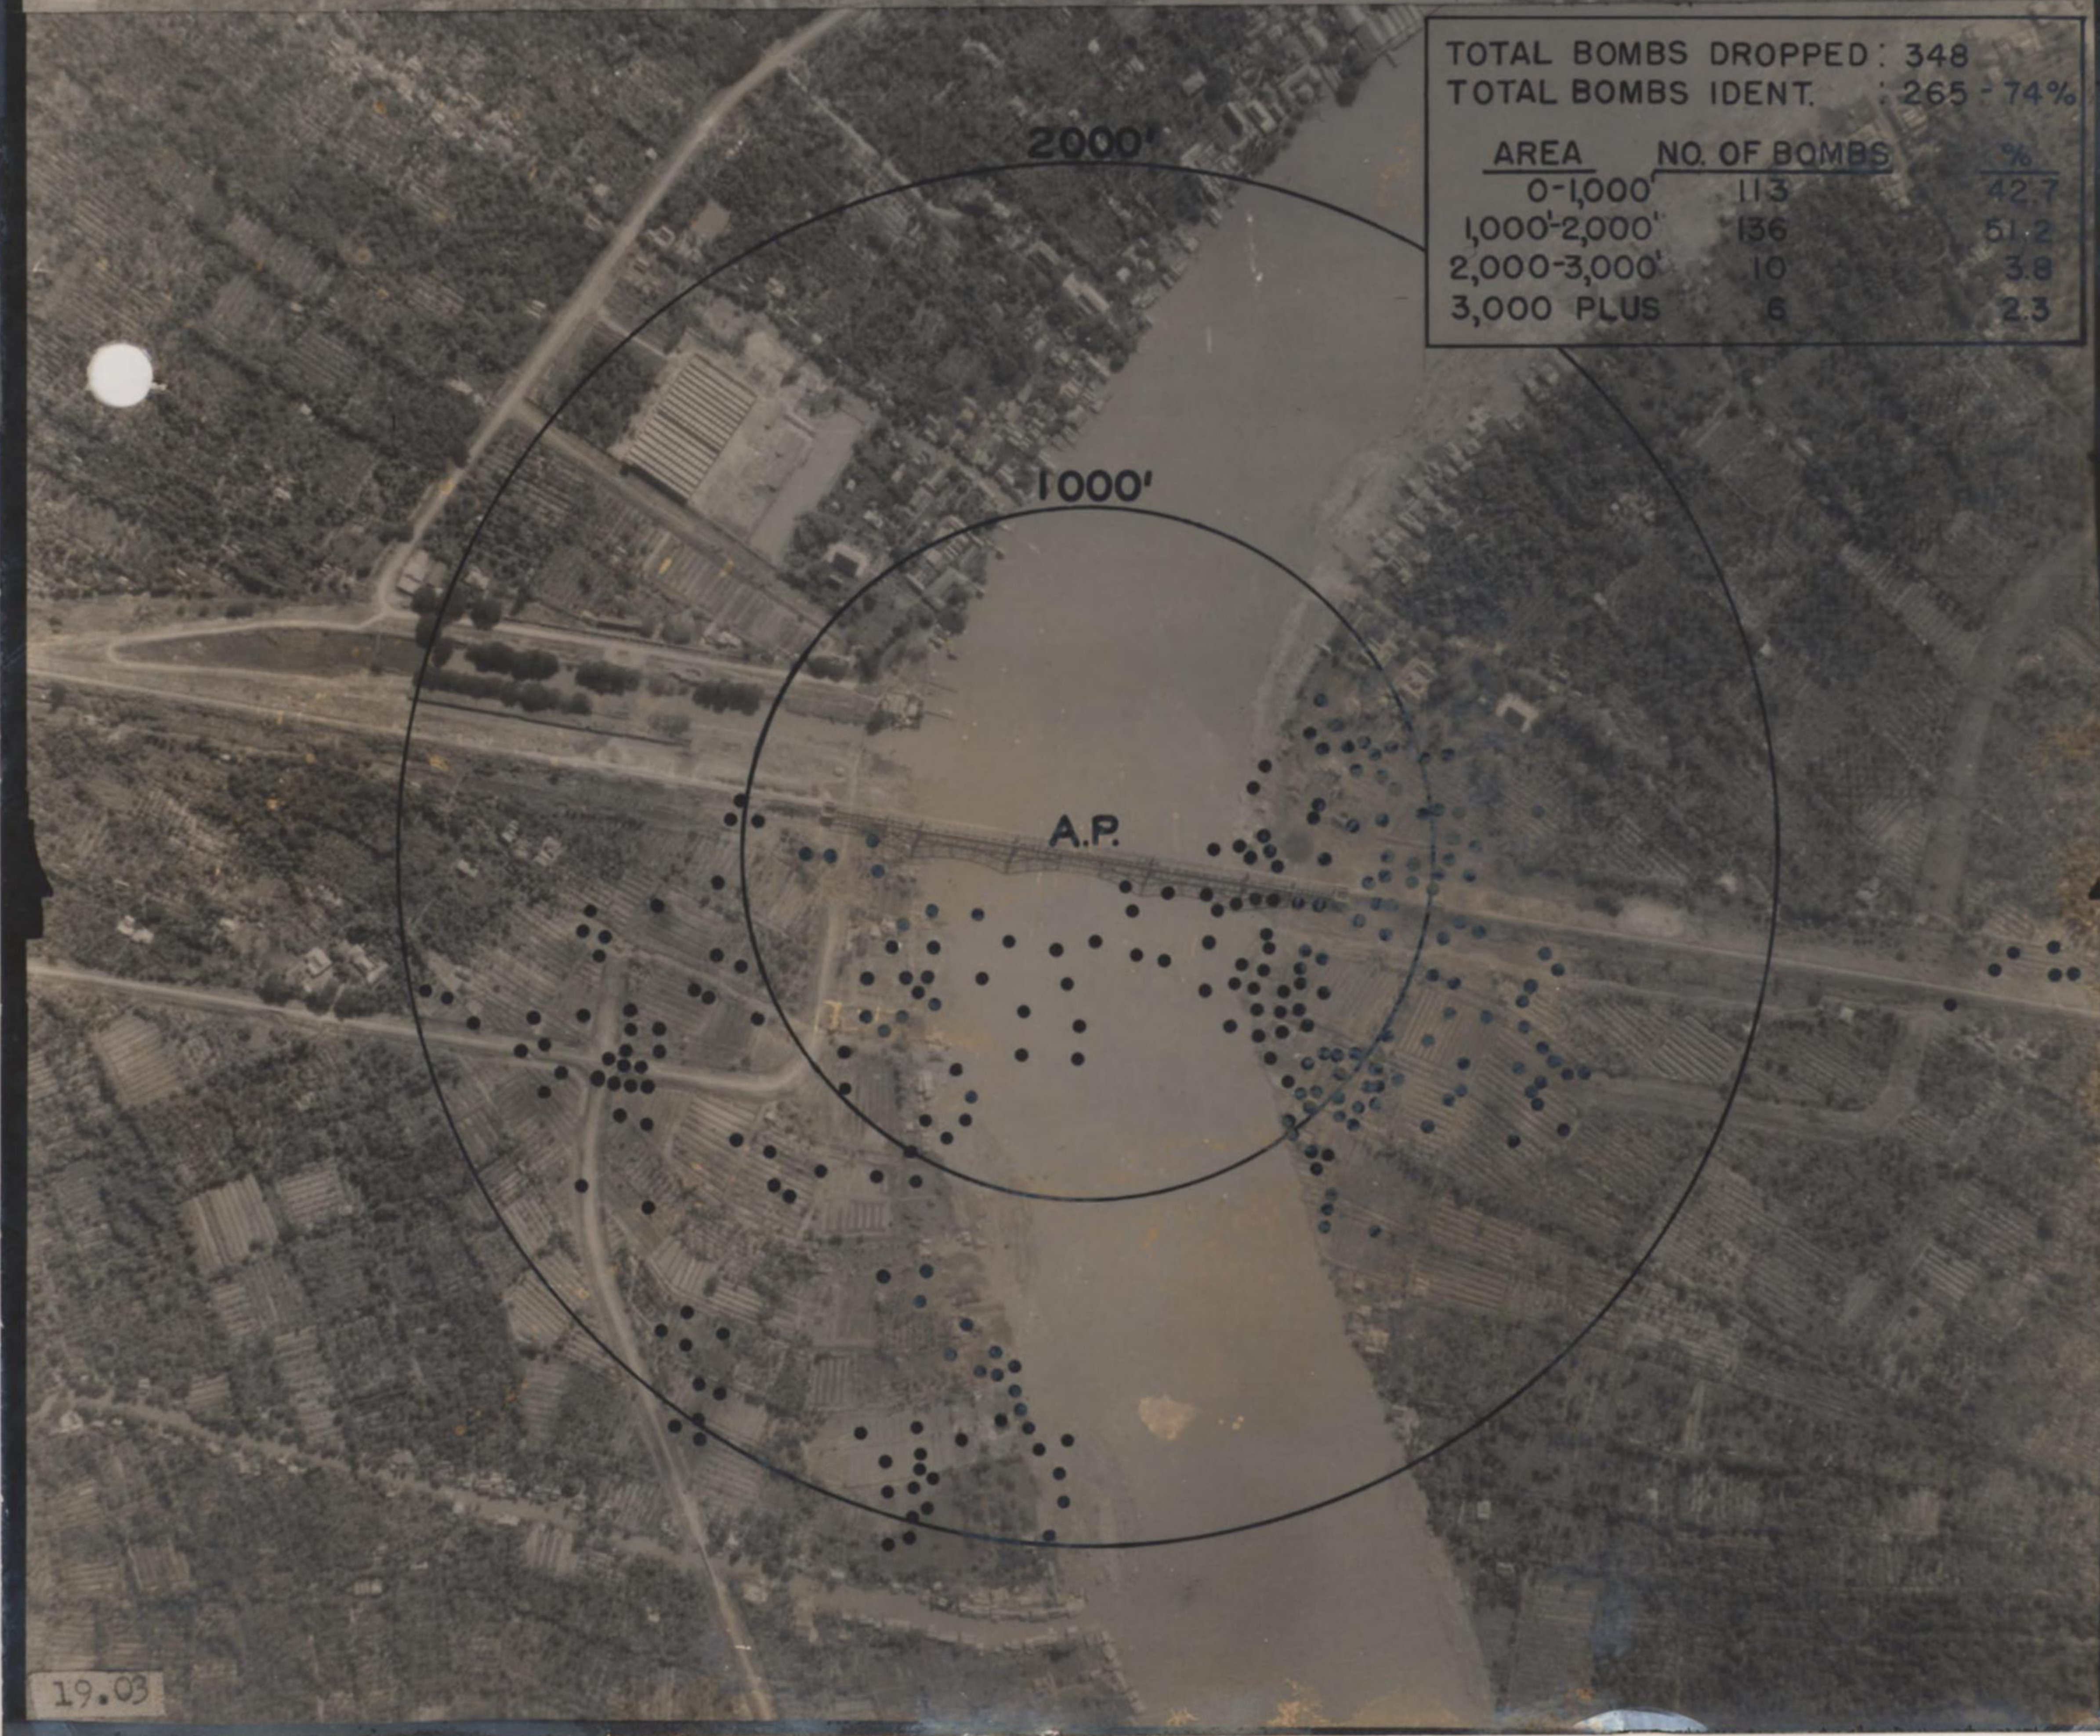
TARGET UNIT. XX B.C.
CONFIDENTIAL

TOTAL BOMBS DROPPED : 348		
TOTAL BOMBS IDENT. : 265 - 74%		
AREA	NO. OF BOMBS	%
0-1,000'	113	42.7
1,000'-2,000'	136	51.2
2,000-3,000'	10	3.8
3,000 PLUS	6	2.3

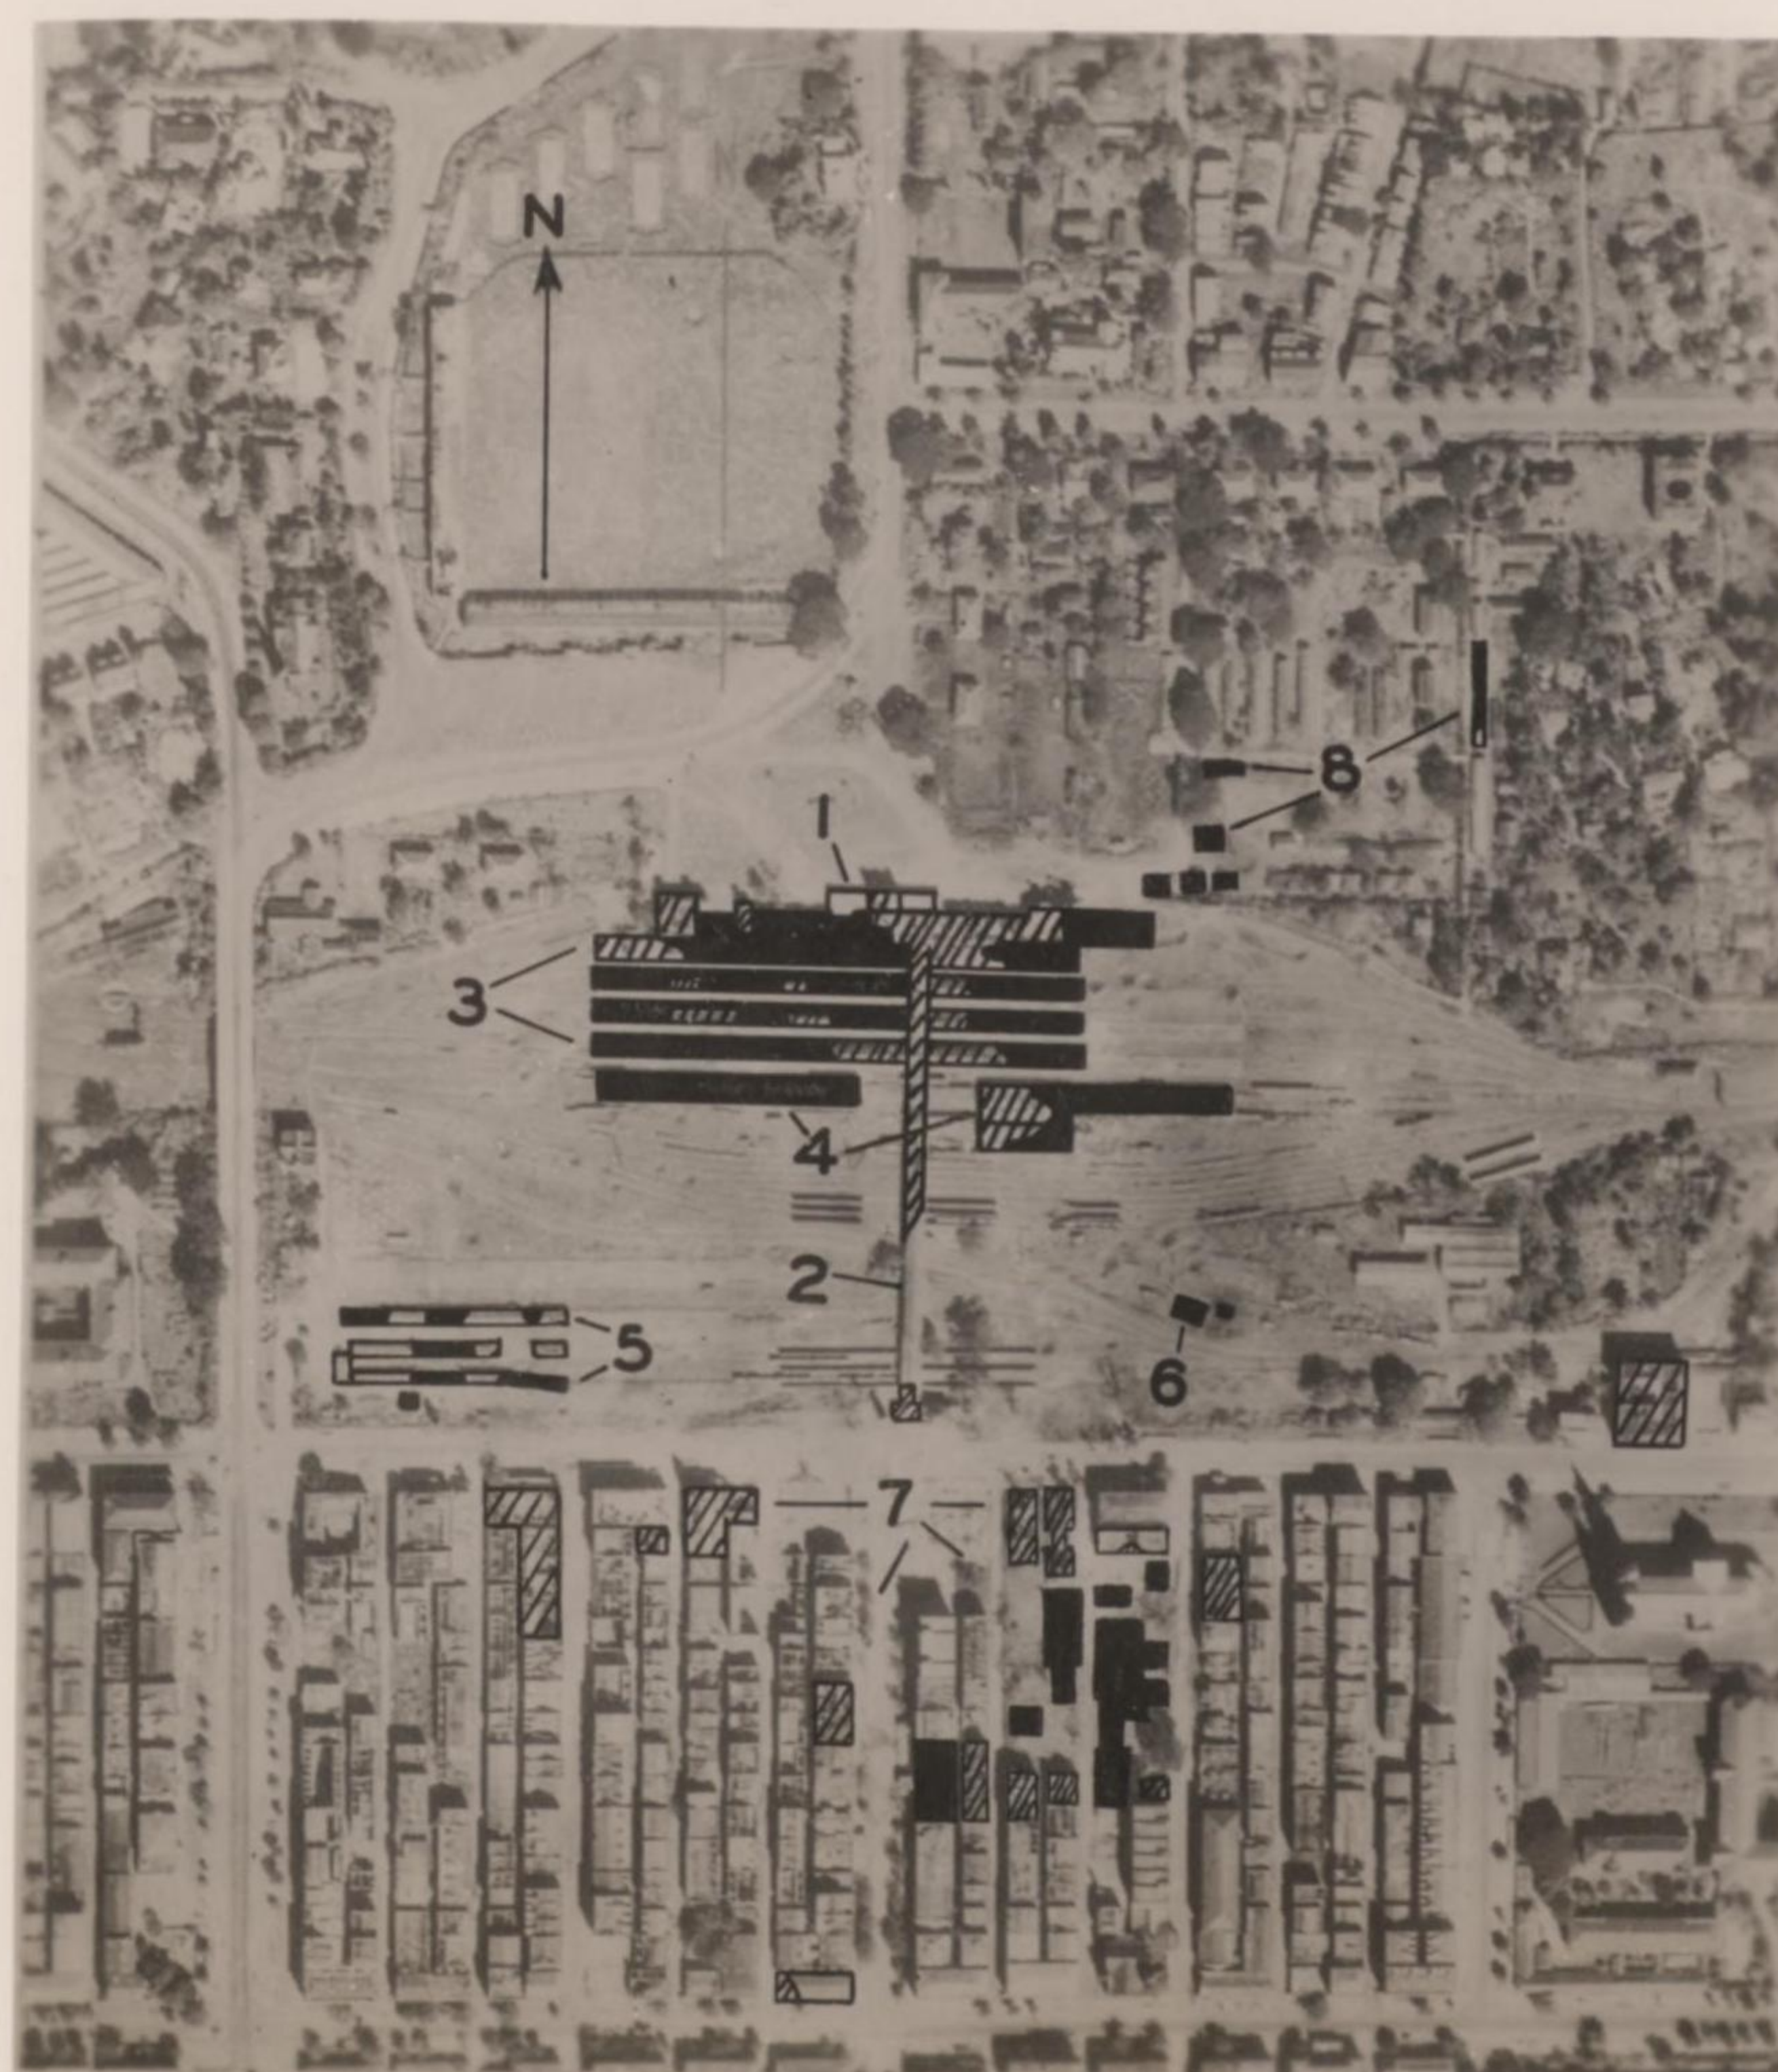
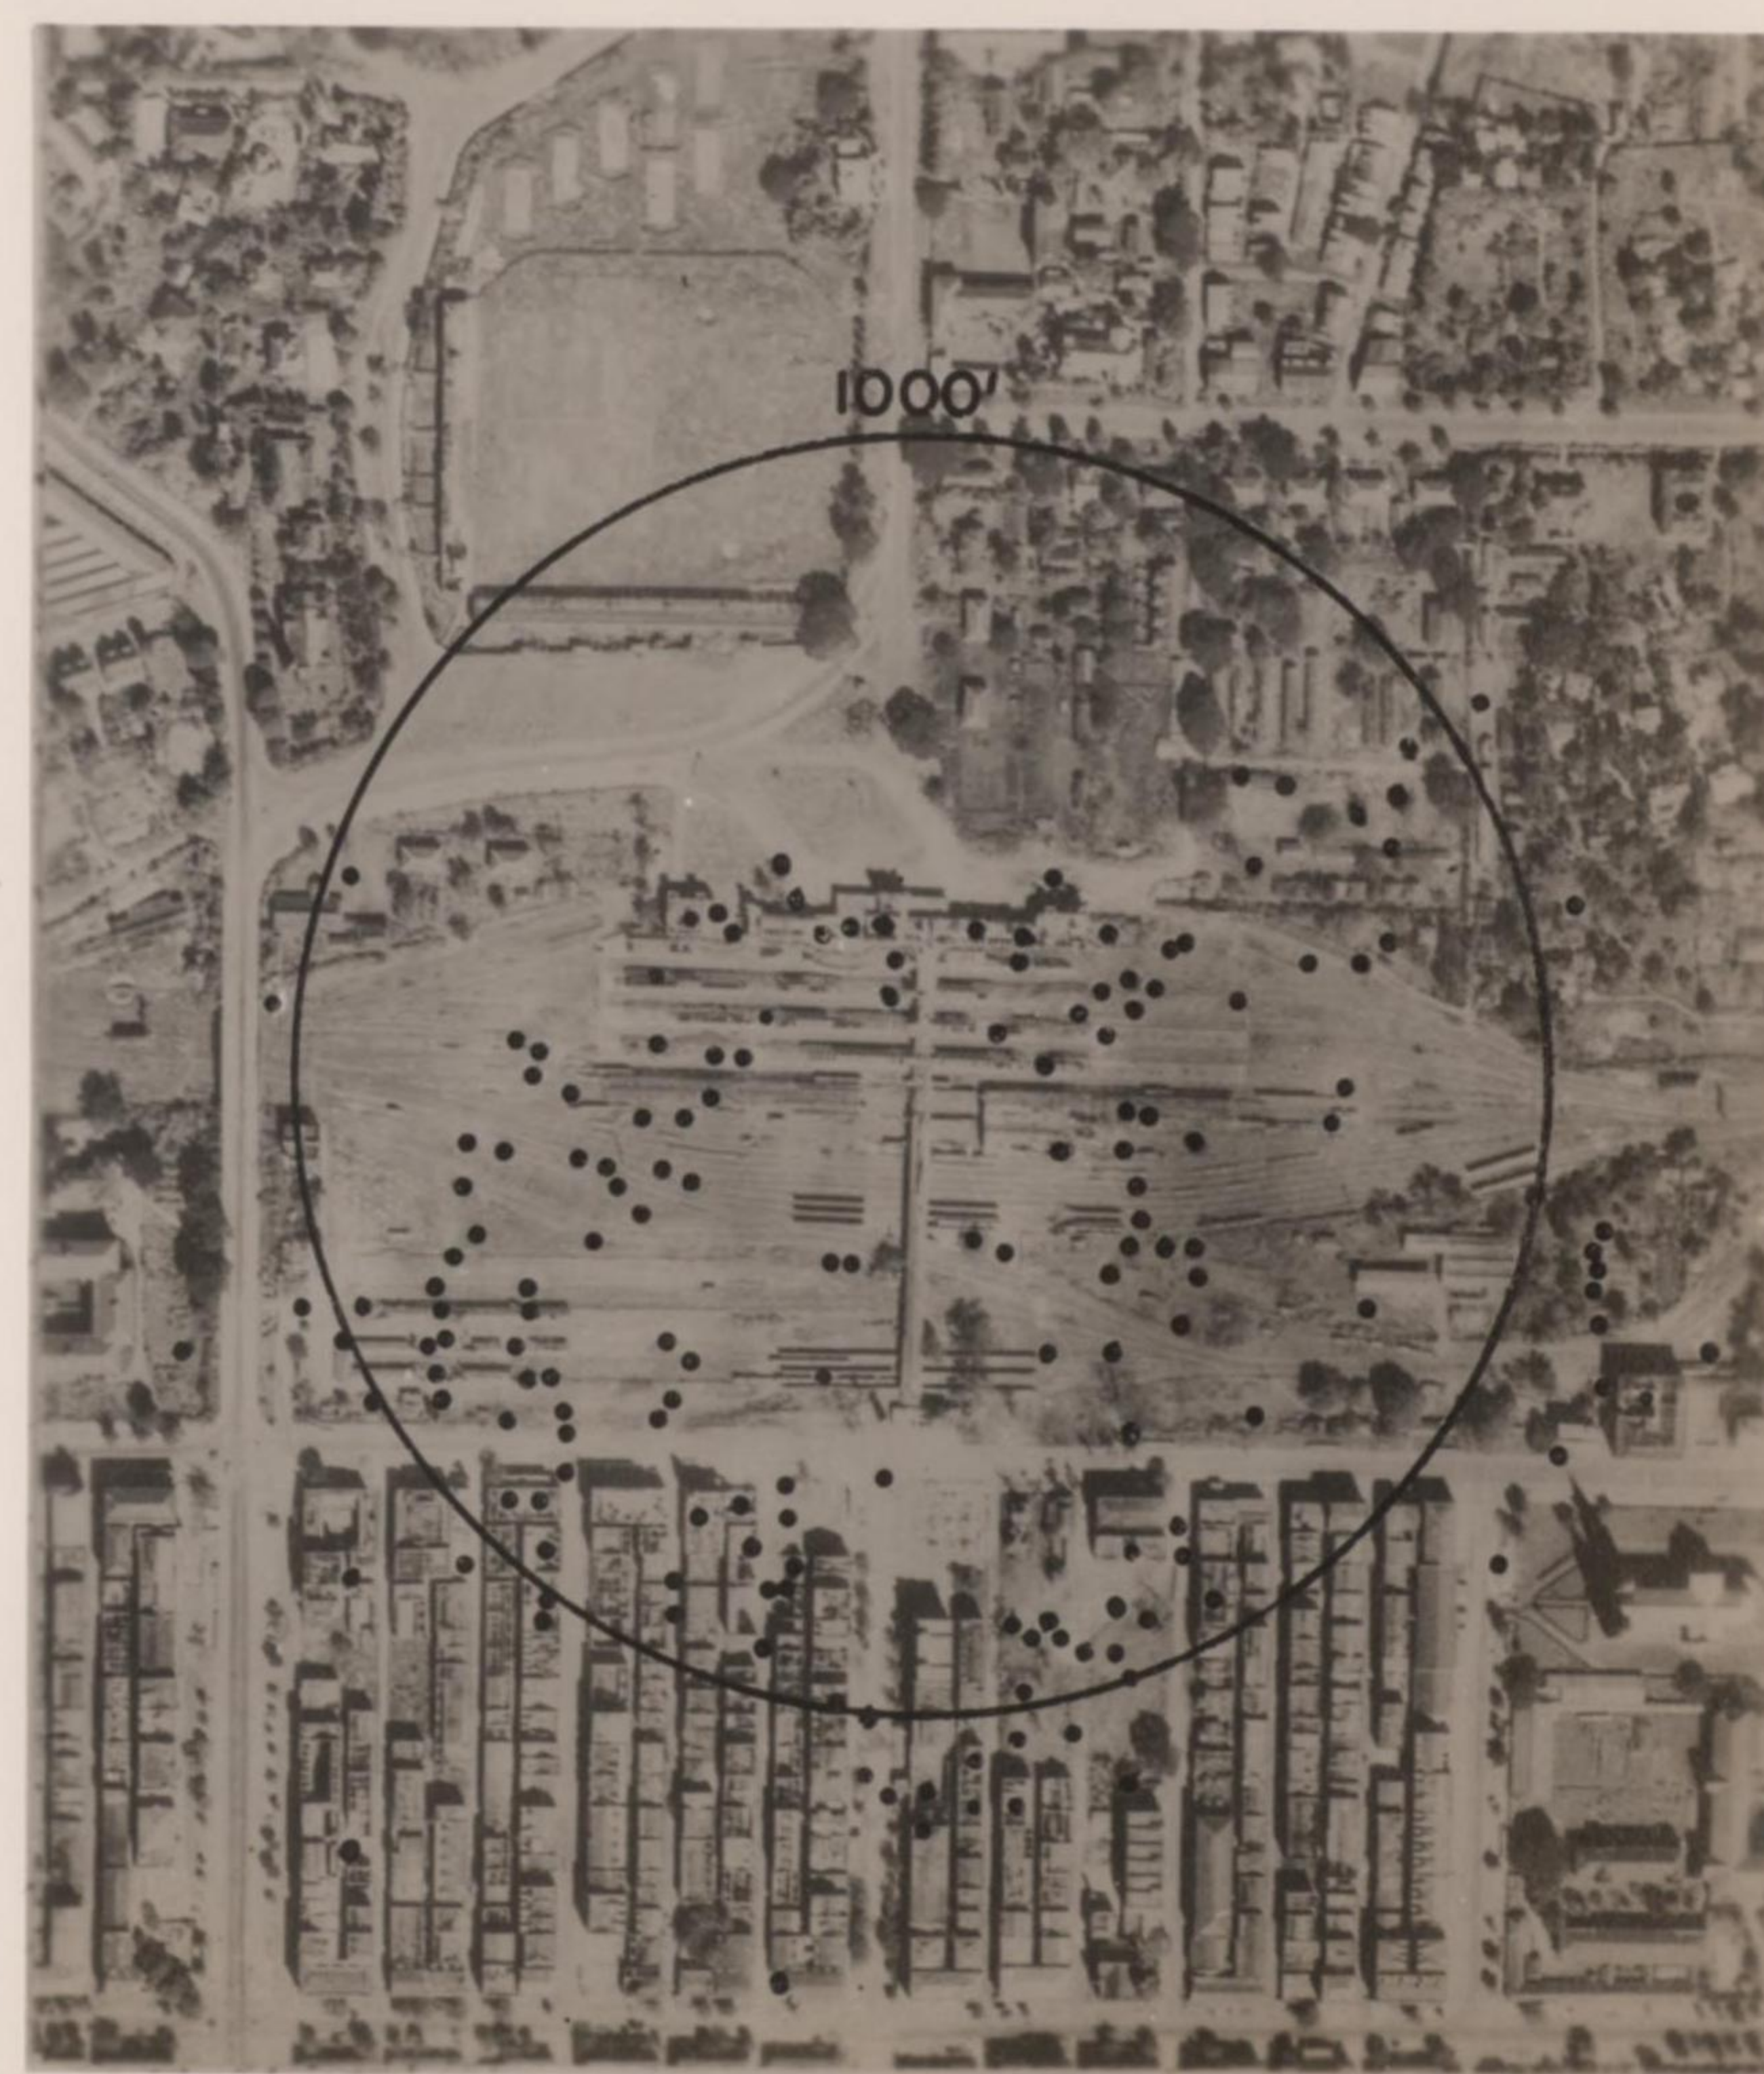
BOMB PLOT: PERCENTAGE 0-1000' - 80.1
PERCENTAGE 1-2000' - 19.9
