AQUATIC HABITAT INVENTORY IN THE
HOT DESERT EIS AREA, UTAH

August 9, 1976

Center for Health and Environmental Studies
Brigham Young University
Provo, Utah 84602

Paul L. Howard, State Director
Utah State Office
U. S. Bureau of Land Management
Contract Number YA-512-CT6-77

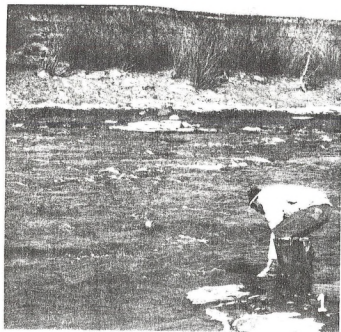
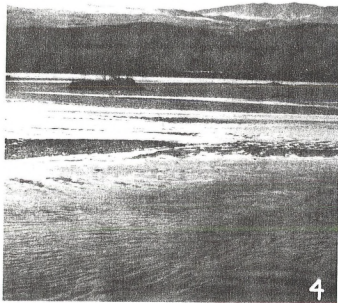
Picture 3. Virgin River below Bloomington, Utah (See S-1, Fig 1). Stream channel wide, meandering, banks unstable sand, substrate mostly shifting sand. 16 January, 1976

Picture 4. Virgin River below Bloomington, Utah. View looking NNW across the channel. 16 January, 1976

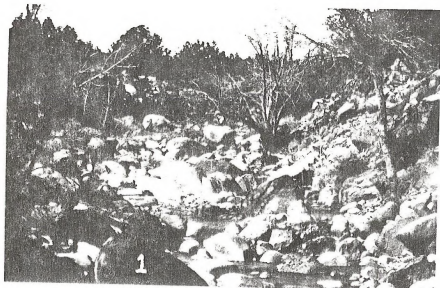
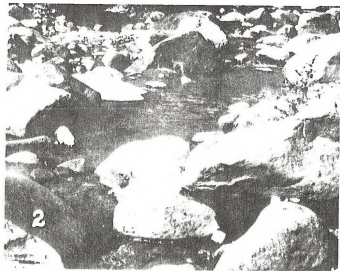
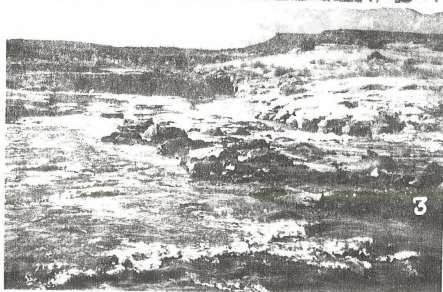
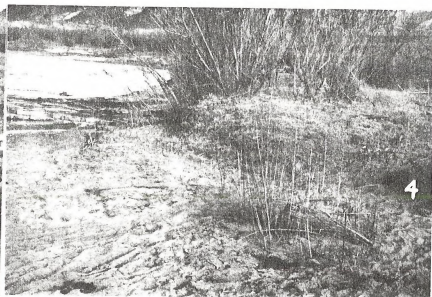
PLATE II

Picture 1. Leap Creek 100 meters above I-15, 20 February, 1976. Large rock strewn channel, heavily scoured, sparse periphyton on rocks indicate high spring and summer storm runoff. Pinón-juniper trees dominate streamside vegetation.

Picture 3. Virgin River above LaVerkin and below North Creek (Fig. 1, S-4) 15 January, 1976. Rocky outcrop is shown with a waterfall in the upper-center of picture. This habitat is good for macro-invertebrates, especially in a predominantly sandy substrate river.

Picture 4. Virgin River--same as Picture 3. Cattle tracks and droppings plus heavily grazed vegetation give visual evidence to heavy grazing pressures on streamside vegetation in desert situations.

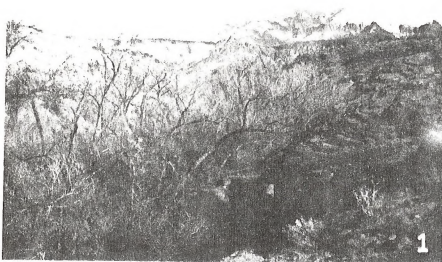
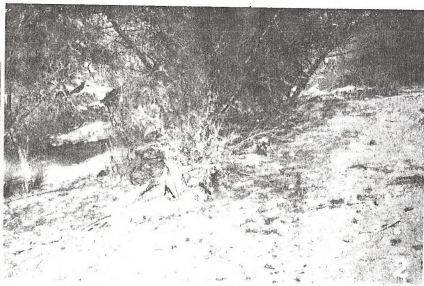
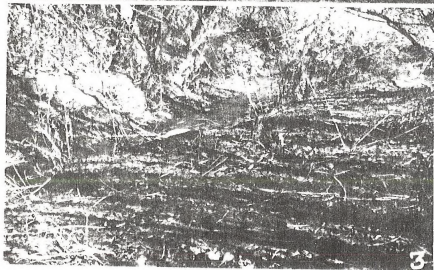
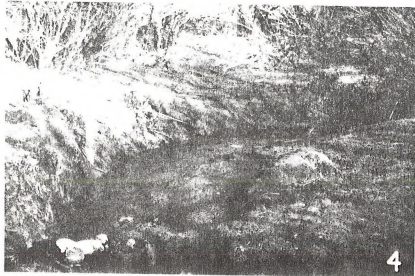
PLATE III

Riparian vegetation consisted of willow, cottonwood and sage. Heavy cattle damage was noted with many cattle trails worn several inches deep along both banks of the stream. Vegetation showed heavy use with no young vegetation present, only mature, partly dead trees and brush (Plate III, pictures 2, 3 and 4).

Mill Creek from mouth of Gorge to I-15 crossing, 20 February 1976 (Figure 1).

Picture 3. Vegetation trampled down by cattle passage.

Picture 4. Stream showing bare banks and worn cattle trails.

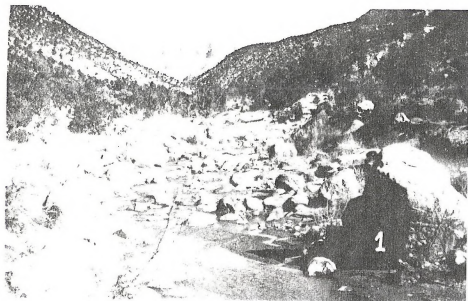
PLATE IV

Picture 1. LaVerkin Creek, S-3, below Zion's Park boundary, 16 January 1976. Pinon-juniper forest, sparsely vegetated.

Picture 3. LaVerkin Creek, S-2, above canyon mouth, 16 January 1976. Sparse streamside vegetation and wide, shallow channel are the prominent features of this photograph.

Picture 4. LaVerkin Creek, S-1, above LaVerkin, Utah, 16 January 1976. Streamside vegetation mainly cottonwood trees and willows. Area under intensive agricultural use.

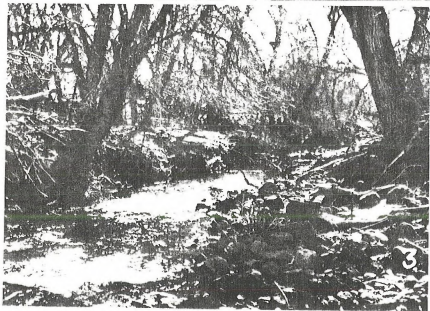
PLATE V

Picture 1. North Creek, below Zion's Park boundary, 15 January 1976. Note bare rock stream side with wide shallow stream channel.

Picture 3. Santa Clara River, S-5, two miles above Baker Dam Reservoir, 17 February 1976. Note the mature trees, dead branches, lack of new young trees. Stream-side heavily grazed.

Picture 4. Santa Clara River, S-5, 17 February 1976. Frequent rock outcrops have allowed creation of quality pool and riffle habitat.

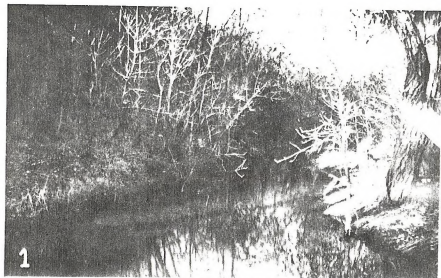
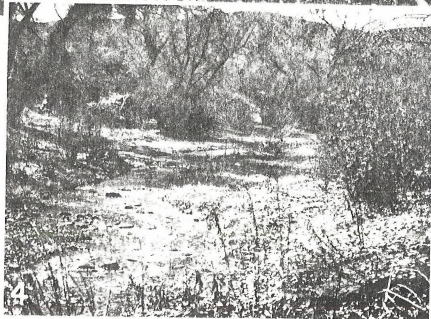
PLATE VI

Site S-1 (Plate VI, picture 4), 1 mile west of Santa Clara, Utah. The Santa Clara River was heavily silted from Gunlock Reservoir downstream to the Virgin River, resulting from geological formations plus poor management of the drainage. At S-1 50 percent of the substrate was sand-silt which explains the poor pool quality (Class IV and V) and poor riffle/pool ratio of 2:1. Bank cover and stability were both low, 25 and 63 percent respectively. Cattle were present and grazing damage was high. There was only approximately 20 percent of the stream shaded, provided mostly by cottonwood trees and willows.

Picture 1. Santa Clara River, S-4, at Veyo, Utah above Veyo Resort, 17 February 1976. Stream is at the bottom of a narrow gorge with steep volcanic rocks. Water flow is slow, water temperature is high due to numerous springs, and streamside vegetation is dense.

Picture 3. Santa Clara River, S-2, one-half mile below Gunlock Reservoir, 19 February 1976. Stream largely spring fed as reservoir outflow was near zero. Heavy algal growths indicated high CO₂ and nutrient levels. Habitat stream-like.

Picture 4. Santa Clara River, S-1, one mile west of Santa Clara, Utah, 19 February, 1976. Stream sides heavily grazed, stream shallow with poor quality pool habitat.

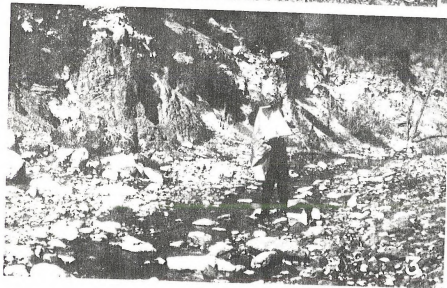
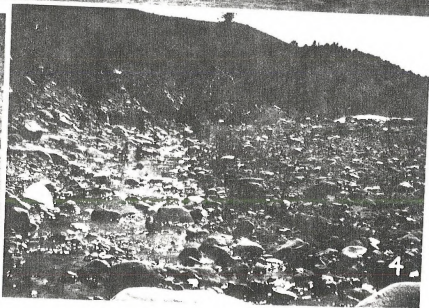
PLATE VII

Picture 1. West Fork Beaver Dam Wash at fork with Slaughter Creek, 18 February 1976. West Fork left of center with Slaughter Creek coming in on right of gravel bar. Wide channel indicates severity of periodic high flows.

Picture 3. East Fork Beaver Dam Wash, S-1, one mile below Goldstrike, Utah and below Black Canyon, 18 February, 1976. Note small discharge but wide rocky channel and unstable right bank.

Picture 4. East Fork Beaver Dam Wash, S-1, 18 February 1976. View looking downstream showing wide rocky channel, lack of large pools, unstable banks.

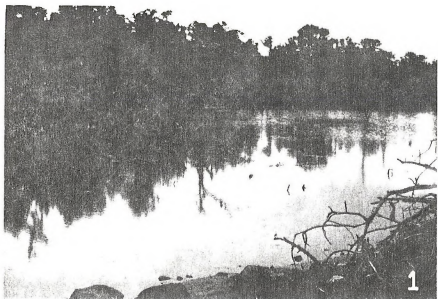
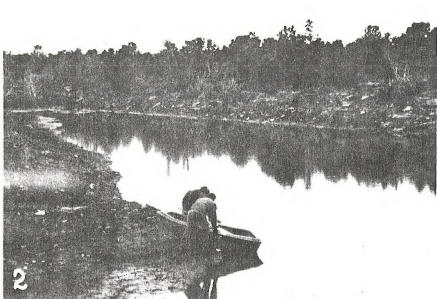
PLATE IX

On the plateau are extensive areas of sandstone slick-rock. The reservoirs are merely a damming up of the lower portion of the drainage off these slick-rocks with no continuous inflow or outflow of water (Plate IX, 1, 2, 3). The reservoirs are heavily silted, shallow and largely void of shoreline vegetation. Summer water temperatures are high as are evaporation rates. It is doubtful that under present conditions any of these reservoirs could support a quality fisheries except for seasonal put-and-take management.

This reservoir is of little biological value under present conditions and has the same limiting factors as Reservoir #1 (Plate IX, 2).

Picture 1. Little Creek Mountain Reservoir
number 3, 13 April 1976.

Picture 3. Little Creek Mountain Reservoir
number 5, 13 April 1976.

Picture 4. Gunlock Reservoir, northeast
side of reservoir, 14 April 1976.

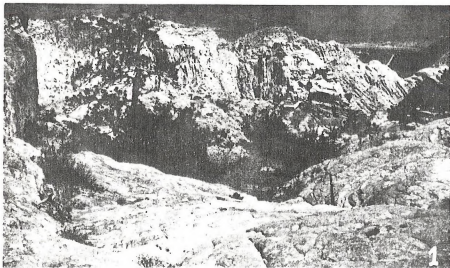
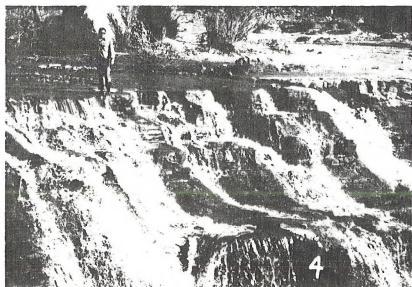
PLATE X

The Red Mountain Lakes are merely depressions in red sandstone slick-rock (Plate X, 1, 2, 3). Many of them are now either entirely filled in with sand and silt or nearly so. Those observed by the author on 30 April 1976 varied from small mudholes with water 1 inch or less in depth to two large ones of approximately the same size-- 12 feet long by 7 feet wide and maximum depths of eight inches. The preceding months had been exceptionally hot and dry and existing water levels were far below capacity. One had a maximum depth nearing five feet before spillover with the others varying from five feet to only several inches.

Picture 1. Red Mountain, dry lake basin, 30 April 1976. Note slick rock in fore ground with depression in center of picture. During rainy season this basin would probably be full of water.

It is recommended that Red Mountain be closed to domesticated animals and the area be preserved for wildlife only. There should be no improvement to roads entering the area and the only management of Red Mountain Lakes recommended from this study would be: 1) the removal of sand from some of the pot holes thus increasing their storage capacity; and 2) blockage of the drainage of others allowing them to capture a greater percentage of the natural runoff.
