MISSION NO. 17

TACTICAL MISSION REPORT

OMURA AIRCRAFT PLANT

21 NOVEMBER 1944

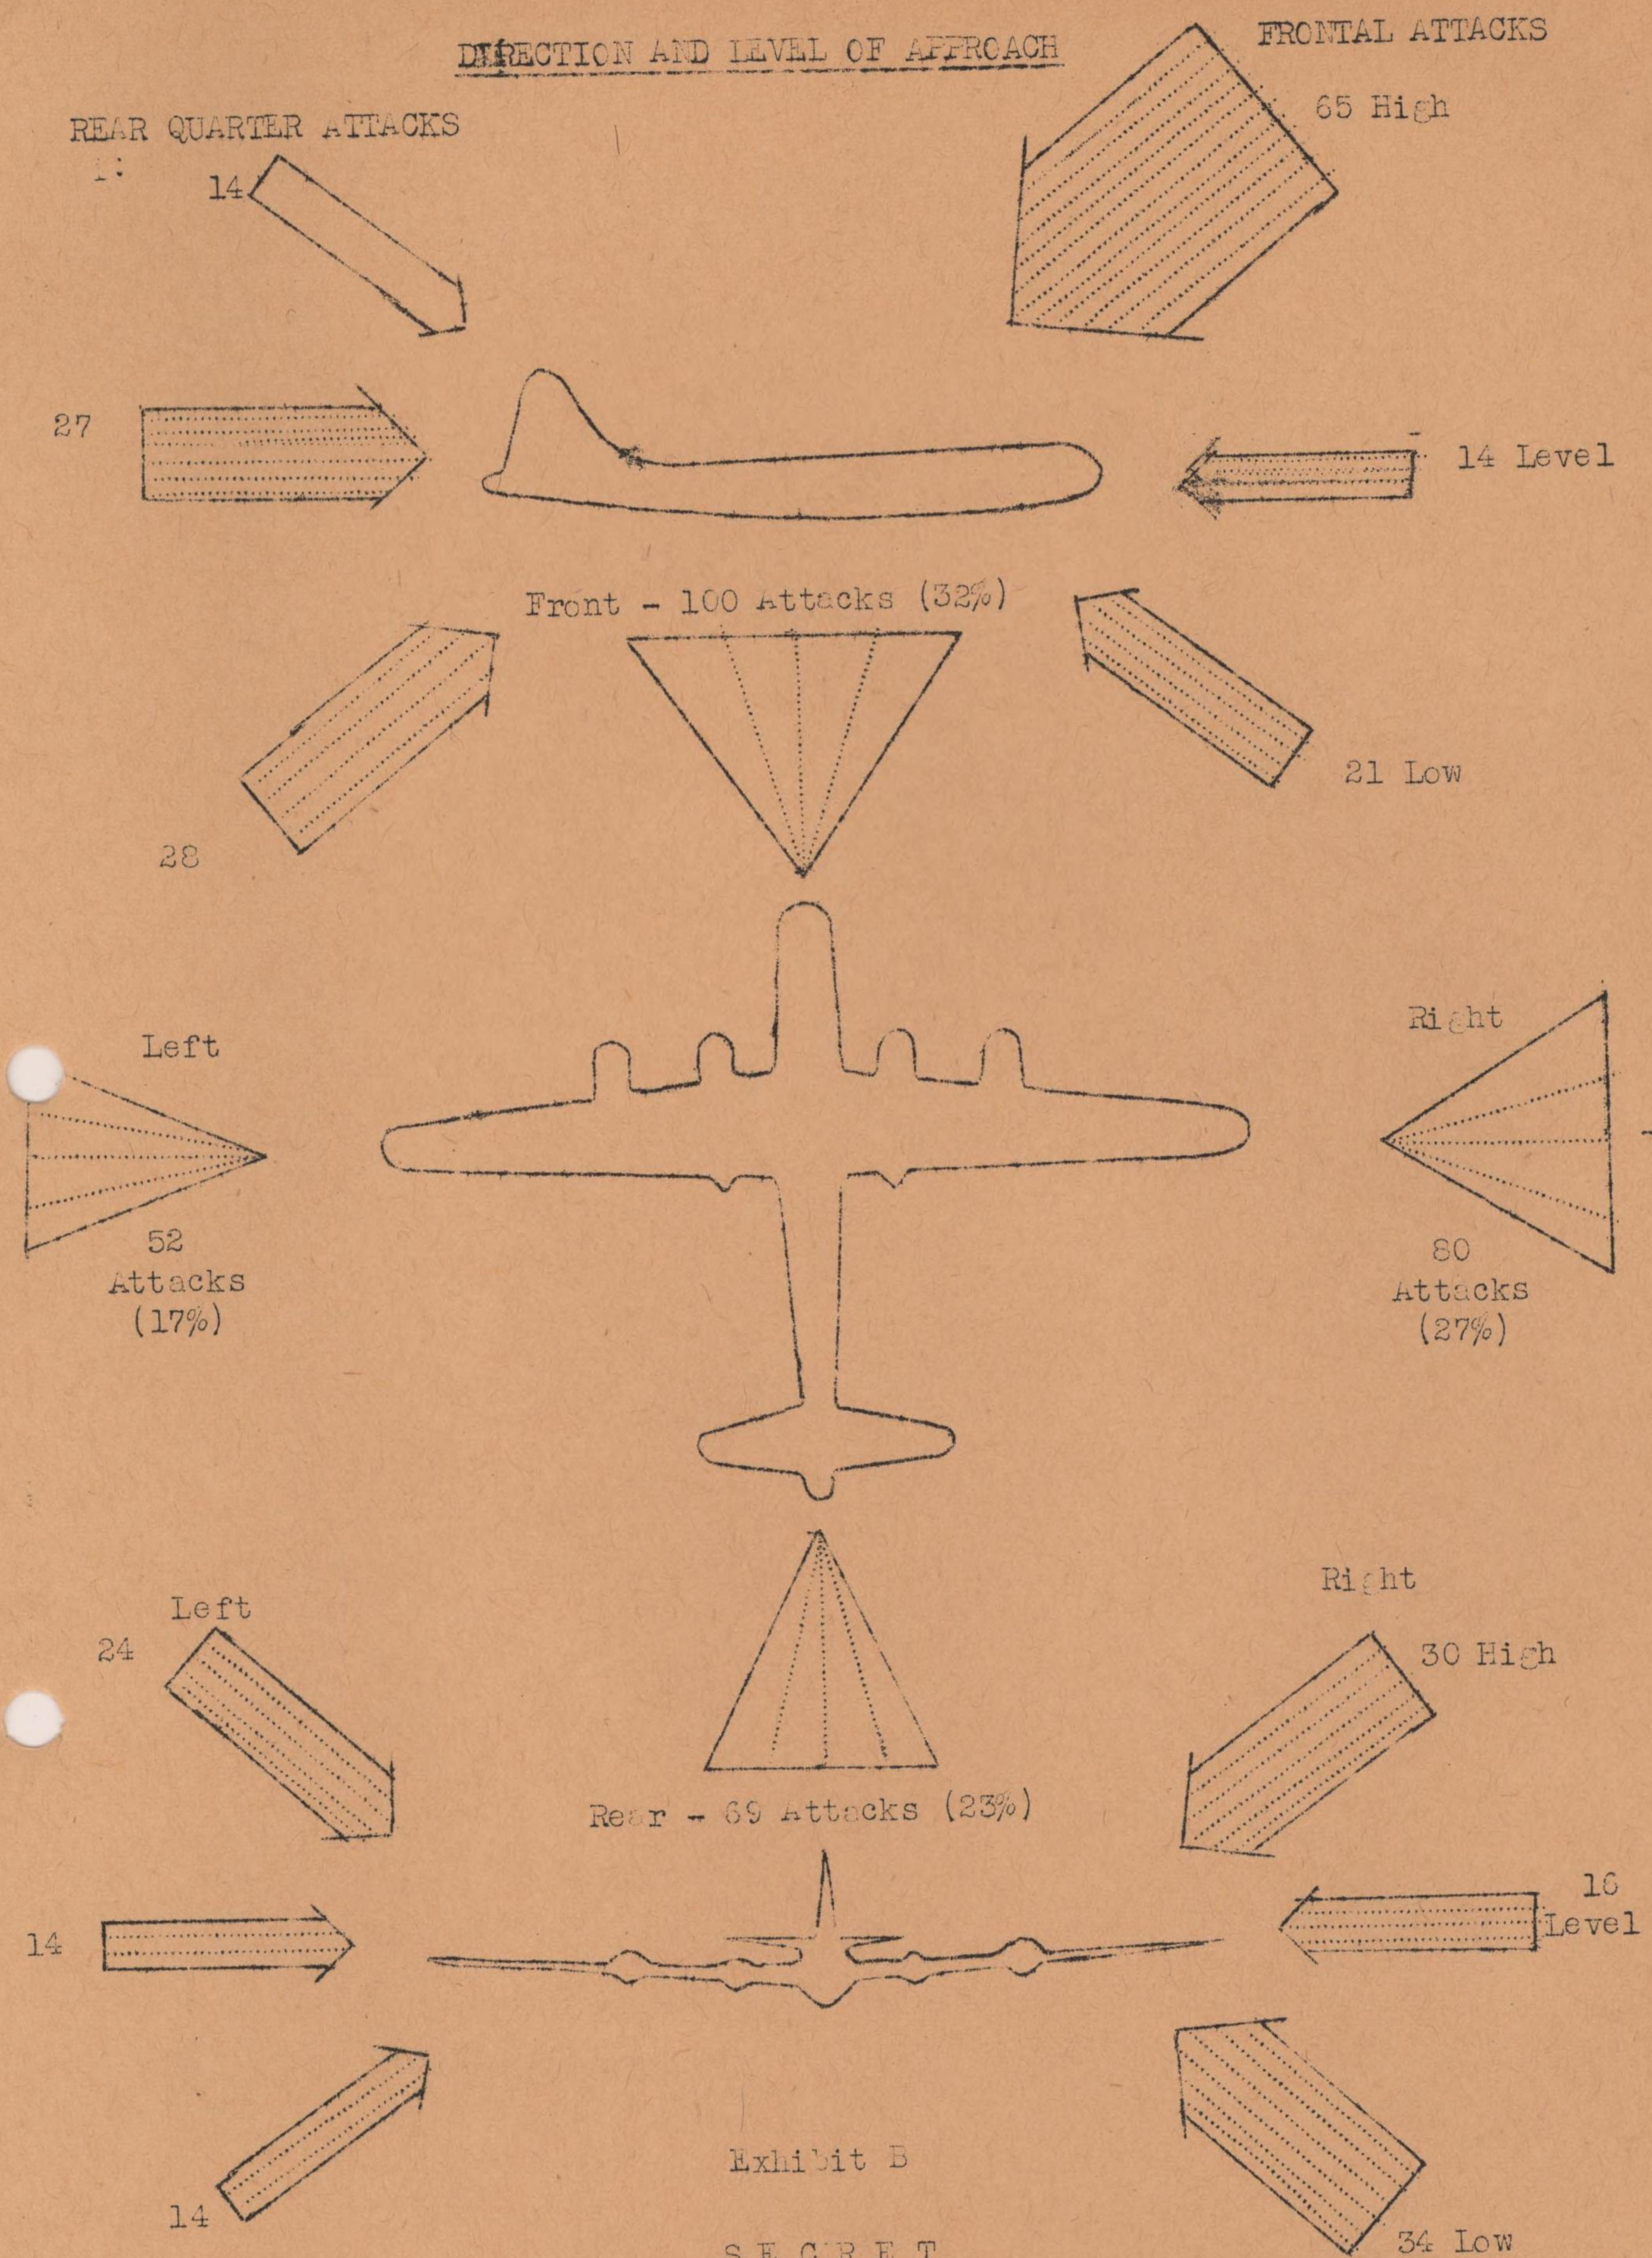
DIRECTION AND LEVEL OF APPROACH

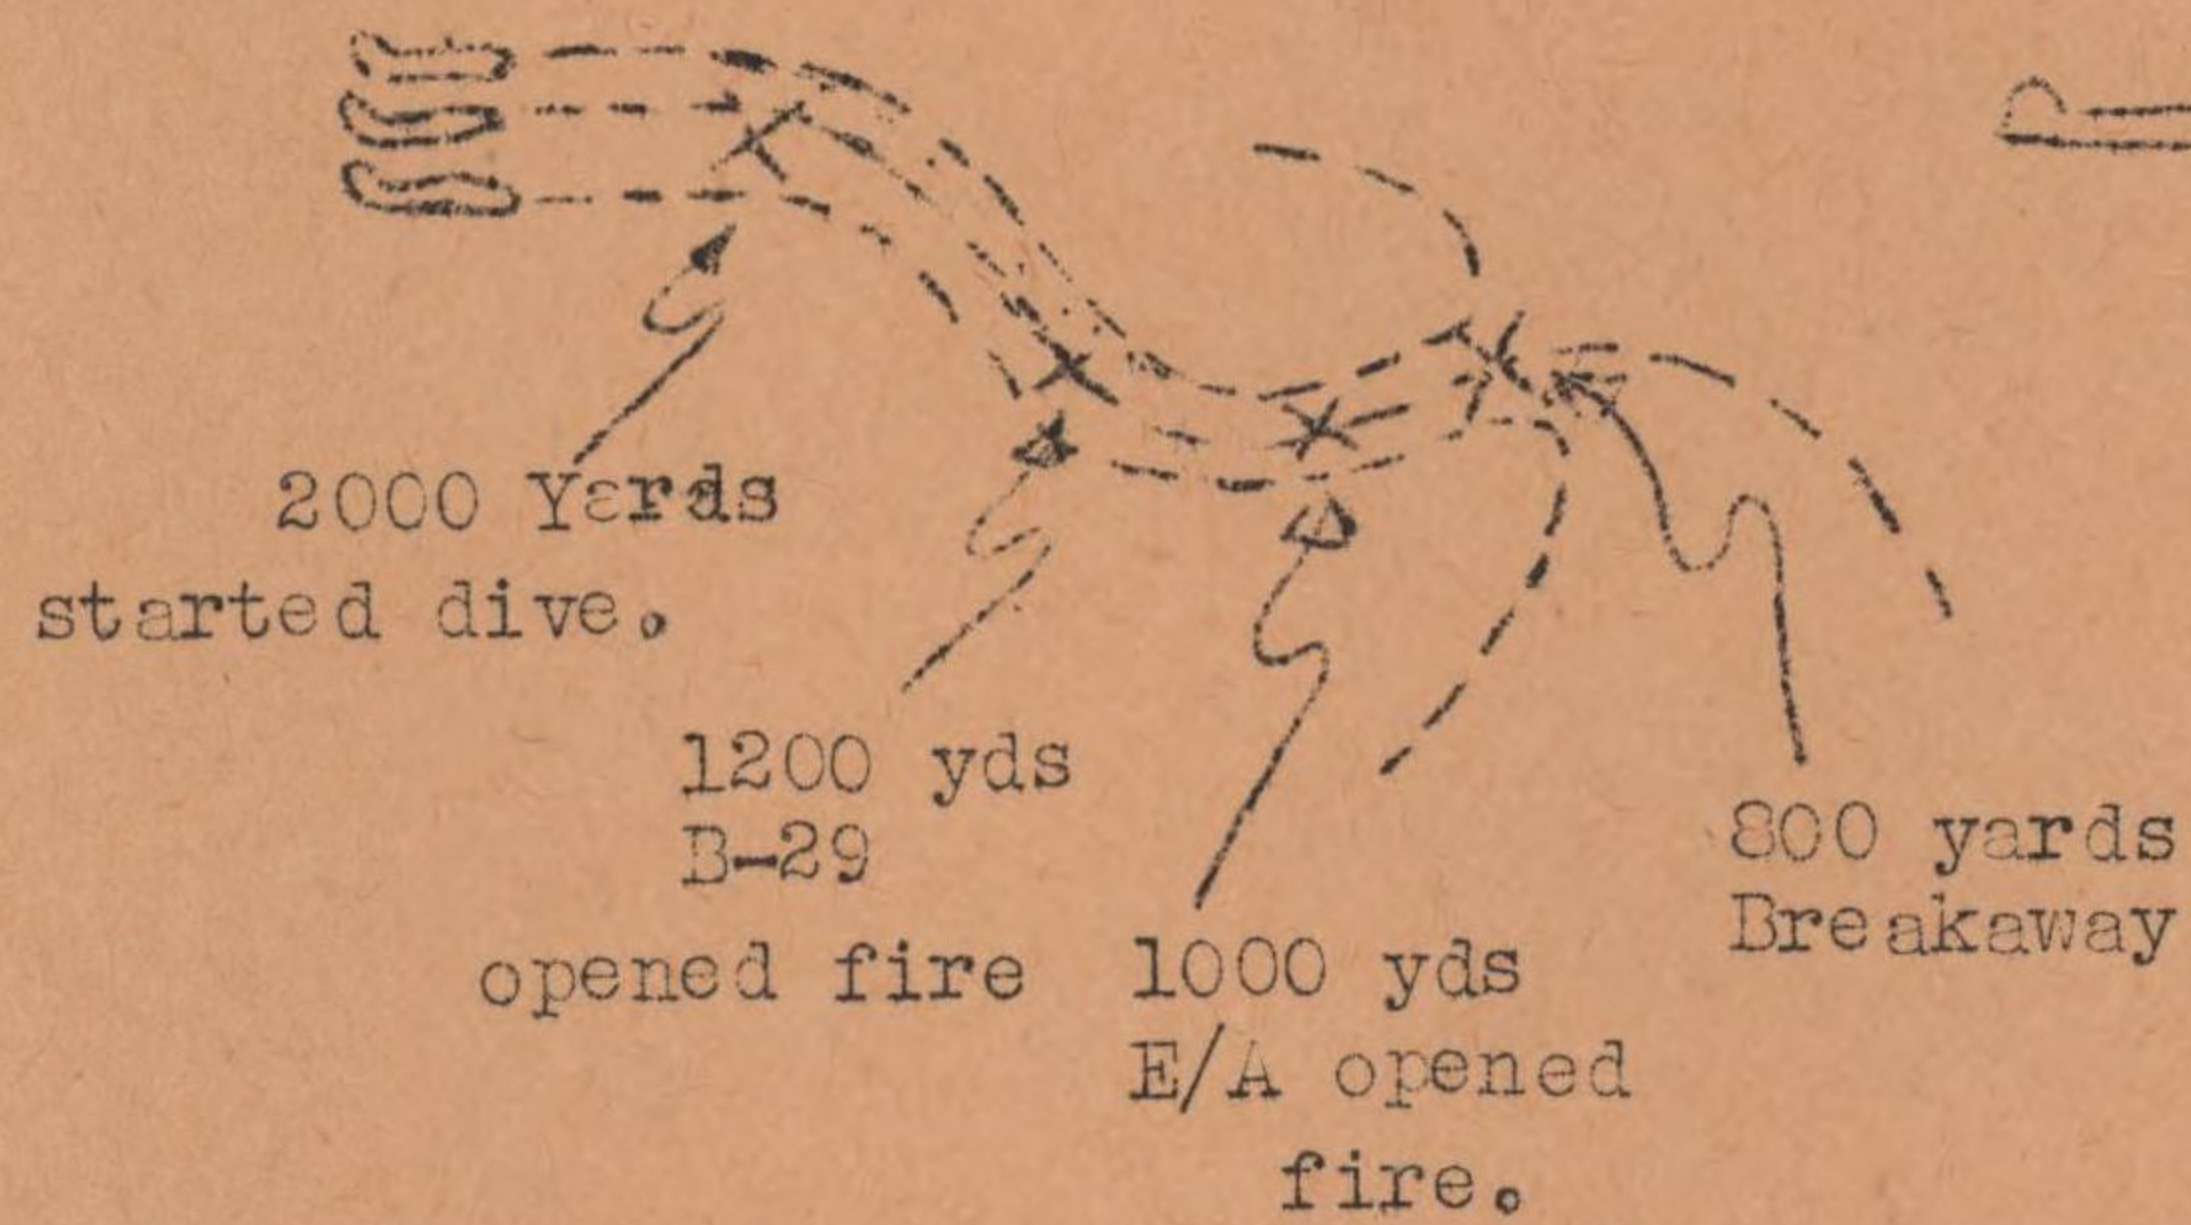
d. A "Belly Button" attack was reported by one B-29. Three Tojos were sighted at 6 o'clock, level, coming in line abreast. At 2000 yards they went into a dive, then, zoomed for the tail of the B-29, opening fire at 1000 yards. They closed to 800 yards, then broke away with one enemy fighter passing below the B-29, and the others, to the right and left respectively. The B-29 fired at 1200 yards, but made no claims against the enemy aircraft. No damage to the B-29 was reported. Diagram follows:

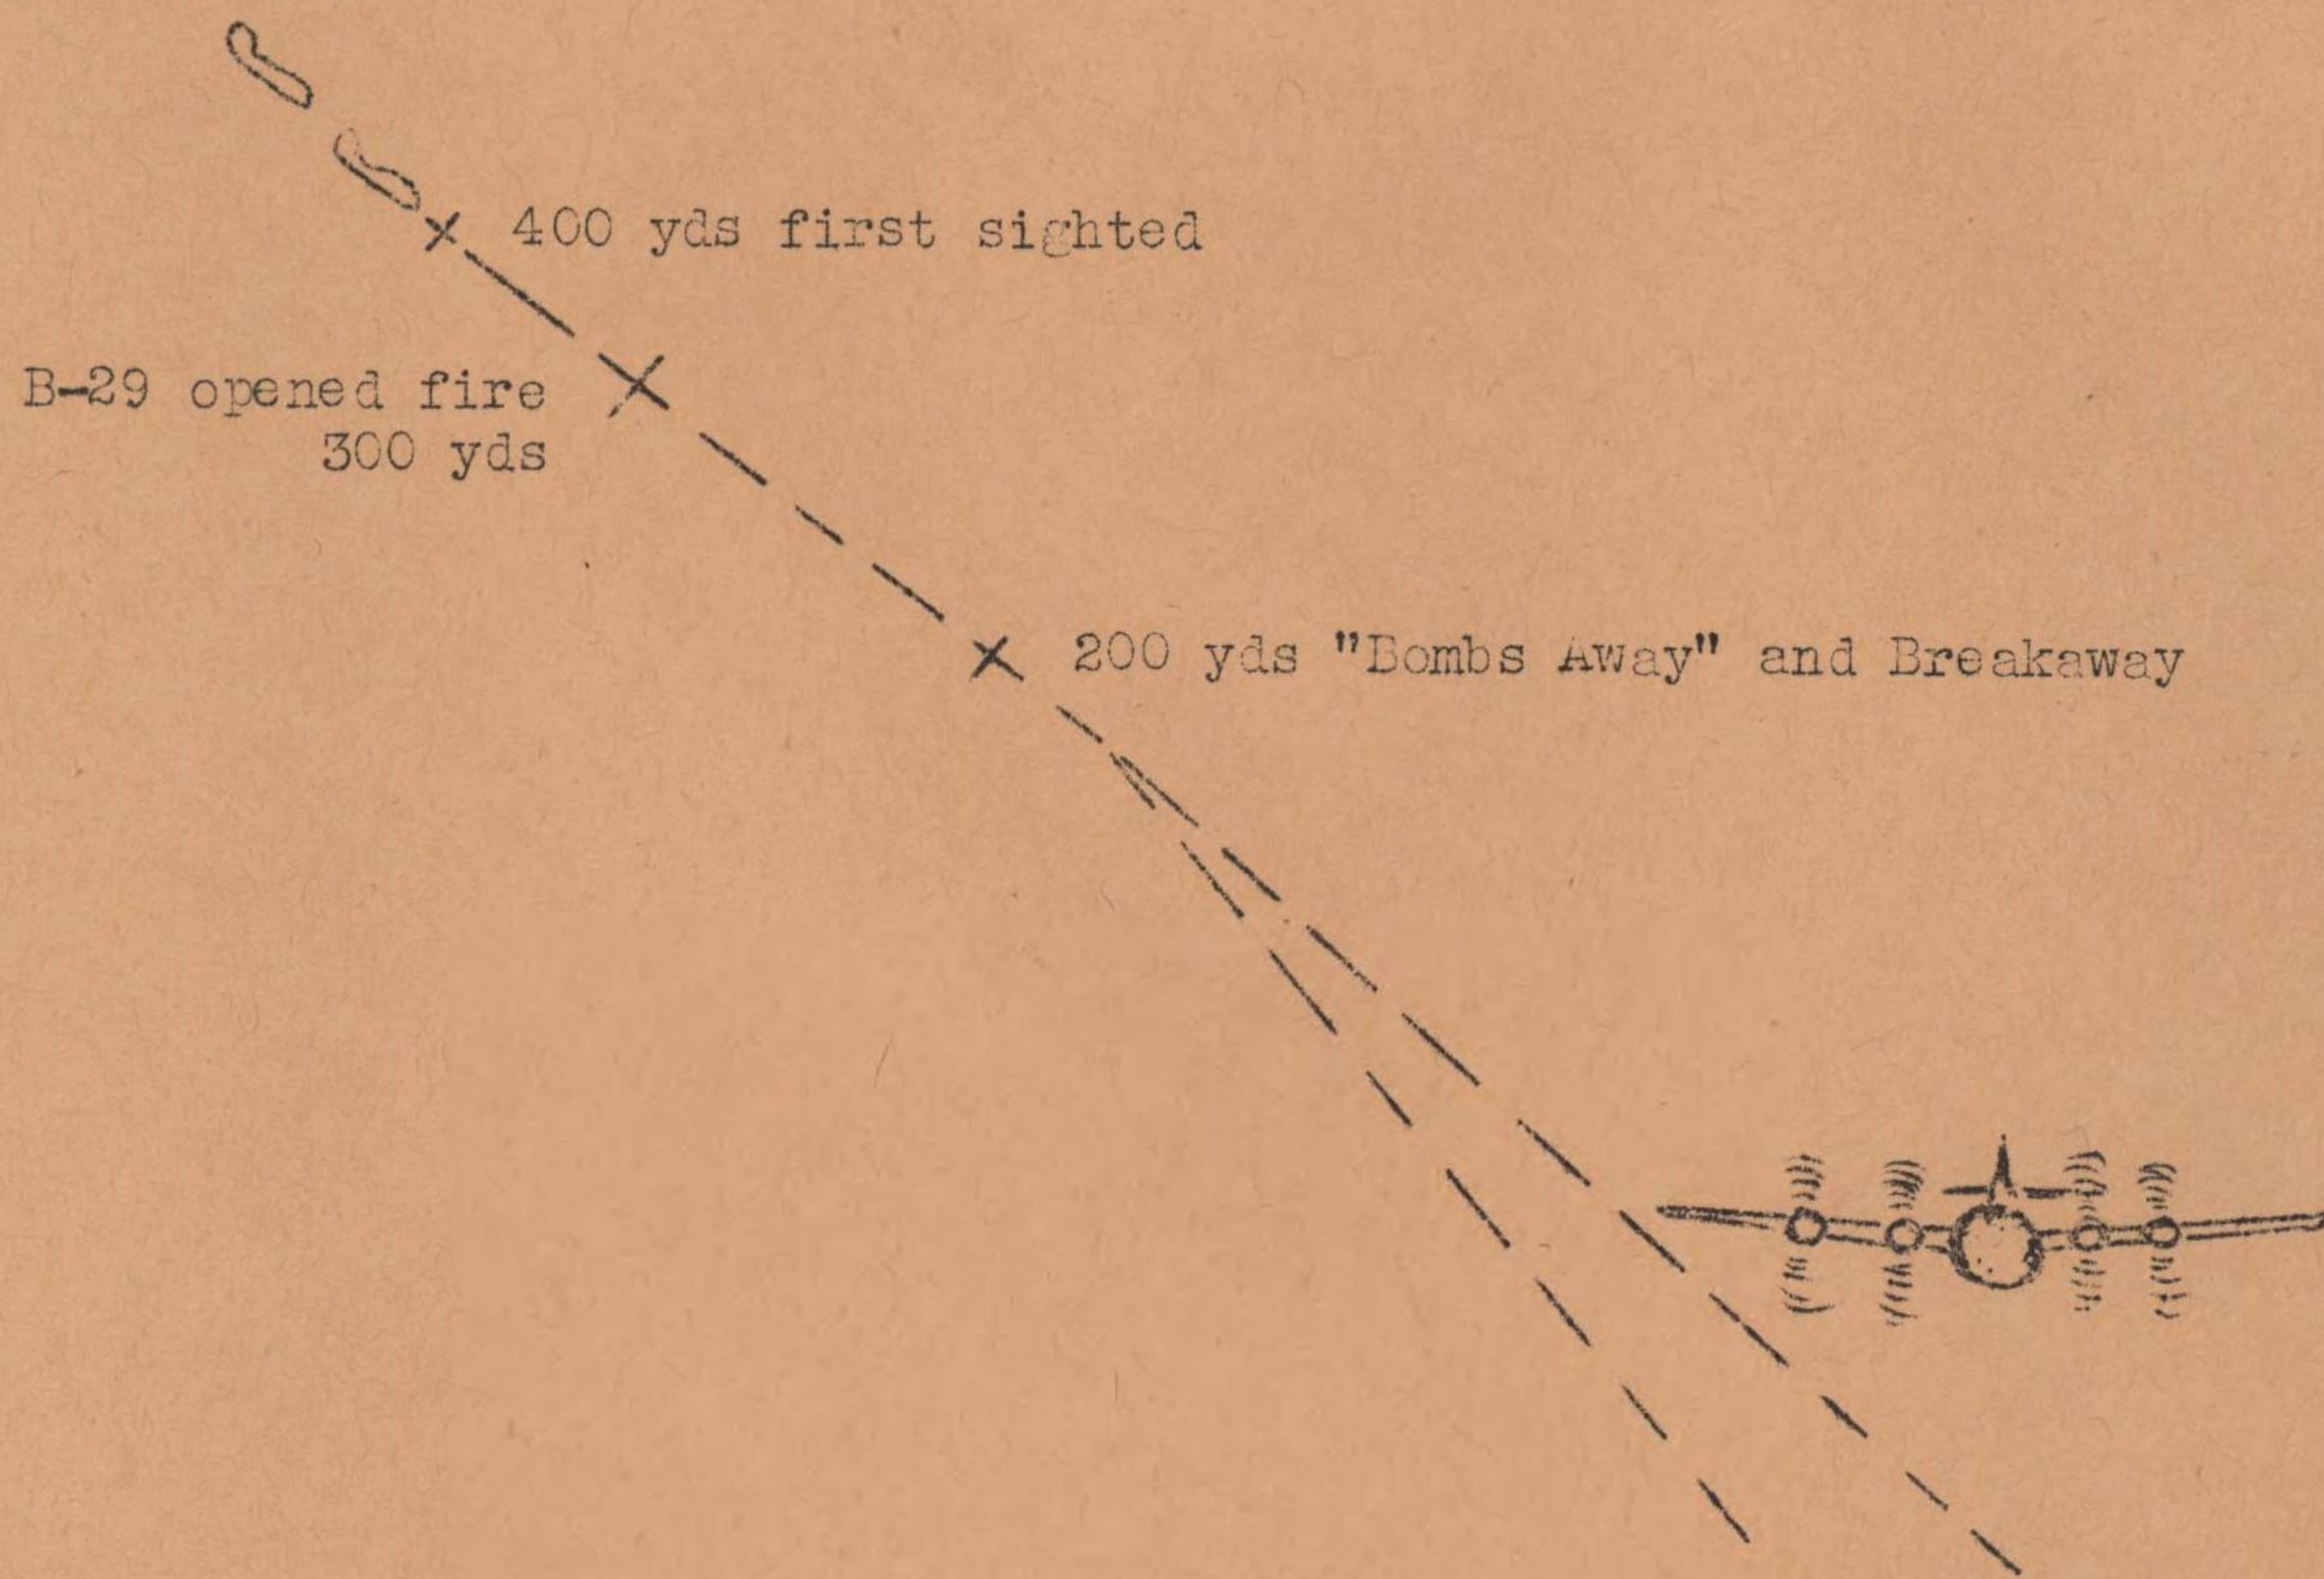
e. A coordinated aerial bombing attack was executed by 2 Oscars who came in one after the other from 3 o'clock, high. They were sighted at 400 yards, and closed to 200 yards where they made tight turns and "flipped" their bombs over. They broke away at 200 yards, the first to 11 o'clock, low, and the second, after flying along side the B-29 long enough to "flip" his bomb, to 10 o'clock, low. The B-29 fired at 300 yards and claimed a "probable" on the second Oscar. No damage was reported to the B-29. Diagram follows:

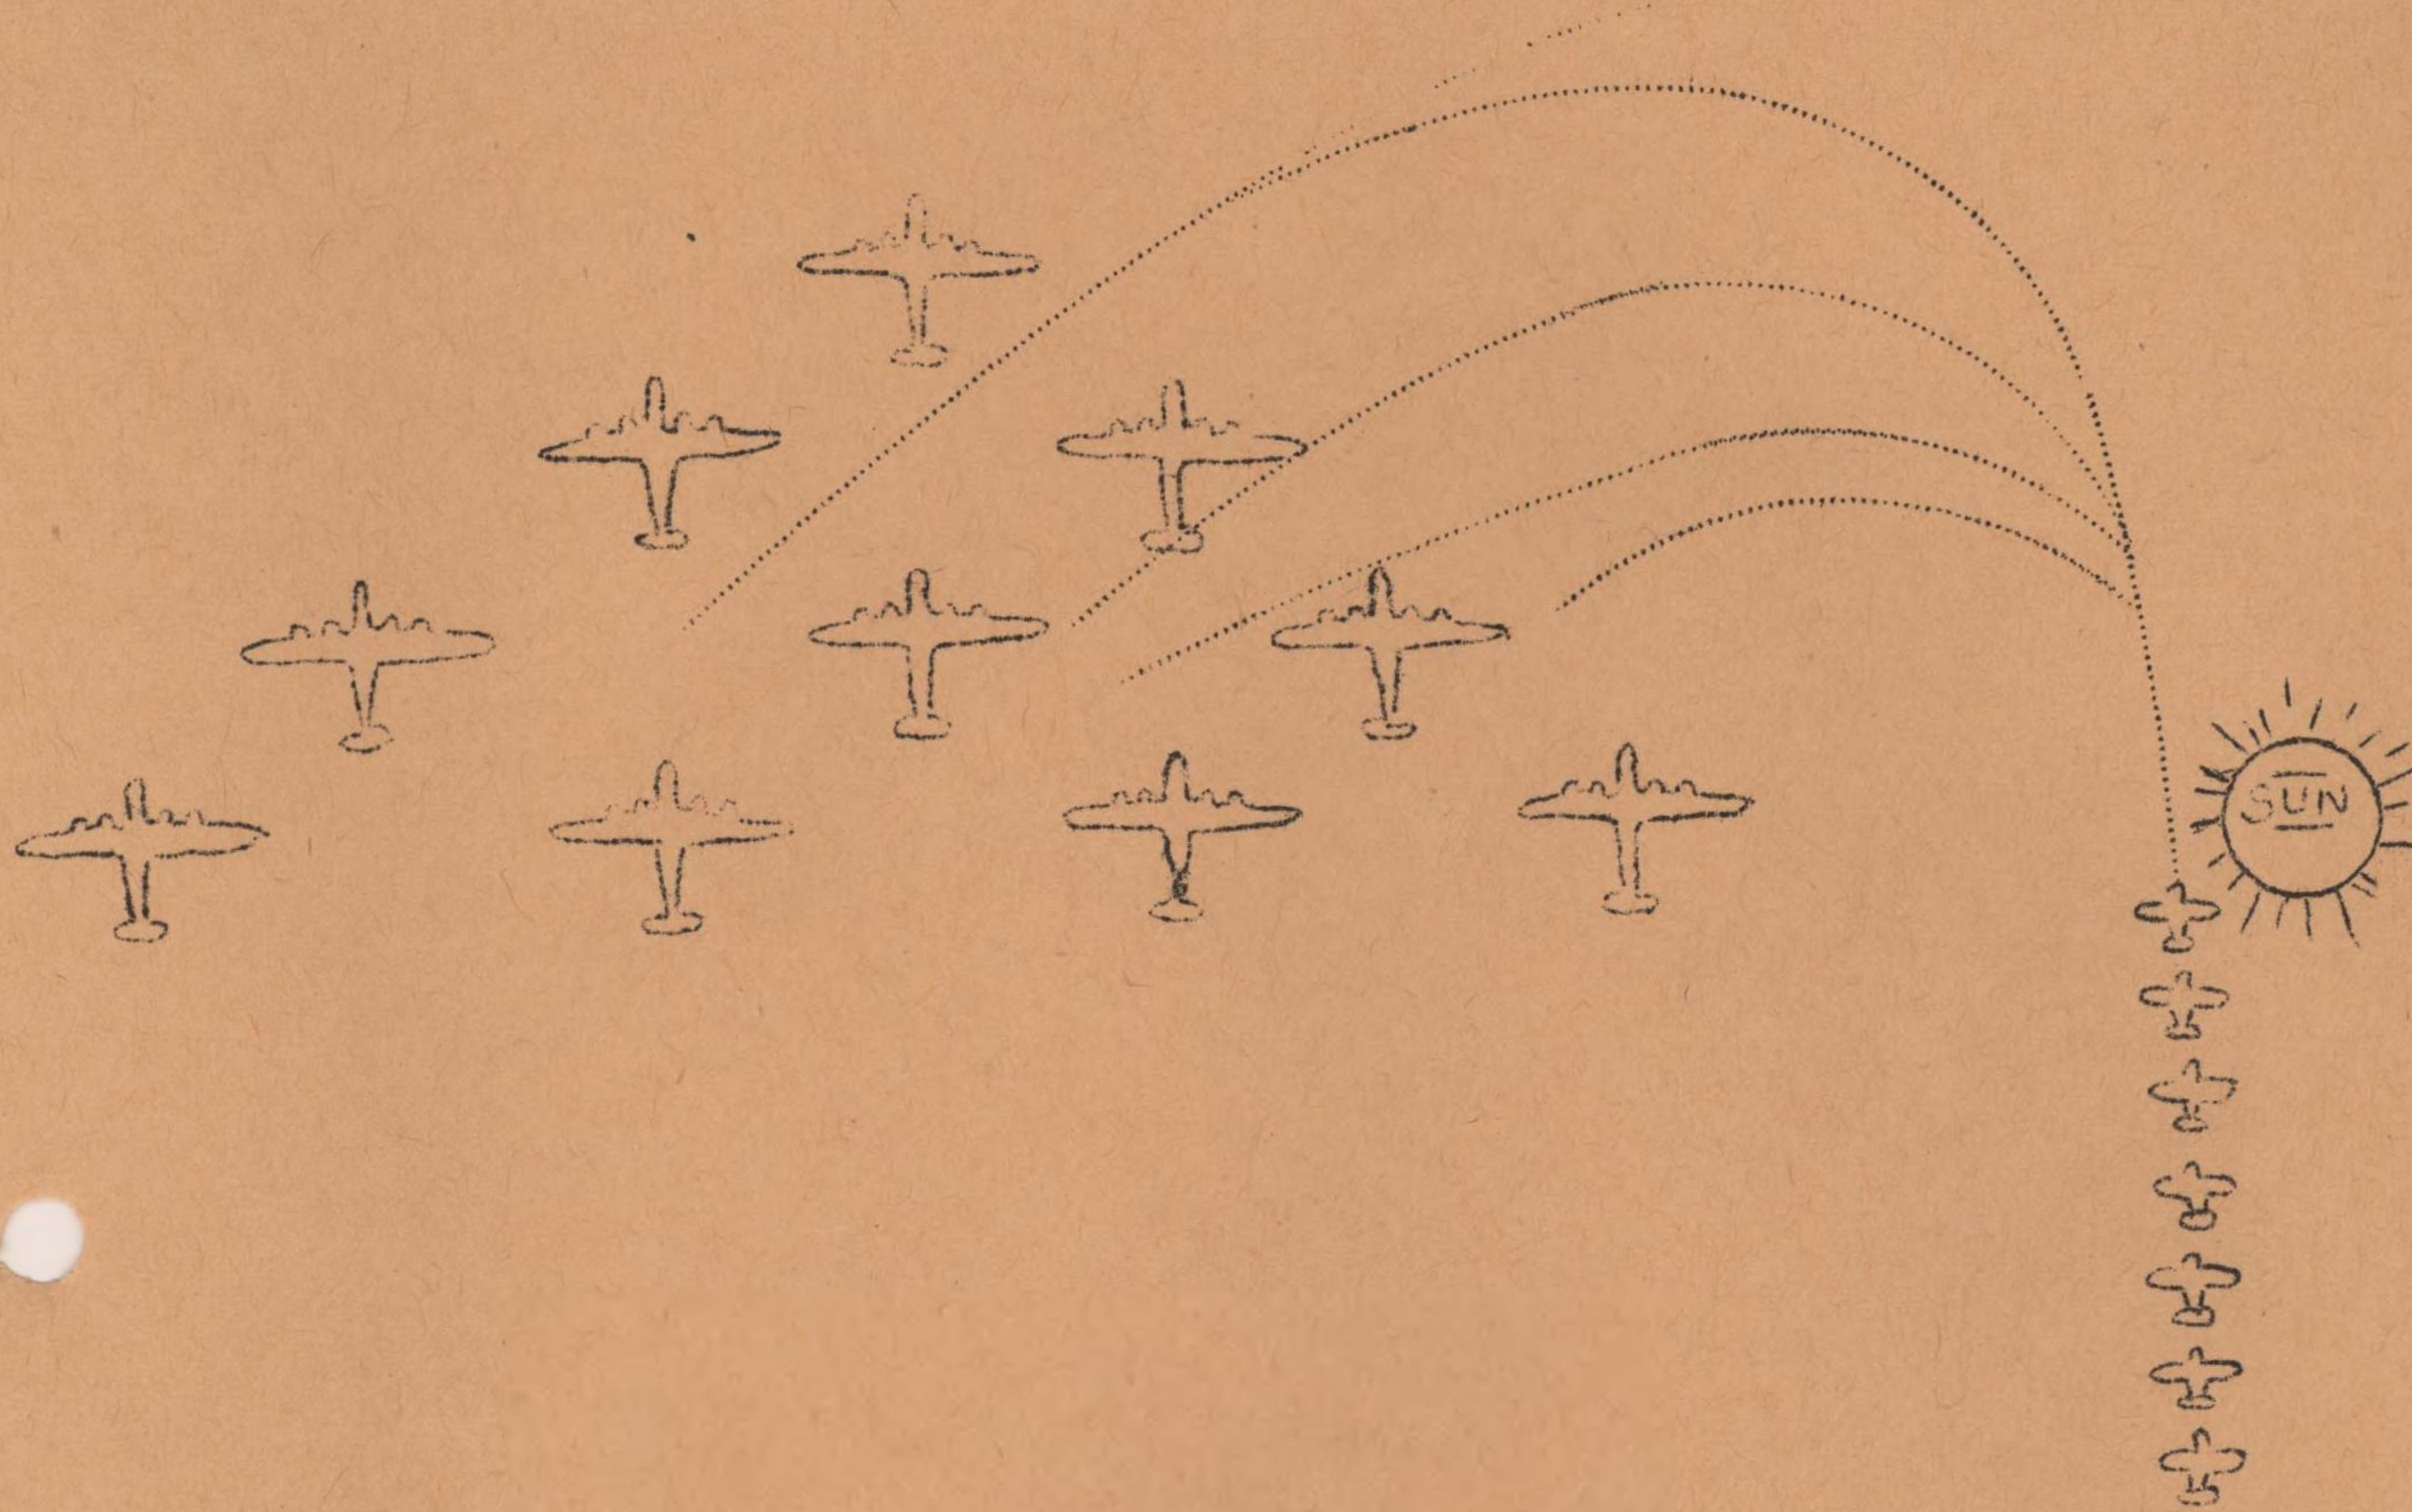
f. A "Chow Line" coordinated attack was witnessed by an observer in a nearby B-29 formation. Seven enemy fighters, possible Oscars, flying line astern, were high, to the right and rear of a formation, and in the sun. One after another they pulled forward toward the front of the B-29 formation, then banked sharply and turned in to attack, coming in high, between 1 and 3 o'clock. Several of the enemy aircraft were seen to fly right through the formations on their breakaways. (Exchange of fire and damage data not available).

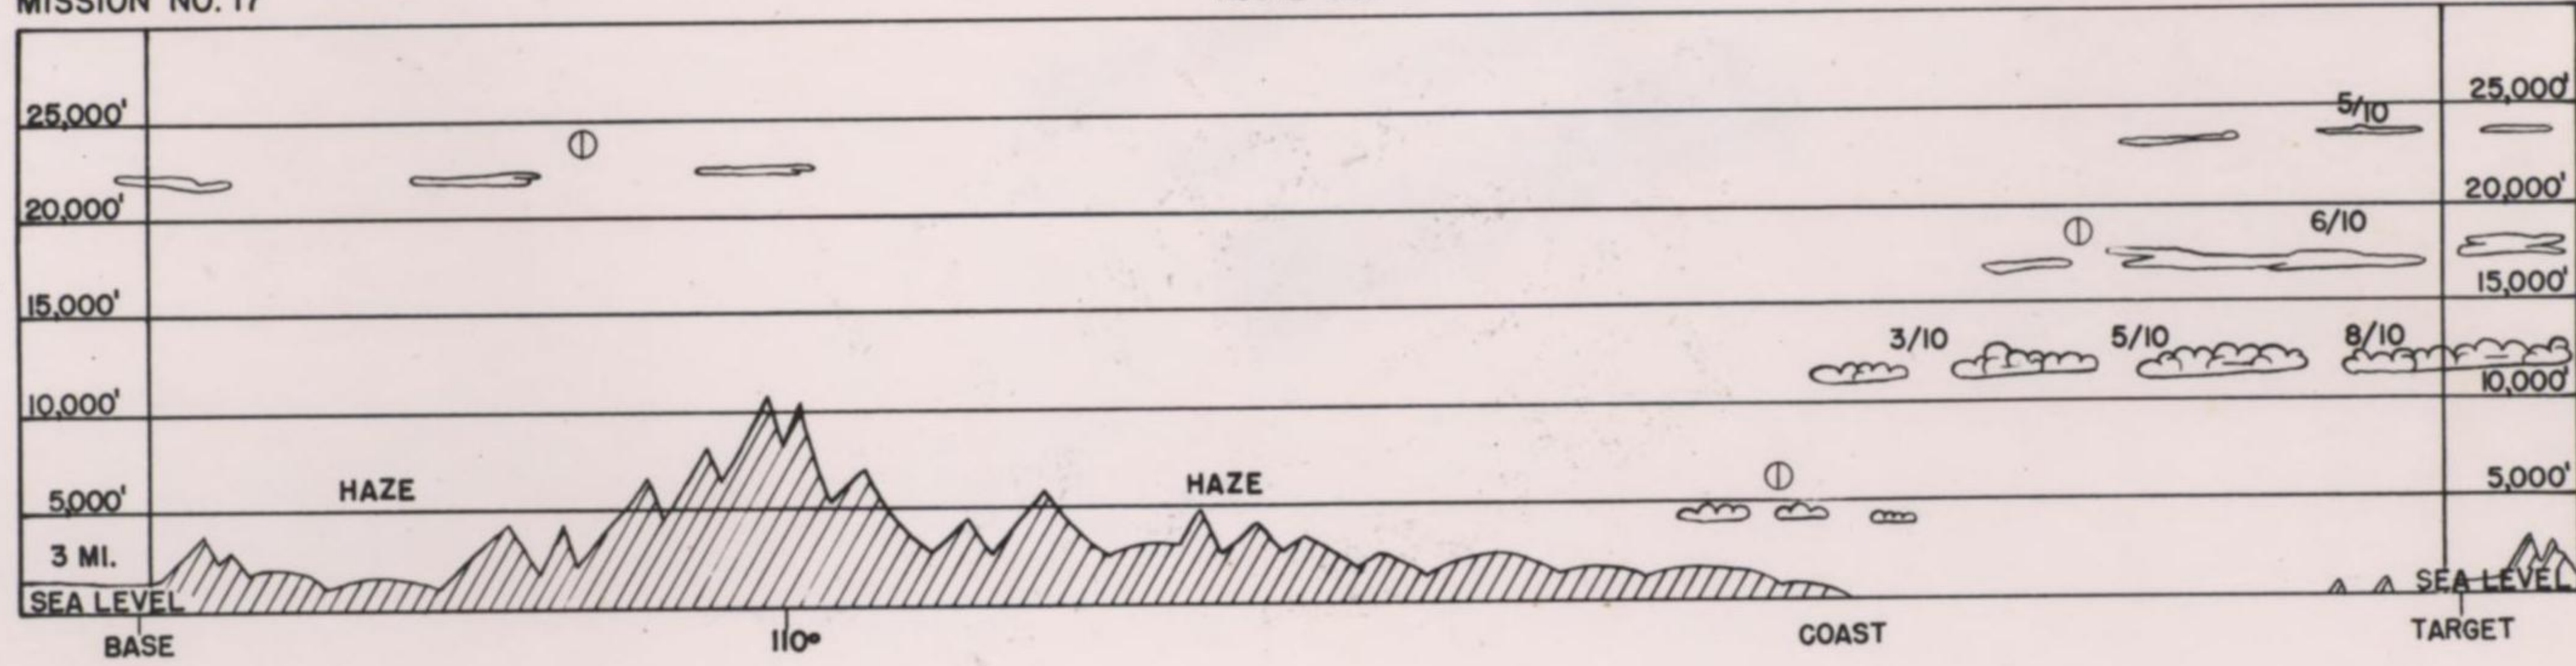
WEATHER AS ENCOUNTERED
ROUTE OUT

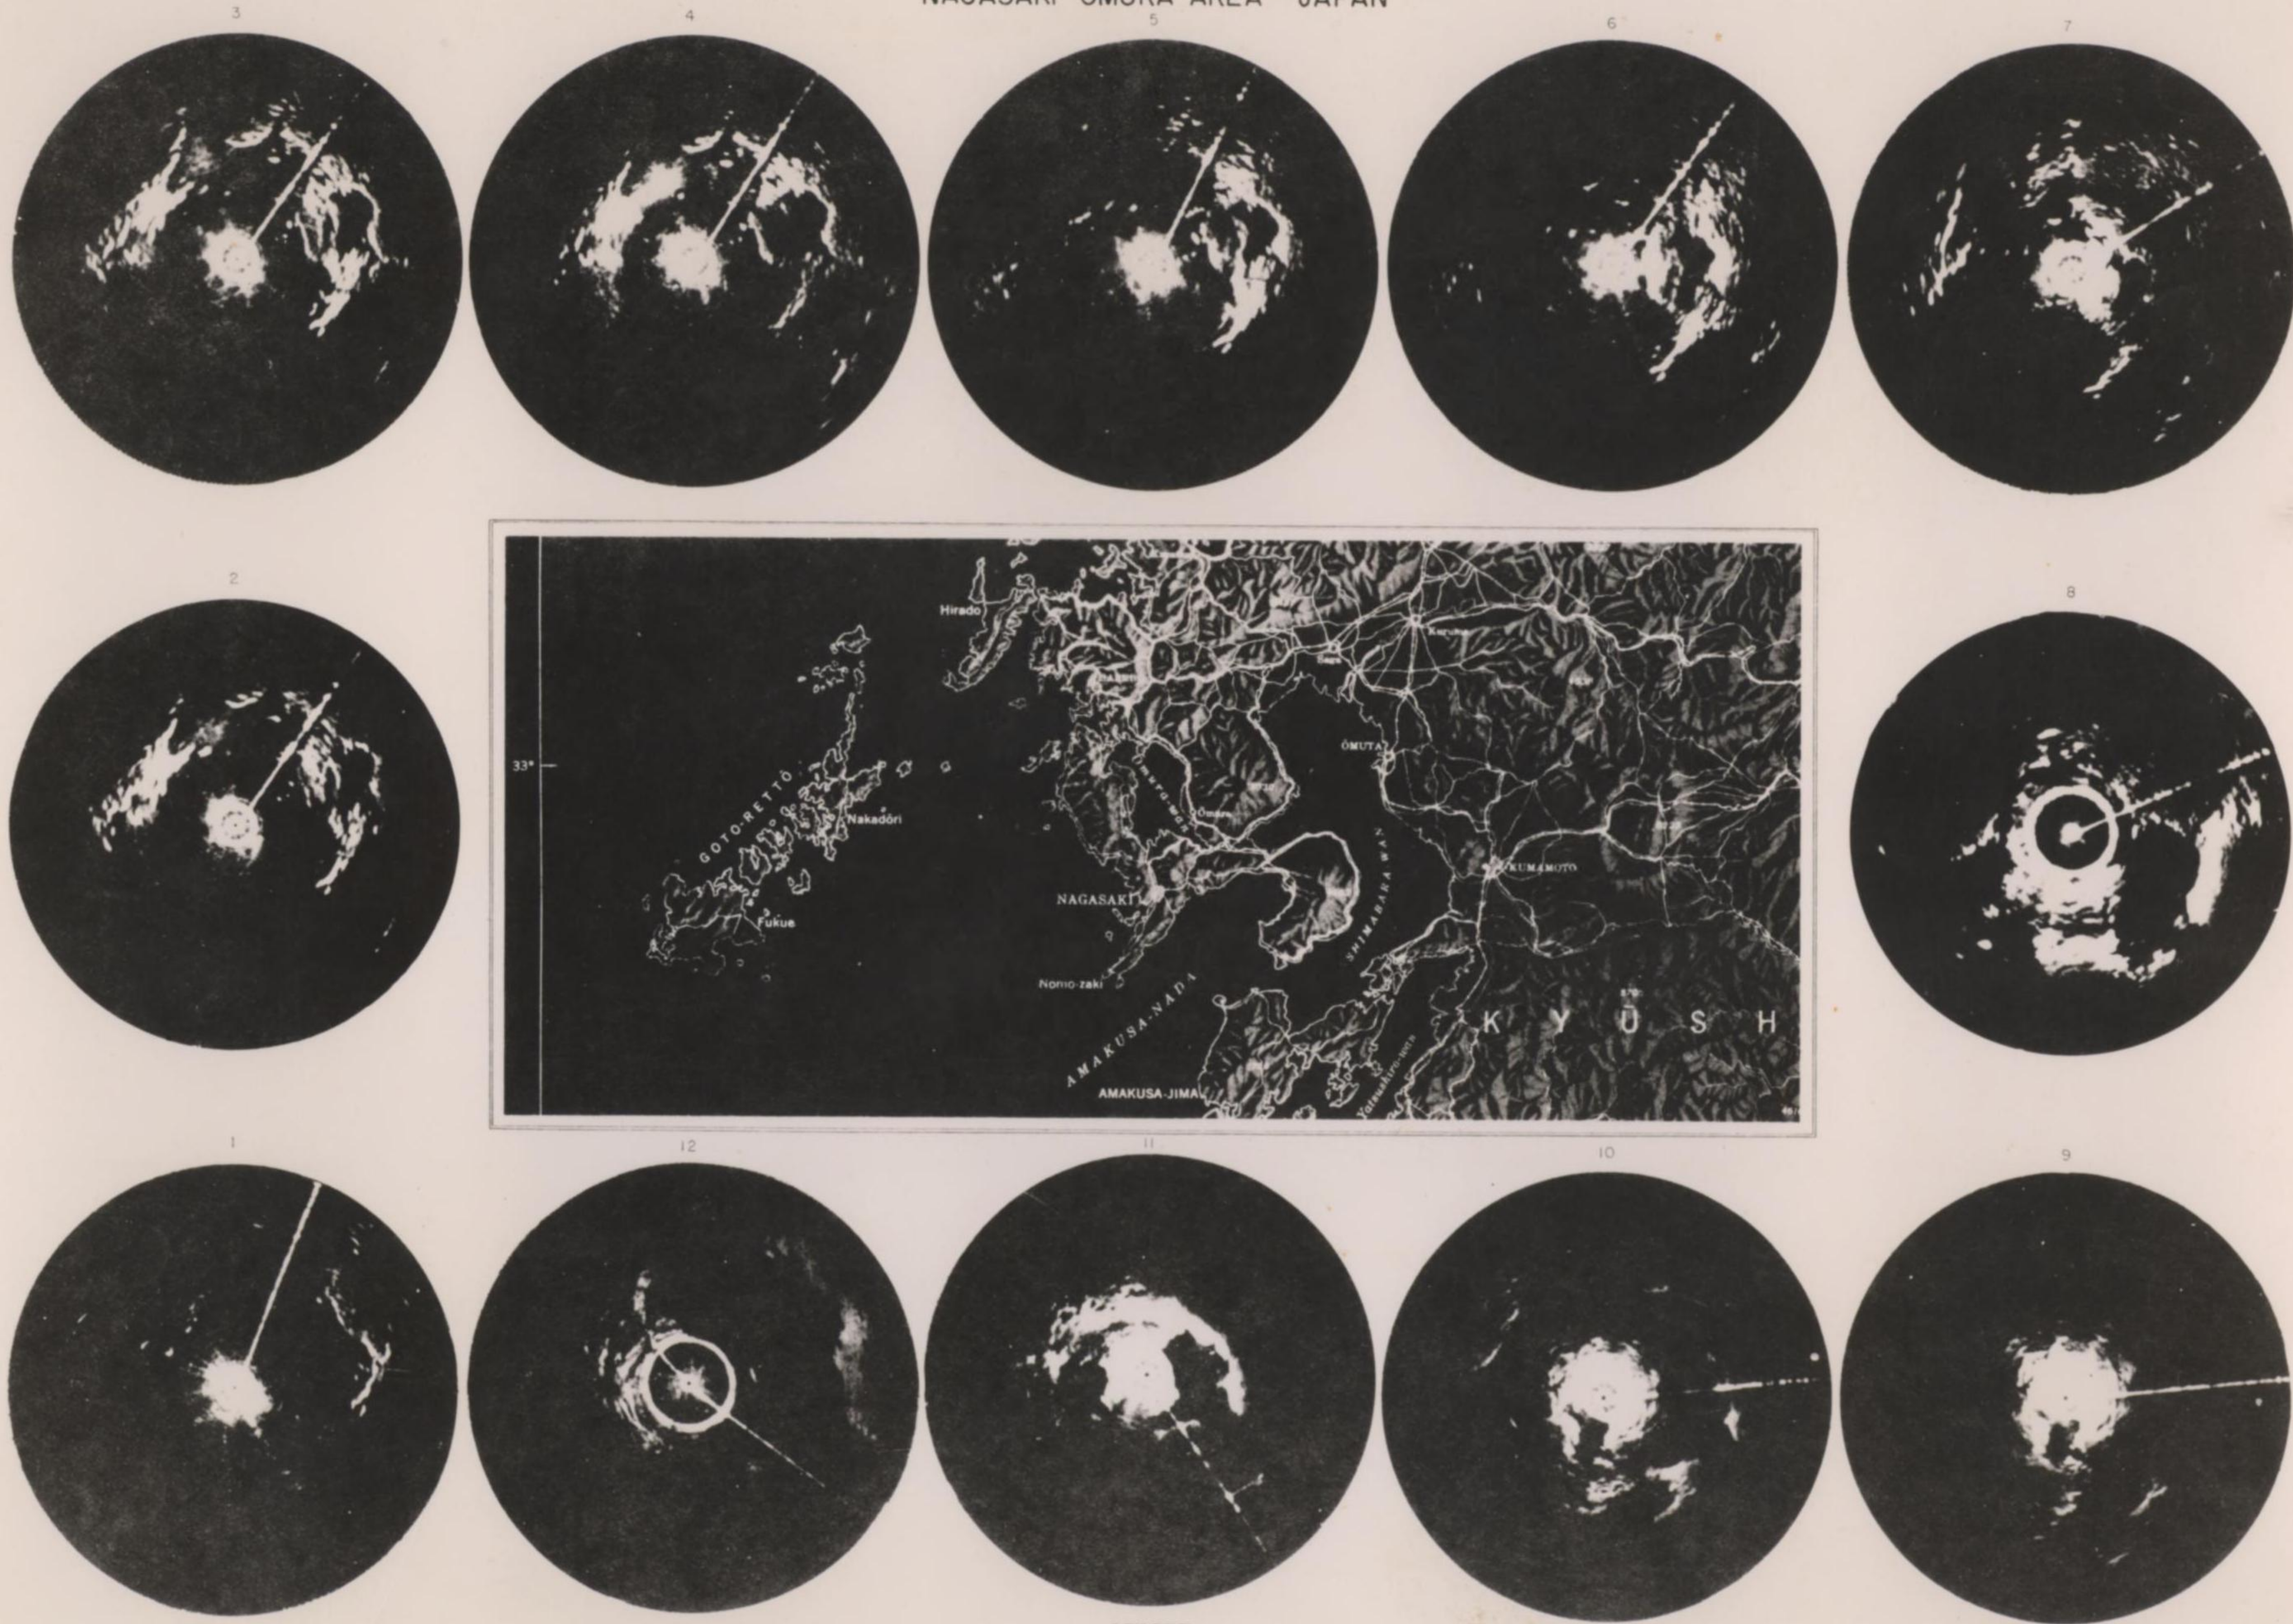
SHEET D

SECRET
RADAR SCOPE PHOTOGRAPHS
NAGASAKI-OMURA AREA - JAPAN
