MISSION NO. 17

TACTICAL MISSION REPORT

OMURA AIRCRAFT PLANT

21 NOVEMBER 1944

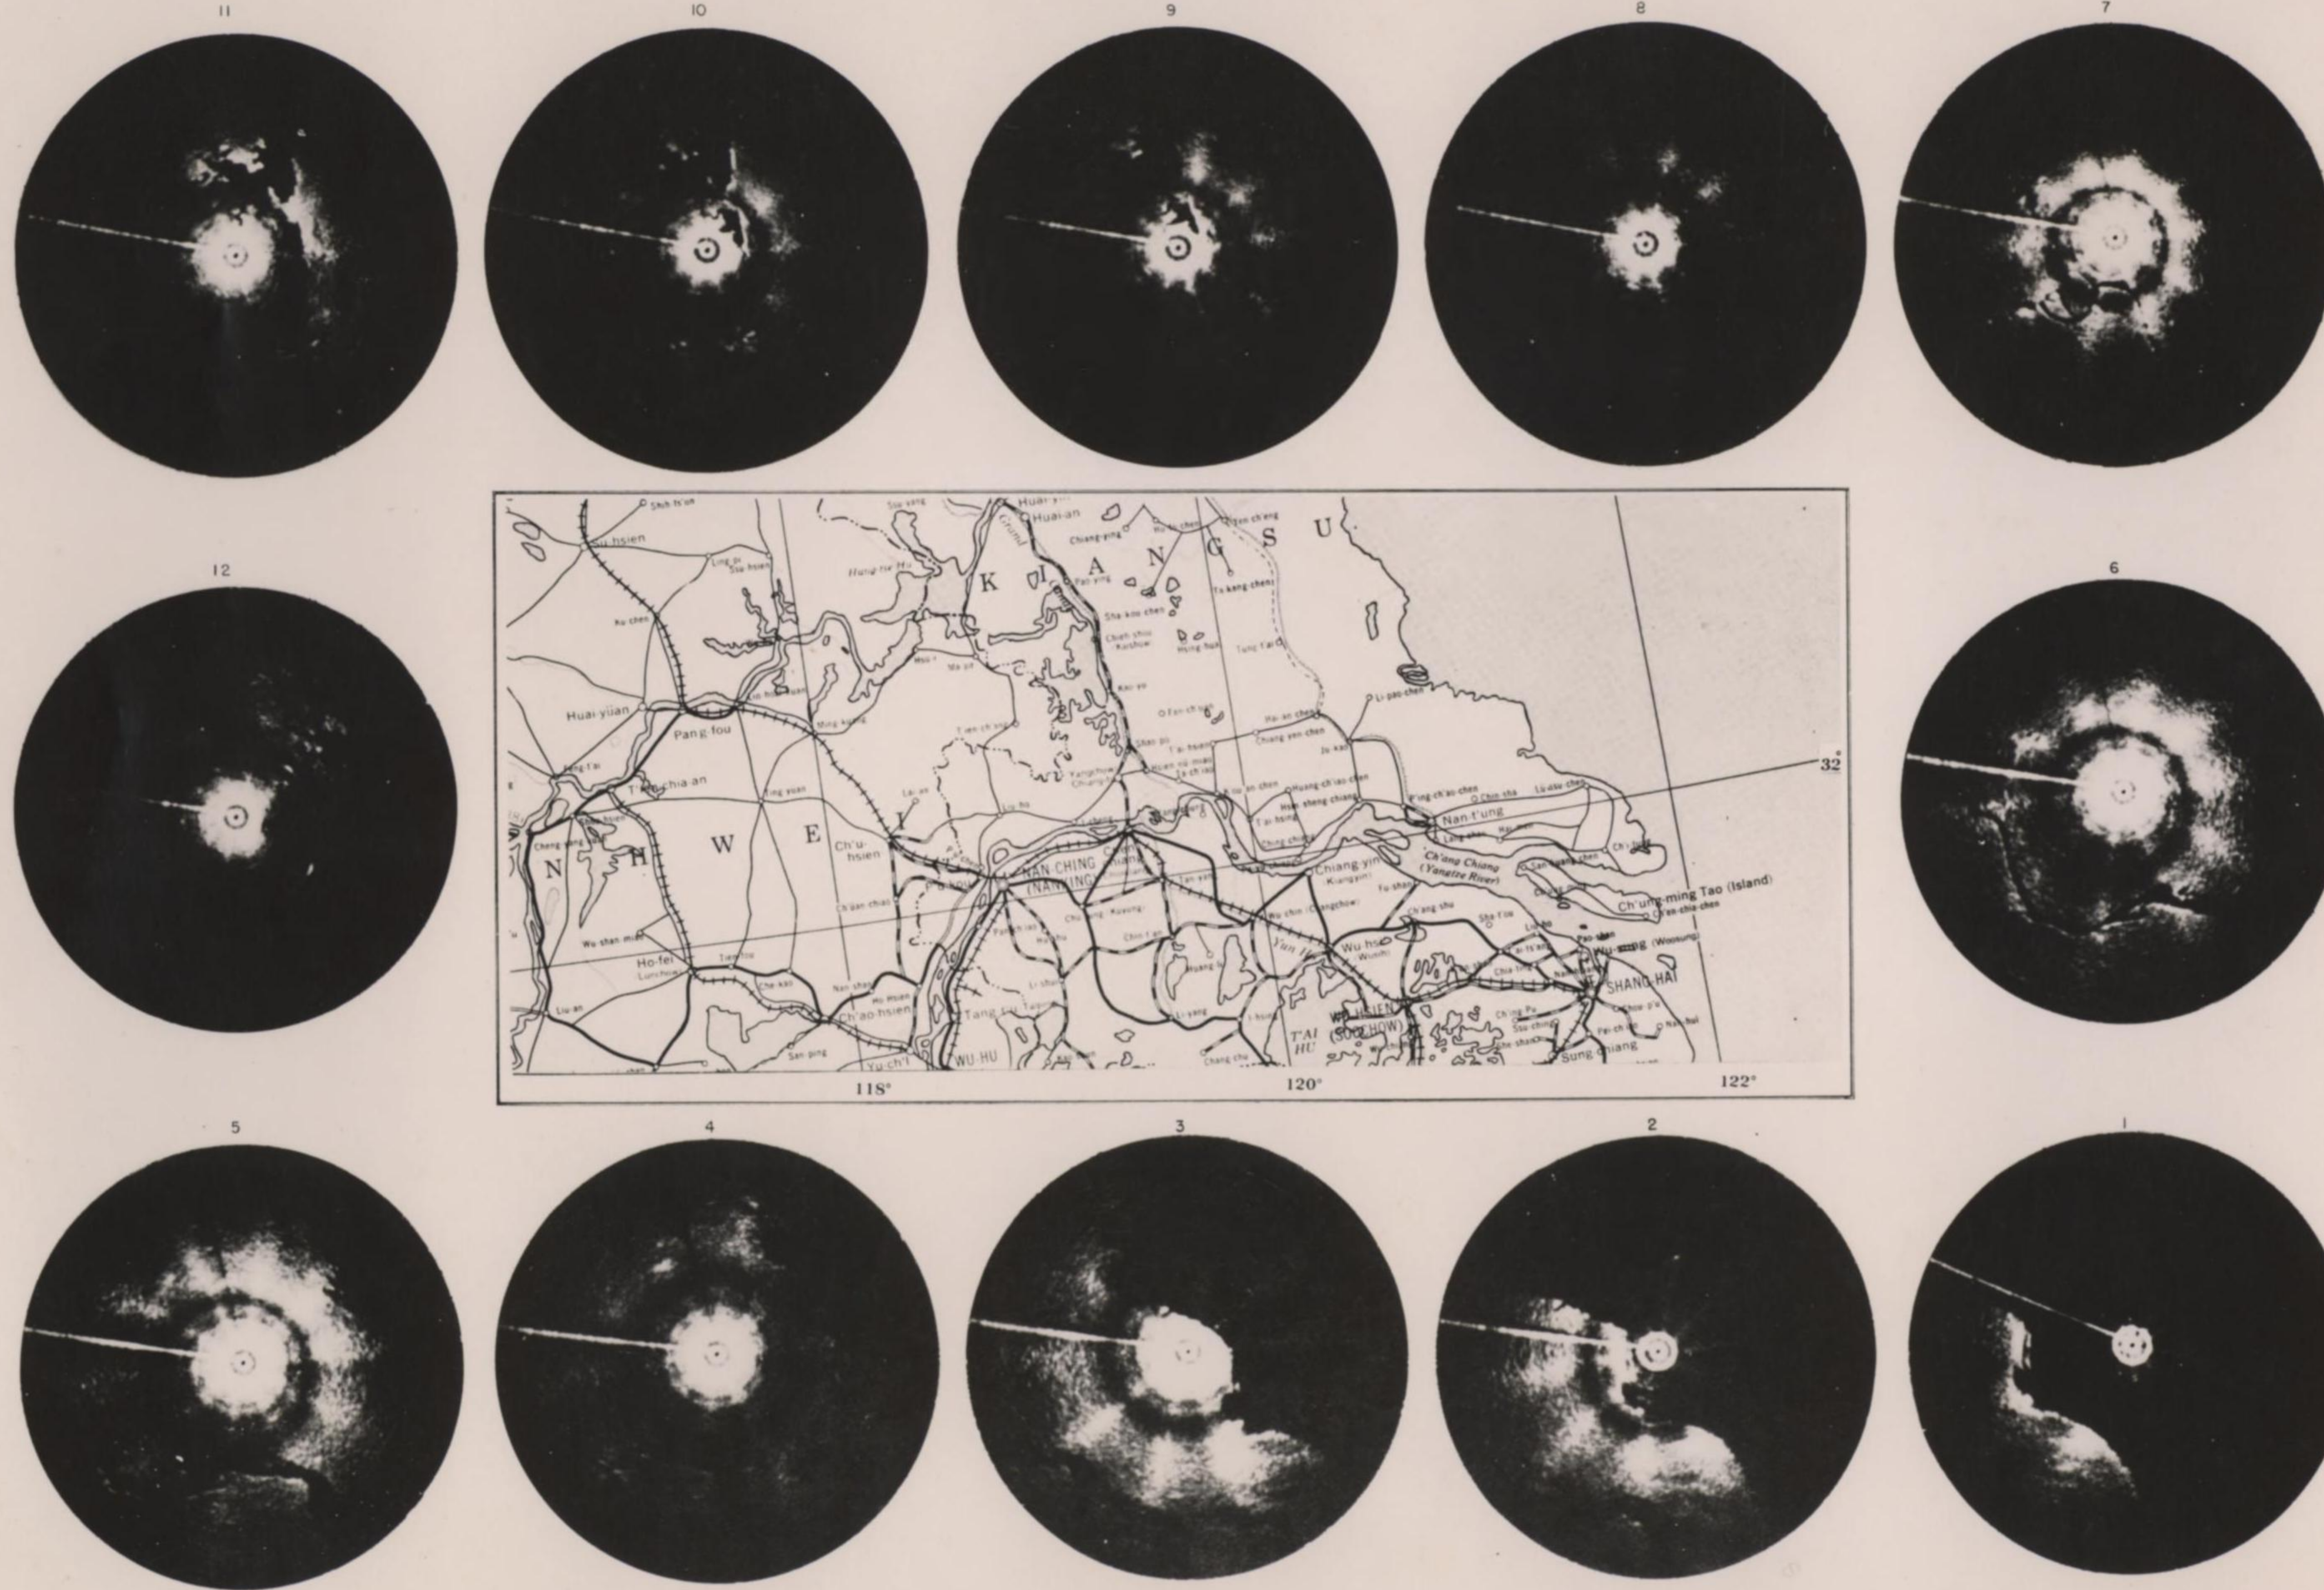
SHEET A

RADAR SCOPE PHOTOGRAPHS
YANGTZE RIVER-PAOYING LAKE-CHINA COAST AREA-CHINA

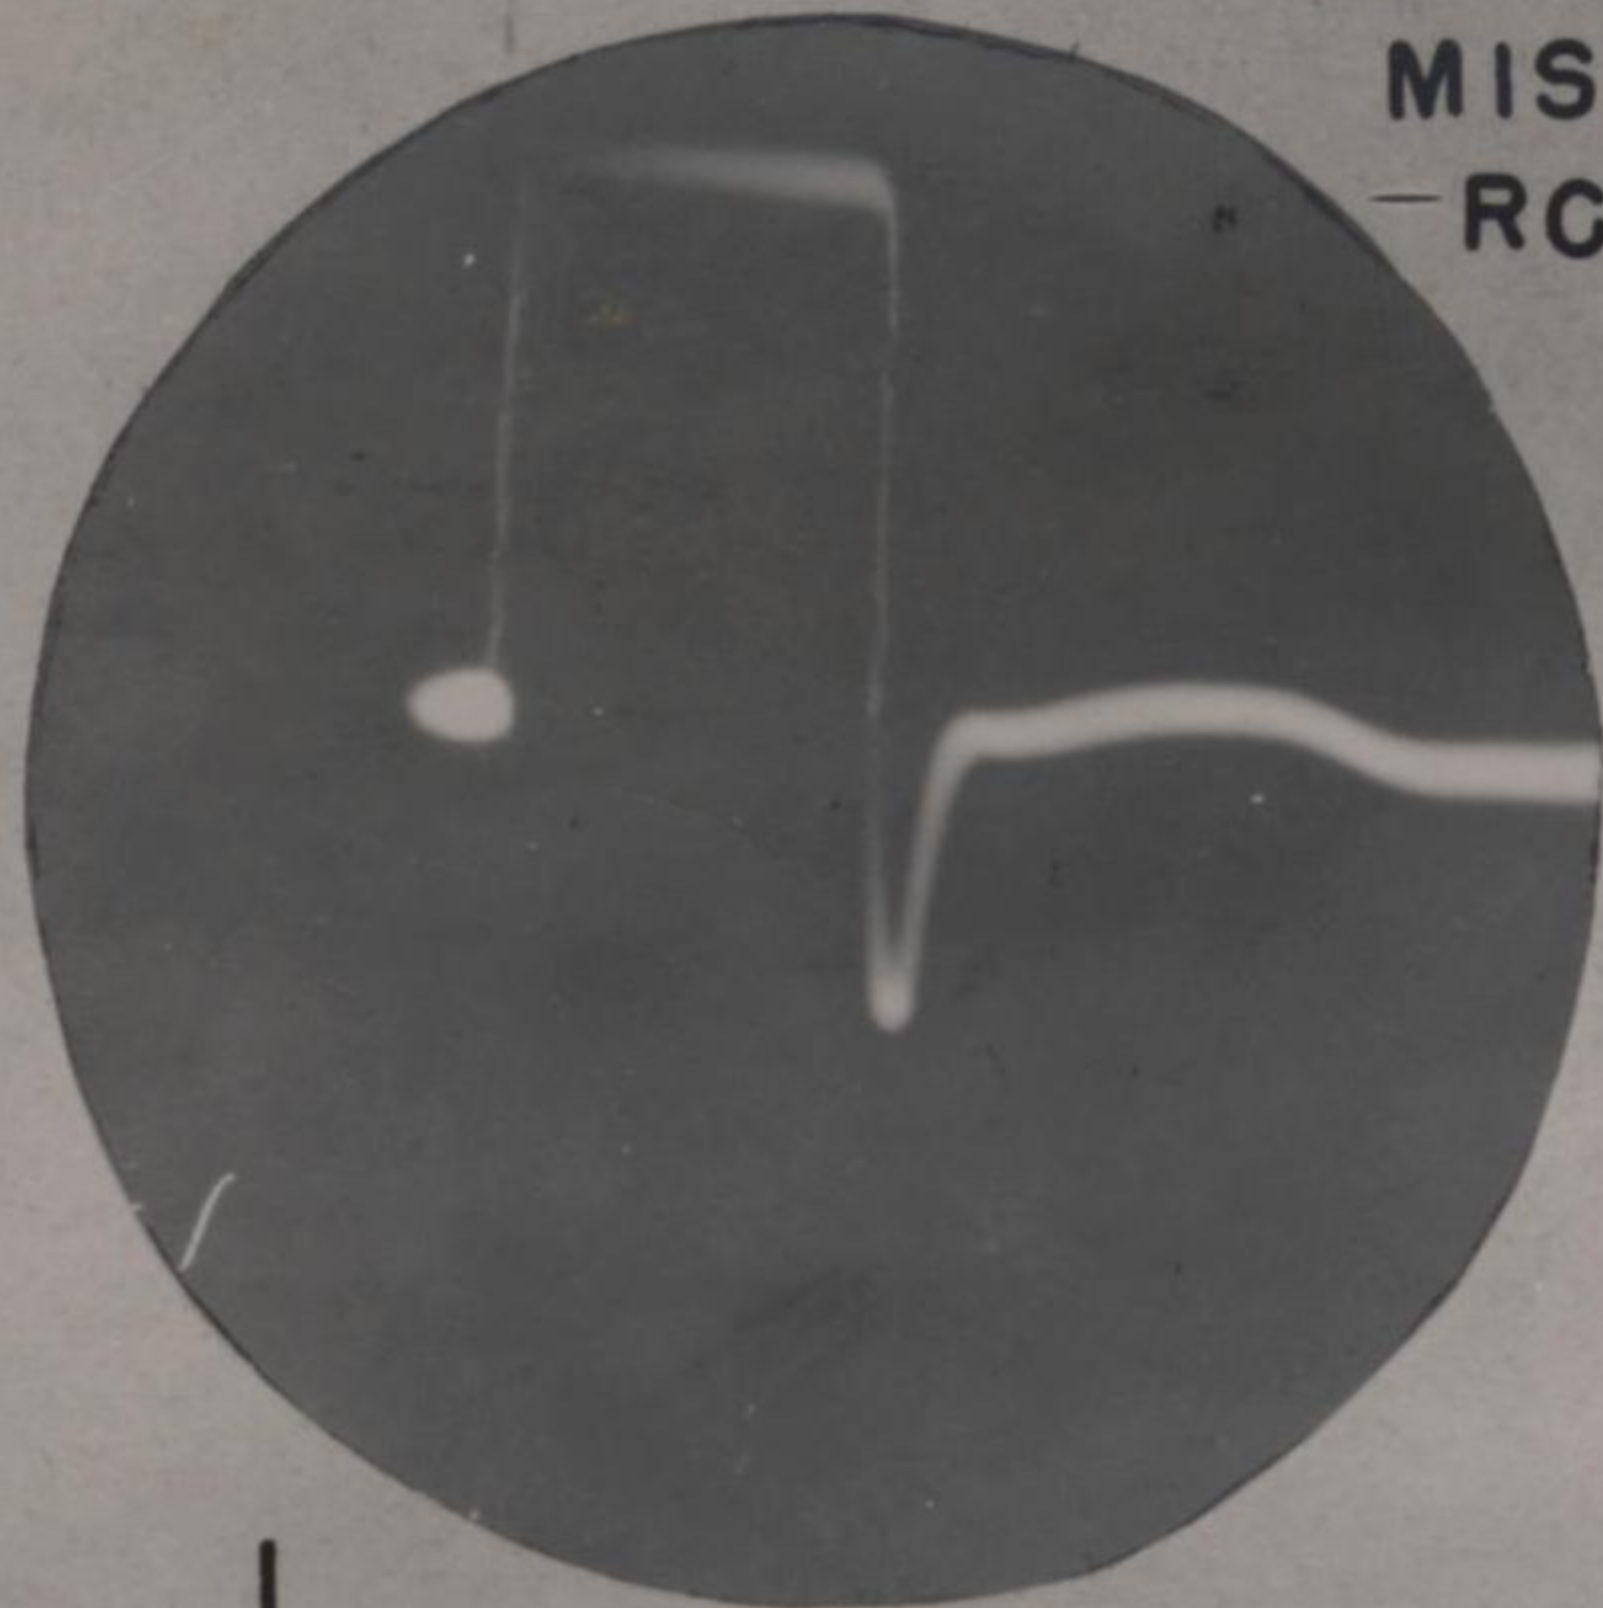
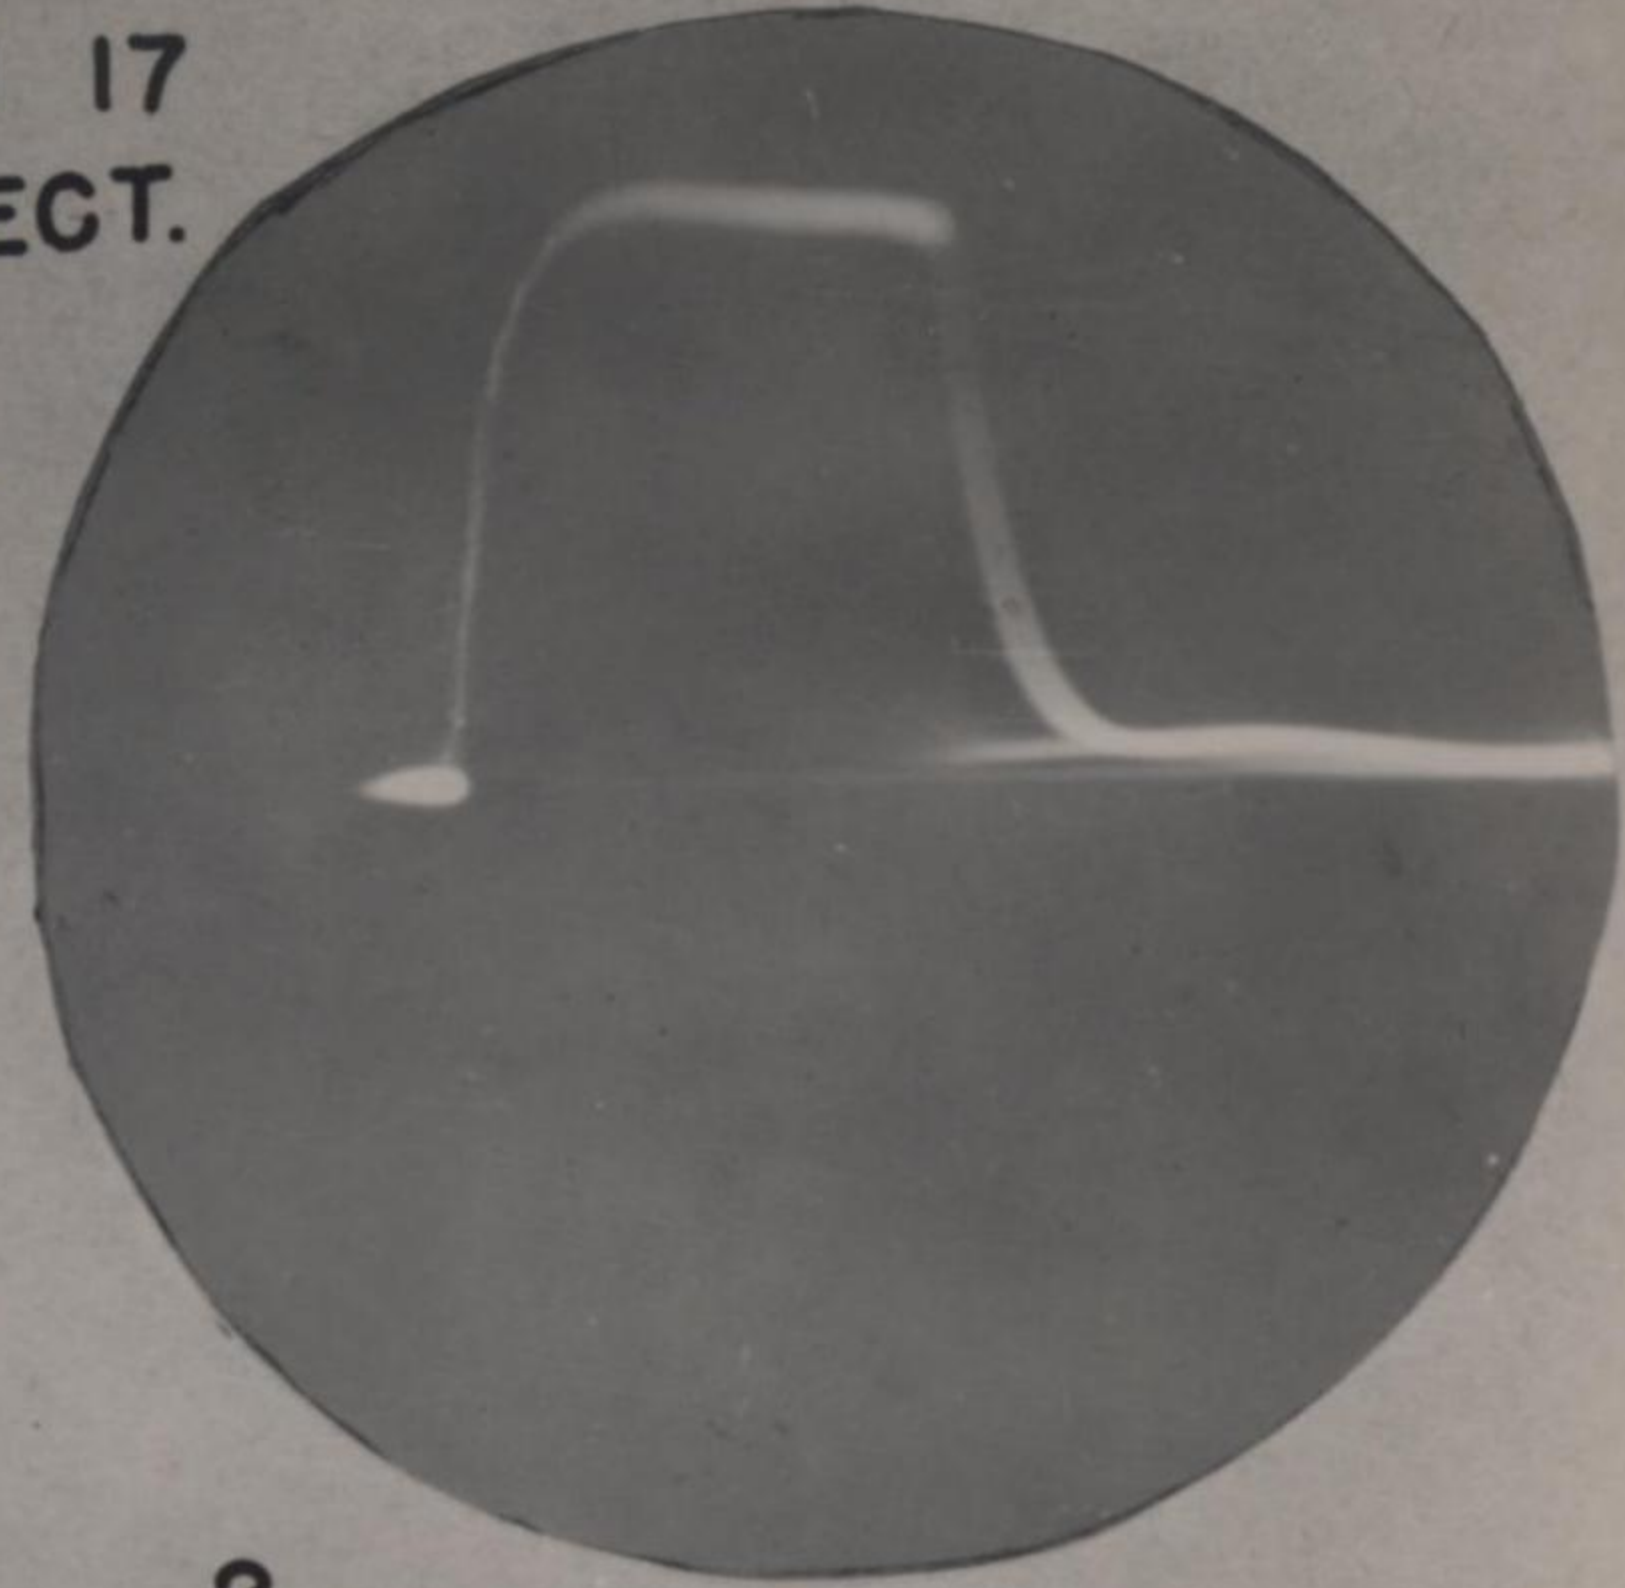
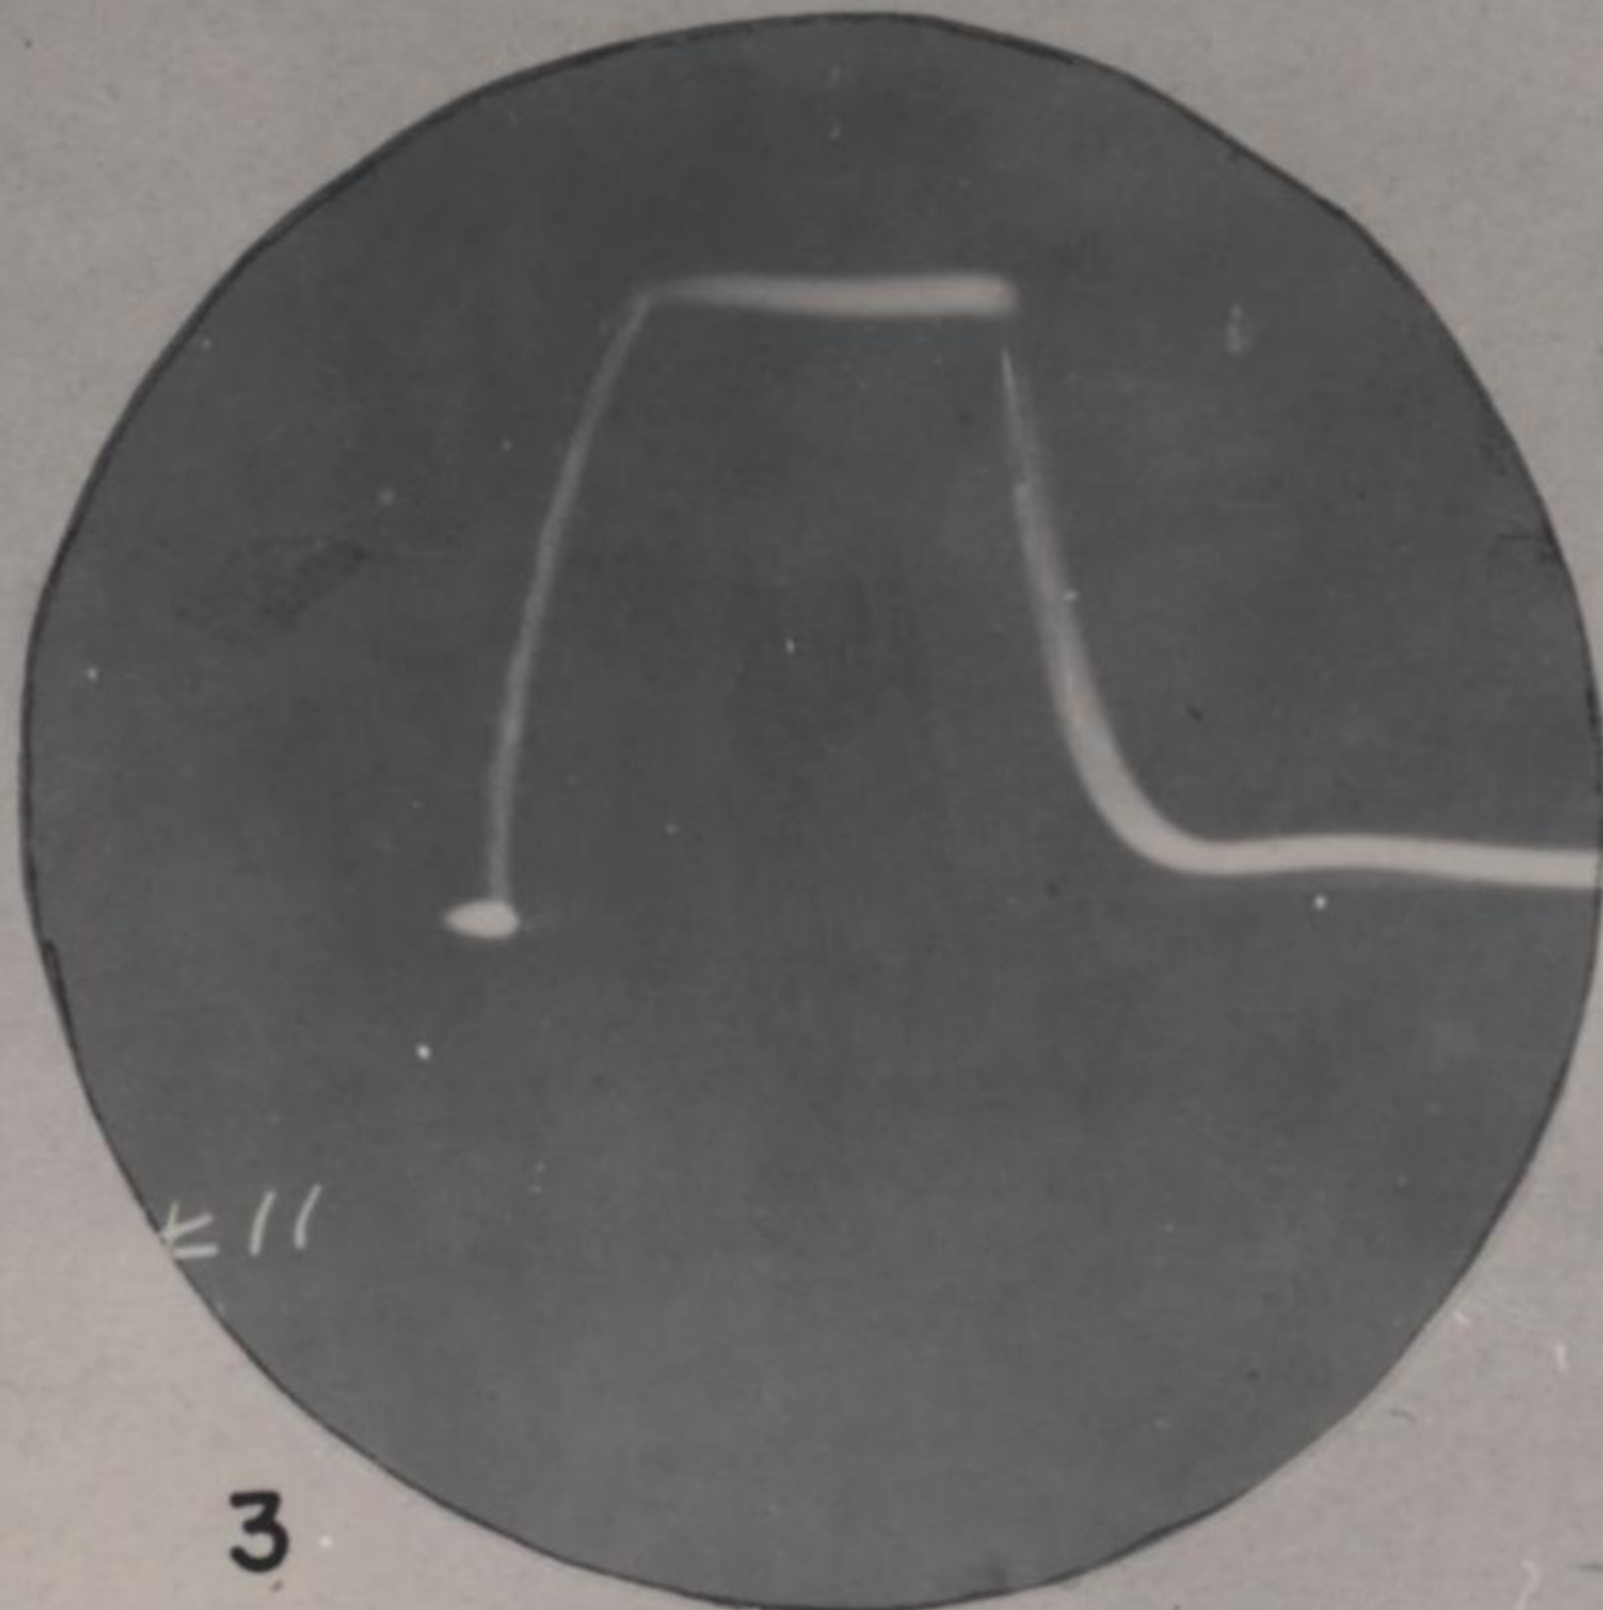
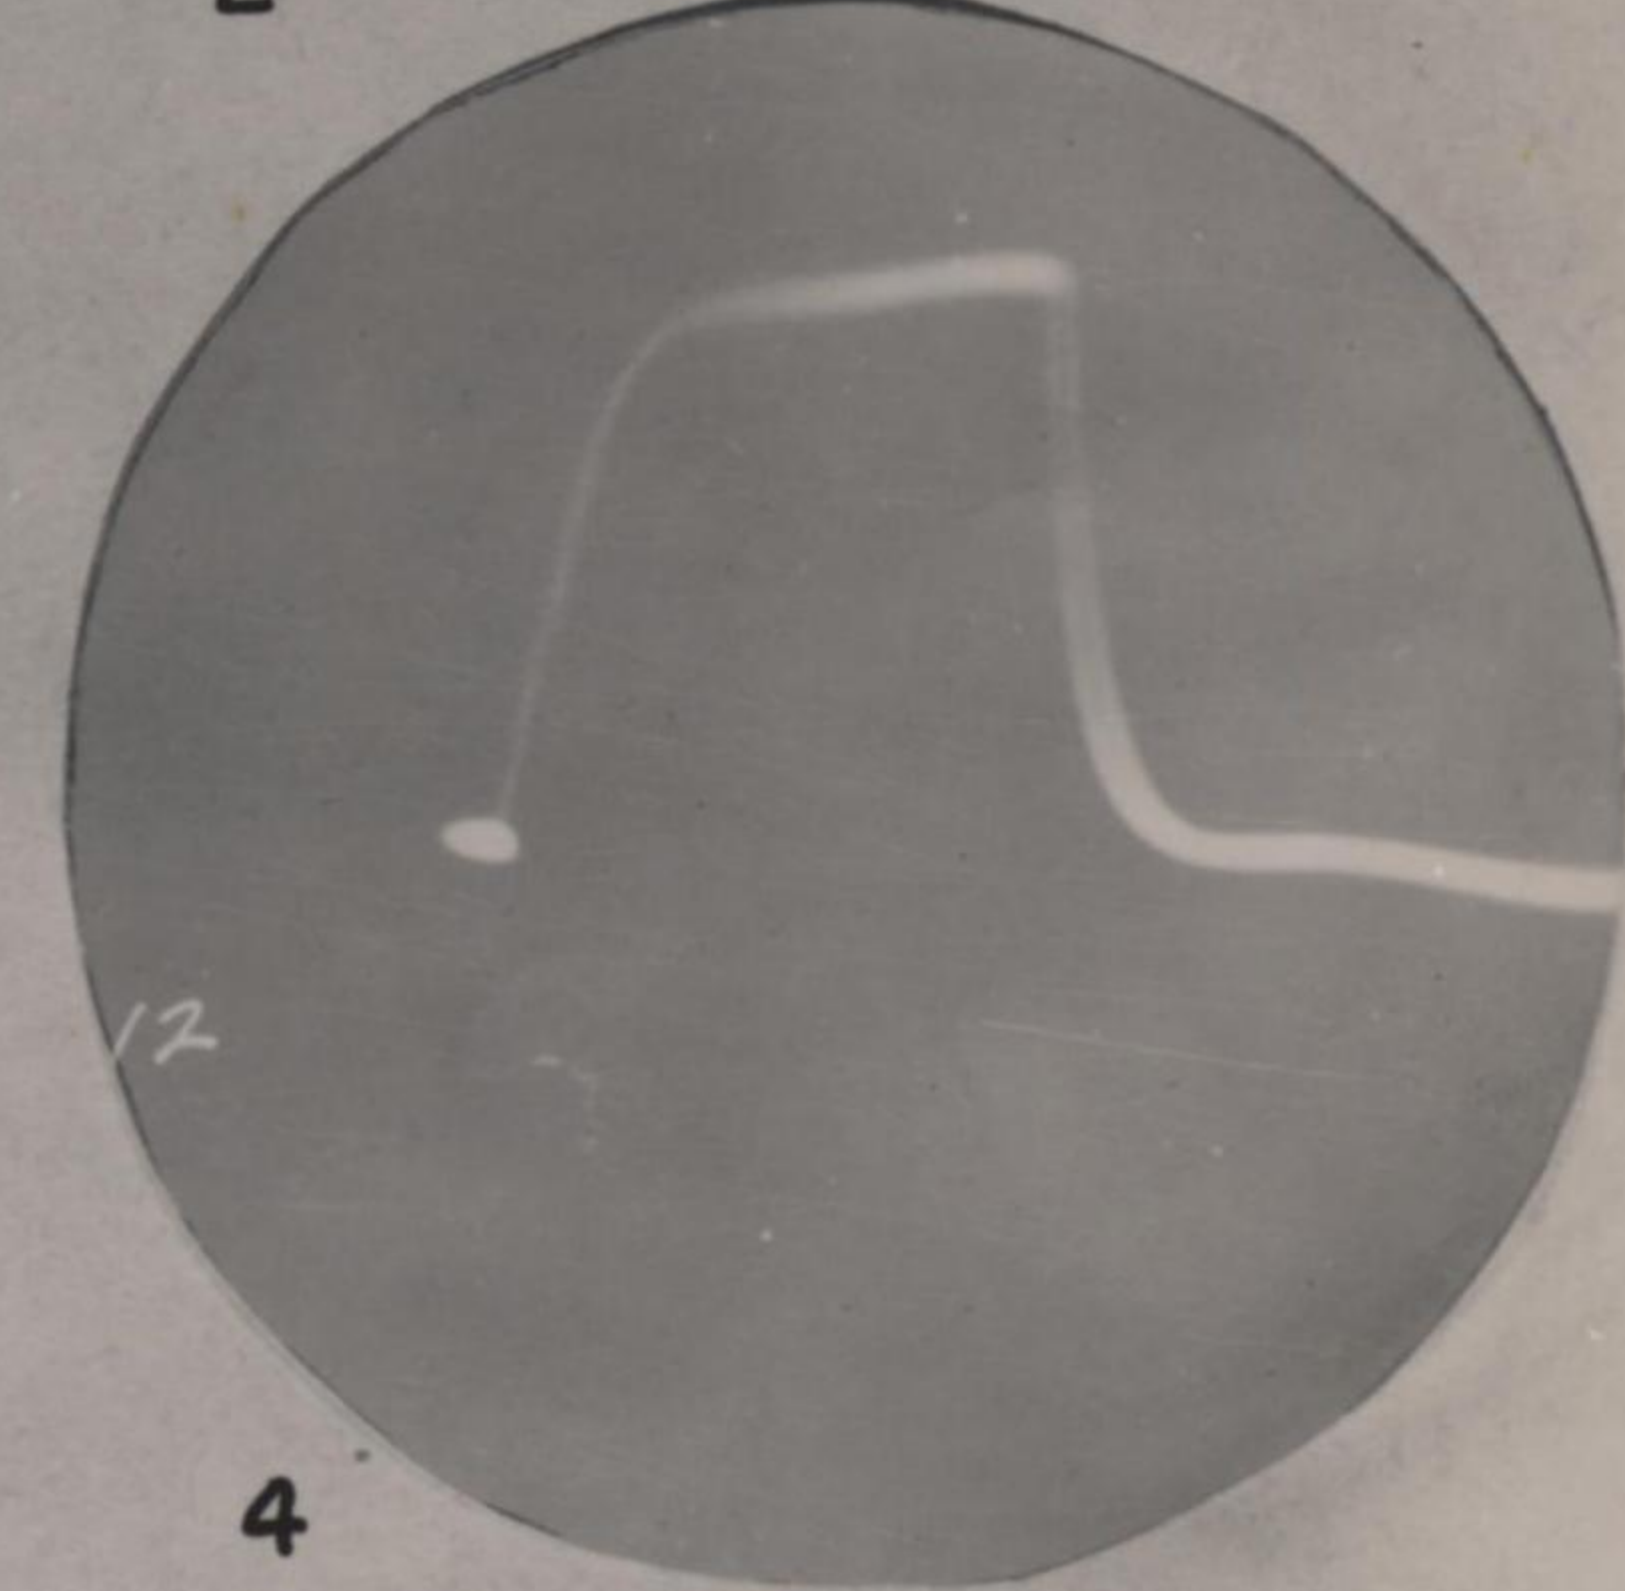
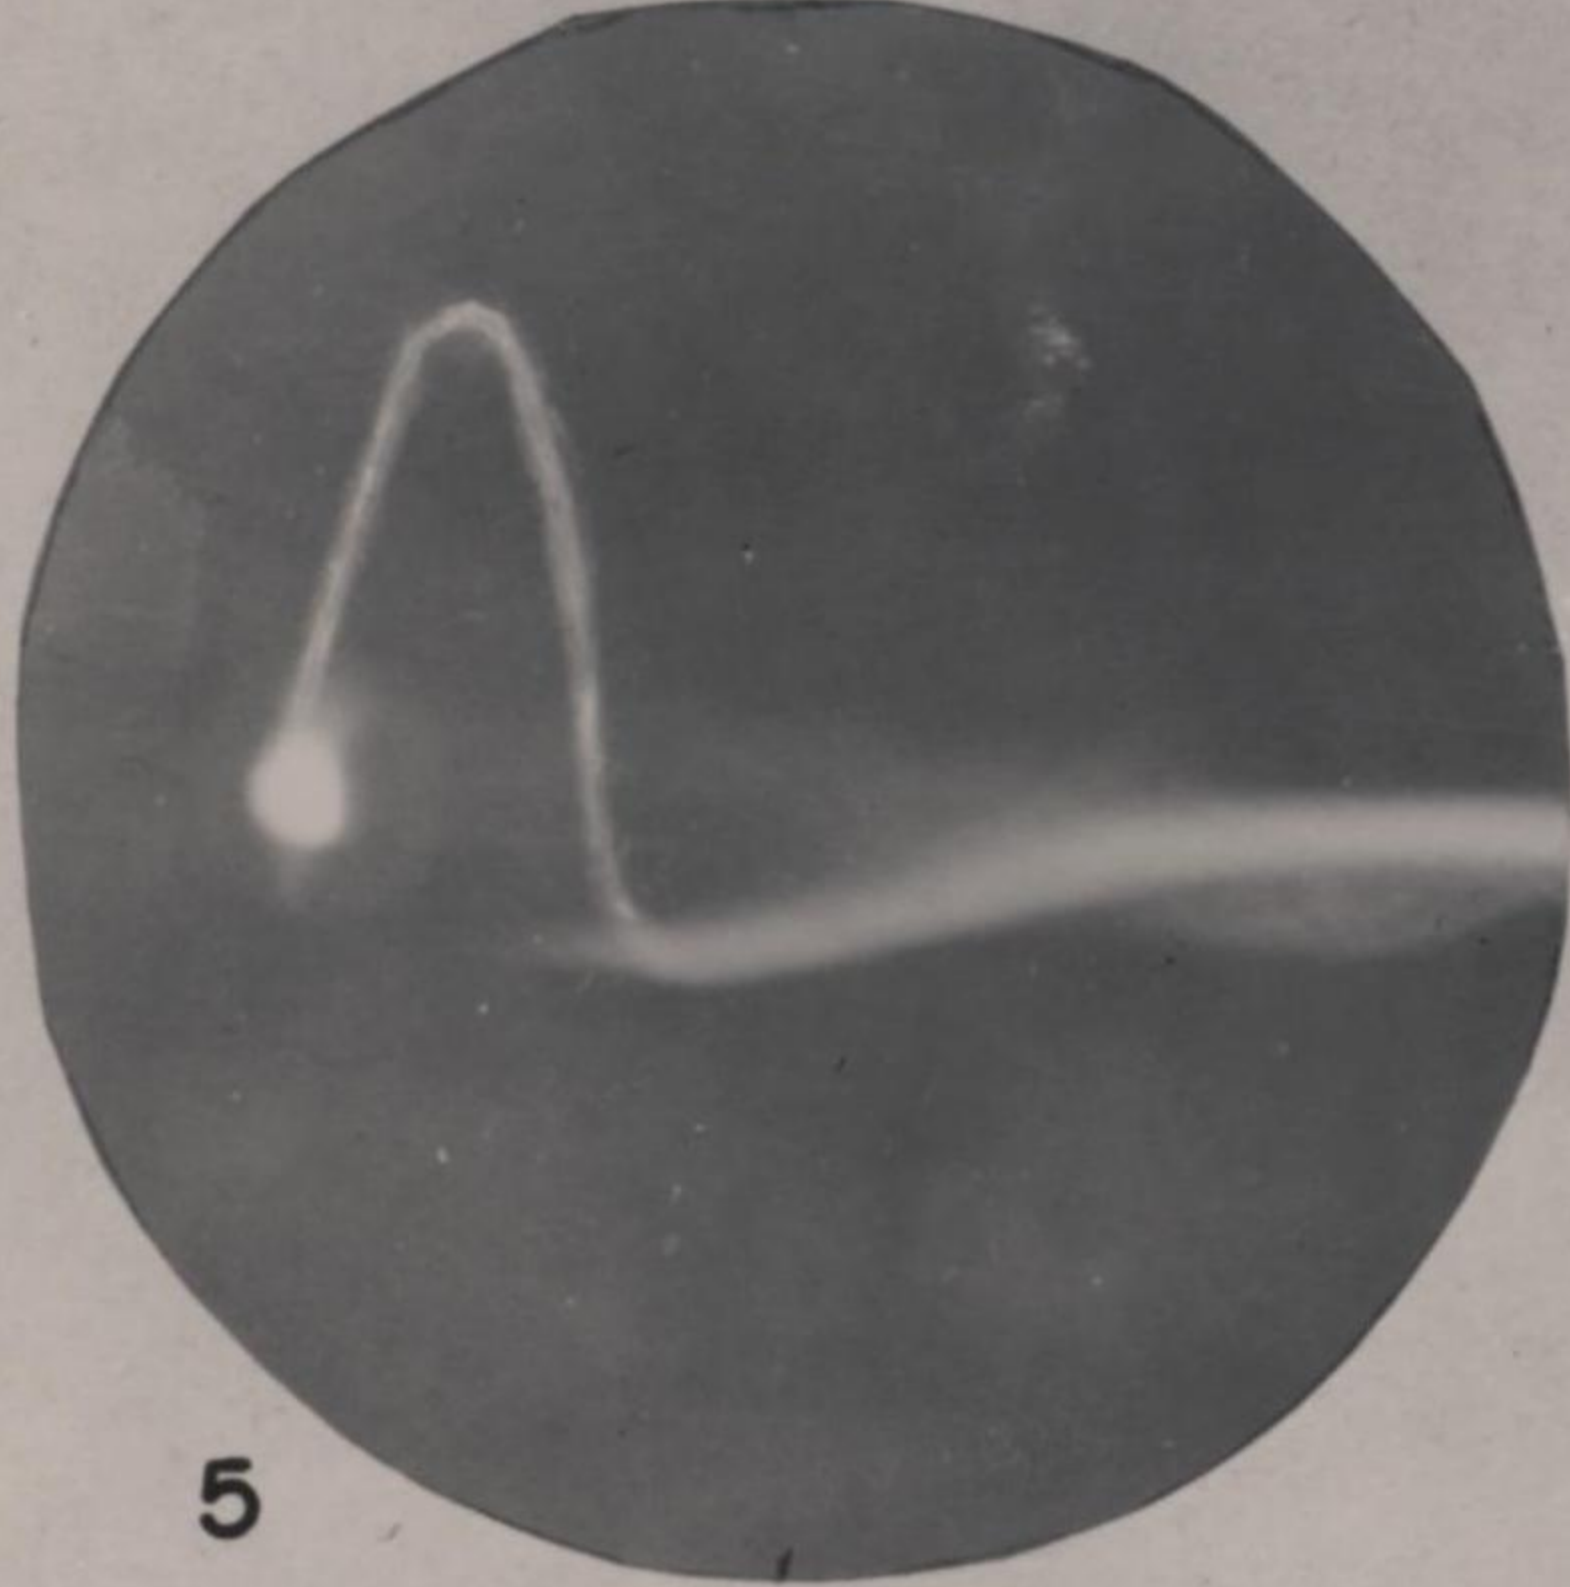
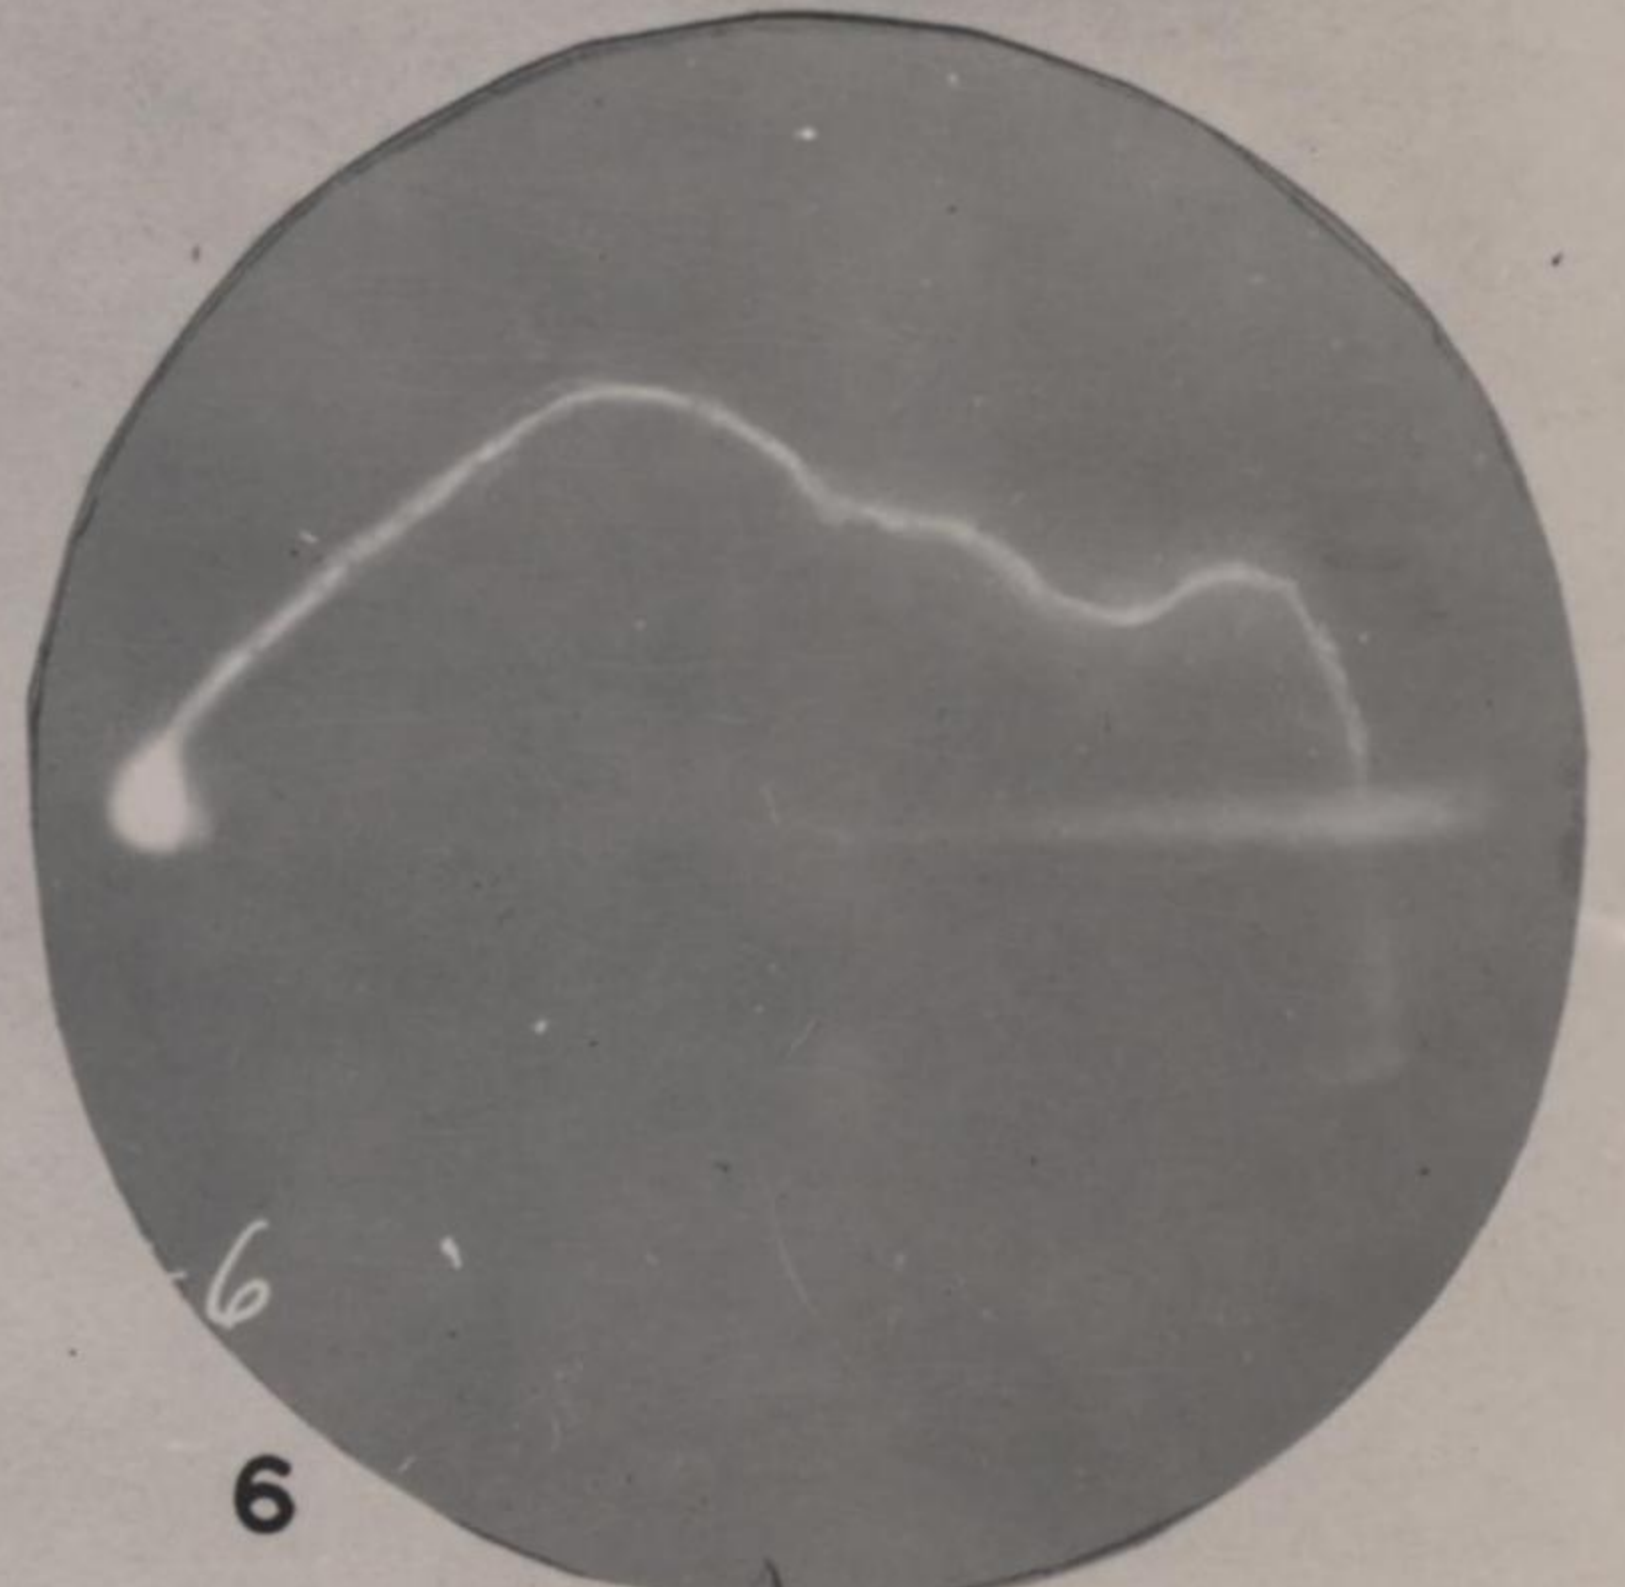
Note: In making up the prints, several of the trace lines were not as clear as they should have been, so in order to bring them out, some retouching was done on the photos. It was done under the close supervision of the RCM Observer and presents the pulse shape just as it appeared on the APA-6X Pulse Analyzer.

SECRET
PHOTOS OF ENEMY RADAR PULSES
MISSION 17
-RCM SECT.
