# The SAN DIMAS EXPERIMENTAL FOREST

# Lawrence W. Hill

1963

> Pacific Southwest Forest and Range Experiment Station - Berkeley, California Forest Service - U. S. Department of Agriculture

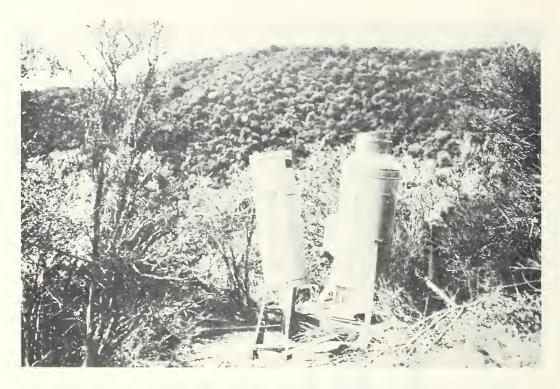
Figure 2.--More accurate measurements of rainfall result when storage gages are tilted (left) and recording gages are fitted with "stereo" funnels (right).

One of our first tasks was to learn when rain occurs, how much, and how intensely. We soon found that conventional vertical raingages gave inaccurate rainfall measurements. They were especially inaccurate during high intensity storms when accurate measurements were most needed (fig. 1). After testing raingages of many sizes and shapes, we found that if the receiving rim of the gage were parallel to the mountain slope upon which it is placed, the measurements were much more accurate. Now storage gages are tilted, and recording gages, which must stand vertical, are fitted with funnels cut parallel to the slope (fig. 2). This permits reliable records with much fewer raingages. To meet the needs of expanded research we now sample rainfall with a network of 115 raingages. Most of them are concentrated in special research areas.

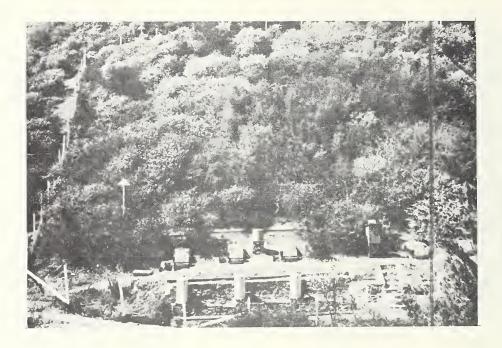
Figure 4.--Soil moisture-runoff plots. Above, the plots with original brush cover; below, the same plots after converting them to a shallow-rooted grass cover.

Can we get a greater yield of usable water by replacing chaparral with a shallow-rooted grass cover? For several years we measured runoff, erosion, and soil moisture on 9 hillside plots heavily covered with native brush--mostly scrub oak (fig. 4). These plots are on unusually deep soil, averaging about 12 feet (3.7 meters). In 1951, we cleared six brush plots, planted them to annual ryegrass, and compared evaporation and transpiration losses.

In brief, we found that during a winter of average rainfall, the soils under both brush and grass were wet to field capacity. Then, during the long dry season, evaporation and transpiration dried the brushcovered soils to depths of at least ll feet (3.4 meters)(fig. 5). At the same time, a substantial soil-moisture saving and potential ground water yield was obtained under the grass cover where the soil was still wet below 3 feet. But the following year when we permitted deep-rooted weeds to invade the grass-covered plots, no soil-moisture gains were recorded.

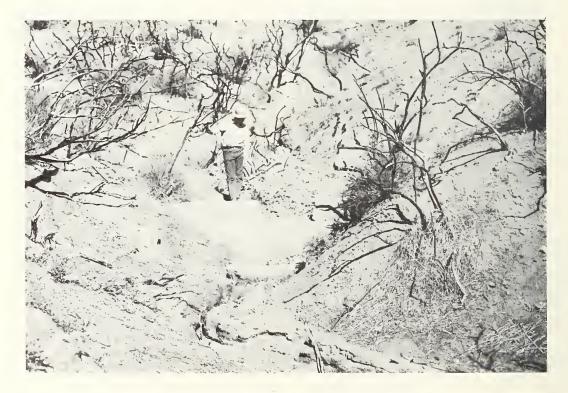
Figure 9.--Stream channel checks. Their purpose is to prevent channel downcutting and to stabilize canyon side slopes.

Small dams were constructed of cement combined with soil and rock available at the dam sites in nine of the watersheds (fig. 9). The purpose of these dams is to prevent channel downcutting, to stabilize side slope soils, and to spread out streamflow and thus reduce its velocity and erosive power.

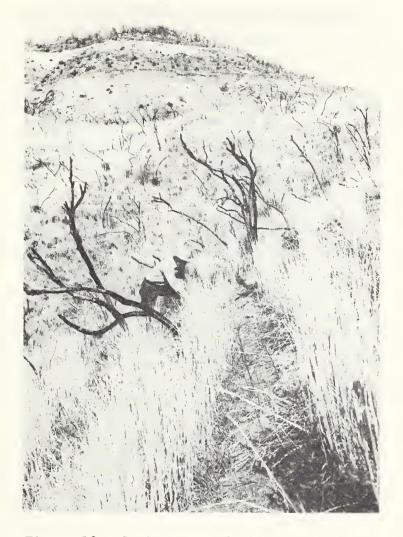
Figure 10.--Contour row planting of barley. Barley impedes overland flow of water and sediment.

Barley seed and fertilizer were placed in furrows in nine small watersheds to form dense rows on 2-foot (.61 meters) contour intervals (fig. 10). Barley (<u>Hordeum vulgare var. Atlas</u>) was chosen because it grows more vigorously than most species during cool winter weather. The fertilizer was included to promote earlier and heavier growth. The purpose of this treatment is to impede overland flow of water and sediment on side slopes.

2. Barley contour-row plantings (alone and in combination with trenches) seem to be our best first-aid treatment.
