HITACHI ENGINEERING WORKS

DAMAGE ASSESSMENT REPORT 127

90.14-1476  
HITACHI ENGINEERING CO., KAIGAN PLANT  
36/35N - 140/39E

Mission No.: 3FR5M323 Target Area: Mito (90.14)  
Date Flown: 6 July 1945 Altitude: 29,000'

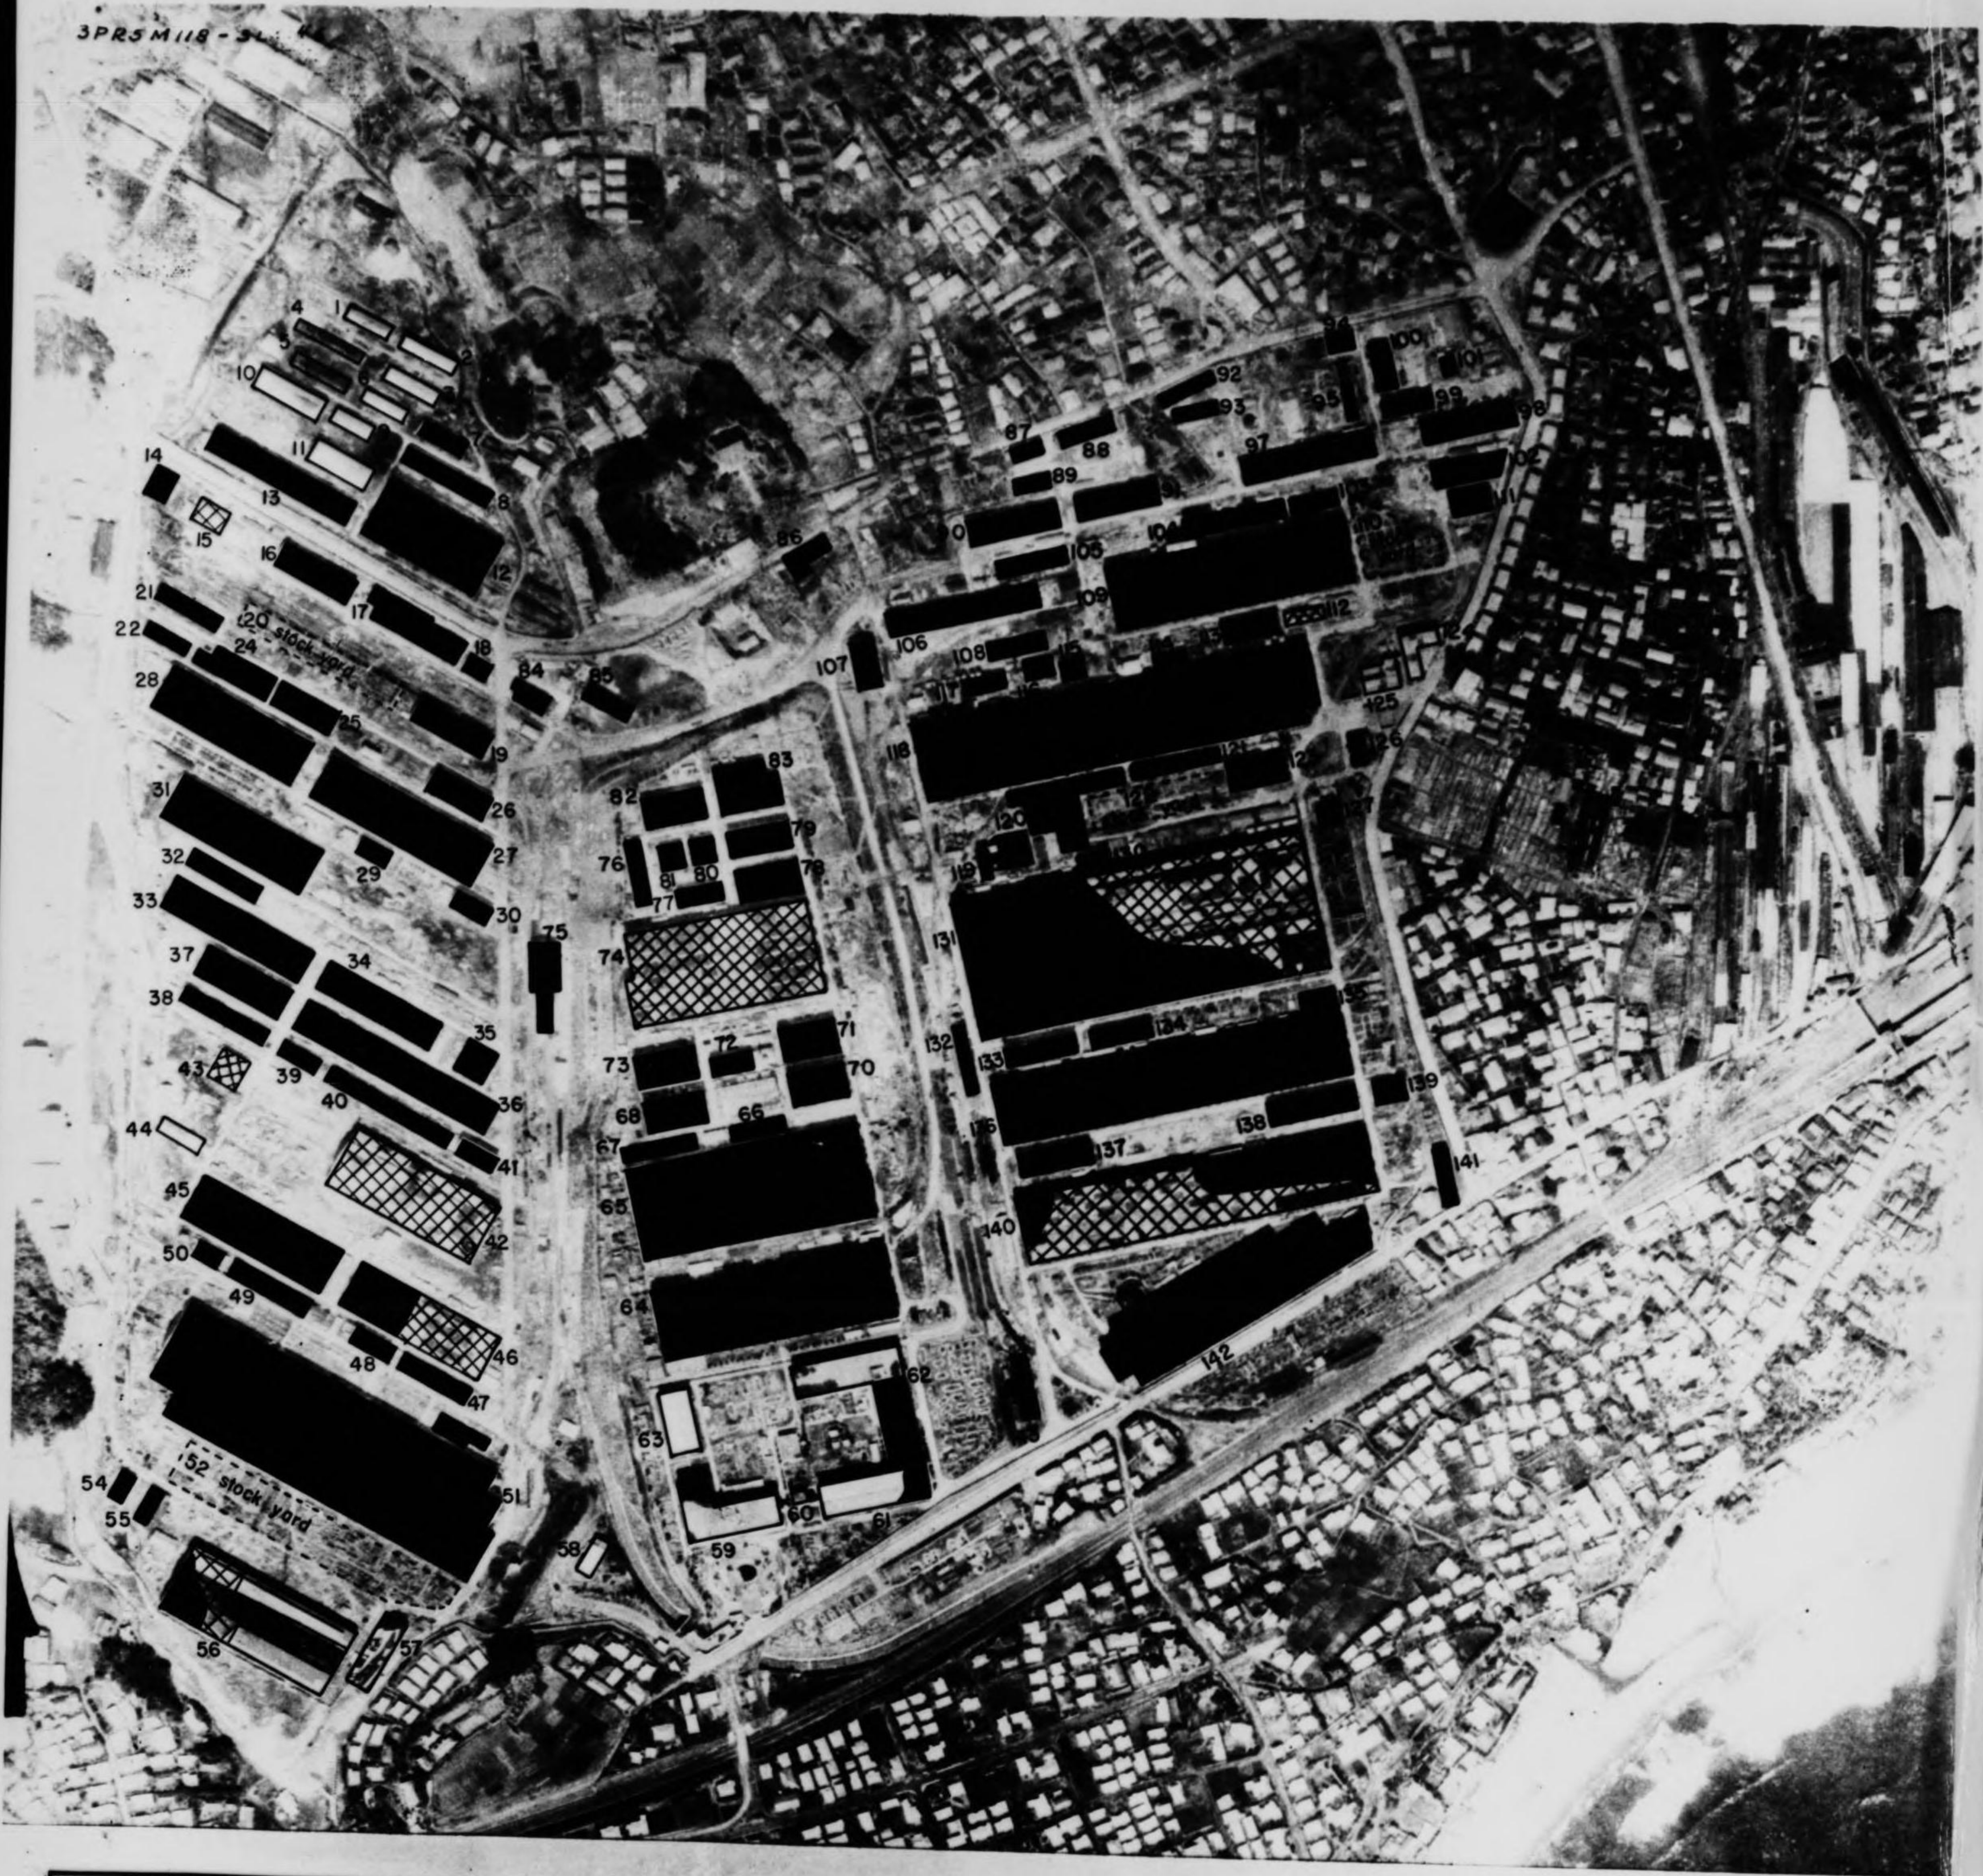
TARGET 90.14-1476  
 HITACHI ENGINEERING CO.  
 KAIGAN PLANT  
 DAMAGE ASSESSMENT REPORT 127  
 C.I.U. - XXI BOM.COM.

Post-strike photos show Target 1476 to be virtually destroyed. Total damage is about 2,142,900 sq.ft., which represents approximately 96.8% of the total roof area.

About 1,781,040 sq.ft., or 80.5% of the total roof area was destroyed or suffered structural damage. All major buildings are completely damaged, most of them being either destroyed or structurally damaged.

Three stock storage yards (20, 52 and 110 on the attached annotated print) show signs of having been heavily damaged. Railway facilities within the plant area were completely demolished.

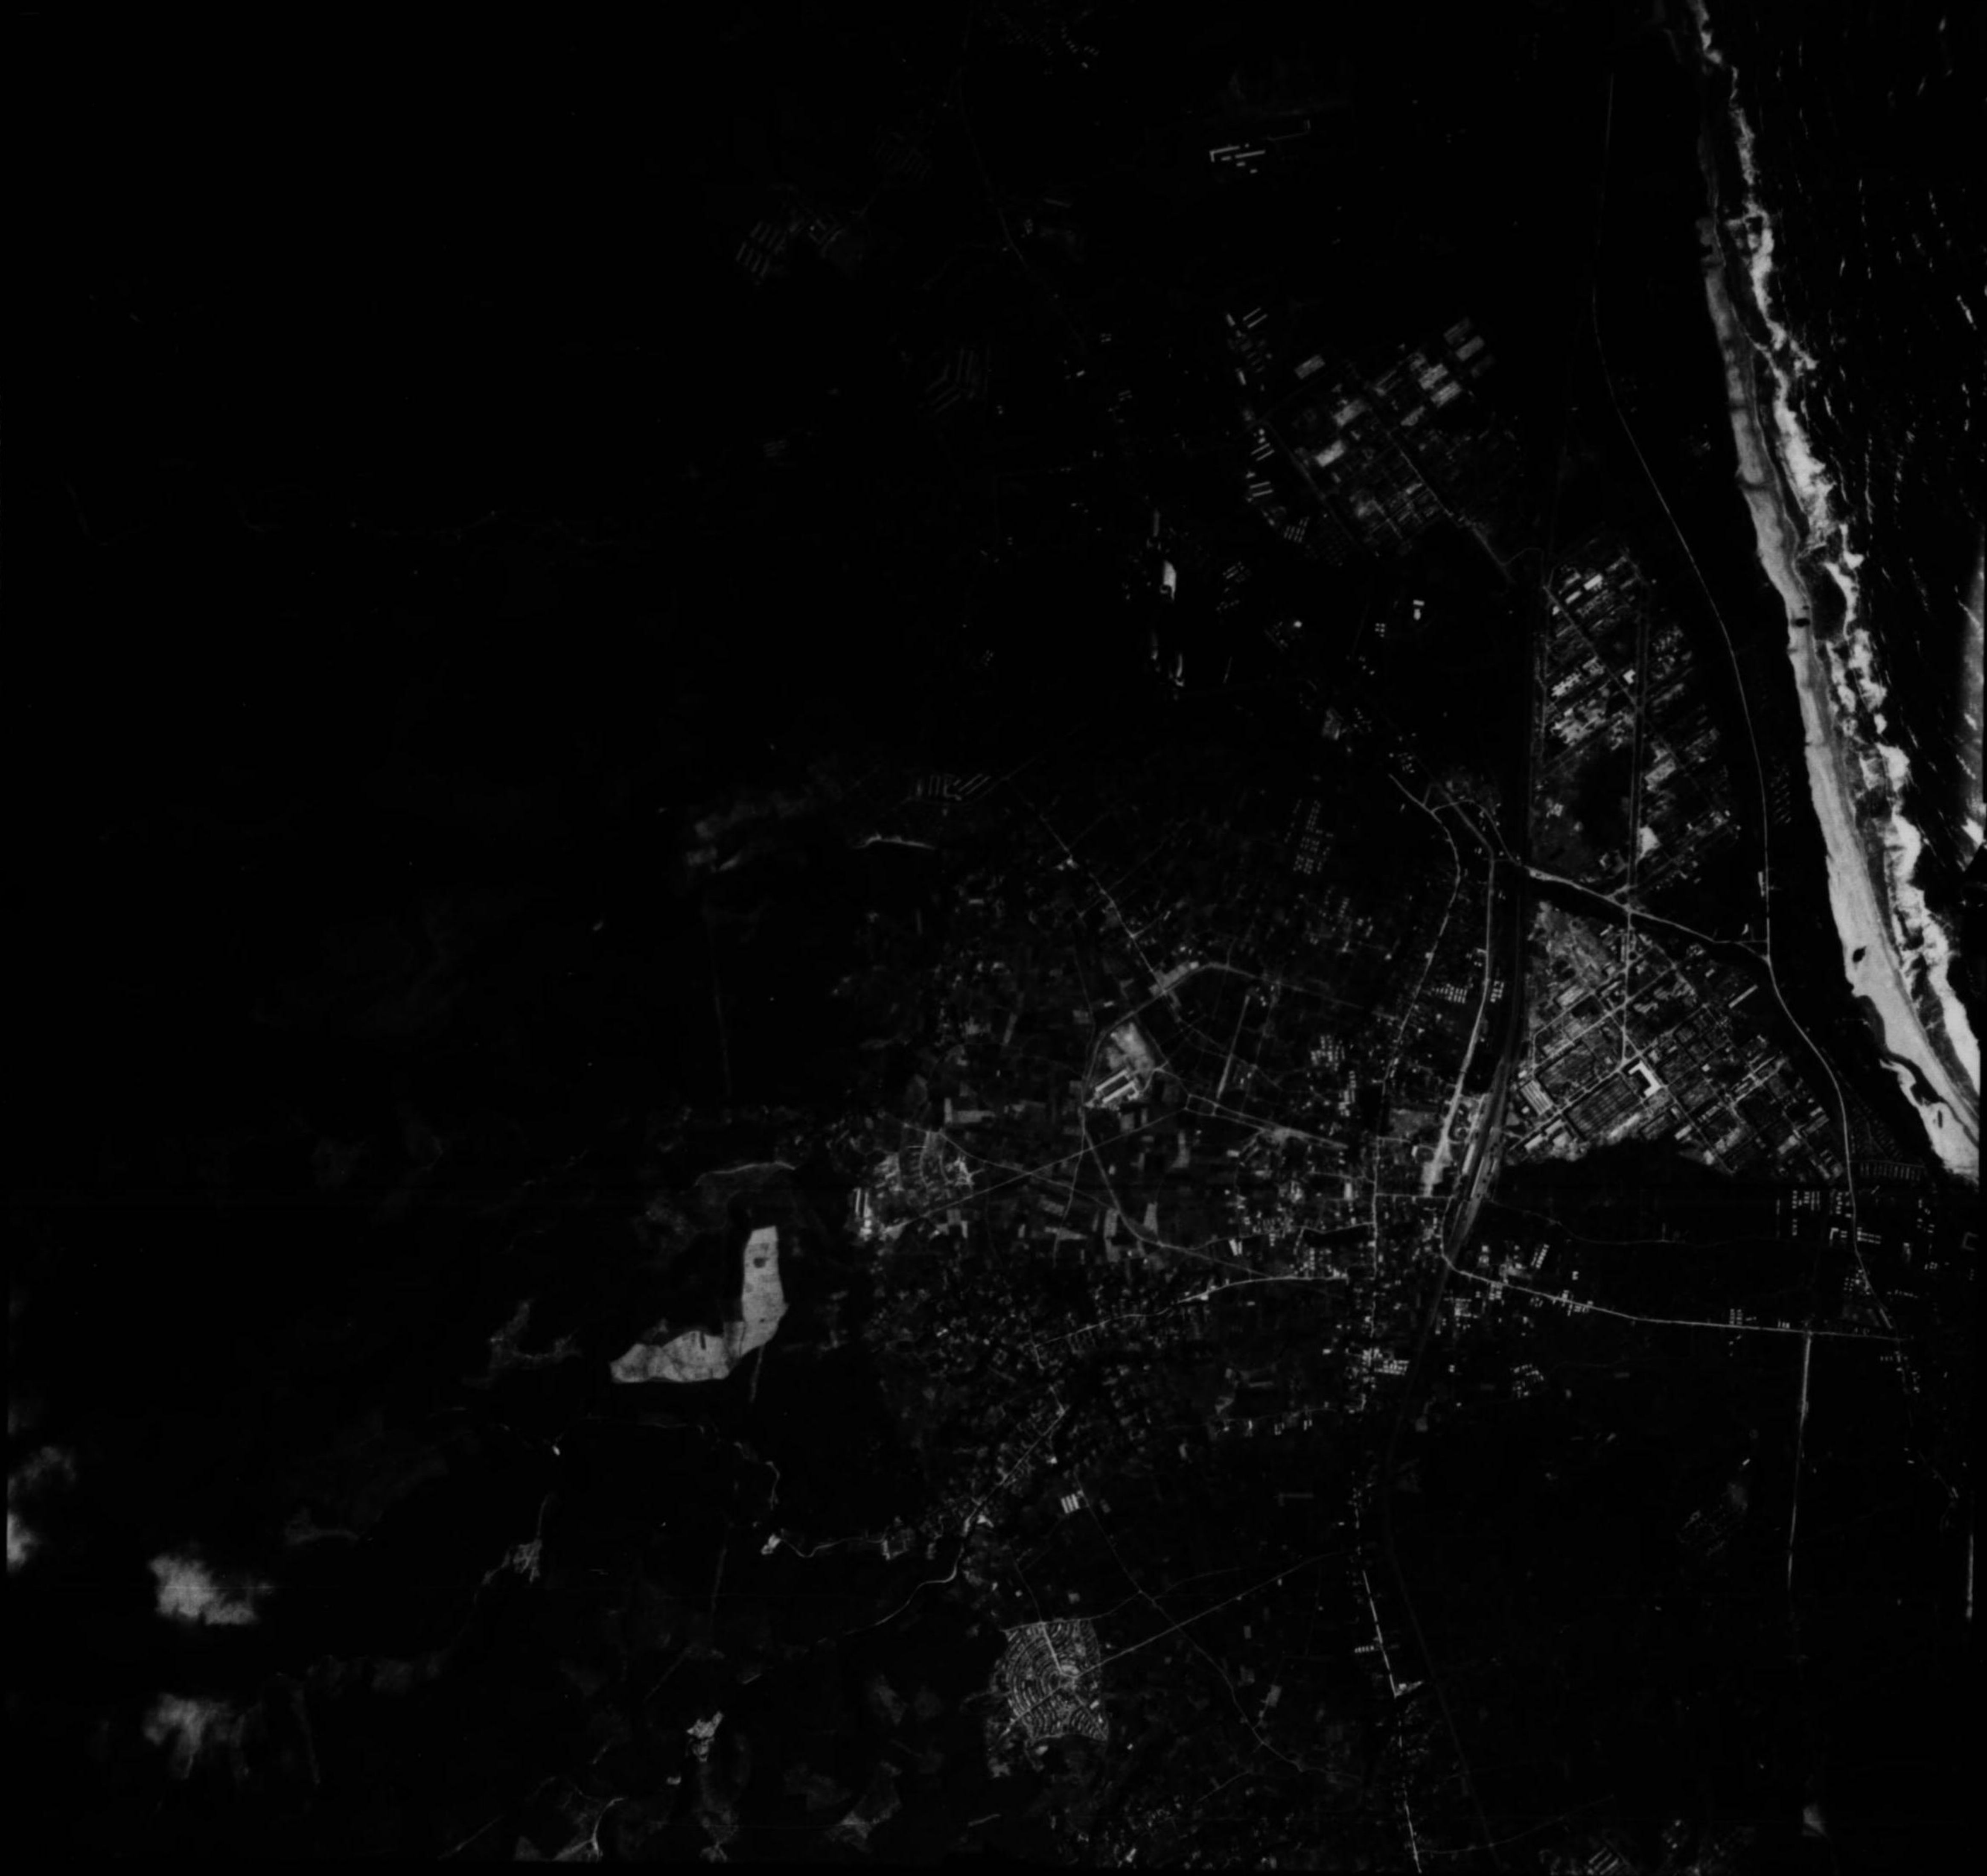
3 PR 5M 523-3:13

POST STRIKE  
TARGET 90.14-1476  
HITACHI ENGINEERING CO., KAIGAN PLANT  
DAMAGE ASSESSMENT REPORT 127  
C.I.U. - XXI BOM. COM.

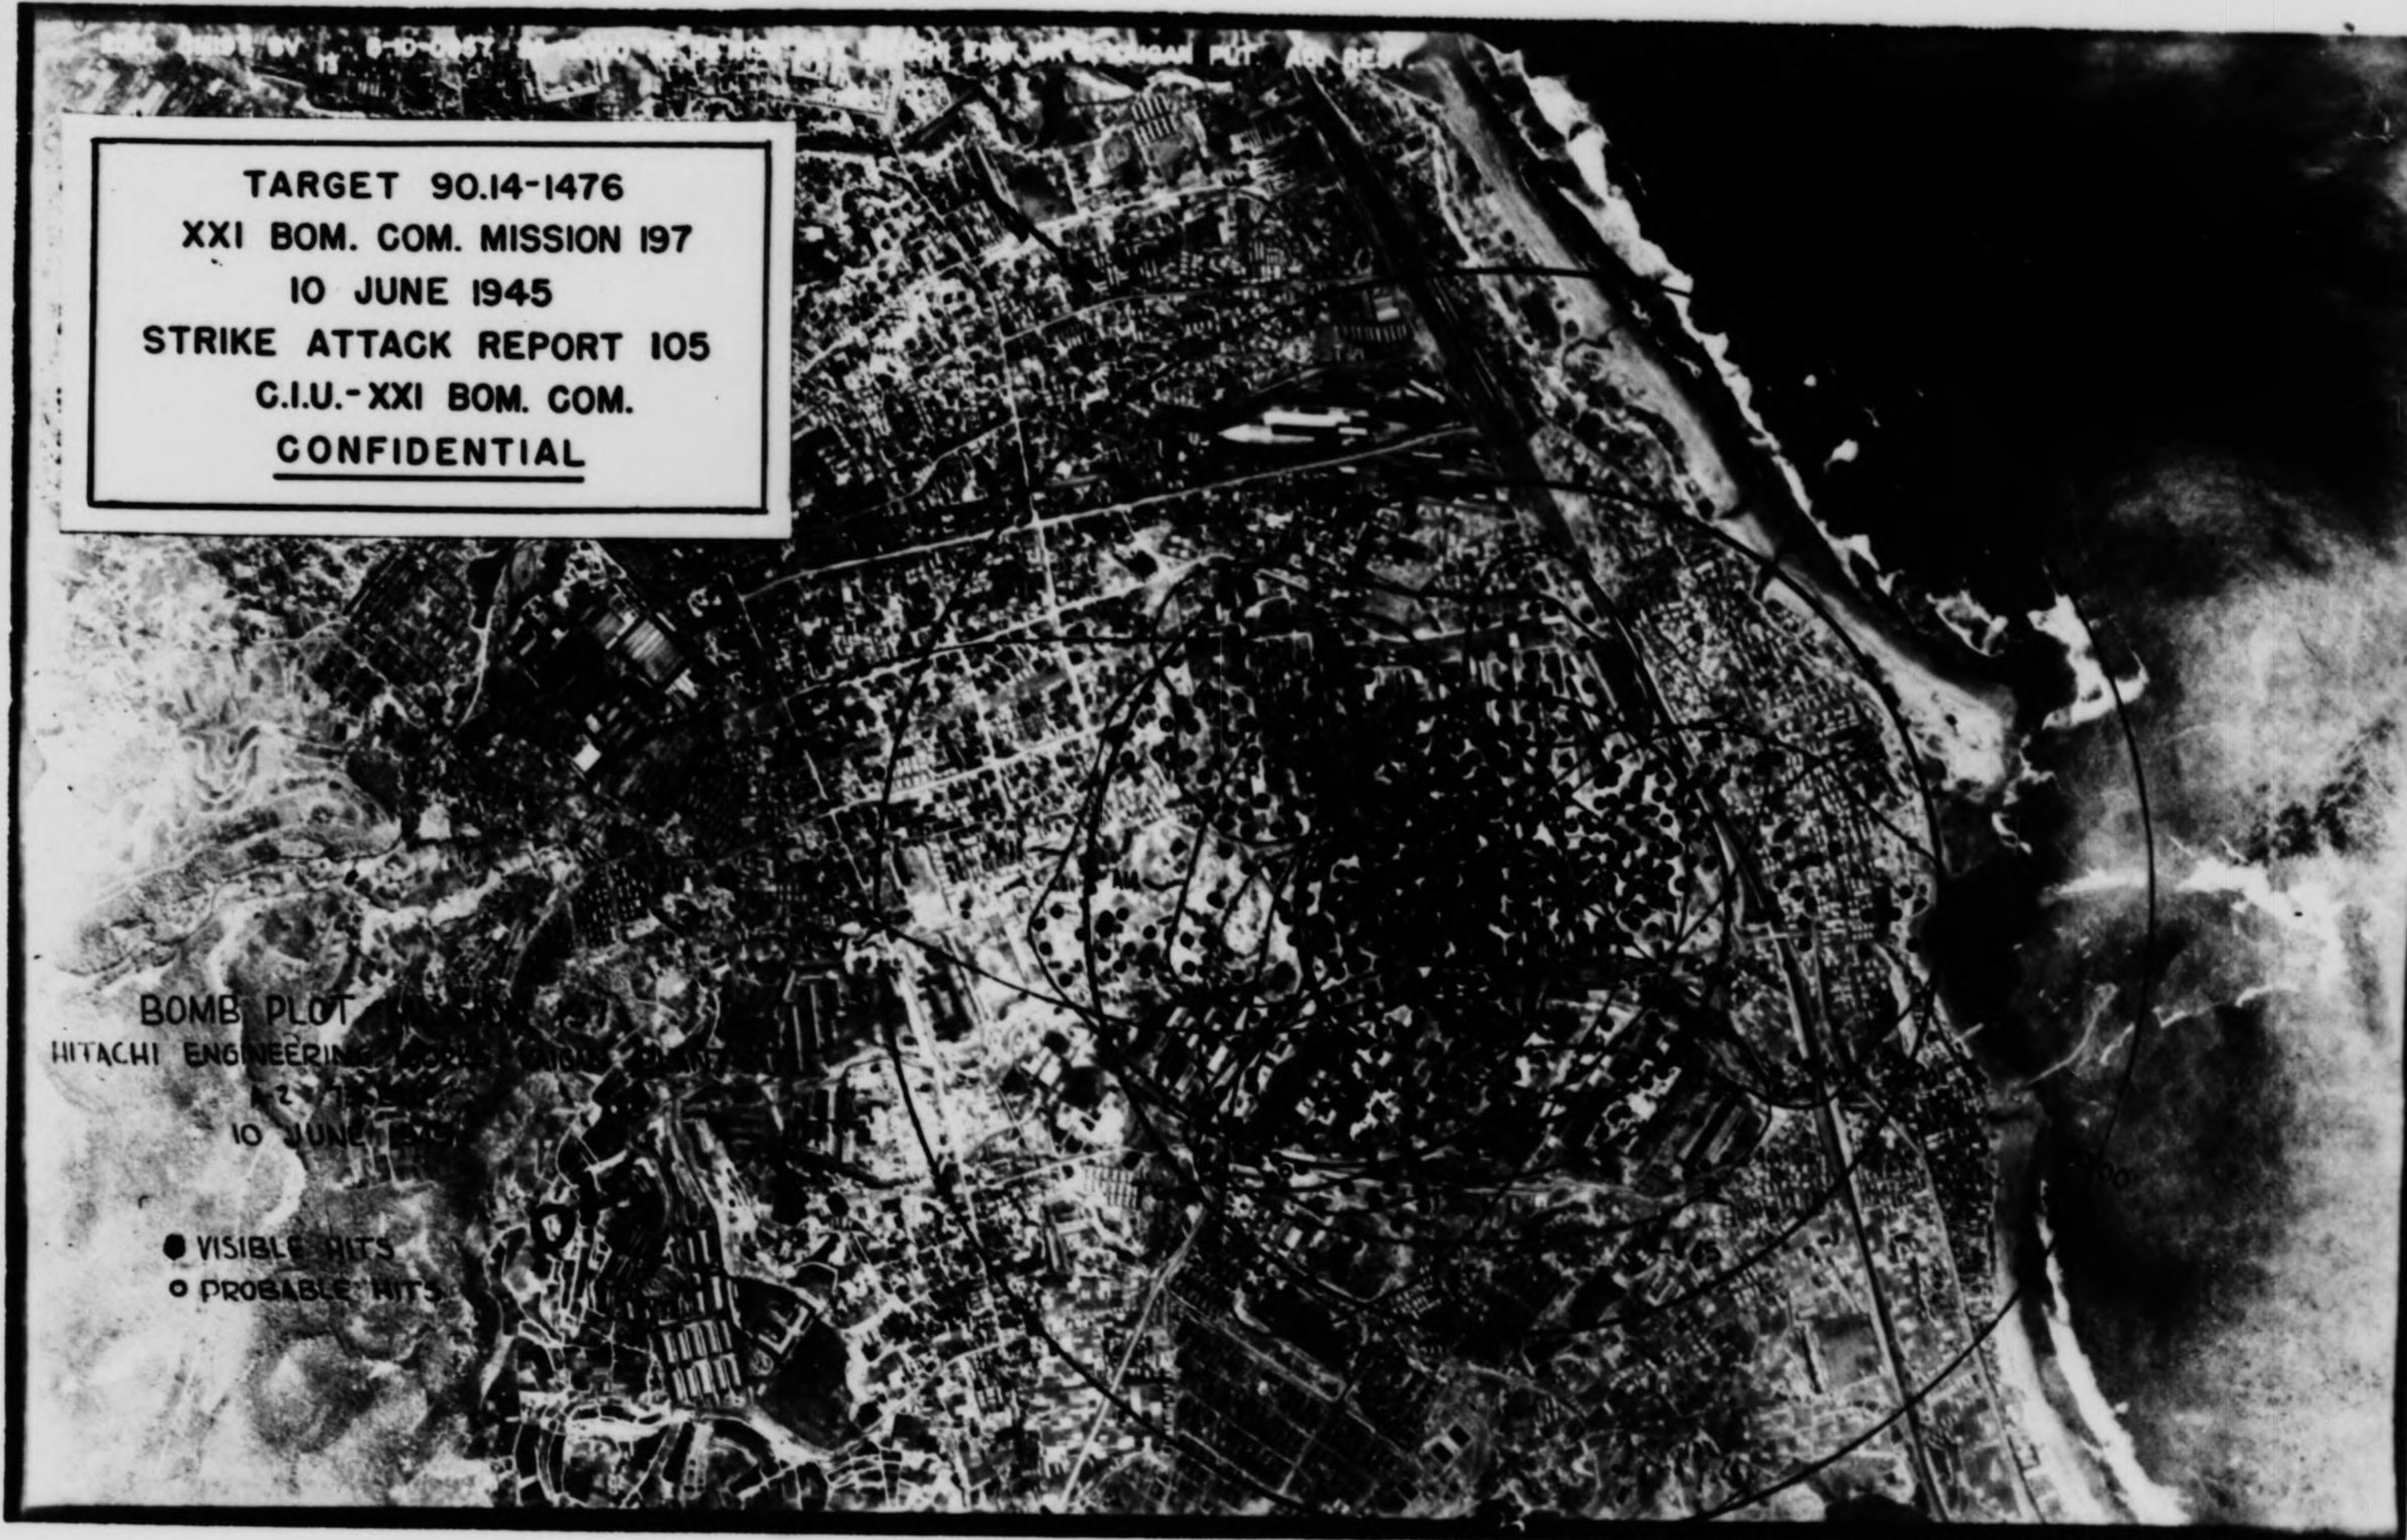
BOMB PLOT  
HITACHI ENGINEERING WORKS  
12-75  
10 JUNE 1945

● VISIBLE HITS  
○ PROBABLE HITS

Plotted Bombs in Target Area

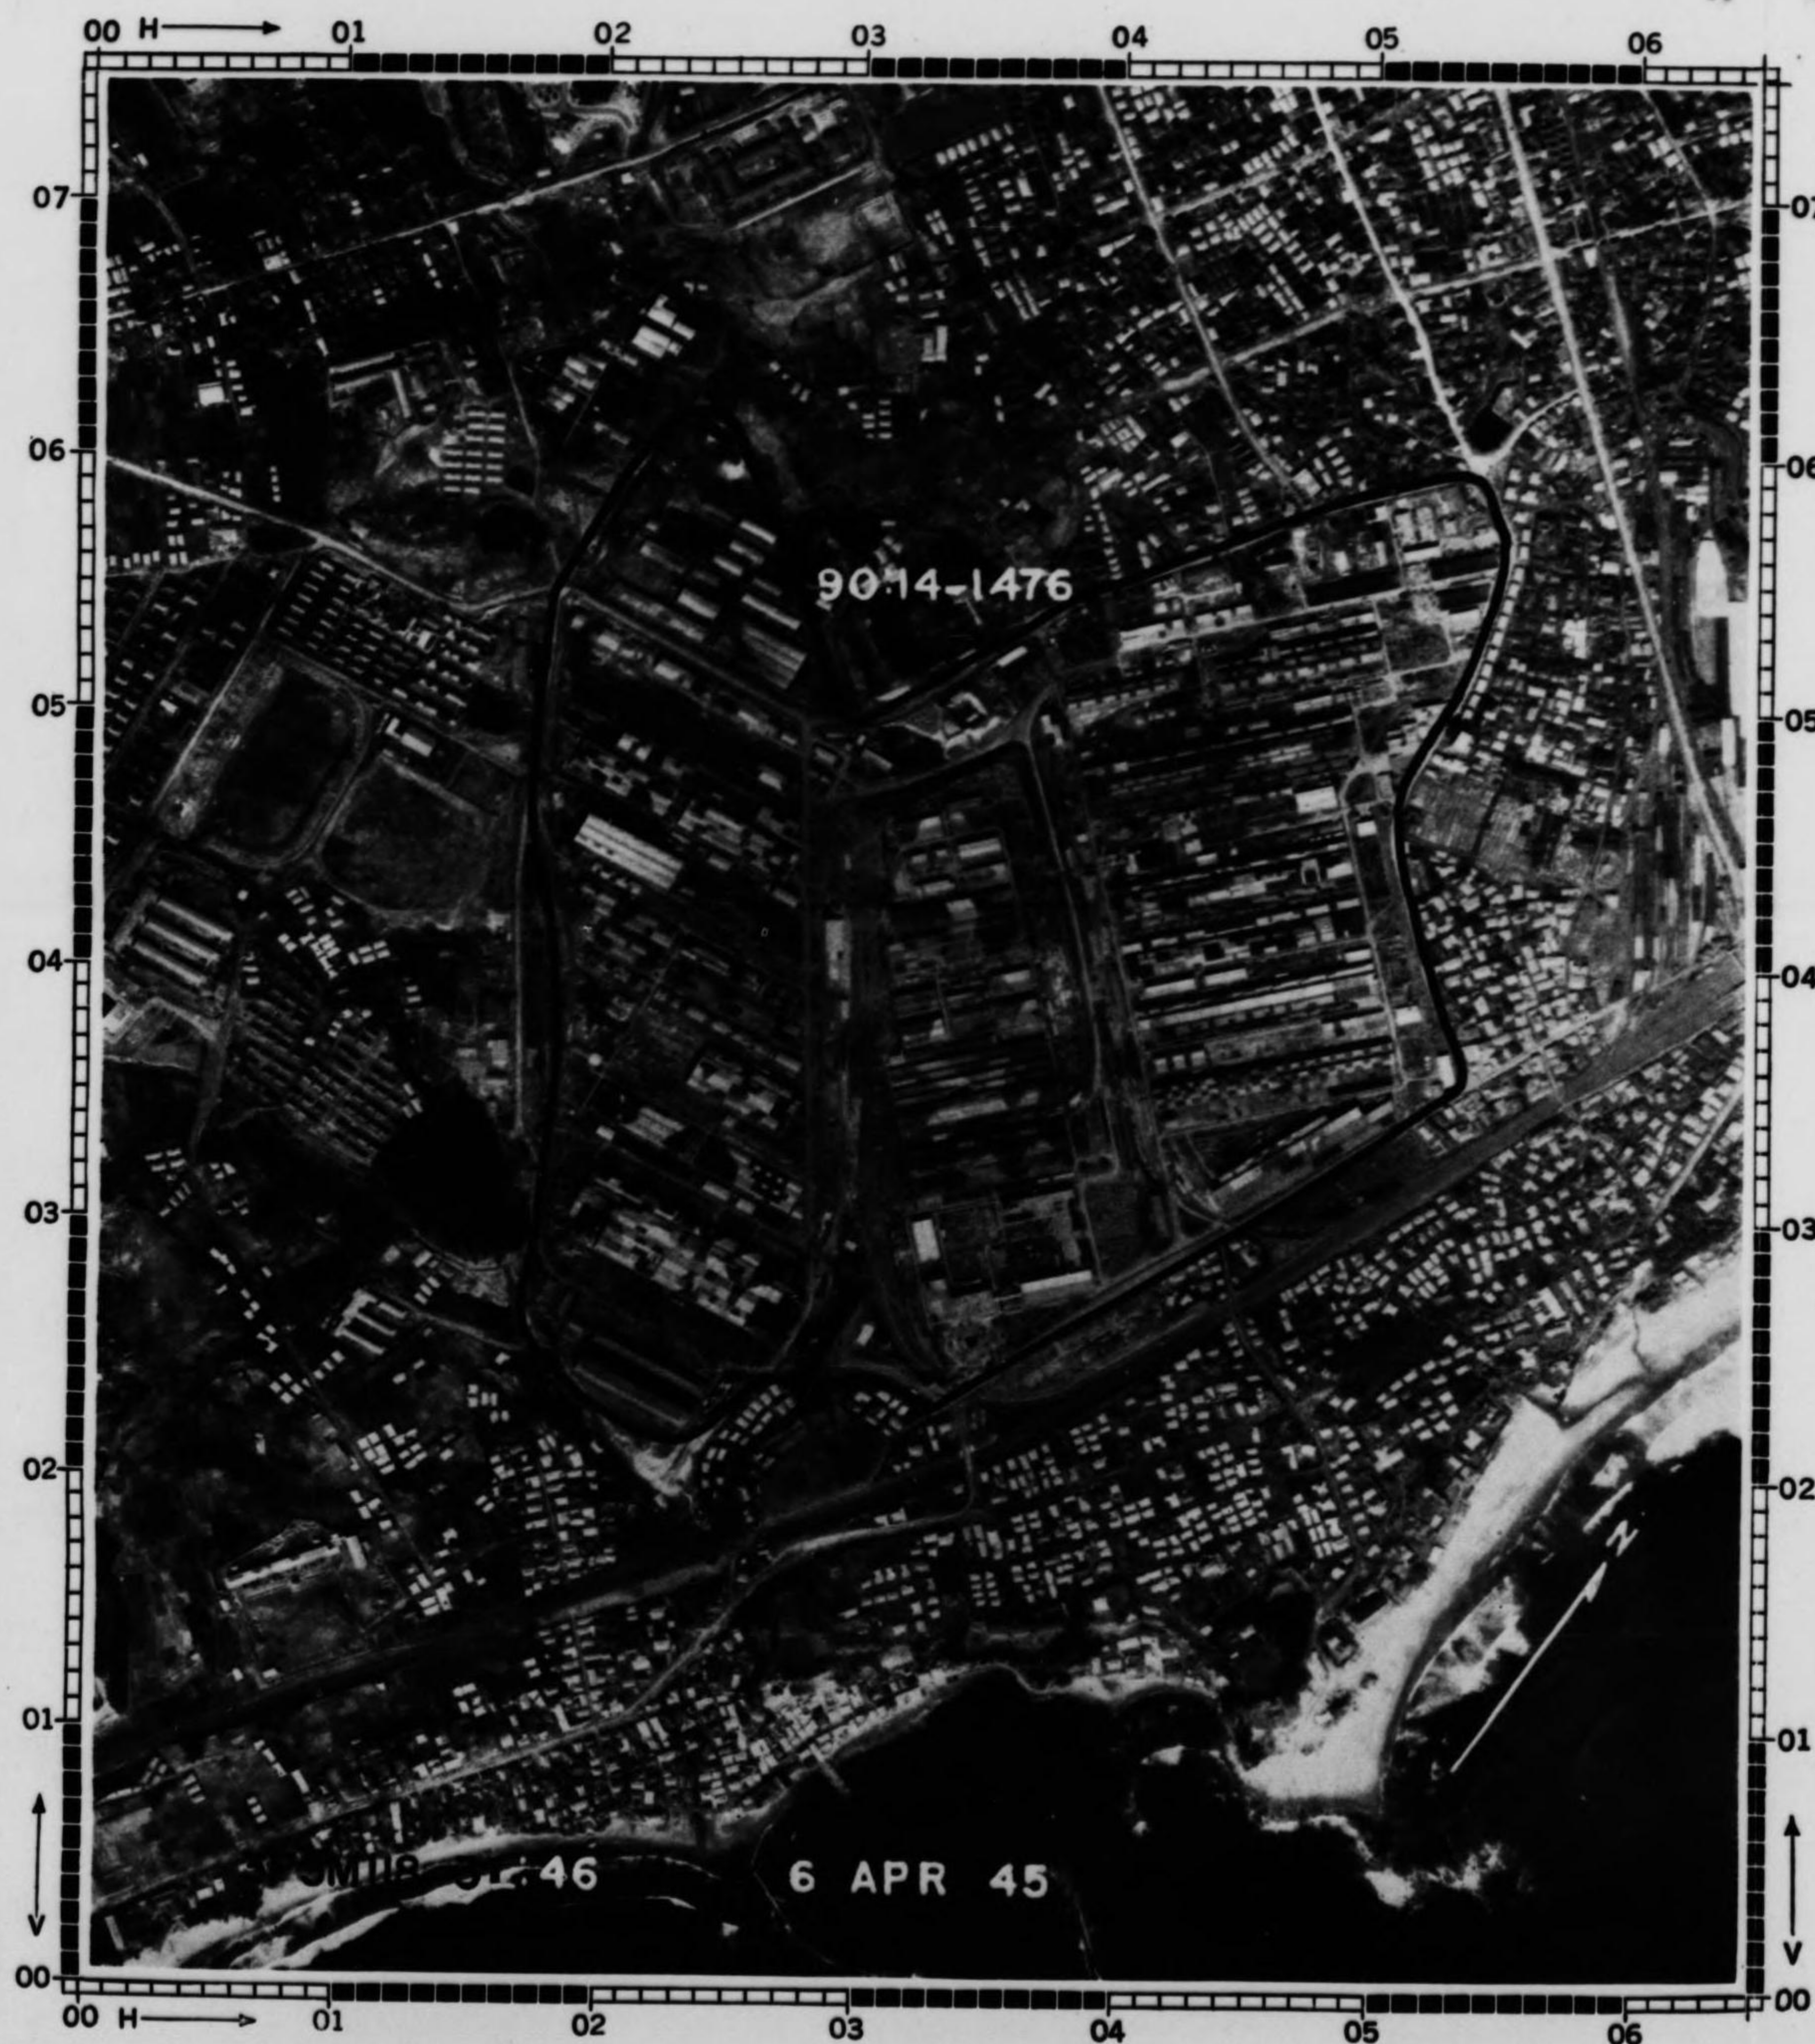
**LARGE SCALE ILLUSTRATION—SCALE APPROX.: 1:9,750**

One of largest heavy electrical equipment plants in Japan. Produces medium and large motors, generators, turbines, transformers, elevators, hoists, conveyors, switchboards and electric locomotive parts. Pre-war production estimated at 30% of Japanese heavy generator output and 40% of all power plant machinery.

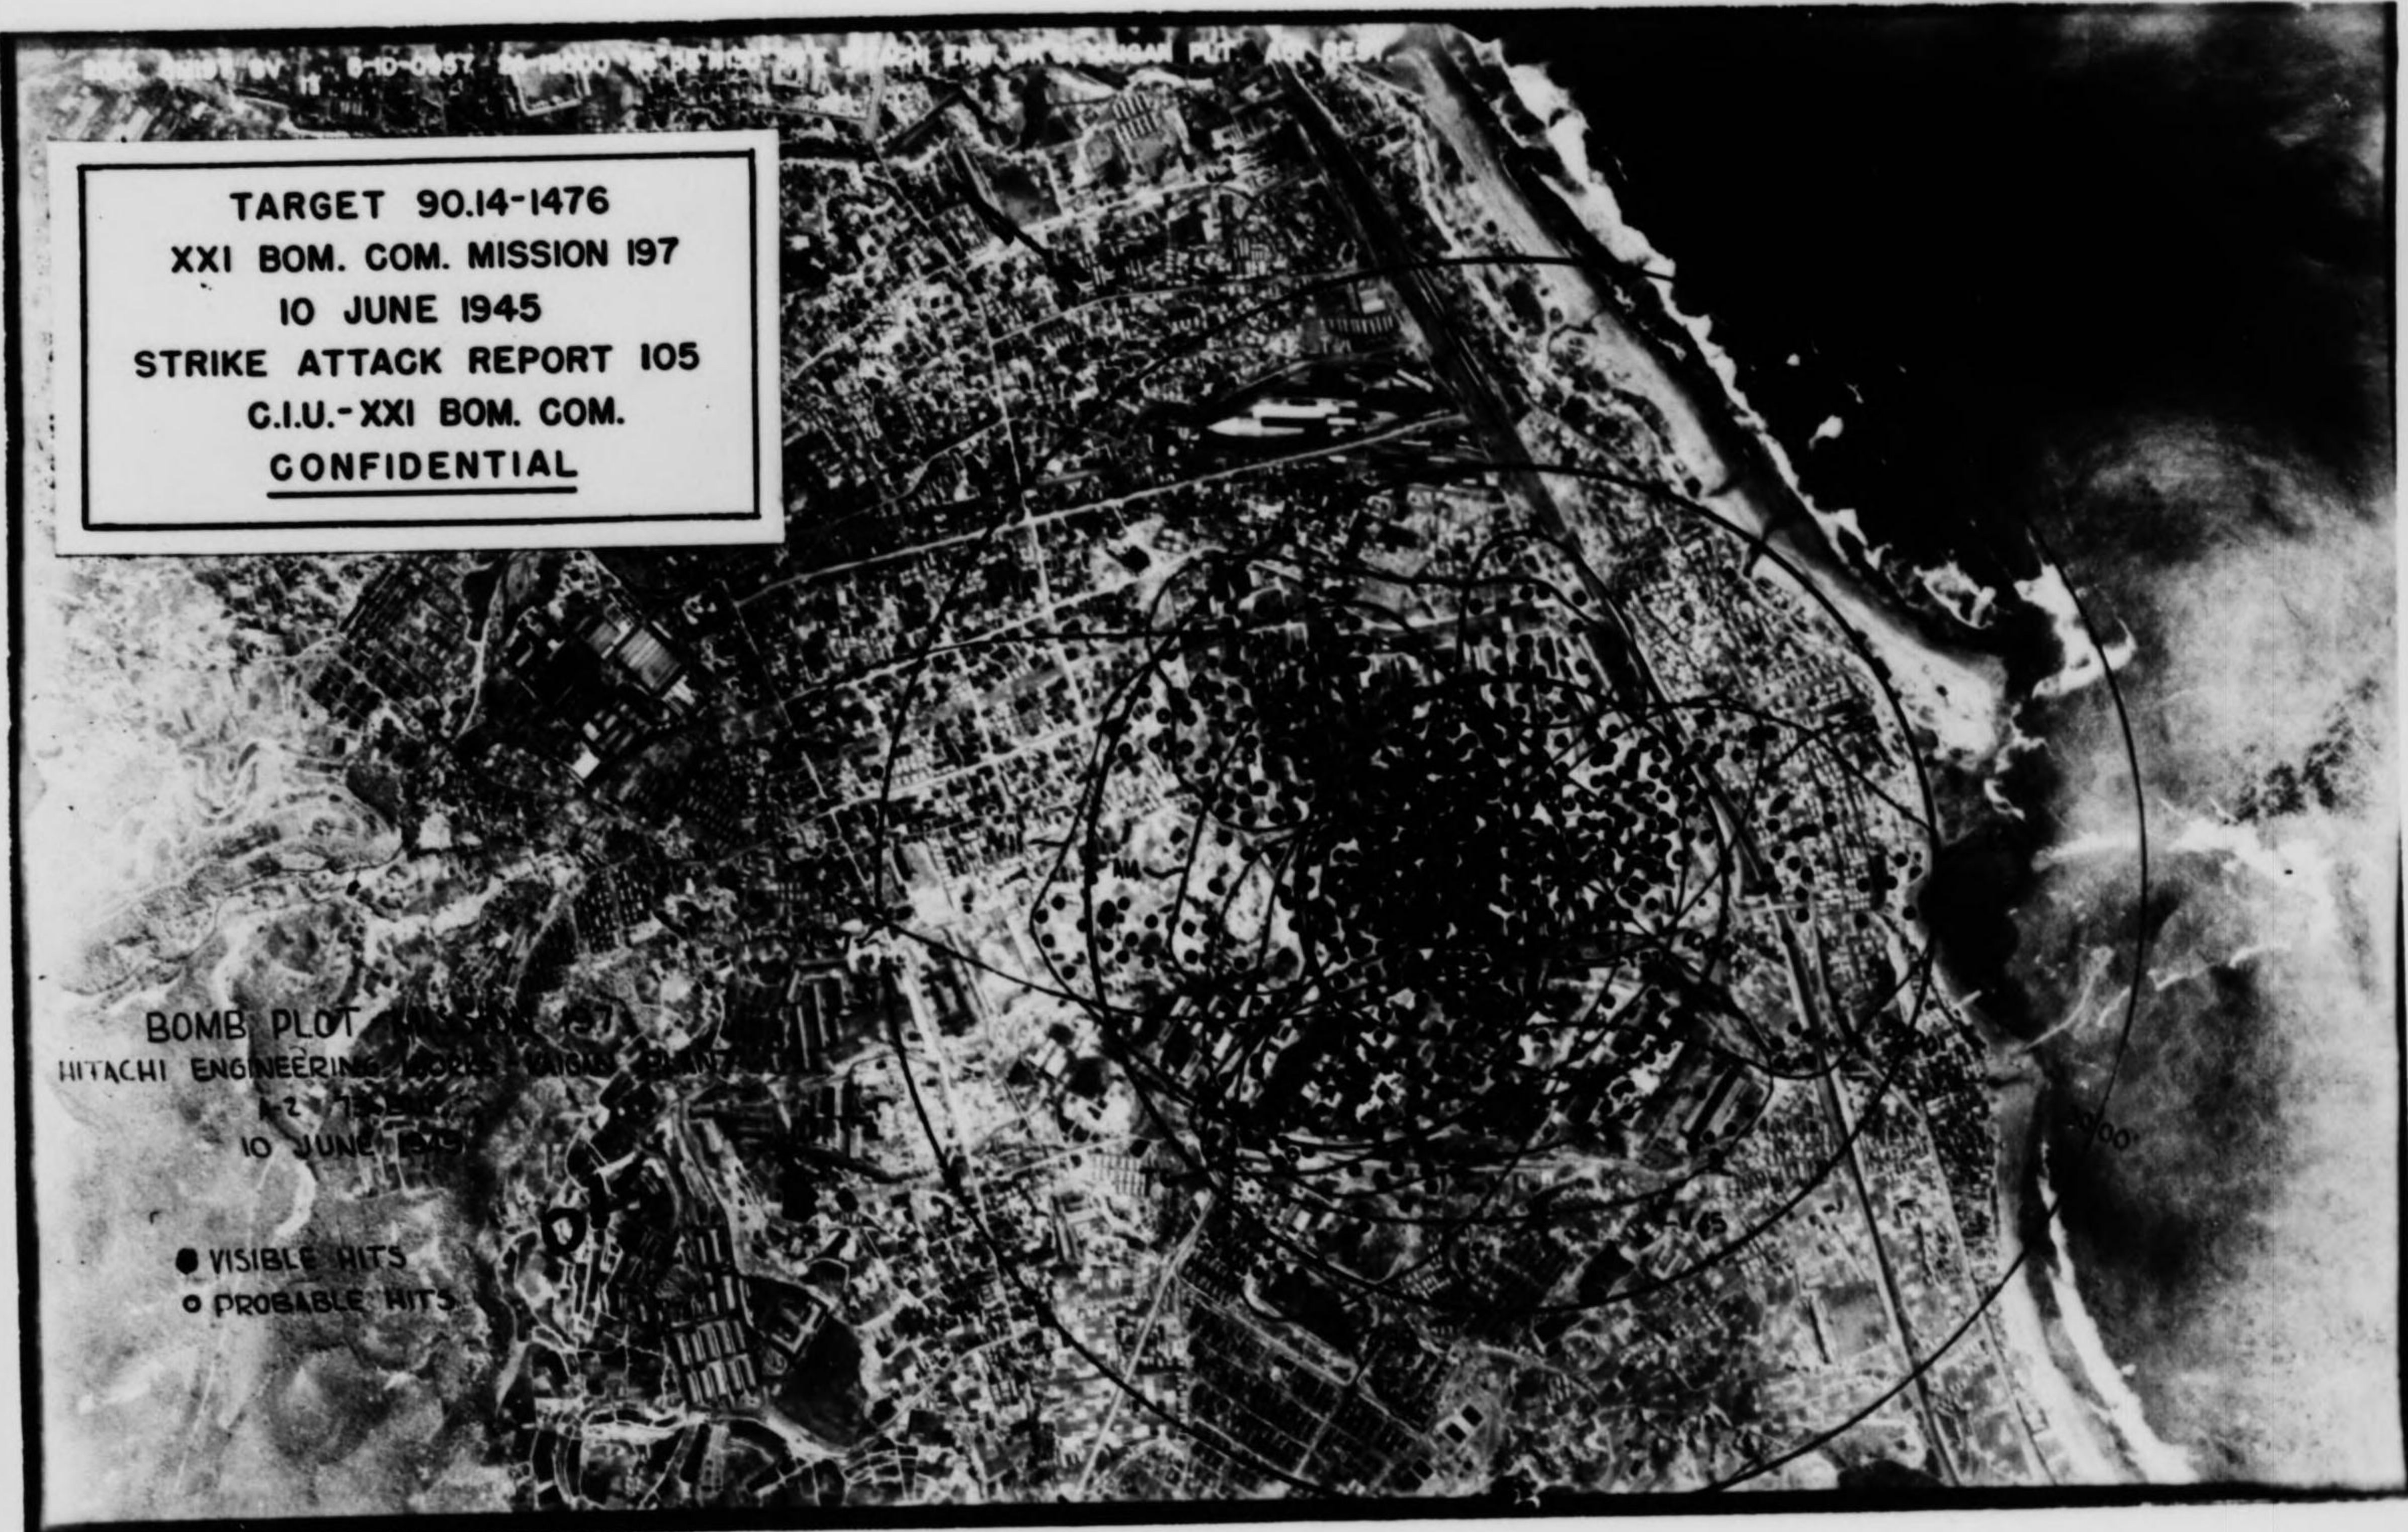
BOMB PLOT  
HITACHI ENGINEERING WORKS  
1-2-75  
10 JUNE 1945

Good quality strike photos from all squadrons show excellent bombing results. Approximately 85 percent of the target is destroyed. Reinforced concrete buildings at the center of the E edge of the target received at least 10 direct hits. Internal damage is impossible to assess but is believed to be severe.

All other major buildings are gutted or destroyed. Smoke from several fires in the target area limits assessment of damage. Direct hits are visible on the railroad E of the plant. Numerous small houses are destroyed about 550' E of the target.

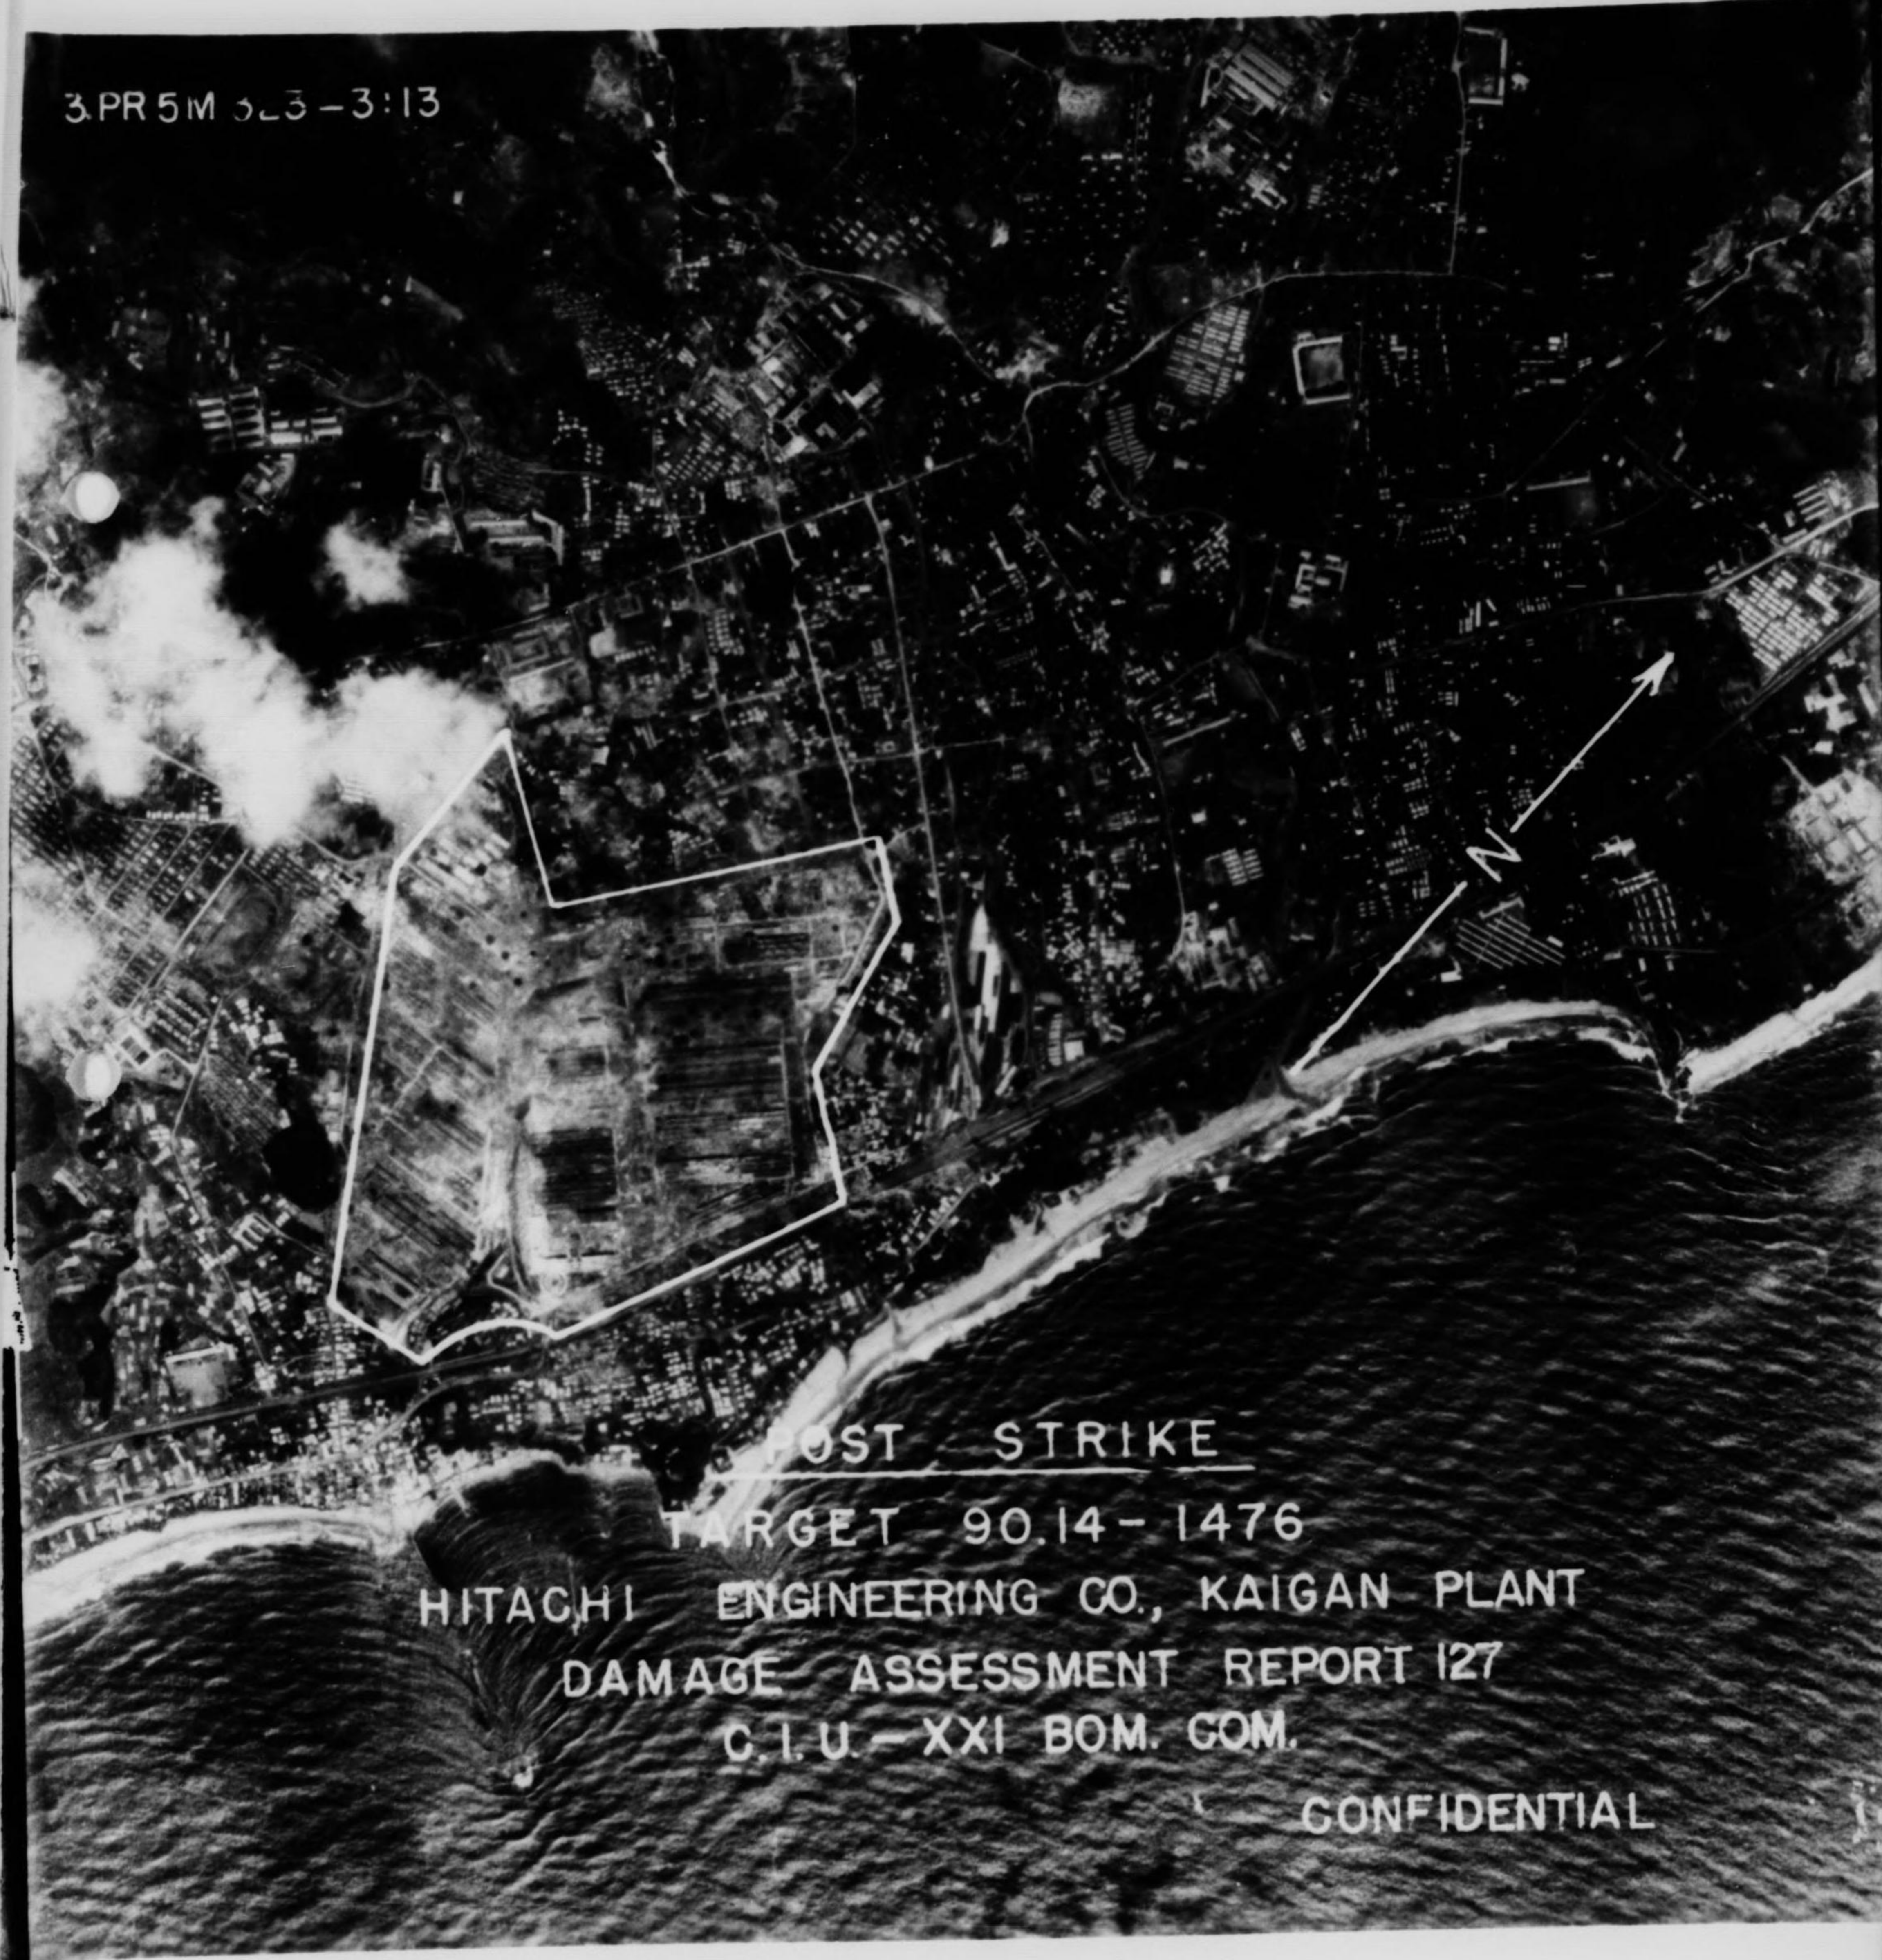
3.PR 5M 523-3:13

Post-strike photos show Target 1476 to be virtually destroyed. Total damage is about 2,142,900 sq.ft., which represents approximately 96.8% of the total roof area.

POST STRIKE
