HITACHI ENGINEERING WORKS

DAMAGE ASSESSMENT REPORT 127

90.14-1476  
HITACHI ENGINEERING CO., KAIGAN PLANT  
36/35N - 140/39E

Mission No.: 3FR5M323 Target Area: Mito (90.14)  
Date Flown: 6 July 1945 Altitude: 29,000'

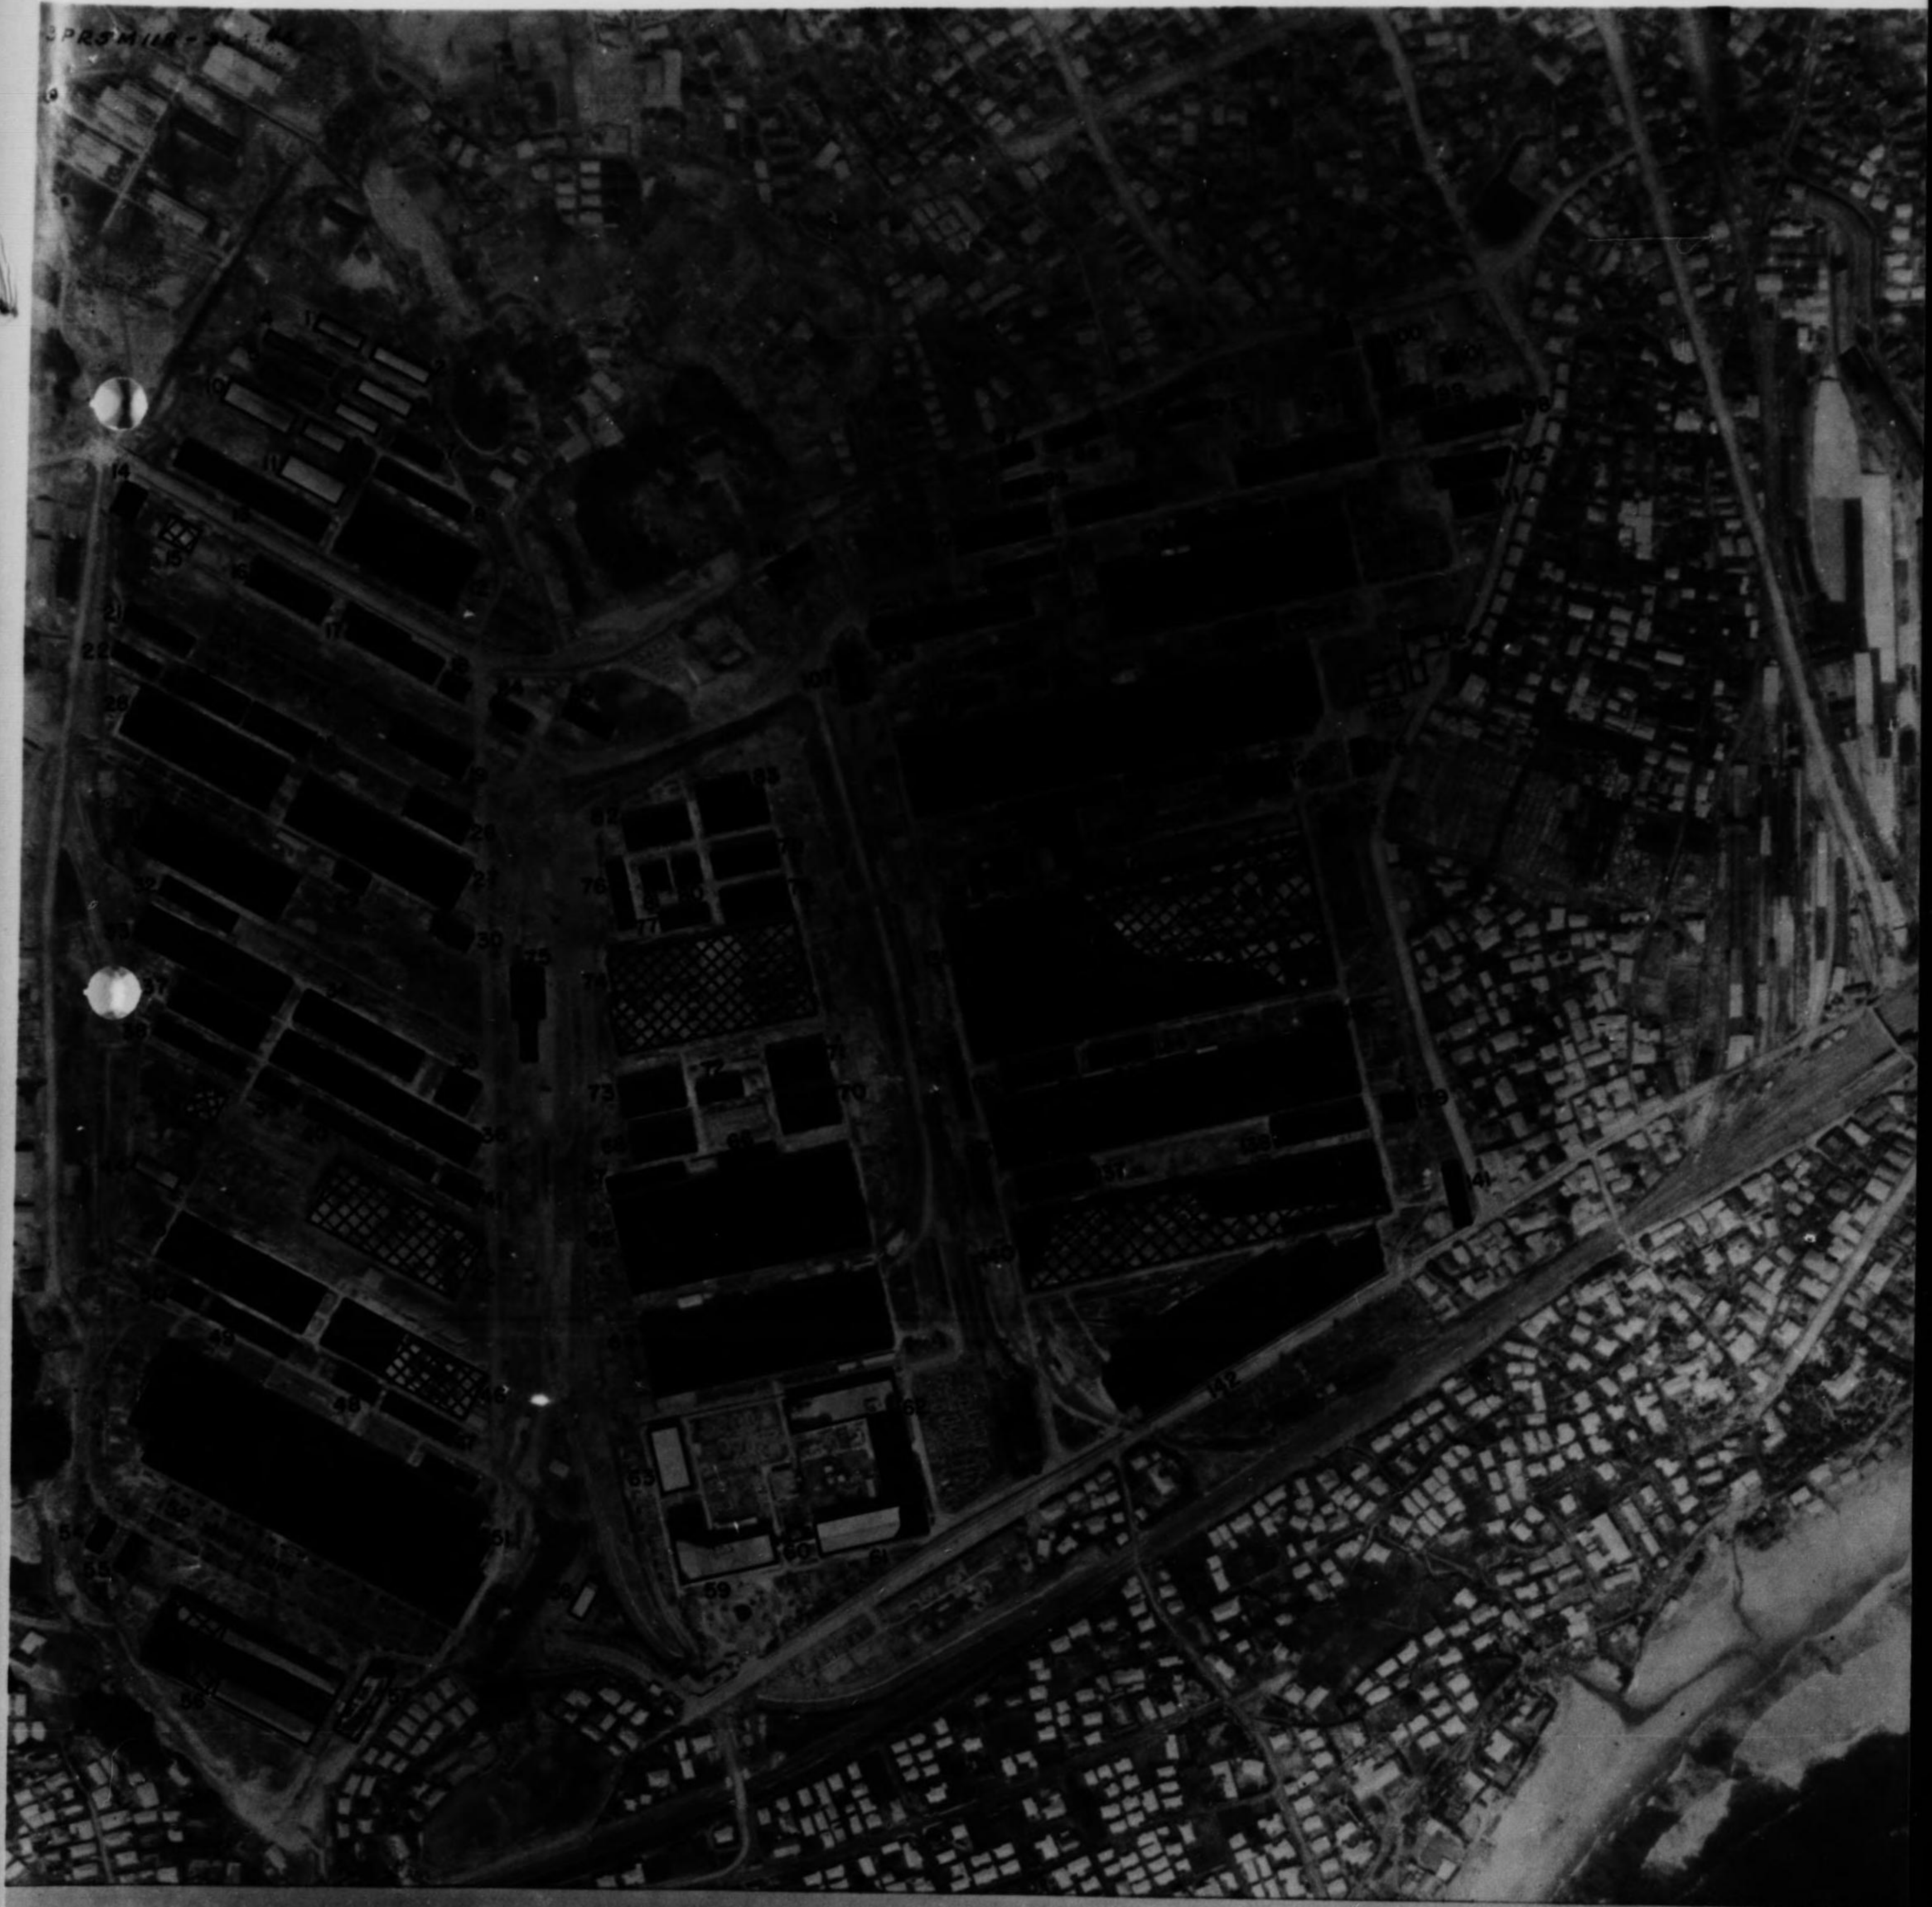
TARGET 90.14-1476  
HITACHI ENGINEERING CO.  
KAIGAN PLANT  
DAMAGE ASSESSMENT REPORT 127  
C.I.U. - XXI BOM. COM.

About 1,781,040 sq.ft., or 80.5% of the total roof area was destroyed or suffered structural damage. All major buildings are completely damaged, most of them being either destroyed or structurally damaged.

Three stock storage yards (20, 52 and 110 on the attached annotated print) show signs of having been heavily damaged. Railway facilities within the plant area were completely demolished.
