XXBOMBER COMMAND
MISSION NO 5
DATE 10-11 August 1944

TACTICAL MISSION

REPORT

PLADJOE REFINERY, PALEMBANG

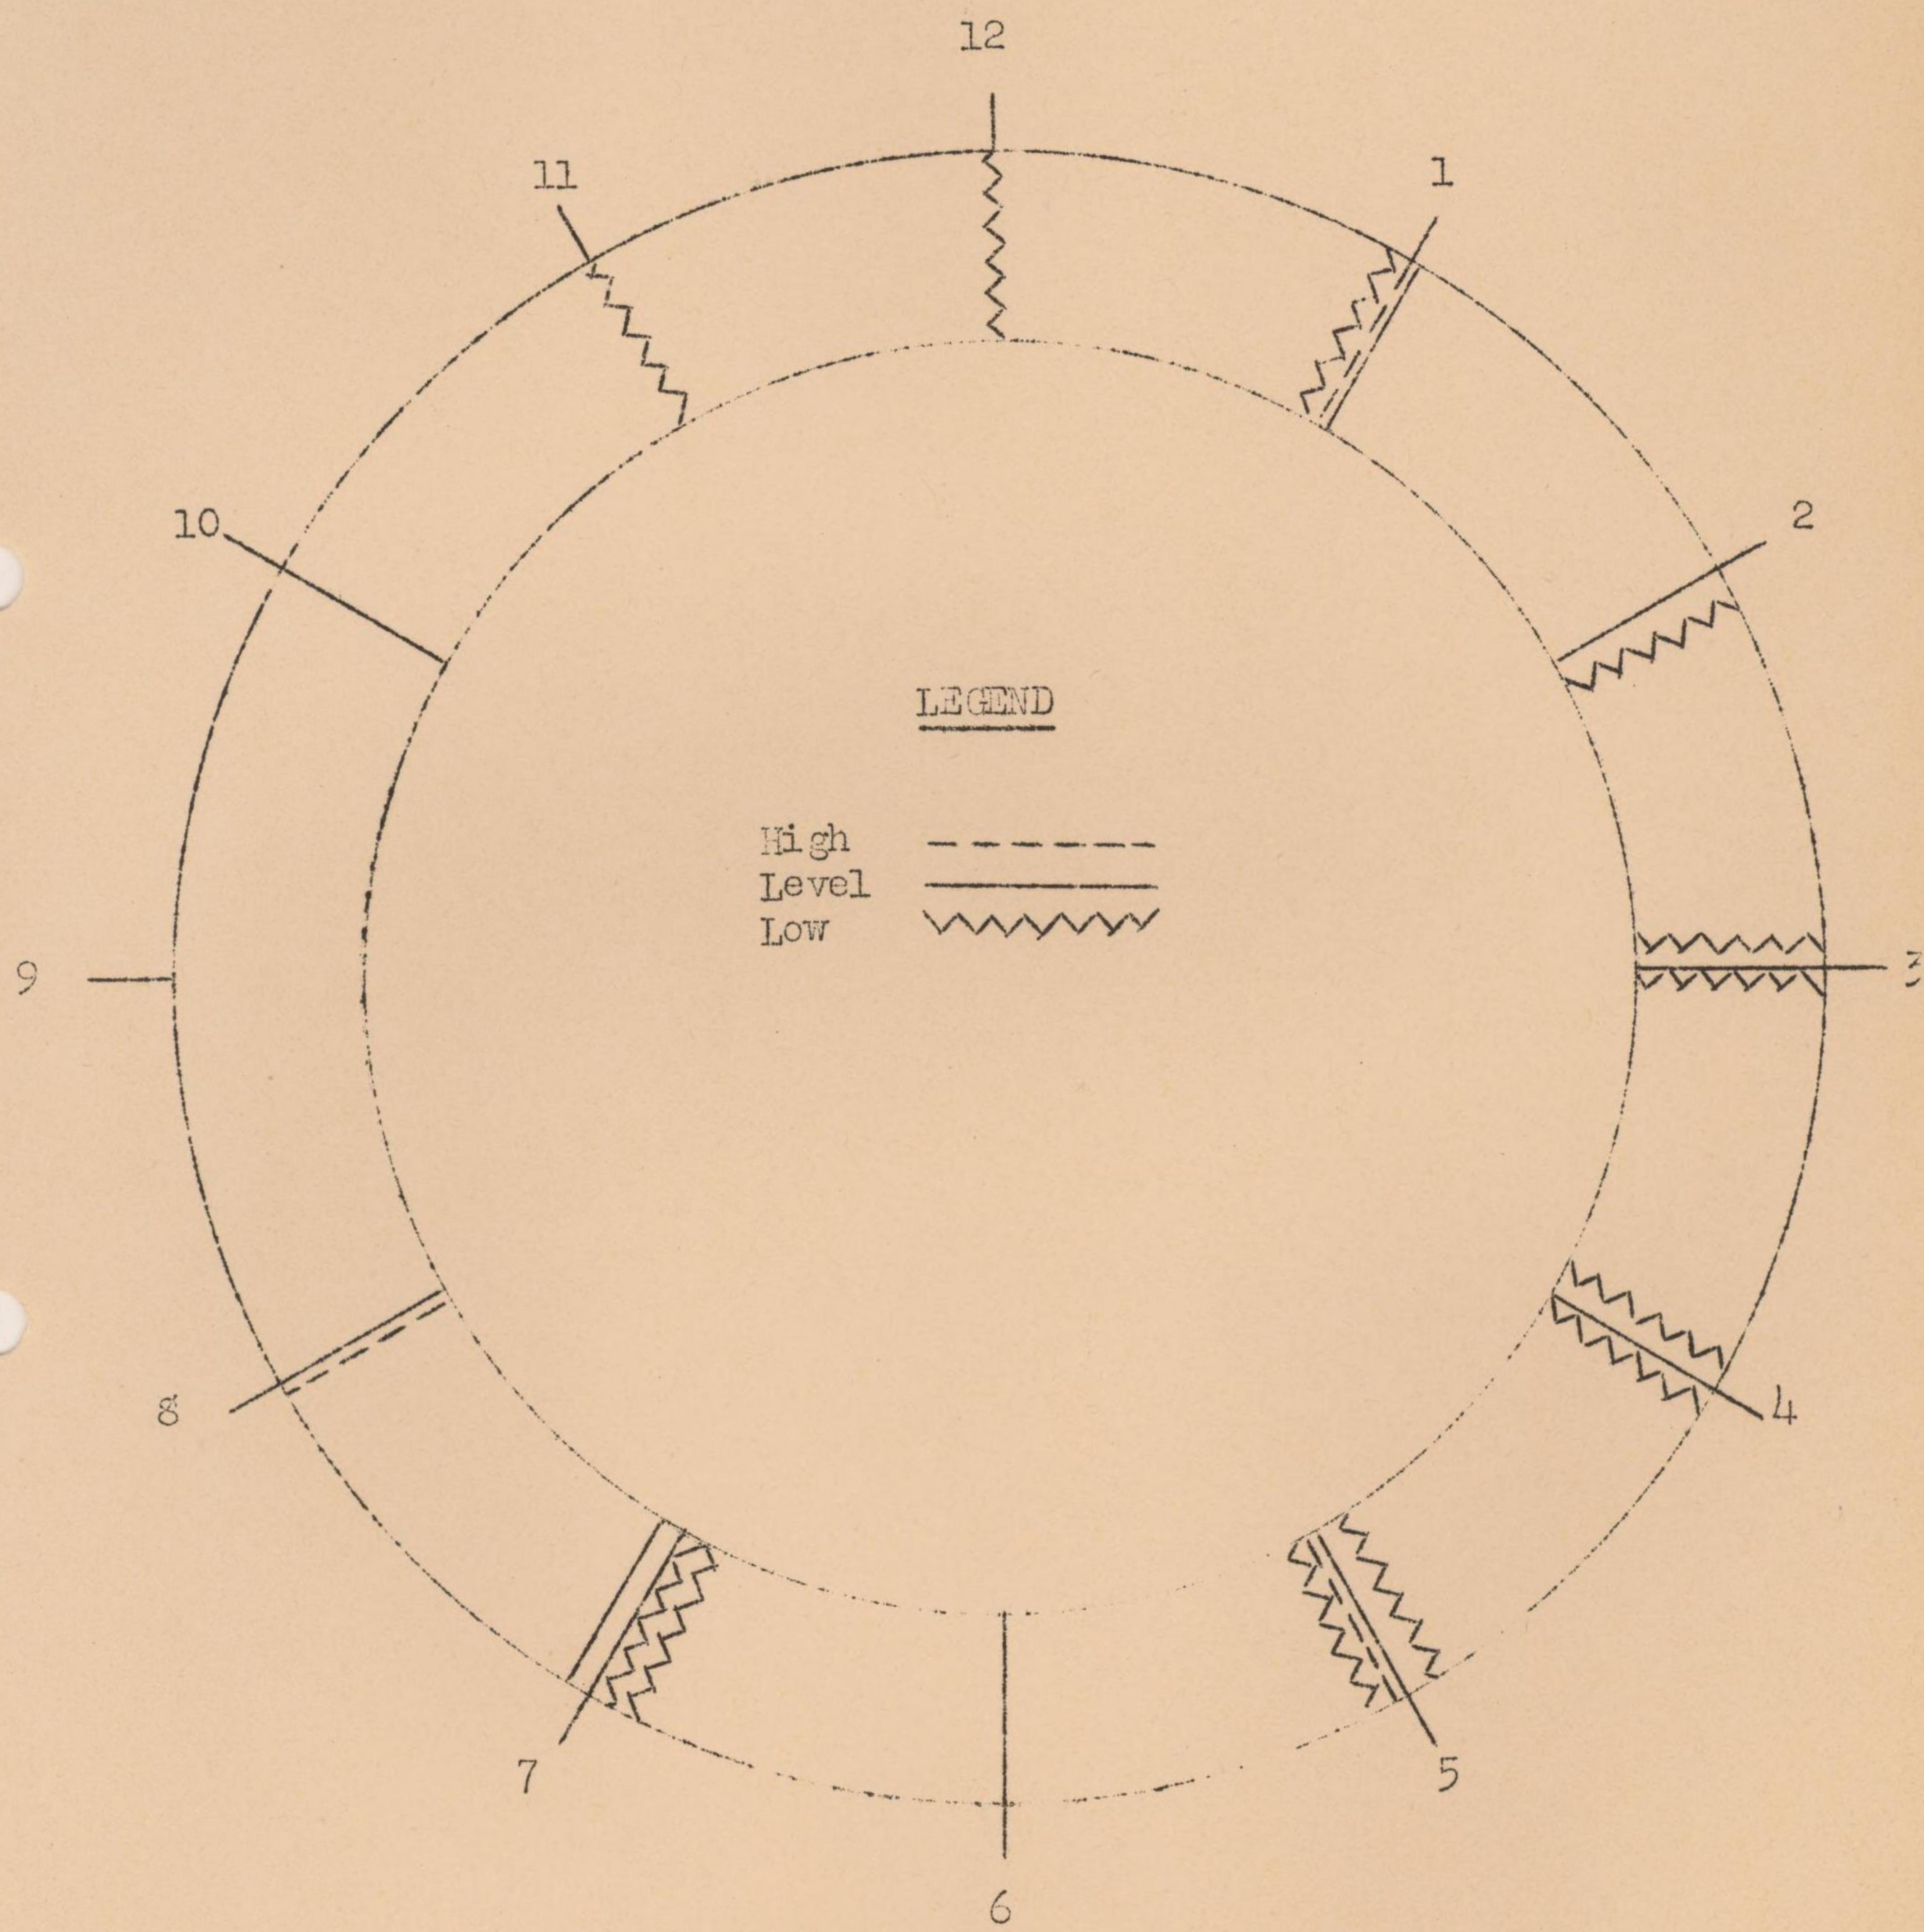
C-10

Note: In addition there was one belly attack originating directly below.

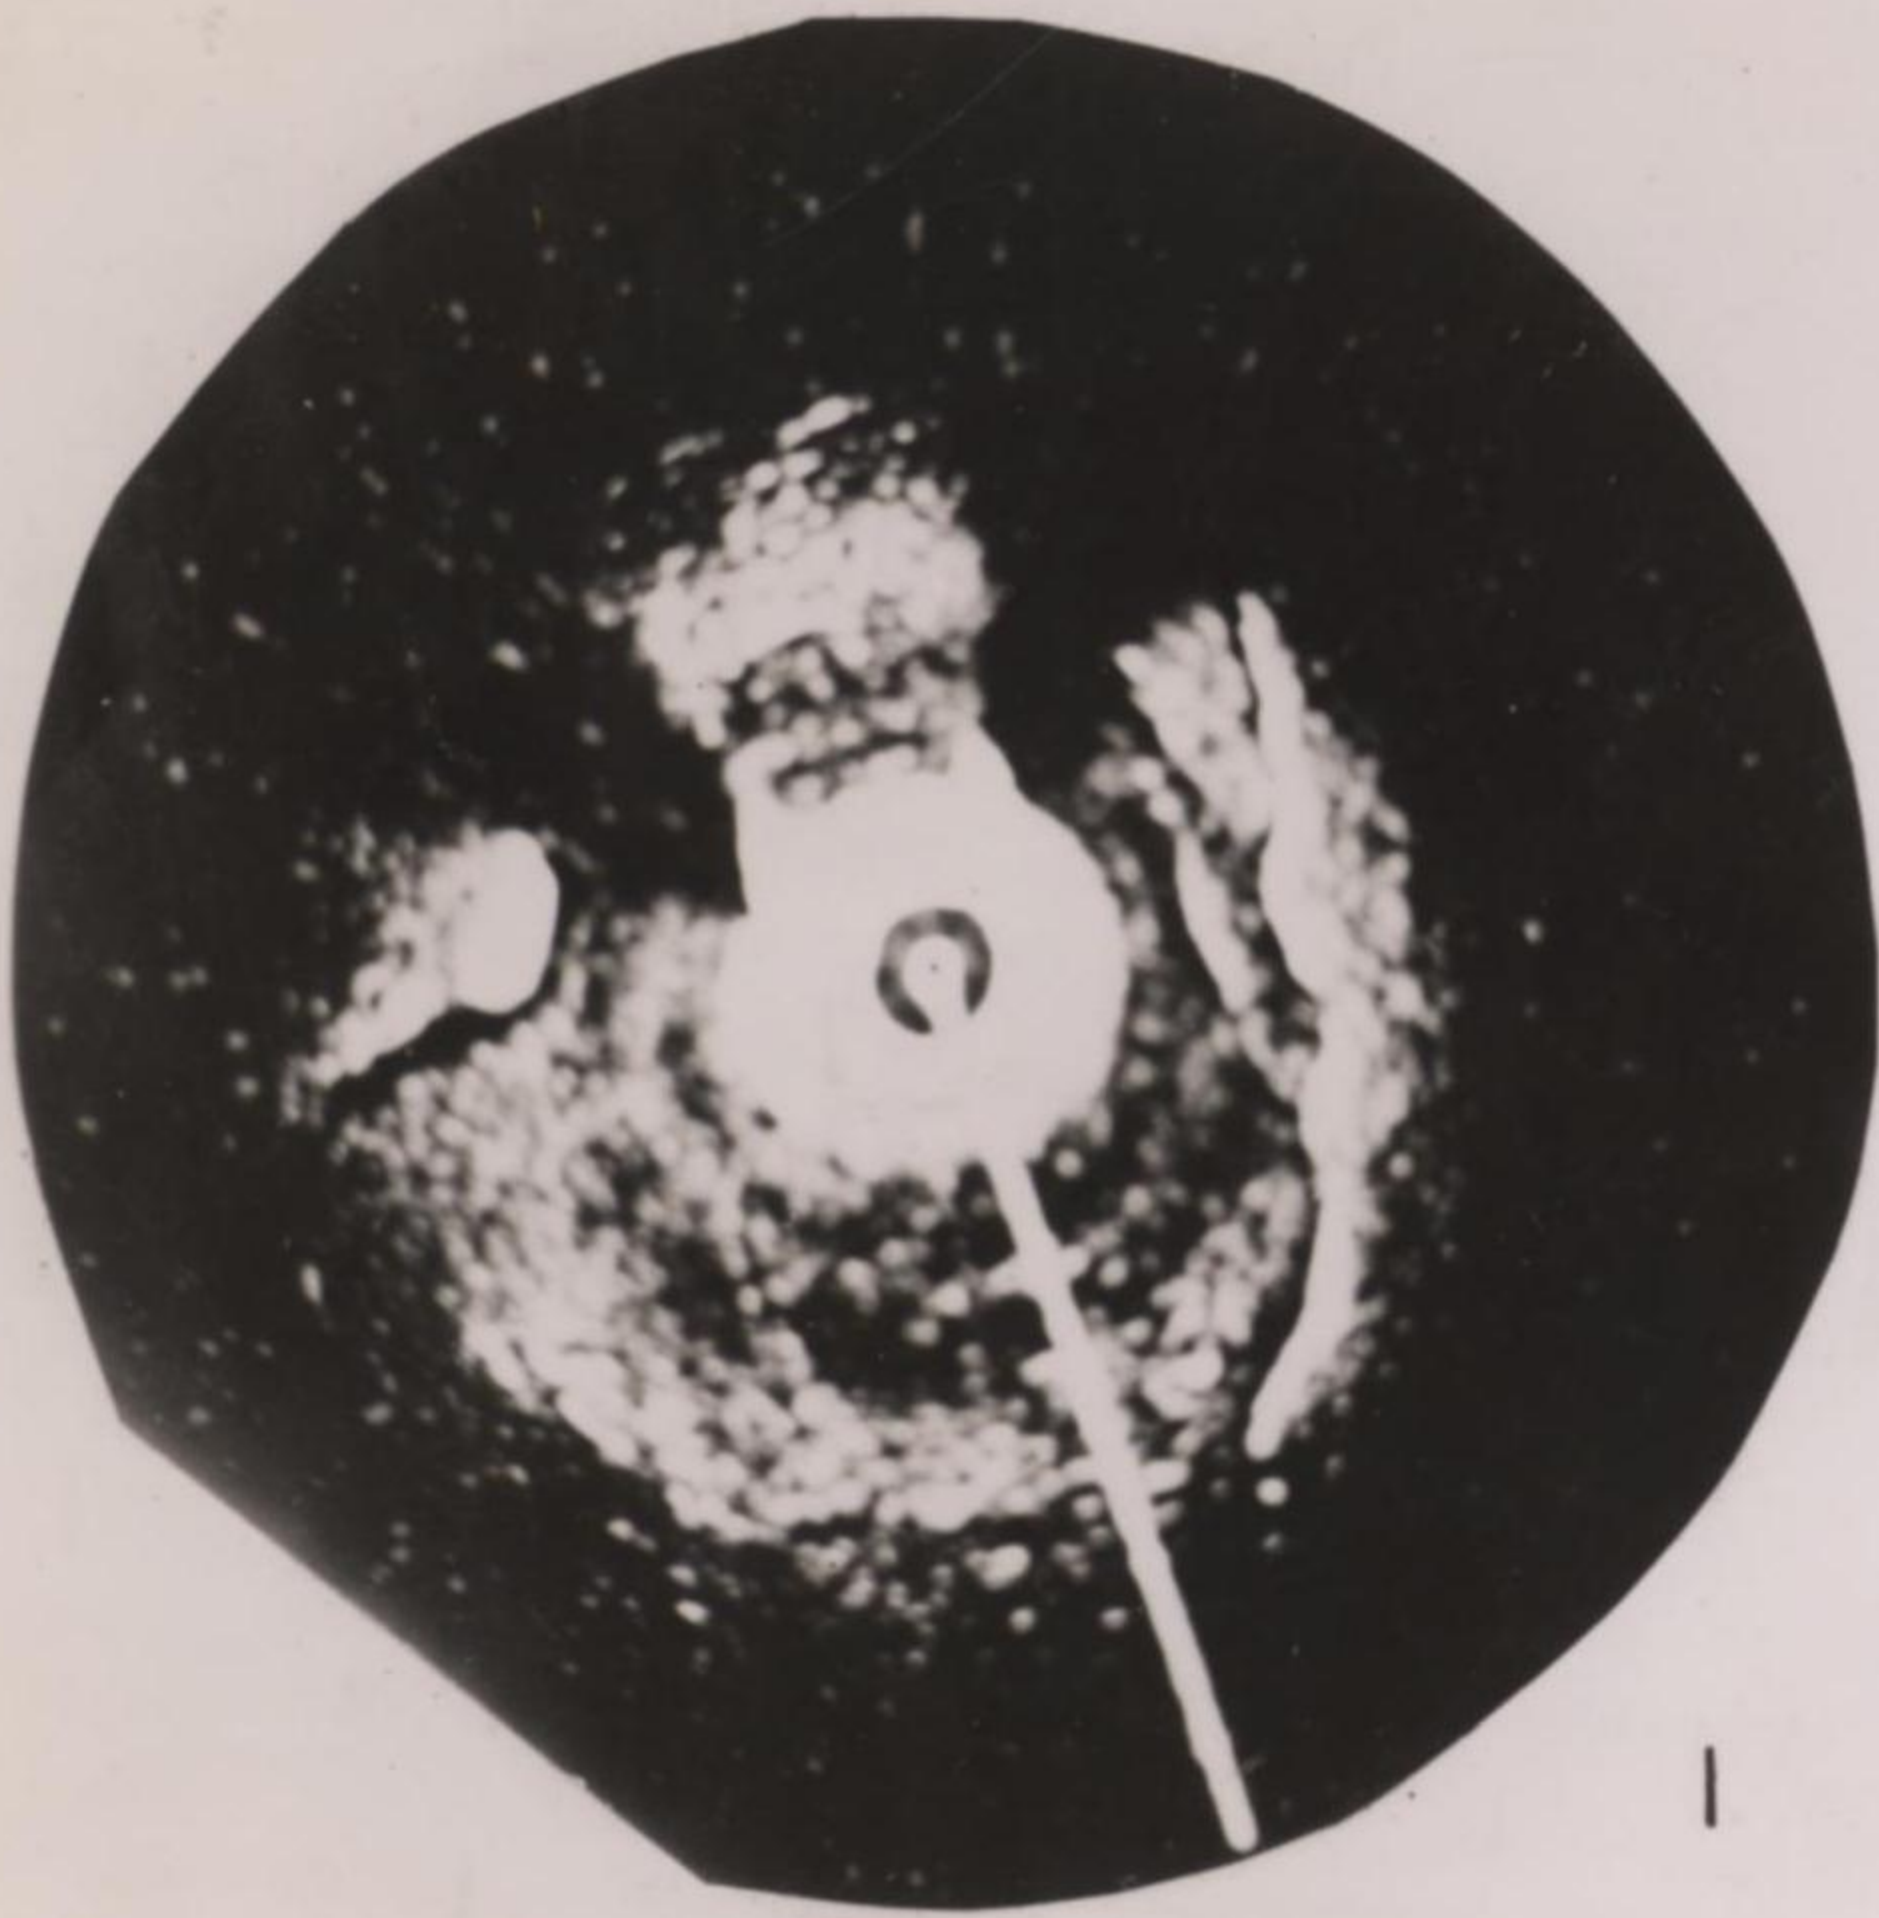
1

RADAR SCOPE PHOTOGRAPHS
PLADJOE OIL REFINERIES
A/C #280 444TH BOMB GROUP

20 MILE SWEEP
MOESI RIVER 9 MILES
FROM 2 O'CLOCK TO 5 O'CLOCK

(4) Radar-Scope Photography: Of the 9 aircraft equipped with C-3 radar cameras, 6 failed to bomb the primary target. However, the remaining 3 aircraft secured usable sets of photographs, 2 sets of which were excellent. It was noted that the actual scope photographs compared favorably with the briefed scope appearances.

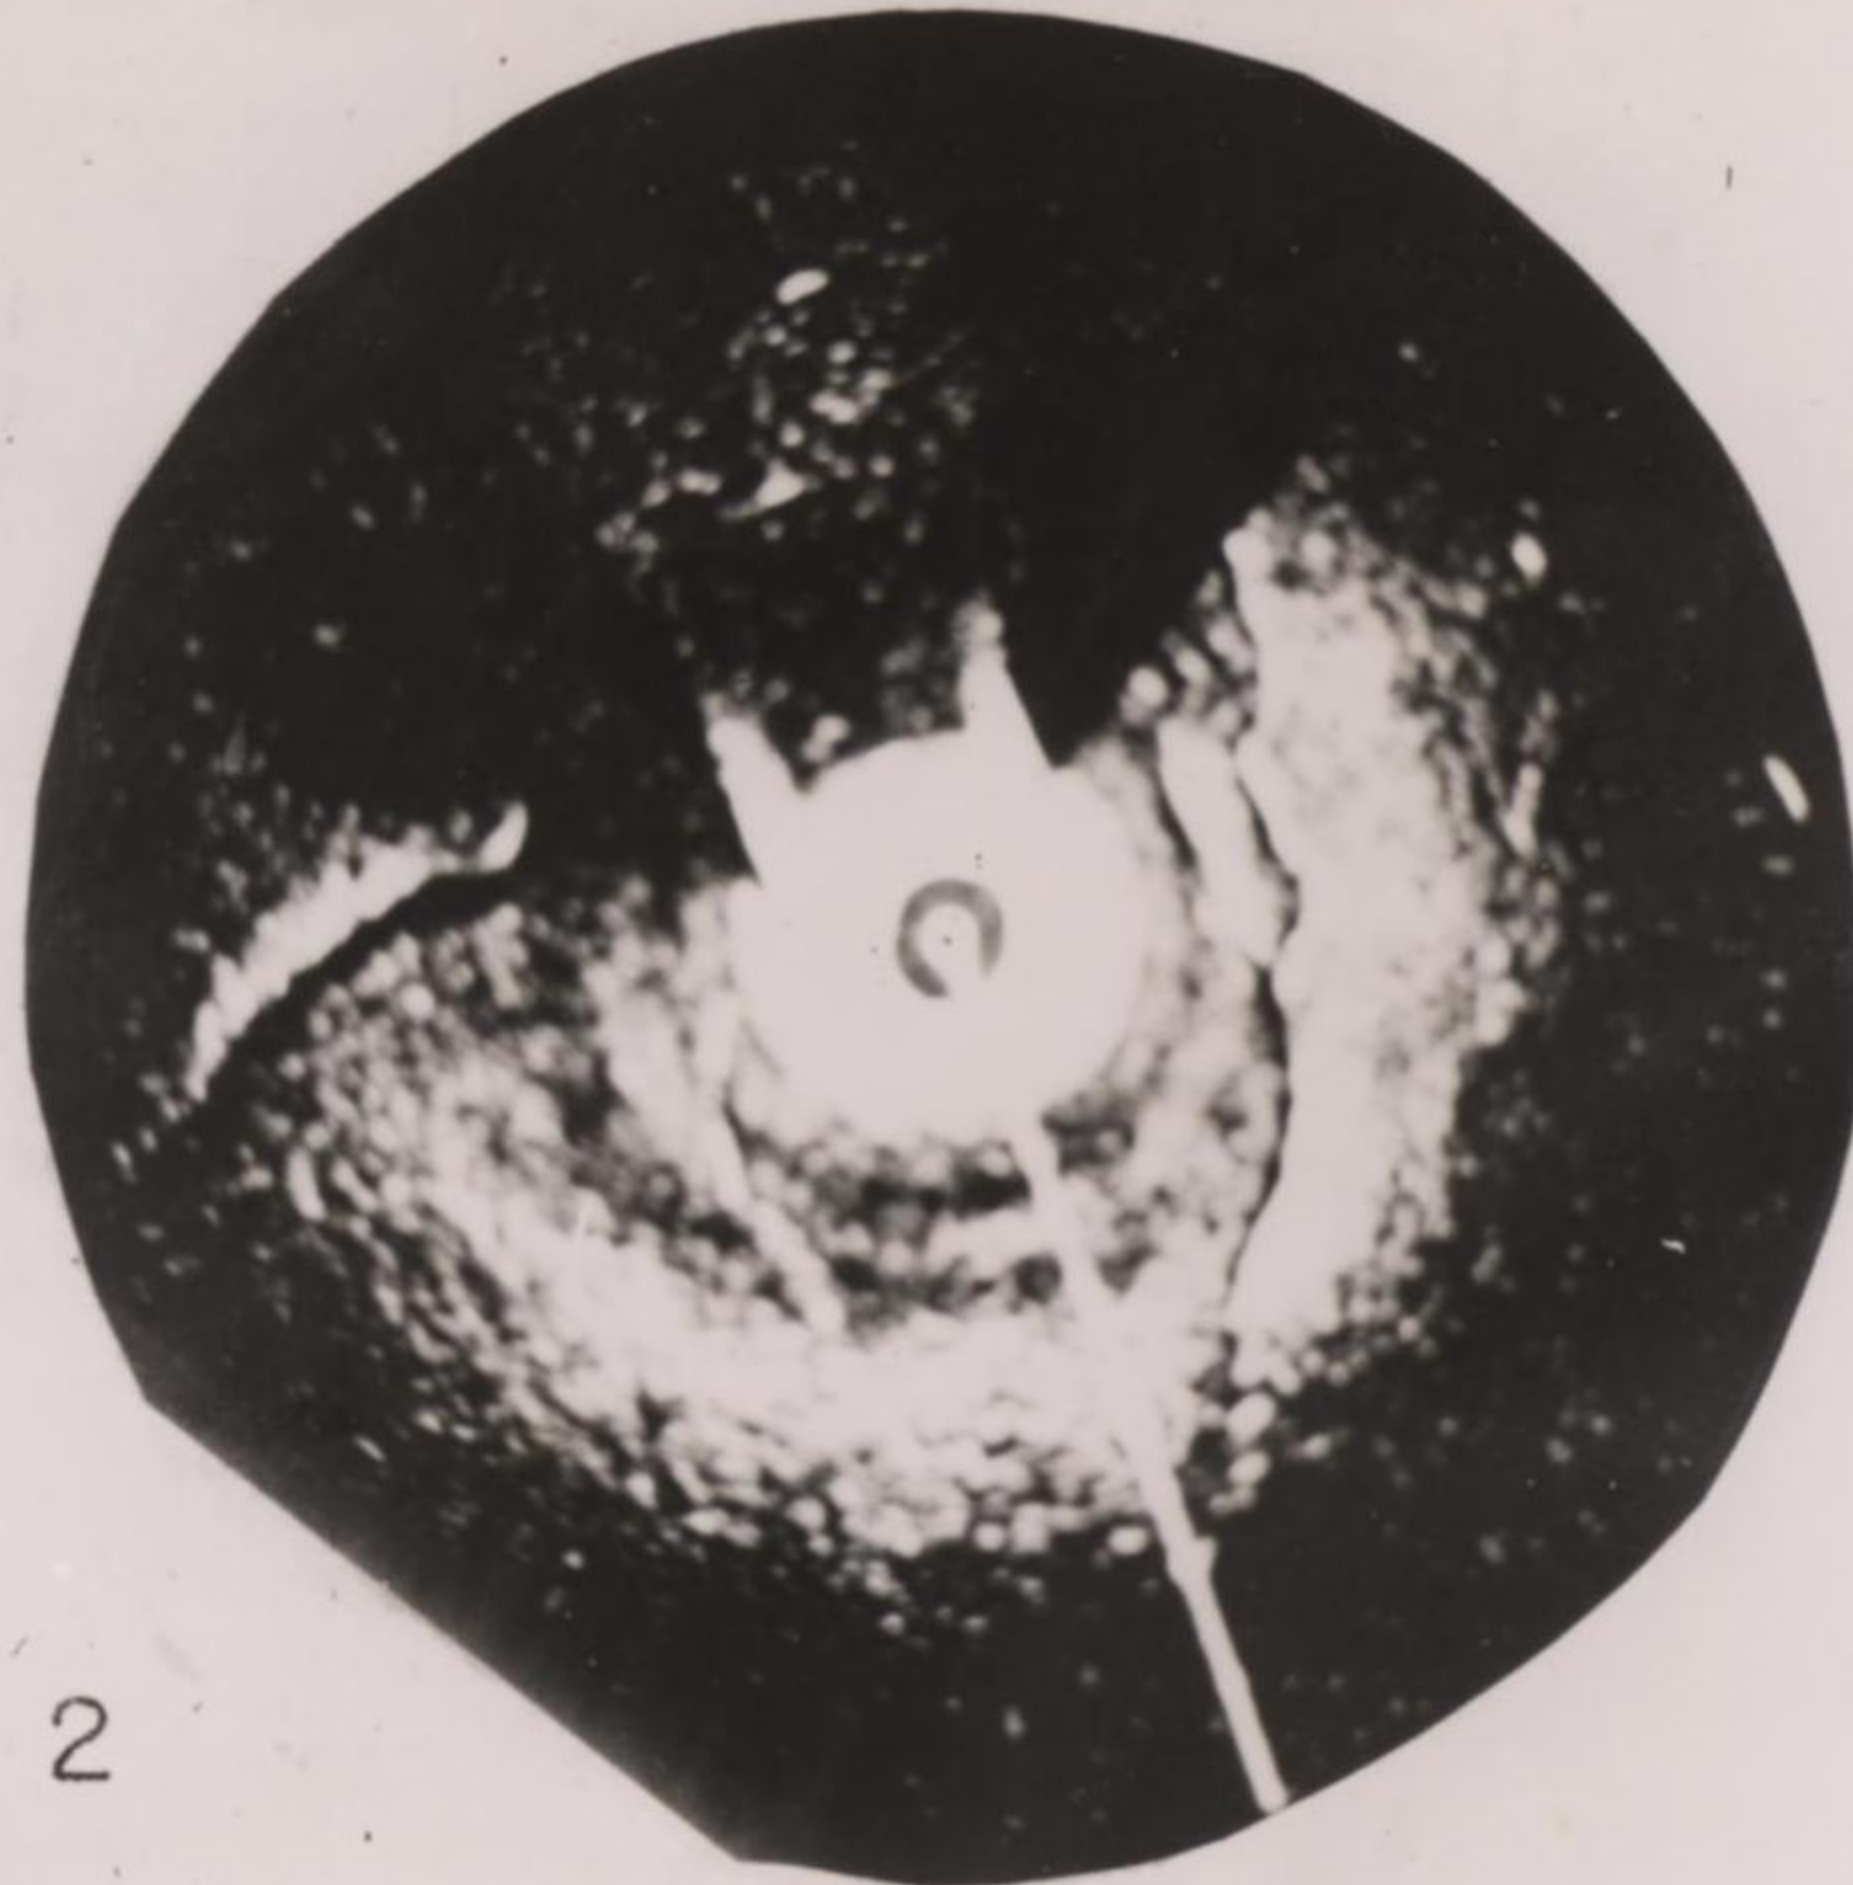
2

20 MILE SWEEP
MOESI RIVER 8 MILES HEADING 160°
NOTE BOMBAY DOOR SHADOW

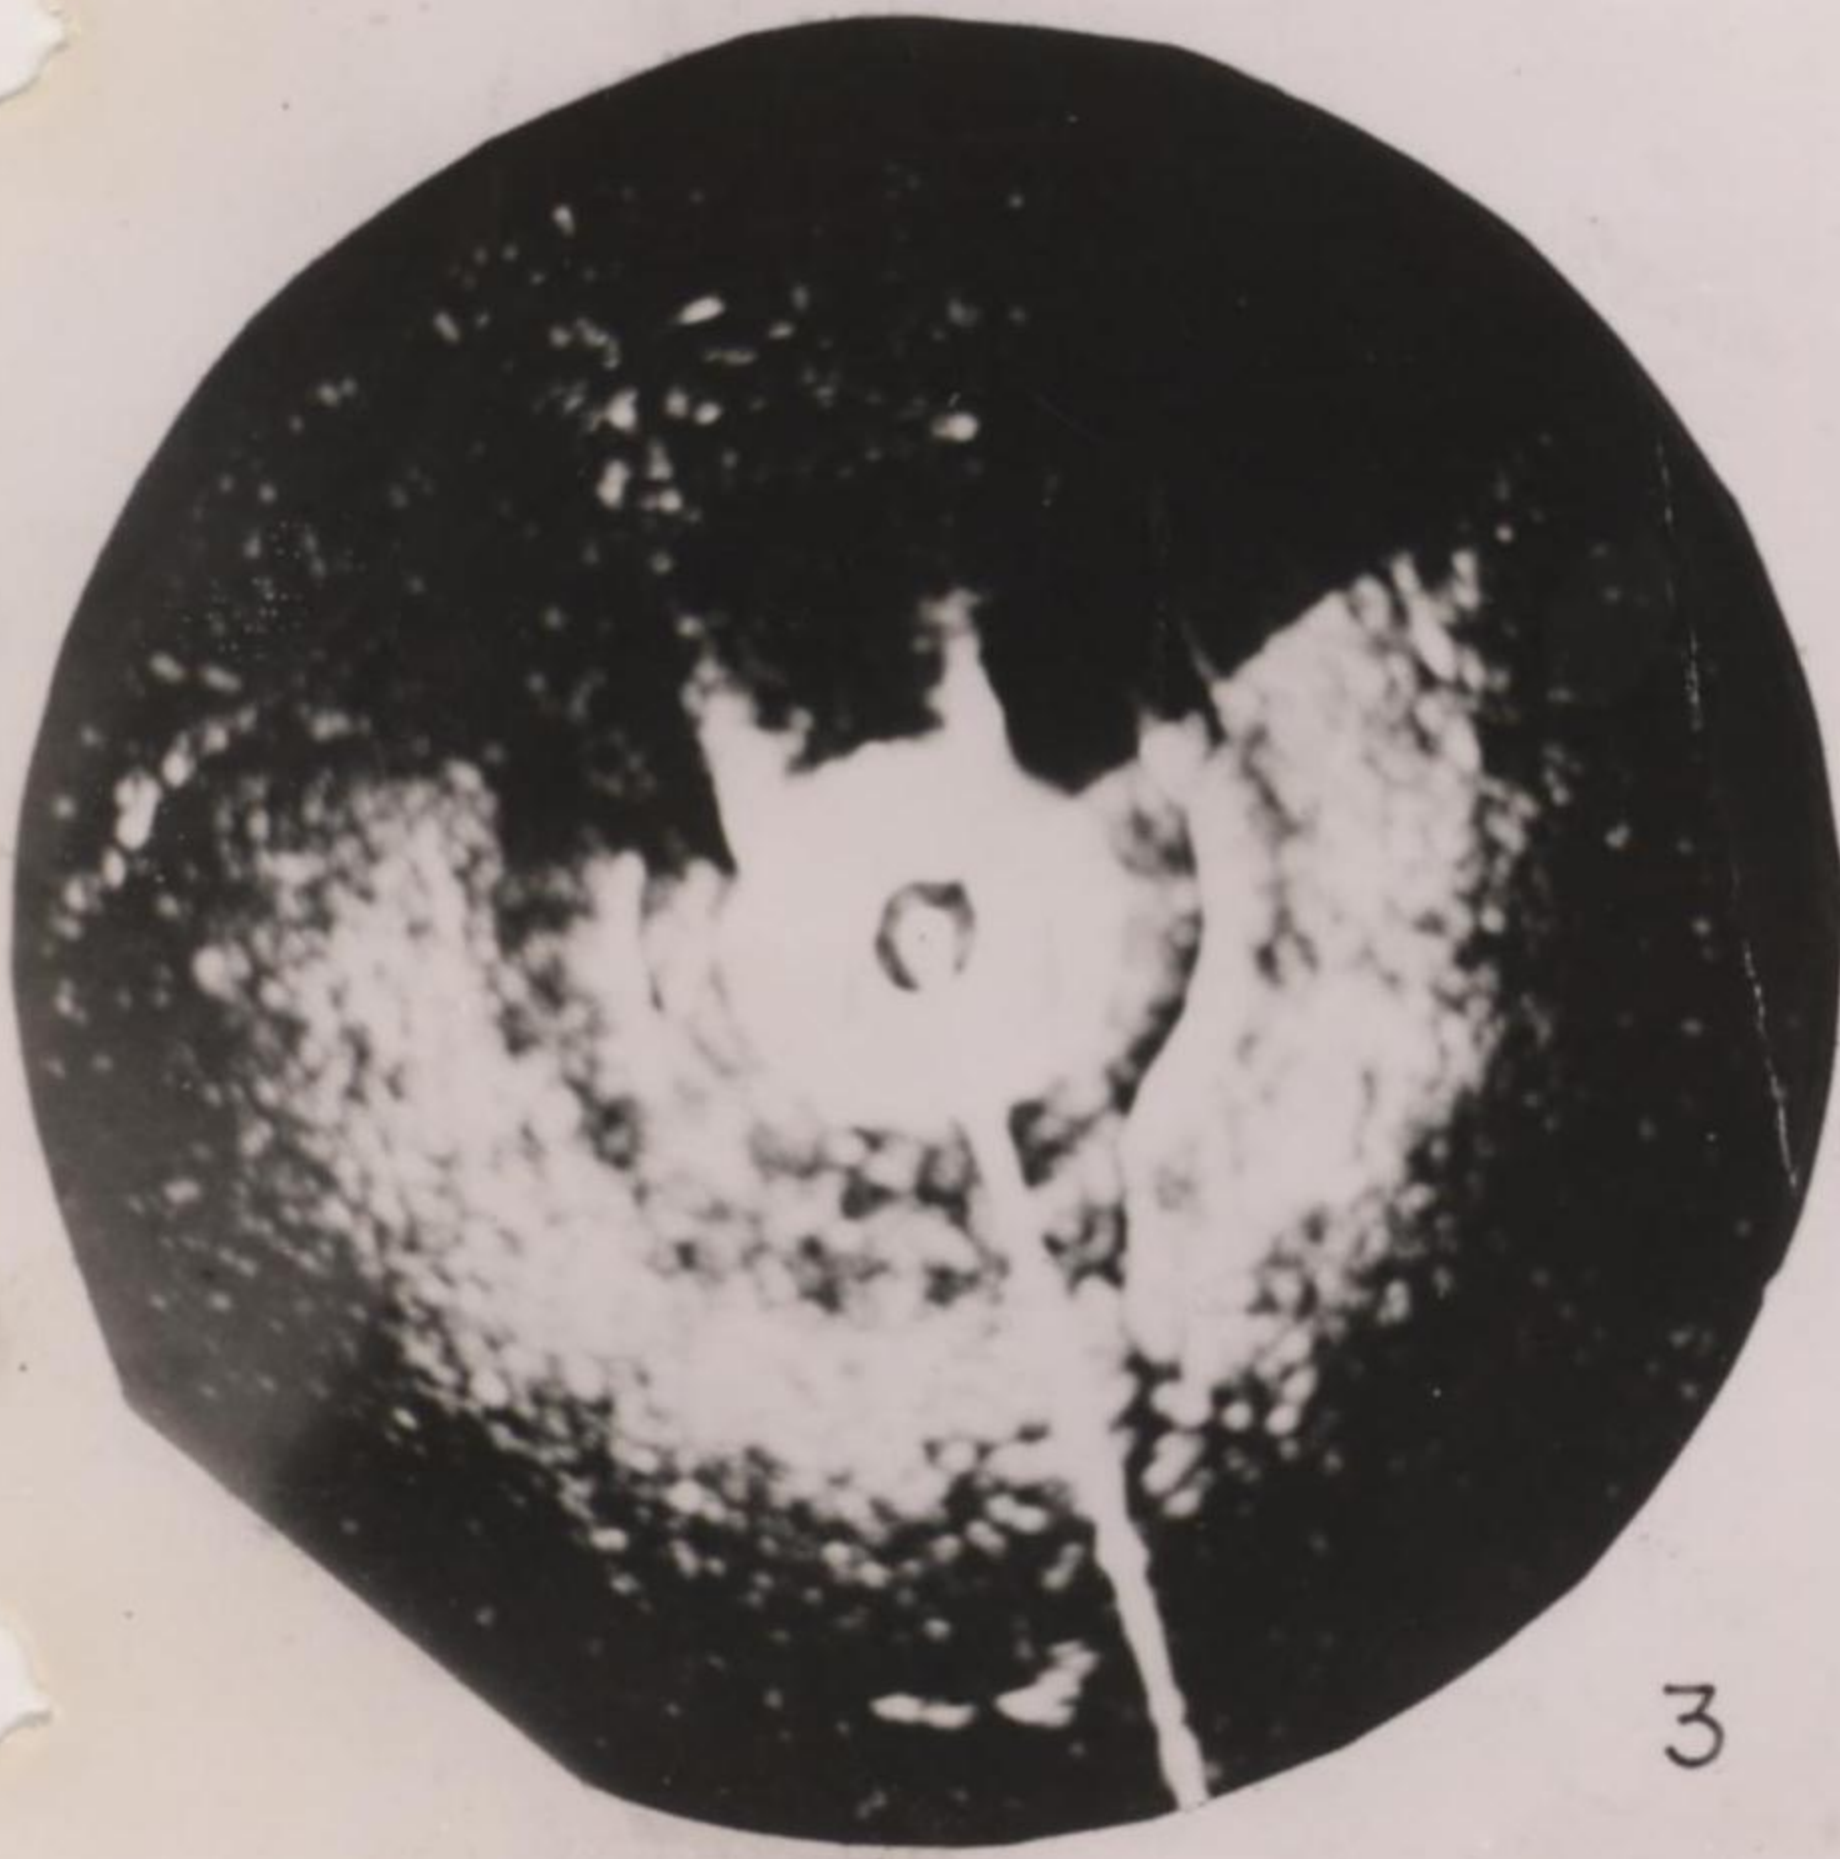
3

20 MILE SWEEP
PLADJOE 17 MILES
AT 6 O'CLOCK

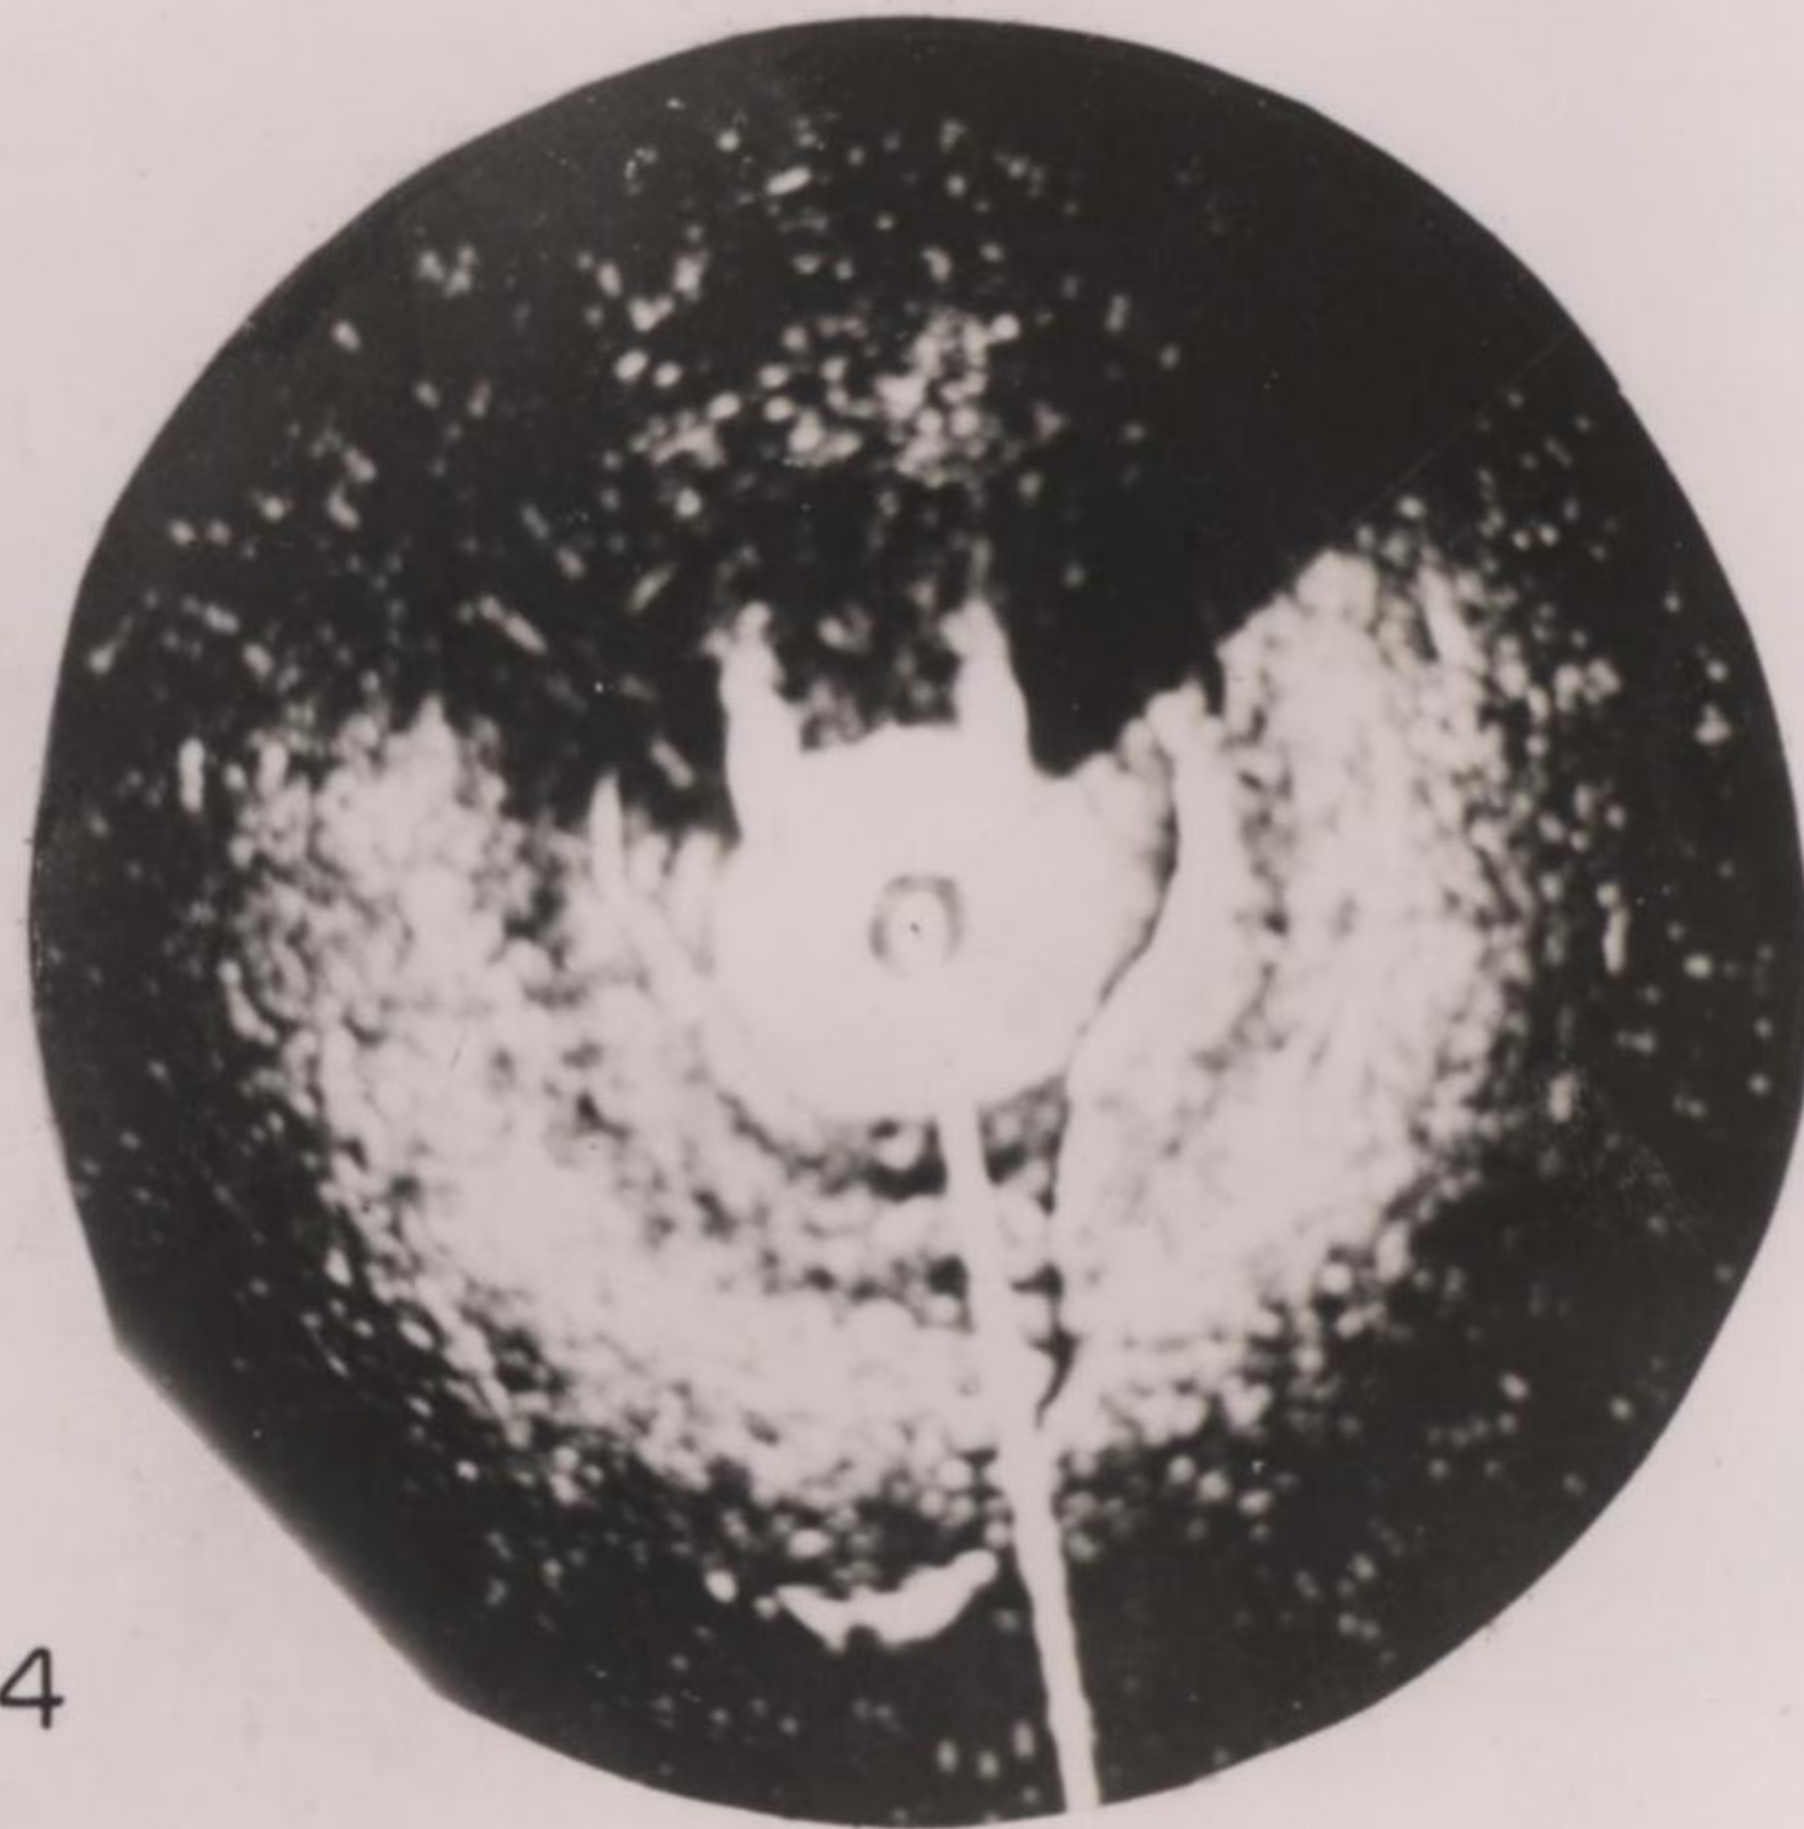
4

20 MILE SWEEP
PLADJOE 15 MILES
HEADING 170°

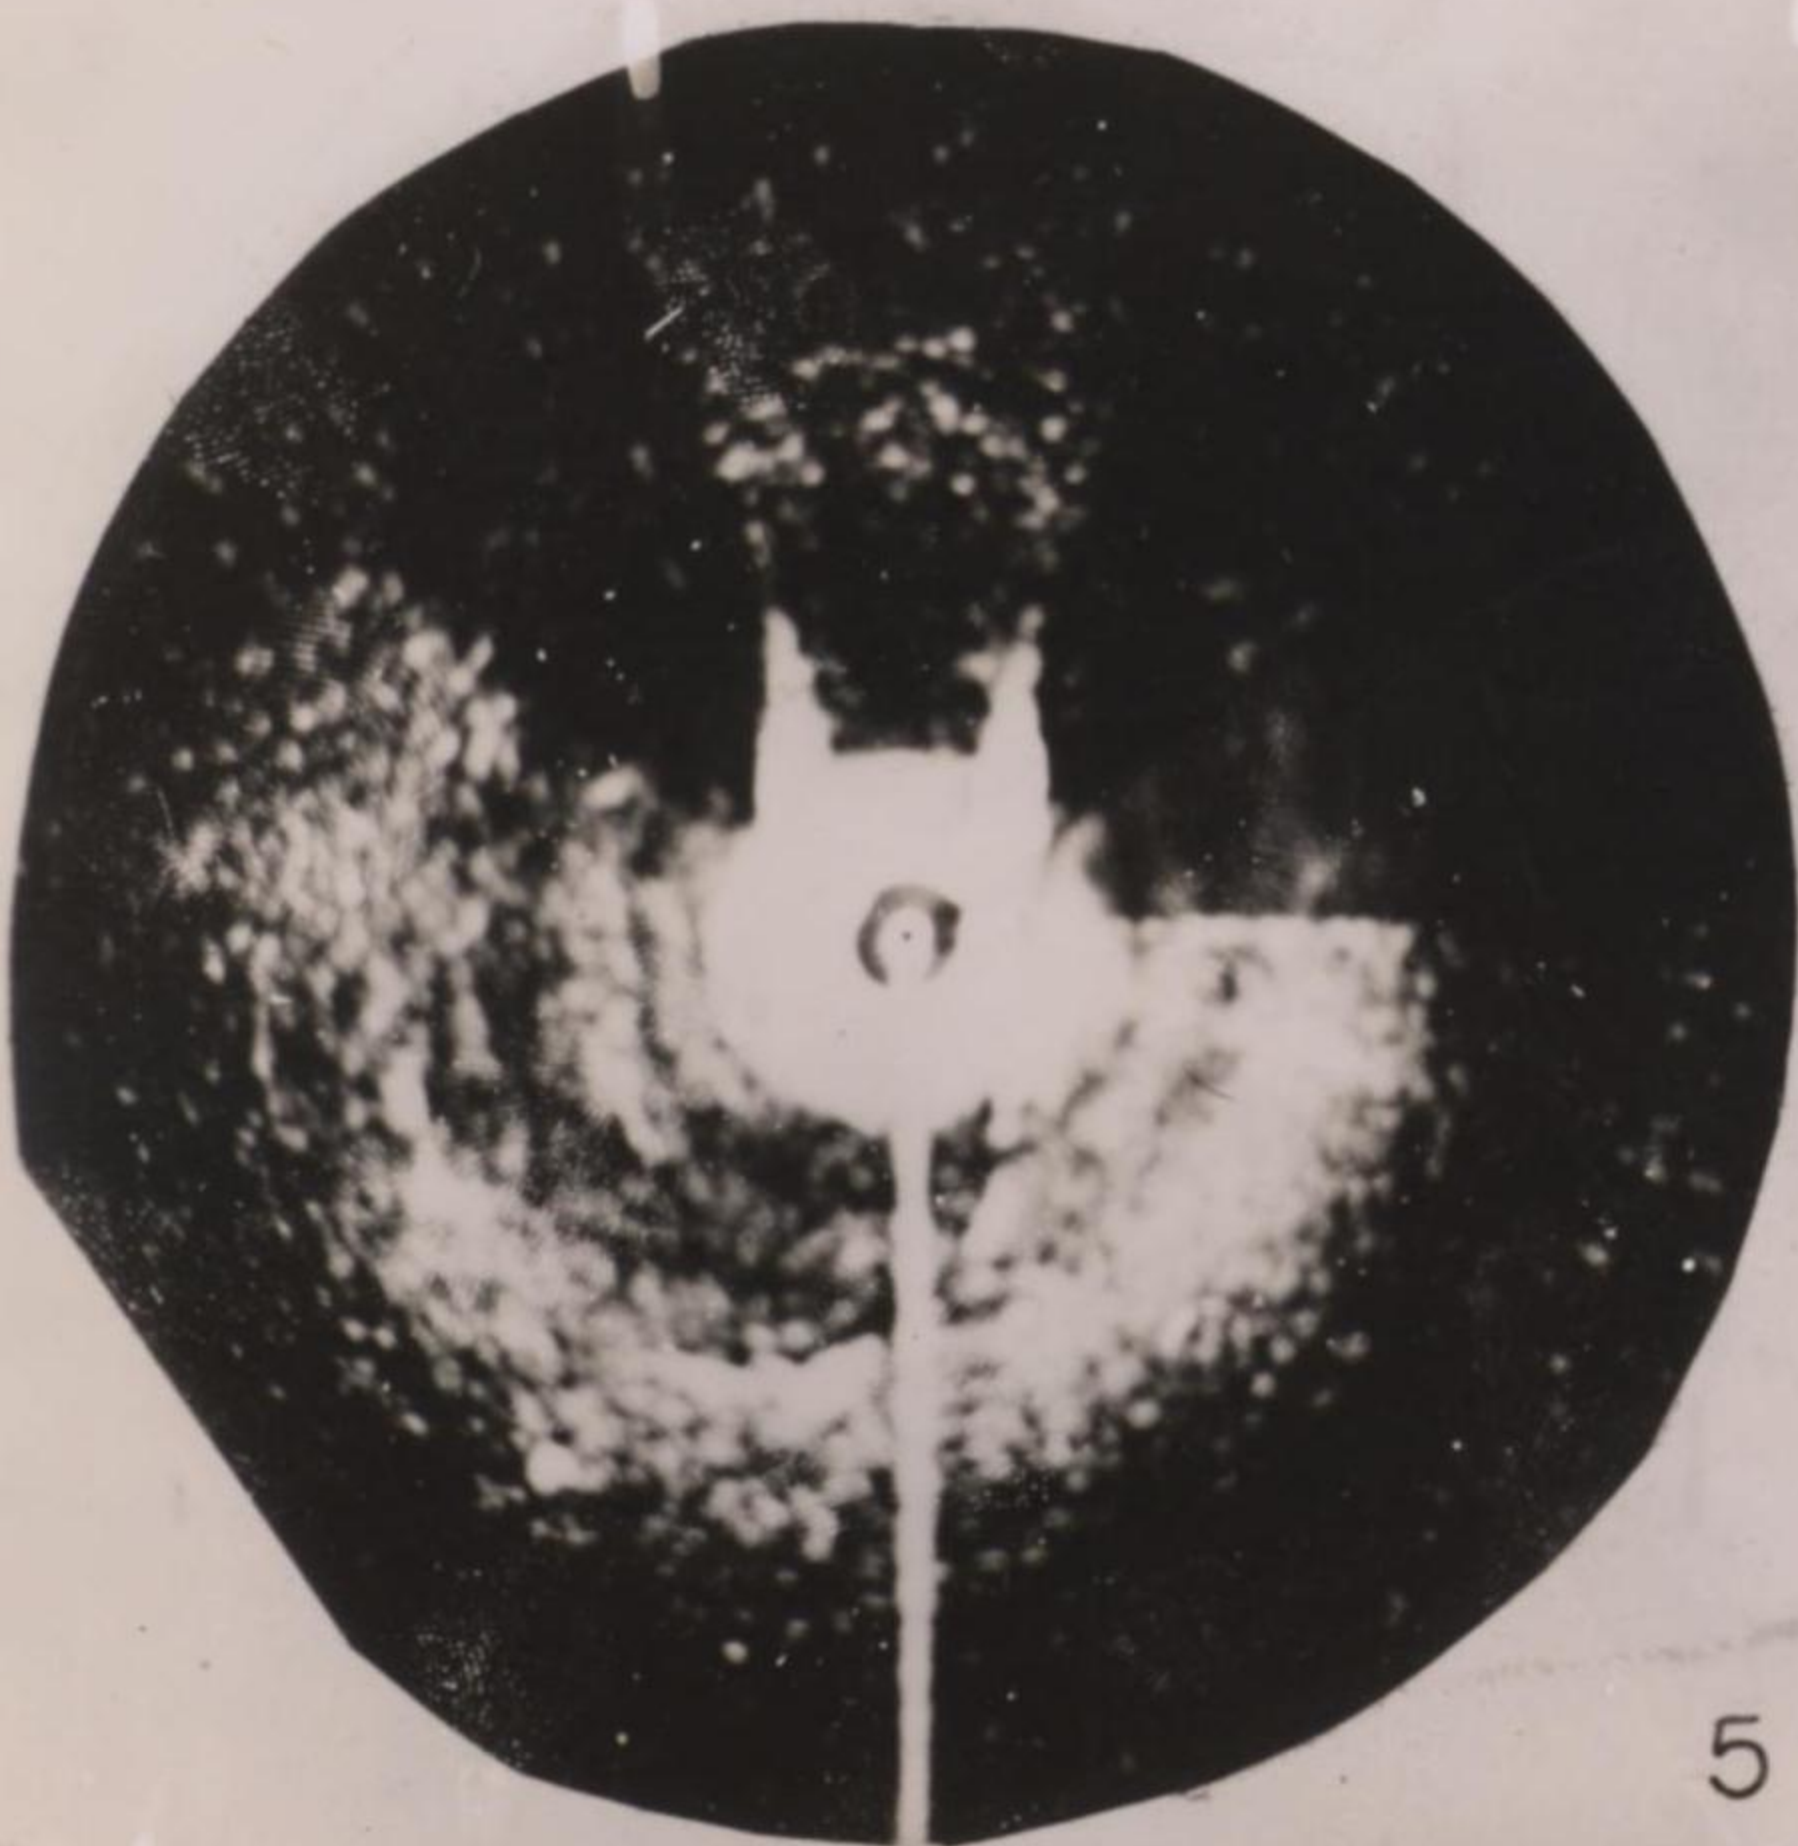
5

20 MILE SWEEP
PLADJOE 11 MILES HEADING 180°
NOTE BOMBAY DOOR SHADOW
