XXBOMBER COMMAND
MISSION NO 5
DATE 10-11 August 1944

TACTICAL MISSION

REPORT

PLADJOE REFINERY, PALEMBANG

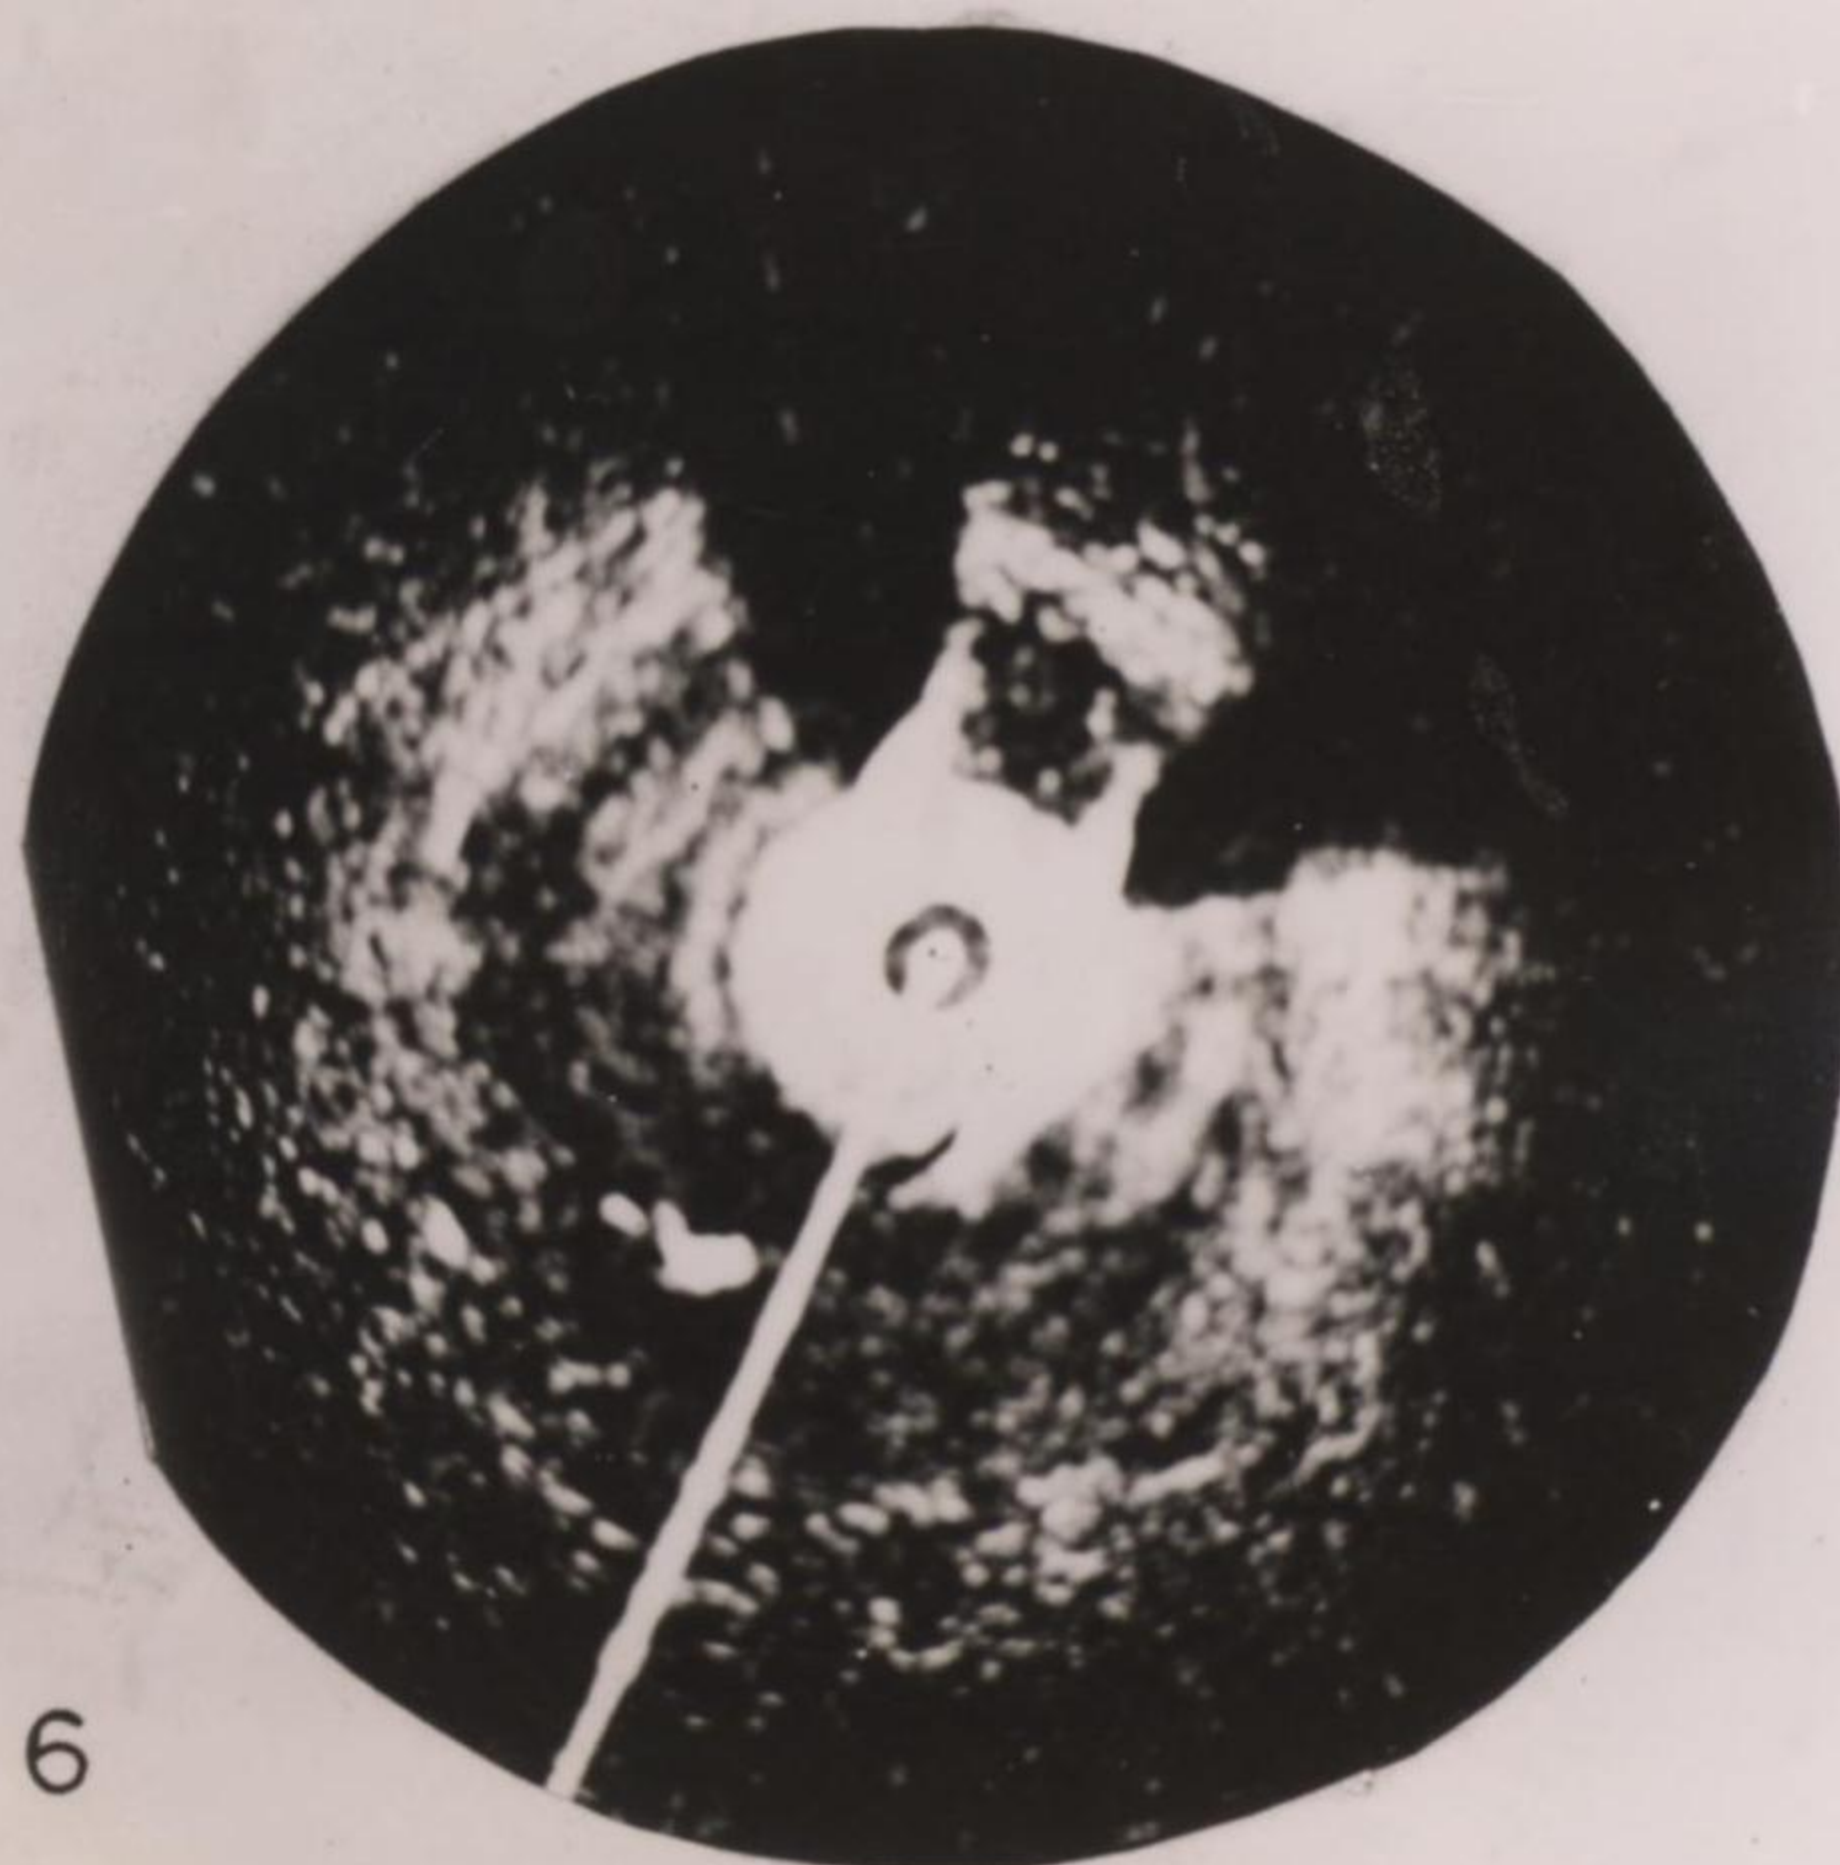
6

20 MILE SWEEP
PLADJOE 7 MILES
HEADING 200°

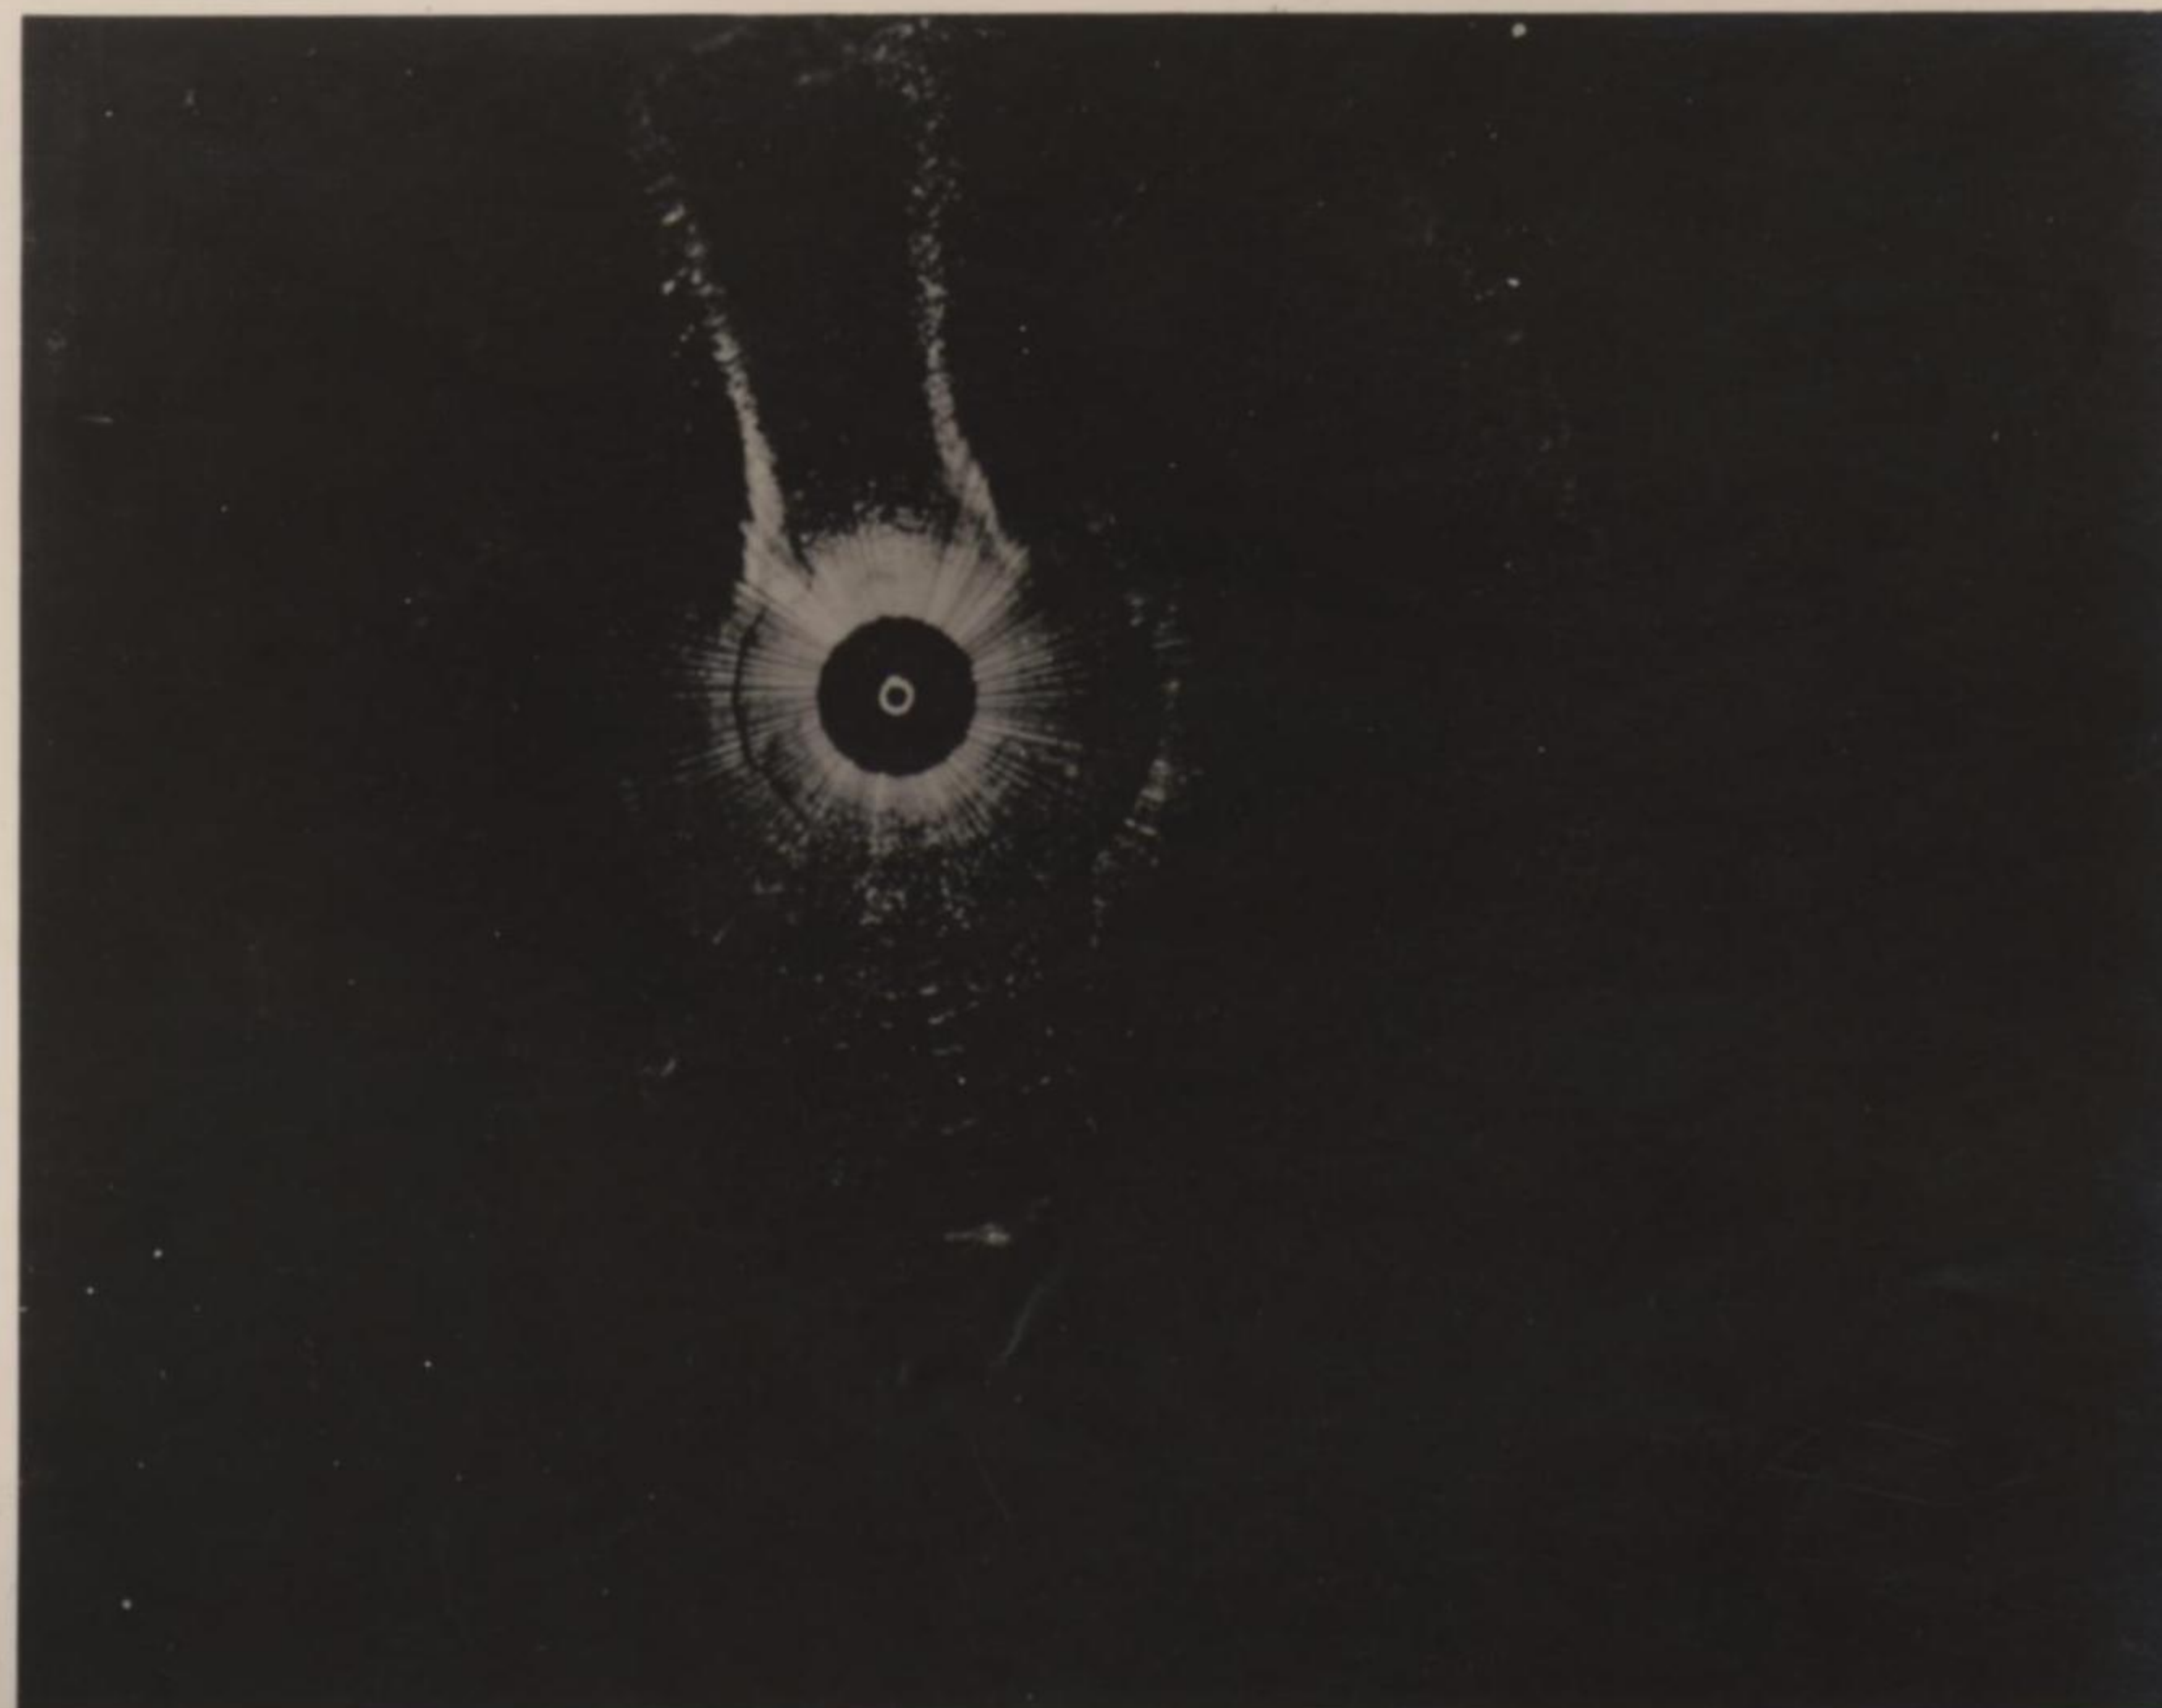
1A

PICTURE #1A. 20 MILE
SWEEP. HEADING 170°
MAG. NOTE: TARGET AT
19 S. MILES RANGE

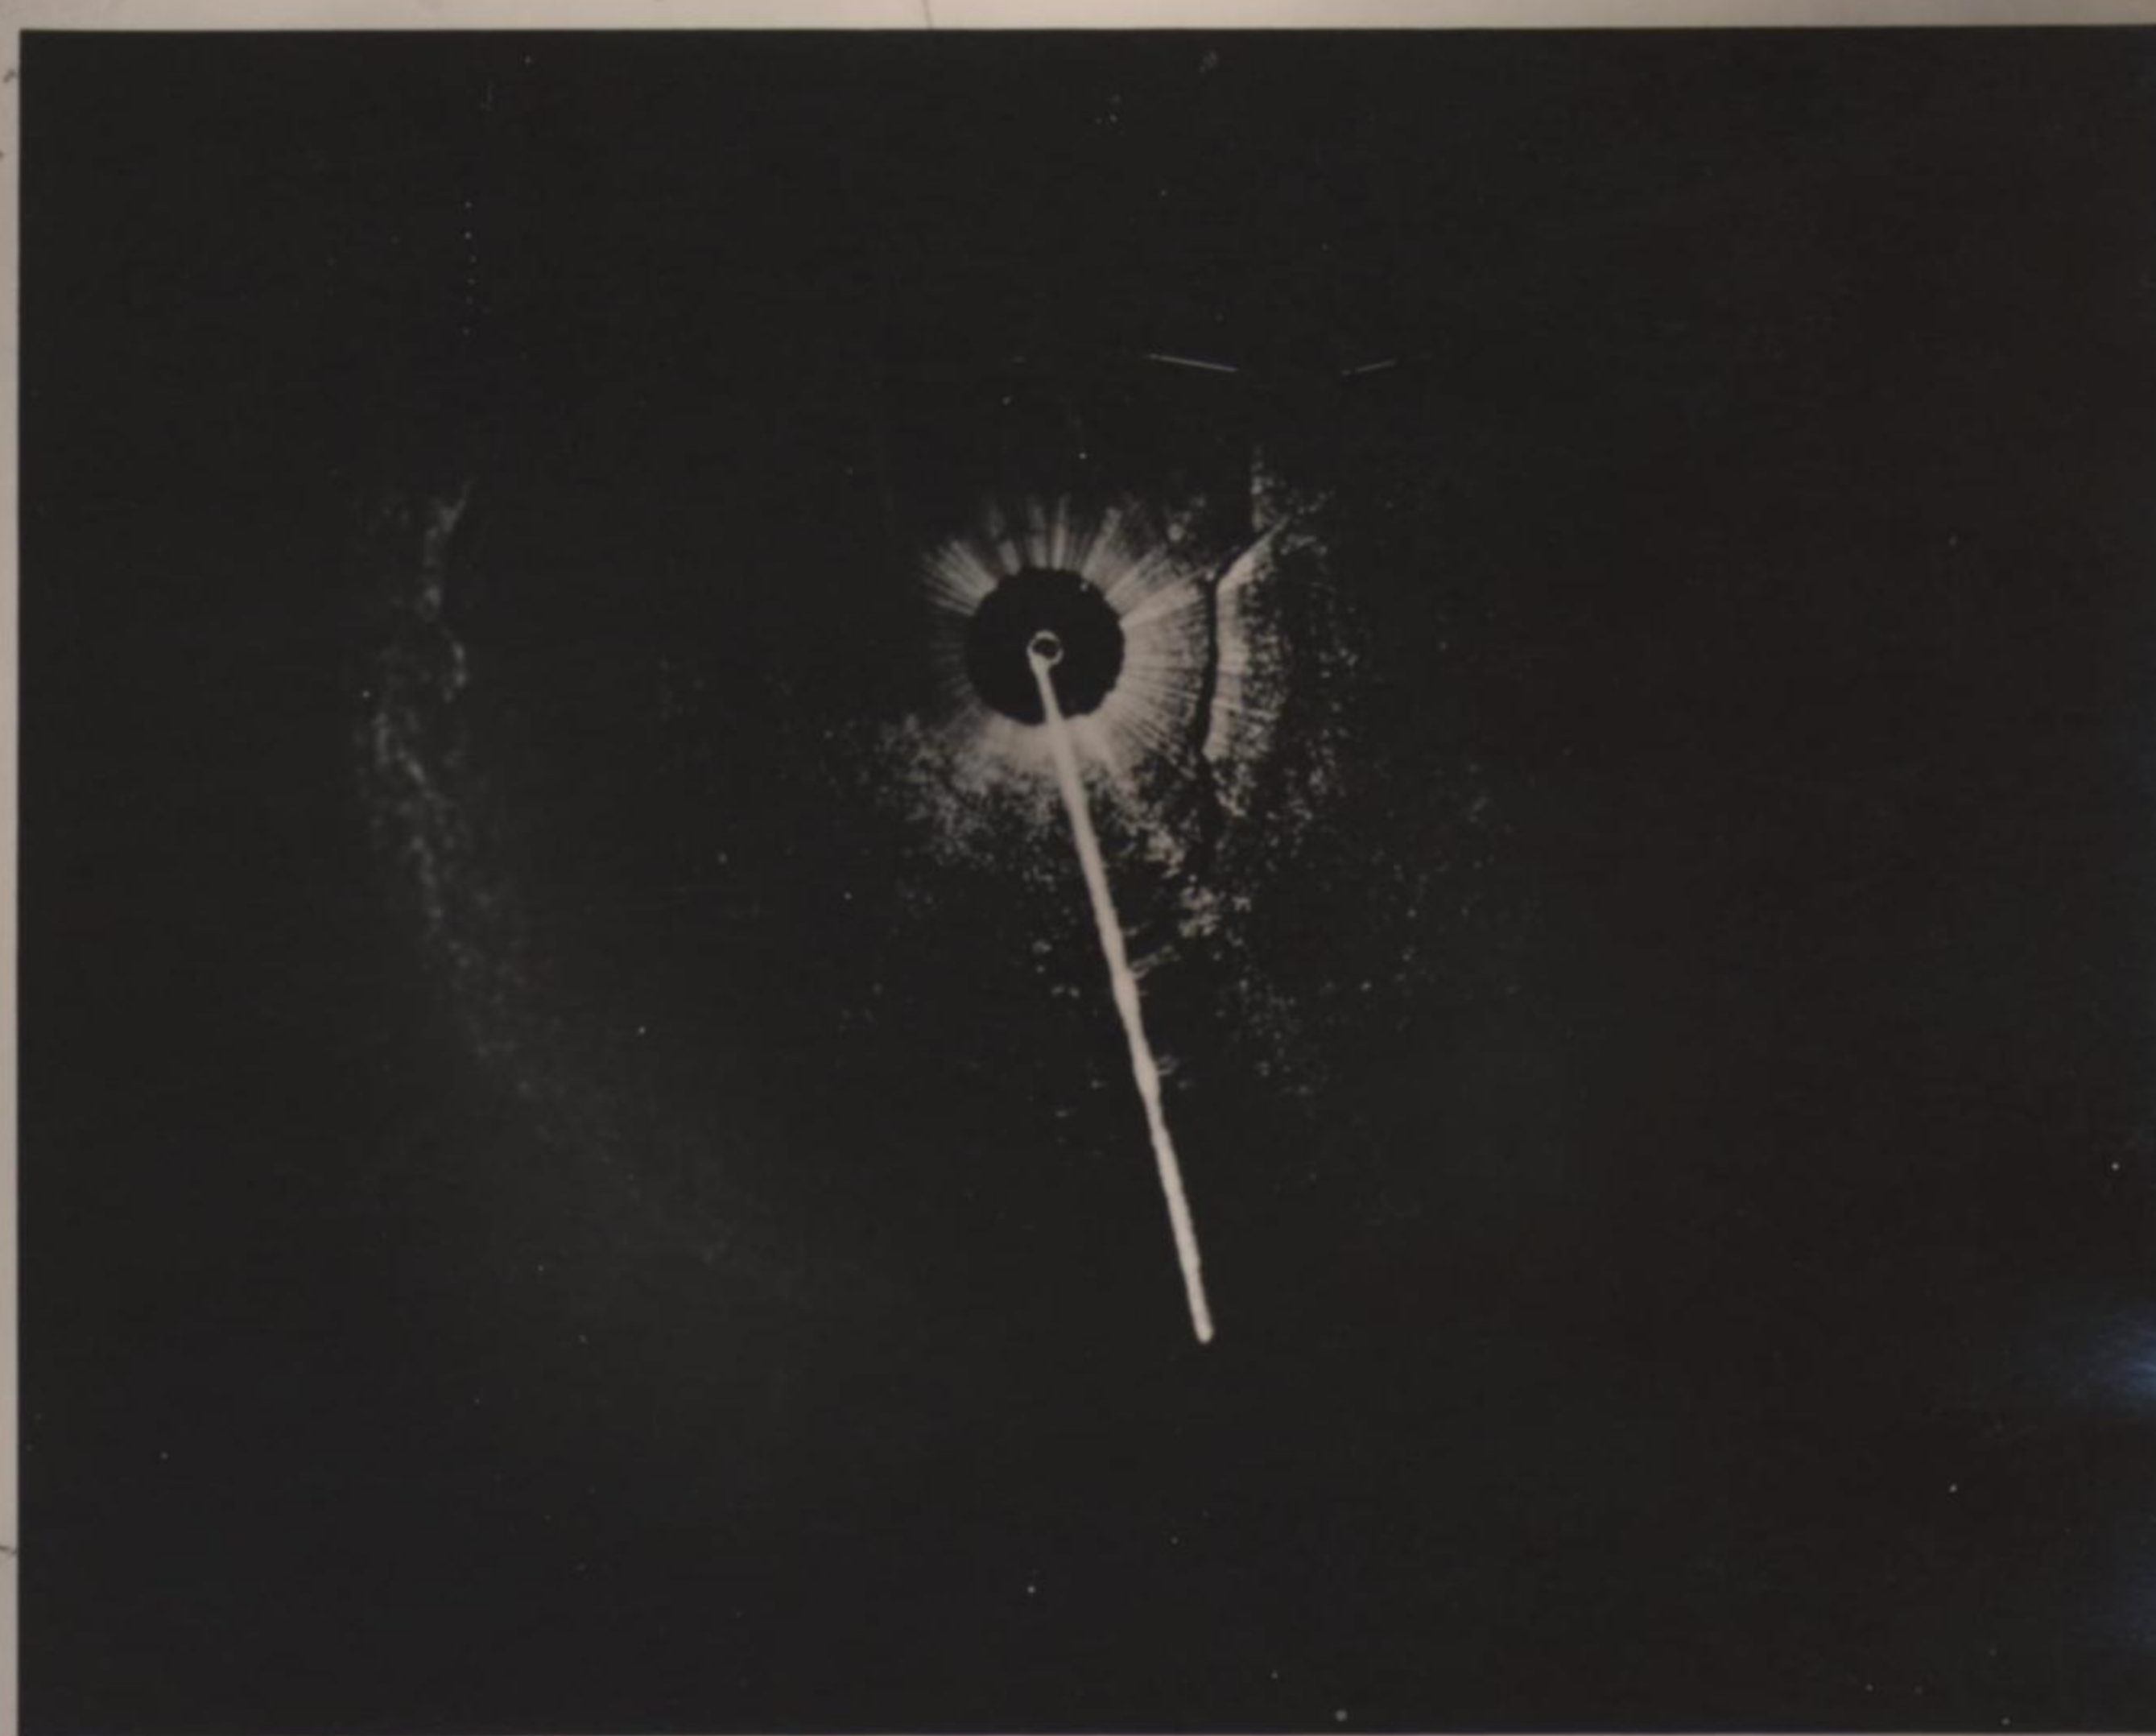
2A

PICTURE #2A. 20 MILE
SWEEP. HEADING 170°
MAG. NOTE: BOMB BAY
DOOR SIGNALS ON ALL
3 PICTURES

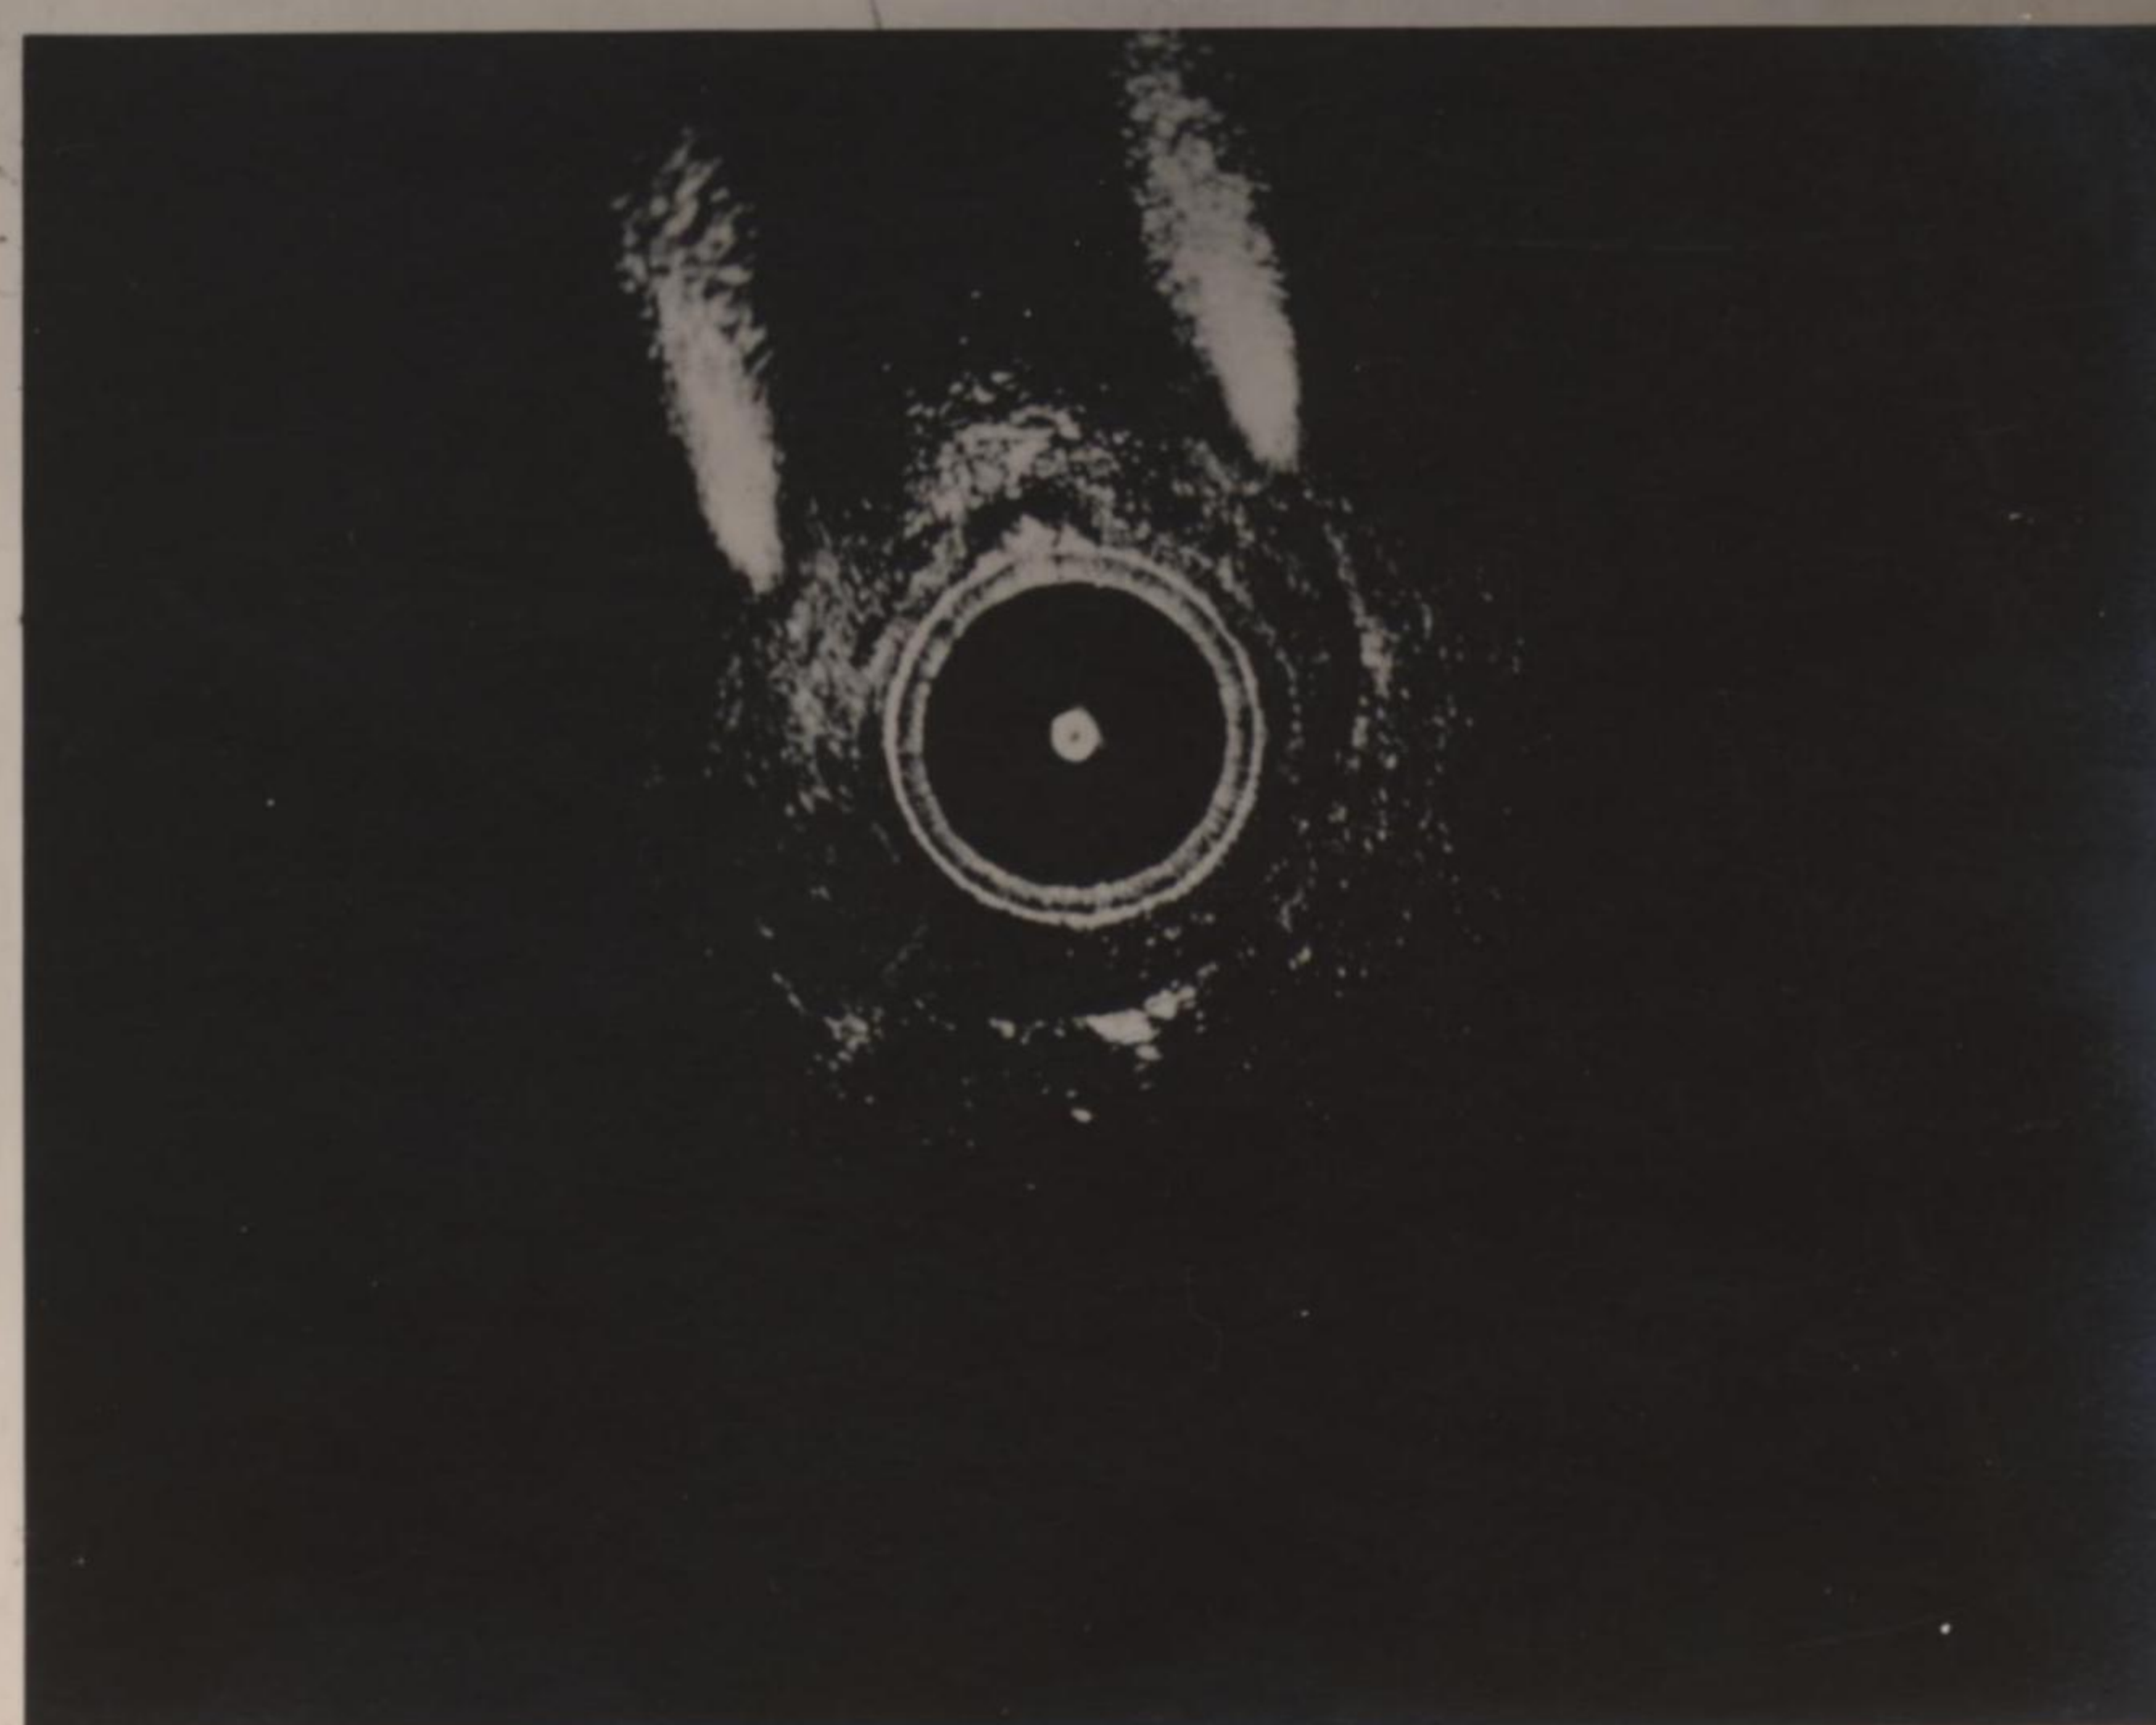
3A

PICTURE #3A. 10 MILE
SWEEP. HEADING 170°
MAG. TARGET 4 S. MILES.
RANGE TRACK INDICATES
LOW DEFLECTION ERROR

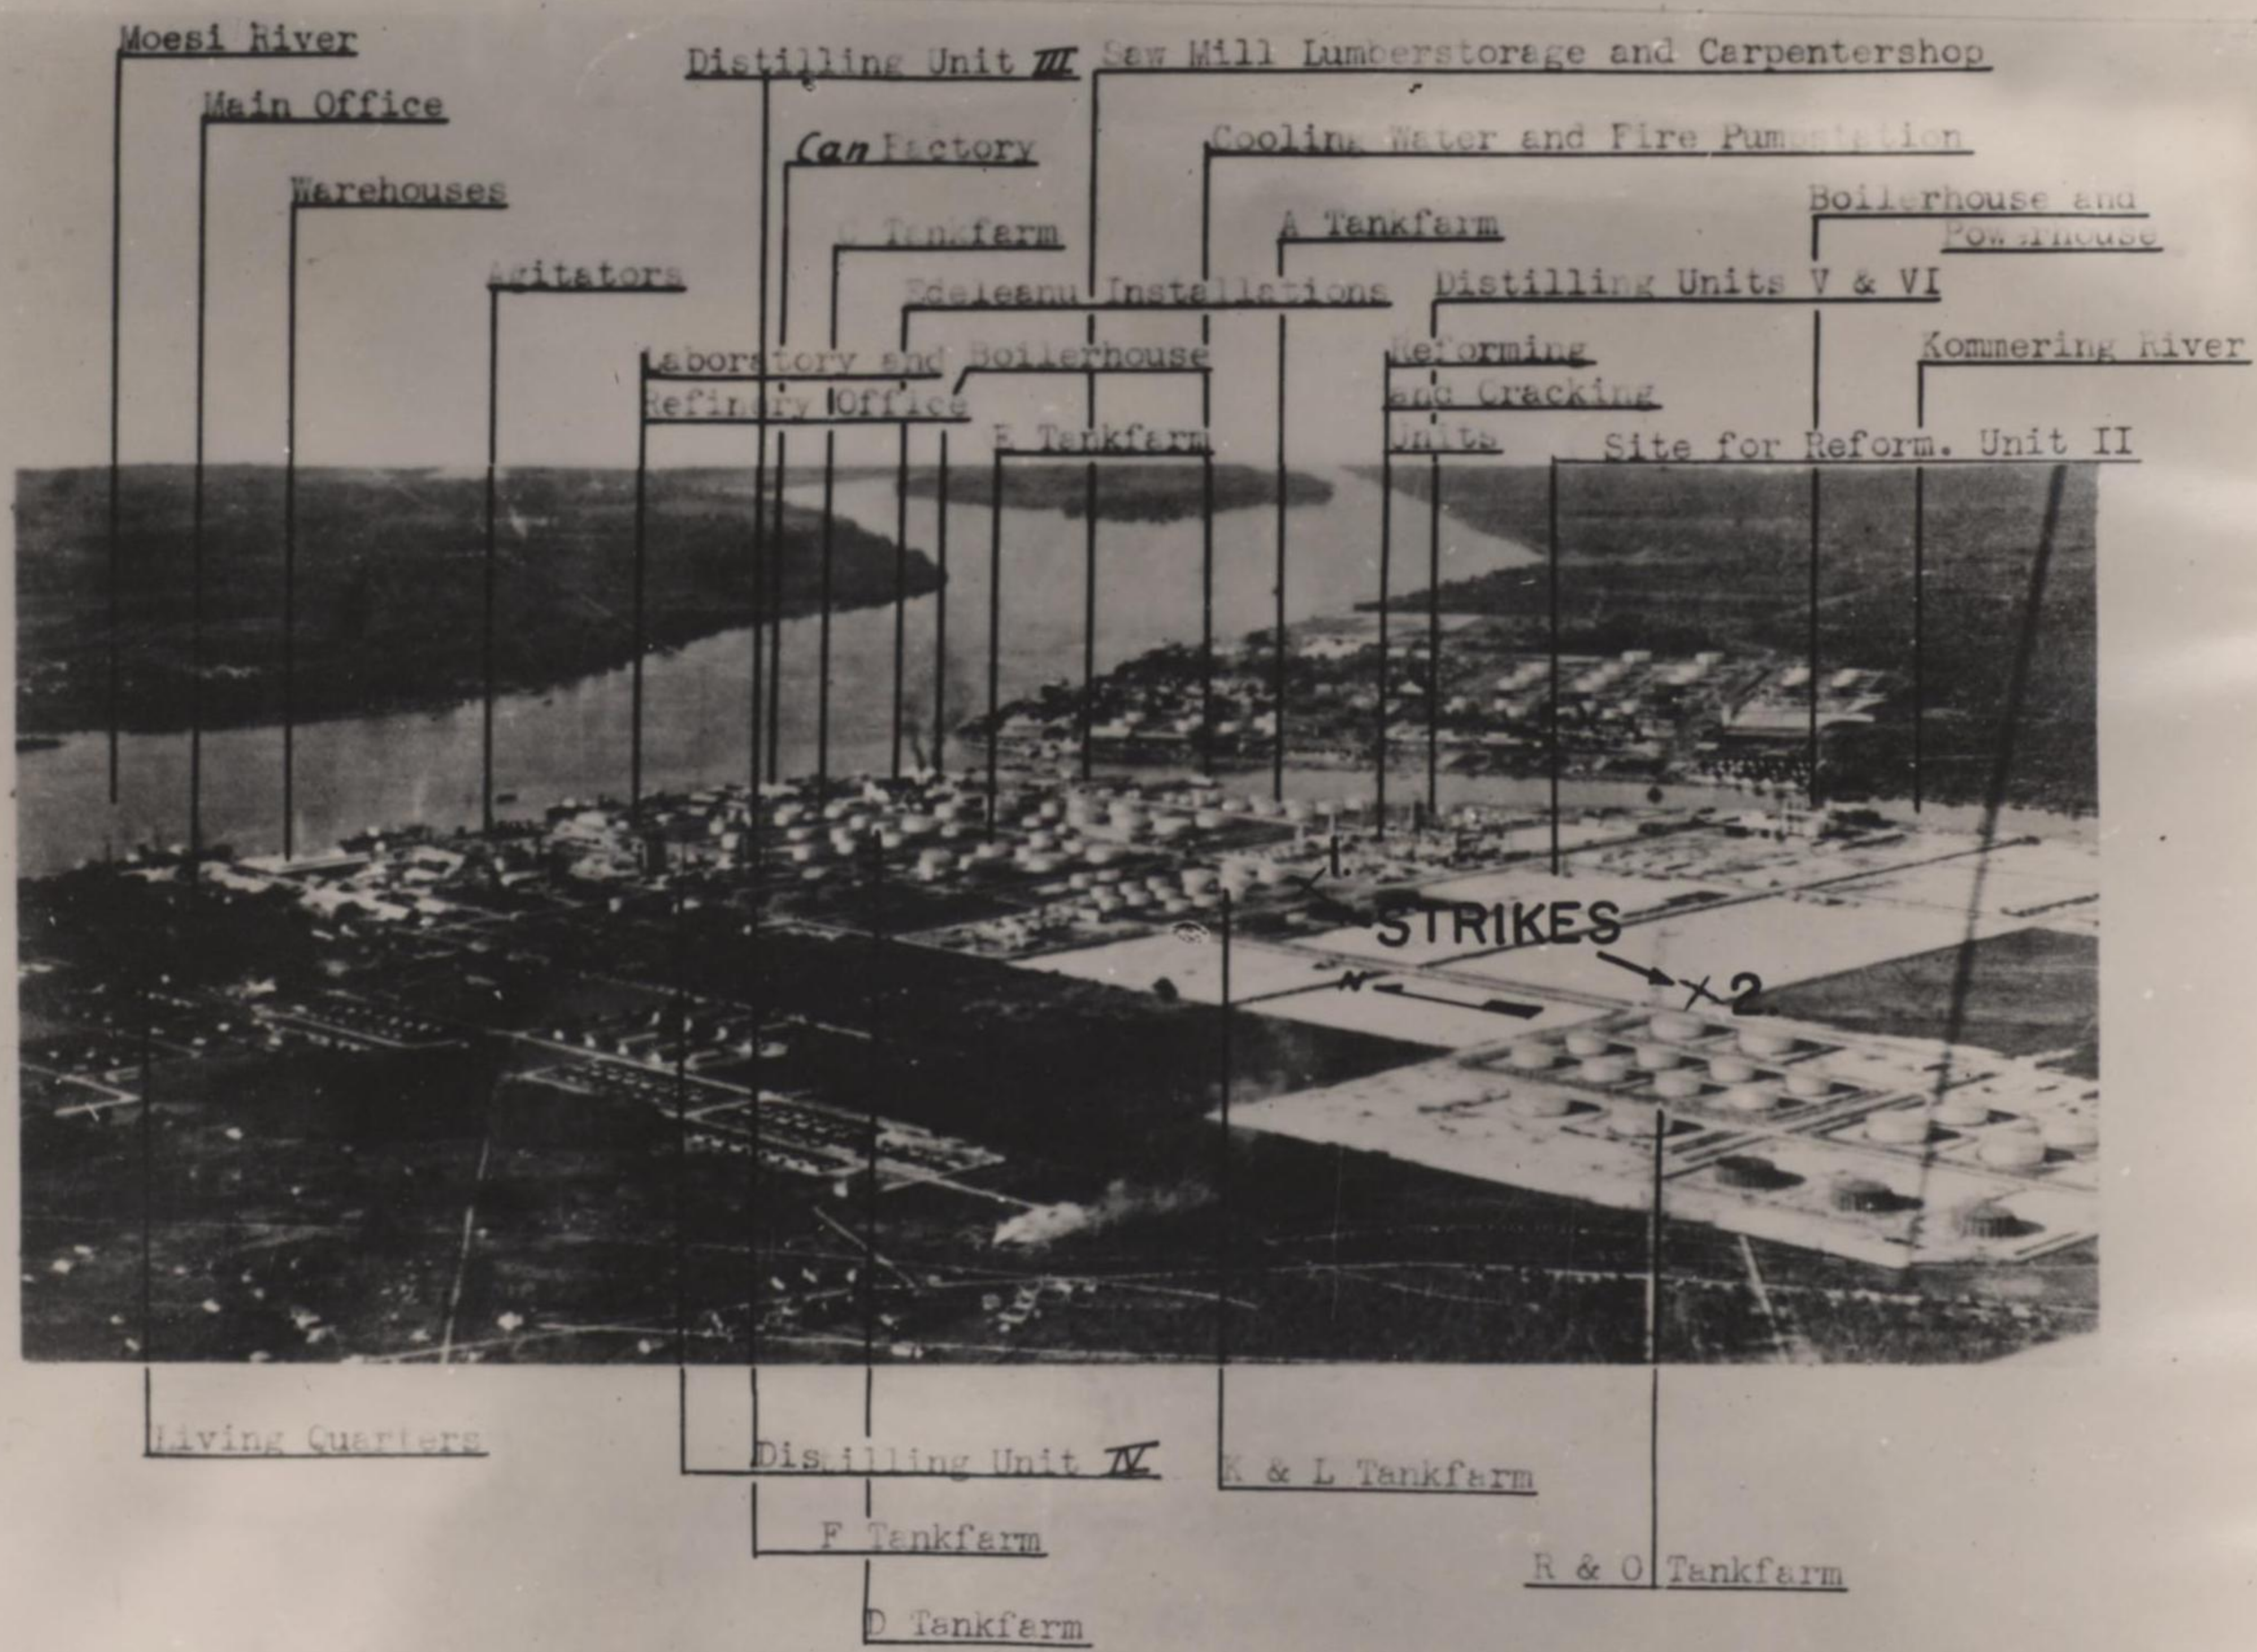
Annex 2
D. A. Report No. 6 (Provisional)
Pladjoe Refinery
Palembang, Sumatra

AERIAL VIEW OF PLADJOE REFINERY (FOREGROUND) AND SOENGEI GERONG REFINERY (BACKGROUND)
Coordinates: 03°00'S. -- 104°50'E. Photograph taken about 1939. Direction: N.W.
