**ASSESSMENT OF
EXISTING FLOOD PROTECTION
IN UPSTREAM WATERSHEDS**

**CONNECTICUT RIVER BASIN
SUPPLEMENTAL STUDY**

An Assessment of
Existing Flood Protection
in Upstream Watersheds

Phase 1 Report
(1.1 D, 1.3 D, 1.3 E, 1.4 D)

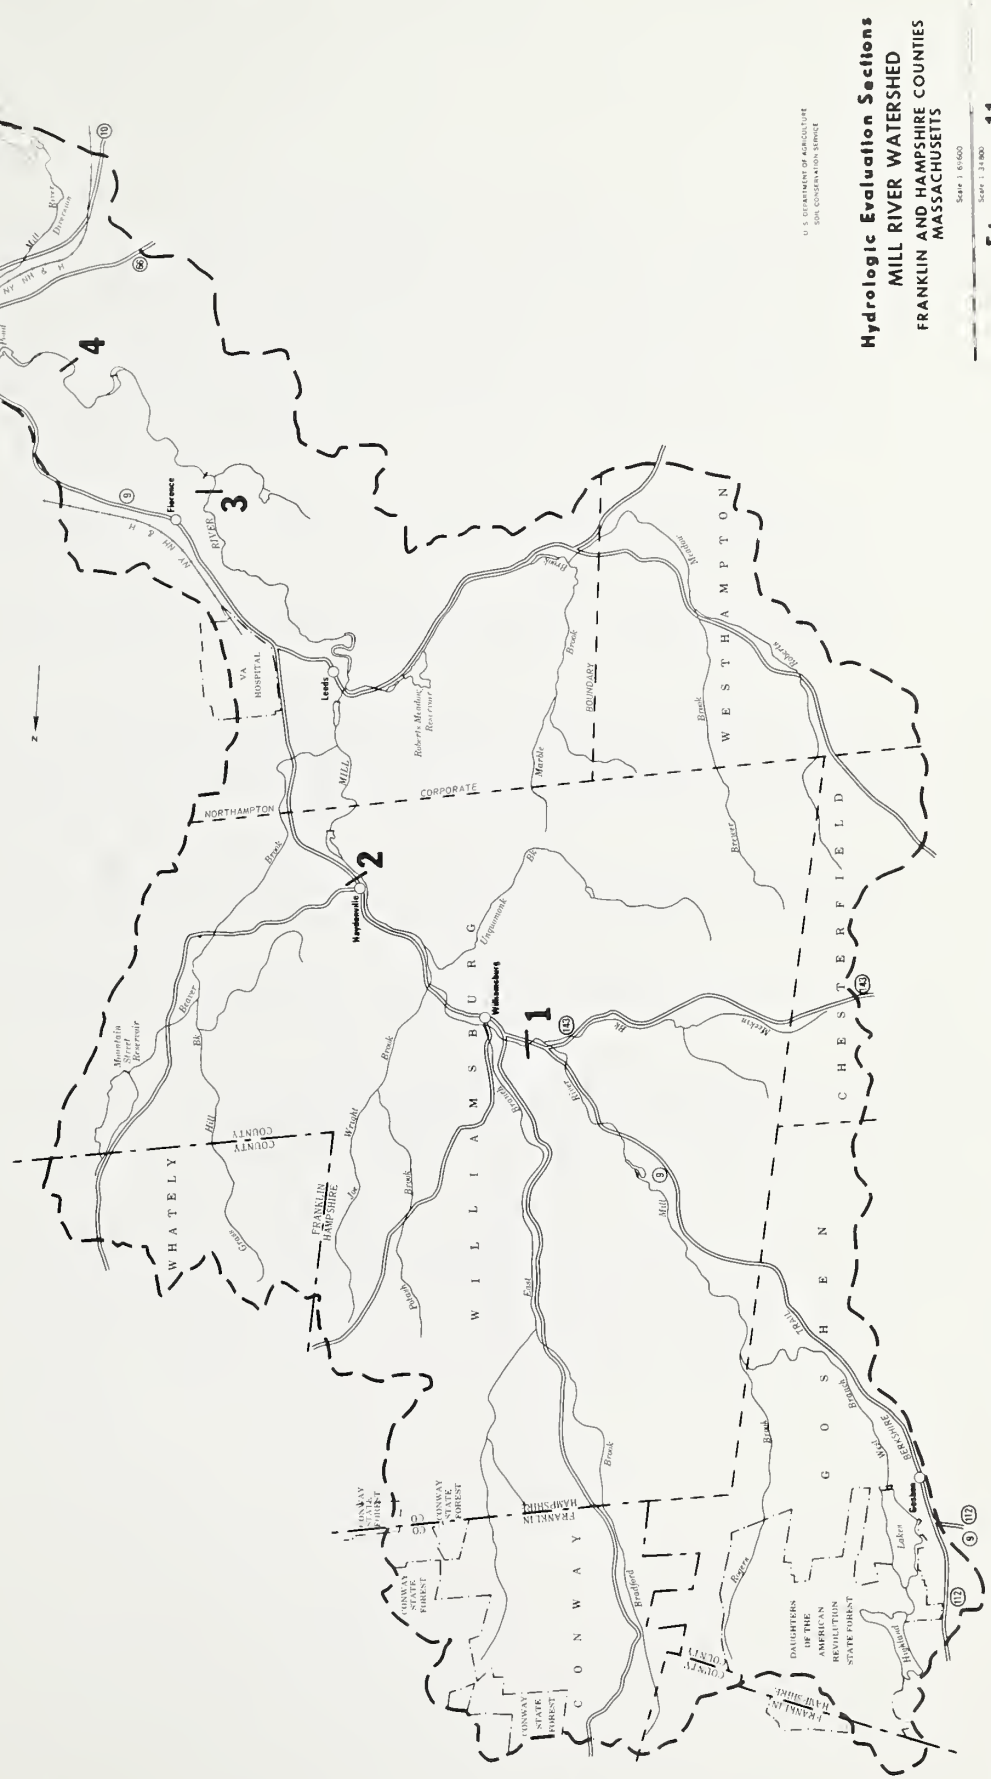
**Hydrologic Evaluation Sections
MILL RIVER WATERSHED
FRANKLIN AND HAMPSHIRE COUNTIES
MASSACHUSETTS**

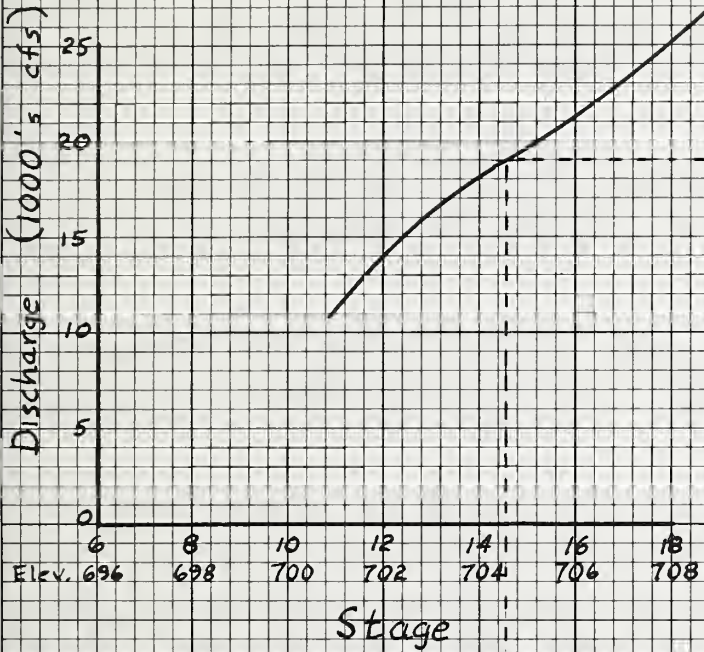
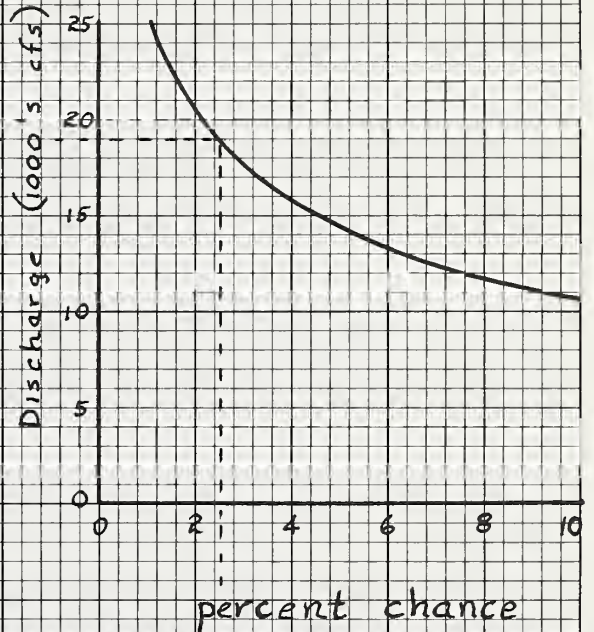
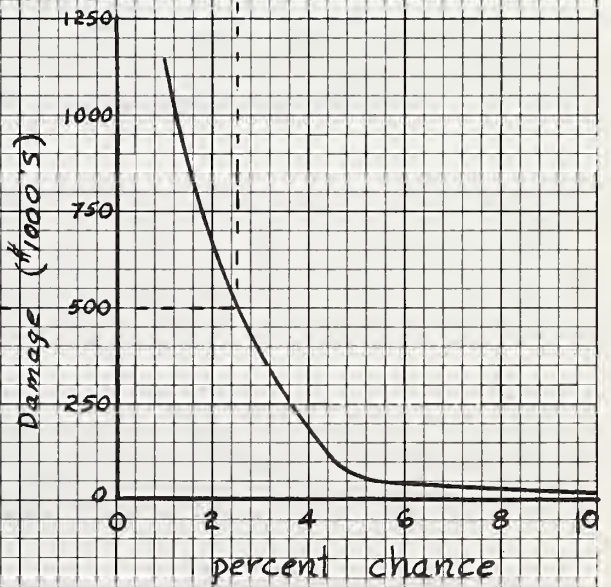
Flood Damage Reach V Passumpsic River

Stage - Discharge

Discharge - Frequency

Stage - Damage

Damage - Frequency

and damage-frequency curves were developed for each evaluation reach. The curves for two selected reaches in the flood plains of Whetstone Brook, Mill River and Passumpsic River are included in this report as appendix 1. The procedures for making the economic and hydrologic analyses are described in the Procedures section. The information reports for the three watersheds follow.

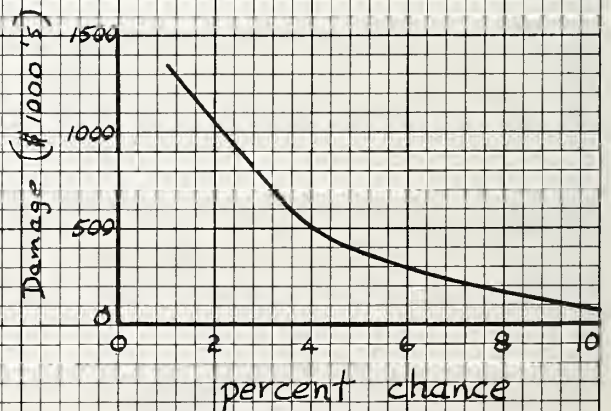
Flood Damage Reach VII Passumpsic River

Stage-Discharge

Discharge-Frequency

Stage-Damage

Damage-Frequency

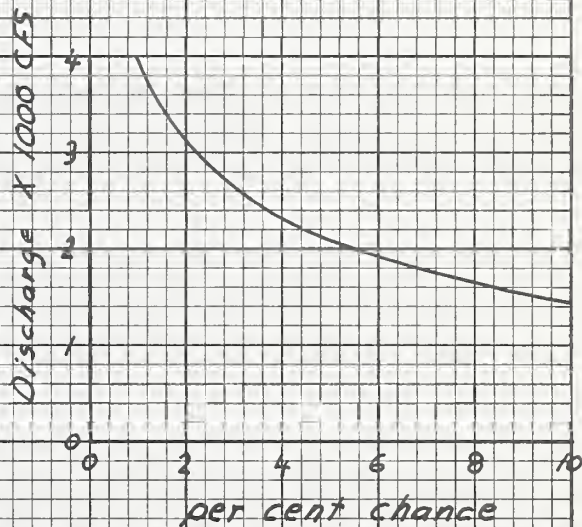
Mill River Flood Damage Reach IB

Stage - Discharge

Discharge - Frequency

Stage - Damage

Damage - Frequency
