MISSION #35 BANGKOK "CAPACIOUS 5"
7 February 1945

Tactical Mission Report

No. 35

TARGET: RAMA VI BRIDGE, BANGKOK, THAILAND

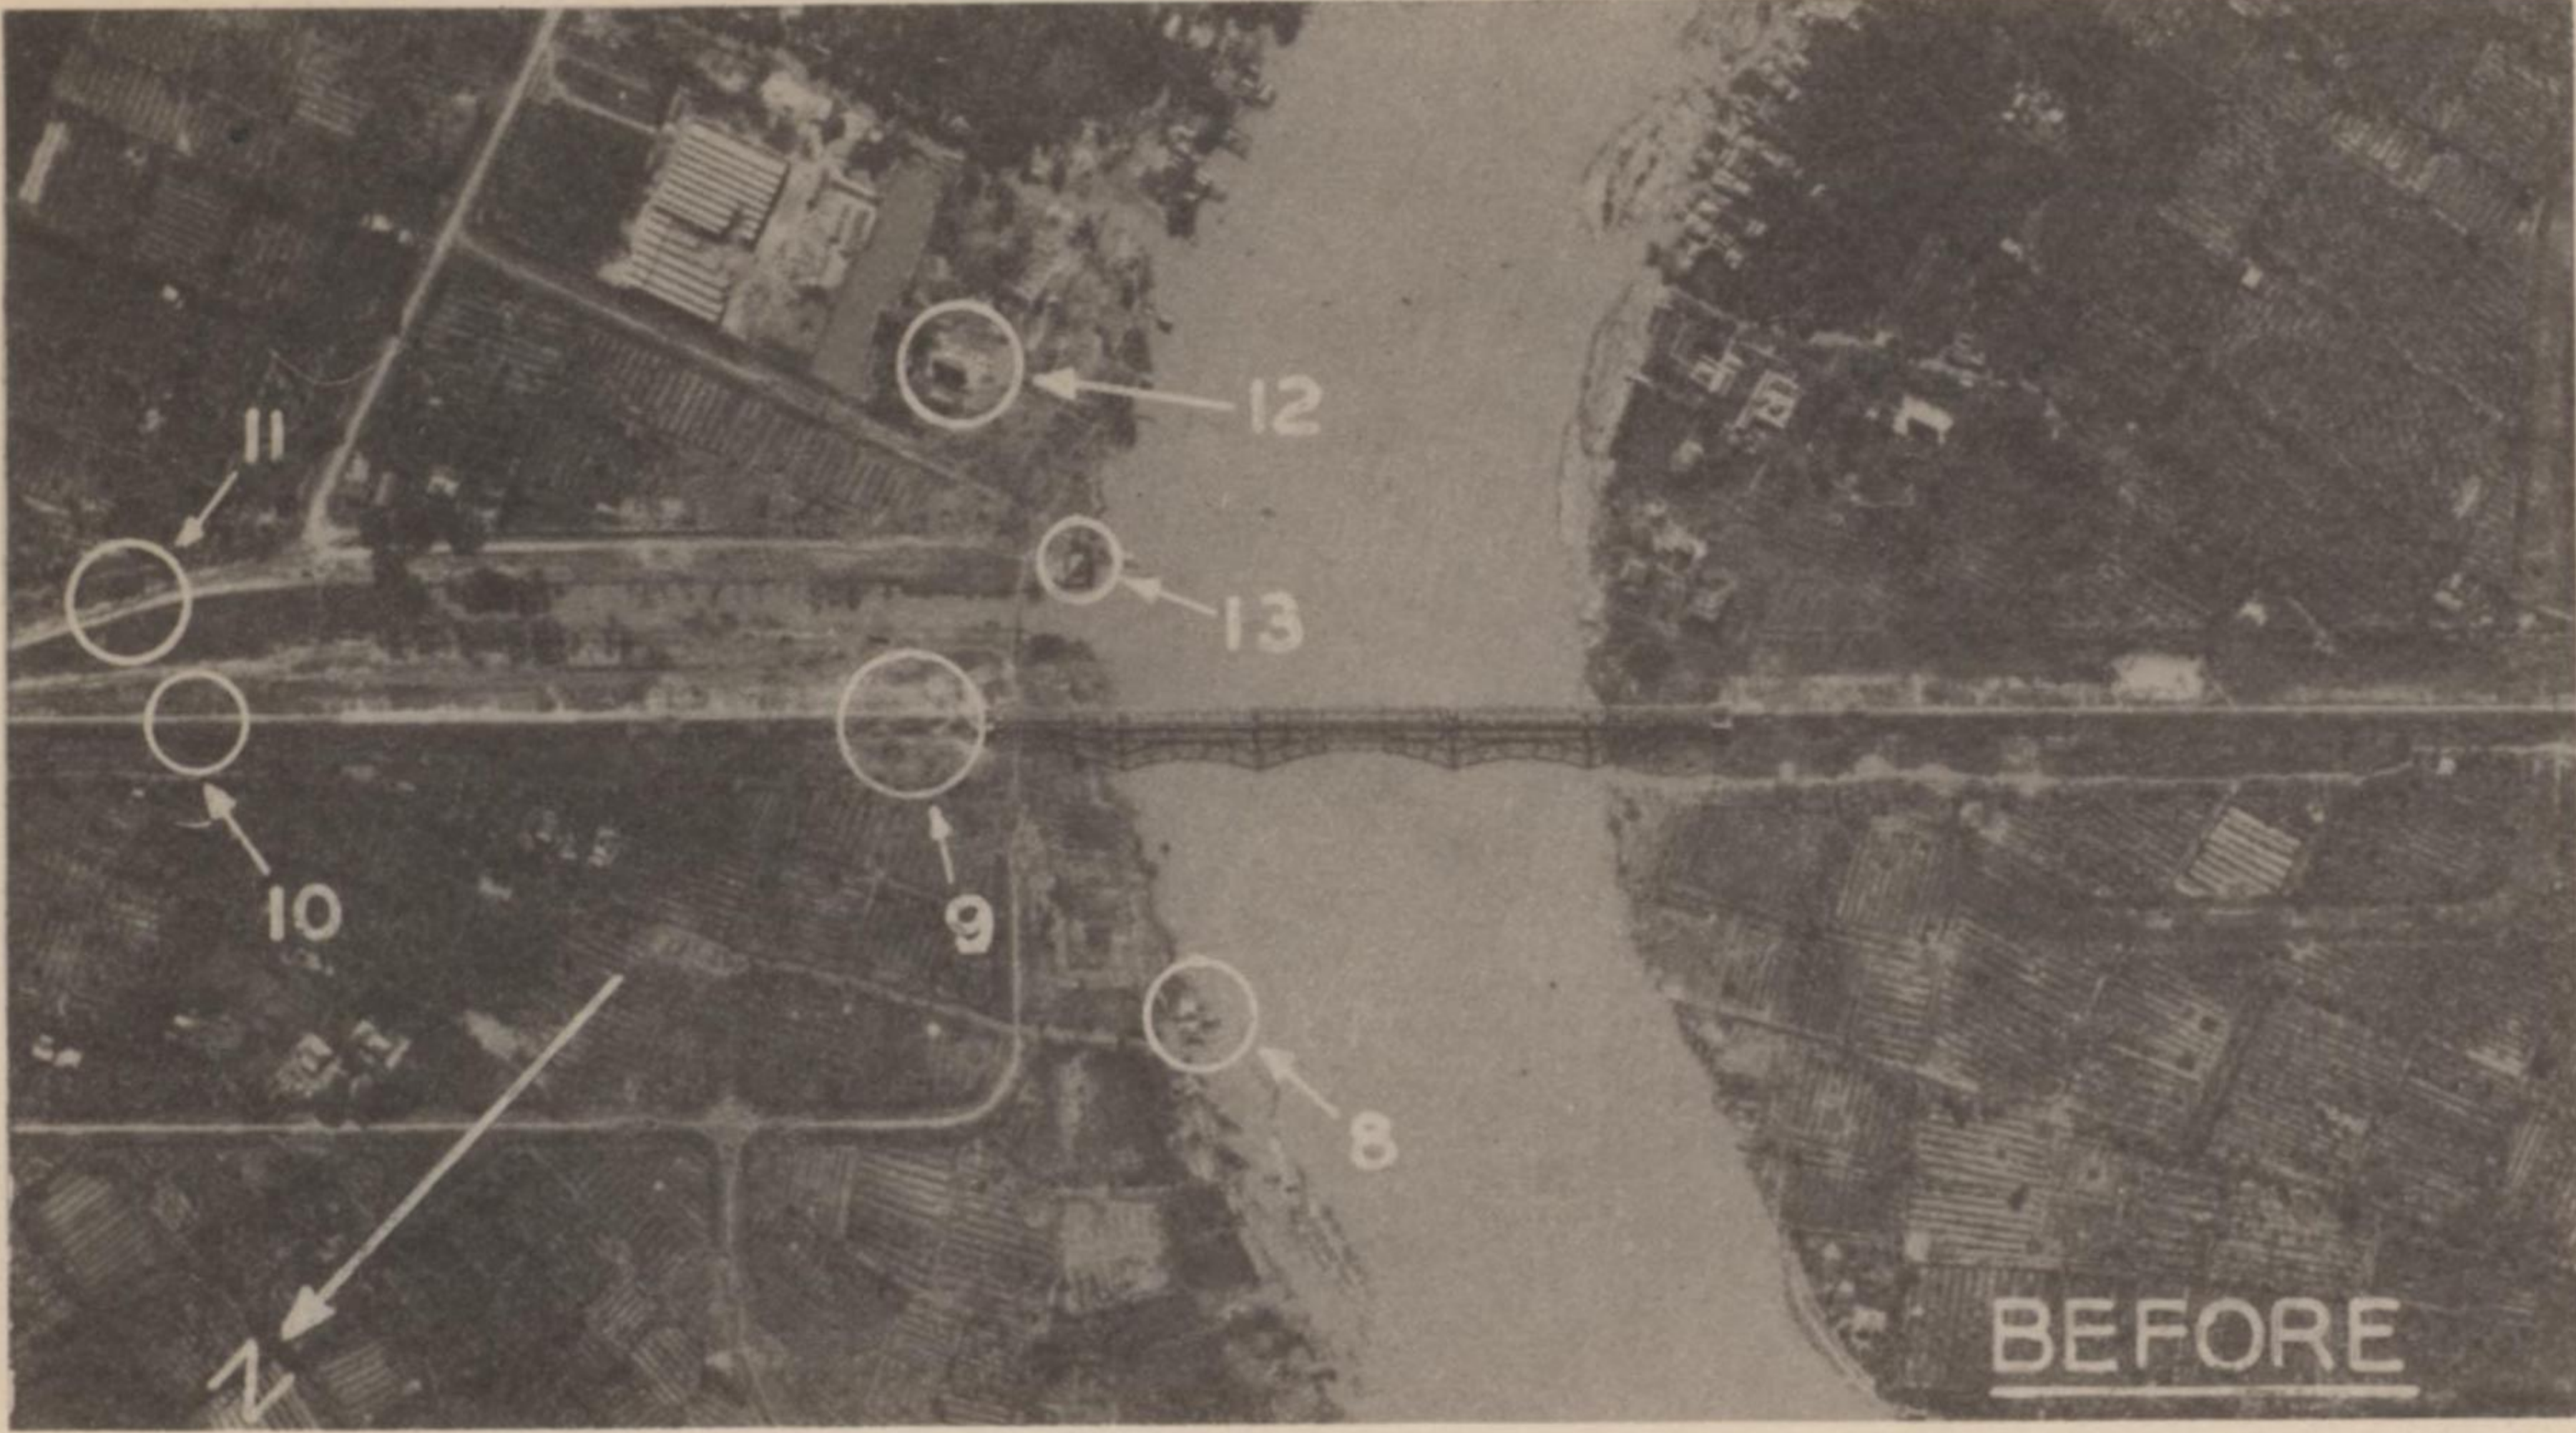
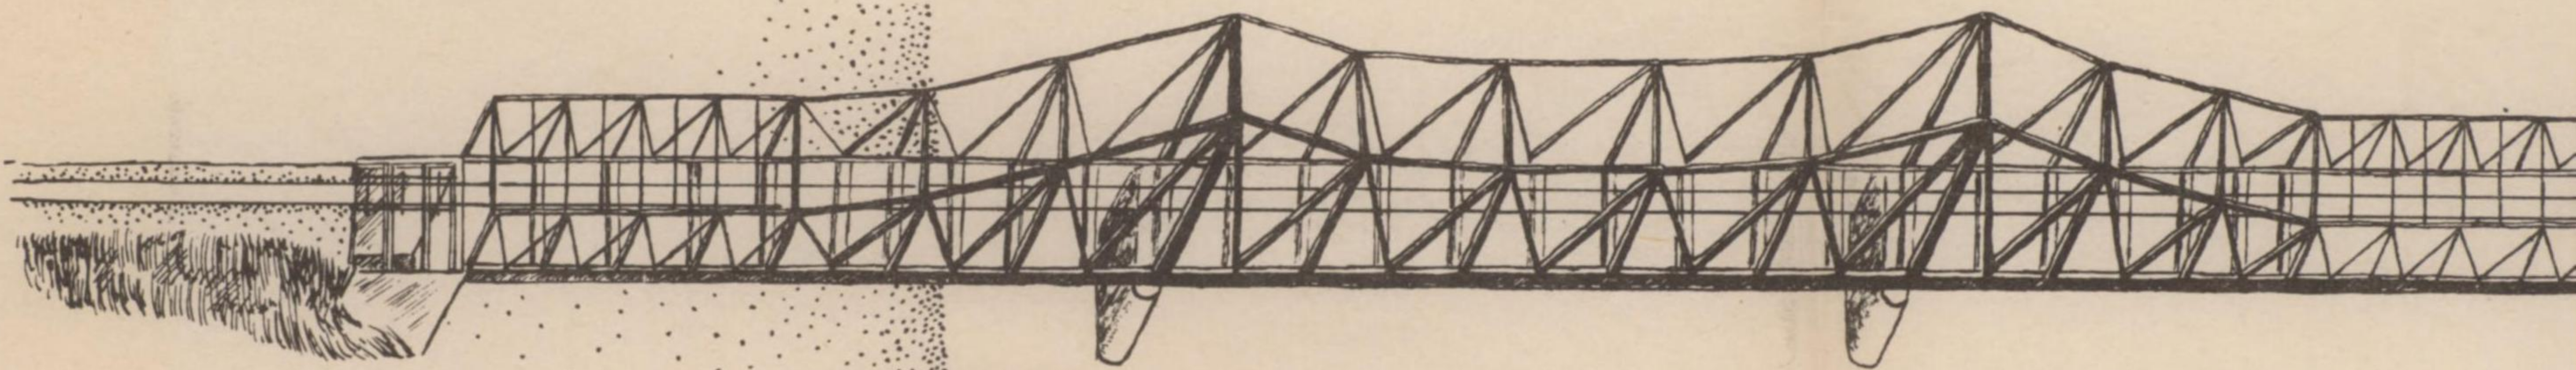
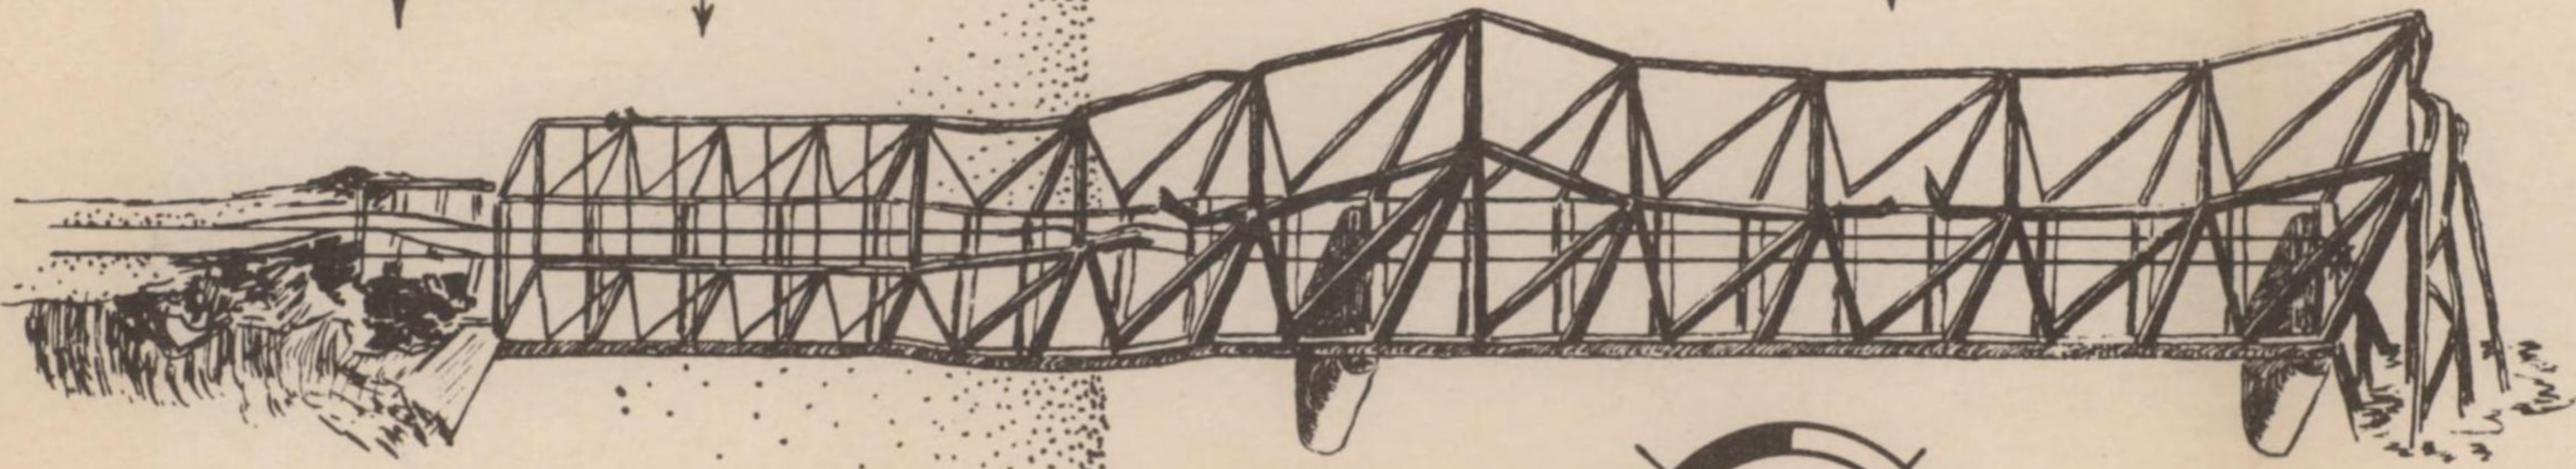
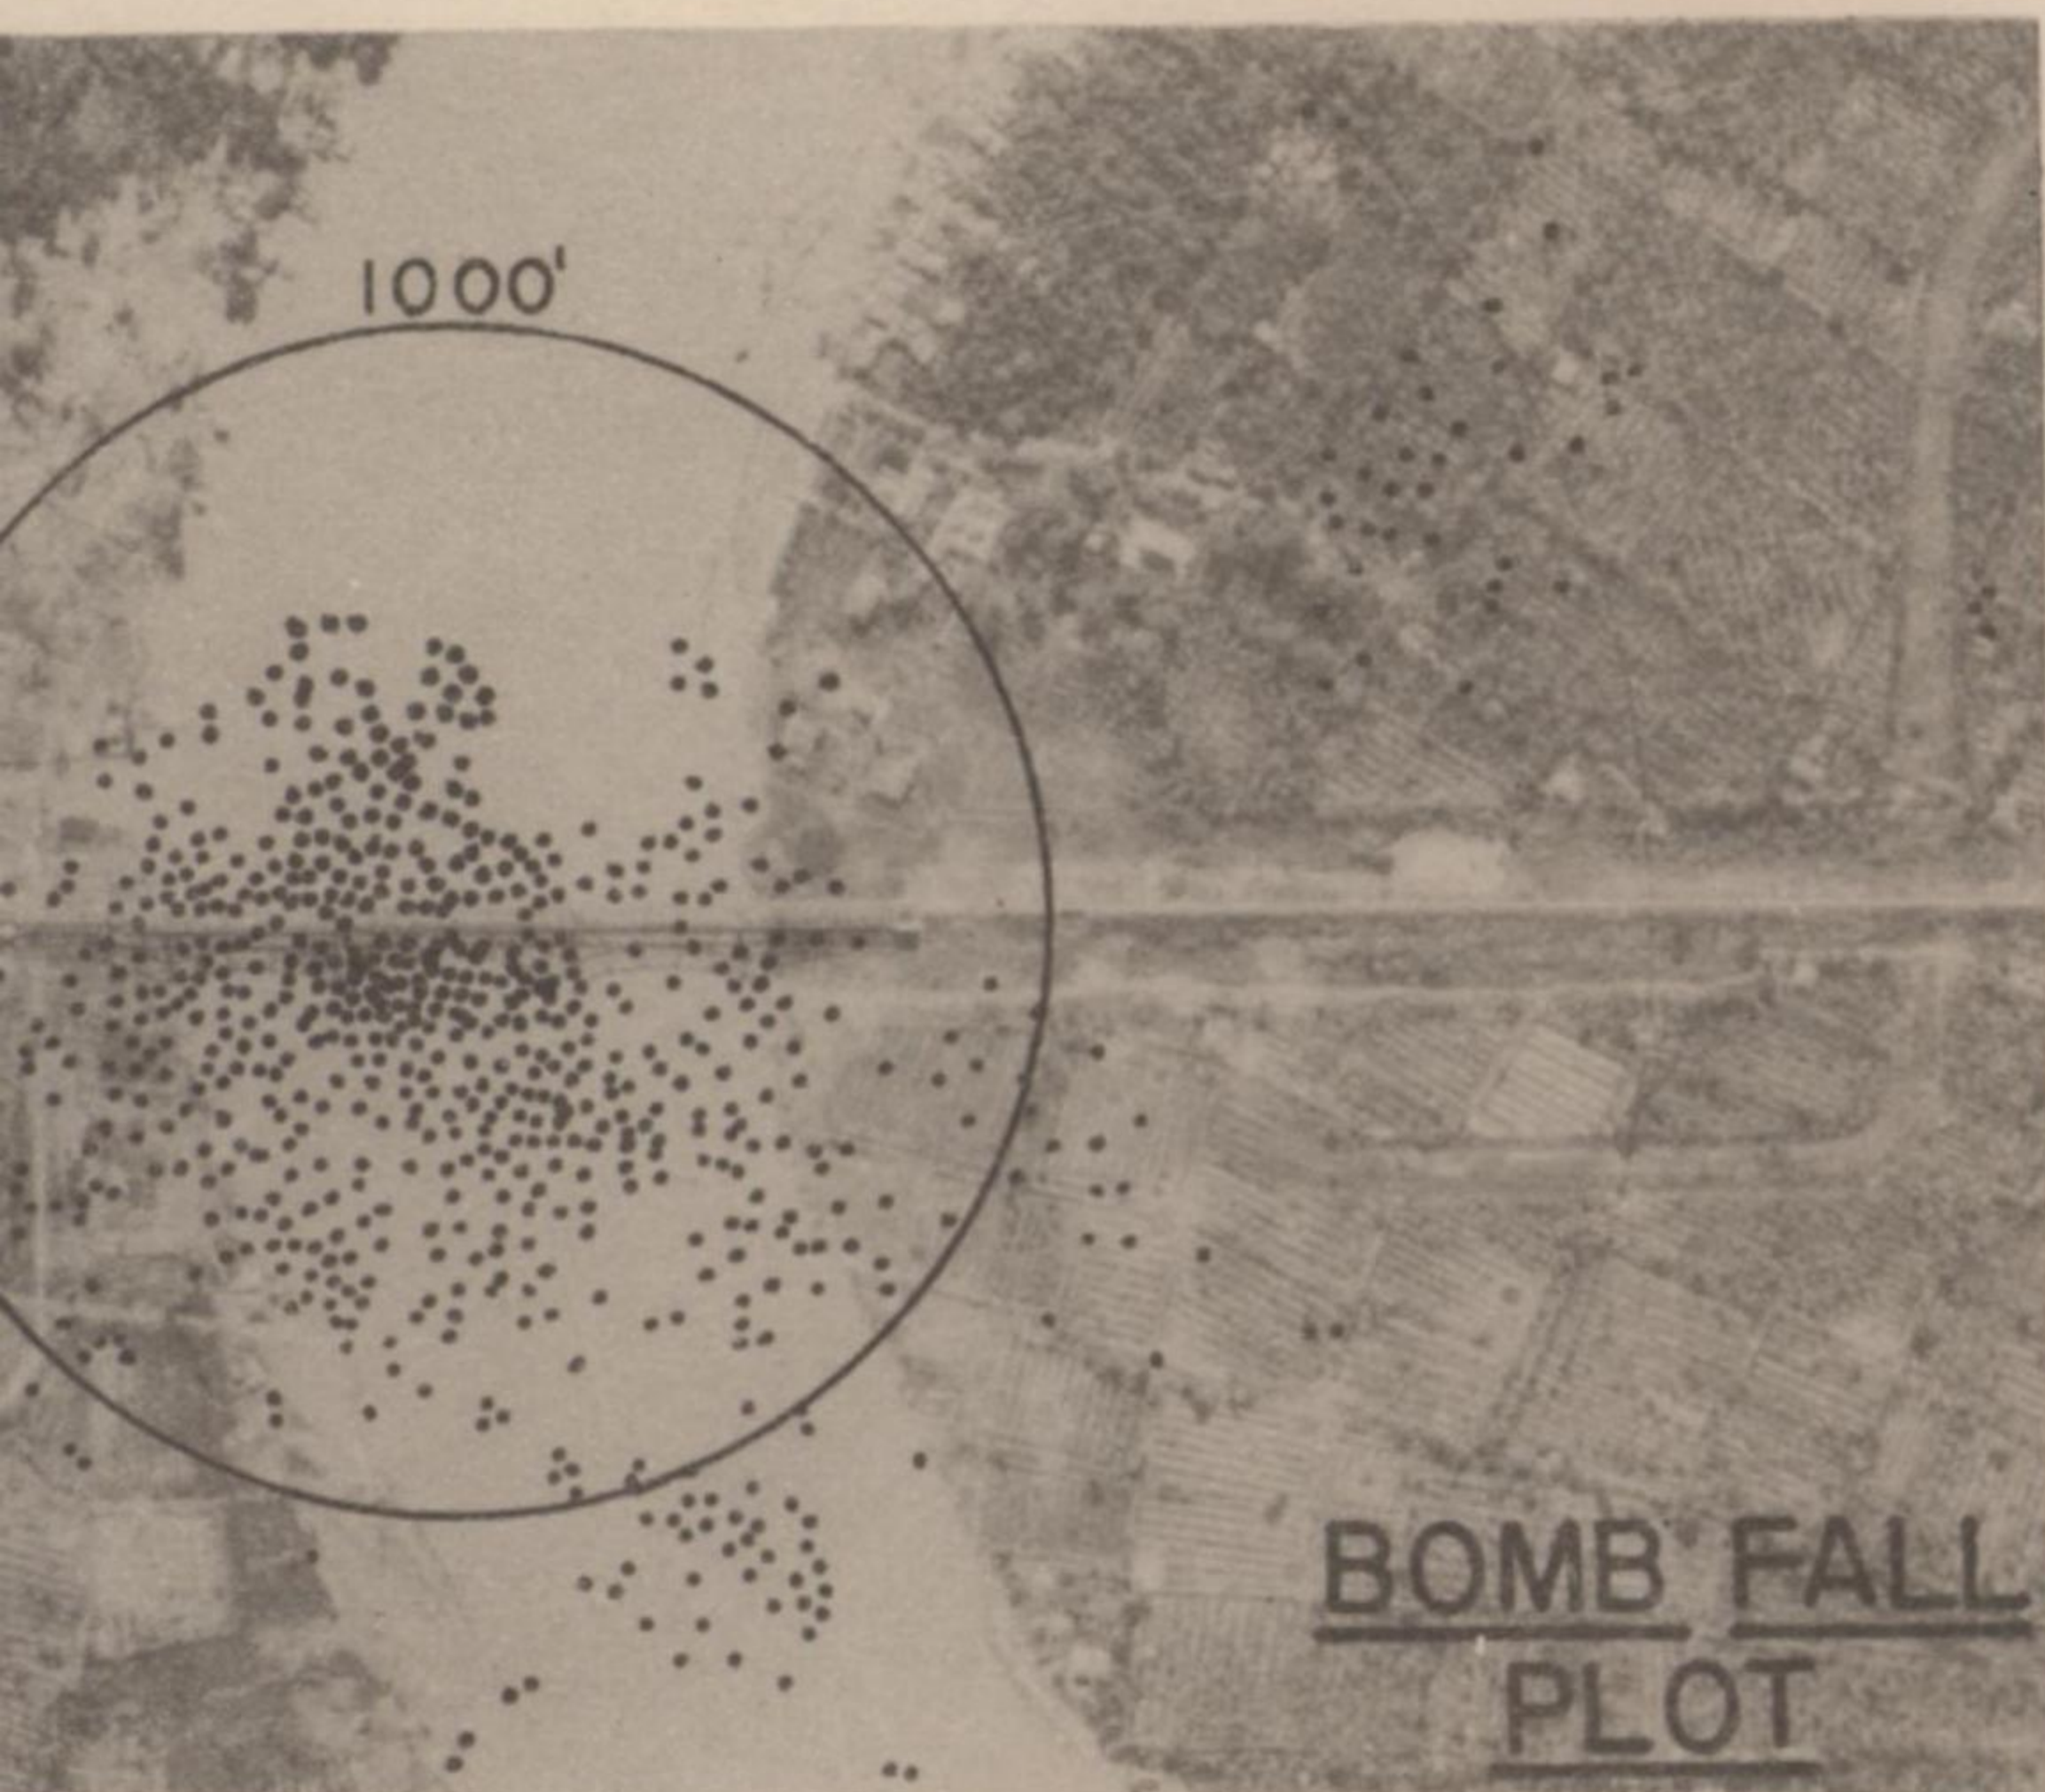
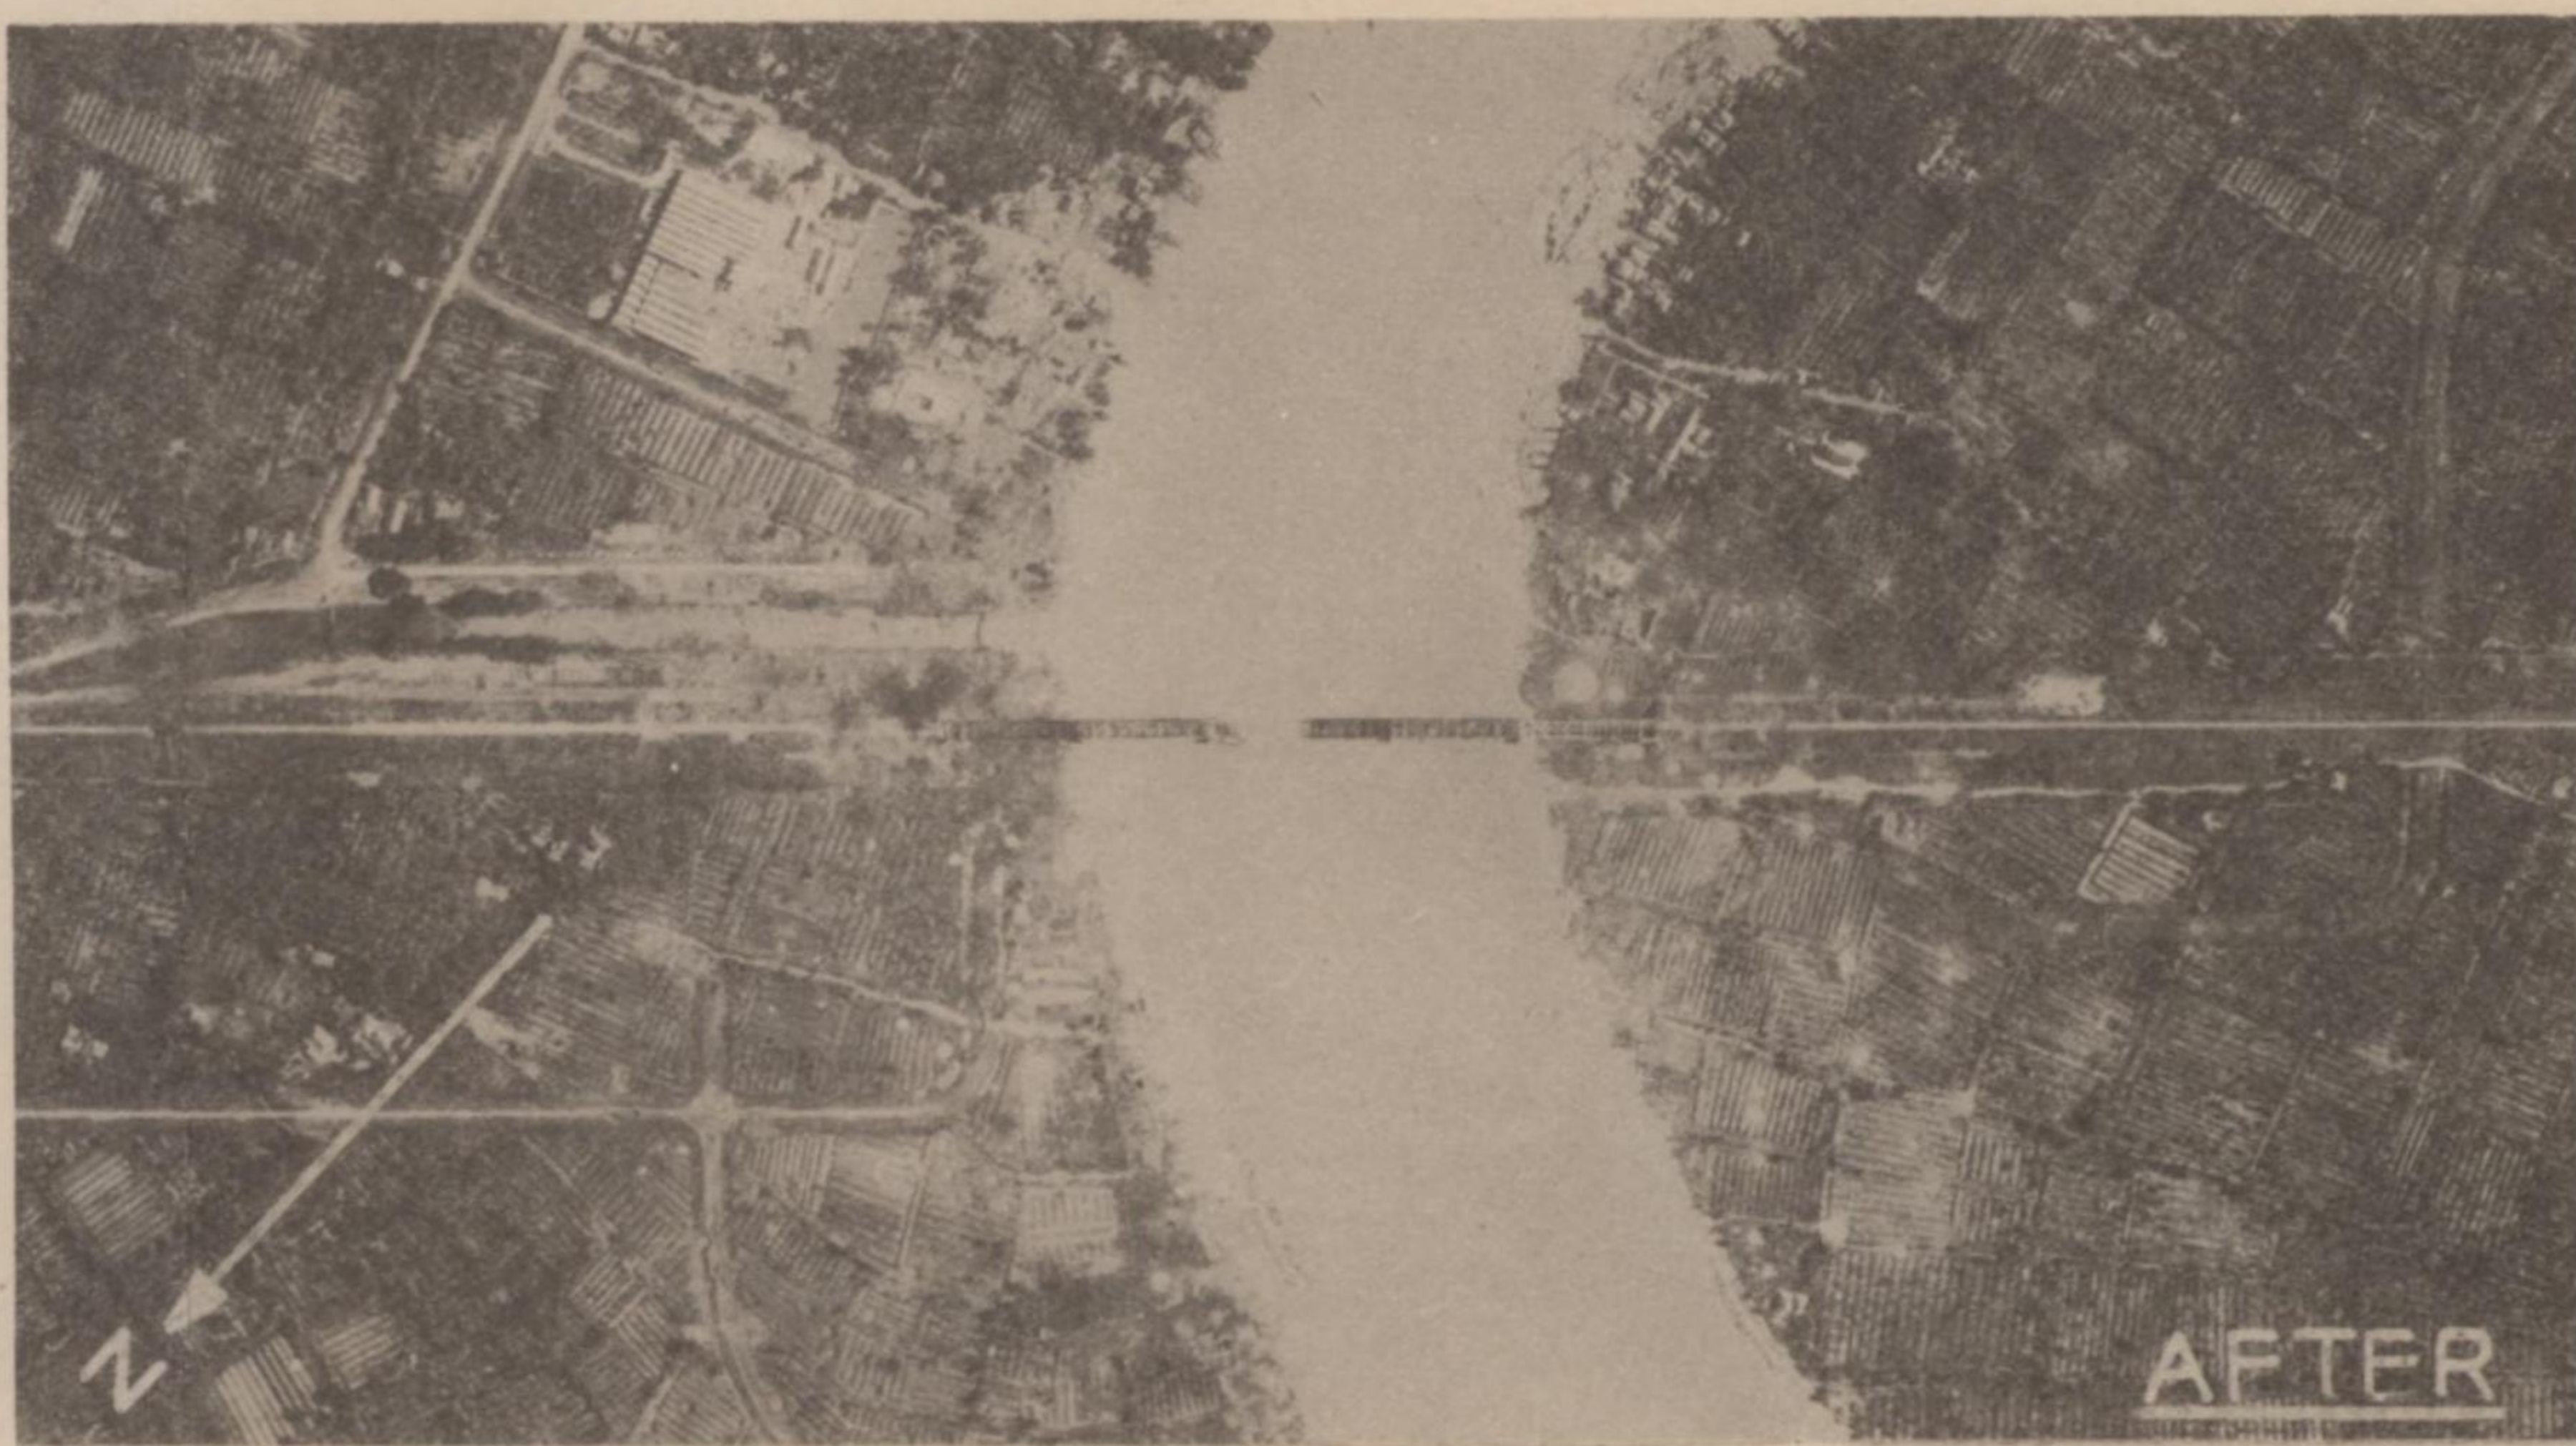
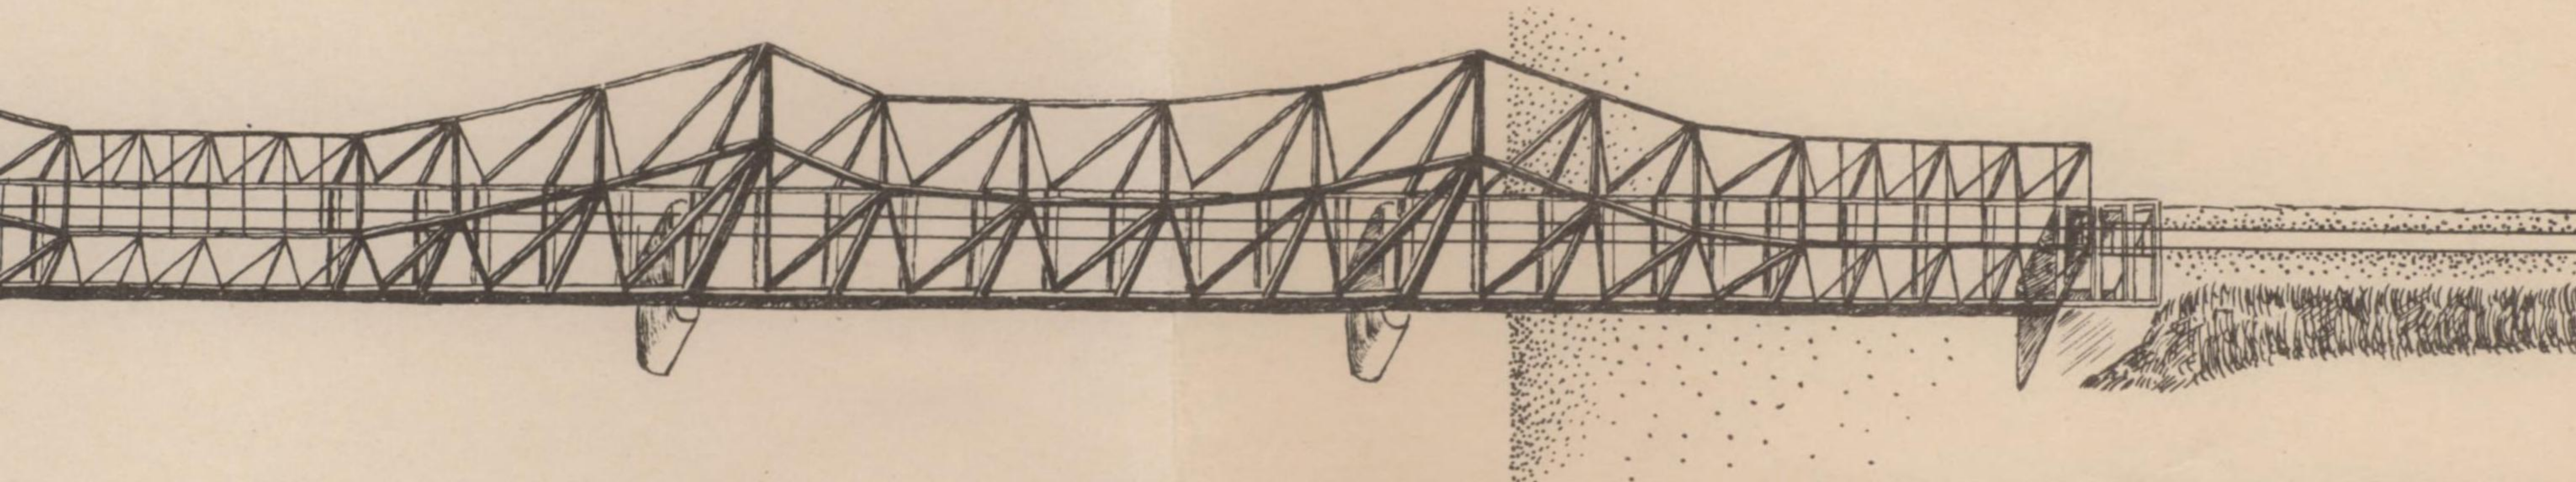
DAMAGE ASSESSMENT REPORT NO. 42

Some repair activity was evident to damage sustained during the previous attack especially to and in the vicinity of the northernmost approach abutment. It is believed however, that the bridge was still unserviceable.

Approximately 160 feet of the NE approach tracks and 90 feet of siding tracks were destroyed by direct hits. Five small buildings averaging 25 ft. x 37 ft. were destroyed and a 130 ft. pier NW of the bridge was damaged.

- (1), (2) These two items refer to damage sustained during the previous attack. Item (1), the northeast approach abutment, suffered heavily with both track-supporting girders and the tracks proper having been destroyed. Photos obtained just prior to this attack show some repair activity to and in the vicinity of the abutment. The state of repair, however, does not appear to have been such that the bridge could have been serviceable. One of the top principal members of the truss frame of Span "A", Item 2, which was severed in the last attack remains unchanged.
