WATER and RELATED LAND RESOURCES ESTANCIA SUB-BASIN UPPER RIO GRANDE BASIN NEW MEXICO

PRELIMINARY EARLY ACTION OPPORTUNITIES

PREPARED BY
SOIL CONSERVATION SERVICE - ECONOMIC RESEARCH SERVICE - FOREST SERVICE
ALBUQUERQUE, NEW MEXICO 1971

PRELIMINARY REPORT
ESTANCIA SUBBASIN
UPPER RIO GRANDE BASIN
NEW MEXICO

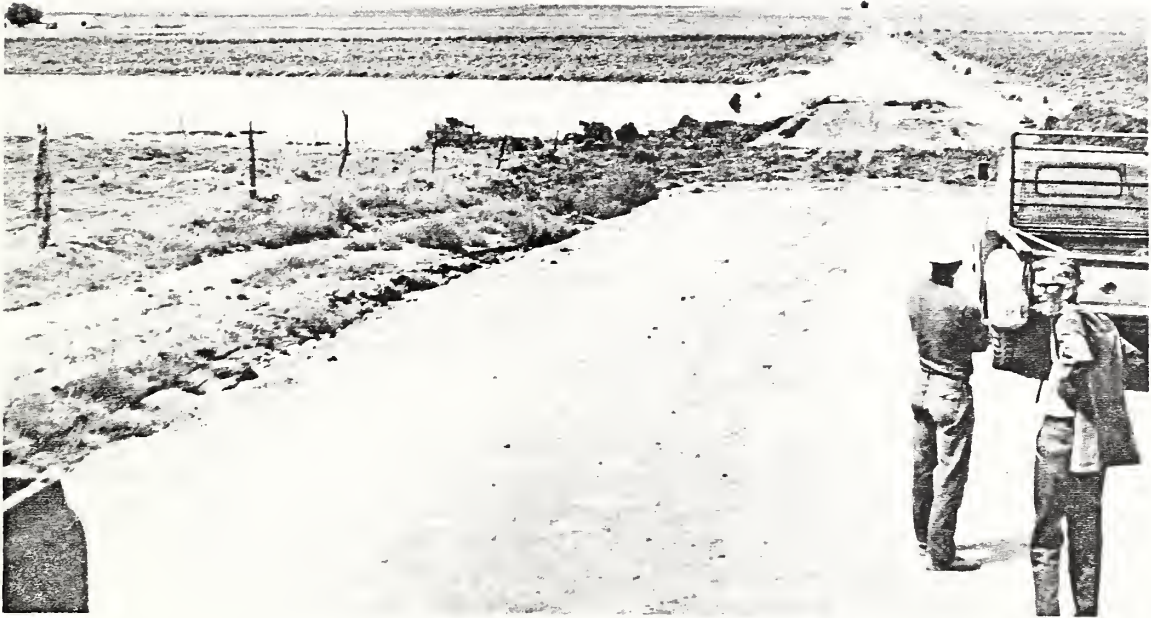
SCS PHOTO 12-P573-5

Highway and crop damage from floodwater from Tajique and Torreon Draws.

Watershed problems identified in the investigation are (1) flood damage to irrigated farms, state, county, and private roads, and the railroad; (2) loss of flood runoff to natural lakes or basins which prevent beneficial use of the floodwater, and (3) erosion and sediment damage from poorly vegetated areas in the upper watershed.

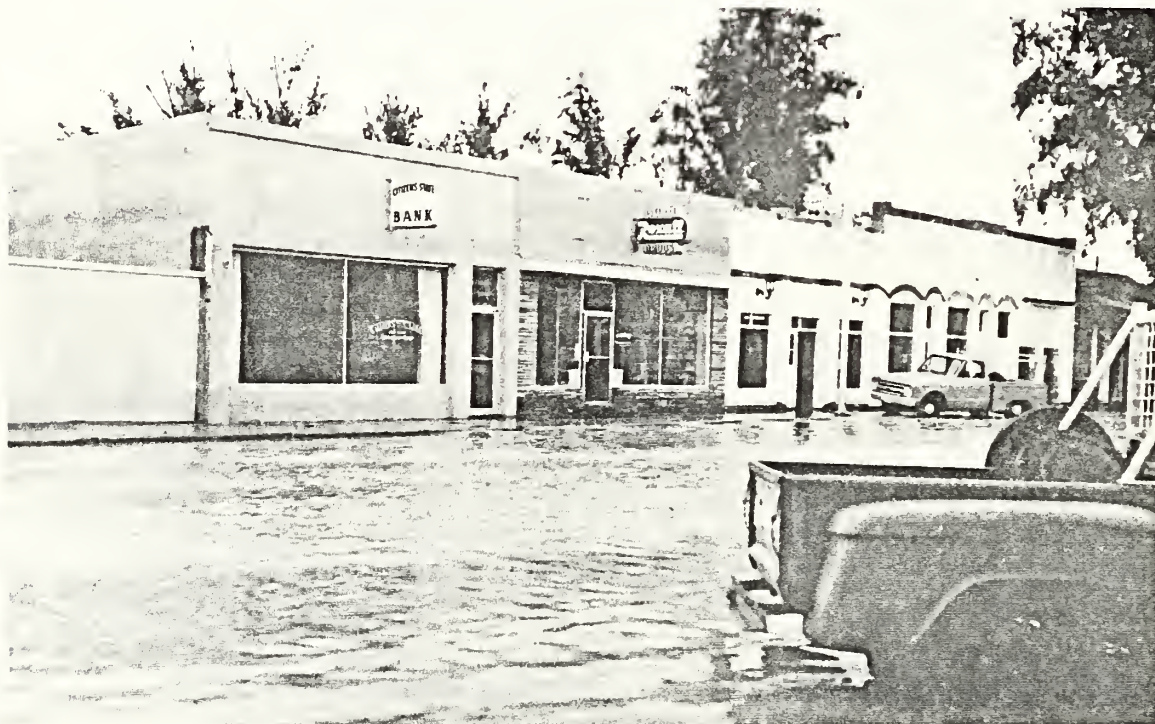
SCS PHOTO 12-PS14-7

Main street of Estancia, New Mexico under floodwaters from Milbourne and Compton Draws

The principal watershed problems are flood damage to irrigated land and associated improvements, urban damage in Estancia, and damage to highways, roads, and the railroad. Other significant problems are erosion by wind and water to unprotected upland areas of the watershed particularly the formerly cropped fields.

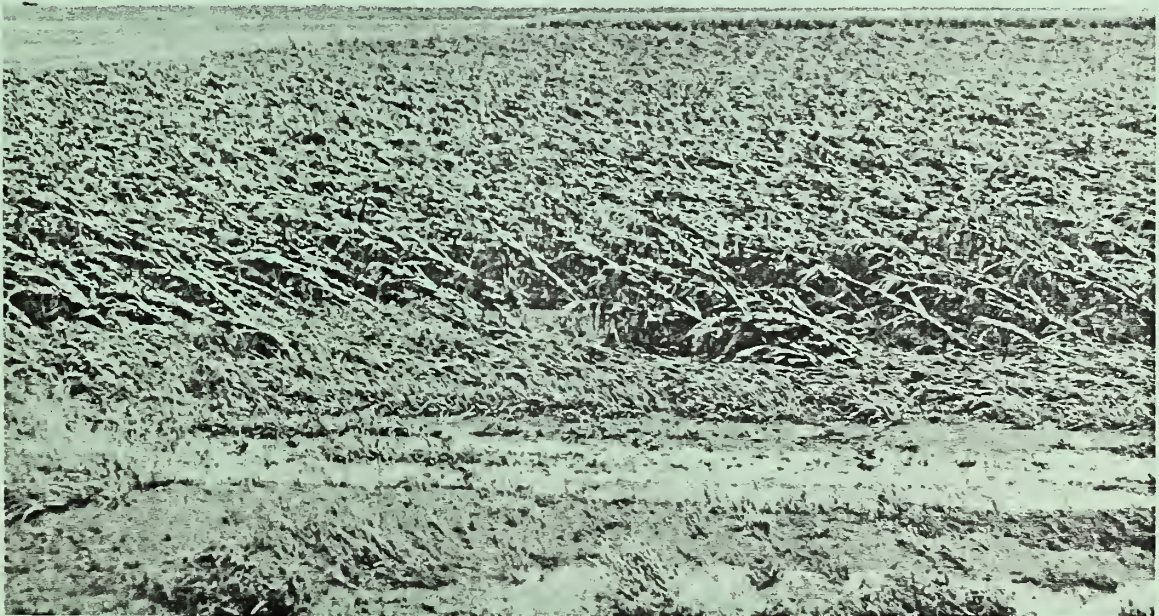
SCS PHOTO 12-P573-3

Typical floods in Estancia Subbasin. Corn damaged by floods.

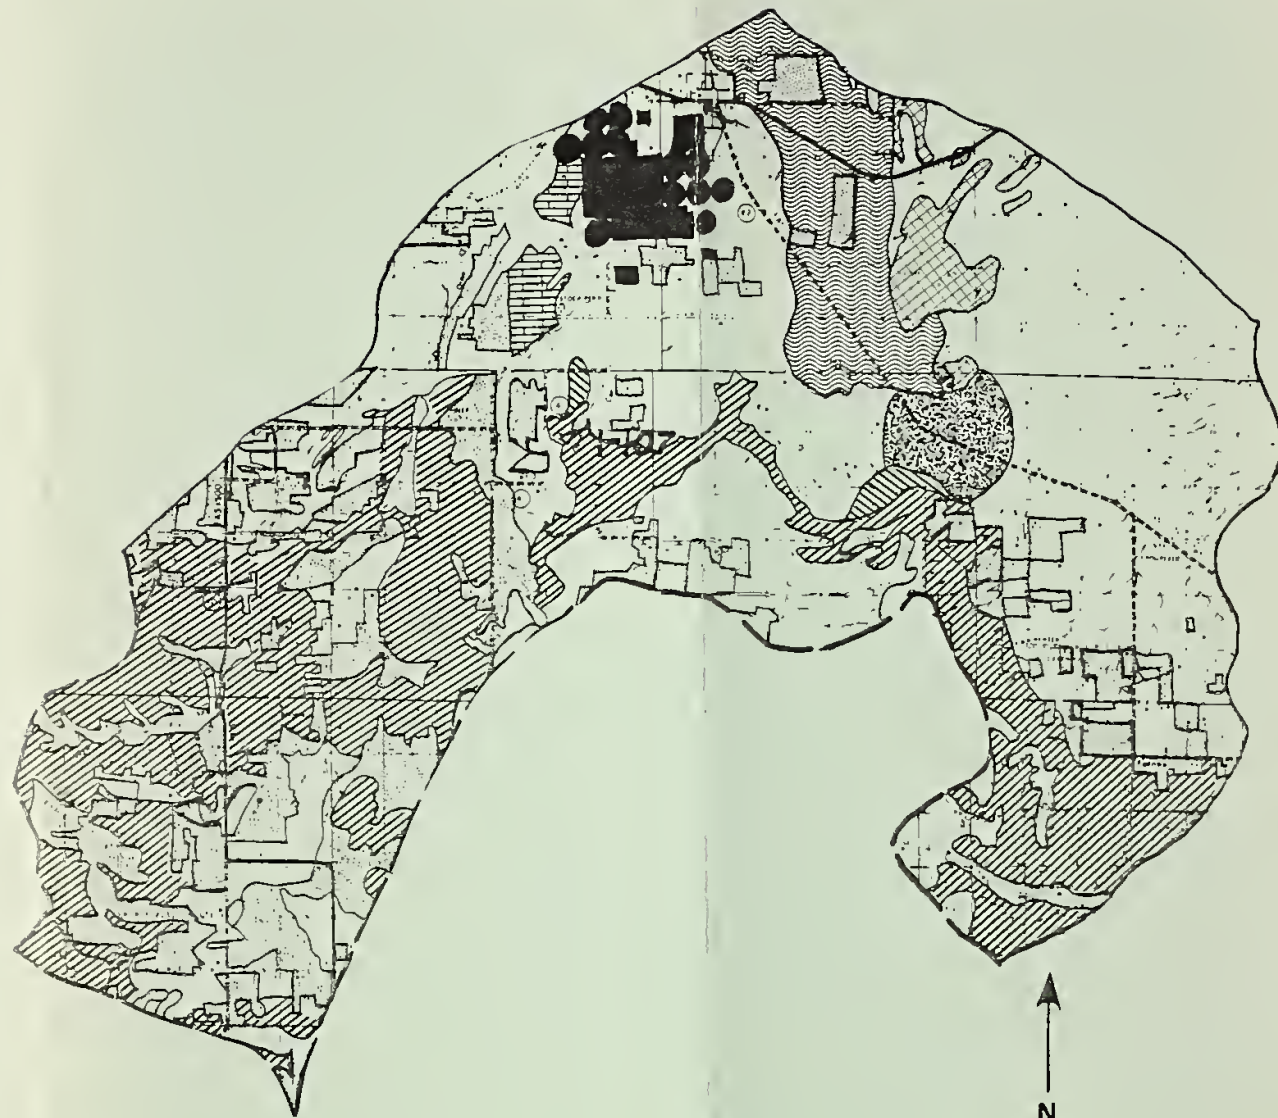
LAND TREATMENT
ROCK LAKE WATERSHED
UPPER RIO GRANDE BASIN

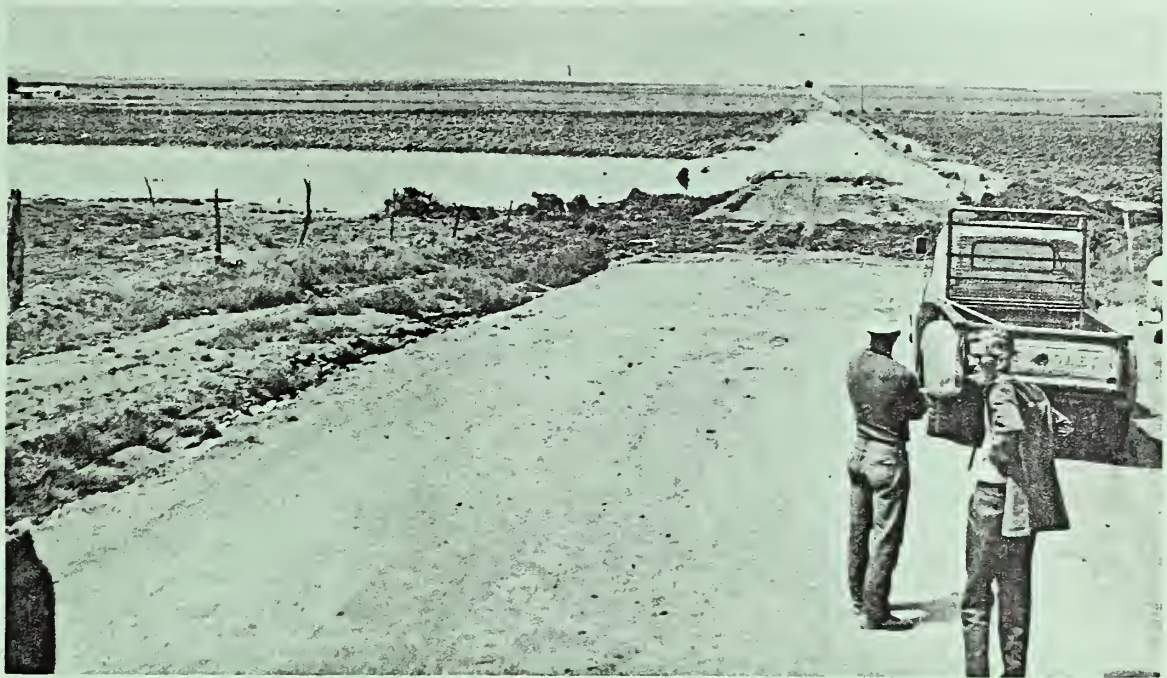
SCS PHOTO 12-P573-5

Flood damage to roads and crops

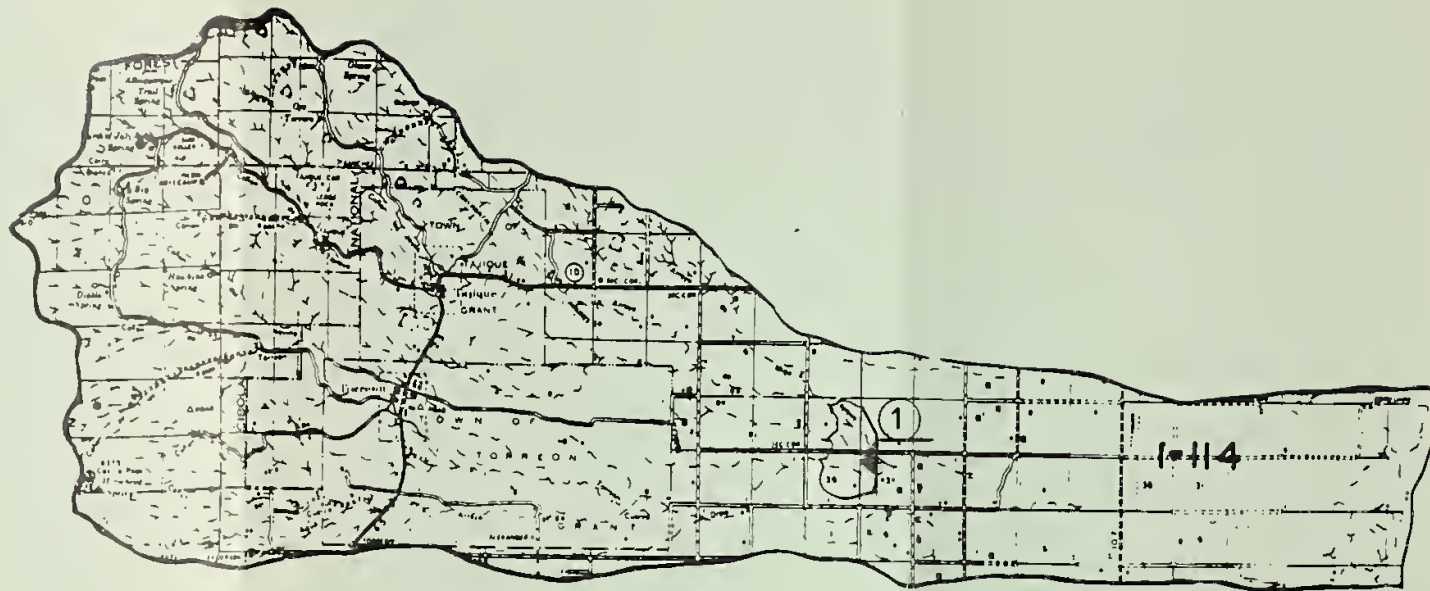
STRUCTURE LOCATION
TAJIQUE WATERSHED
UPPER RIO GRANDE BASIN

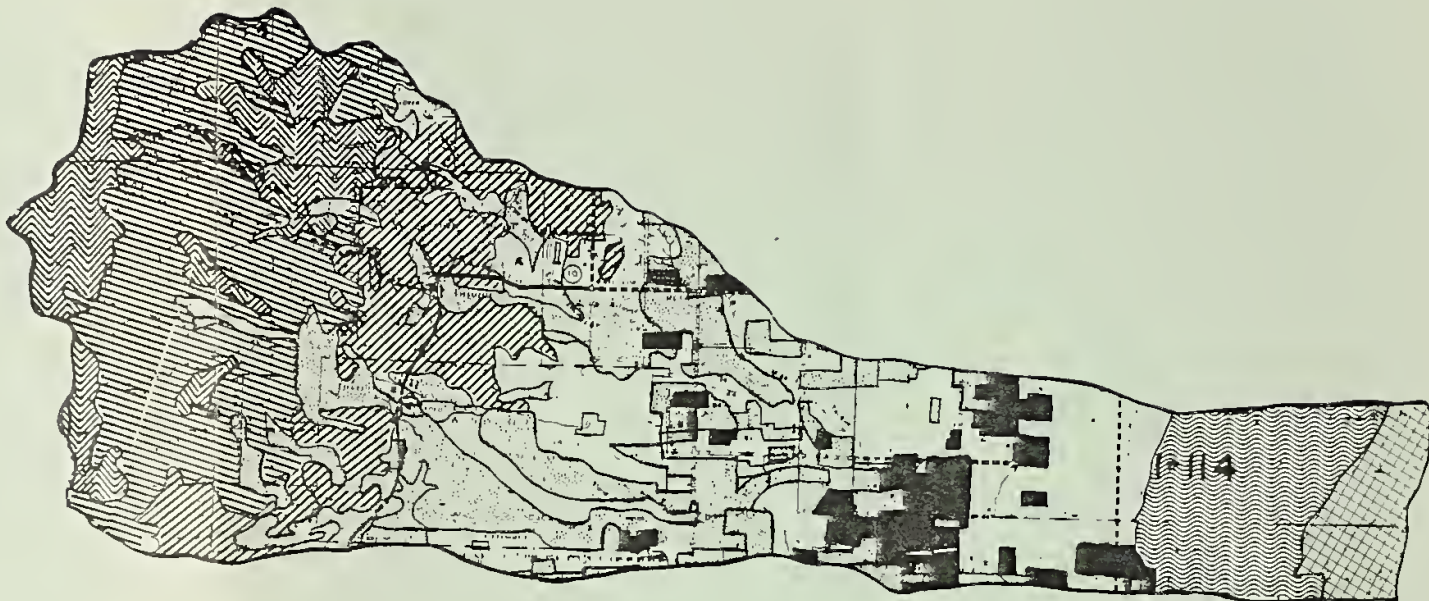
LAND TREATMENT
TAJIQUE WATERSHED
UPPER RIO GRANDE BASIN

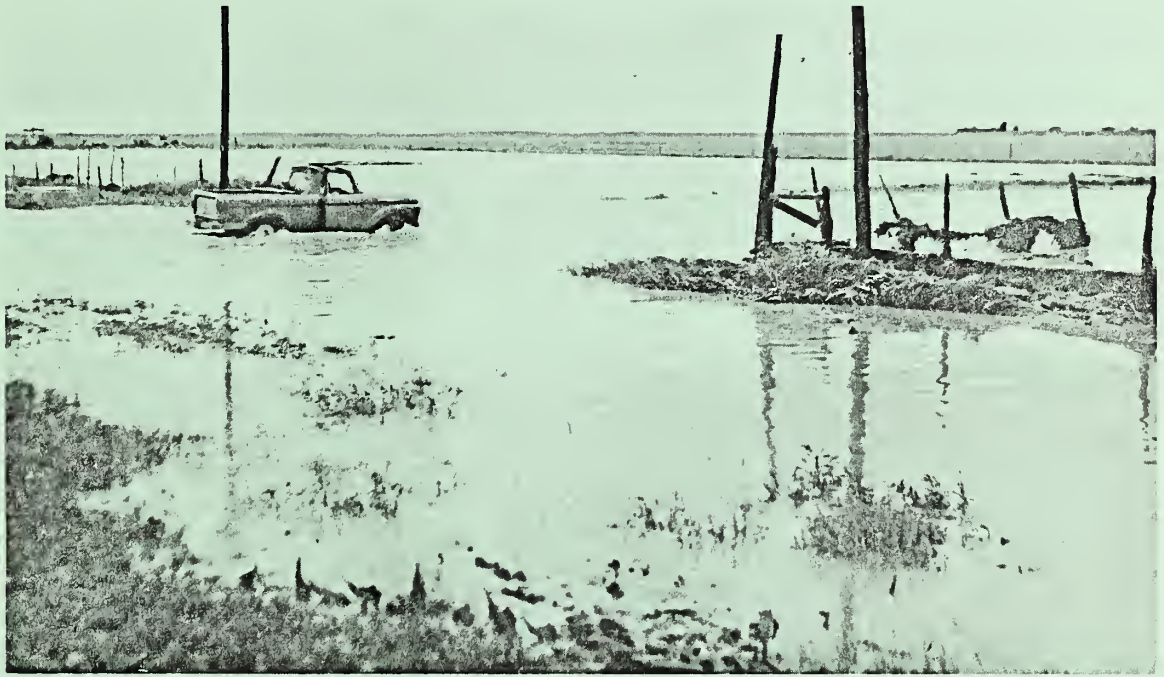
SCS PHOTO 12-PS14-11

Irrigated land damage. Note high-water mark on fence

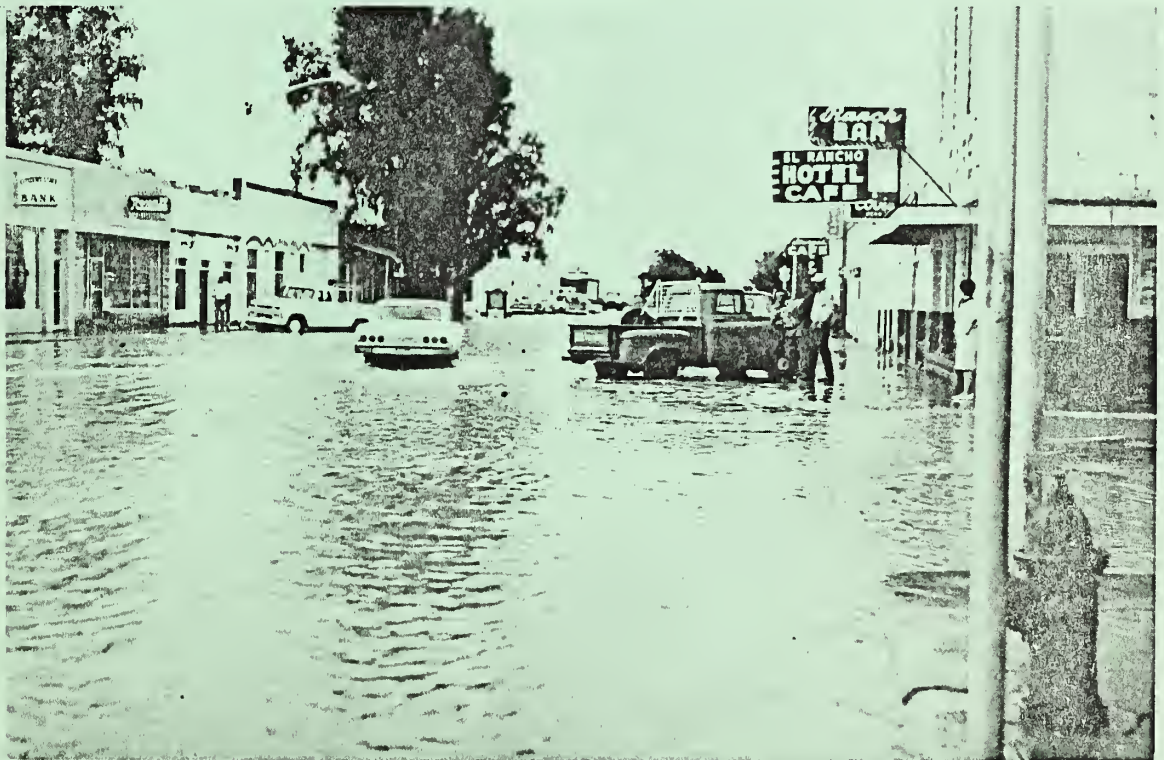
SCS PHOTO 12-PS14-12

Main street of Estancia under floodwater from August 1967 flood from Milbourne and Compton Draws.

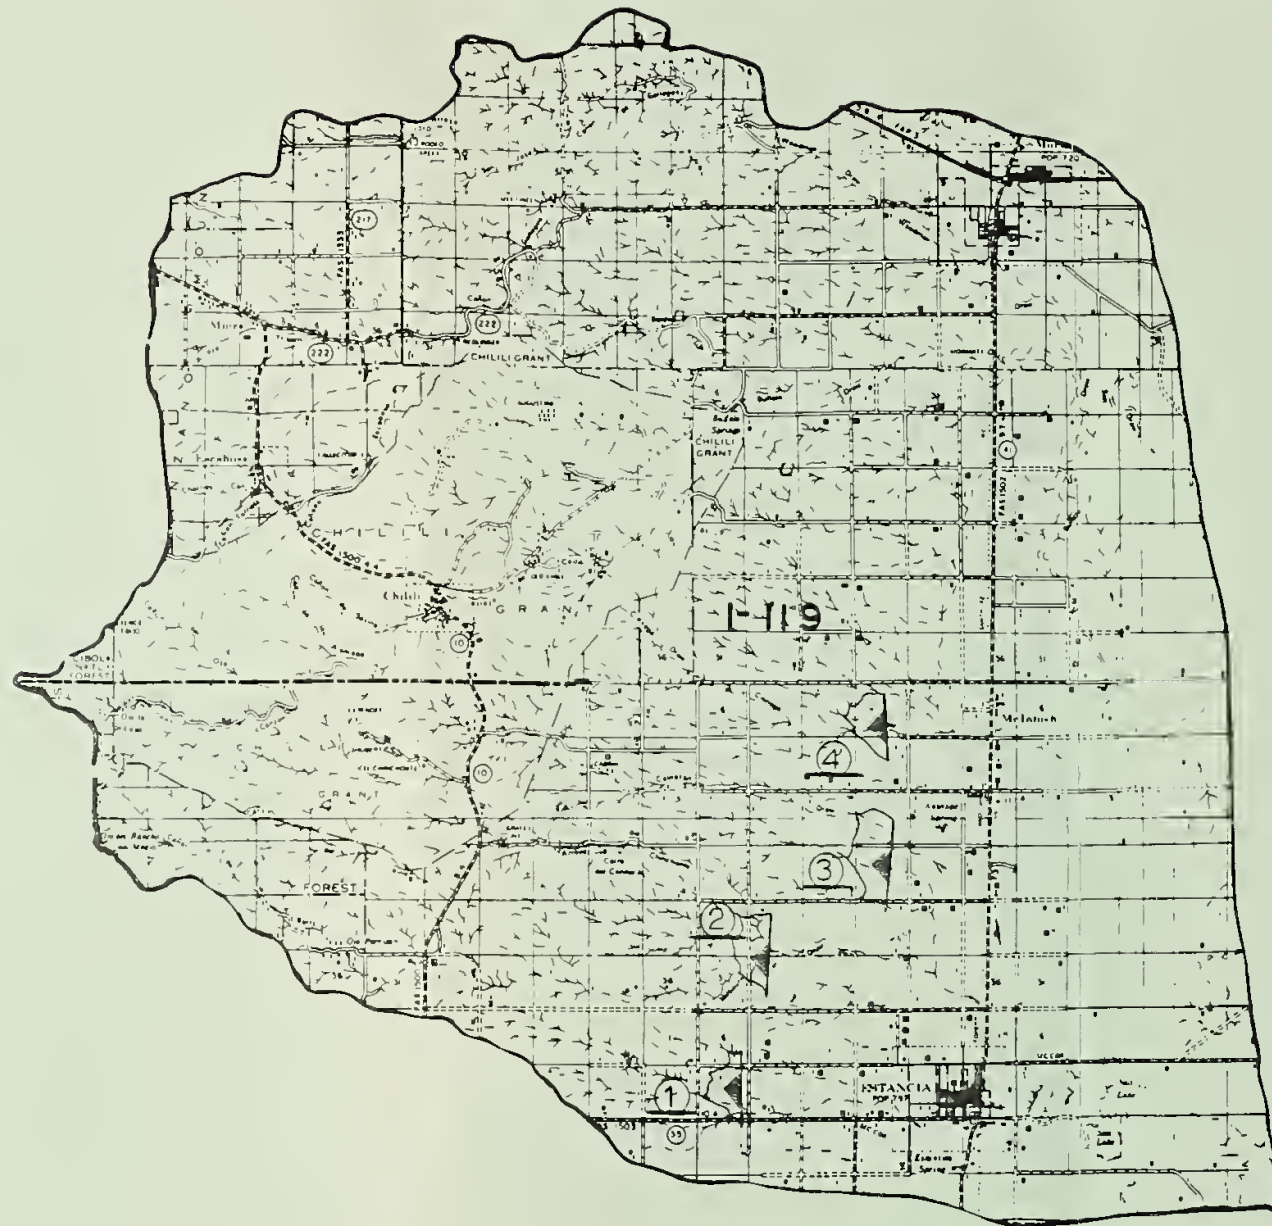
**STRUCTURE LOCATION
BUFFALO SPRINGS WATERSHED
UPPER RIO GRANDE BASIN**

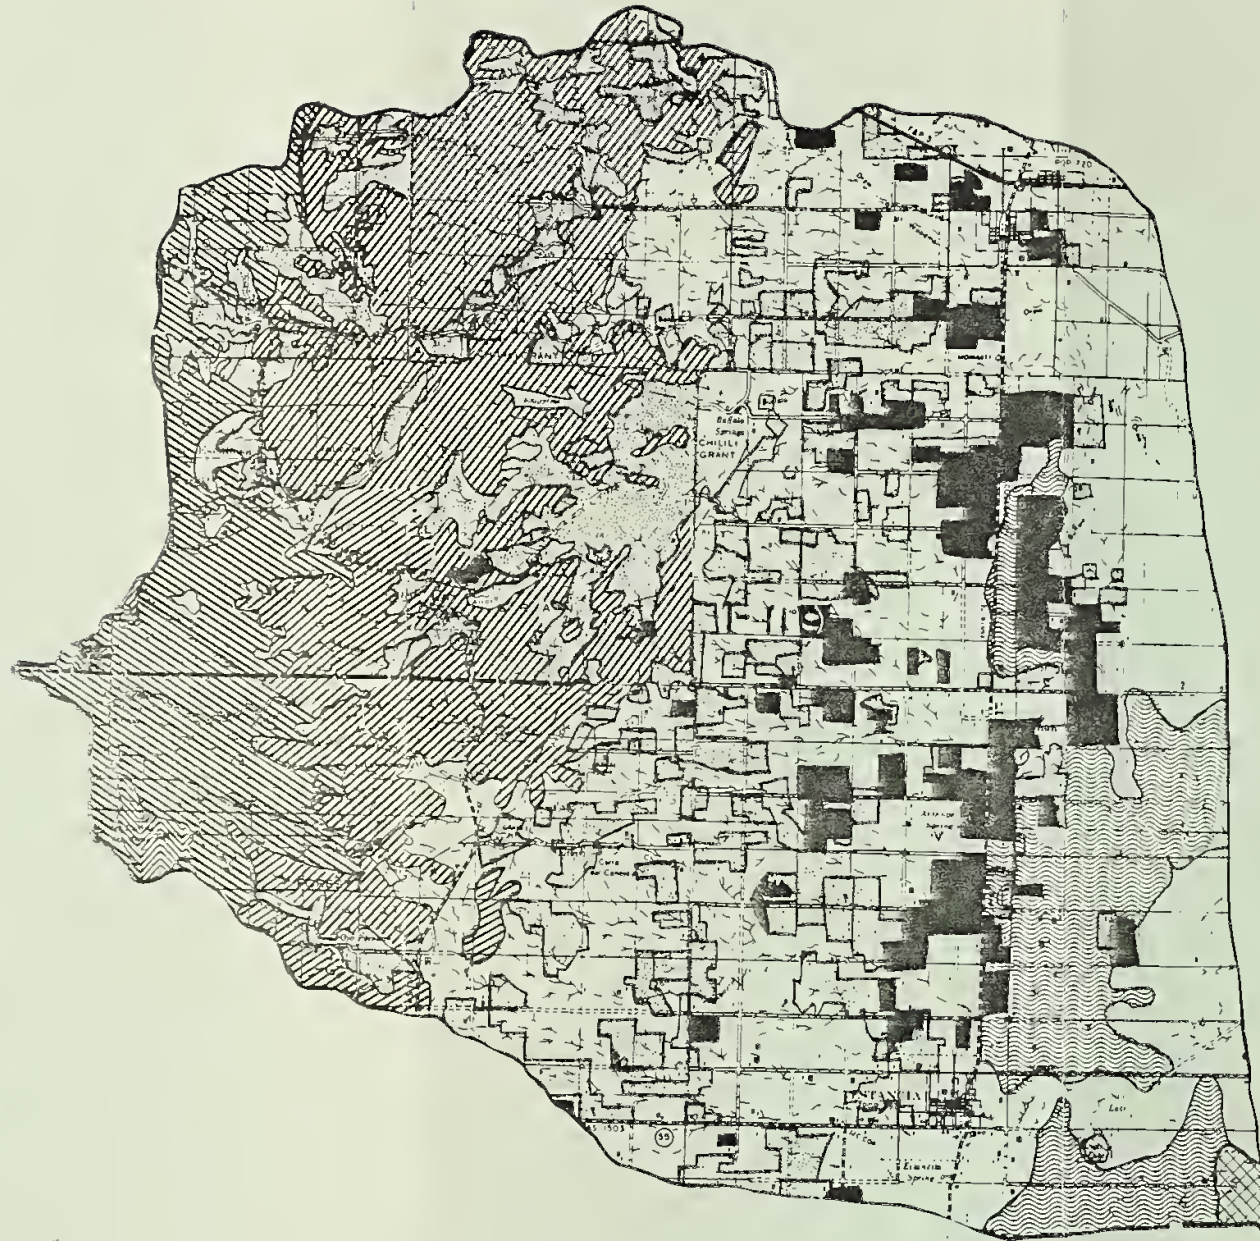
LAND TREATMENT
 BUFFALO SPRINGS WATERSHED
 UPPER RIO GRANDE BASIN

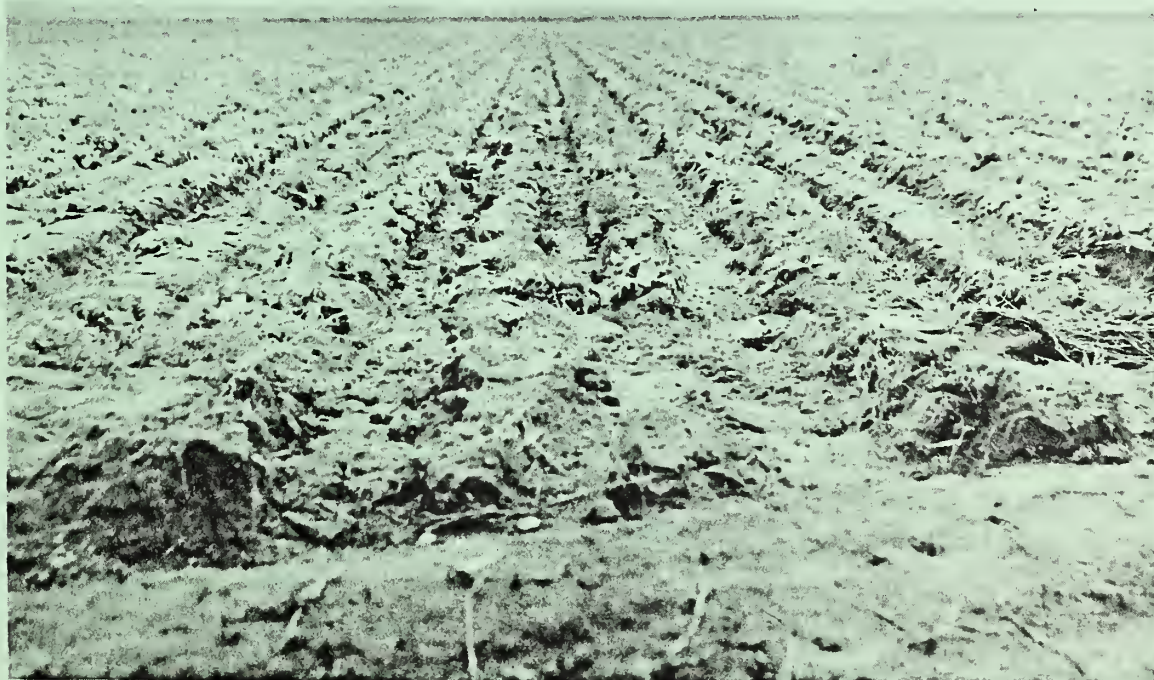
SCS PHOTO 12-P573-8

Lettuce crop destroyed by floodwater from 1967 storm. Irrigated crops are damaged frequently by floods.
