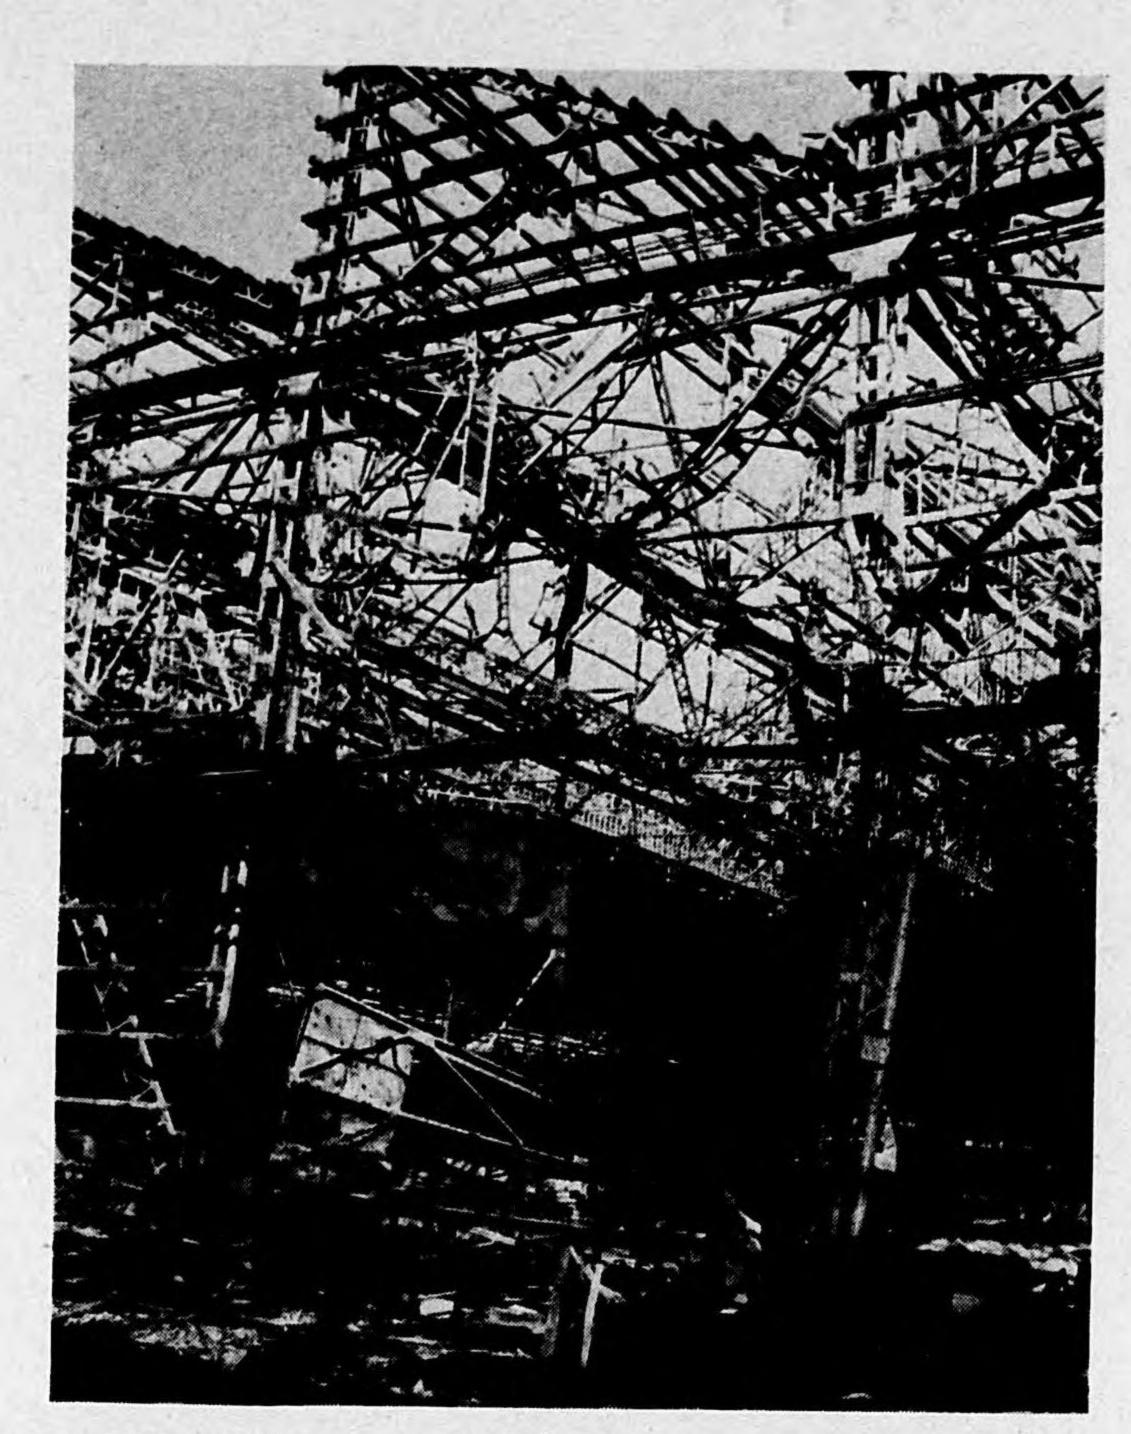
Photo 1.—Building 1, Bombs 1 and 2; damaged exterior column and roof steel.

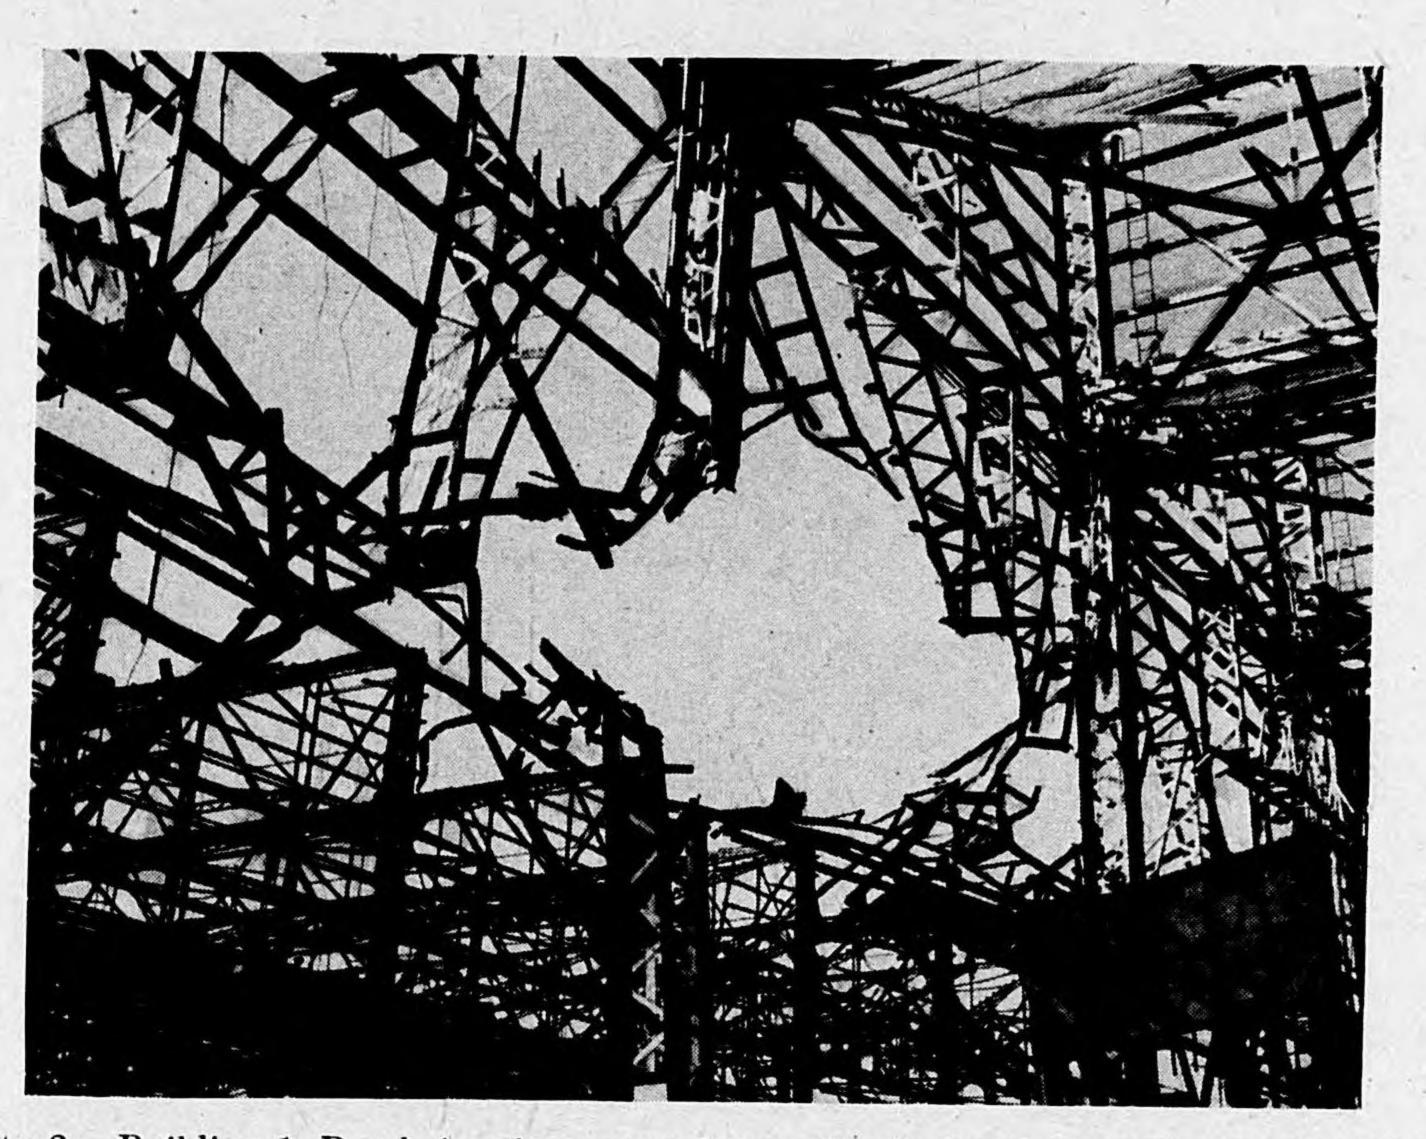
Photo 2.—Building 1, Bomb 1, column cut; lower chord of exterior stiffening truss cut.

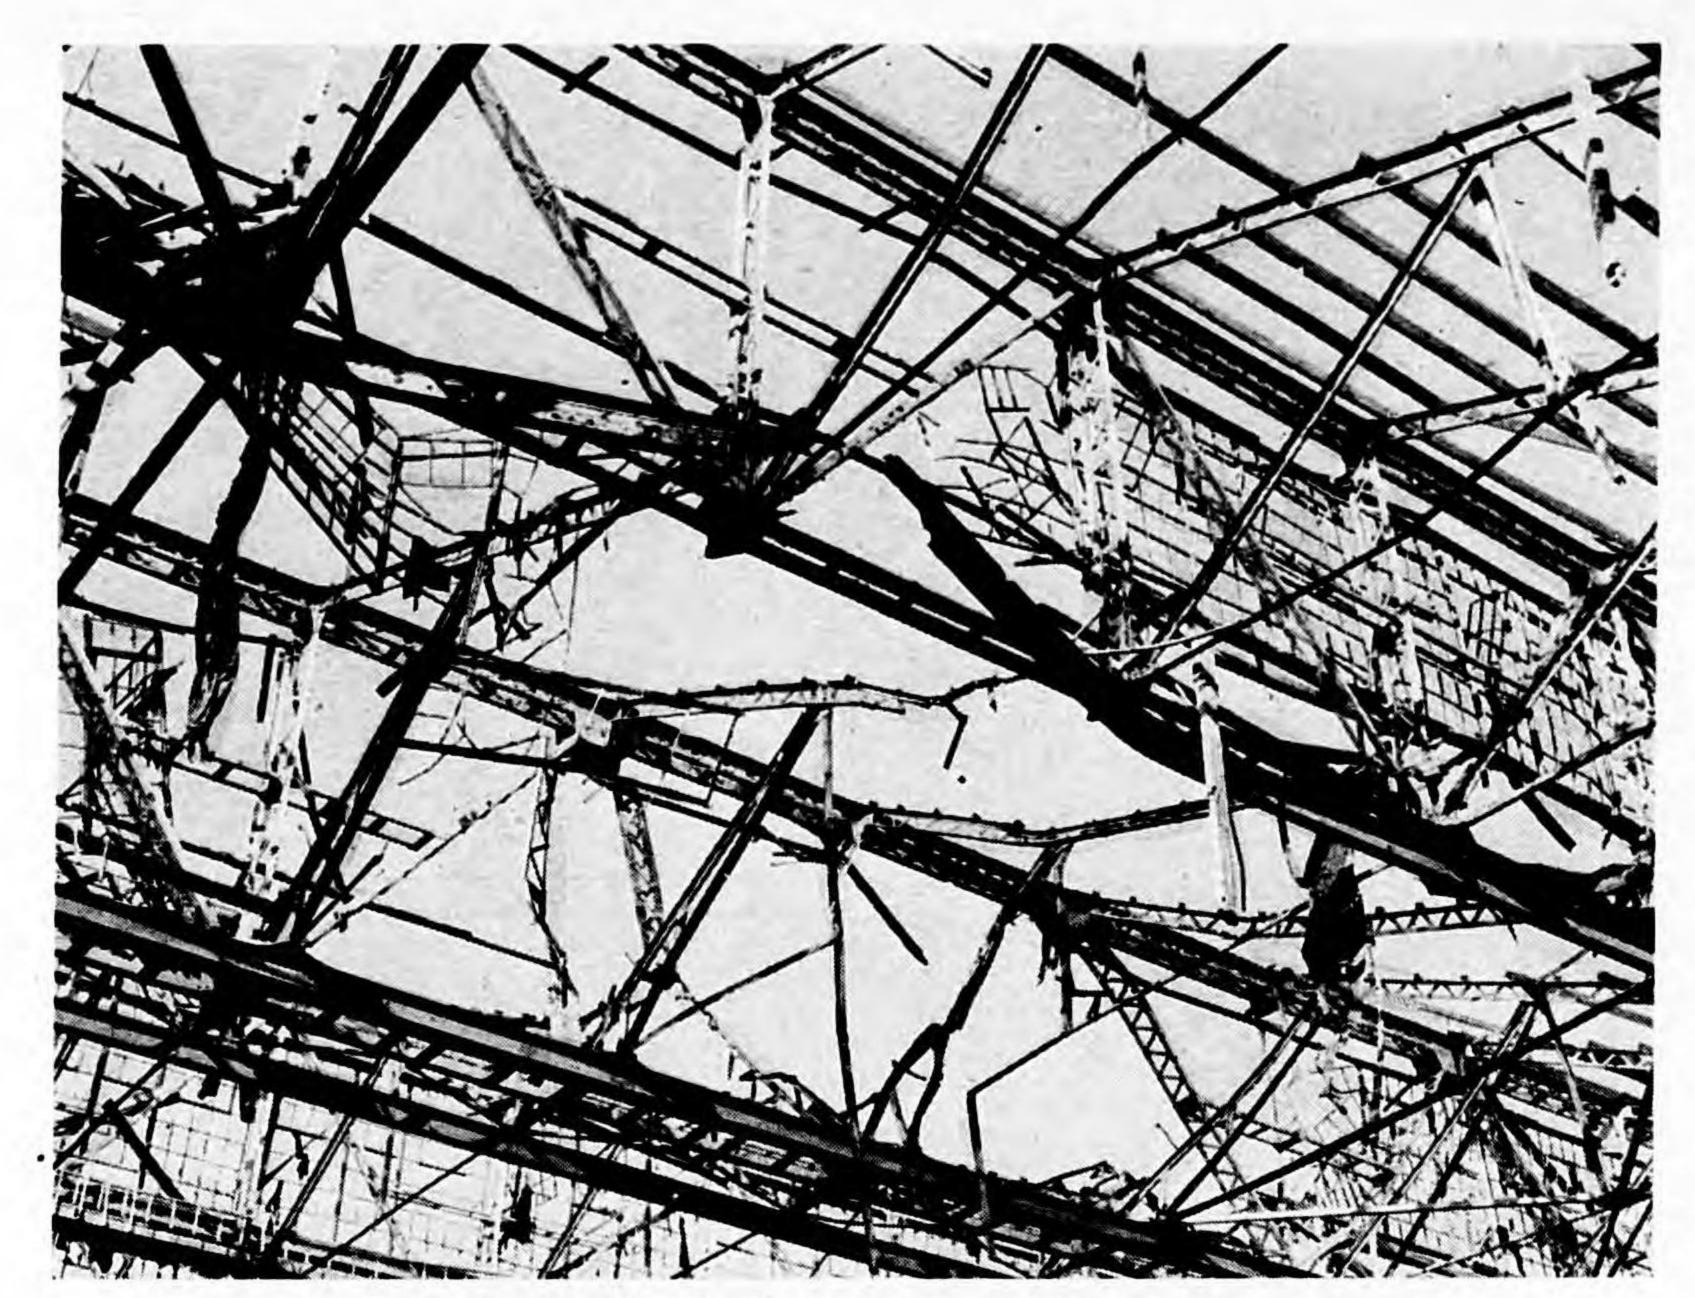
Photo 3.—Building 1, Bomb 2; damaged roof steel.

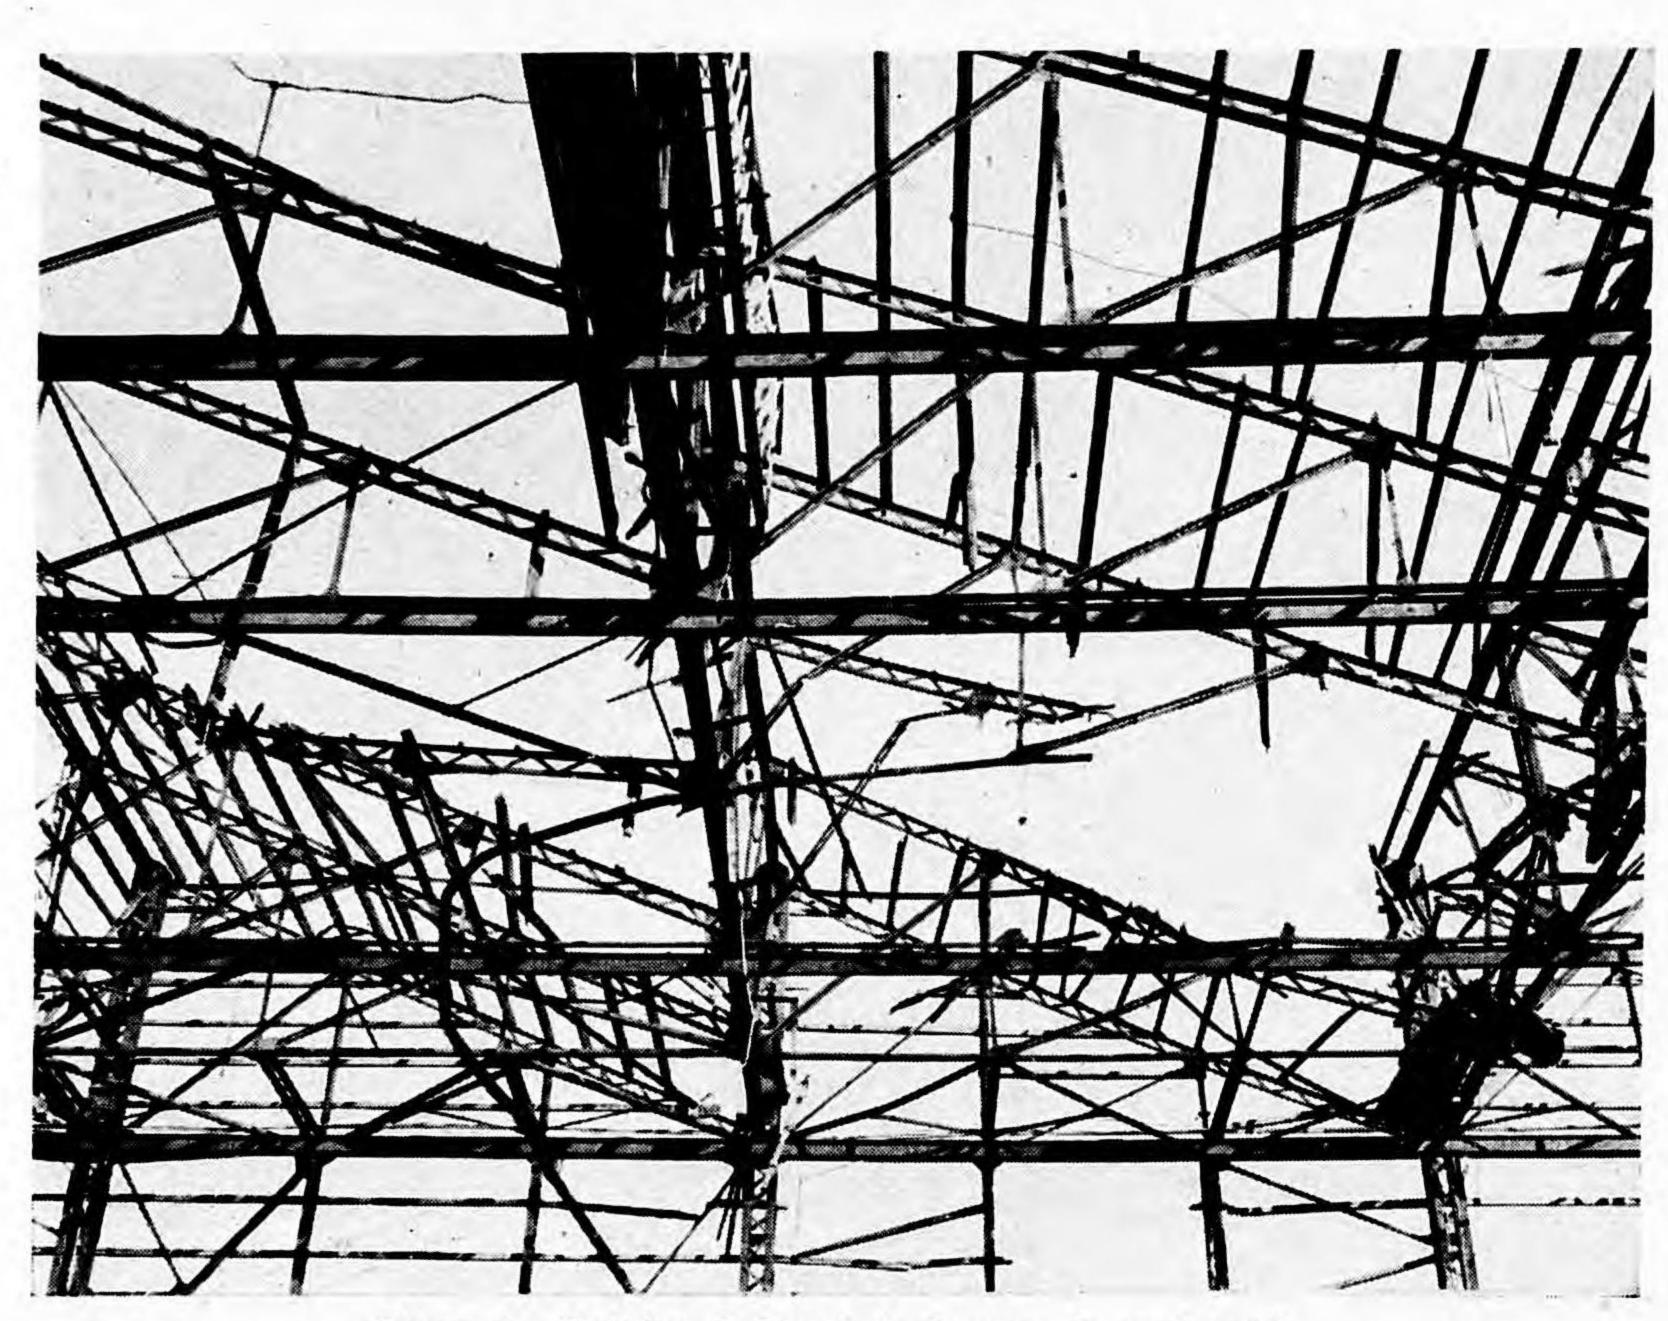
Photo 4.—Building 2, Bomb 4; damage to roof steel.

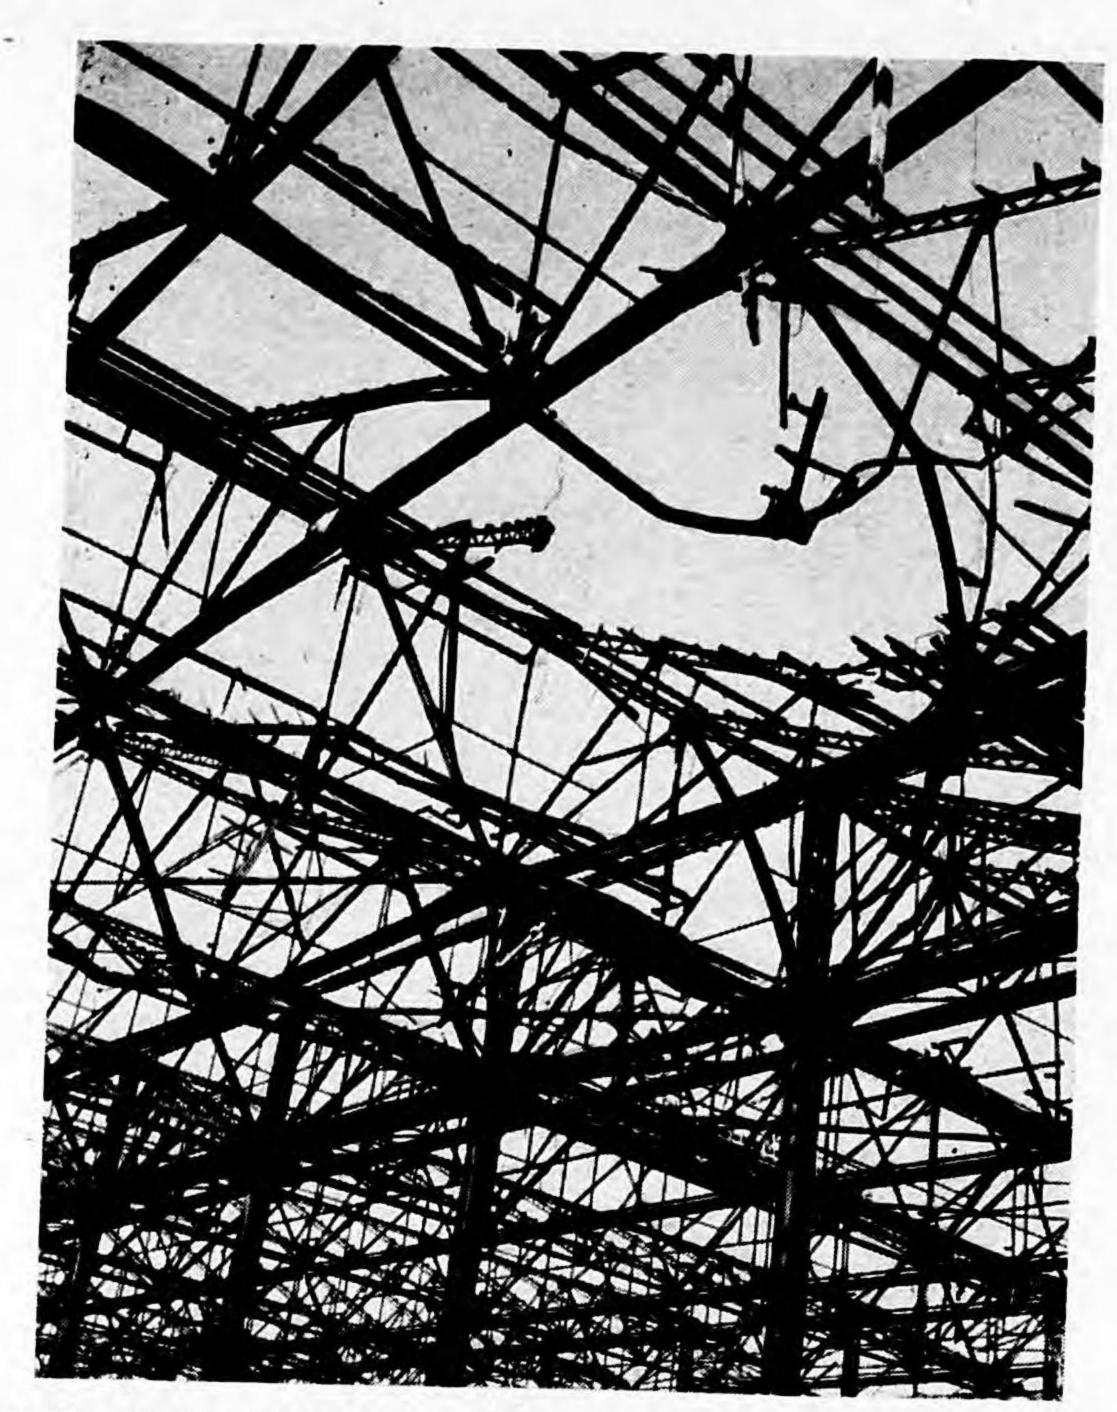
Photo 5.—Building 2, Bomb 6; damage to roof steel; bent hoist runway.

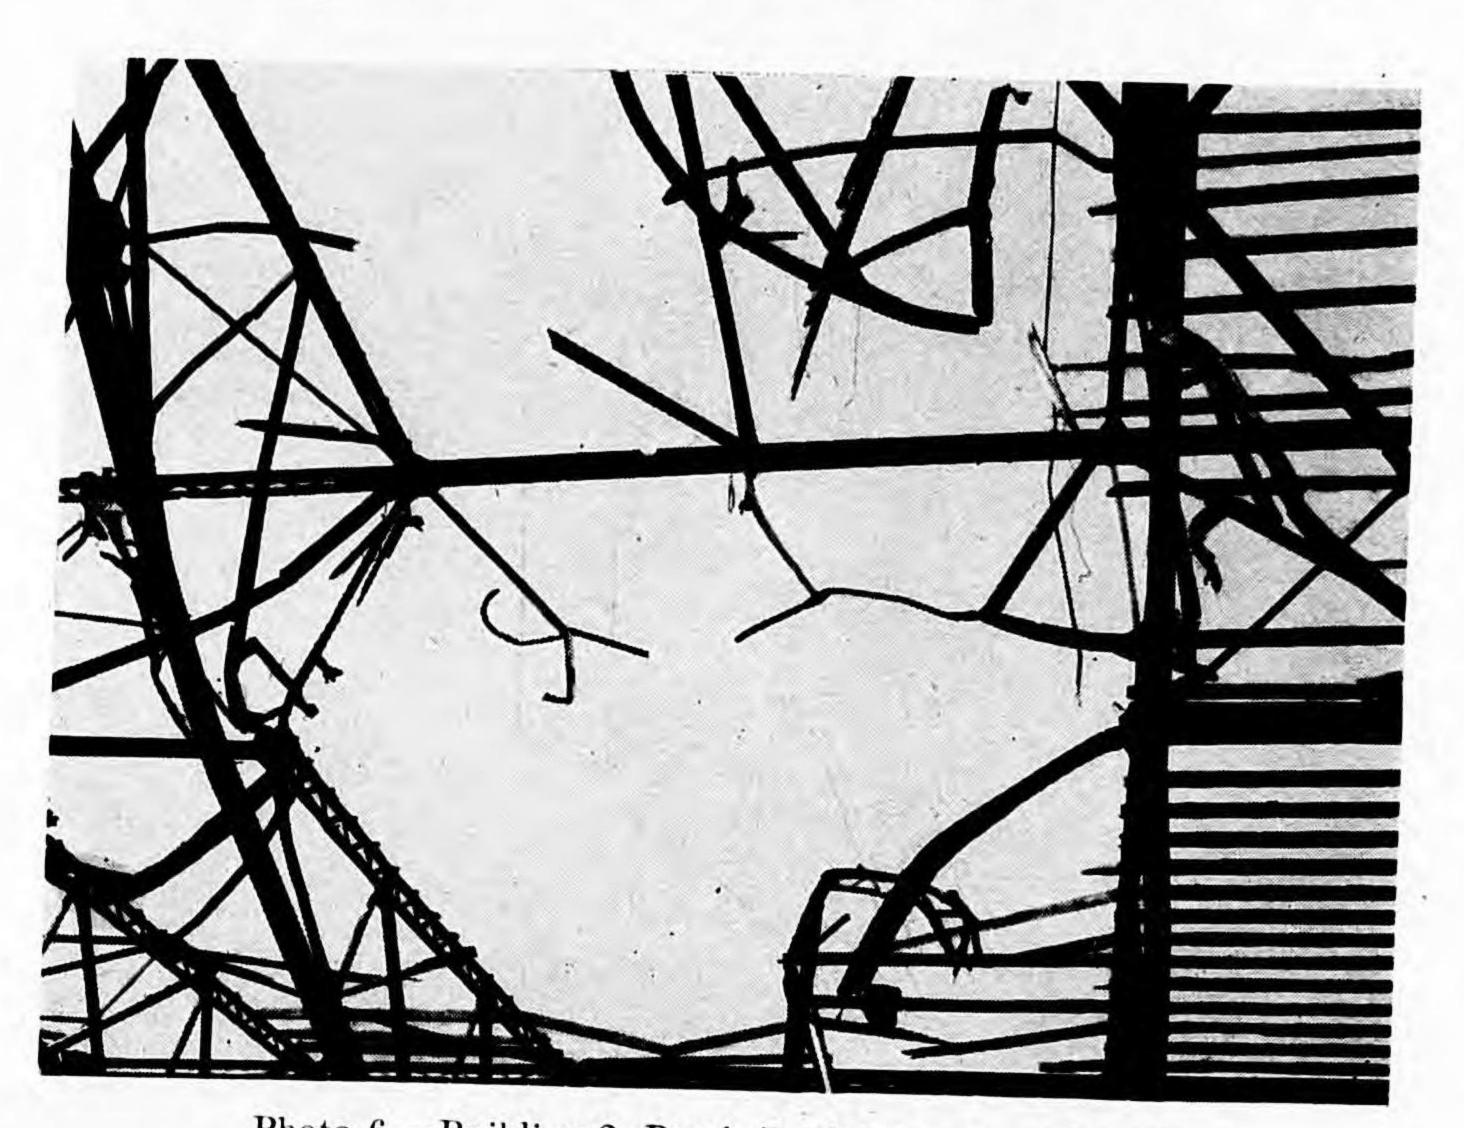
Photo 6.—Building 2, Bomb 7; damage to roof steel.

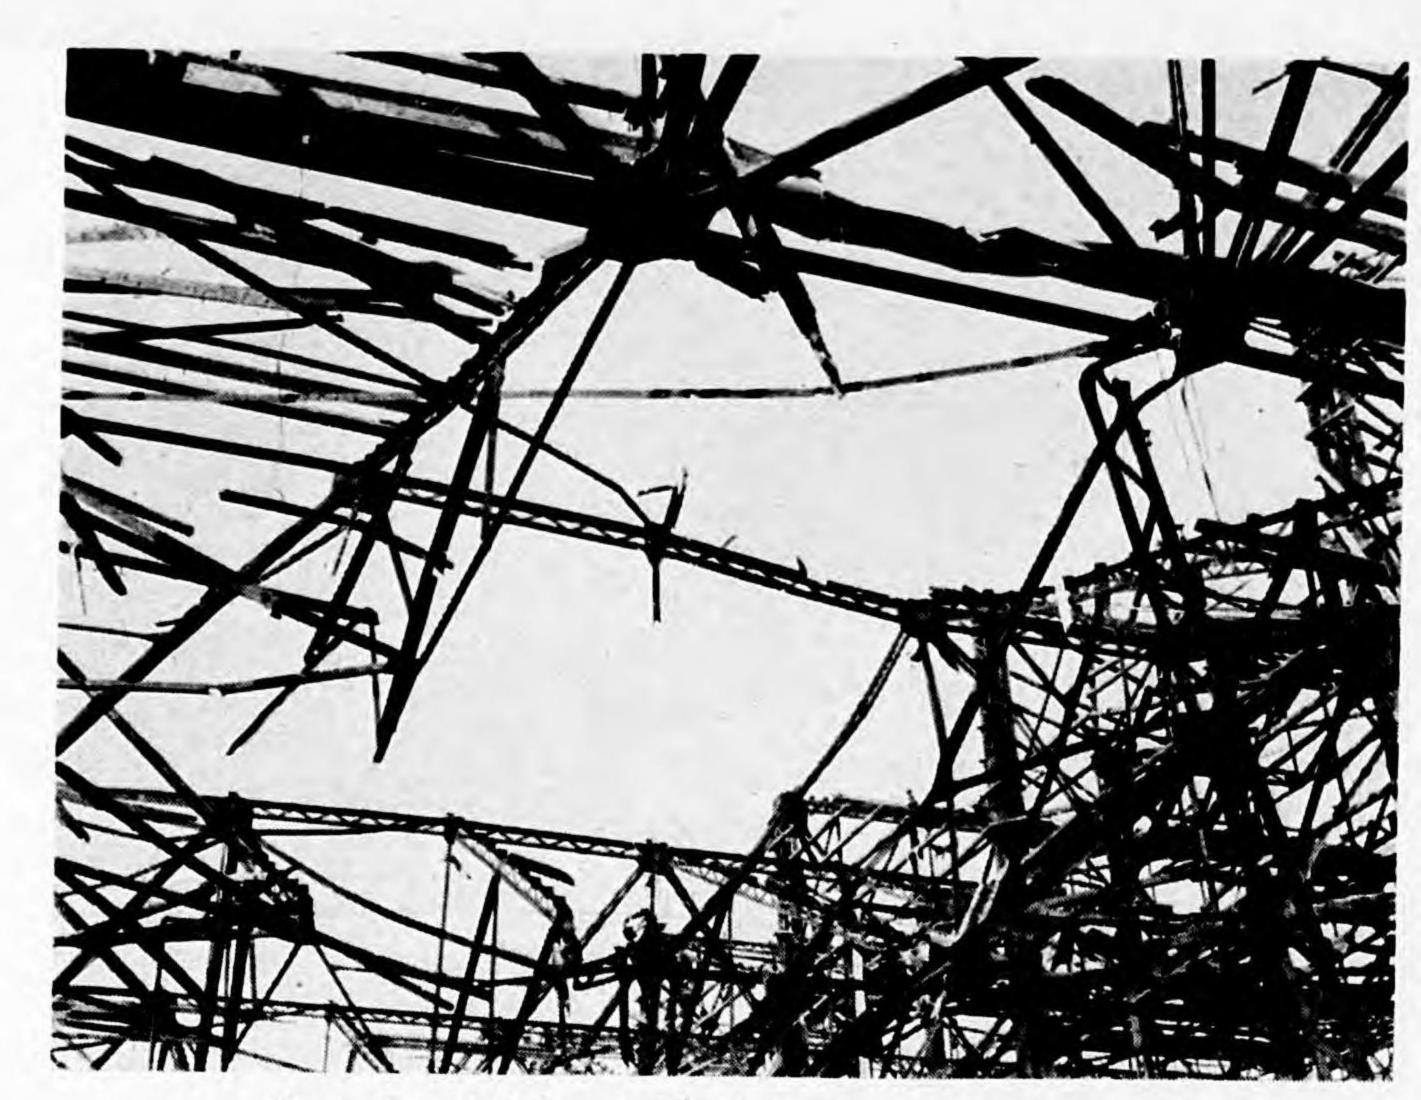
Photo 7.—Building 2, Bomb 8; damage to roof steel.

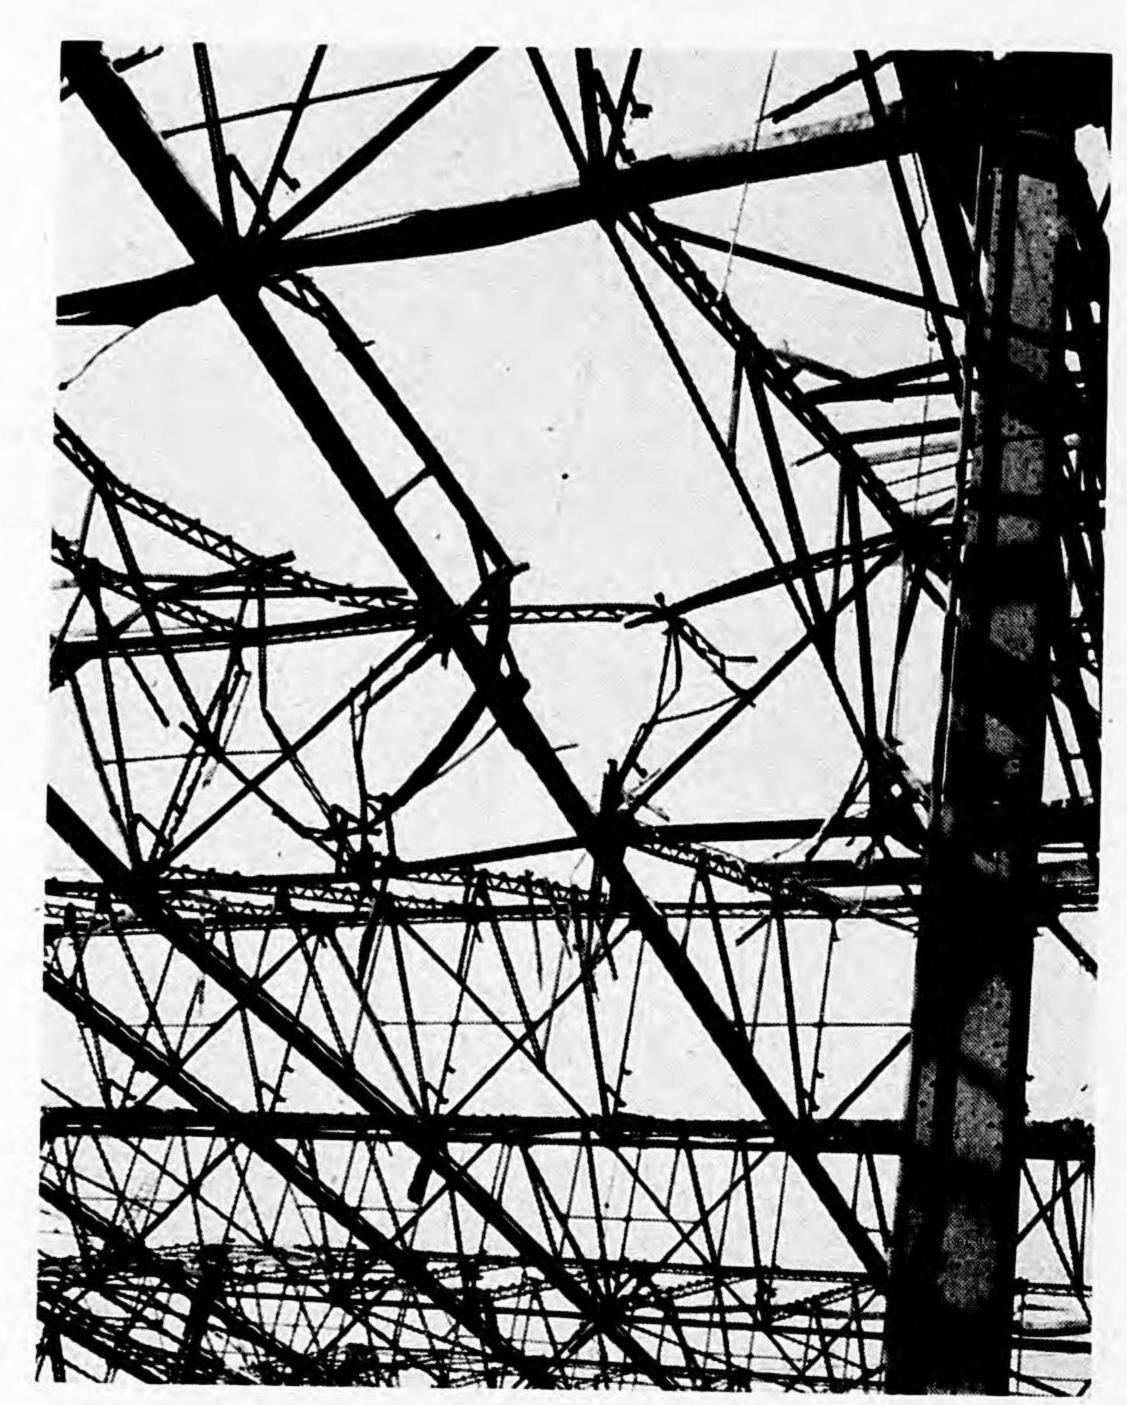
Photo 8.—Building 2, Bomb 9; damage to roof steel.

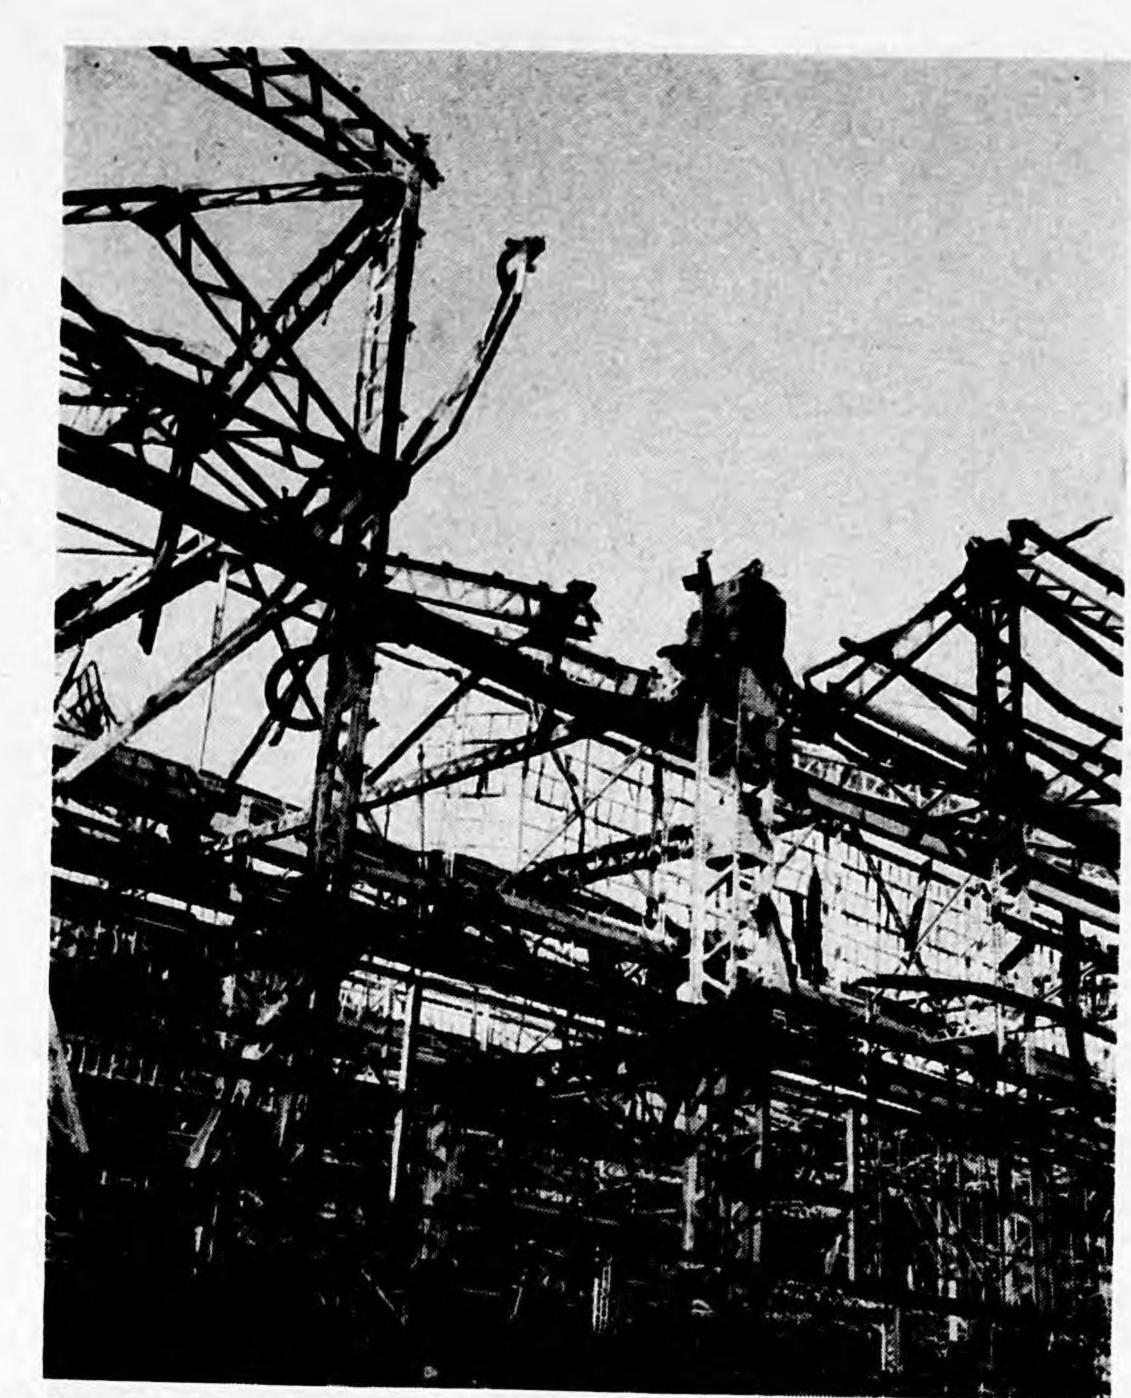
Photo 9.—Building 3, Bomb 10; exterior column cut; roof steel damaged.

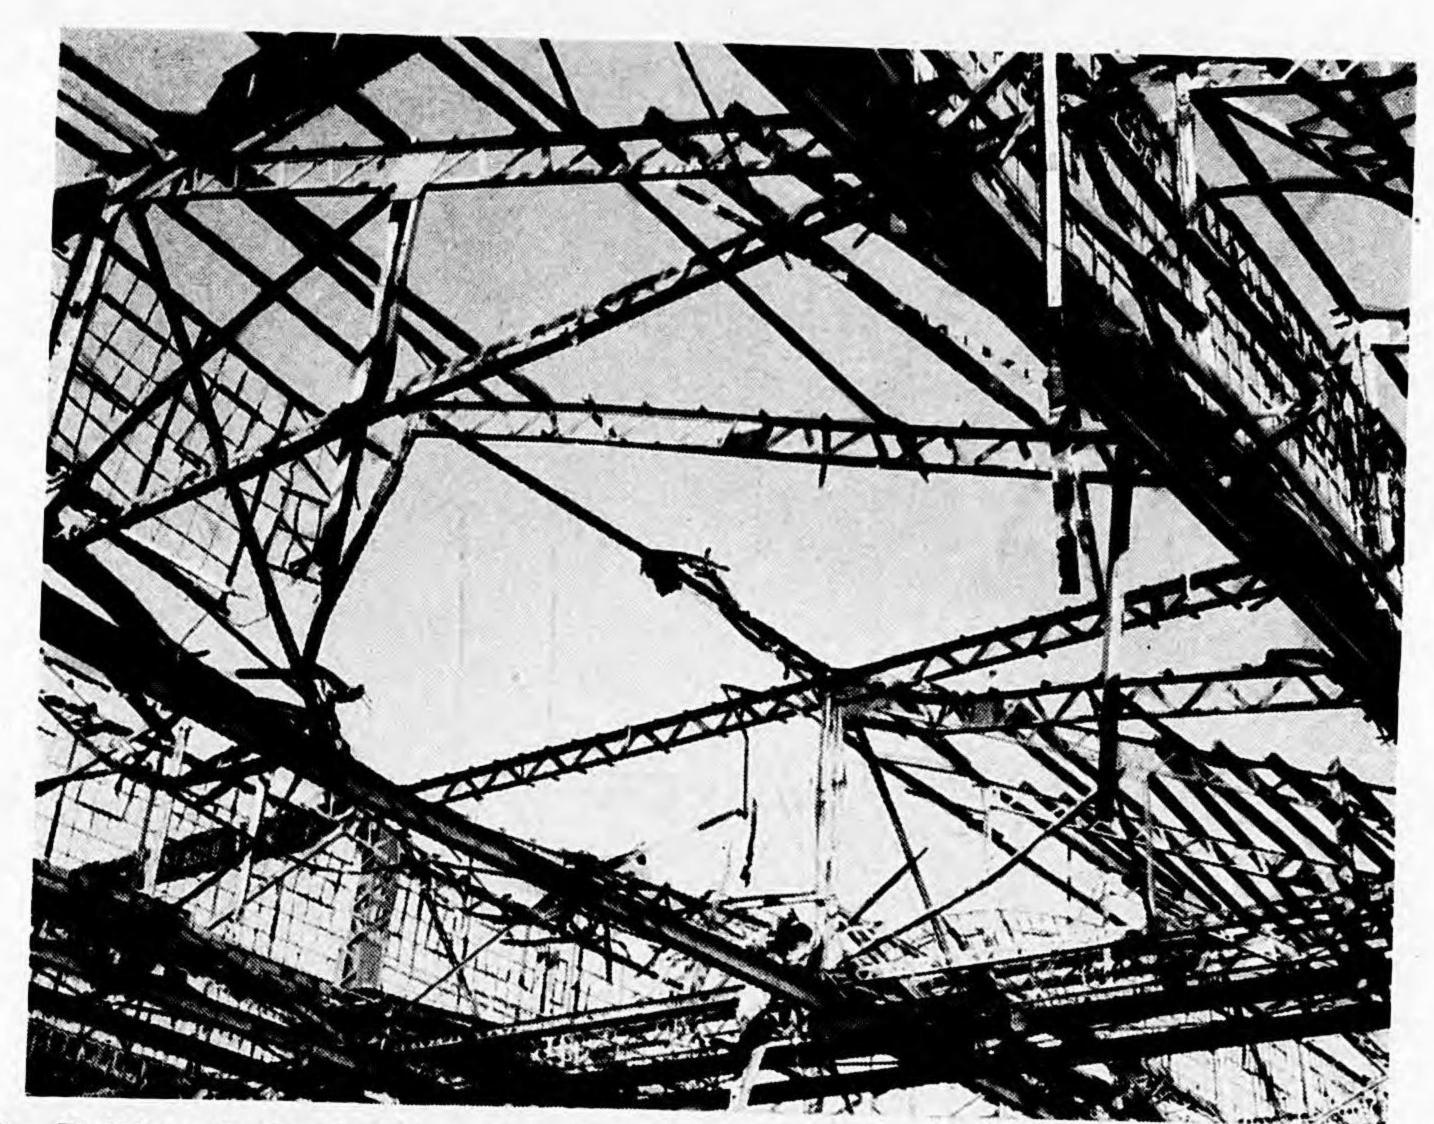
Photo 10.—Building 3, Bomb 12; roof steel damaged; horizontal members intact. (Image reversed).

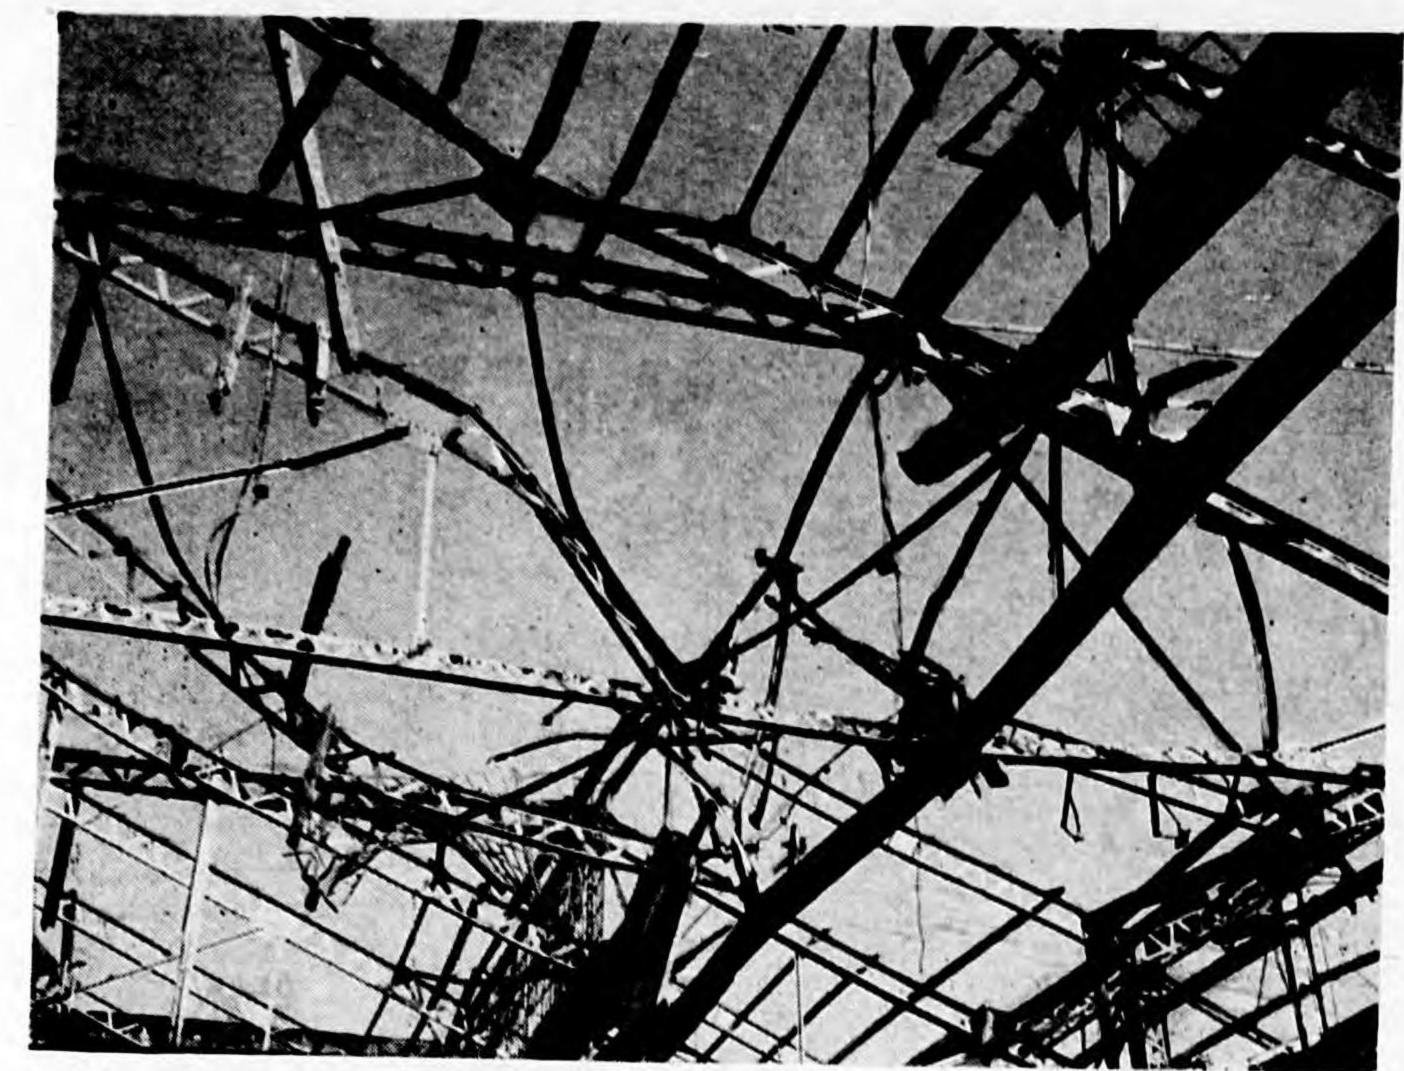
Photo 11.—Building 3, Bomb 15; damaged roof steel; bent crane runway.

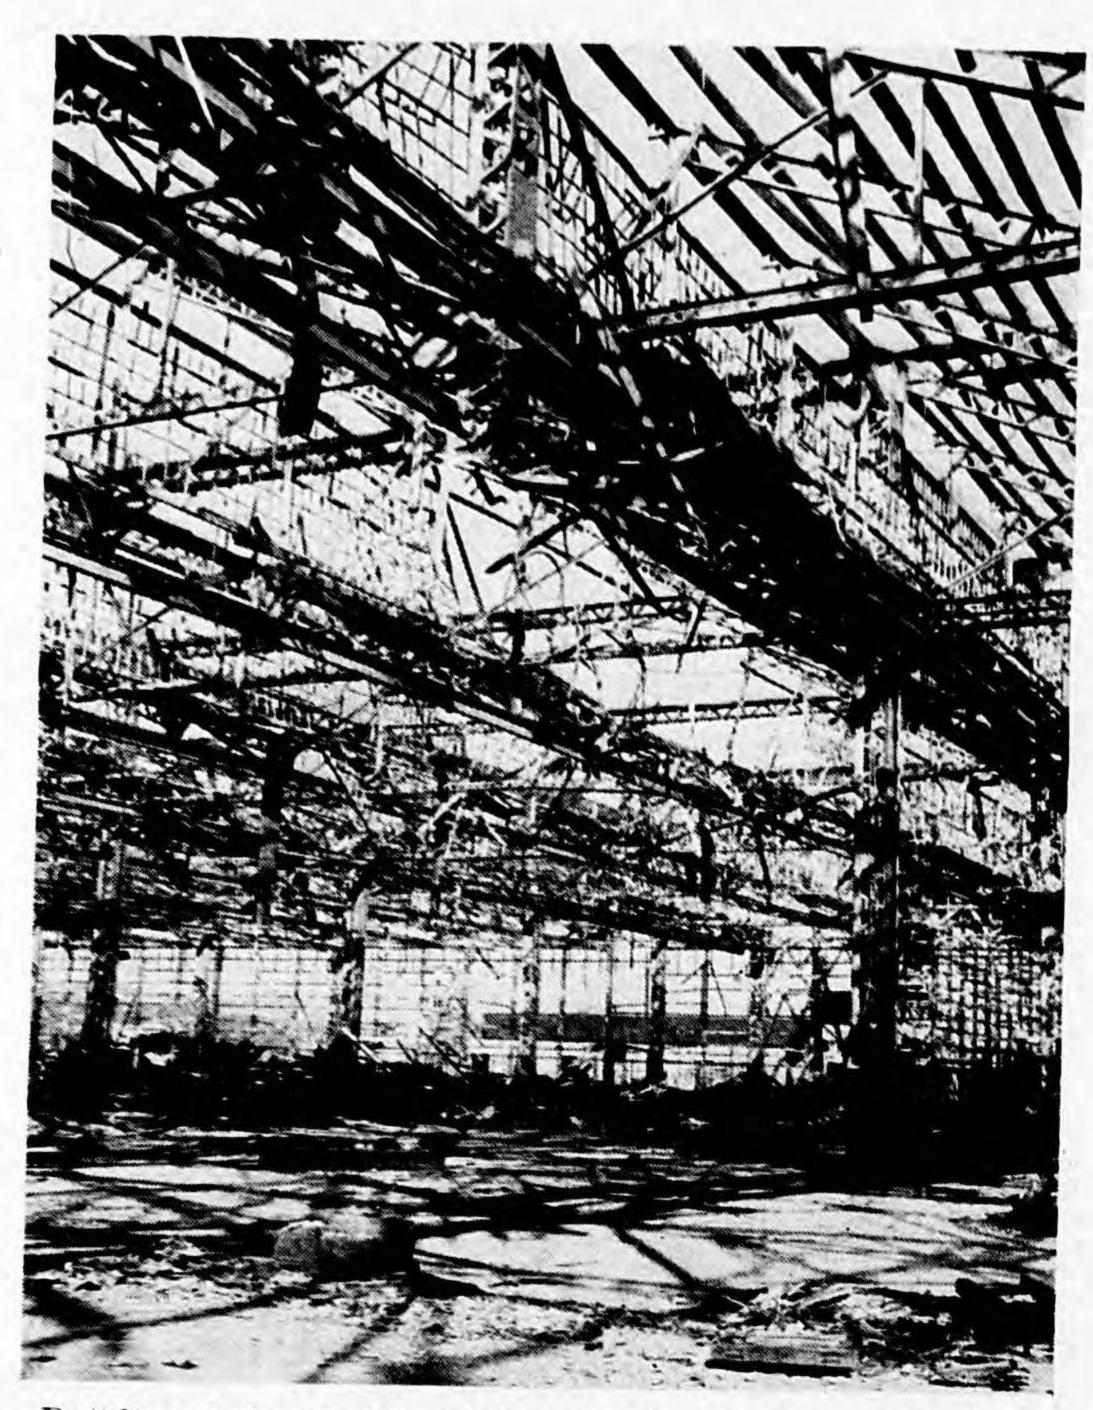
Photo 12.—Building 3, Bomb 17; column destroyed; view of damage and debris.

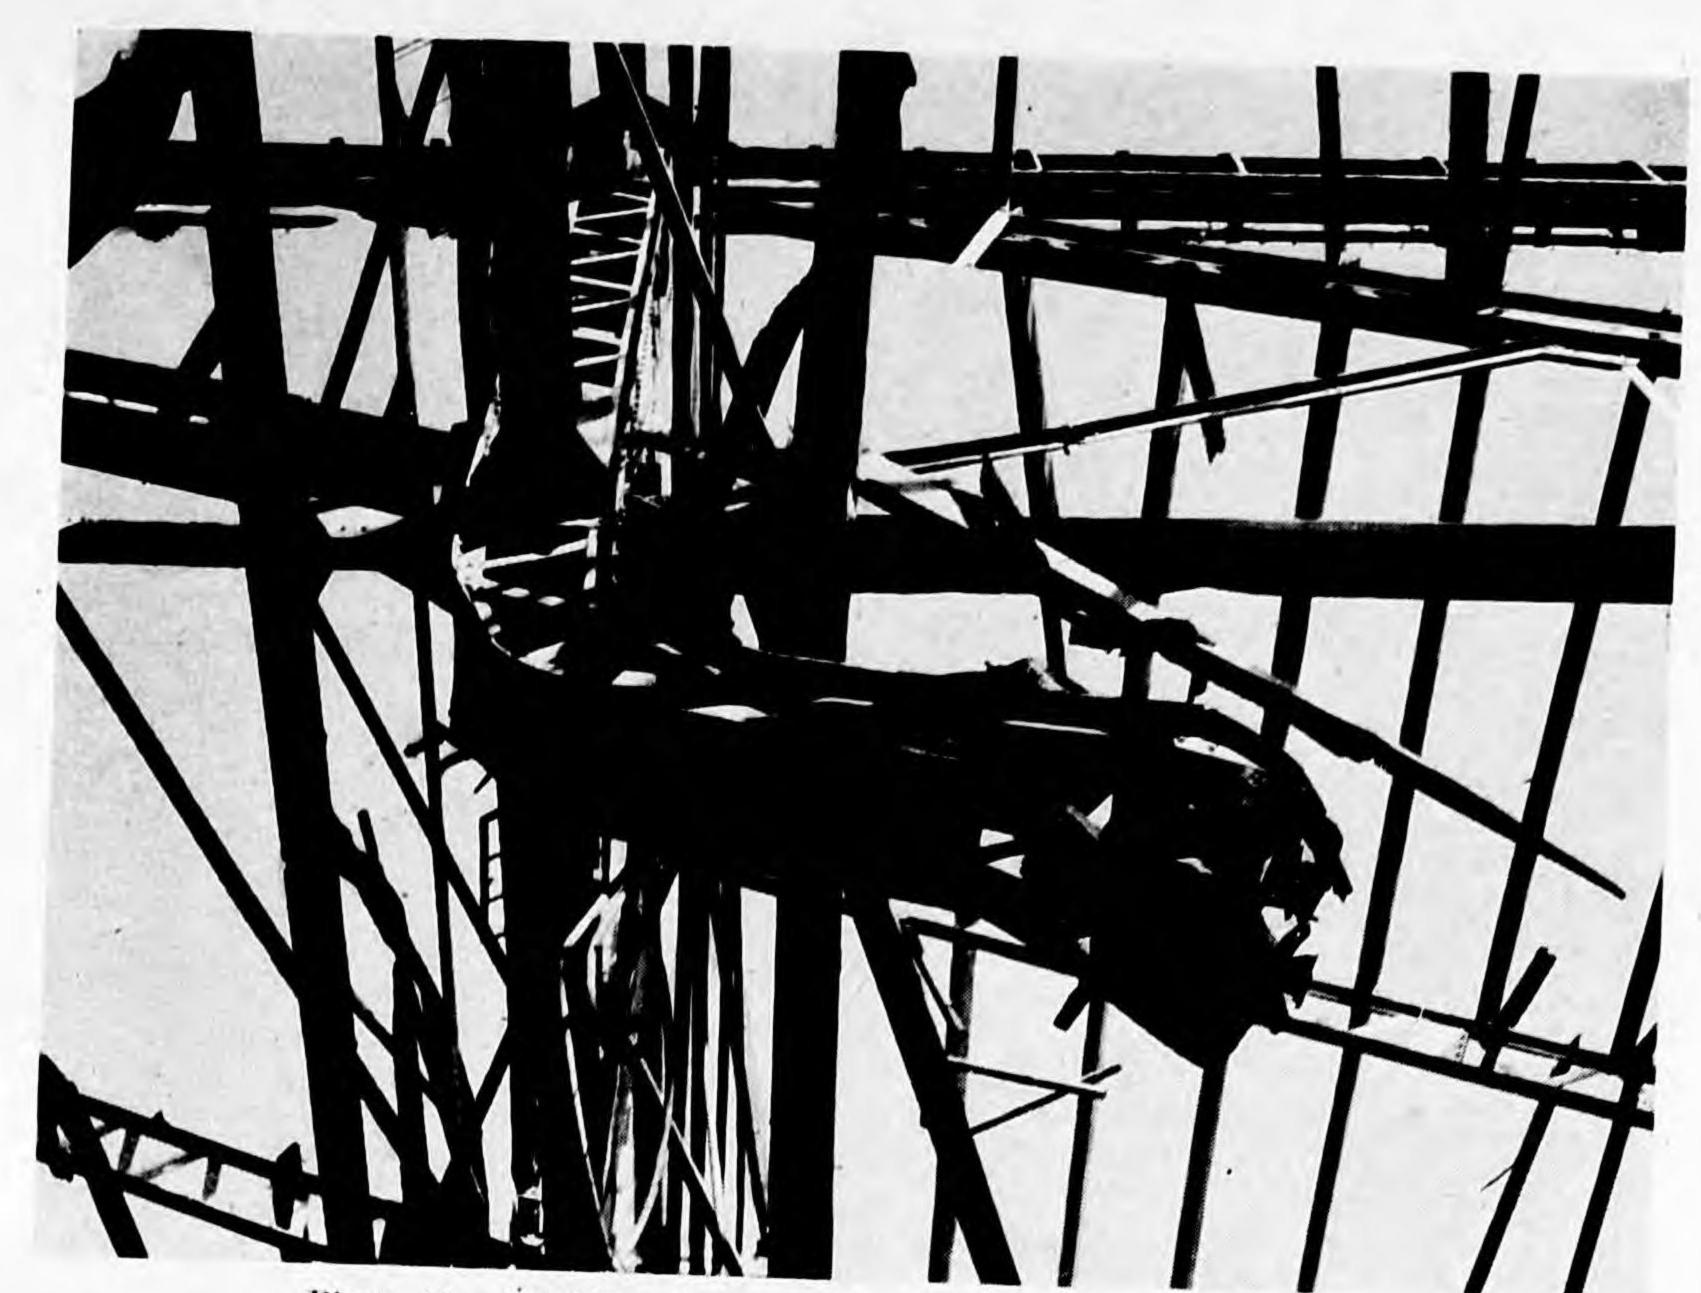
Photo 13.—Building 3, Bomb 17; detail of destroyed column.
