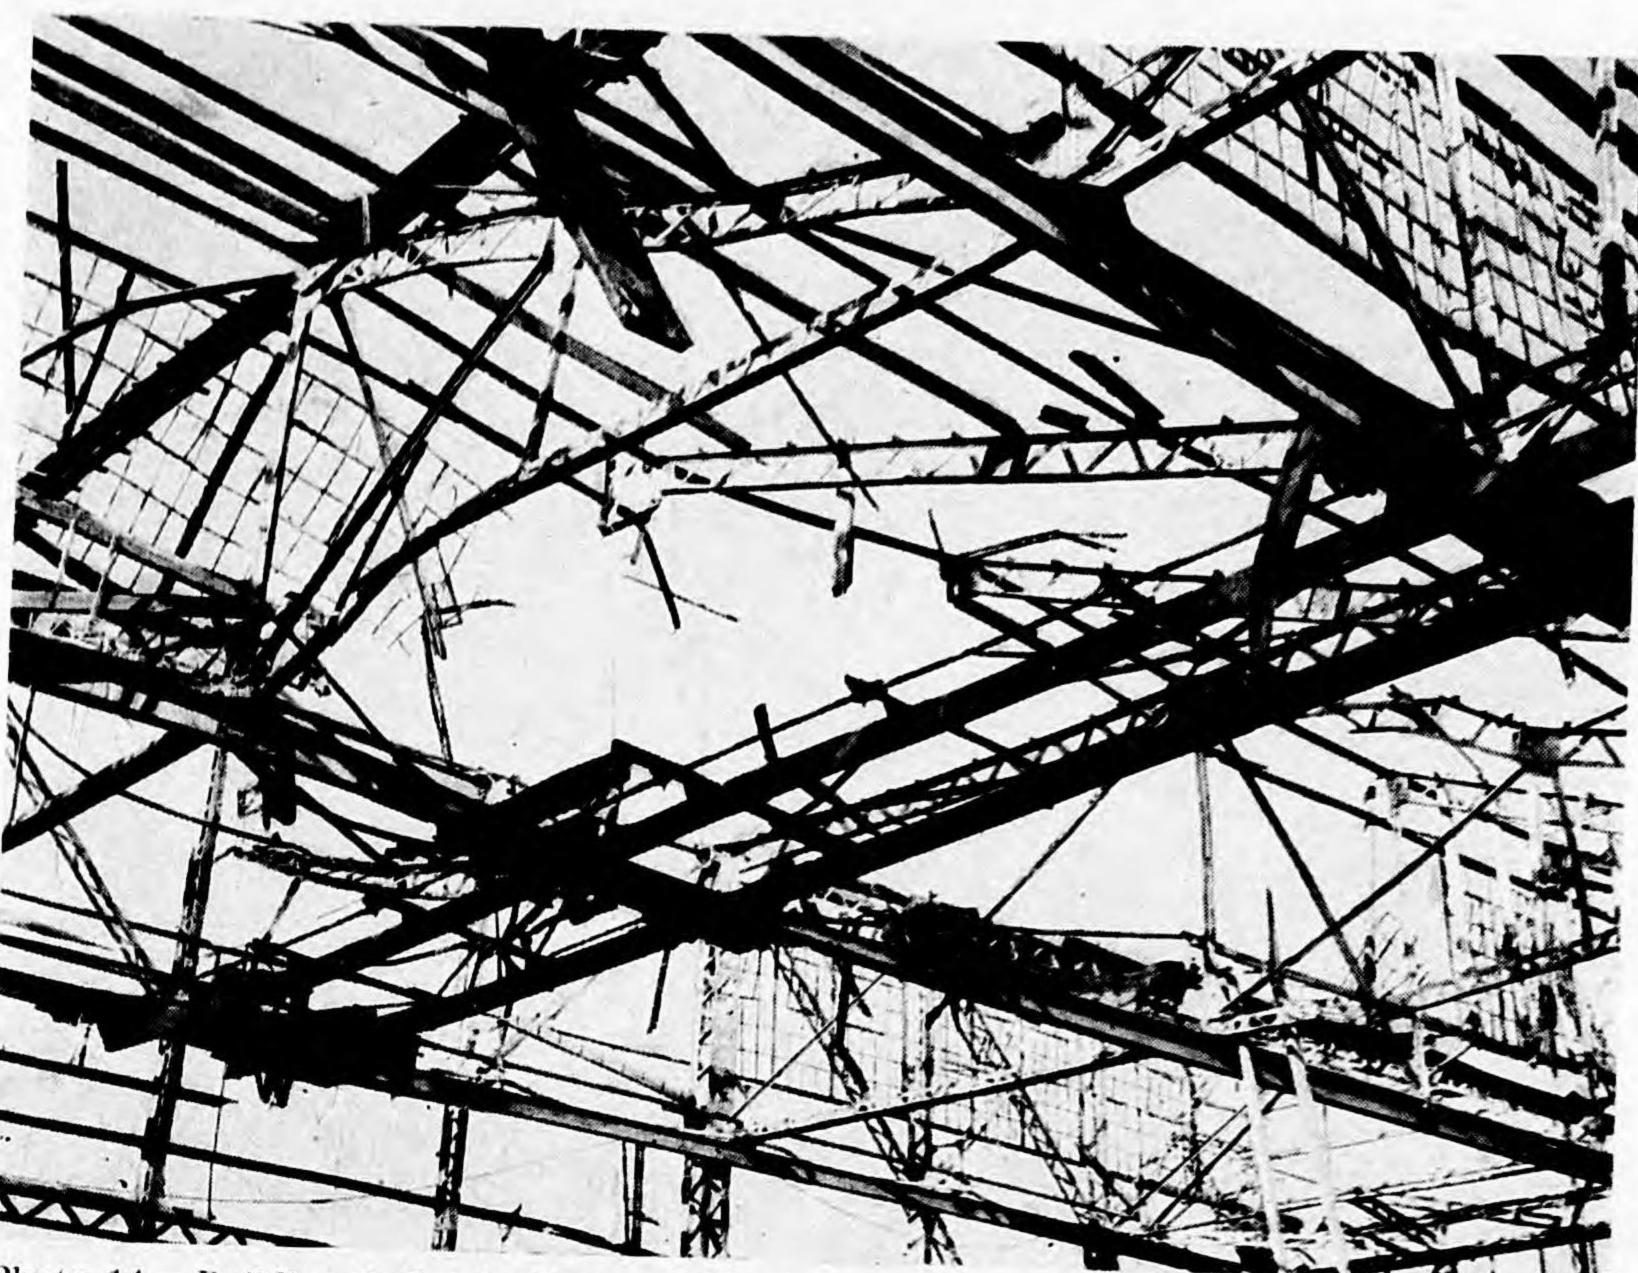
Photo 14.—Building 3, Bomb 22; bomb hit above crane; roof damage; crane knocked down.

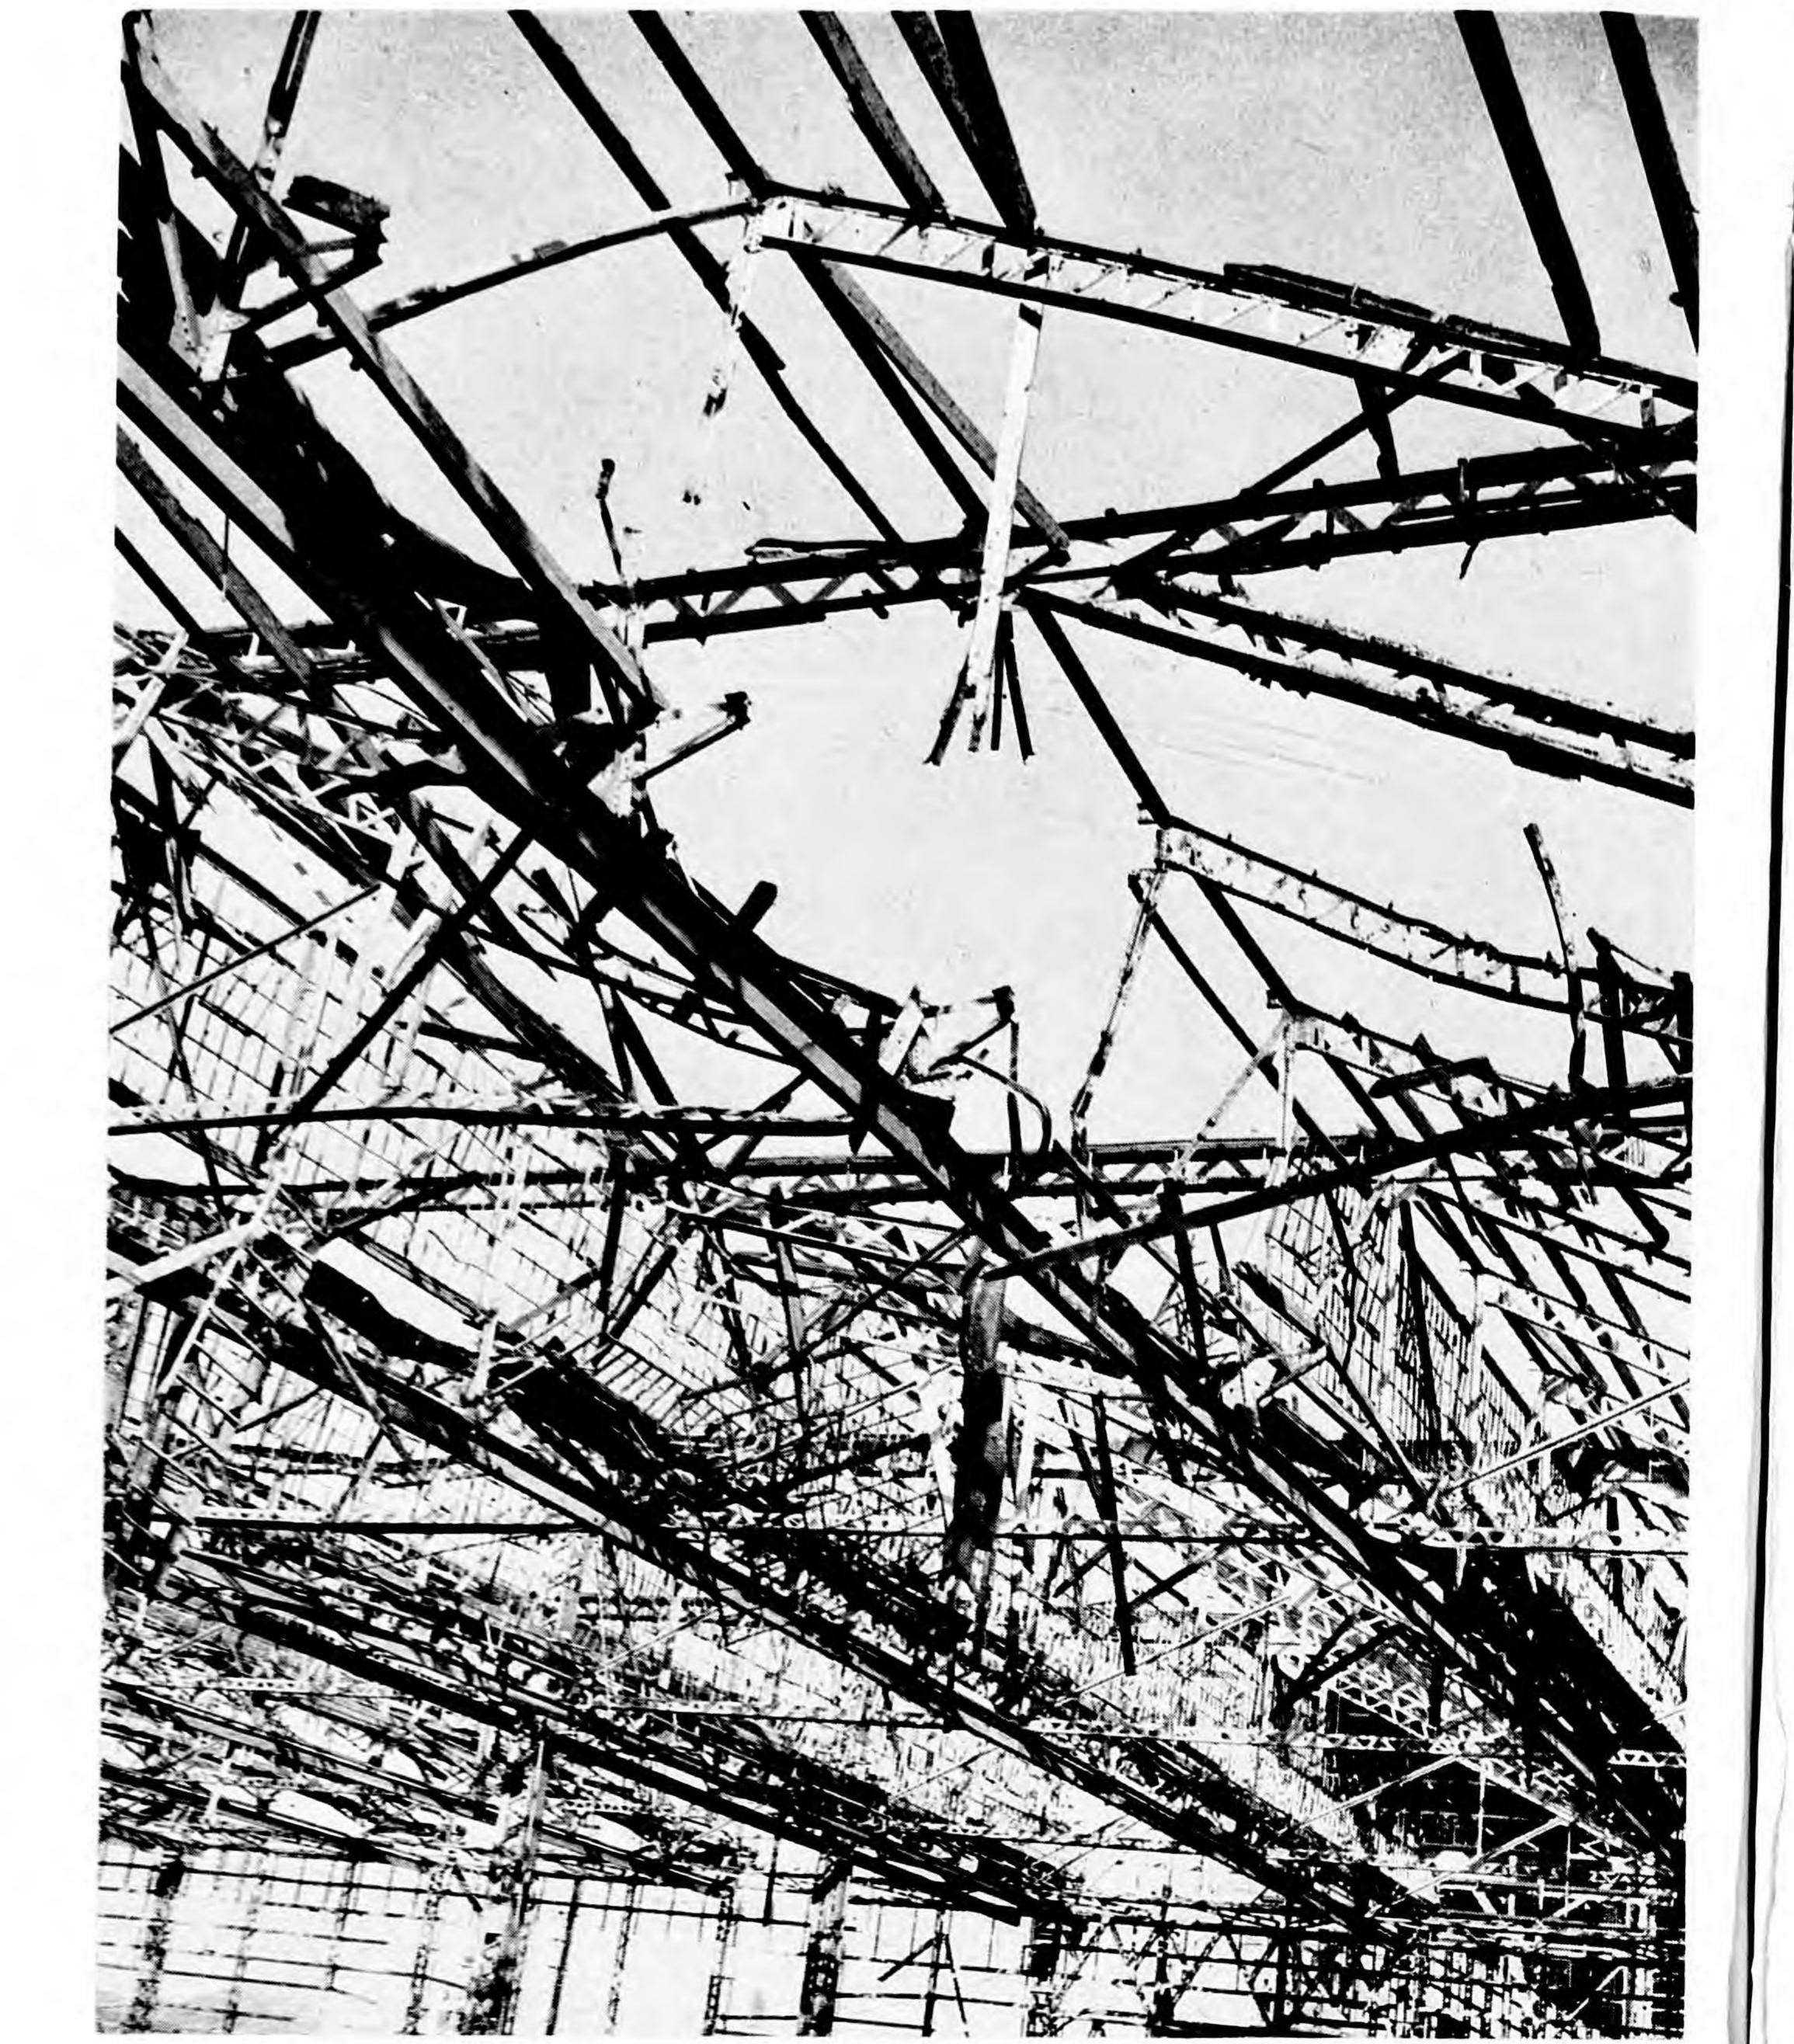
Photo 15.—Building 3, Bomb 28: roof damage; heavy members intact.

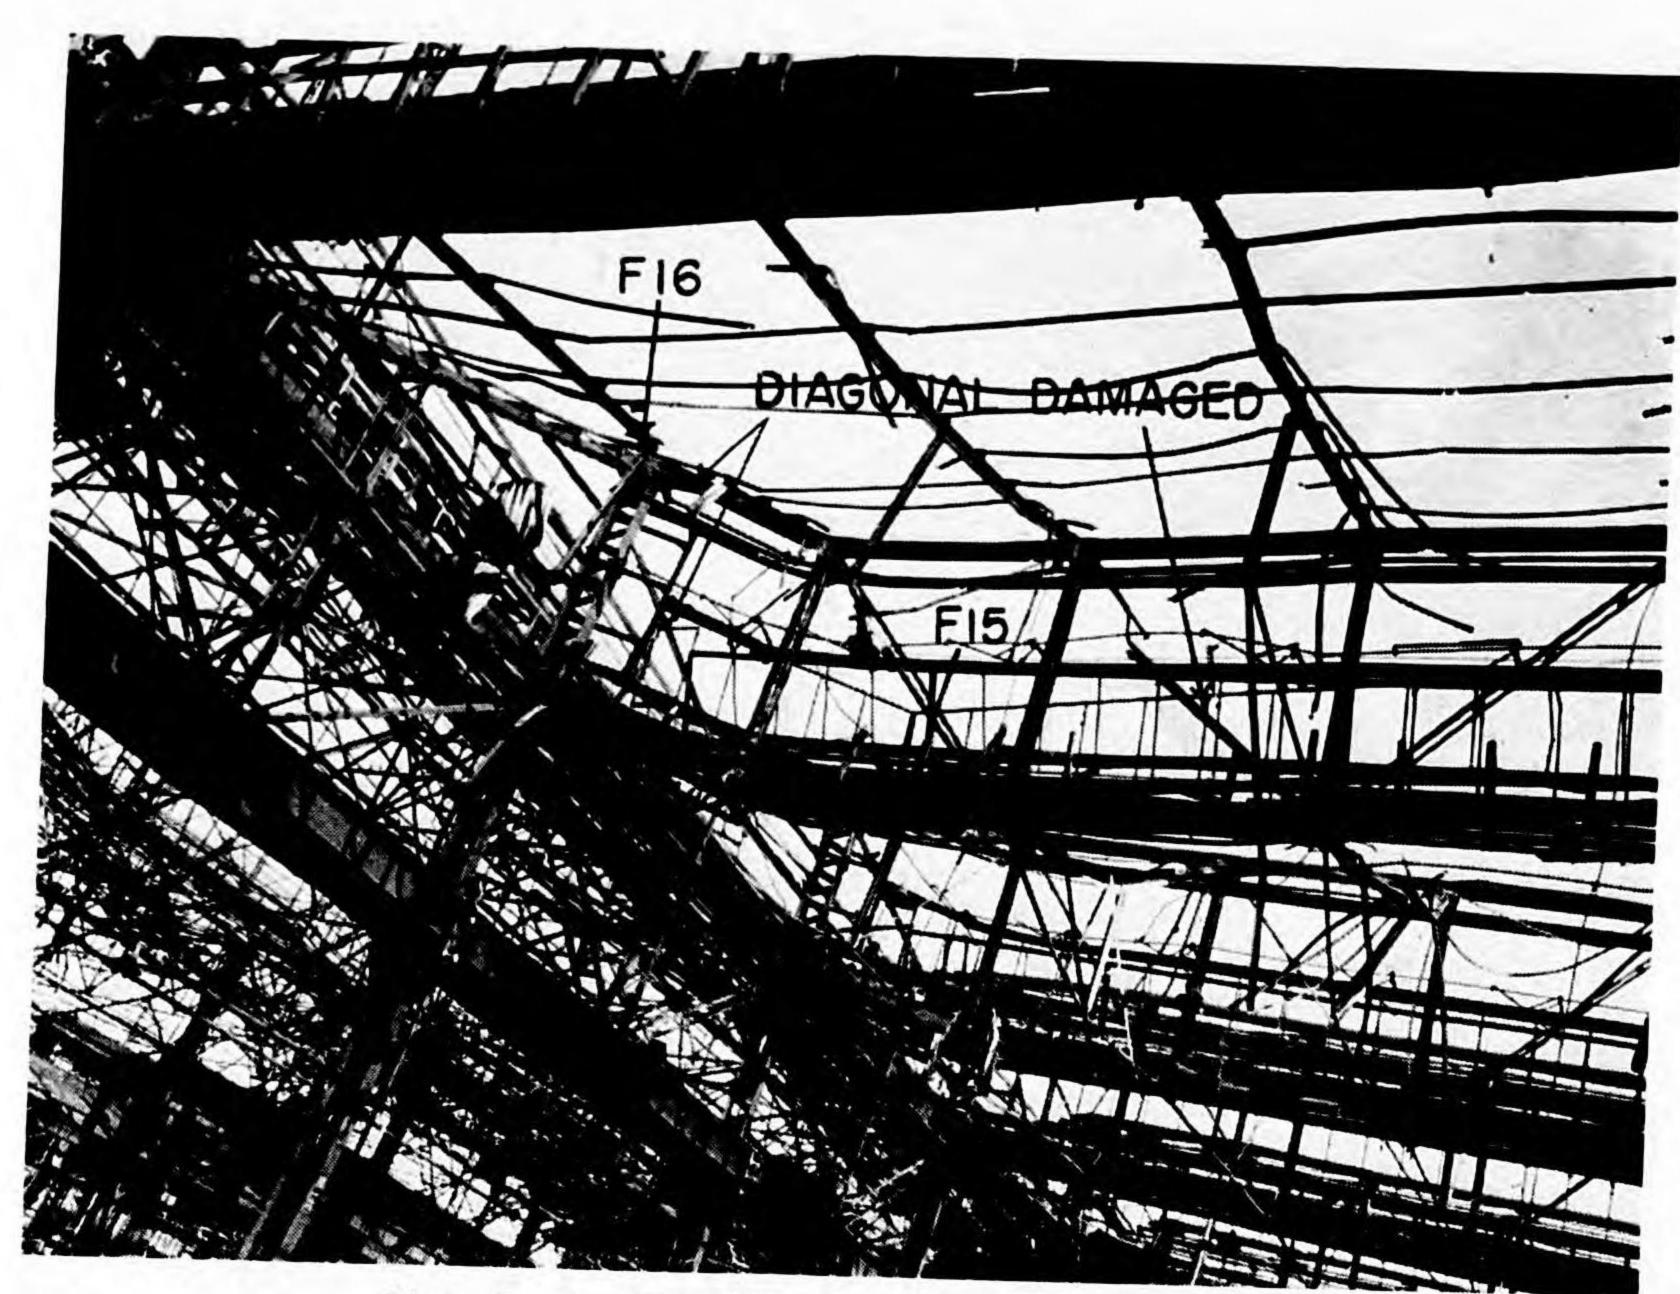
Photo 1.—Building 301a, Bomb 26; damage looking N.

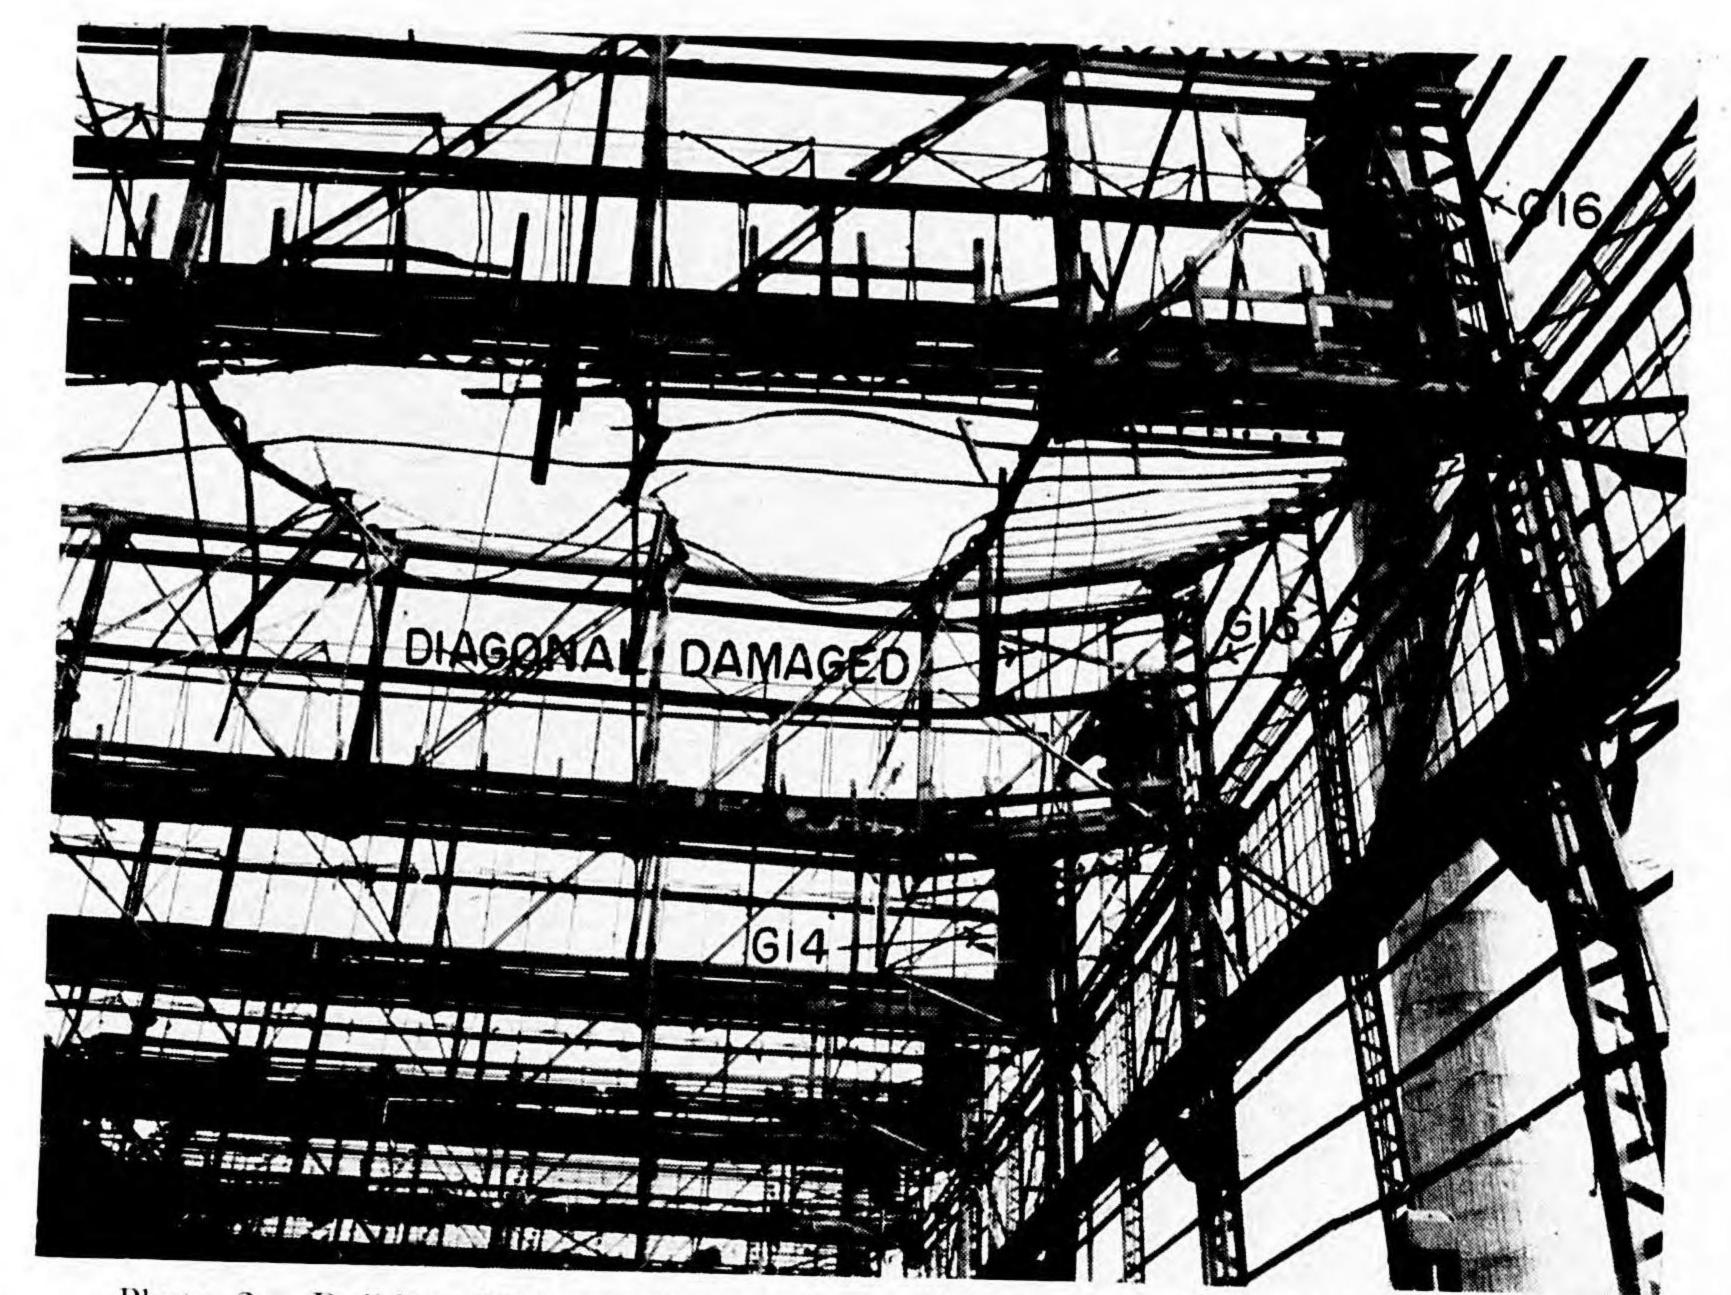
3. One type of damage was noted to saw-tooth roof trusses in buildings 301a and 304 in which the diagonal in the end panels of certain trusses was damaged, thereby causing a perceptible sagging of the truss between columns. This was responsible · for a considerable area of structural roof damage as in most cases the trusses would have to be taken down for repairs. The end members were two light angles tied with batten plates (exhibit A) and where one angle was damaged by fragmentation the inclined member was seriously weakened. Photos 1 and 2 indicate failures of the member in building 301a. Photos 5, 6, and 20 show similar failures of the member in building 304.

Photo 2.—Building 301a, sagging of truss connecting to Column (G15) looking NE.

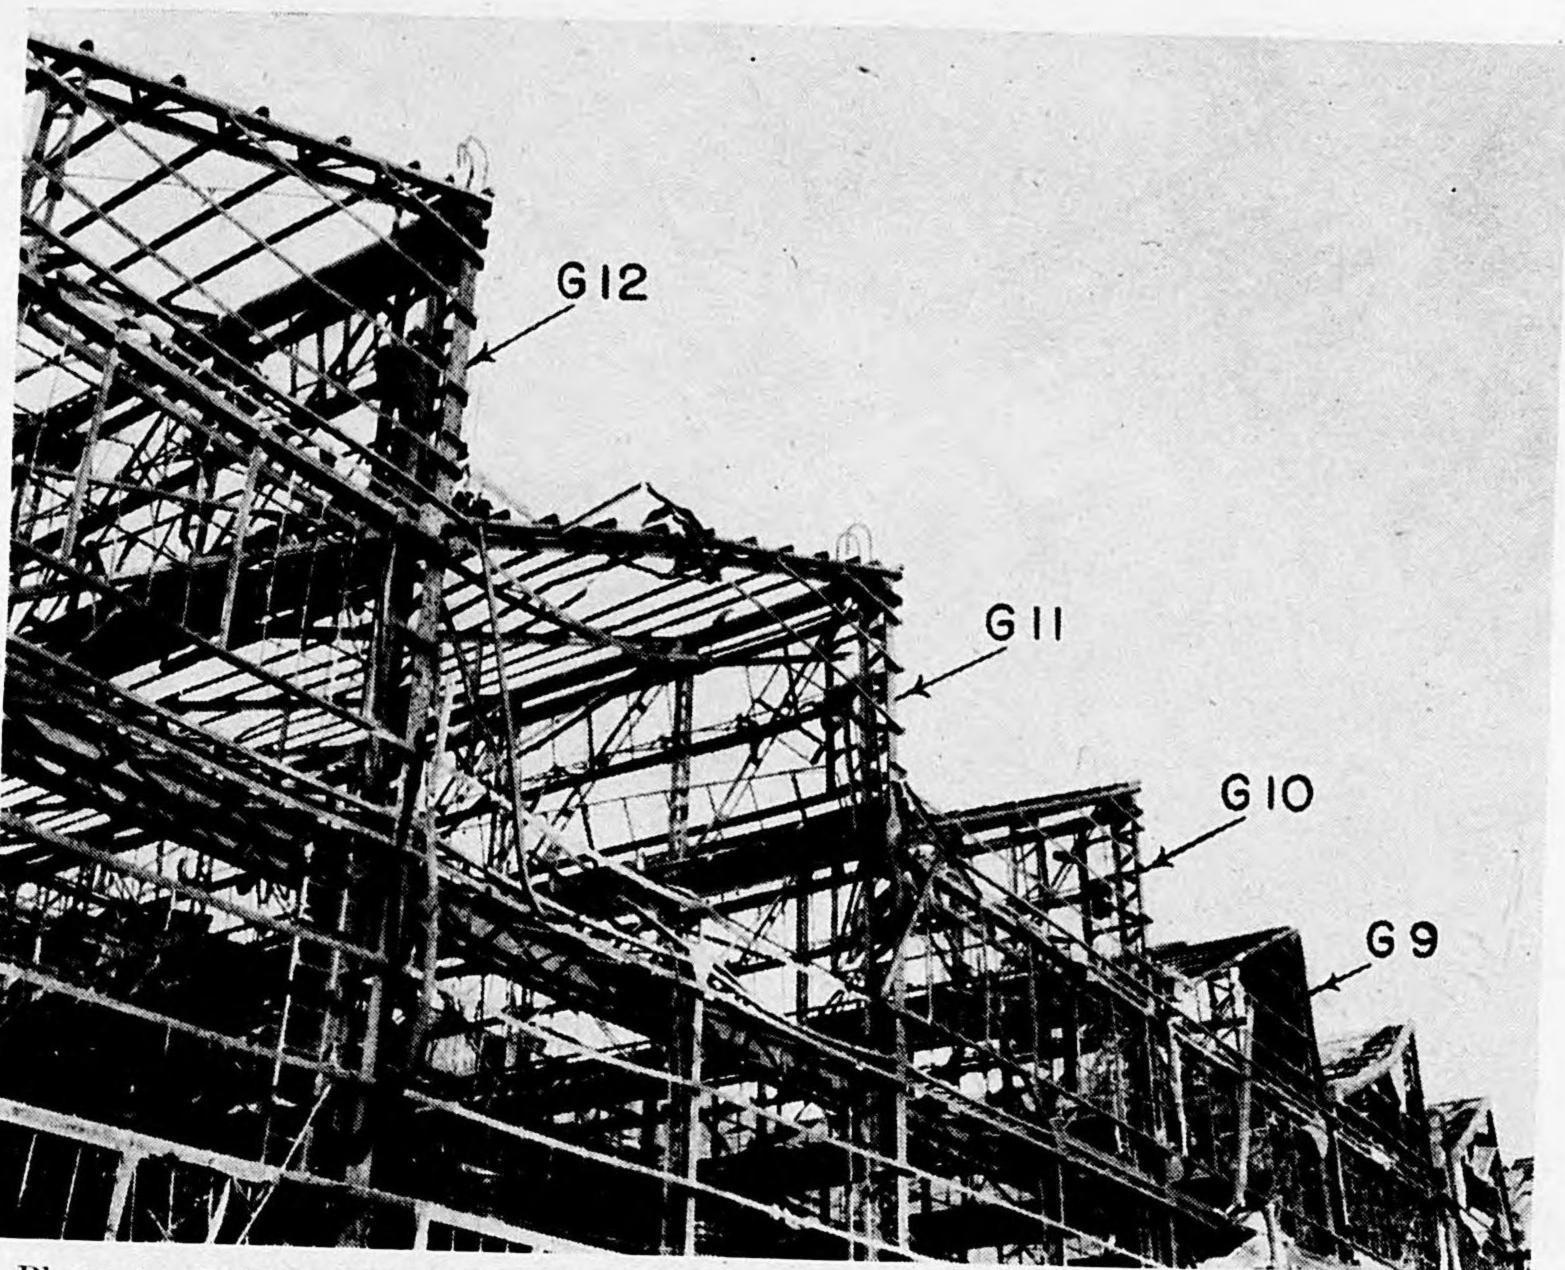
Photo 4.—Building 301a, Bomb 30; damage between Columns G12 and G11 looking NE.

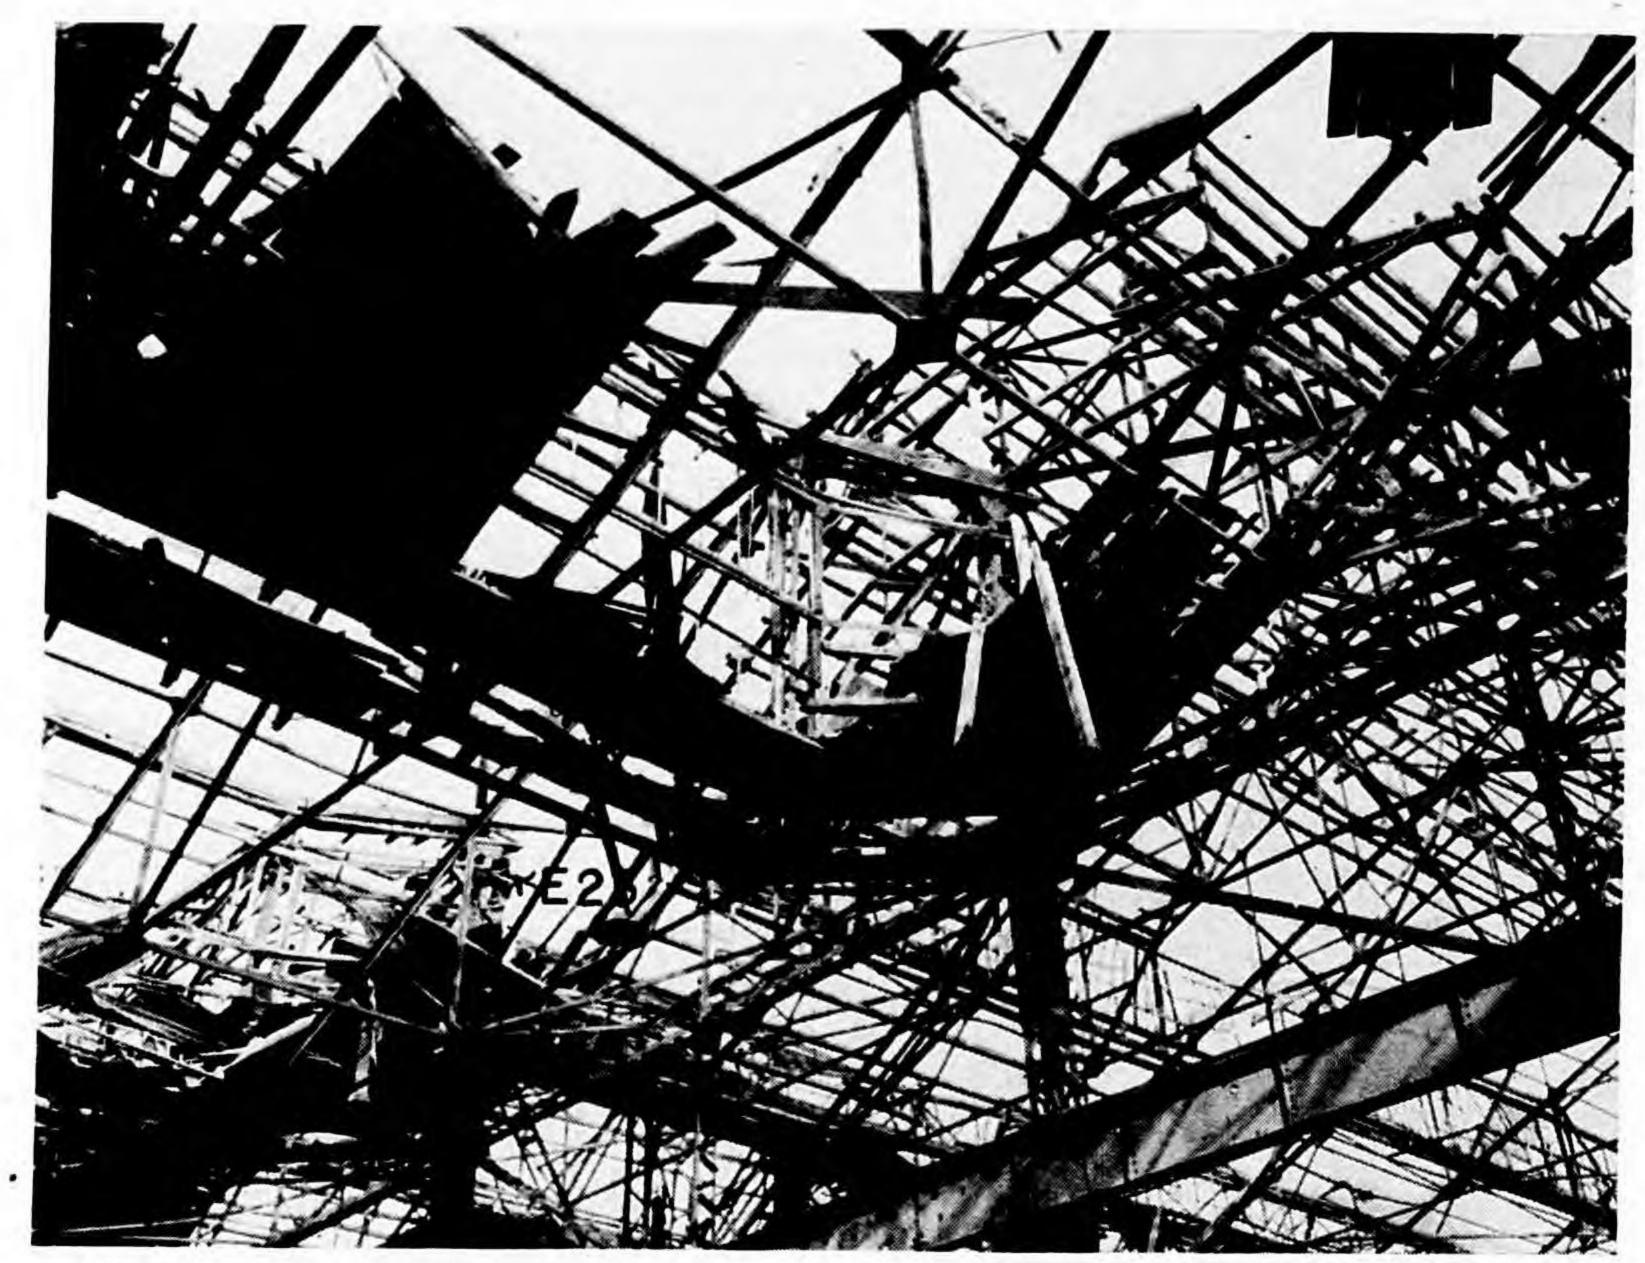
Photo 5.—Building 304; damage to truss connecting to Column E23 looking NNW.

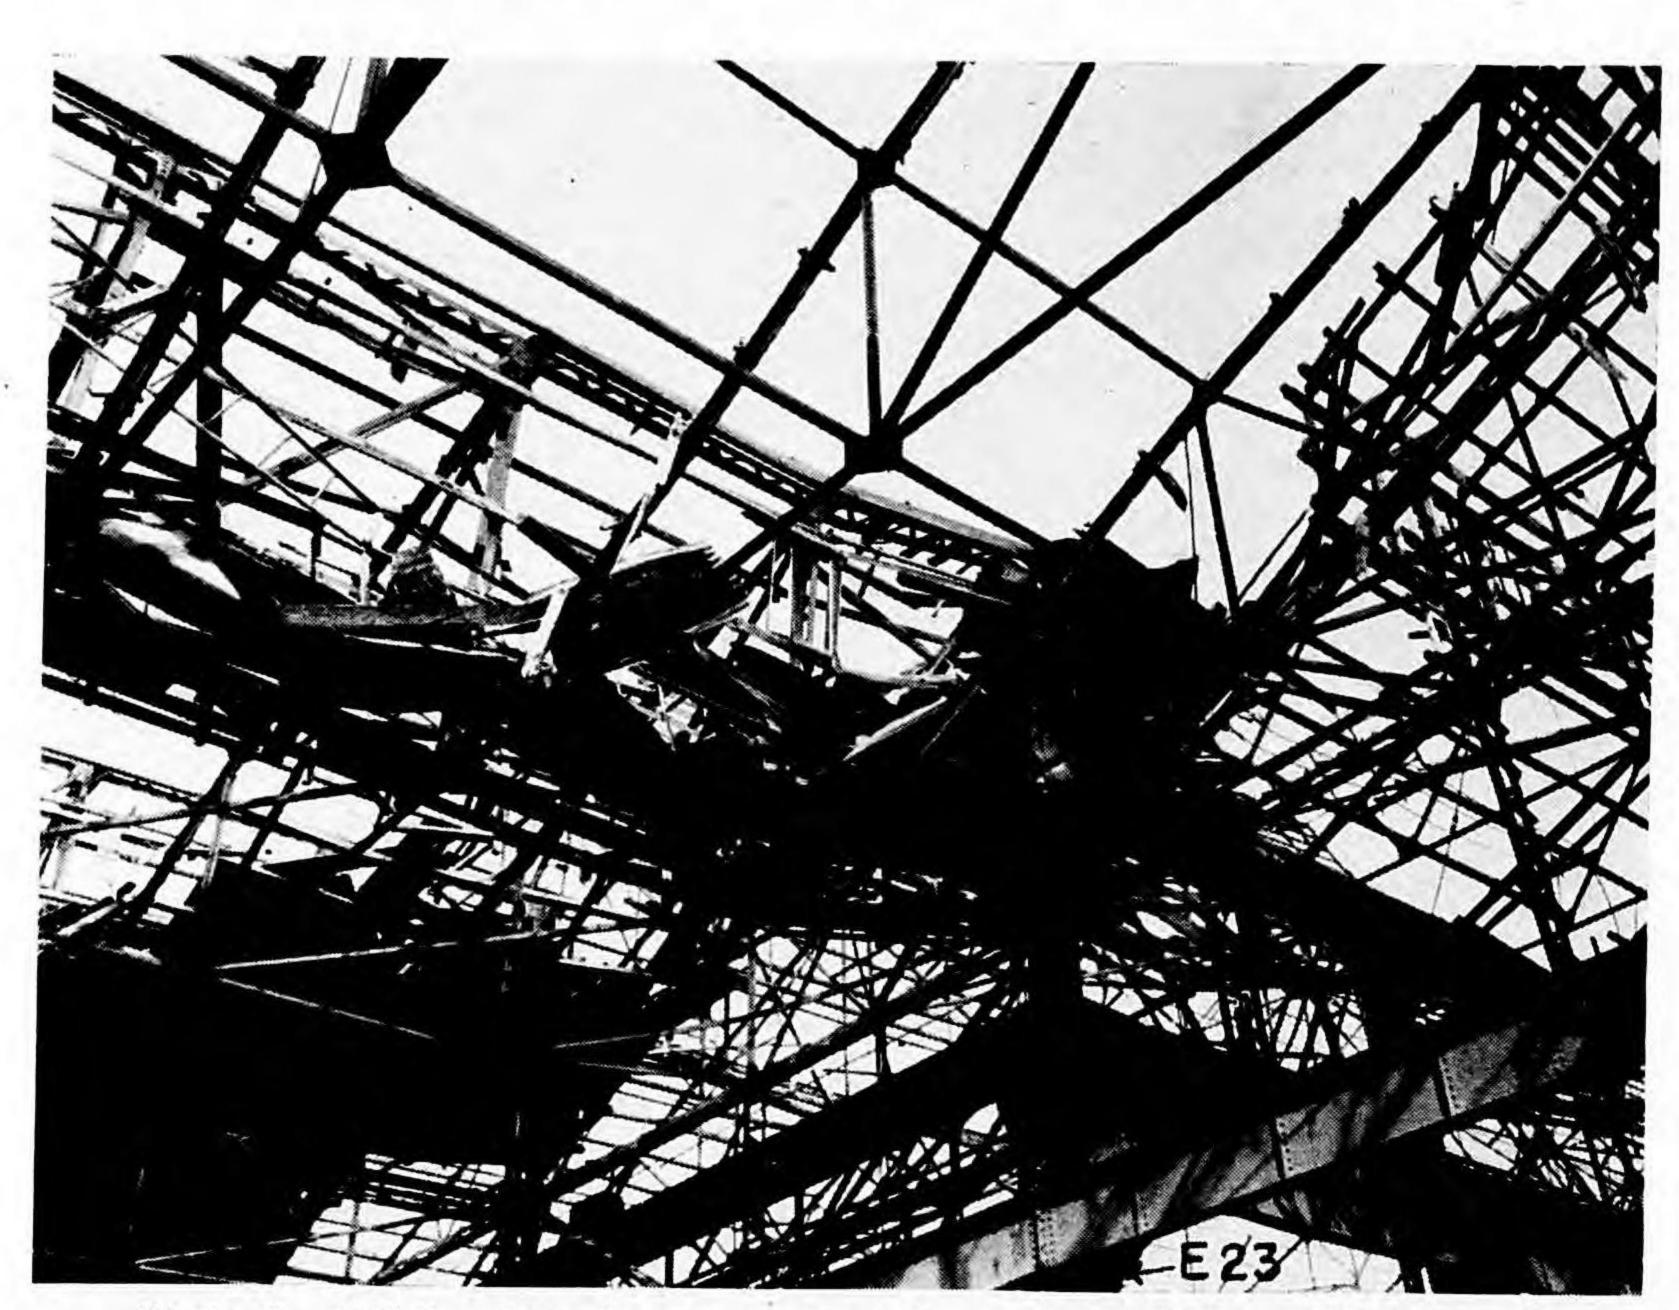
Photo 6.—Building 304; damage to truss Connecting to Column E23 looking N.

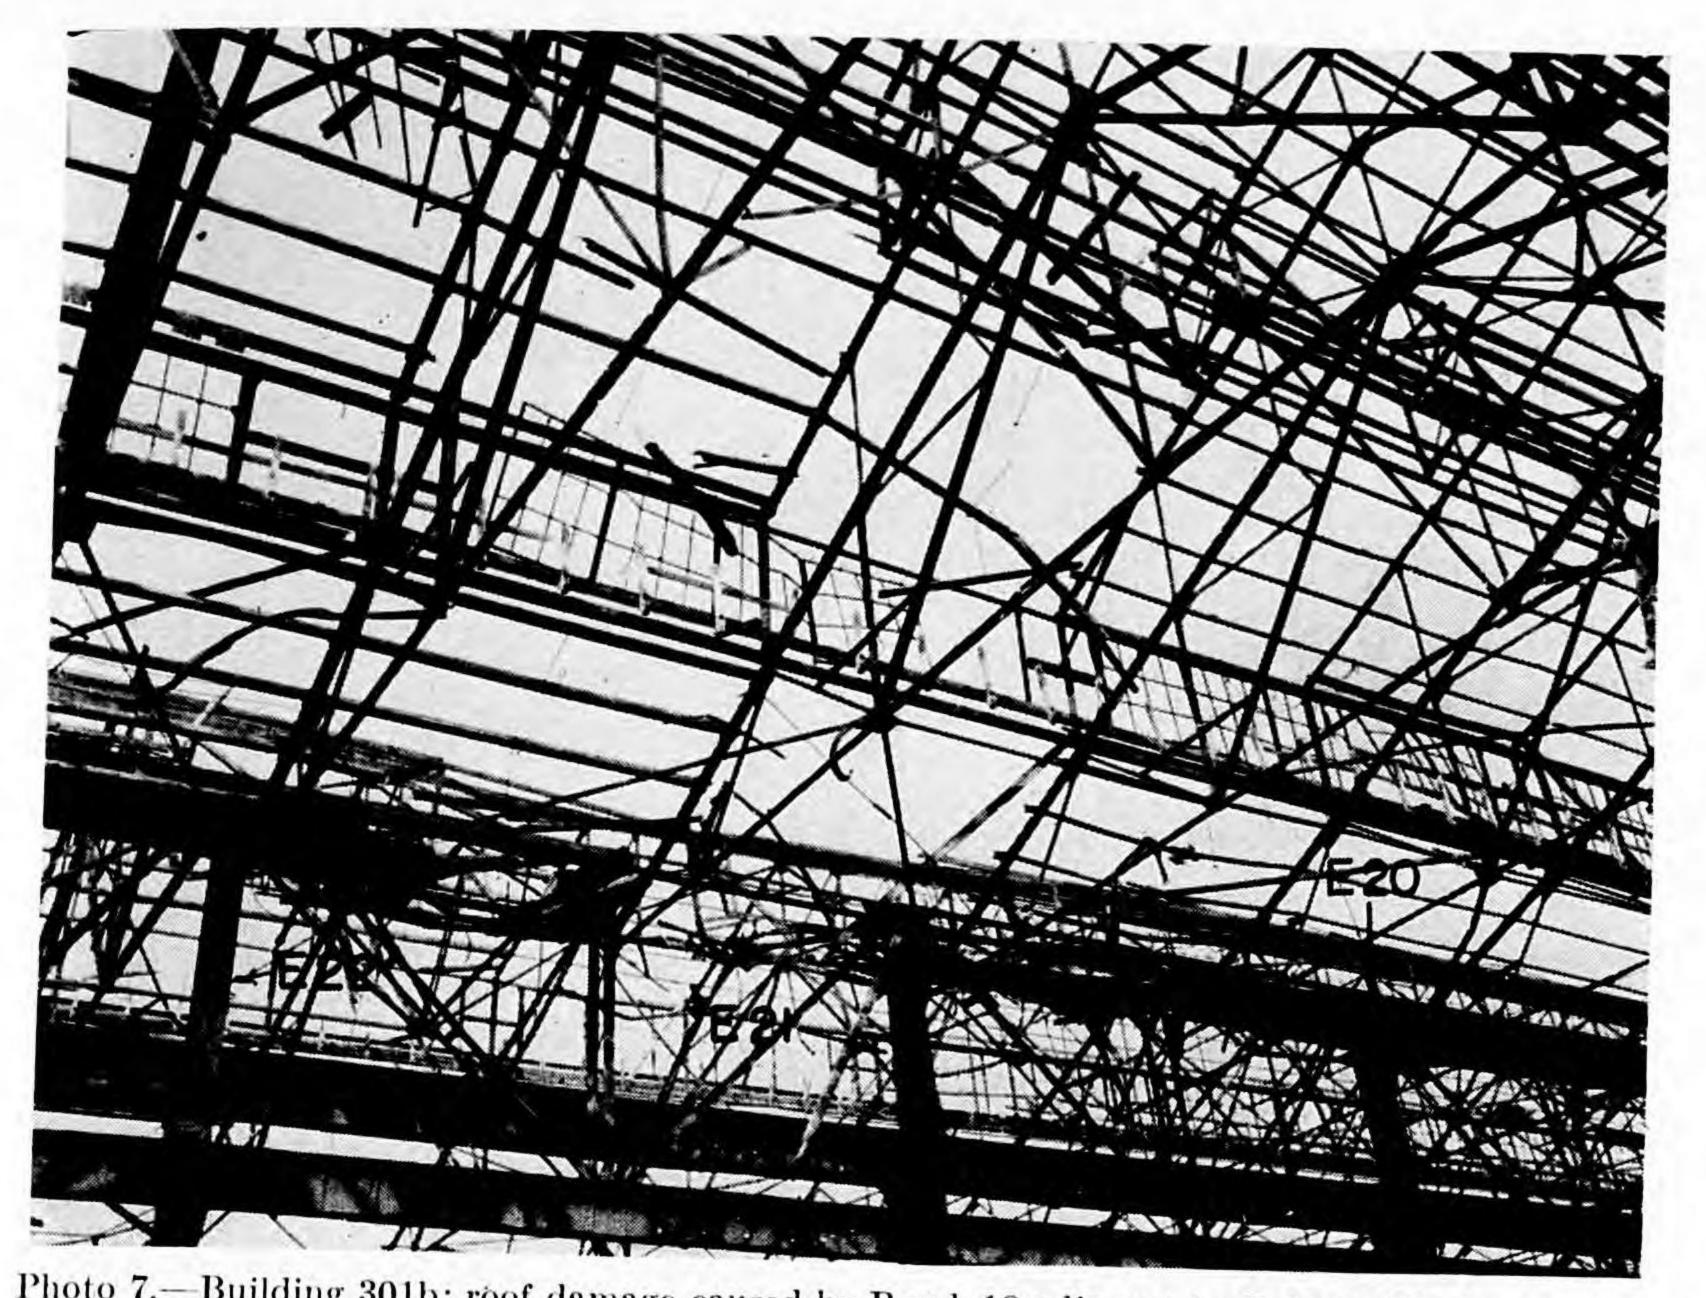
Photo 7.—Building 301b; roof damage caused by Bomb 18 adjacent to Column E21 looking N.

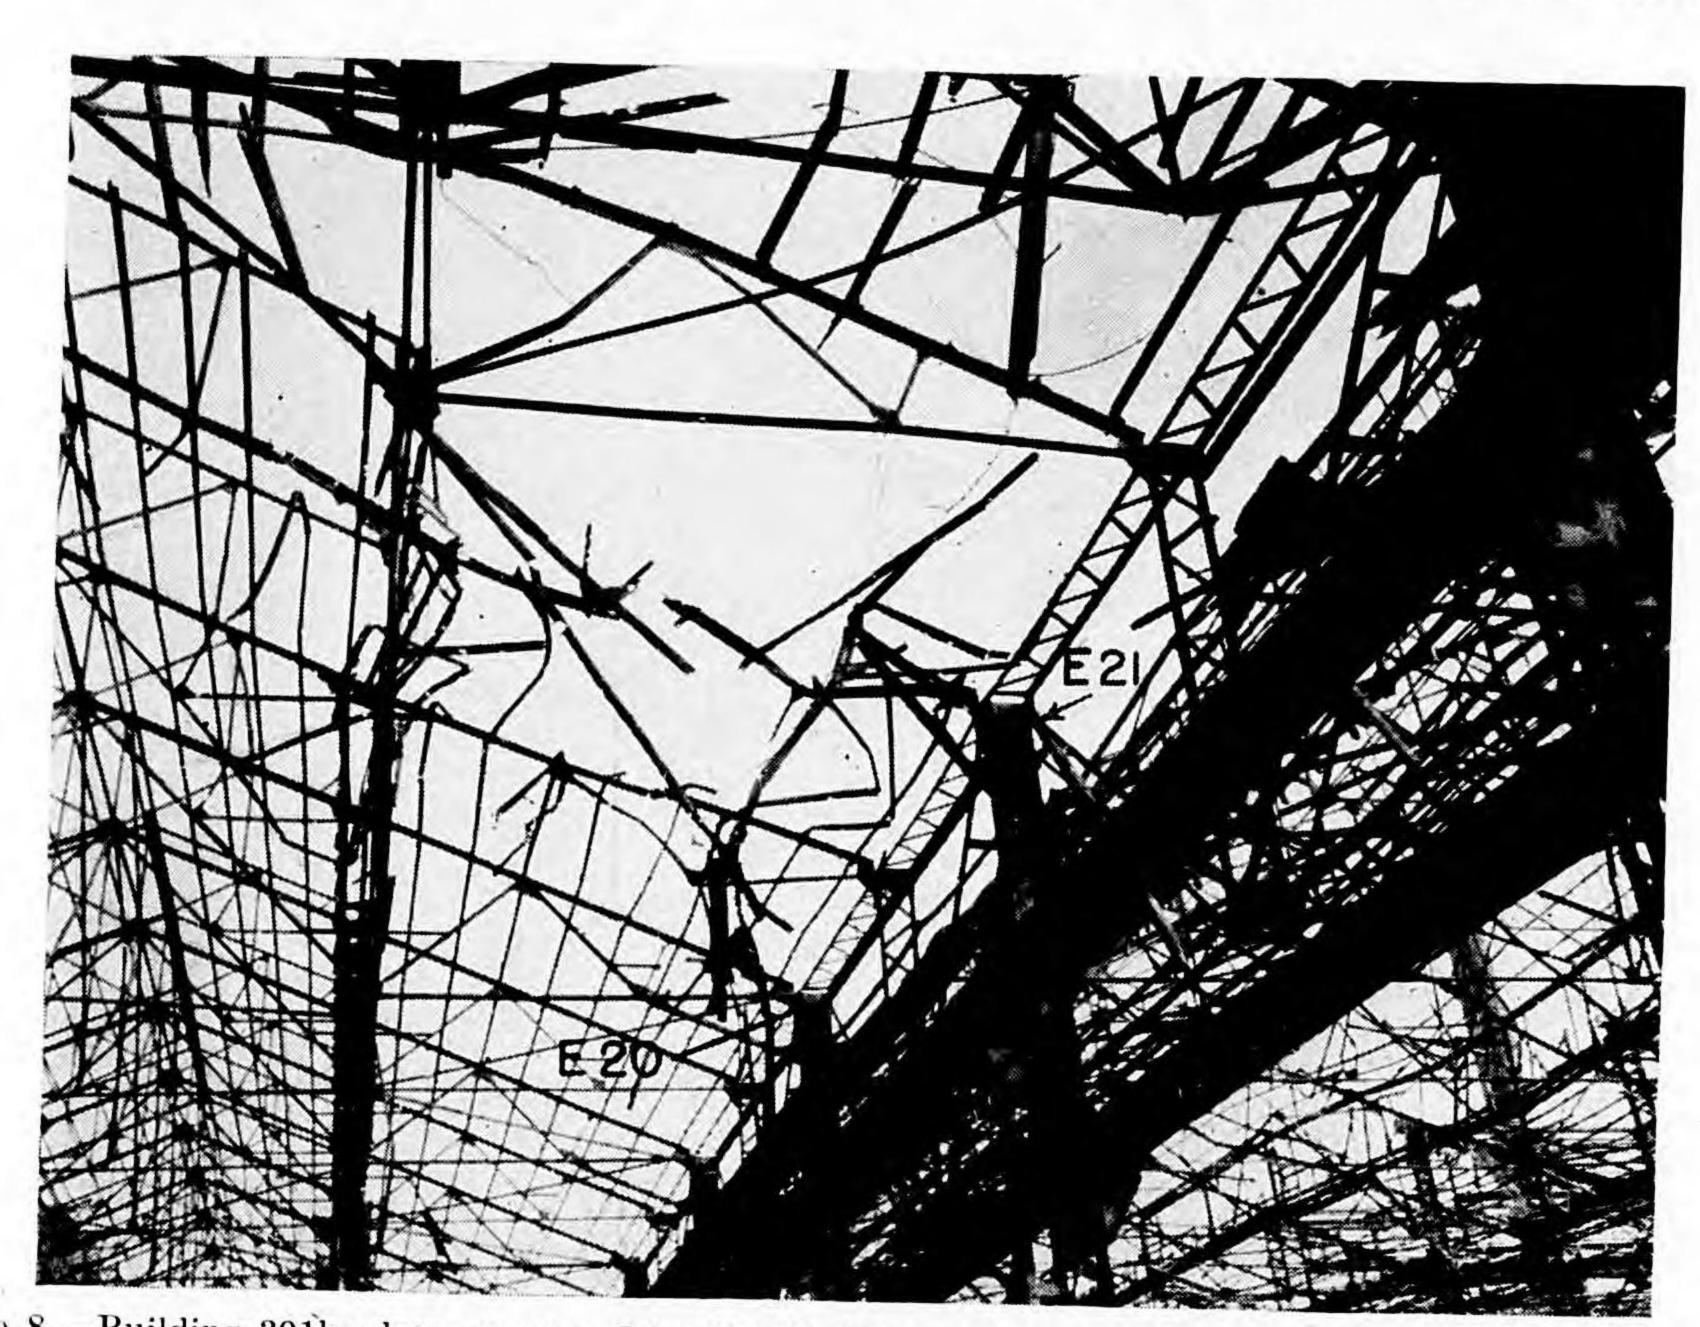
Photo 8.—Building 301b; damage caused by Bomb 19 to roof trusses adjacent to Column E21 looking NE.

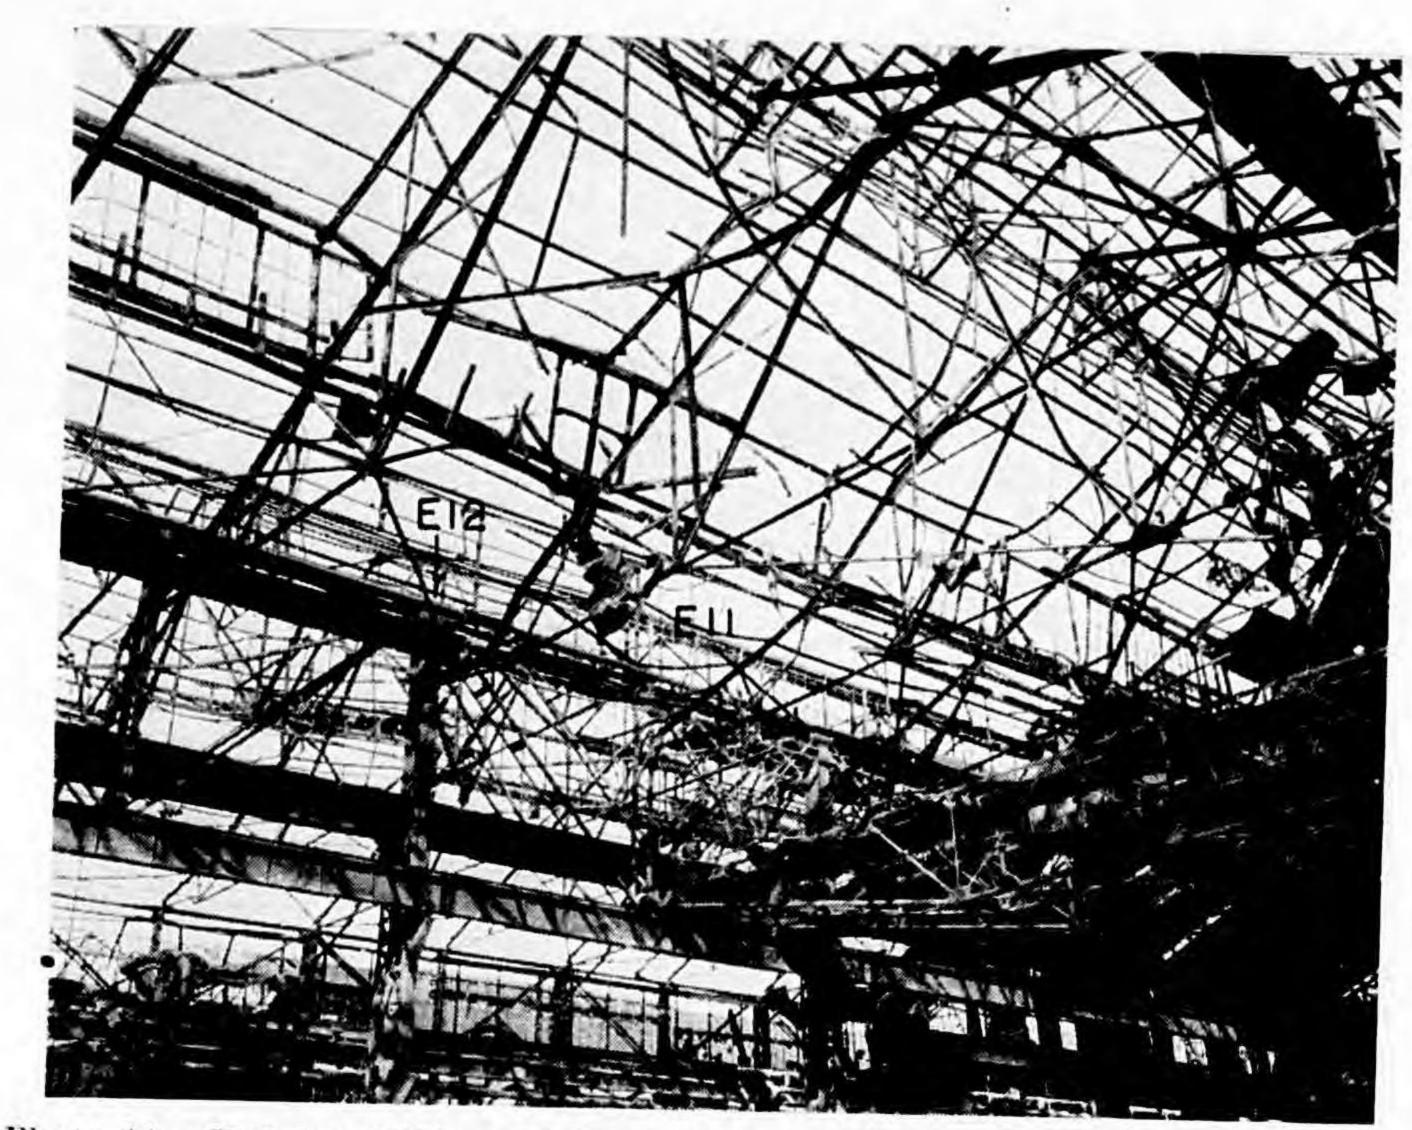
Photo 11.—Building 301b; roof damage between Columns E12 and E11 looking N.
