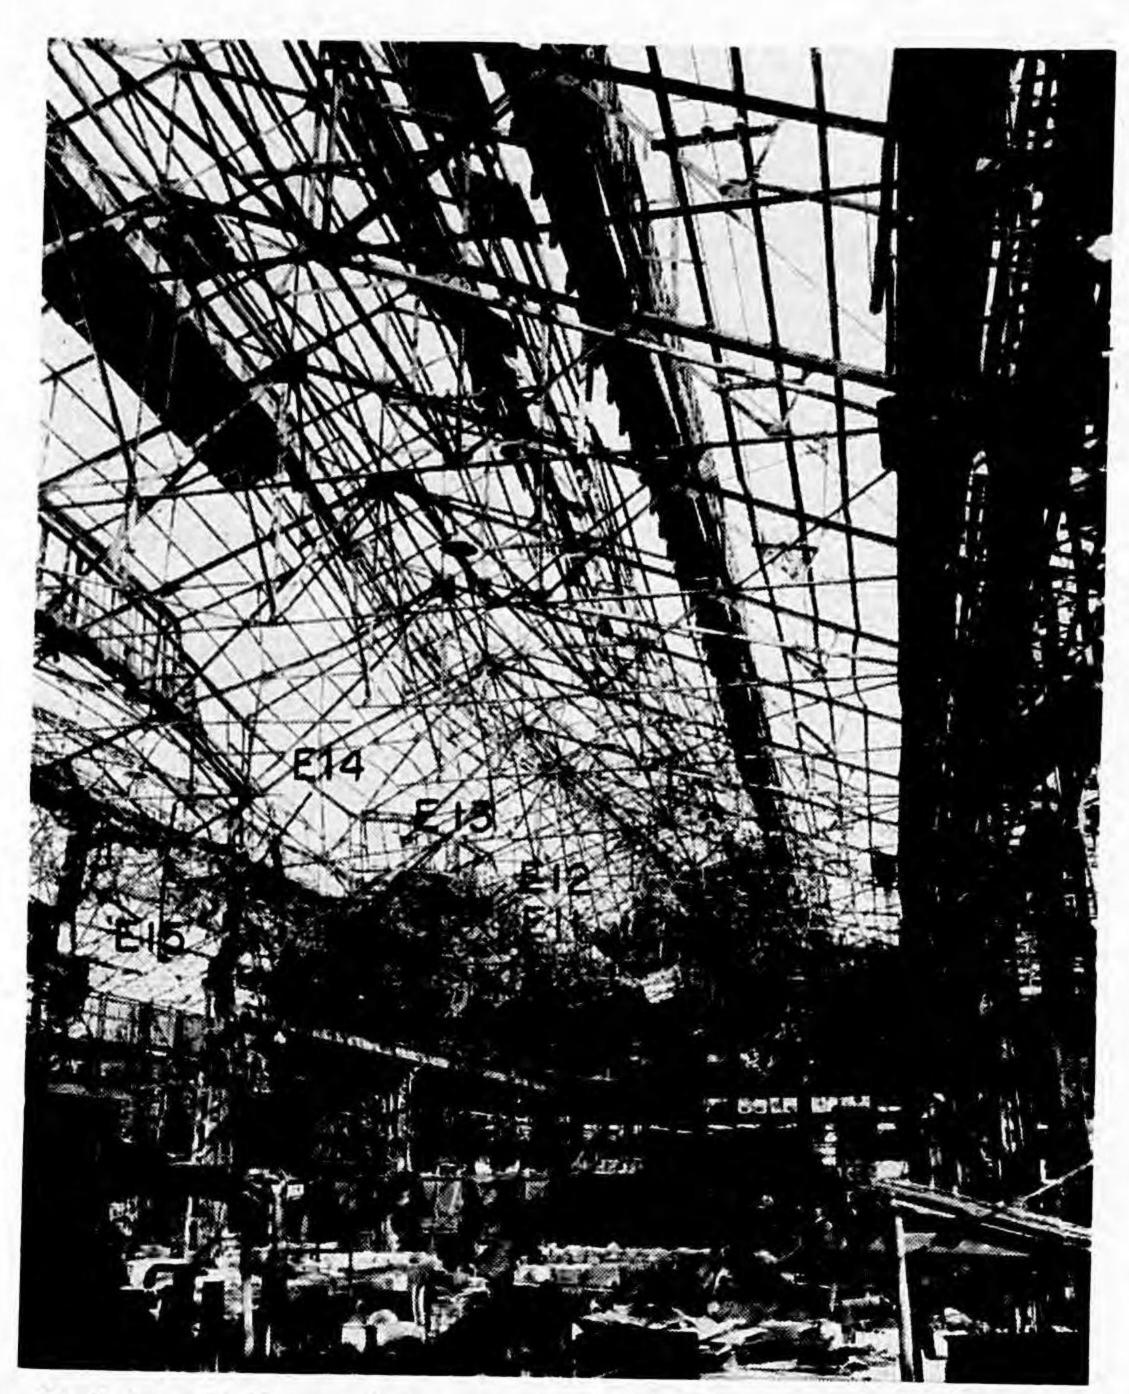
Photo 12.—Building 301b; roof damage between Columns E15 and E16 looking NE.

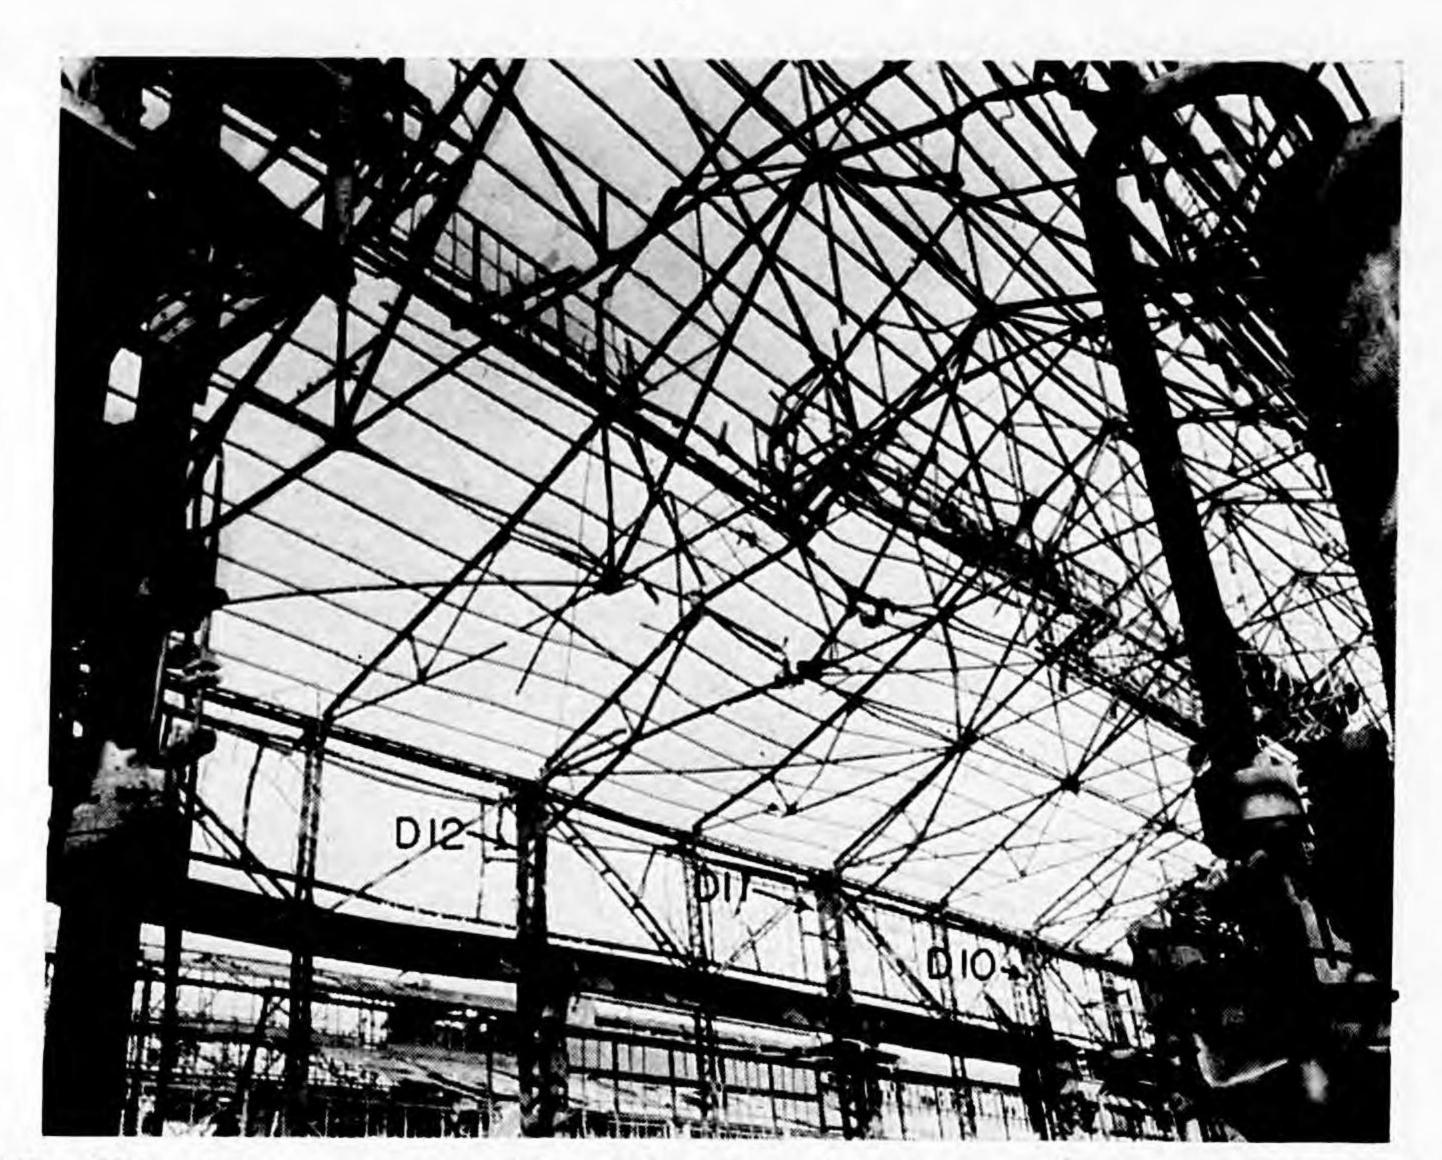
Photo 13.—Building 301b; damage to crane girder and roof members between Columns D13 and D11 looking NNW.

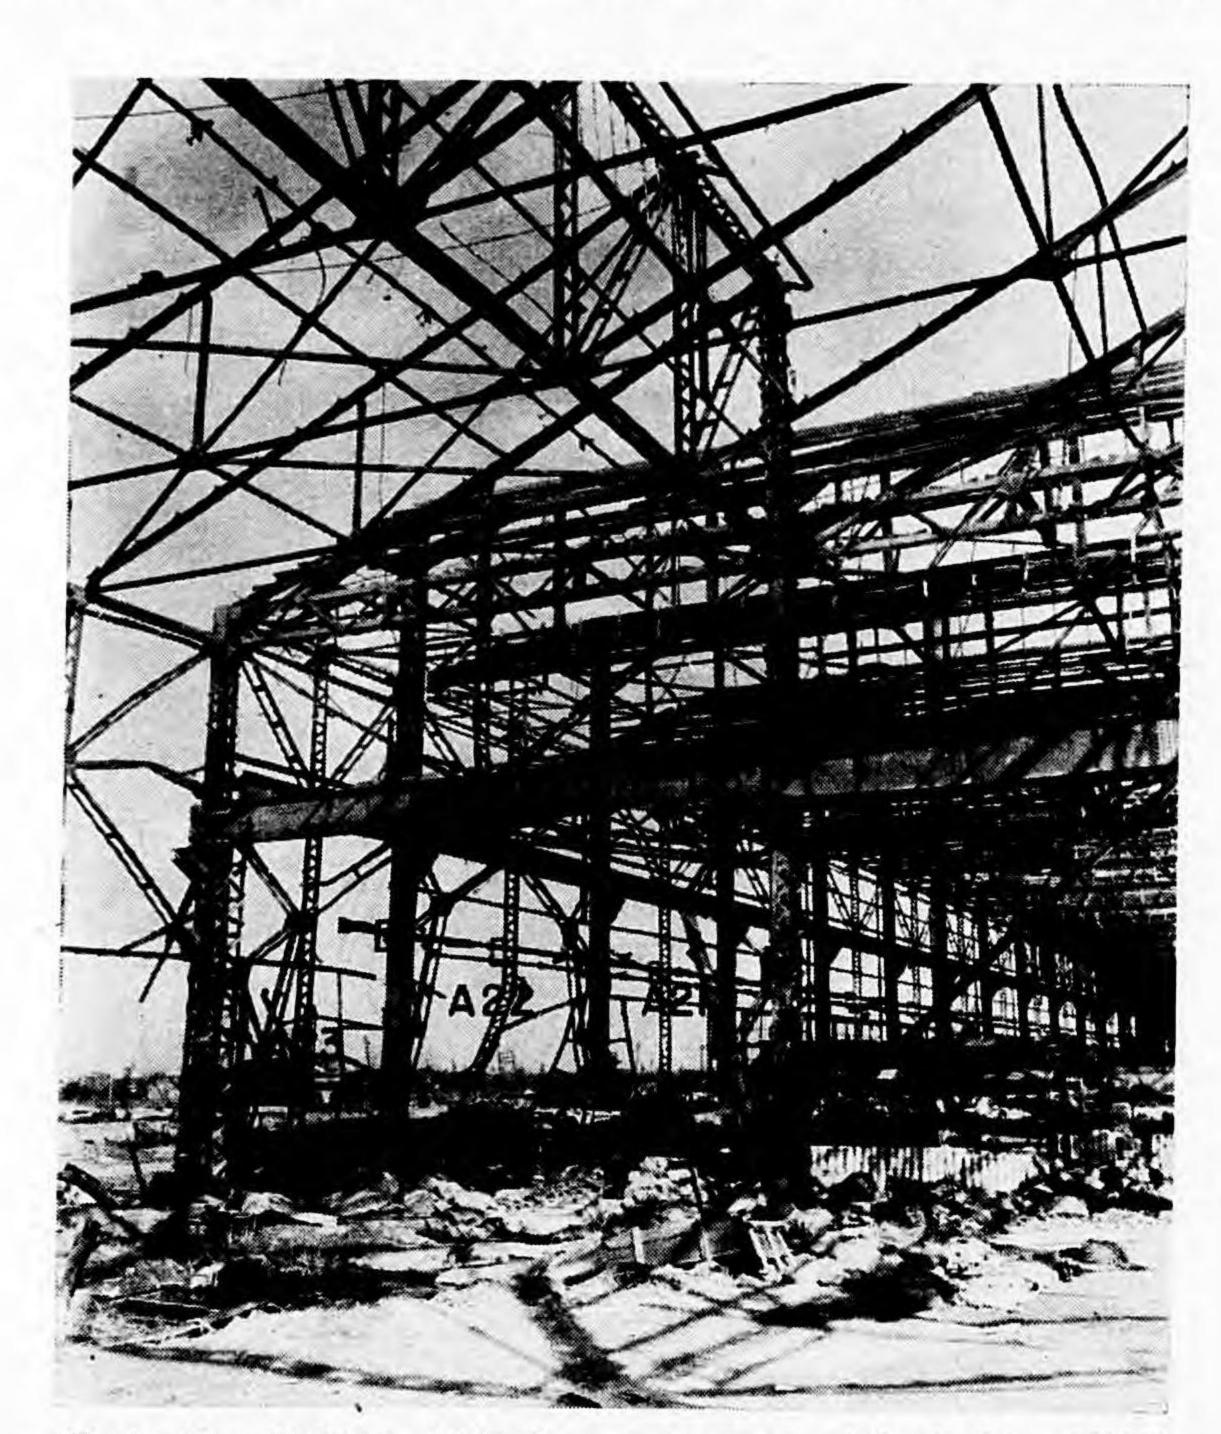
Photo 14.—Building 304; damage to crane girder looking NNE.

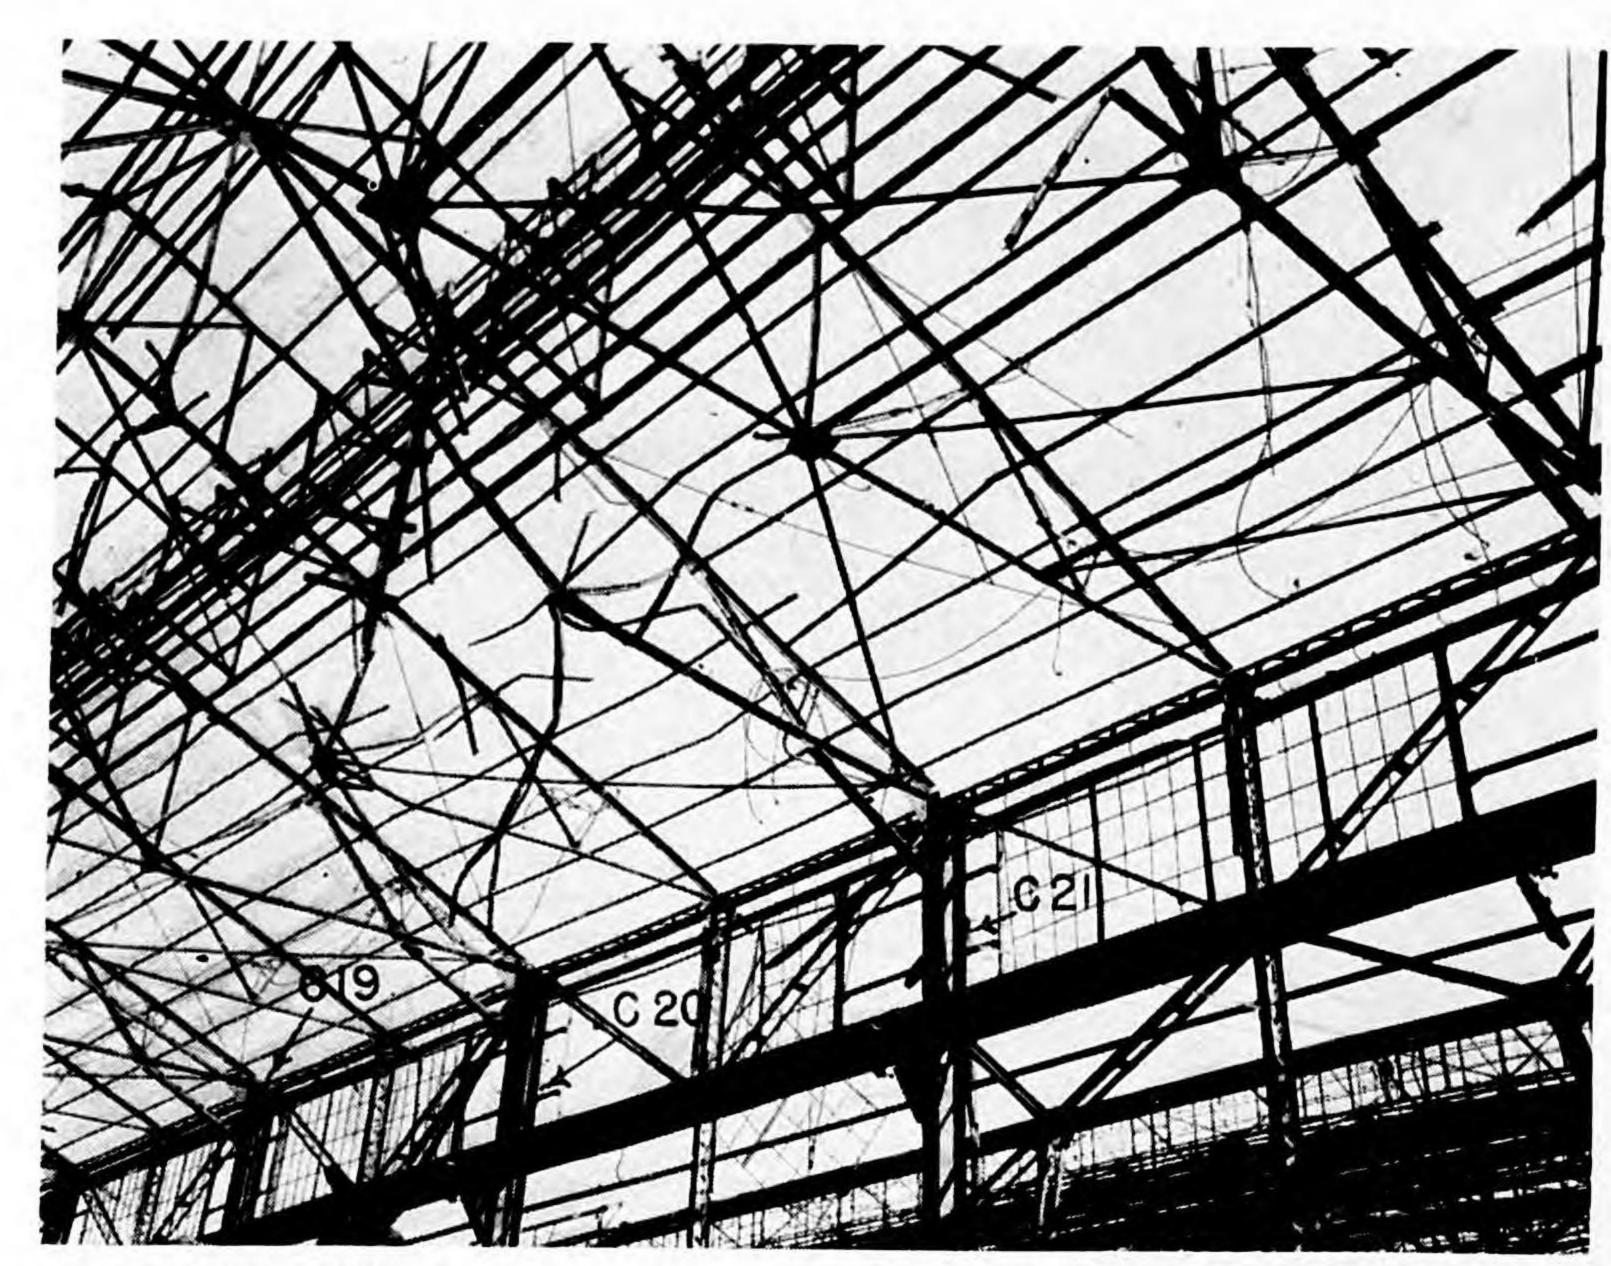
Photo 17.—Building 302a; damage to roof trusses adjacent to Columns C21 and C20 looking ENE.

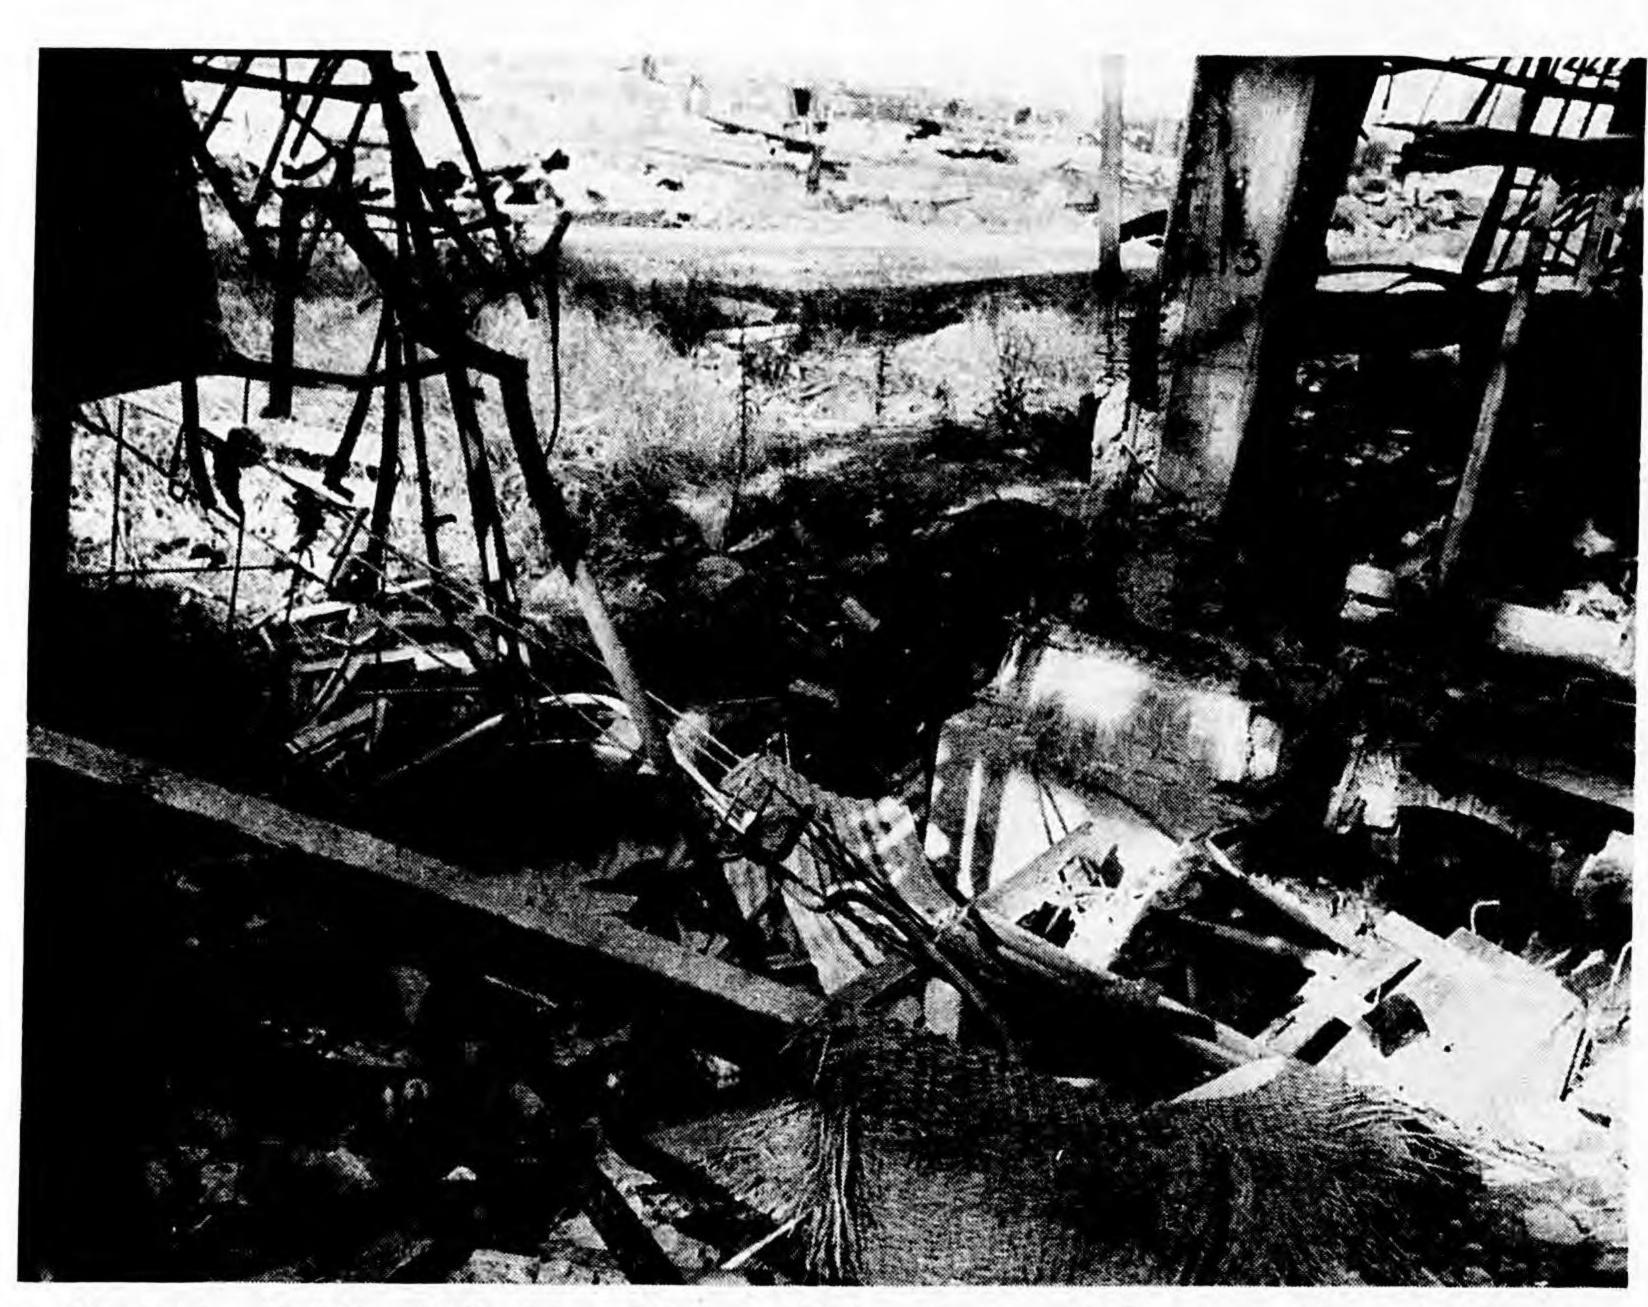
Photo 18 —Building 302b; base of Column A13 undamaged by cratering bomb looking N.

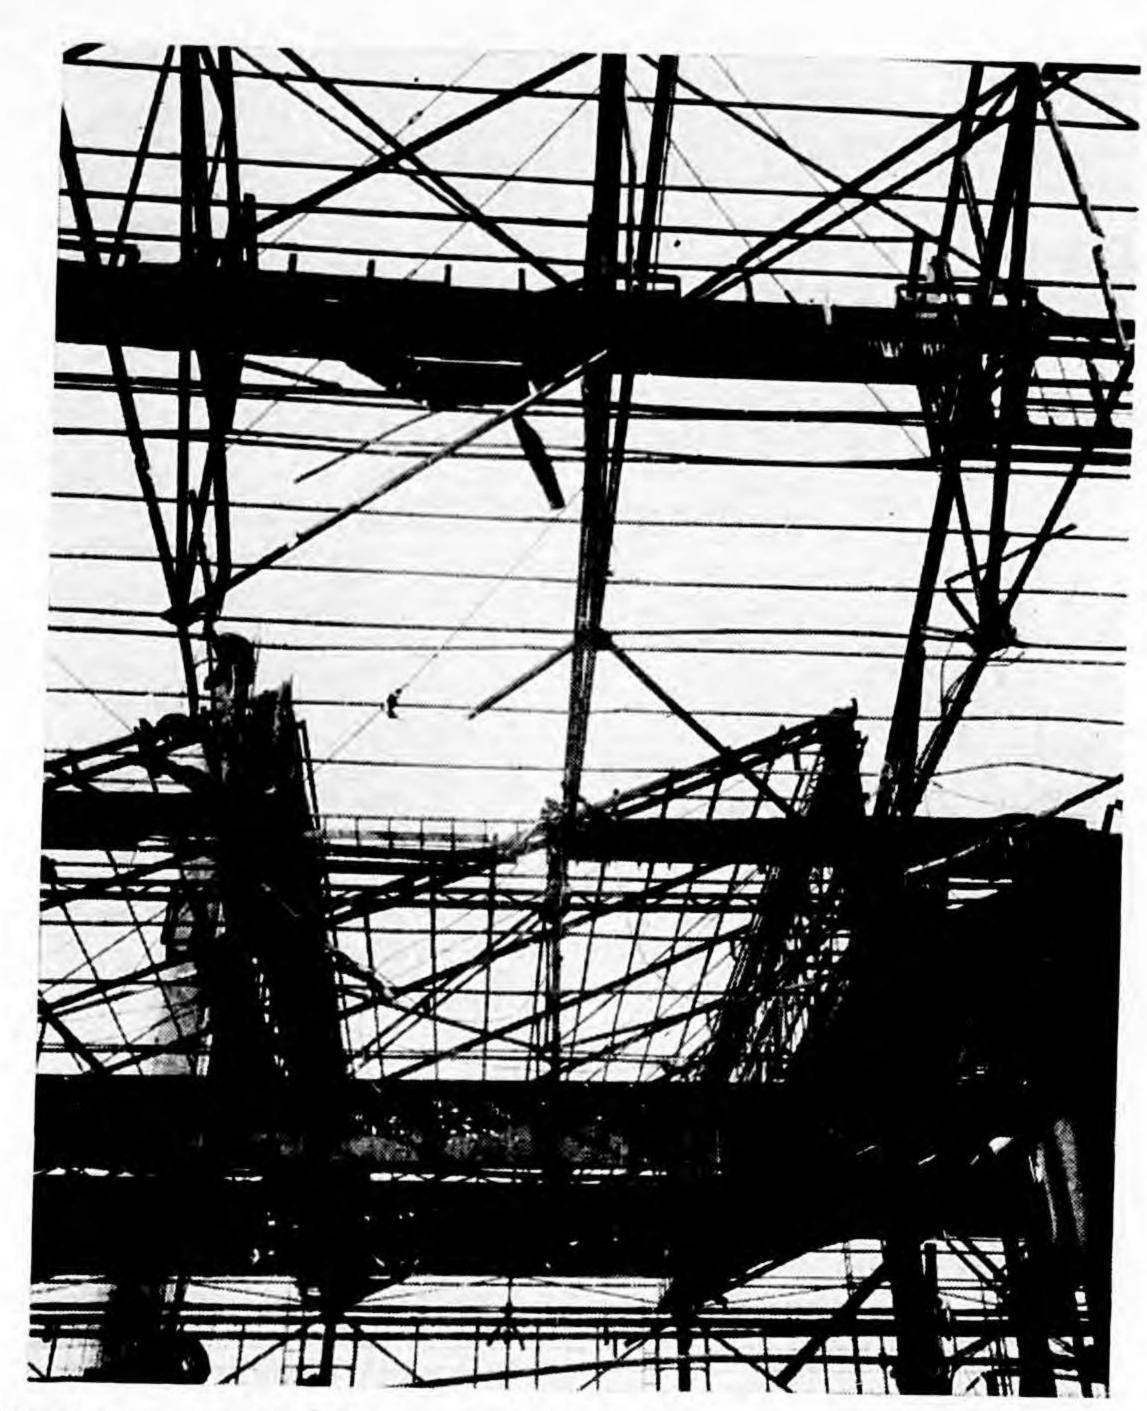
Photo 19.—Building 302a; damage to roof trusses and crane girders between Columns B13 and B12 looking NW.

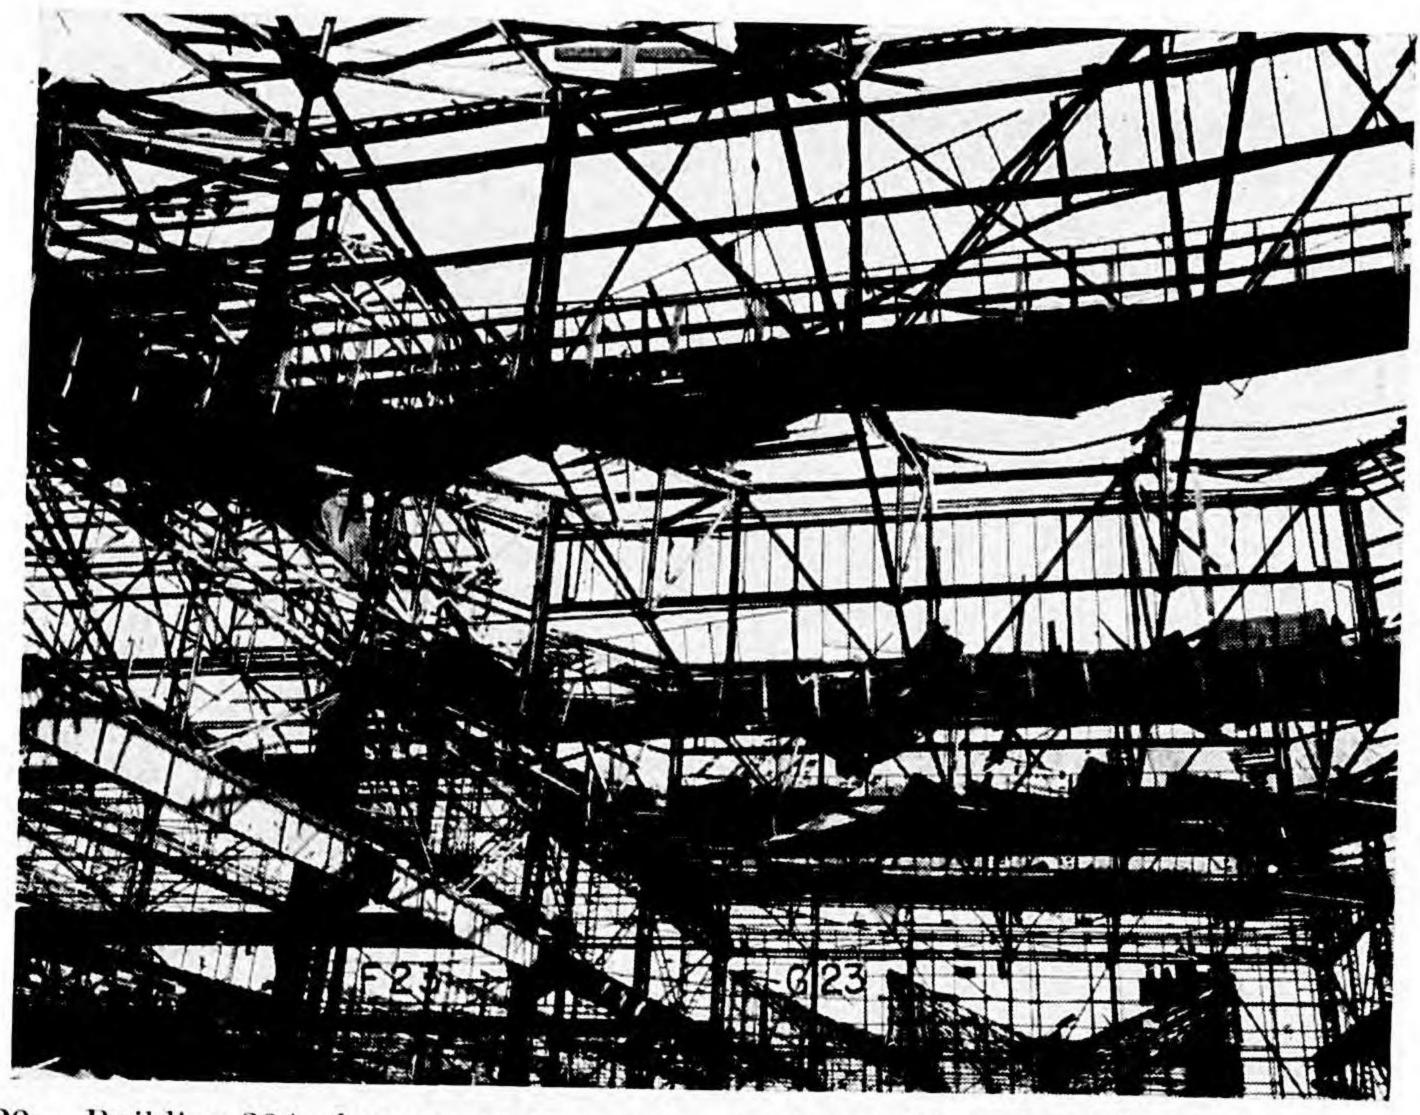
3. One type of damage was noted to saw-tooth roof trusses in buildings 301a and 304 in which the diagonal in the end panels of certain trusses was damaged, thereby causing a perceptible sagging of the truss between columns. This was responsible · for a considerable area of structural roof damage as in most cases the trusses would have to be taken down for repairs. The end members were two light angles tied with batten plates (exhibit A) and where one angle was damaged by fragmentation the inclined member was seriously weakened. Photos 1 and 2 indicate failures of the member in building 301a. Photos 5, 6, and 20 show similar failures of the member in building 304.

Photo 20.—Building 304; damage to trusses connecting to Columns E23 and F23 looking ESE.
