DAMAGE TO MACHINE TOOLS BY ATOMIC BOMB

CHAPTER V
DAMAGE TO UTILITIES

ATOMIC BOMBS
PLANT UTILITIES
HIROSHIMA - NAGASAKI

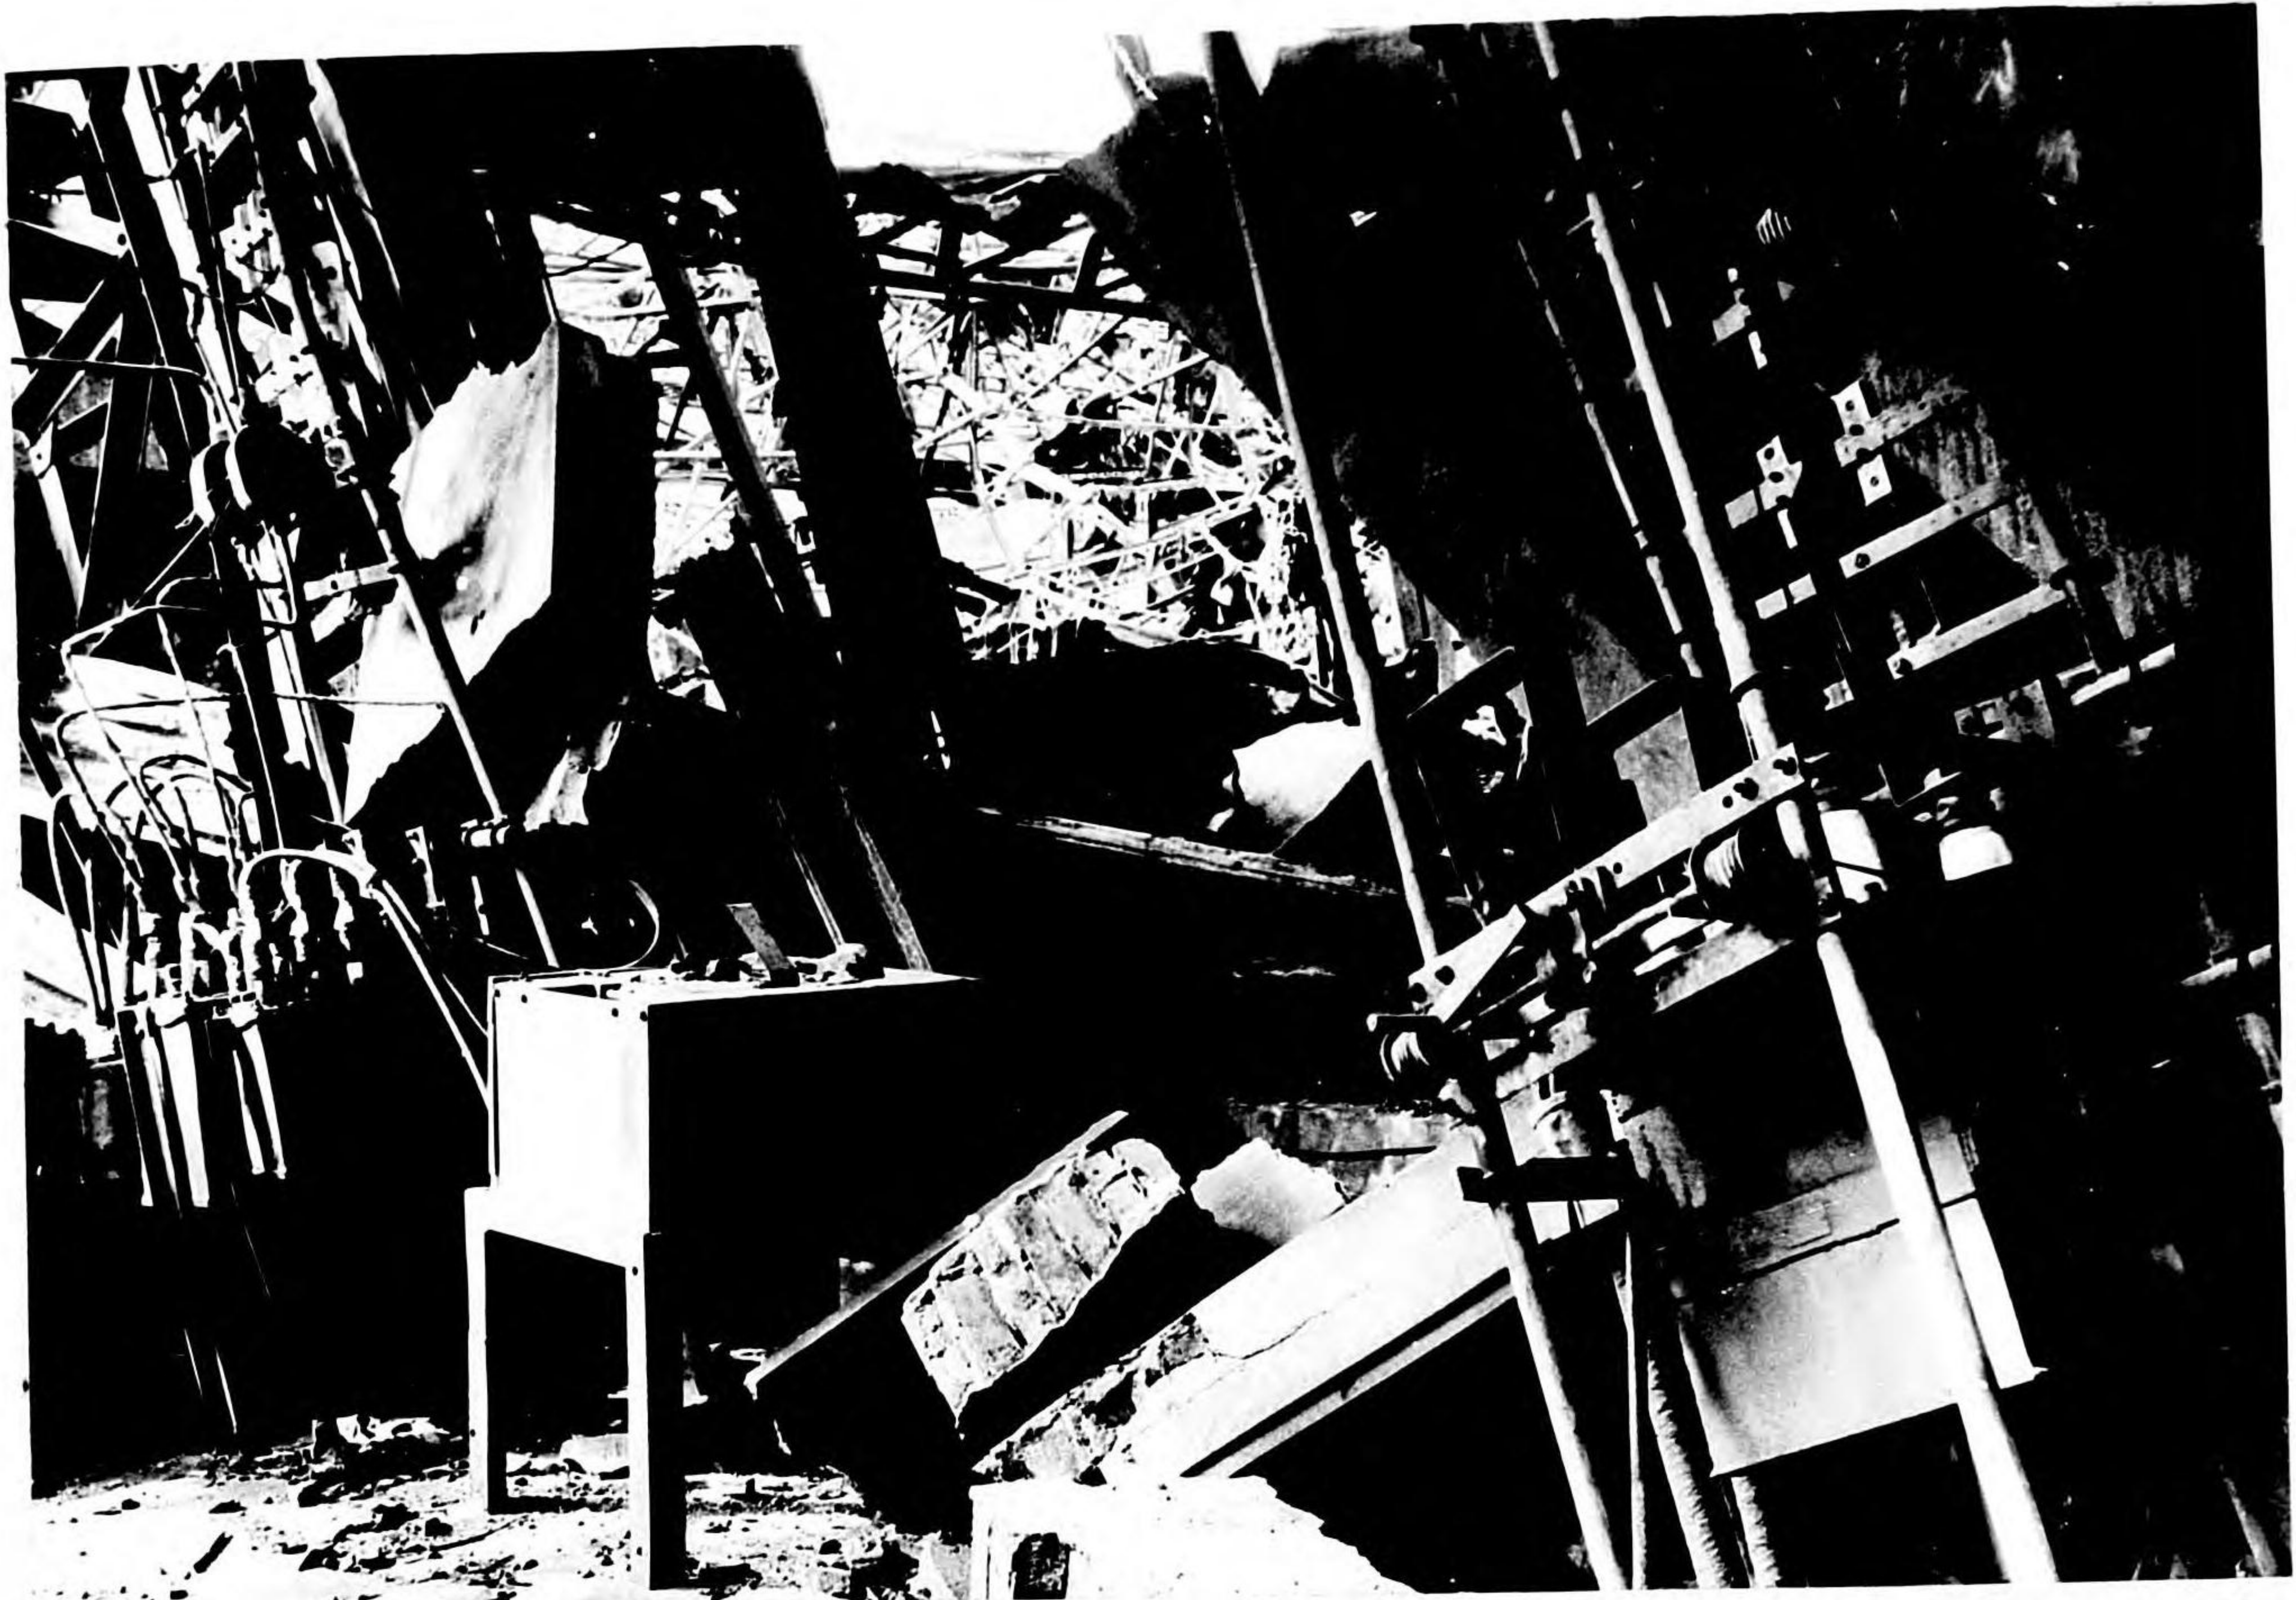
Photo 120. Nagasaki, 2,500 feet from GZ. Switchboard and circuit breakers heavily damaged by blast.

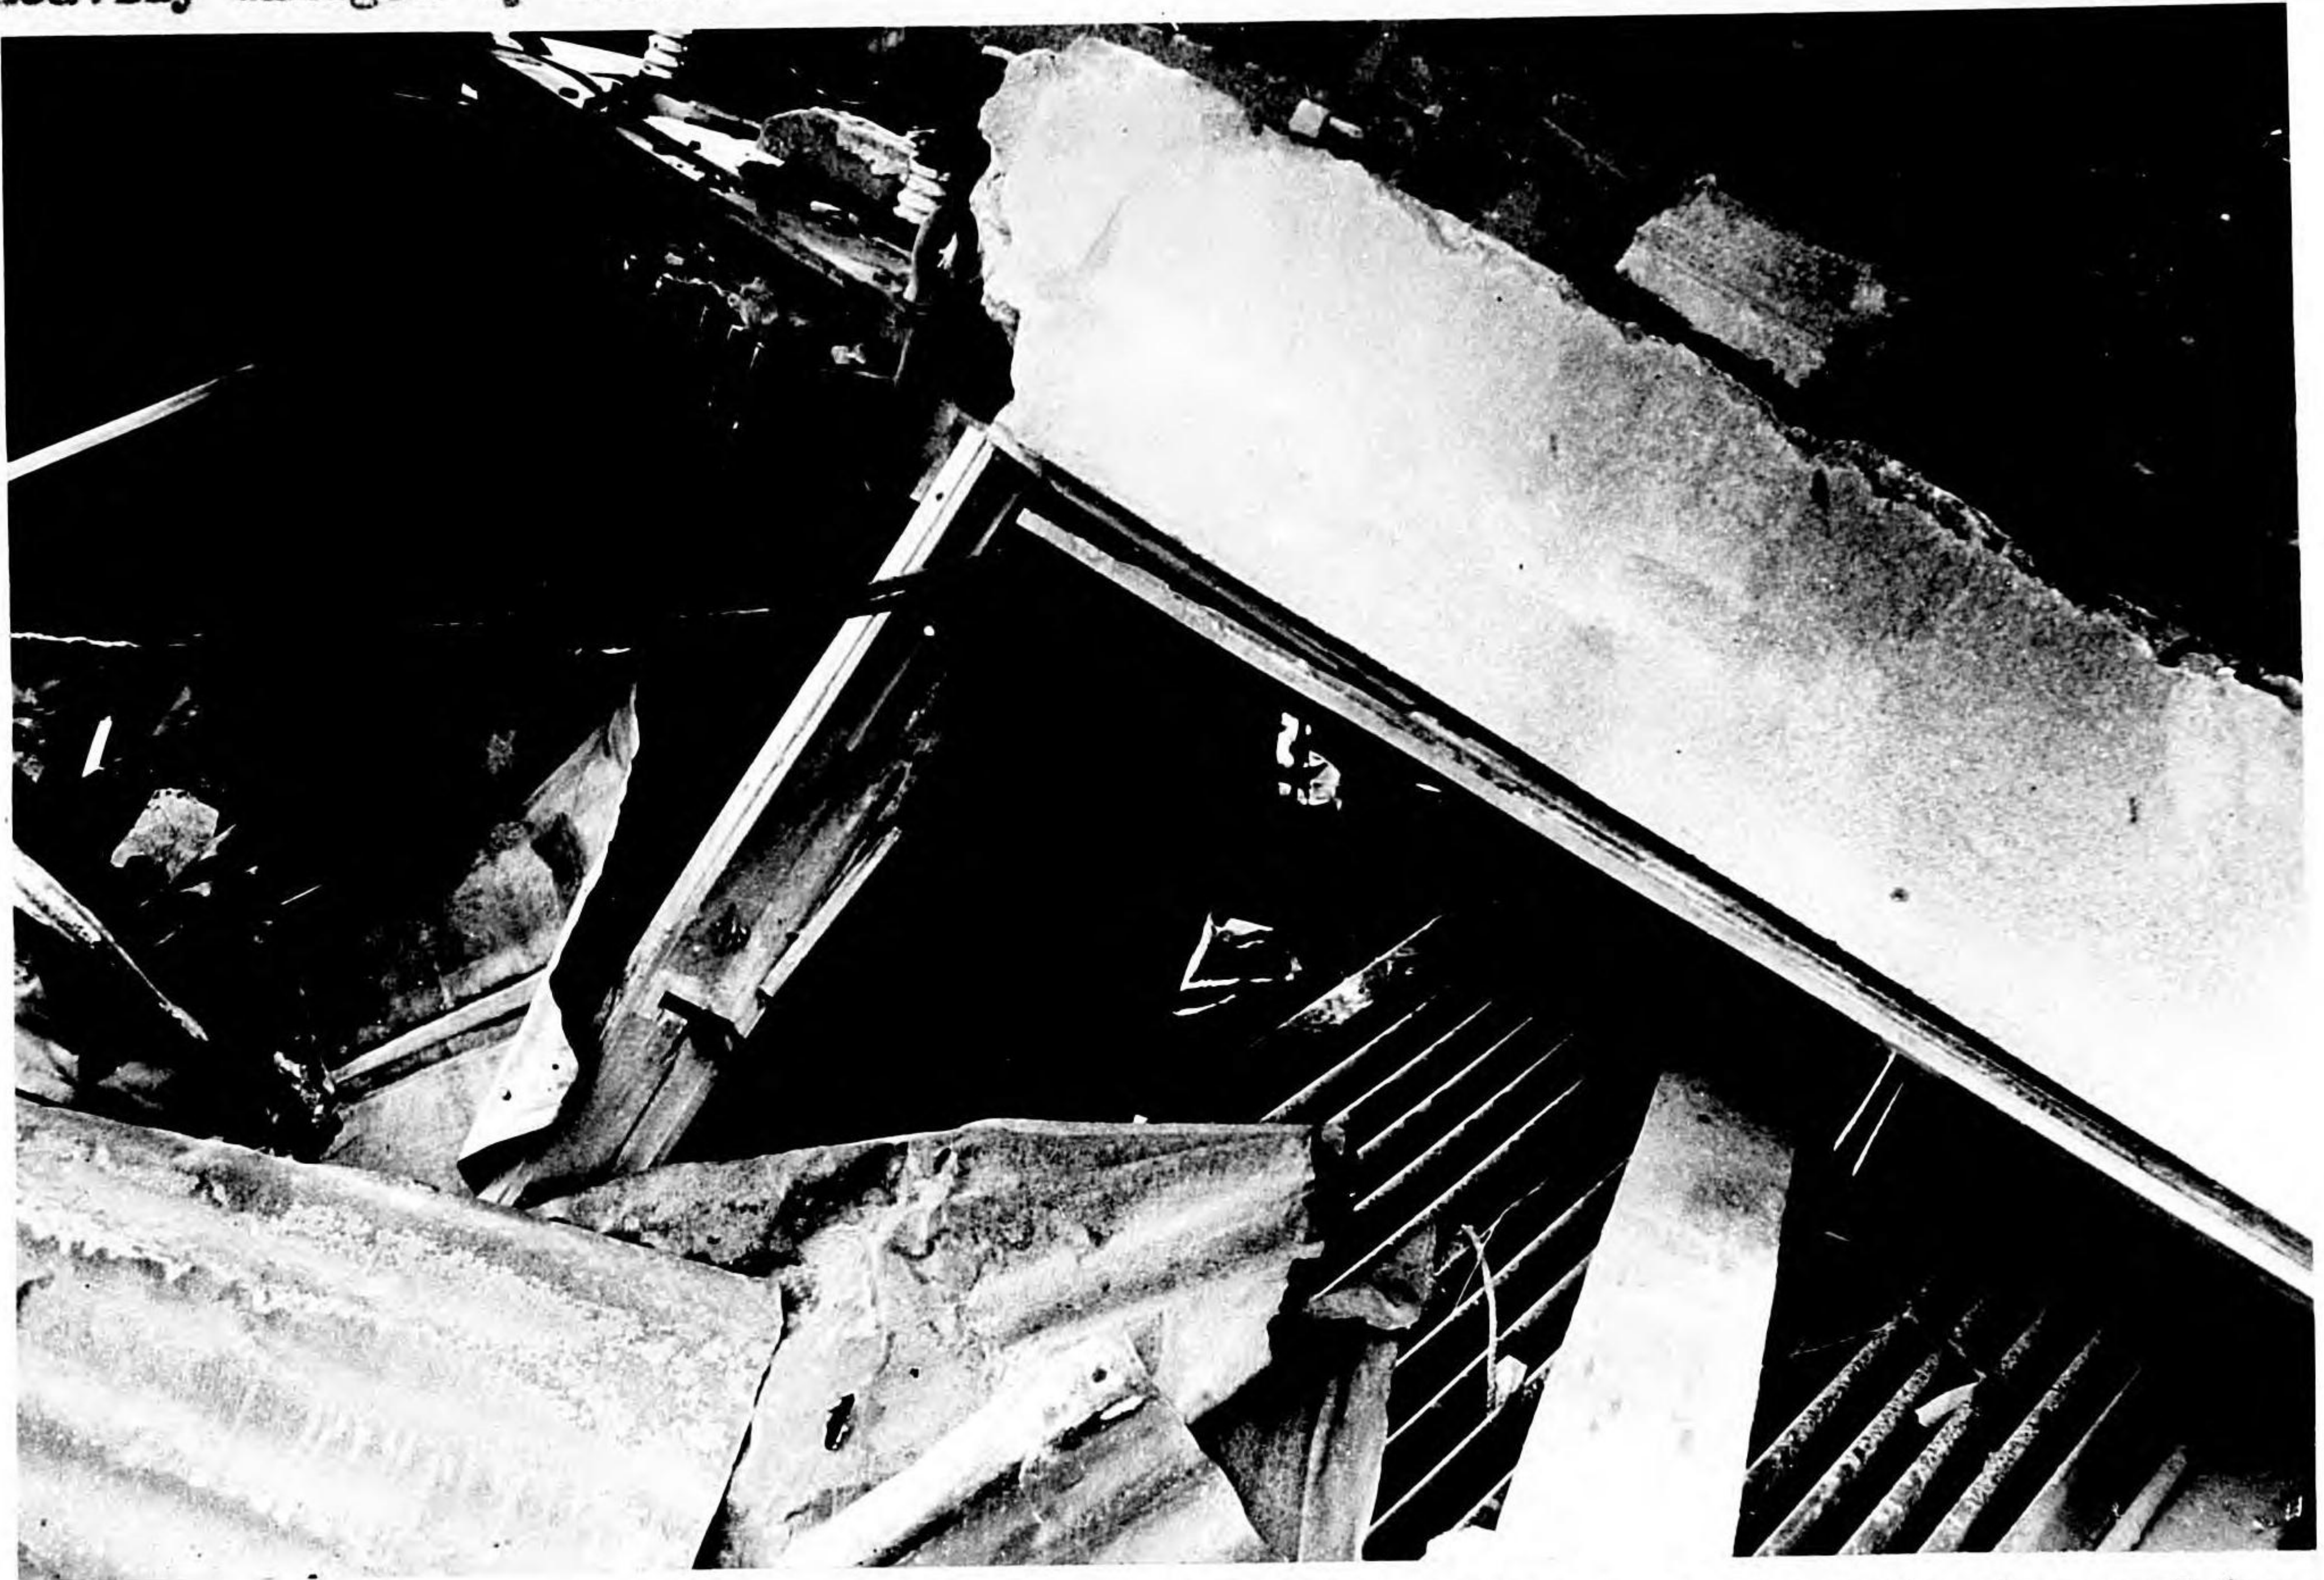
Photo 121. Nagasaki, 2,500 feet from GZ. Transformers slightly damaged by debris.

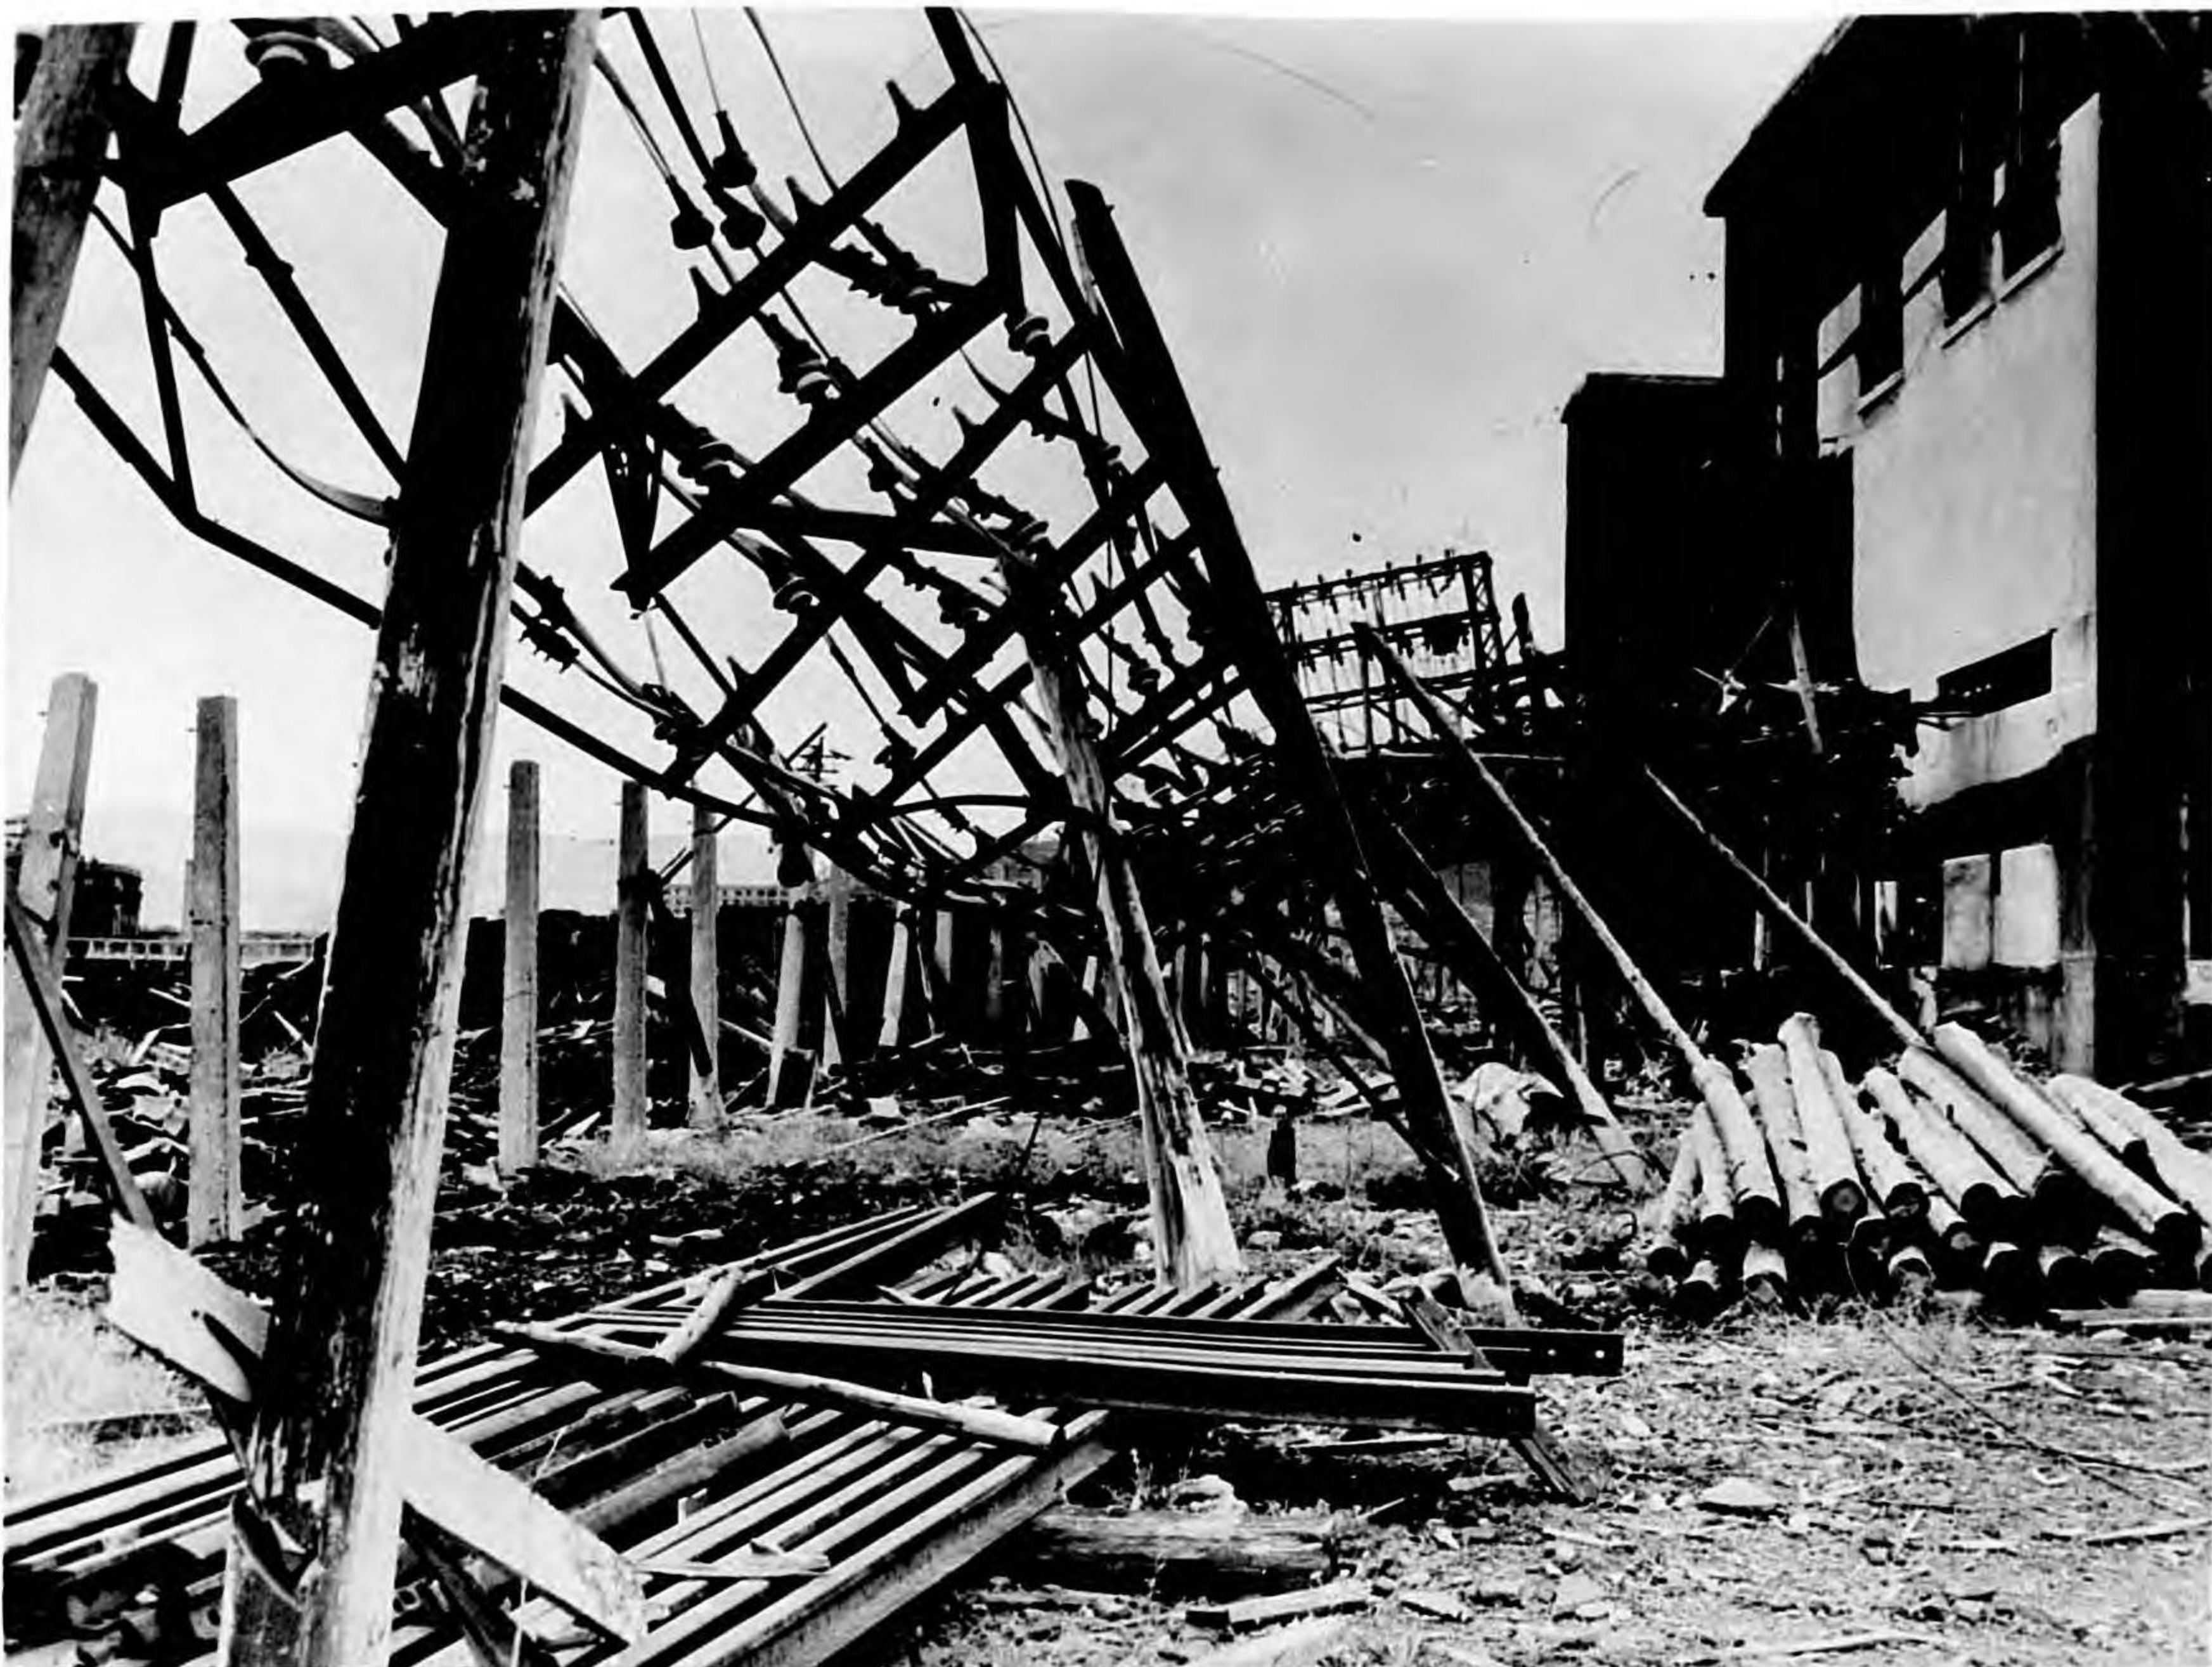
Photo 122. Nagasaki, 3,600 feet from GZ, Takenokube Substation. Damage to three-circuit copper bus structure. Flash burns on poles.

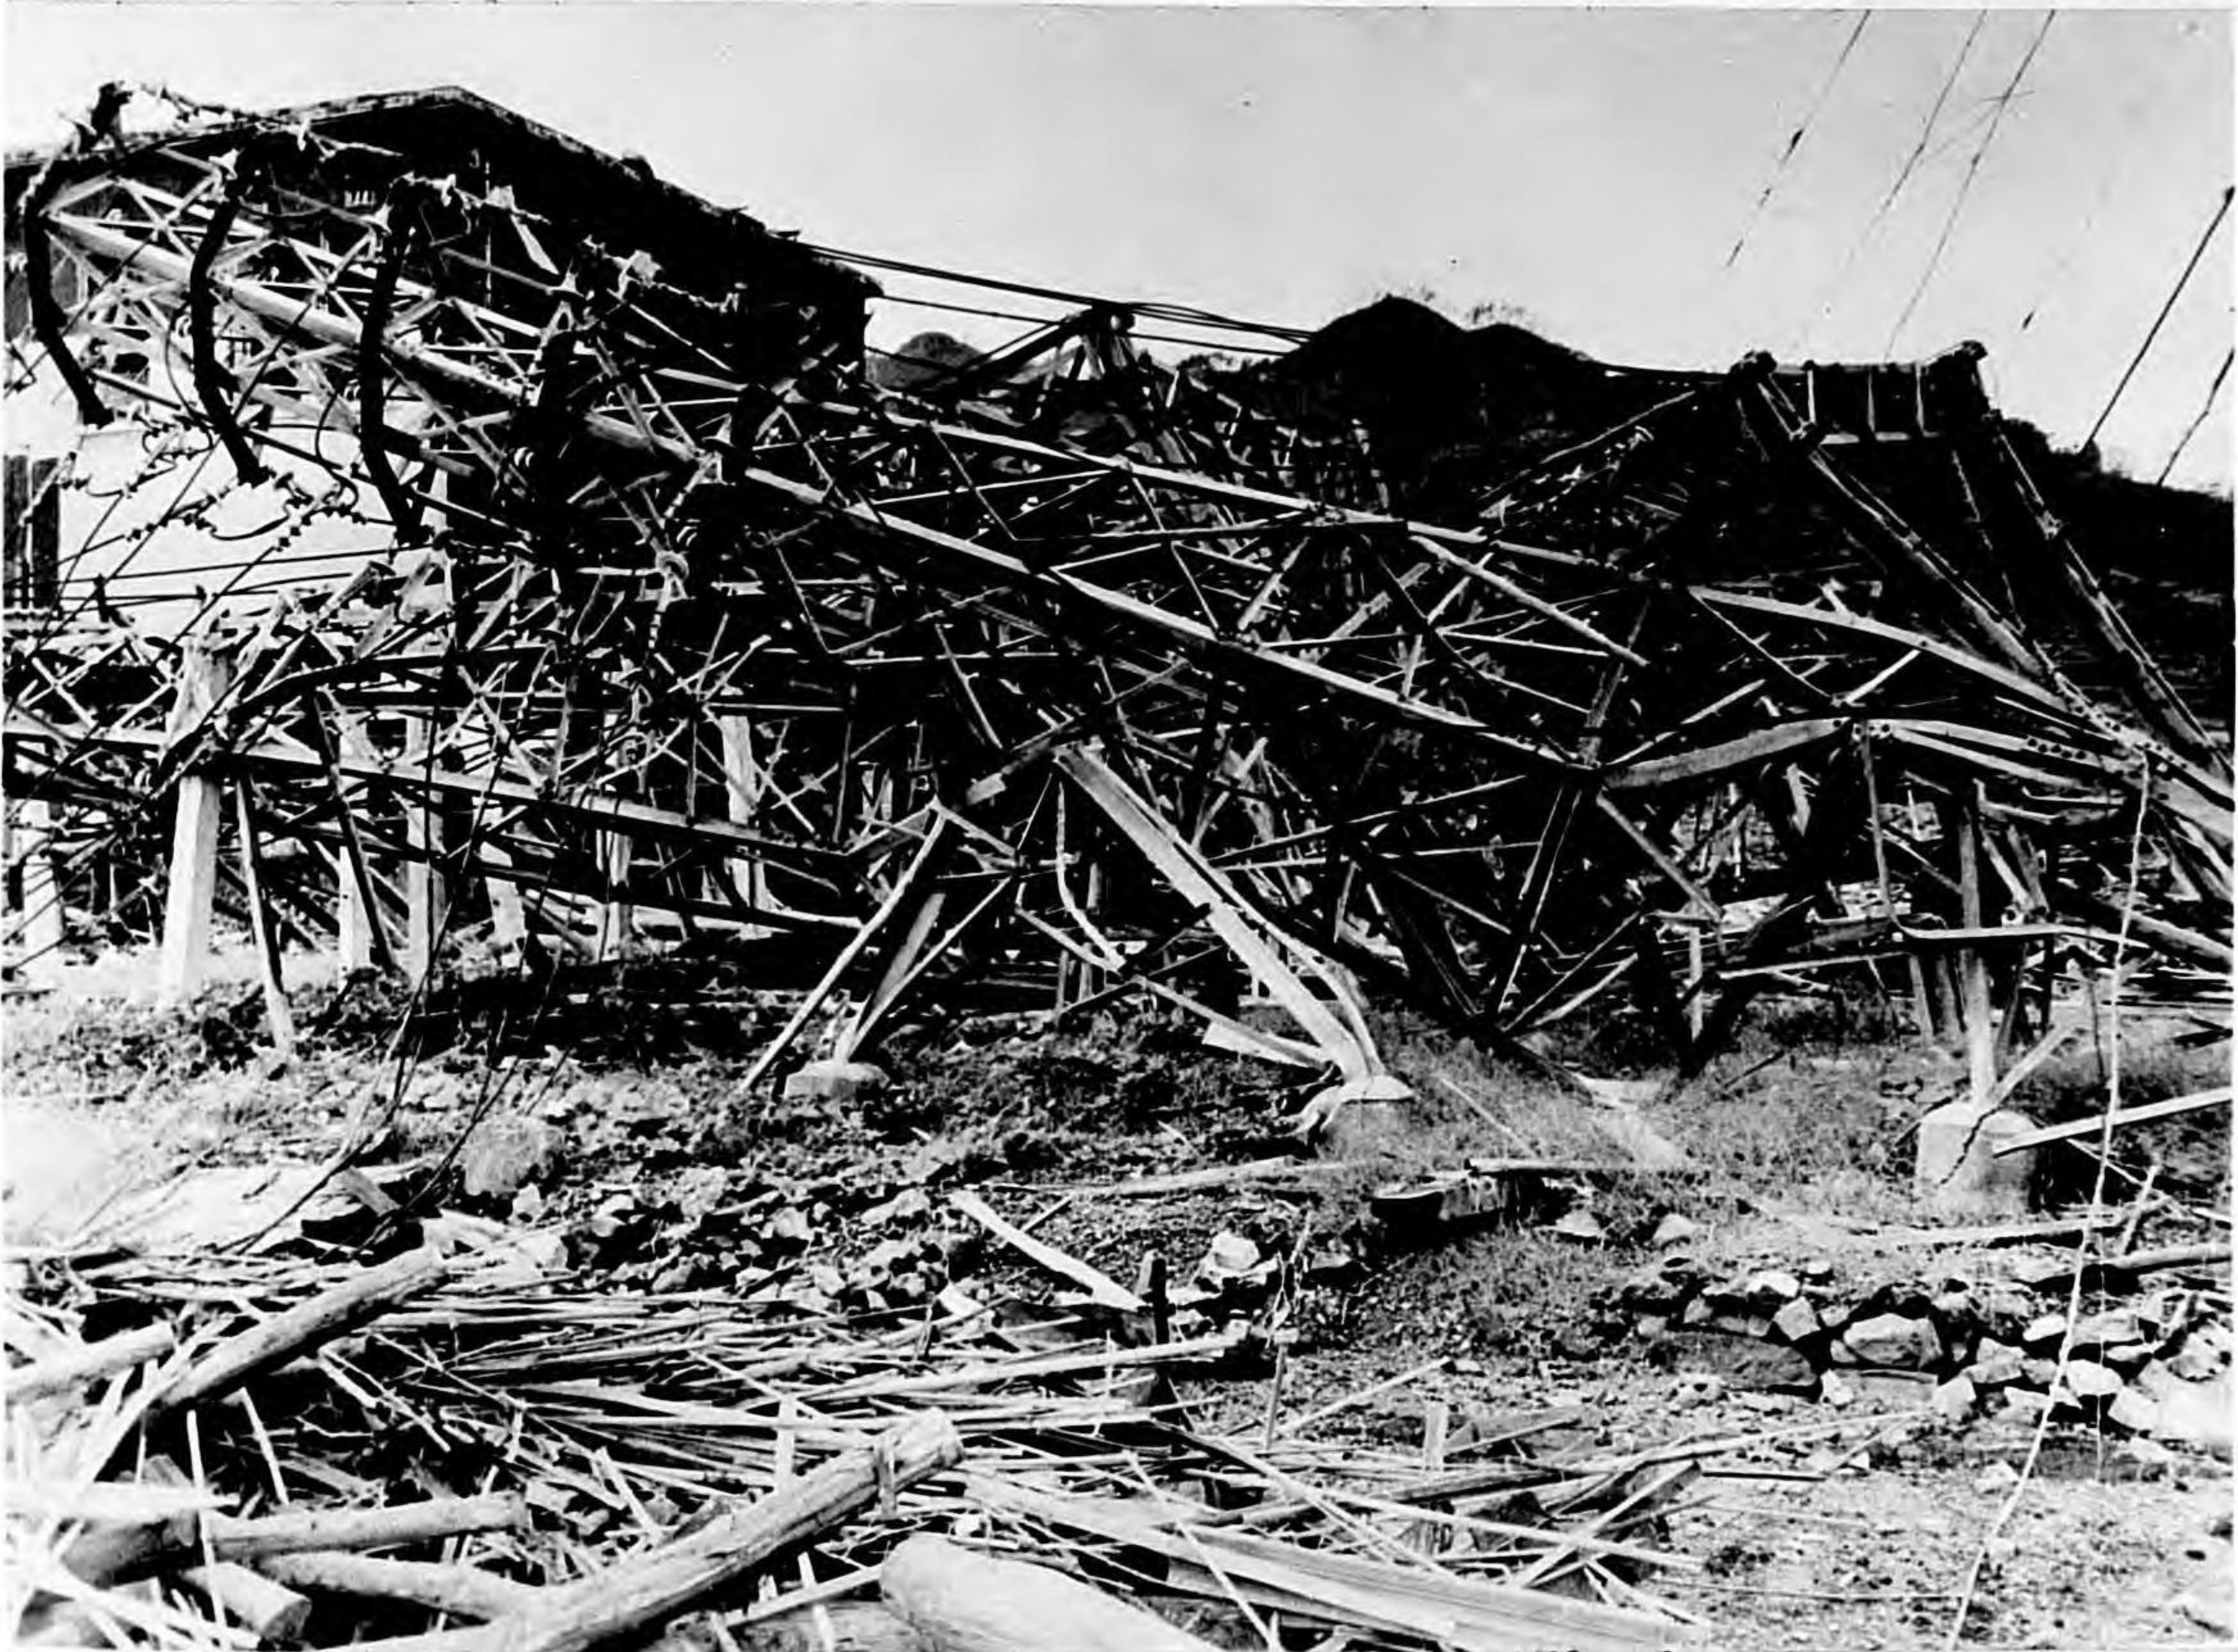
Photo 123. Nagasaki, 3,600 feet from GZ, Takenokube Substation. Damage to 3.5-kv switch rack and first tower.

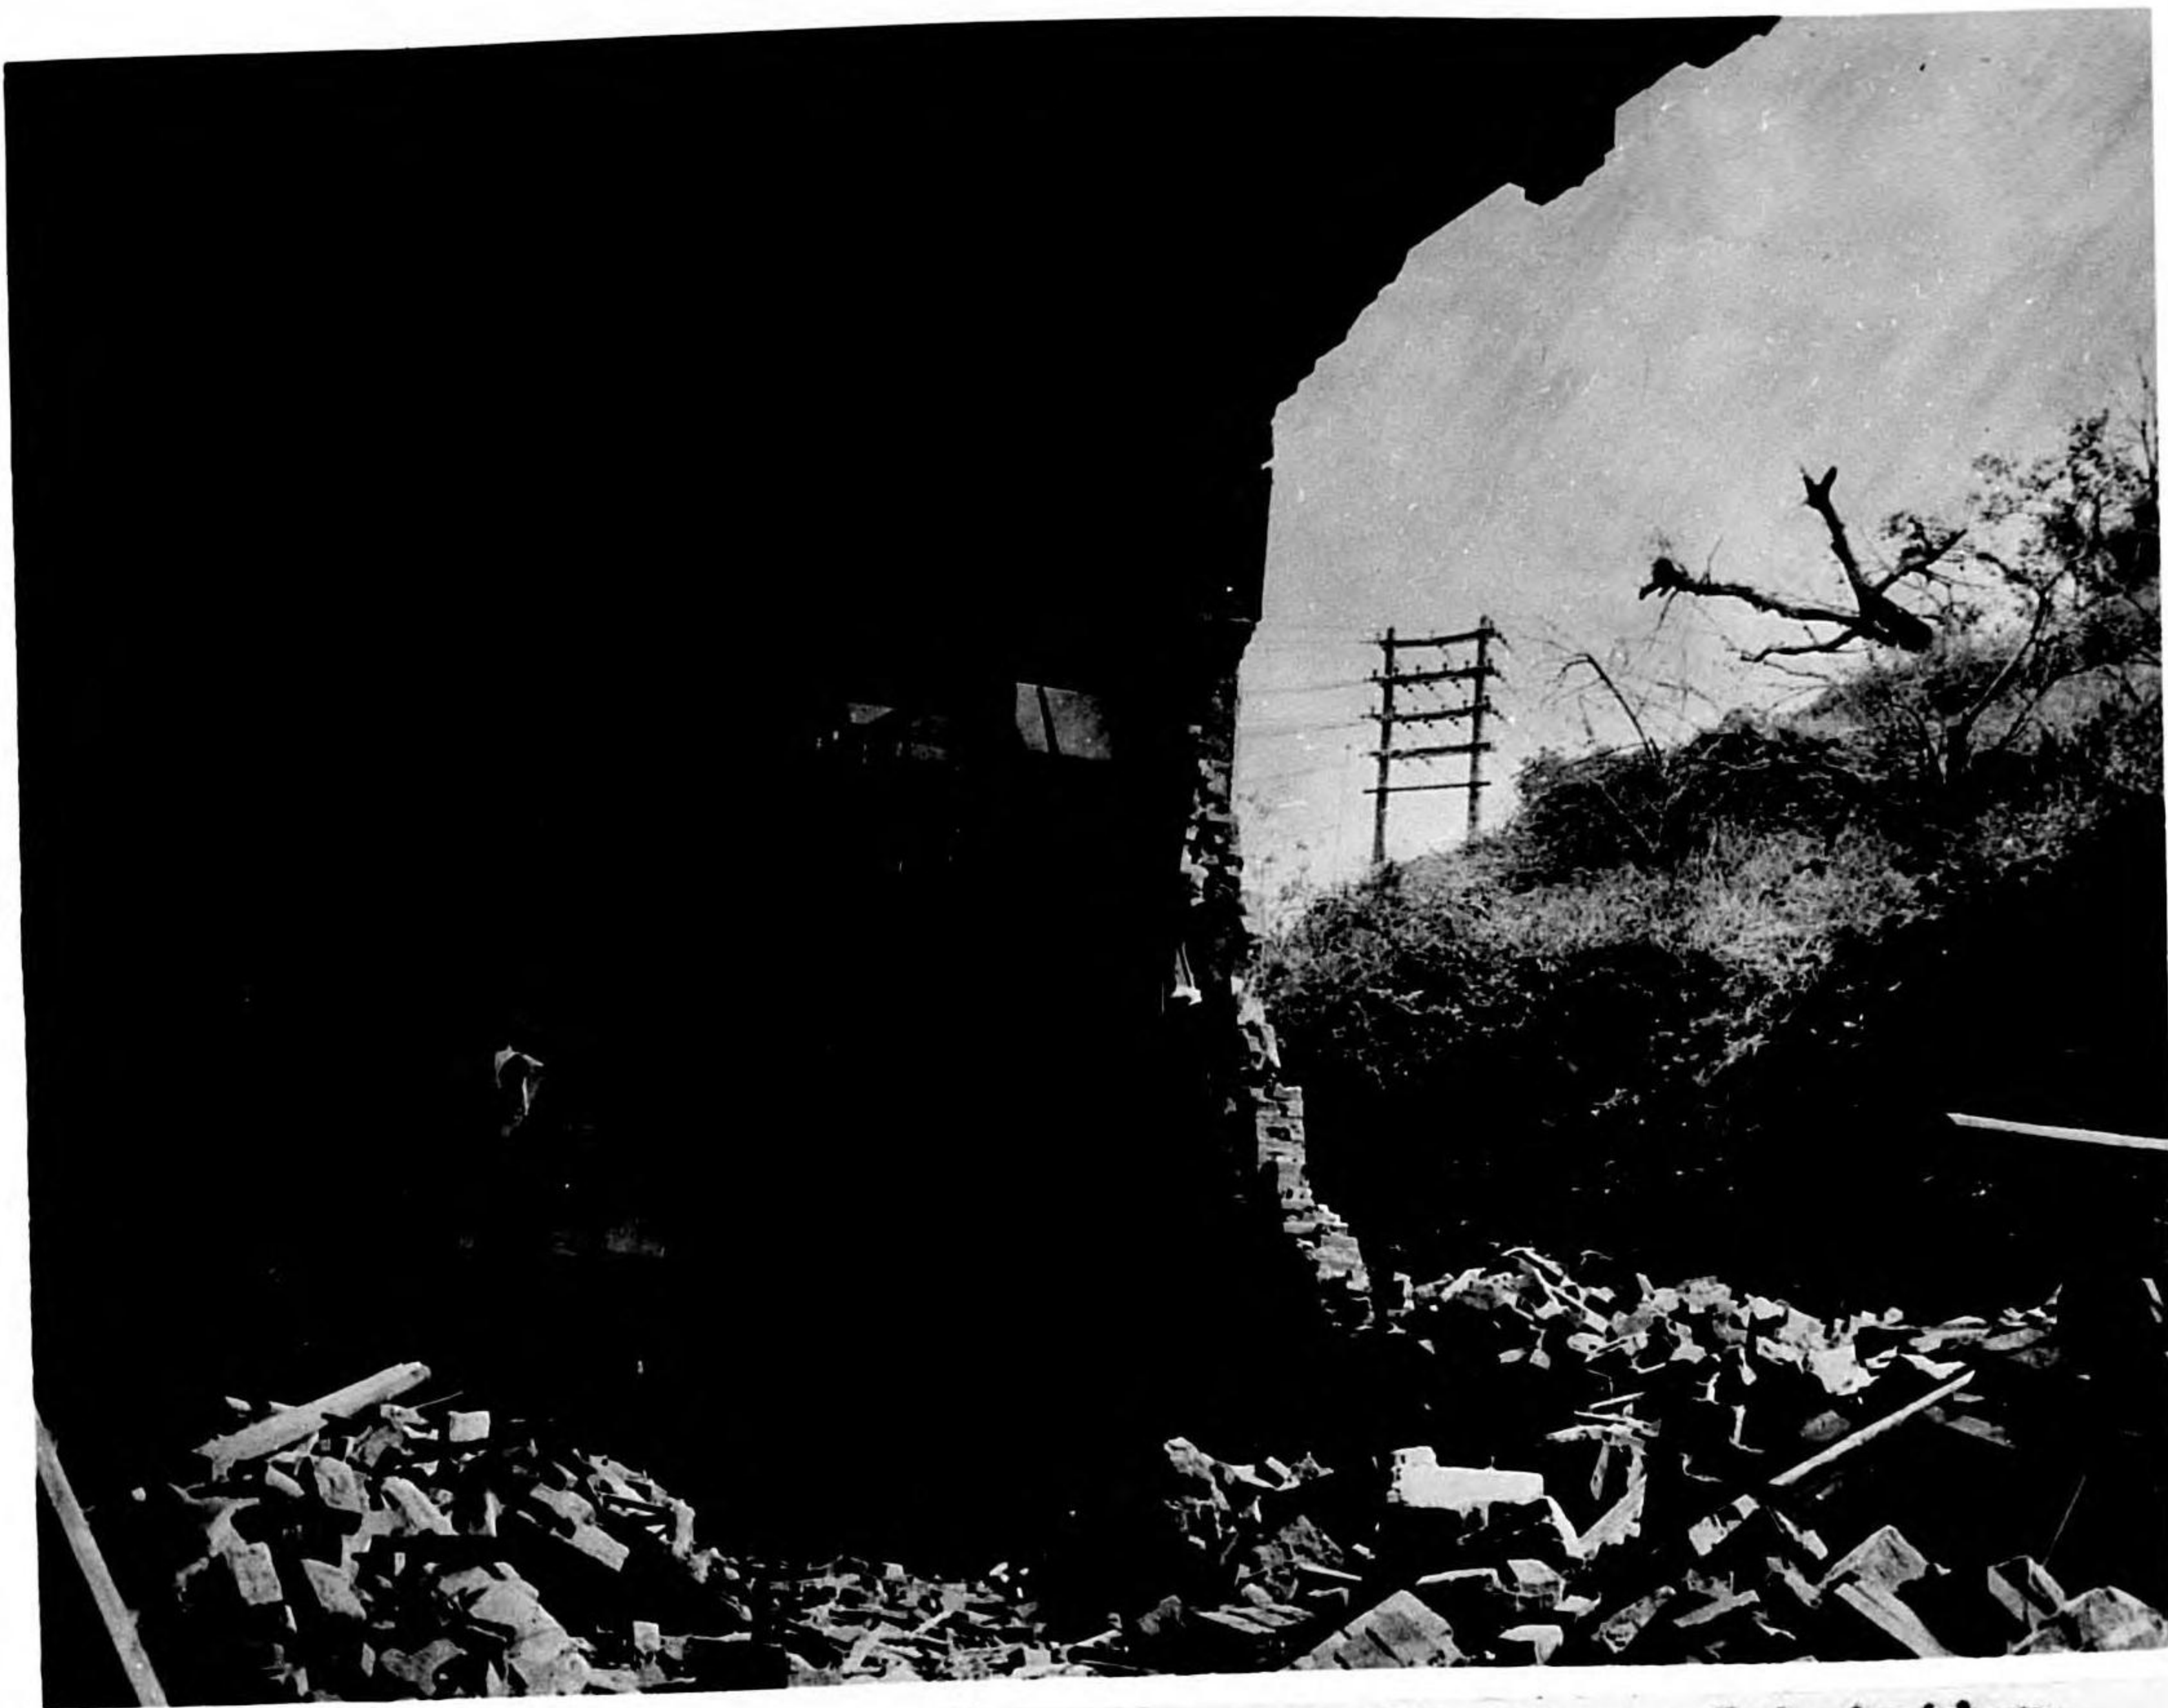
Photo 124. Nagasaki, 5,400 feet from GZ, Zenza Substation.
Southeast corner of control and switch room.

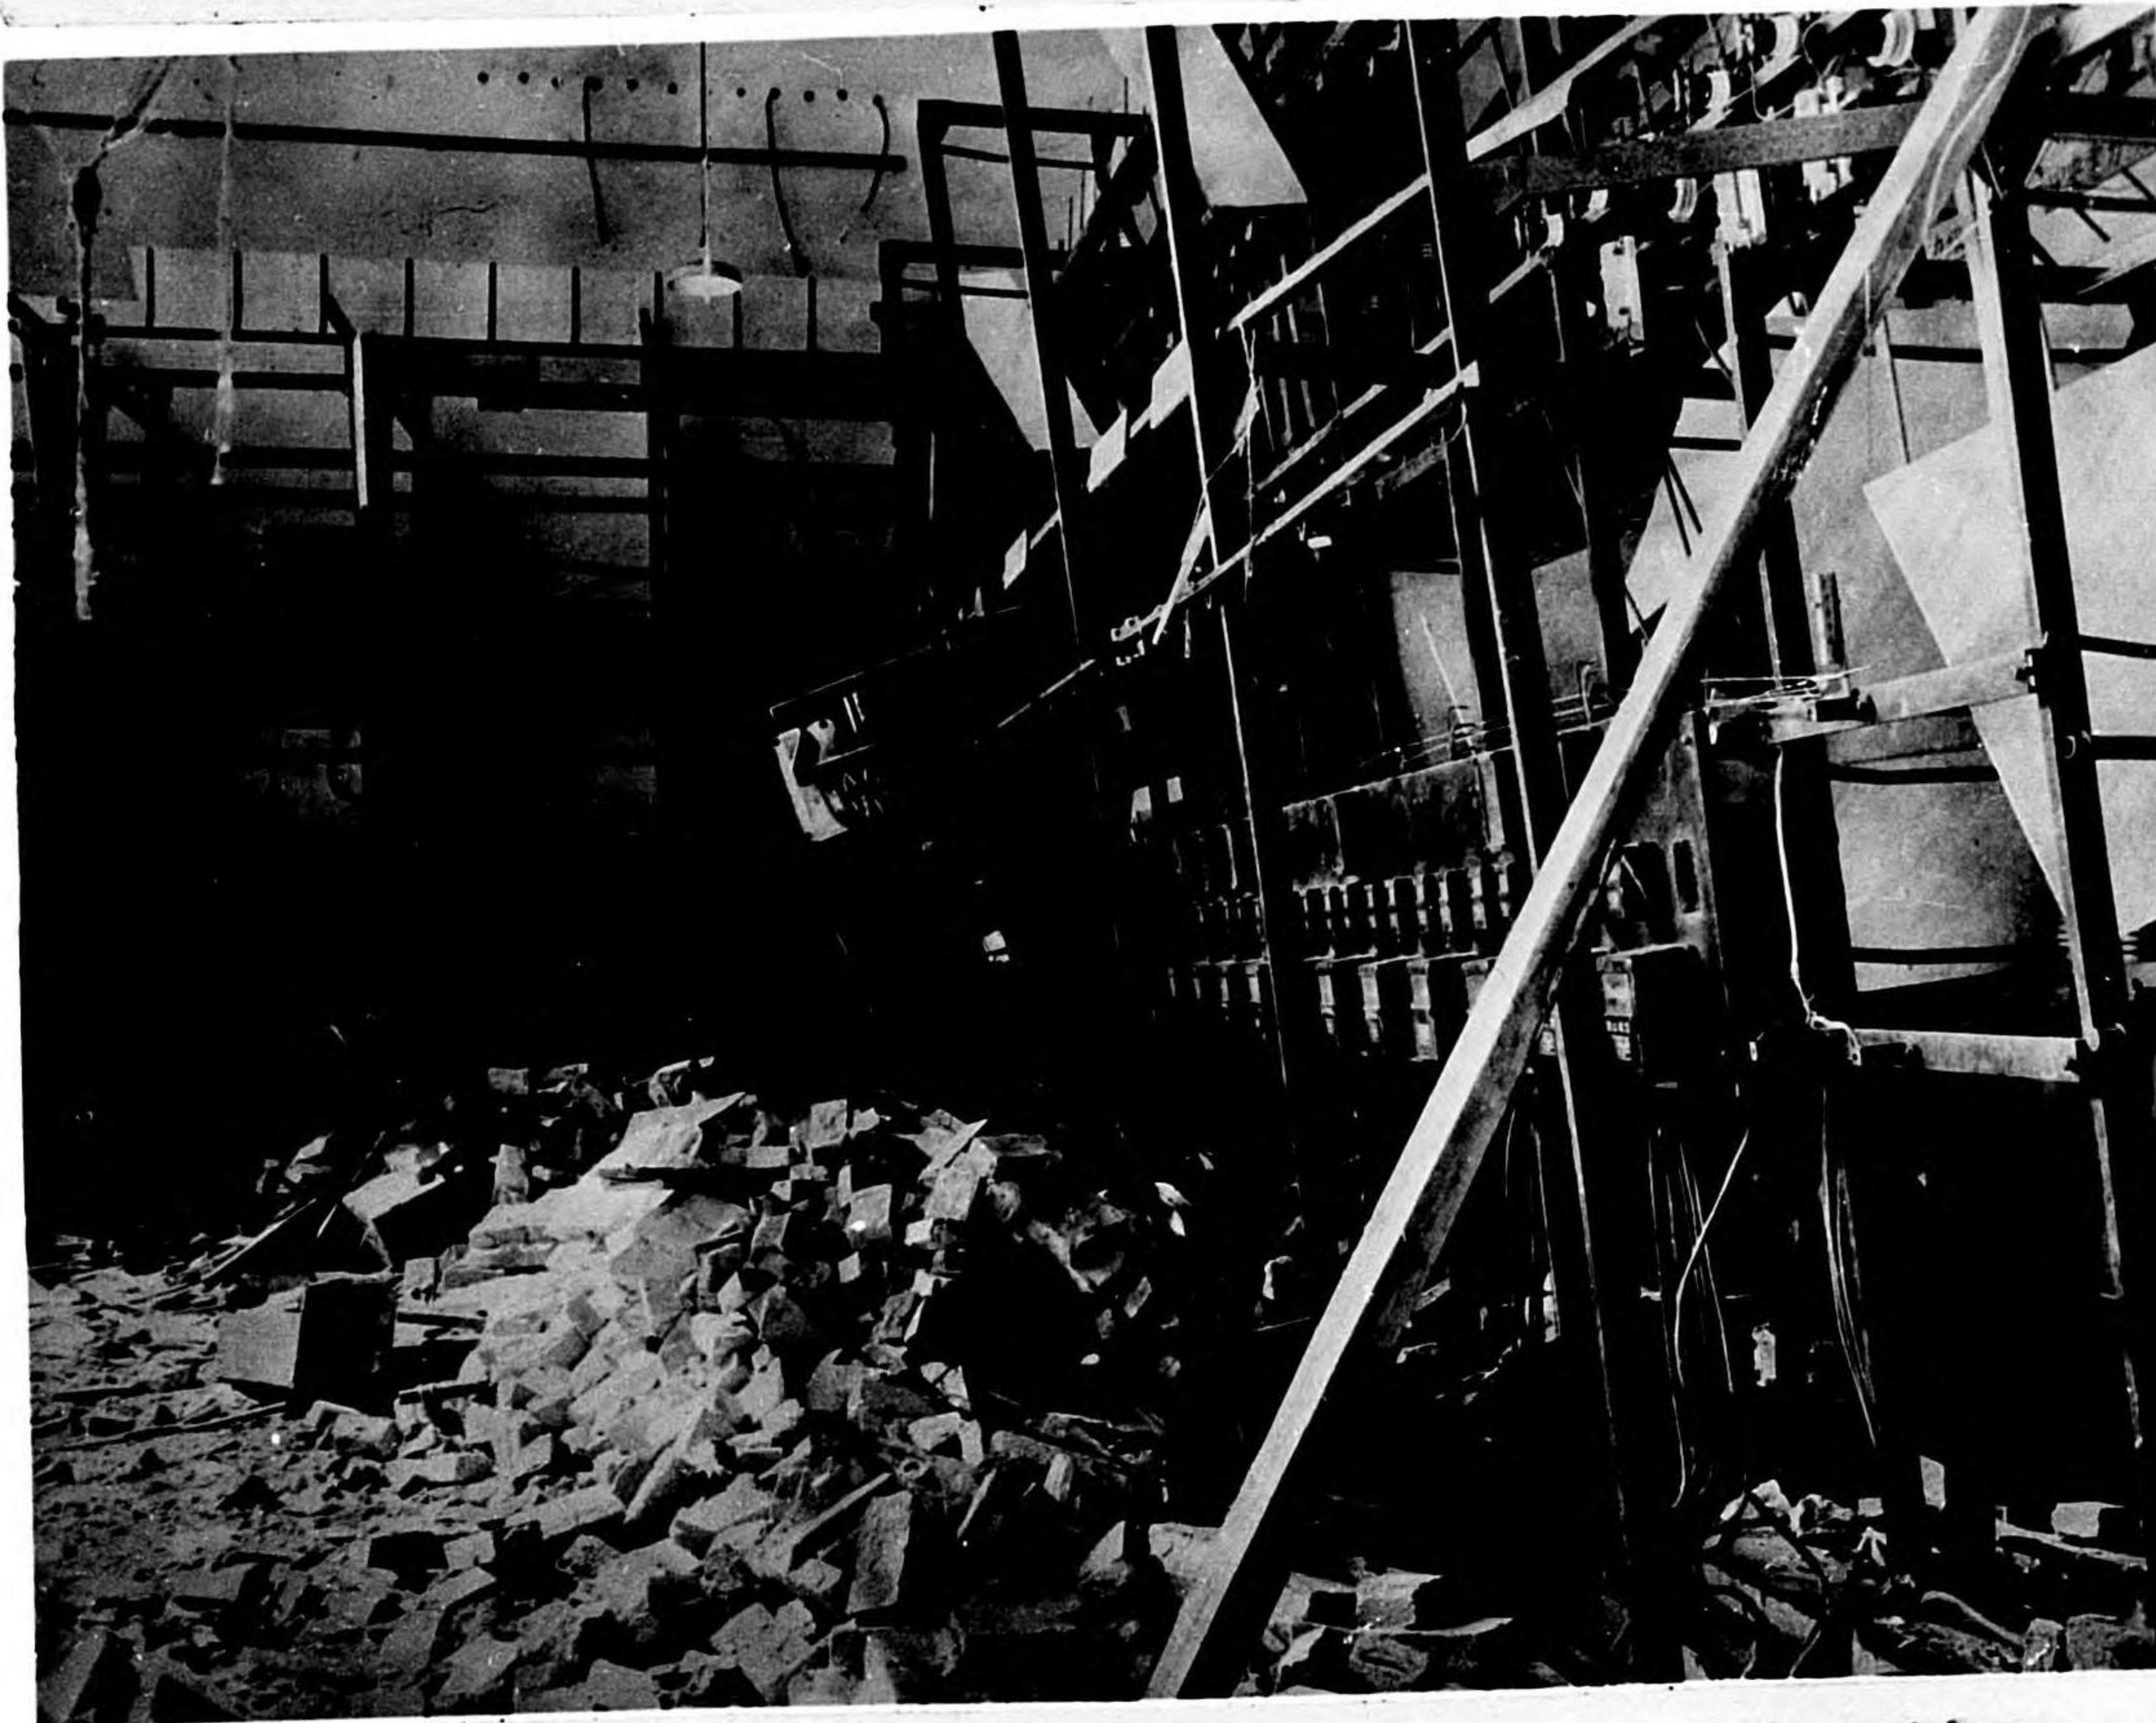
Photo 125. Nagasaki, 5,400 feet from GZ, Zenza Substation.
Controls, 3.5-kv busses and oil-circuit breakers.
