DAMAGE TO MACHINE TOOLS BY ATOMIC BOMB

CHAPTER V
DAMAGE TO UTILITIES

ATOMIC BOMBS
PLANT UTILITIES
HIROSHIMA - NAGASAKI

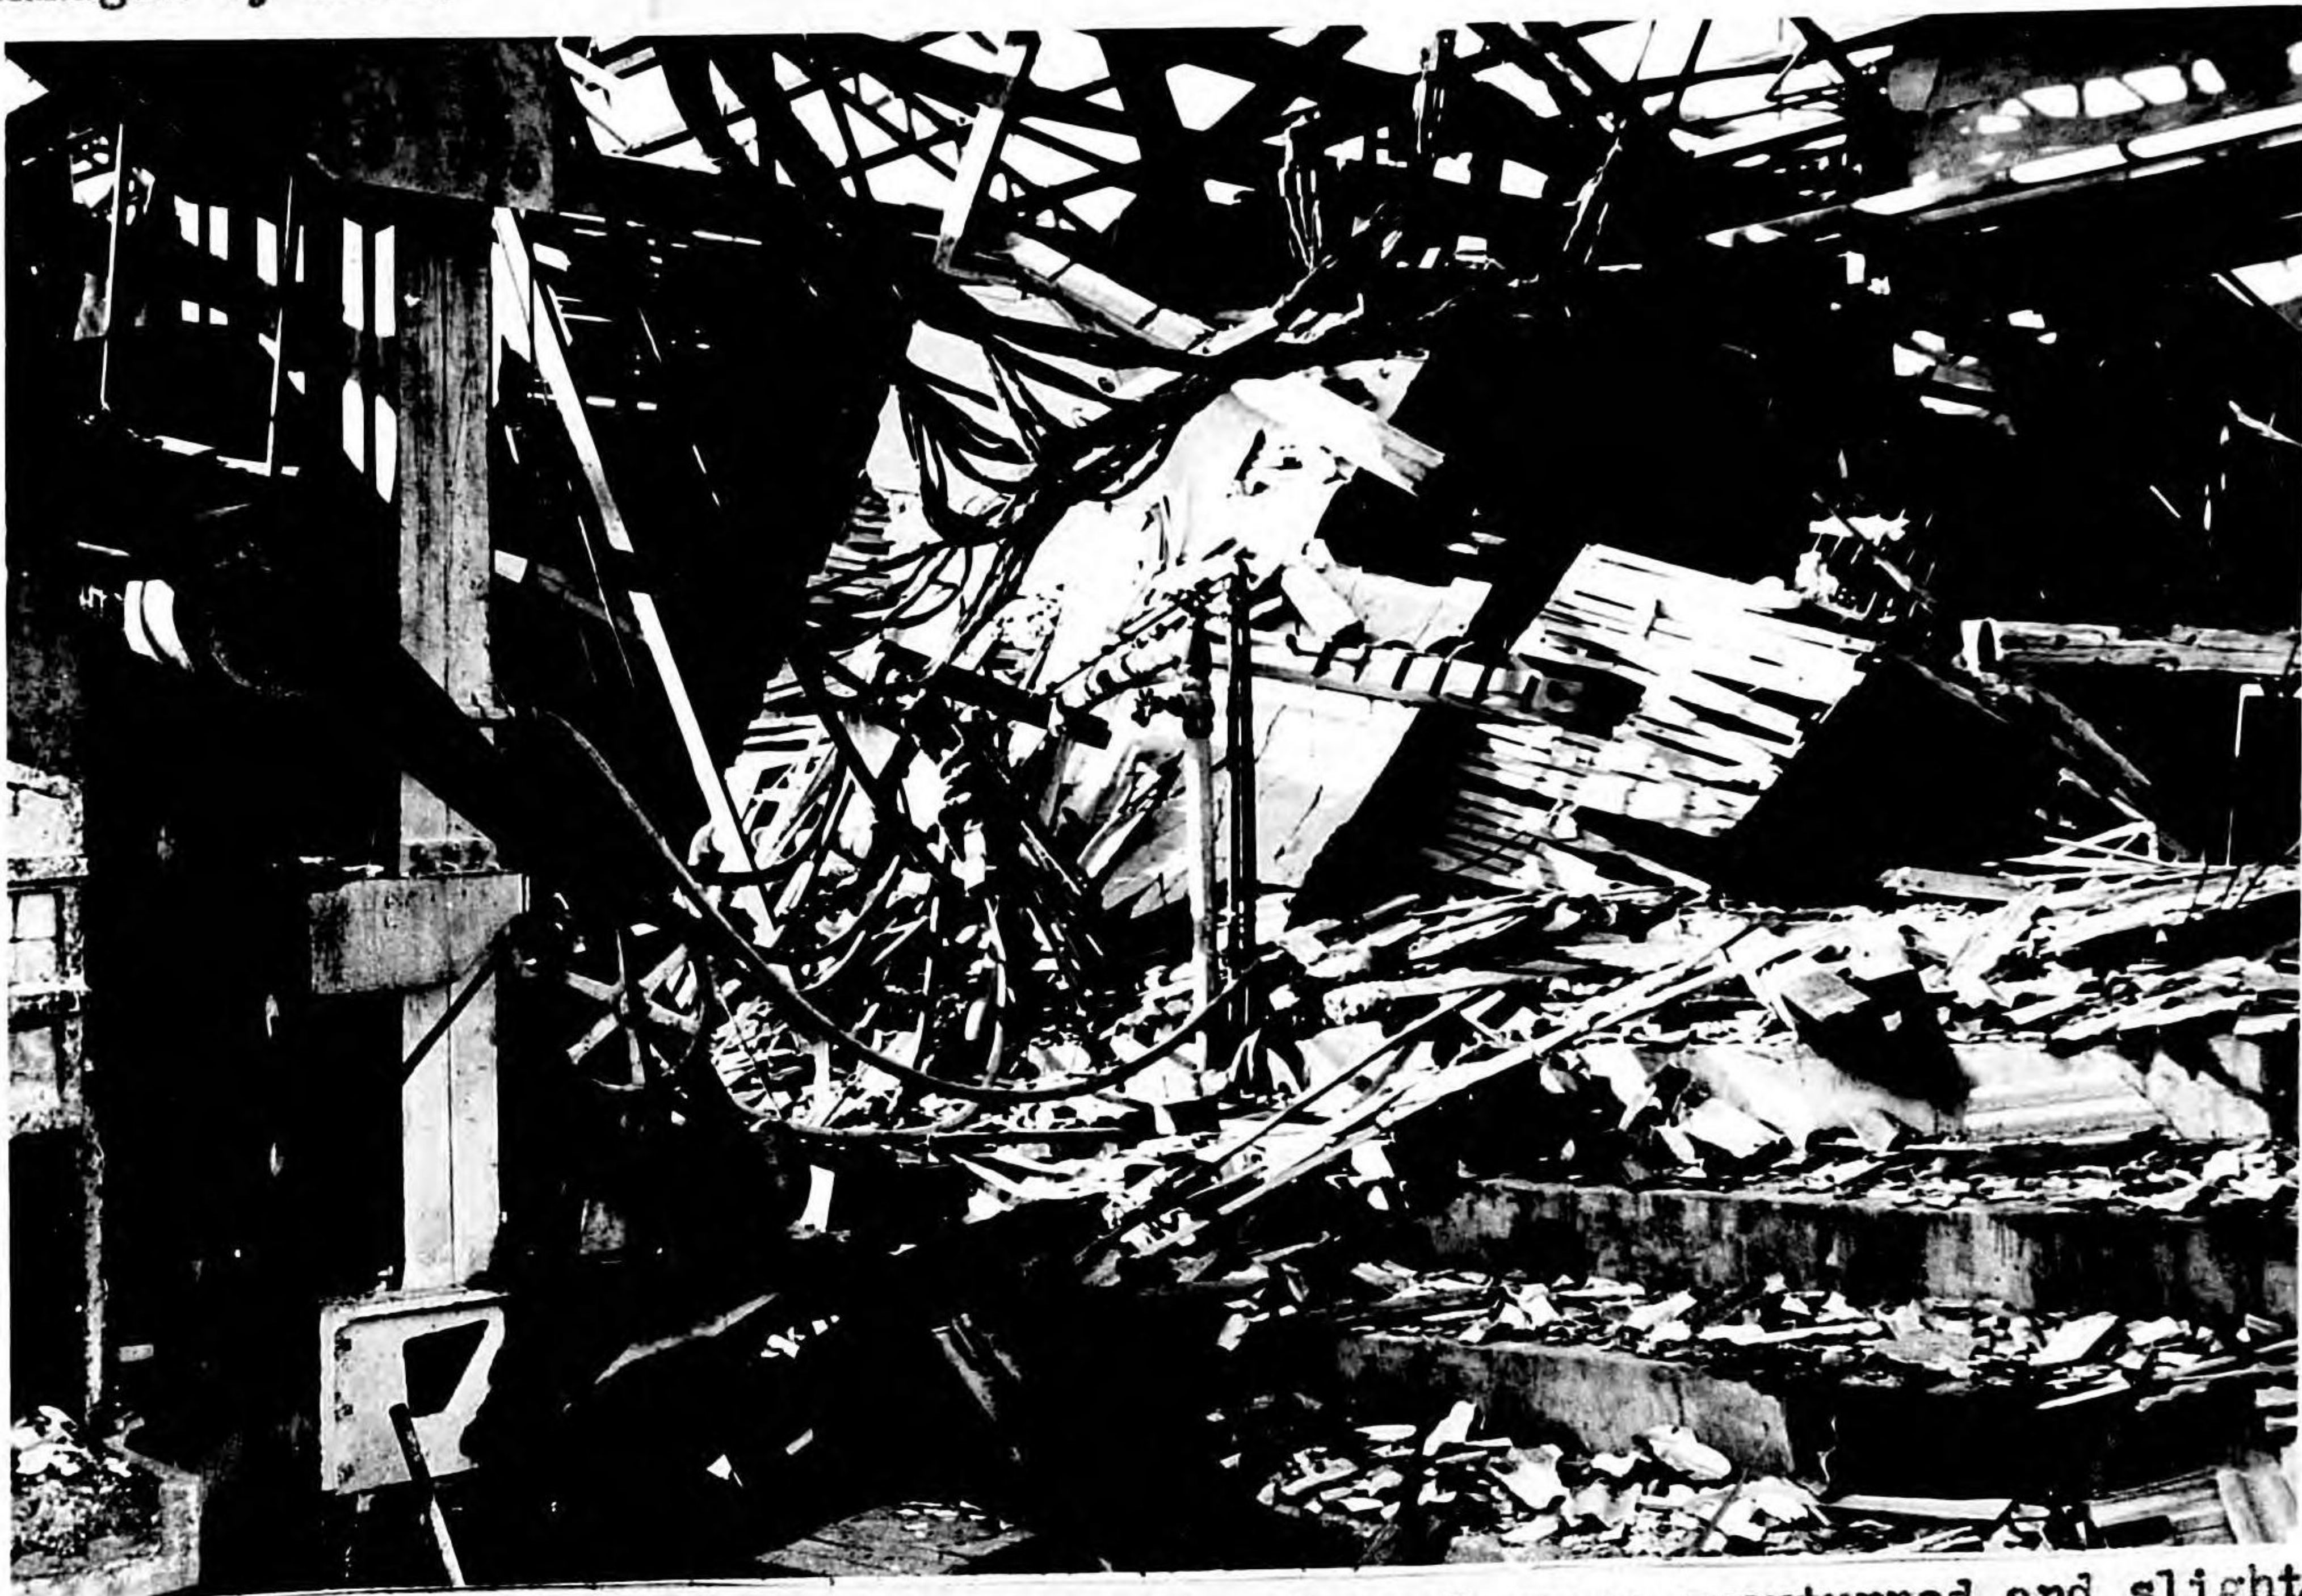
Photo 127. Nagasaki, 4,000 feet from GZ. Transformers overturned and slightly damaged by blast.

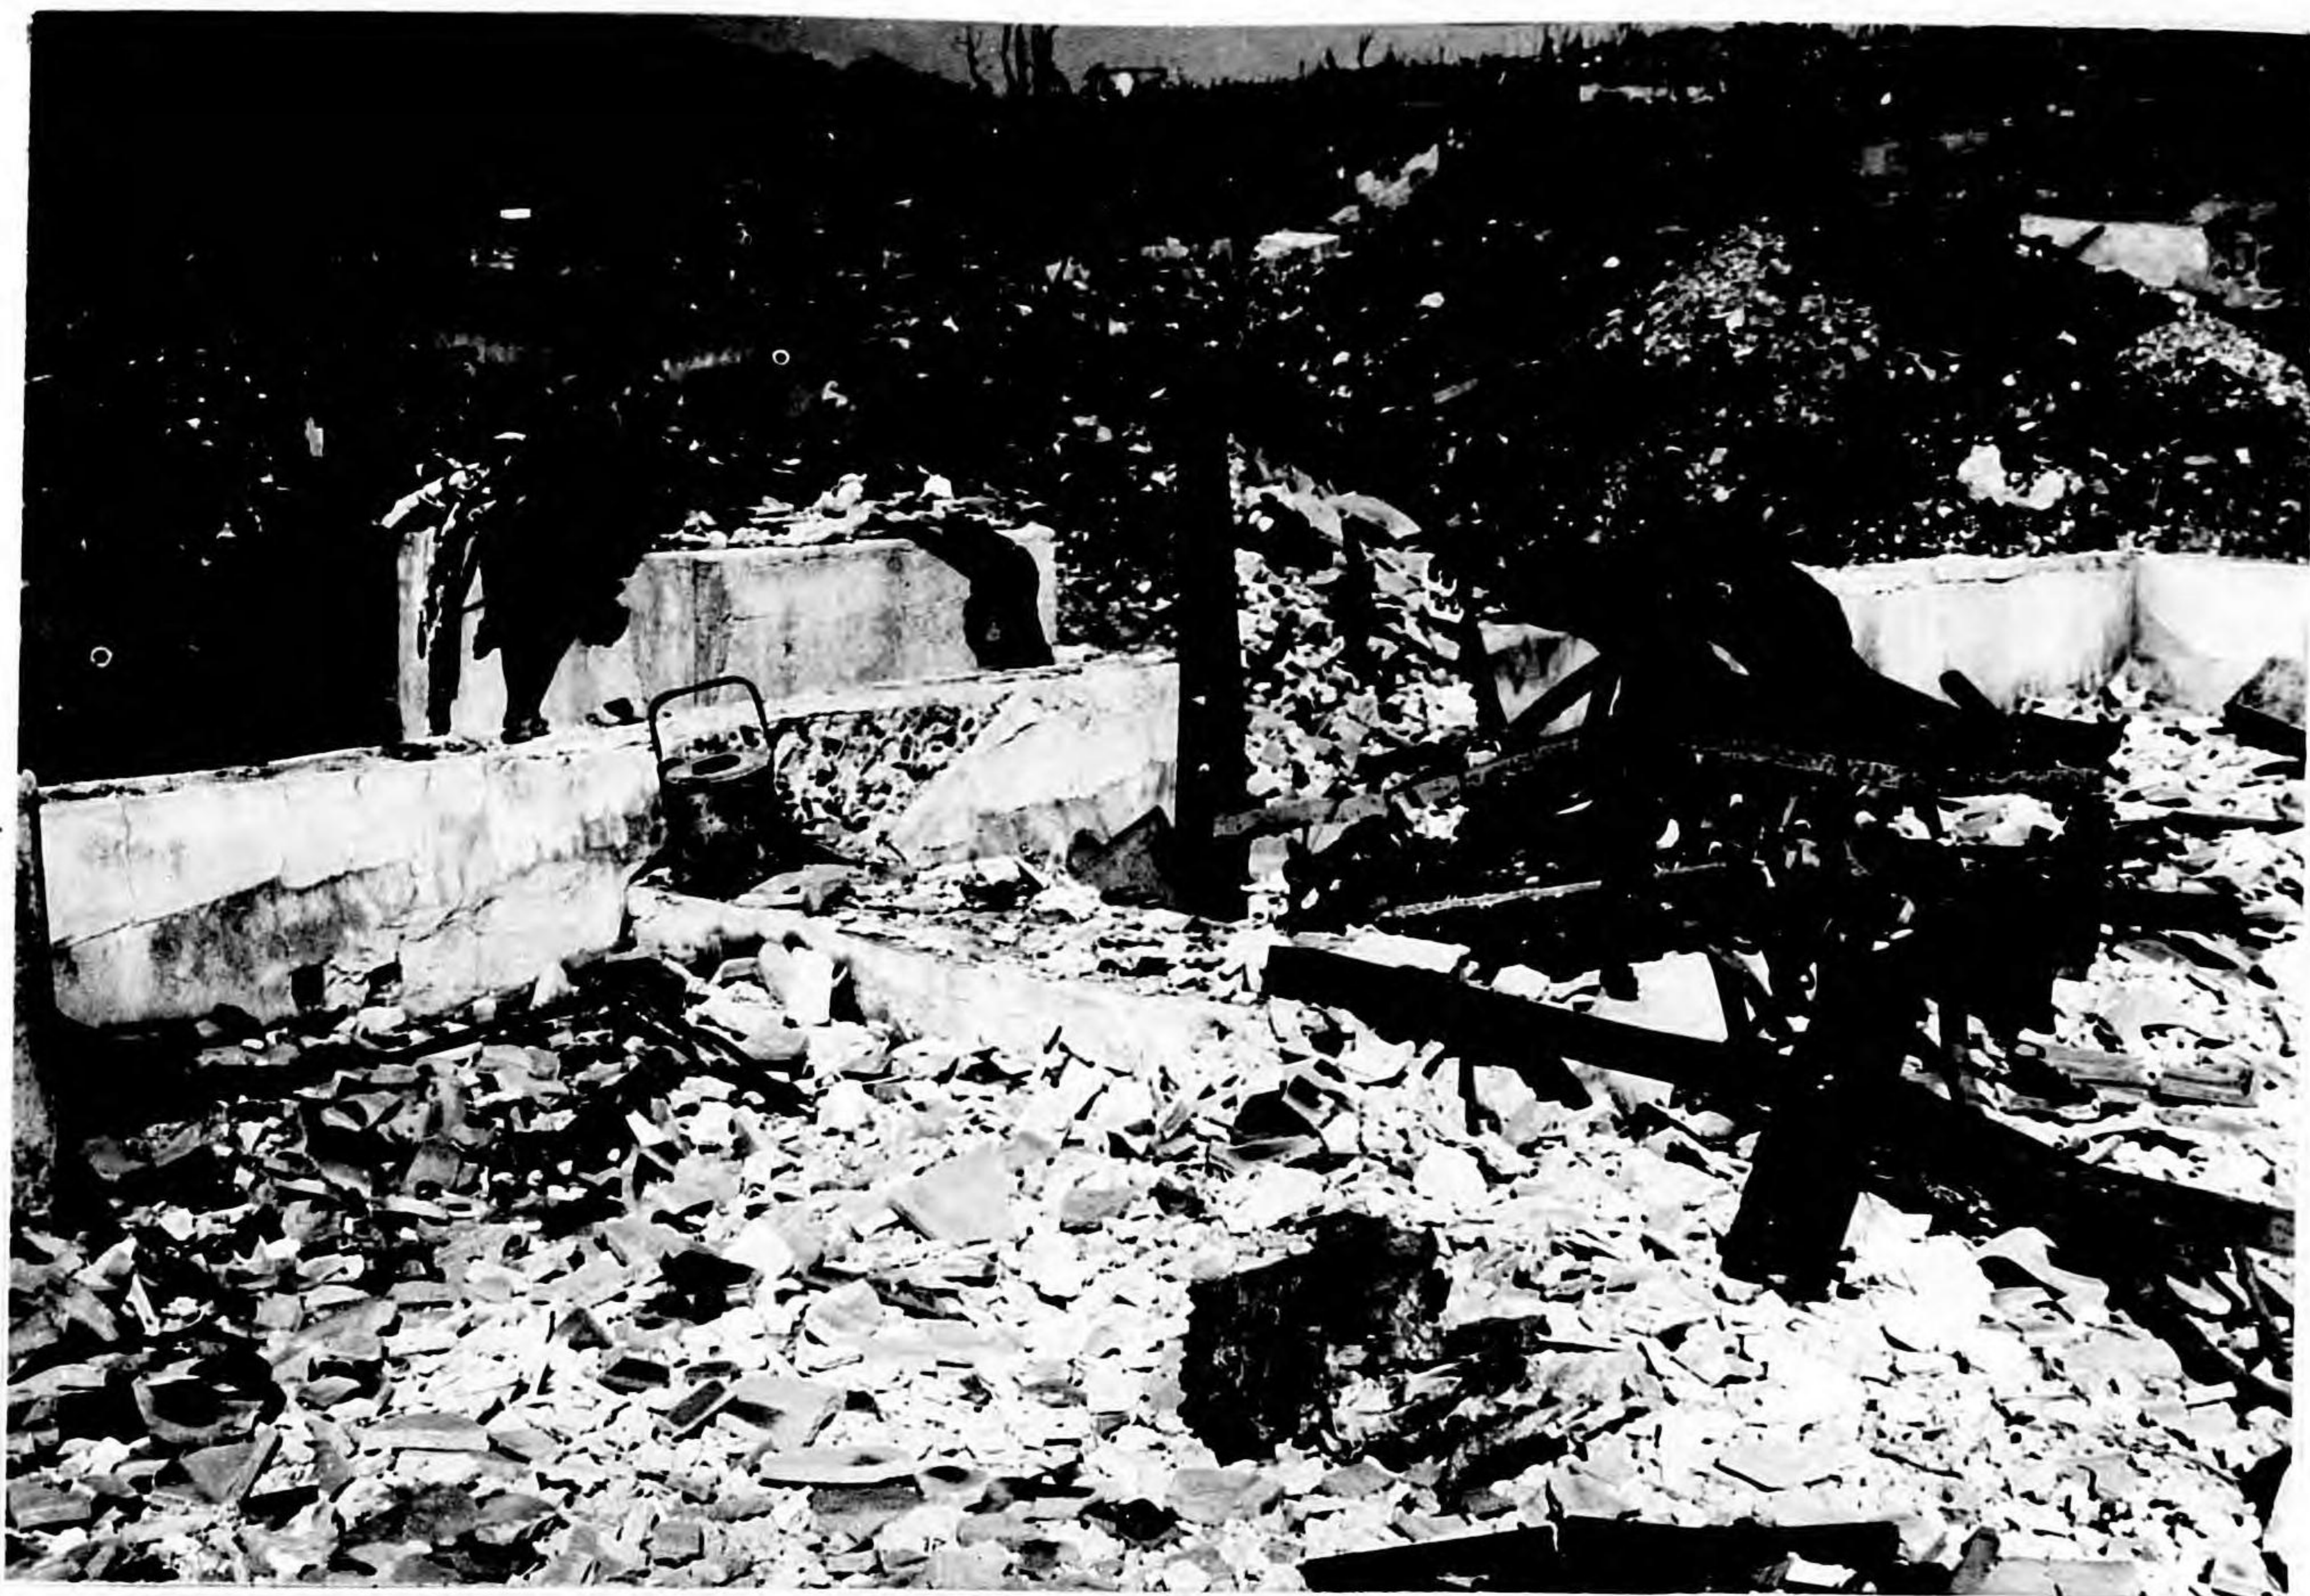
Photo 128. Nagasaki, 2,000 feet from GZ. Electrical system destroyed by fire.

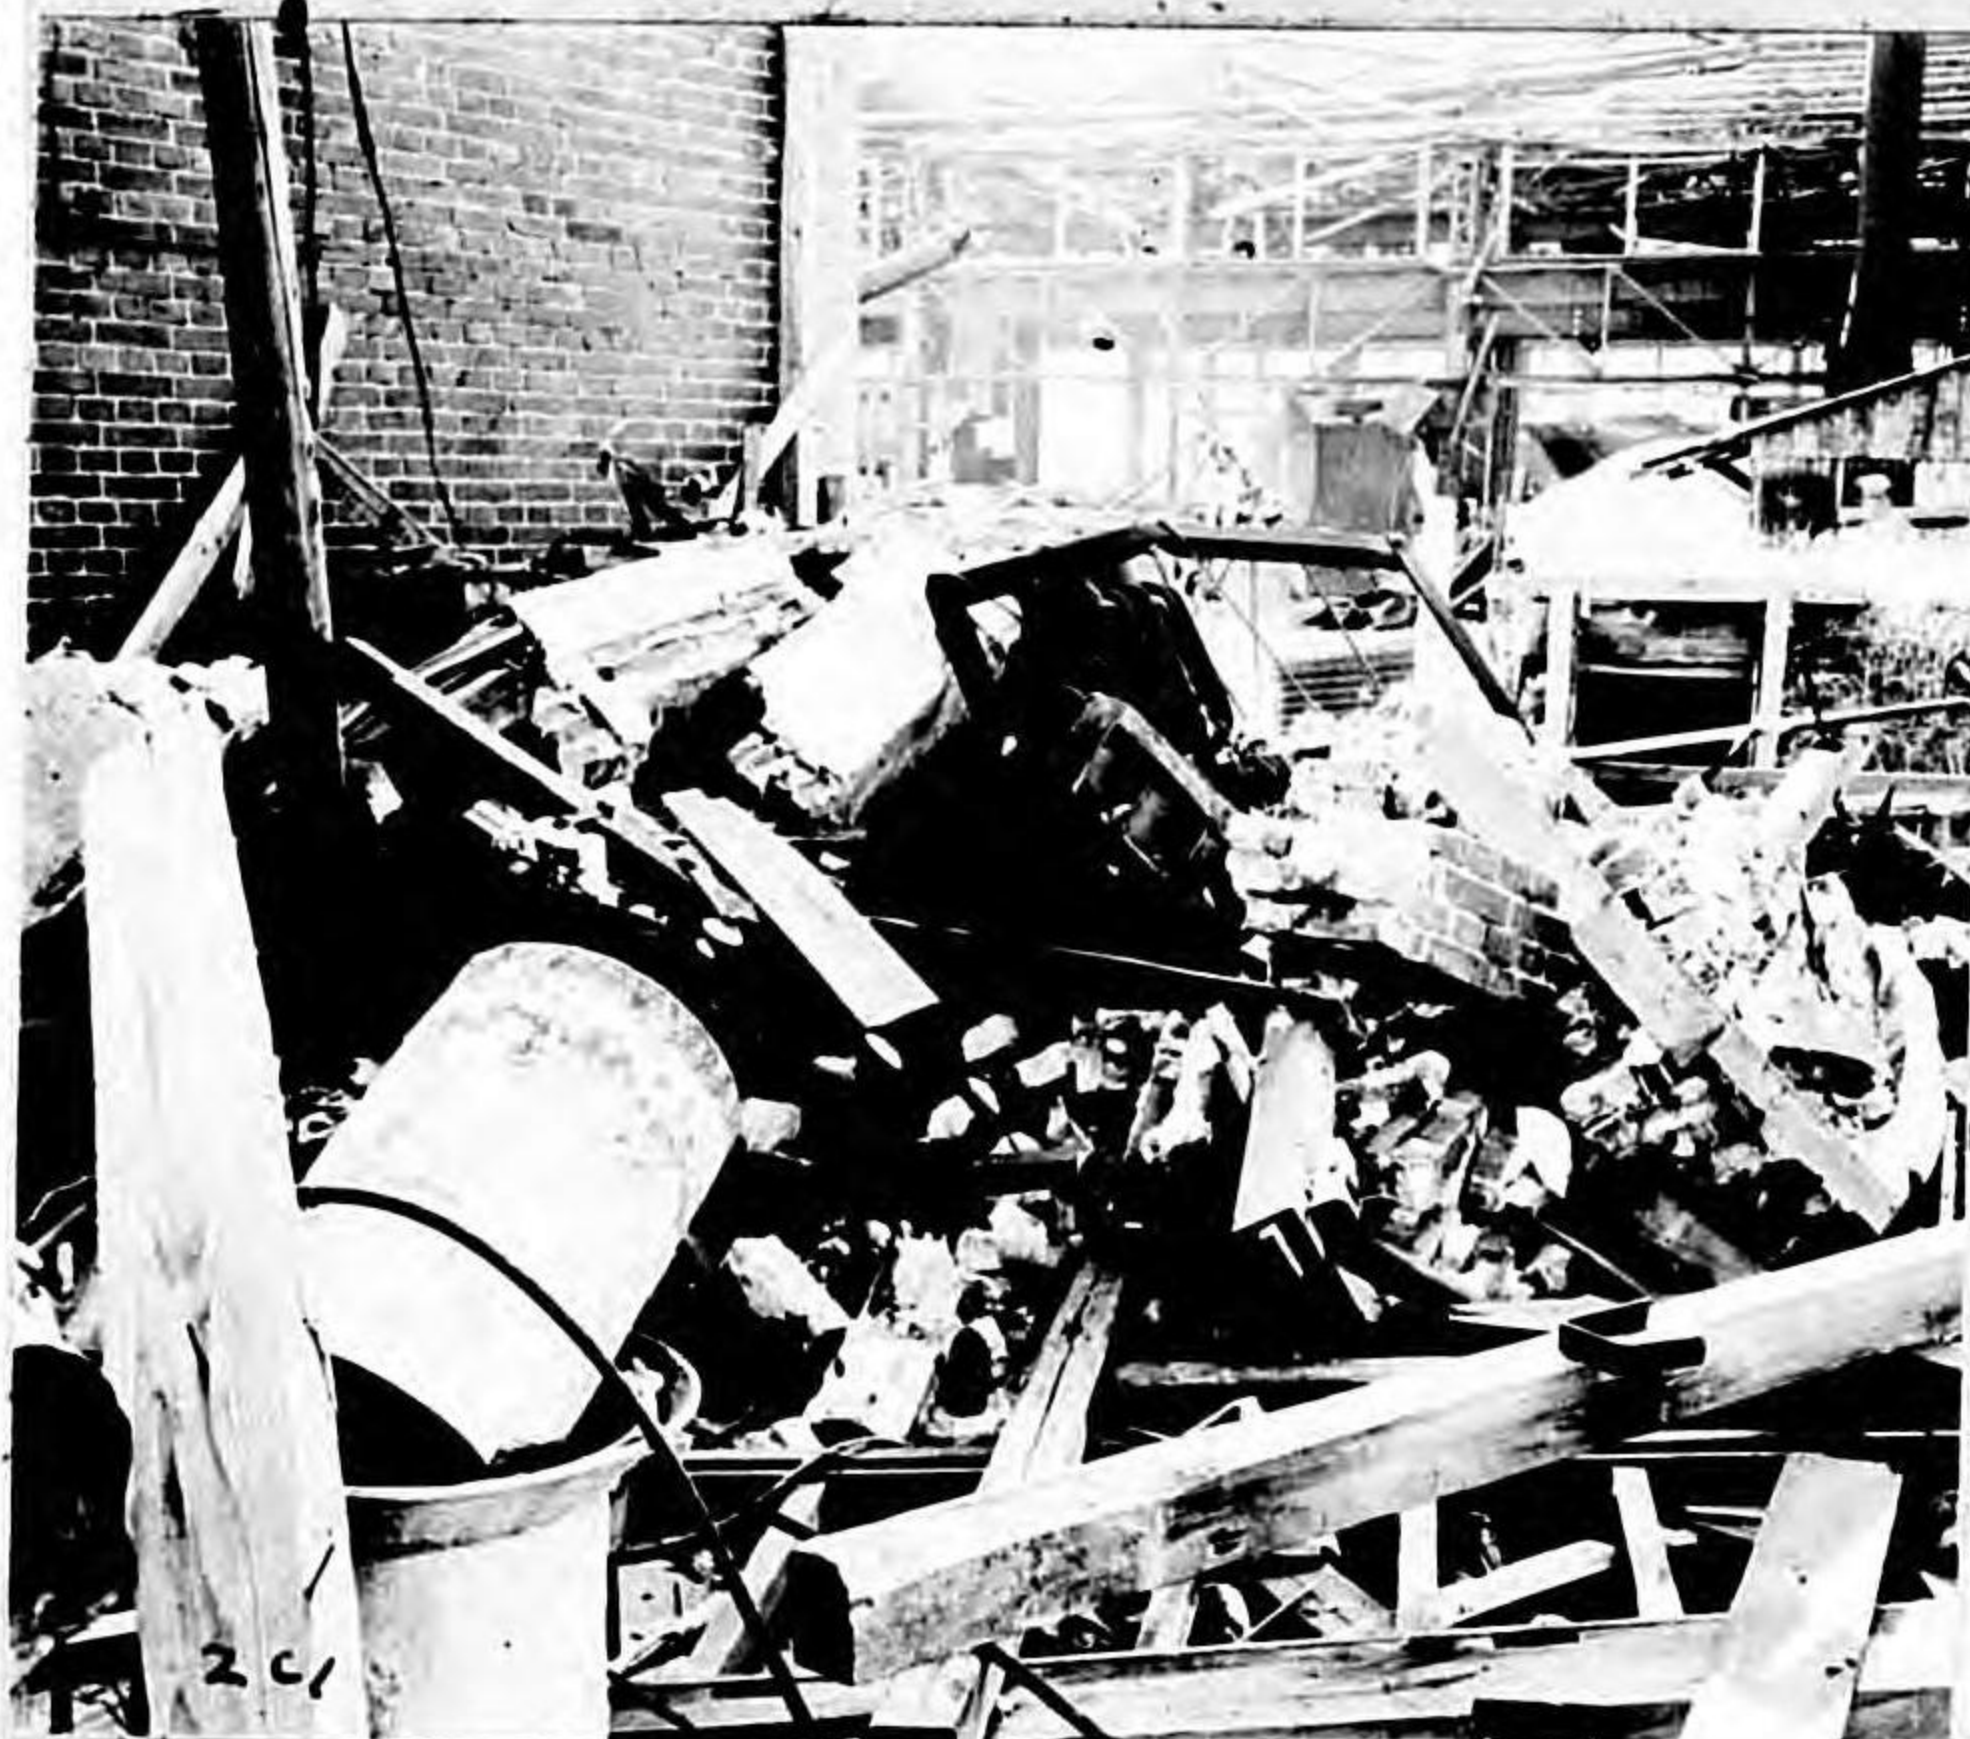
Photo 130. Nagasaki, 3,800 feet from GZ. Transformers overturned but undamaged by blast and debris.

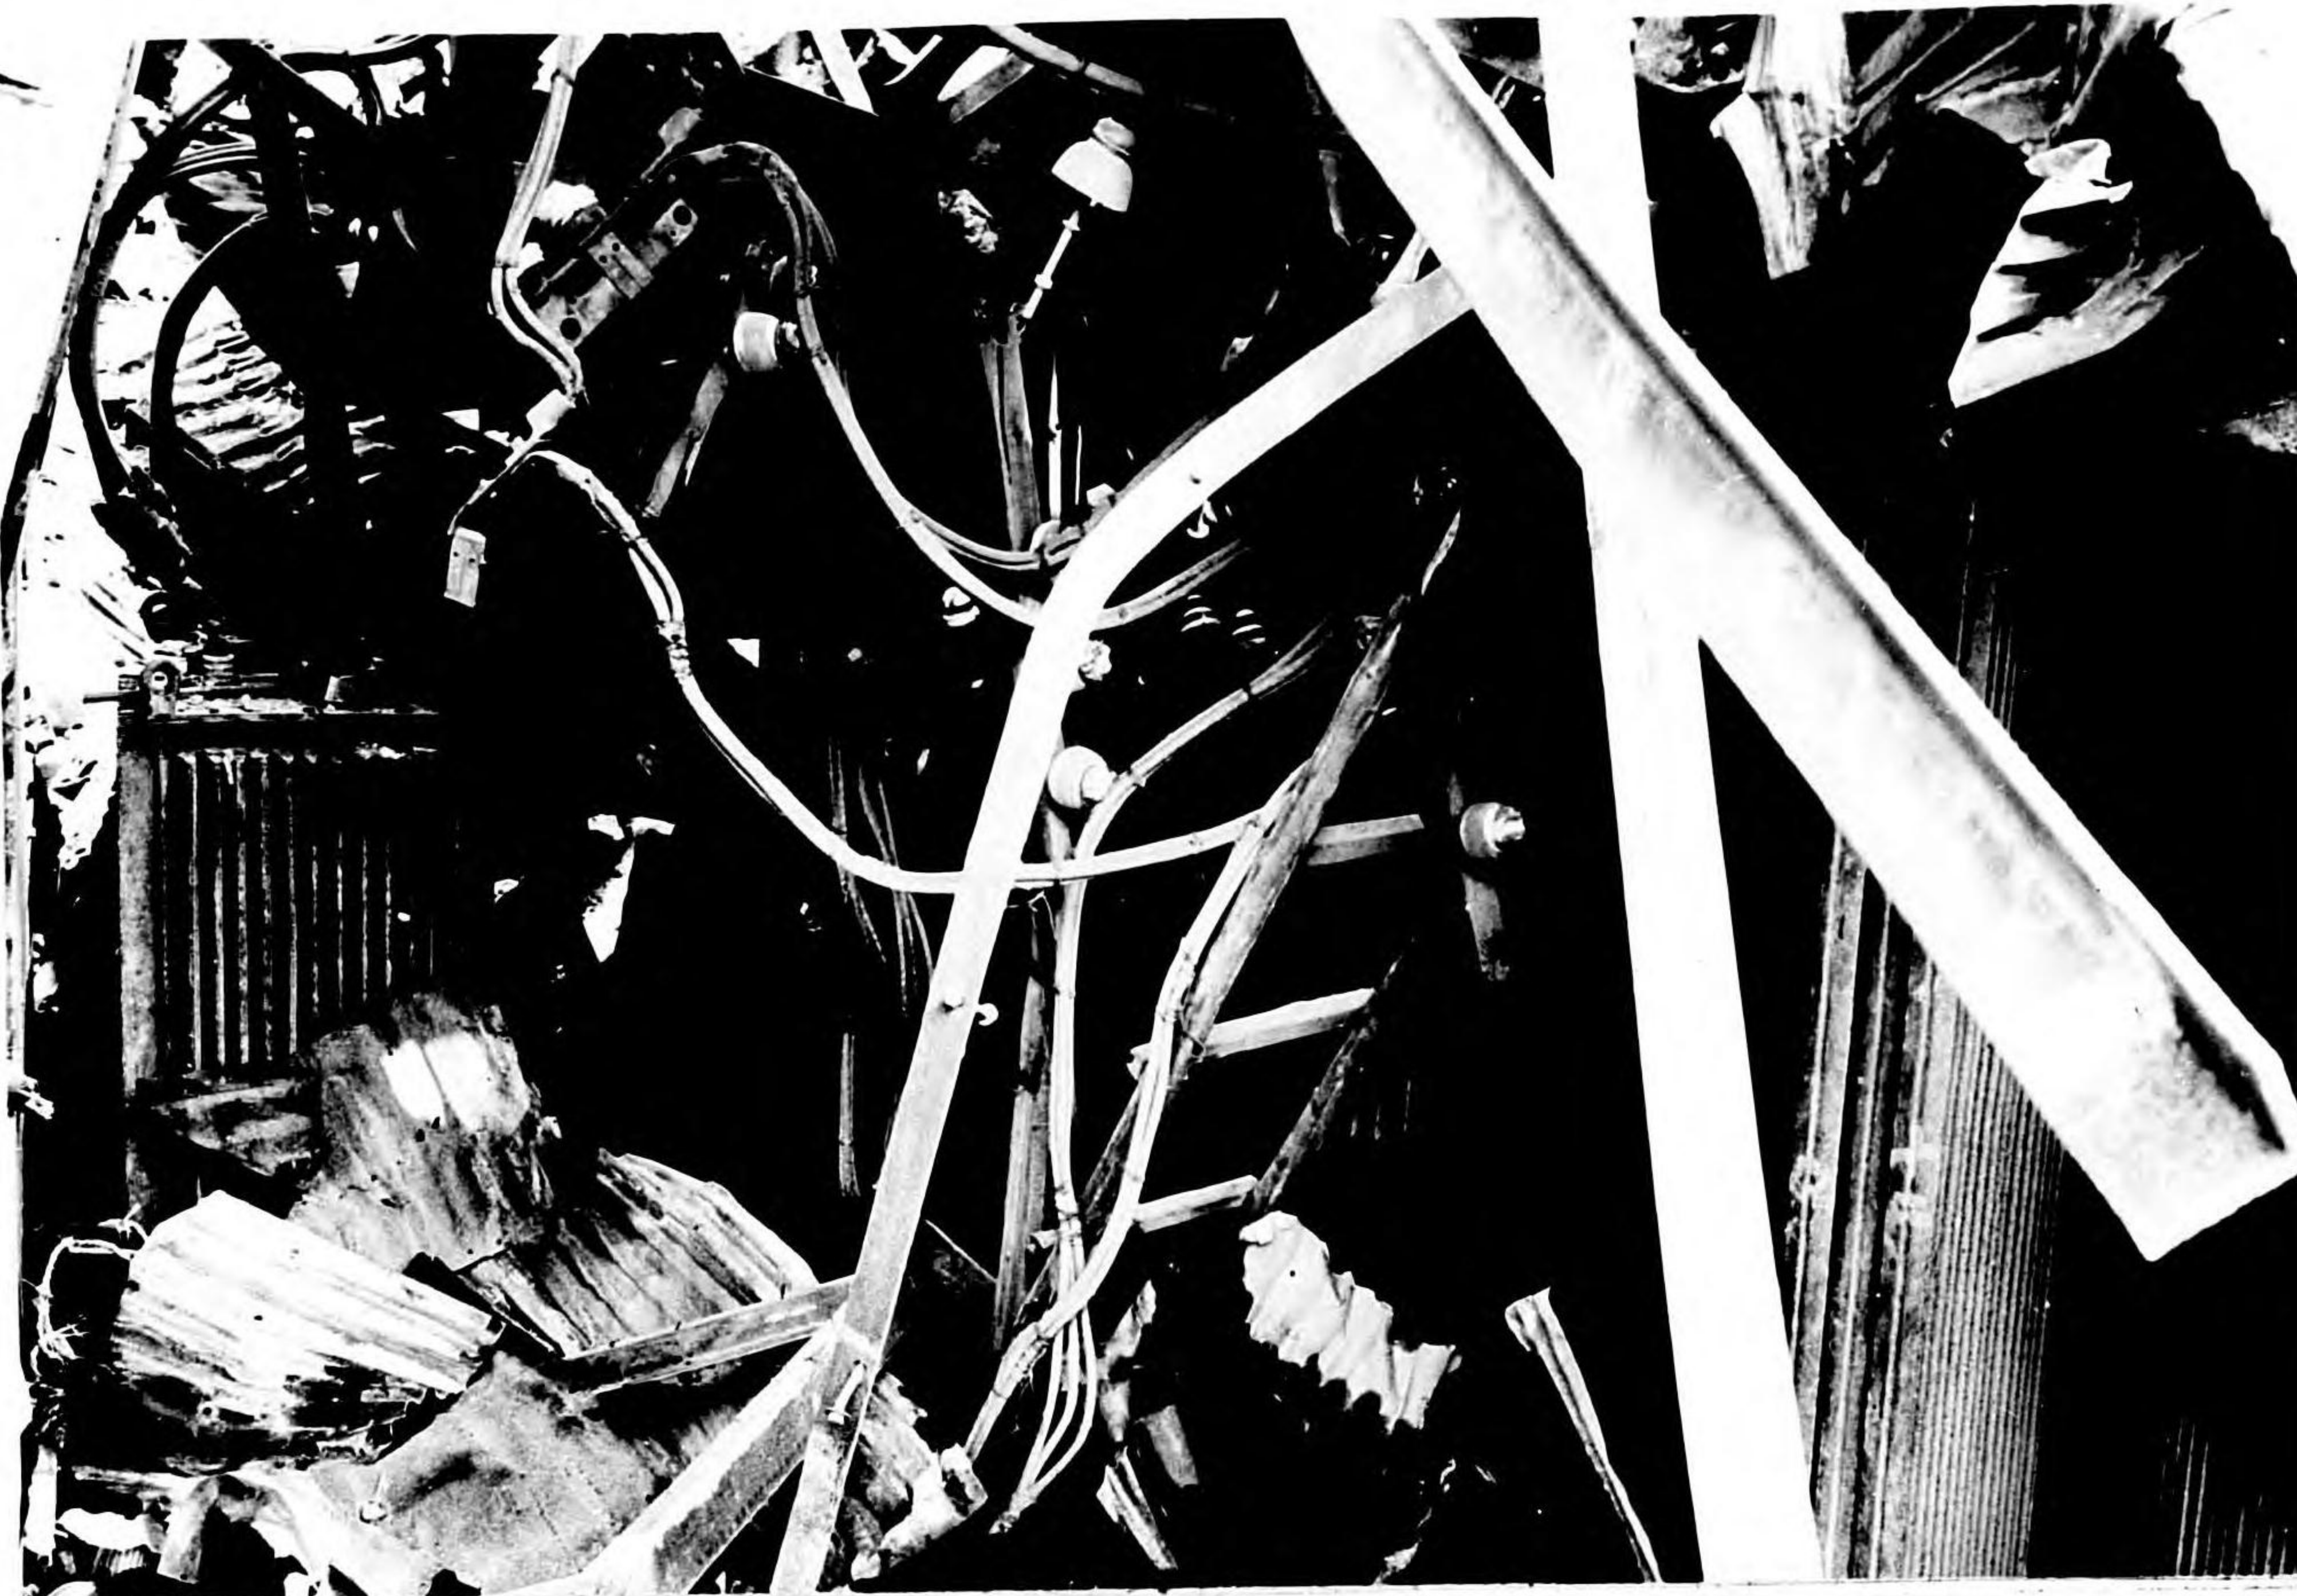
Photo 131. Nagasaki, 3,800 feet from GZ. Debris on transformers for electrical furnace.

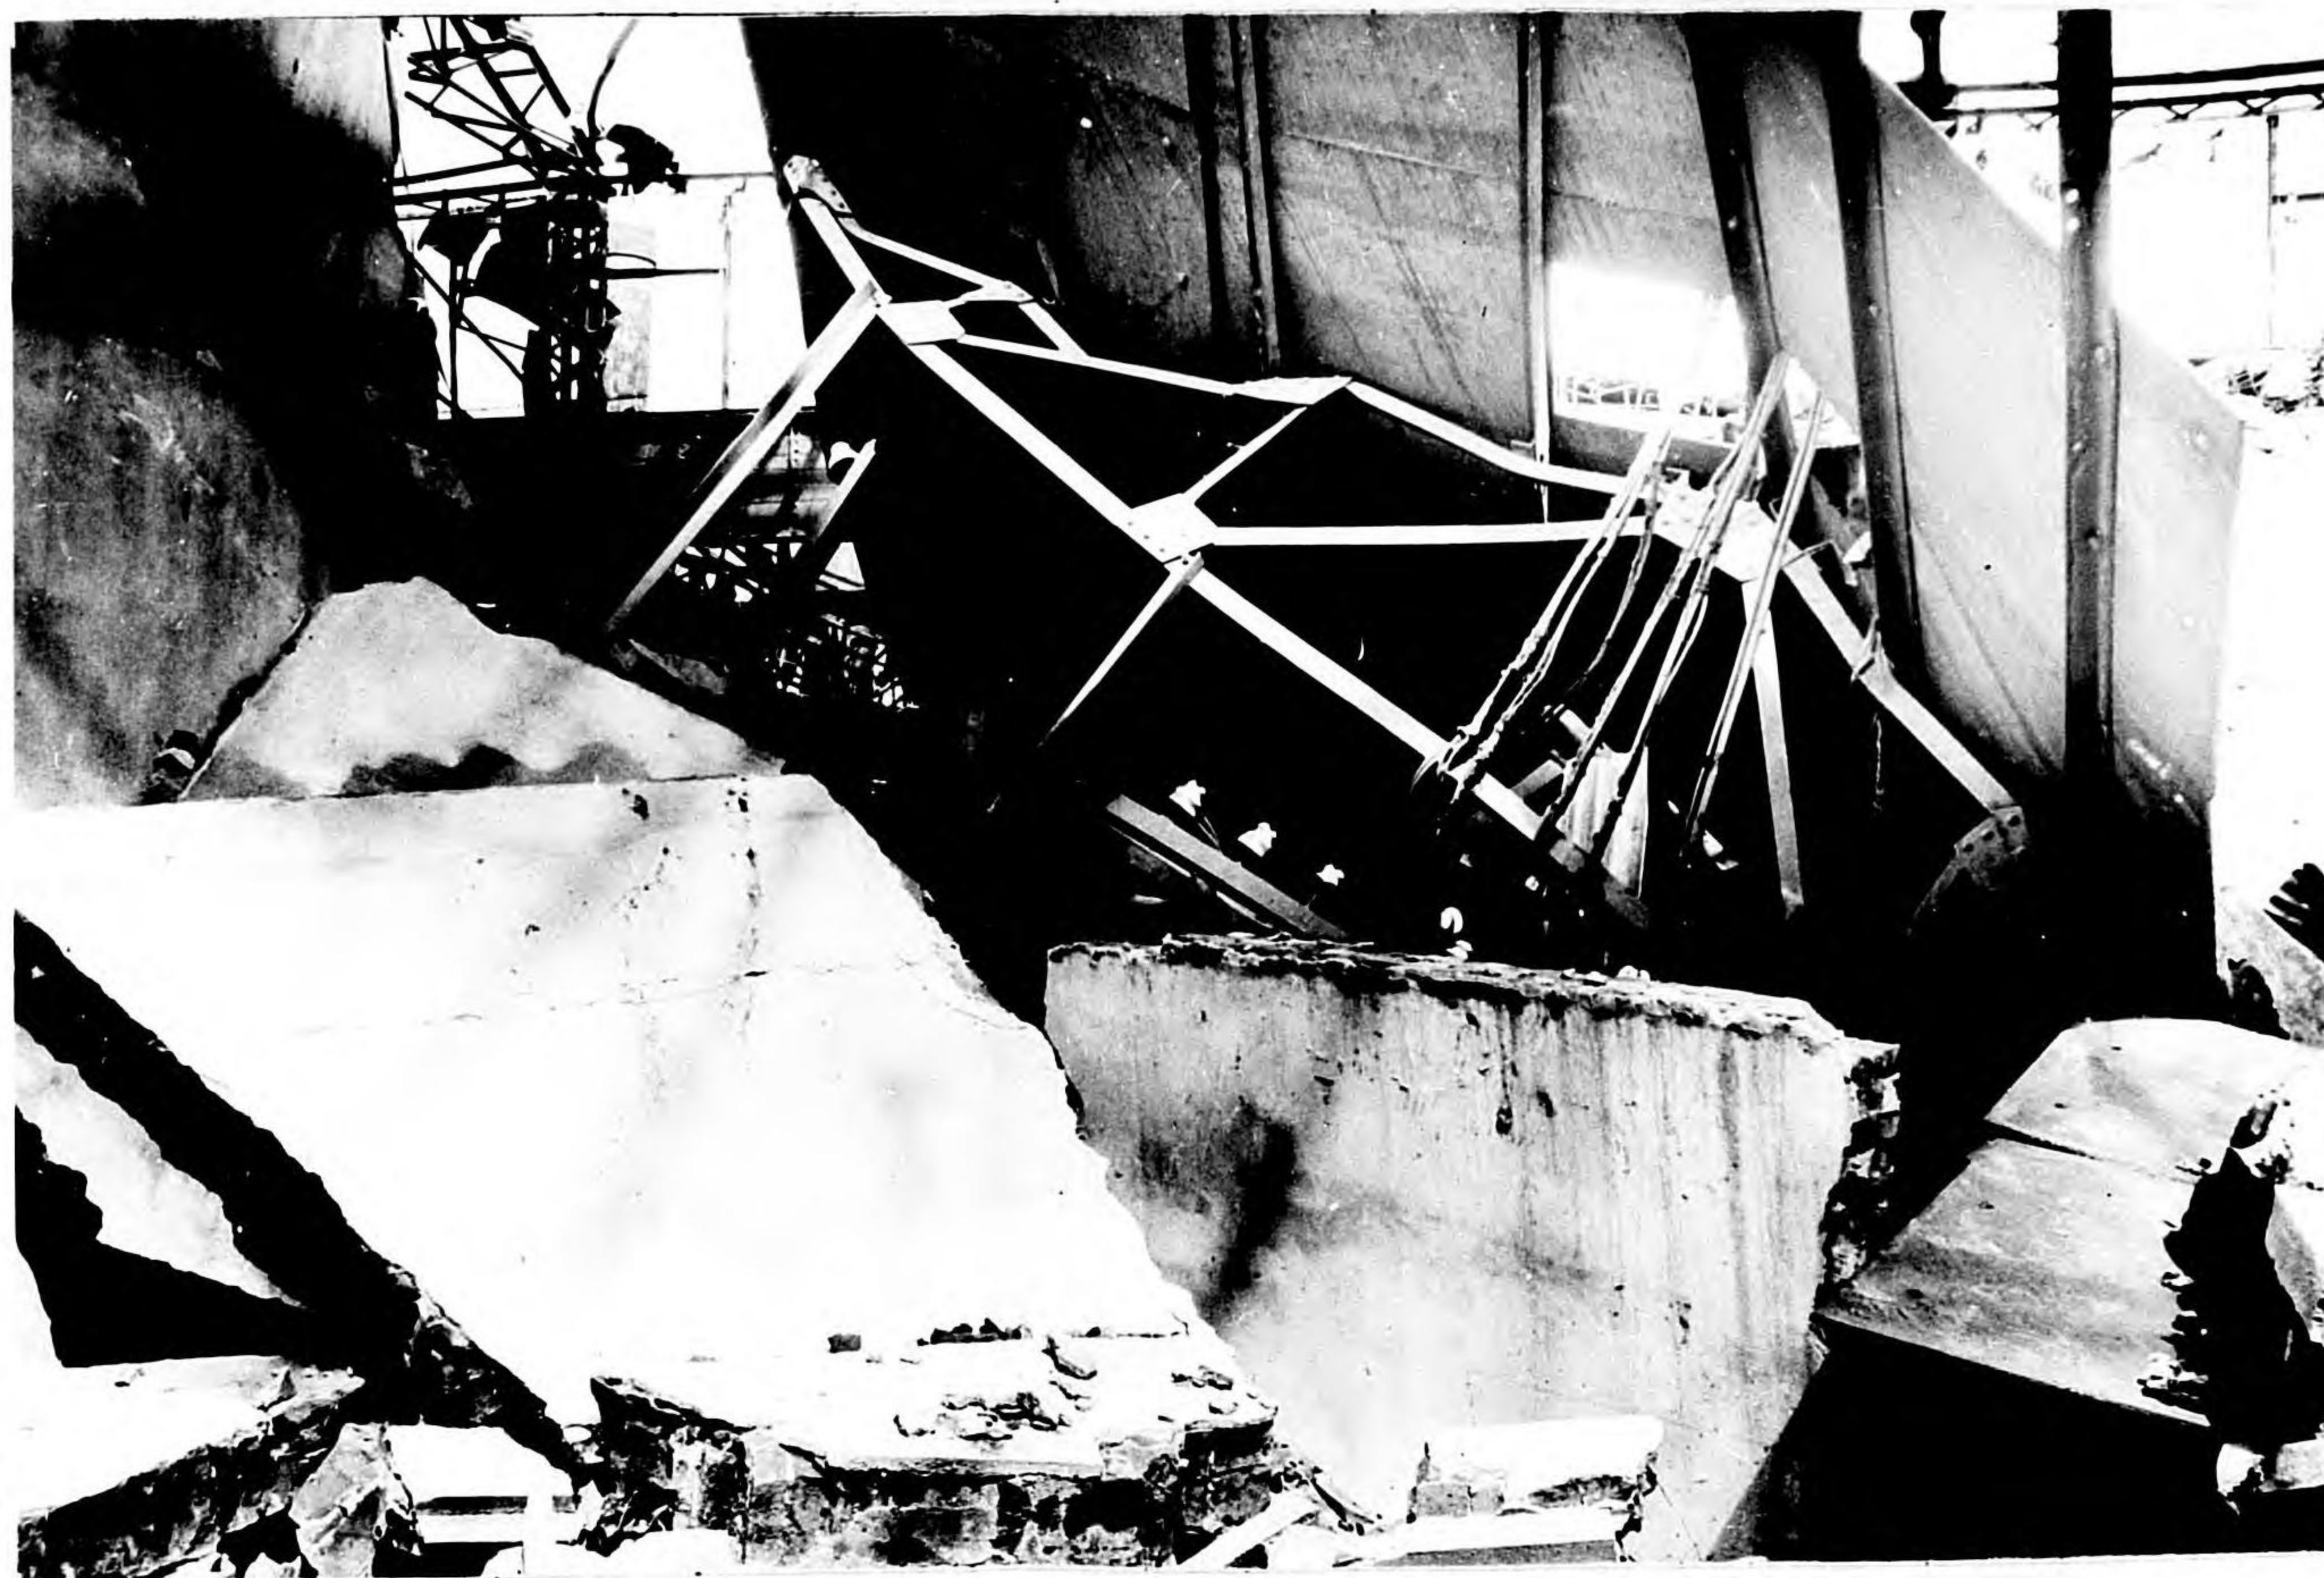
Photo 132. Nagasaki, 3,800 feet from GZ. Bus structure damaged by blast.

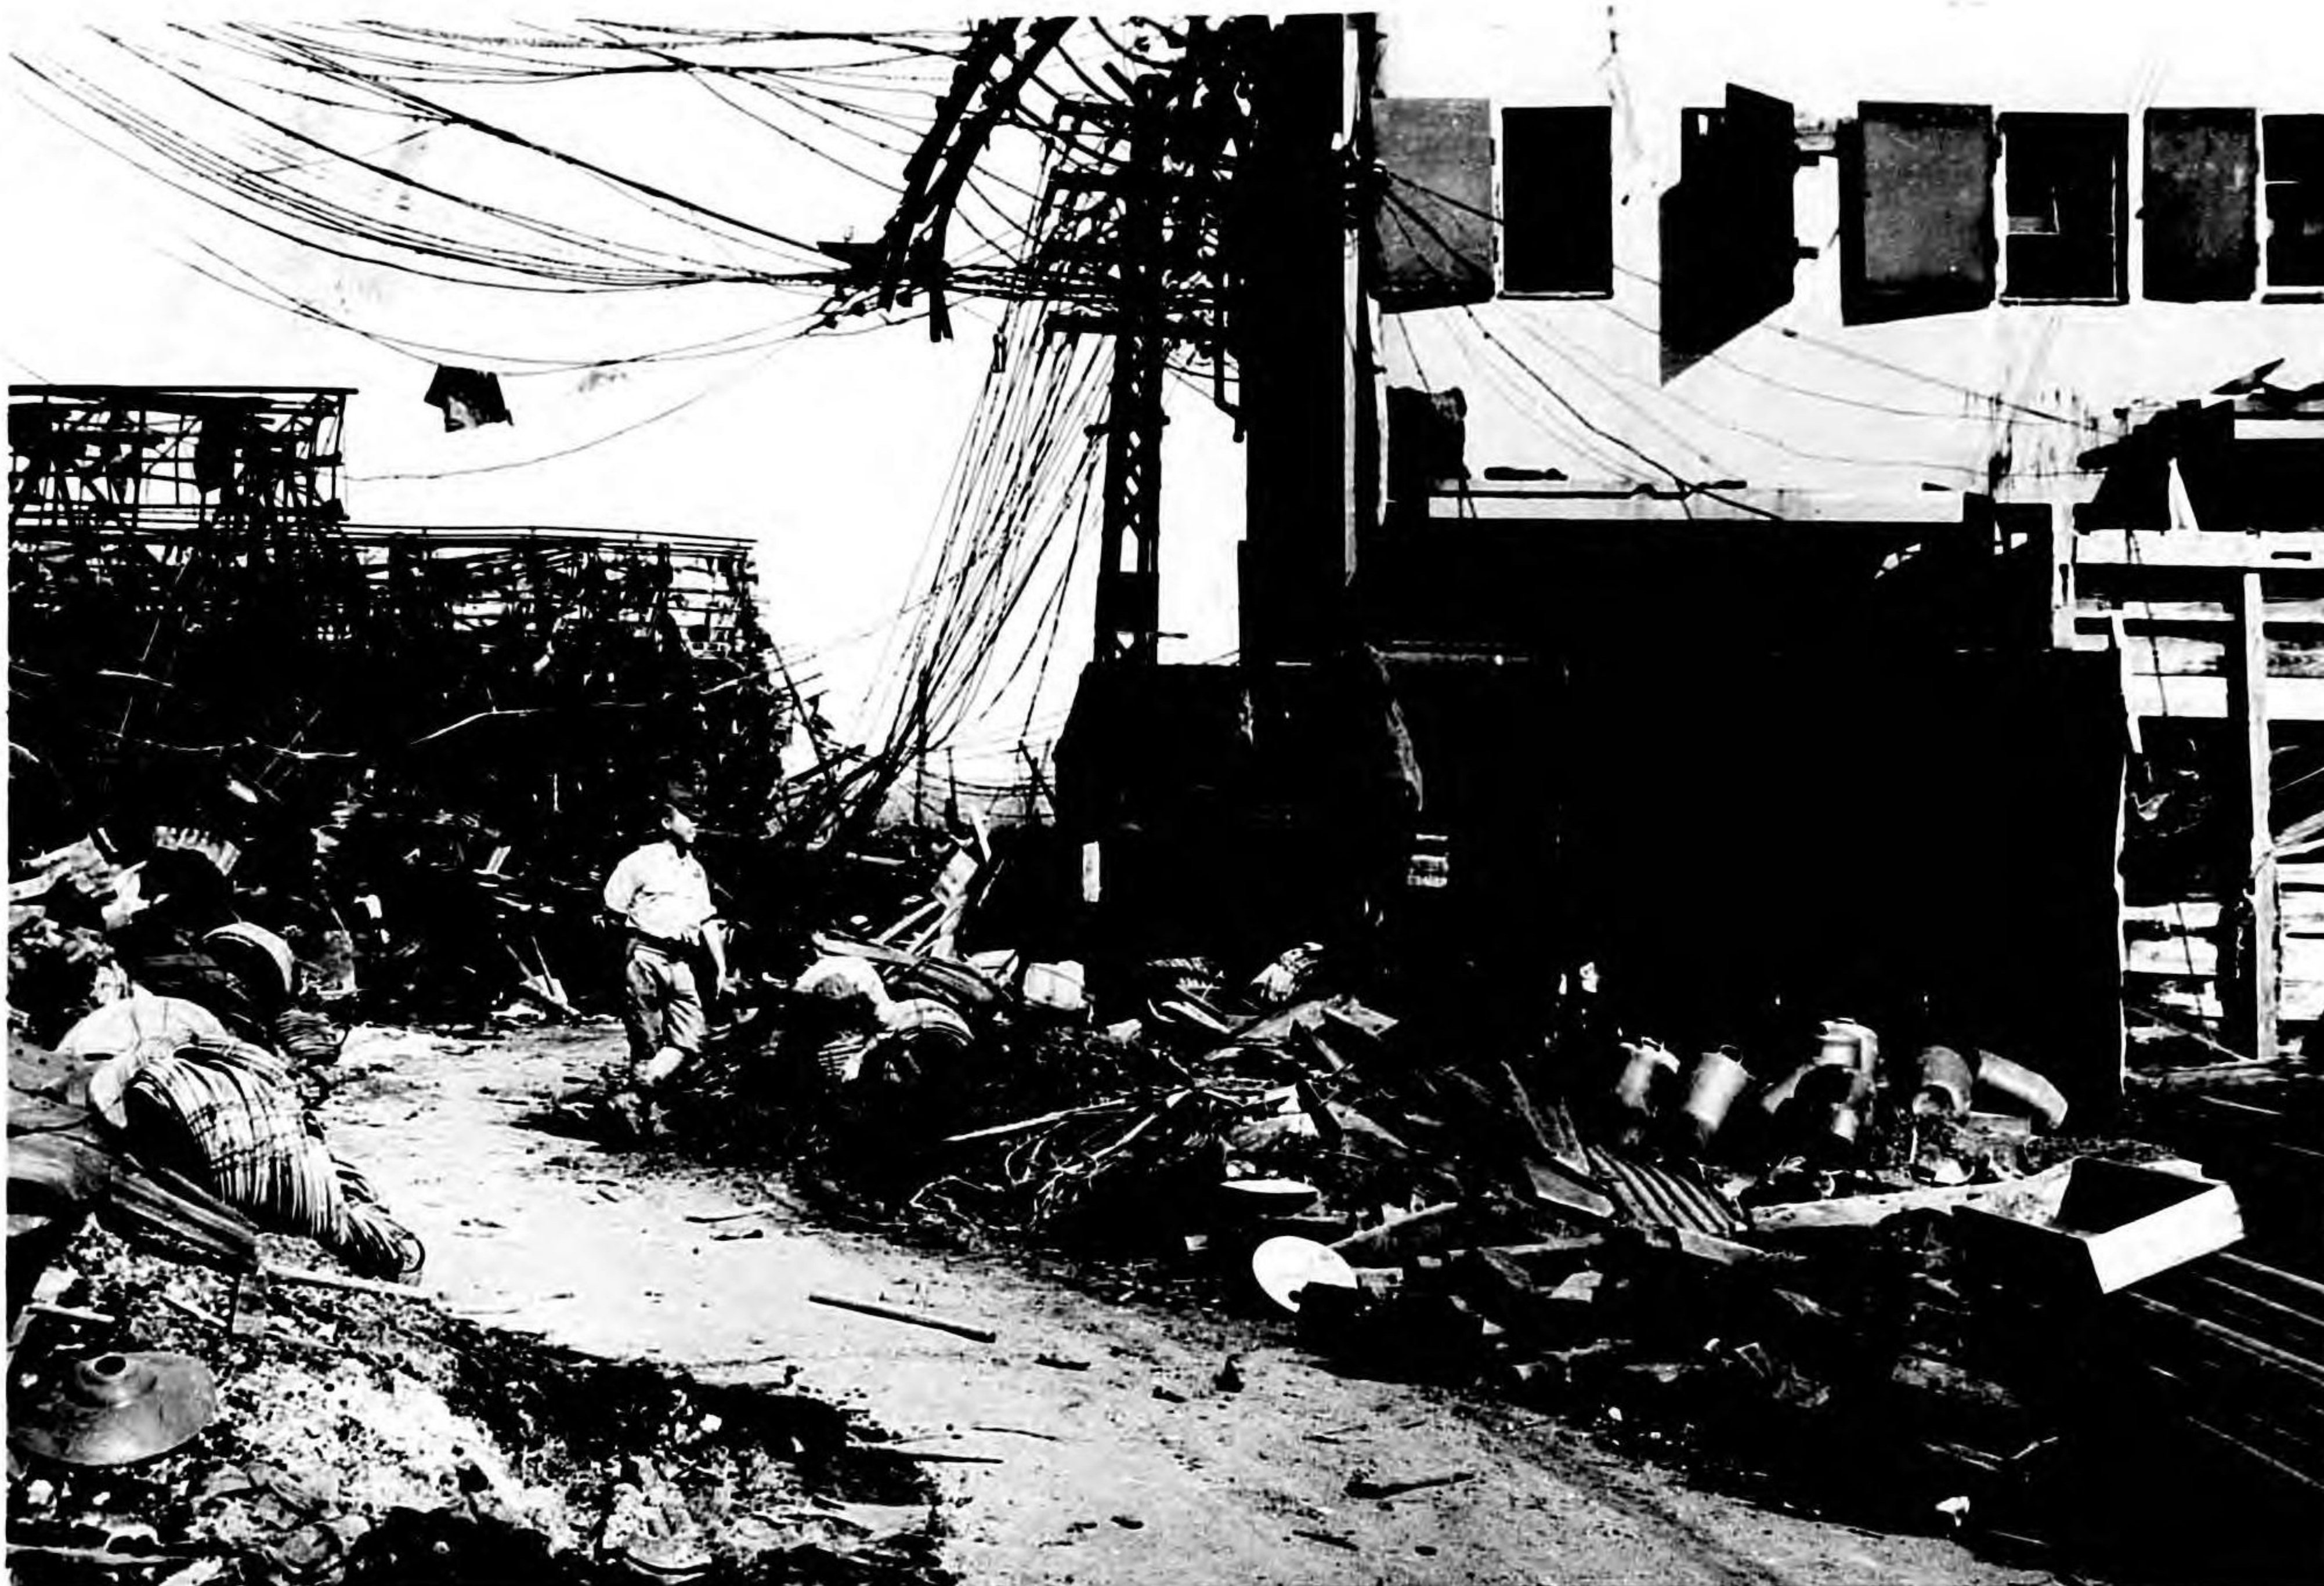
Photo 133. Nagasaki, 3,400 feet from GZ. Typical blast damage to overhead wiring.
