DAMAGE TO MACHINE TOOLS BY ATOMIC BOMB

CHAPTER V
DAMAGE TO UTILITIES

ATOMIC BOMBS
PLANT UTILITIES
HIROSHIMA - NAGASAKI

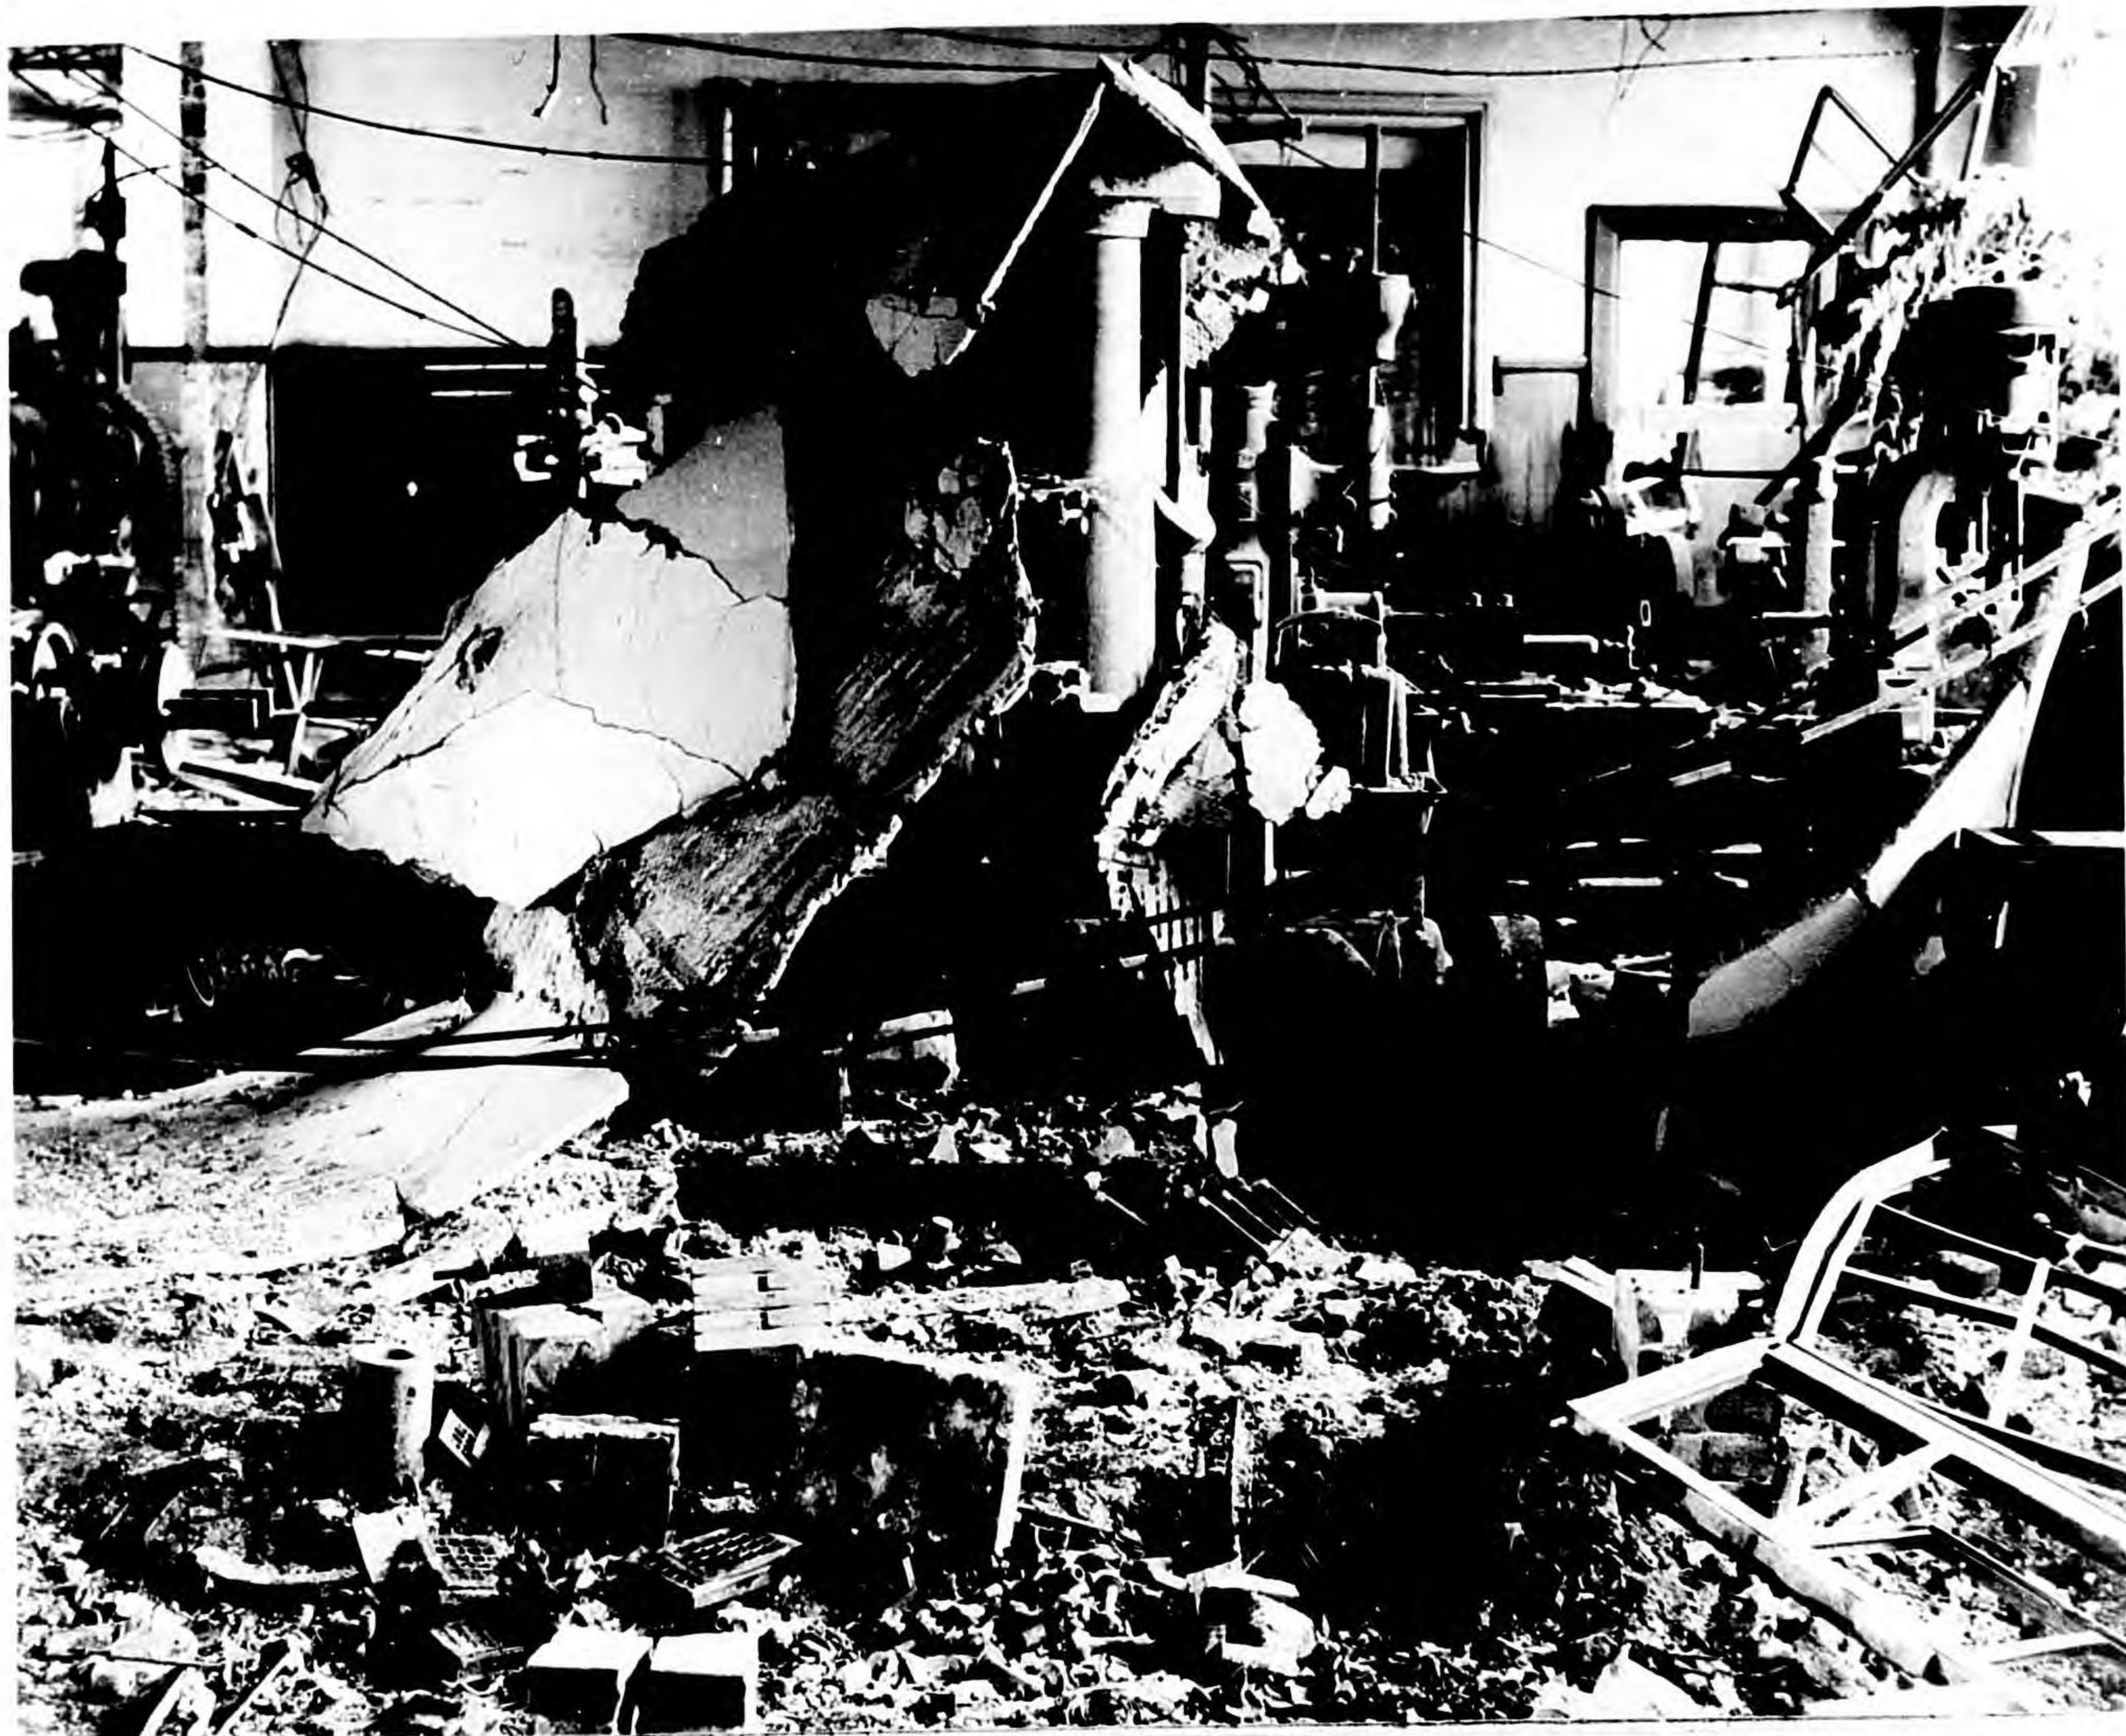
Photo 135. Nagasaki, 3,700 feet from GZ. Radial driller on first floor damaged by debris and fire.

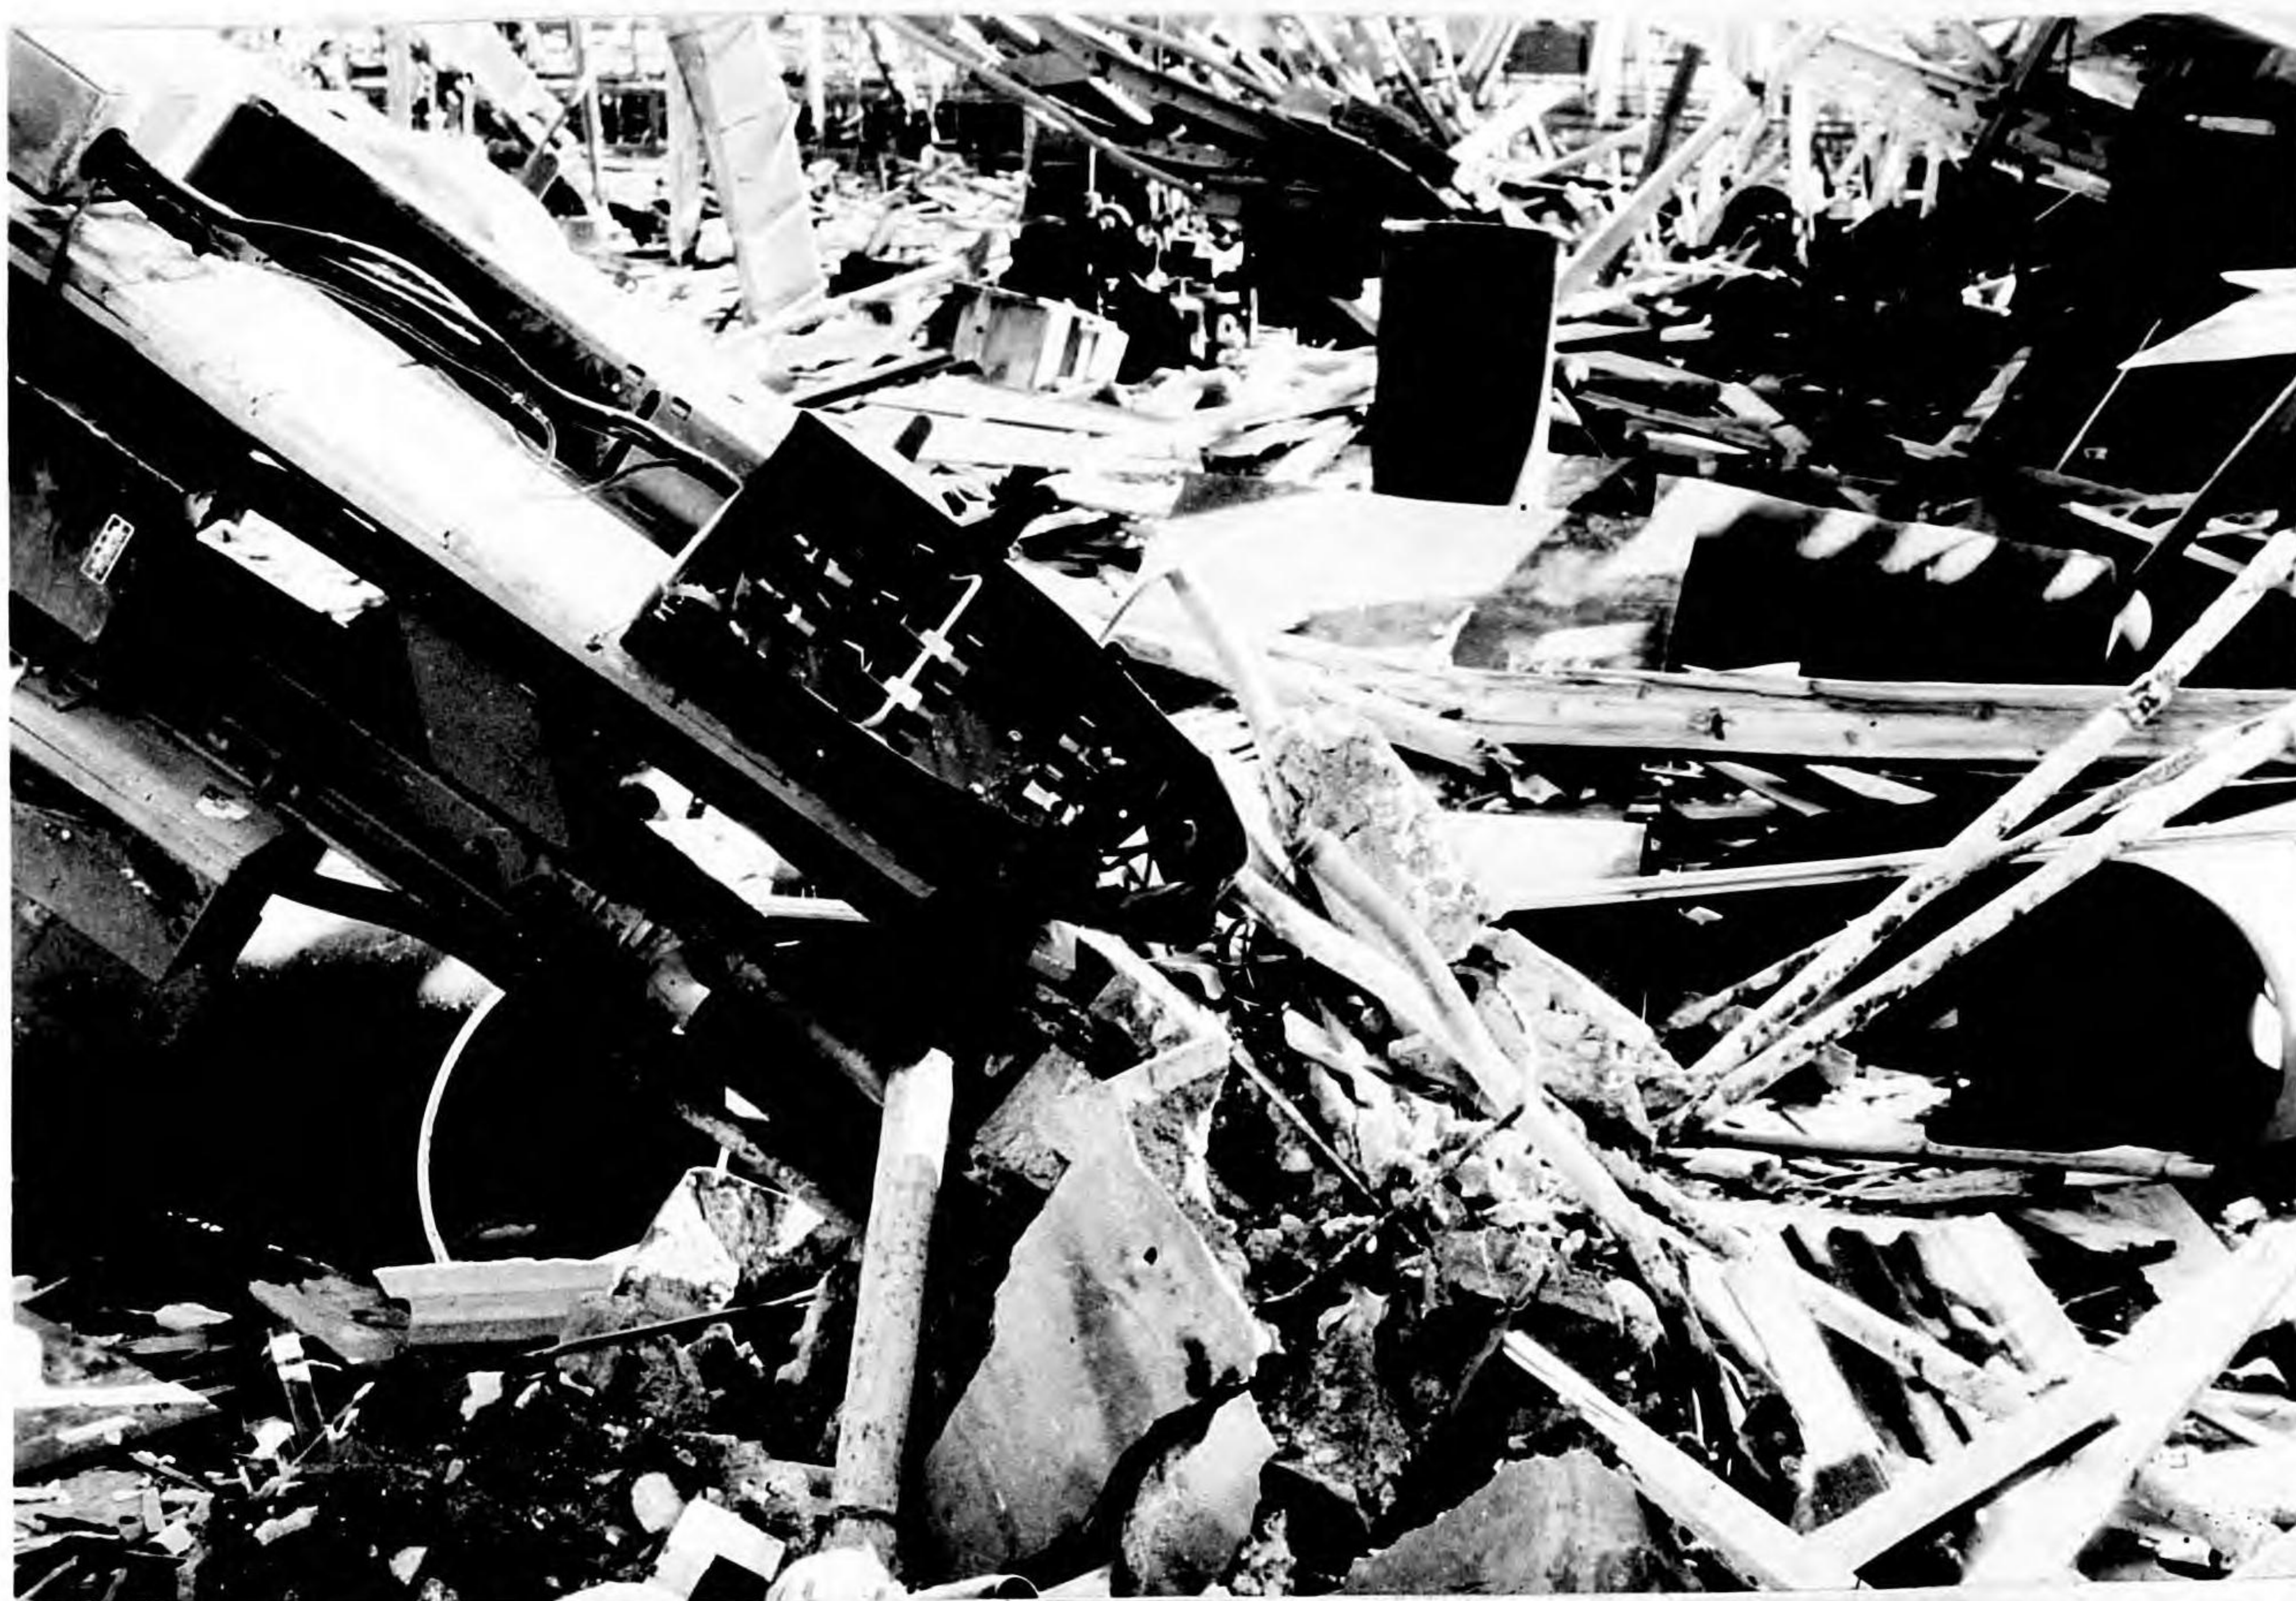
Photo 138. Nagasaki, 4,200 feet from GZ. Utilities destroyed by collapsed structure.

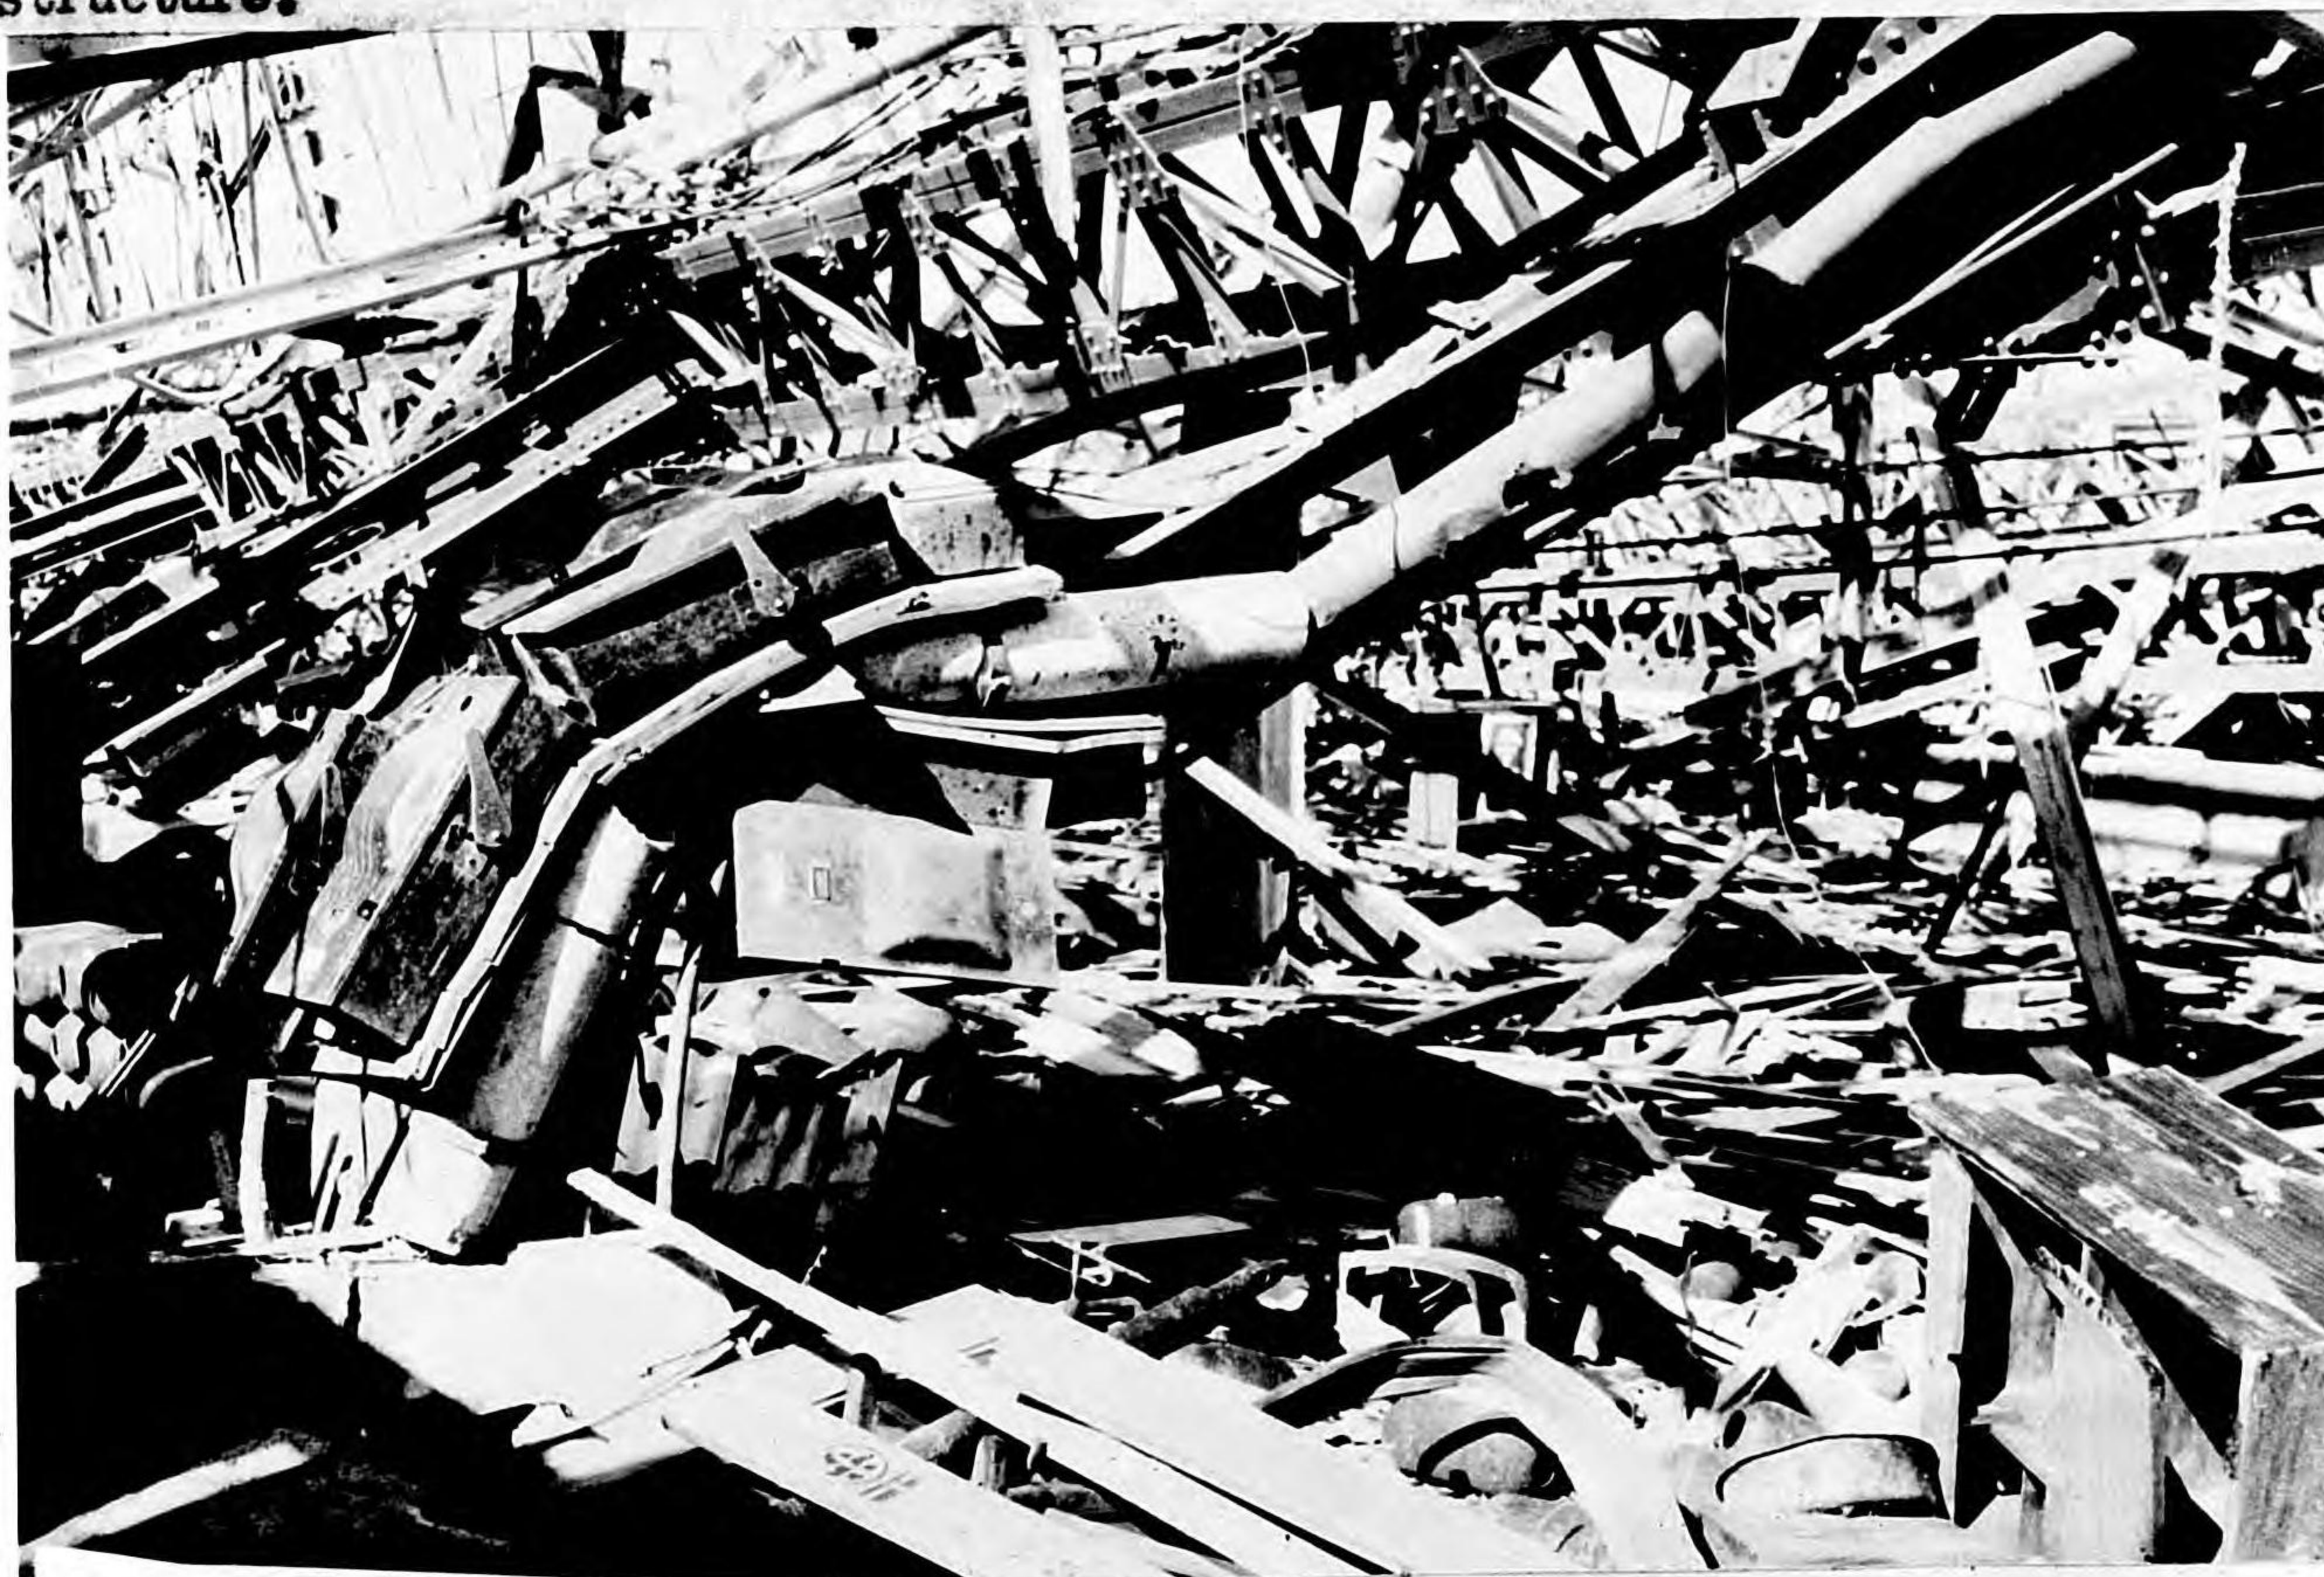
Photo 139. Nagasaki, 4,200 feet from GZ. Typical utility damage in steel-
structure.

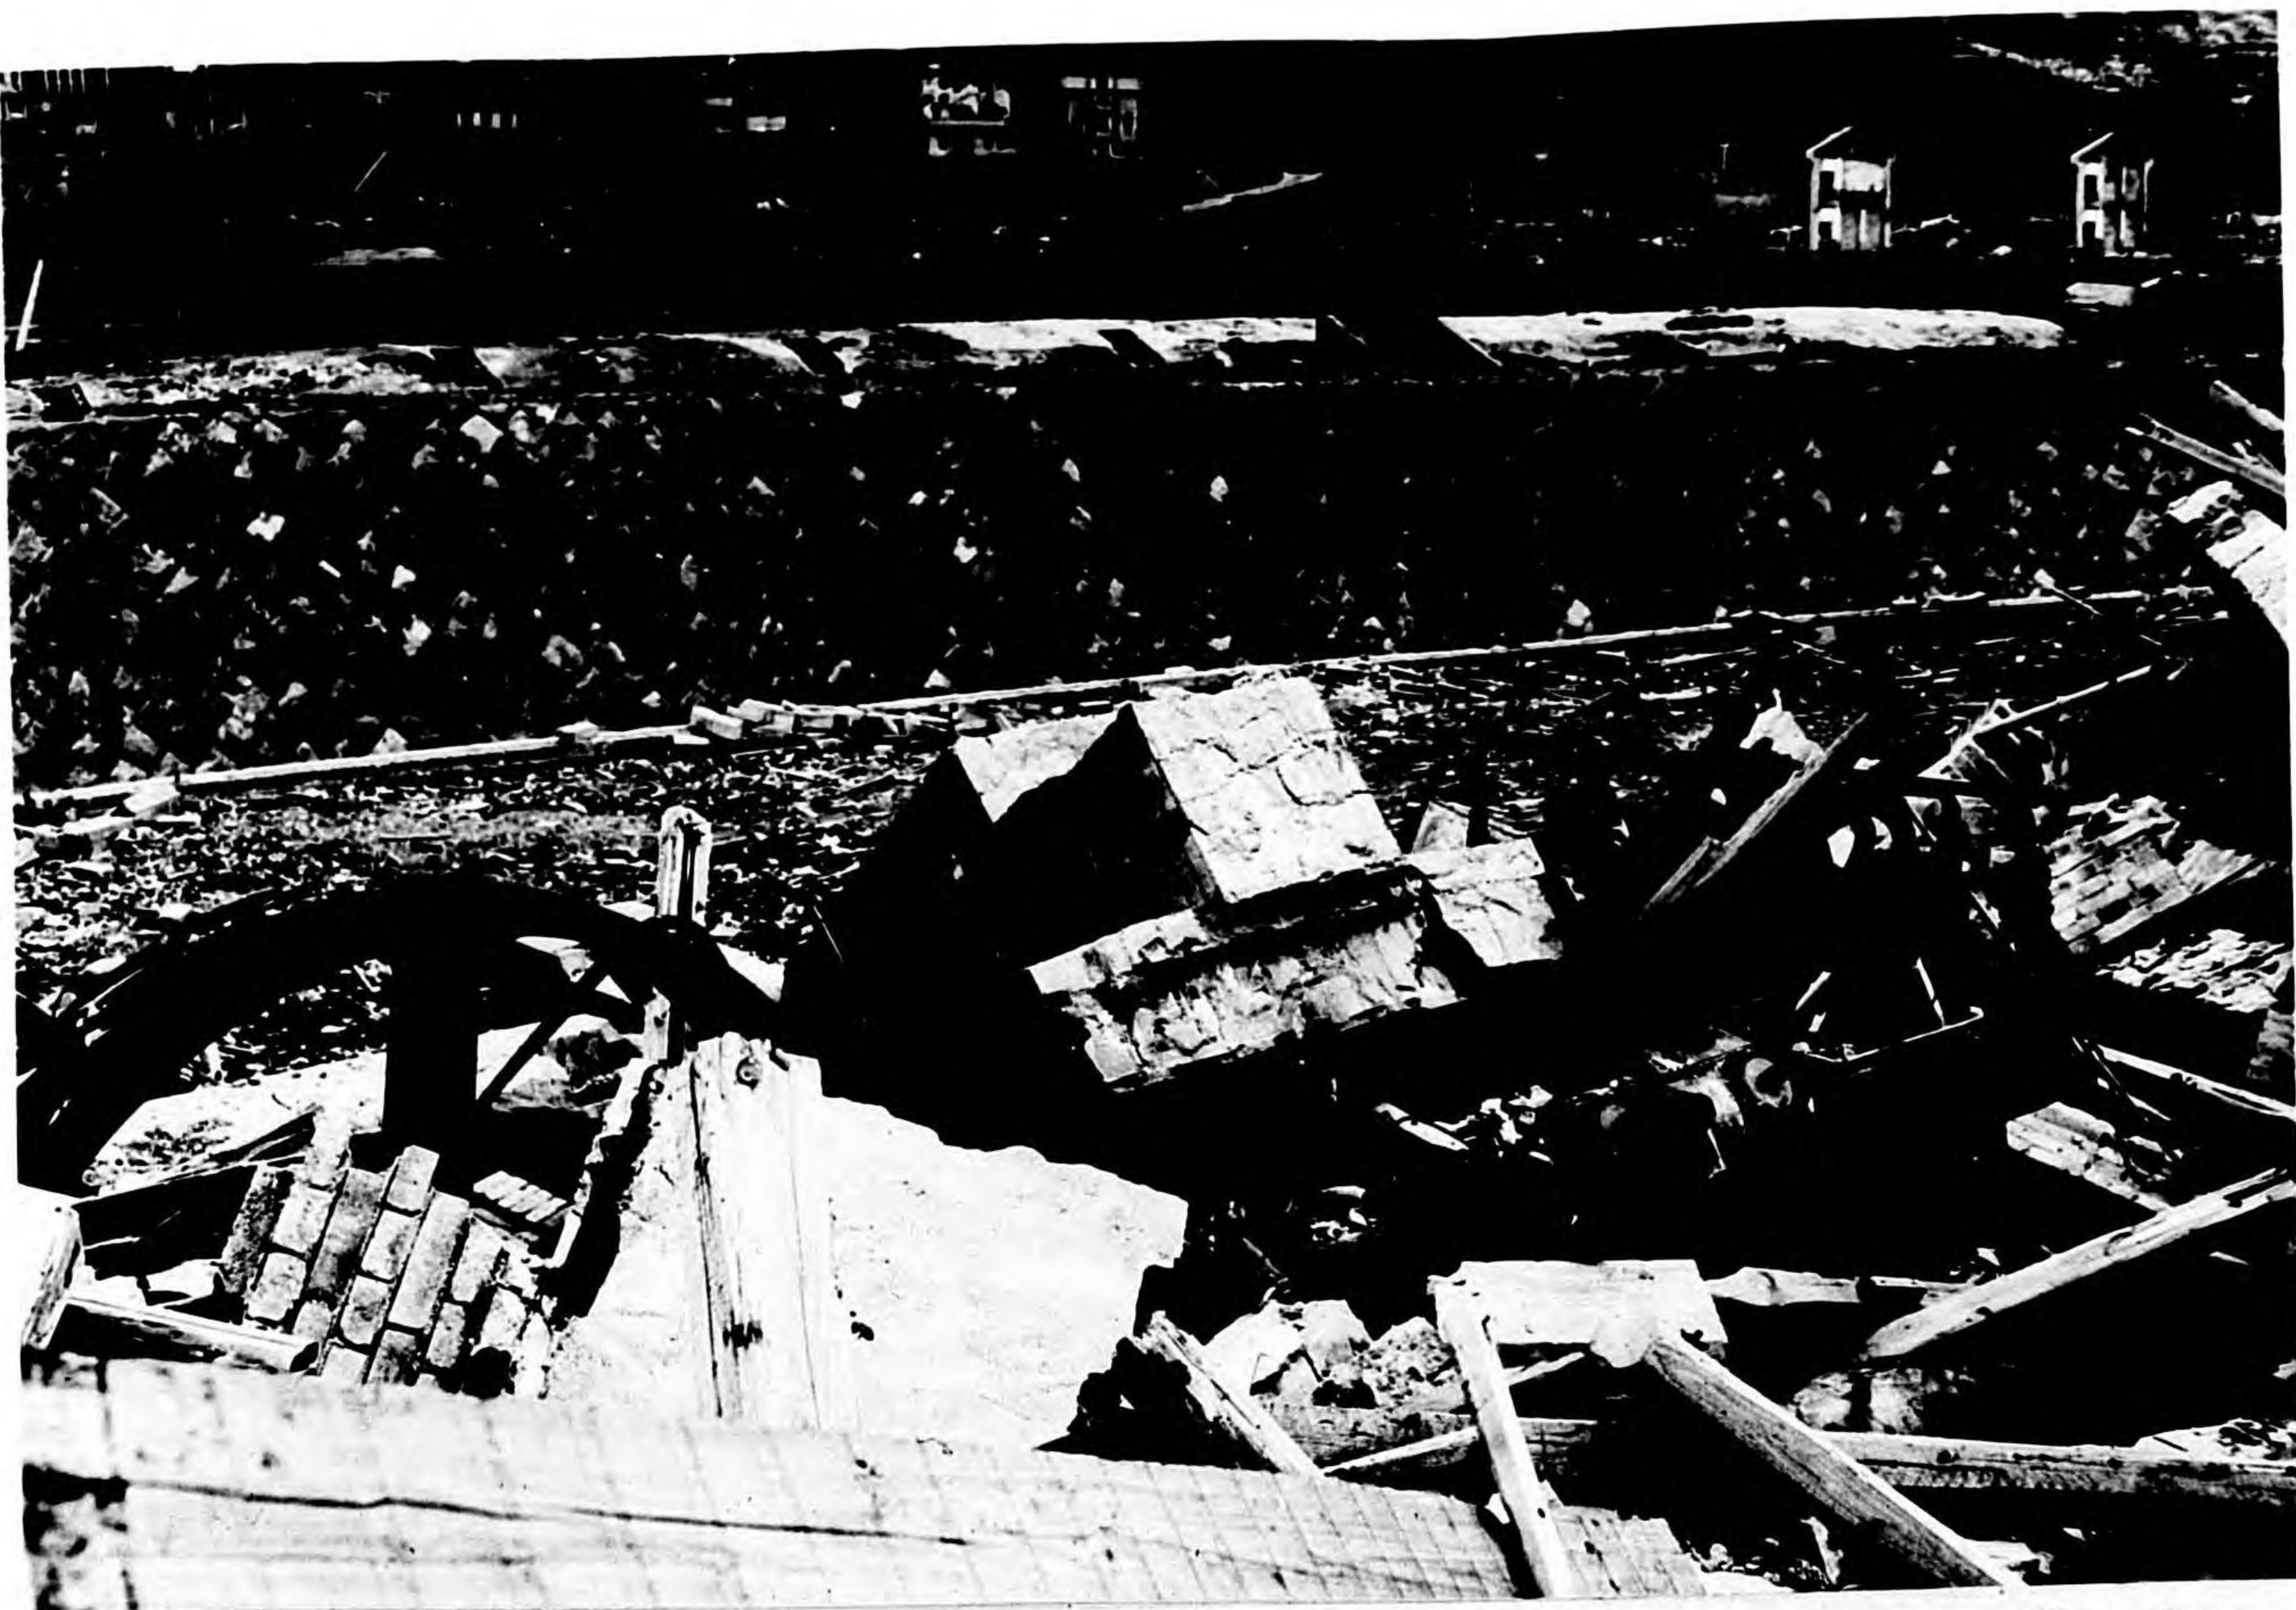
Photo 140. Nagasaki, 1,100 feet from GZ. Oxygen compressors heavily damaged by debris.

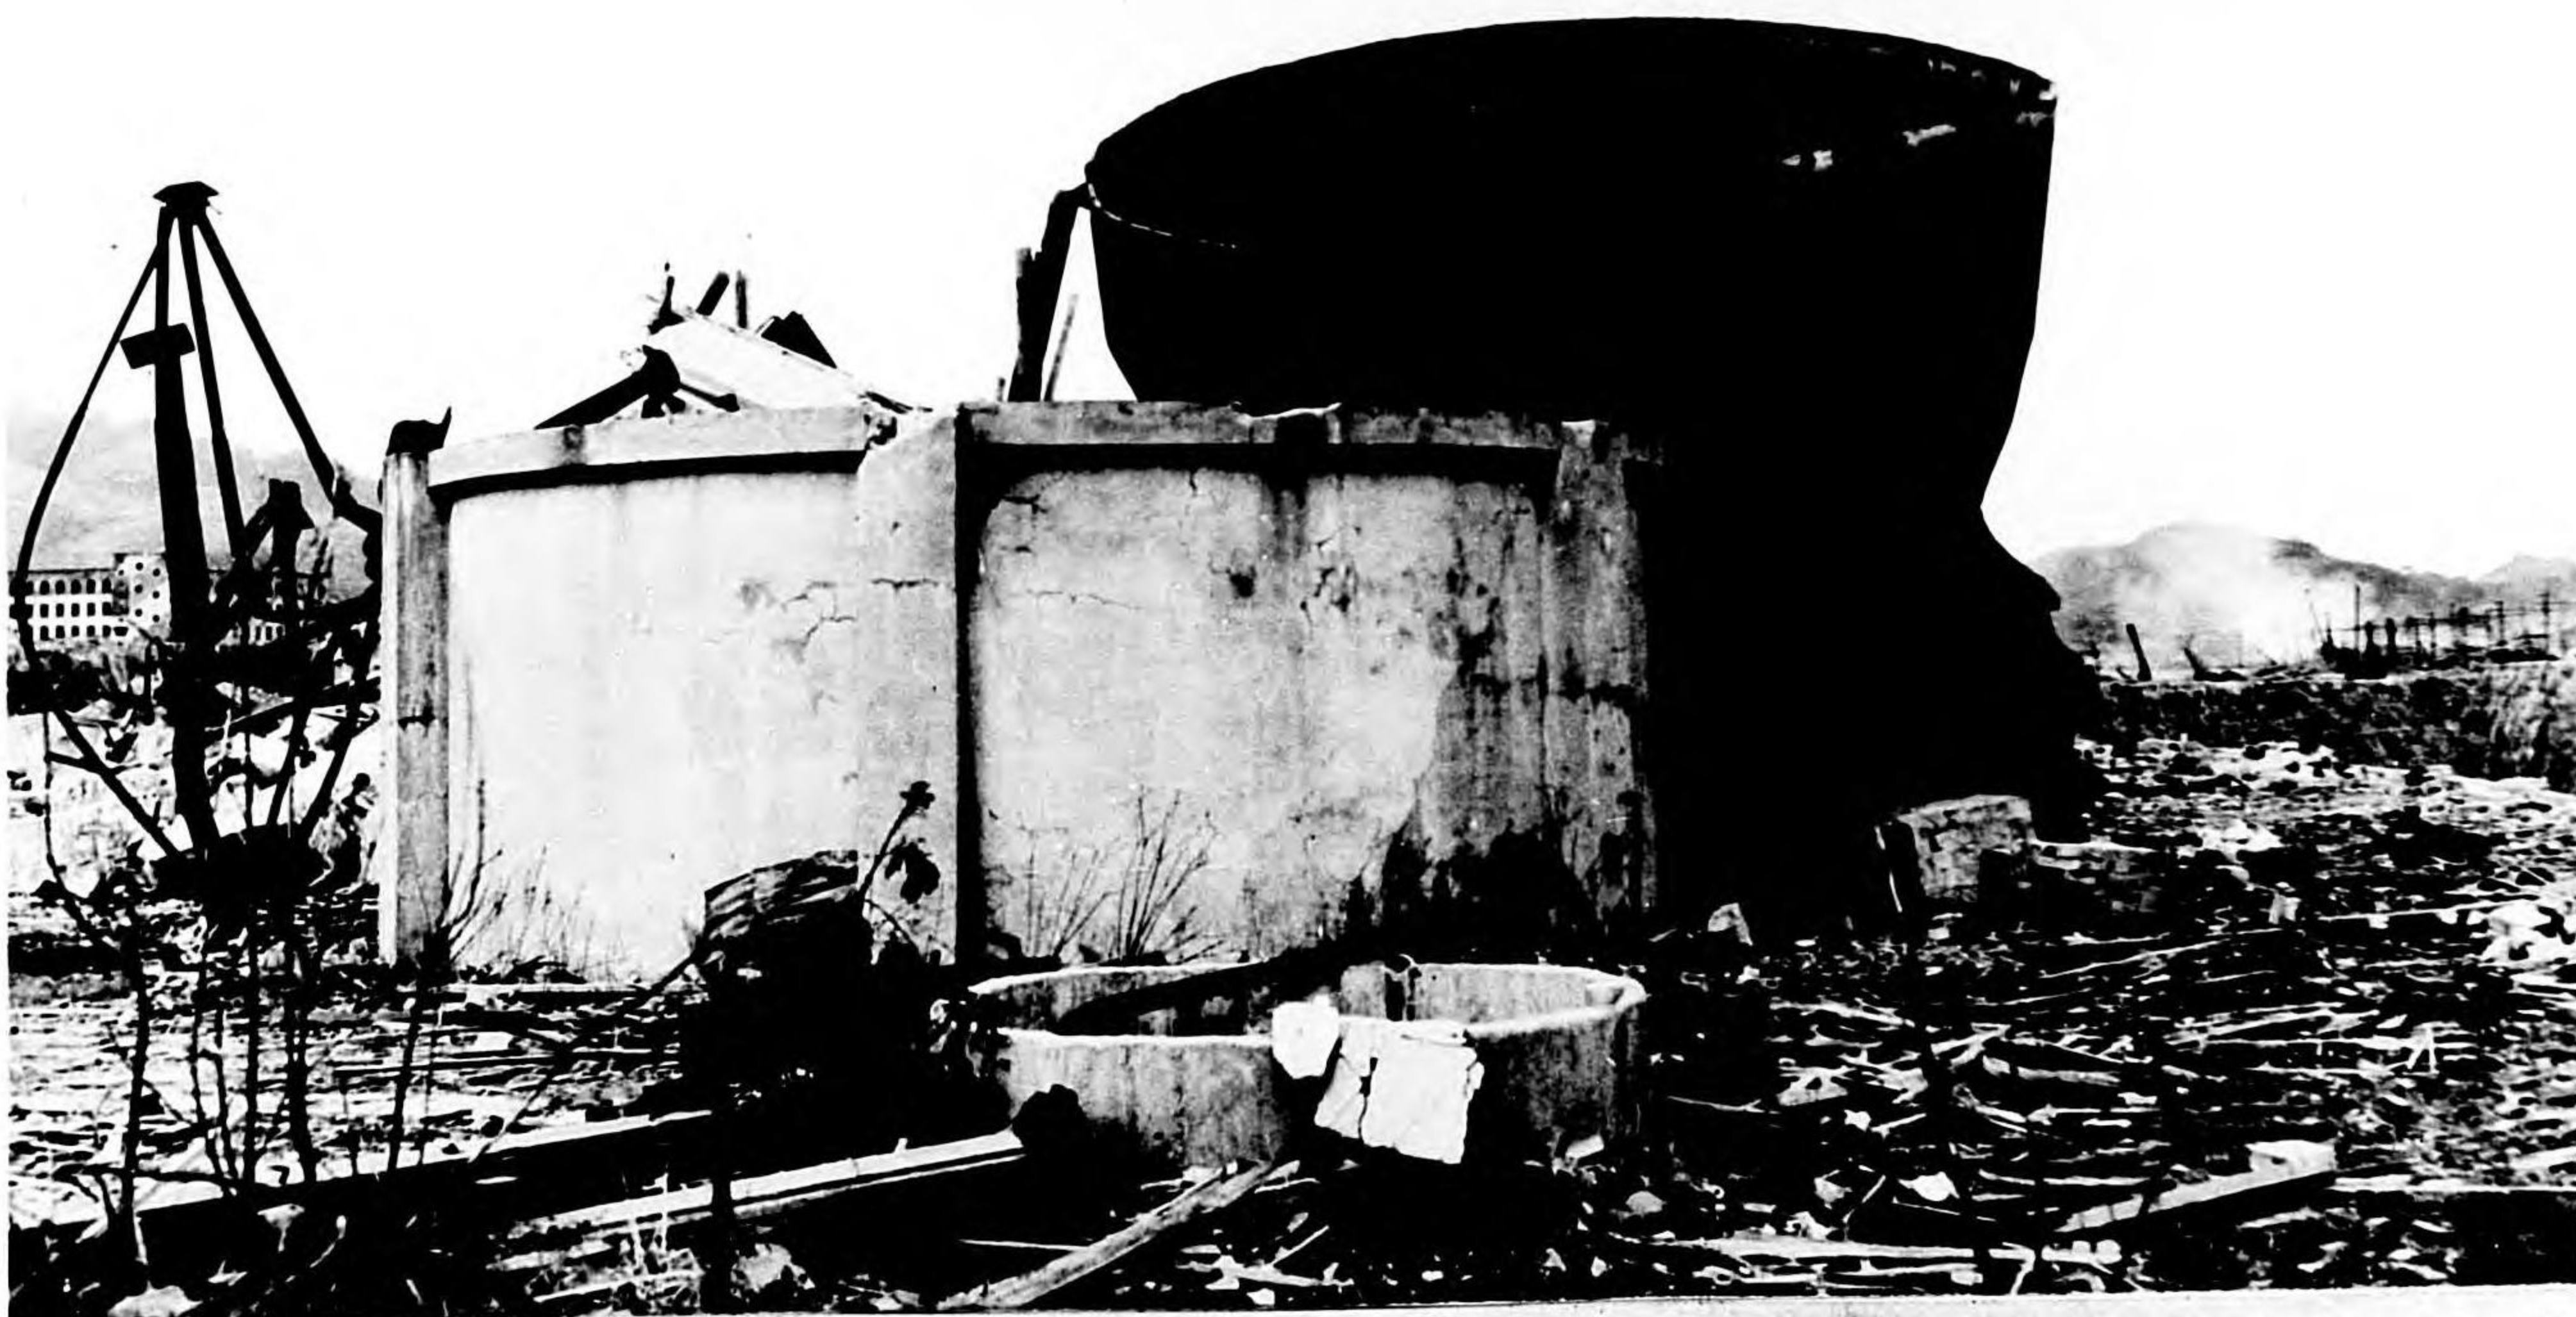
Photo 141. Nagasaki, 1,100 feet from GZ. Oxygen holder destroyed by blast and fire.

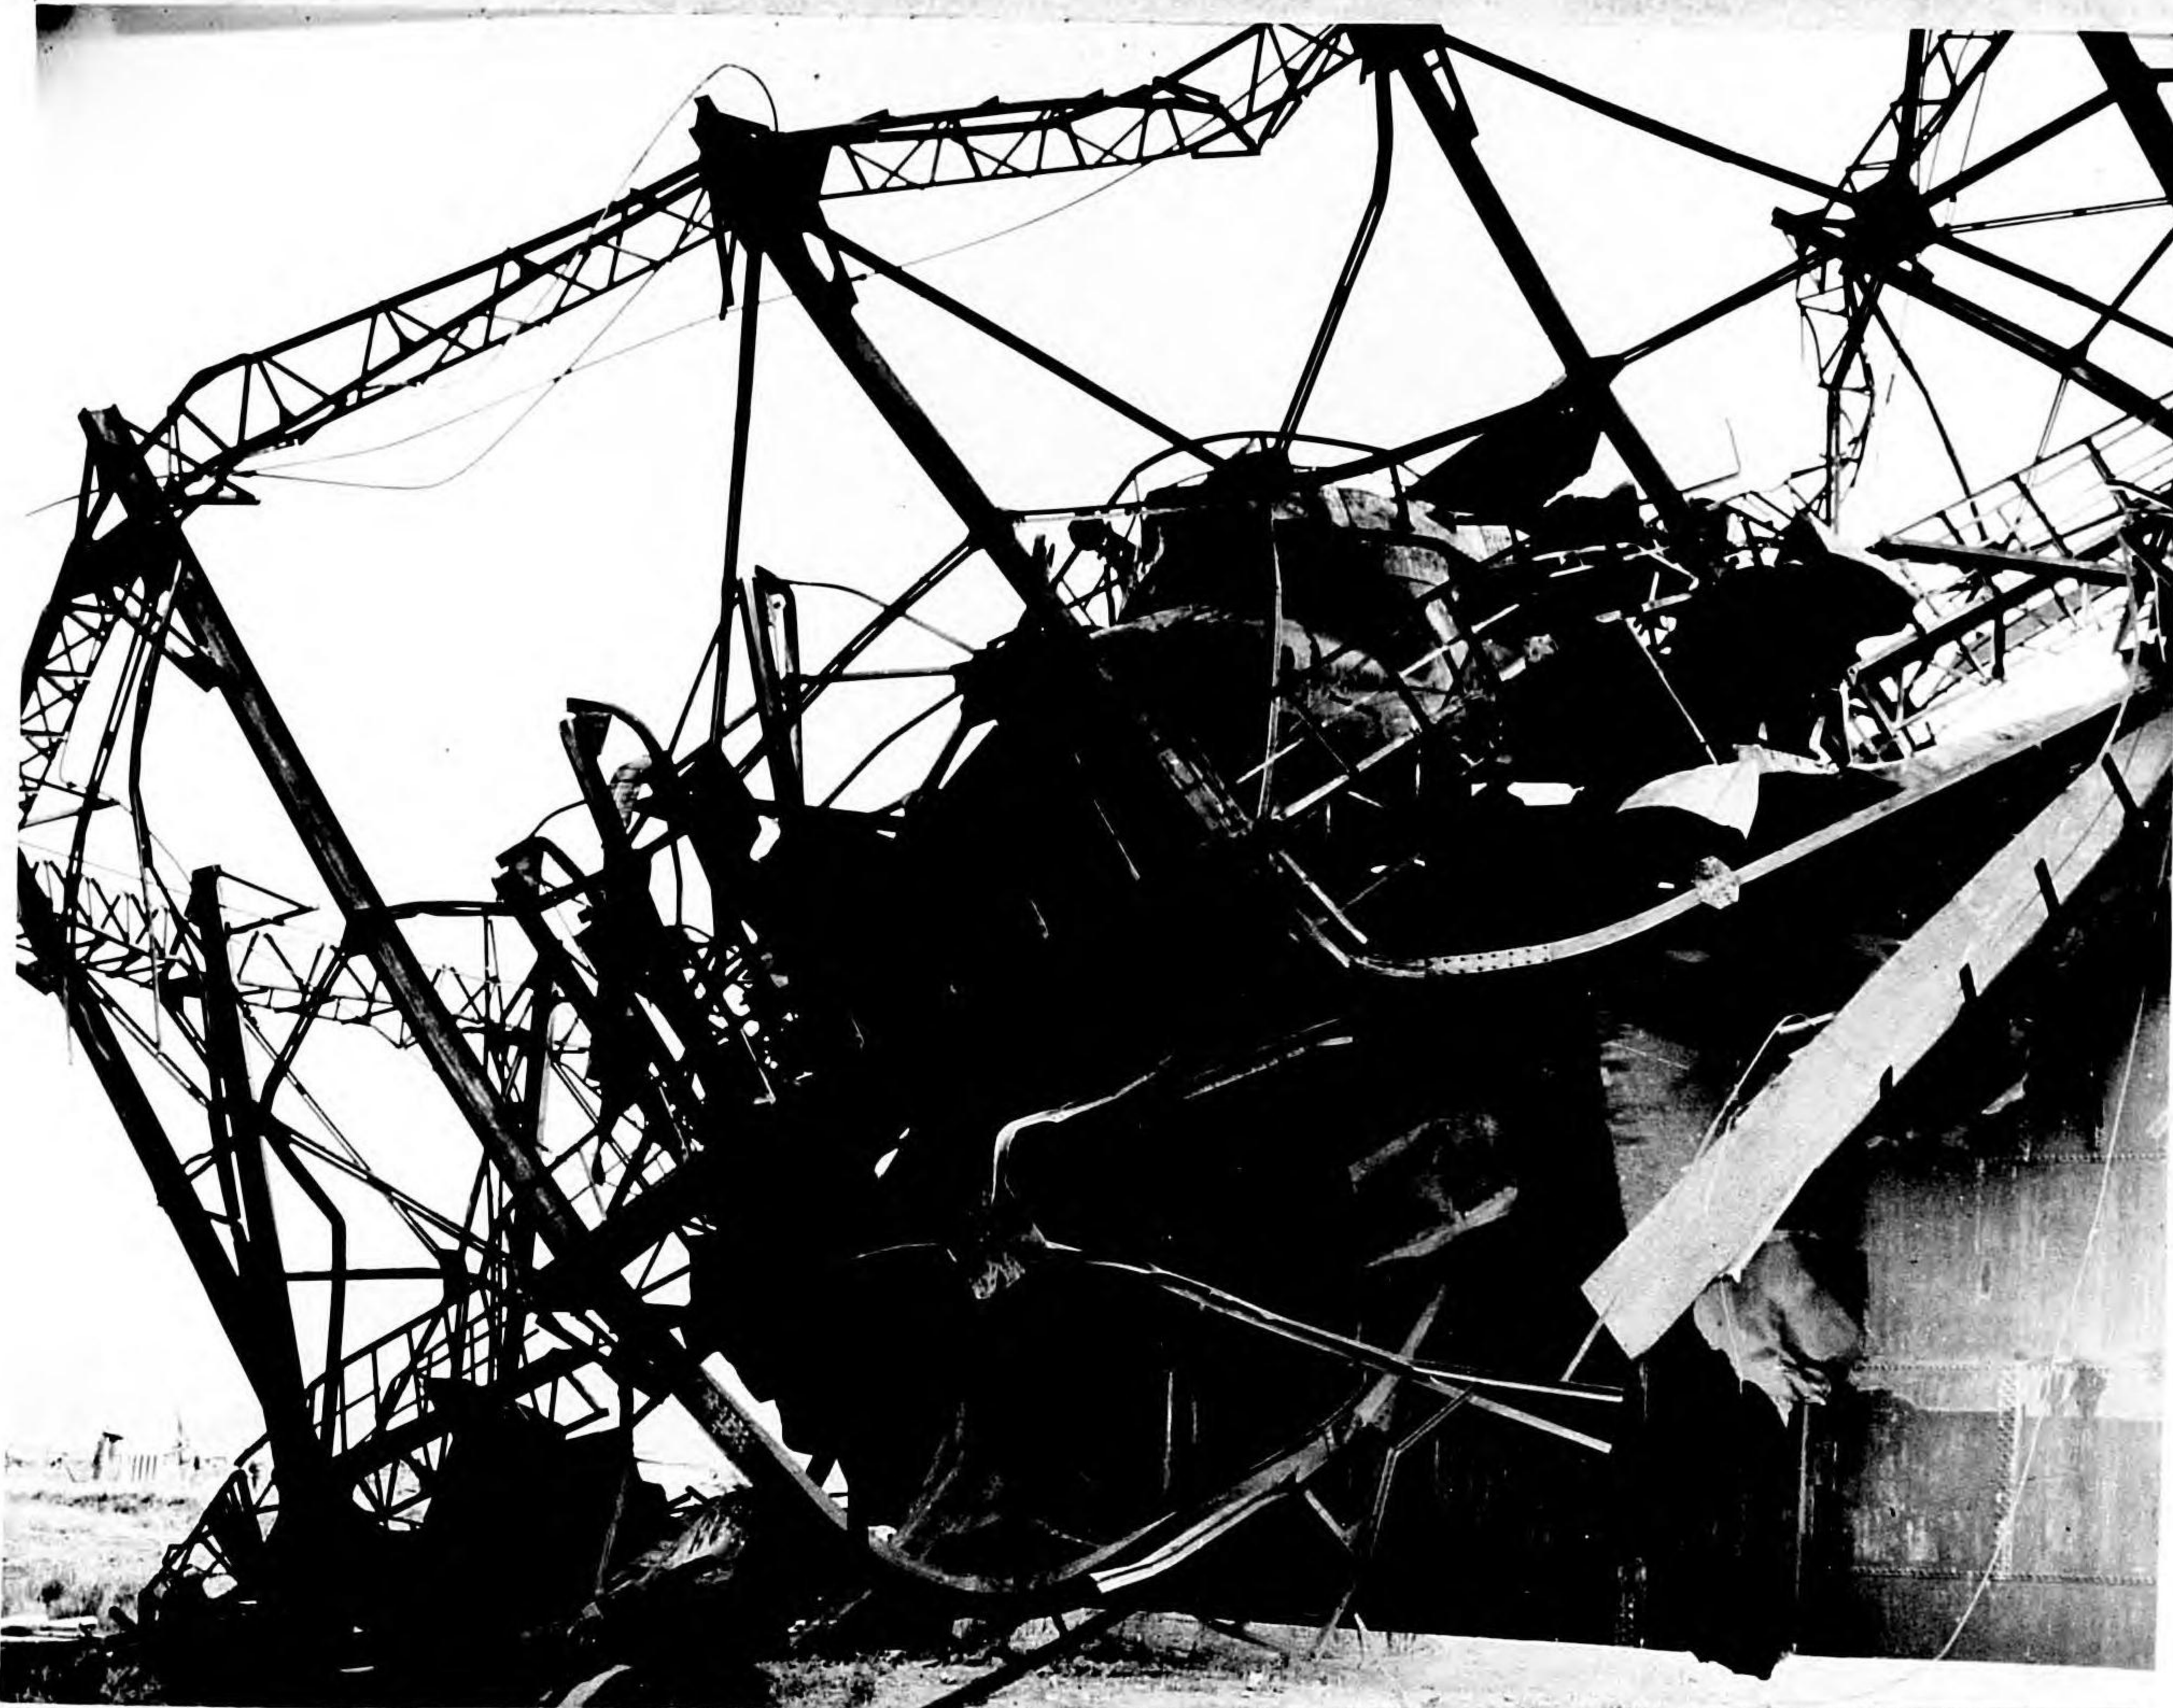
Photo 143. Nagasaki, 3,000 feet from GZ, Ohashi Gas Works. Damaged tank top of gas holder.
