DAMAGE TO MACHINE TOOLS BY ATOMIC BOMB

CHAPTER V
DAMAGE TO UTILITIES

ATOMIC BOMBS
PLANT UTILITIES
HIROSHIMA - NAGASAKI

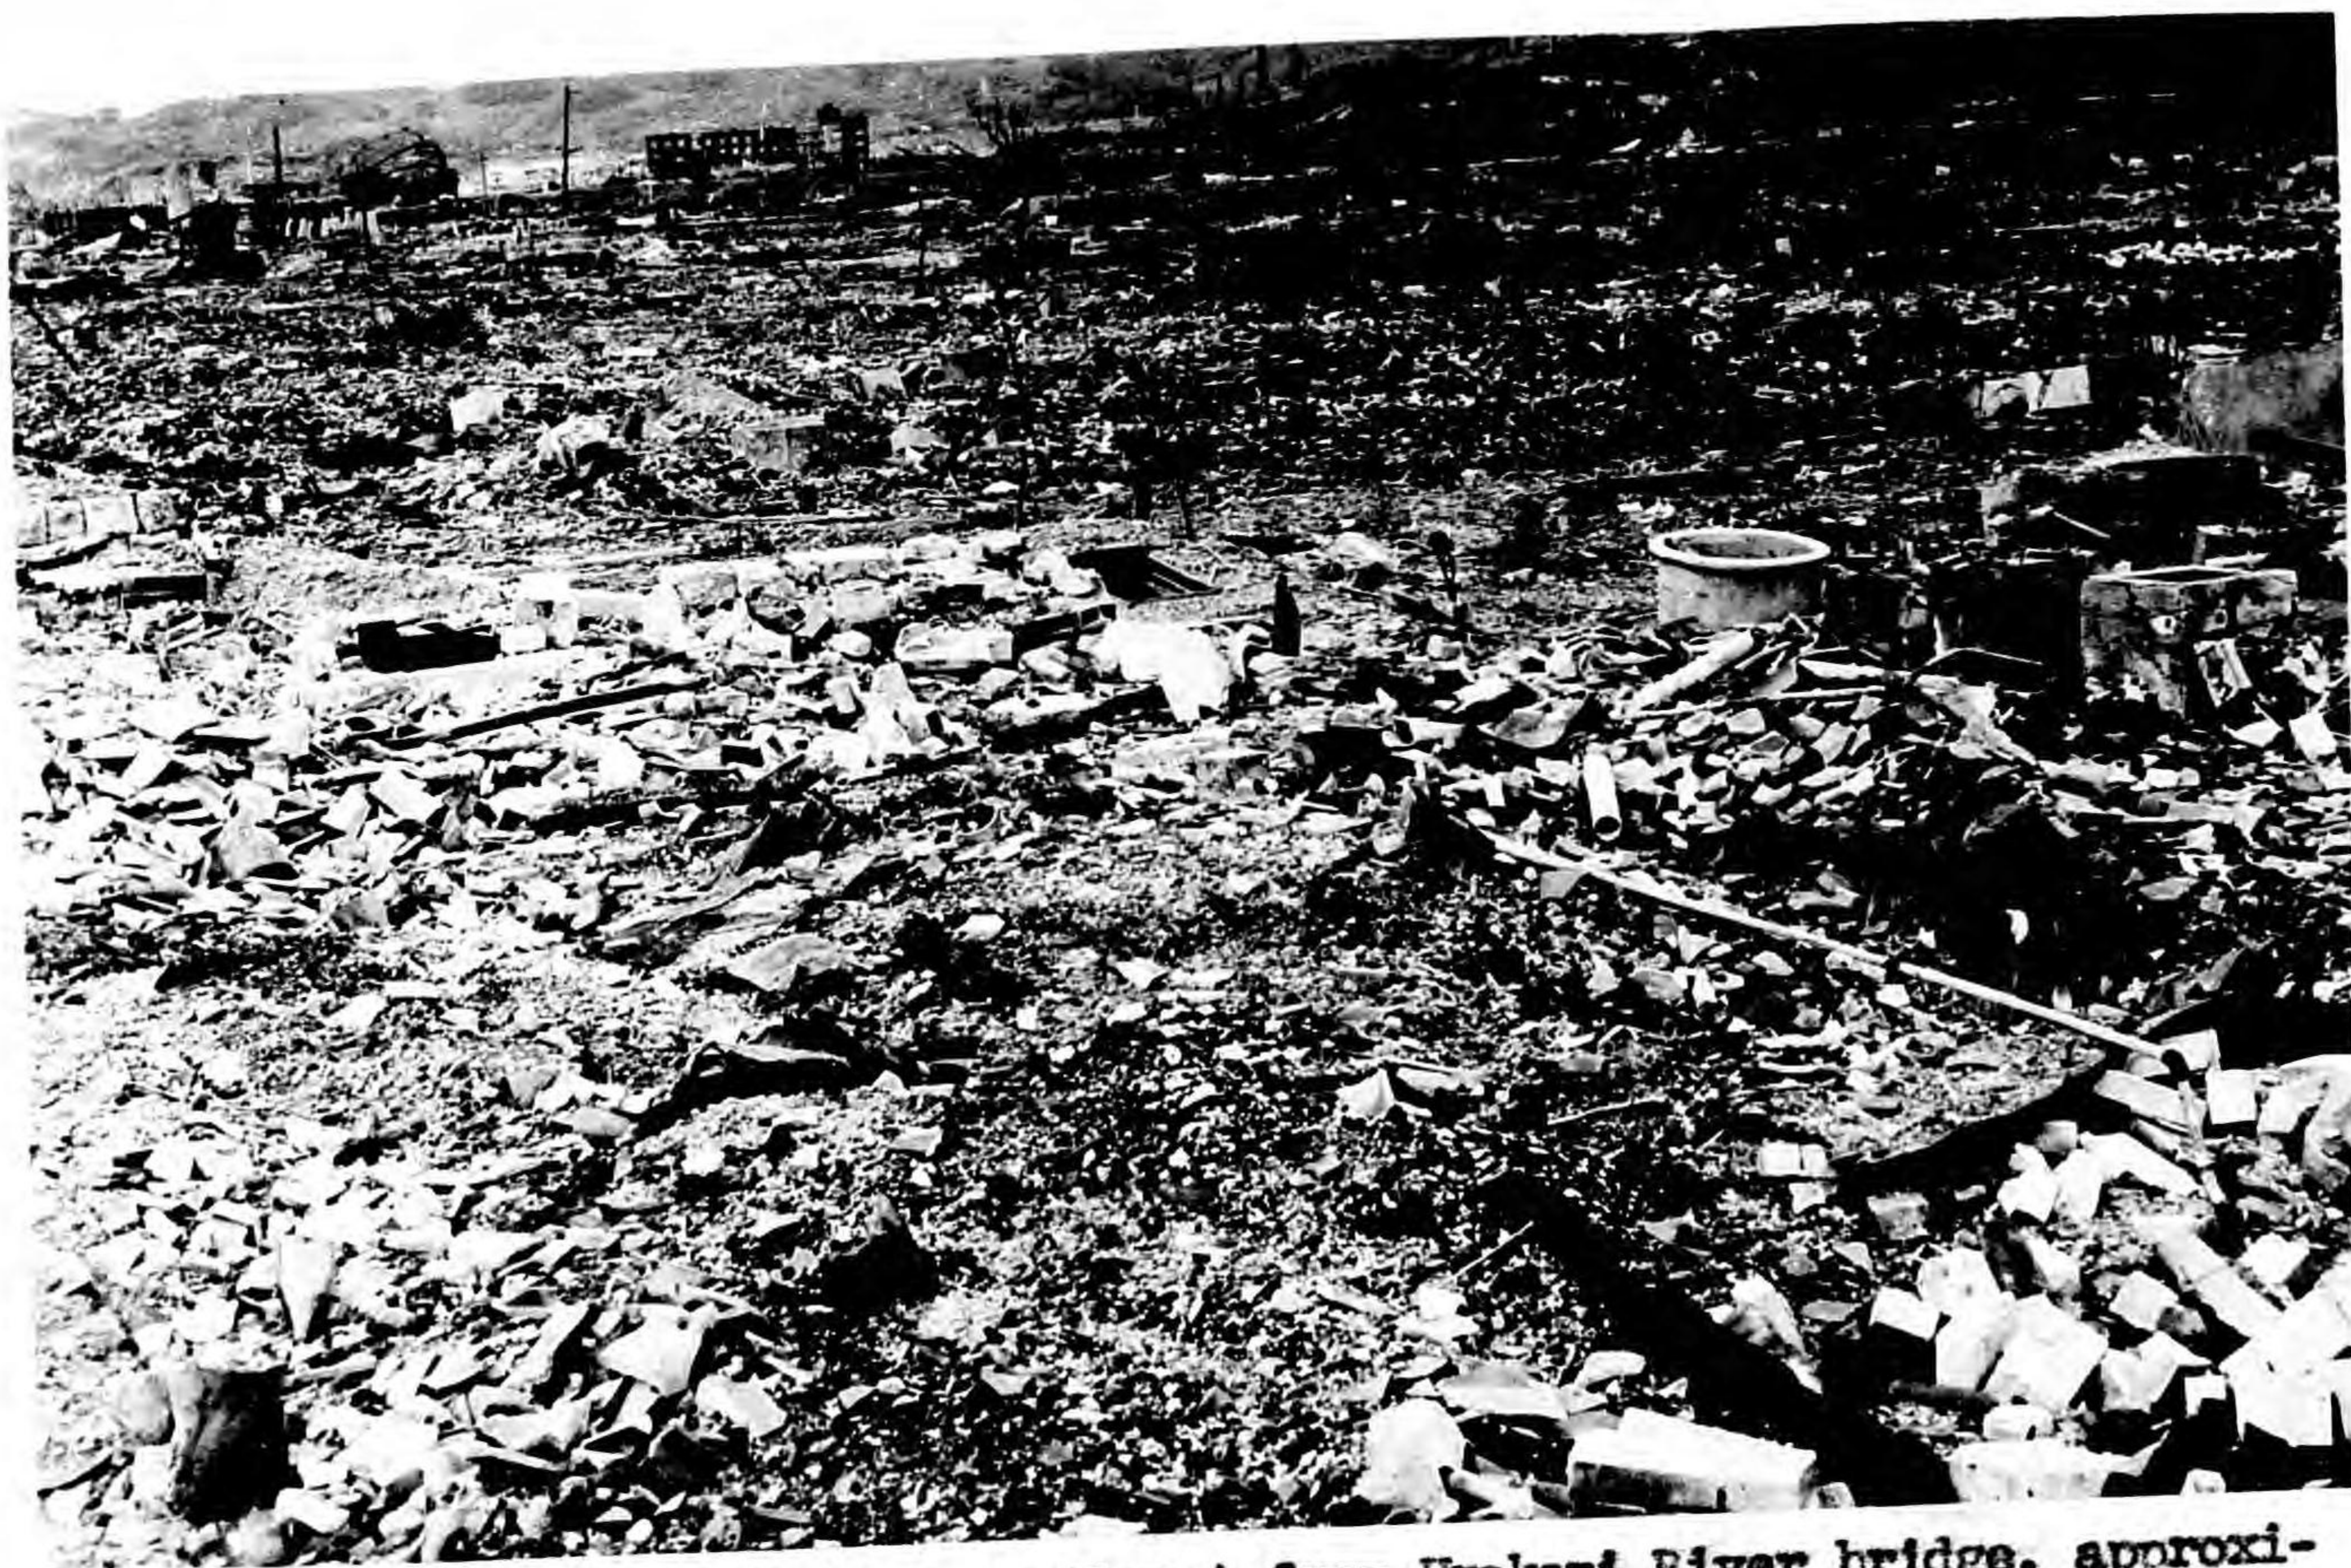
Photo 156. Nagasaki, looking northwest from Urakami River bridge, approximately 1,600 feet from GZ. This area, containing small and unimportant structures of wood, steel frame, brick, and reinforced concrete, was completely devastated by blast and fire.

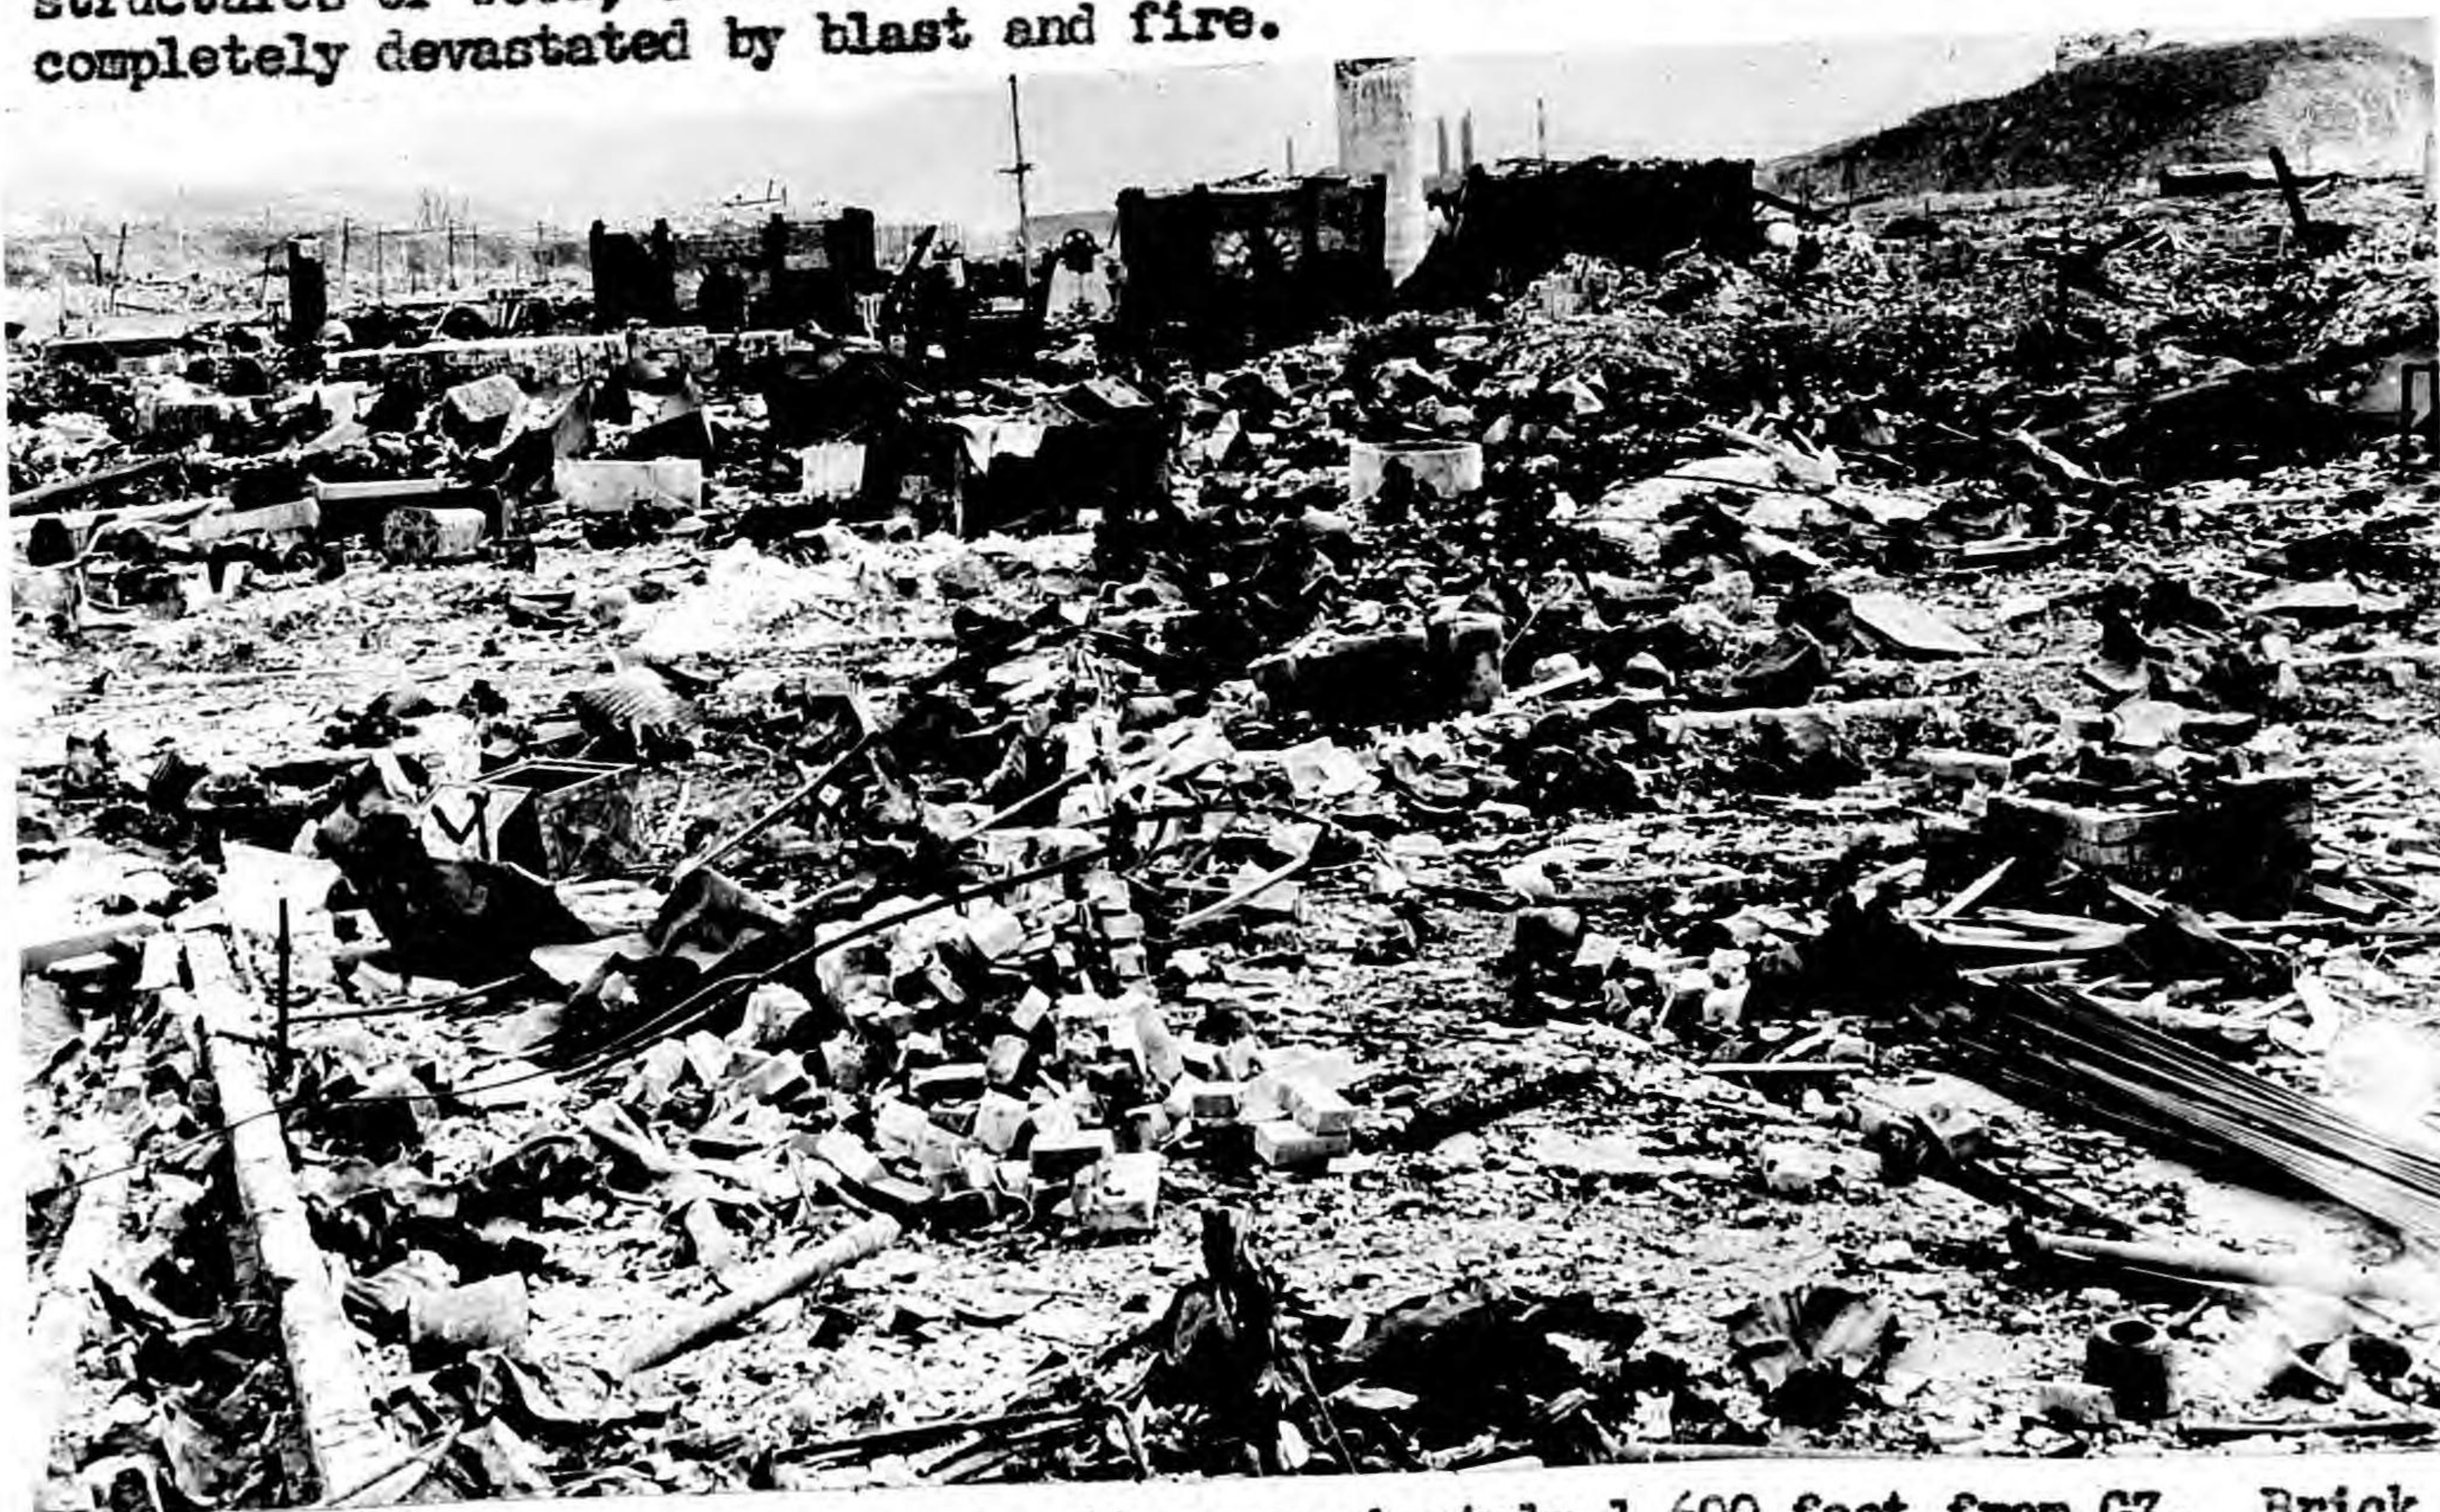
Photo 157. Nagasaki, looking south approximately 1,600 feet from GZ. Brick plant: 10-foot high, brick-vaulted roofs totally damaged by blast and fire, 3/4-inch brick walls badly cracked.

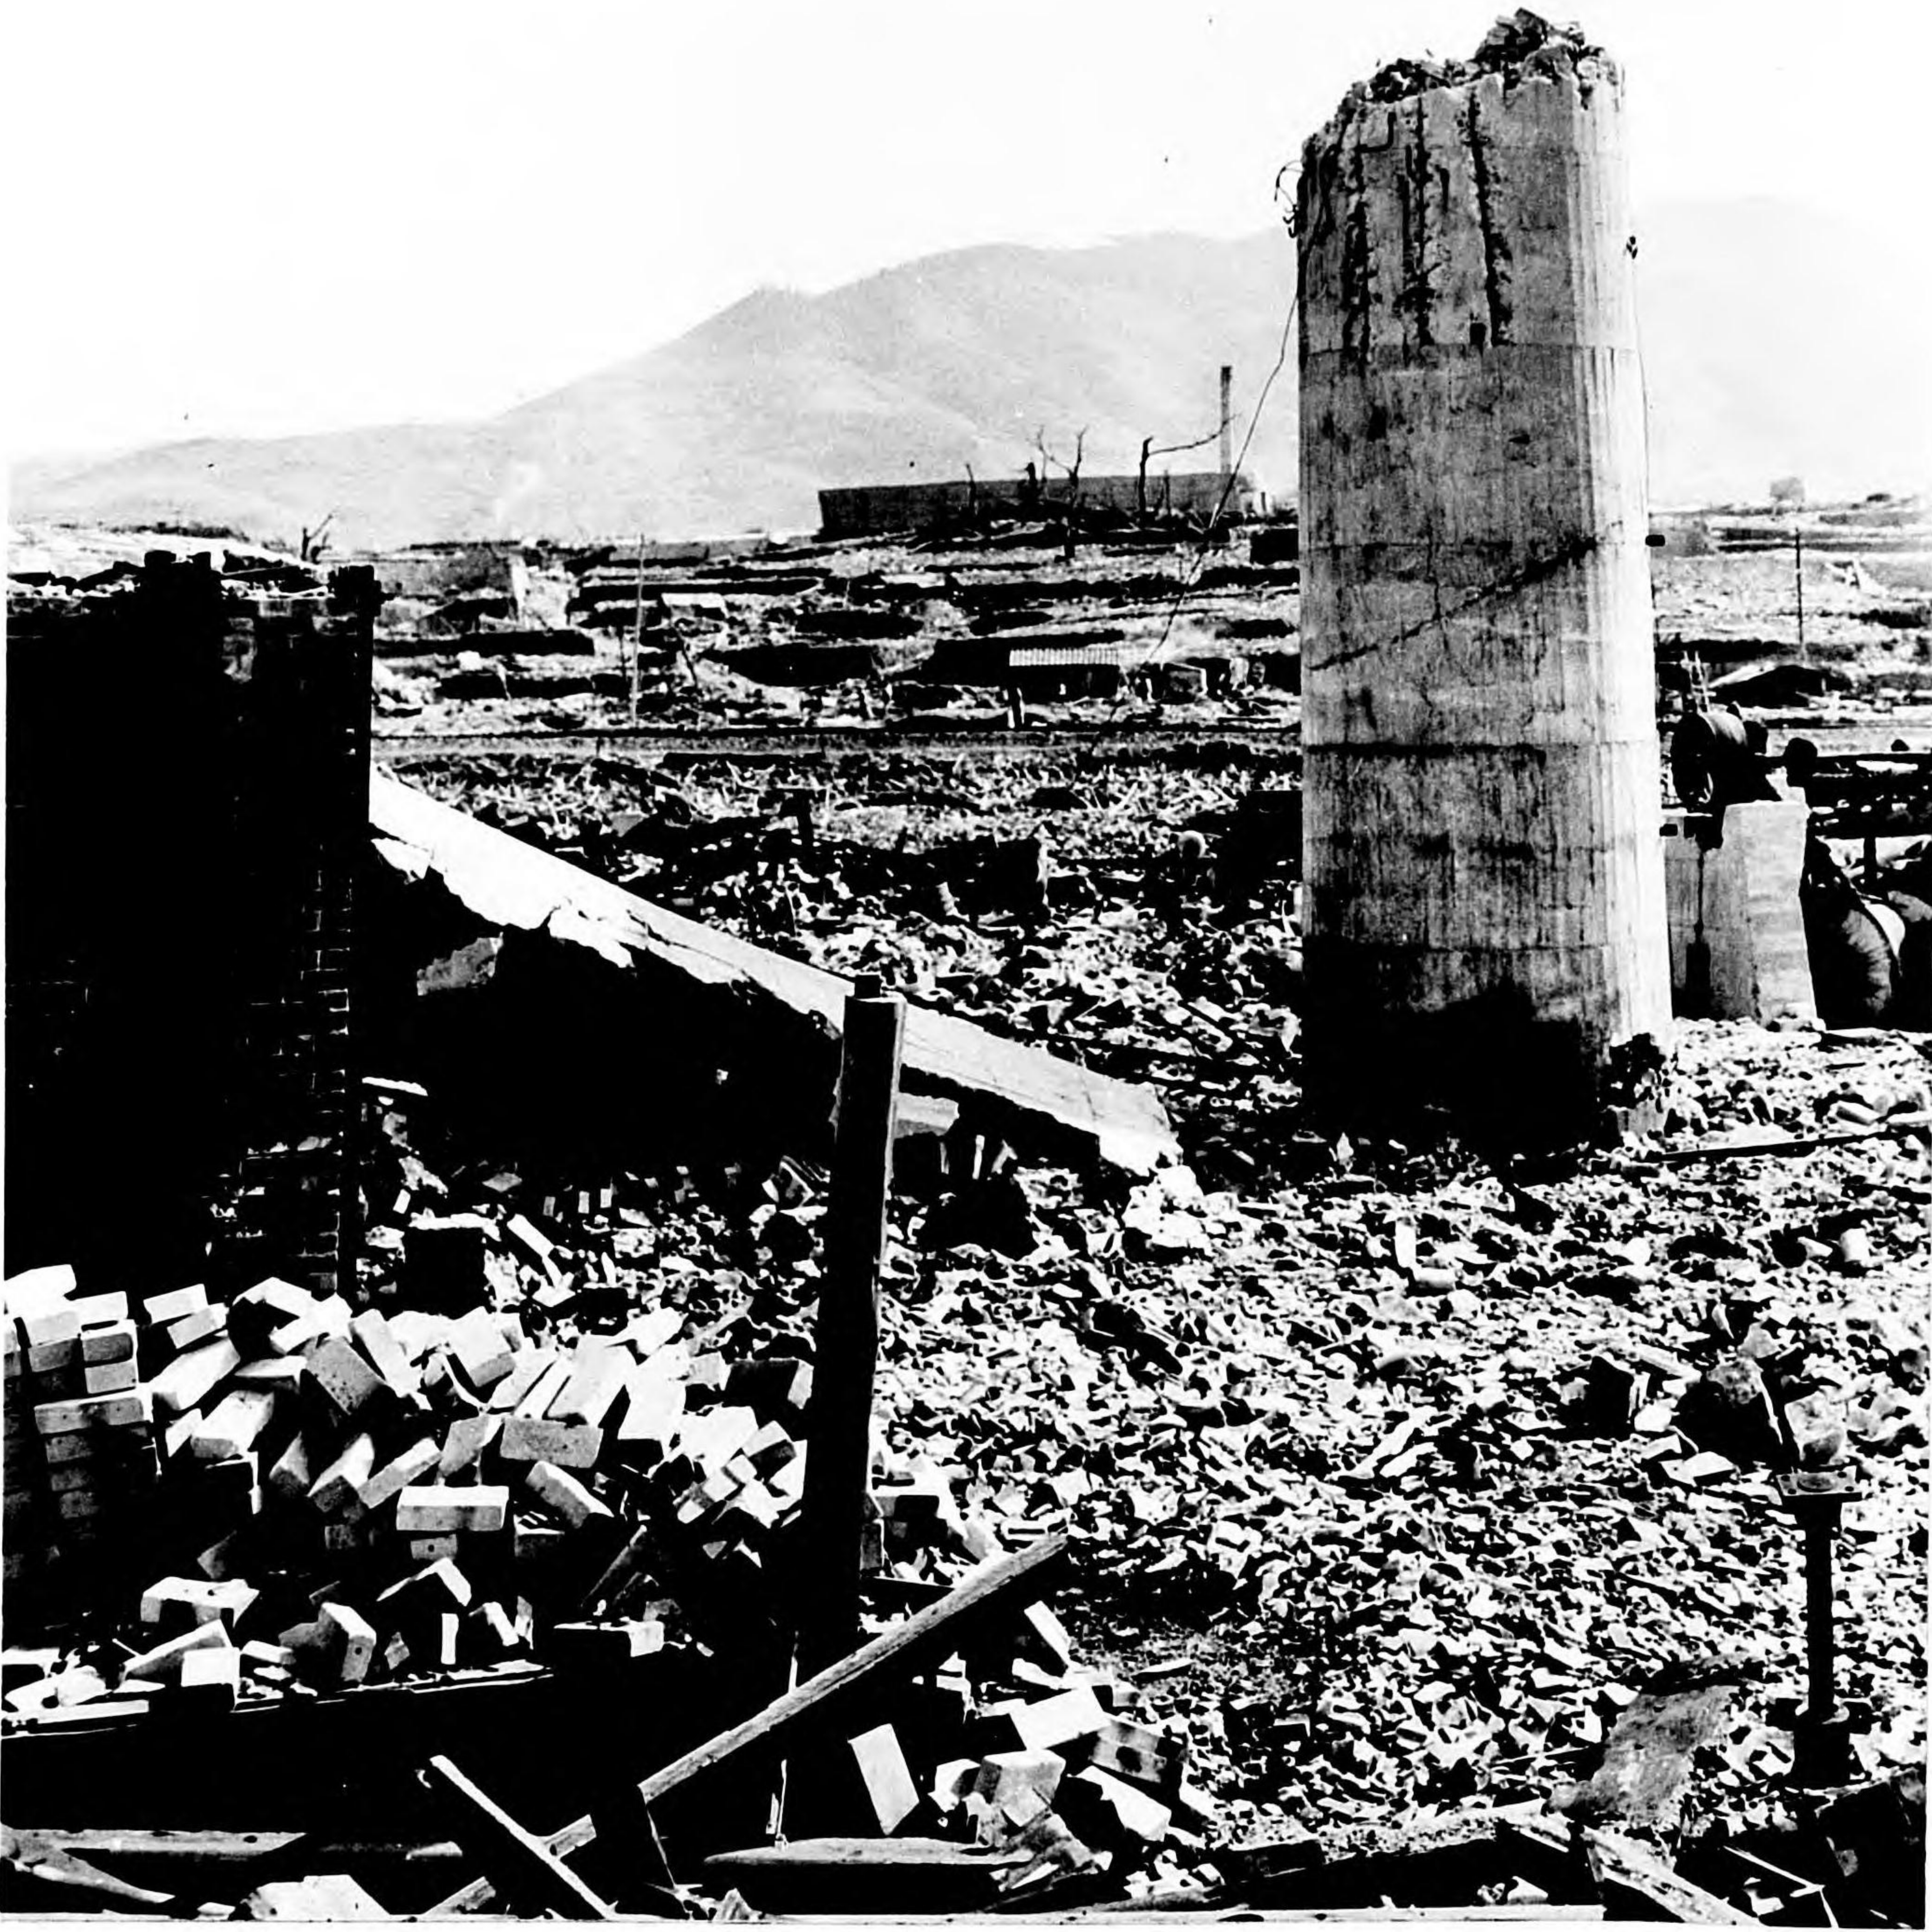
Photo 158. Nagasaki. Area west of railroad and highway in fork of Urakami River. Concrete stack, four feet in diameter and 70 feet high, fell to north-west. Brick kiln at left of photo.

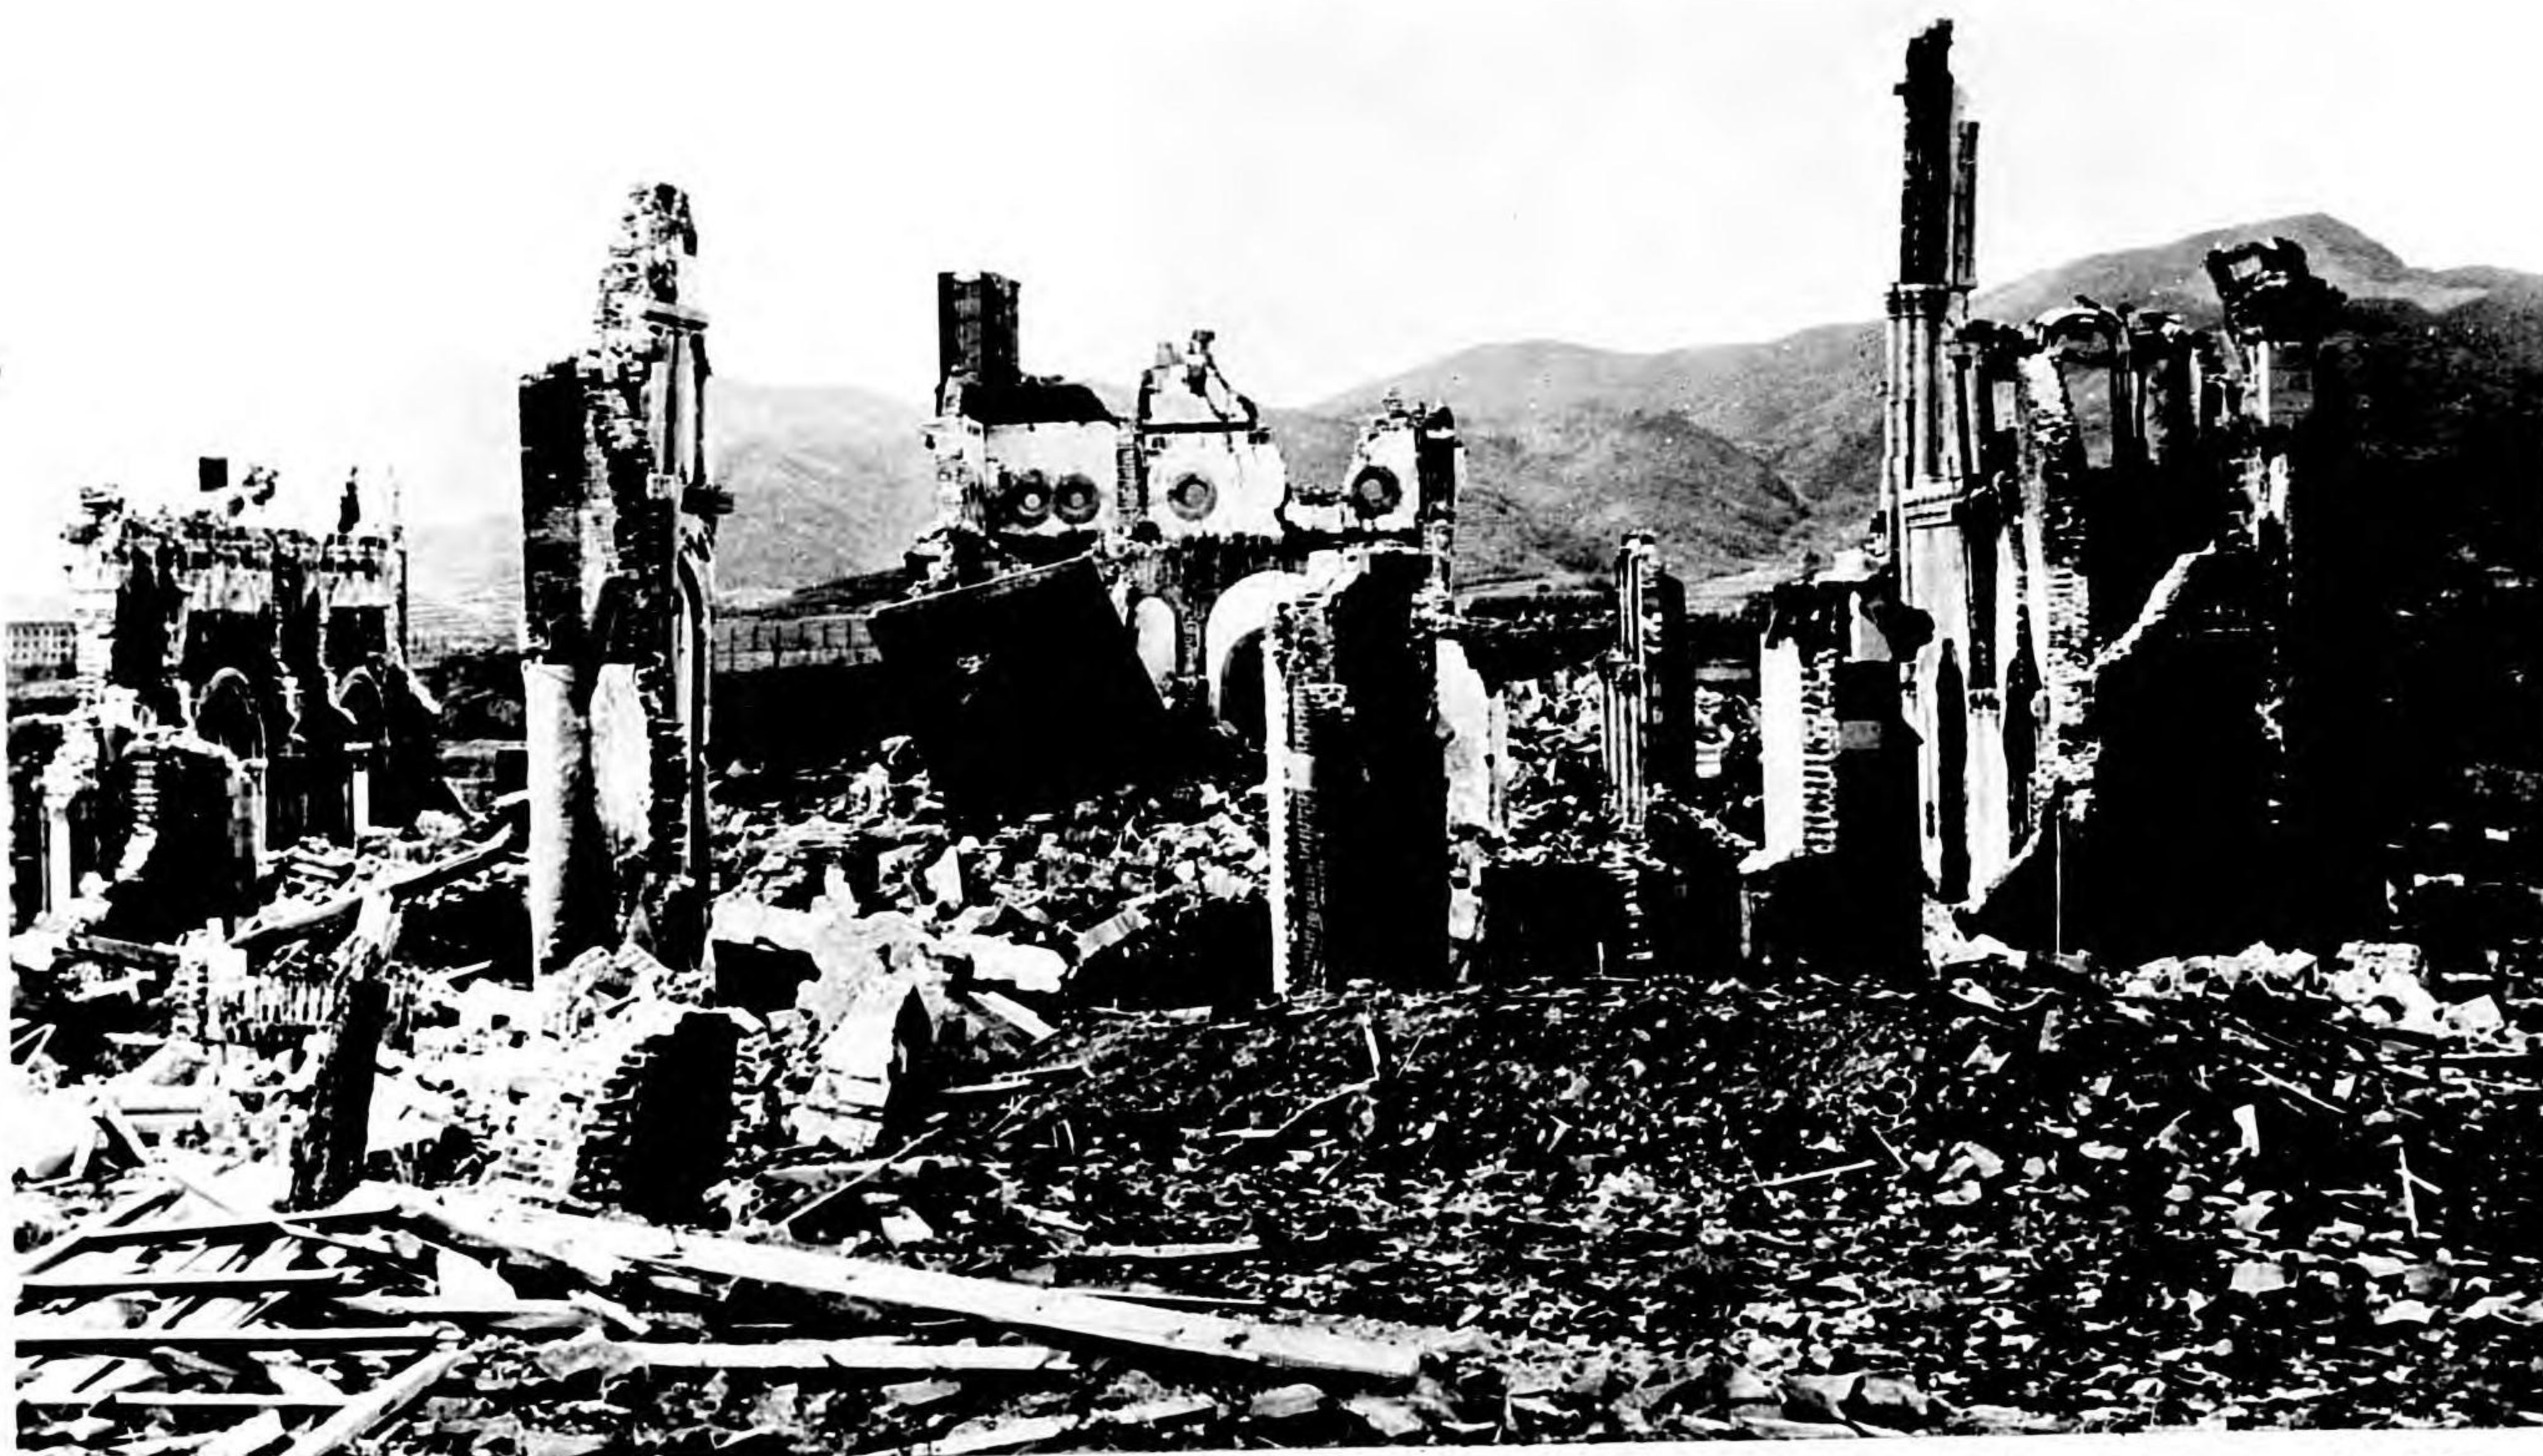
Photo 158. Nagasaki. Urakami cathedral. Brick and stone building, 1,800 feet from GZ, totally damaged by blast. Concrete dome from west tower resting in center of debris.

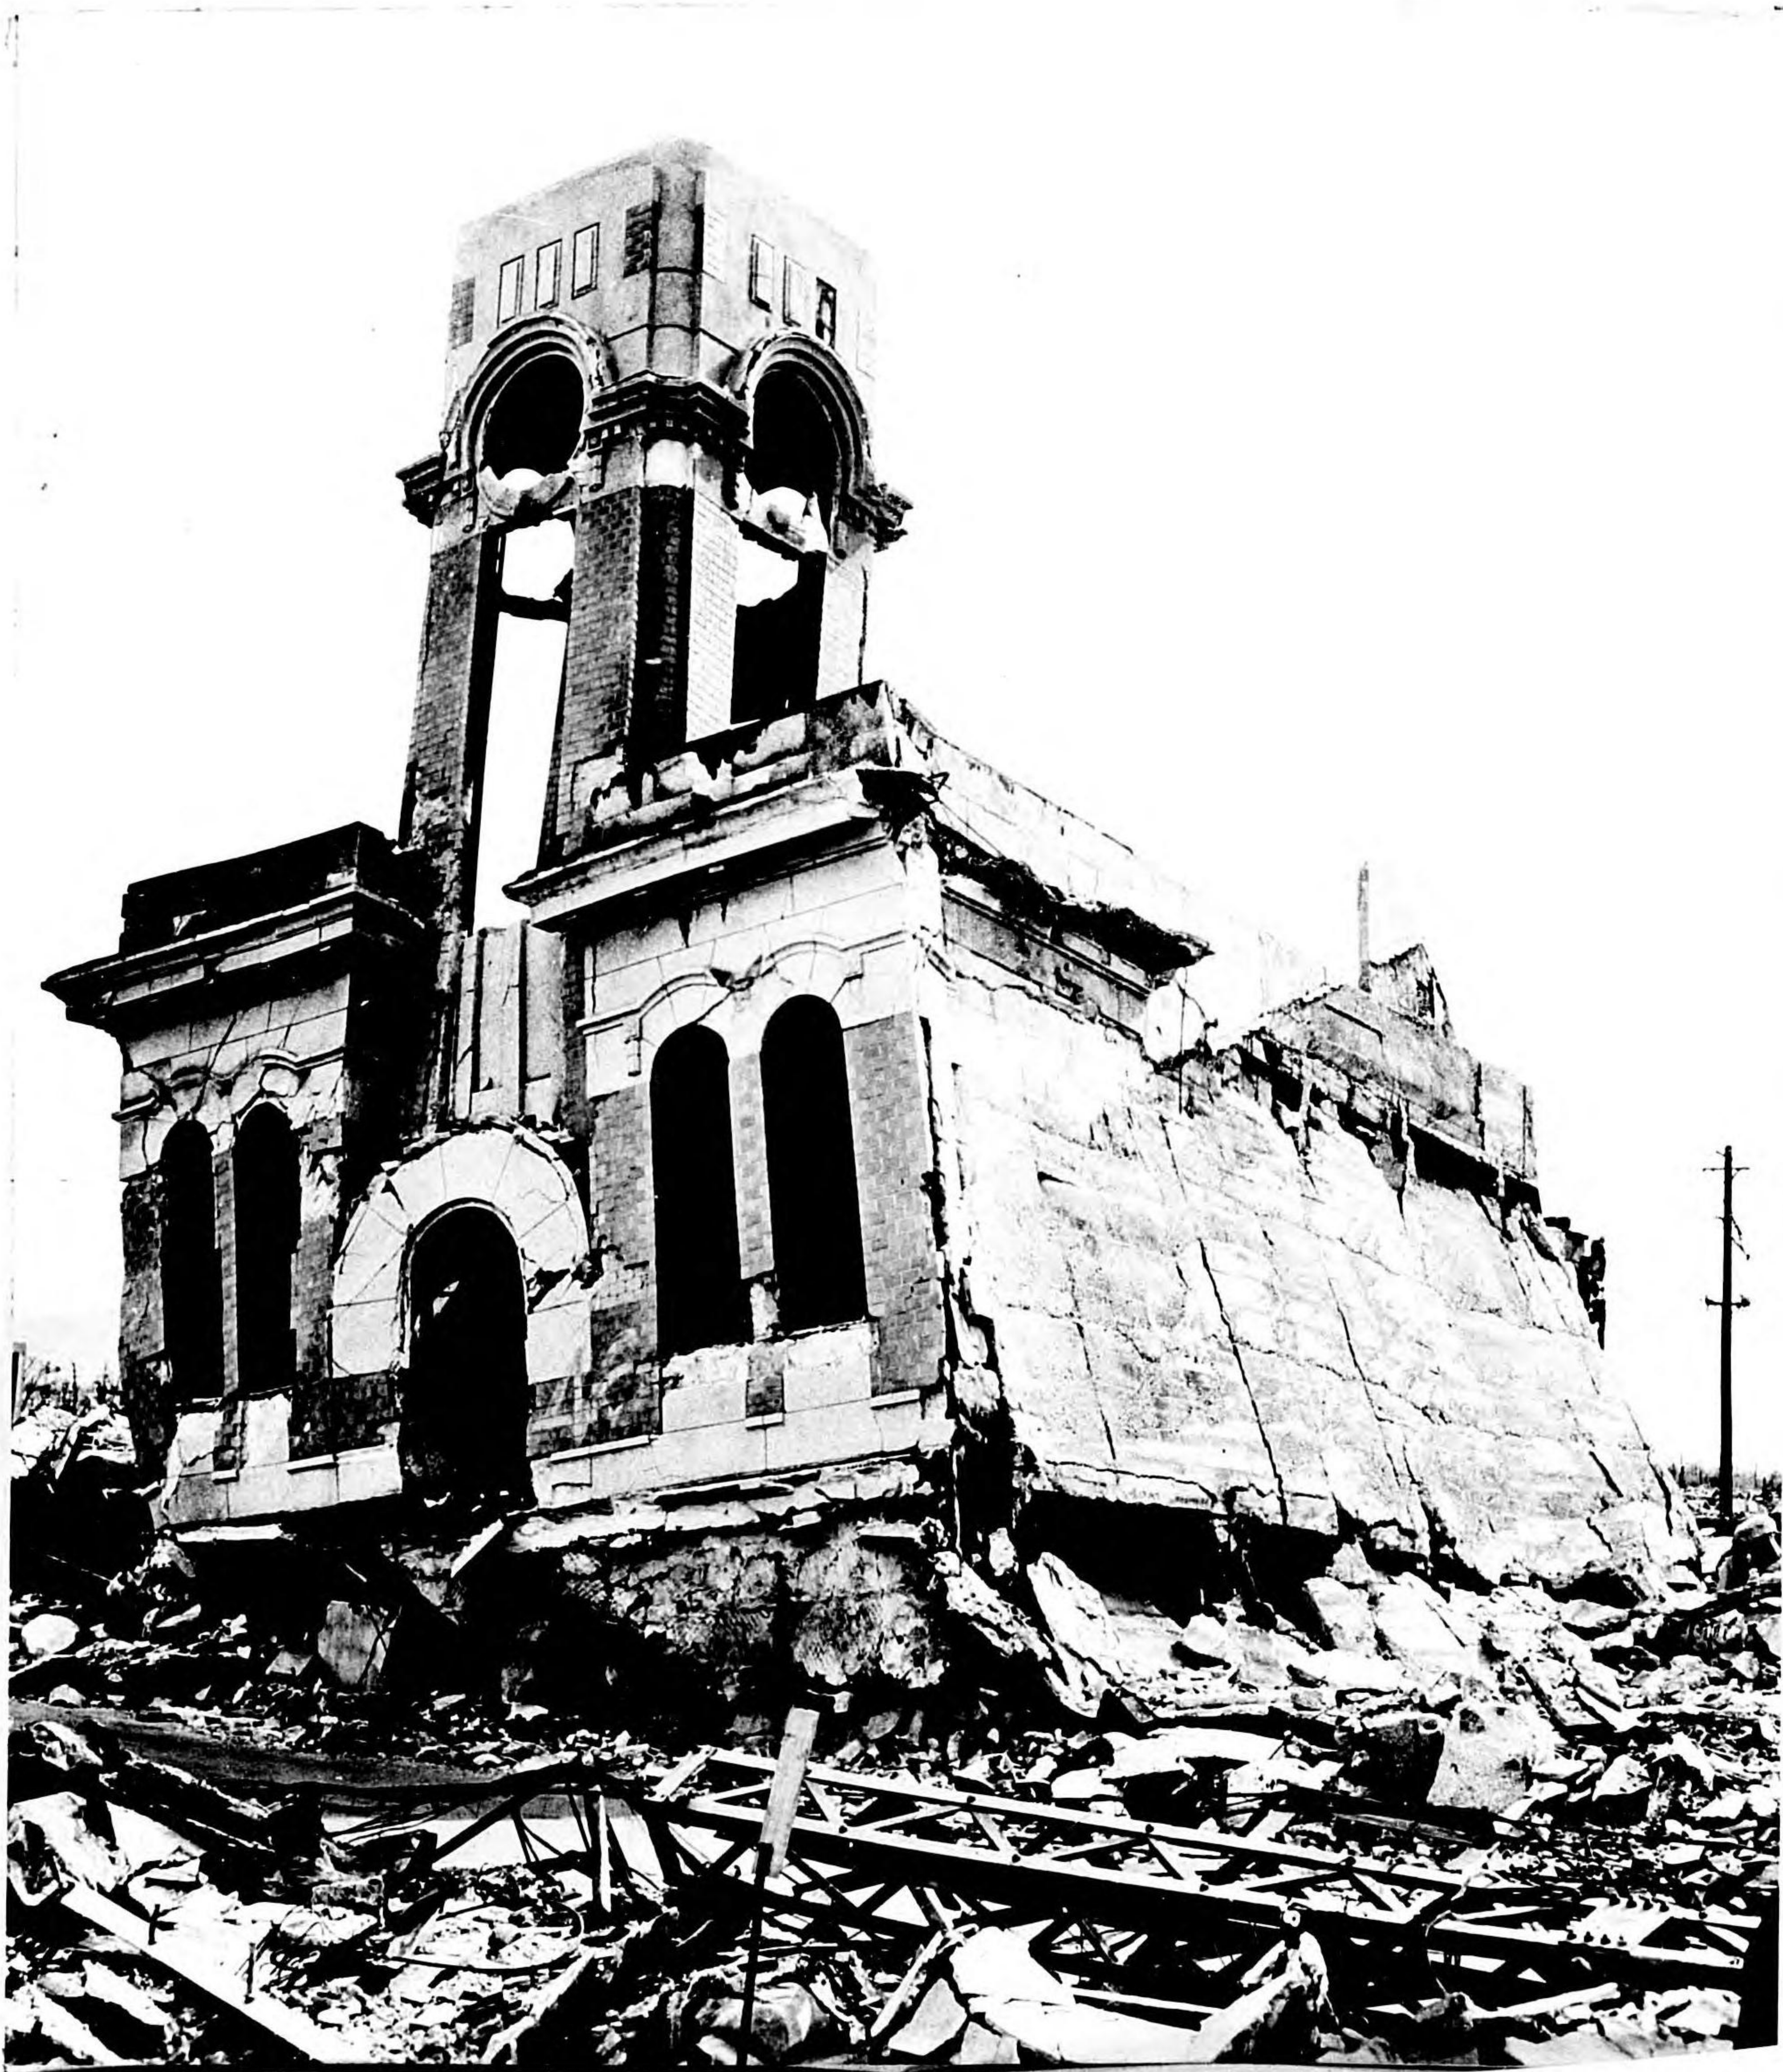
Photo 163. Hiroshima. Shimomura Watch Shop, 2,000 feet from GZ. Second story of steel-frame building resting on ground. Columns and walls of first story at right. Combustible debris burned.

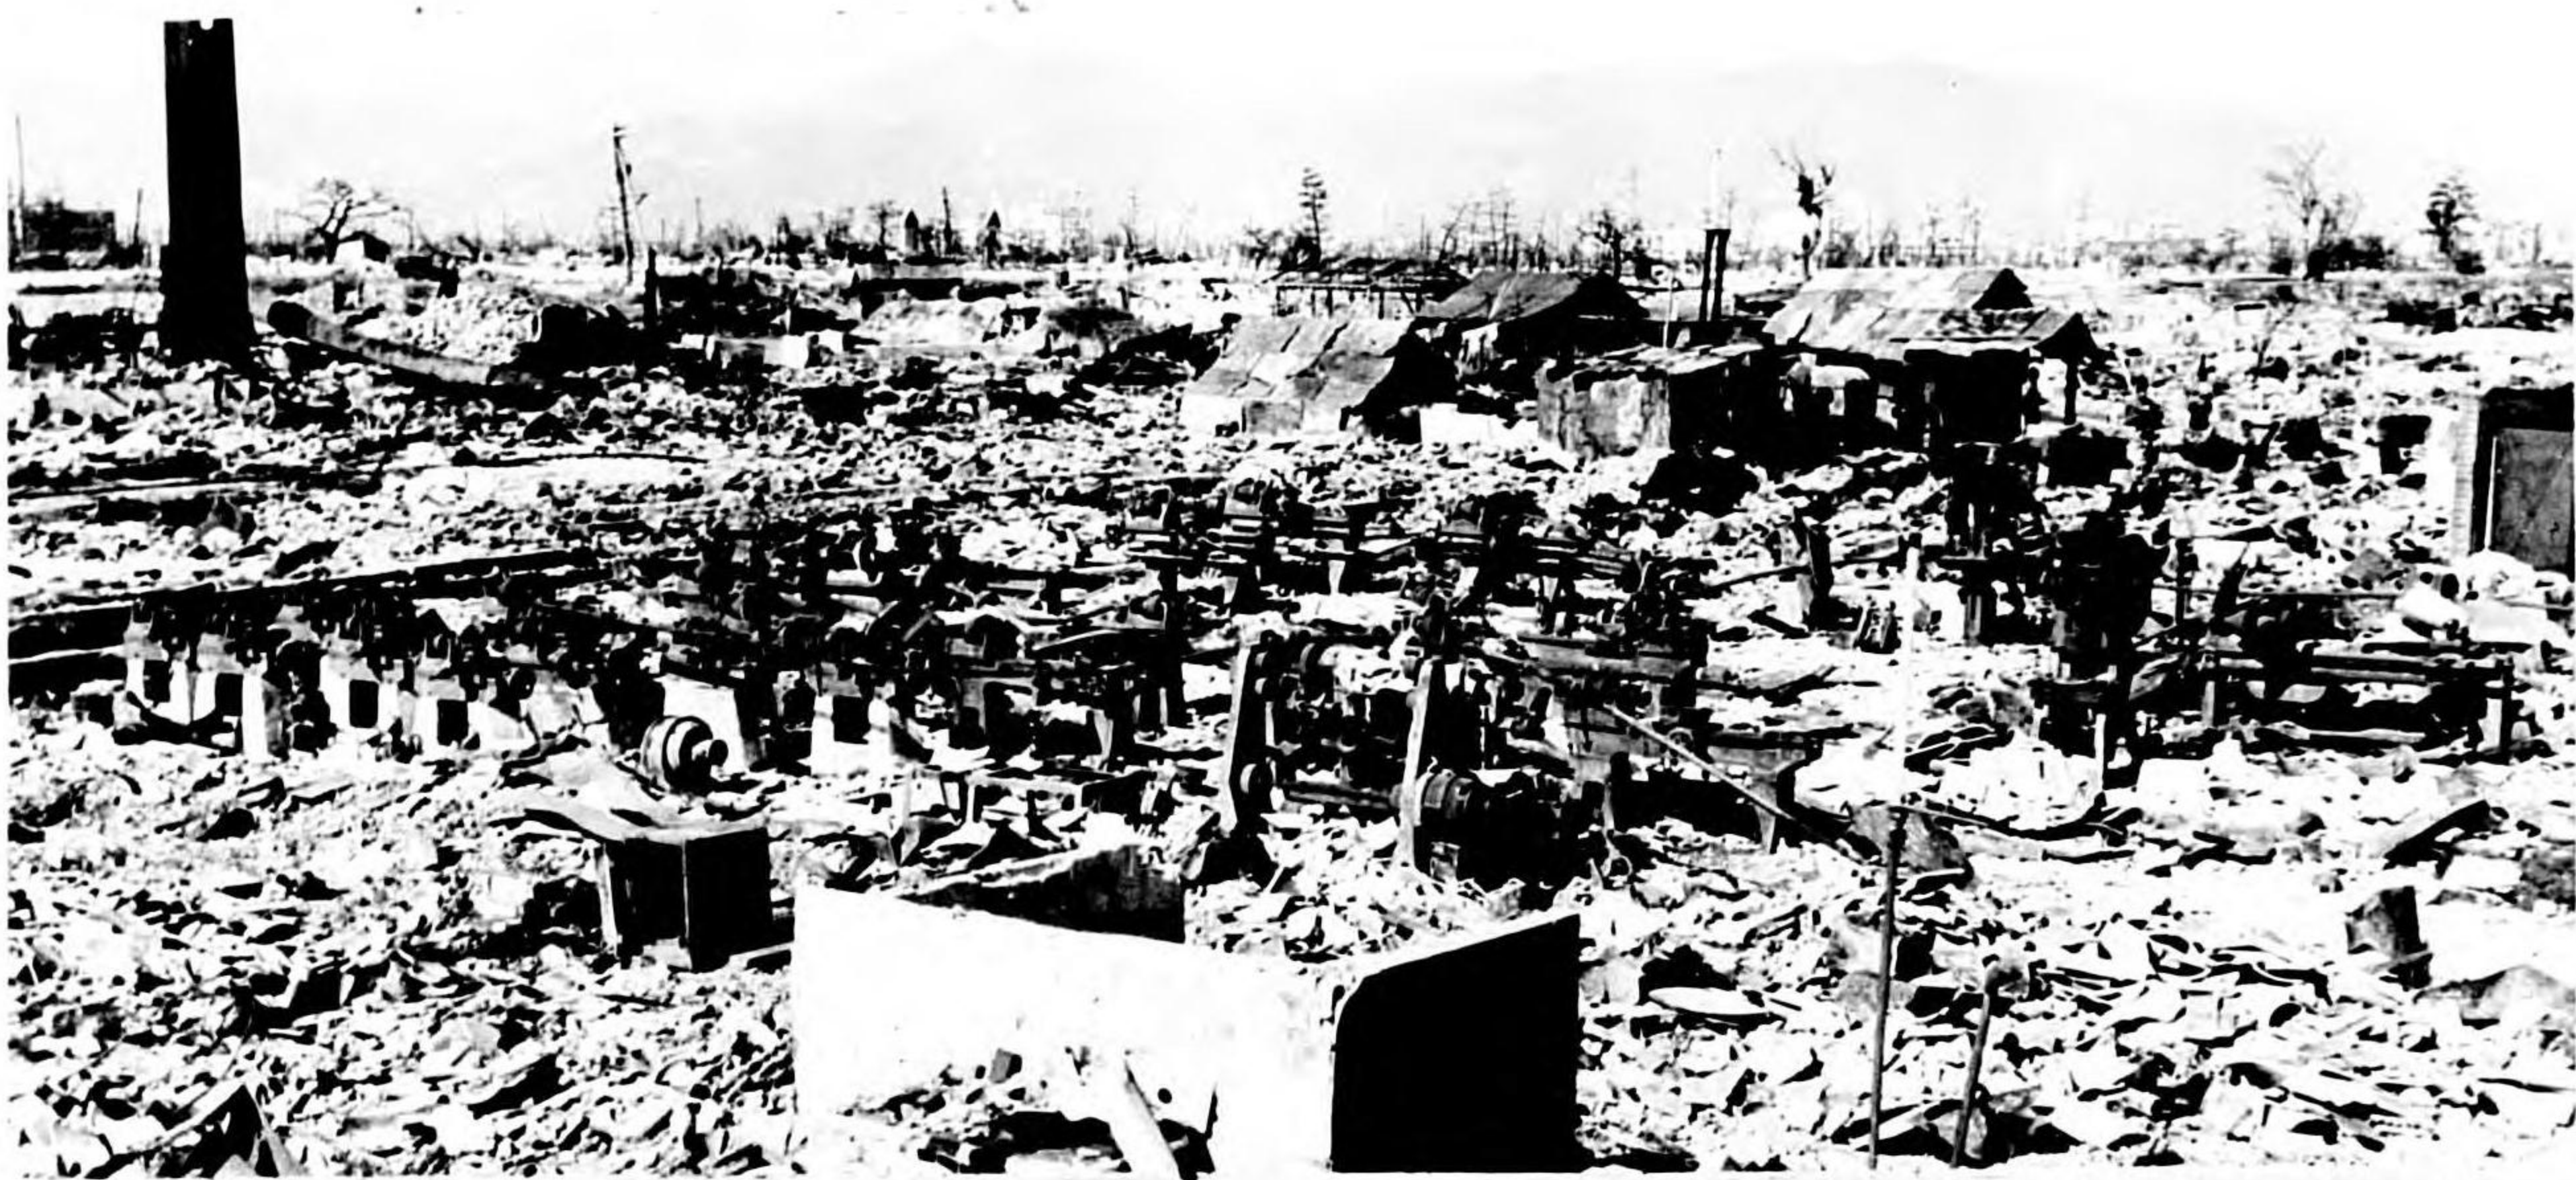
Photo 163. Hiroshima, 6,500 feet from GZ. Wood-frame, light-engineering shop structurally damaged by blast and then consumed by fire.

~~buildings~~ of similar construction were structurally damaged within a radius of 10,000 feet from Ground Zero, or within an area of 9.9 square miles. These buildings were generally of inferior construction and design. Supporting members and columns were easily buckled by blast pressure on roofs, leading to mass distortion and collapse of framework. Structural damage to wood-frame buildings as a result of blast generally extended well beyond the area of fire damage. Wood-frame and all-wood domestic buildings in Hiroshima were totally or heavily damaged throughout an area of 6 square miles; in Nagasaki, throughout an area of 7.5 square miles. (Photos 163-165)
