DAMAGE TO MACHINE TOOLS BY ATOMIC BOMB

CHAPTER V
DAMAGE TO UTILITIES

ATOMIC BOMBS
PLANT UTILITIES
HIROSHIMA - NAGASAKI

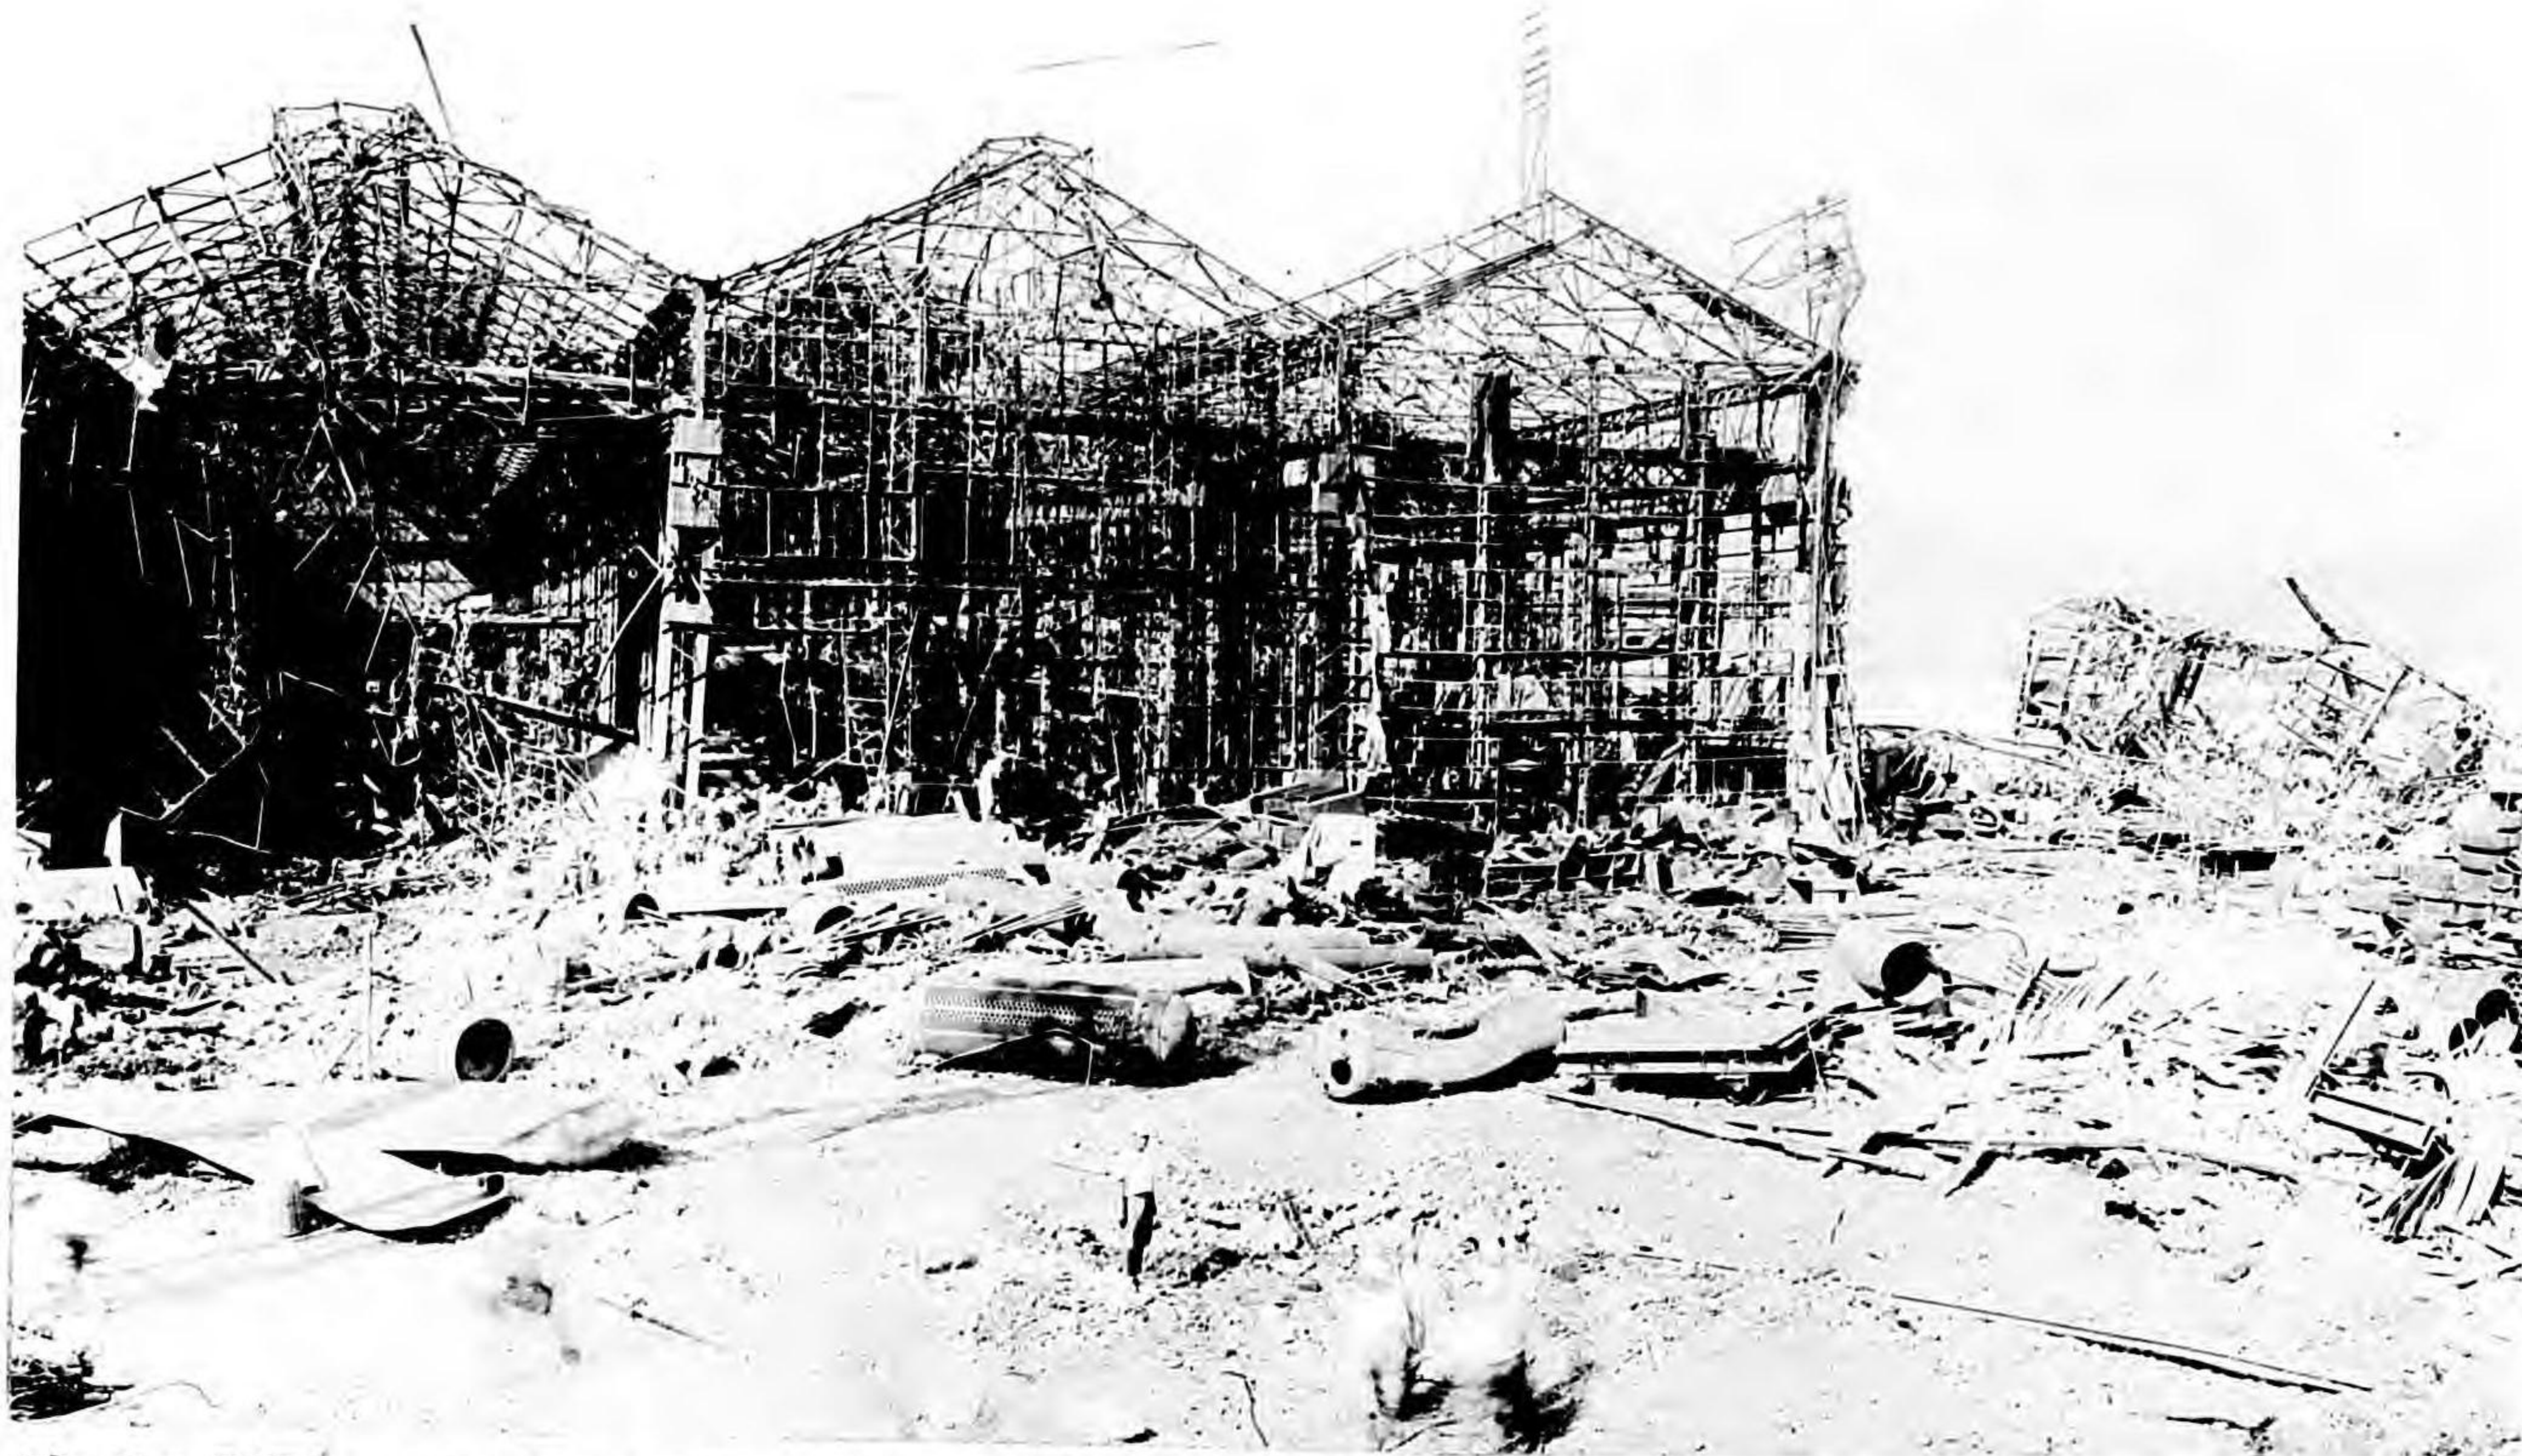
Photo 167. Akuncoura Engine Works. Steel-frame boiler shop which suffered heavy structural and superficial damage from high-explosive bombs, but little additional damage from atomic bomb.

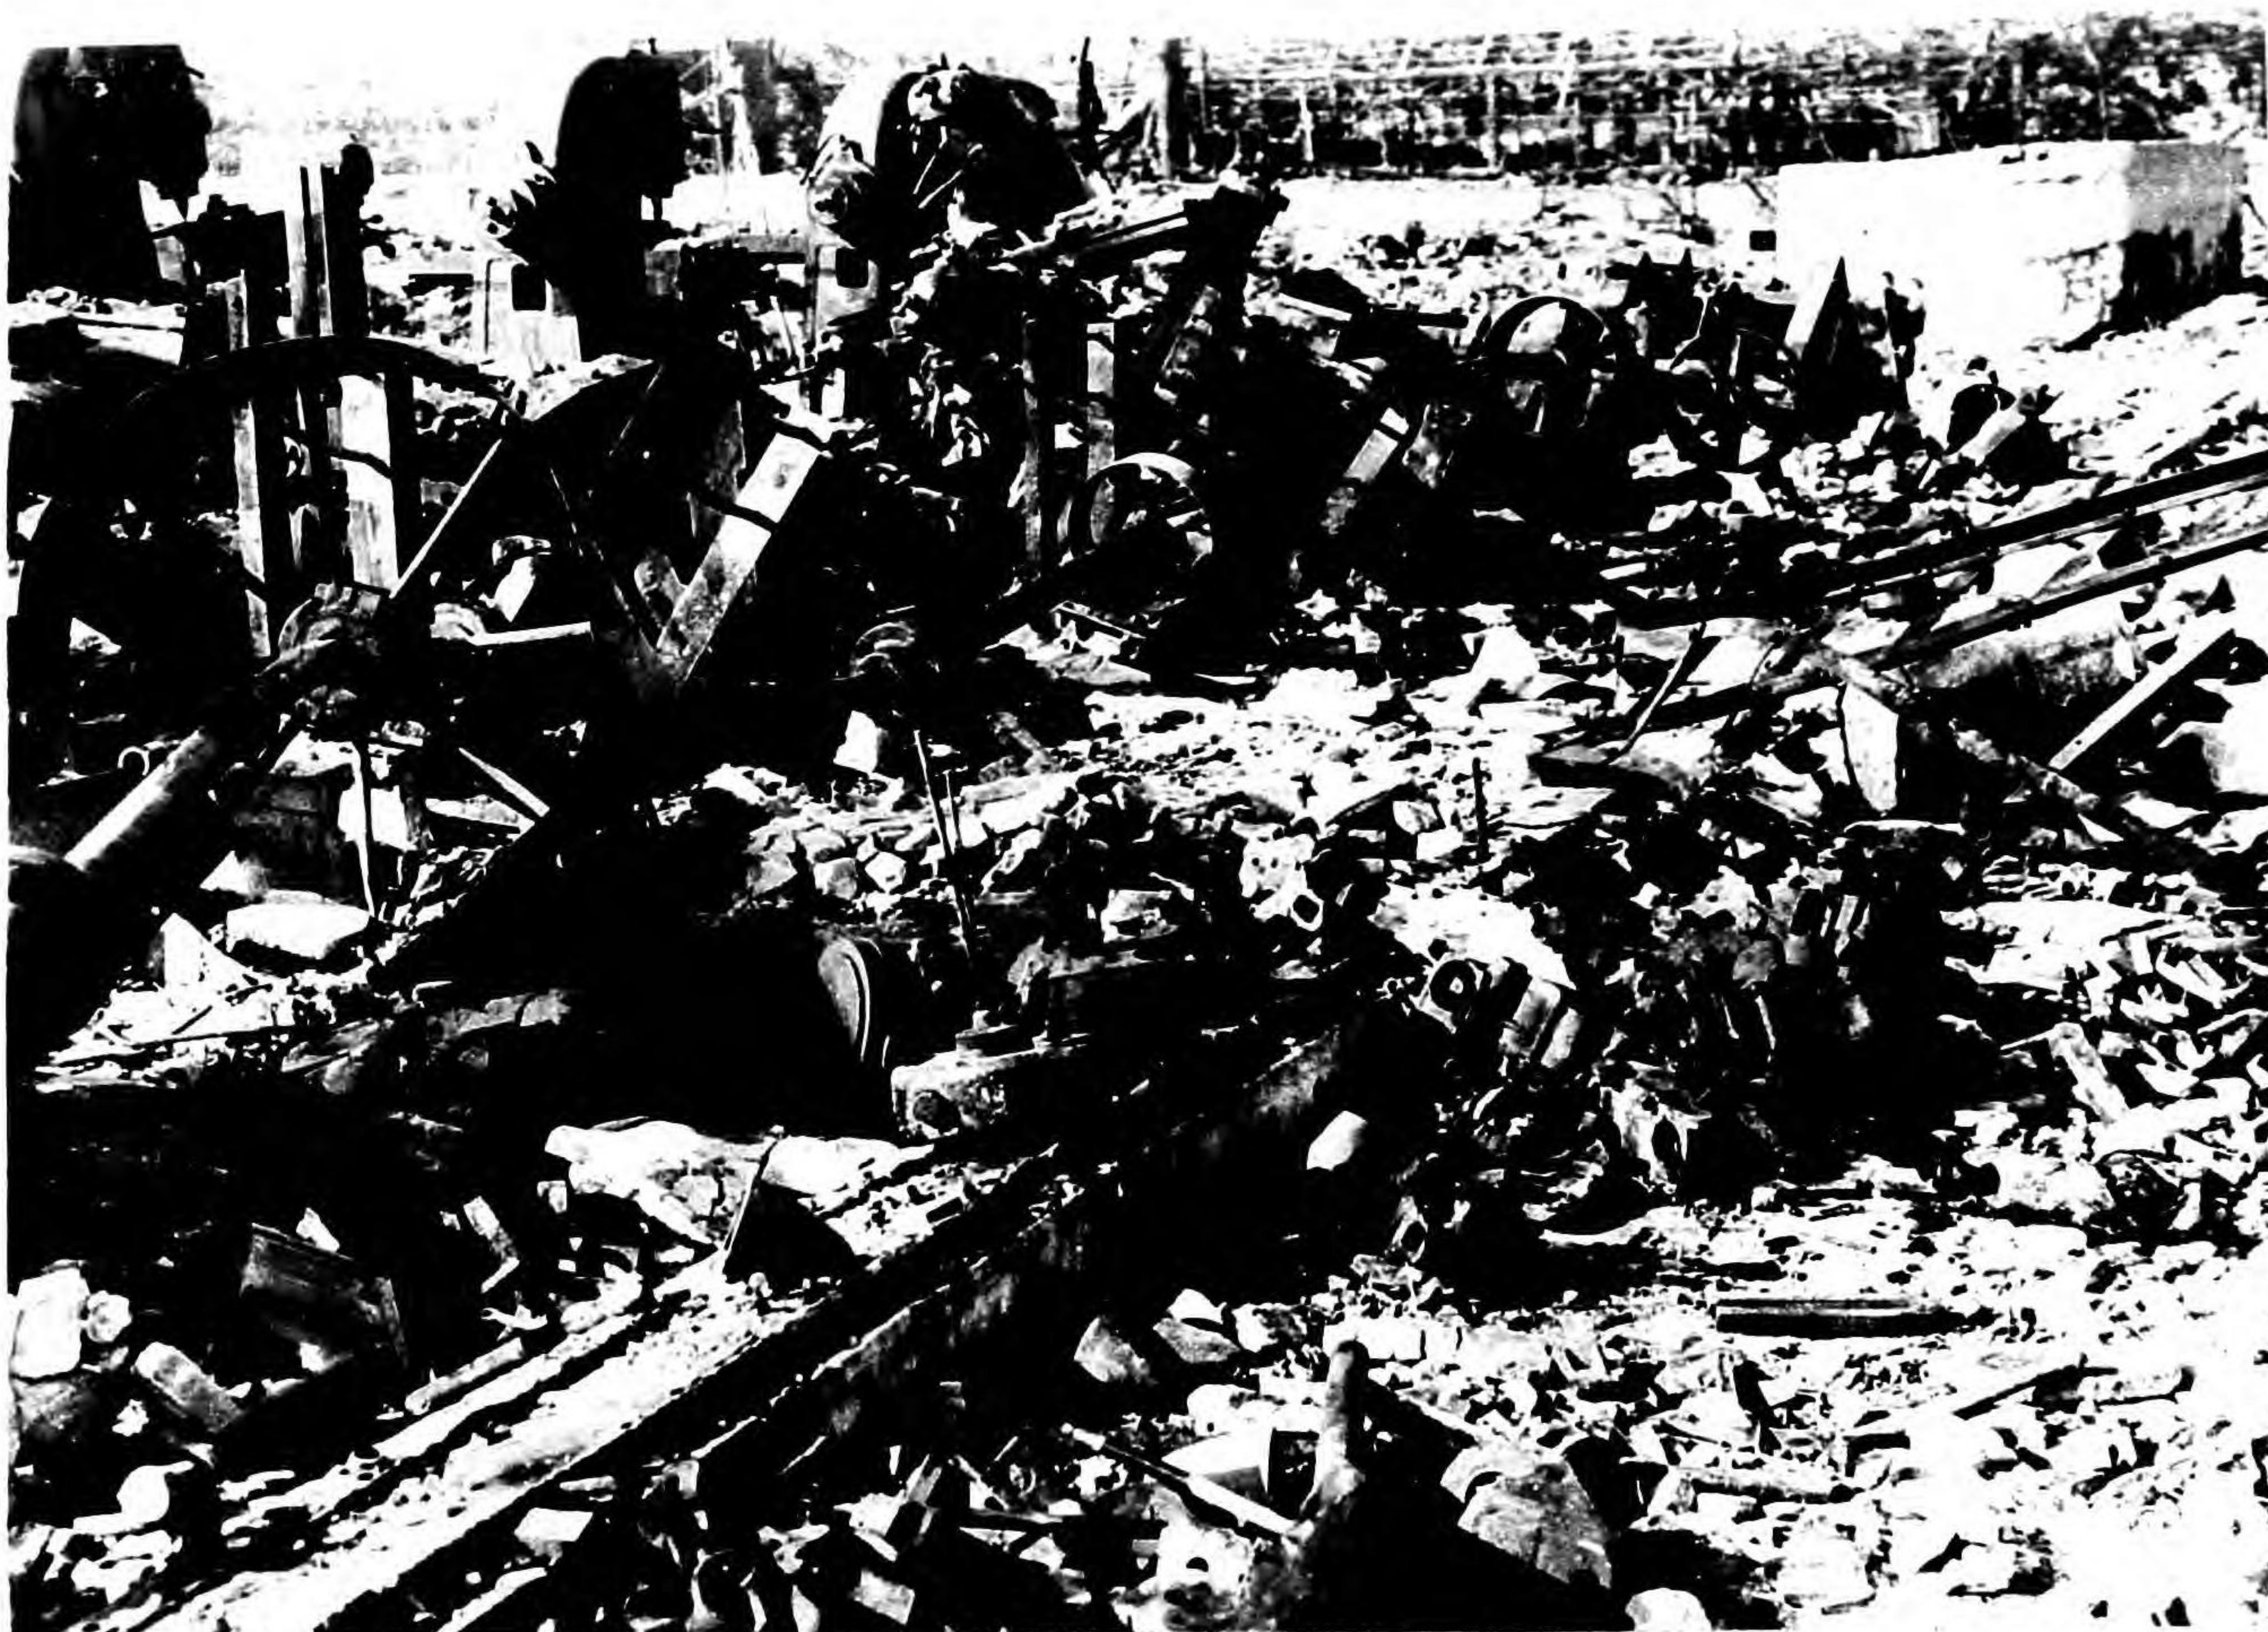
Photo 168. Nagasaki. Mitsubishi Boys Industrial School. Wood-frame building used for industrial purposes totally damaged by blast and fire. Machine tools totally or heavily damaged by blast, debris, and fire.

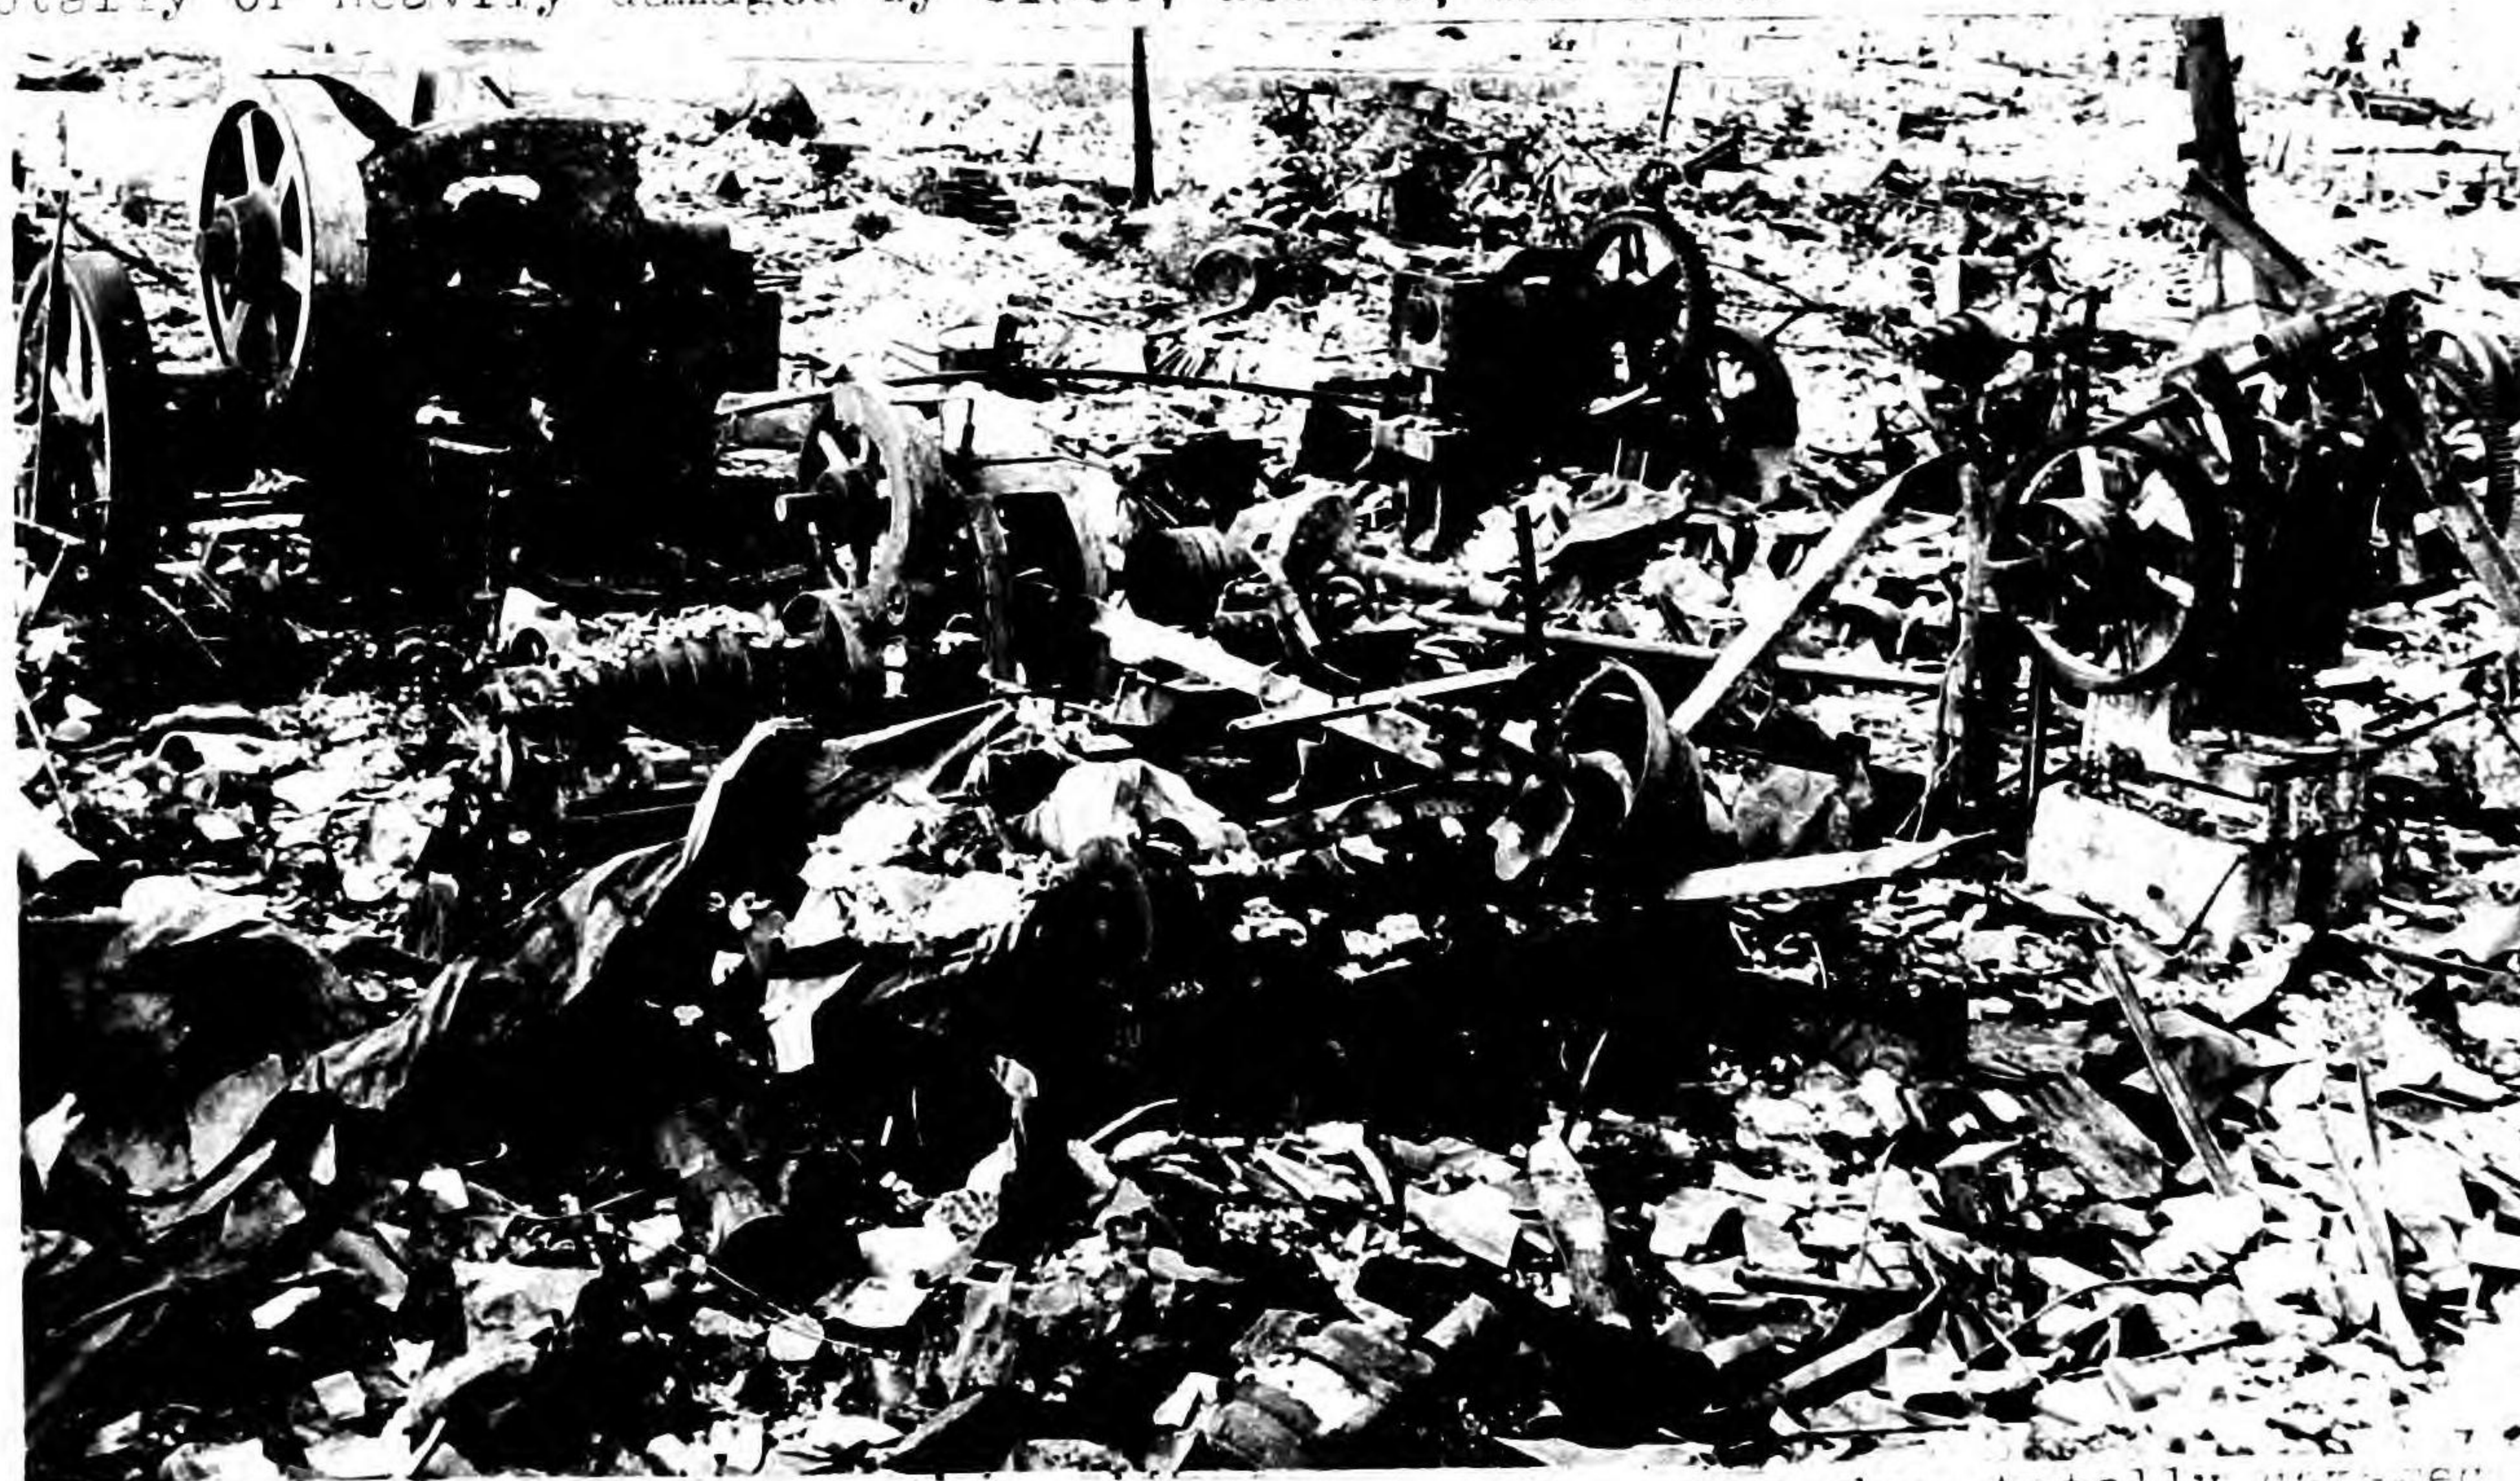
Photo 169. Hiroshima. Wood-frame, light-engineering shop totally damaged by blast, 1,600 feet from GZ. Debris broke casting of shear at left, but casting was weak, having been cracked and welded previously. Fire burned combustible debris and heavily damaged machine tools.

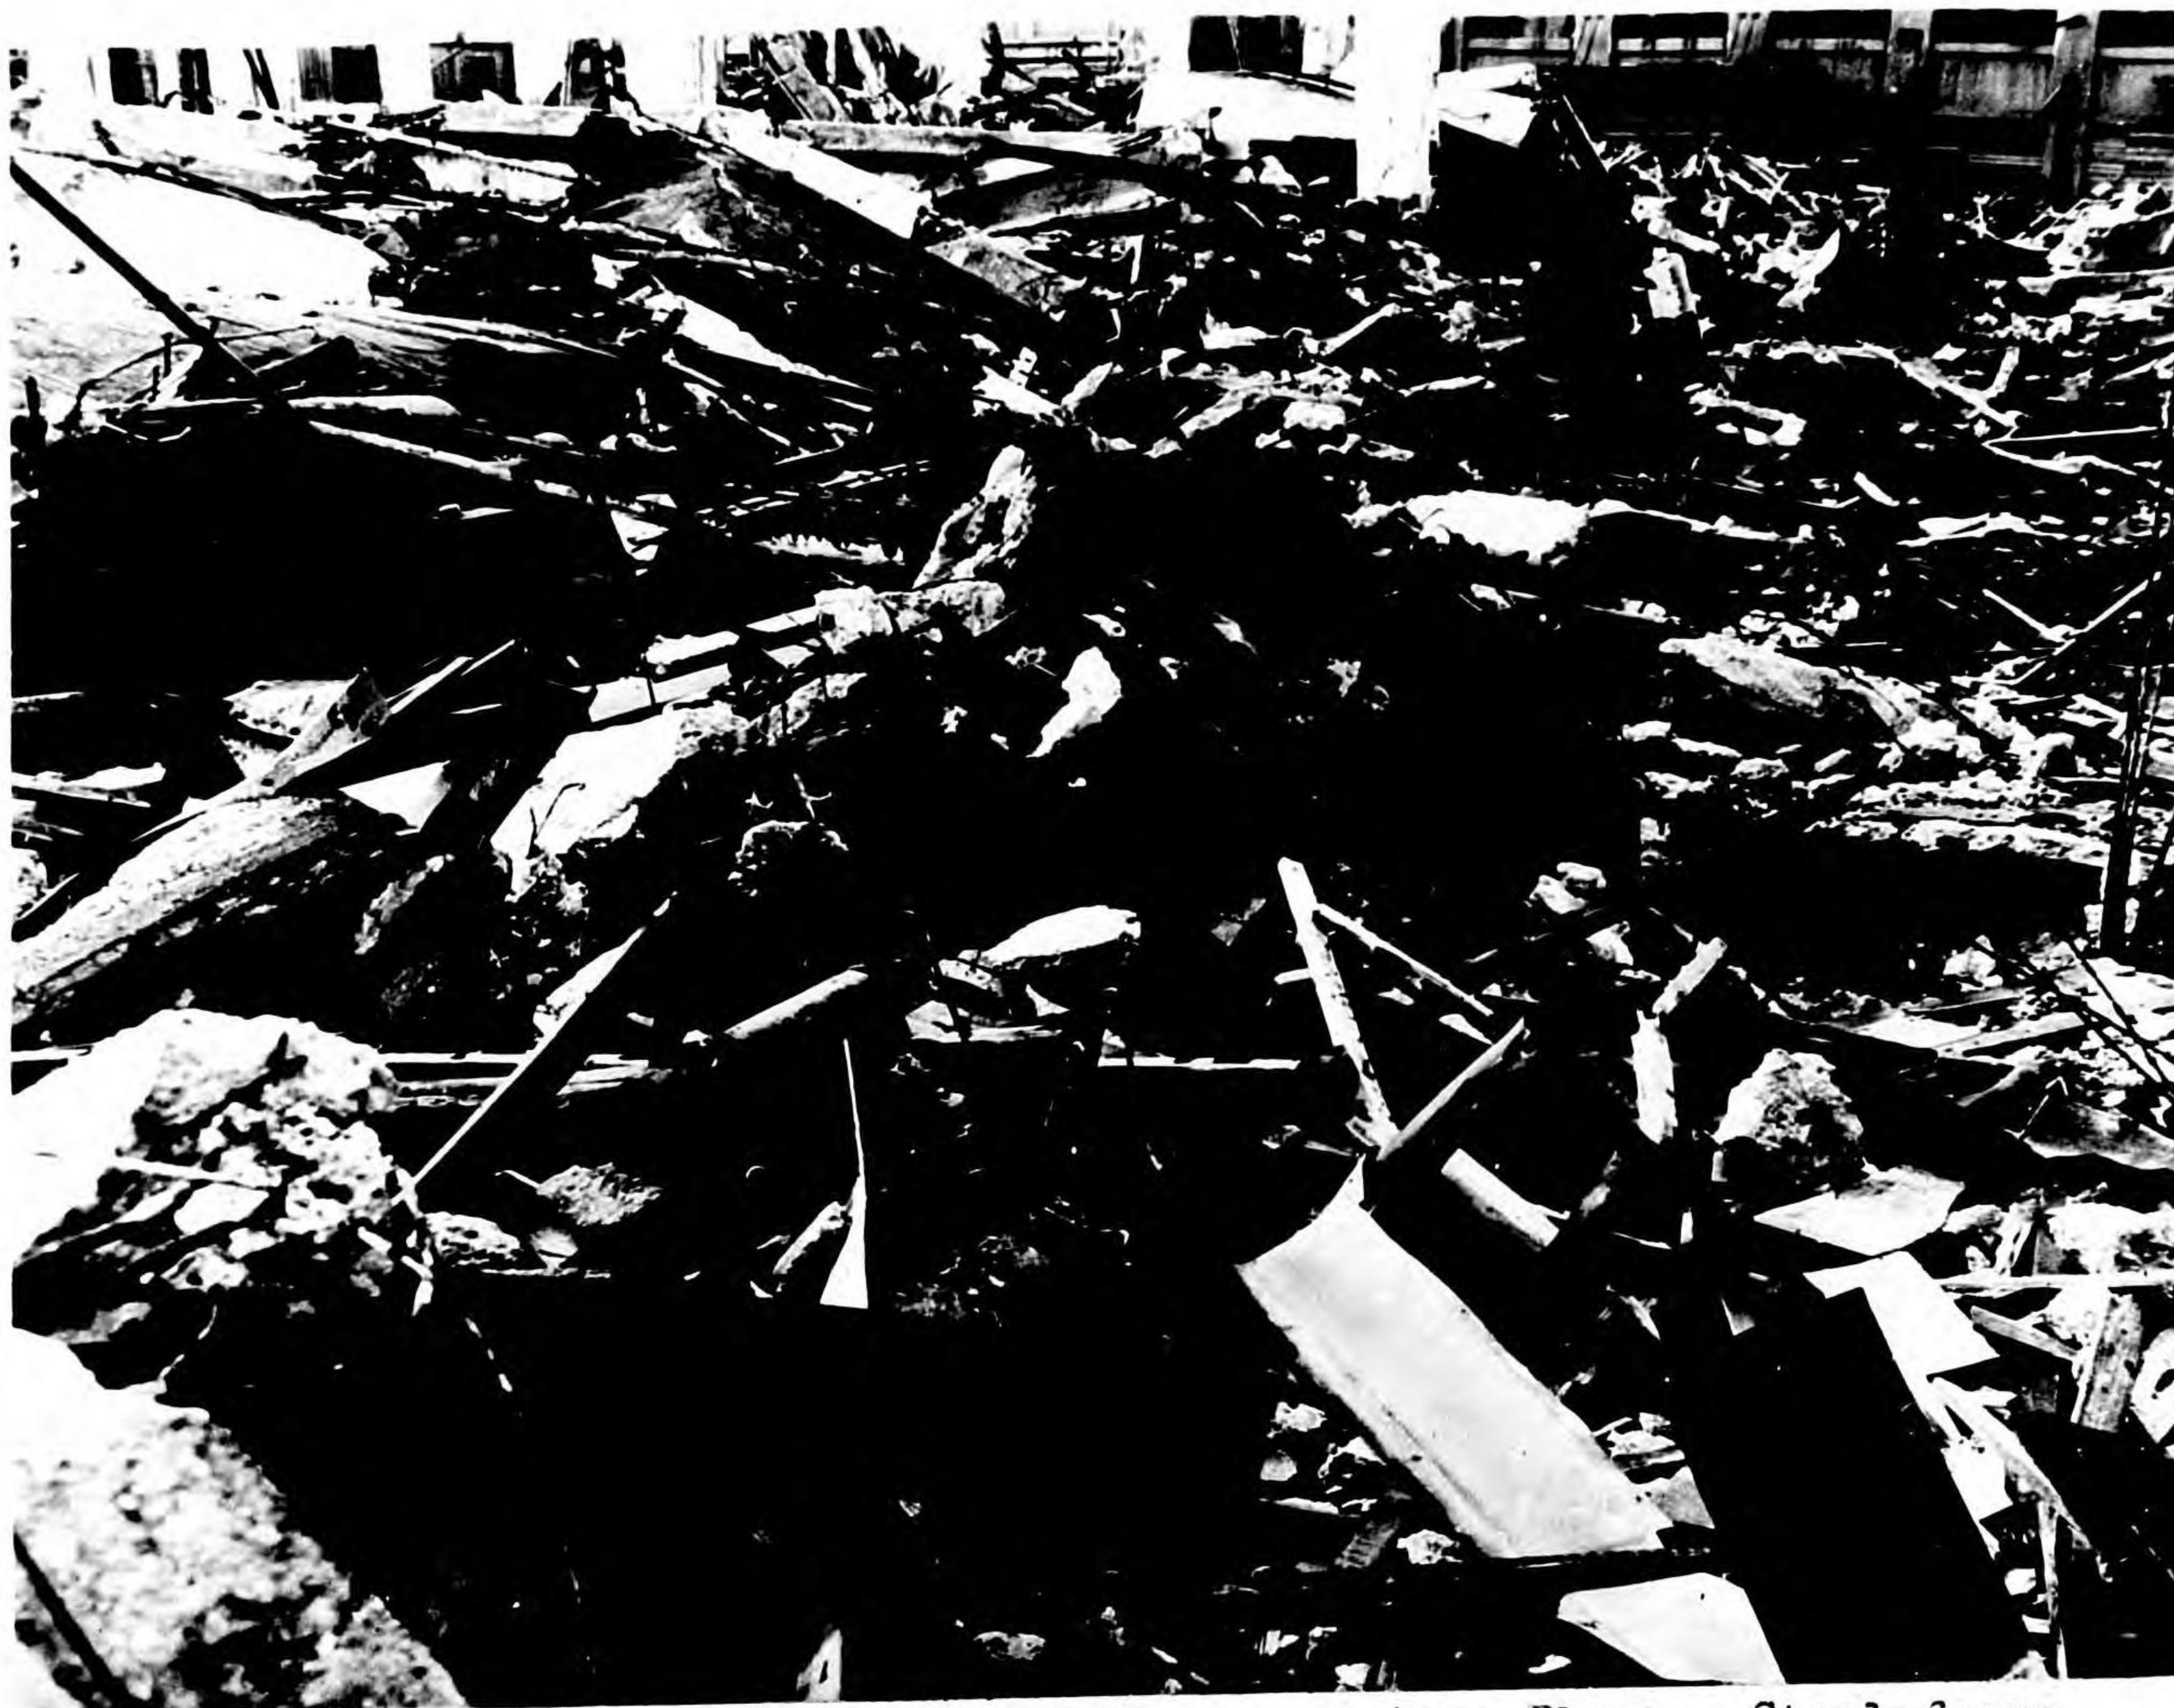
Photo 170. Nagasaki. Mitsubishi Steel and Arms Plant. Steel-frame building damaged by blast and machines totally damaged by collapse of reinforced-concrete roof.

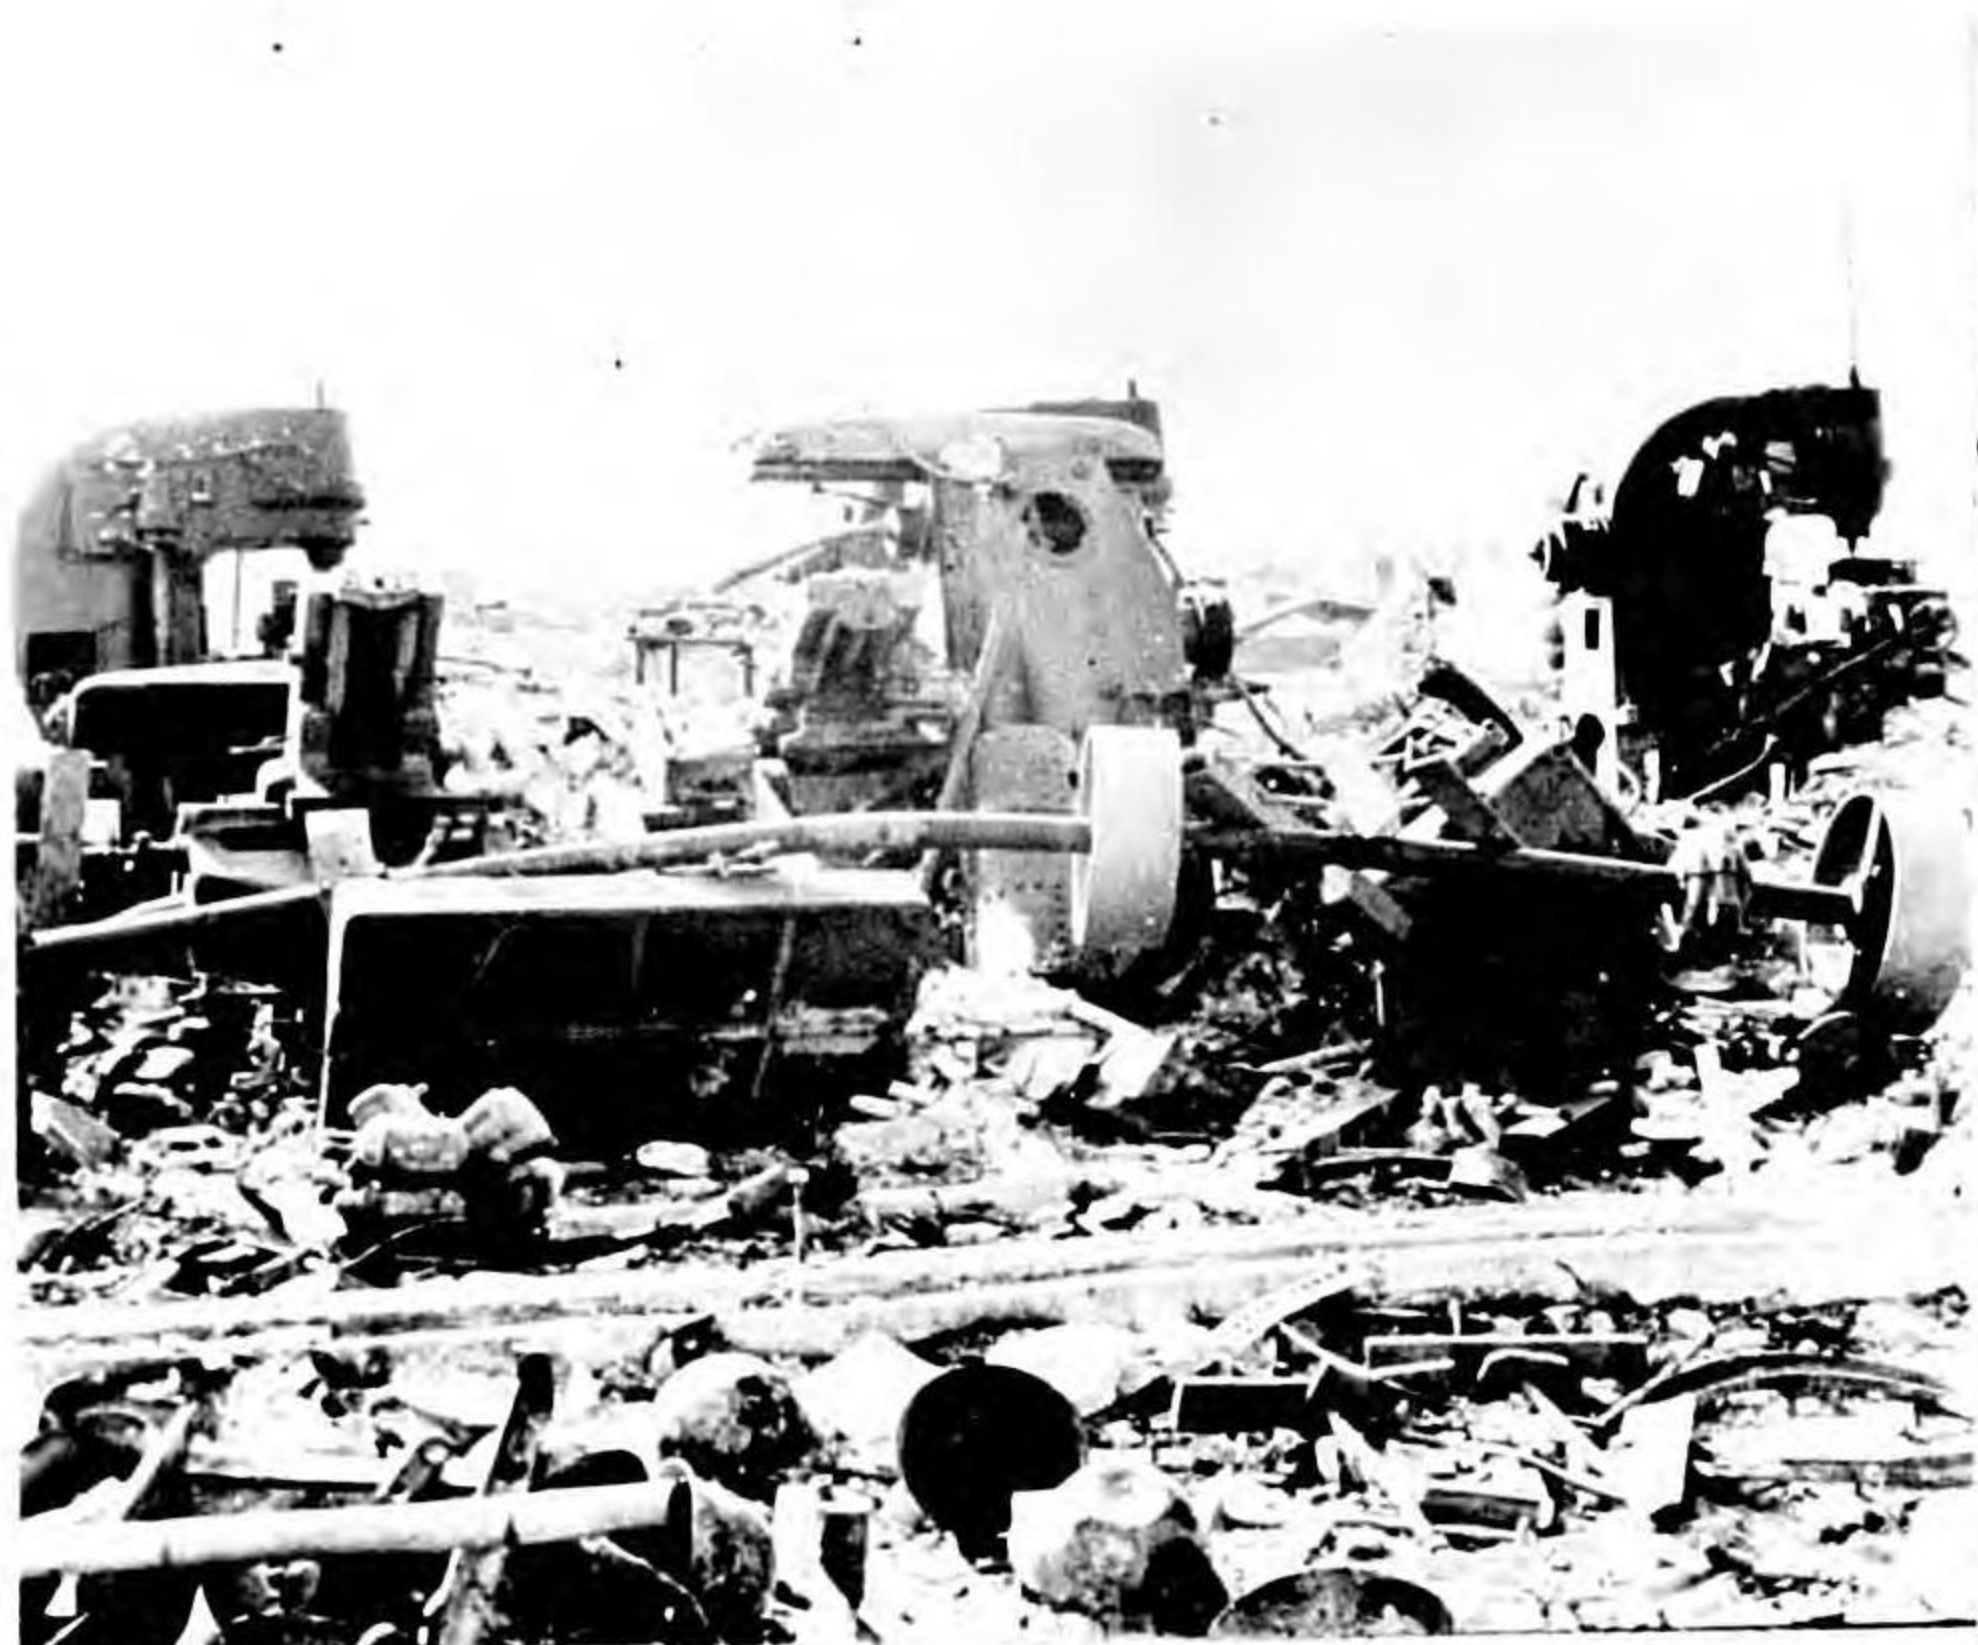
Photo 171. Nagasaki. Mitsubishi Boys Industrial School. Wood-frame building totally damaged by blast, but vertical millers still standing.

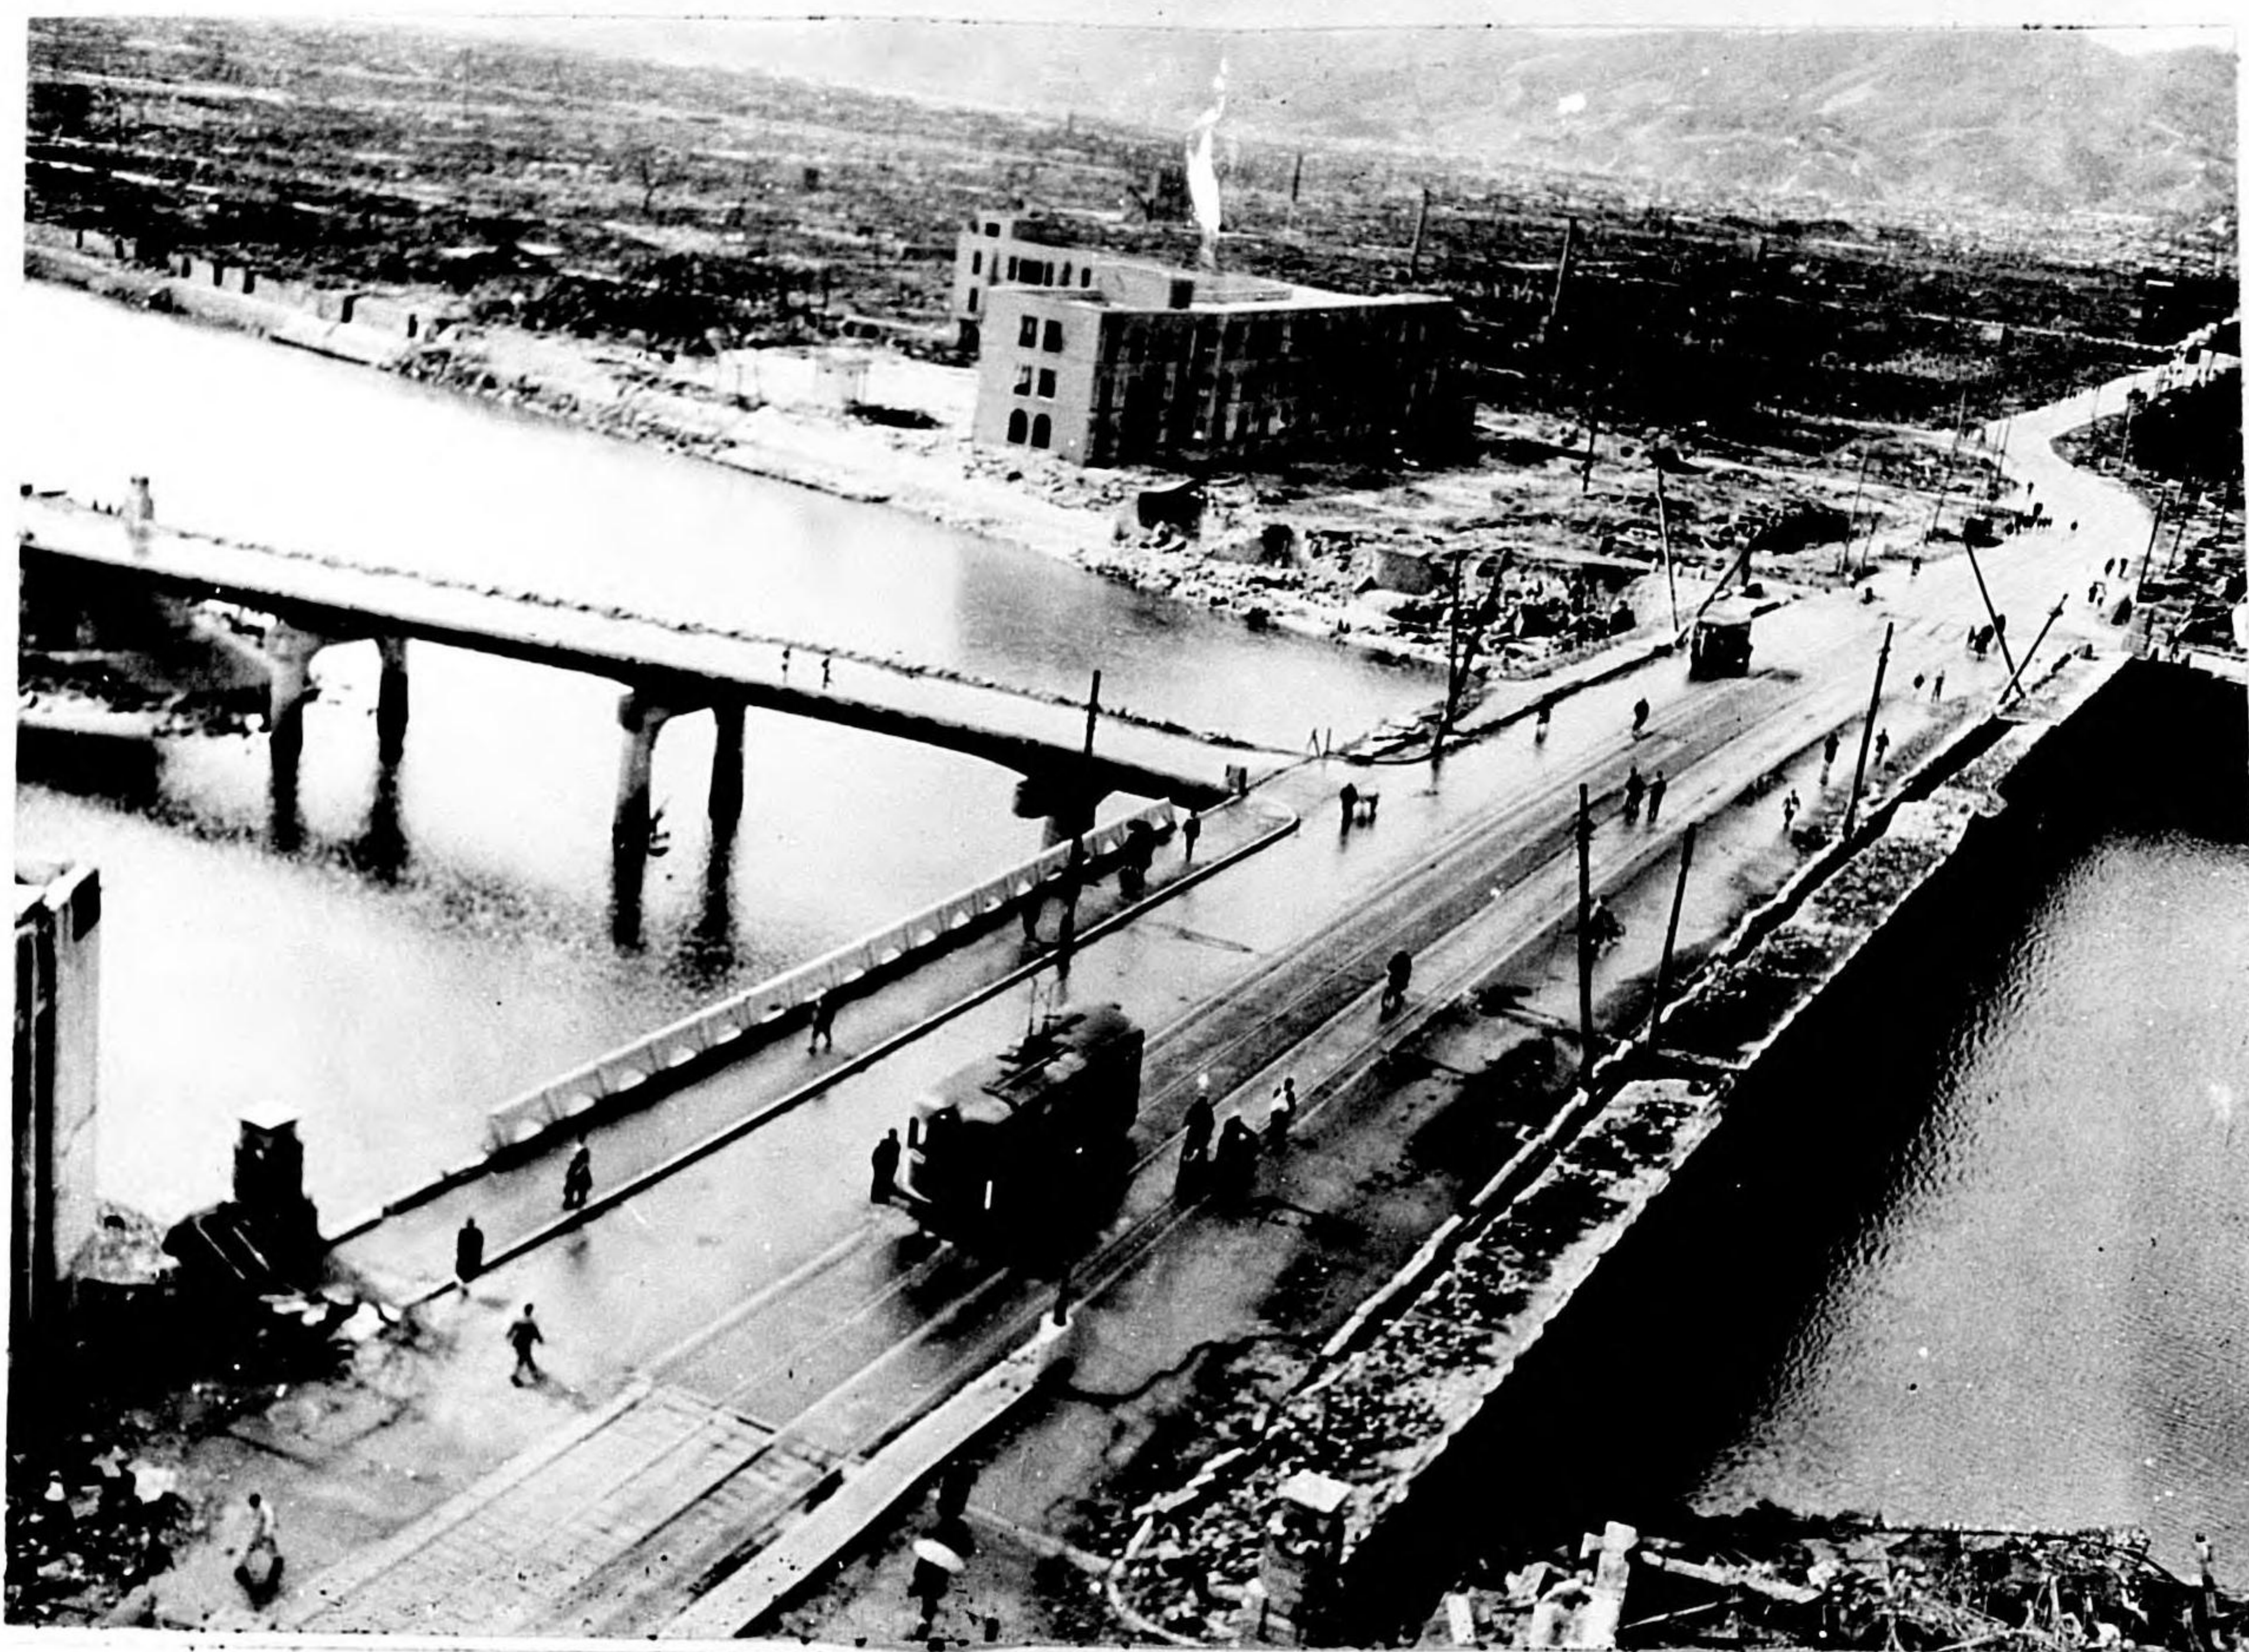
Photo 173. Hiroshima. Intersection of two bridges, approximately 930 feet from GZ. All damage caused by blast.

a. Blast. At Nagasaki two steel-plate-girder railroad bridges, one 840 and the other 900 feet from Ground Zero, were displaced and suffered heavy structural damage as a result of blast. One timber bridge was totally demolished by blast, 5,760 feet from Ground Zero. Two bridges, one of steel and concrete, the other concrete, 1,950 and 2,330 feet from Ground Zero, respectively, had spans blown off ^{their supports,} In addition, the decks of the remaining spans of the steel and concrete bridge were blown 150 feet away. Four concrete bridges from 300 to 1,710 feet from Ground Zero sustained lateral displacement from one to eight inches as a result of blast. Blast damage to six other concrete bridges at Nagasaki at distances from 750 to 3,750 feet from Ground Zero ranged from displacement of deck and spalling of concrete girders to demolished railings. At Hiroshima, two steel street-railway bridges, 1,000 and 4,670 feet, respectively, from Ground Zero, were heavily damaged by blast. One steel highway bridge, 1,190 feet from Ground Zero, was totally collapsed. Five concrete (4,270 to 6,450 feet from GZ) and five steel highway bridges (260 to 7,600 feet from GZ) were damaged in extent ranging from distorted decks to superficial damage, such as blown-off railings and trim. ^(Photo 173) Flood and typhoon were credited with
