DAMAGE TO MACHINE TOOLS BY ATOMIC BOMB

CHAPTER V
DAMAGE TO UTILITIES

ATOMIC BOMBS
PLANT UTILITIES
HIROSHIMA - NAGASAKI

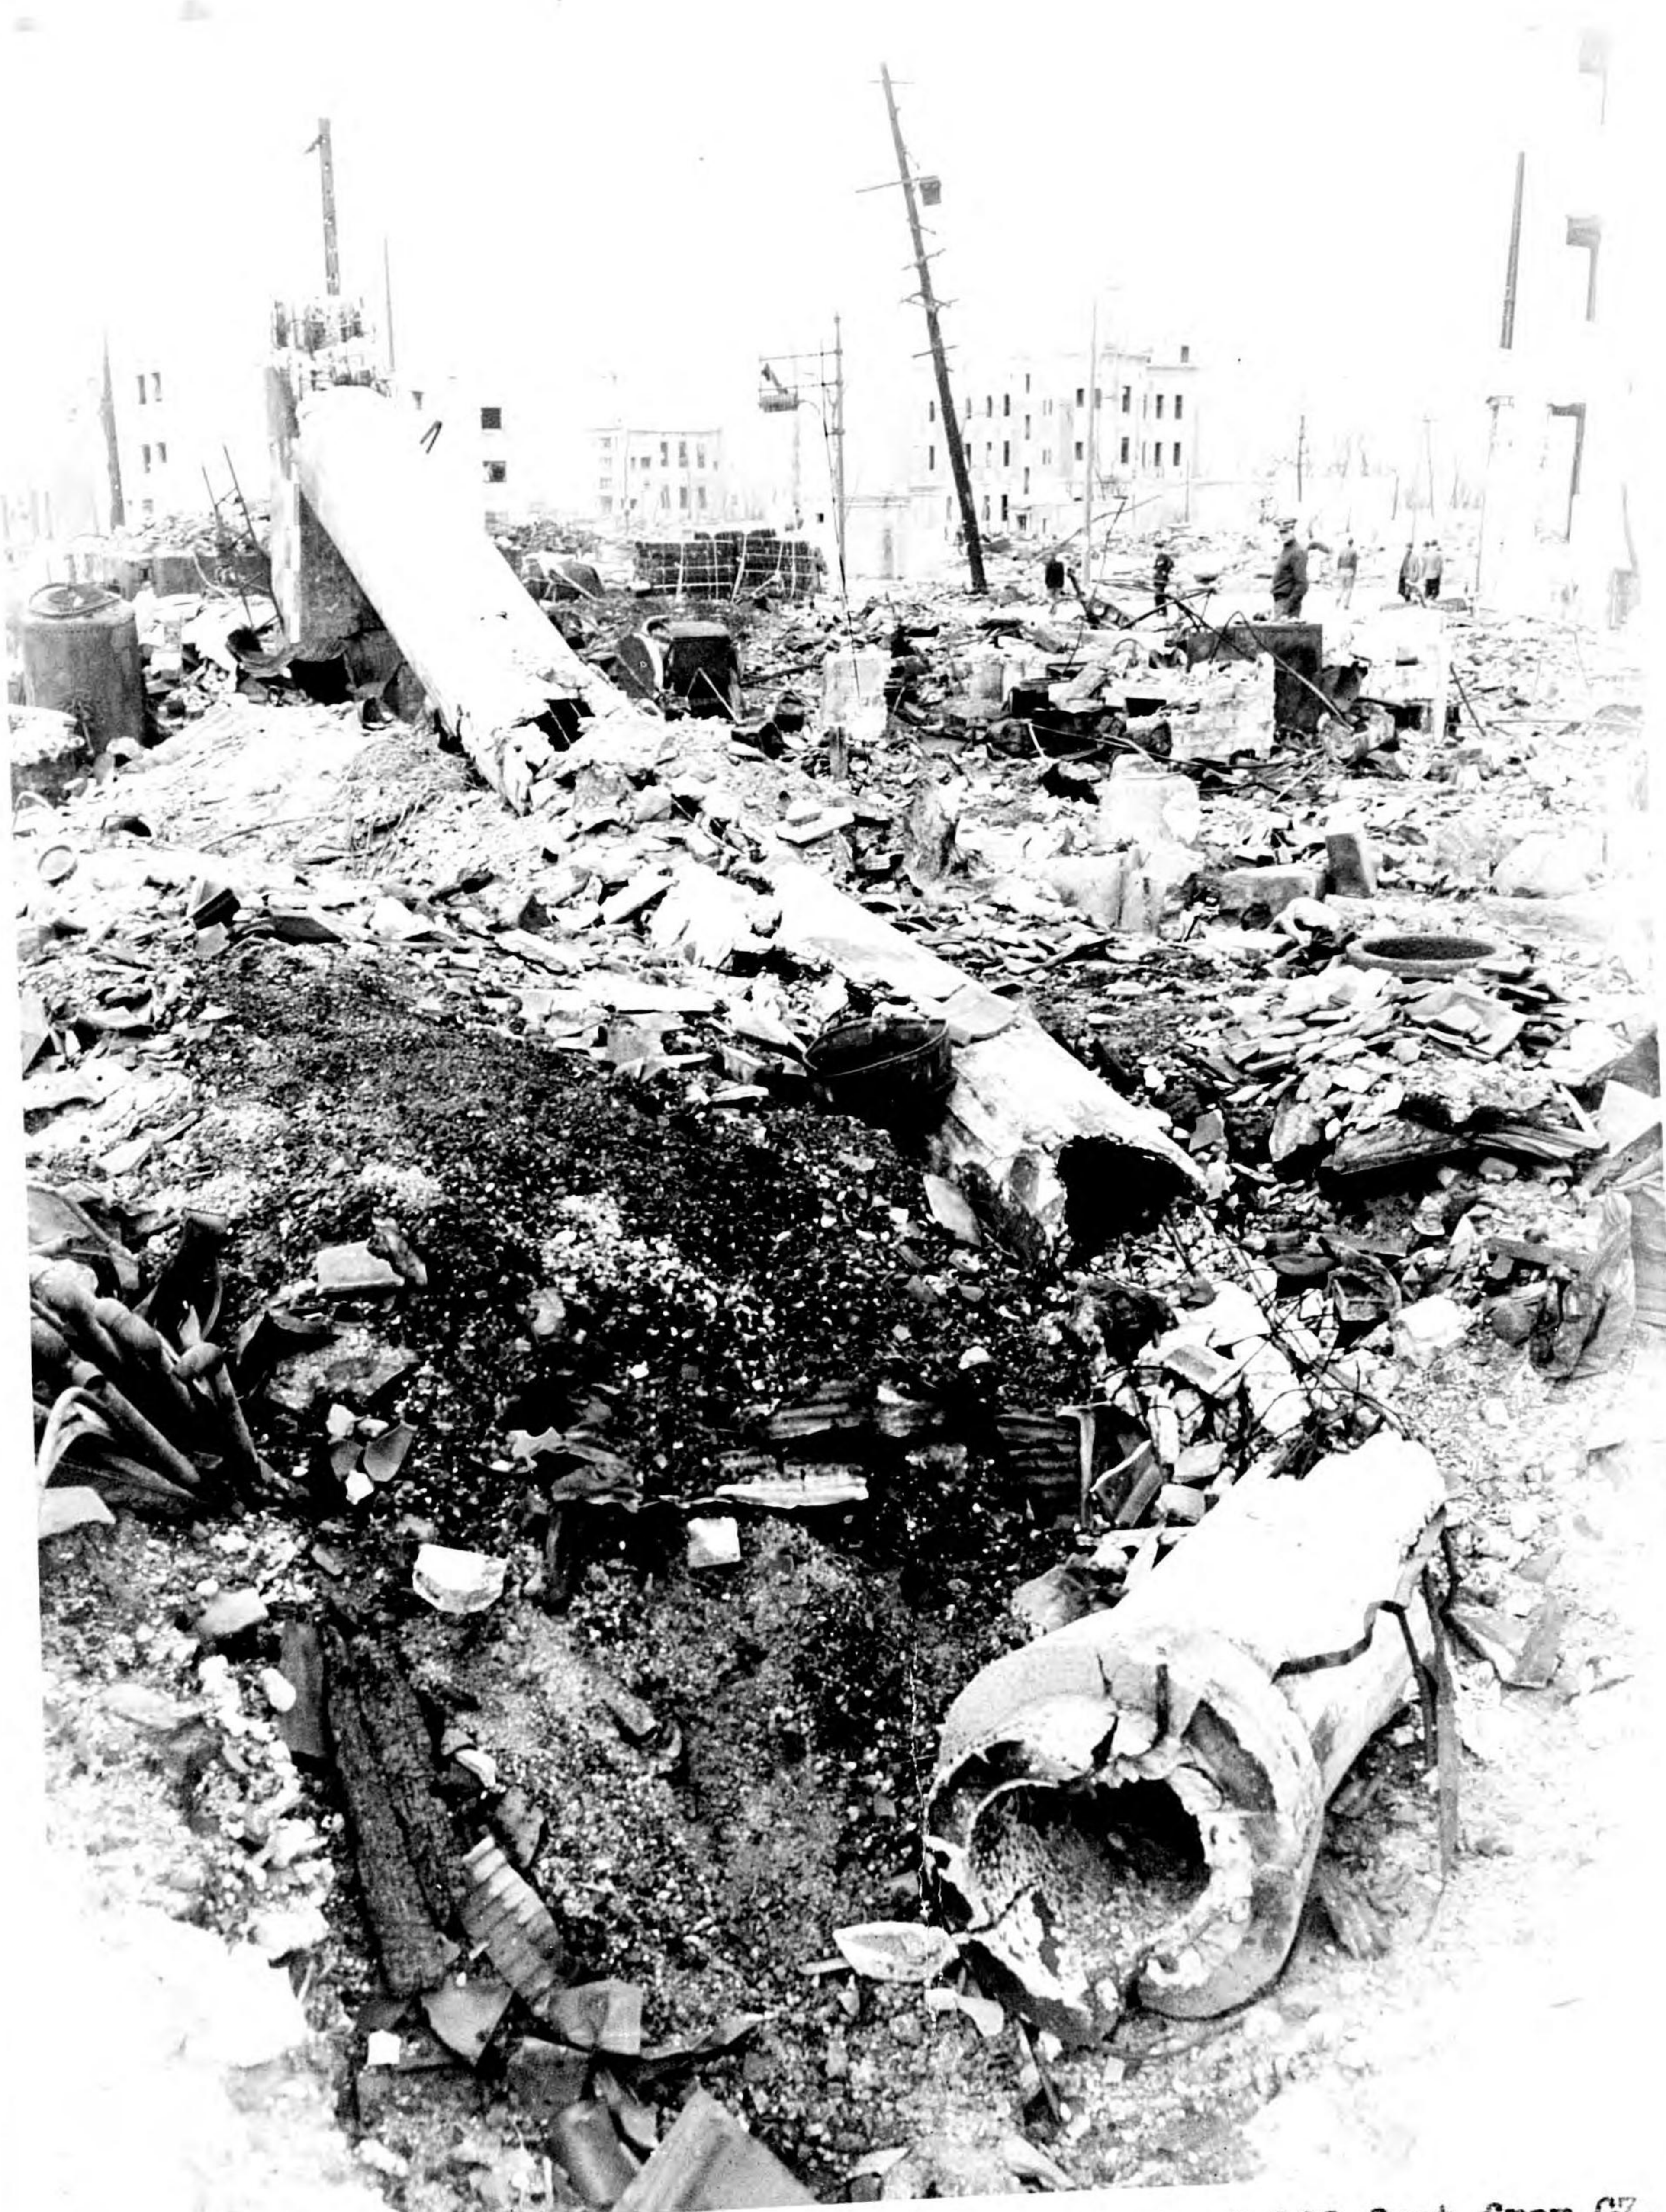
Photo 174. Hiroshima. Reinforced-concrete stack, 1,100 feet from GZ, 60 feet high, 4 feet in diameter, sheared off at 12 feet.

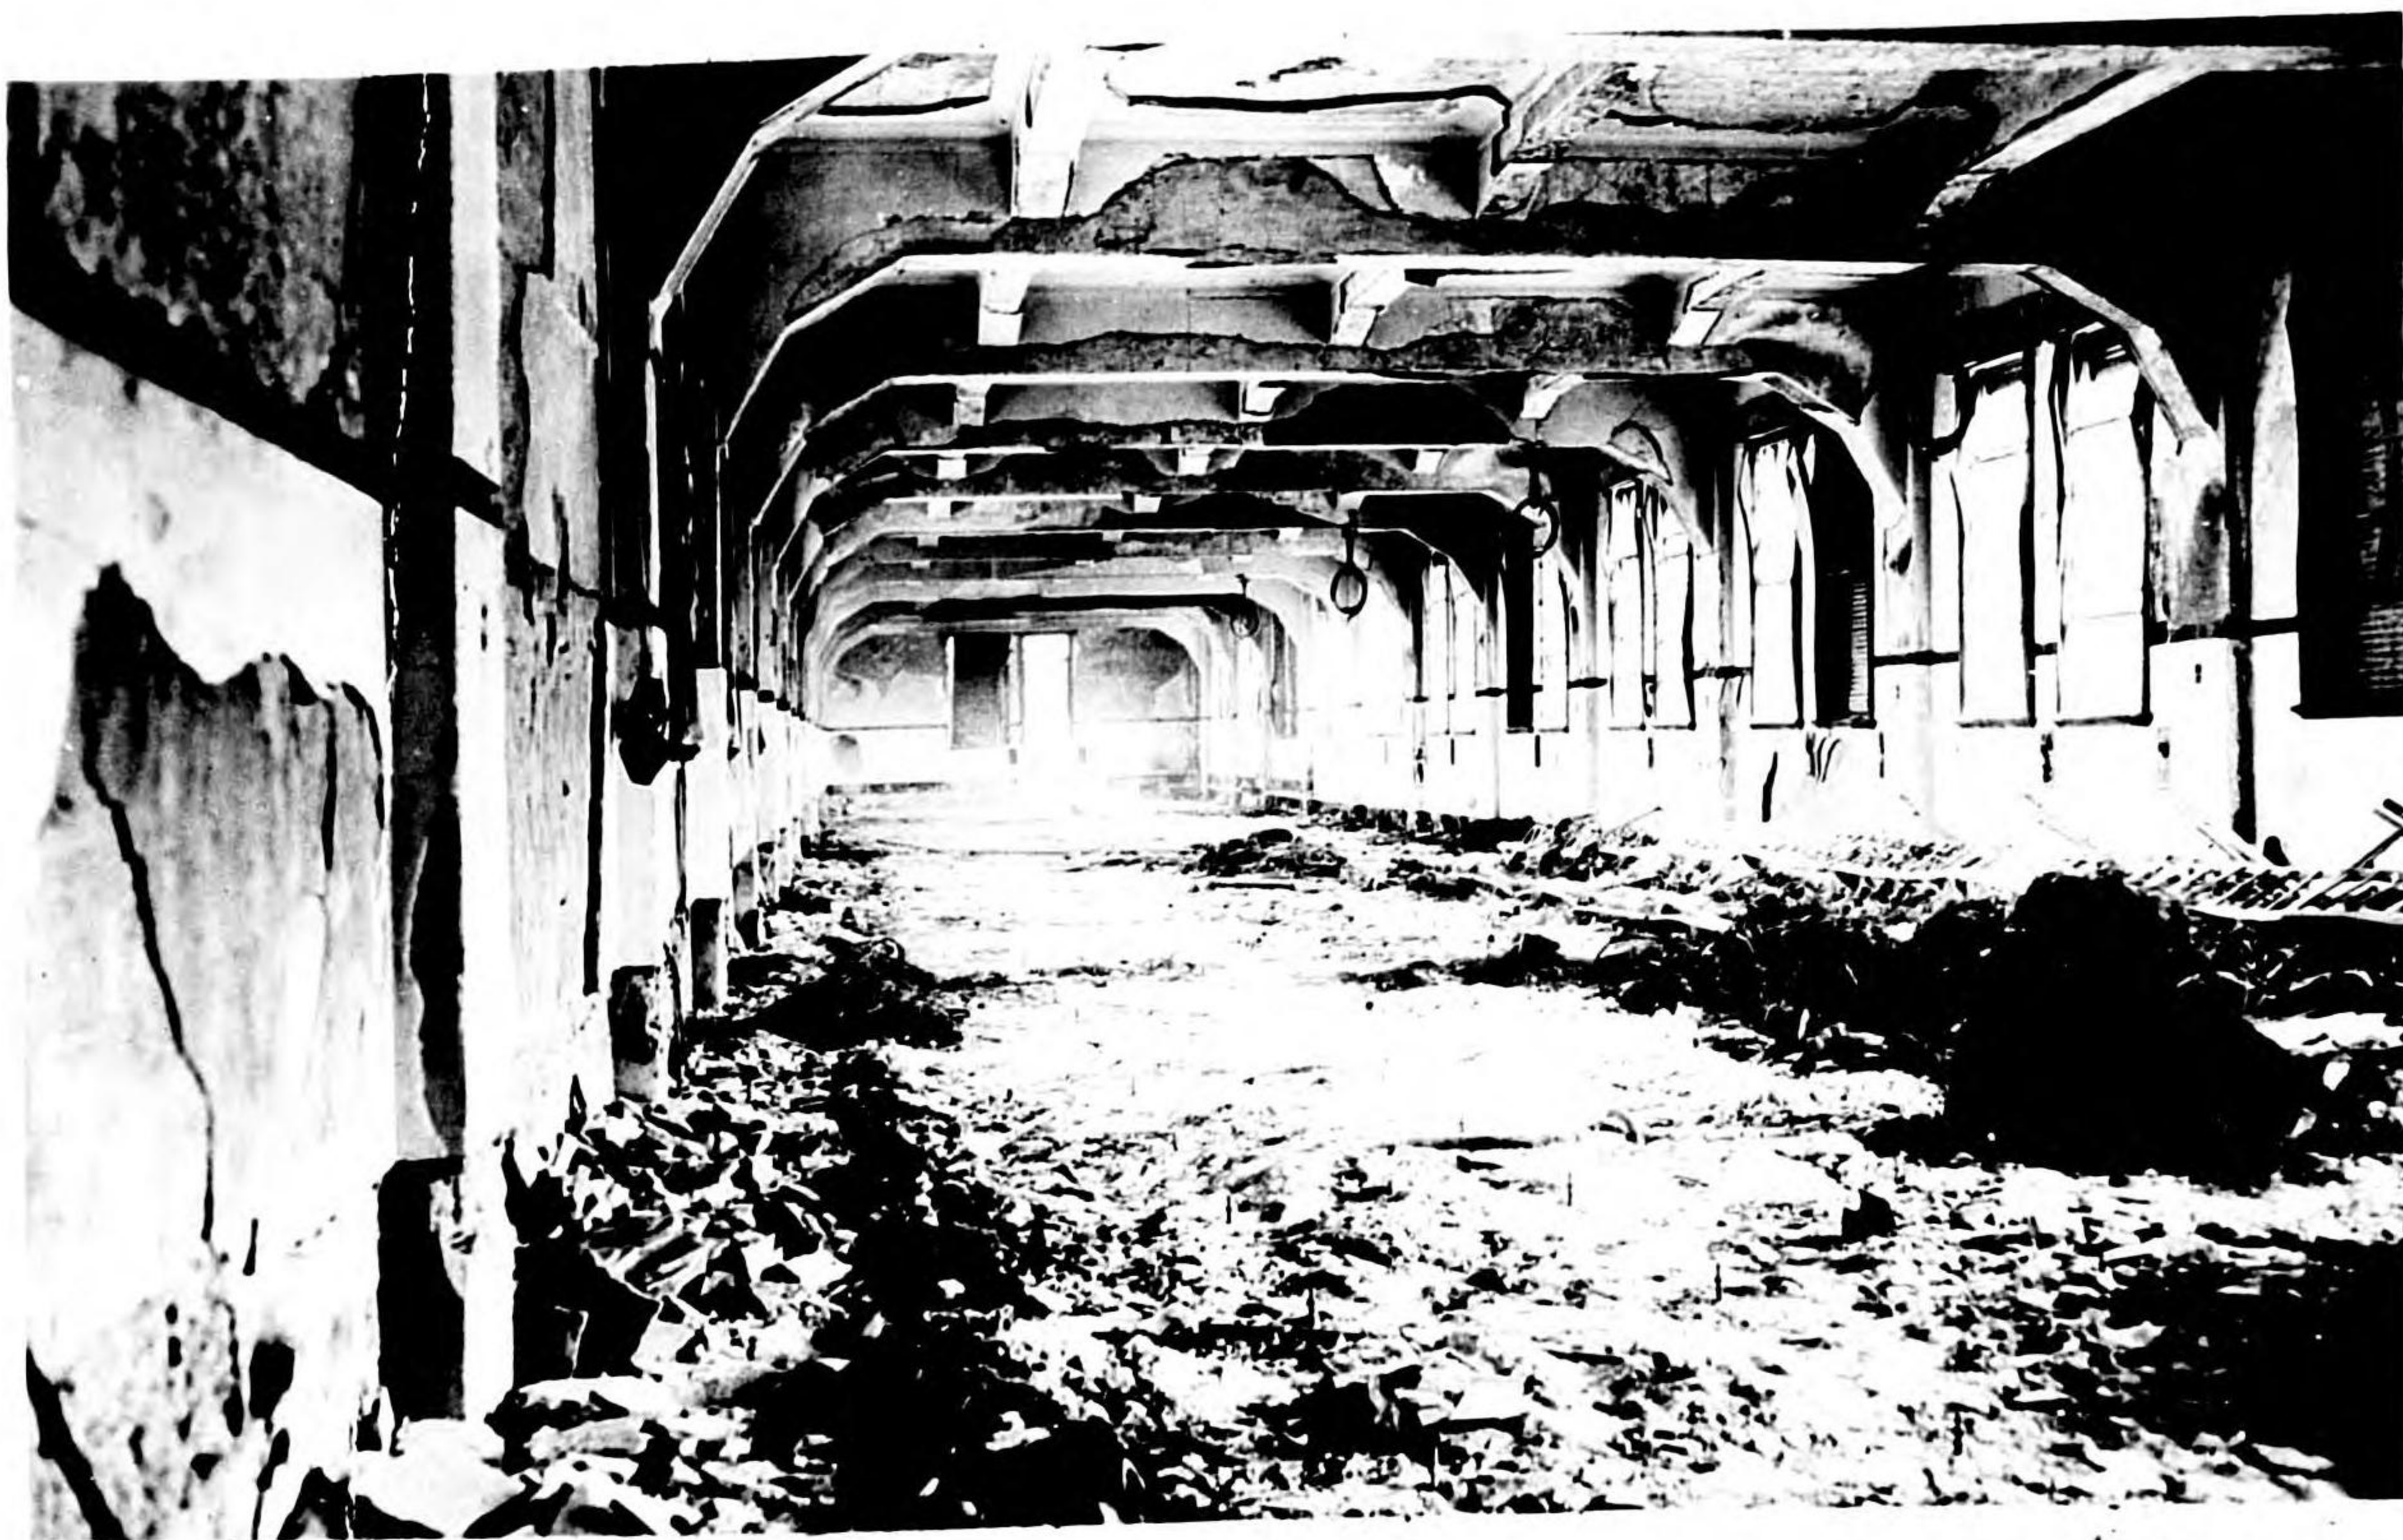
Photo 177. Hiroshima. Bureau of Telephones Central District exchange building. Damage to equipment in reinforced-concrete building 2,000 feet from GZ.

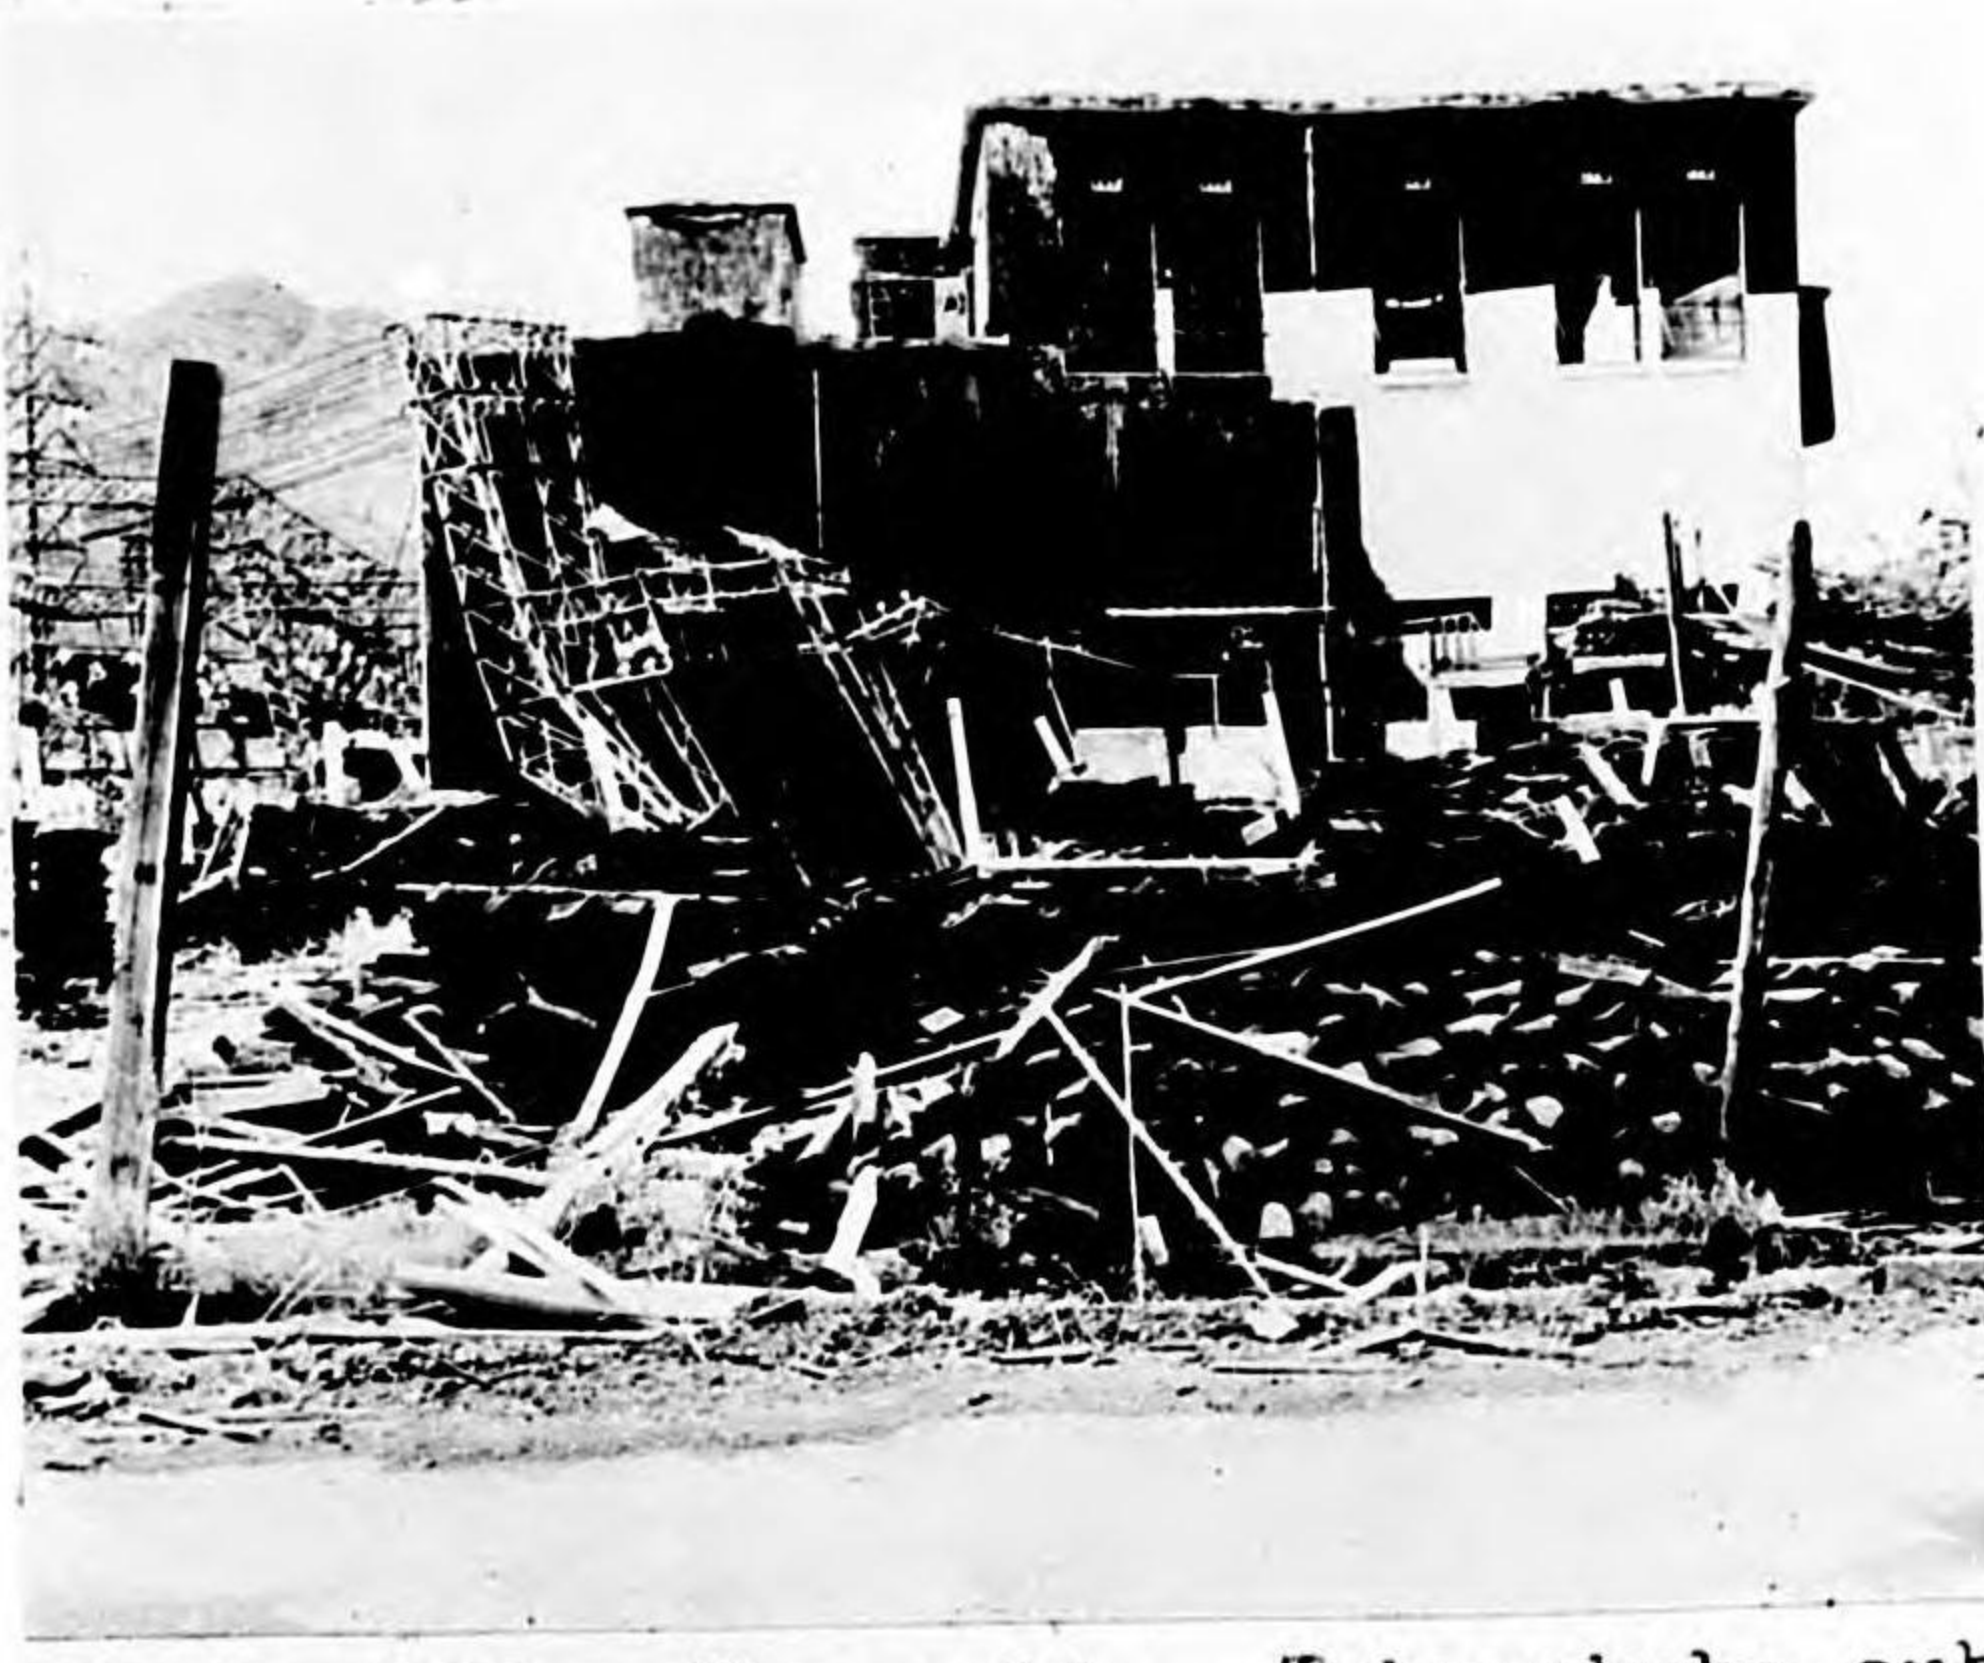
Photo 180. Nagasaki. Takenokubo substation, 3,600 feet from GZ. Unusually heavy concrete and steel construction withstood blast well.
