THE RELATION OF LOW TEMPERATURE
DEFORMATION AND SUSCEPTIBILITY TO HYDROGEN
EMBRITTLMENT OF AUSTENITIC STAINLESS STEELS

NAVAL POSTGRADUATE SCHOOL

THESIS

December 1974

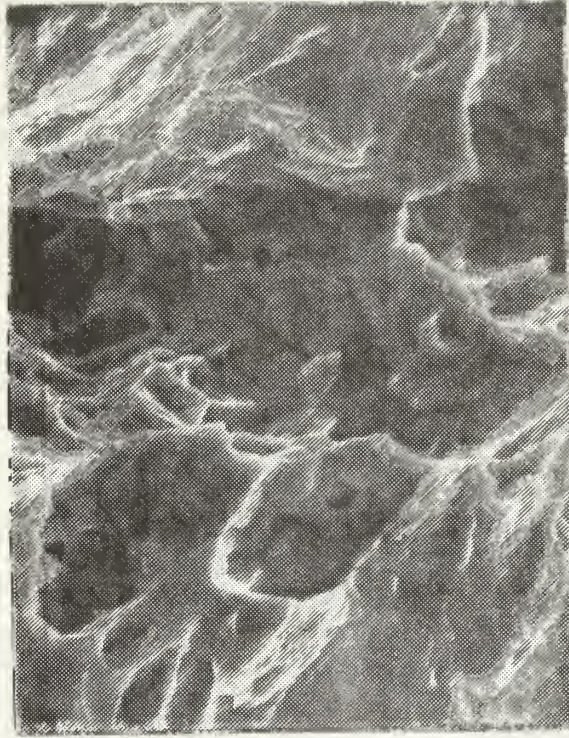
SEM FRACTOGRAPH 7

2400X

Tear ridges coupled with shear dimples in a predominantly pebbled substructure. Minor stretching noted.

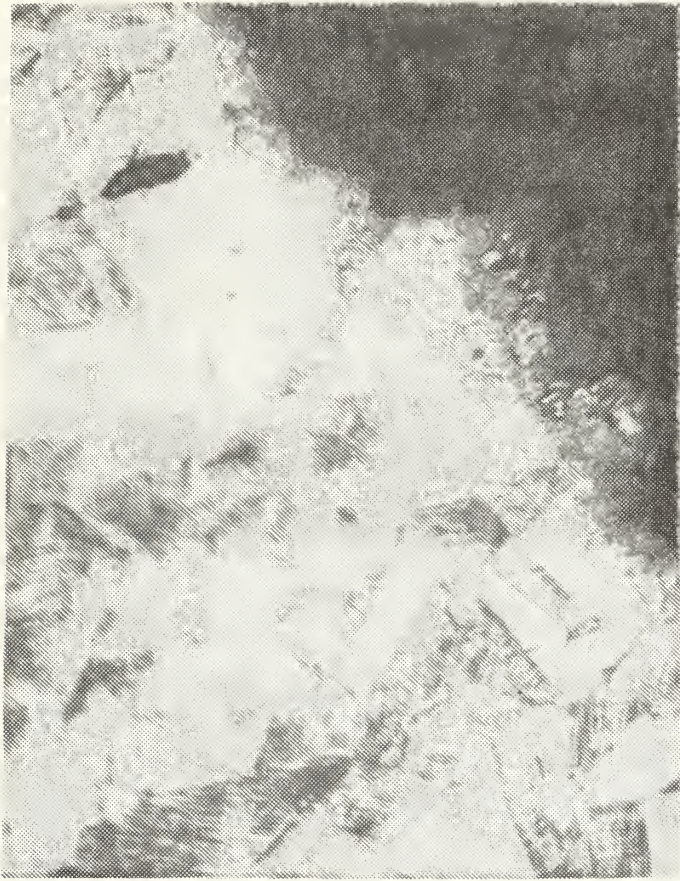
FIGURE 69. METALLOGRAPHIC PHOTO, 21-6-9,
76°K, NOTCHED GEOMETRY

The metallographic analysis of 21-6-9 indicated that no martensitic structure occurred by deformation and/or by temperature activation. Slip lines are evident throughout the grains of this specimen in a uniform manner.

Selected notched samples of 304-L and 21-6-9 were mounted, polished and etched to determine if any martensitic structure had formed. Because of the variation in composition of these two stainless steels two separate etchants had to be utilized. 21-6-9 required five grams of ferric chloride, 50 ml. of hydrochloric acid and 100 ml. of water. 304-L's etchant consisted of five ml. of nitric acid, one ml. of hydrofluoric acid and 44 ml. of water. Figures 68 and 69 are the result of this study.
