MISSION #44 Rangoon FESTOONERY 3  
17 March 1945

TACTICAL MISSION  
REPORT

Field Orders No. 44

TARGET: DUMP "B", RANGOON AREA,  
BURMA

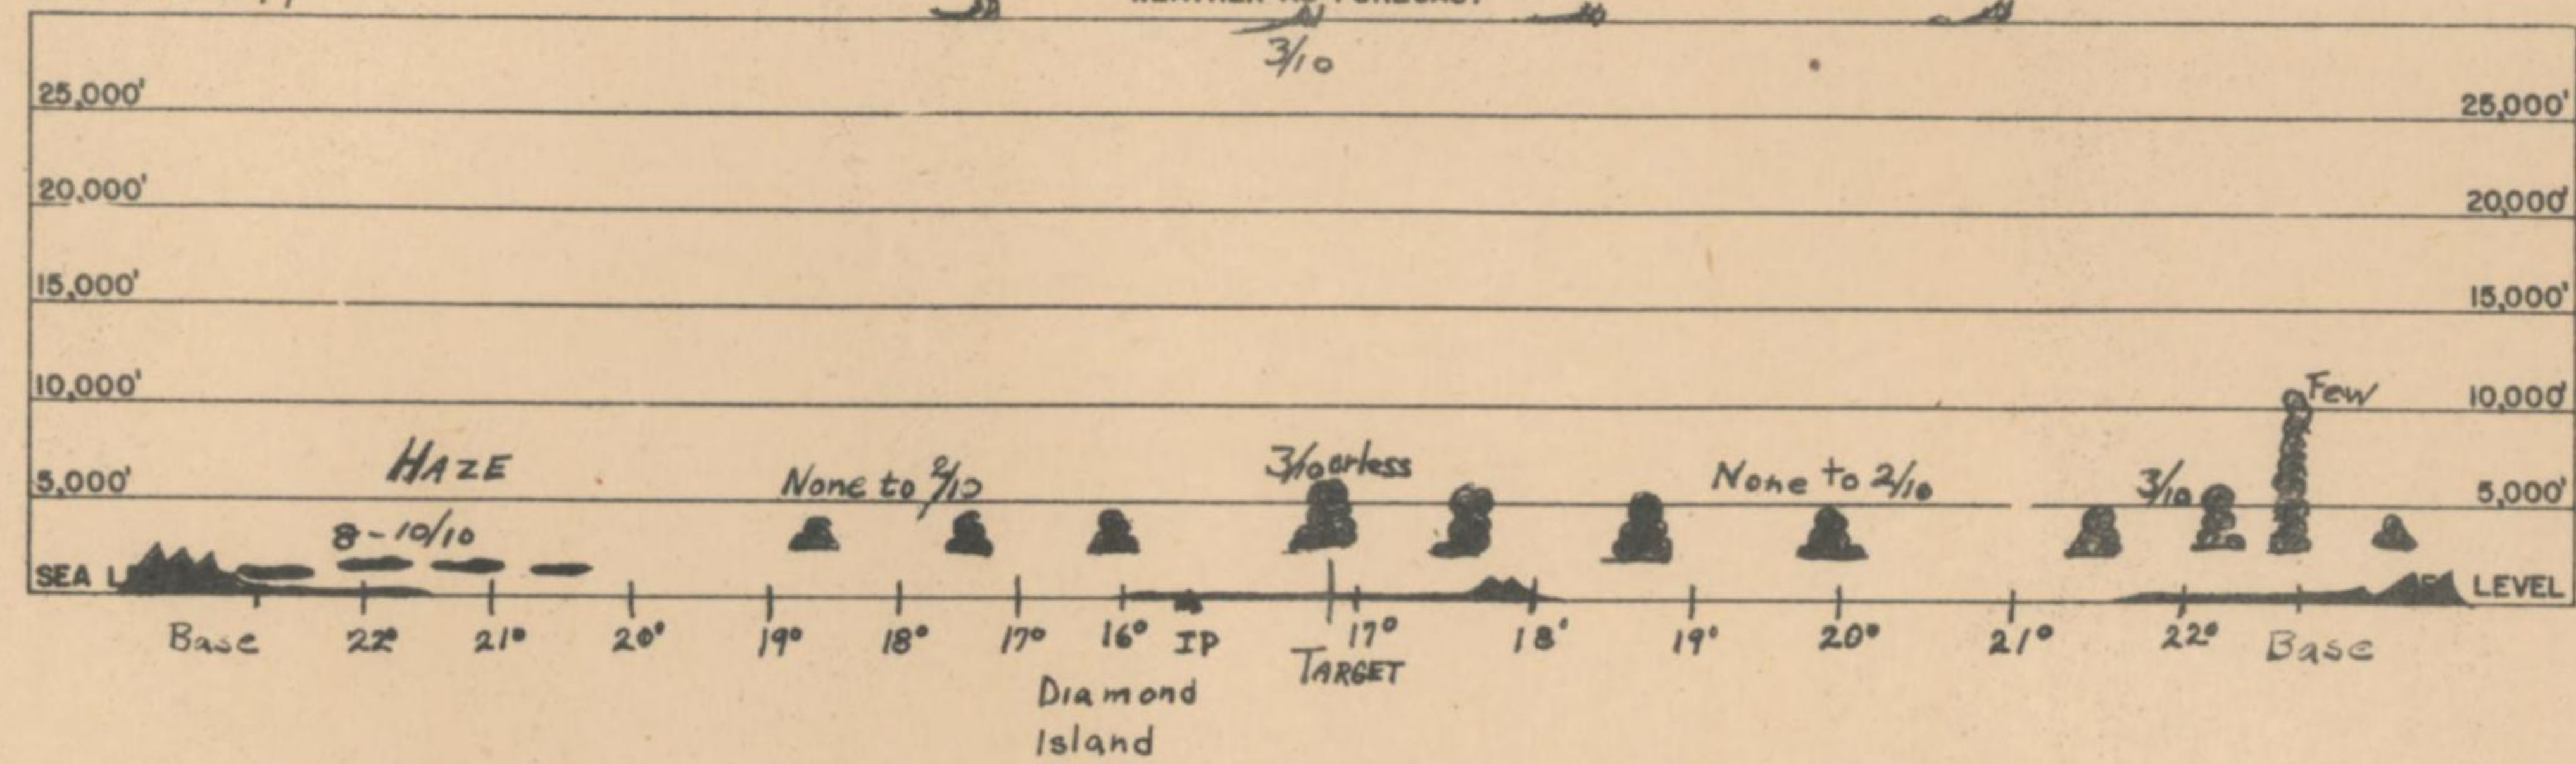
MISSION NO. 44

XX BOMBER COMMAND  
 WEATHER AS FORECAST

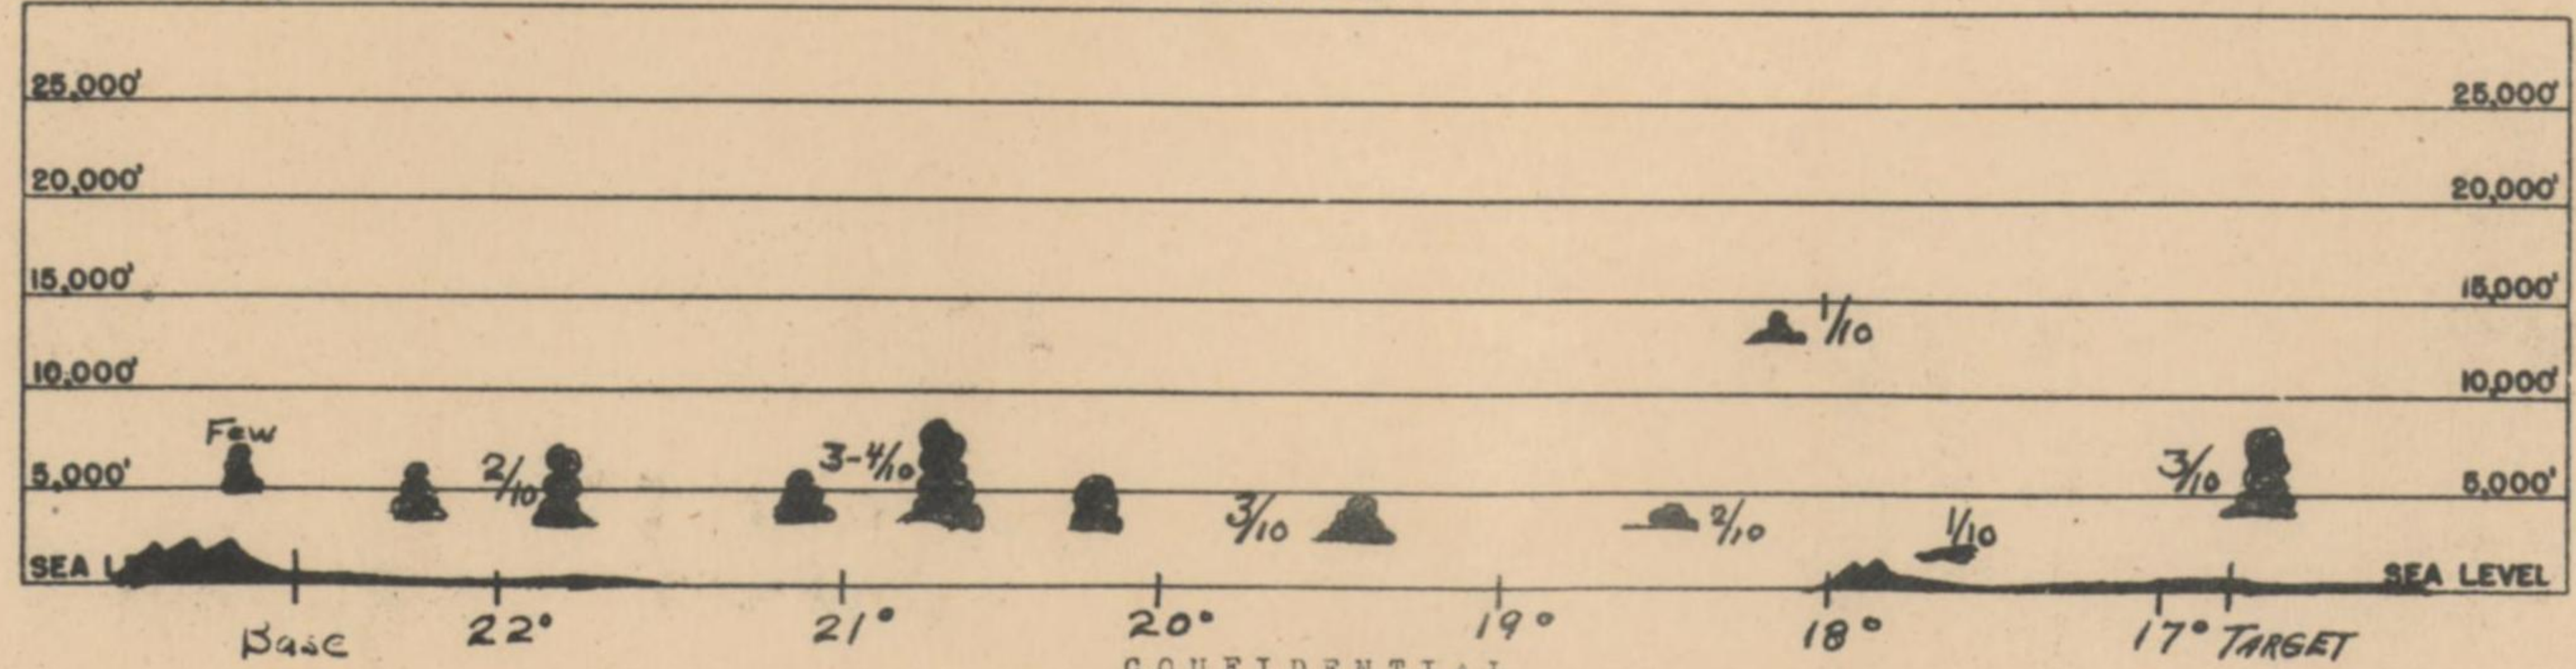
MISSION NO. 44

WEATHER AS ENCOUNTERED  
 ROUTE BACK

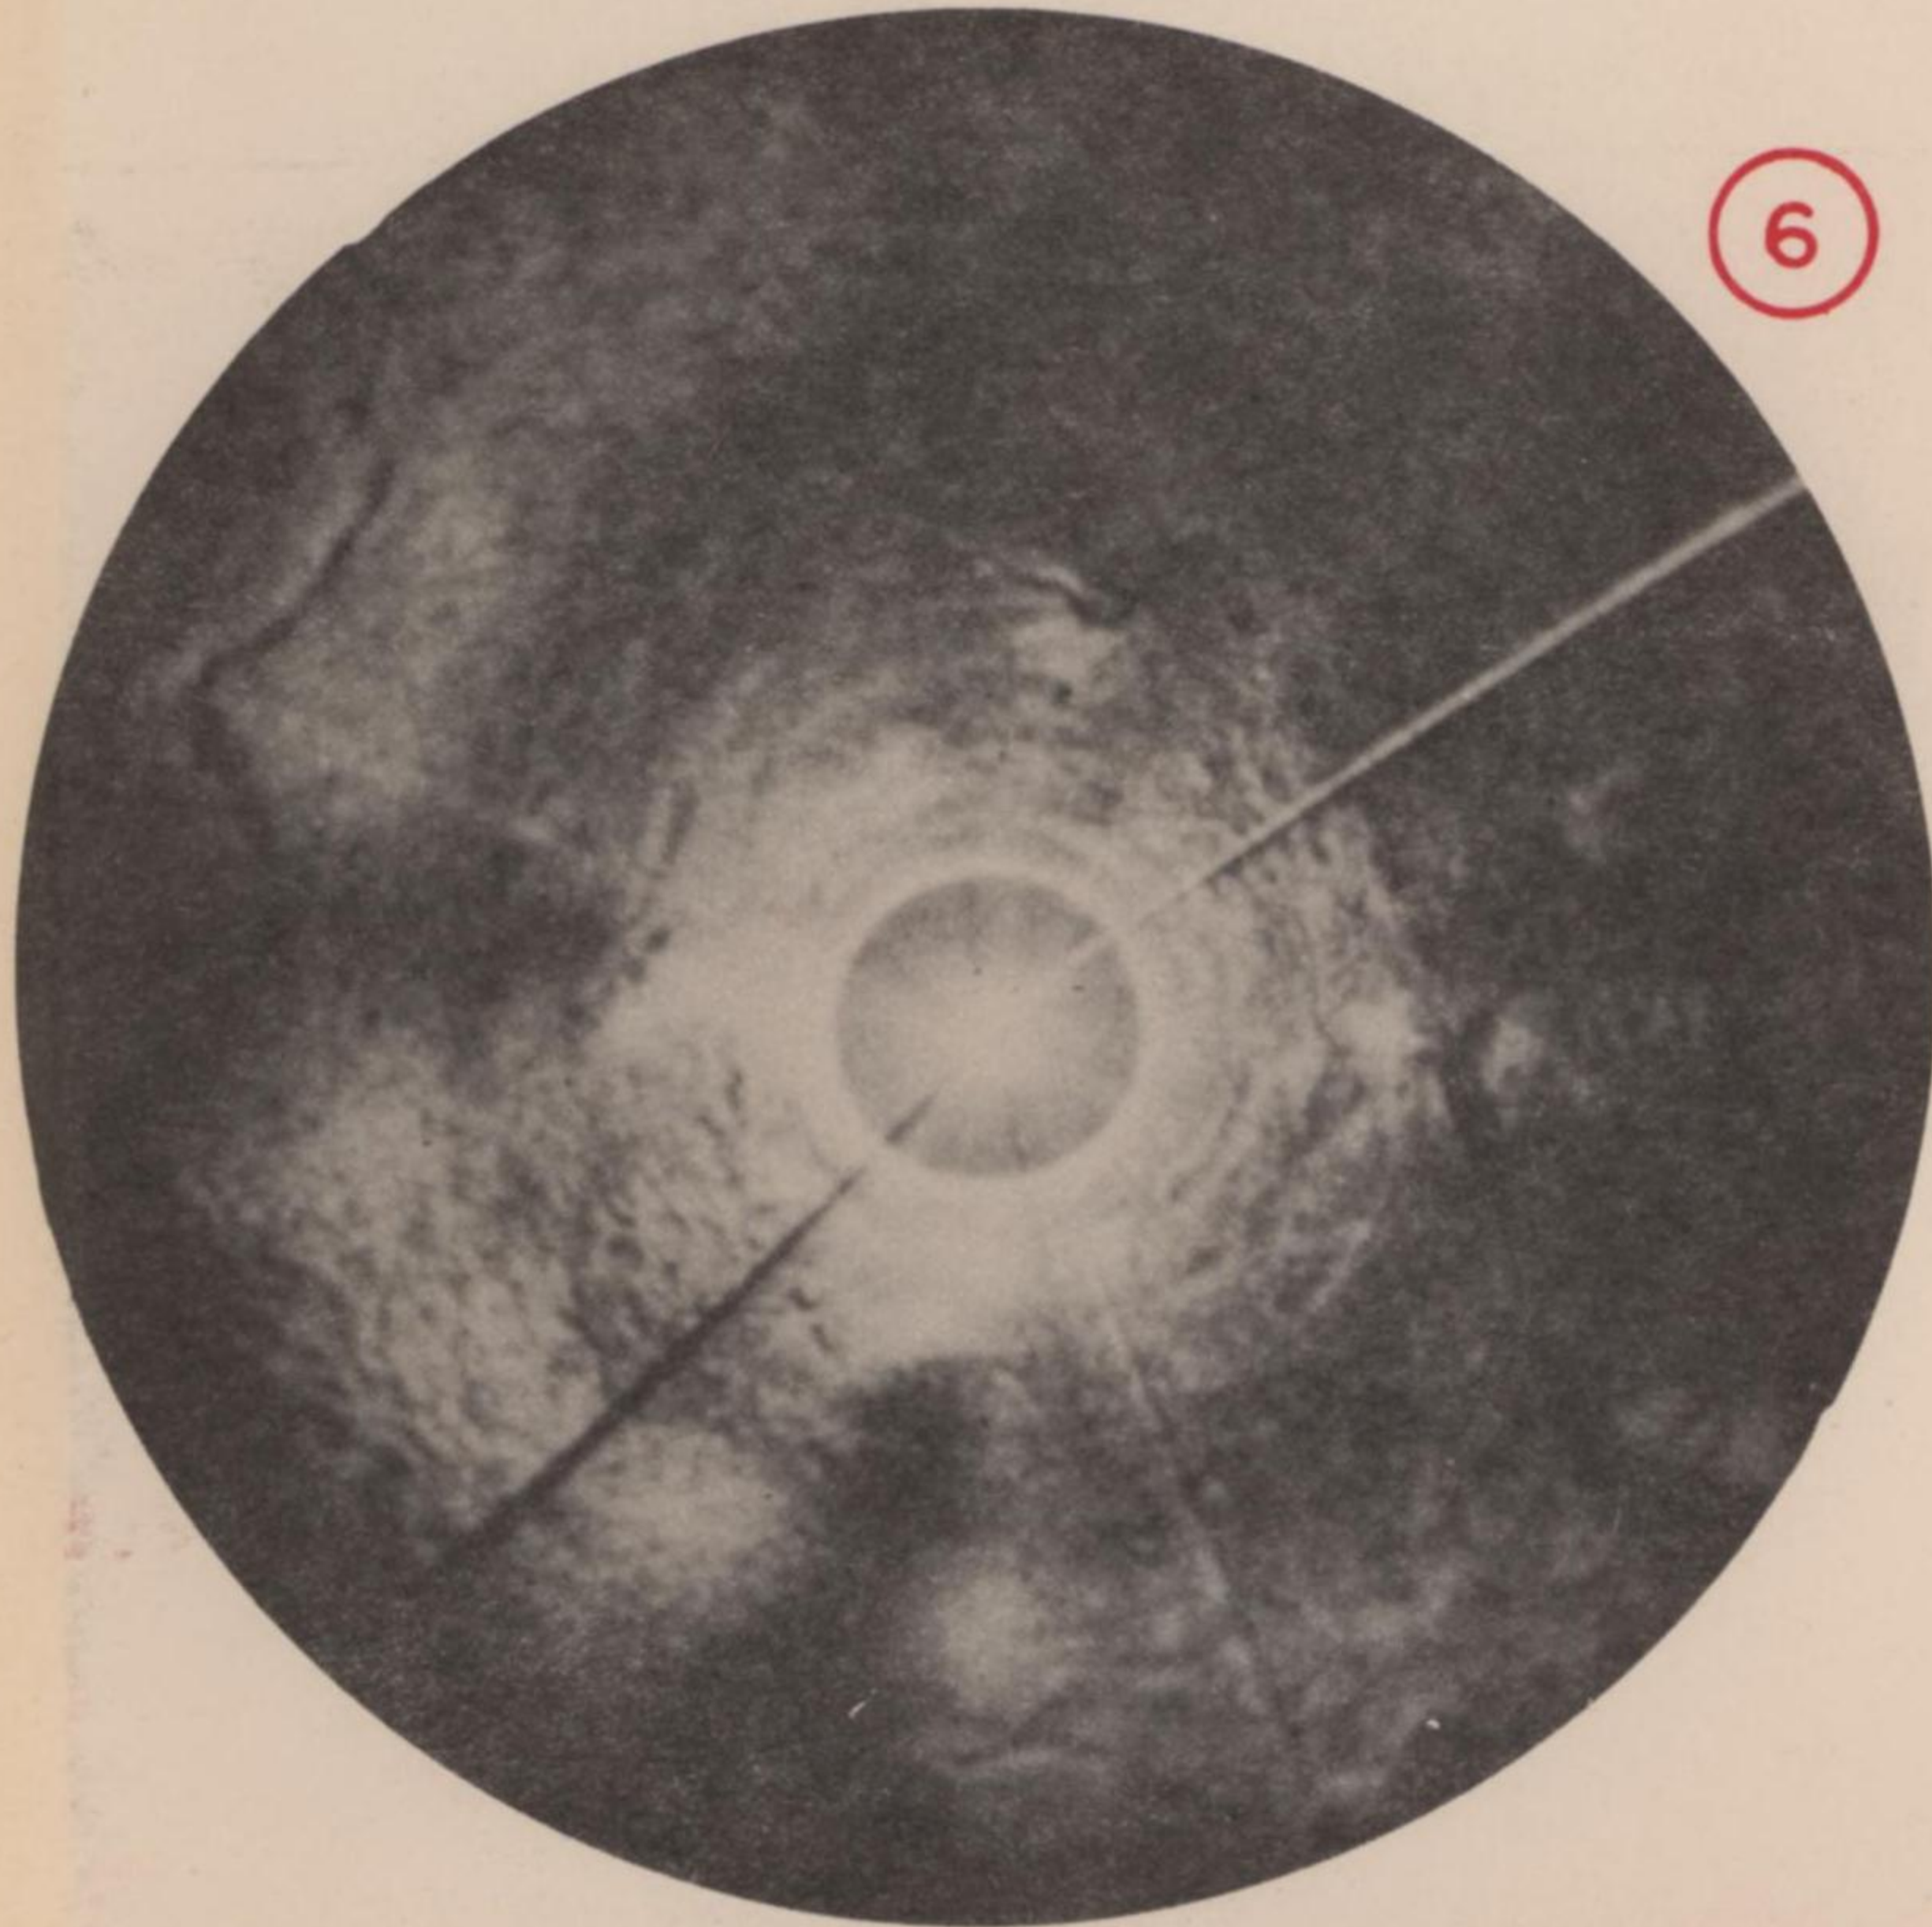
6

HEADING 61° MAG.

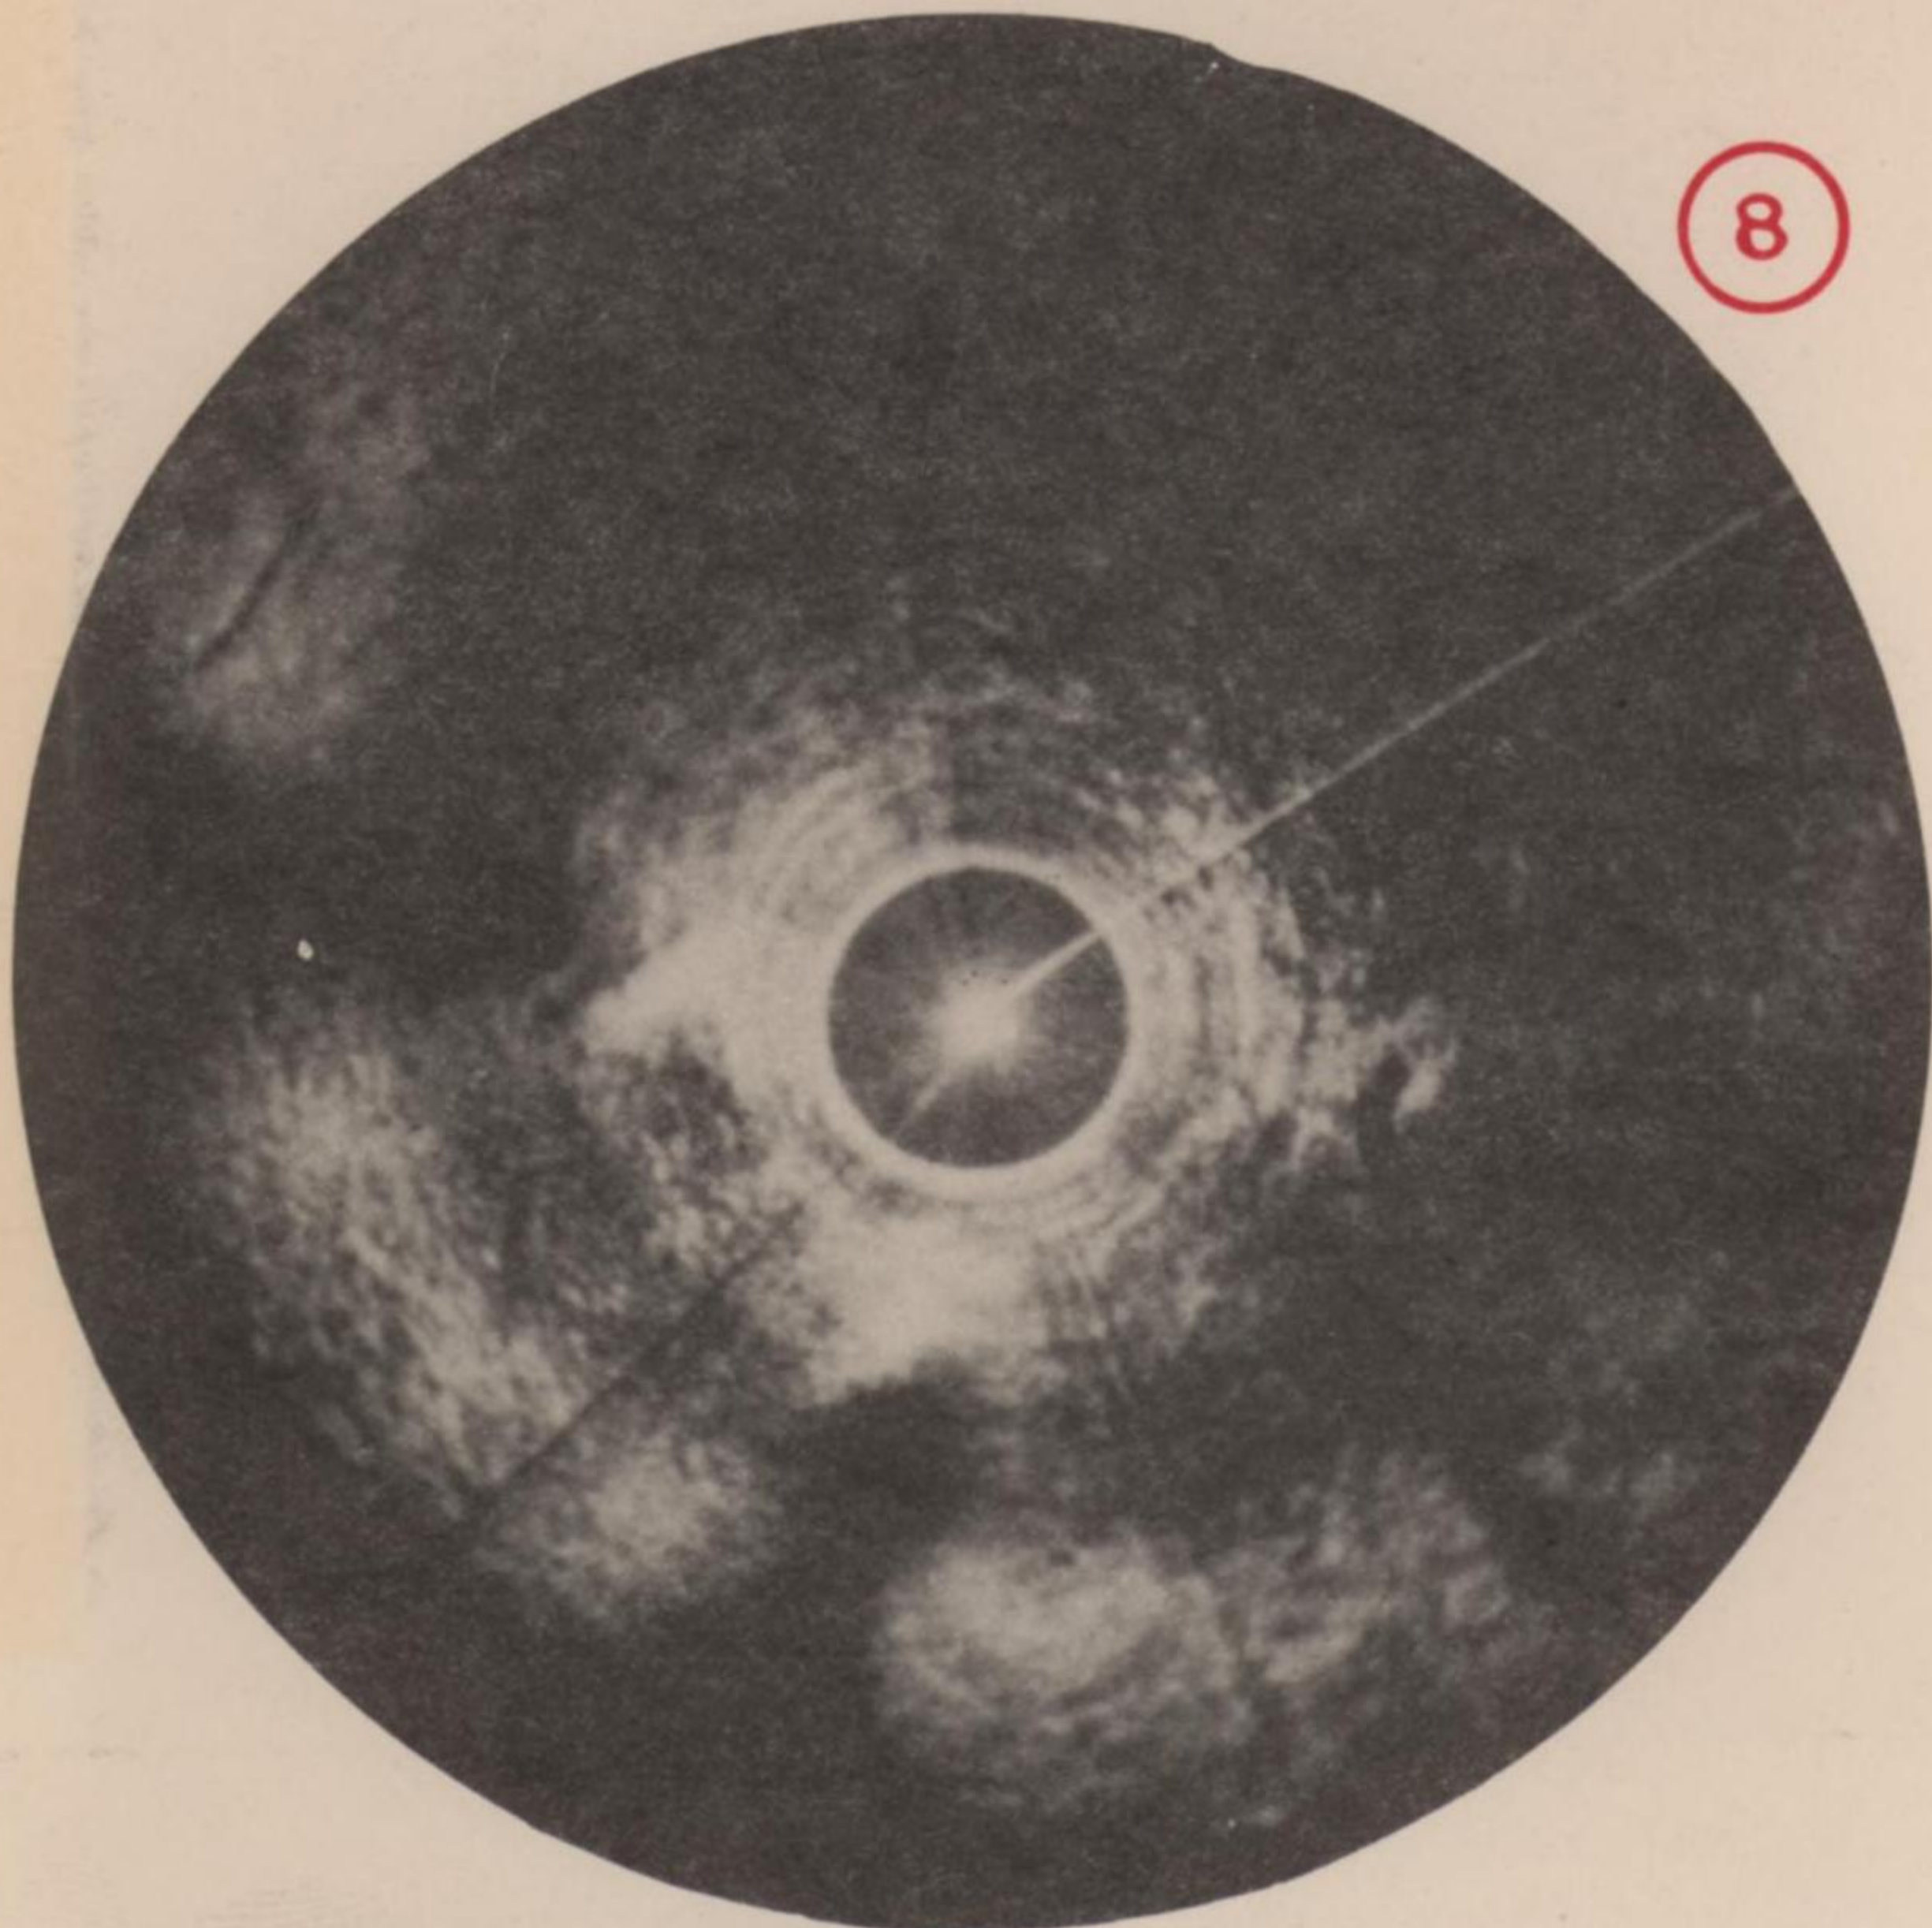
8

HEADING 61° MAG.

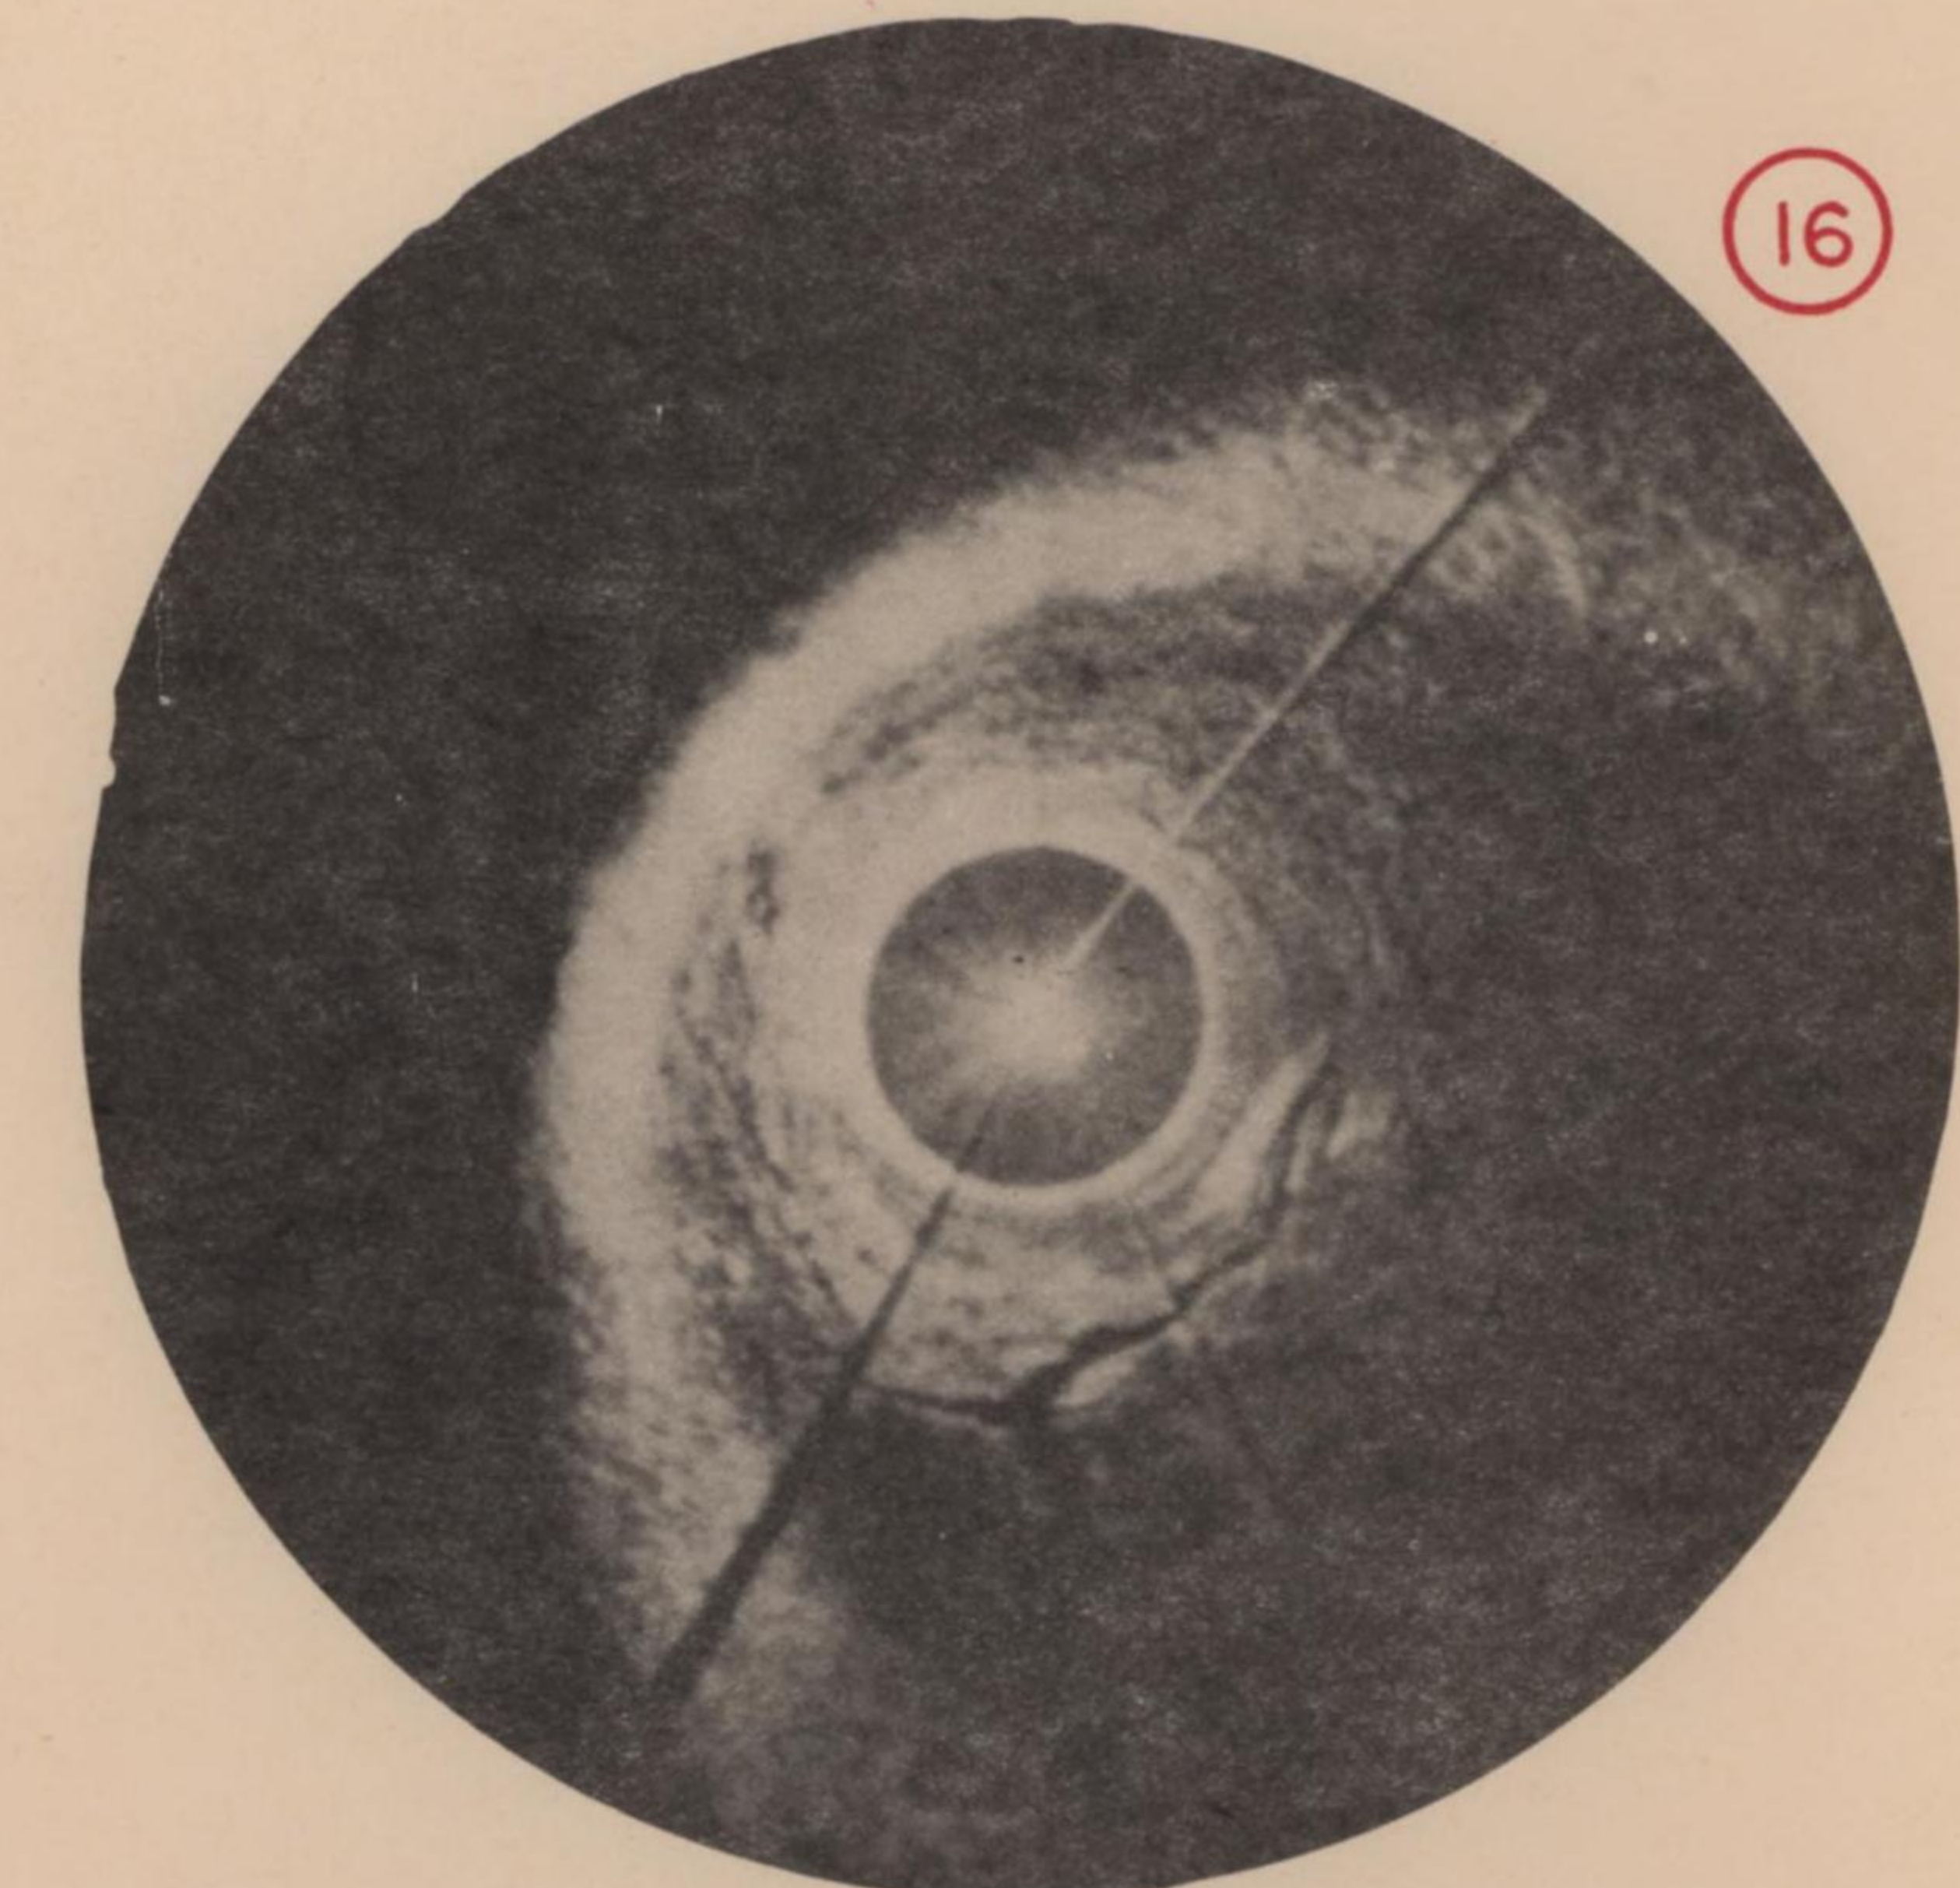
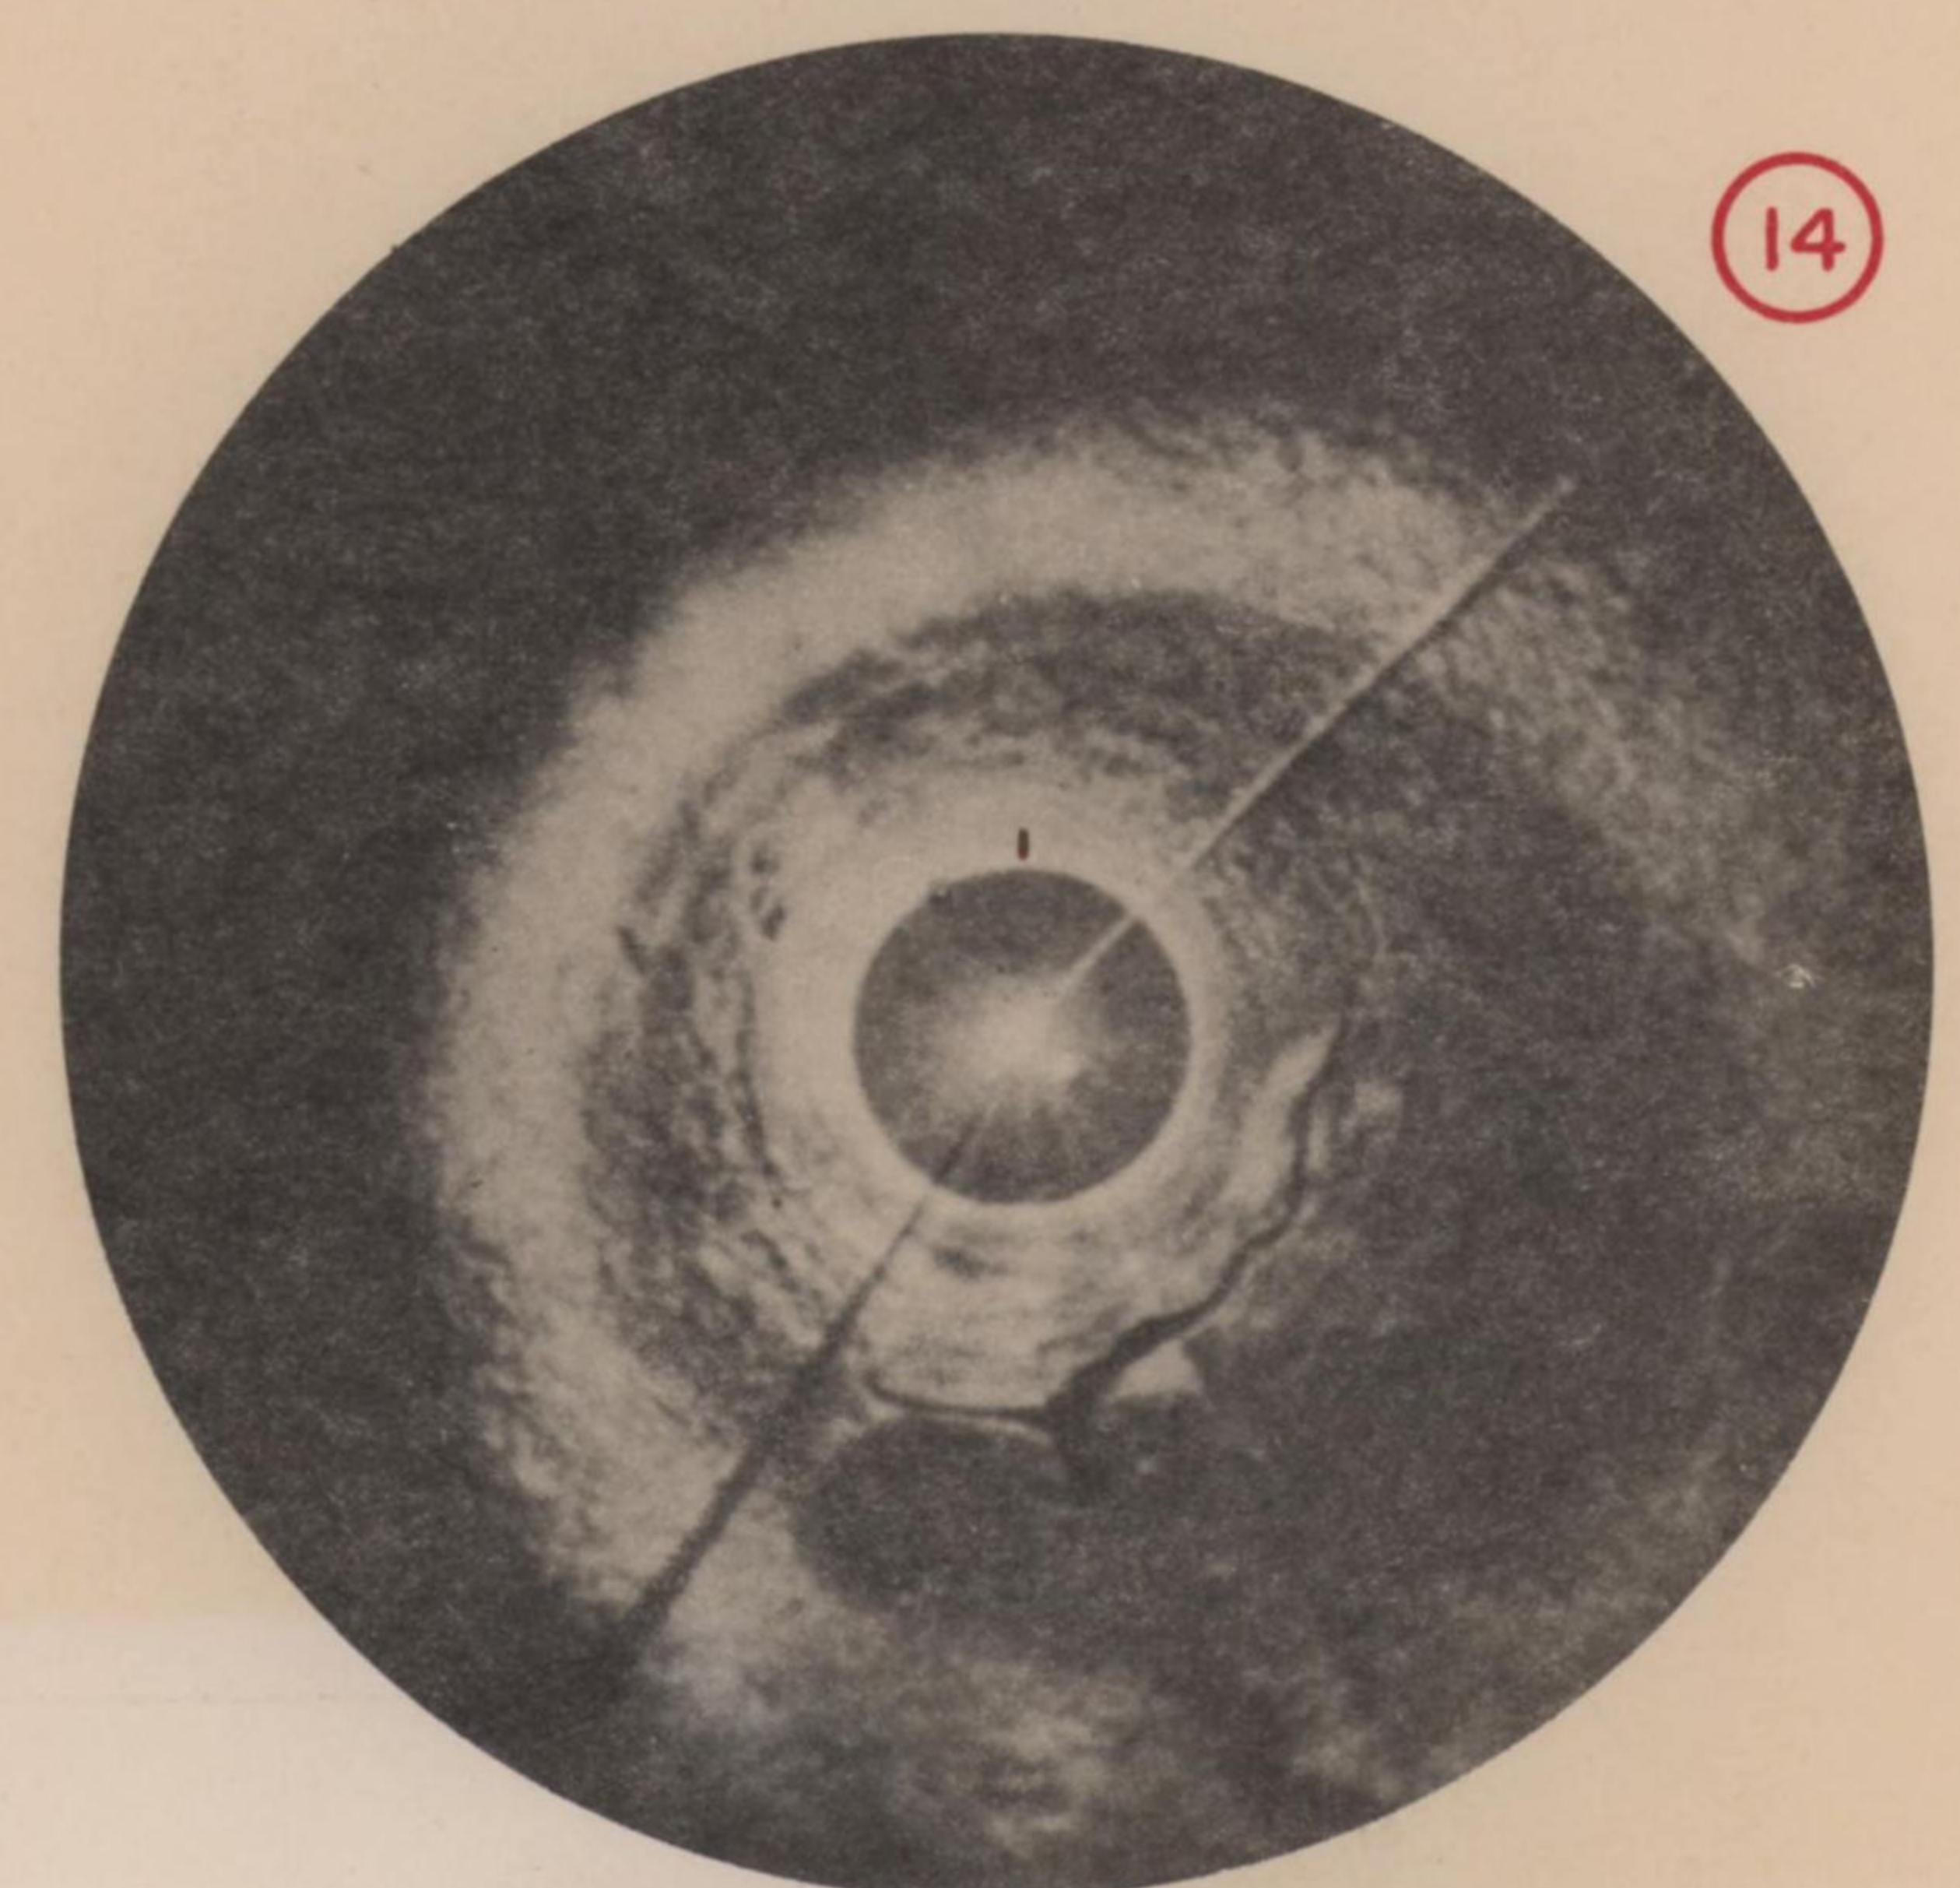
R82.2-N SHEET A.

CONFIDENTIAL  
RADAR PHOTOGRAPH ANALYSIS  
RANGOON AREA—BURMA  
MISSION NO. 44

HEADING 45° MAG.

HEADING 49° MAG.
