MISSION #40 Singapore REPEATEDLY 2
27-28 February 1945

Tactical Mission Report

No. 40

MINING AREA: JOHORE STRAIT FIELD, SINGAPORE,
MALAYA

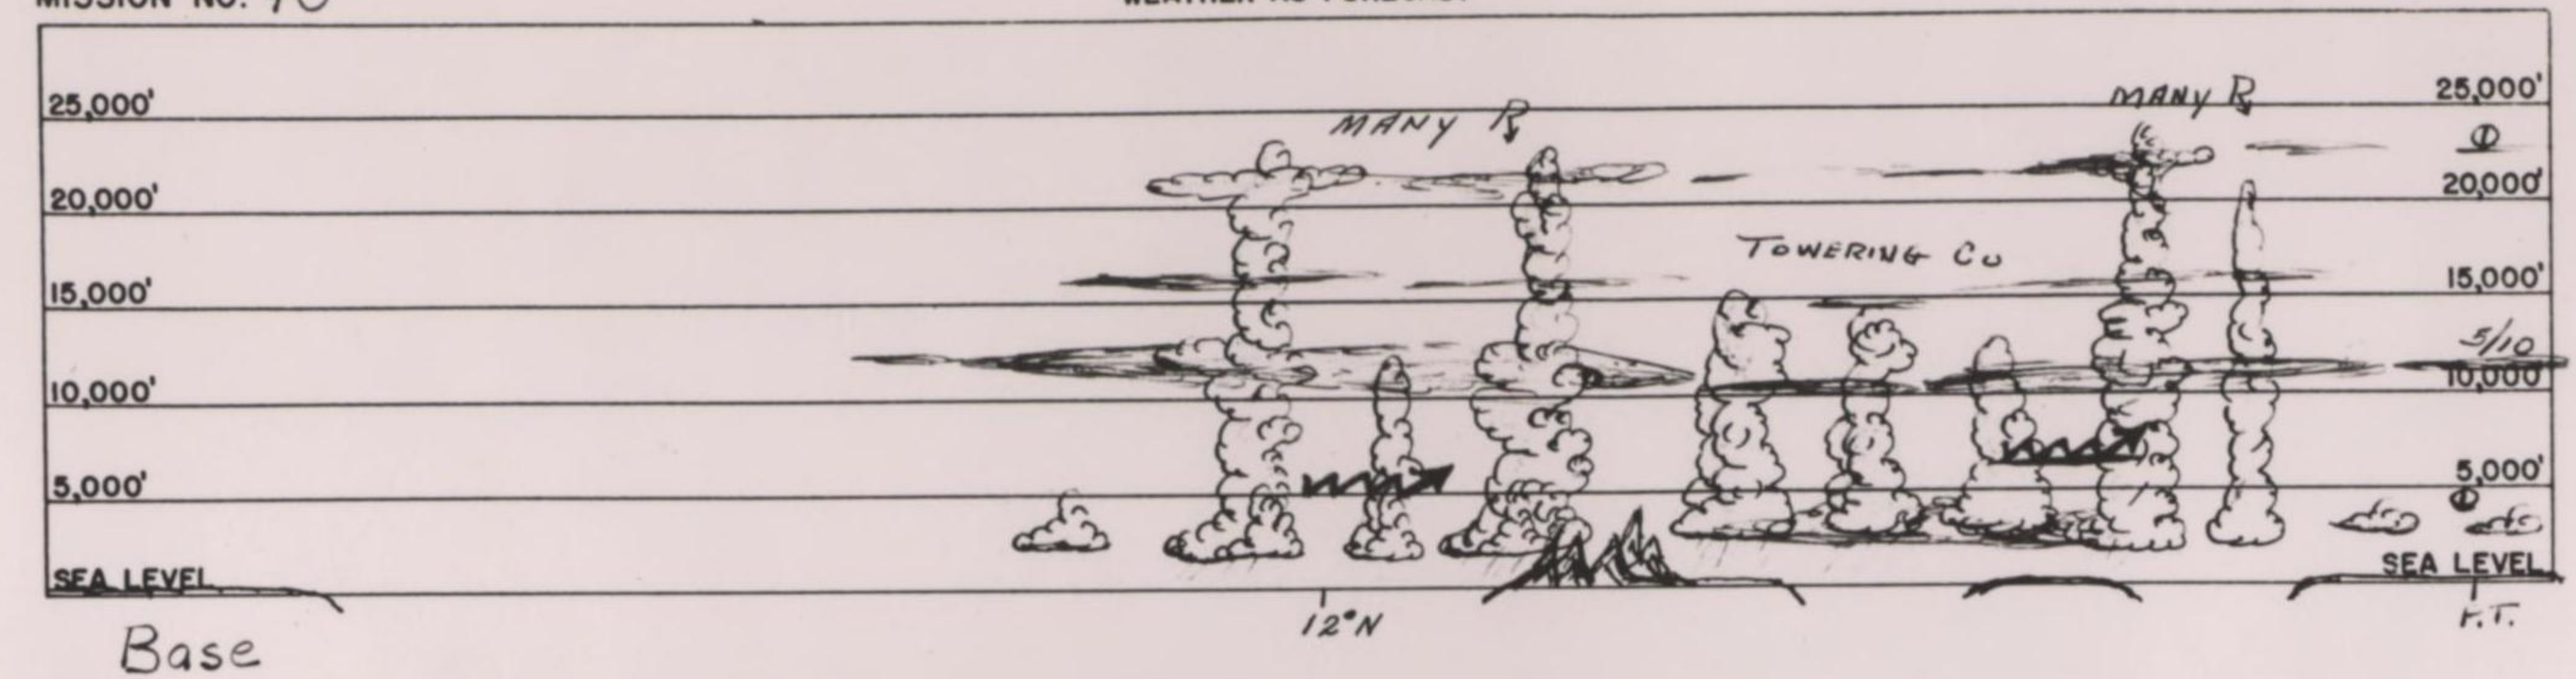
SECRET
 XX BOMBER COMMAND
 WEATHER AS FORECAST

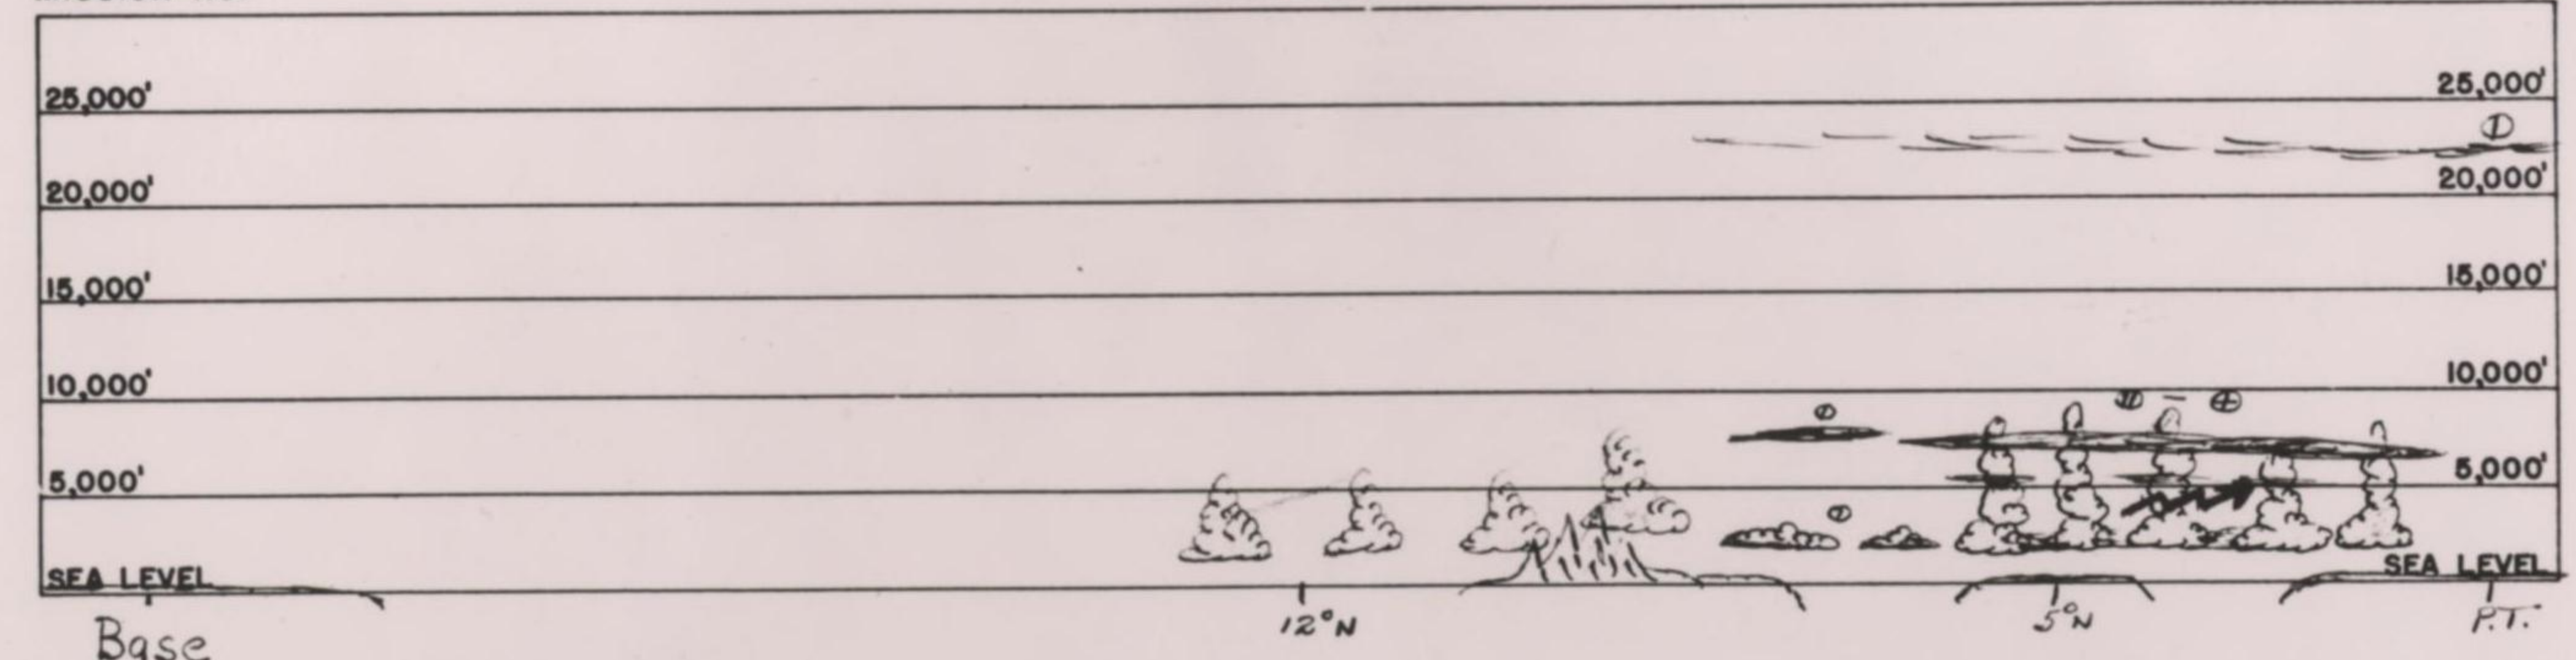
MISSION NO.
 WEATHER AS ENCOUNTERED
 ROUTE OUT

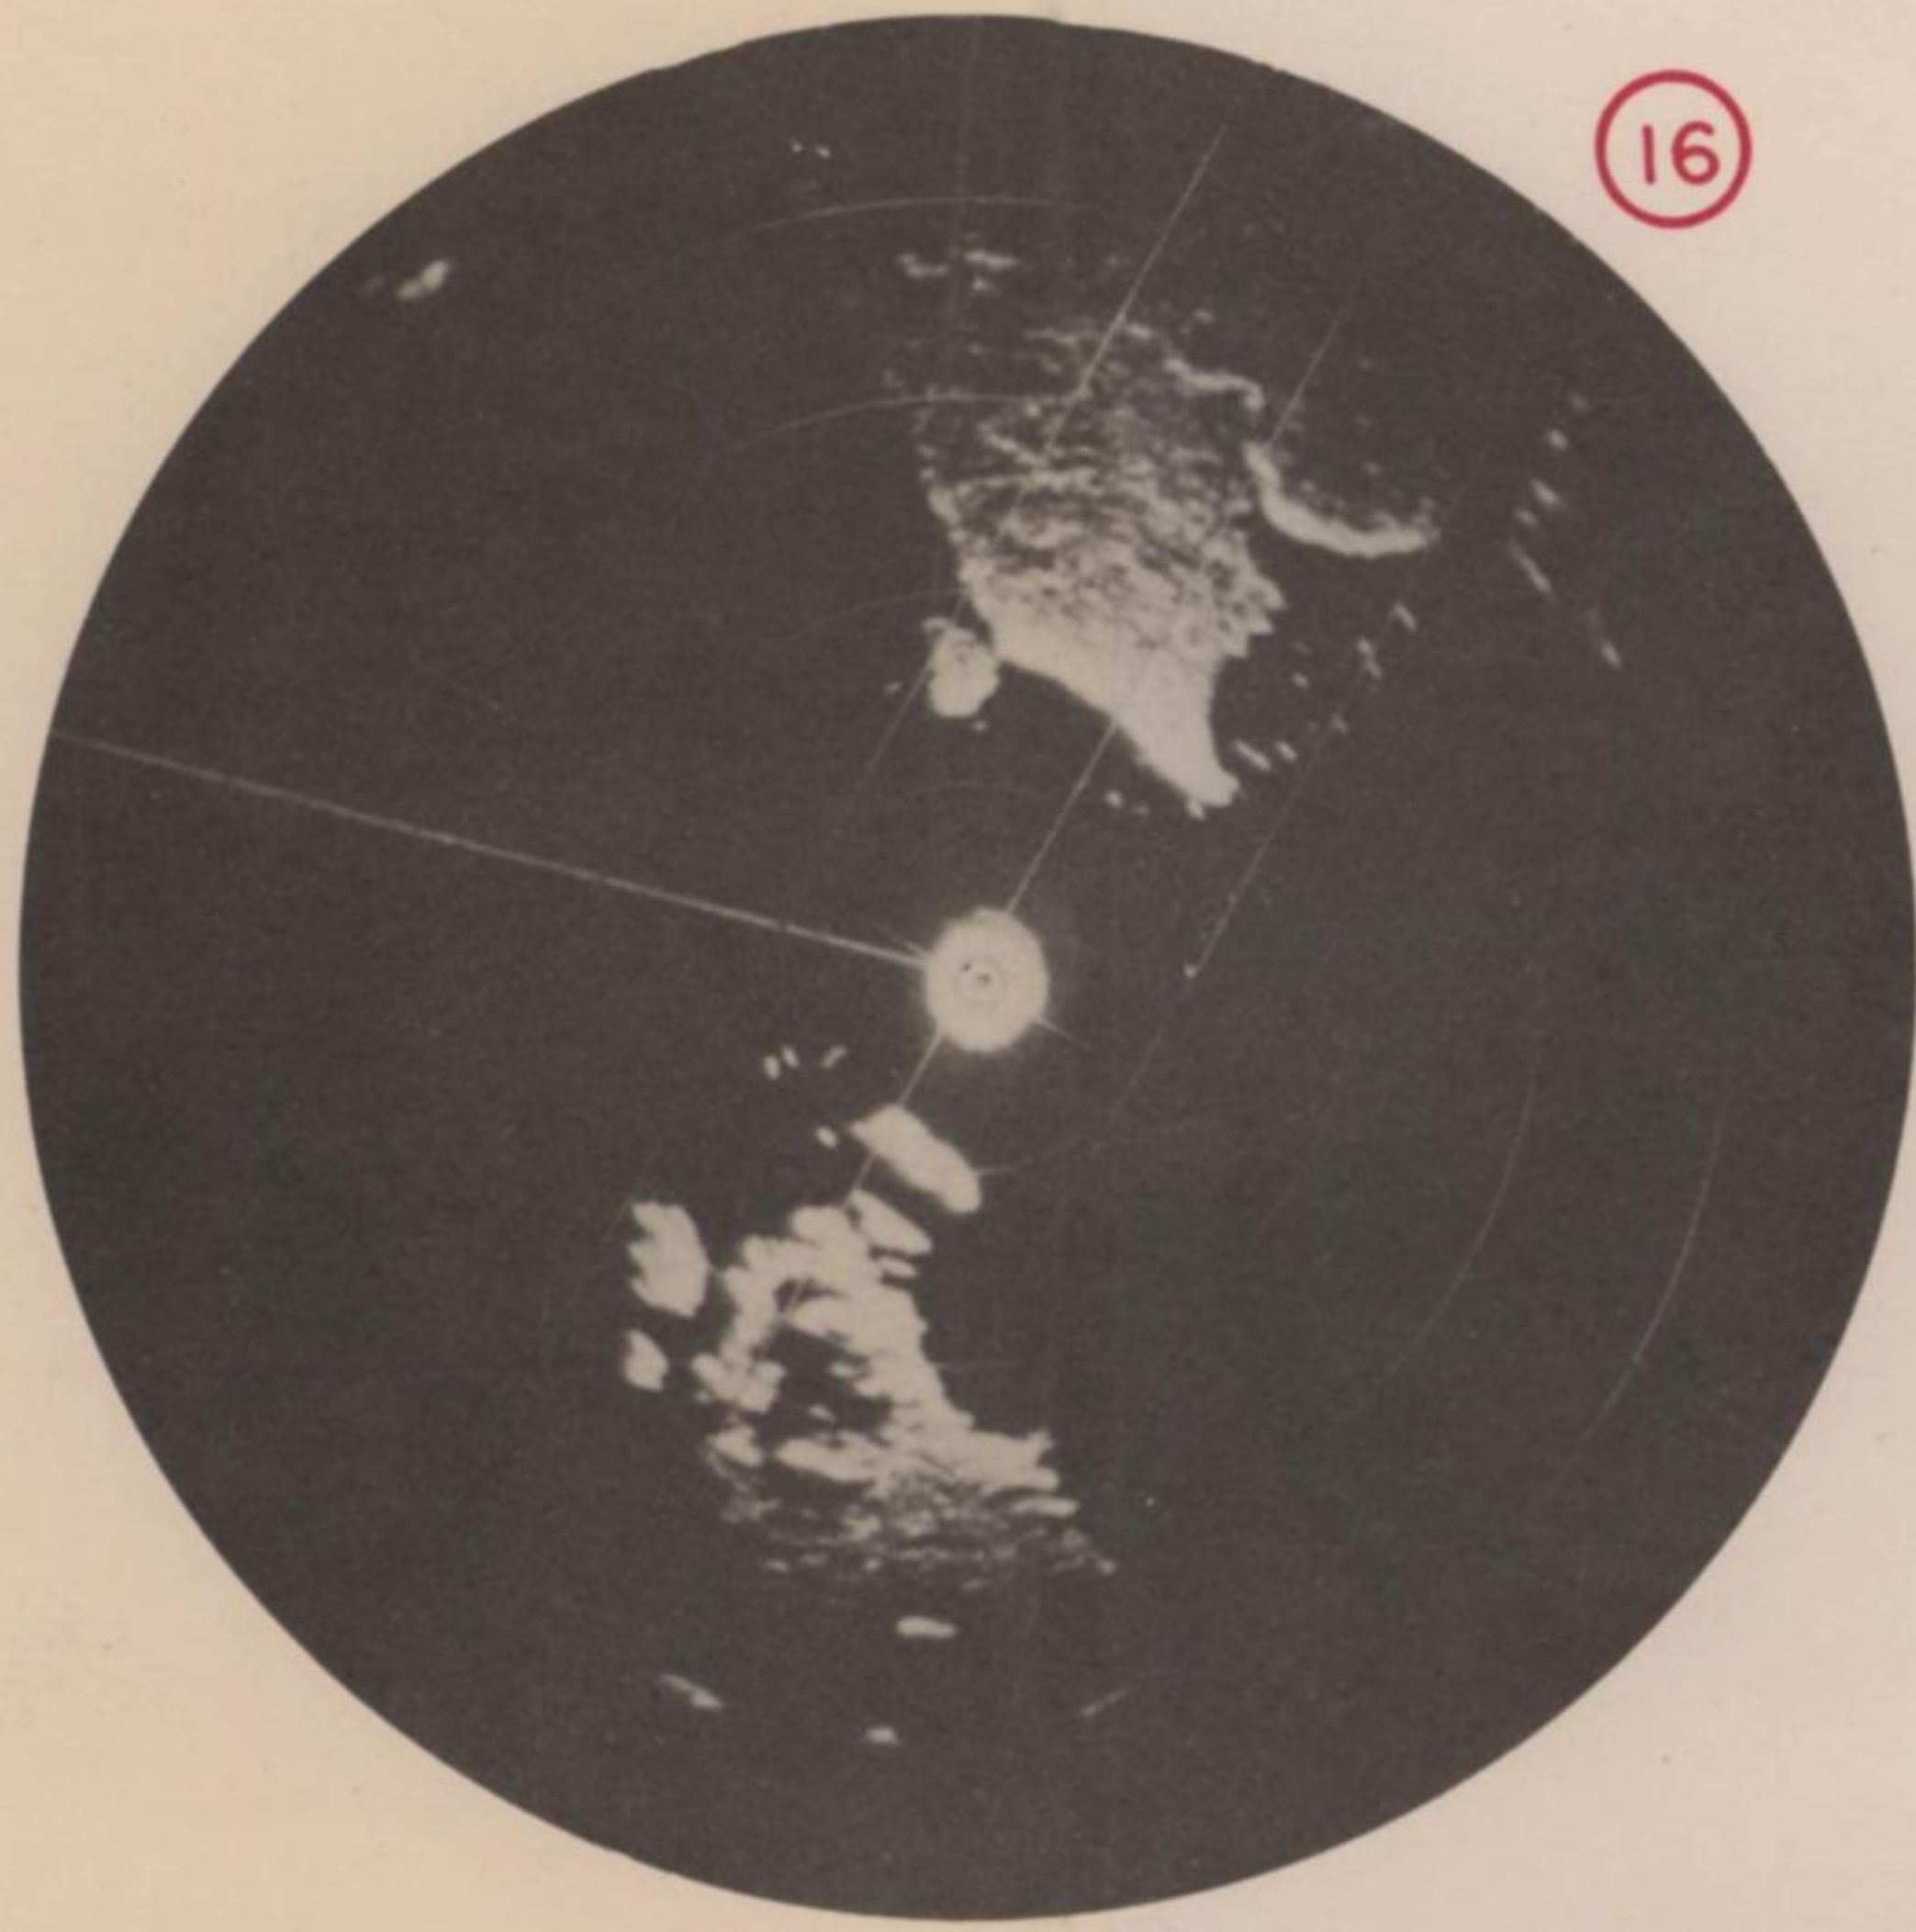
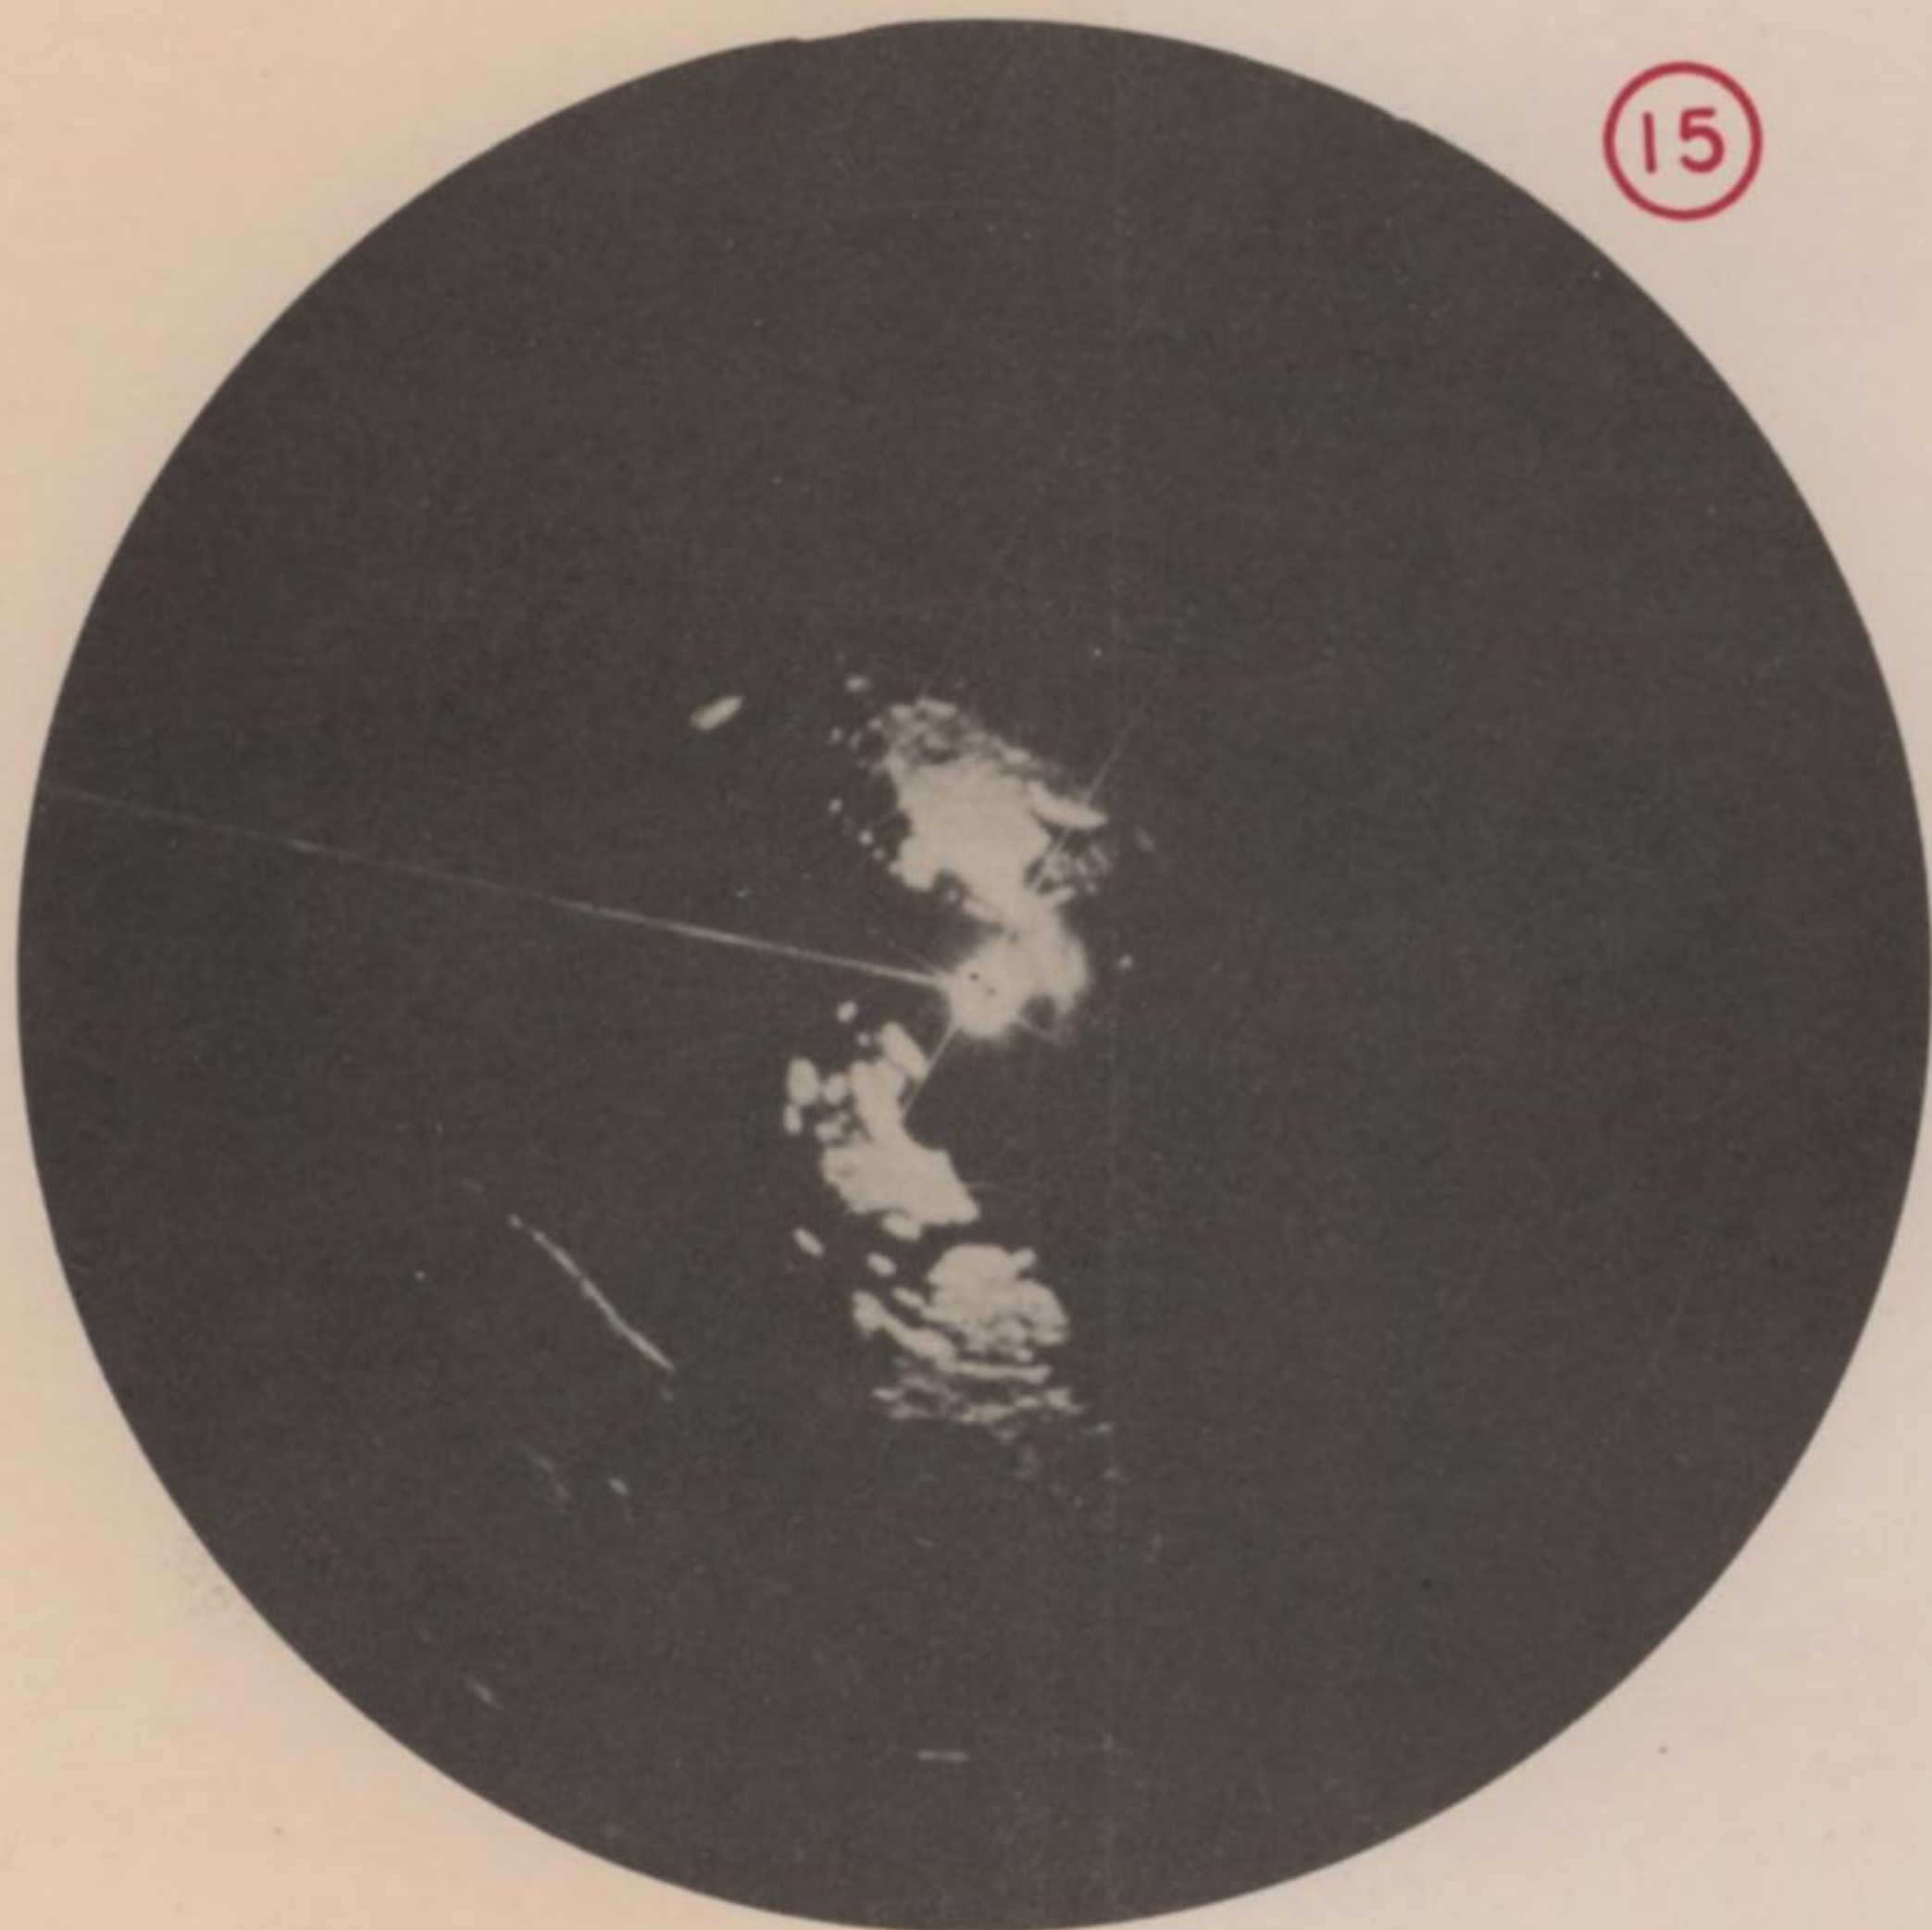
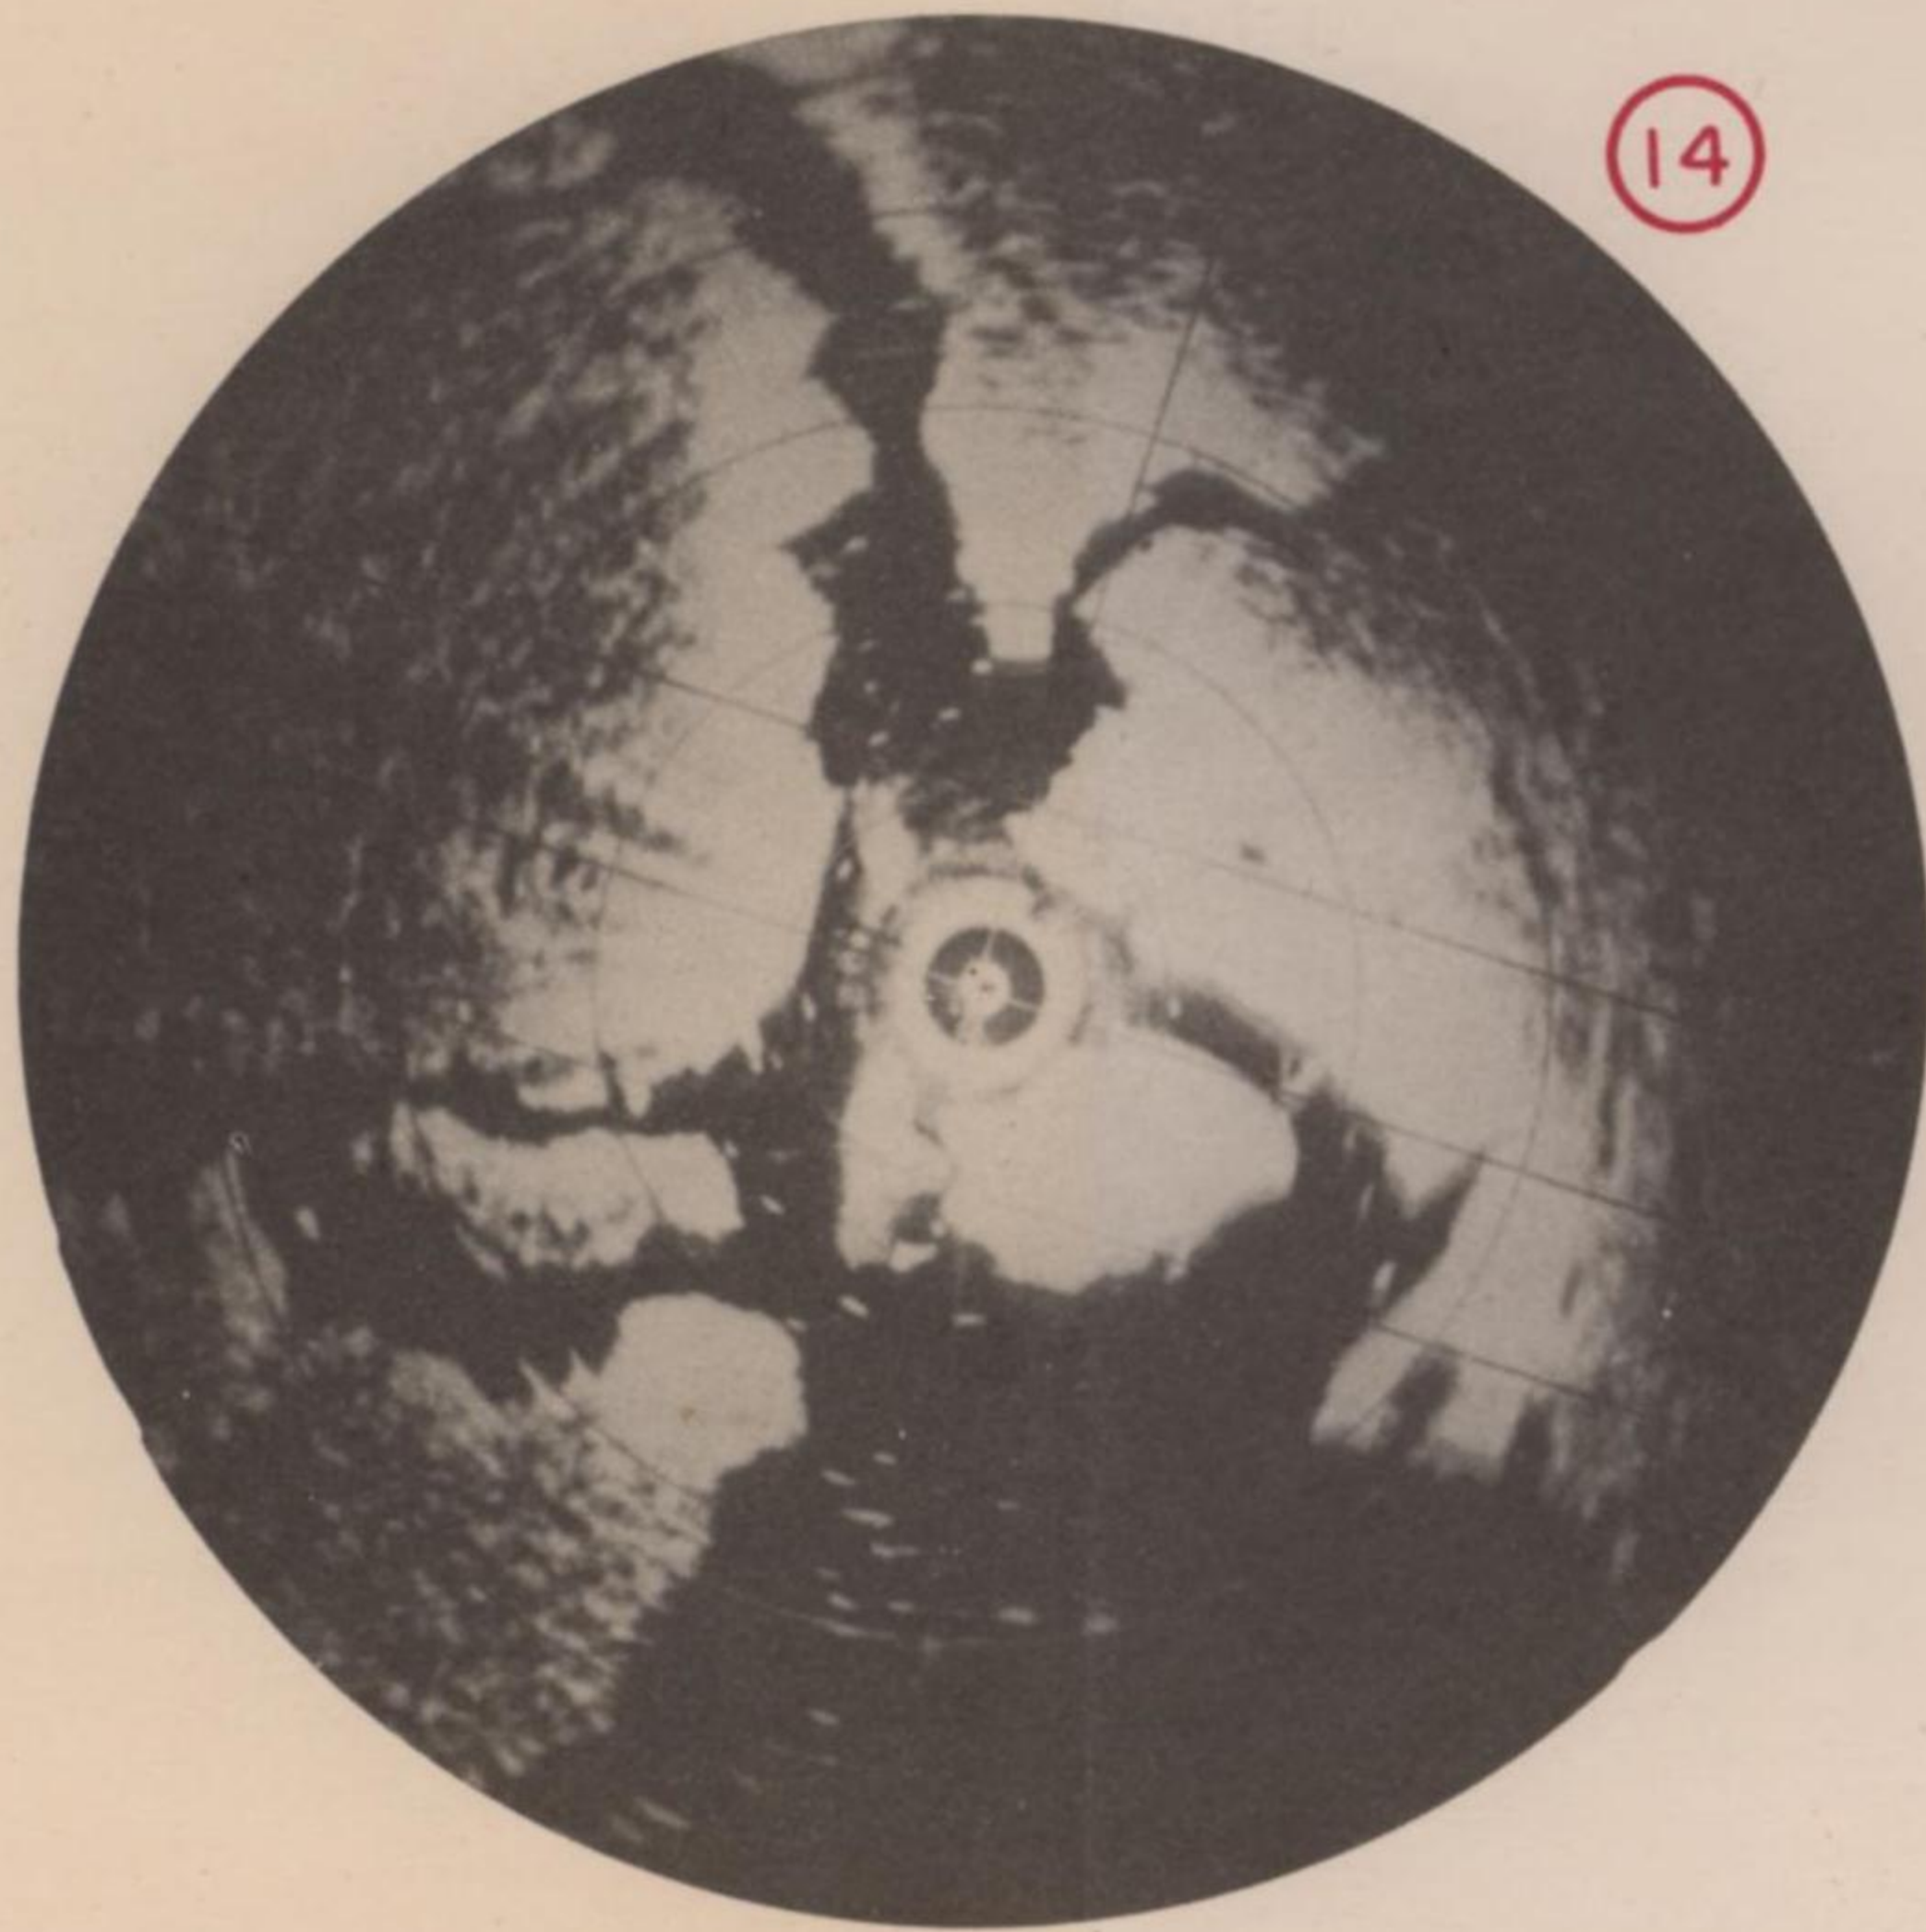
ALL ALTITUDES 4,000'

HEADING 284° MAG. 20 MILE SWEEP

HEADING 281° MAG. 50 MILE SWEEP

HEADING 184° MAG. 10 MILE SWEEP

b. Scope photographs indicated this mine field could have been set entirely by radar if conditions prevented visual mining. Photographic results were satisfactory and many useable pictures were returned.
