MISSION #40 Singapore REPEATEDLY 2
27-28 February 1945

Tactical Mission Report

No. 40

MINING AREA: JOHORE STRAIT FIELD, SINGAPORE,
MALAYA

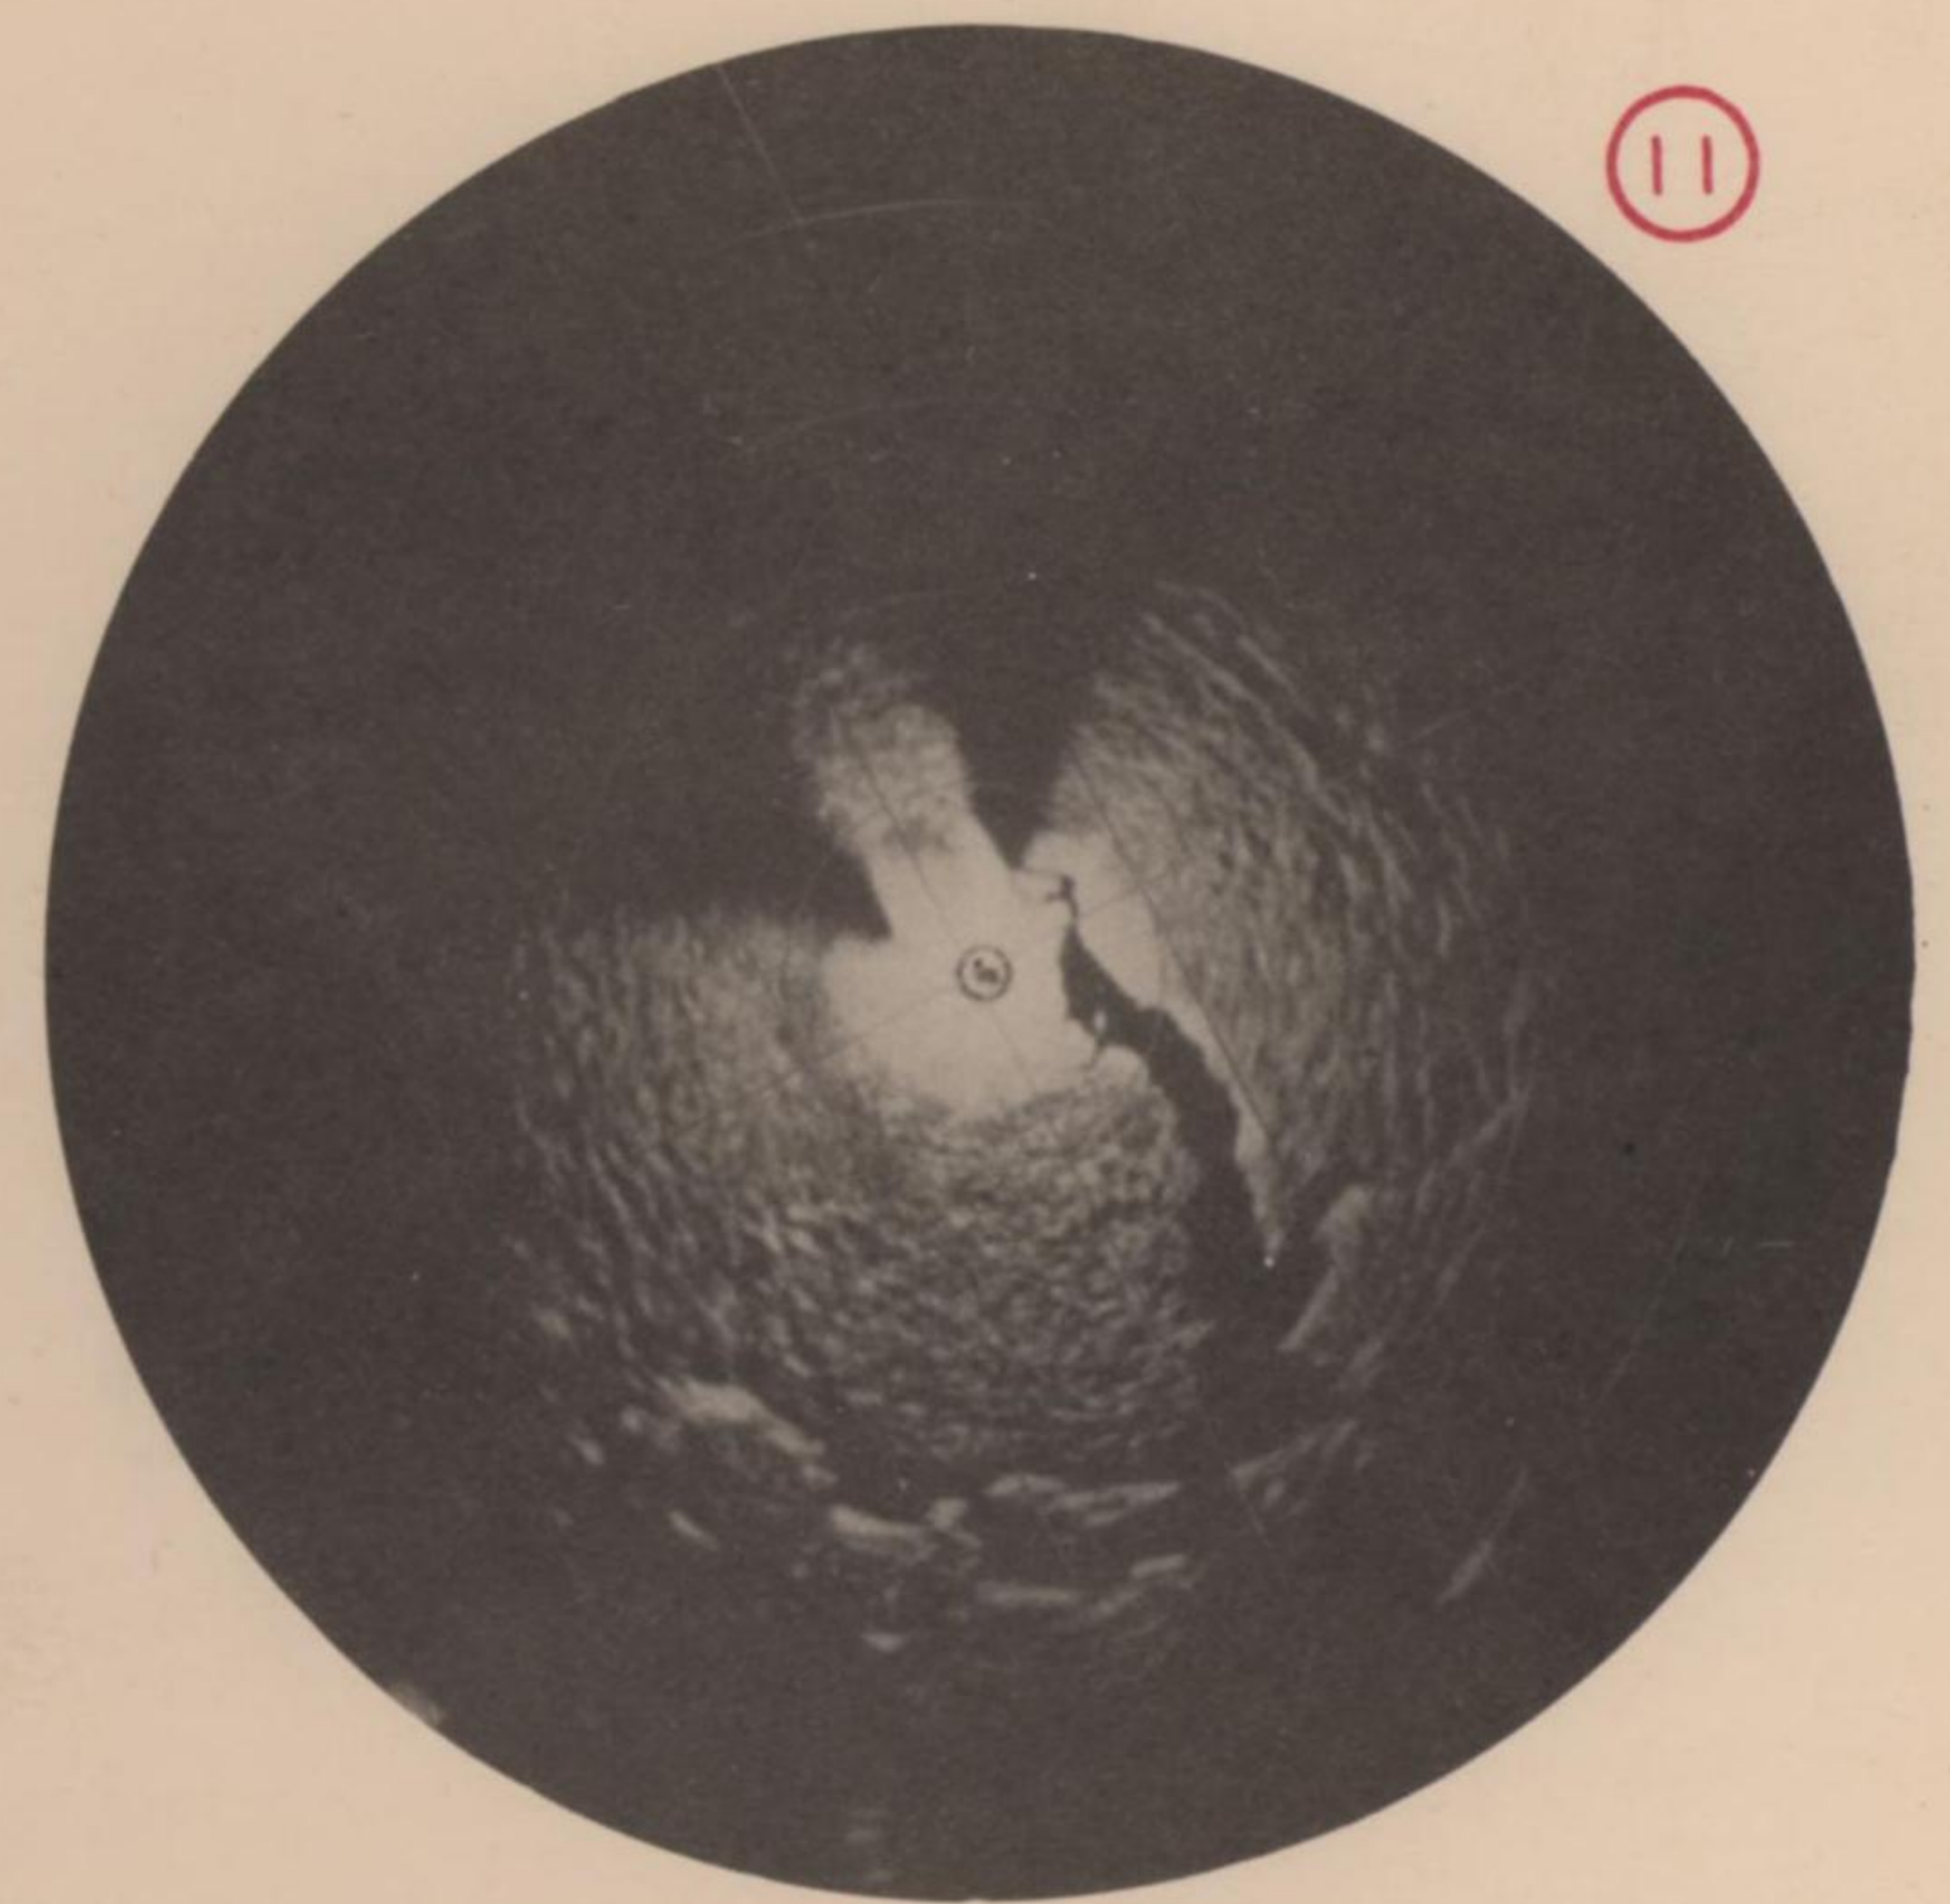
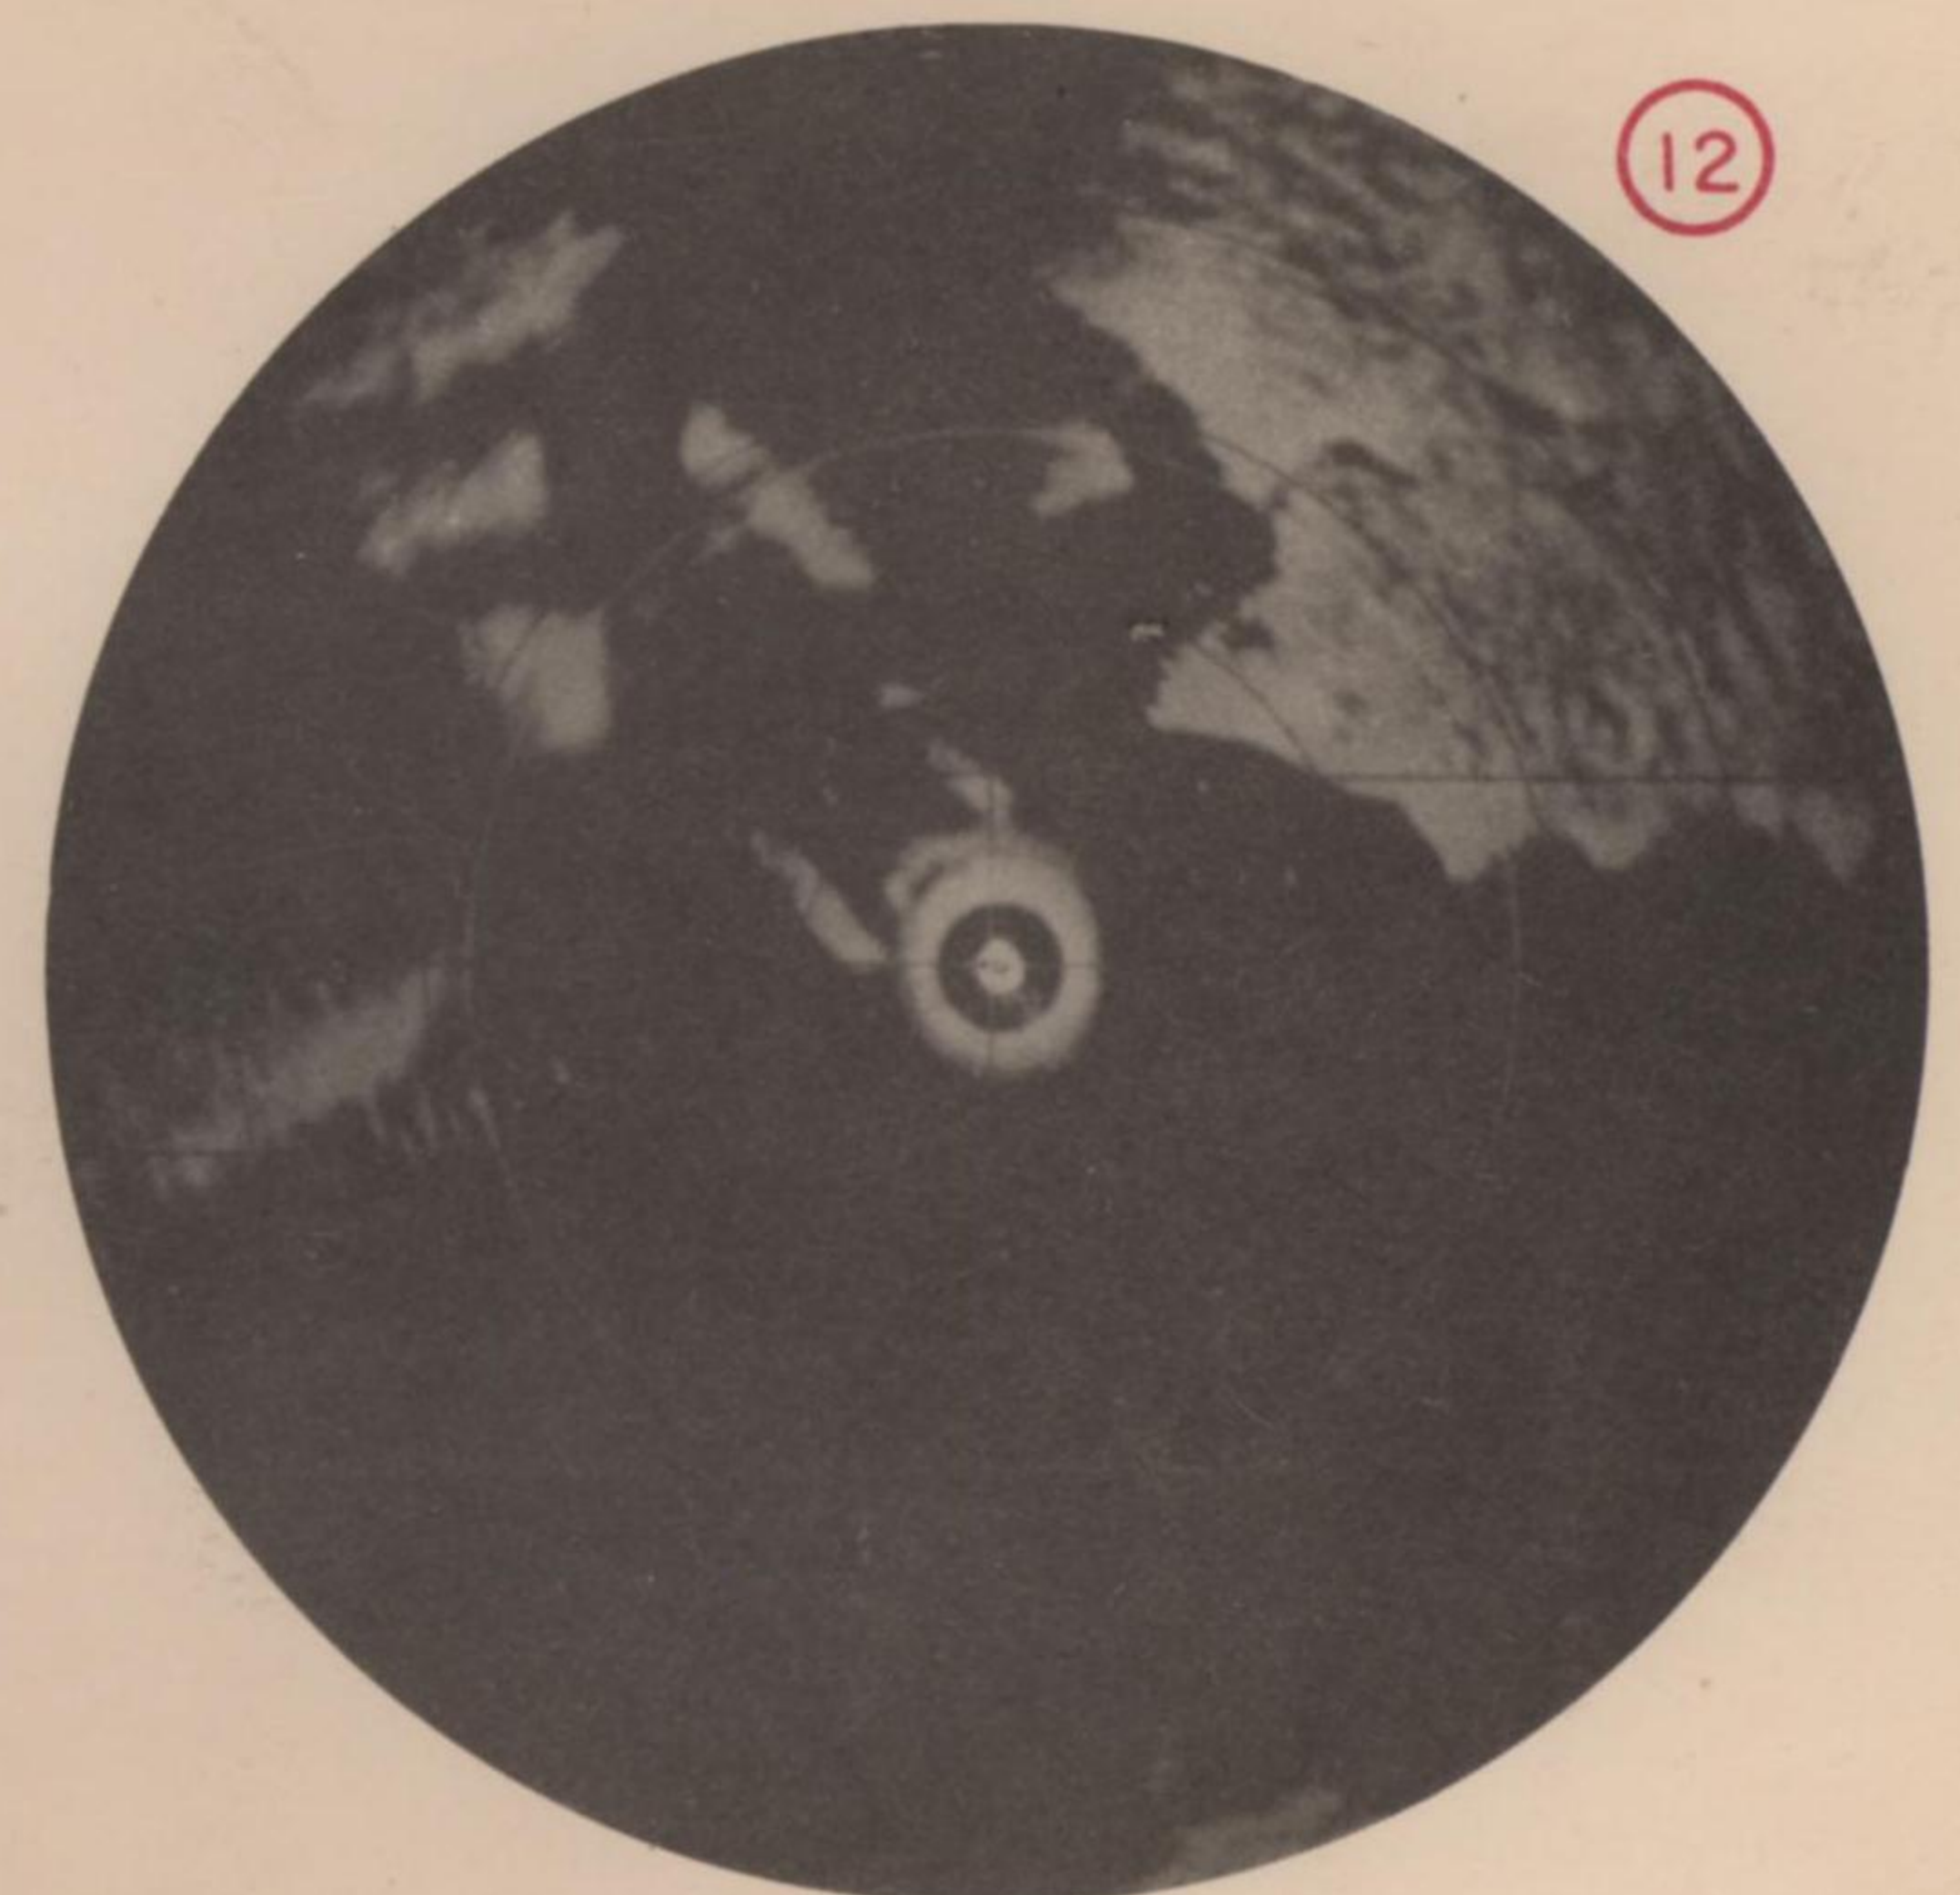
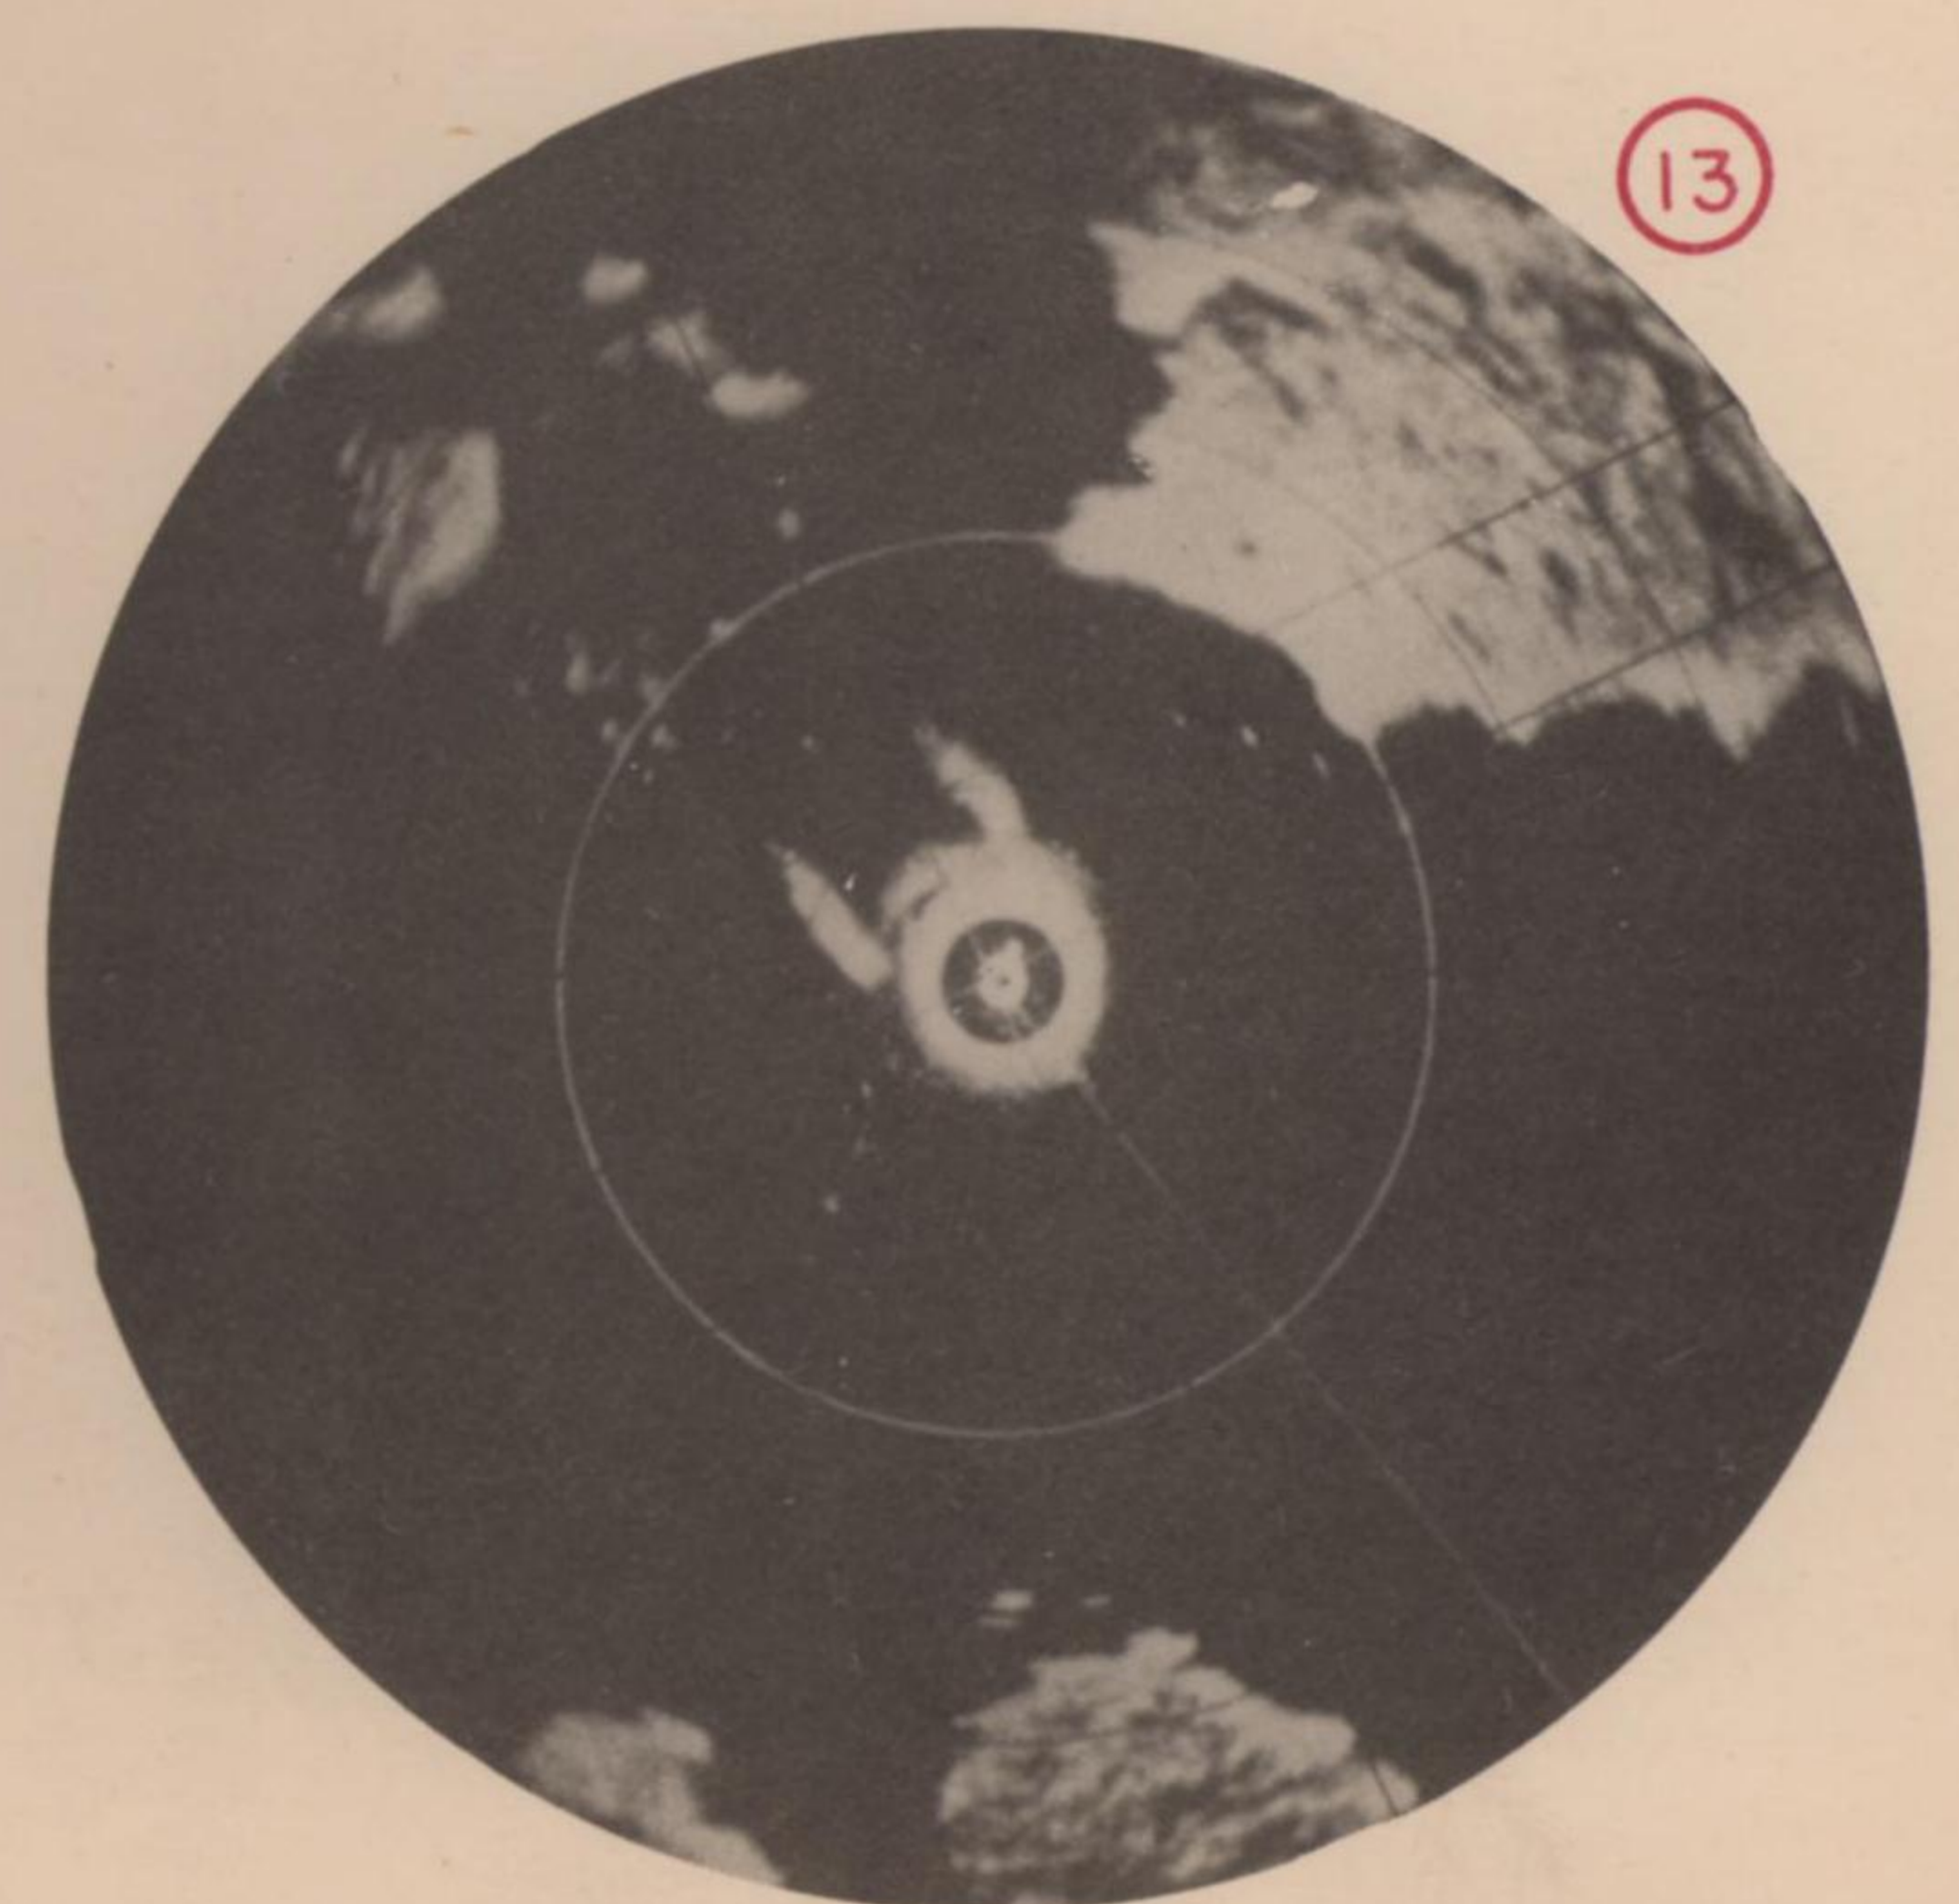
HEADING 147° MAG.

20 MILE SWEEP

HEADING 139° MAG.

10 MILE SWEEP

HEADING 141° MAG.
