MISSION #40 Singapore REPEATEDLY 2
27-28 February 1945

Tactical Mission Report

No. 40

MINING AREA: JOHORE STRAIT FIELD, SINGAPORE,
MALAYA

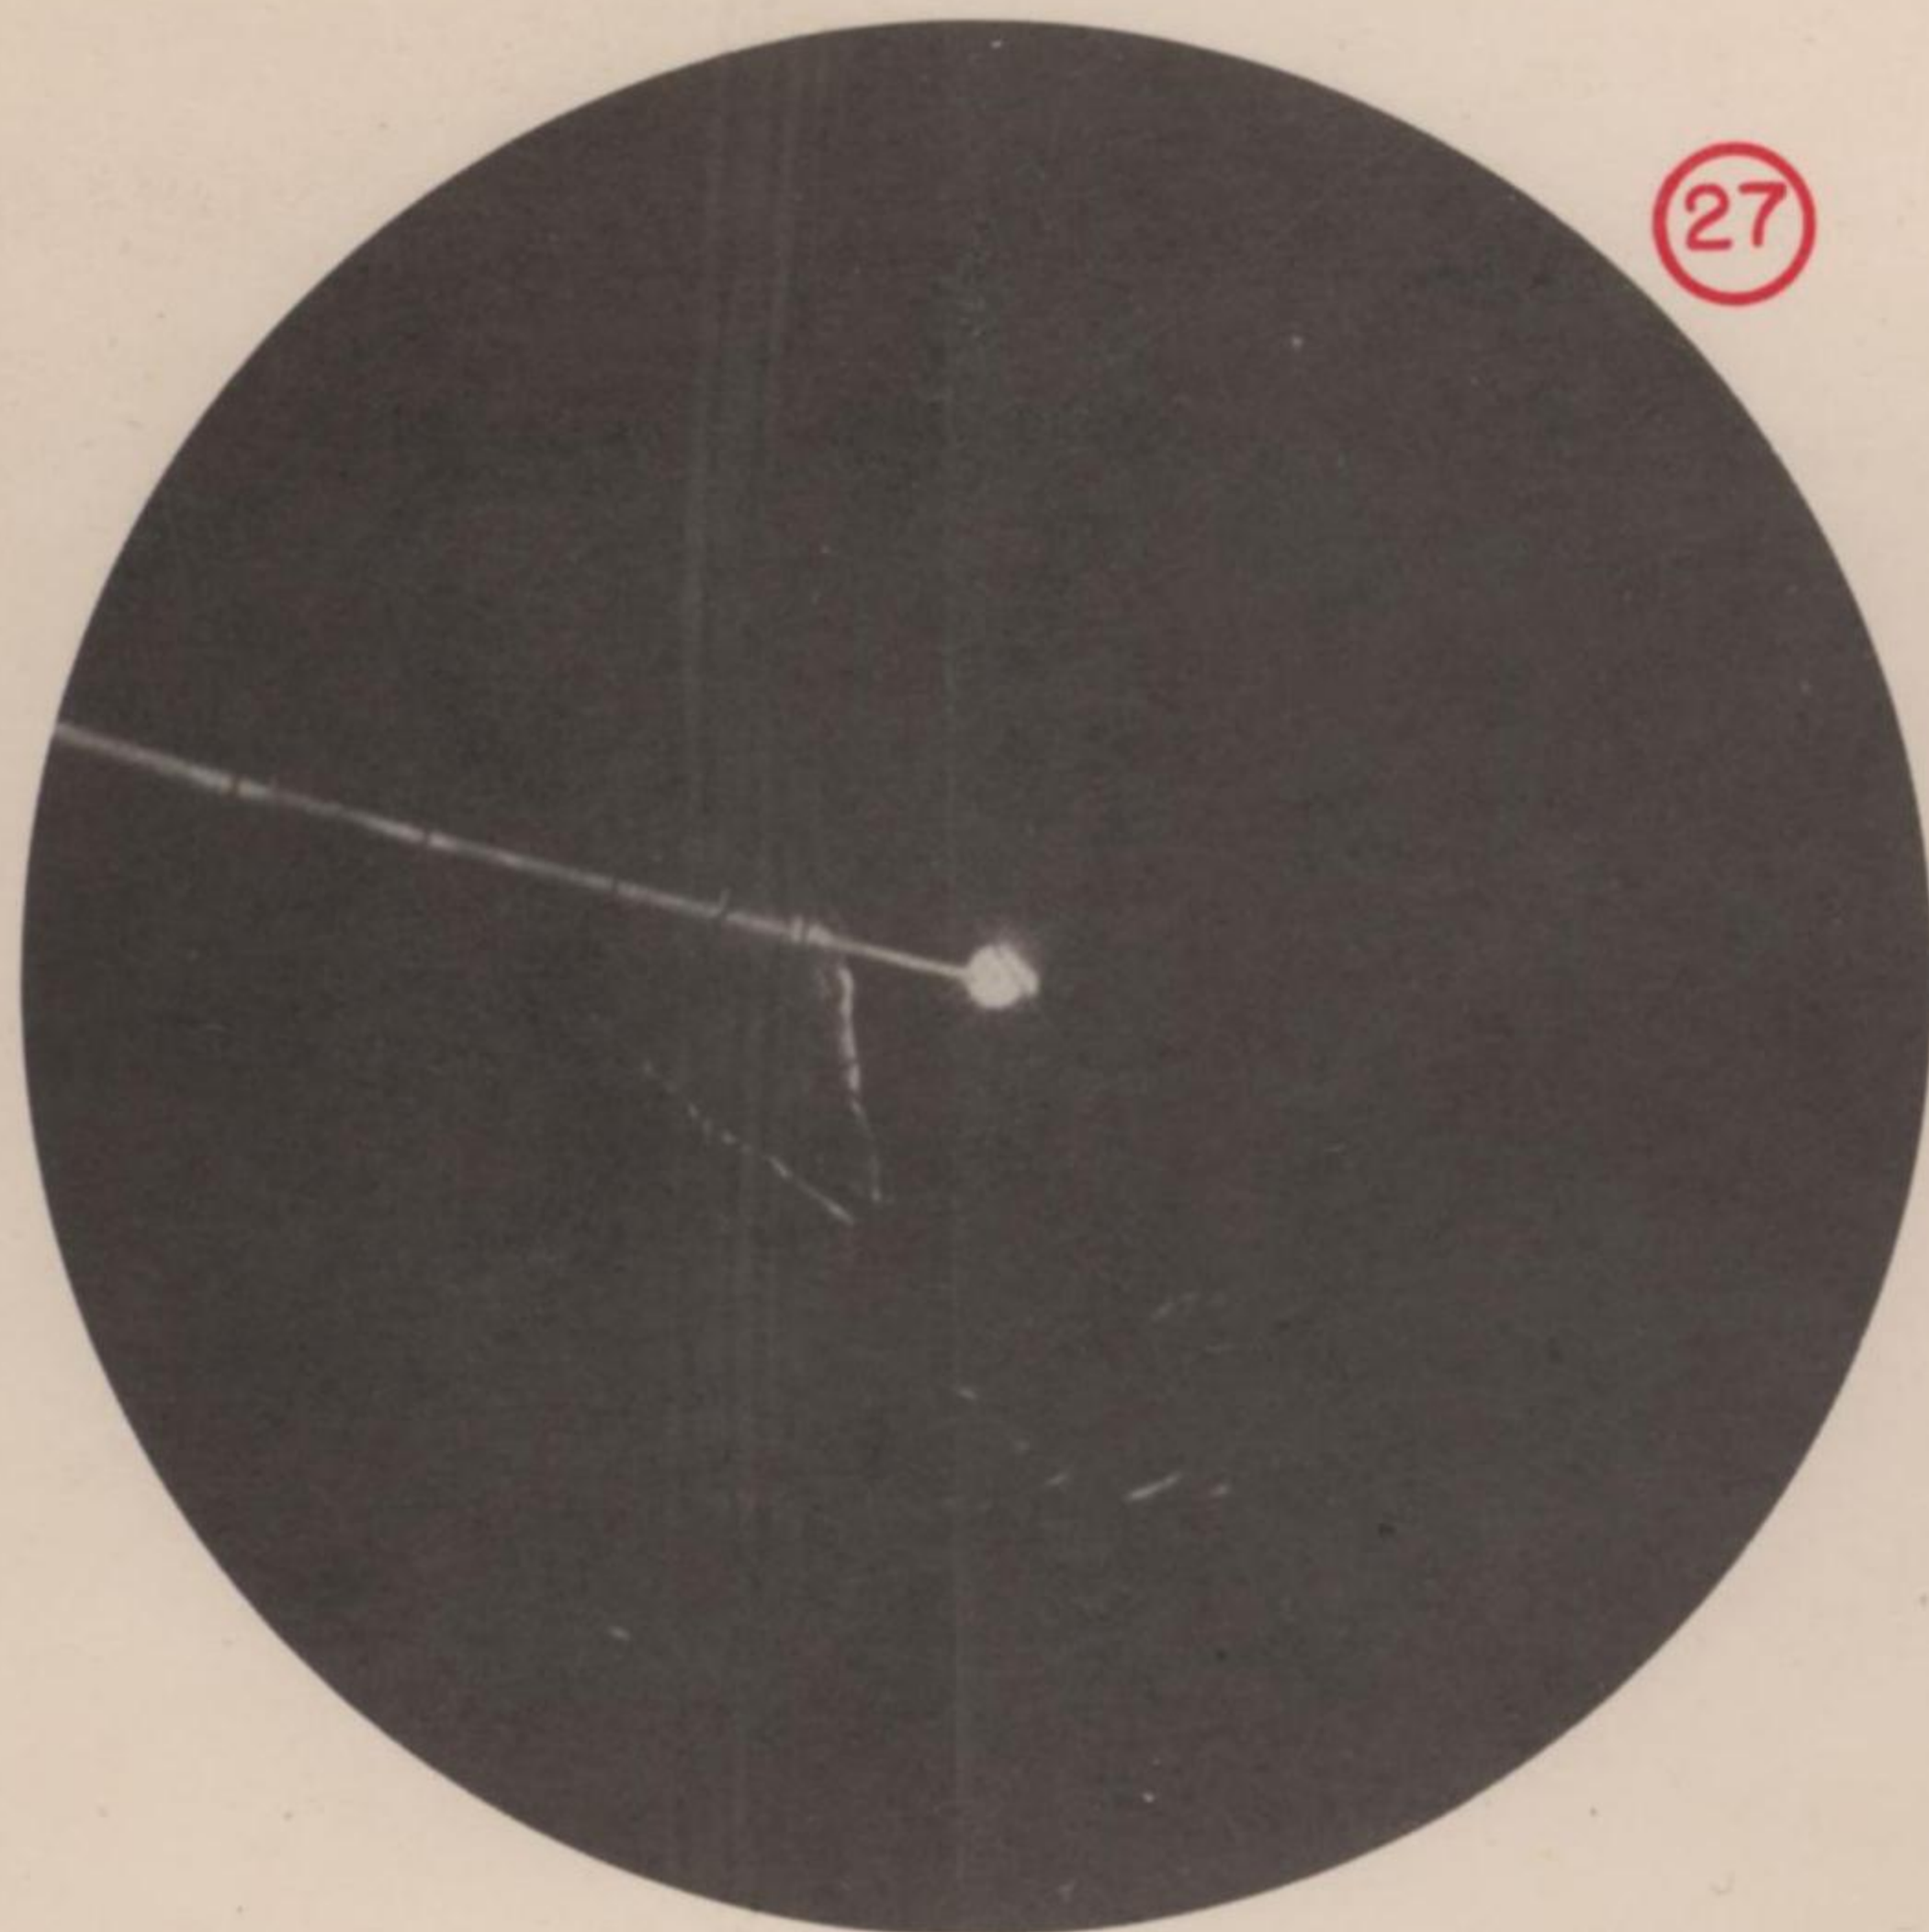
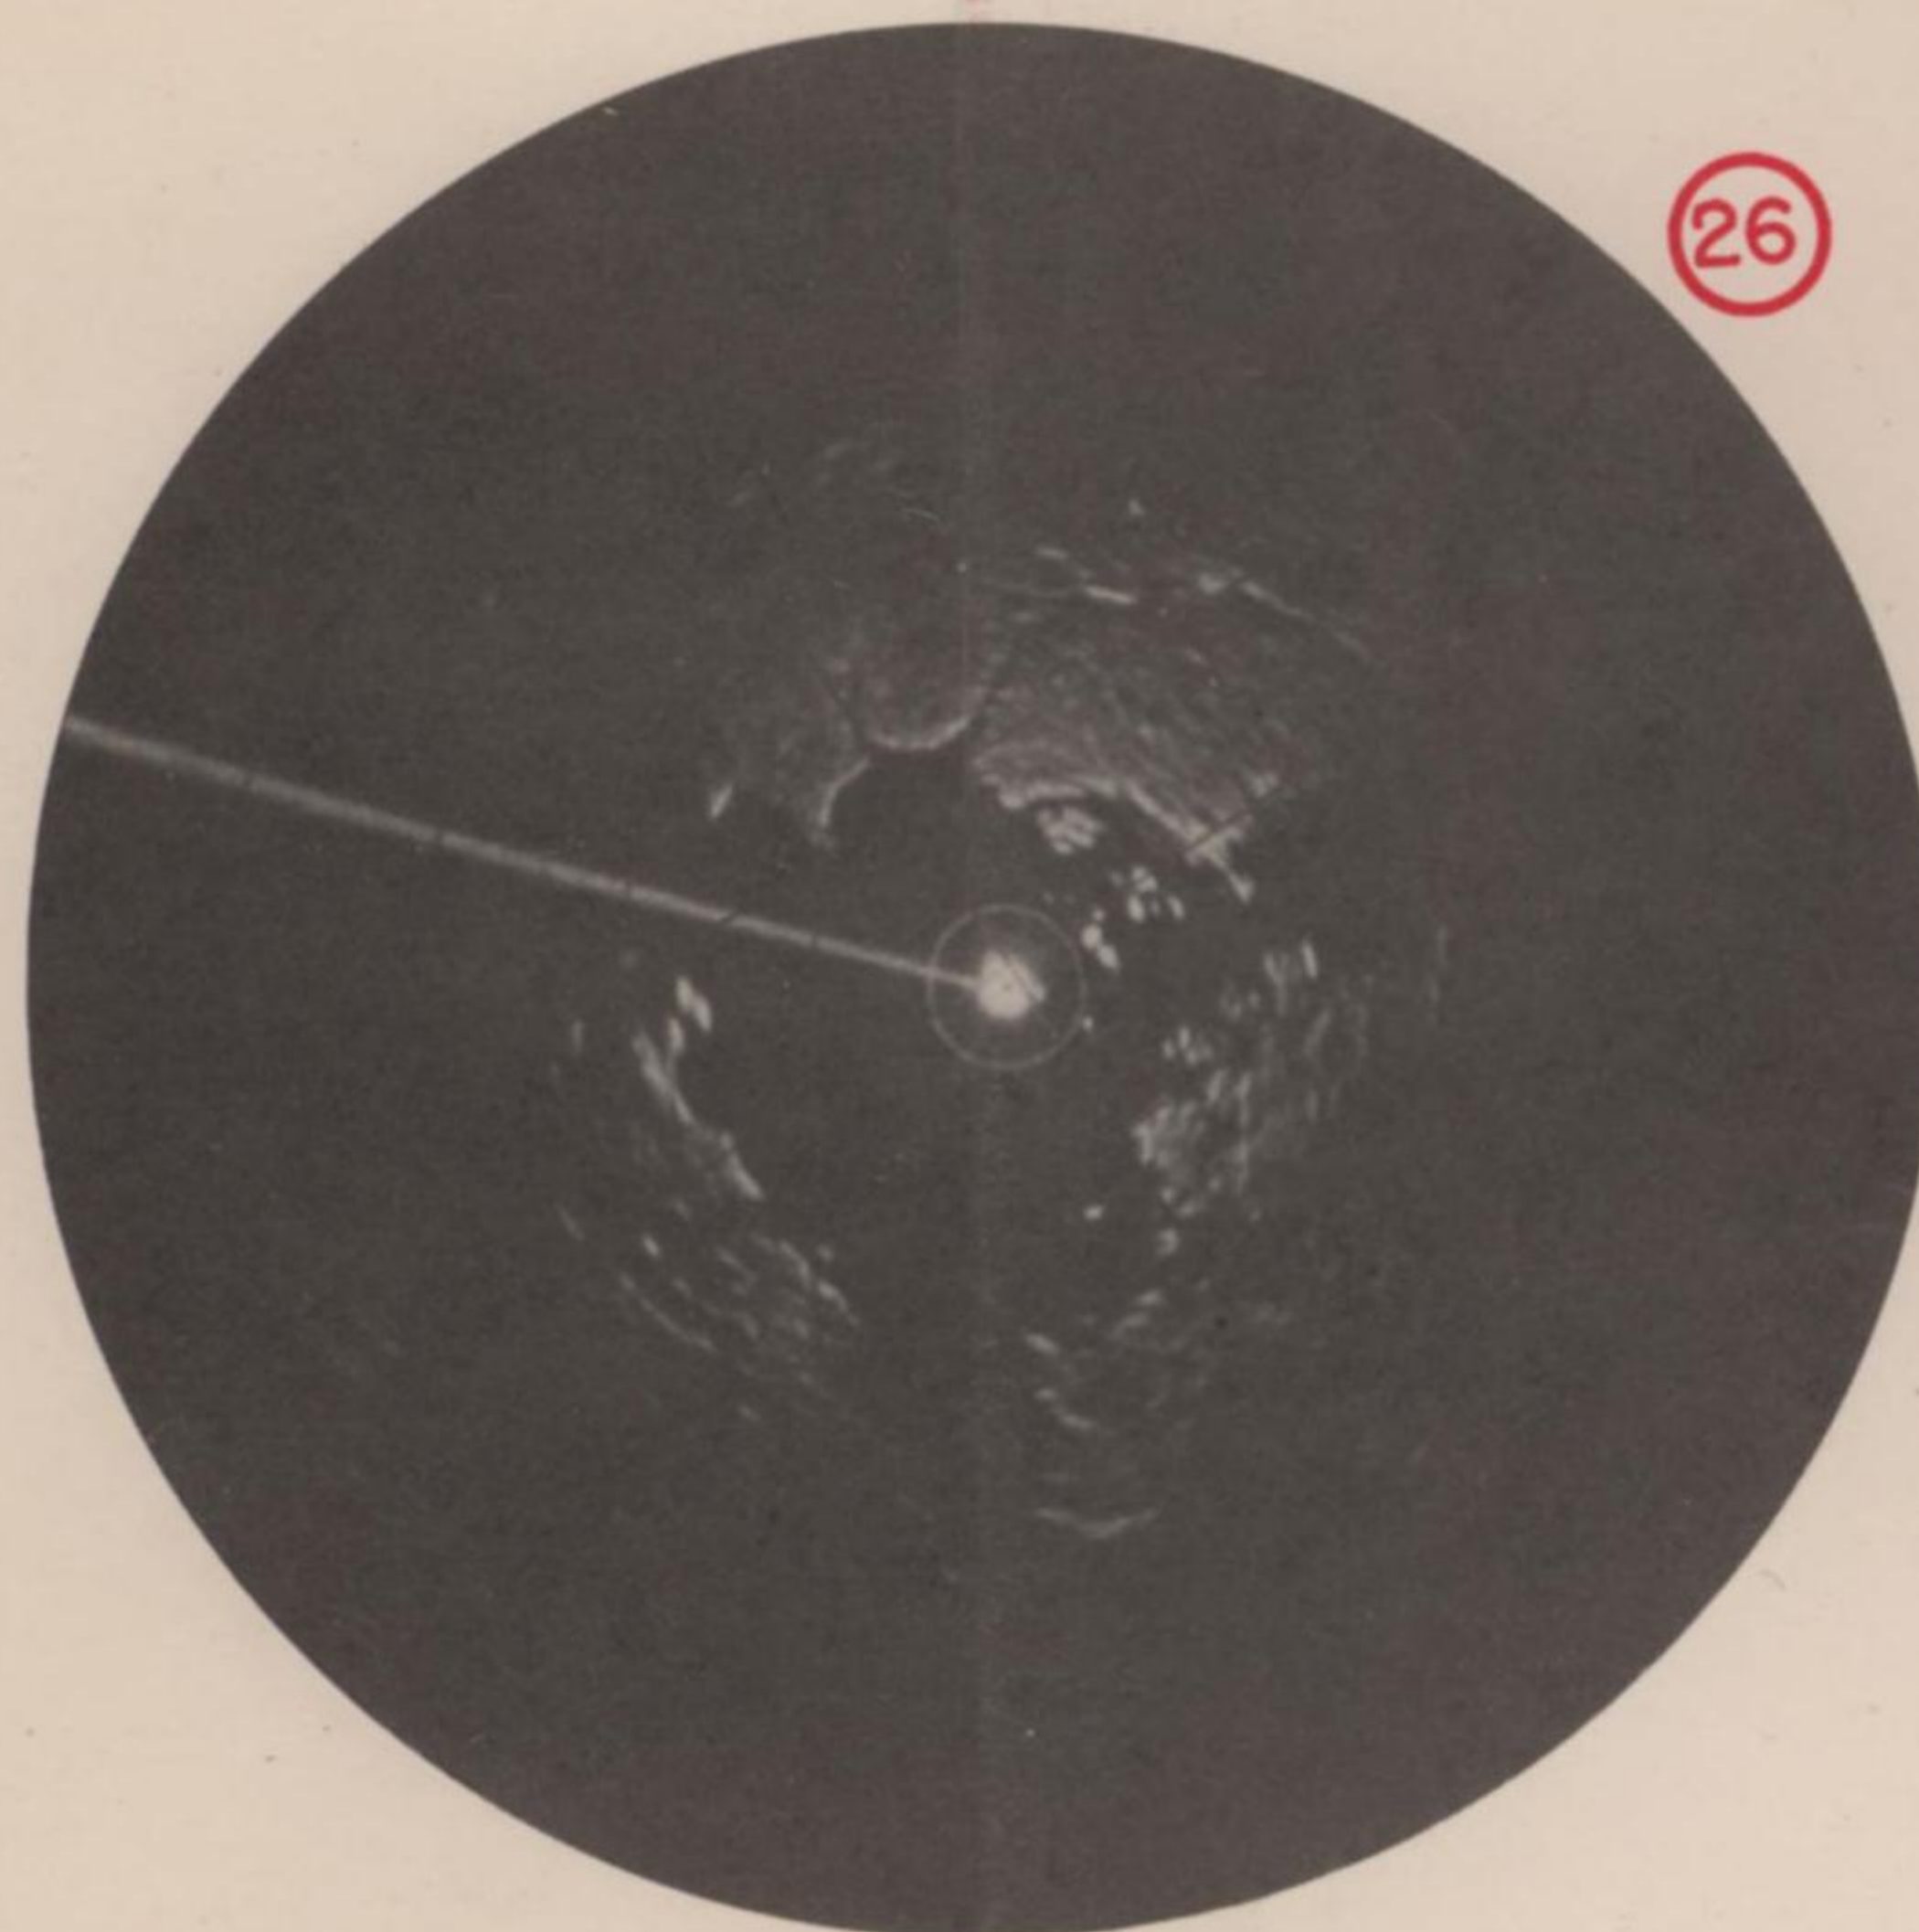
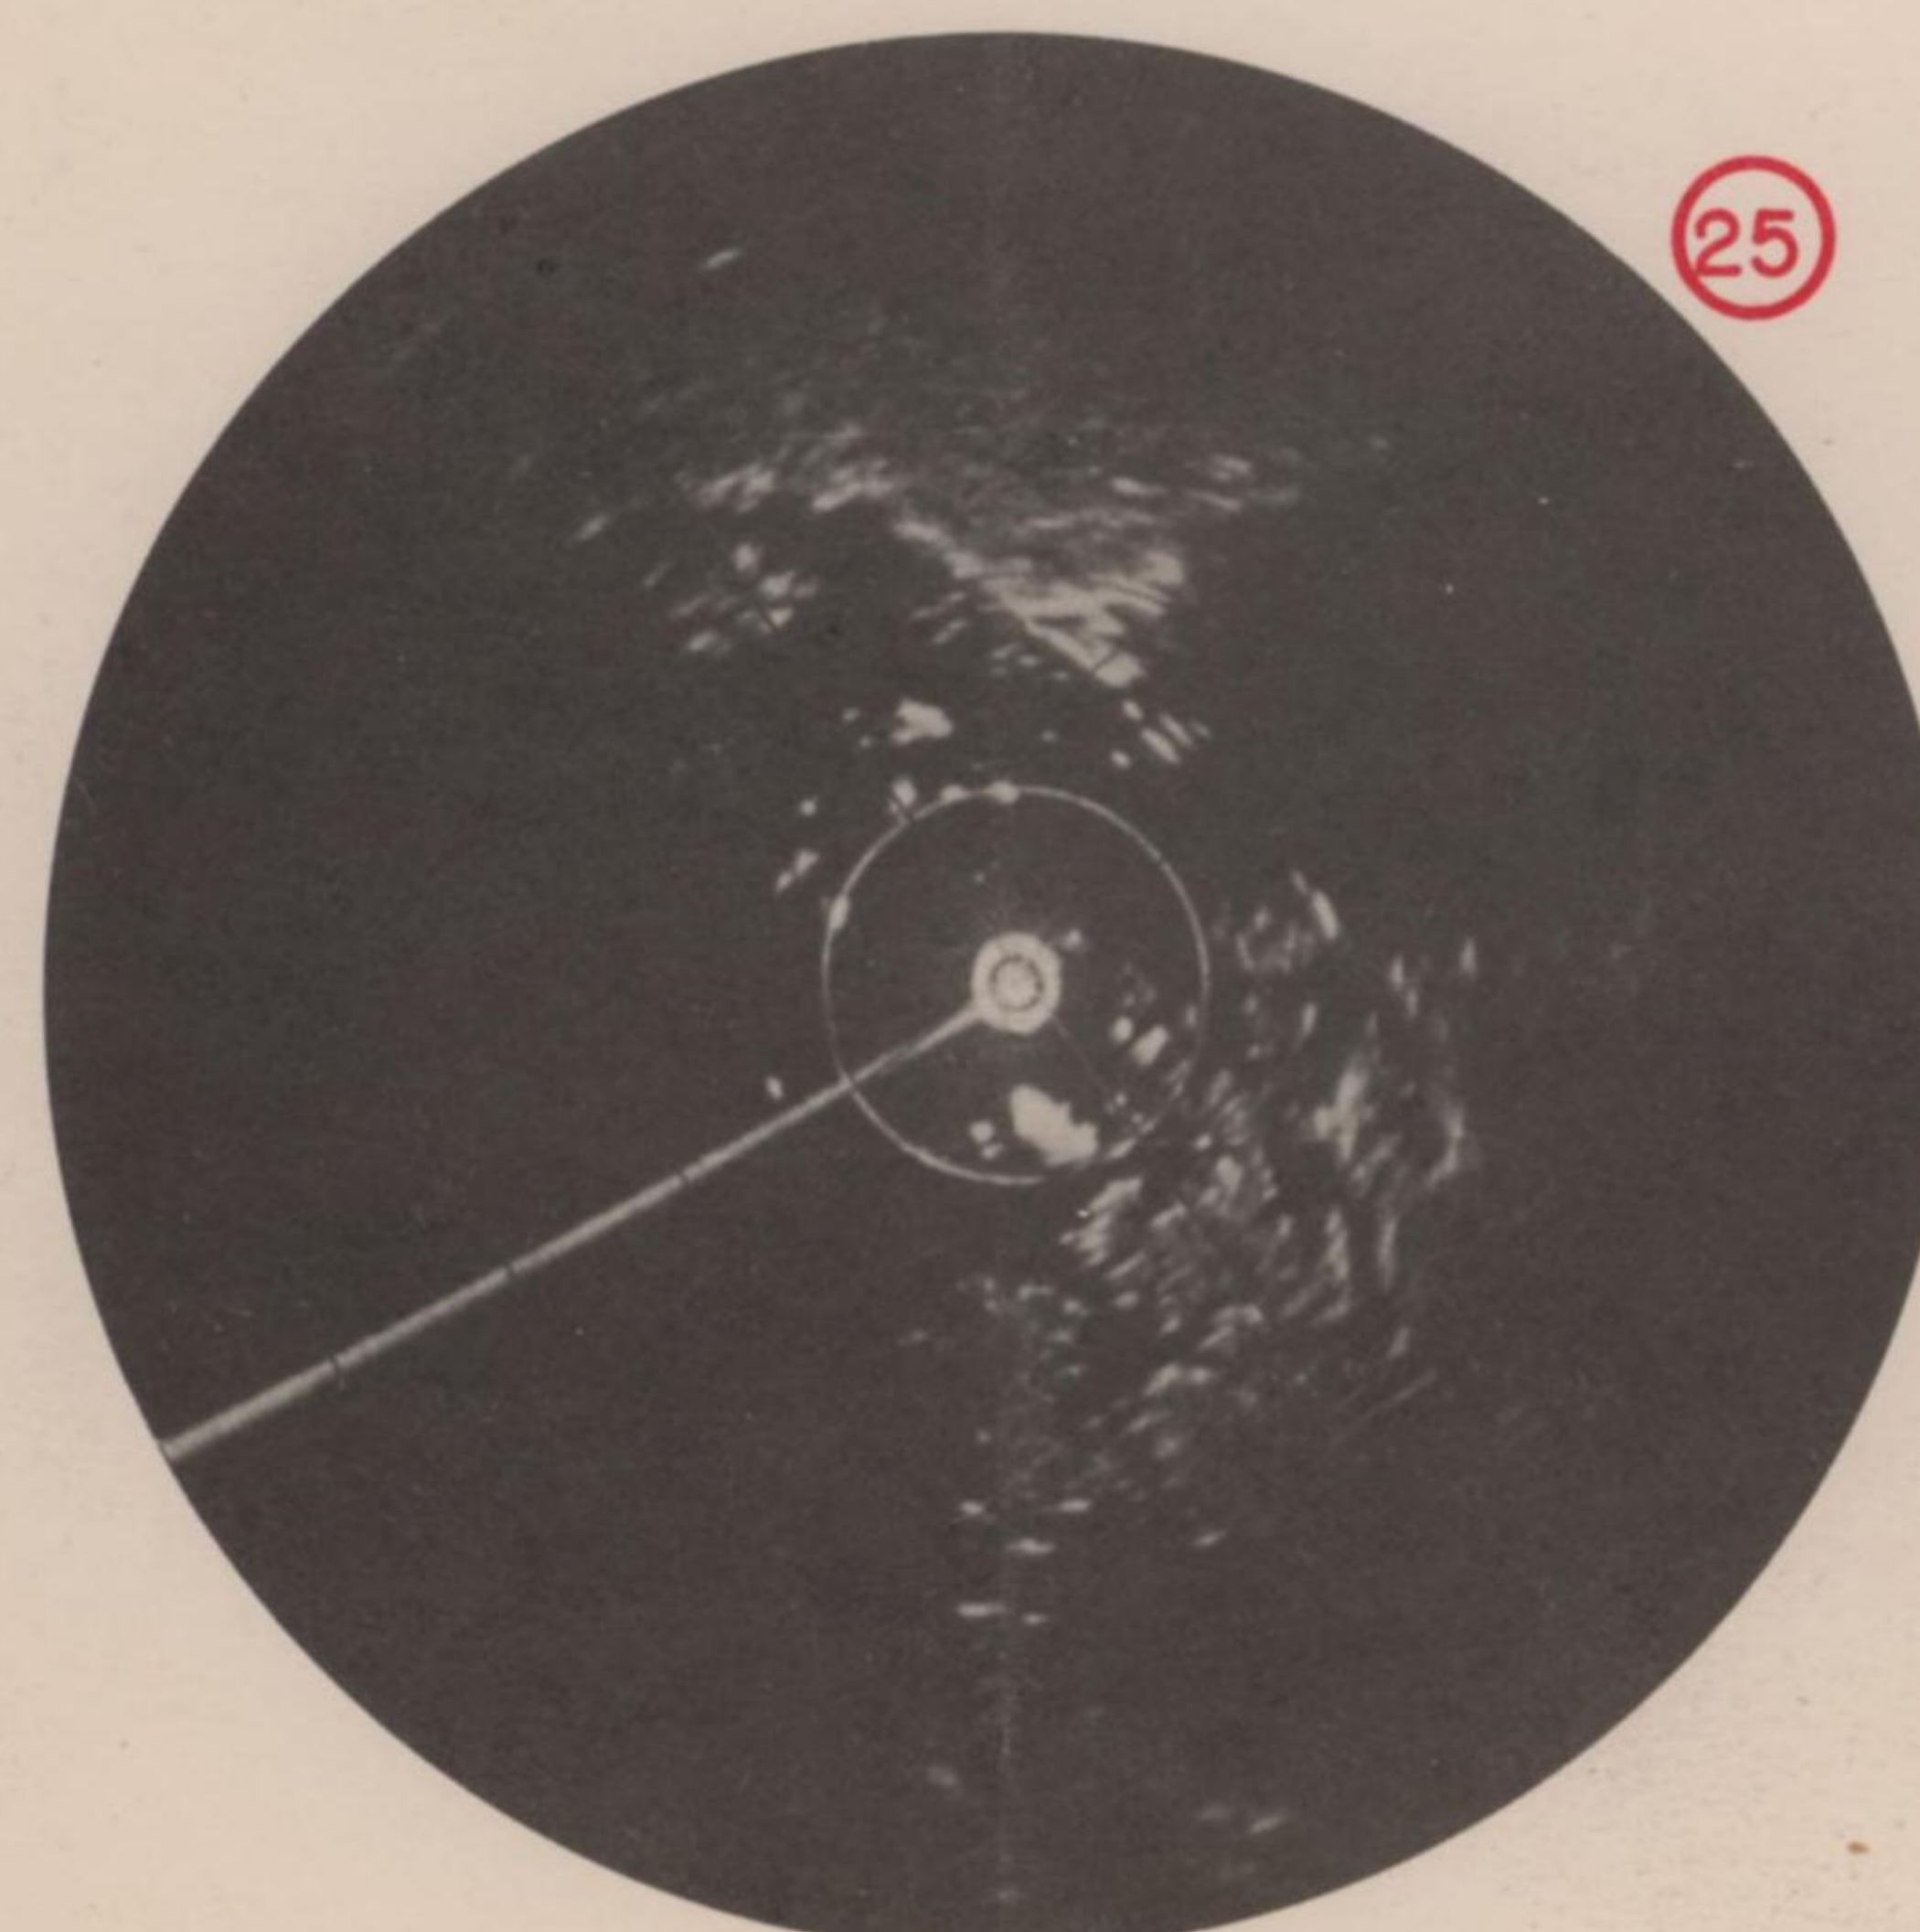
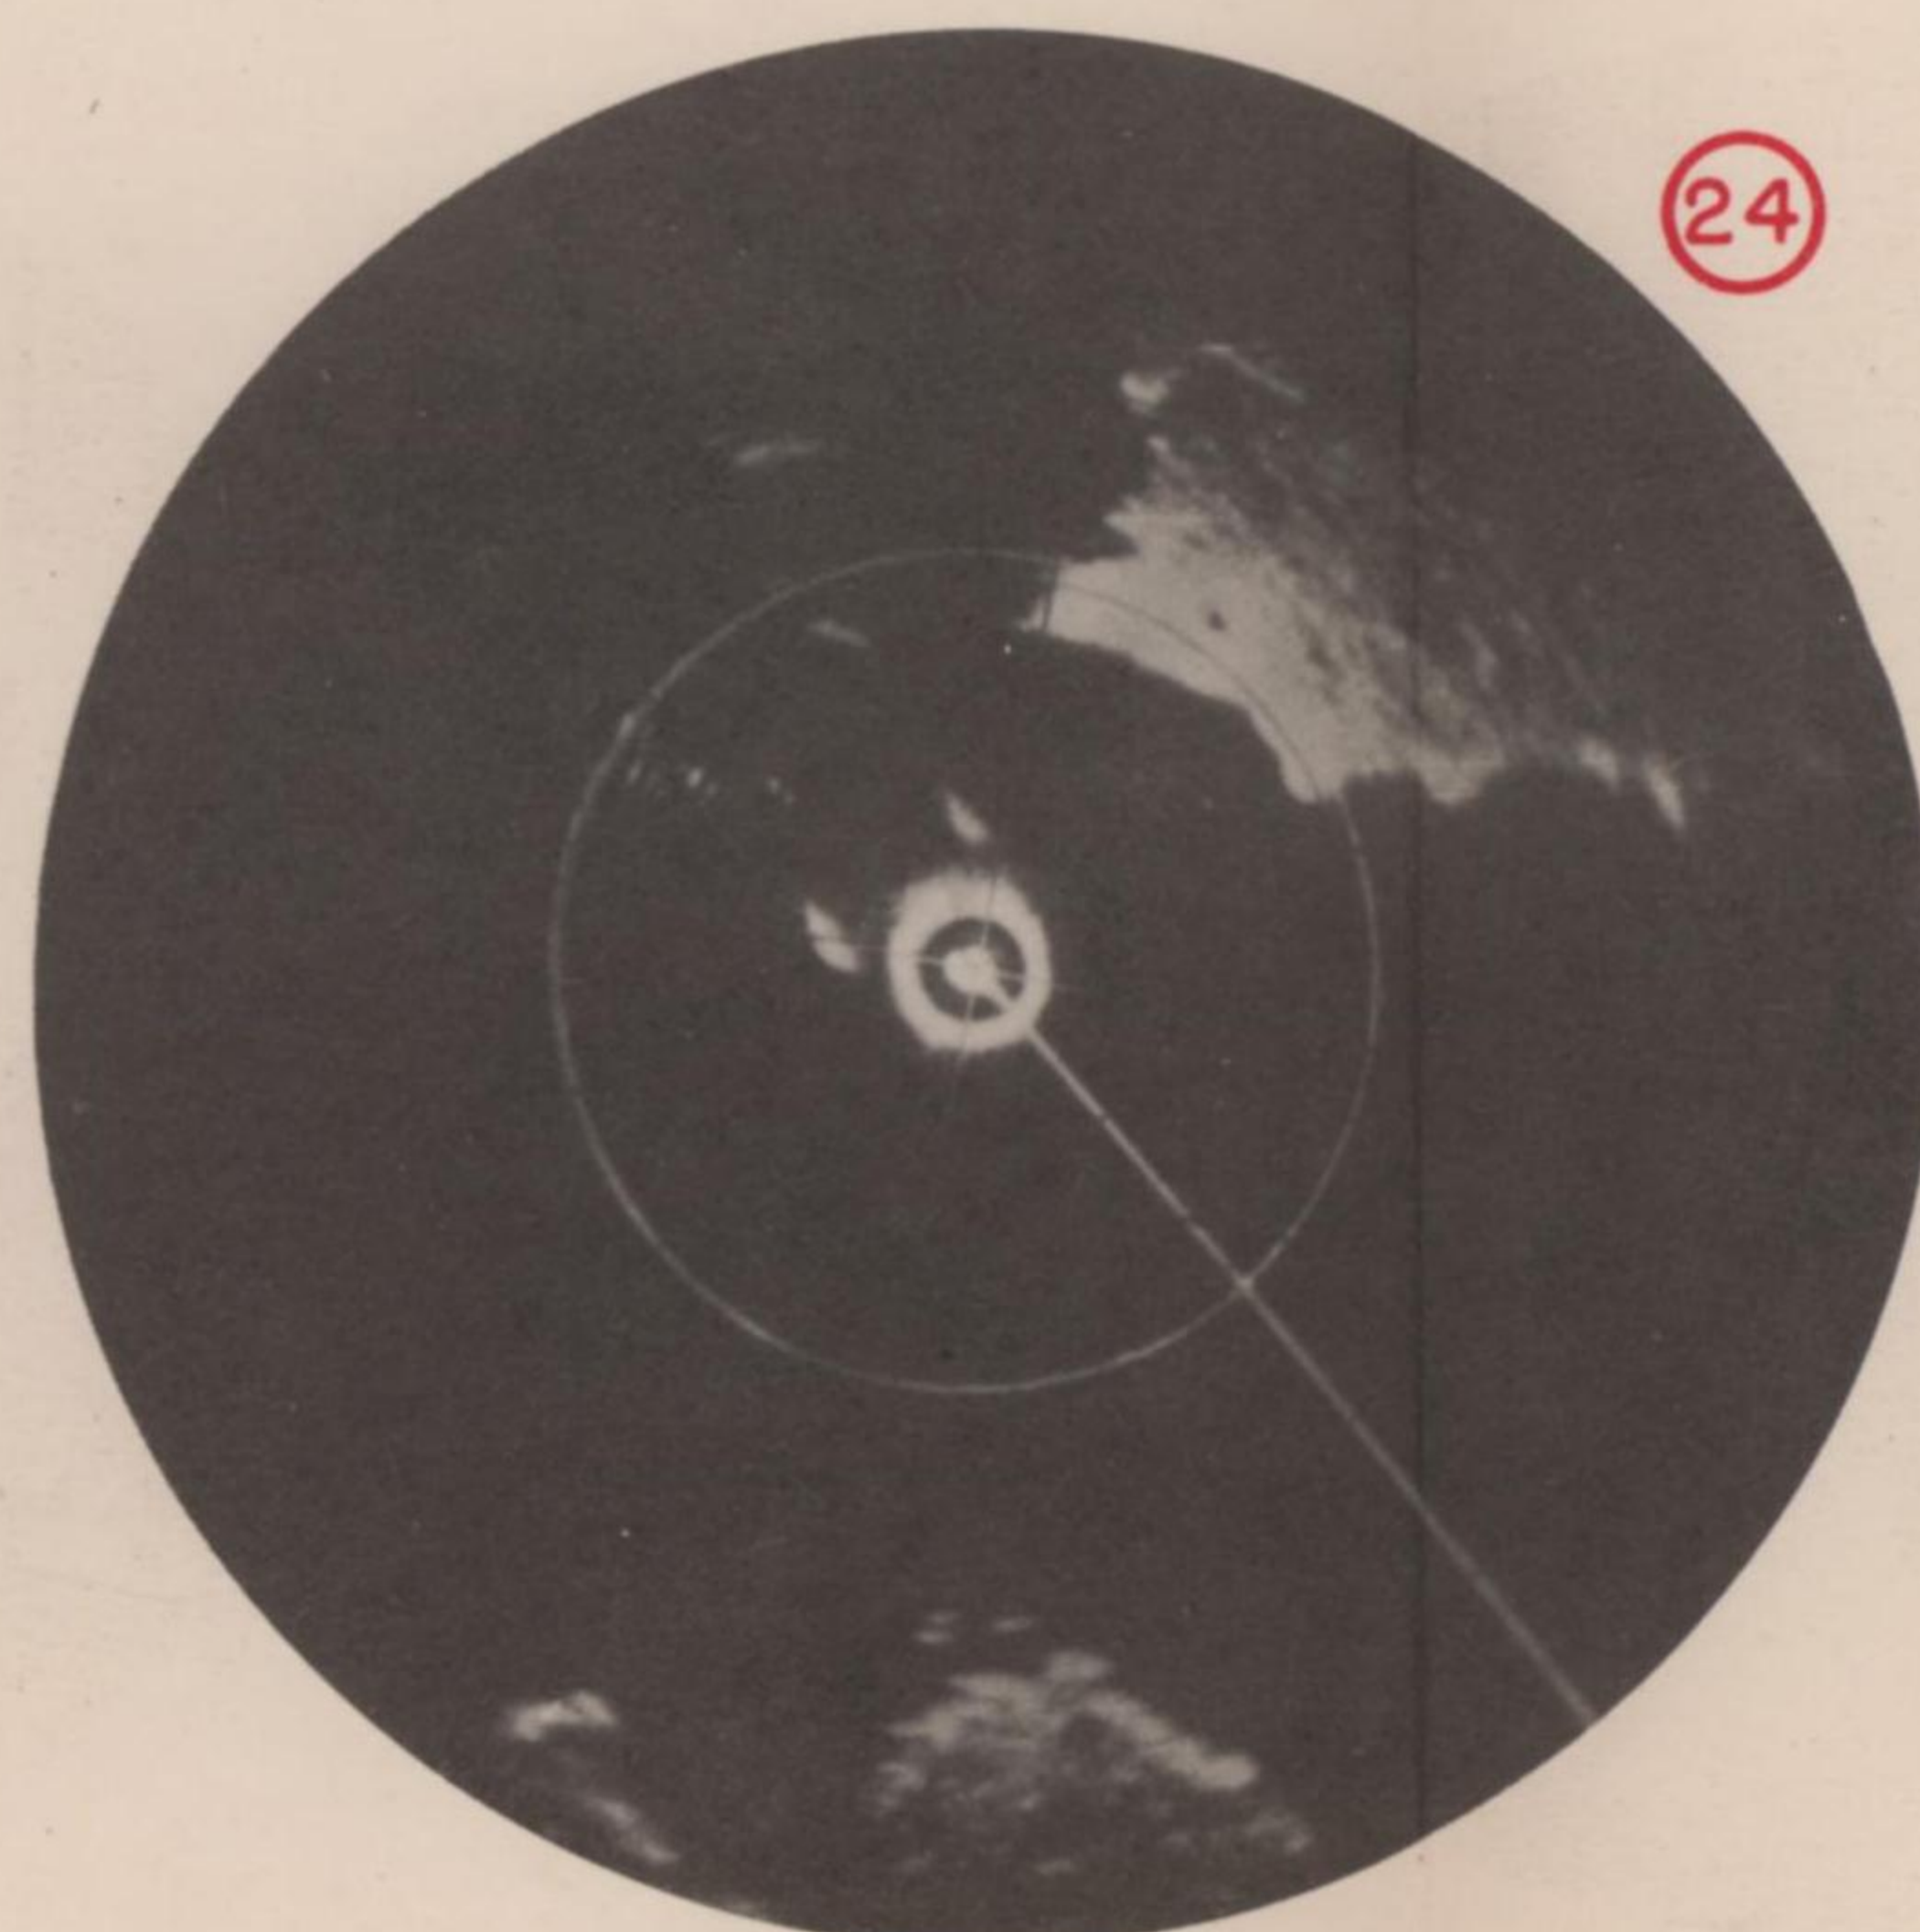
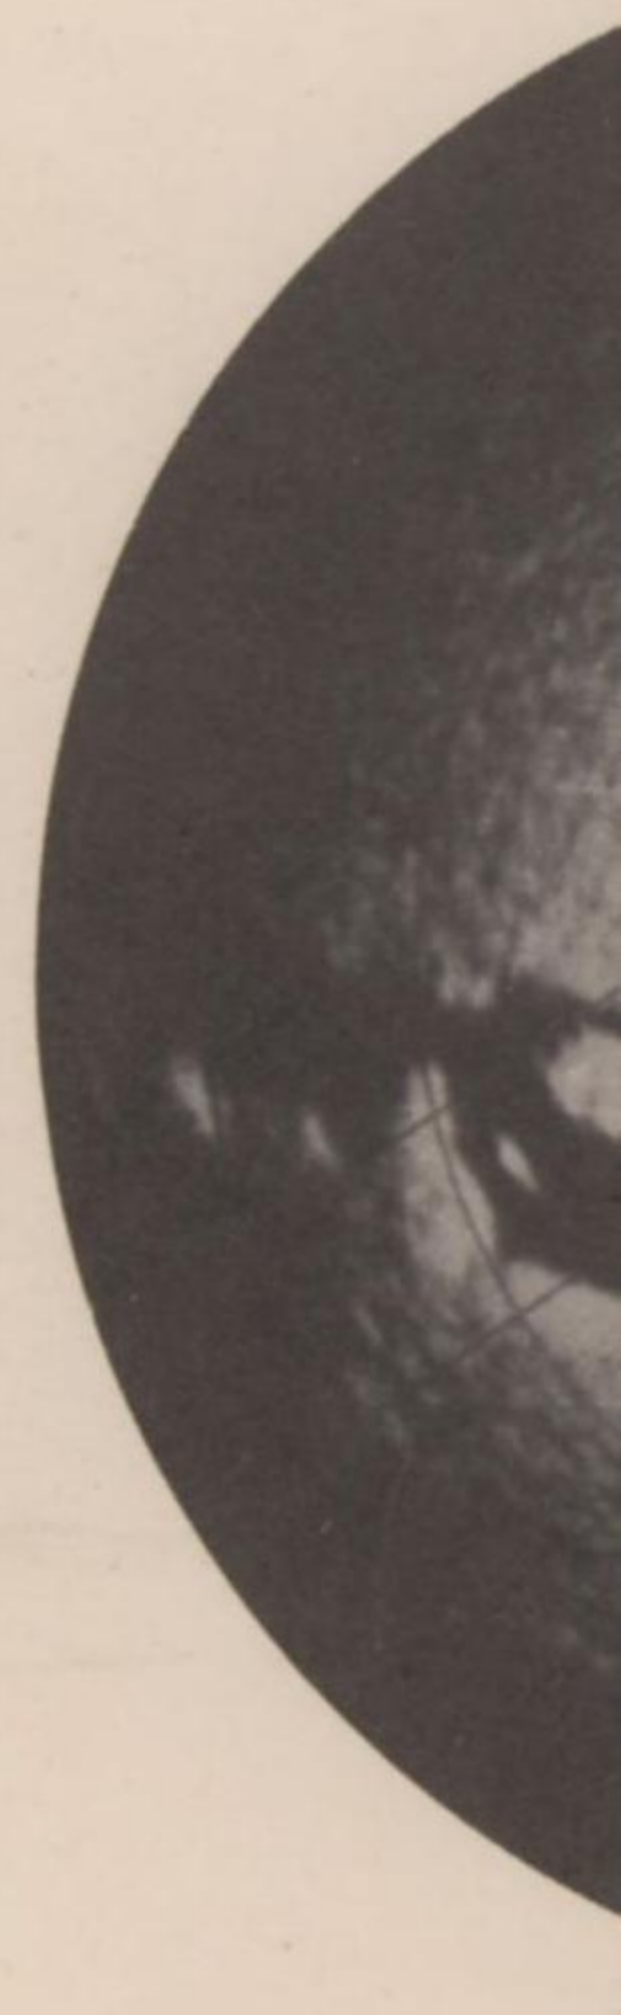
JOHORE STRAIT FIELD

SECRET
 RADAR PHOTOGRAPH ANALYSIS
 SINGAPORE AREA-MALAY STATES
 MISSION NO. 40 MINING OF APPROACHES TO HARBOR

HEADING 285° MAG. 50 MILE SWEEP

HEADING 241° MAG. 20 MILE SWEEP

HEADING 140° MAG. 10 MILE SWEEP

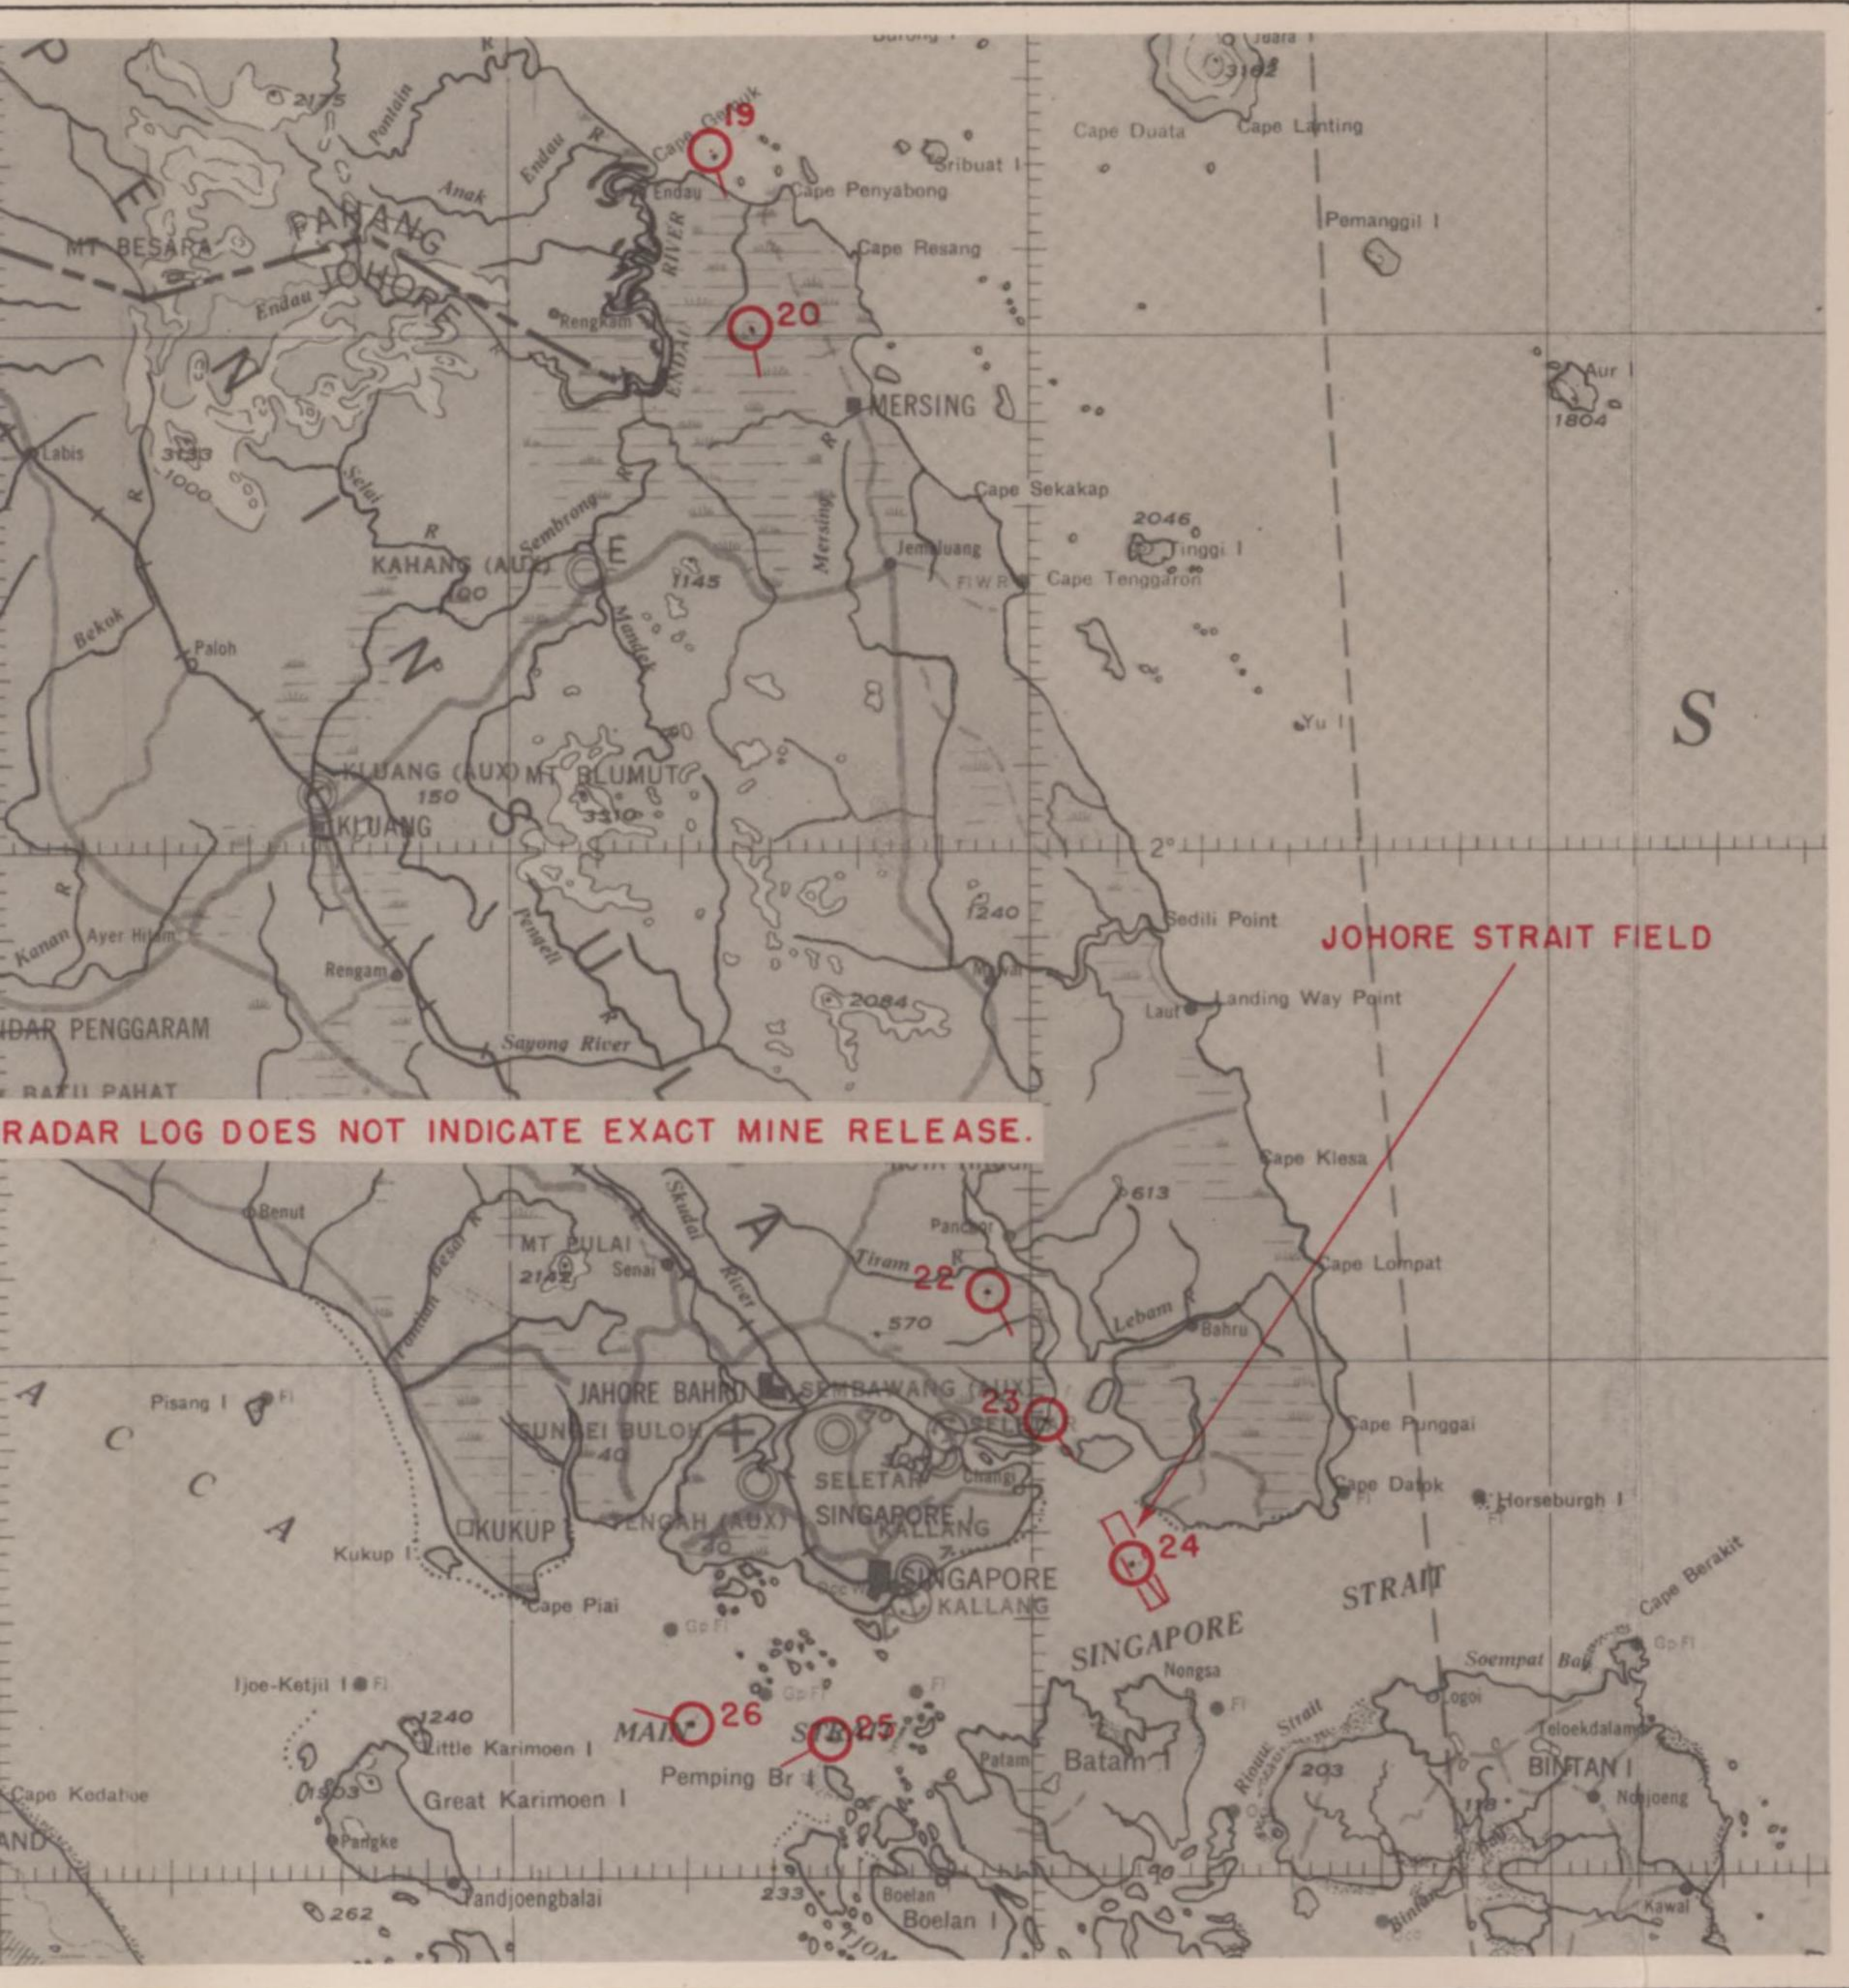
JOHORE STRAIT FIELD

RADAR PHOTOGRAPH ANALYSIS
SINGAPORE AREA-MALAY STATES
40 MINING OF APPROACHES TO HARBOR & NAVAL BASE

HEADING 156° MAG. 20 MILE SWEEP
