MISSION #40 Singapore REPEATEDLY 2
27-28 February 1945

Tactical Mission Report

No. 40

MINING AREA: JOHORE STRAIT FIELD, SINGAPORE,
MALAYA

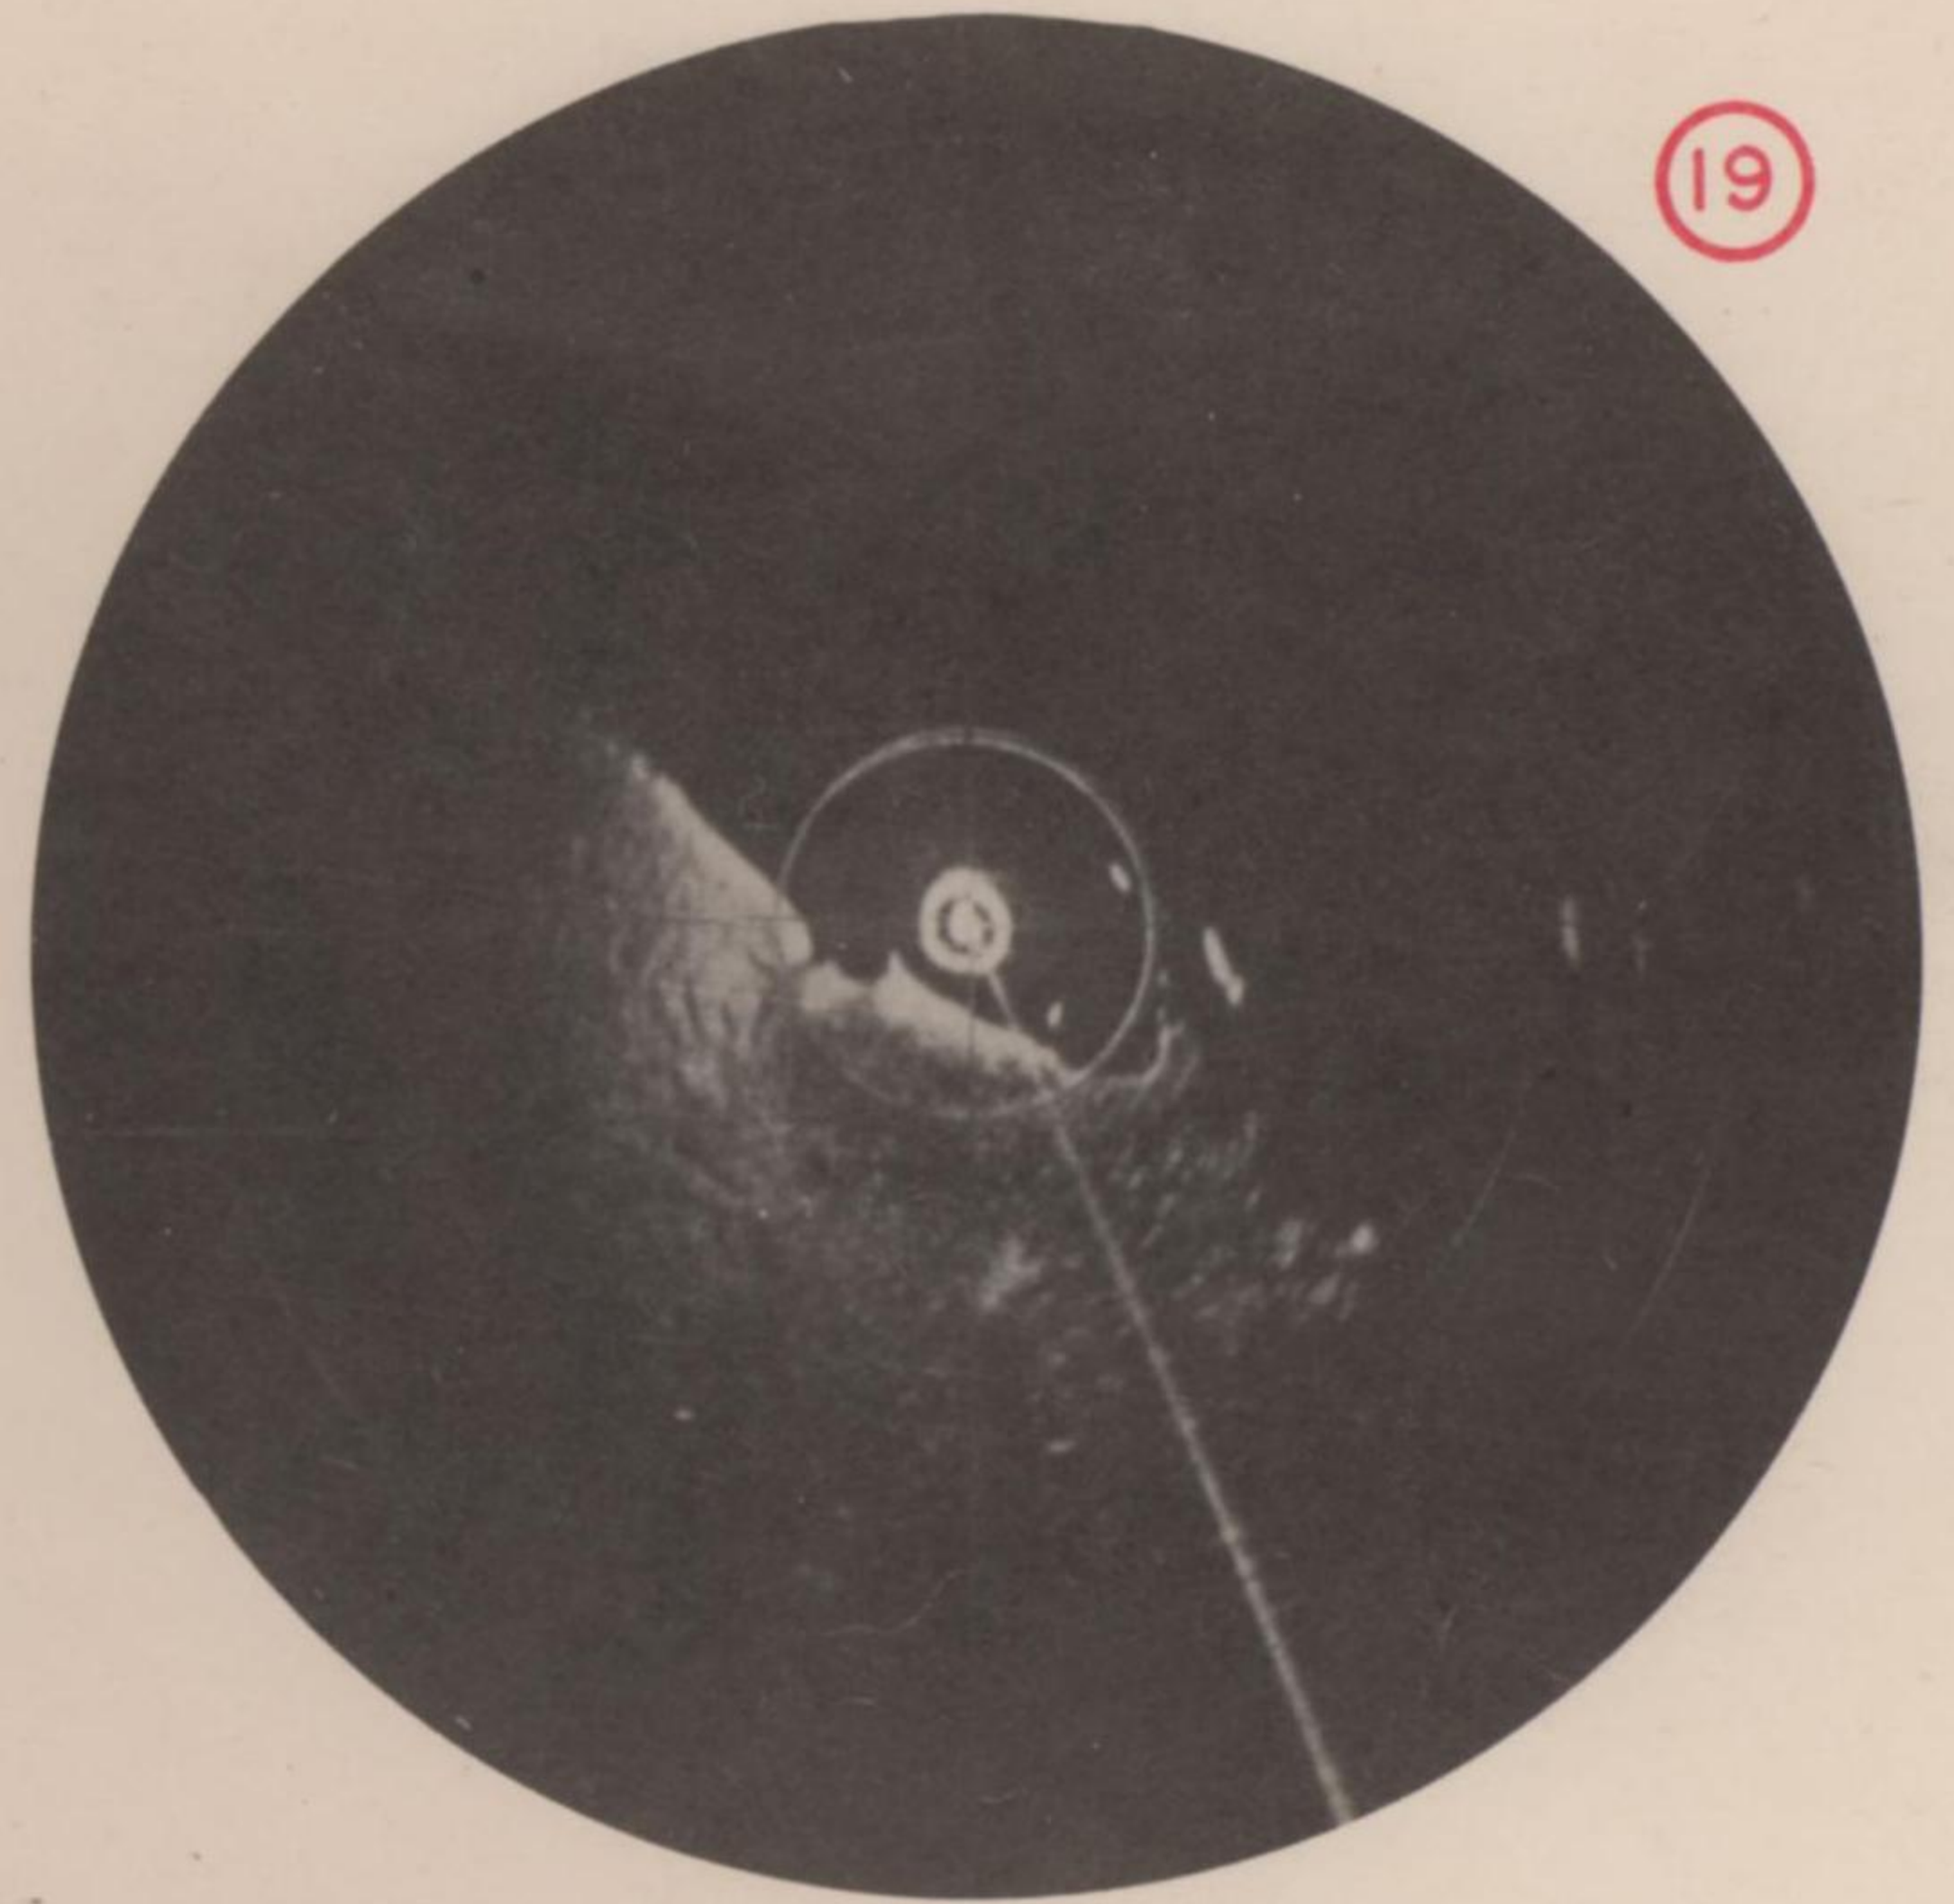
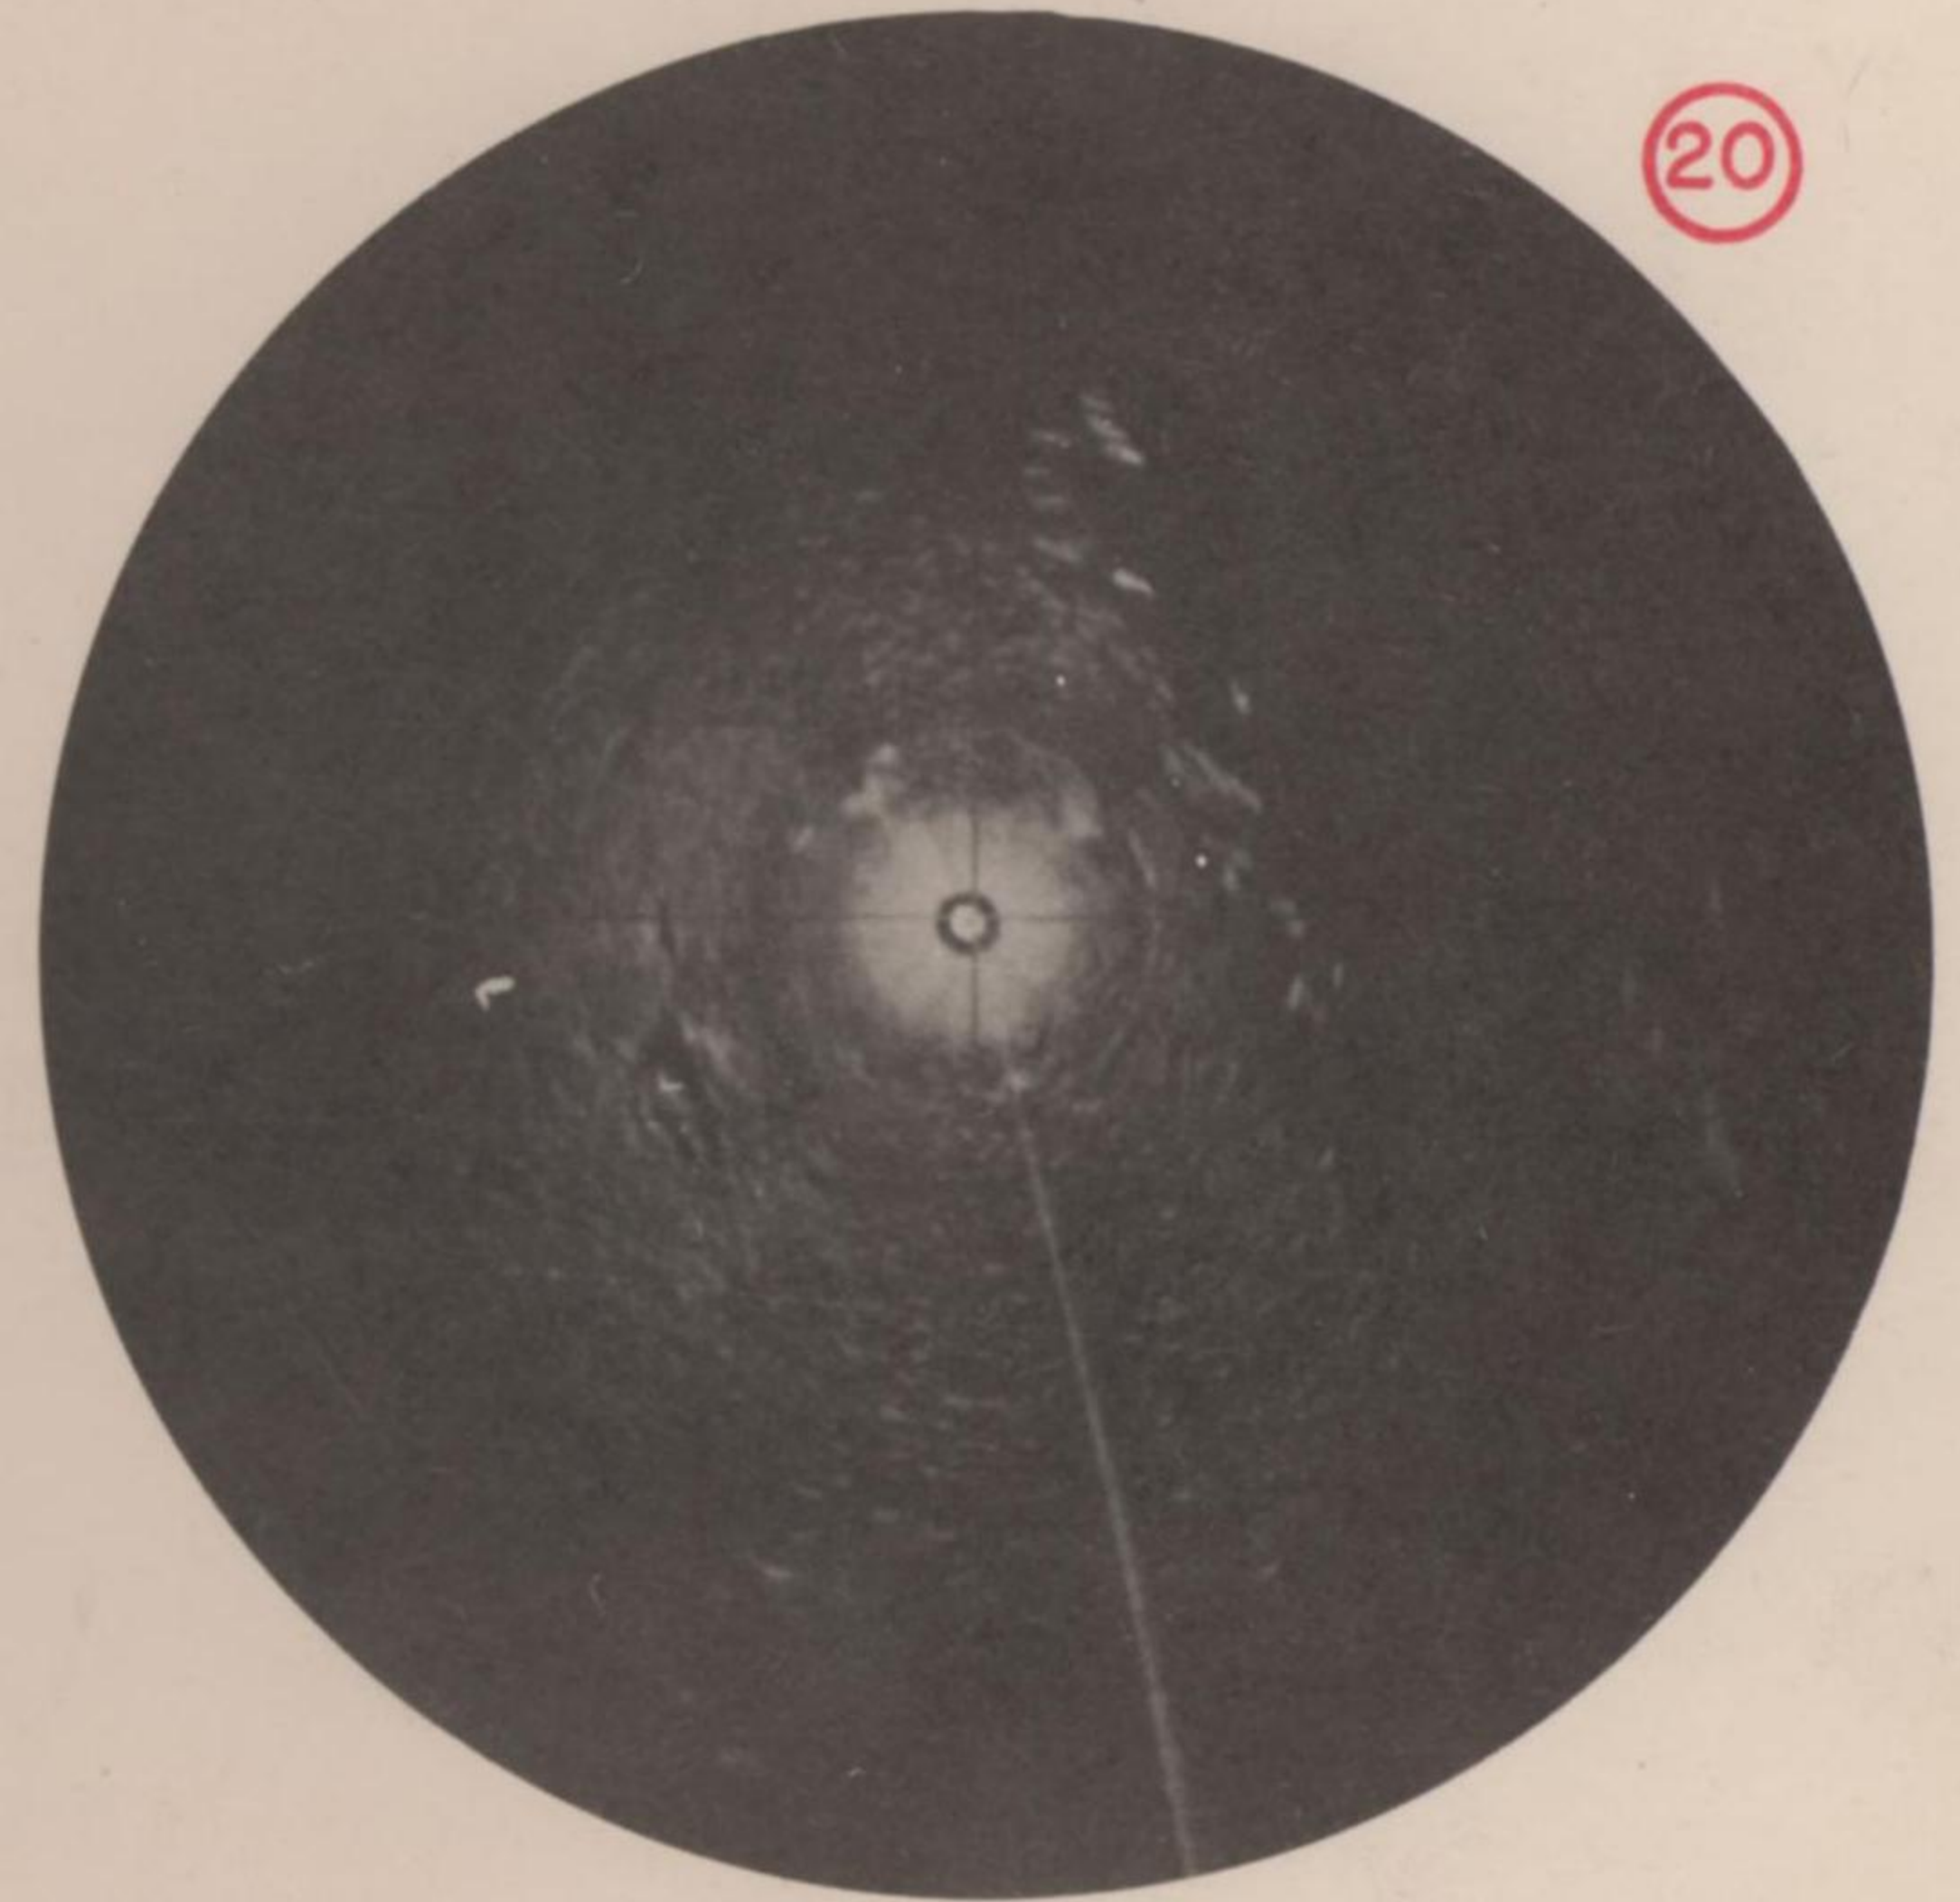
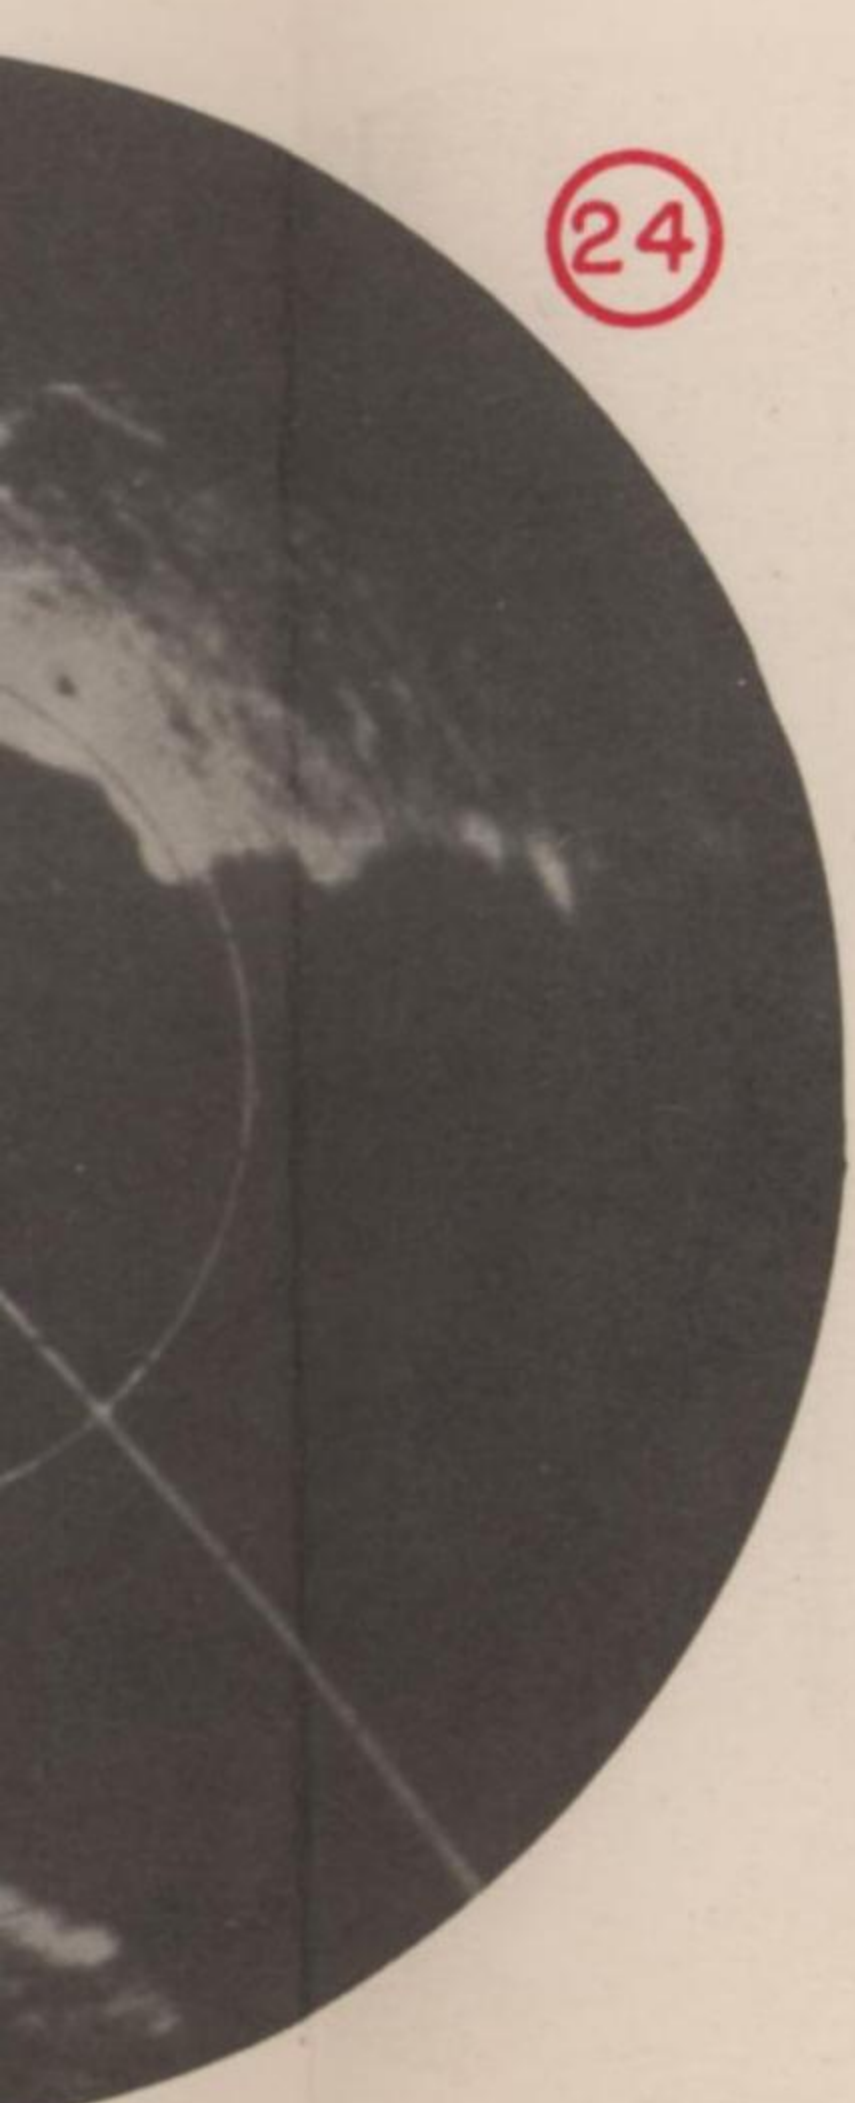
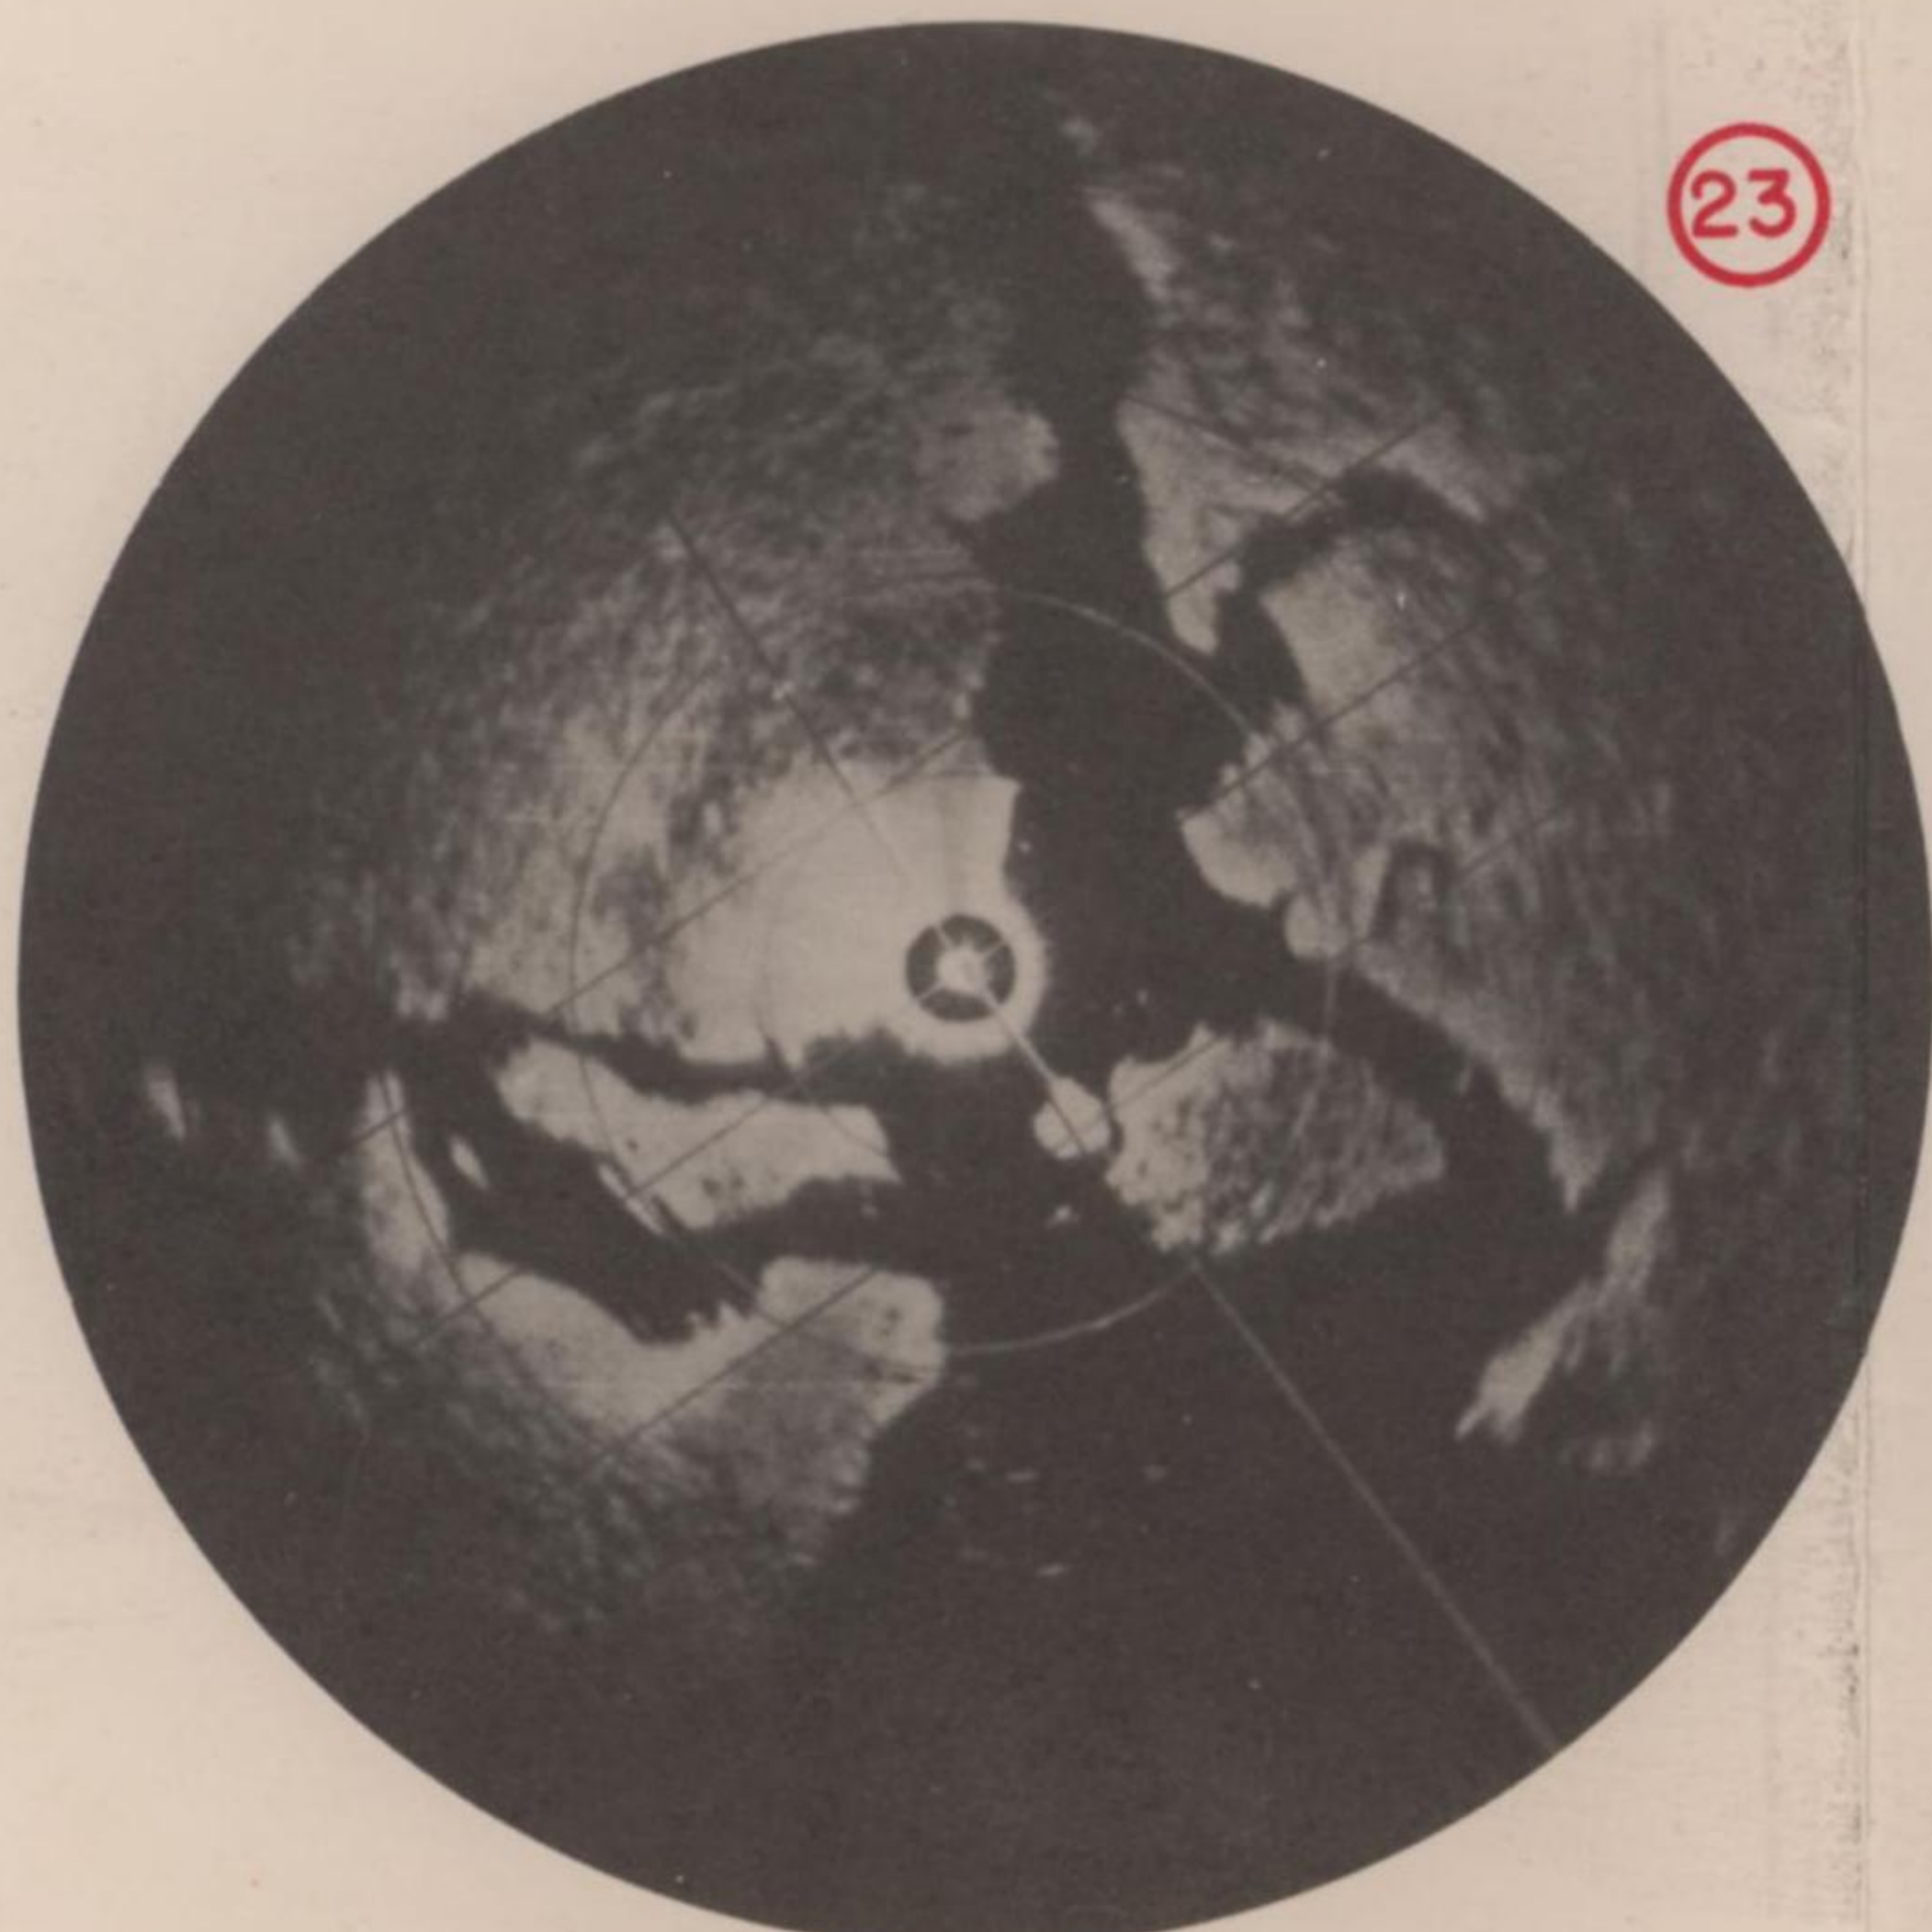
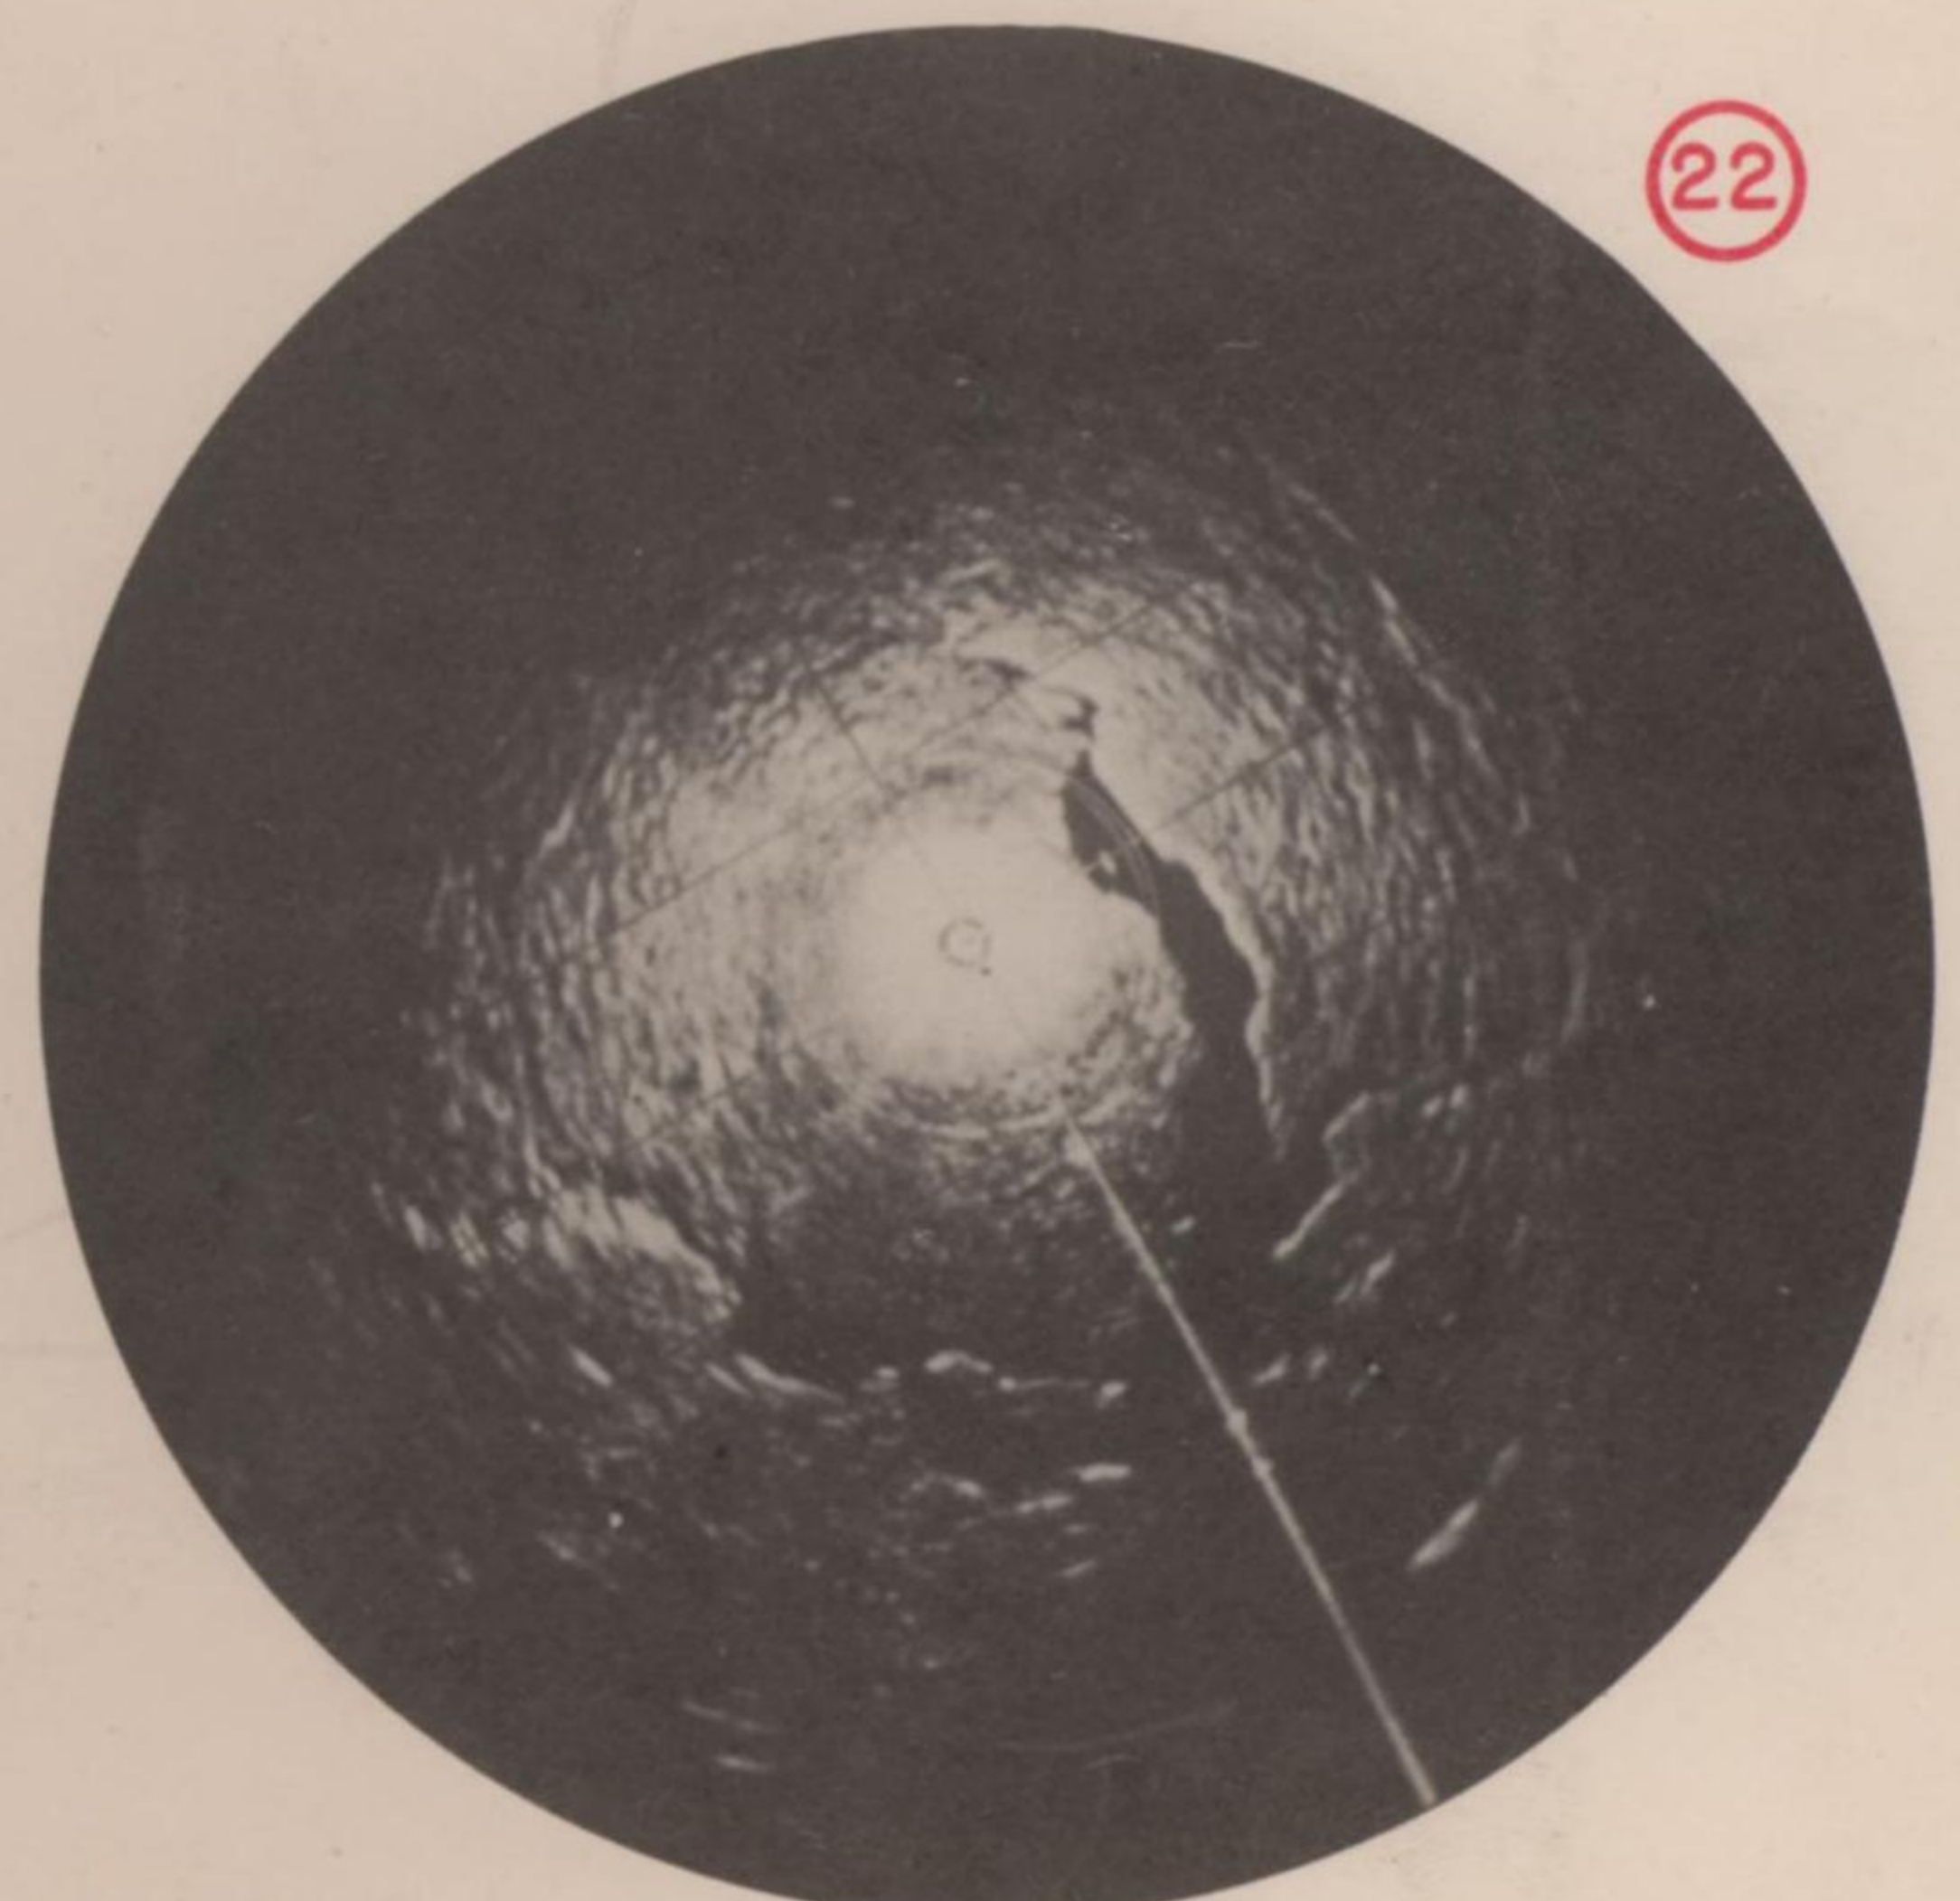
JOHORE STRAIT FIELD

RADAR PHOTOGRAPH ANALYSIS
SINGAPORE AREA-MALAY STATES
40 MINING OF APPROACHES TO HARBOR & NAVAL BASE

HEADING 156° MAG. 20 MILE SWEEP

HEADING 166° MAG. 20 MILE SWEEP

10 MILE SWEEP

HEADING 142° MAG. 10 MILE SWEEP

HEADING 151° MAG. 20 MILE SWEEP
