MISSION #40 Singapore REPEATEDLY 2
27-28 February 1945

Tactical Mission Report

No. 40

MINING AREA: JOHORE STRAIT FIELD, SINGAPORE,
MALAYA

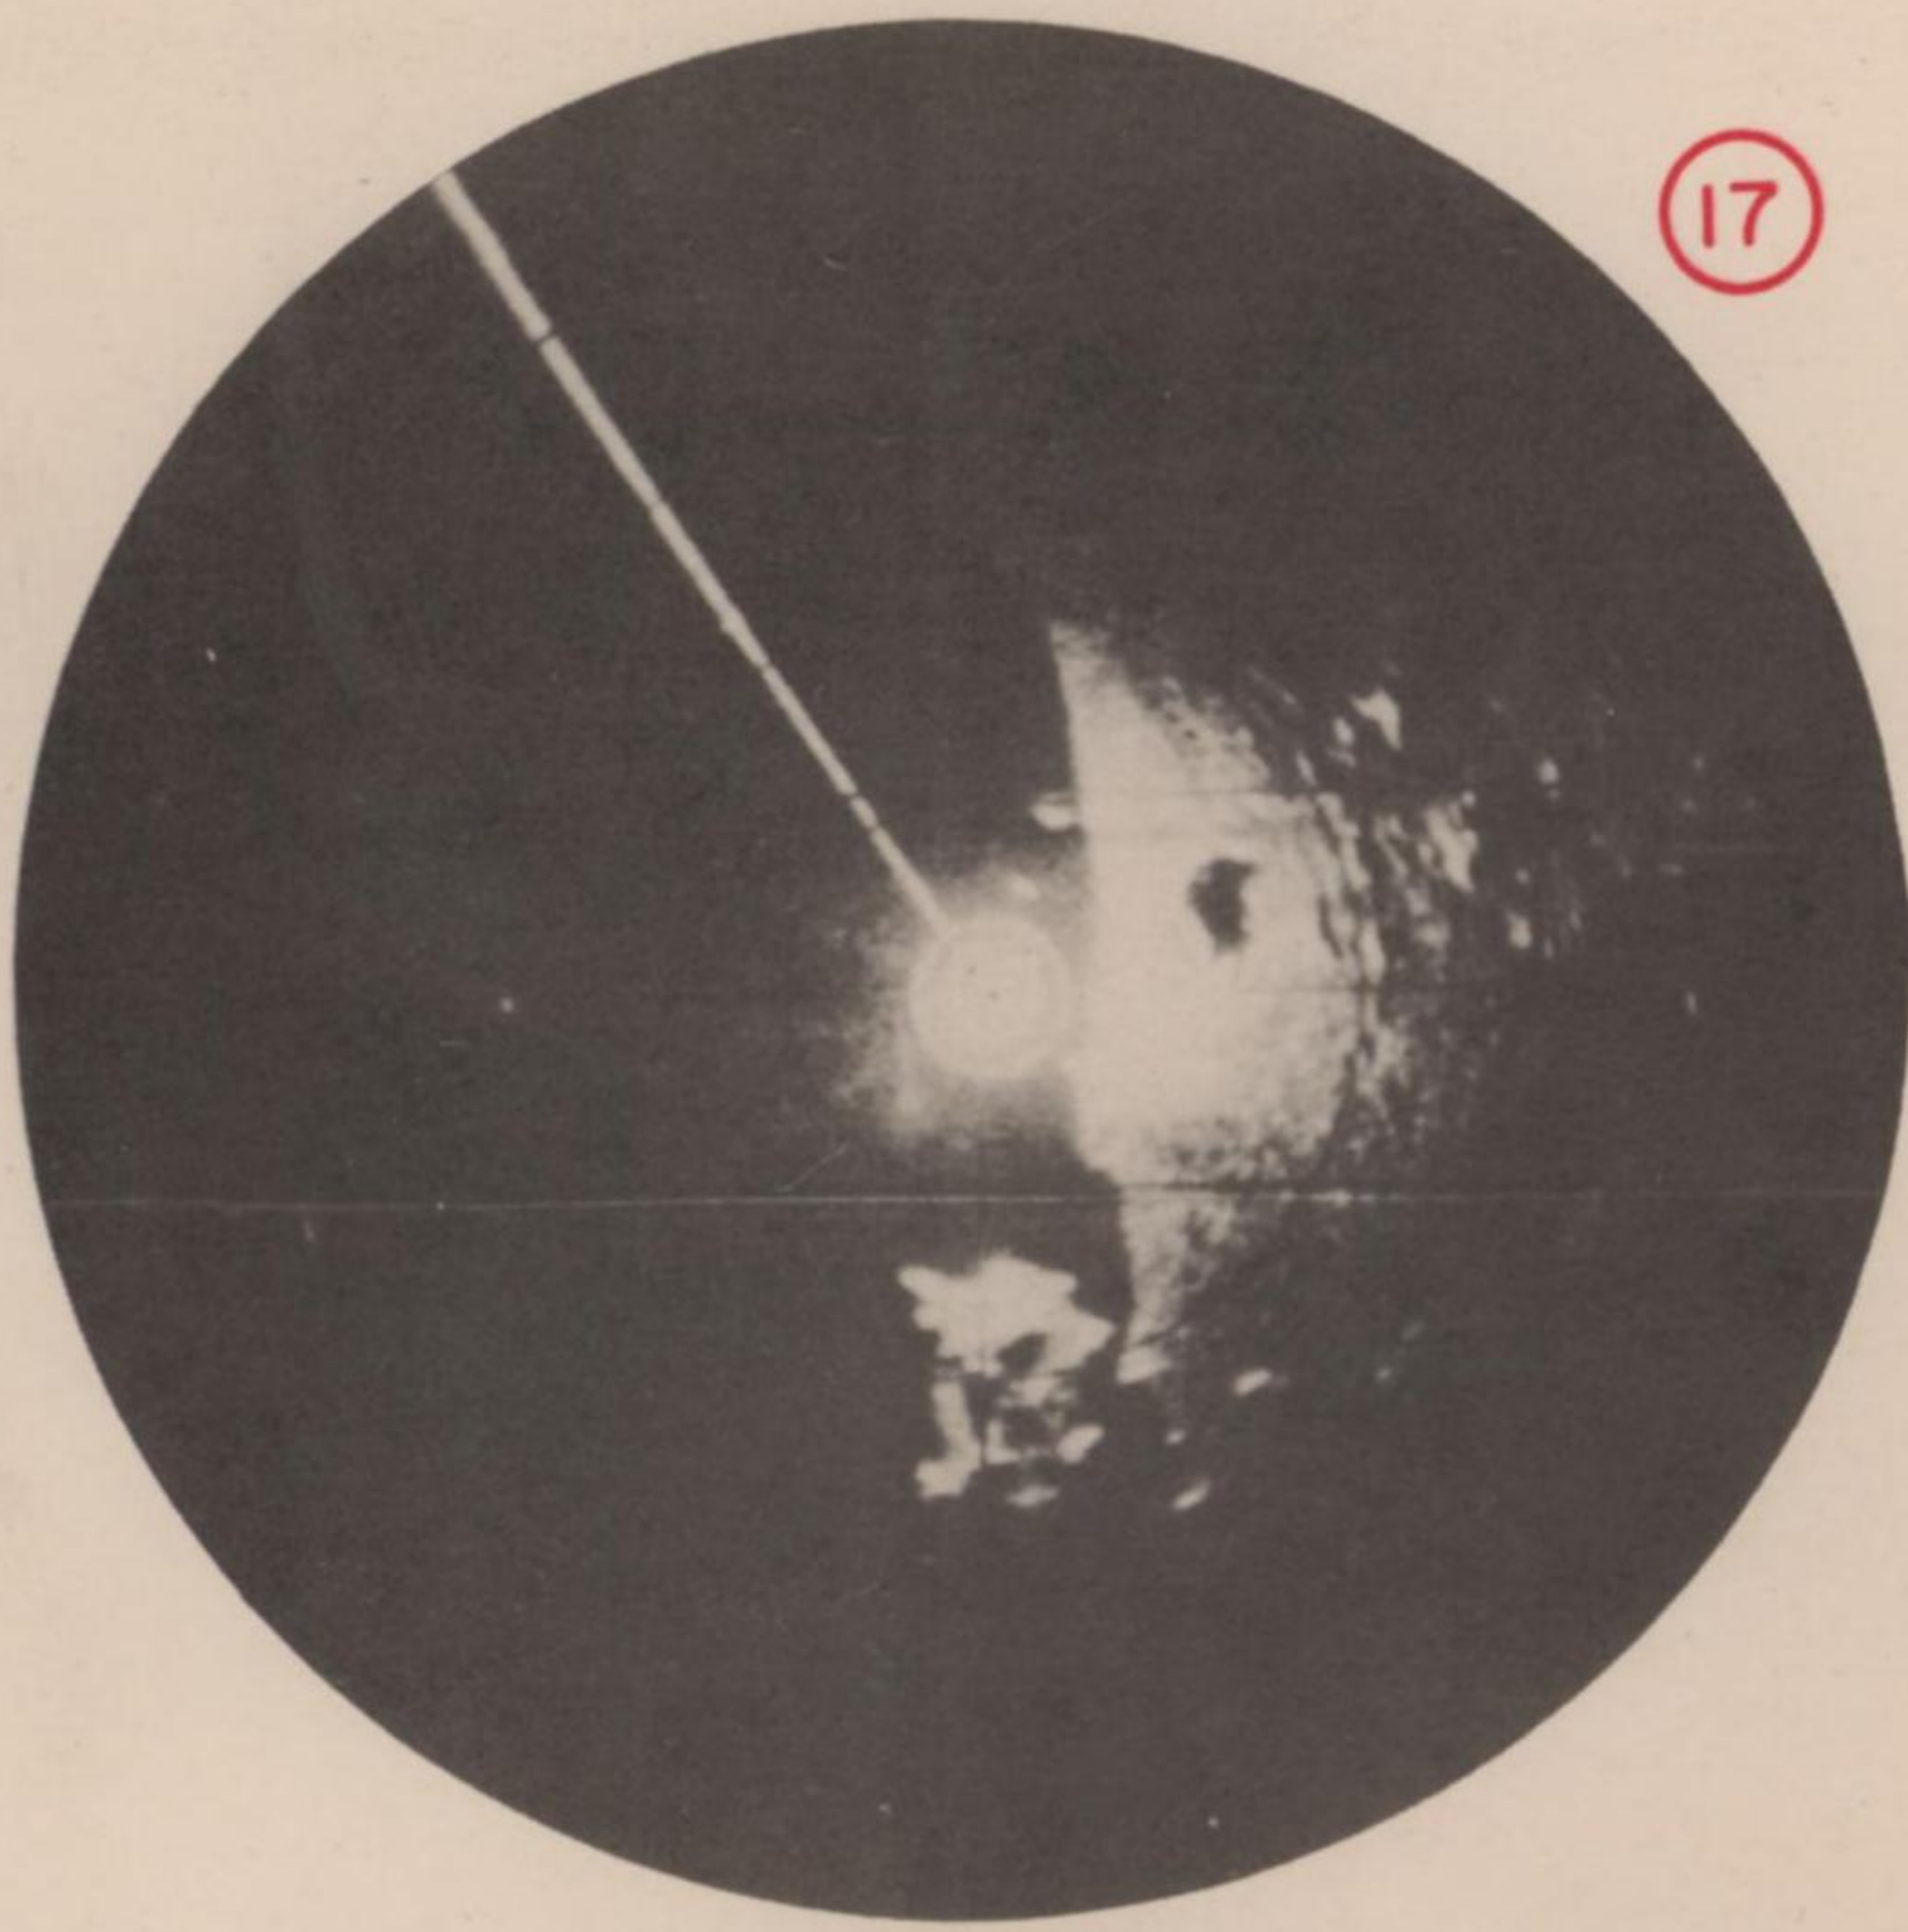
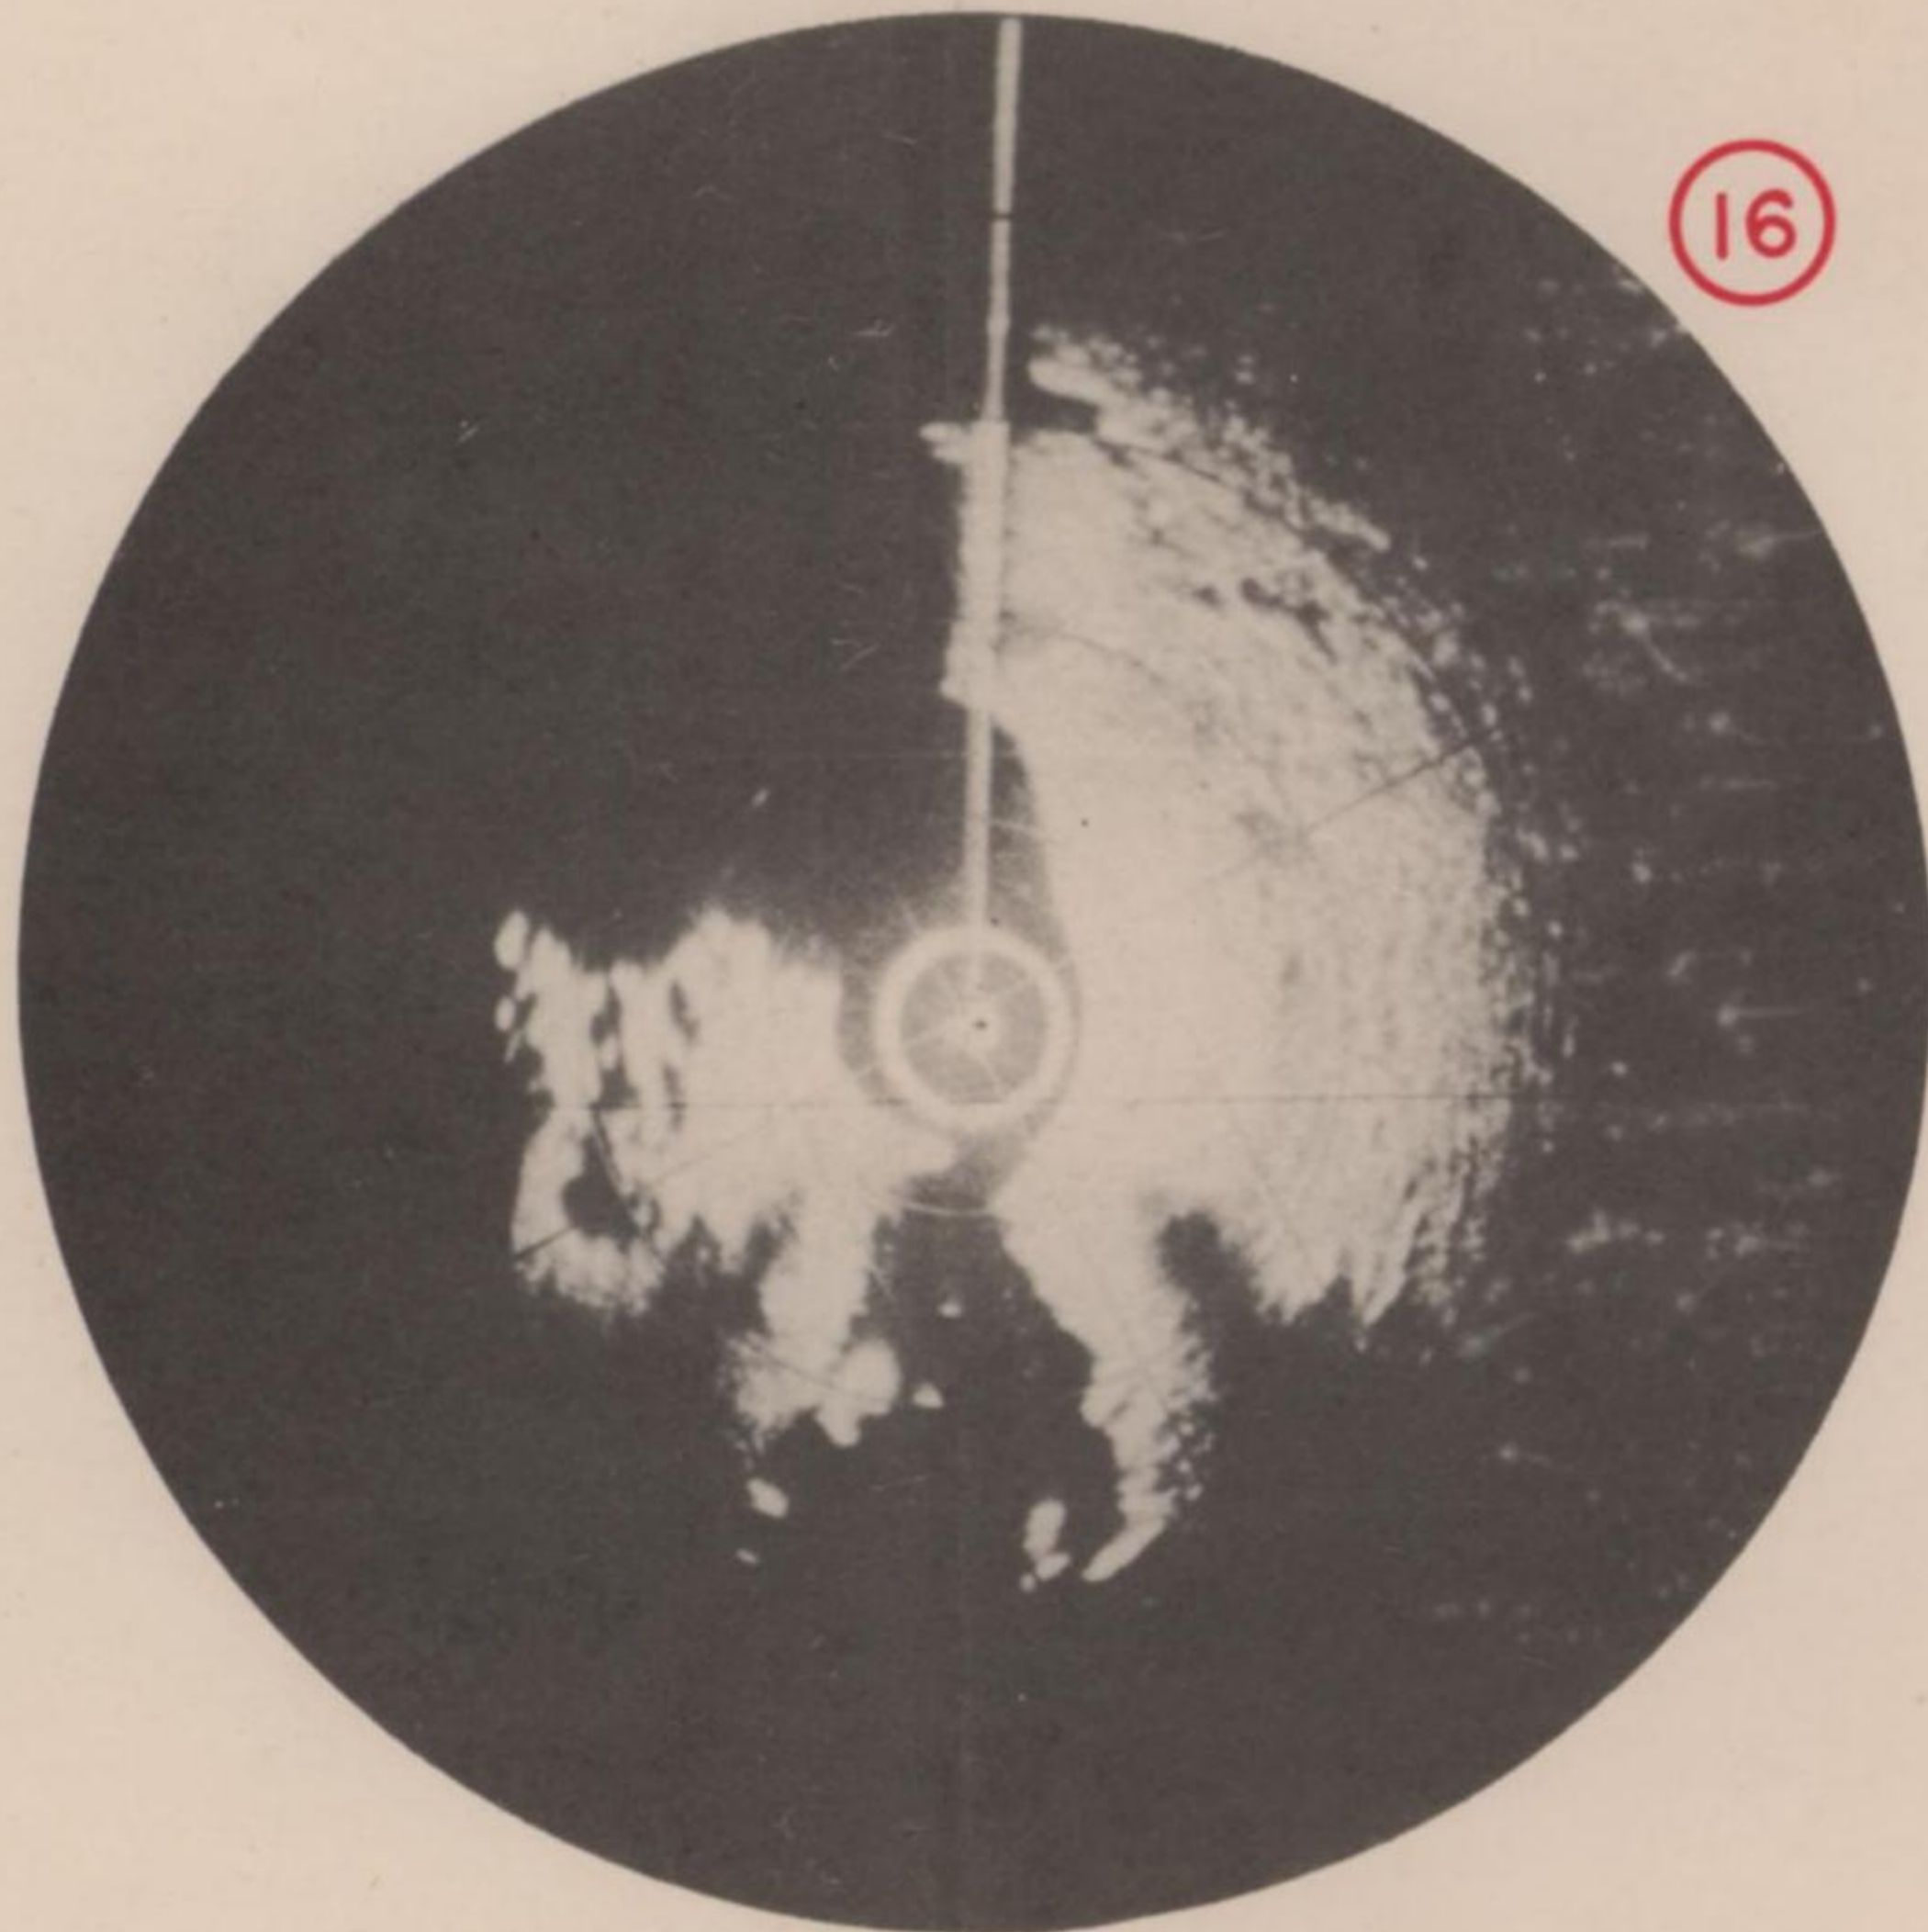
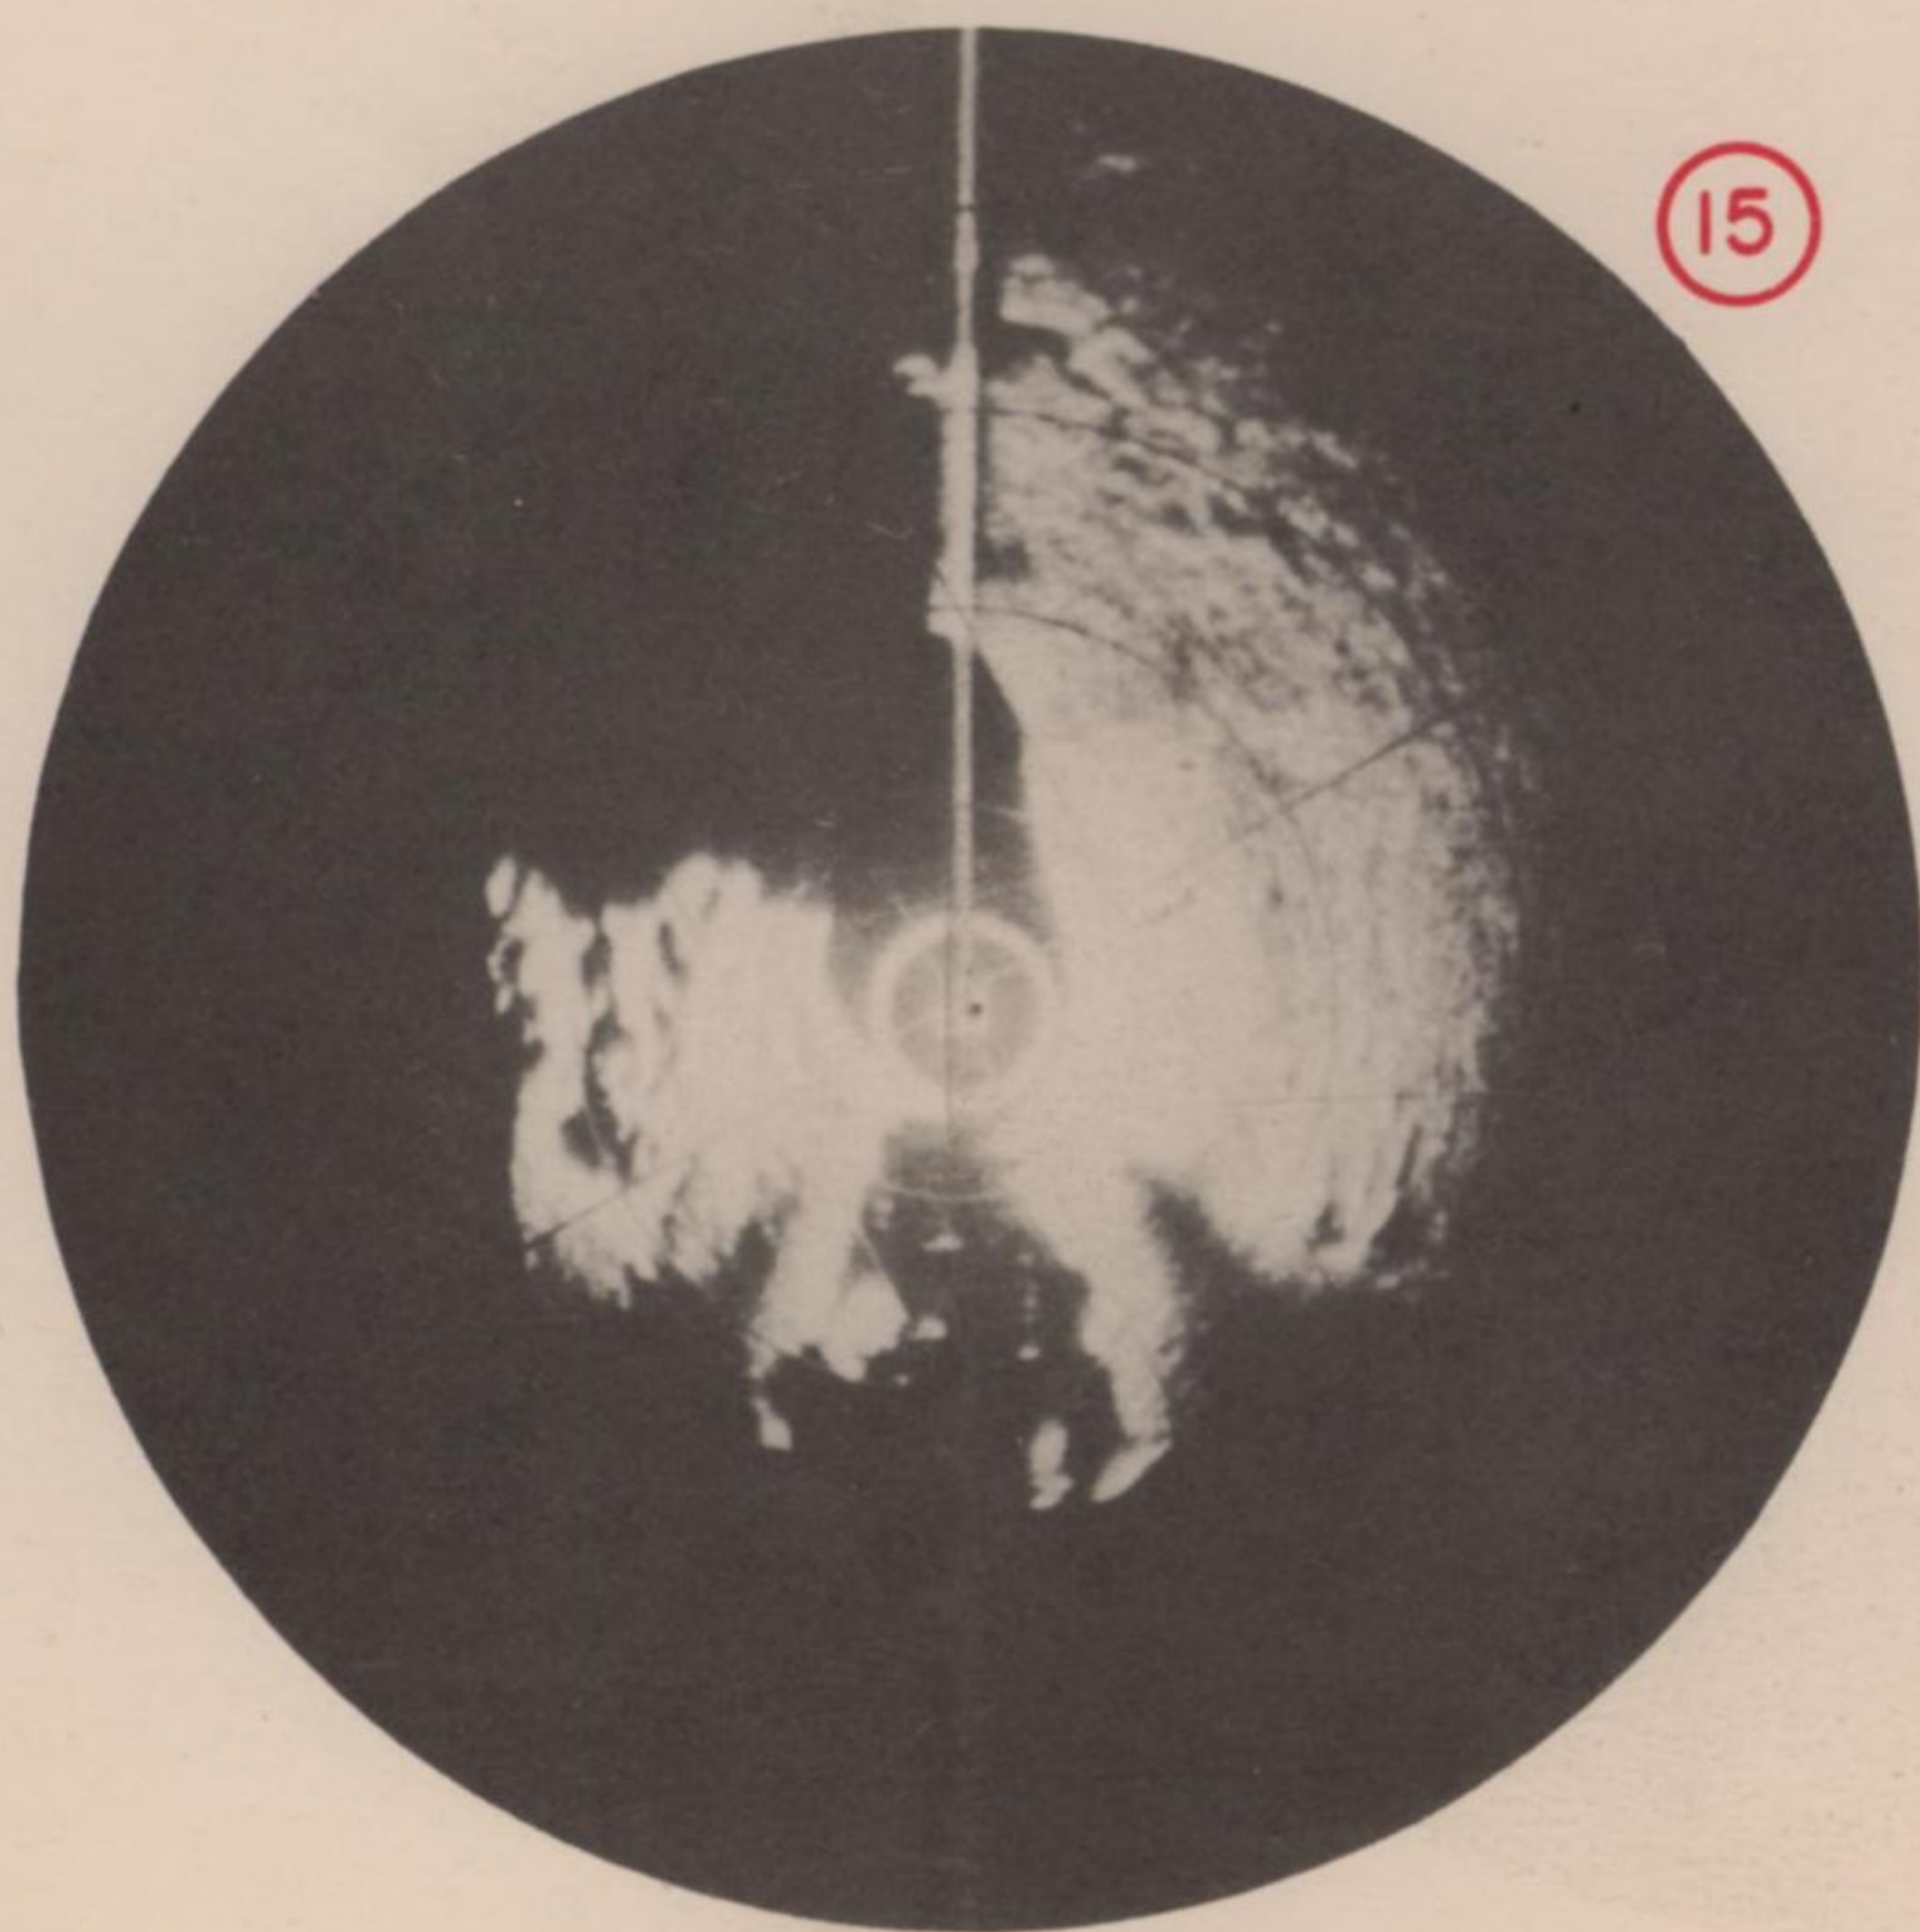
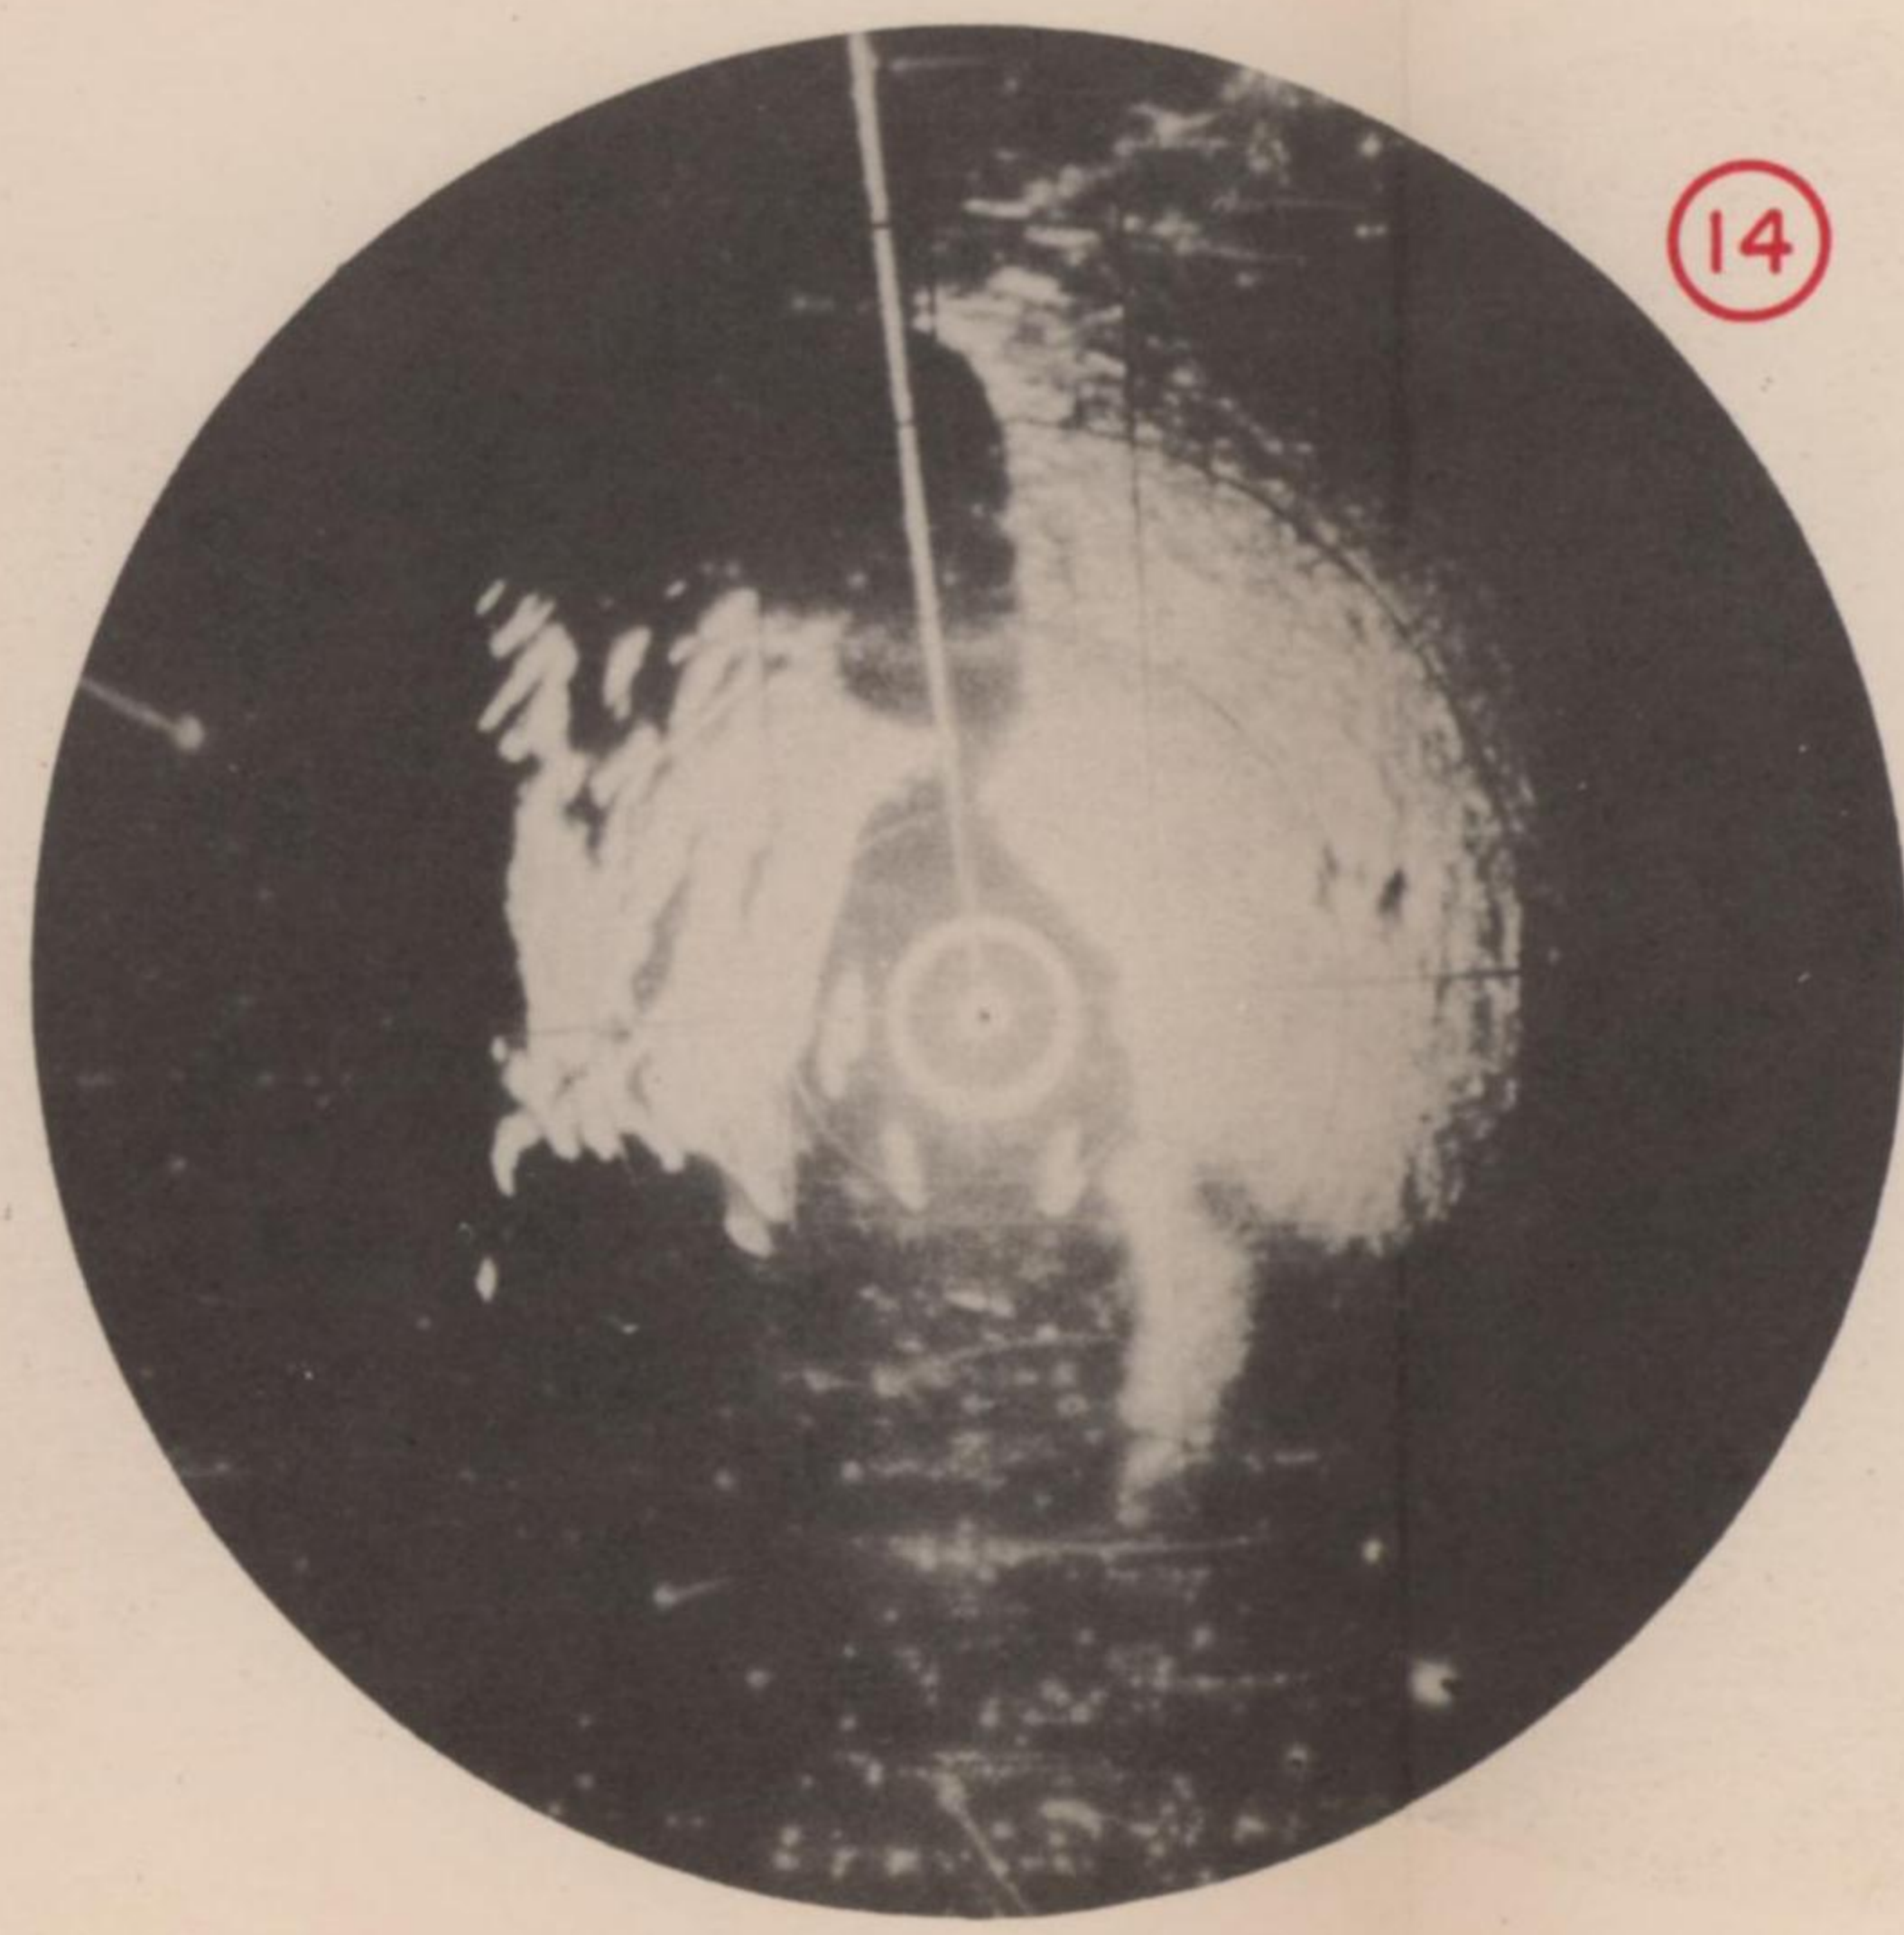
PANANG AREA-MALAY STATES

MISSION NO. 40 - MINING OF APPROACHES TO

HEADING 327° MAG. SWEEP 50 MILES

HEADING 02° MAG.

HEADING 360° MAG.

HEADING 352° MAG.
