MISSION #40 Singapore REPEATEDLY 2
27-28 February 1945

Tactical Mission Report

No. 40

MINING AREA: JOHORE STRAIT FIELD, SINGAPORE,
MALAYA

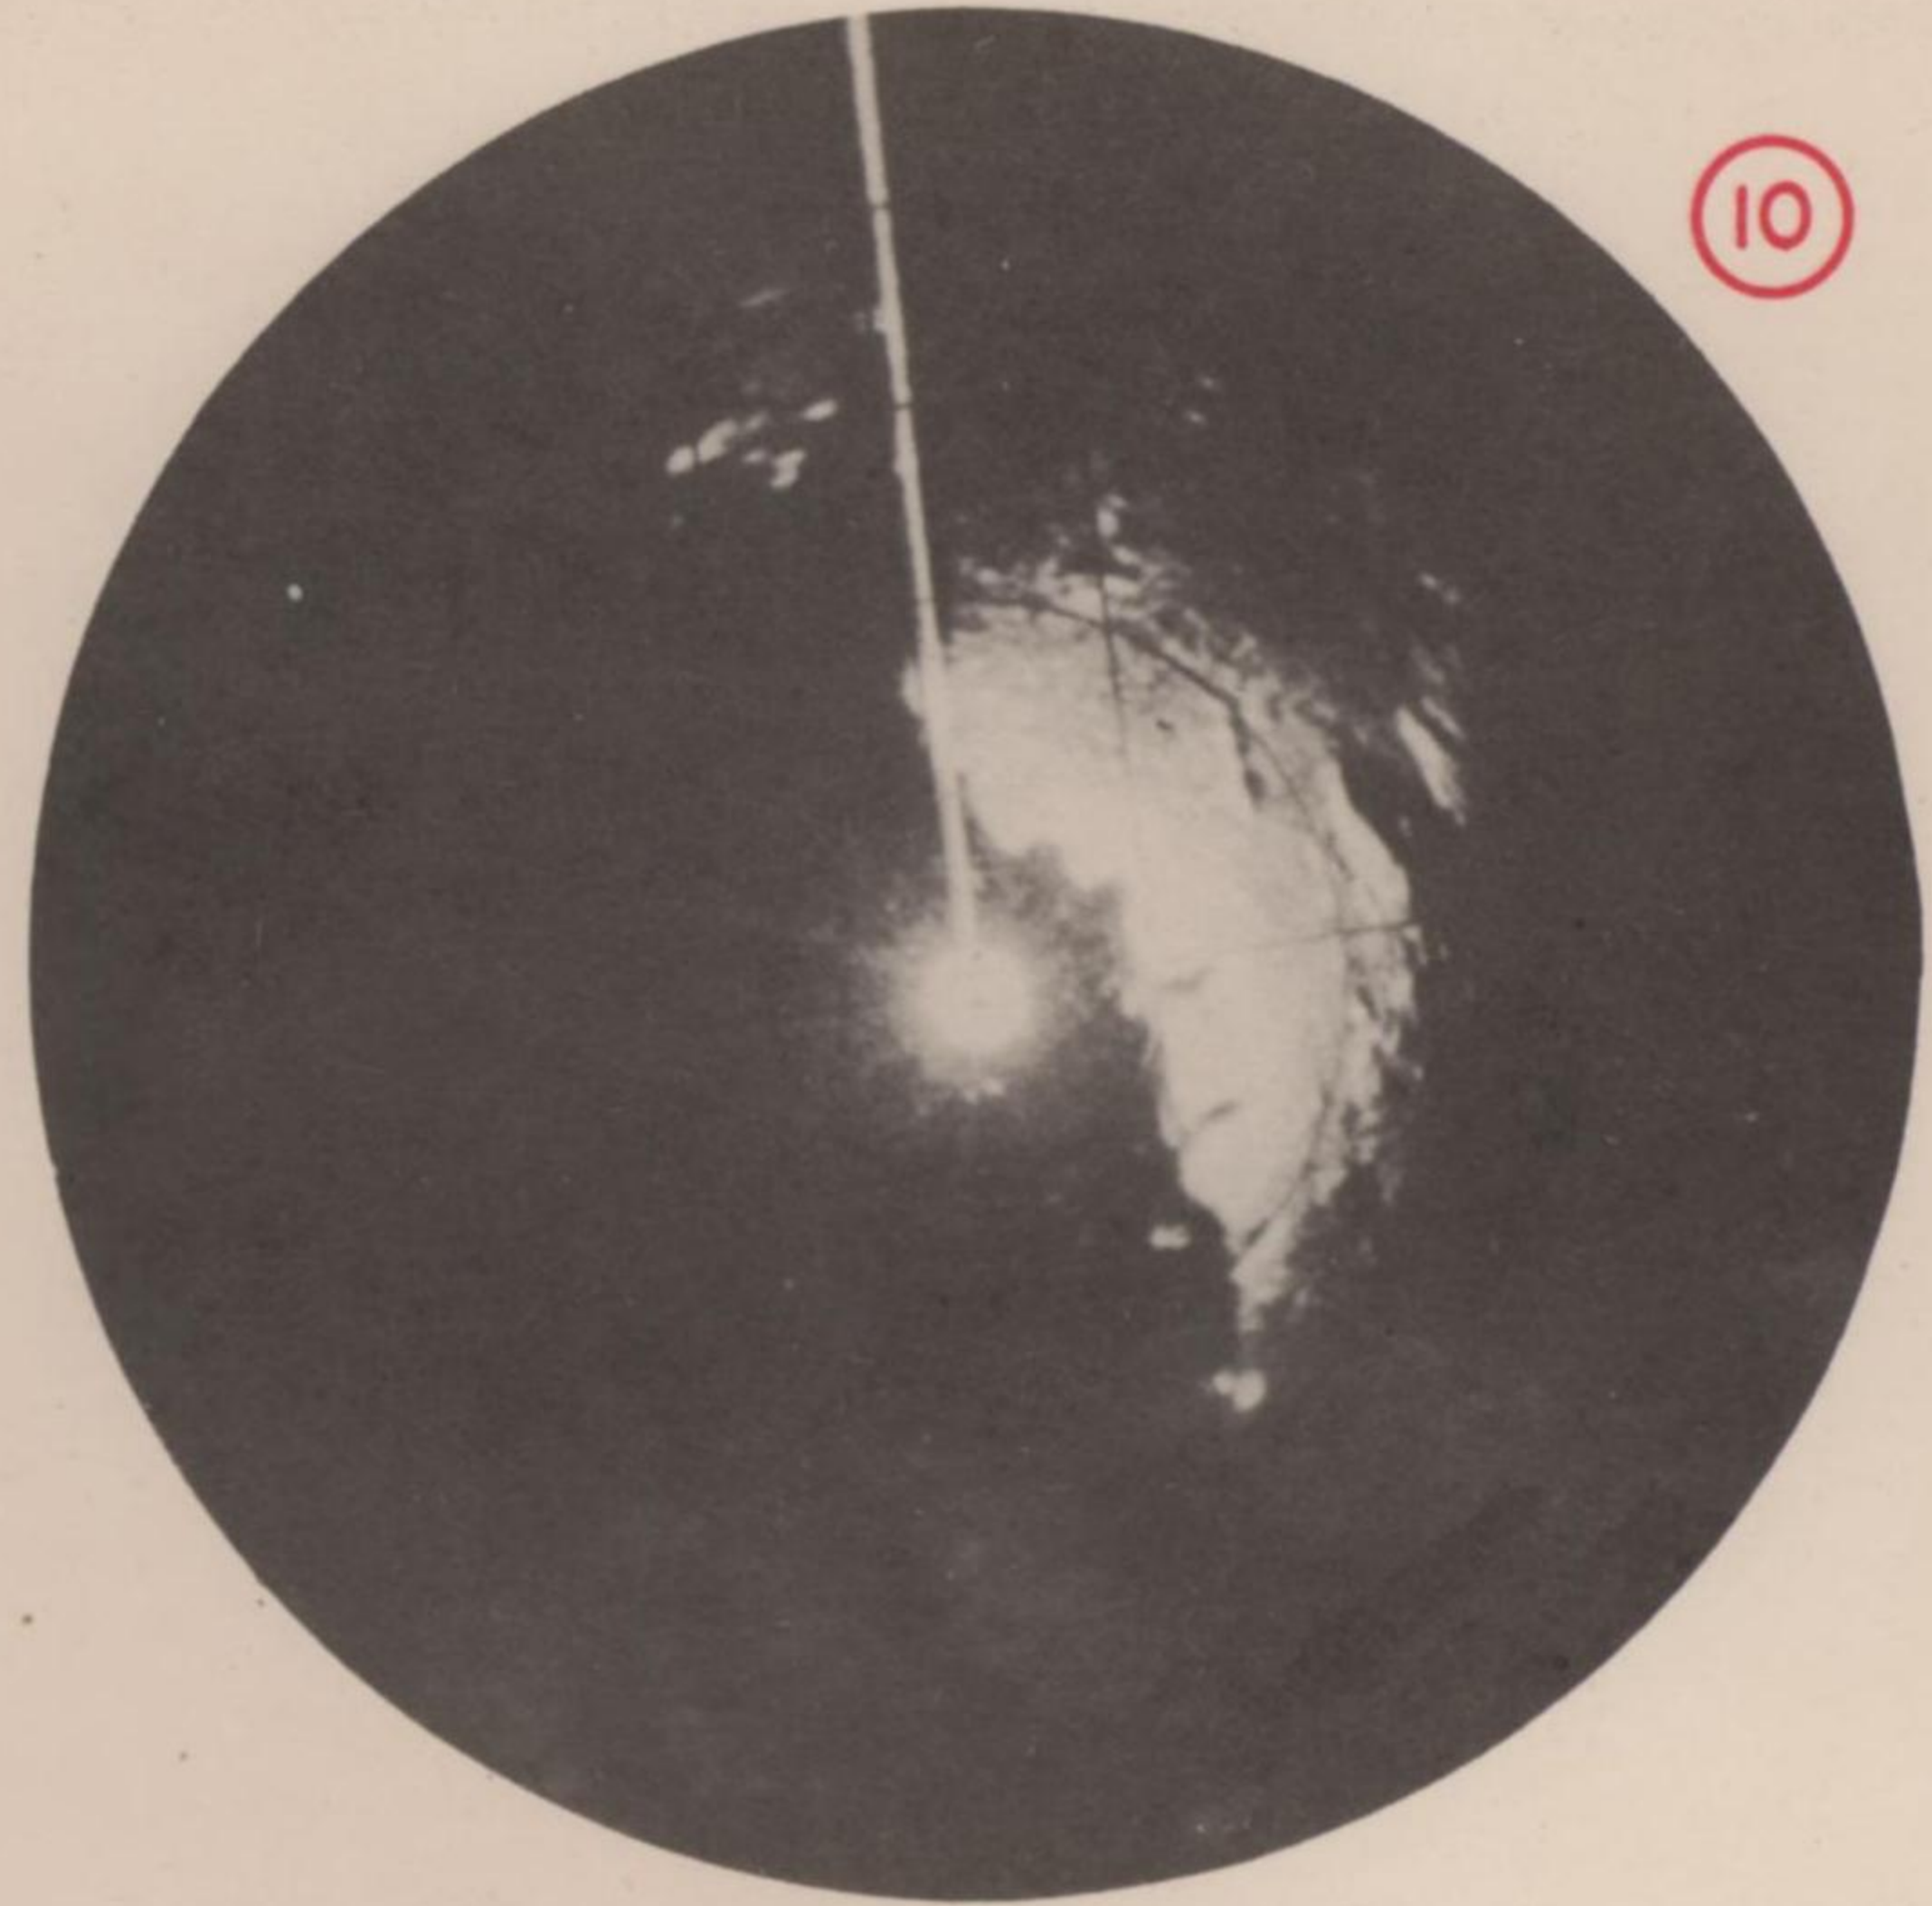
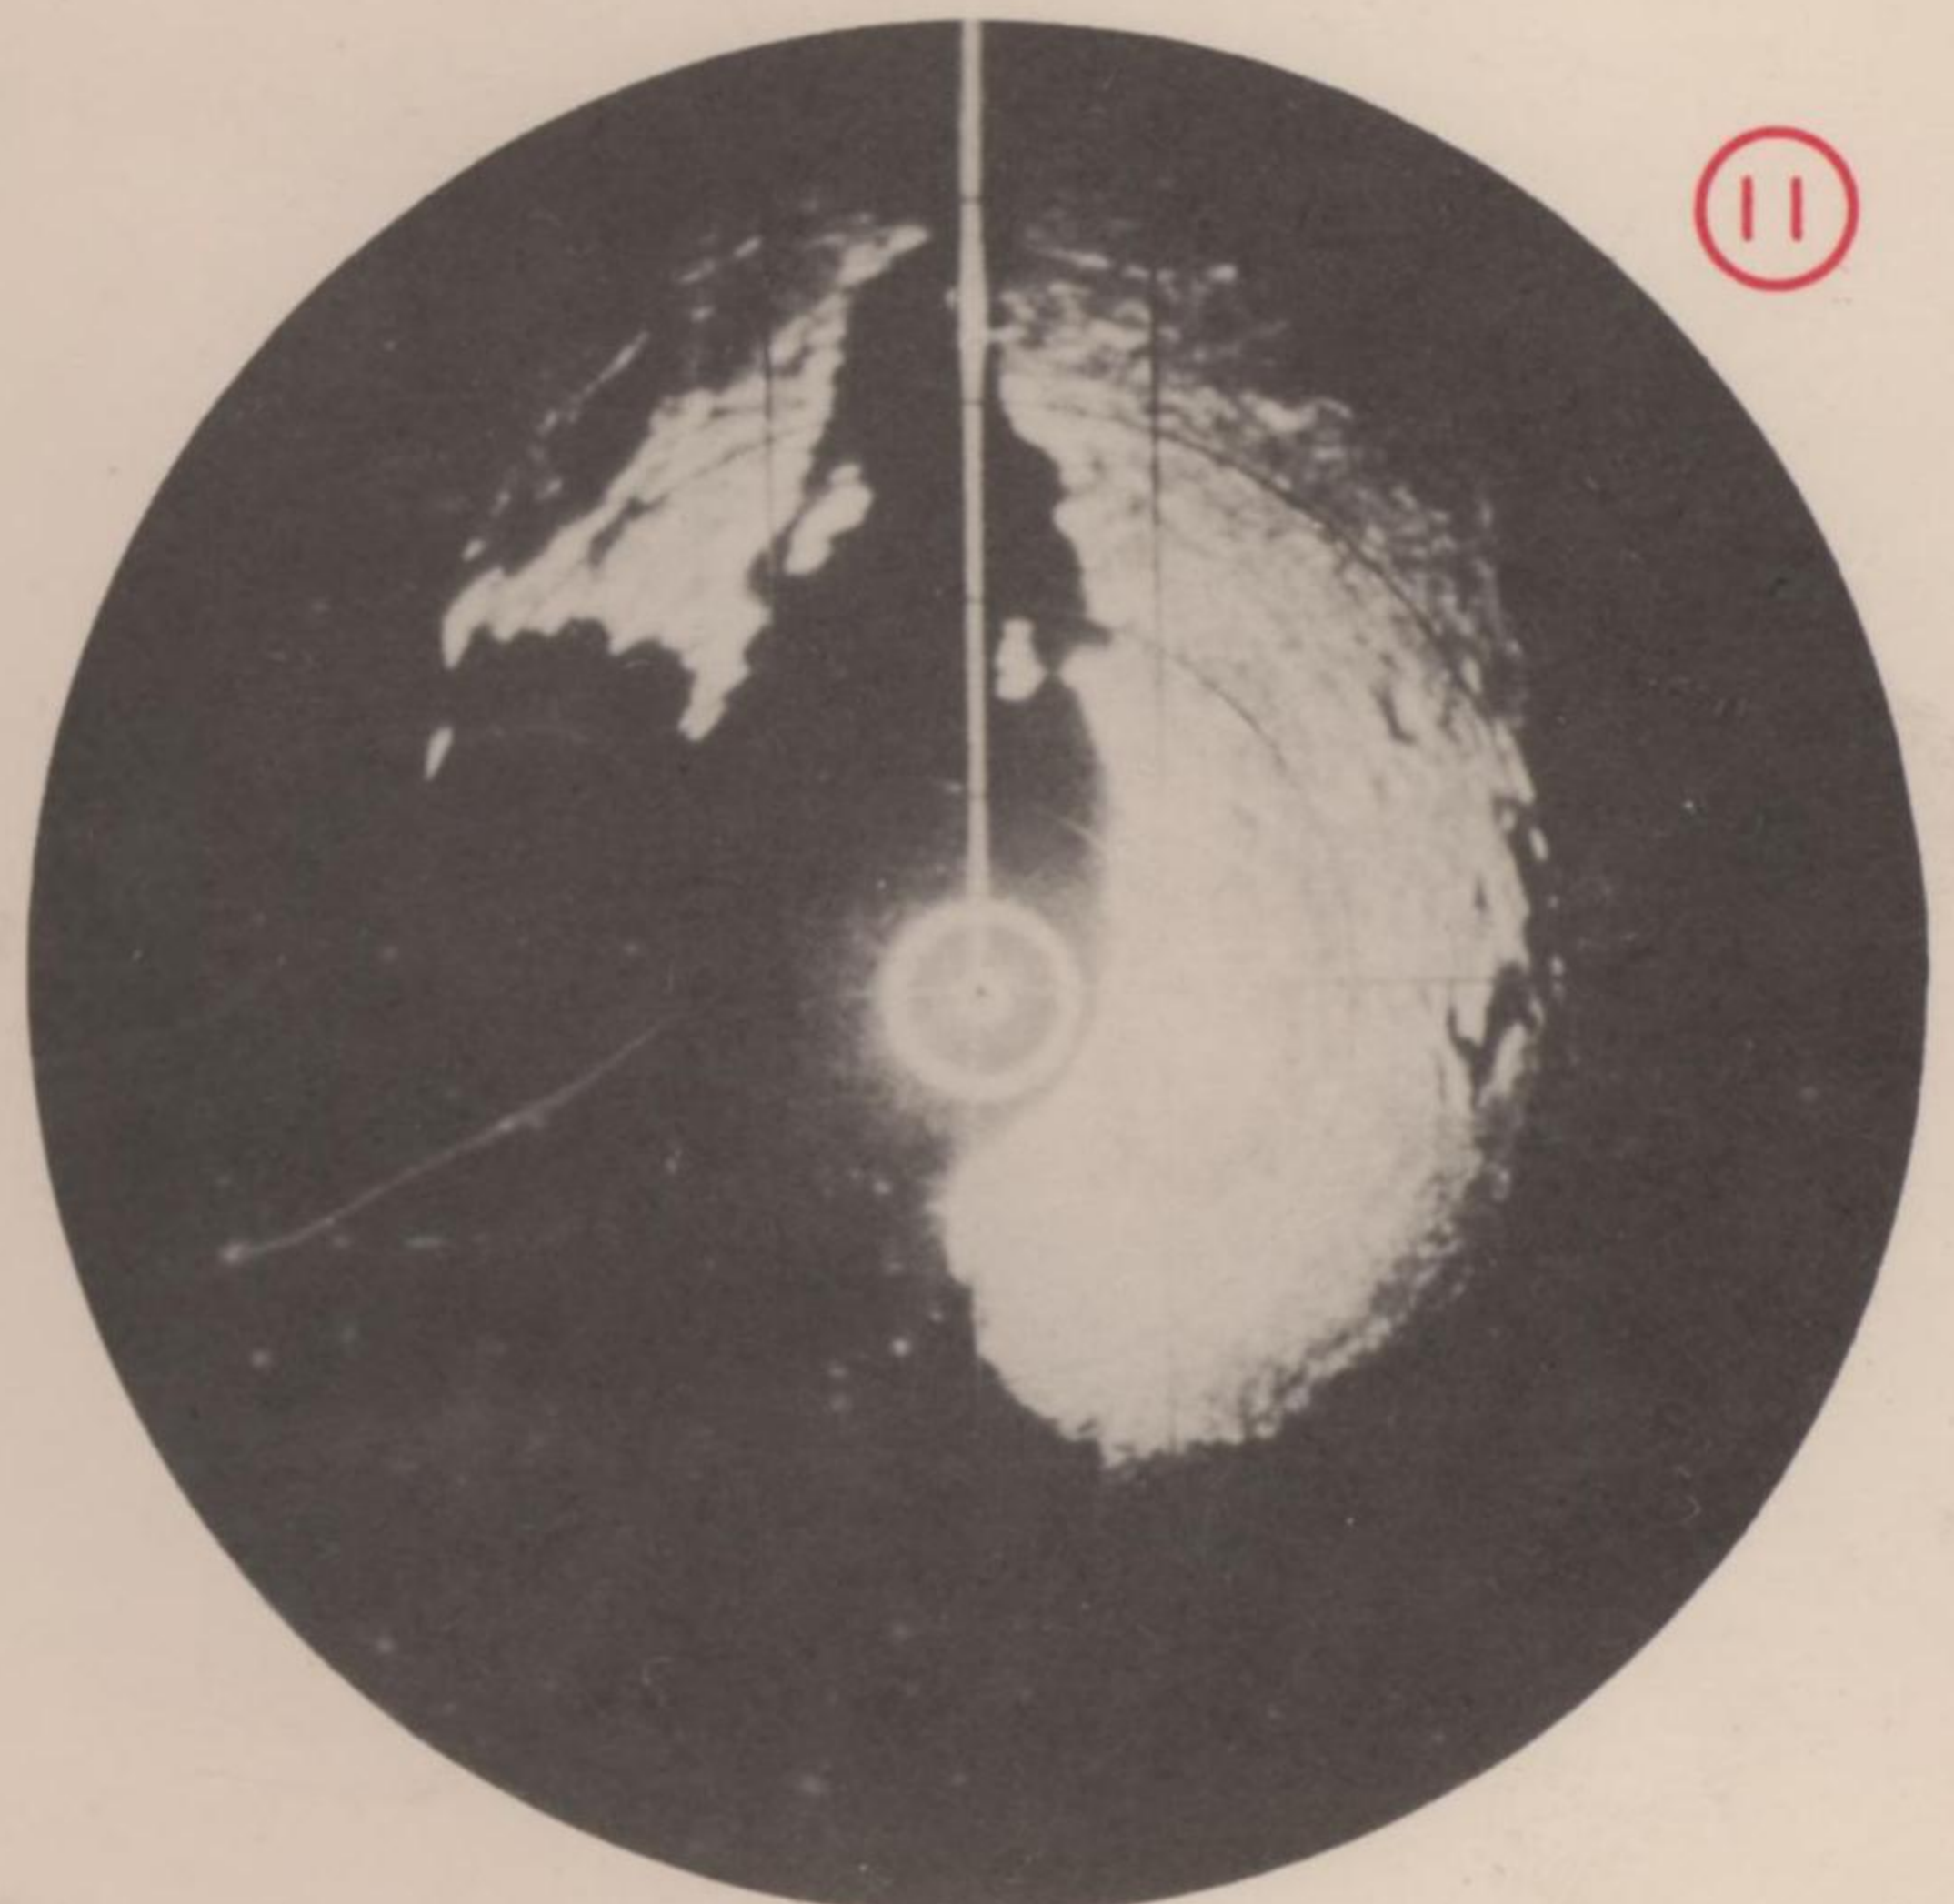
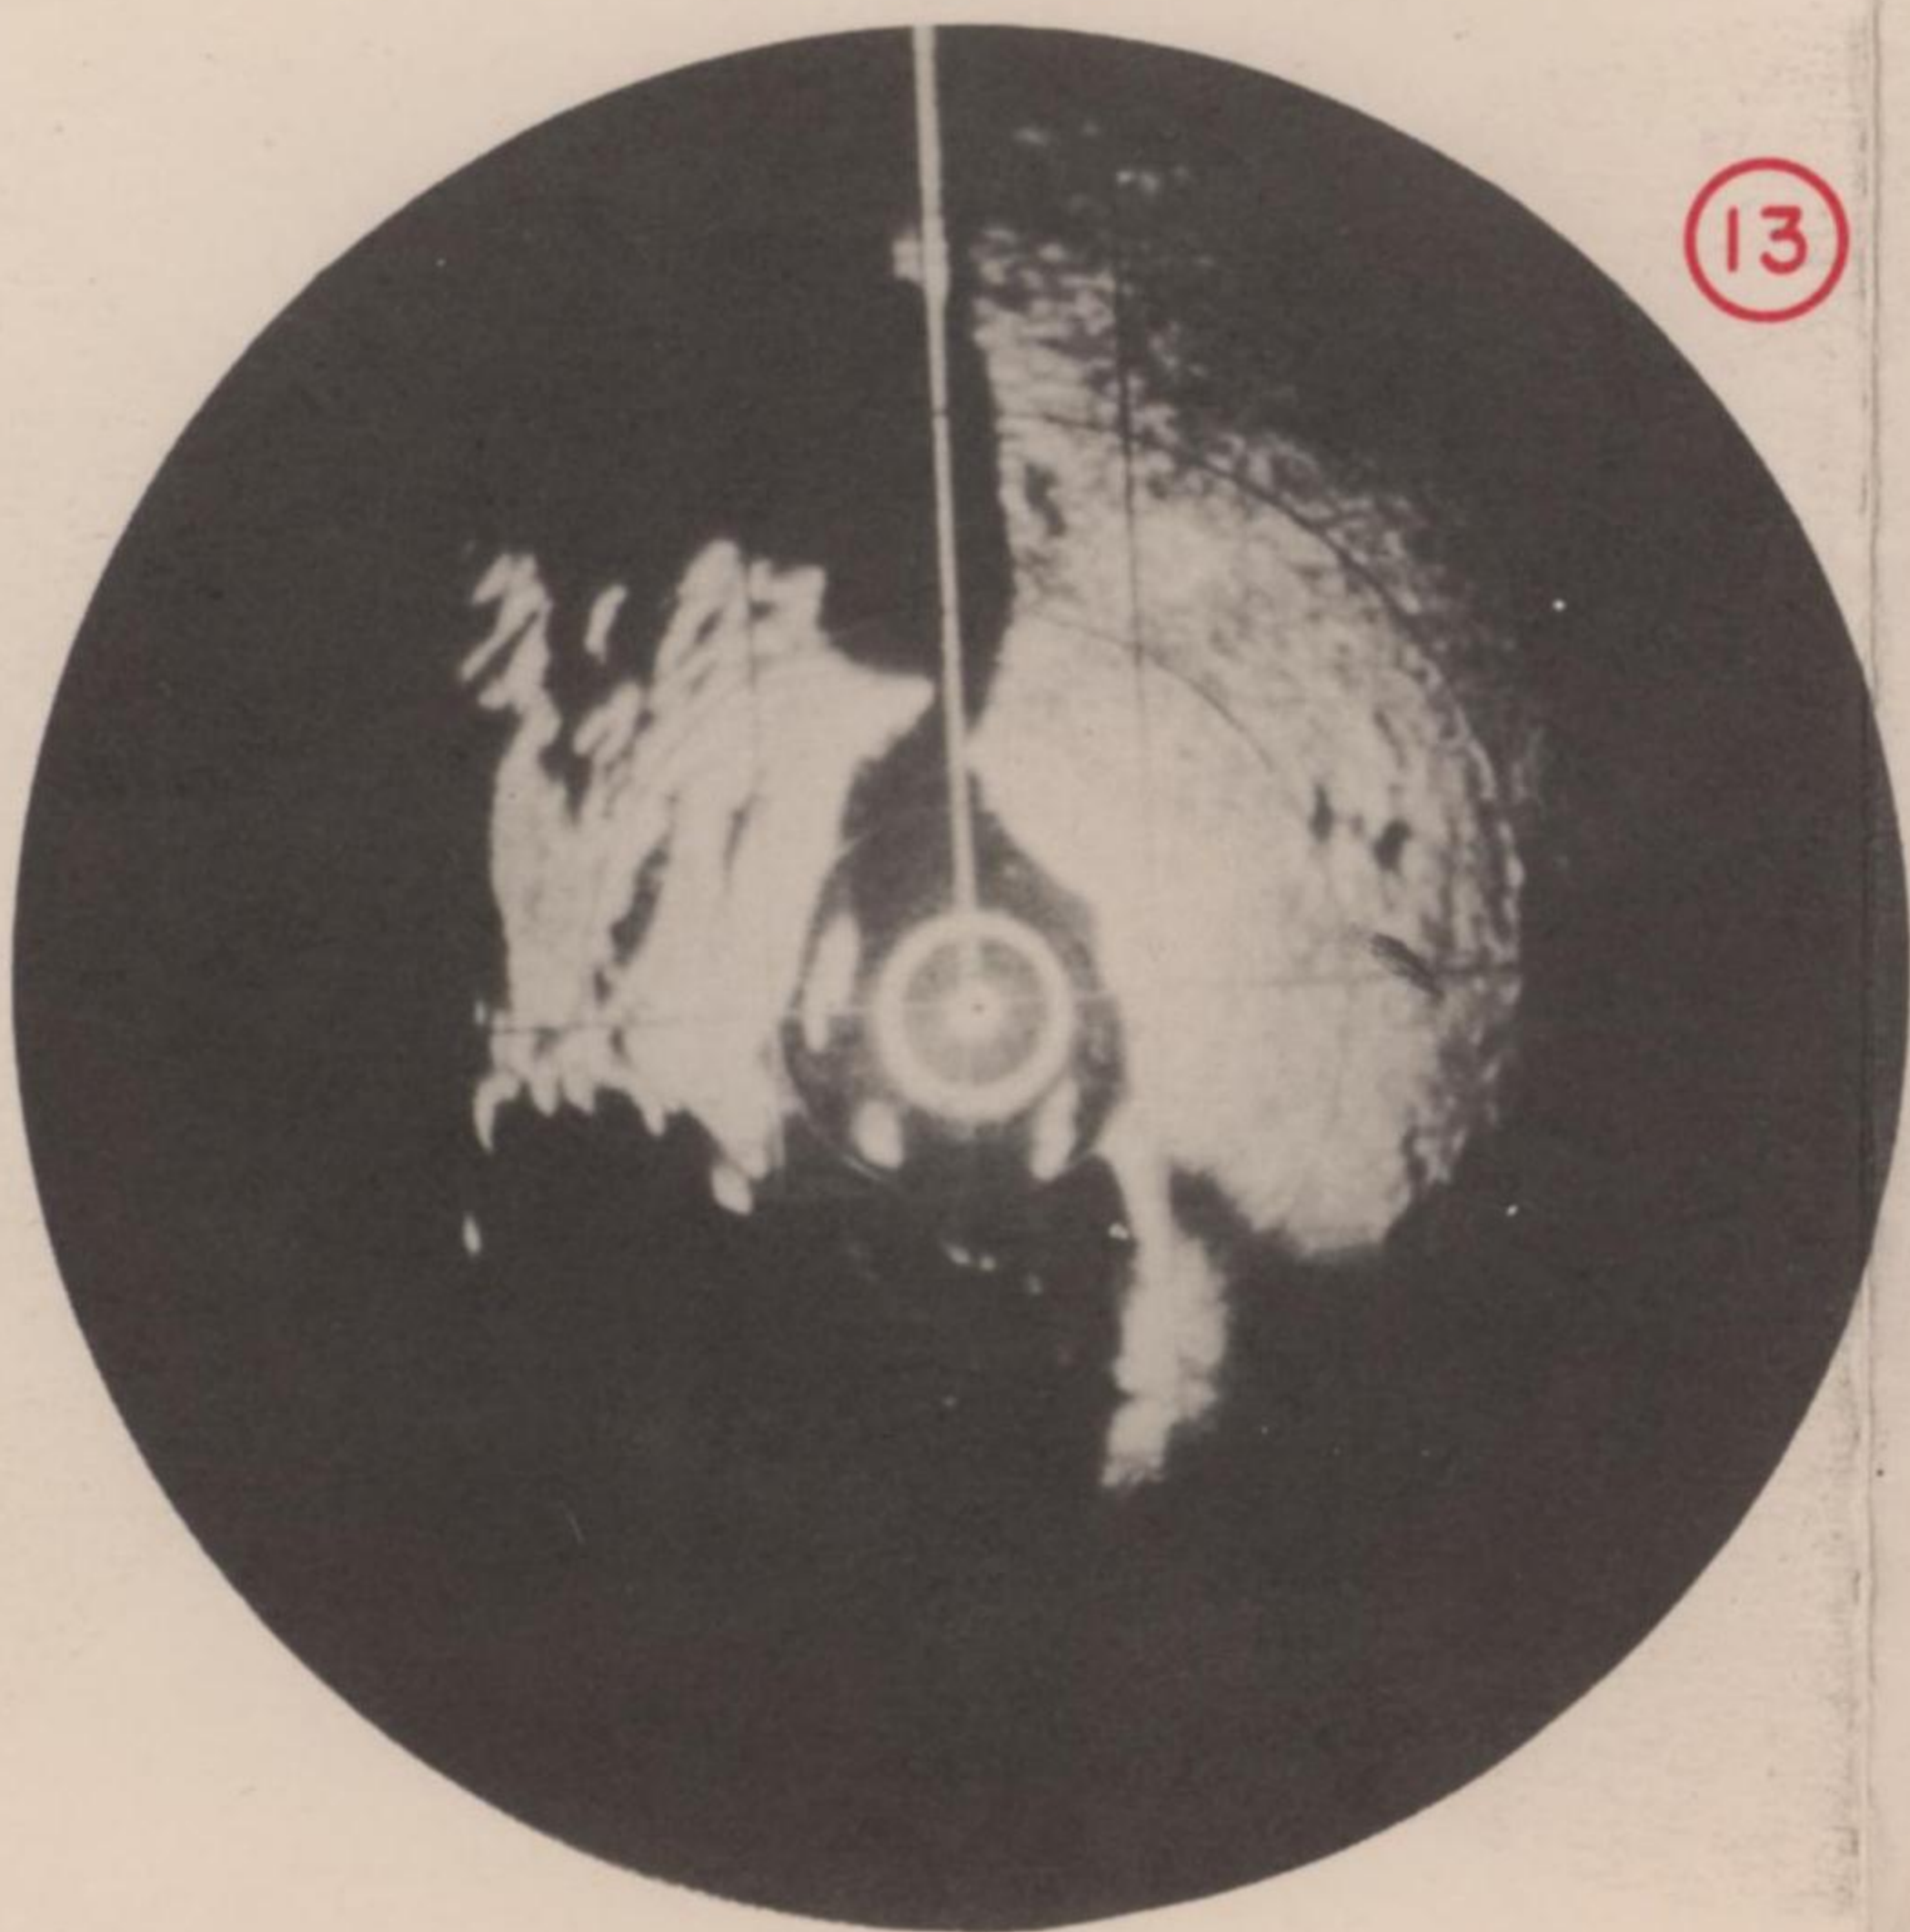
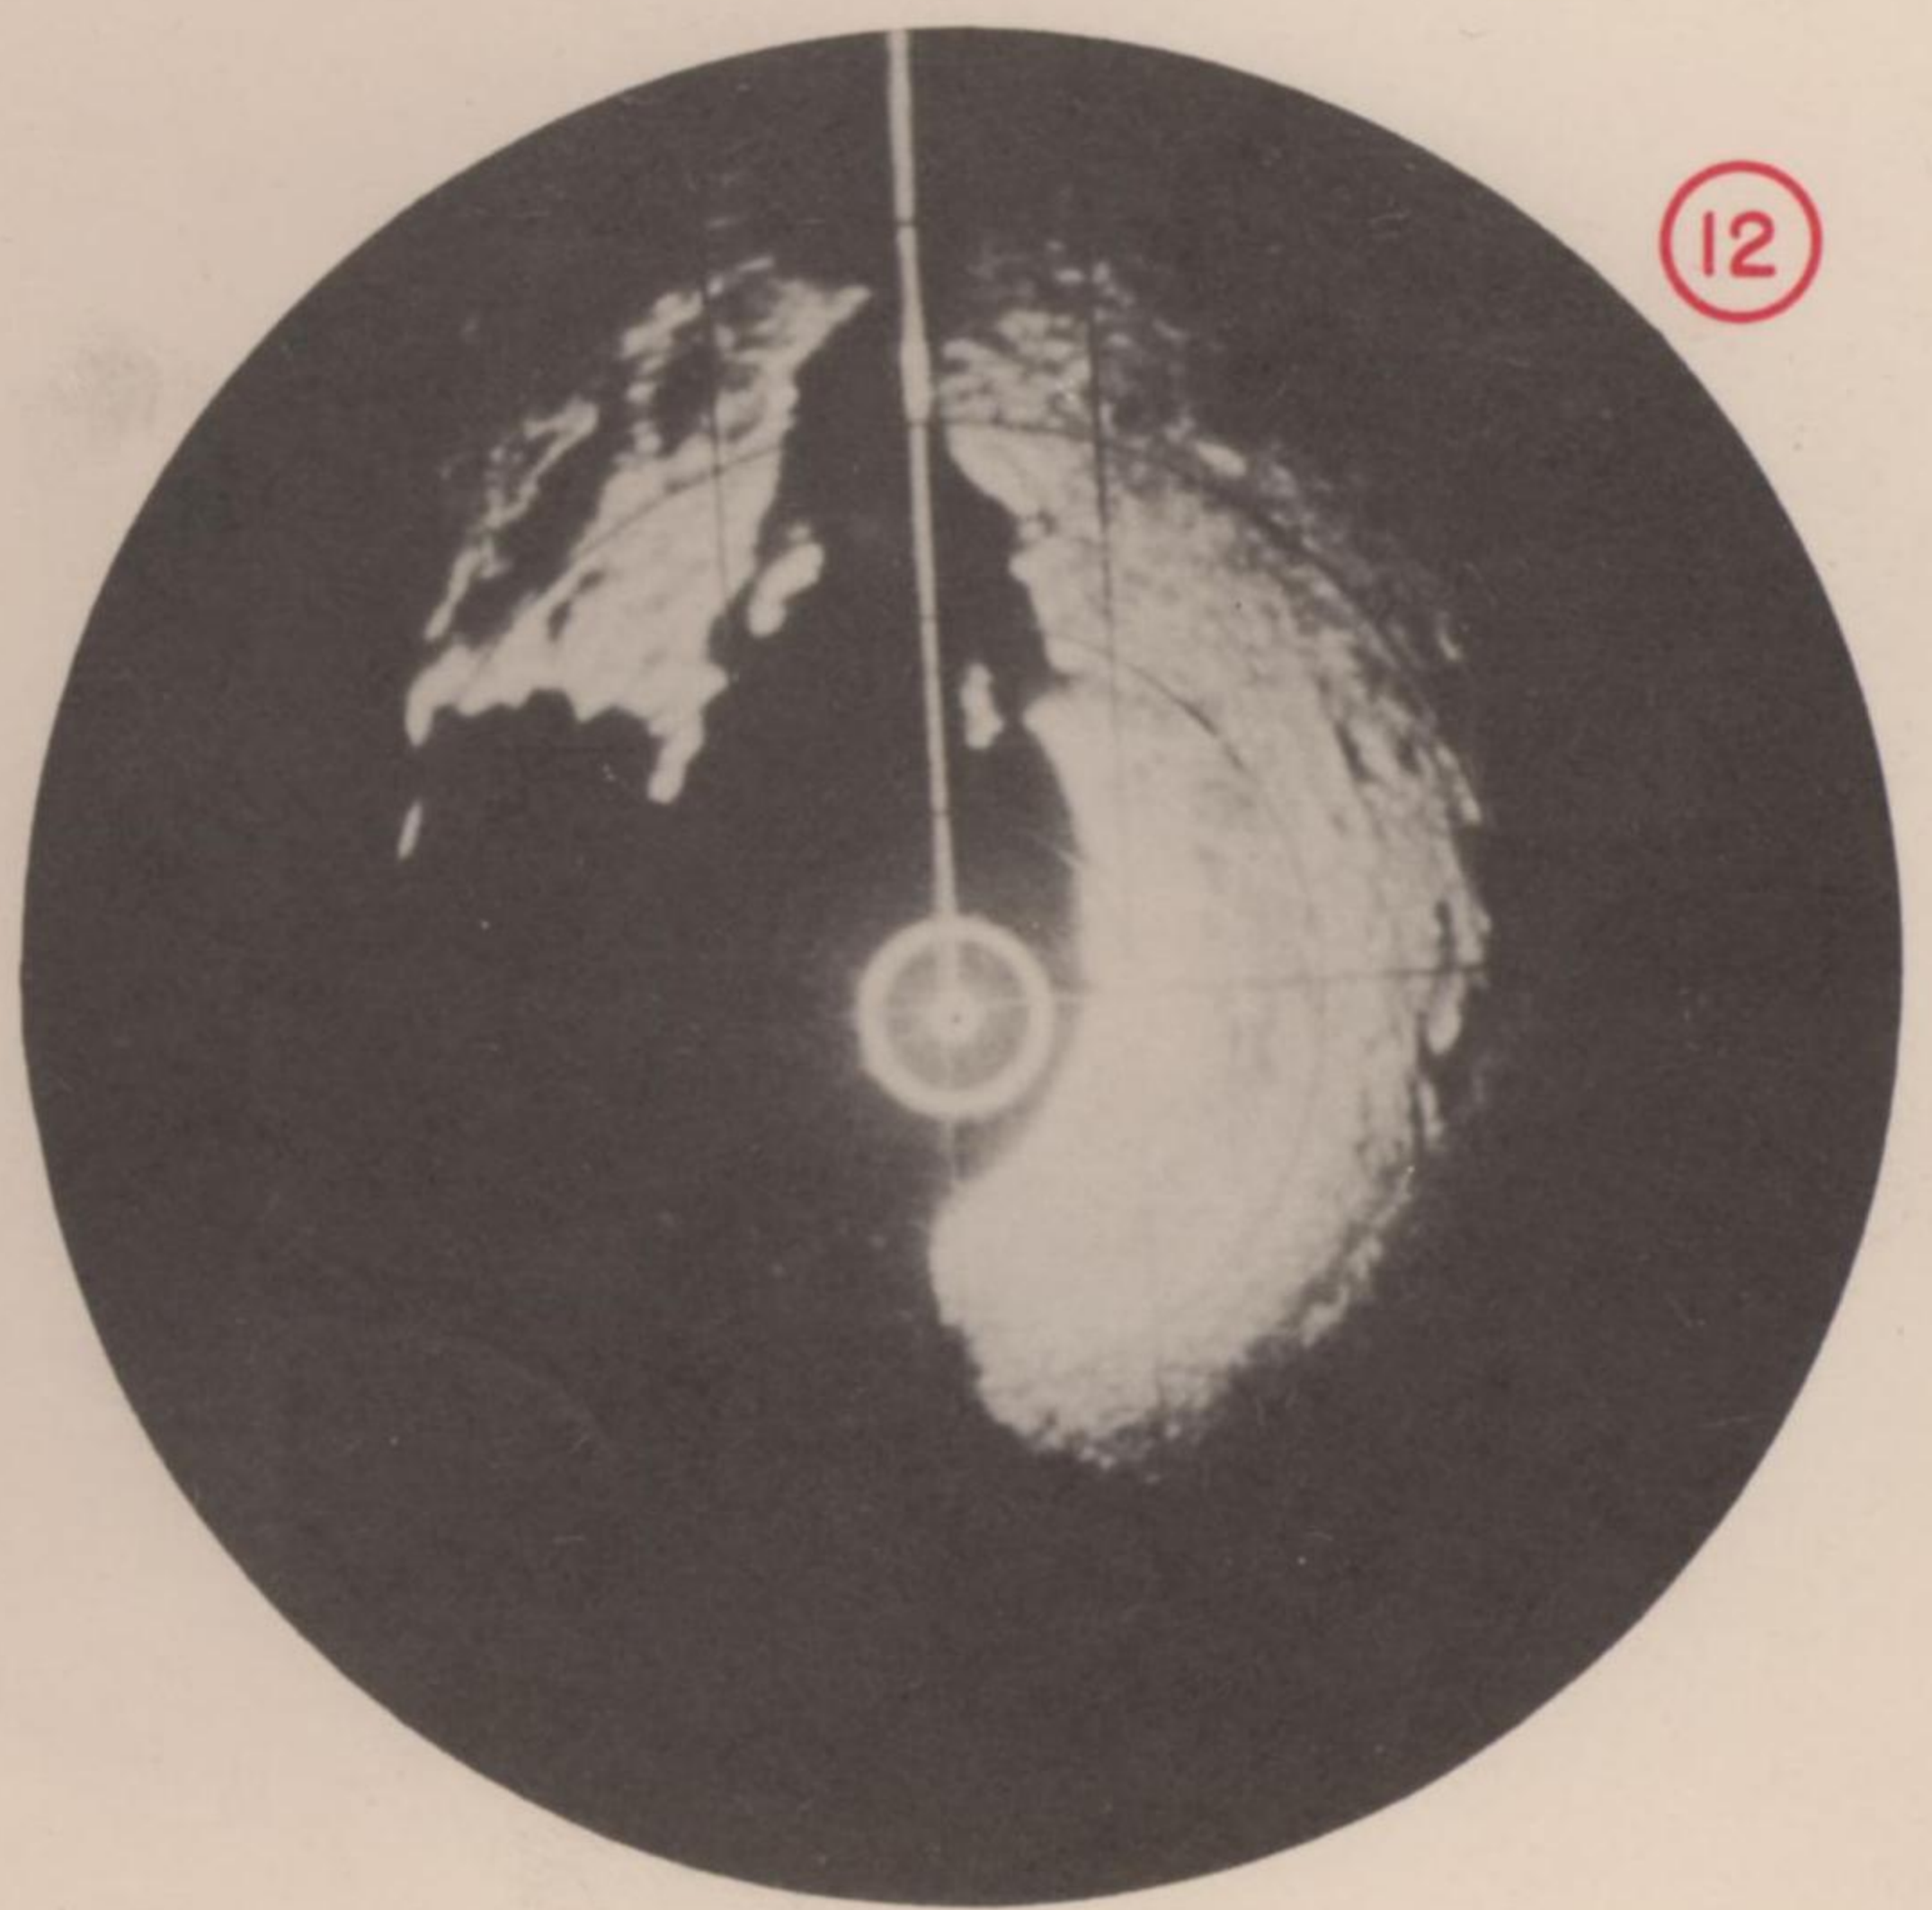
R 92.1 SHEET B

NO. 40 - MINING OF APPROACHES TO HARBOR

HEADING 253° MAG. SWEEP 50 MILES

HEADING 359° MAG.

HEADING 356° MAG.
