MISSION #23

MUKDEN
21 Dec 44

XX BOMBER COMMAND

TARGET: MANCHURIA AIRPLANE MANUFACTURING COMPANY

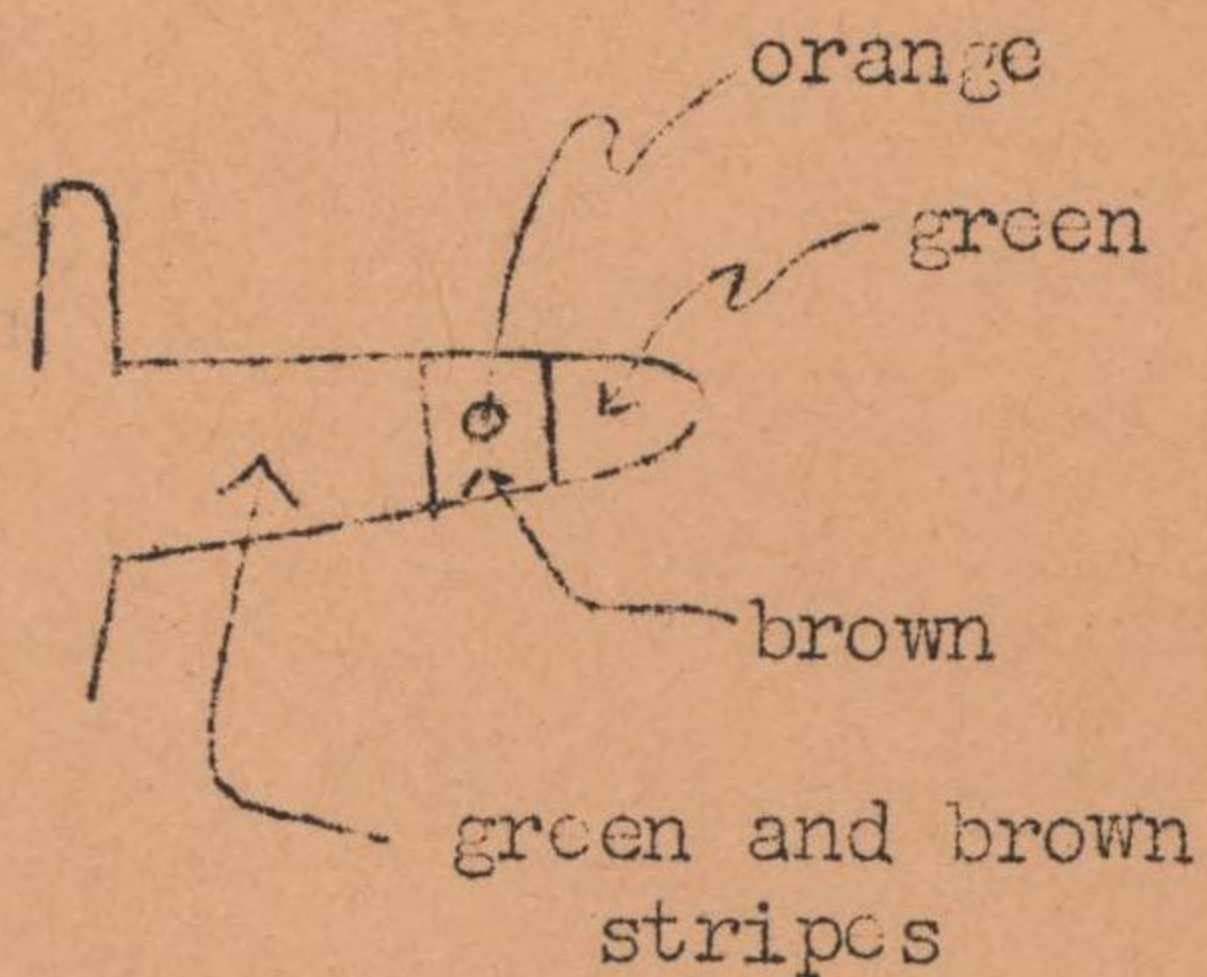
<u>Color</u>	<u>Enemy Aircraft</u>	<u>Wing and Fuselage Markings</u>	<u>Tail Markings</u>
Camouflaged	TOJO	No markings observed.	
"	OSCAR	No markings observed.	
"	NATE	Yellow stripes on wing tips.	
" (OD)	NATES	Red balls on wings and fuselage.	
"	S/E	Bright yellow bellies.	
"(OD)	NICKS	Orange sun on wings, red cowling.	
Unreported color	TONYS	Red rising sun on wing, red rings around fuselage.	
"	E/A	Red cowlings.	
Yellow	VALS	No markings observed.	
Green & brown	ZEKE	Red dots.	
Green	S/E (resembled P-40)	Orange sun on brown stripe and the upper surface of the wing between the spot and fuselage was striped with green and brown. Diagram:

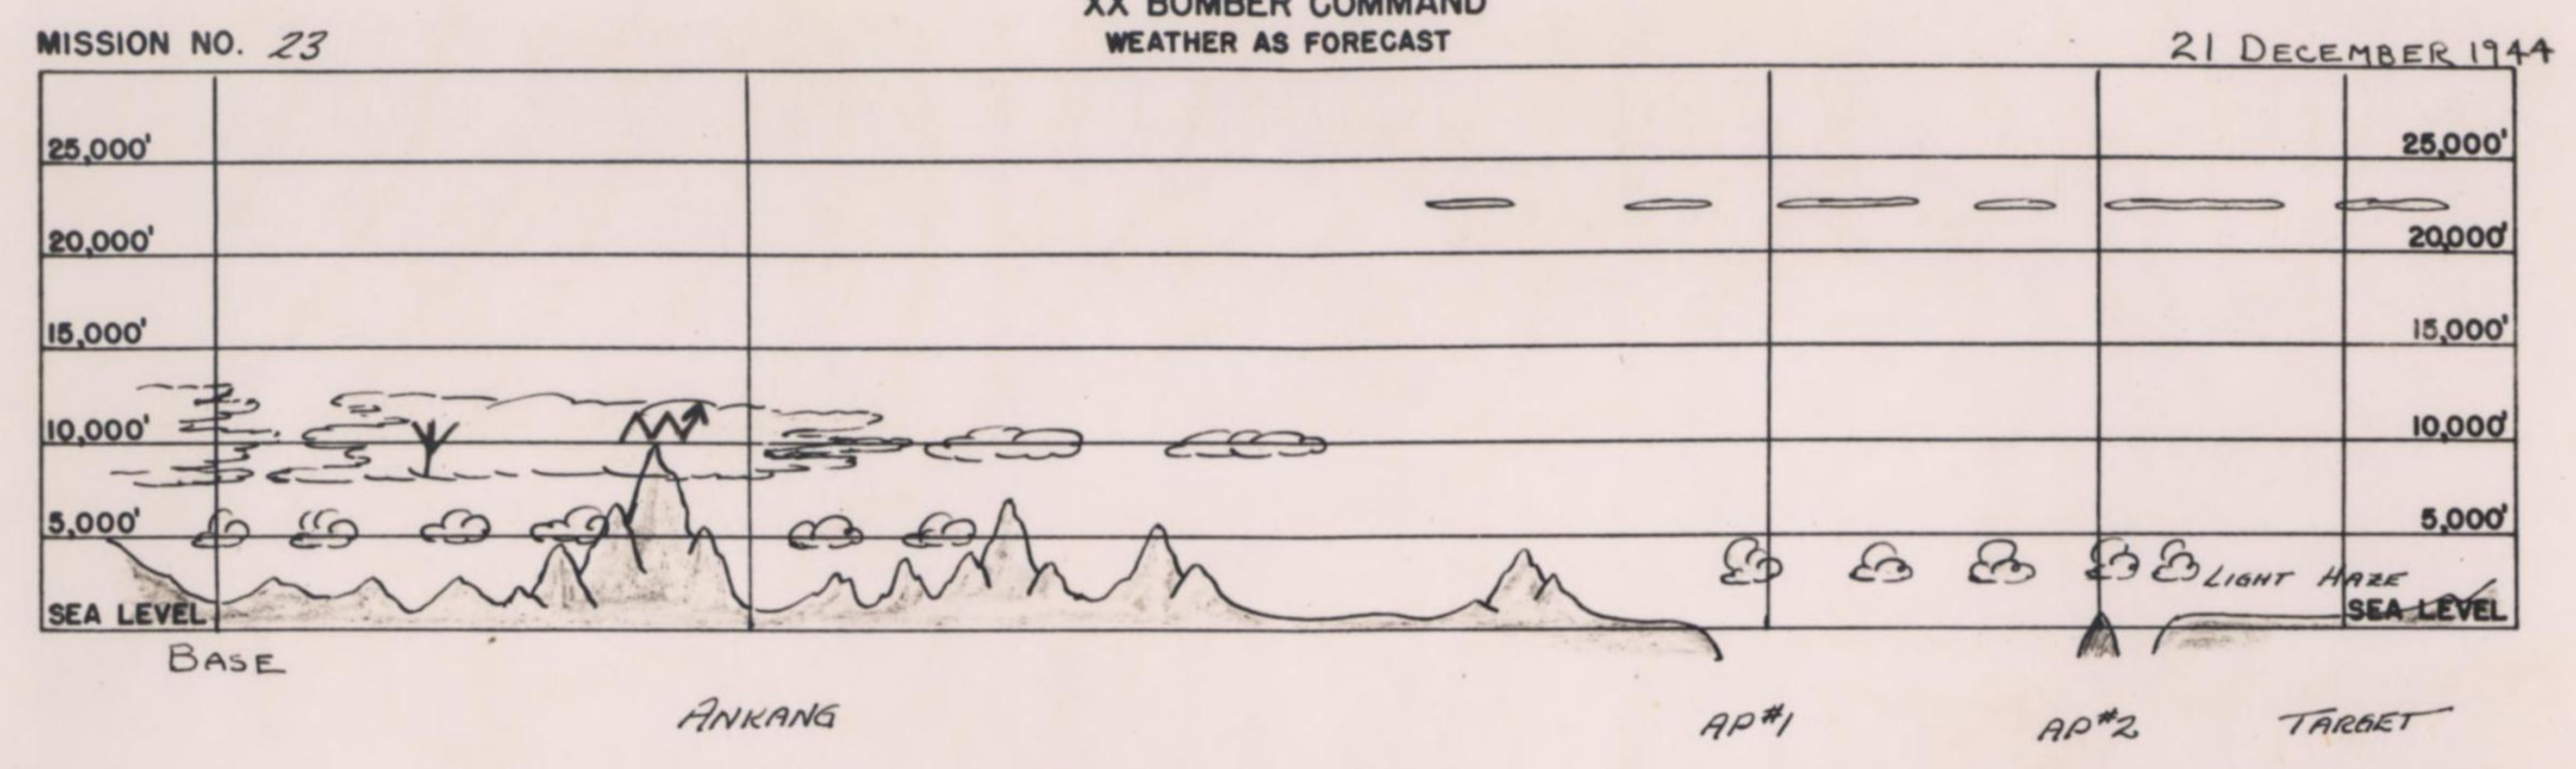
SECRET
 XX BOMBER COMMAND
 WEATHER AS FORECAST

As Forecast	As Encountered
base (Take-off)	8/10 altocumulus at 8000', top 13,000' msl. 3/10 stratocumulus at 4500', top 6500' msl. Visibility 2 miles in haze. Light rime in clouds.	HSINCHING; 7000' broken. Visibility 2 miles in haze. Wind calm. KWANGSIAN; 9000' overcast. Visibility 2 miles in haze. Wind calm. PENGSIAN; 9000' overcast with tops at 11,000'. Visibility 2 miles in haze. Wind calm. KIUNGAI; 6000' overcast. Visibility 2 1/2 miles in light fog, wind N. 2 mph.
Route Out	BASE TO MOUNTAINS; Overcast altocumulus at 8000', top 12,000'. Lower broken stratocumulus in valleys. Surface visibility 1/2 to 1 mile in haze and fog. Light turbulence over mountains. MOUNTAINS TO COAST; Overcast becoming scattered over northern China. 4/10 cirrostratus at 22,000'. Visibility 15 miles in haze. OVER GULF; Low scattered, occasionally broken stratus and stratocumulus.	BASE TO MOUNTAINS; Thin altostratus with base at 9000' and tops at 11-12,000'. Visibility 2-3 miles in haze. Very light icing in clouds. MOUNTAINS TO COAST; Clear almost to coast except for a few scattered stratus at 7-8000'. A system of overcast layers of altostratus and cirrostratus began shortly before the coast was reached. The base of this system is unknown but estimated at 15,000' with the tops at 20-22,000'. Light to moderate turbulence was experienced, but no icing. The haze layer extended to 10,000' and limited visibility to 15 miles. OVER GULF; The existing cloud cover obscured the first assembly point but dissipated over the gulf and the second assembly point was clear. Light vapor trails were observed.

Target Area	PRIMARY TARGET; 6/10 cirrostratus at 22-24,000' vapor trails above 15,000'. Visibility 10 miles in haze. Pressure at target; 30.21 in. (sea level). Mean temperature to 22,000' -24°C. SECONDARY TARGET; Broken to overcast morning stratus along coast becoming 4/10 fair weather cumulus by 0900 China time.	PRIMARY TARGET; Clear. Visibility 20 miles in light haze. SECONDARY TARGET; 9/10 layer of thick altostratus from 14,000' to 23,000'. Visibility 5 miles in haze. These conditions improved to 6/10 cover and 15 mile visibility. TERTIARY TARGET; Clear. Visibility 4 miles in haze.
Return Route	No change except 3/10 cumulus in hills, base 5000', top 7000'. Visibility 6-8 miles in haze below 8000'.	As the return route lay north of the outgoing route the cloud cover over the China Coast was not encountered. Conditions were clear with visibilities limited to 10 miles in haze until Hsian was reached. On the west side of the mountains patches of

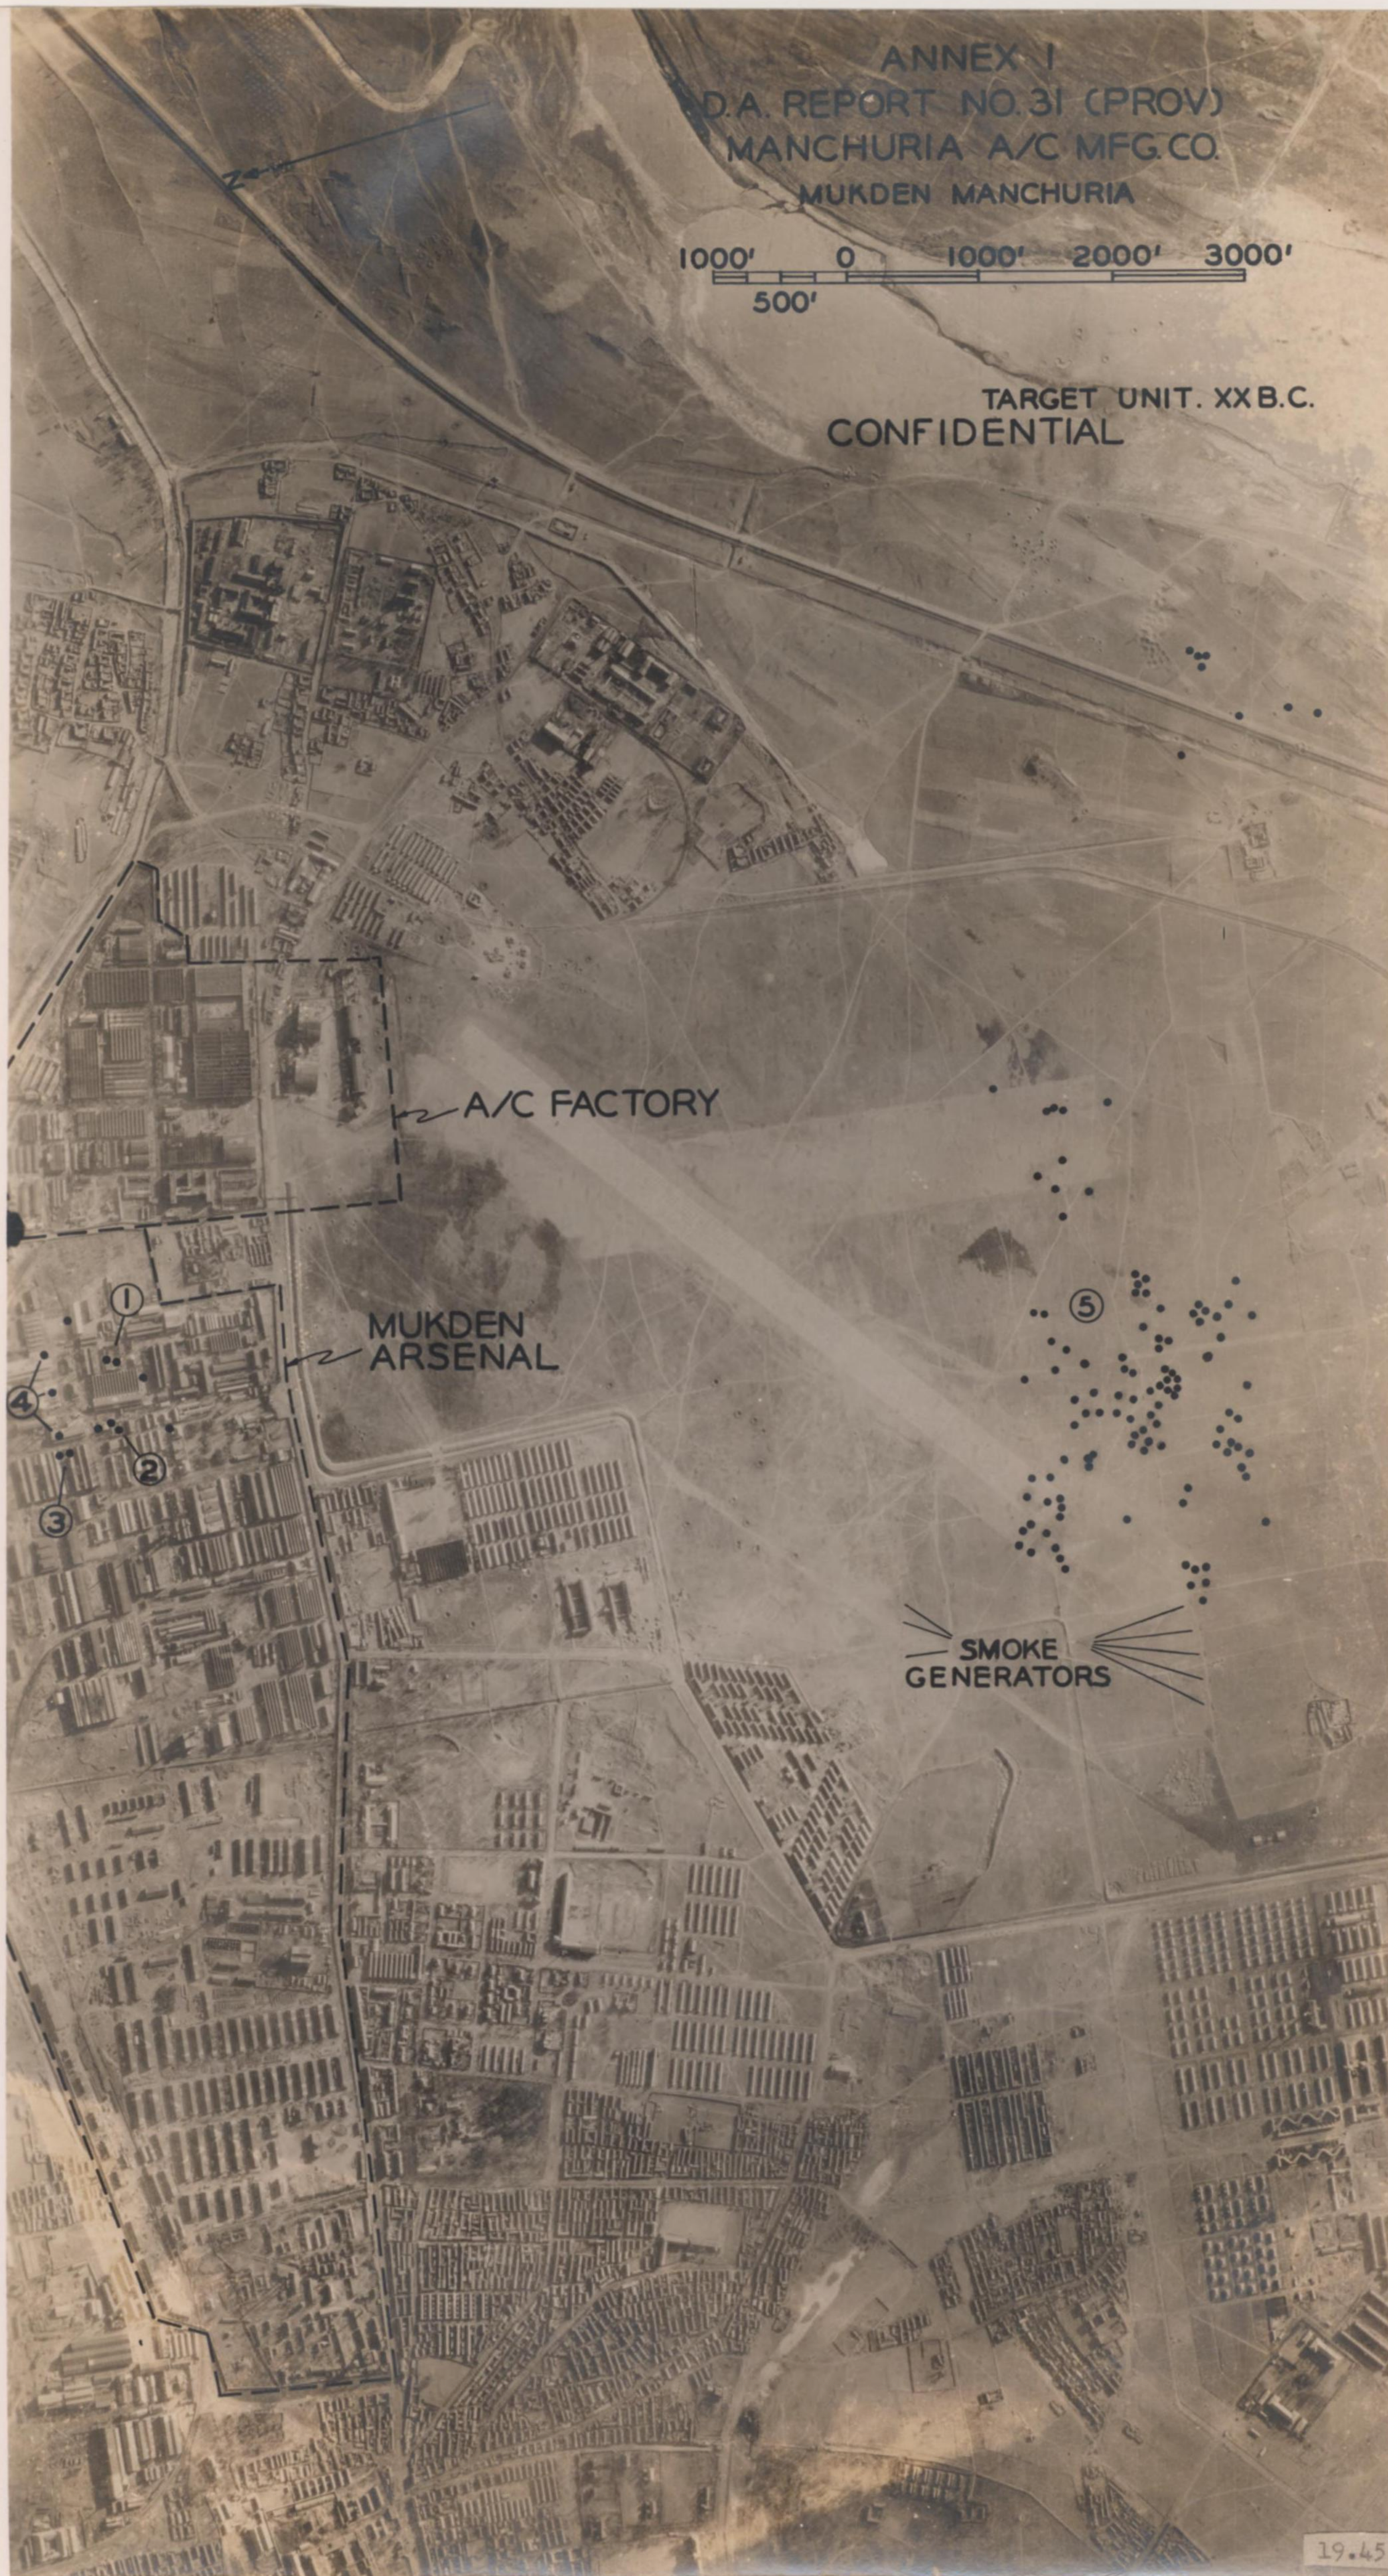
ANNEX I
D.A. REPORT NO. 31 (PROV)
MANCHURIA A/C MFG. CO.
MUKDEN MANCHURIA

(3) Incendiary bombs from 1 aircraft struck in the Mukden Arsenal approximately 2000 feet west of the target center, gutting completely 2 medium sized workshops. A smaller workshop and a small section of a light machine shop were also destroyed. Direct hits were made on 2 heavy forge shops and 1 light forge shop, but in these cases the buildings did not ignite and only slight damage is visible.

(5) The fourth formation's bombs, dropped by radar, fell in the Mukden Railway Yards and eastwards for several thousand feet into the city proper. Cloud and smoke and lack of post-strike photo coverage preclude a statement of damage.
