U. S. STRATEGIC BOMBING SURVEY  
PHYSICAL DAMAGE DIVISION TEAM NO. 3

TARGET NO. 90.25 - 1702

Photo Titles -1702

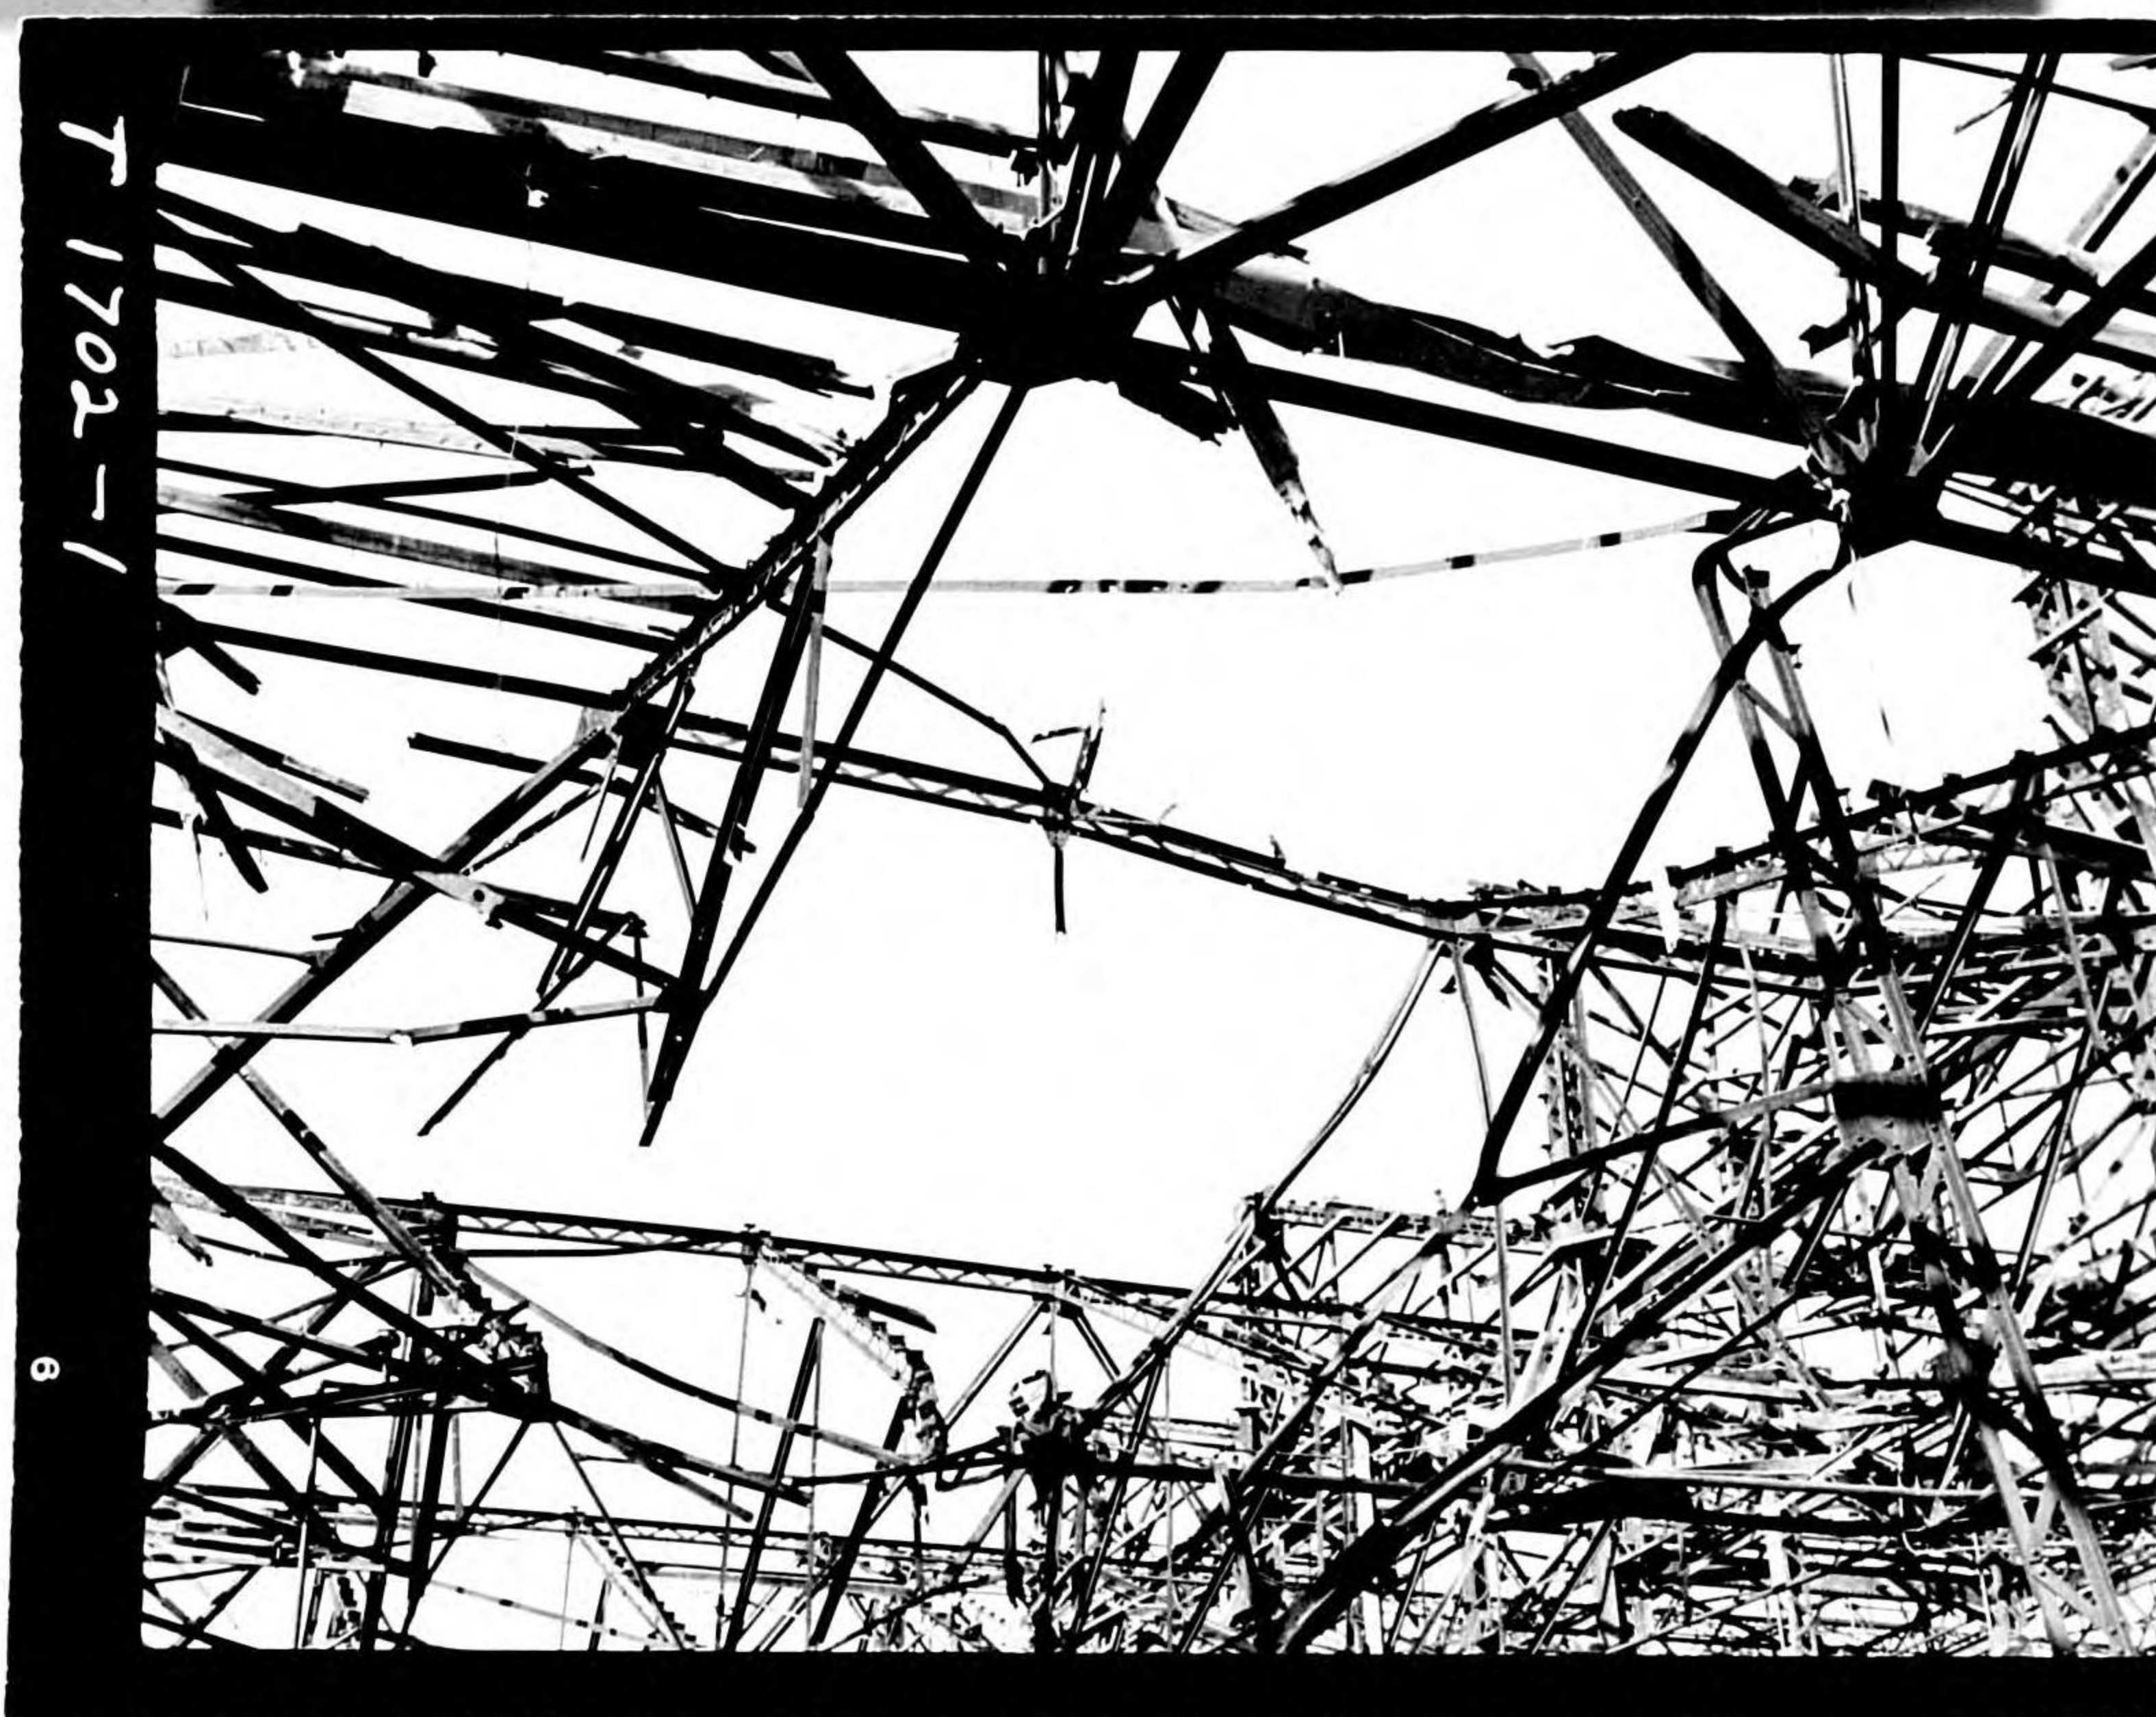
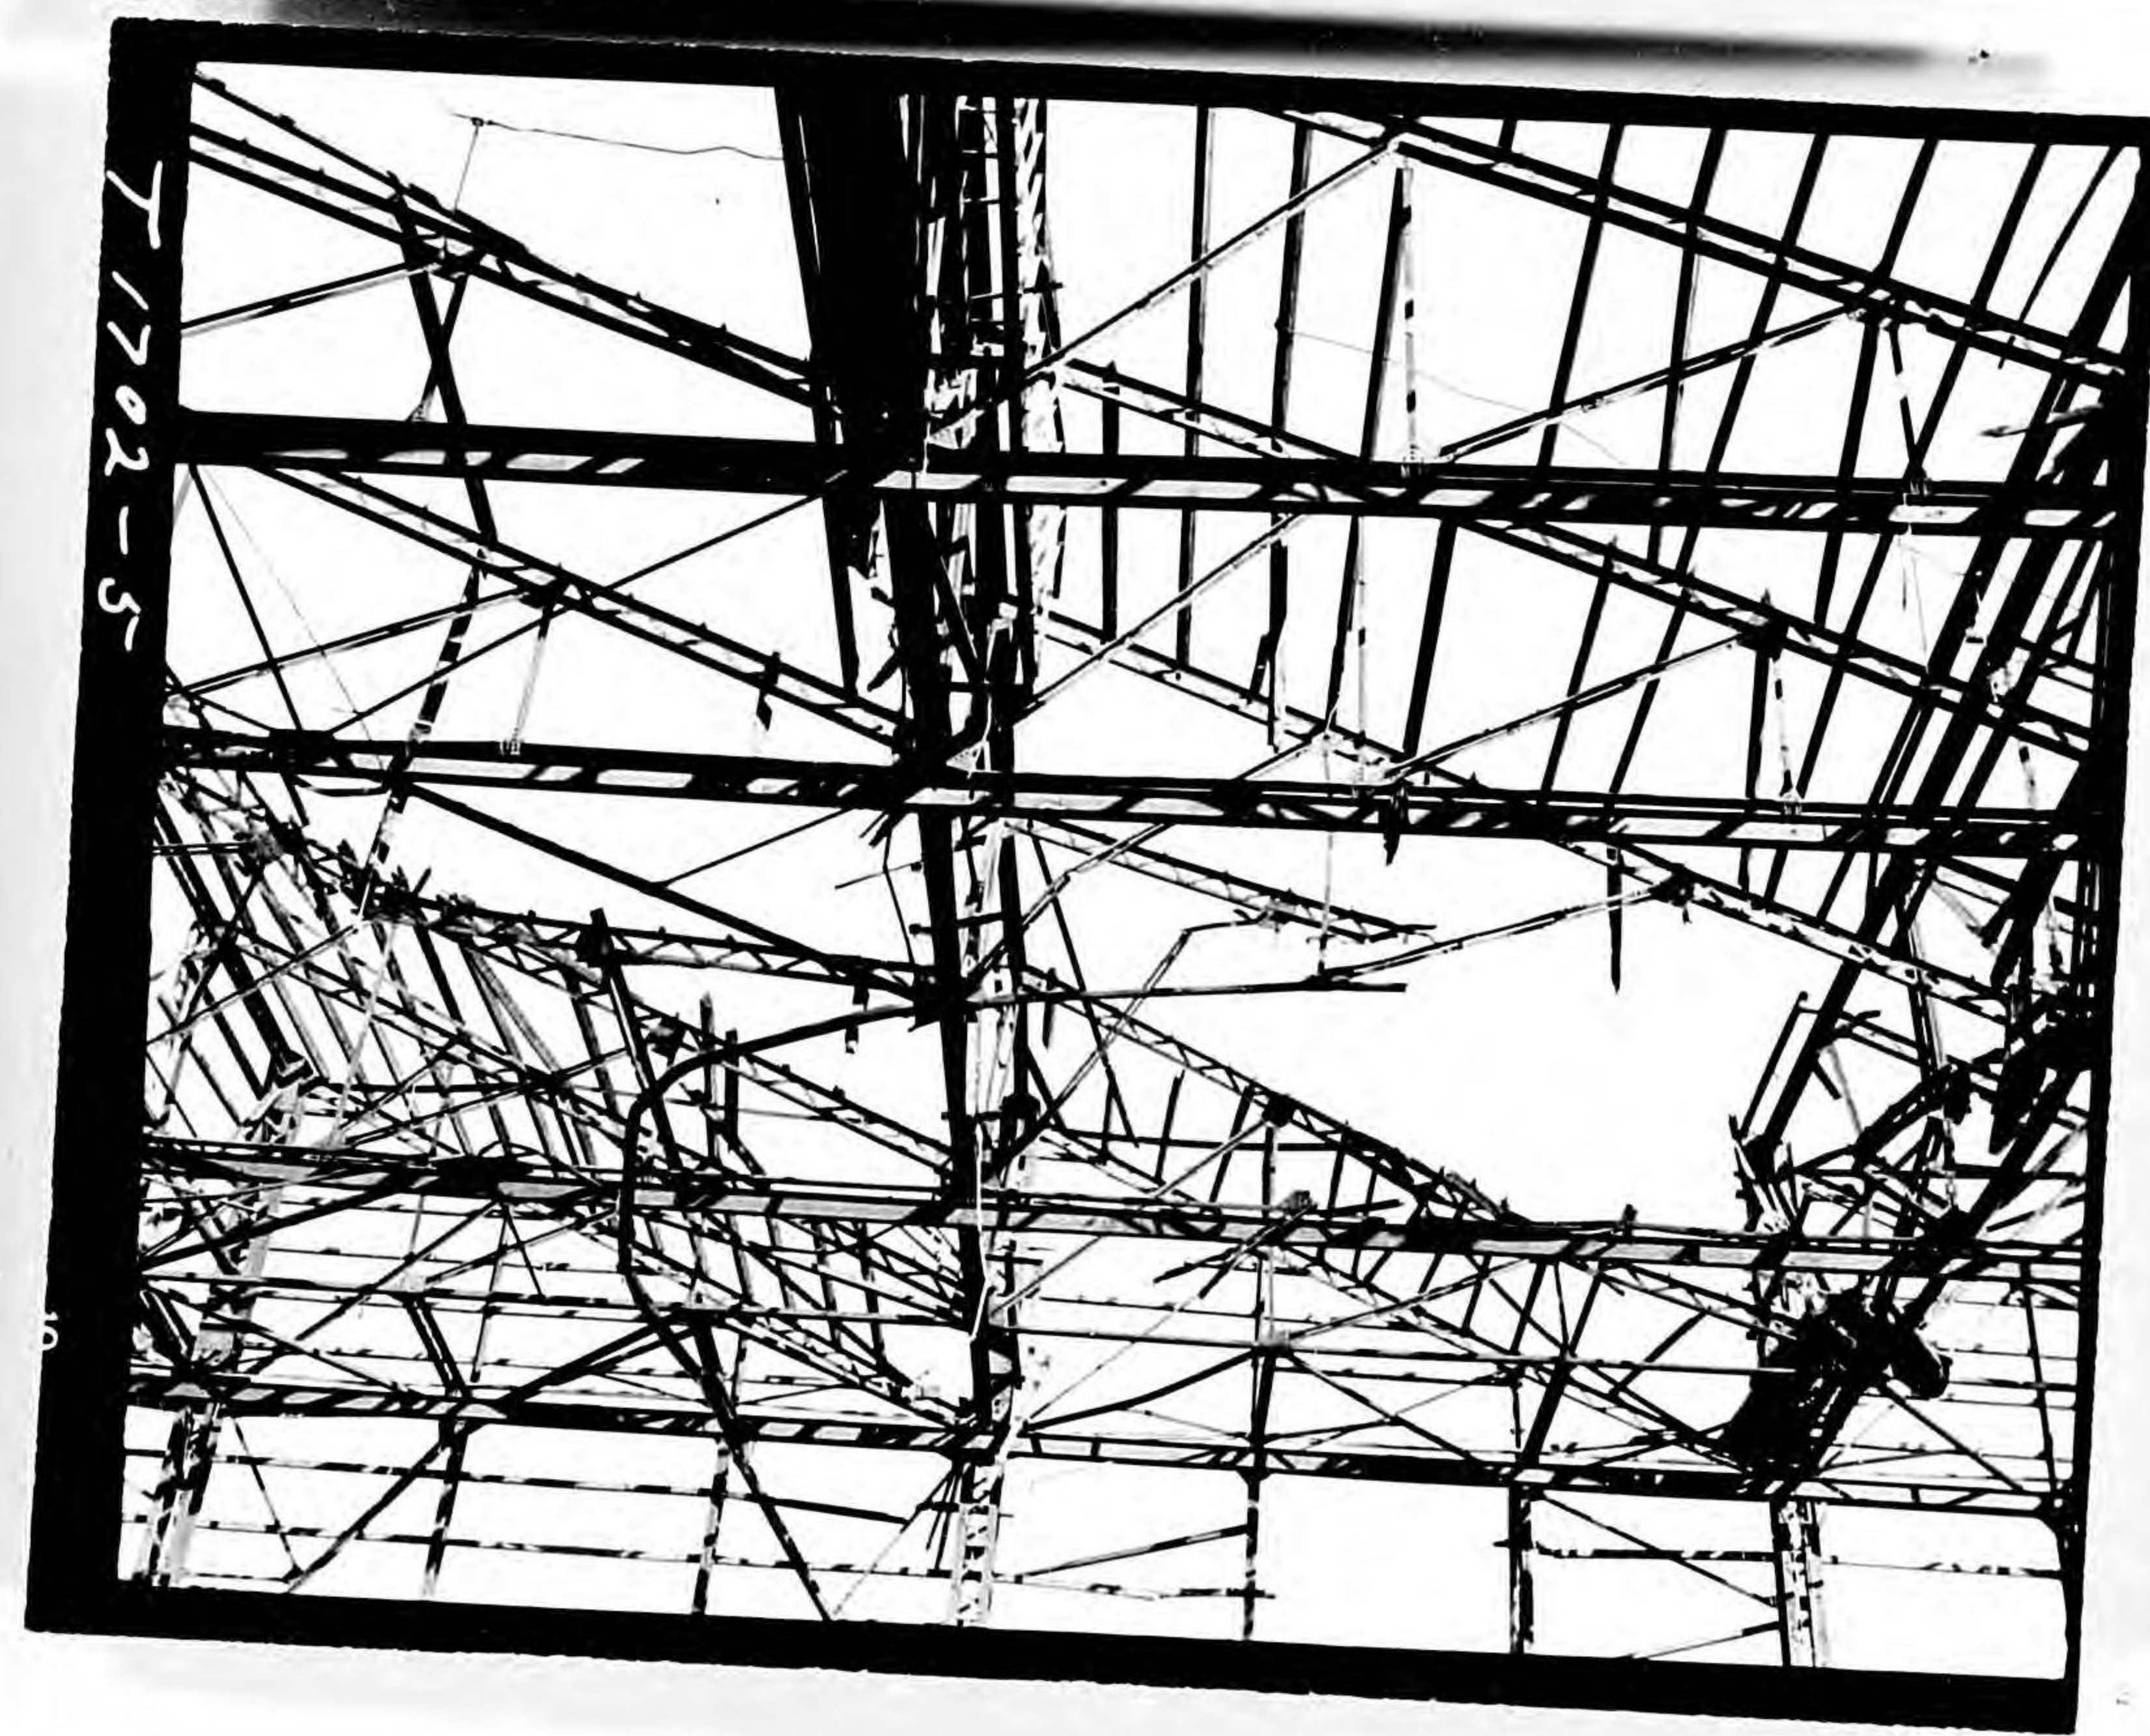
PHOTO	BLDG. NO.	PHOTO NOTES BOMB NO.
1	2	8
2	2	7
3	2	6
4	2	9
5	2	4
6	1	1,2
7	1	2
8	1	1
9	3	10
10	3	12
11	3	15?
12	3	17
13	3	17
14	3	28
15	3	22

Photo no		Title
1.	7	Bldg 2, Bomb 8; Damage to Roof Steel
2	6	Bldg 2, Bomb 7; Damage to Roof Steel
3.	5	Bldg 2, Bomb 6; Damage to Roof Steel; Bent Hoist Runway
4	8	Bldg 2, Bomb 9 Damage to Roof Steel
5	4	Bldg 2, Bomb 4 Damage to Roof Steel
6	1	Bldg 1, Bombs 1 & 2 Damaged Exterior Column, Roof Steel
7	3	Bldg 1, Bomb 2 Damaged Roof Steel
8.	2	Bldg 1, Bomb 1 Col. cut, lower chord of ext. stiffening truss cut.
9.	9	Bldg 3, Bomb 10 Ext. Col. cut; Roof Steel damaged
10	10	Bldg 3, Bomb 12 Roof Steel Damaged; Horizontal members intact (Image reversed)
11.	11	Bldg 3, Bomb 15 Damaged Roof steel; Bent Crane runway
12.	12	Bldg 3, Bomb 17 Col. destroyed, view of damage & debris
13	13	Bldg 3, Bomb 17 Detail of destroyed Col.
14	15	Bldg 3, Bomb 28 Roof Damage, Heavy Members Intact
15.	14	Bldg 3 Bomb 22 Bomb hit above crane, Roof dam- age, crane not knocked down
