NBS TECHNICAL NOTE **837**

Barrier Penetration Tests

Sixteen structural barrier panels were tested to determine their resistance to forcible penetration through the use of readily available tooling. Thirteen of these represented experimental techniques to reinforce an existing structural barrier of low penetration resistance; the other three were designs which would be most appropriate to consider as replacement barriers. Minimum man-passable sized openings were made in the barriers in working times which averaged 7.85 minutes and ranged from 1.52 to 25.56 minutes. One of the replacement and two of the reinforcing designs showed superior cost-effectiveness.

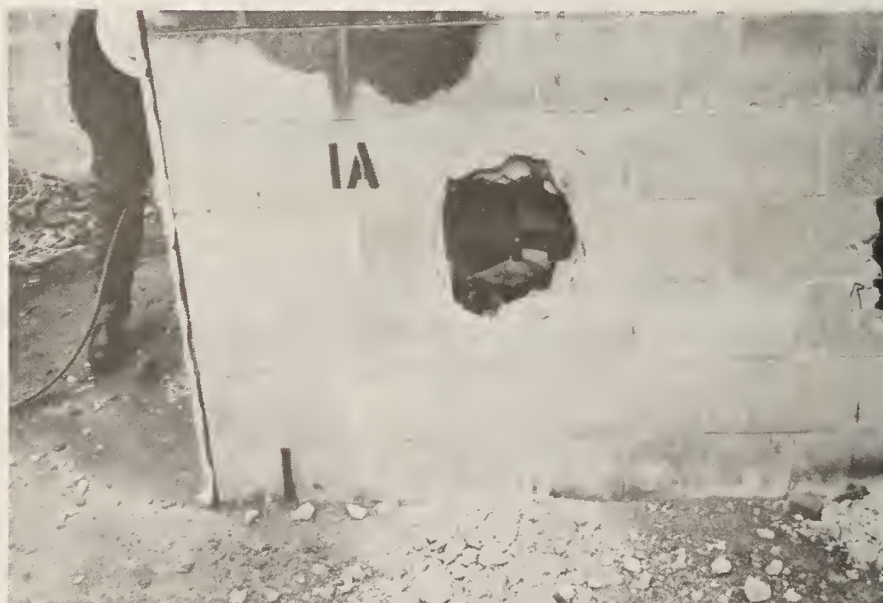
Figure 3. Opening Produced by Test 1A

A ten-pound sledgehammer was used to attack the target area. The initial breakthrough occurred after 54 blows which required 1.31 minutes working time. After another 47 blows and 1.12 minutes, the opening had been enlarged to approximately 12" X 15". The hammering produced SPL readings of 87 to 88 dBC as observed at a distance of 12 feet. A multiple sweep recording of the vibrational disturbances is shown in figure 2. A single reinforcing rod bisected the opening and required two cuts with an oxygen acetylene torch to remove it. The torch was operated at 20 p.s.i. oxygen pressure and 7 p.s.i. acetylene pressure

and a number 5 cutting tip was employed. (Unless otherwise noted, these same gas pressures and tip size were used for all torch cuts in the test series.) The two cuts were made by a relatively inexperienced operator and required 1.41 minutes yielding a total working time of 3.84 minutes and elapsed time of 5.03 minutes for the penetration shown in figure 3. A more experienced torch operator then demonstrated that the section of reinforcing bar removed from the opening could be cut in only 19 seconds. It appears reasonable to expect that this operator could have completed the penetration in a total working time of only 3.06 minutes.

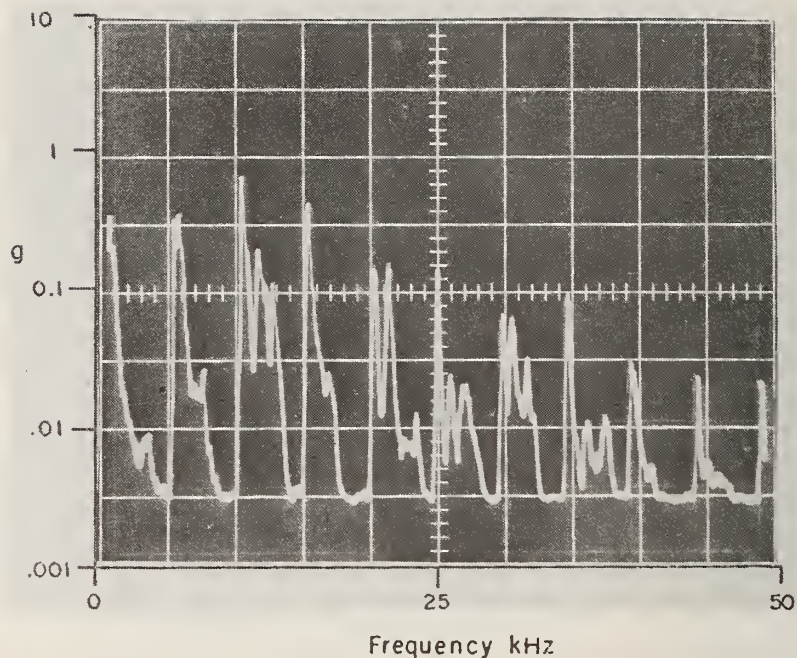
Figure 4. Test 1K. Vibration from Drilling

Using a rotohammer with 3/4-inch drill, a circular pattern of holes was made at the target location. Five equispaced holes were to be drilled on the circumference of a 12-1/4-inch diameter circle to a depth of 5 inches. One of the holes was inadvertently drilled completely through. At a sixth hole at the center of the circle, a reinforcing bar was encountered at a depth of about 3-1/2 inches. Then five more holes were drilled to a depth of 3 inches at points along the circumference of the circle, midway between each of the 5-inch deep holes, and three additional holes were drilled equispaced on the circumference of a smaller 5-3/4-inch diameter concentric circle. One of these latter holes also encountered a reinforcing bar. Vibrational disturbances produced by the drilling are shown in figure 4. When any reinforcing bar was encountered, drilling on that hole was terminated and the hole was marked so that subsequent spalling operations could readily bypass such holes. The drilling required 3.60 minutes working time for the nominal 54 inches giving an average rate of 4.1 seconds per inch.

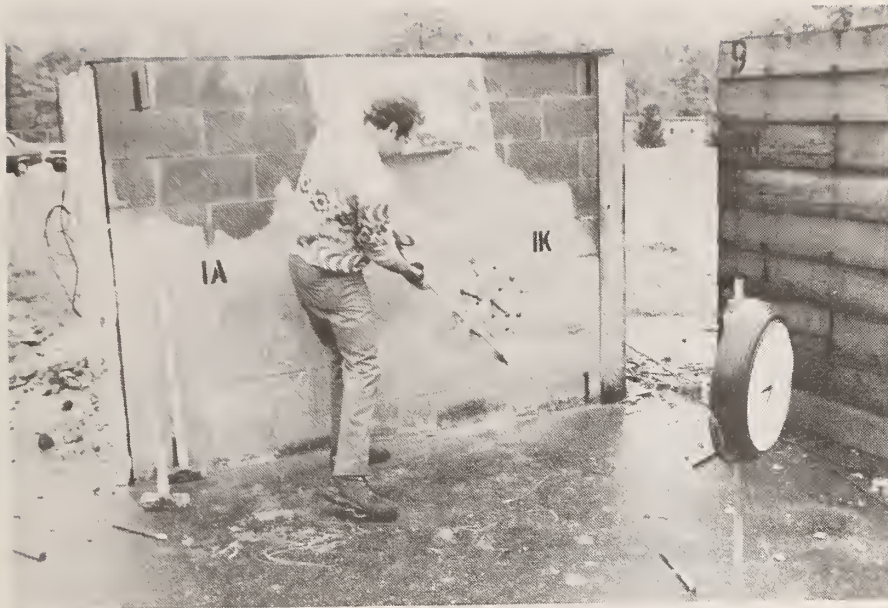
Figure 5. Spalling from Hole Pattern;
Test 1K

Next, using a 10-pound sledgehammer and a variety of steel punches, material was spalled from the bottoms of the unmarked 5-inch deep holes on the interior of the panel. Four of these holes were spalled out with 41 blows of the sledgehammer. The fifth hole was more resistant and when the punch bent attention was shifted to the intermediate 3-inch deep holes. These also resisted spalling and two more punches were bent (see figure 5) so it was decided to remove the punches and drill an inch deeper on the unmarked 3-inch holes. These spalling activities had consumed an additional 1.89 minutes of working time. The extra drilling required 0.92 minute. The spalling was then resumed and proceeded fairly rapidly, being completed in another 1.05 minutes and producing vibrational disturbances as shown in figure 6. Typical SPL readings of 82 to 87 dBC were observed at a distance of 12 feet.

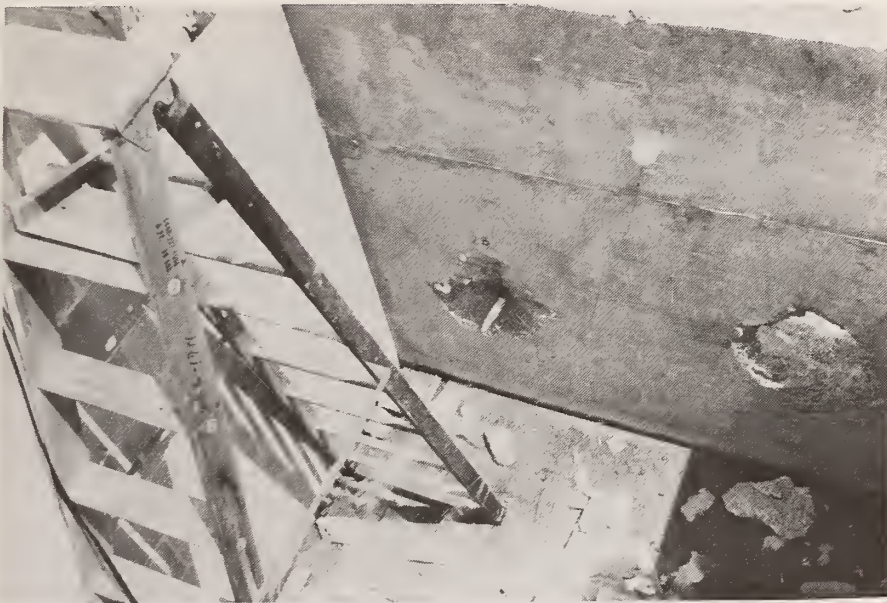
Figure 18. Spalling Produced by
Punch in Center Hole;
Test 2B

Next, a 3/4" diameter bull point punch was inserted in the center hole. When 40 blows on this with a 10-pound sledgehammer bent the punch and failed to spall through the liner, it was decided to try to spall in easier stages and alternate holes around the periphery of the attack circle were drilled 1-1/2" deeper to a point which was calculated to be halfway through the liner. These four holes were then quickly spalled out with the punch using a total of only six blows from the sledgehammer. At this point the working time was 6.40 minutes and elapsed time was 8.42 minutes.

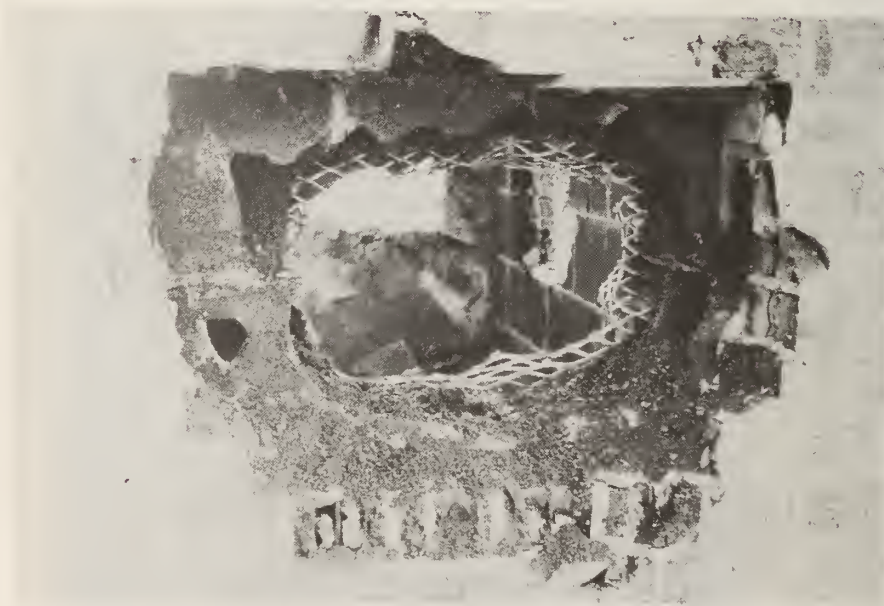
Figure 39. Opening Produced by Test 5A

The 10-pound sledgehammer was used to attack the target area. Multiple sweeps of the acoustical disturbances are shown in figure 37 and the vibrational disturbances in figure 38. SPL readings of 84 to 95 dBC were observed at 12'. Initial breakthrough occurred after 2.66 minutes working time and 106 blows. Forty-six more blows enlarged the opening to an oval shape approximately 14" X 9" and flattened the expanded metal against the sides of the hole. The final opening is shown in figure 39.

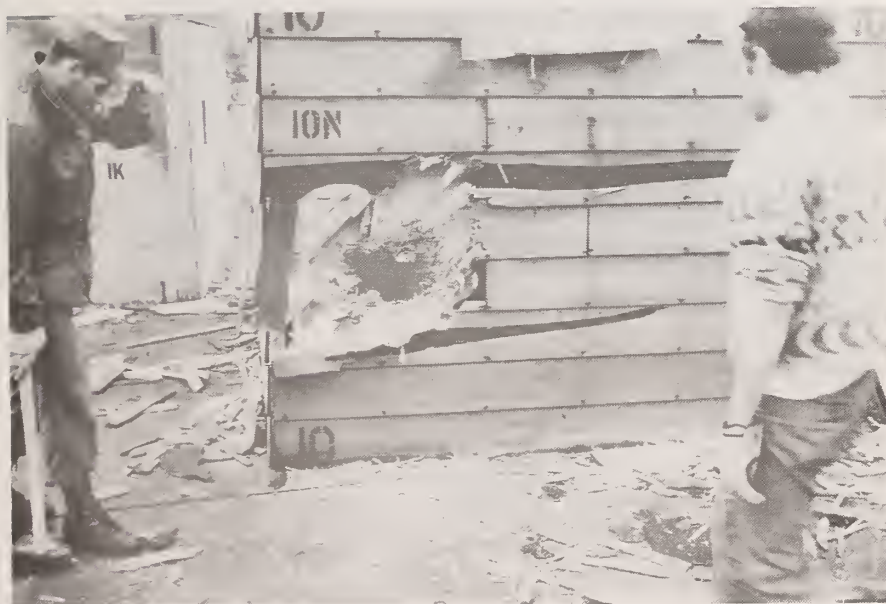
Figure 83. Test 10N. Completed Opening

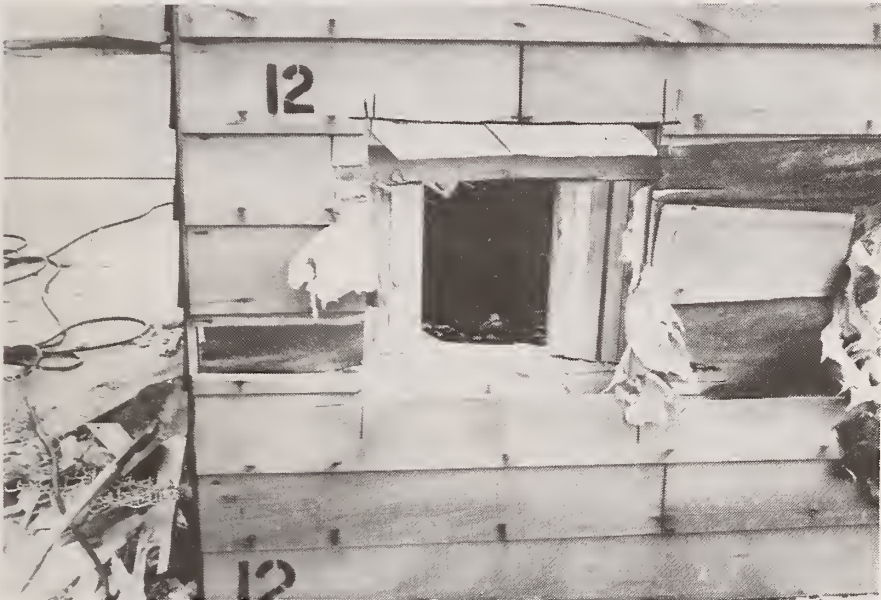
Figure 103. Completed Opening;
Test 12

The nailed timbers in the remaining plug were driven out with the 10-pound sledgehammer in 46 blows delivered in 1.11 minutes. The resulting opening shown in figure 103 measured 13" X 18" and was produced in 6.79 minutes working time and 9.70 minutes elapsed time. It is estimated that both of these times could have been reduced at least a minute if a replacement blade for the hubless saw had been available.

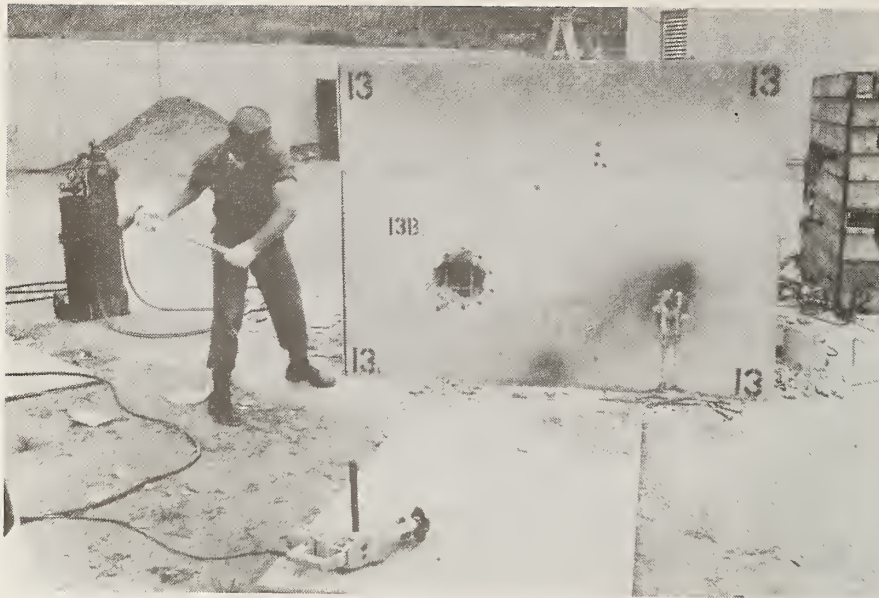
Figure 113. Test 13B Using Taper Punch to Spall from Edge of Holes into Central Opening

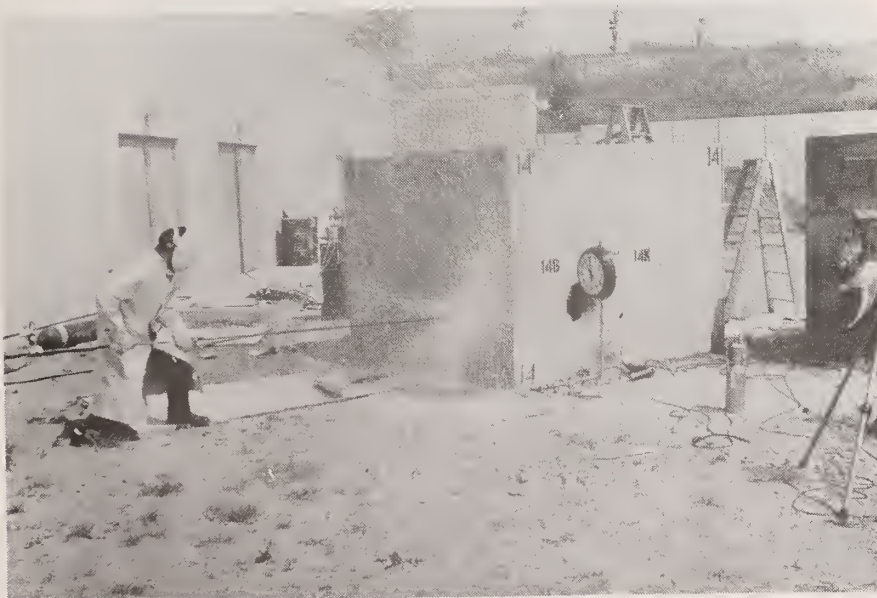
Figure 116. Test 13D. Beginning of Burning Bar Attack

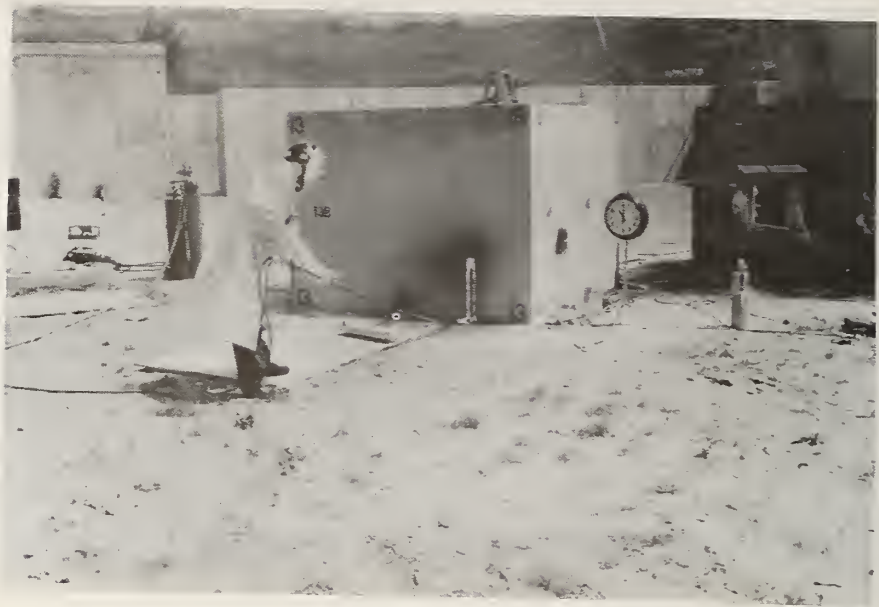
Figure 117. Test 13D. Continuation of Attack

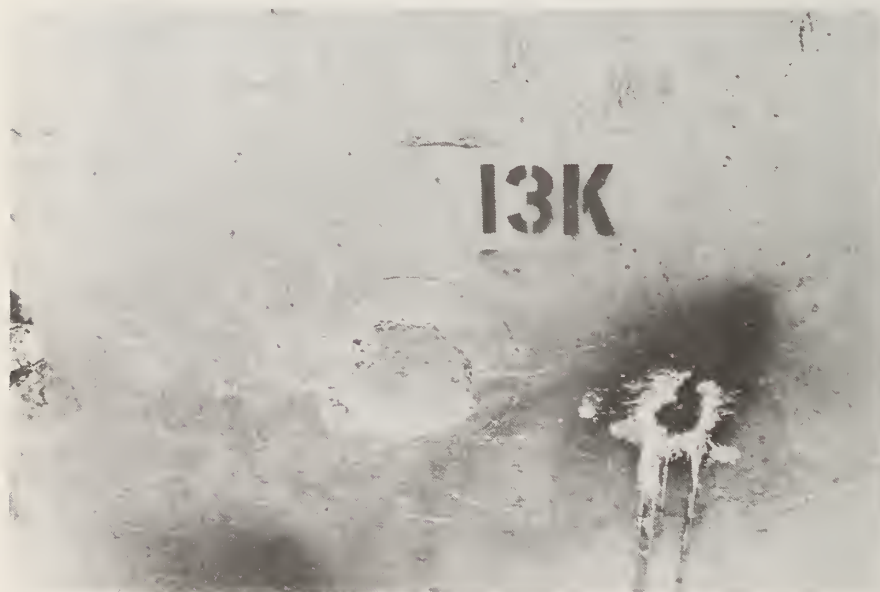
Figure 124. Spalling Produced by 301 Blows from Battering Ram ; Test 13K
100

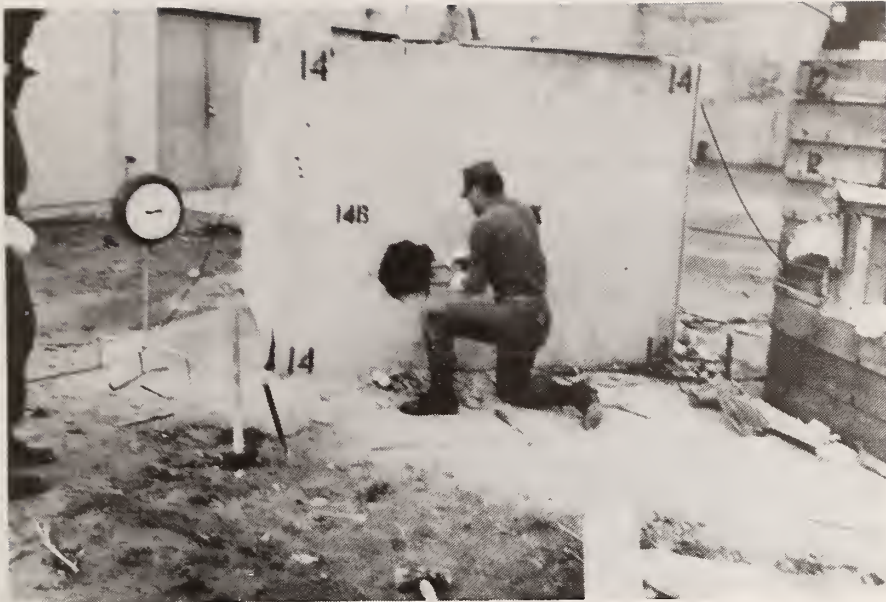
Figure 130. Cutting Reinforcing Rod
with Bolt Cutters ; Test 14B

Finally, as shown in figure 130, the reinforcing rod was cut with 3/8" bolt cutters in 0.74 minute. The 16 cuts required an average time of 2.74 seconds each. The total working time on this test was 9.75 minutes and the elapsed time was 12.24 minutes.

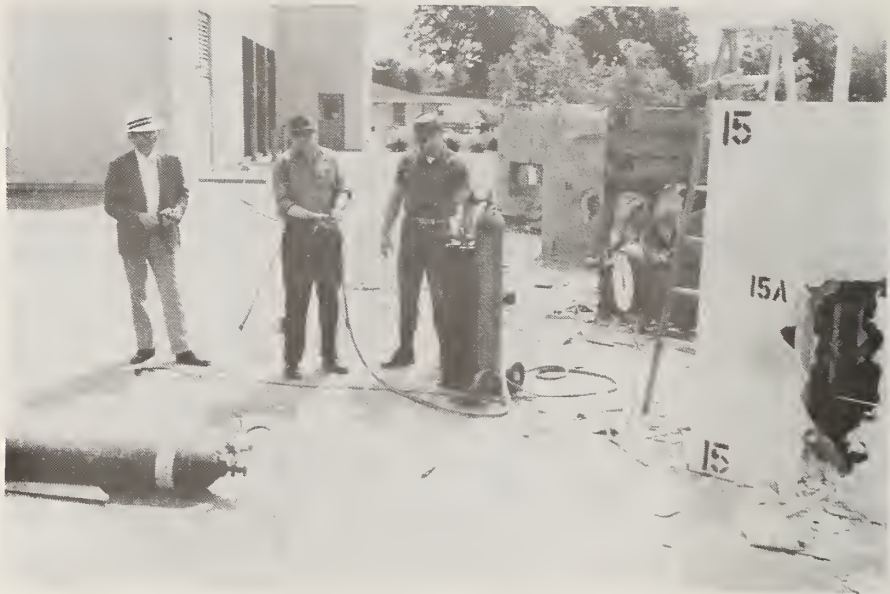
Figure 141. Test 15U. Preparing to Ignite Burner

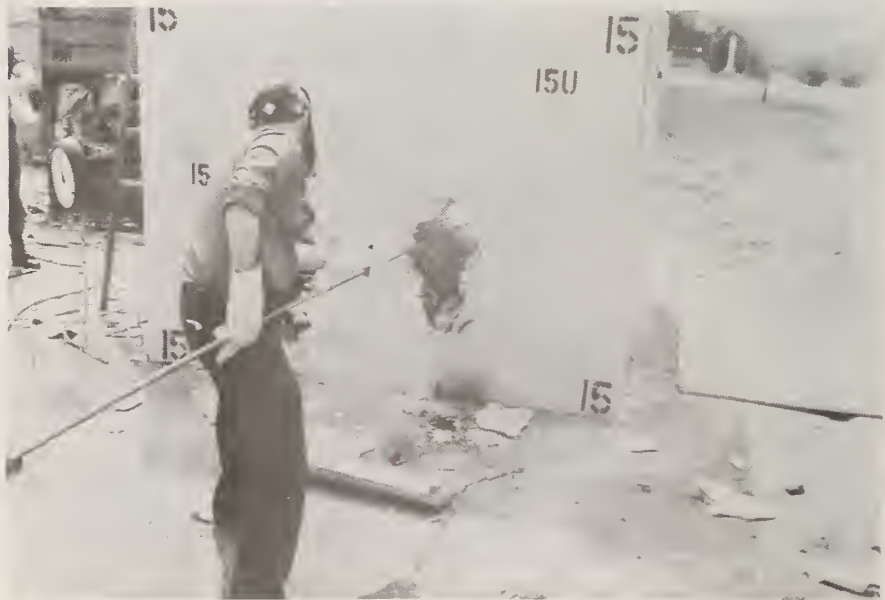
Figure 142. Test 15U. Cutting with Burning Bar

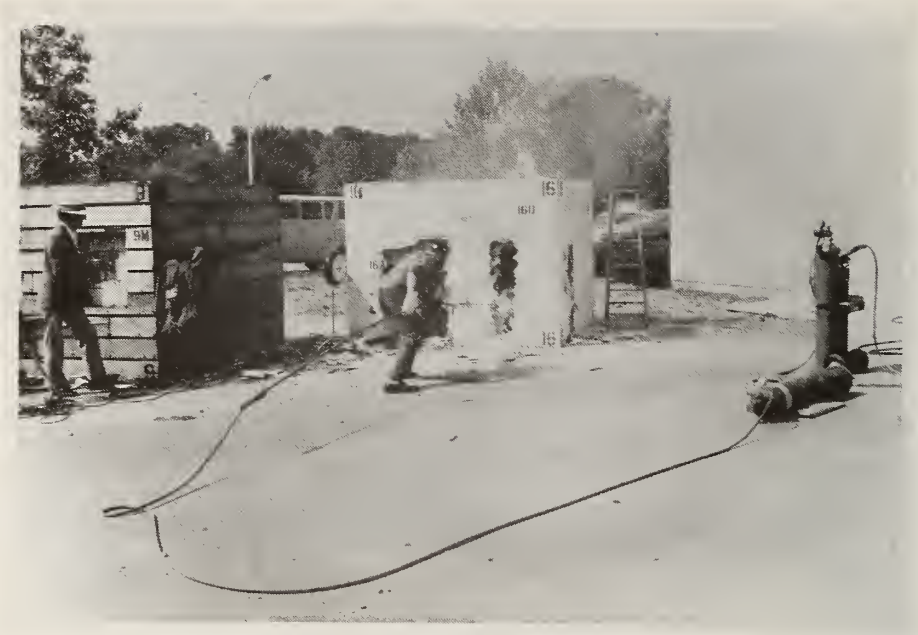
Figure 150. Burning Bar Cutting Through
Steel Reinforcing; Test 16U

The plasterboard was kicked out of the target area in 0.46 minute. Then a two section (20') long burning bar was used (see fig.150) to cut through the steel reinforcing. It was operated at 75 p.s.i. oxygen pressure and consumed 52" of bar in the 1.45 minutes working time required to make the approximately 9" X 12" opening shown in figure 151. Acoustical and vibrational disturbances are shown in figures 152 and 153, respectively. SPL readings at 12' were 86 dBC. Total working time was 1.91 minutes and elapsed time 2.70 minutes.

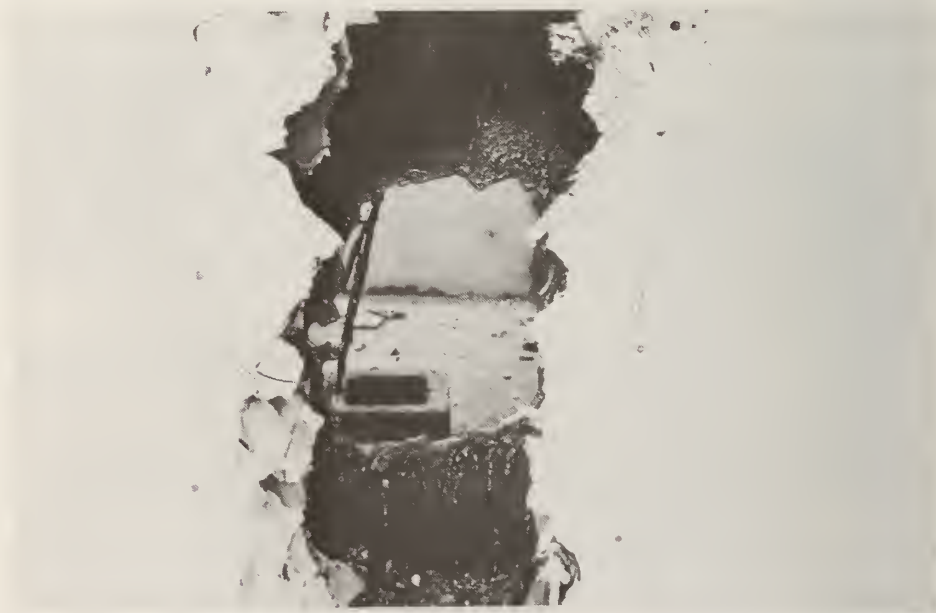
Figure 151. Hole Produced by
Burning Bar; Test 16U

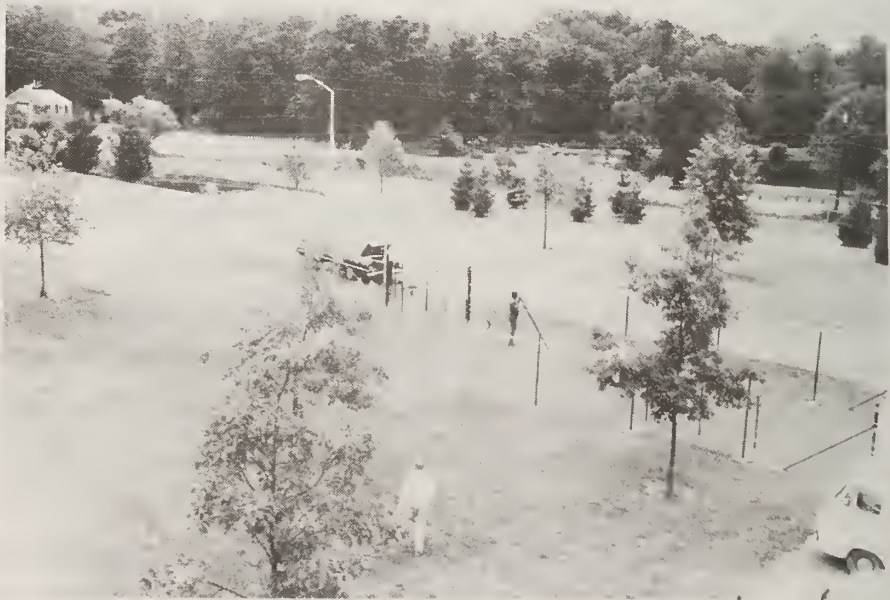
Figure 156. Overview of Site Configuration of Fences during Tests

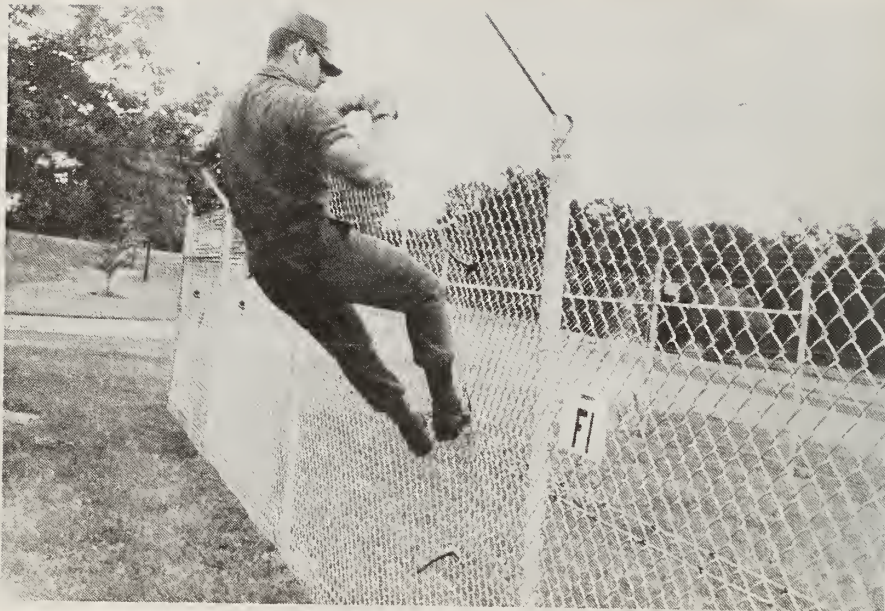
Figure 161. Climb Over Fence Using
Linesman's Pliers to
Make Steps ; Test F1

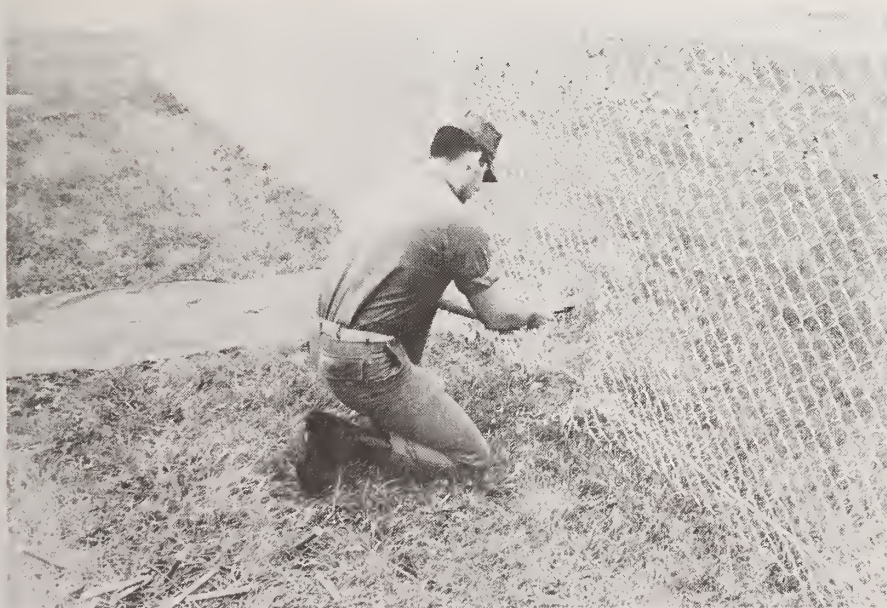
Figure 164. Cuts Being Made with Combination
Fencing Tool; Test F1

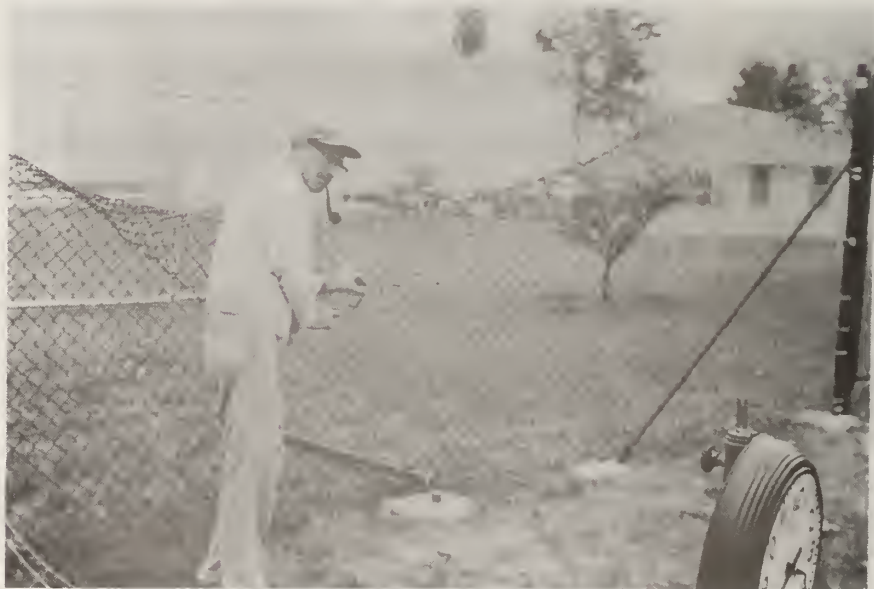
Figure 193. Metric Fence Pole Broken Off by Two-man Attack; Test F4

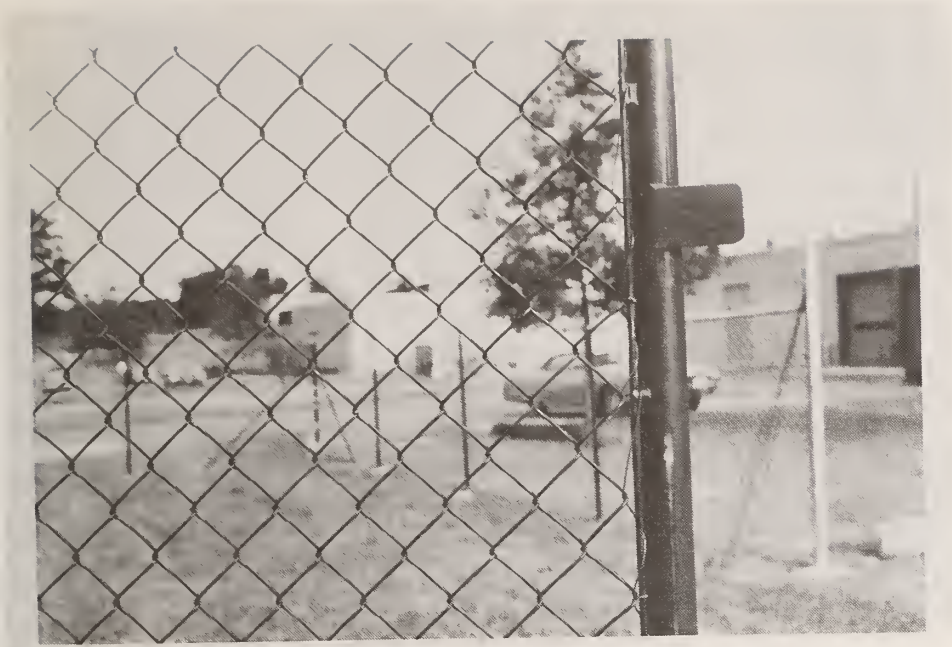
Figure 194. Details, Metric Fabric
Attachment to Gate Frame;
Test F4

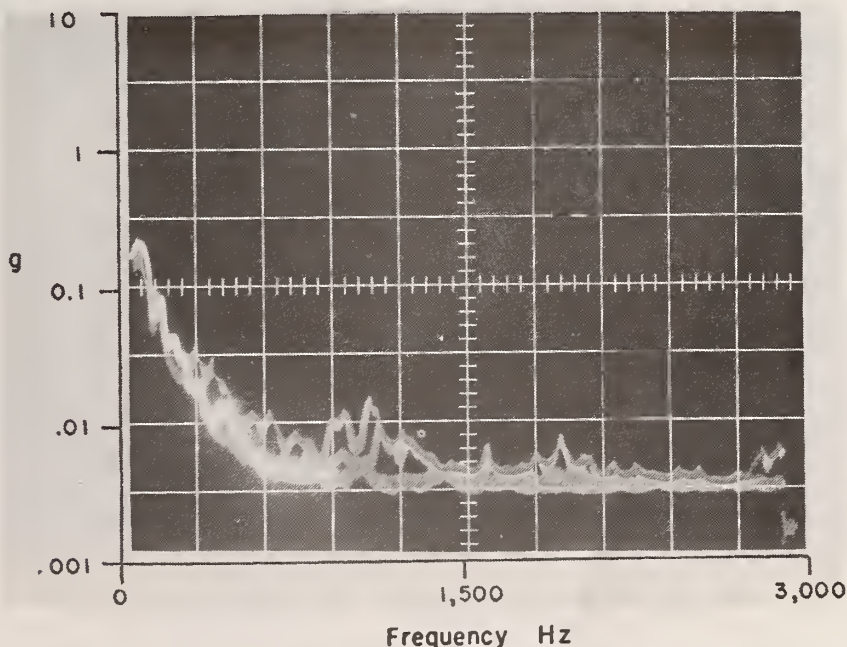
Figure 202. Vibrational Disturbances Produced by Linesman's Cutters Attacks; Test F6
