FLOODPLAIN MANAGEMENT STUDY WILLOW CREEK WAUSHARA COUNTY, WISCONSIN

Prepared by: United States Department of Agriculture Soil Conservation Service Madison, Wisconsin

April 1989

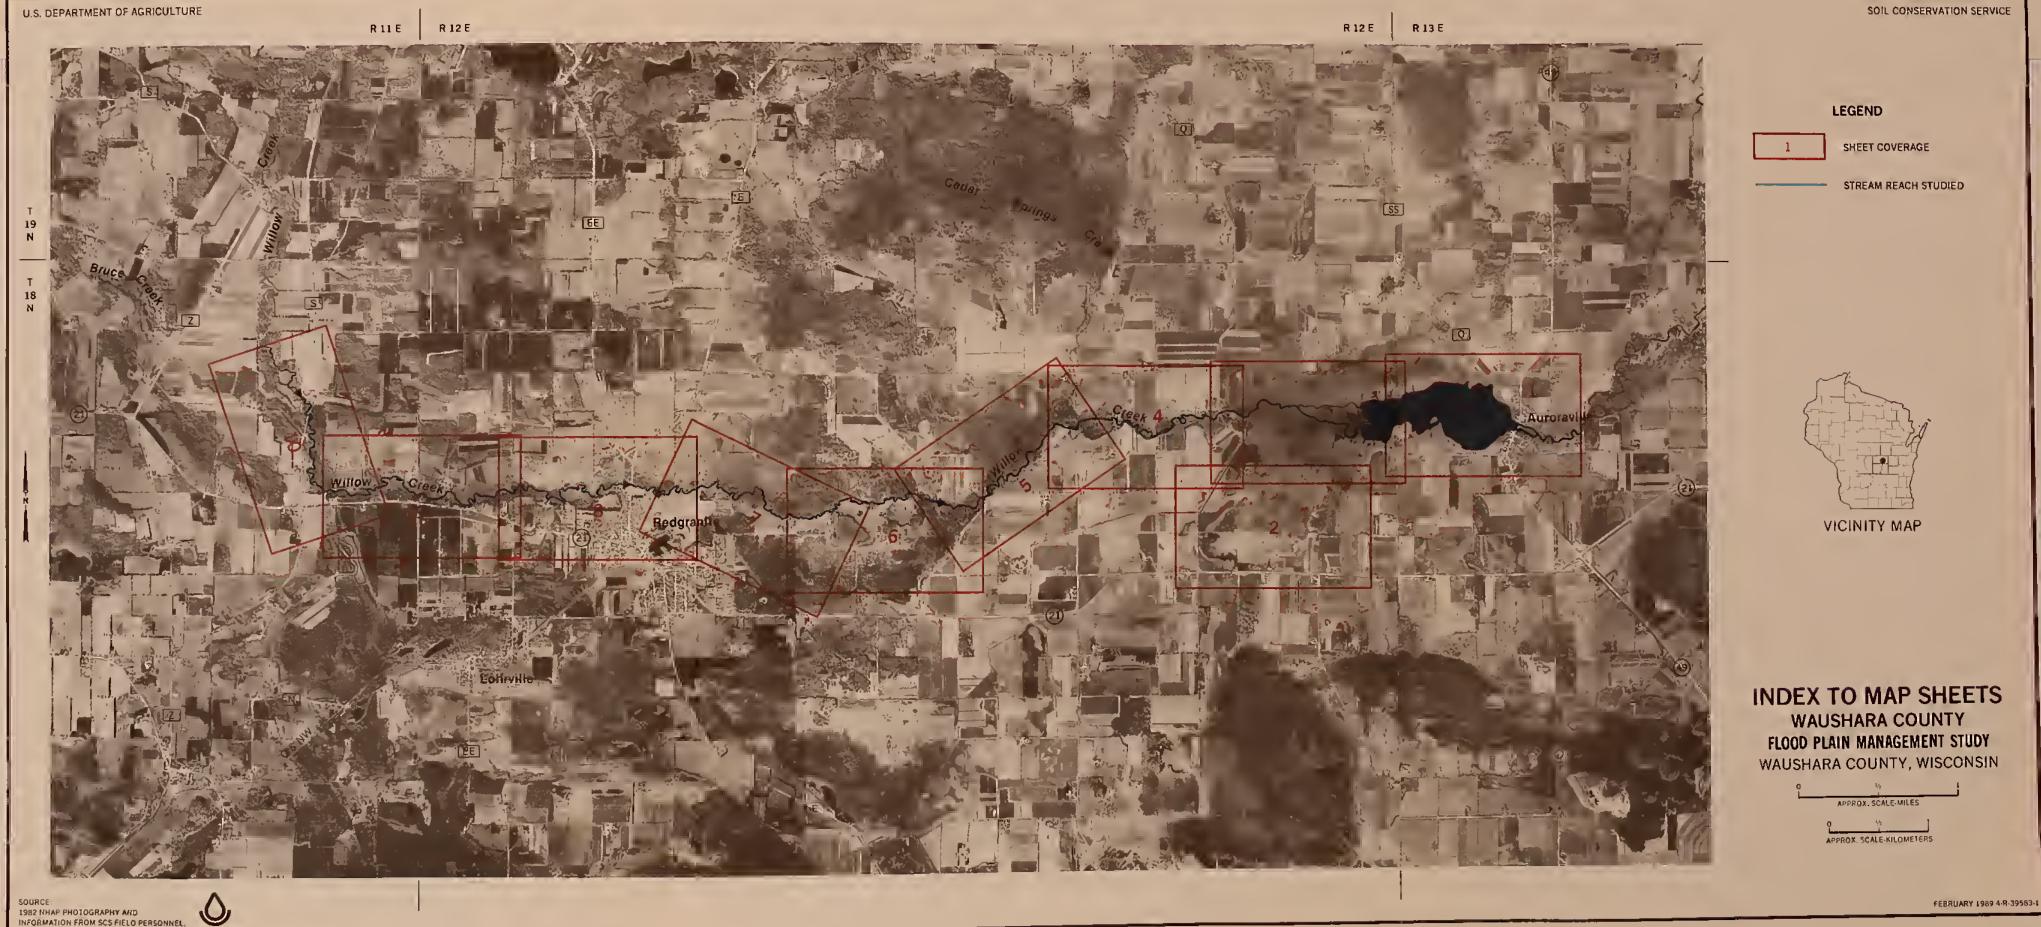
SOURCE: 1982 NHAP PHOTOGRAPHY AND INFORMATION FROM SCS FIELO PERSONNEL.

The 100-year floodplain and the dam breach flood area have been delineated on the photomaps of Appendix A. The high water elevations and floodplain delineations are based on 5-year projected land use of the watershed, stream, floodplain, existing road crossings and a dam failure (breach) analysis.

The floodplain, floodway limits and cross section locations are shown on photomaps in Appendix A.
