# The Locomotive

THE HARTFORD STEAM BOILER  
INSPECTION AND INSURANCE CO.

**VOL. XXXVI.**

# INDEX TO VOL. XXXVI.—1926-1927

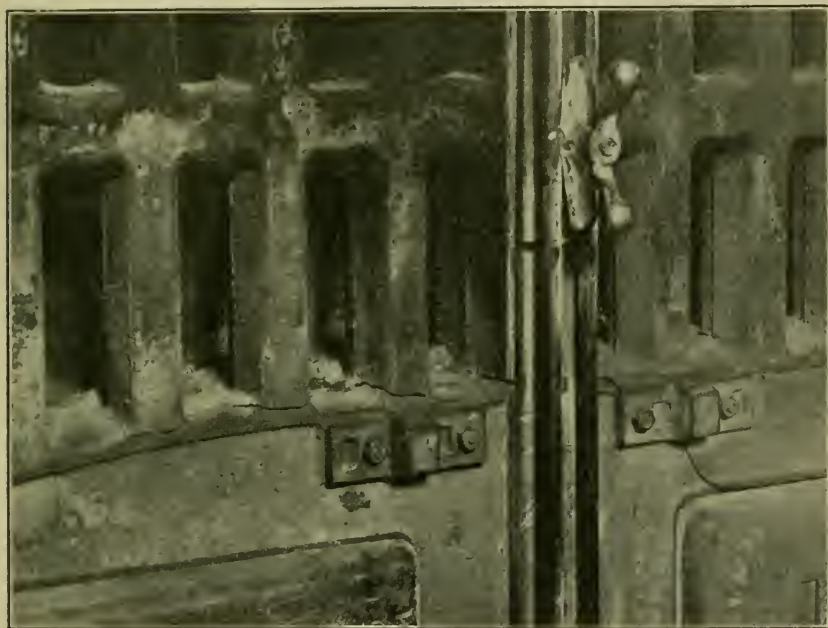
CRACKED SECTION IN BOILER RATED AT 16,800 SQUARE FEET. BOILER WAS RED HOT WHEN OIL BURNER WAS SHUT OFF.

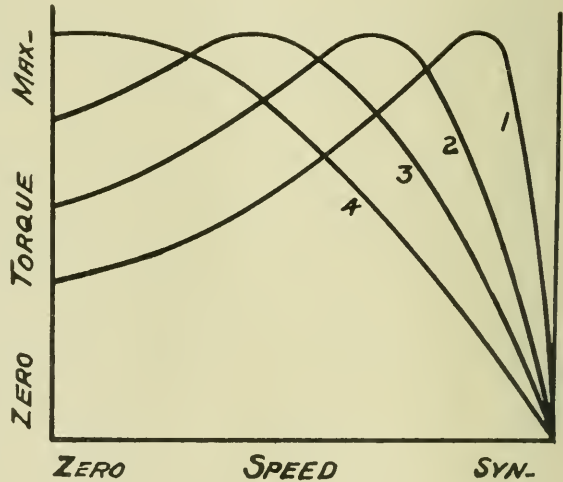
FIG. 2. CURVES SHOWING EFFECT ON LOAD OF EXTERNAL RESISTANCE IN ROTOR CIRCUIT OF WOUND ROTOR MOTORS.

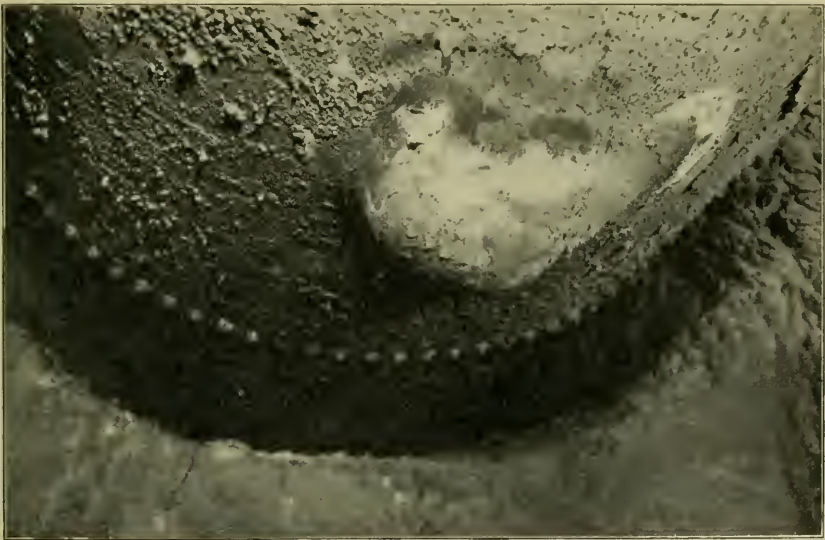
BAGGED BOILER SHELL RESULT OF SCALE DEPOSIT.

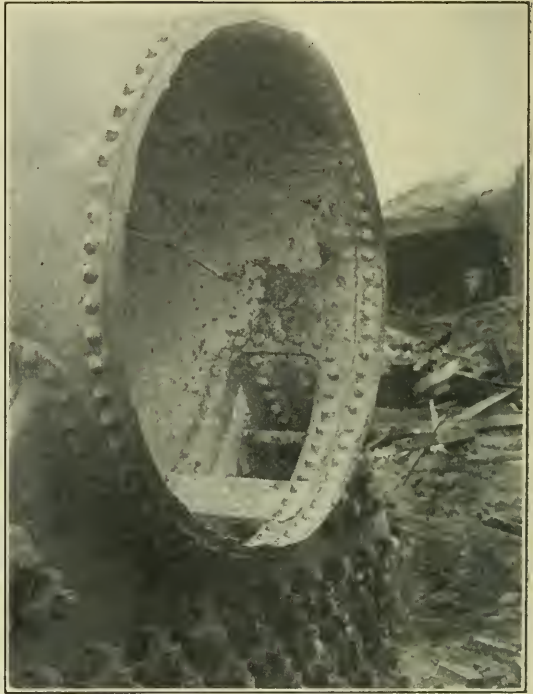
FIG. 3.

The cause of the explosion was a cracked head. As can be seen from Fig. 3, the head was severed completely around its circumference along a line about 2 inches from the row of rivets and just at the turn of the flange. Examination of the material along this line of rupture shows that a crack had developed extending almost completely around the head. Cracks such as this in the heel of a flange are generally regarded as fatigue failure of the metal. The exact pressure of steam at the time of the accident is not known.

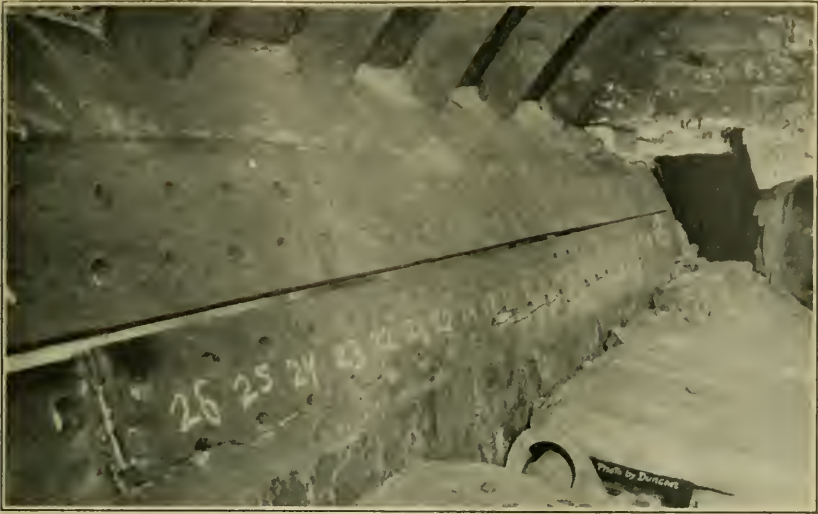
*The destructive work of caustic embrittlement is plainly evident in this steam drum of a water tube boiler. Removal of the strap after a Hartford inspector had discovered symptoms of embrittlement disclosed a crack extending through 27 rivet holes. Two other boilers in the plant were found similarly affected.*

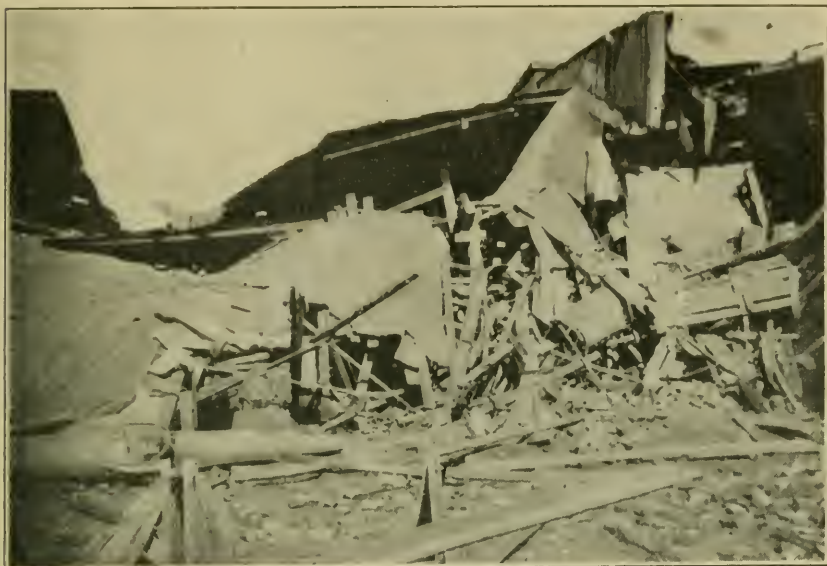
*Excessive internal corrosion in a horizontal tubular boiler at a brick yard in Richmond, Va., caused the explosion shown above. The accident demolished the building and wrecked an engine, causing property damage of almost \$10,000.*
