Capping Survey at the
New London Disposal Site
February 3, 1989

Disposal Area Monitoring System DAMOS

Contribution 71
January 1990

**Report No.
SAIC-89/7554&C76**

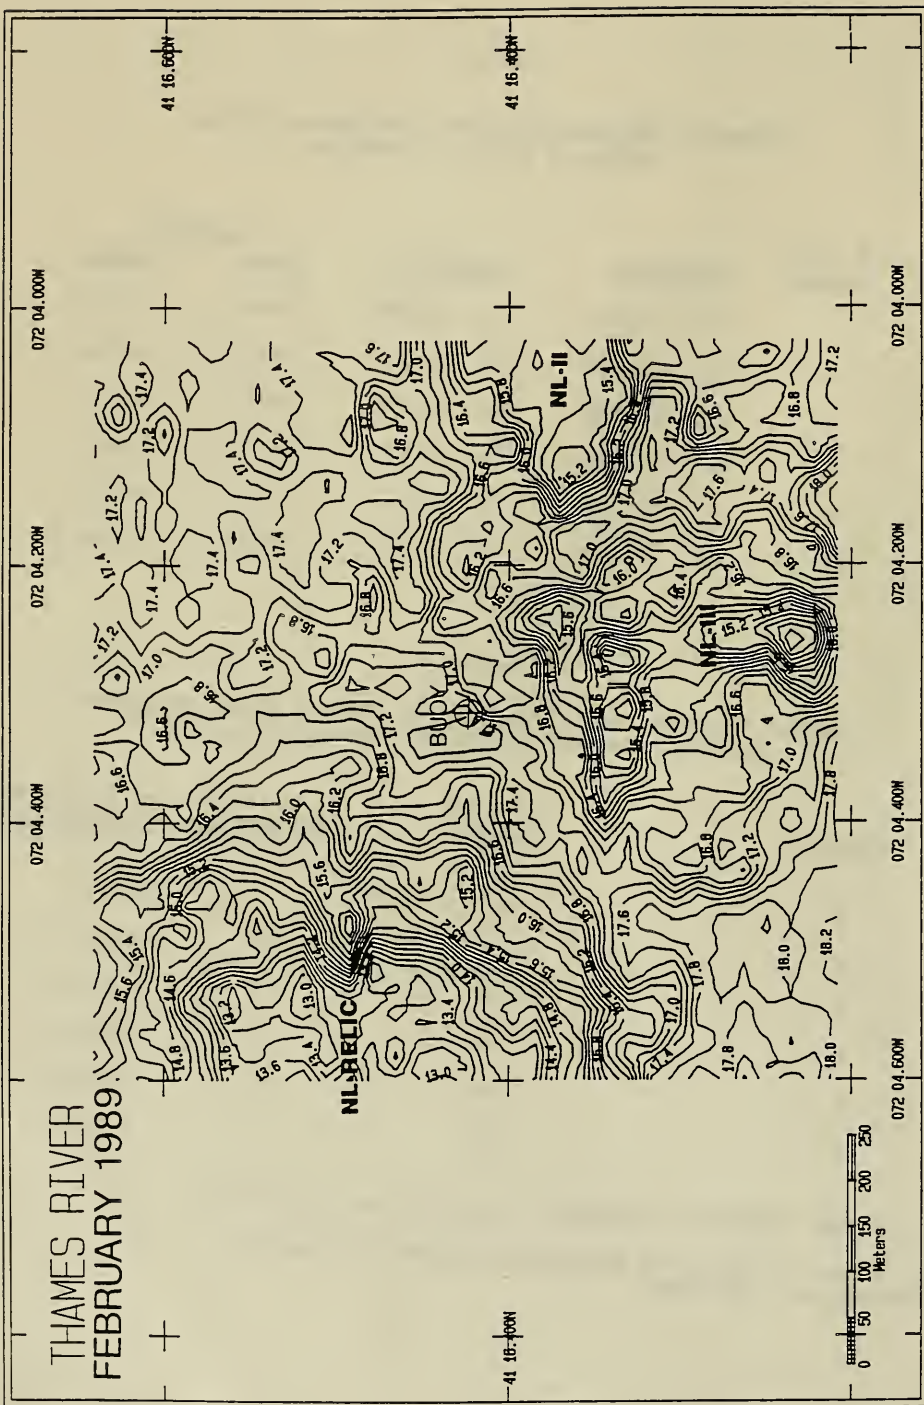
Figure 1 Post-capping bathymetric contour plot of the Thames River Shipyard Disposal Location, February 1989. Contours at 0.2 m intervals.

The contour plot from analysis of the 1989 bathymetric data revealed a highly variable topography of old disposal mounds resulting from dredged material disposed in previous years, as well as from cap material disposed at the buoy location (Figure 1). The clearly visible north-south contours running along the western border of the survey area delimited the eastern flanks of the old disposal mound NL-RELIC. The NL-III mound was seen along the southern border of the survey area. The western flanks of the NL-II mound were also shown on the eastern limits of the survey area. Changes in topography resulting from capping material deposition were indicated by comparison of this contour plot with the results of the October 1988 post-disposal survey (Figure 2).

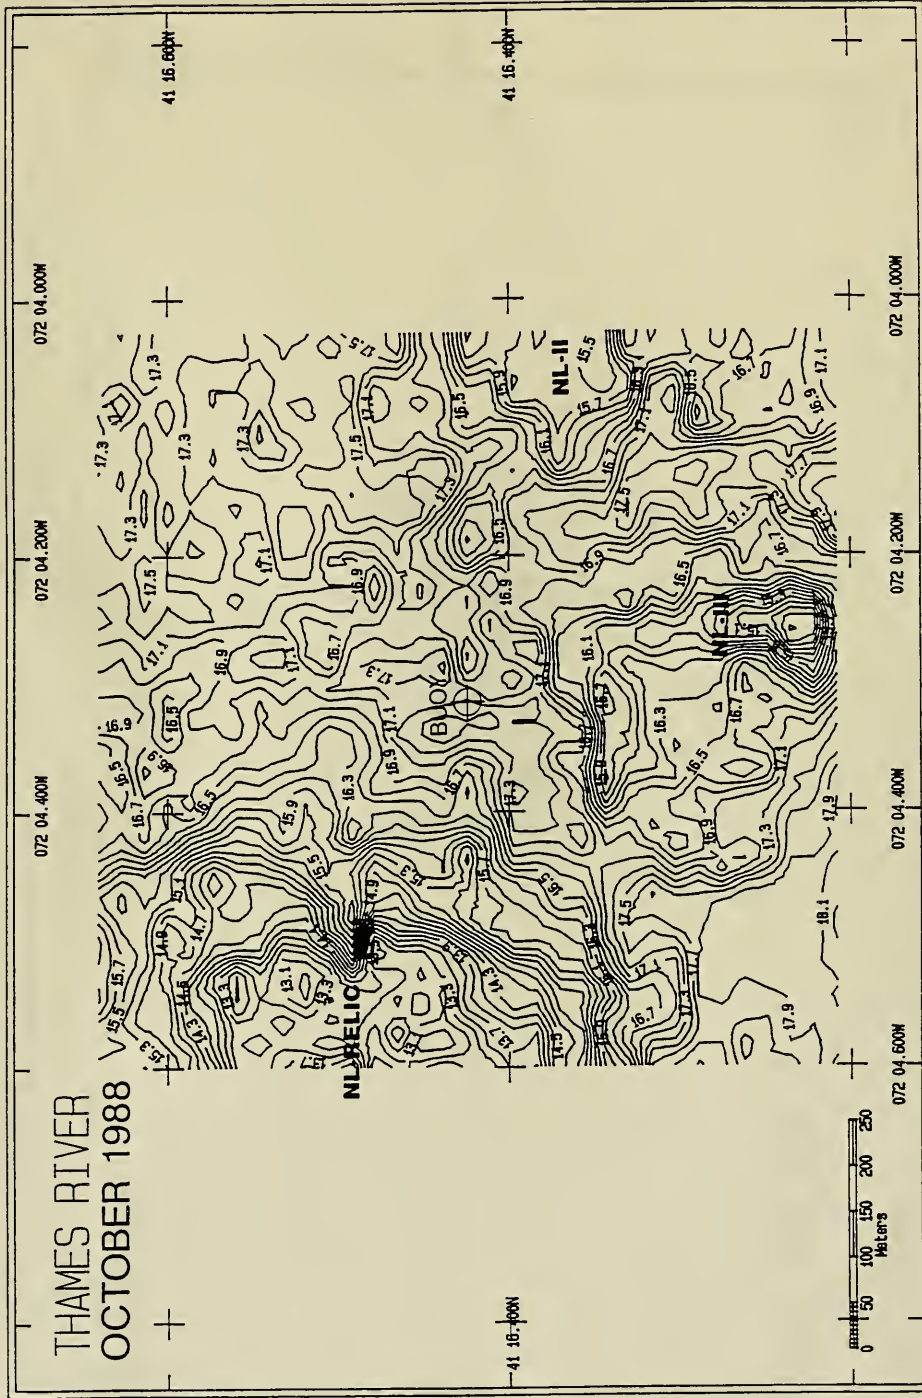
Figure 2

Post-disposal bathymetric contour plot of the Thames River Shipyard Disposal Location, October 1988. Contours at 0.2 m intervals.

Most of the capping material was evident in the area to the southeast of the buoy. At roughly 150 m south of the buoy, the cap layer showed a minimum depth of 14.8 m, in comparison to the 1988 minimum depth of 15.5 m at this location. Another topographic high of 15.6 m was detected 140 m southeast of the buoy in the 1989 contour plot, 0.6 m higher than the 16.2 m shown at this location in the 1988 contour plot. While this capping layer was relatively steep-sided in parts, it showed several isolated topographic highs. This reflected both the areal extent of the underlying disposal mound as well as a spatial variation in cap thickness ranging from 10 to 70 cm. It should be noted that in 1988 the western part of NL-II showed a minimum elevation of 15.5 m, whereas in 1989 the very western part of the mound showed a minimum elevation of 15.2 m. This indicated an extension of the cap layer to the edge of NL-II with a thickness of approximately 30 cm in this area.

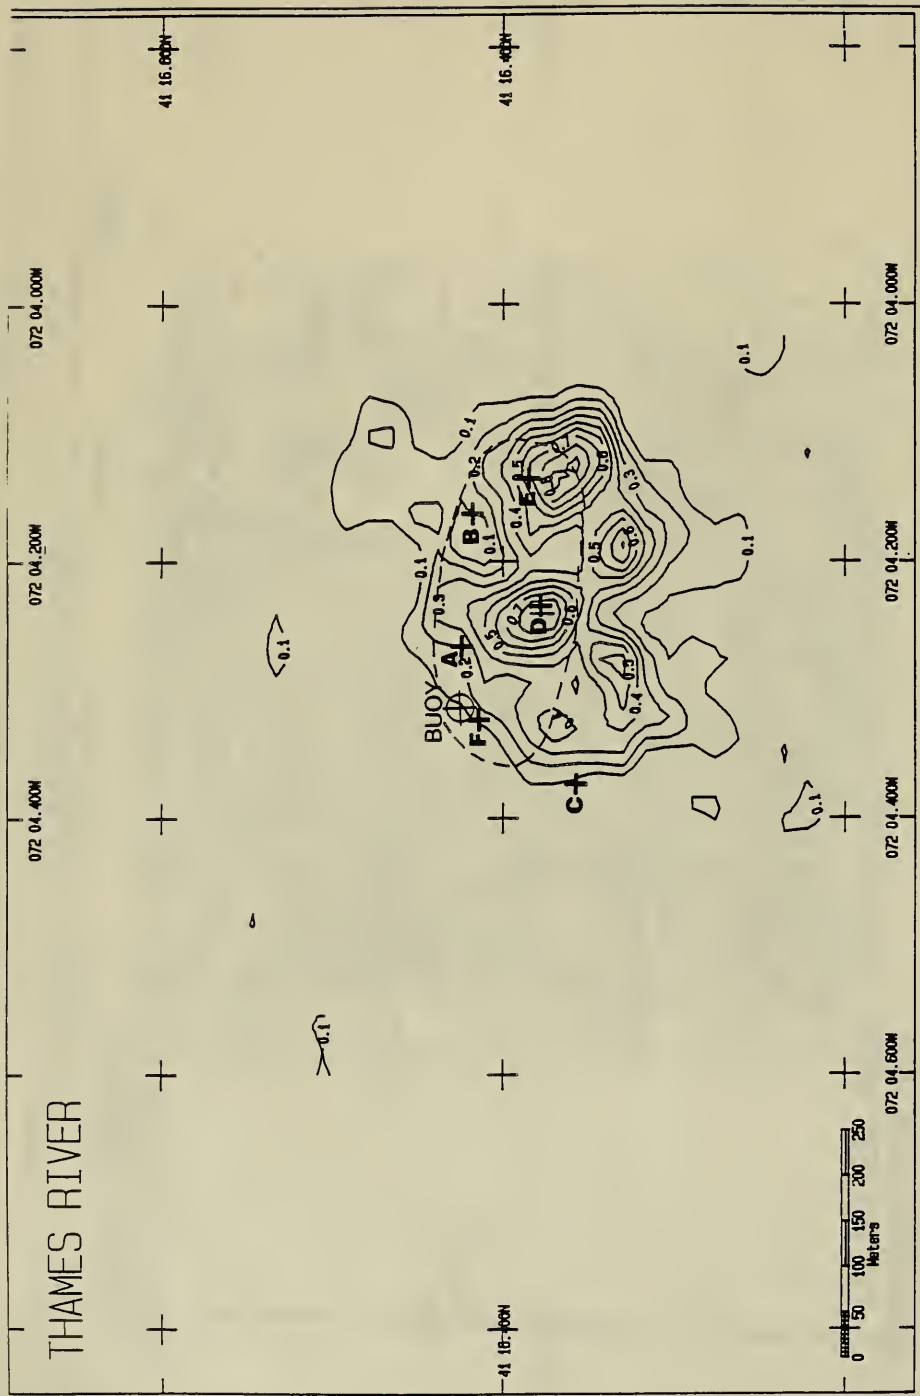
Figure 3 Depth difference contour plot of the Thames River Shipyard Disposal Location, showing the distribution of cap material, February 1989 - October 1988. The dashed contour line indicates the mapped distribution of contaminated dredged material as detected by the REMORS survey of October 1988. Points "A" - "F" are the disposal point locations recommended in the Thames River Shipyard capping plan (SAIC, 1988).

To determine cap thickness a depth difference plot was prepared by subtracting the depth matrix of the October 1988 bathymetric survey from that of the February 1989 survey (Figure 3). The cap material clearly showed a roughly circular and continuous distribution varying in thickness from 10 to 80 cm. This depth difference comparison resulted in a calculation of 28,270 m³ of cap material detected at the site. According to scow log records an estimated 59,517 m³ of cap material was deposited between October 1988 and January 1989 (Table 2).

Examination of the distribution of cap thickness in relation to the six recommended disposal points revealed that cap material was clearly deposited at points "D" and "E". These were the locations of the two thickest parts of the cap layer, having cap material accumulations of 80 cm (Figure 3). Cap thicknesses of 50 to 60 cm were also established to the southwest of these two disposal points. However, point "A" was intended to have received the most scow loads of cap material because of the contaminated dredged material thickness at this point (Table 1). The depth difference contour plot indicated only 20 cm of cap material here. At disposal points "B", "C", and "F" only 10 cm of cap material appeared to have been deposited (Figure 3).

The erratic topography of the cap layer generally reflects the spatial distribution of the recommended disposal points (Figure 3). However, detected cap thicknesses surrounding these locations suggests a consistent shift in cap material deposition to the southeast. The largest volumes of cap material were reportedly disposed of at points "A" and "B" (Table 2). However as already noted, the two thickest parts of the cap layer actually detected are located at points "D" and "E". These points are offset to the southeast of points "A" and "B". Similarly at point "F" little cap material was indicated in the depth difference contour (Figure 3), yet a localized cap layer of 40 cm was detected just south of this disposal point. Similar topographic highs in the cap material distribution were indicated south of disposal points "D" and "E" (Figure 3). This suggests that some offset was consistently

affecting the positioning accuracy of cap material deposition during the capping operation. Most likely this was due to a consistent Loran error, resulting in the cap layer effectively covering the majority of the contaminated dredged material with the exception of the northern and western borders of its distribution.

It appears that additional capping material is required at certain locations along the northern and western borders of the disposal mound. It is recommended that additional material be deposited at locations "A", "B", "C", and "F" in order to cover the contaminated material with a sufficiently thick layer of clean material (between 50 to 100 cm). However, because of discrepancies between the recommended disposal point locations and the actual distribution of cap material detected, it is recommended that

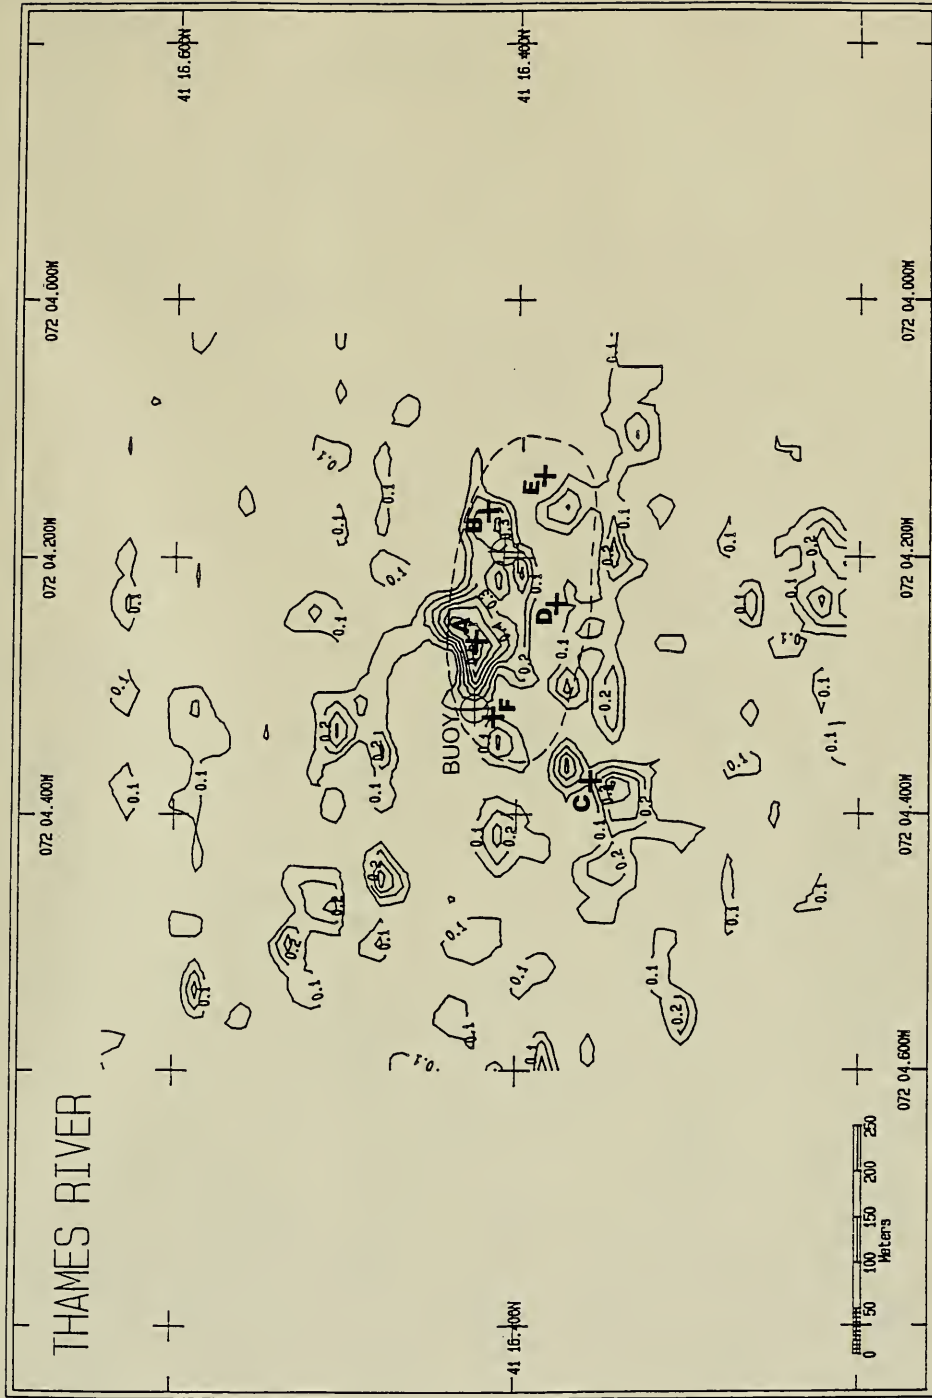
Figure 4

Depth difference contour plot of the Thames River Shipyard Disposal Location, showing the distribution of contaminated dredged material, October - August 1988. The dashed contour line indicates the mapped distribution of contaminated dredged material as detected by the REMOTS survey of October 1988. Points "A" - "F" are the disposal point locations recommended in the Thames River Shipyard capping plan (SAIC, 1988).

Depth difference calculations from the pre- and post-disposal bathymetric surveys of contaminated material revealed the distribution of material requiring capping (Figure 4). The mapped distribution of dredged material indicated from the REMOTS® survey of this area conducted in October 1988 confirmed this distribution detected by bathymetric techniques, and extended it roughly 50 m to the south, east and west (SAIC, 1988). Superimposing this distribution of dredged material as detected by the REMOTS® survey of October 1988 over the cap distribution detected in 1989 again confirmed that most of the contaminated material did receive some cap material (dashed line, Figure 3). However, at disposal point "A", 70 cm of contaminated material apparently received only 20 to 30 cm of cap material (Figures 3 & 4). In addition, at disposal point "F" 10 to 20 cm of contaminated dredged material was apparently capped by only 10 cm of clean material based on the 1989 bathymetric depth difference plot (Figure 3).

The depth difference plot from the pre- and post-disposal bathymetric surveys of contaminated material indicated a small deposit located roughly 150 m southwest of the buoy (near point "C", Figure 4). Although this material fell outside the mapped distribution of dredged material verified by the 1988 REMOTS® survey, it was recommended that this deposit be capped in addition to the main disposal mound because of the substantial amount of material detected here in the depth difference comparison (SAIC, 1988). This location should have been covered by scow loads of cap material deposited at point "C". However, the 1989-1988 depth difference plot indicated little or no cap material at this location. It should be noted that bathymetric surveys are limited in their ability to detect thin layers of sediment typical of disposal mound flank deposits. Thus, it is likely that the actual borders of the cap layer extend further than indicated in the bathymetric depth difference contour plot, covering locations such as disposal point "C". However it is unlikely that such flank layers would be thicker than the minimum change in depth detectable by bathymetric techniques (10 cm).
