BUREAU OF STANDARDS

No. 113

STRUCTURE AND RELATED PROPERTIES OF METALS

JULY 7, 1922

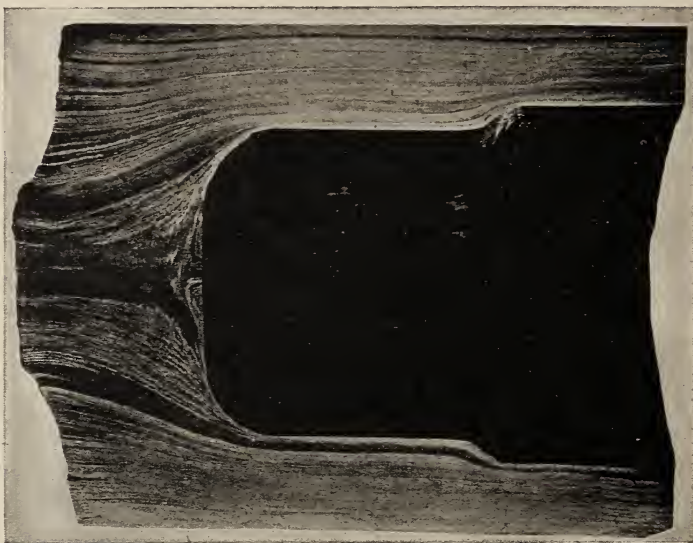
FIG. 5.—Macrostructure of forged steel (longitudinal section of the head of a shrapnel shell) revealed by etching with cupric chloride (Stead's reagent). $\times 4/5$

An acidulated alcoholic solution of copper chloride is often used to reveal the distribution of phosphorus. Various formulas for preparing this reagent have been recommended by different investigators. In general, however, the results obtained are very similar for all of them. The formula of Stead (copper chloride, 10 g; magnesium chloride, 40 g; concentrated hydrochloric acid, 20 cm³; and alcohol to make 1000 cm³) and that of LeChatelier (95 per cent alcohol, 100 cm³; water, 10 cm³; copper chloride, 1 g; picric acid, 0.5 g; and concentrated hydrochloric acid, from 1 to 3 cm³) may be cited as representative. After an immersion of about one minute, the previously polished and cleaned surface of the specimen will usually be found to be covered in certain portions with a firmly adhering film of copper. Other parts remain clear or uncoated. The copper-coated portions are generally considered to be of lower phosphorus content than the clear or slightly coated portions. Other elements in solid solution, however, such as nickel, may produce a similar differential precipitation of the copper, and the work of LeChatelier and Bogitch⁷ appears to indicate that the reagent is primarily useful for demonstrating the distribution of oxide within the steel, the other indications being only secondary ones. Fig. 5 shows a portion of a shrapnel shell which was etched with this reagent.

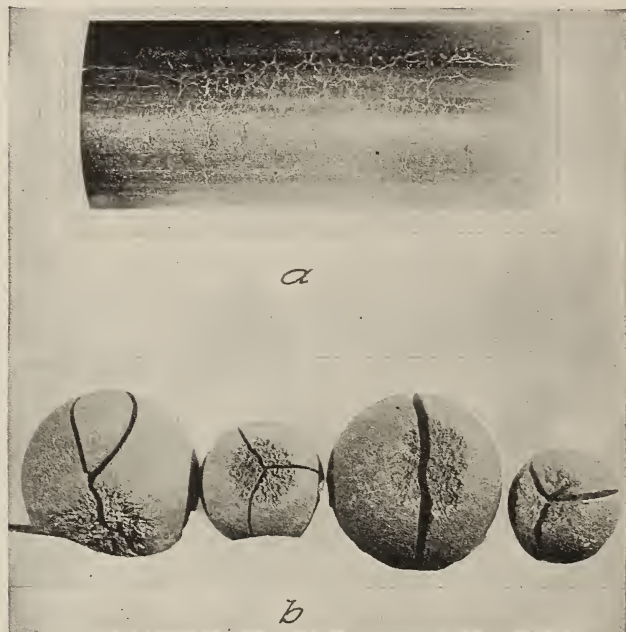
FIG. 10.—Mechanical nonuniformity of wrought metals revealed by deep etching

Cracks resembling those shown result from deep etching may be produced "spontaneously" in service in metals highly stressed internally. (a) Section of a 1-inch manganese bronze rod etched with an acidulated aqueous solution of mercurous nitrate (65 g mercurous nitrate, 15 cm³ nitric acid per liter). $\times 1$. (b) Hardened steel balls which split open when deeply etched with concentrated hydrochloric acid. $\times 2$

Fig. 10 a shows a portion of a cold-worked rod of manganese bronze which has been immersed in a solution of mercurous nitrate acidulated with nitric acid. The cracks which were formed by the action of this reagent may be taken as an indication of what would undoubtedly have occurred spontaneously later in service.¹¹

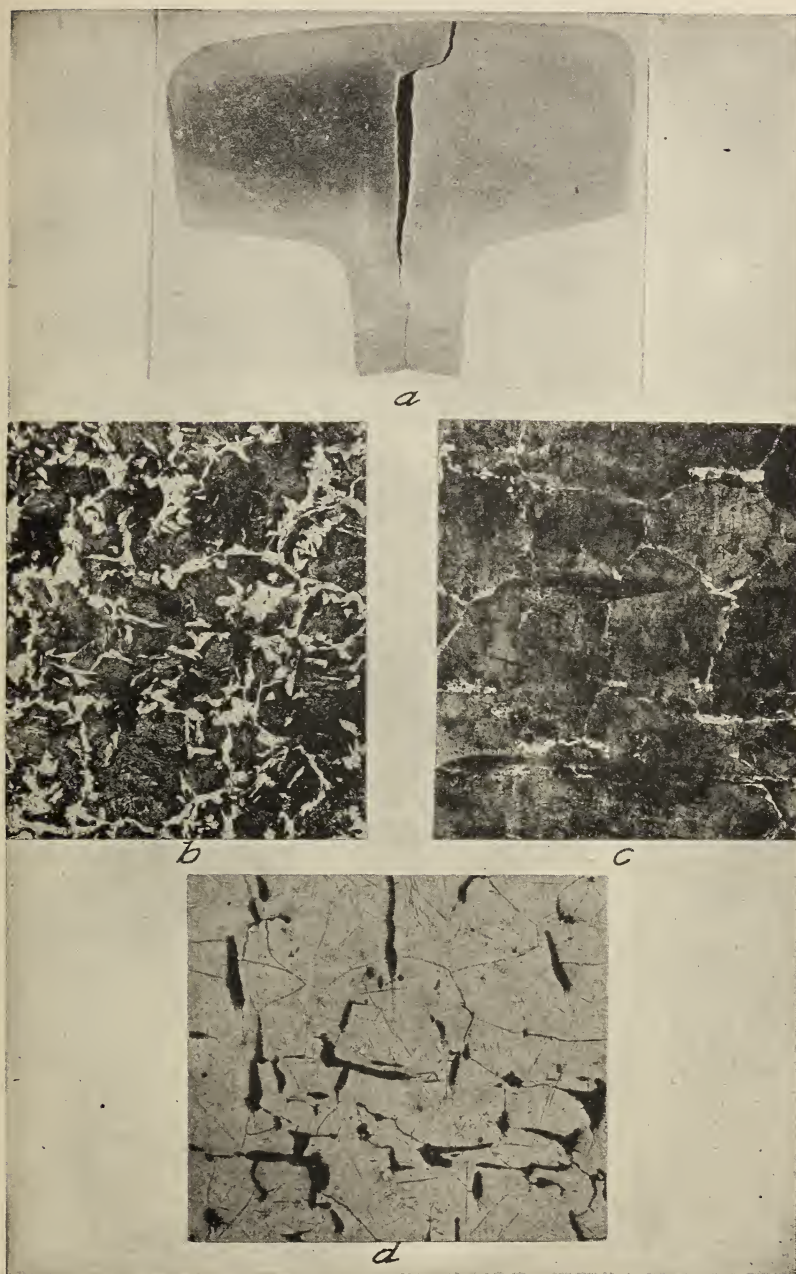
FIG. 16.—Variations in the microstructure of rail steel caused by segregation

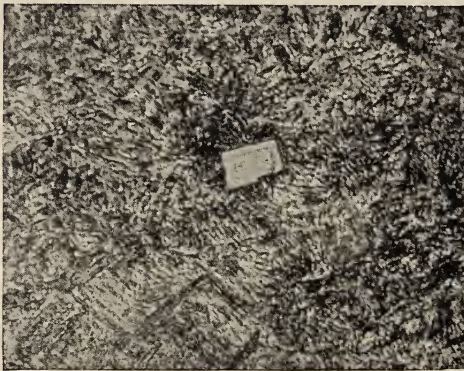
FIG. 17.—Characteristic appearance of an inclusion caused by the addition of titanium to steel.
 $\times 1000$

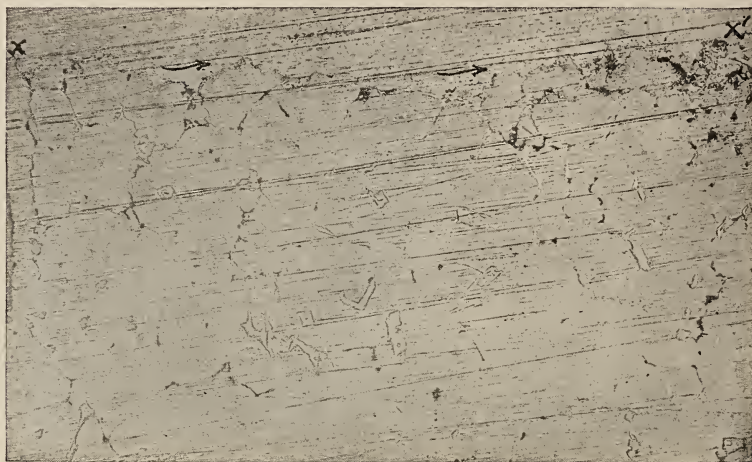
FIG. 28.—Microstructure of cast aluminum alloy showing the "path" of the fracture produced by a tensile stress. $\times 100$

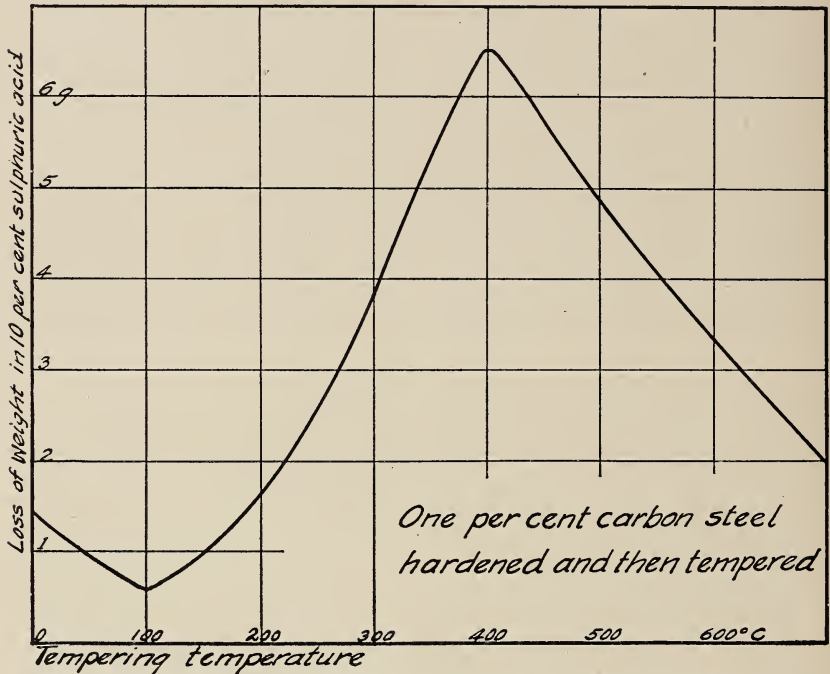
FIG. 37.—Variation in the solubility of 1 per cent carbon steel in dilute sulphuric acid, after hardening and tempering to different temperatures. (Hanemann)

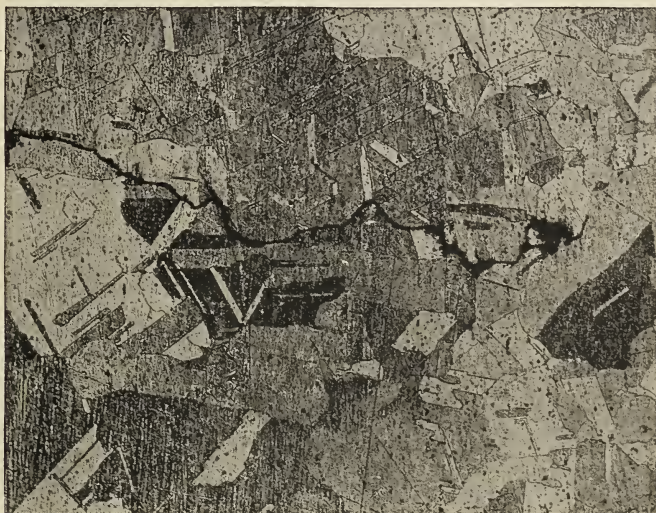
FIG. 46.—Microstructure of copper which was spoiled in annealing as a result of the nature of the surrounding atmosphere. $\times 100$

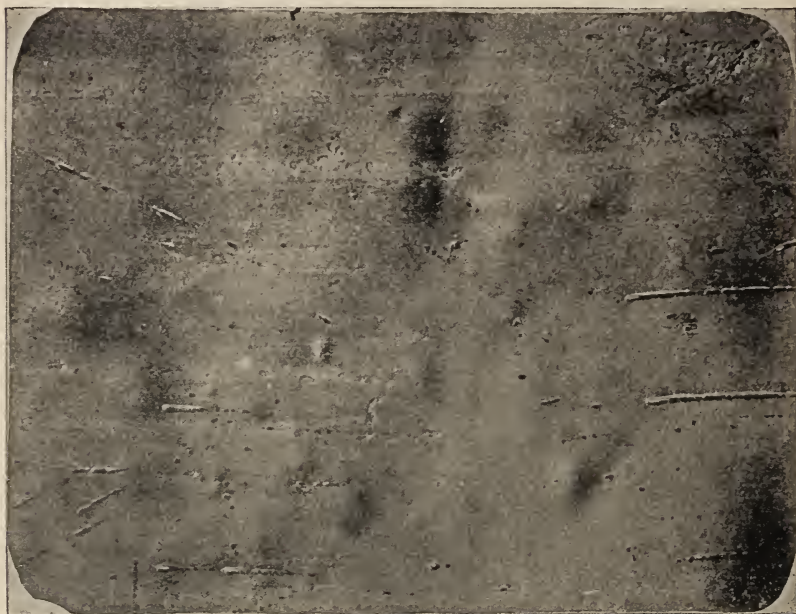
FIG. 49.—*Appearance of the exposed surface of corroded tinned copper sheathing used for roofing purposes. $\times 1$*

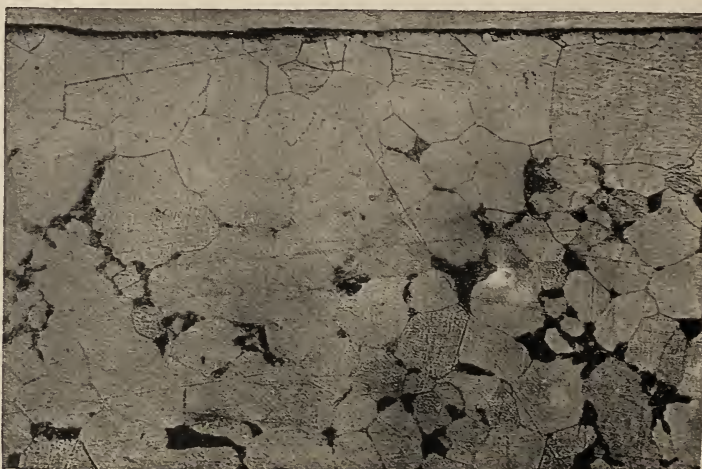
FIG. 51.—Microstructure of an iron-carbon alloy which was decarburized by heating in vacuo. $\times 100$

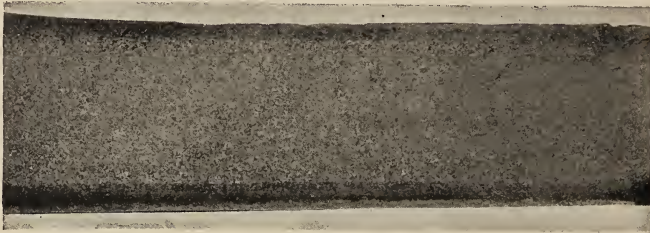
FIG. 58.—Macrostructure of a steel block showing surface changes caused by cutting the steel by means of the oxyacetylene flame. $\times 1$

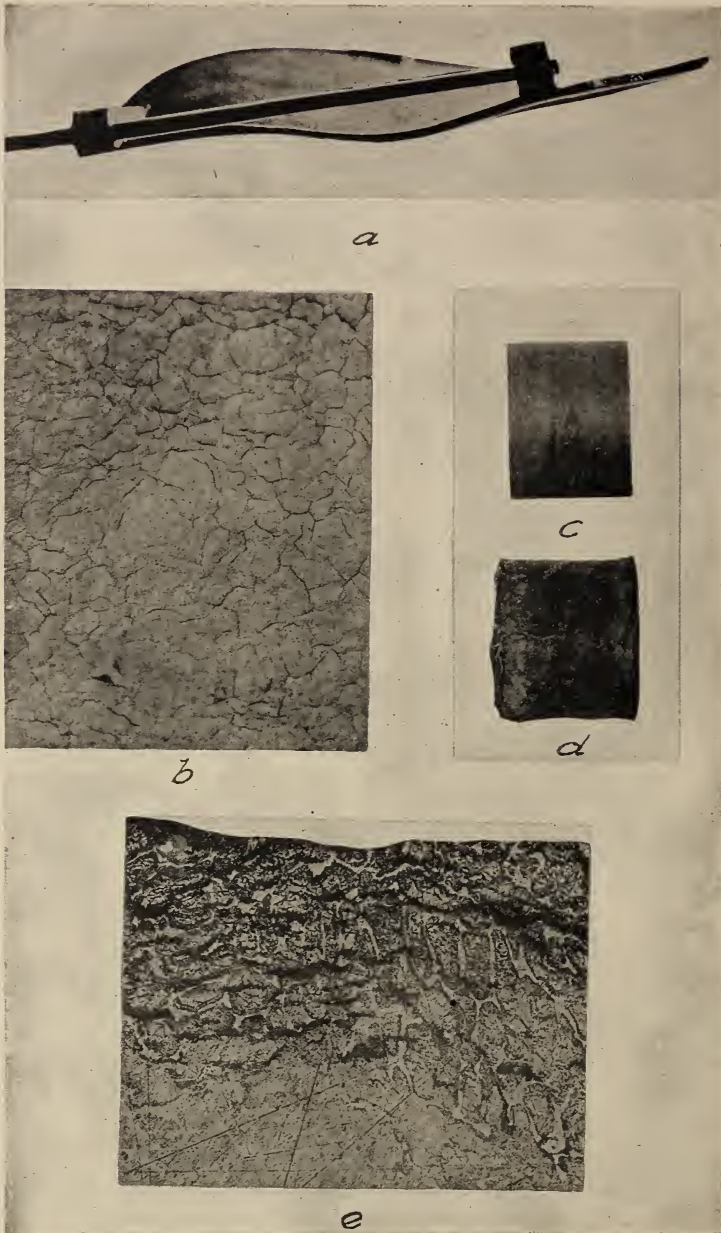
FIG. 64.—Appearance of certain aluminum alloys of high zinc content after deterioration
