MISSION #22 OMURA "BUNCHBERRY 4"
19 Dec 44

Tactical Mission Report

No. 22

TARGET: OMURA AIRCRAFT PLANT

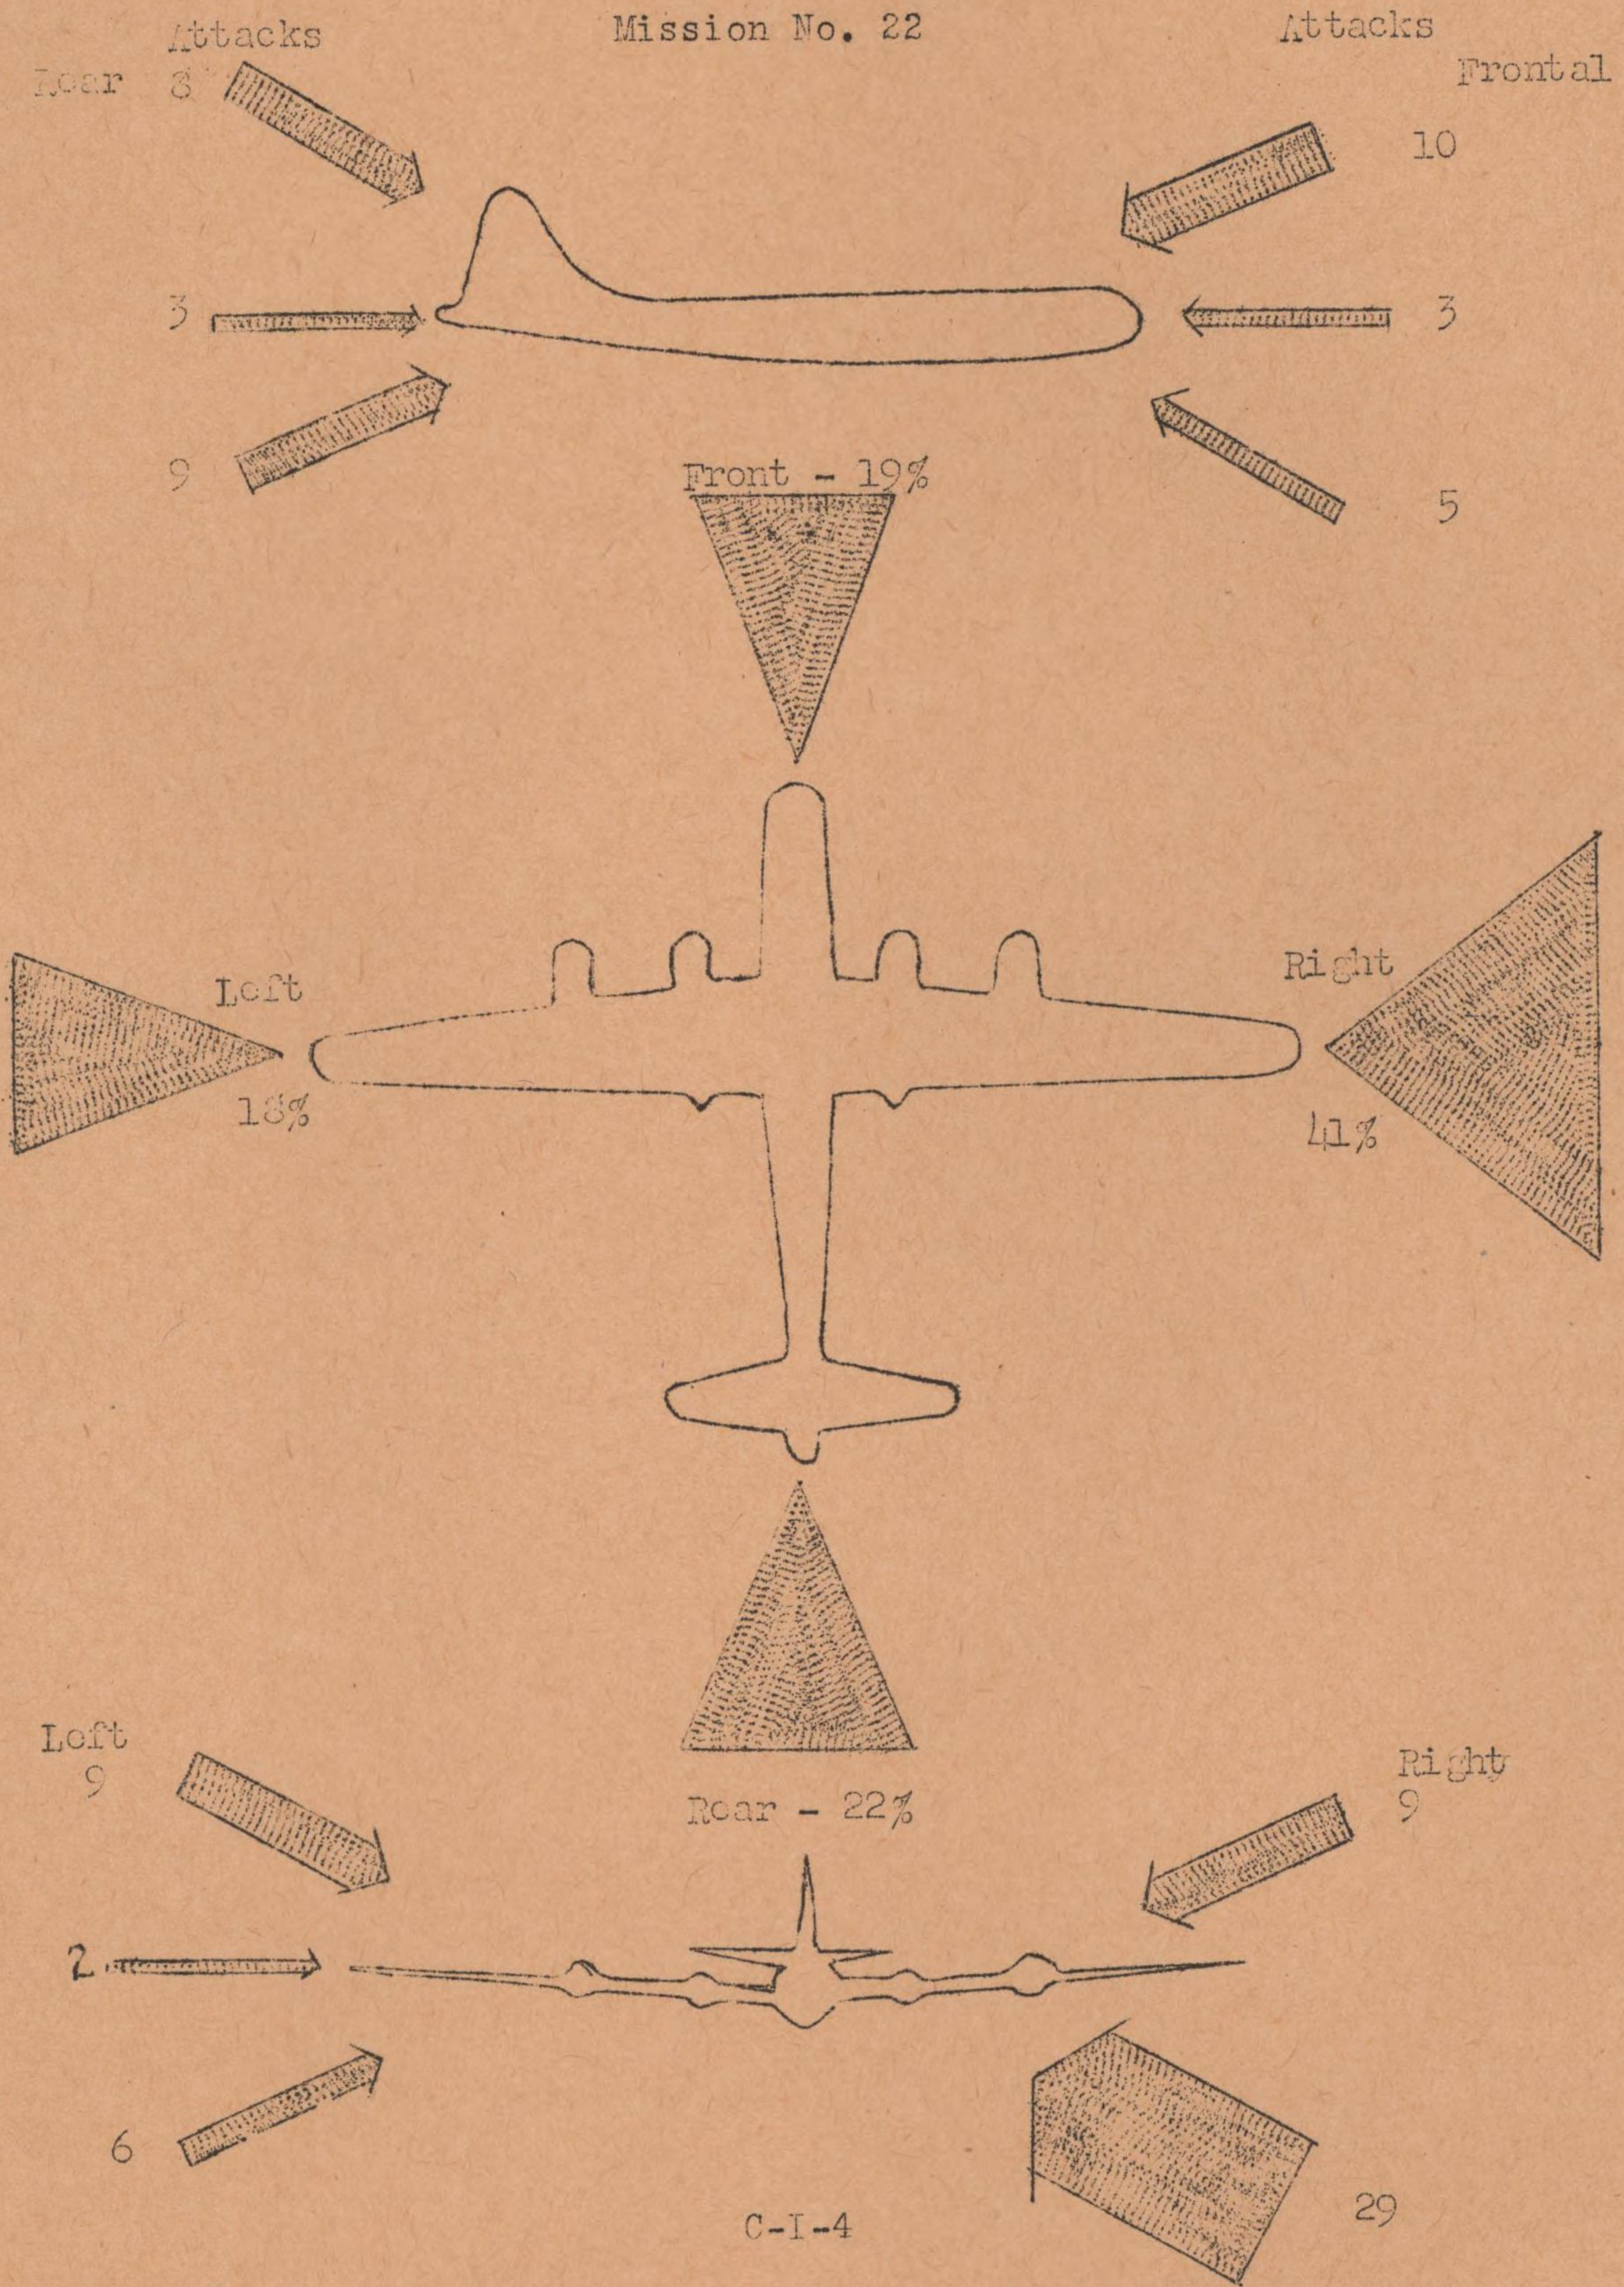
Exhibit A

DIRECTION AND LEVEL OF APPROACH

b. As to level of approach, another interesting change was noted in the predominance of low attacks - 53 per cent. High approaches were 39 per cent, and level approaches were 8 per cent. The coordinated attacks mentioned in the preceding paragraph were largely responsible for this change, too, as the level of approach for all 20 attacks was low.

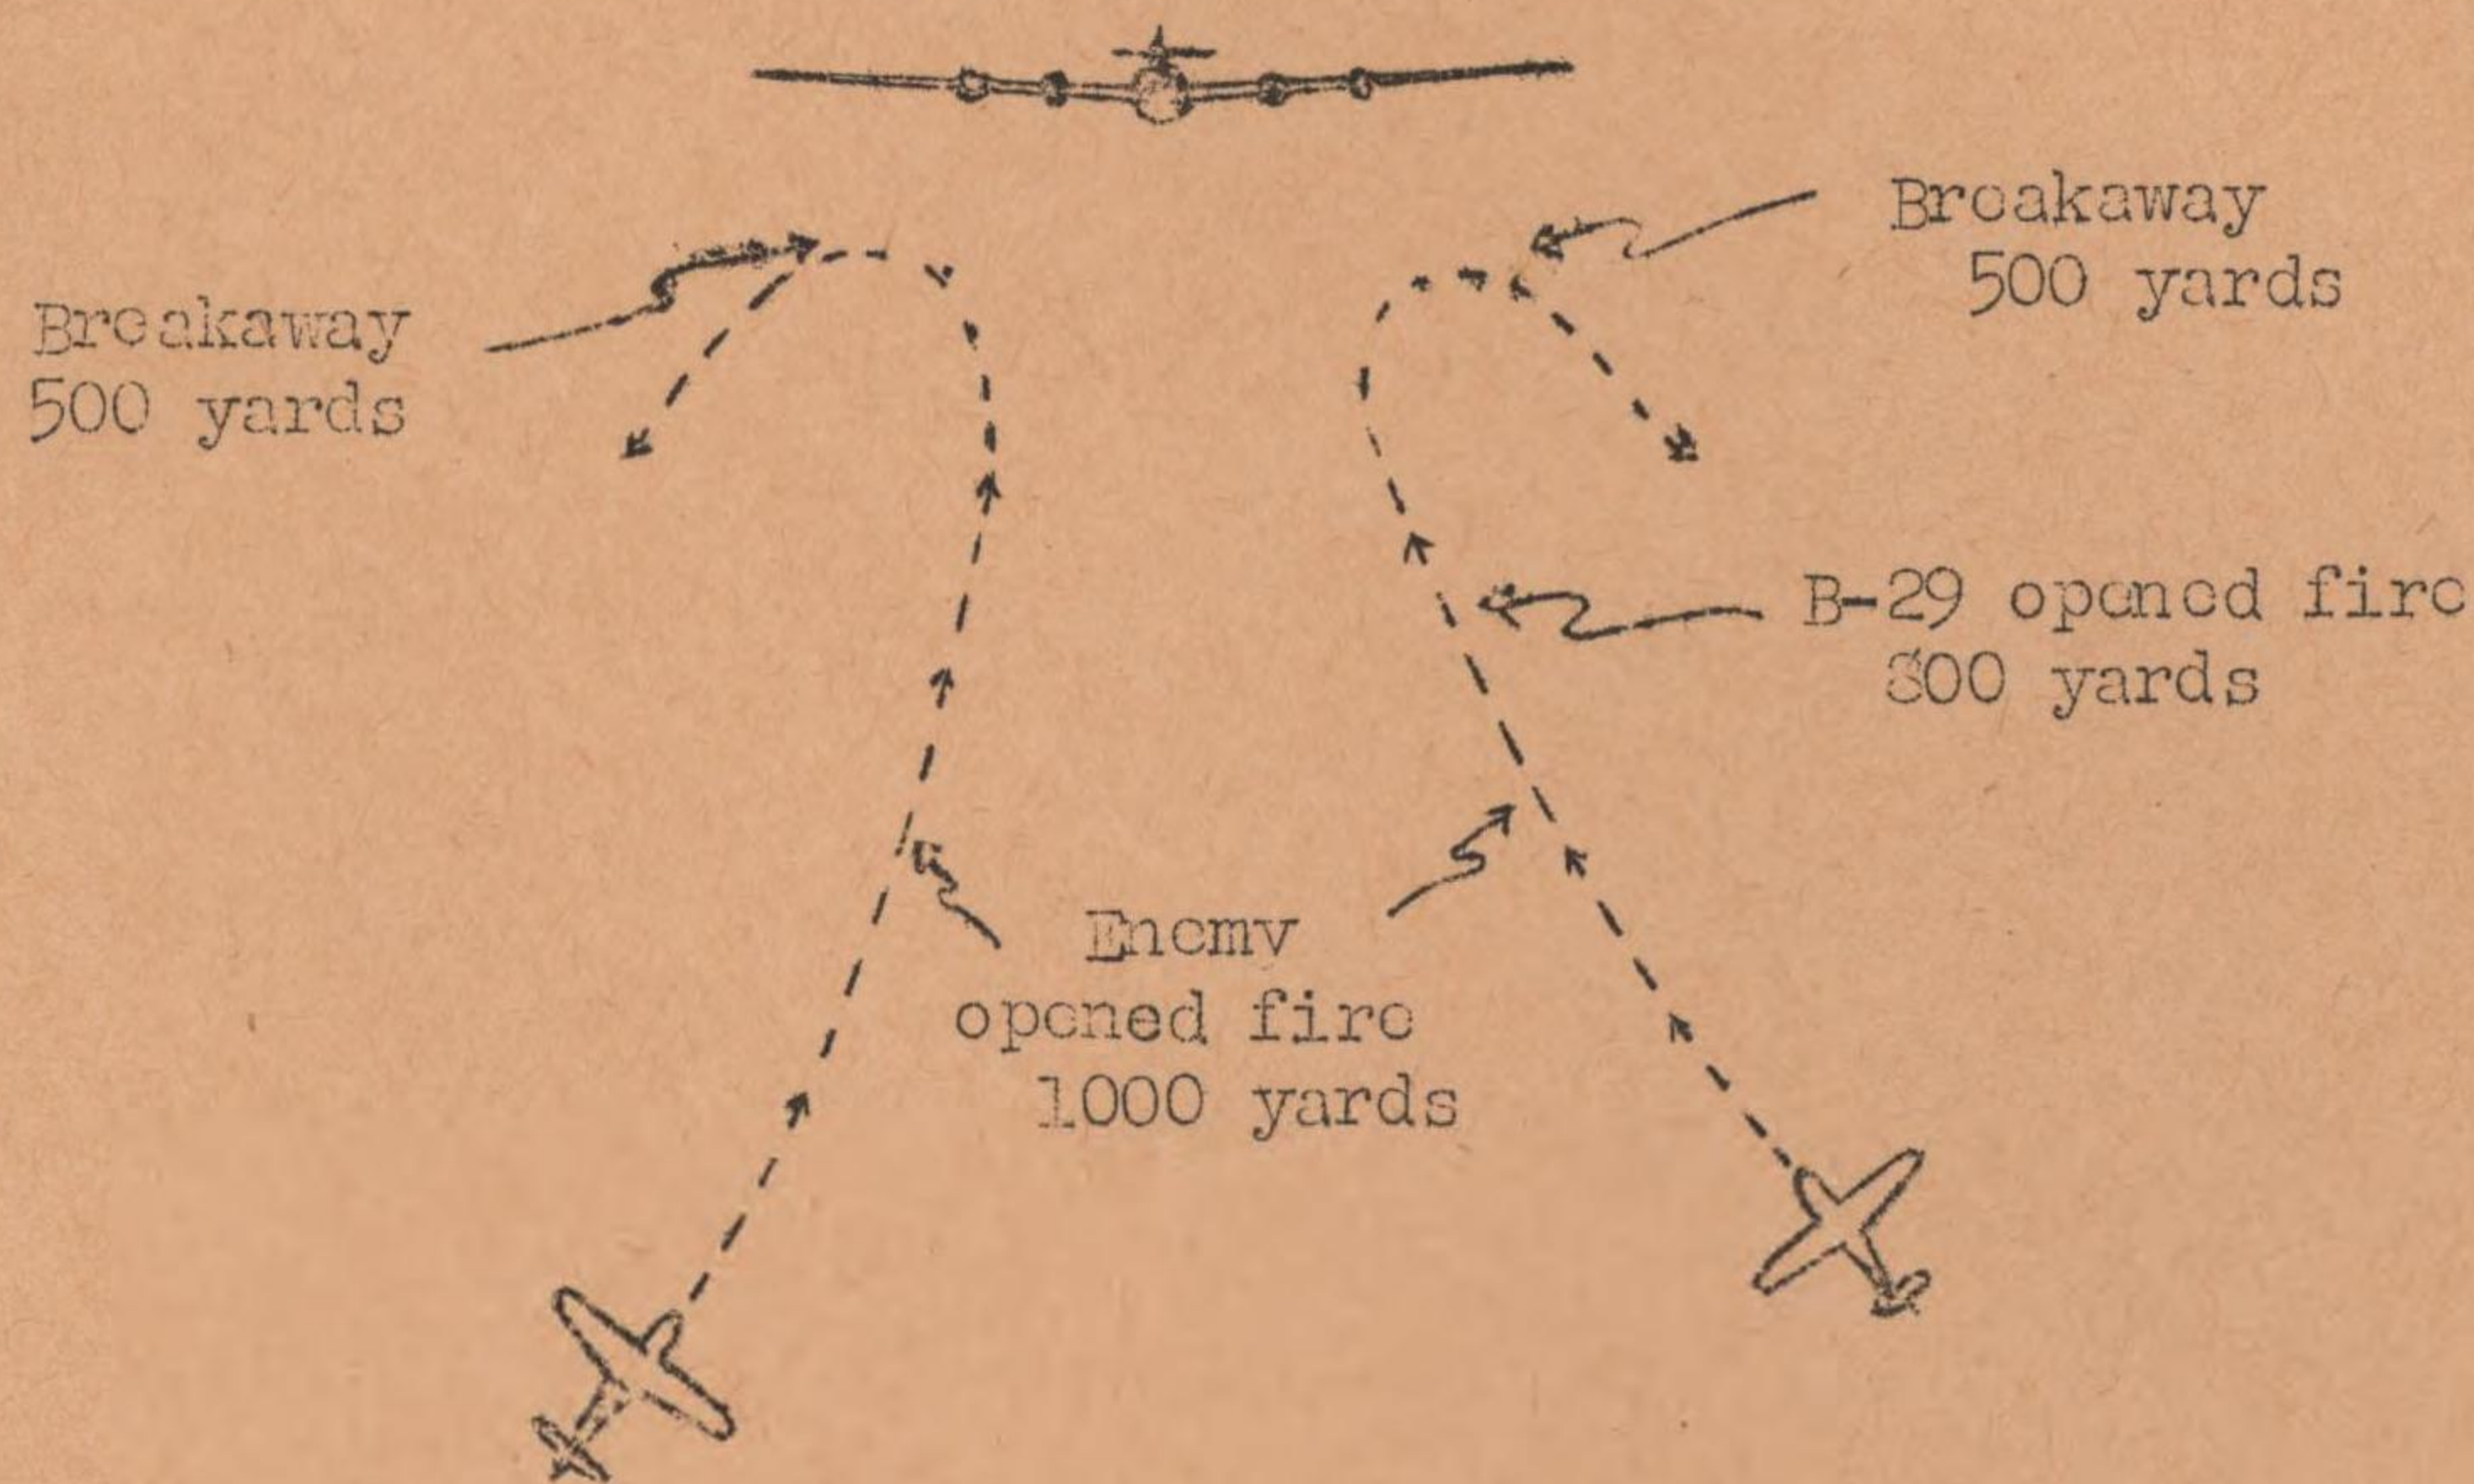
The B-29 opened fire at 800 yards and claimed damage on the 11 o'clock TONY. The other was not hit. No damage was reported to the B-29. Diagram follows:

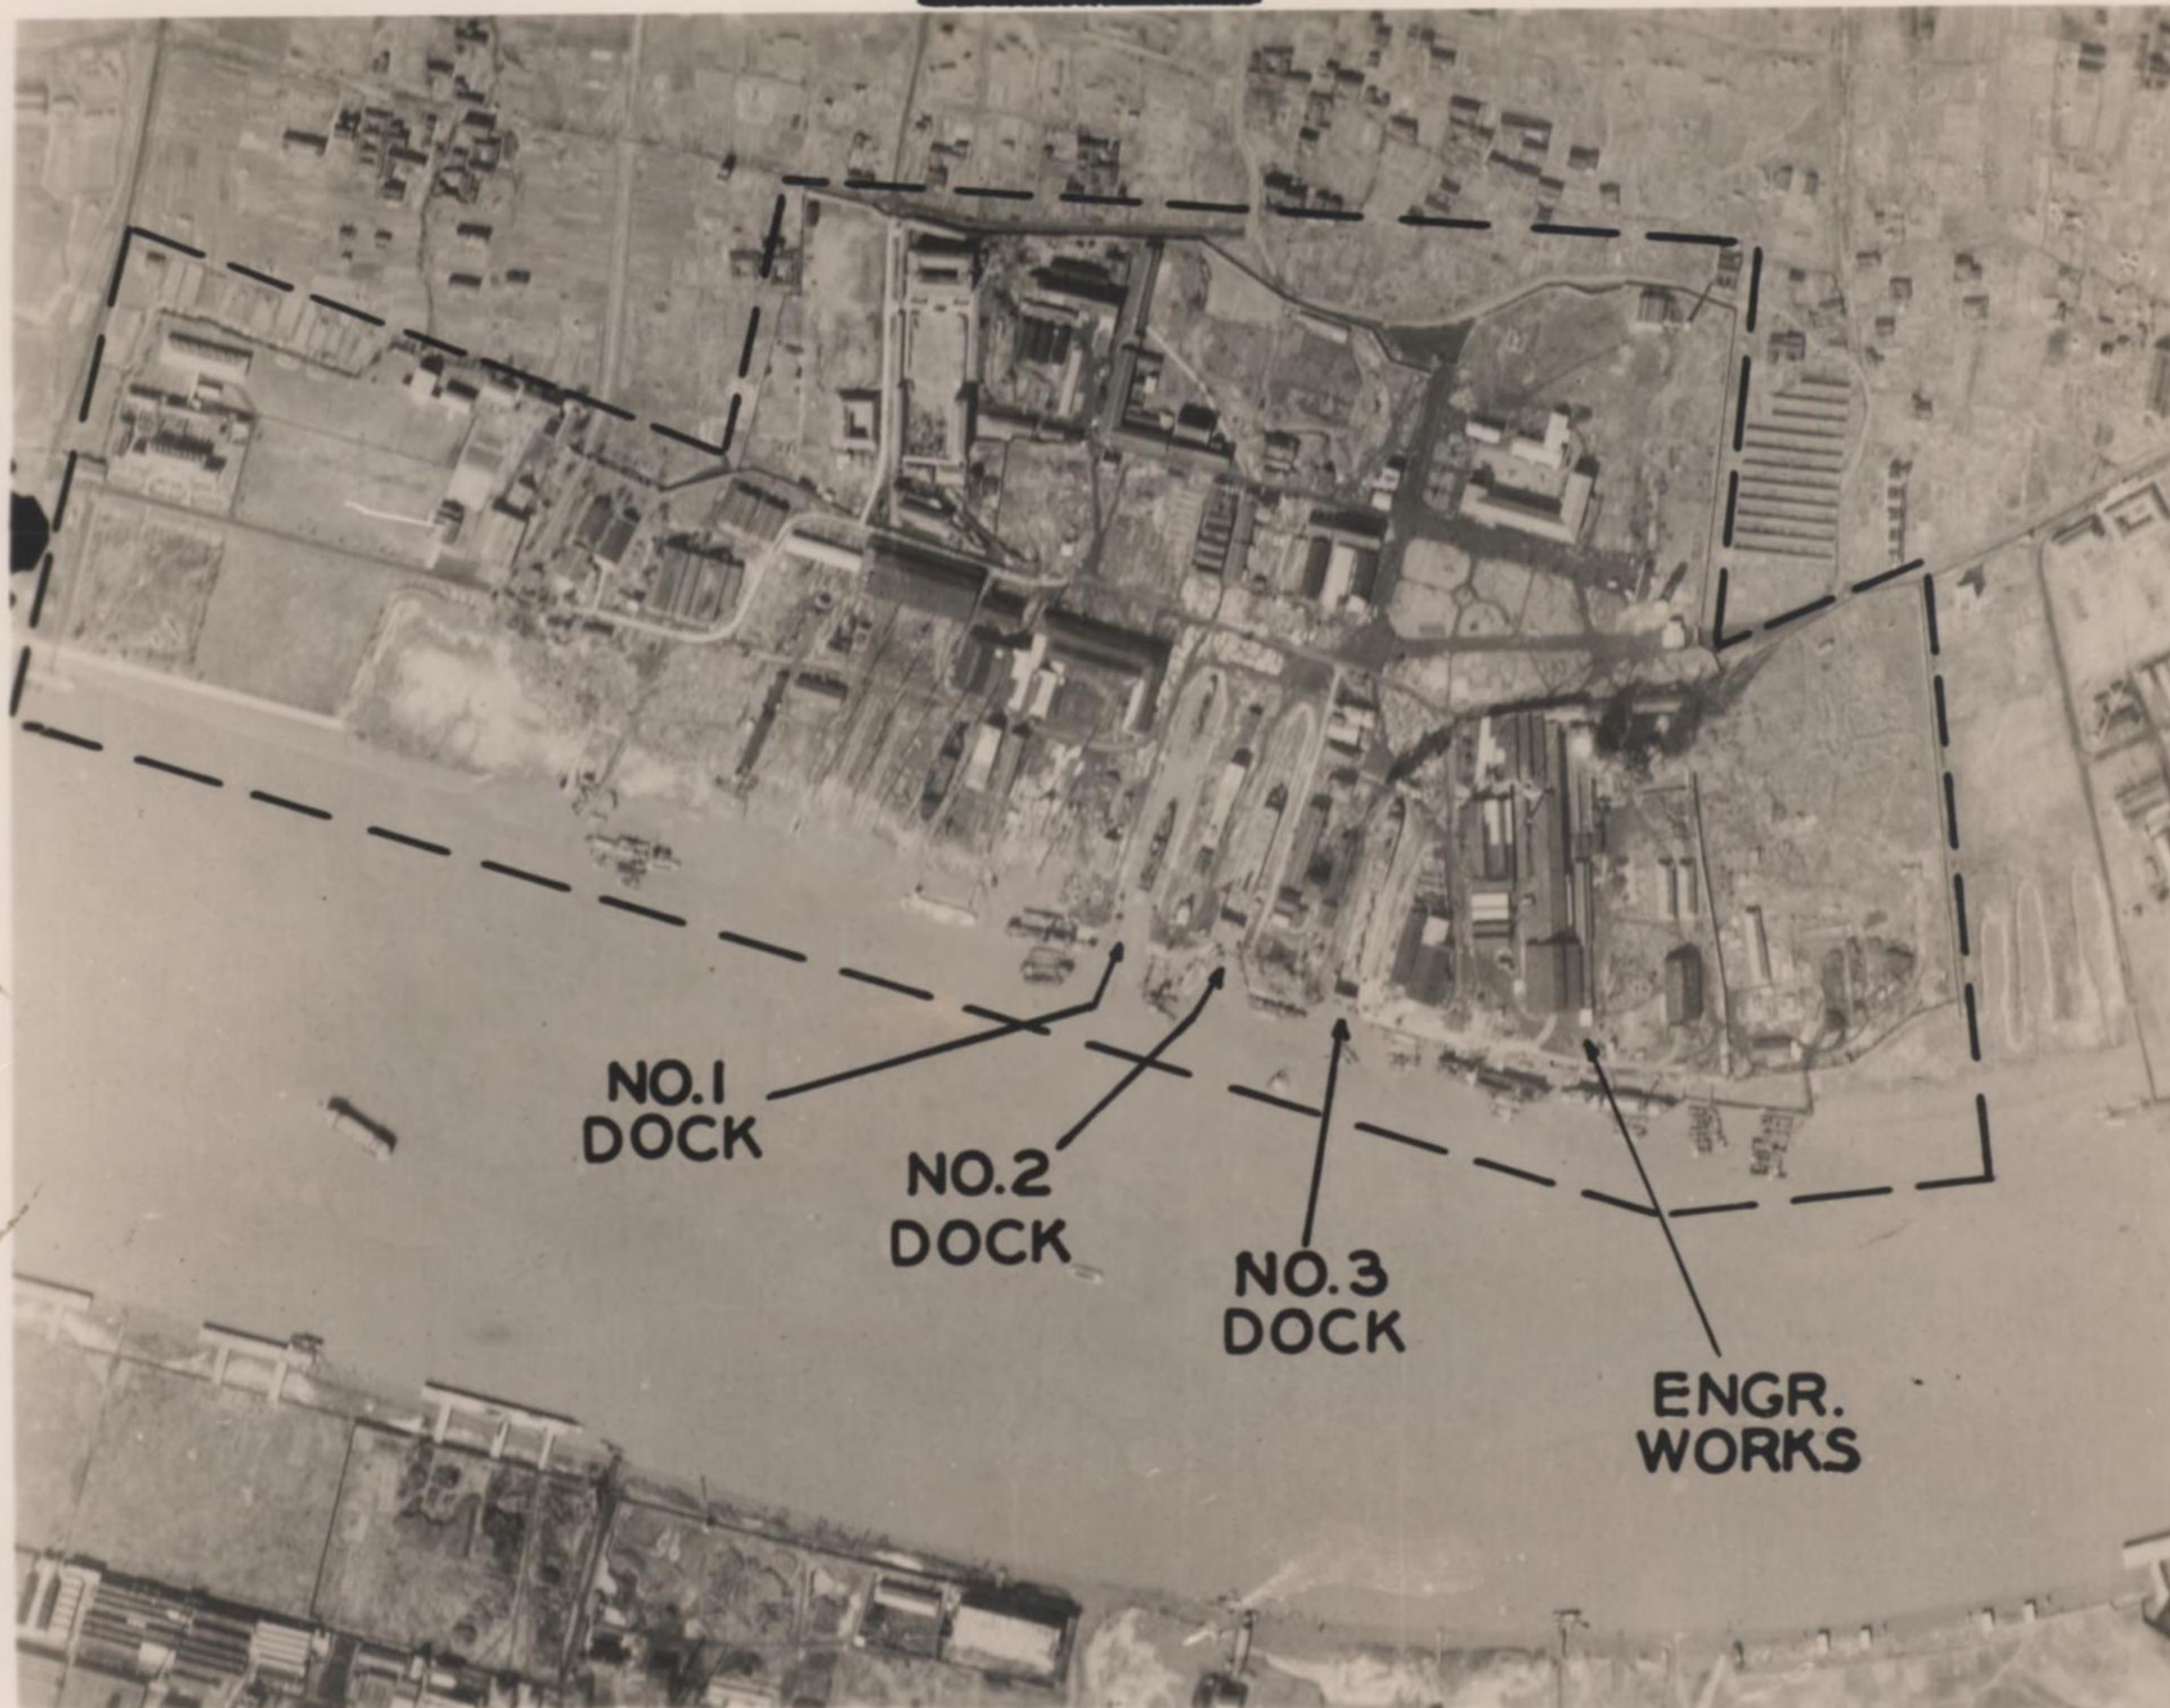
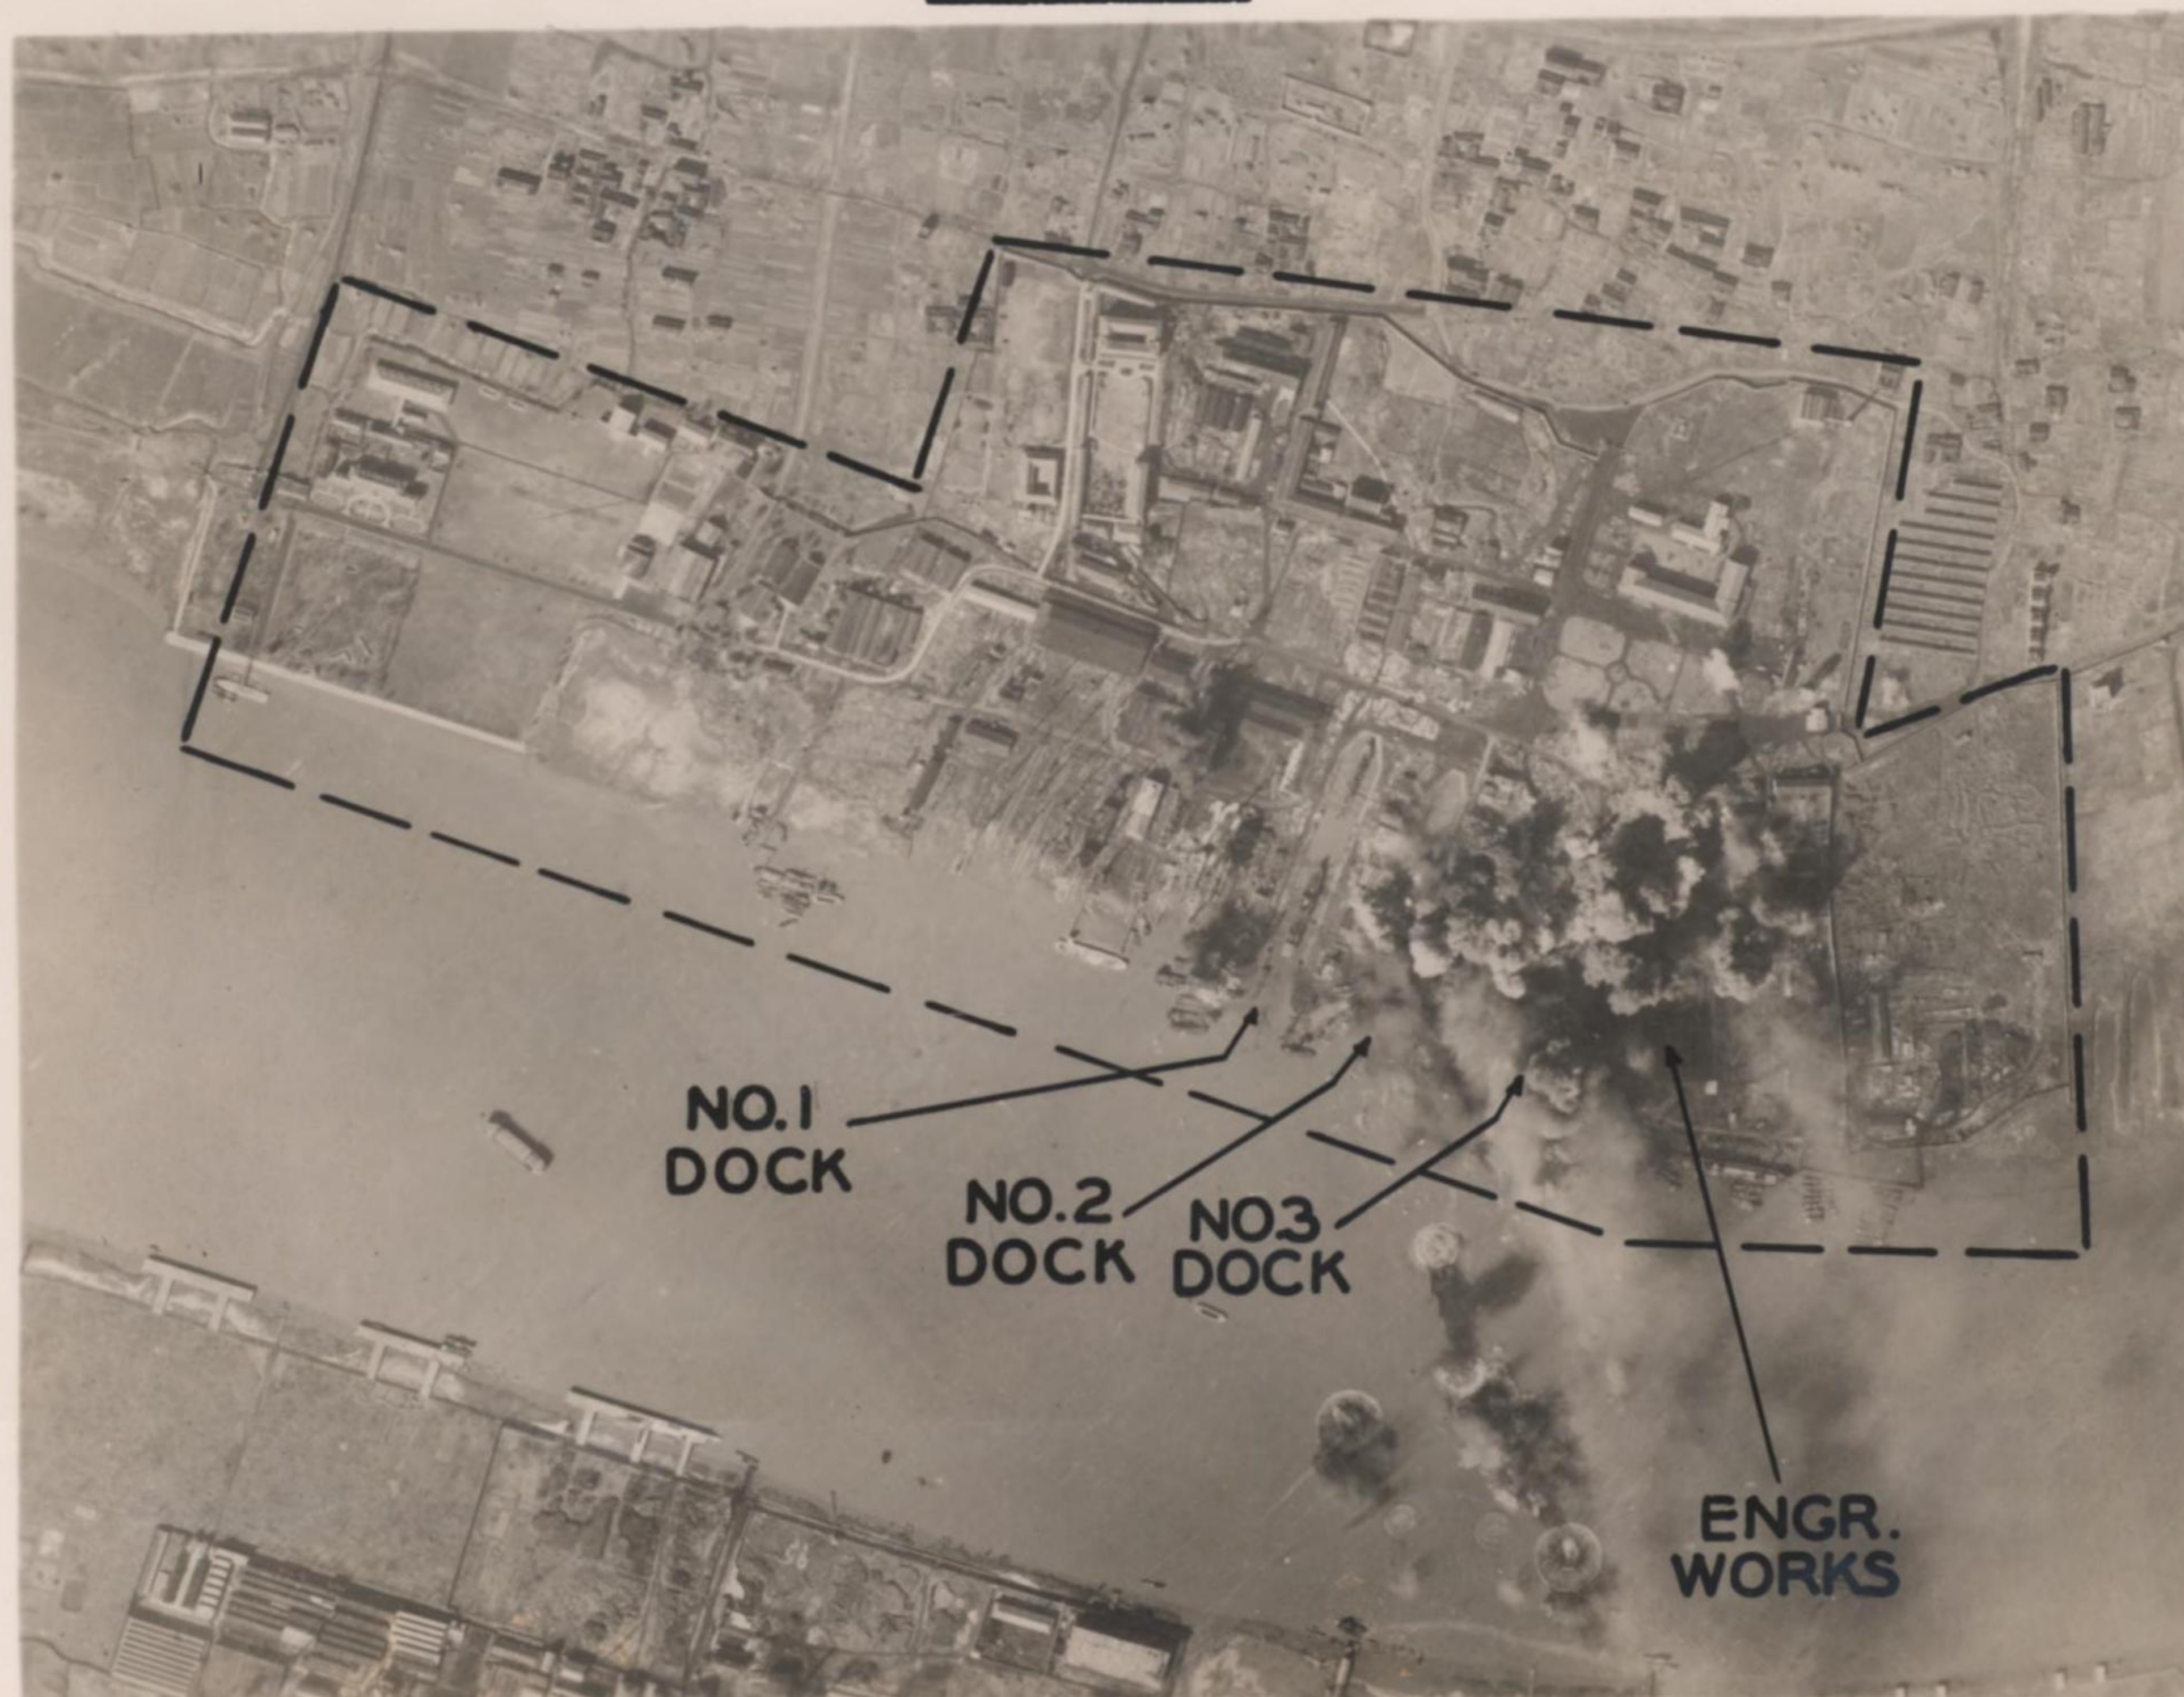
ANNEX I
D.A. REPORT NO. 33 (PROV.)
KIANGNAN DOCKS
SHANGHAI, CHINA
TARGET UNIT ,XXB.C.
CONFIDENTIAL
BEFORE

DURING

(3) The 6 plane formation, last over, centered its pattern on No. 3 Dock with many hits observed on the large Engineering Works Complex of buildings just east, and on workshops adjoining the docks as well as on the large Machine Shop northwest of the No. 3 Dock. In addition hits appear to have been scored on the Steamer in Dock No. 3, on a large barge at the wharf and on a 220' River Steamer tied off Dock No. 3. Damage resulting is believed heavy.
