THESIS

**NPS TERAHERTZ PROJECT: IR HAB FLIGHT
TESTING AND INTEGRATION**

March 2018

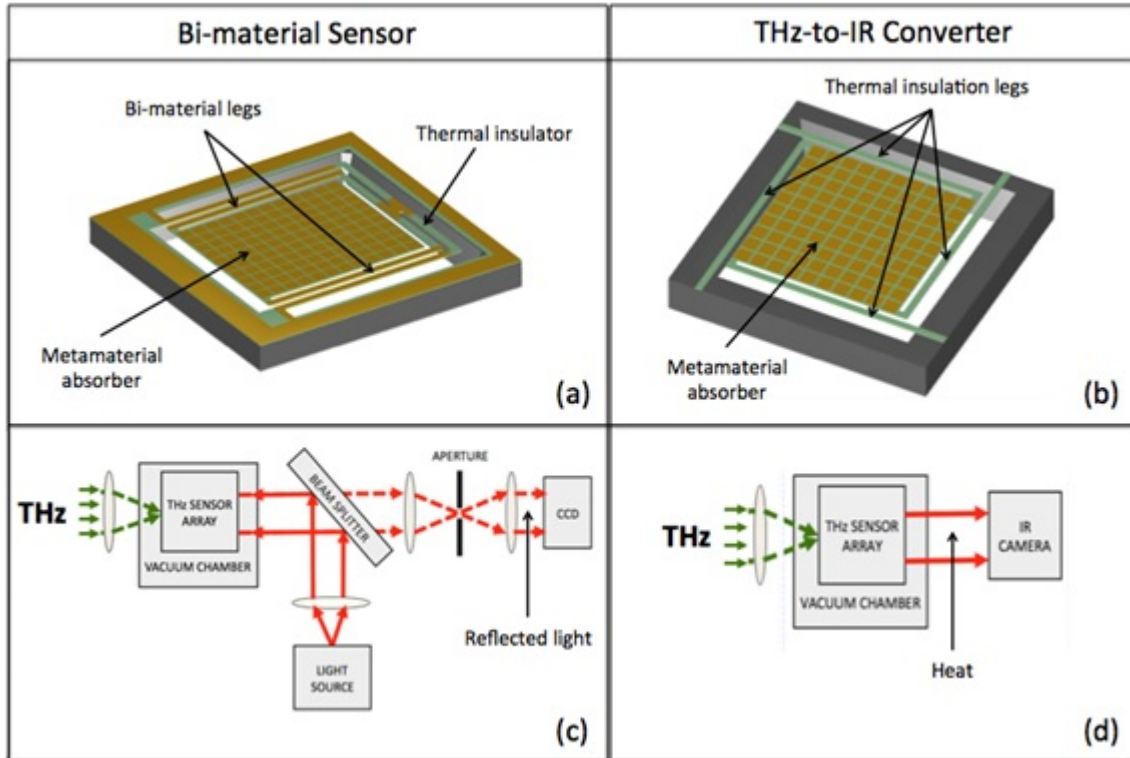
Figure 2. Schematic representation of bi-material sensor and THz-to-IR converter. Adapted from [4].

Driven by the current needs and sponsored by DoD-Space, researchers at the Naval Postgraduate School (NPS) started in 2015 to study the THz region and technologies associated. The objective in the beginning was to develop a highly sensitive and uncooled focal plane array (FPA). In 2016, using Micro-Electrical-Mechanical Systems (MEMS) technology and metamaterial absorbers, THz FPAs exhibiting nearly 100% absorption in two different frequencies, 3.8 and 4.7 THz, were fabricated [4]. This first design, as shown in Figure 2(a), was based on bi-material detectors, where a metamaterial structure is used to convert incoming THz radiation to heat that deforms bi-material legs [4]. The sensor's deformation [5], which is proportional to the absorbed THz radiation, is translated into an image by an optical readout (Figure 2(c)).

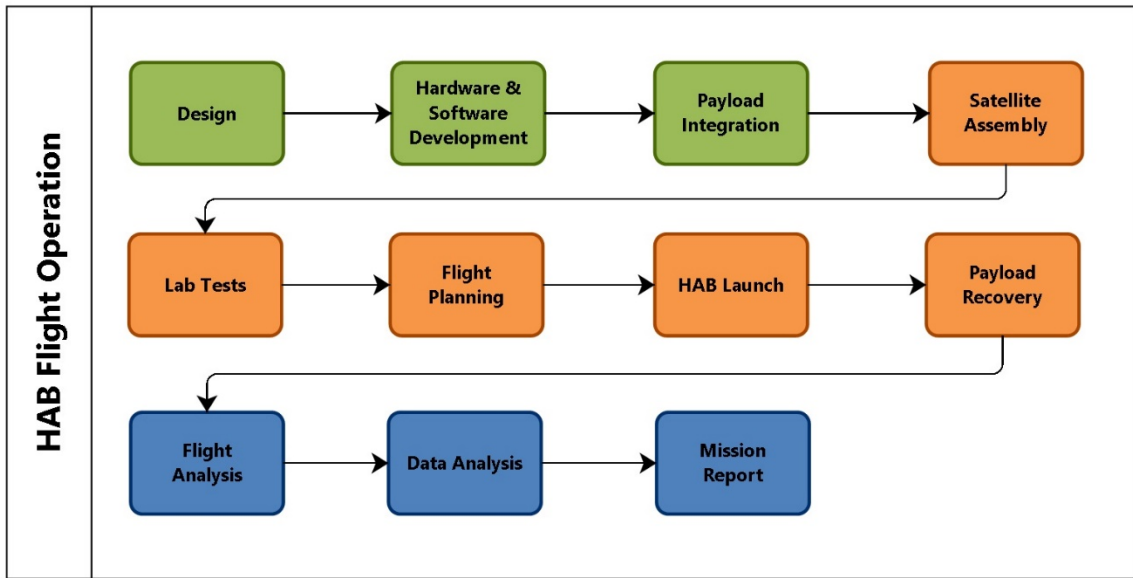
Figure 4. HAB flight operation block diagram

In order to perform a successful HAB flight, a complex operation needs to be planned. This operation is comprised of many steps sequenced in time as shown on Figure 4.

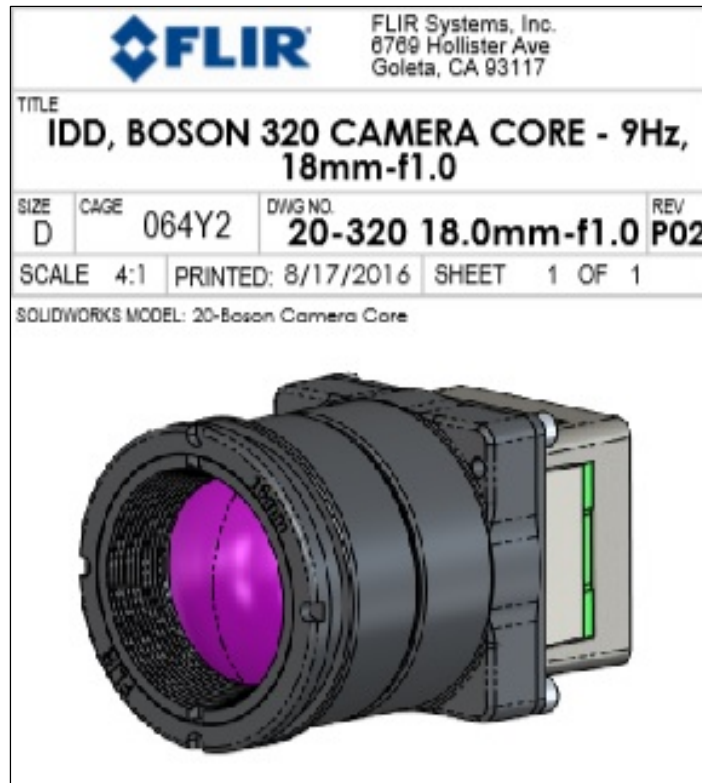
Figure 7. FLIR Boson 320 18mm. Adapted from [10].

The infrared camera is the sensor responsible for collecting IR images in all phases of the flight. Special attention will be given to the images at the near-space. In order to meet all the mission requirements, we had to select a camera that would comply with the requirements and limitations on dimensions, weight, thermal sensitivity, effective focal length, operation temperature range, resolution, power consumption, and cost. The FLIR Boson 320 18mm (Figure 7) was selected among many commercial IR cameras available on the market.

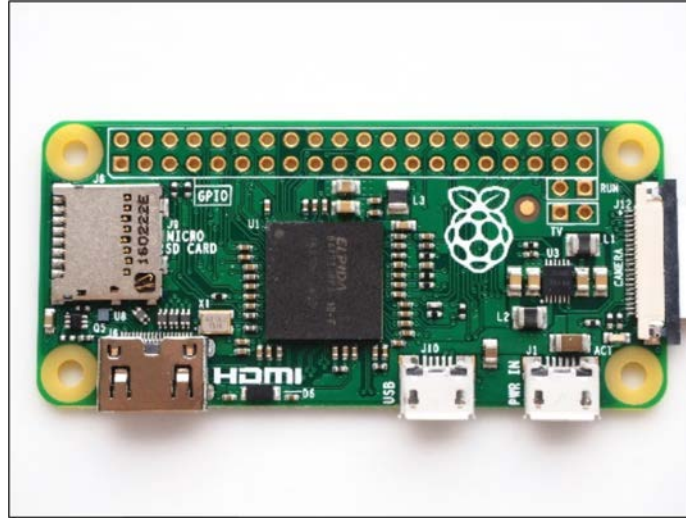
Figure 8. Raspberry Pi Zero board. Source: [12].

The Raspberry Pi Zero is a small form factor single board computer and it was used for two distinct tasks on the flight. The first Pi Zero was used to control the main bus and the second to control the IR and CMOS cameras. The Pi Zero board (Figure 8) was able to communicate with numerous systems and control several parameters during flight. This device is low-cost, low power consumption, and it proved to be a powerful solution to keep all the systems working appropriately the entire flight.

PYTHON was chosen as the software language used to control the Pi Zero. The Pi data storage is a micro SD card, where all the videos recorded during the mission were stored.

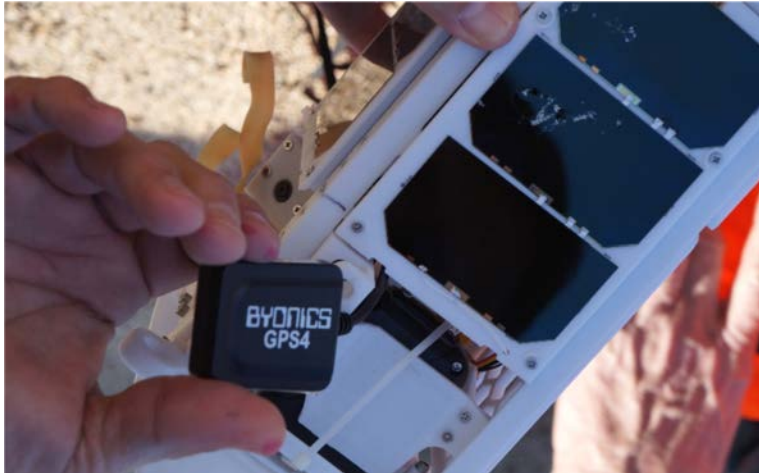
Figure 16. The GPS used on the HAB payload

The GPS used on in this flight was the BYONICS GPS4 (Figure 16). It is powered by 5.0 V, 32 mA of current consumption, accuracy of 2.5 meters, RS-232 serial GPS designed for altitudes up to 84 thousand meters.

The position and altitude information are essential to the analysis of the images as well as flight monitoring and payload recovery. The main bus receives the GPS data and sends via radio to the Cosmos and Teraterm Ground System.

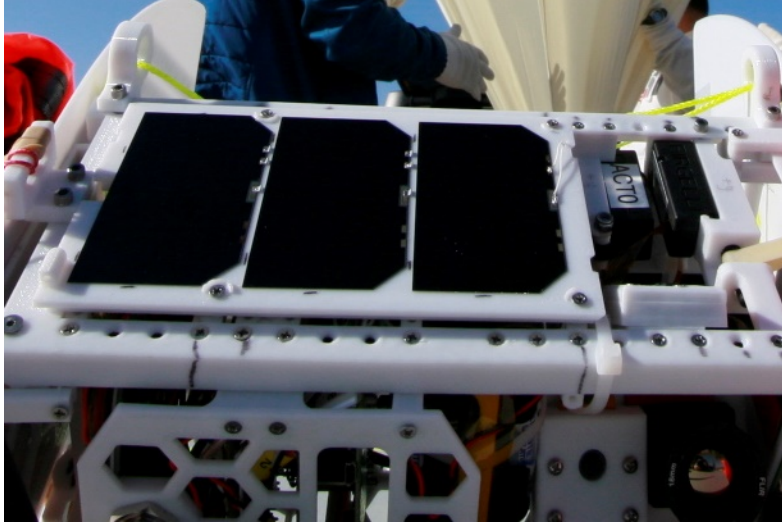
Figure 18. Solar panel on the HAB payload

Solar panels (Figure 18) were designed for the experiment in order to help the batteries to provide the appropriate power to the HAB payload. The system is comprised of two panels with three solar cells in each one. The main bus uses both the batteries and solar cells during the flight. With this configuration we can have appropriate power supply during the flight. We used a triple-junction (InGaP / InGaAs / Ge) photovoltaic cell with monolithic diode from Emcore Corporation. Each cell has 26.6 cm^2 , 28% average efficiency, 16.3 mA/cm^2 of normalized current density, and voltage of 2.33V.

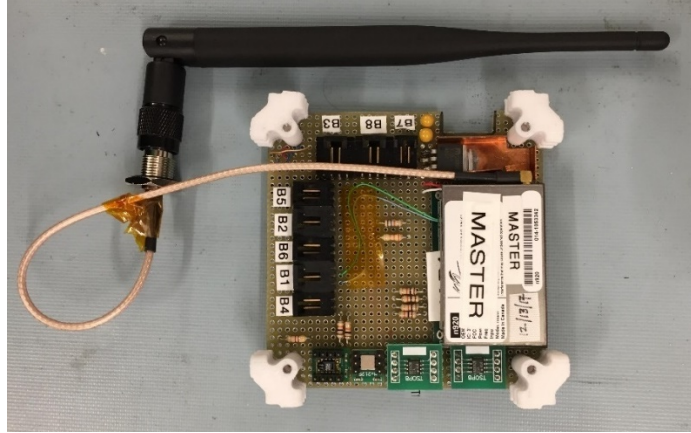
Figure 19. The telemetry antenna and the radio installed on C&DH board

This system is composed by the Spread Spectrum UHF Radio and an omnidirectional Antenna (Figure 19). The system is connected to the main bus and transmits data that can be acquired by a ground station (GS), controlled by two different applications: Cosmos and Teraterm Ground Systems. The hardware on the HAB payload and on the GS are both one Microhard System Nano n920 OEM Radio, which the specifications are shown in Figure 20. Provided by the system, several important information can be received by the GS operators remotely during flight. In addition, the telemetry system is responsible for receiving the control commands from the GS. The commands used on the flights are described on Appendix E. Information as GPS coordinates, altitude, battery temperature and voltage, solar panels voltage, CPU temperature, actuator's position (voltage), barometric pressure, remaining bytes on the main bus storage device and bus camera status (ON or OFF) are displayed by the system.

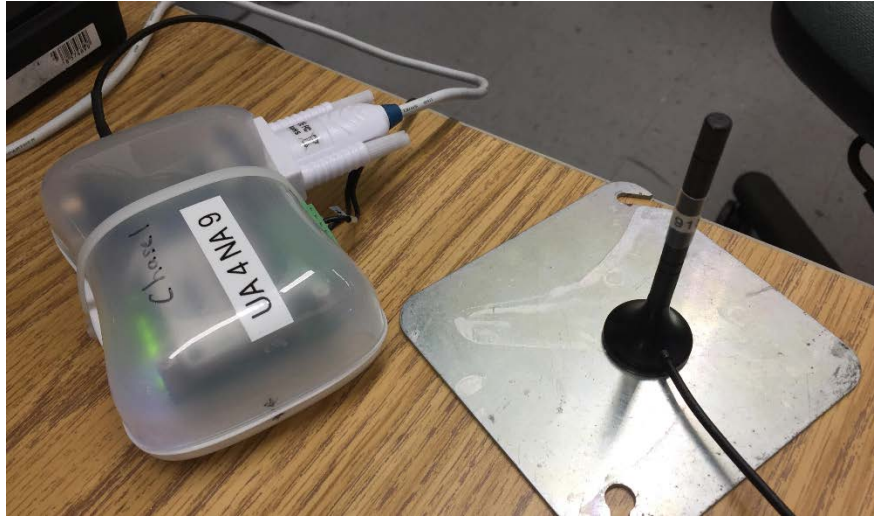
Figure 21. Radio and antenna used on the GS

The GS is comprised of a laptop on which Cosmos and Teraterm are running, the radio, and an antenna (Figure 21). Two different applications are used, Cosmos and Teraterm Systems. The Cosmos System is more user friendly and presents the data in windows easy to interact with (Figure 22). The Teraterm System is the backup one and presents only raw data. You need to type the commands (Appendix E) in a command prompt window.

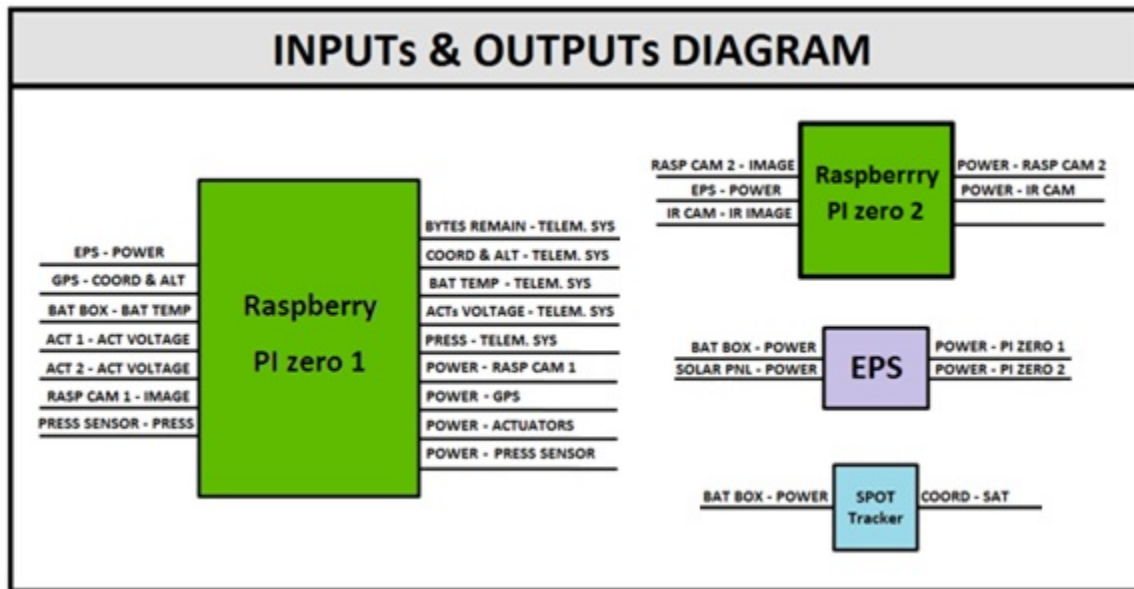
Figure 25. Inputs and outputs diagram of the HAB payload

Figure 25 shows the inputs and outputs of the main components. As we can see from those diagrams, the Telemetry System is able to send some important information as GPS coordinates, altitude, battery temperature and voltage, solar panels voltage, CPU temperature, actuator's position (voltage), barometric pressure, remaining bytes on the main bus storage device and bus camera status (ON or OFF). That information is essential to appropriately conduct the HAB flight mission.

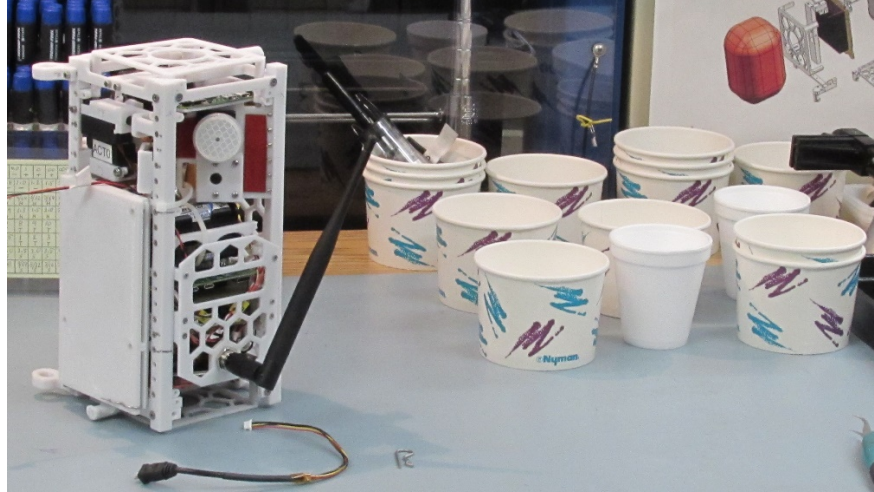
Figure 35. HAB payload assembled after the assembling procedure

Once the current surge problem was fixed, the only concern was the fact that the long duration test was not completely done and we did not have time to start it again because, despite having the entire HAB payload working well, we still had an entire final assembling process to perform (Figures 34 and 35). Besides that, this one should have been very careful, with no chance of any mistake. This procedure was done in about 3 hours.

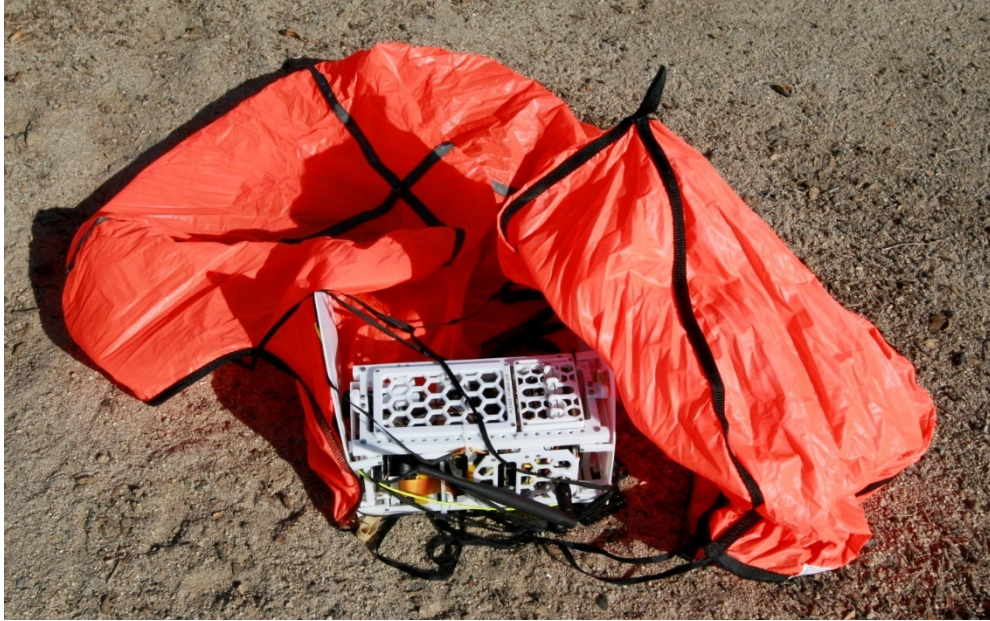
Figure 41. The HAB payload after landing

Given the fact we did not receive parachute release confirmation, we were afraid that both parachutes did not open. The descent rate seemed to be the same during the whole descent time. Once we arrived at the land site, we notice that the parachutes were opened but tangled and the efficiency of them were probably reduced, but they were able to avoid a crash on the ground. The payload components were almost intact, as we can see in Figure 41. The landing was in a hard surface close to a secondary road.

To provide a useful material for analysis, we took pictures from the HAB payload landed at the site, and then folded the parachutes and put it into the case to return to campus. On the following day at SSL we downloaded the videos and the after-flight check list (procedure introduced on this flight) was performed as described on Appendix B. The damages were not severe and we could get the data produced by the sensors.

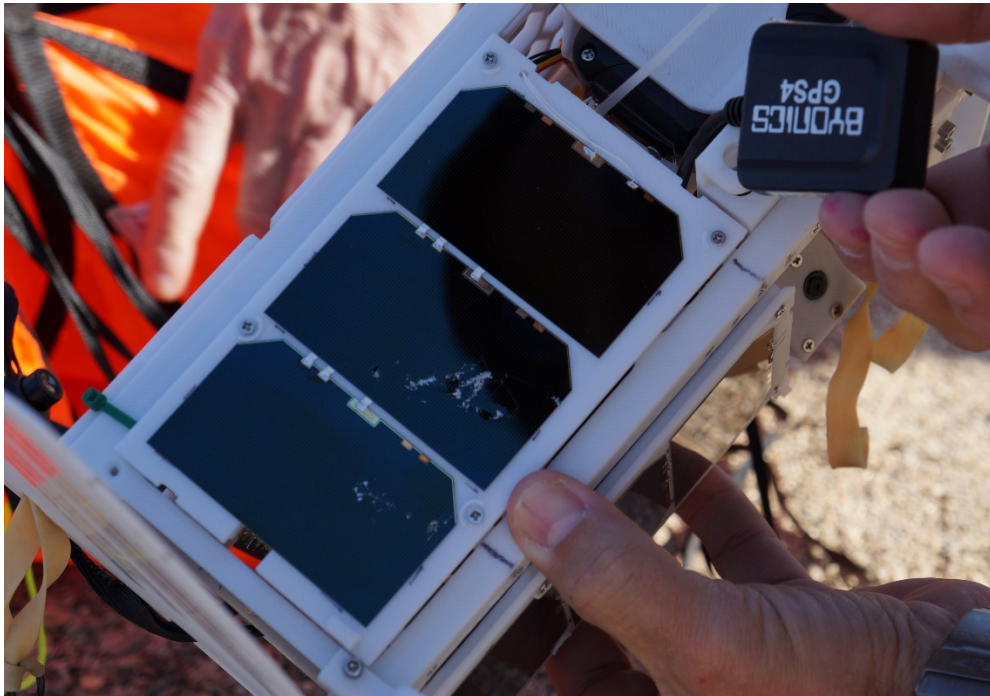
Figure 42. The solar panel damages

The damages found on the HAB payload were minor and basically on the plastic components. The most relevant damage was some cracks on one solar panel, probably caused by the balloon remains (a cord with a metal swivel at the end that connects the balloon to the HAB payload) colliding during the descent. These cracks are shown in Figure 42.

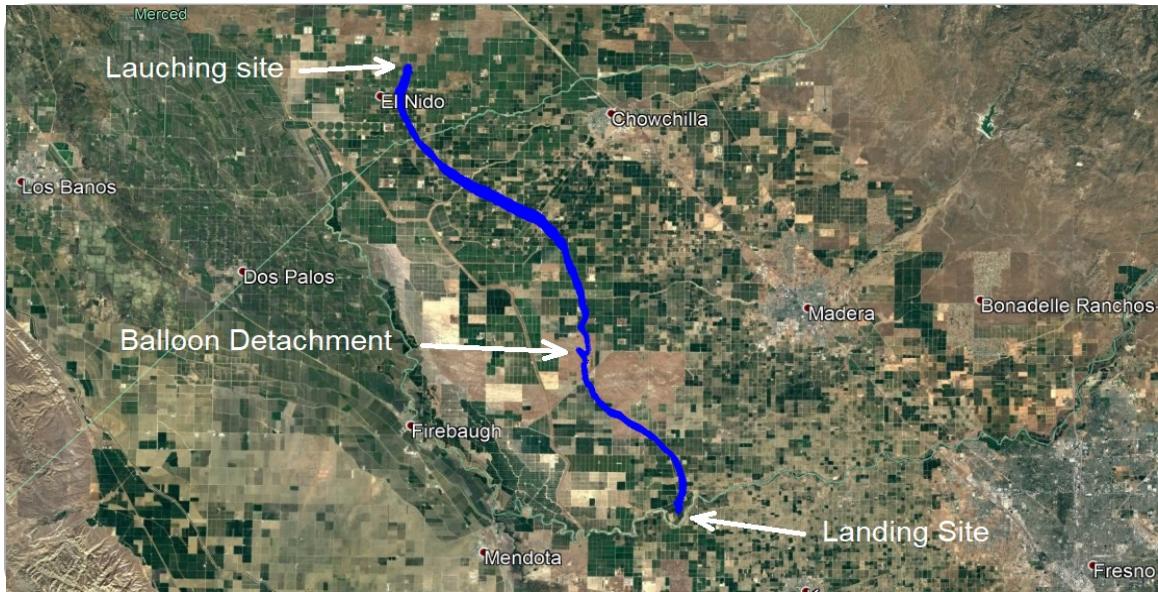
Figure 45. Actual HAB payload flight route

Using the data recorded on the main bus, the log file, we could recover the HAB payload trajectory during the flight based on the latitude and longitude coordinates, as shown in Figure 45.

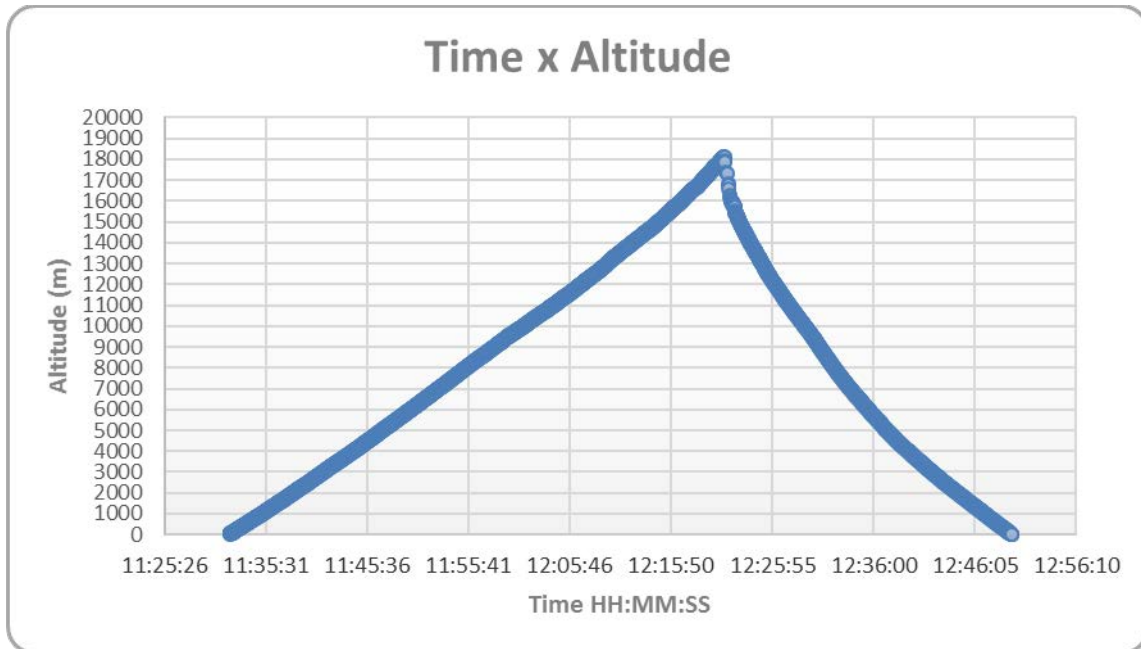
Figure 46. HAB Payload Graph (Time vs Altitude)

The log file downloaded from the main bus was allowed for recovery of another relevant information of the flight, the time and altitude. This graph shown in Figure 46 is a good representation of the vertical path drawn by the HAB payload during its flight.

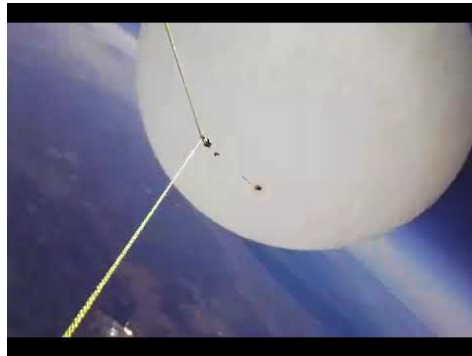
Video available on YouTube at <https://youtu.be/VAXoRkVRljM>.
Video 1. Detachment moment

The first camera, a Raspberry Pi camera controlled by the main bus, was pointed to the balloon and was able to record all balloon behavior during the flight. It was a powerful tool because it could show us the early balloon detachment.

During the chasing operation, we did not know yet what happened to the balloon and why it started to descent earlier than expected. The initial assumption was that the balloon has exploded earlier for some reason. Watching the videos from this camera, we discovered that the balloon was detached and went up undamaged. The 15 second video (Video 1) showing the balloon detachment is available on YouTube (<https://youtu.be/VAXoRkVRljM>). Four frames of the most critical moment are shown in Figure 47.

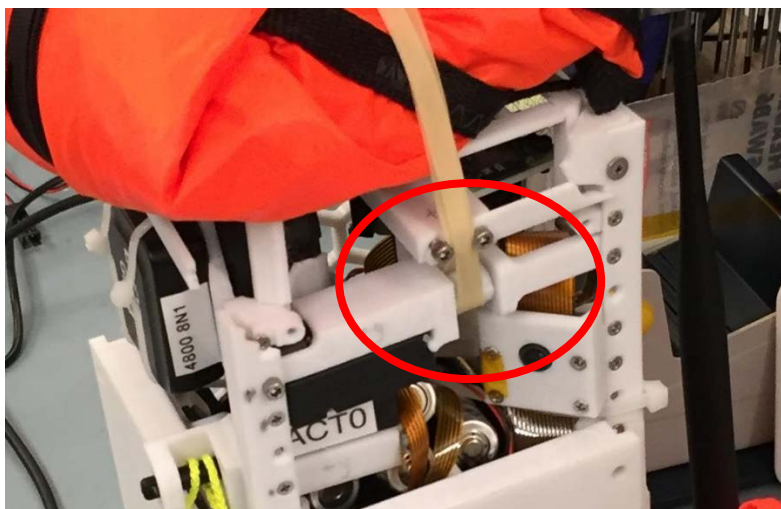
Figure 49. 3D printed sleeve for the actuator axis

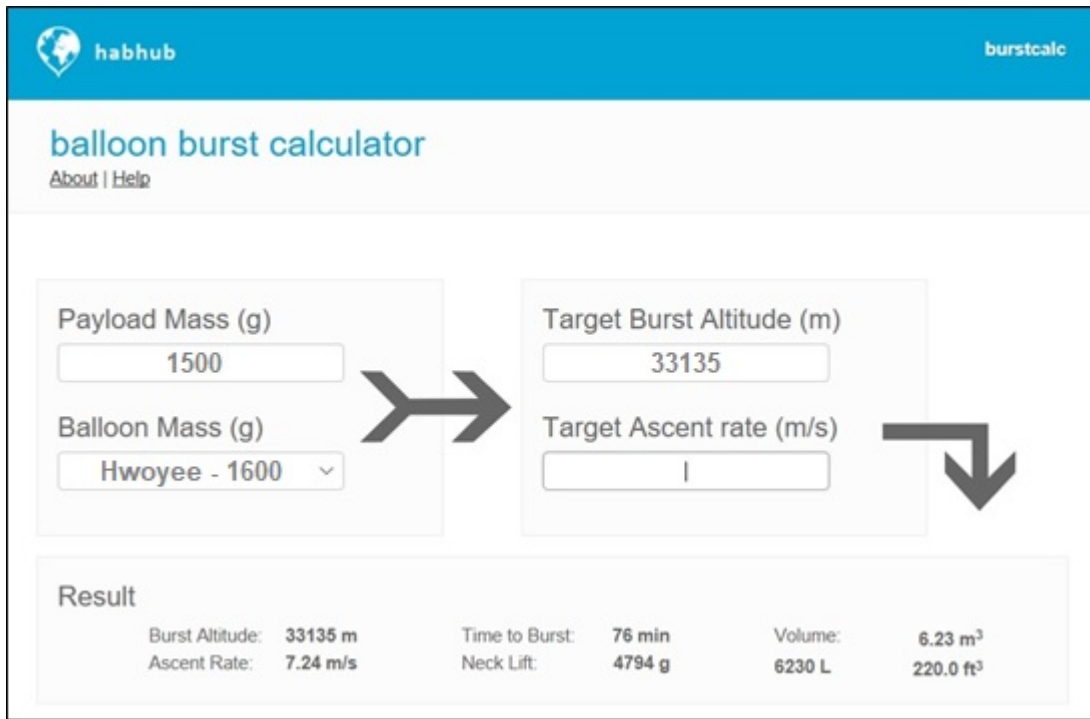
Figure 55. Second flight burst calculation

The chasing operation started without any GPS information. We only had the planned route and the hope for receiving the SPOT information about the HAB payload position for recovering. We knew that SPOT Tracker wouldn't send information in flight, however, we predicted a stop message at the landing site after landing, but it did not happen. The planned flight time for the second flight was a little different from the first one due to the weight difference (no body fins), as defined by the burst calculator in Figure 55.

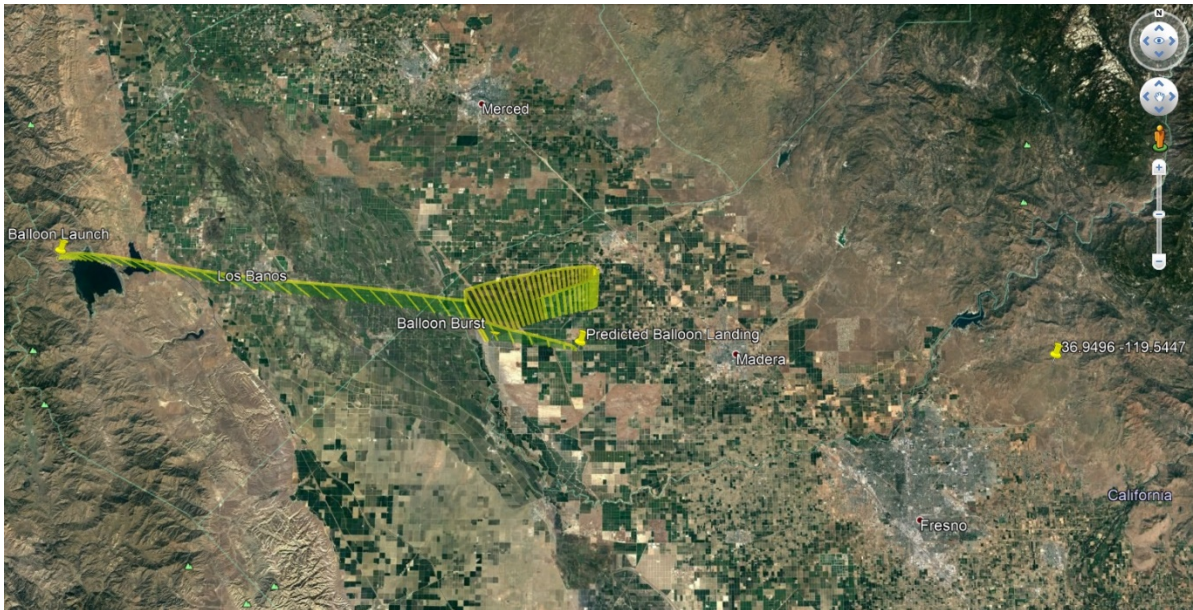
Figure 57. Second flight predicted vs. actual landing site

Because of the flight altitude changes, the predicted landing site was not a useful point for the chasing operation anymore. Since the balloon never crossed the jet stream altitude, it did not reverse its trajectory. It continued going on the same direction all the flight, causing an actual landing point really far away from the predicted one (Figure 57). Moreover, we noticed that the descent rate was less than the predicted one. We discover after the flight that the backup parachute opened inadvertently at the same time the balloon was disconnected. That was the reason for the small descent rate and the long descent trajectory.

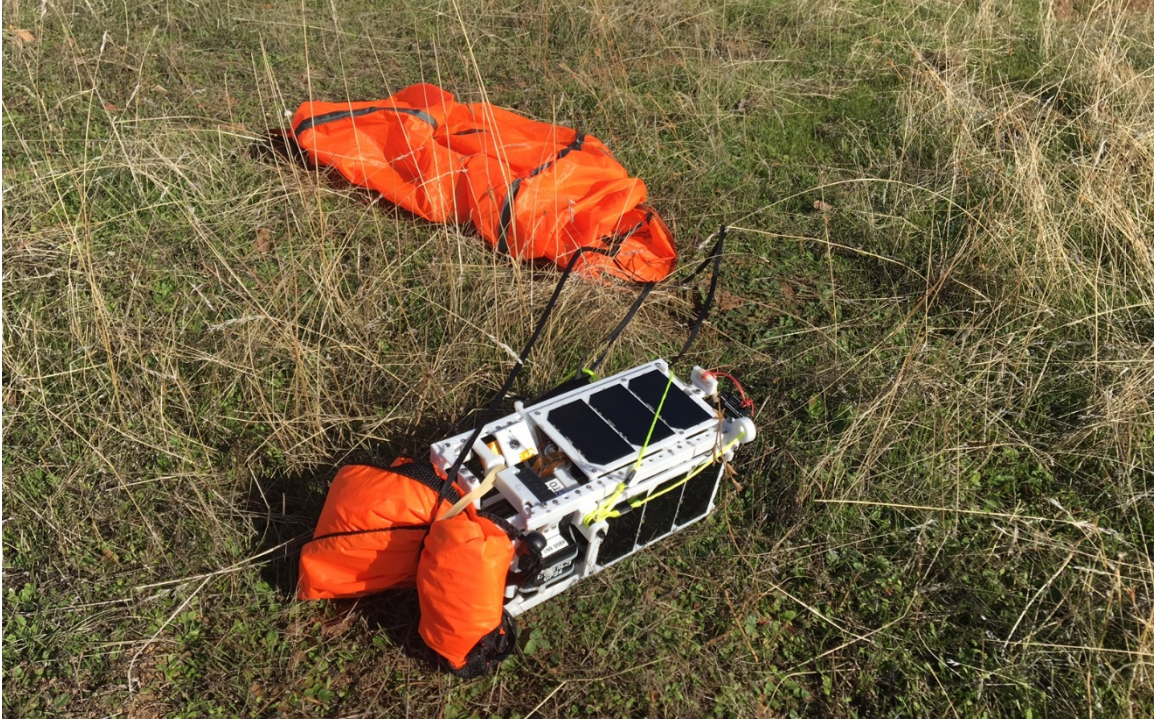
Figure 60. The HAB payload at the landing site

On the following morning (Friday, January 26) we were able to contact the property owner and he allowed us to enter and recover the HAB payload. A small team was designated to recover the HAB payload and they found it easily and very well preserved. They could see only small damage on the plastic structure. They noticed that the balloon and parachute release mechanism did not work, but the backup parachute was opened as shown in Figure 60. On Monday at SSL the videos were downloaded and the after-flight check list, as described on Appendix B, was done. The damages were small and only on the structure. None of electronic component was affected by the landing with only one parachute.

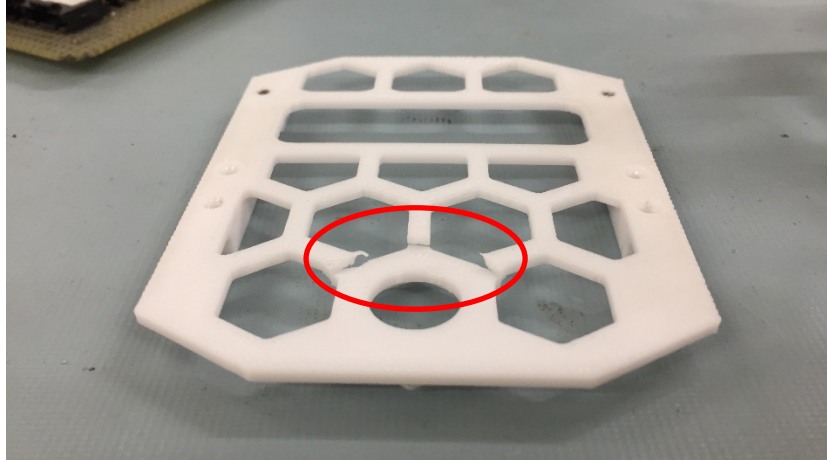
Figure 62. Antenna's face cover damage

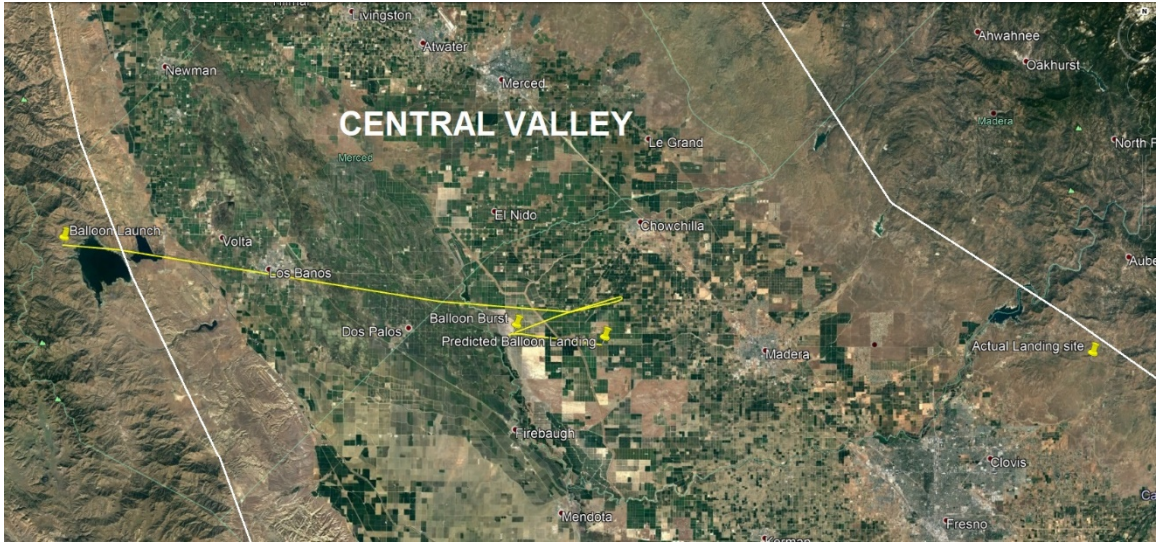
Figure 63. Second flight predicted route and actual landing point

We planned the route based on the predictor tool and we noticed that the wind was blowing in a constant direction, basically west-east, below the jet stream level and in the opposite direction over it. If the HAB payload could not cross this level it could be directed towards the end of the central valley. However, this wouldn't be a problem because with the planned descent rate the HAB payload wouldn't be able to reach the mountains. Nonetheless, we did not expect a low descent rate caused by the backup parachute early opening and it was close to happen (Figure 63). The actual landing area is not a flat area, as we most likely see at the Central Valley, but it did not compromise the recover.

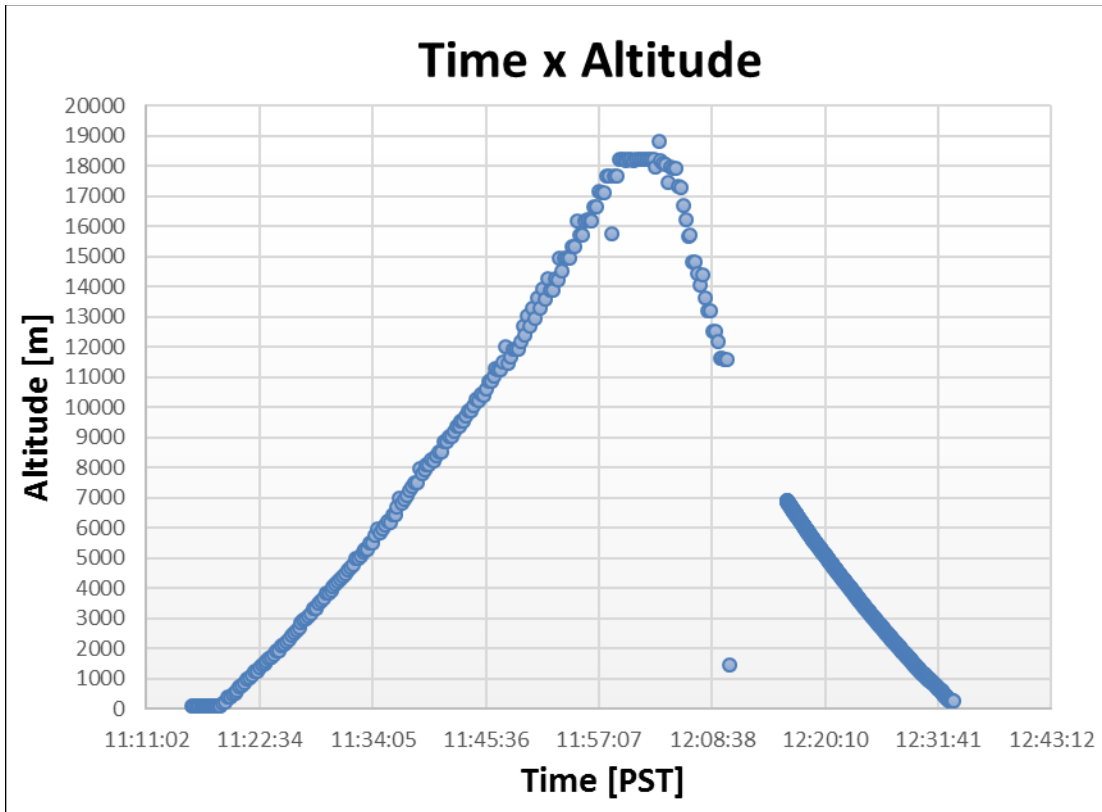
Figure 64. 2nd Flight HAB Payload Graph (Time vs. Altitude)

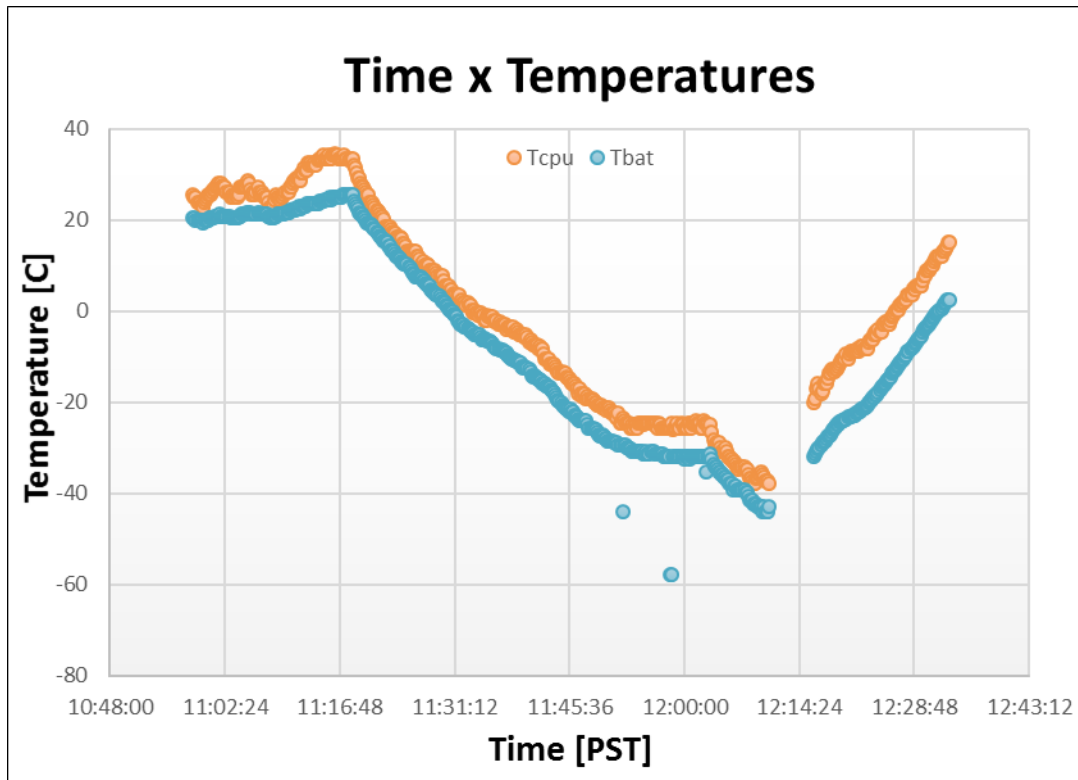
Figure 65. 2nd Flight HAB Payload Graph (Temperatures)

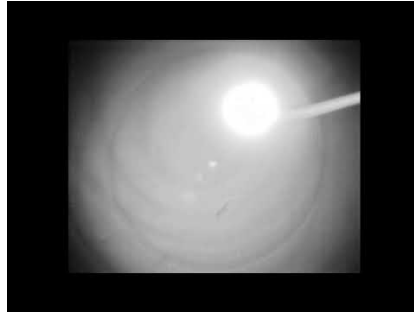
Video available on YouTube at <https://youtu.be/je9rZdY33HM>.
Video 5. Second flight, first sun mark IR camera

Given the fact the IR camera was not able to capture a high-resolution image from the scenario, all details were relevant to build the scene. The sun was very harmful to the sensor as we can see in Video 5, which is available on YouTube: <https://youtu.be/je9rZdY33HM>). The problem happened always when the sun was perfectly on the center of the cameras FOV. It is easy to note the sun just at the image center on the CMOS camera,

as shown in Video 6—available on YouTube at <https://youtu.be/WqyfSC2WIew>. The videos were slowed down in order to show more details about the problem.

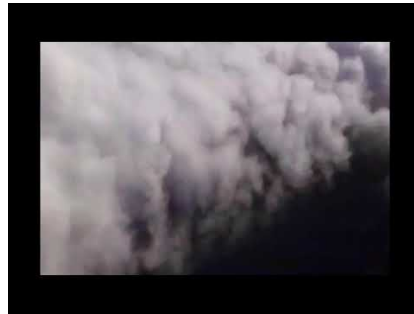
As shown on Videos 5 and 6, only at the second time when the sun appeared on the camera's FOV, a line was created on the IR video. This happened because only at the second time the sun was at the center of both cameras' FOV. We performed another clip presenting the same problem but at different time. In Video 7 (YouTube from https://youtu.be/m_ET7iq7MWE) there are two saturation lines registered.

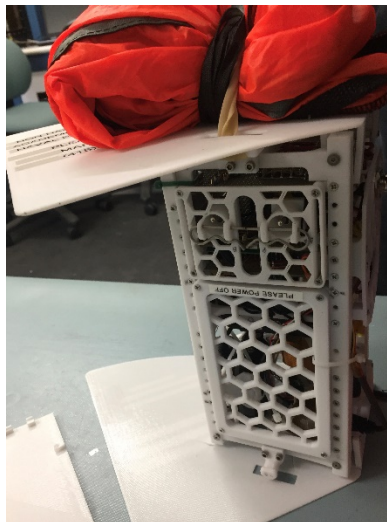
Figure 71. Removing parachutes

It is just to detach the parachute cords from the actuator connection point because the rubber band is already disconnected after the main parachute release command / automatically release of the backup parachute during flight (Figure 71).

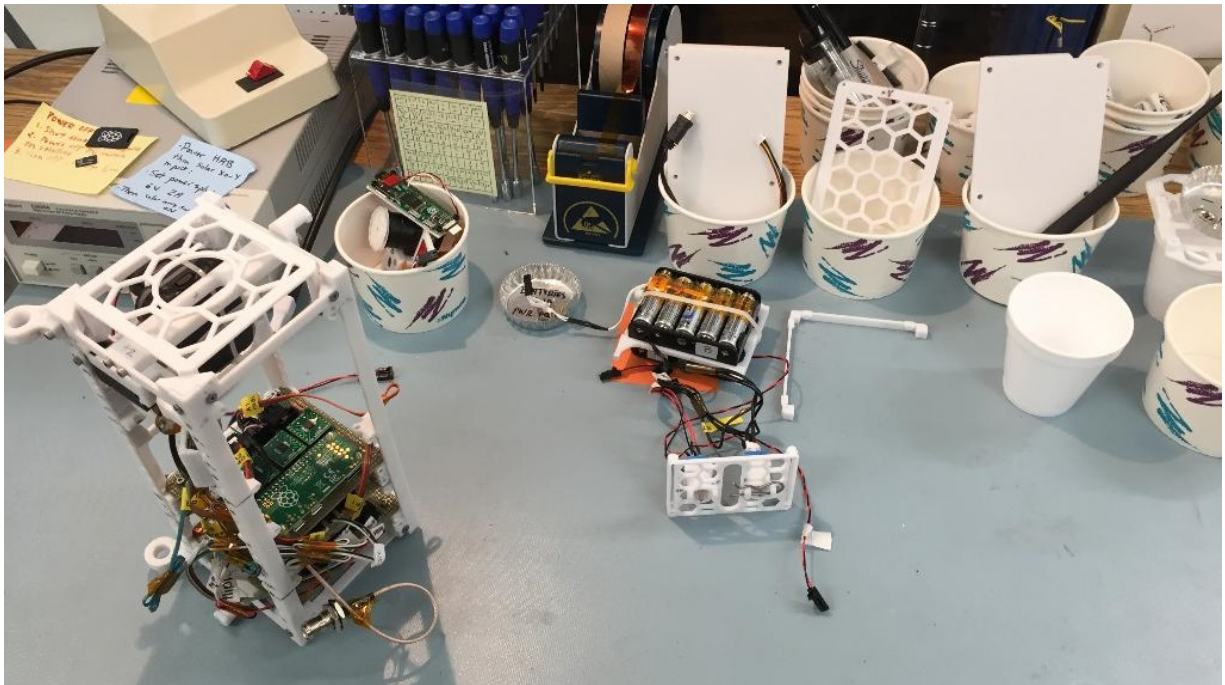
Figure 74. Removing battery and power switch plate

This step is basically a starting point for the electronic parts of the HAB payload. The main payload is hooked to the chassis in six points and have the most important devices attached on it. The designed connection is simple (six screws) and uses a 45 degrees angle to point to the horizon during flight. The power switch plate is almost like a side panel but it has several cables to connect the panel to the power sources on the HAB payload. Besides unscrew the panel, we need to disconnect all cables to remove this part. The battery pack is connected to the chassis in three points and has cables for other connections. The connection with the power switch plate does not have a terminal to disconnect. To remove it is just unscrew the holding points and disconnect the cables (Figure 74).
