DAMAGE ASSESSMENT REPORT 80

YOKOHAMA CITY

Damage to Yokohama city resulting from XXI Bomber Command Mission 186, 29 May 1945, totals 6.9 square miles, which represents about 34% of the entire city.

DAMAGE ASSESSMENT REPORT NO. 47

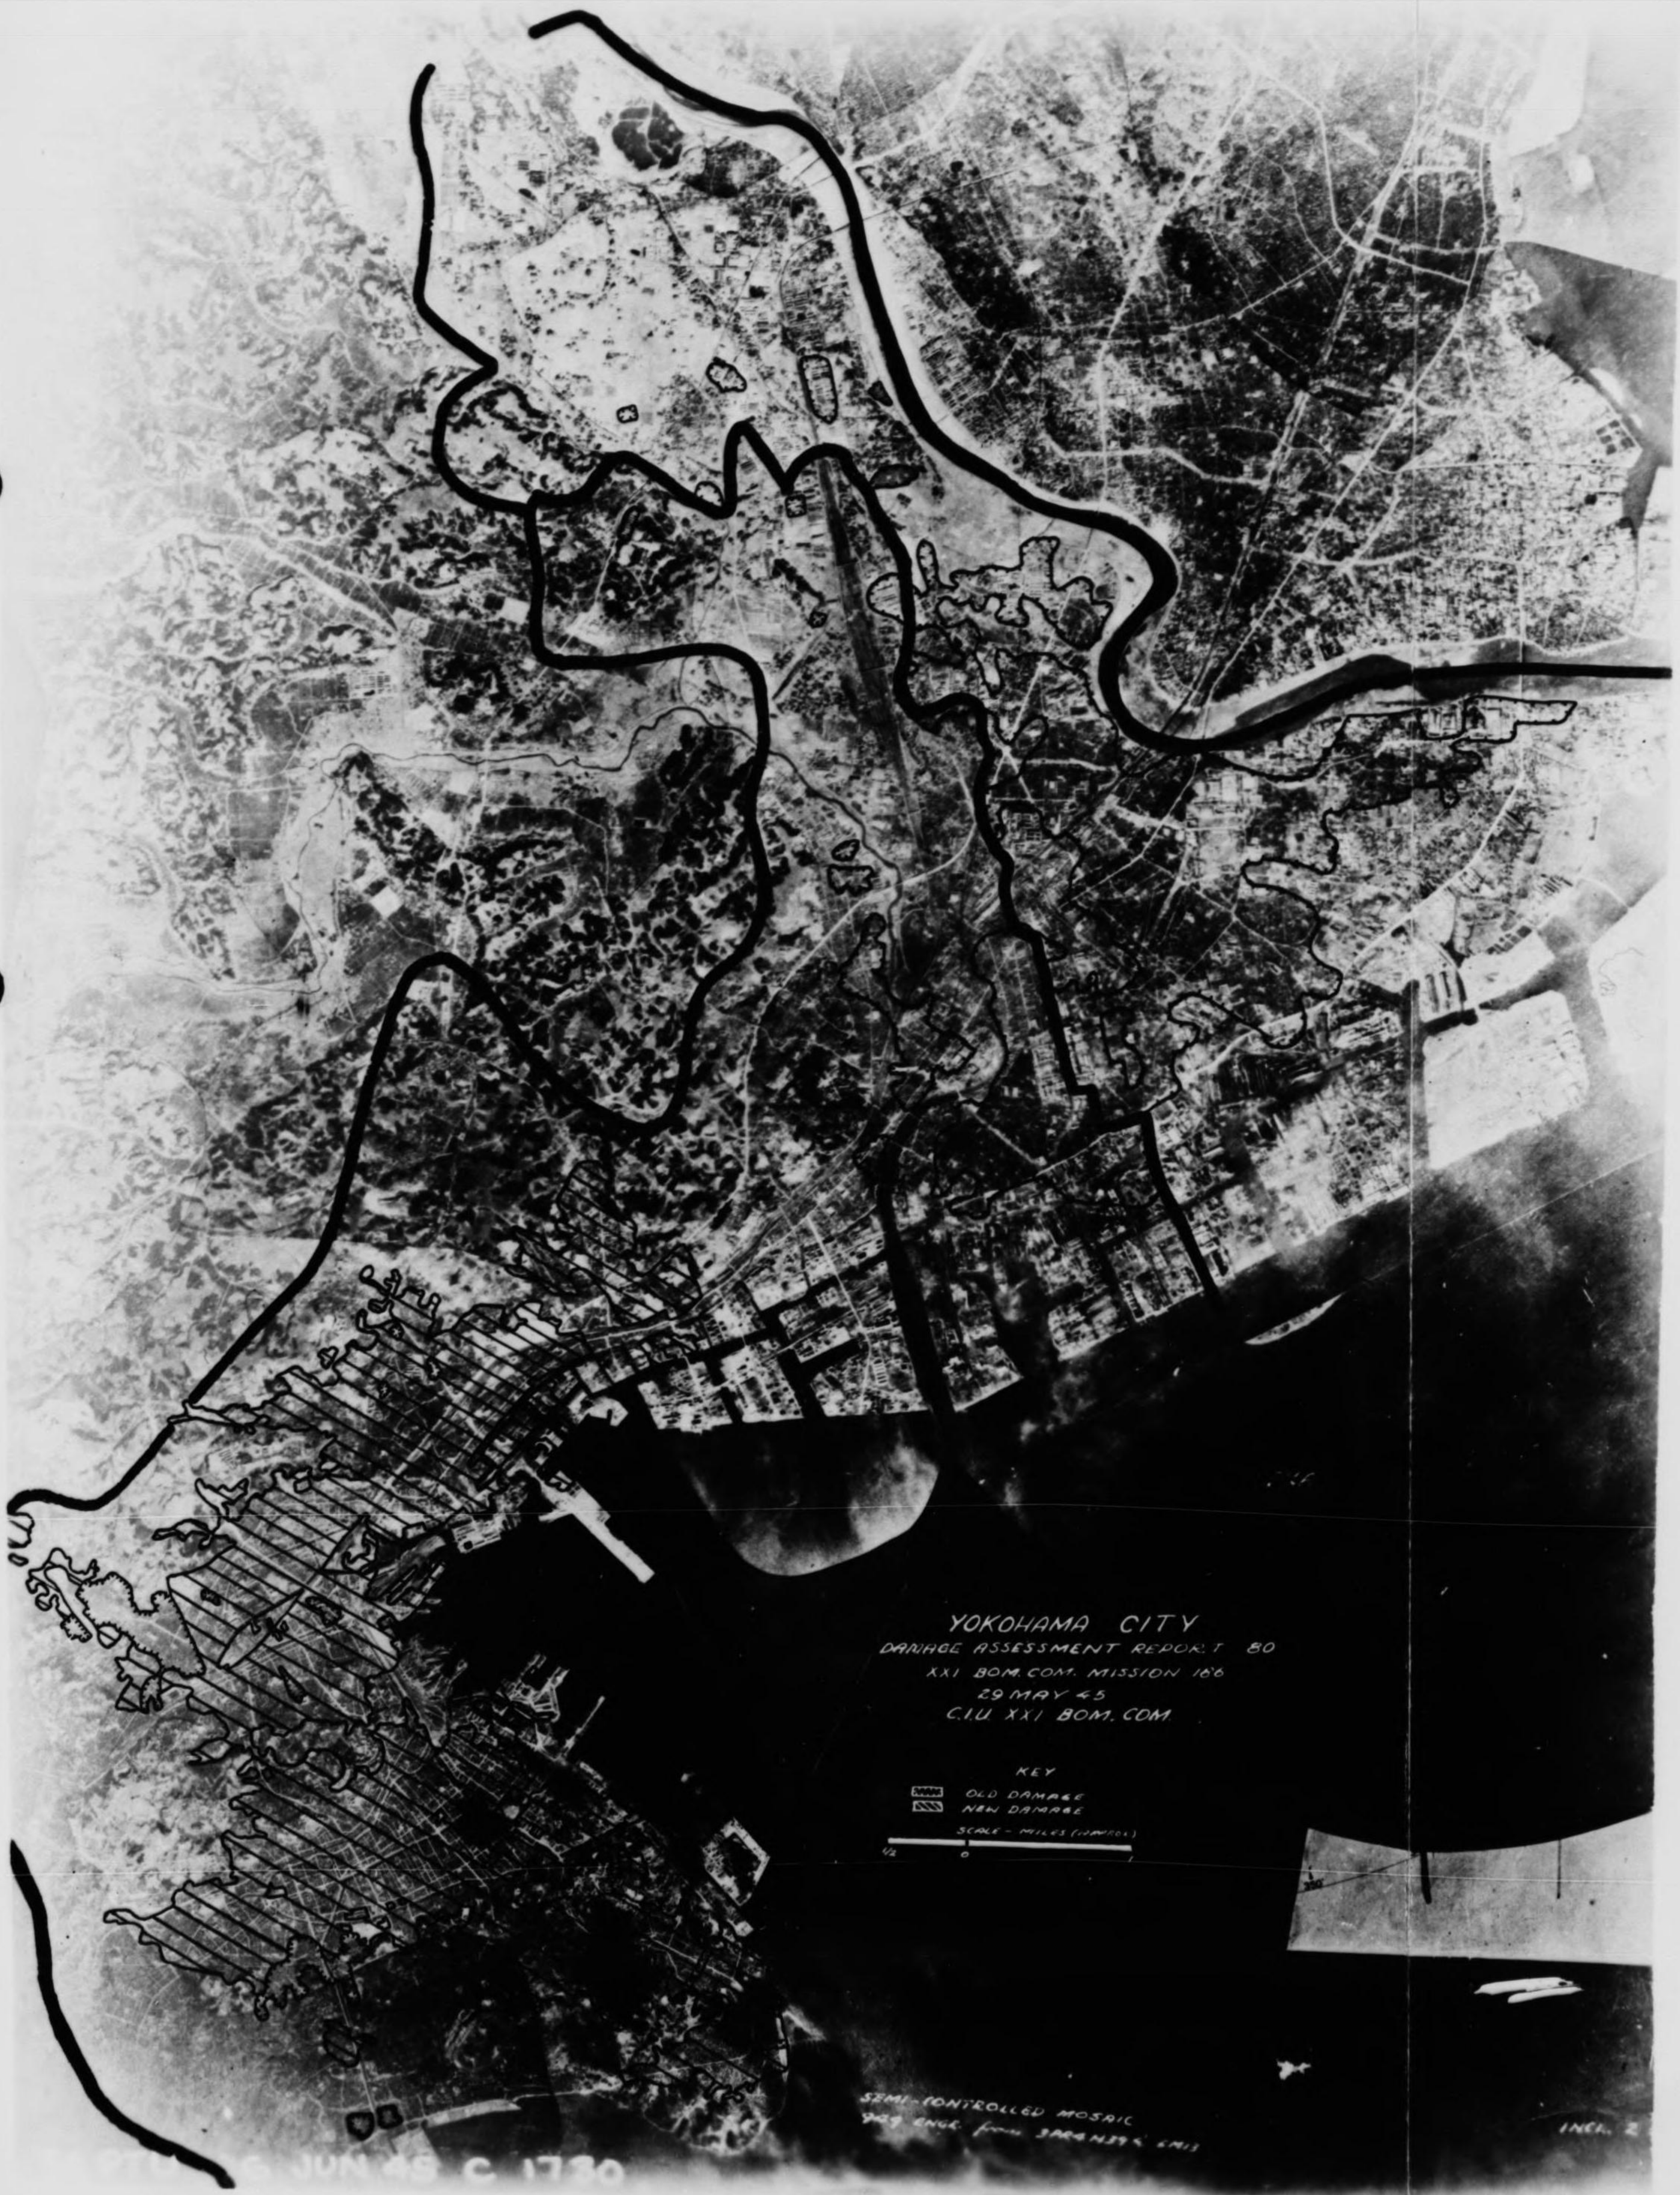
YOKOHAMA CITY
DAMAGE ASSESSMENT REPORT 80
XXI BOM COM. MISSION 166
29 MAY 45
CIU XXI BOM. COM

KEY
OLD DAMAGE
NEW DAMAGE
SCALE - MILES (UNAPPROX)

SEMI-CONTROLLED MOSAIC
200 ENGS. FROM 3000 FT. ALT.

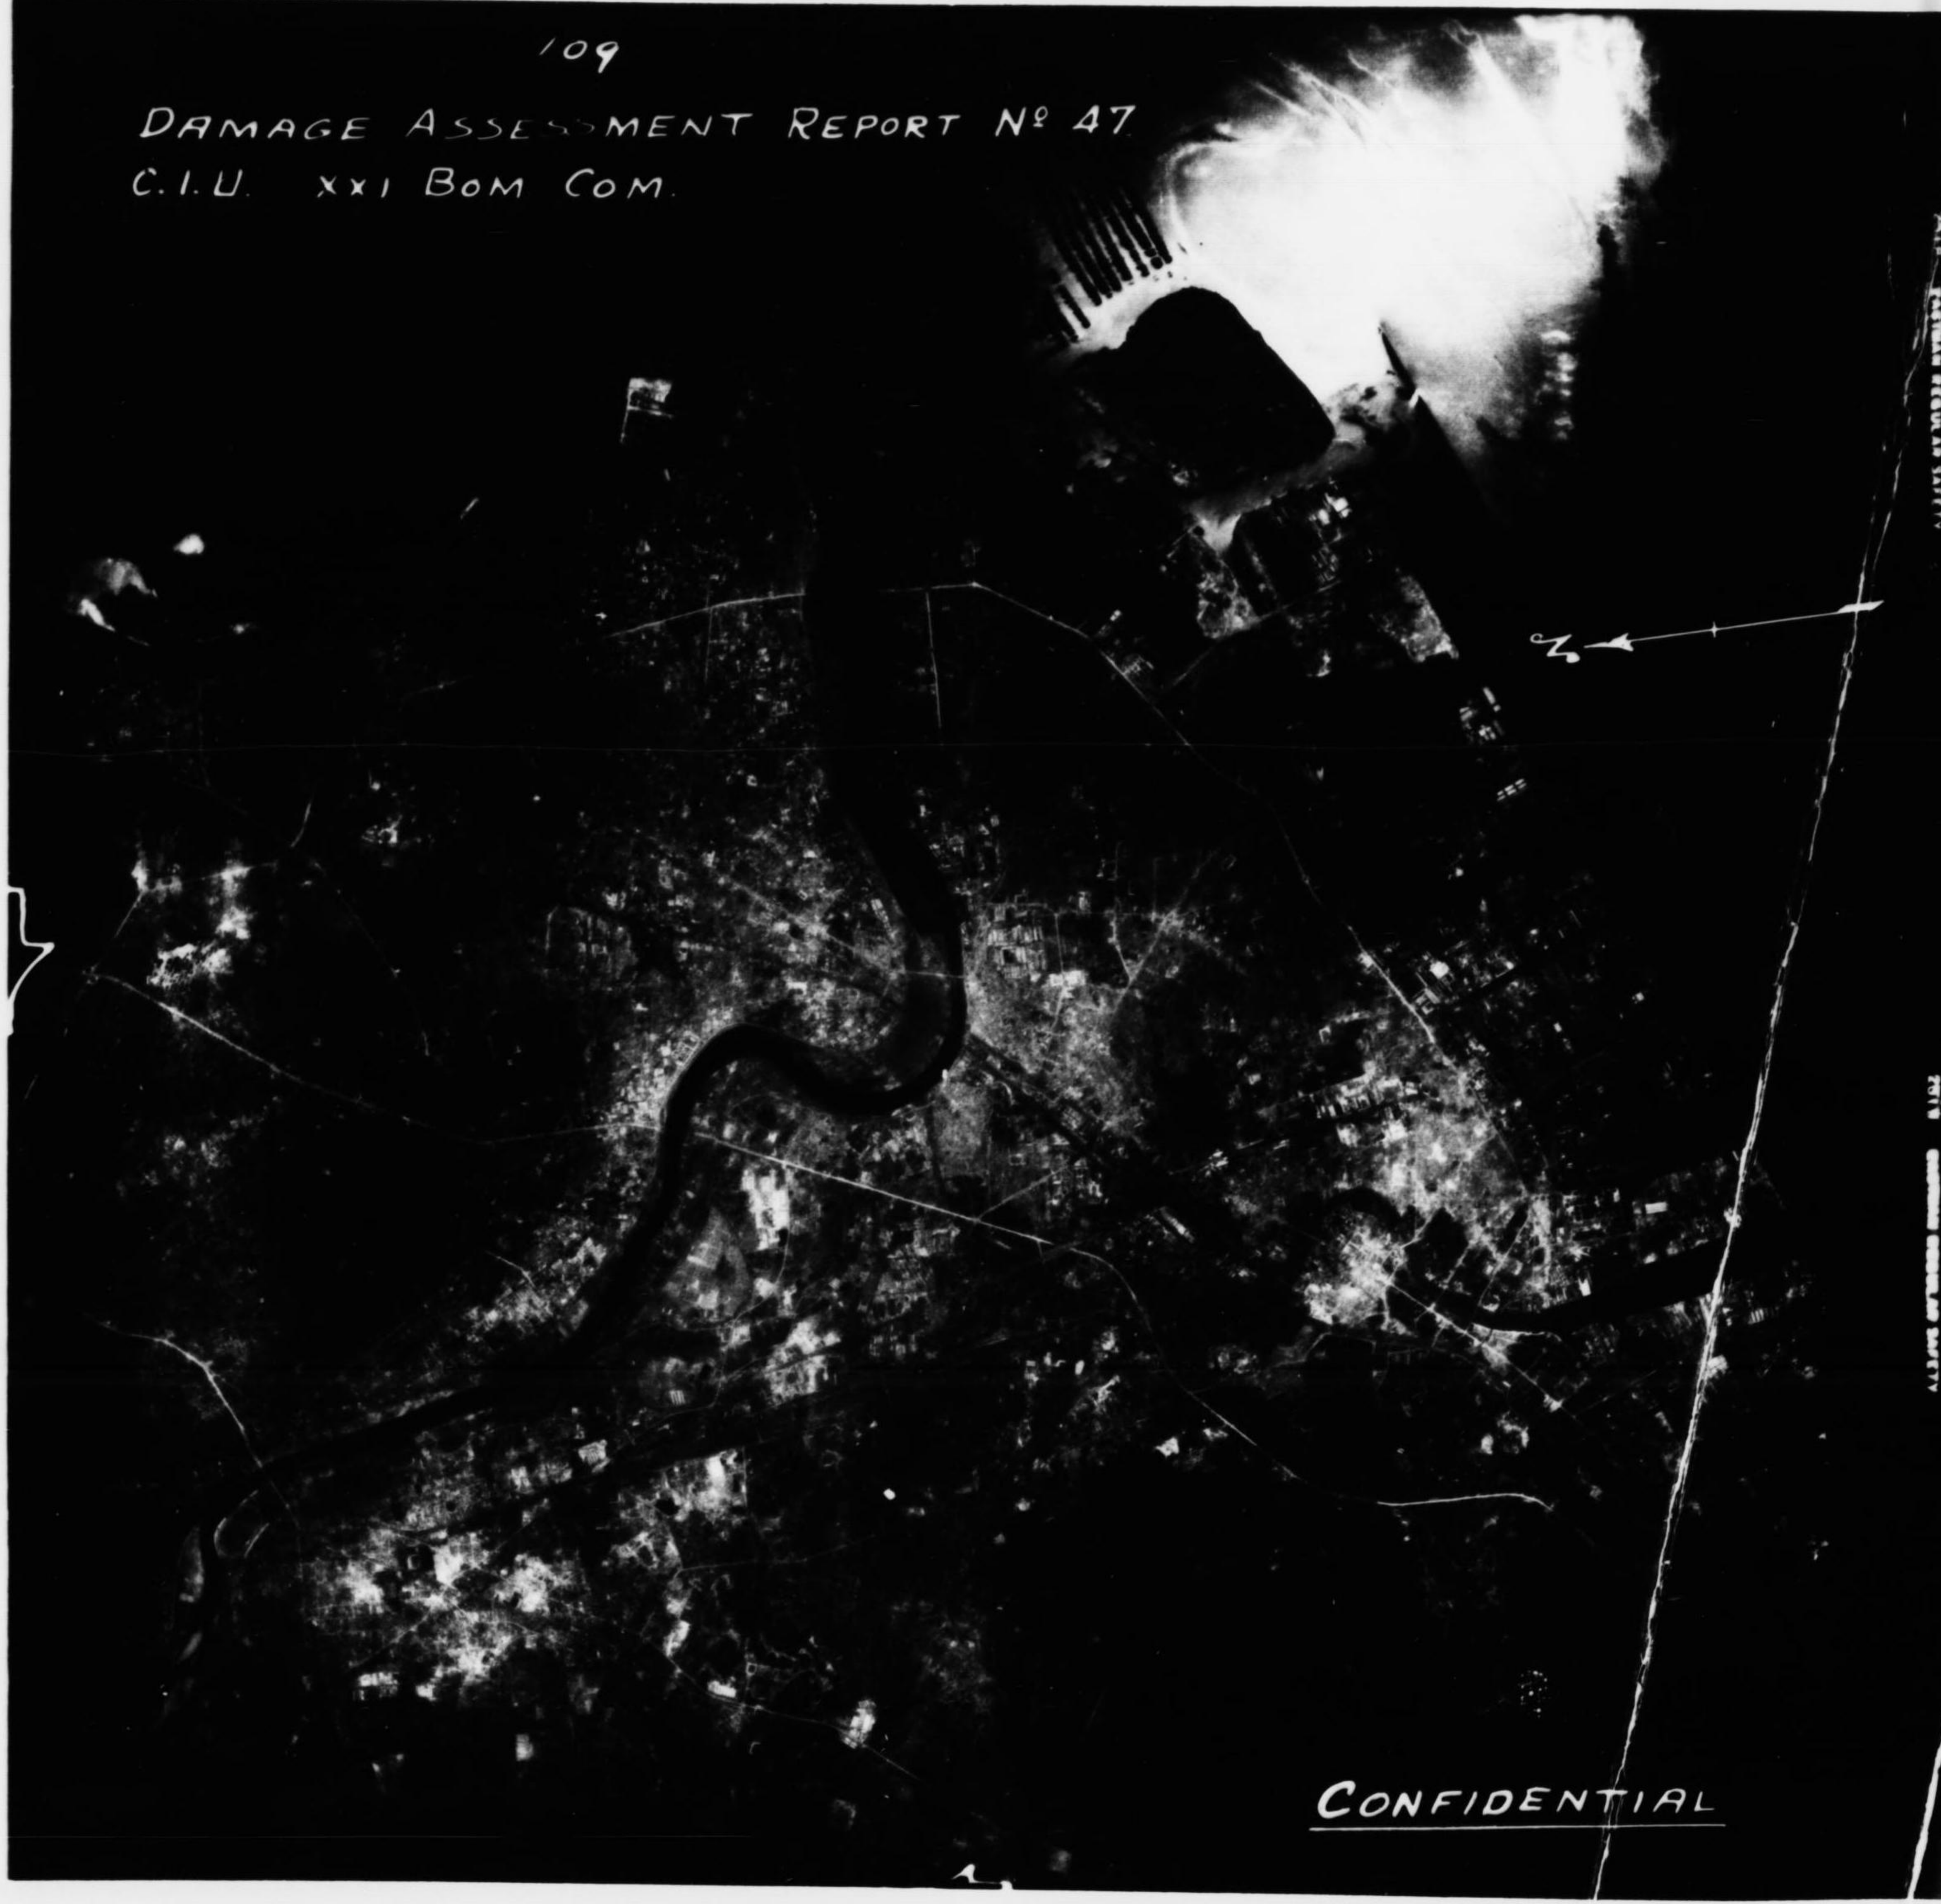
DAMAGE ASSESSMENT REPORT Nº 47
C.I.U. XXI Bom Com.

This report assesses area damage in Yokohama, Kawasaki and S. Tokyo resulting from XXI Bomber Command Missions 68 and 69, 15 April 1945.

Area damage totals approximately 268,000,000 sq. ft. (9.6 sq. mi. or 6100 acres) of destruction within these cities.

Twenty-five numbered industrial targets show varying degrees of damage.
