MISSION # 18 MUSASHINO " ENKINDLE 2"  
9 January 1945

CONSOLIDATED MISSION REPORT

Mission No. 18  
Field Order No. 37  
9 January 1945

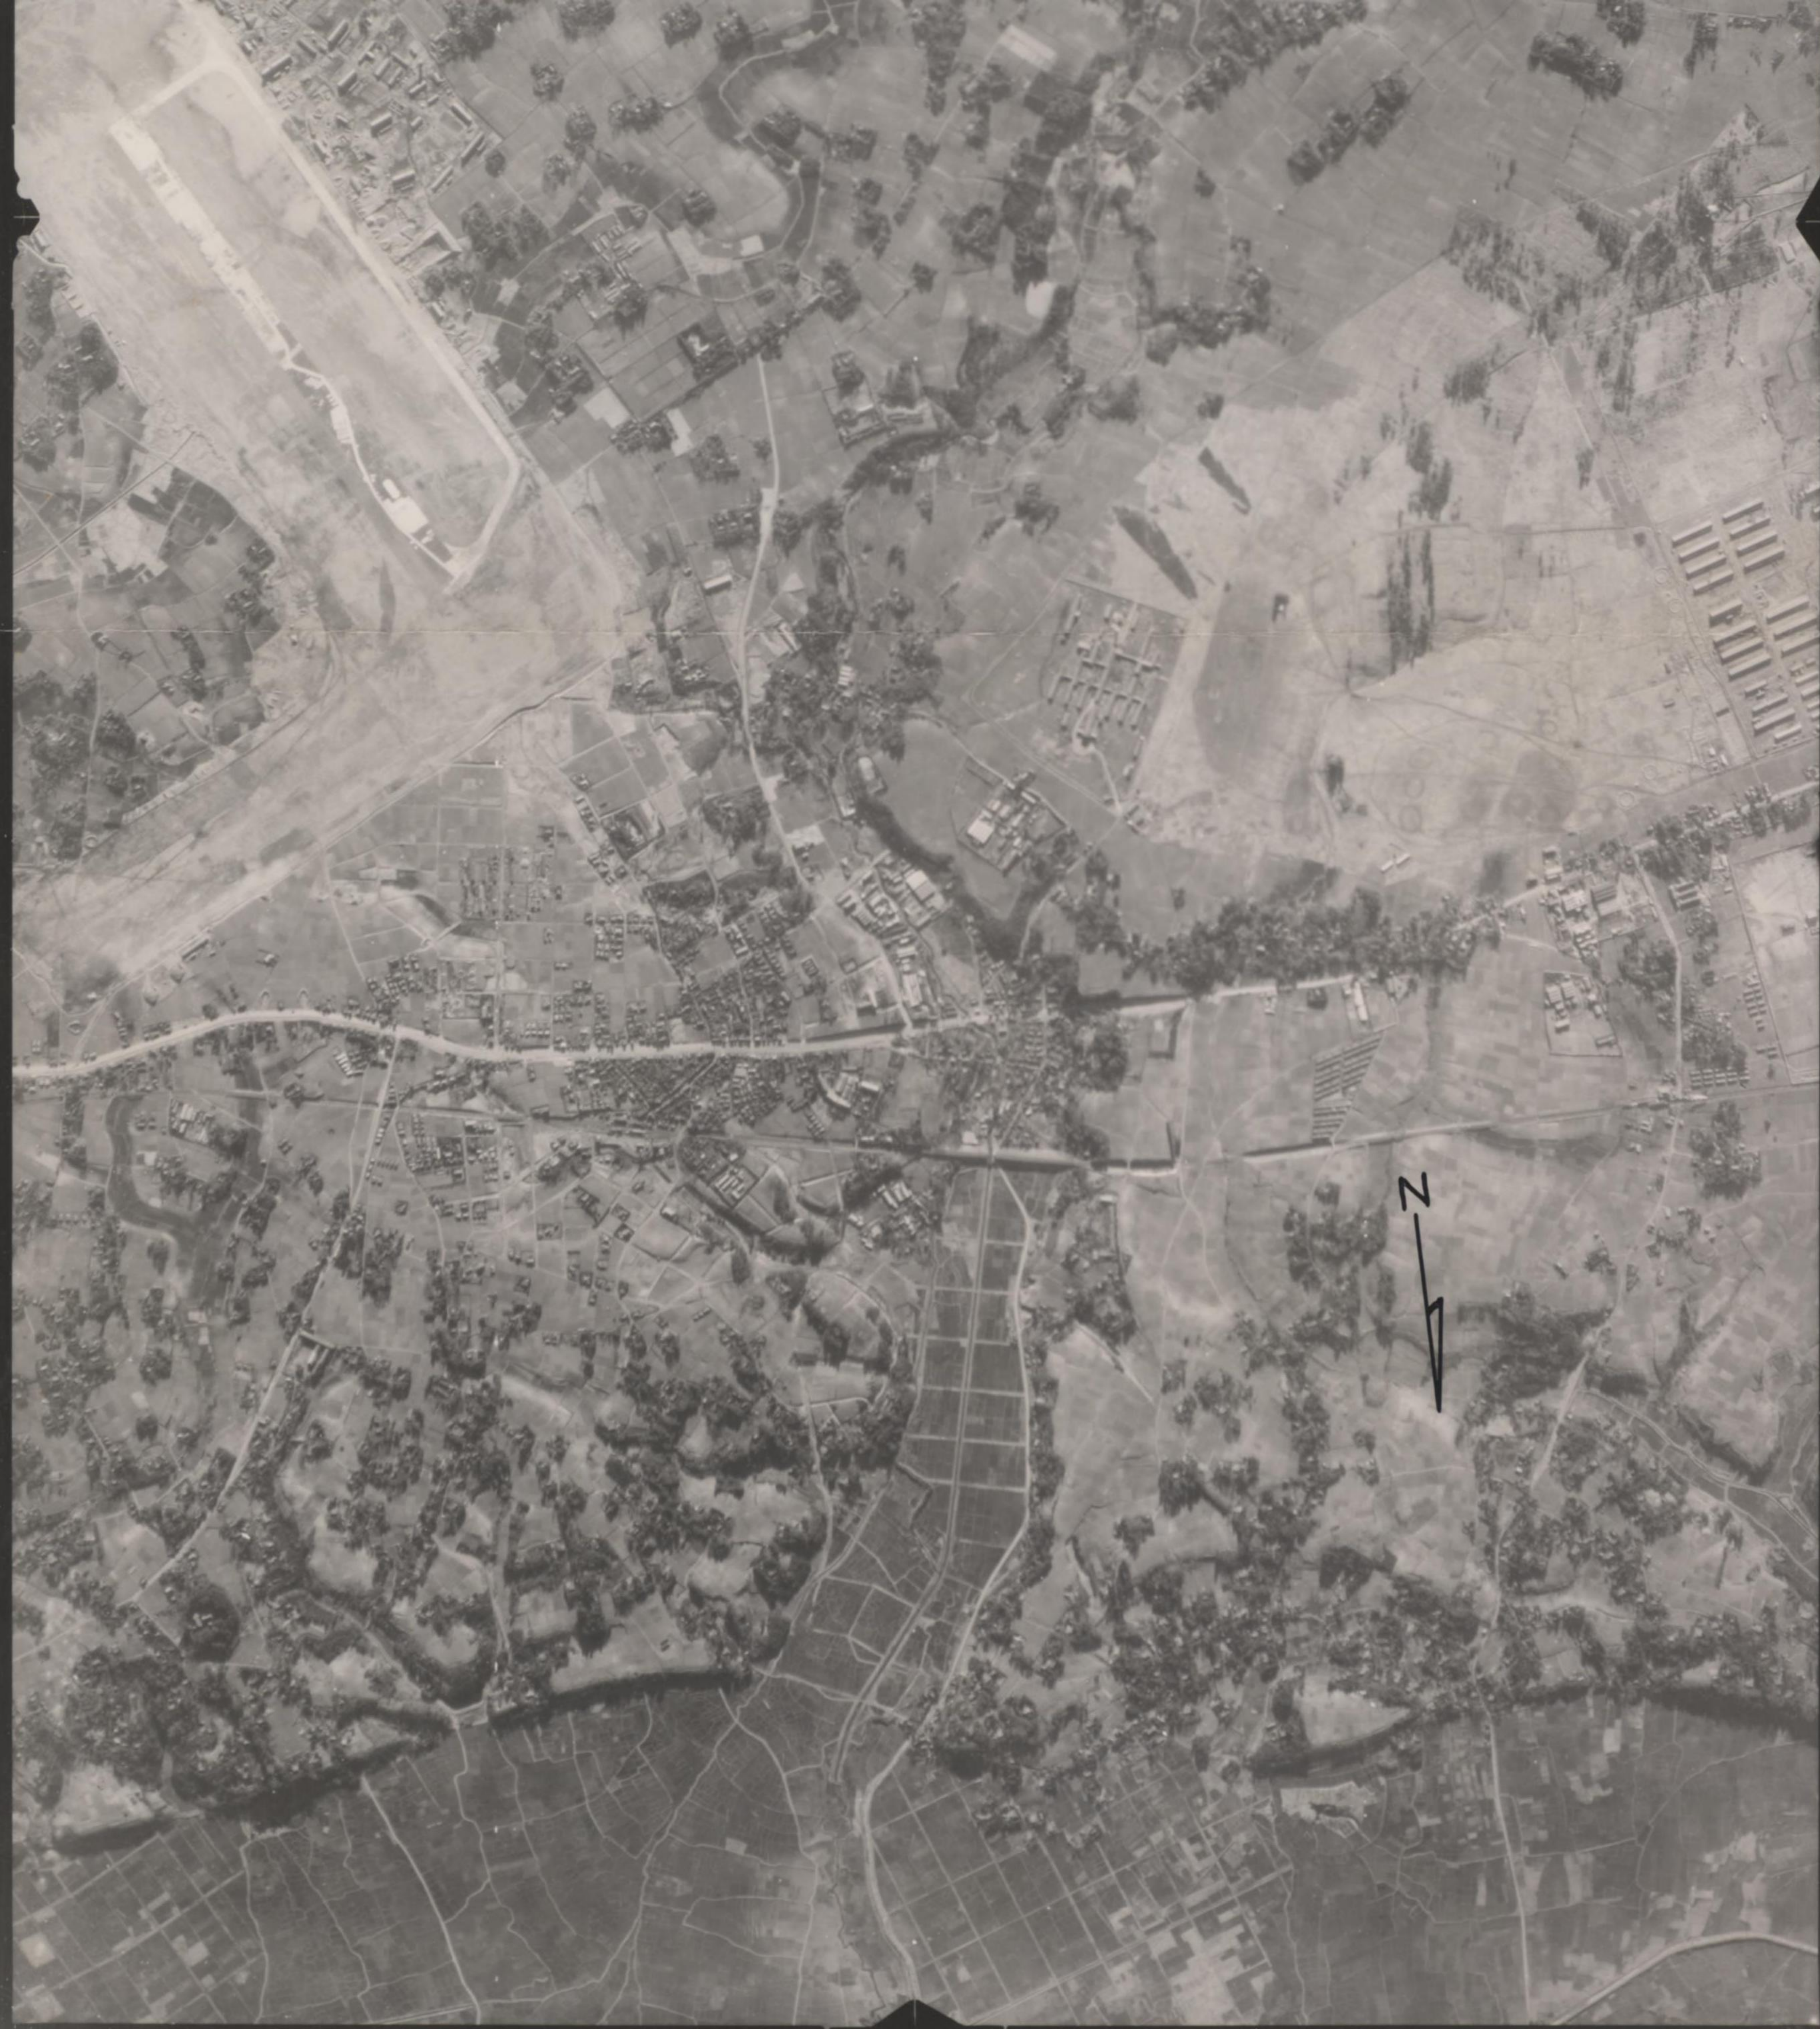
(17PL)(879BS;4673A/C 5M2)(1V8X1:9:1519 X24:33000)(35°45' N, 139°35' E)  
MUSASHINO A/C ENGINE PLANT. TOKYO. CON'E.

In target area, 2 hits are visible, 1 hitting the engine assembly building of the Musashino Plant, and one hitting the impellers section. 1 hit is observed on the building immediately east of the target area. 20 hits are scattered approximately 3000 feet east of the AP, hitting in open fields and small residential areas. 8 hits are observed 17,000 feet northeast of the AP near Narimasu Airfield. 7,500 feet west of the AP, 16 hits are visible and 8 hits are seen 13,500' west of the AP. 12 hits are visible in water east of Tokushima on Awaji Island.
