AIRCRAFT ACTION REPORT

REPORT No. **7**

(a) Target(s) and Location(s) **Tokuno Airfield, Amami Gunto** (b) Time Over Target(s) **1430(-9)** (Zone)
(FOR SHIPS INCLUDE ALL IN AREA UNDER ATTACK)

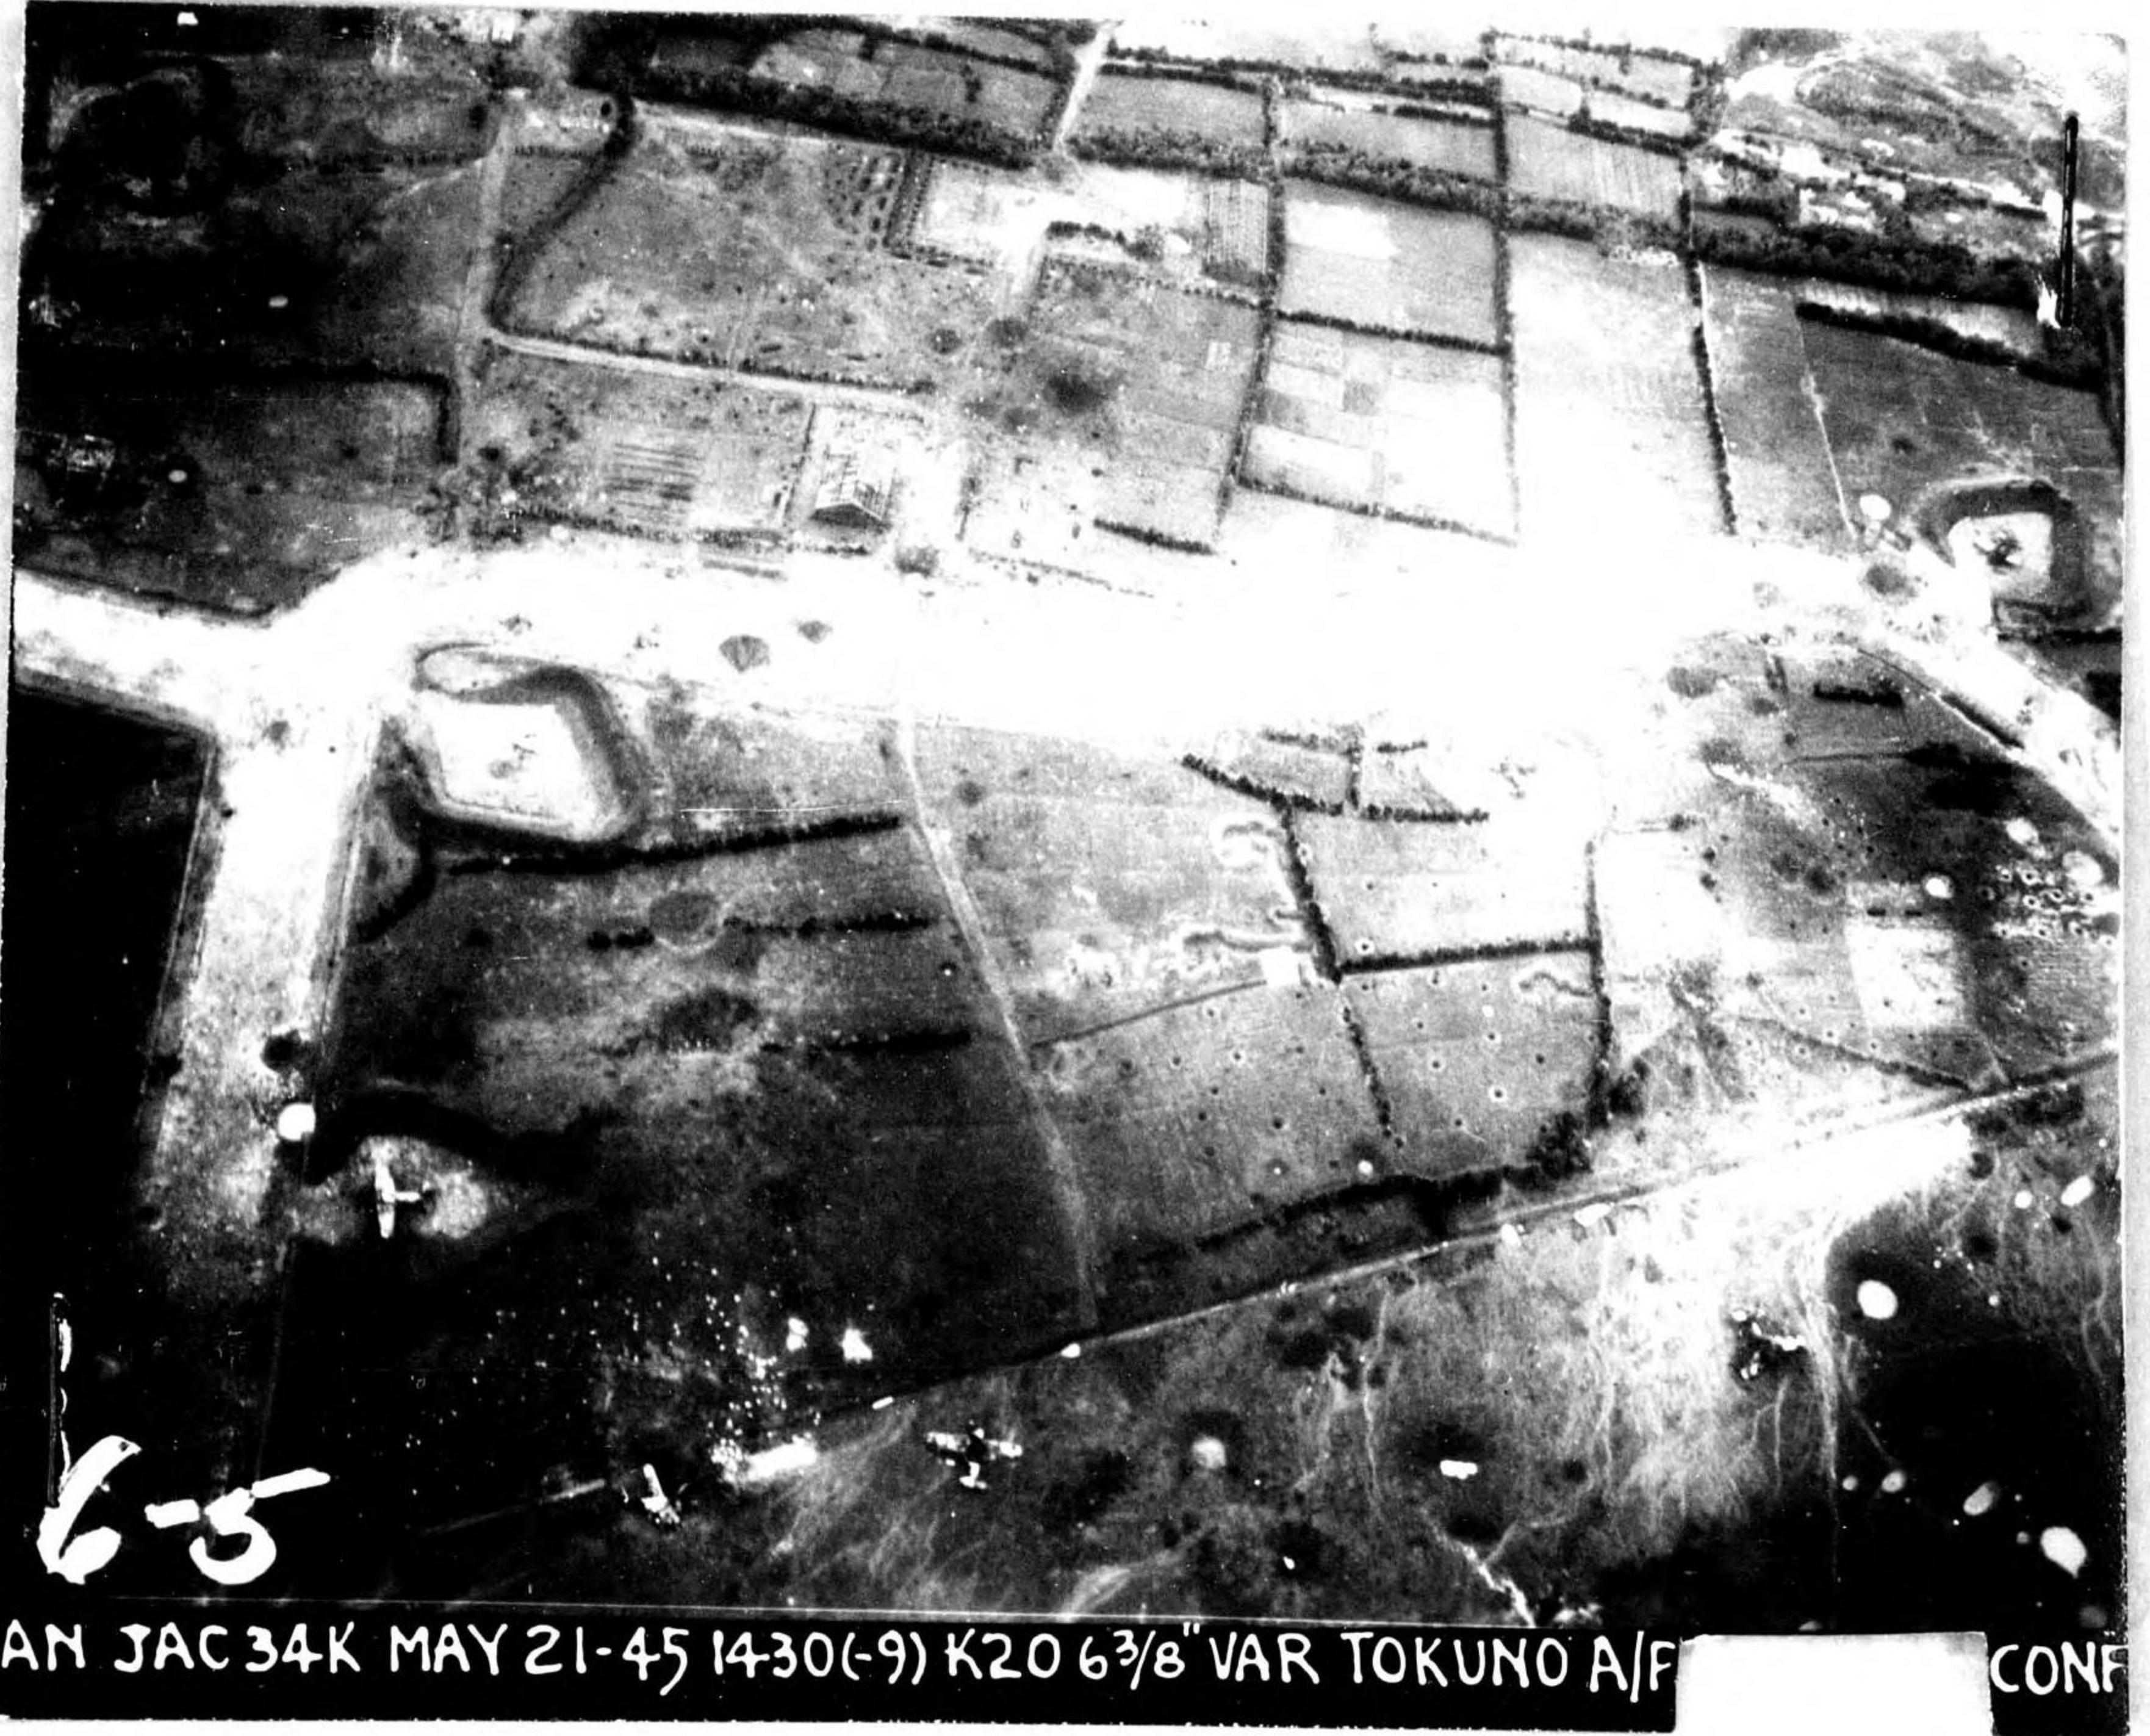
Enclosure (B) shows a close-up of the taxi strips and diamond-shaped revetments. Also evident are damaged aircraft and partially camouflaged planes. These are covered partly by shrubbery, and might be designed to indicate damage which does not exist. Taxiways liberally cratered.

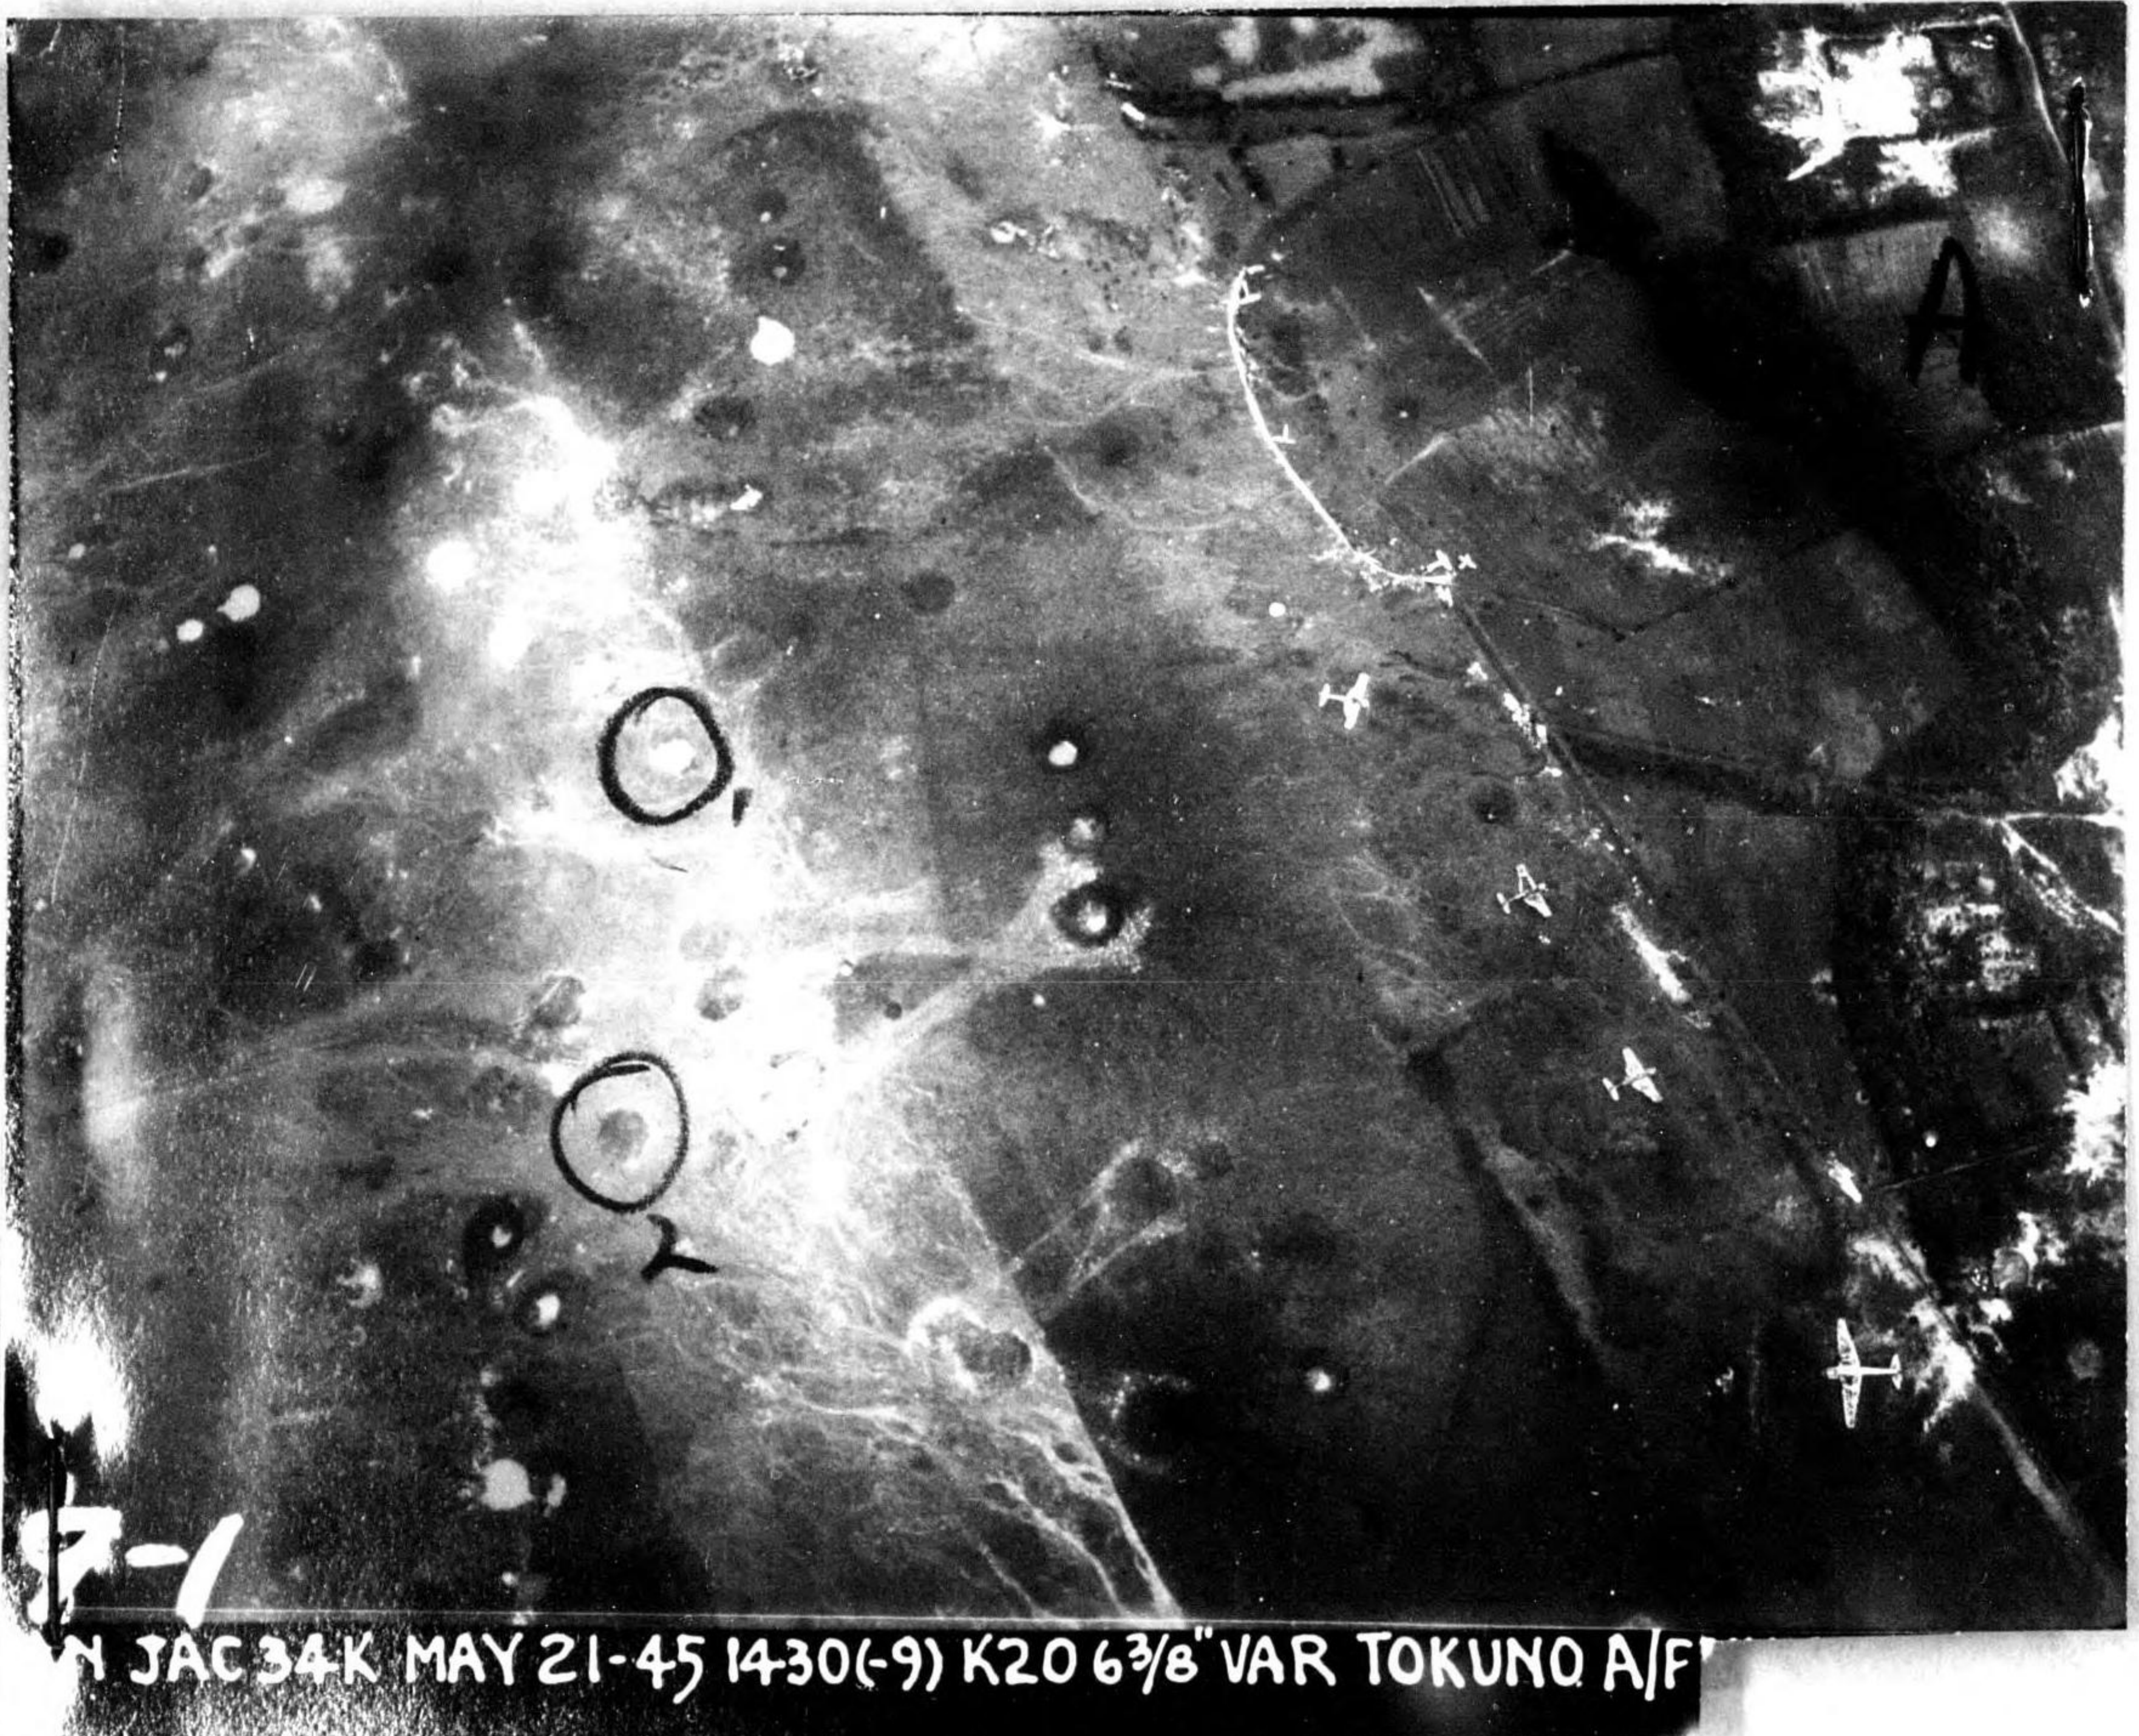
Enclosure (A) shows old craters (filled with water and marked (1)). New hits appear darker (2) and several damaged single engine planes are visible along parking strips.
