MISSION #24 BANGKOK "CAPACIOUS 4"  
2 Jan 45

SUBJECT: Report of B-29 Mission, 2 January 1945.

## Tactical Mission Report

DAMAGE ASSESSMENT REPORT NO. 34

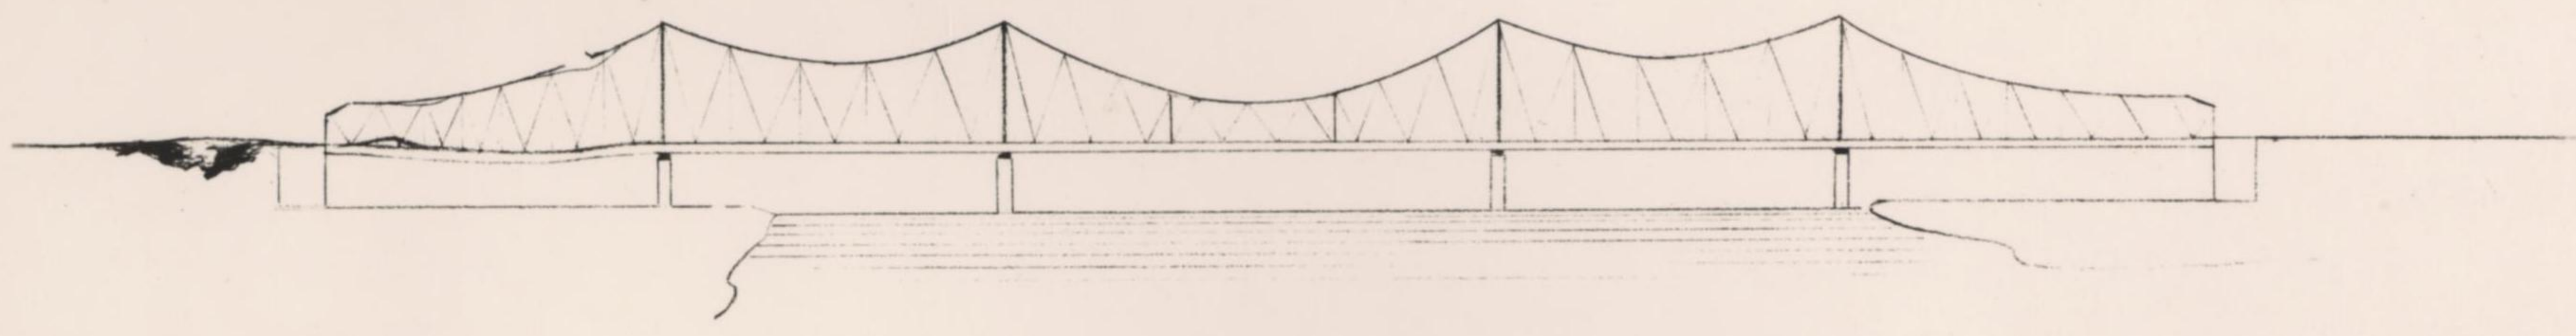
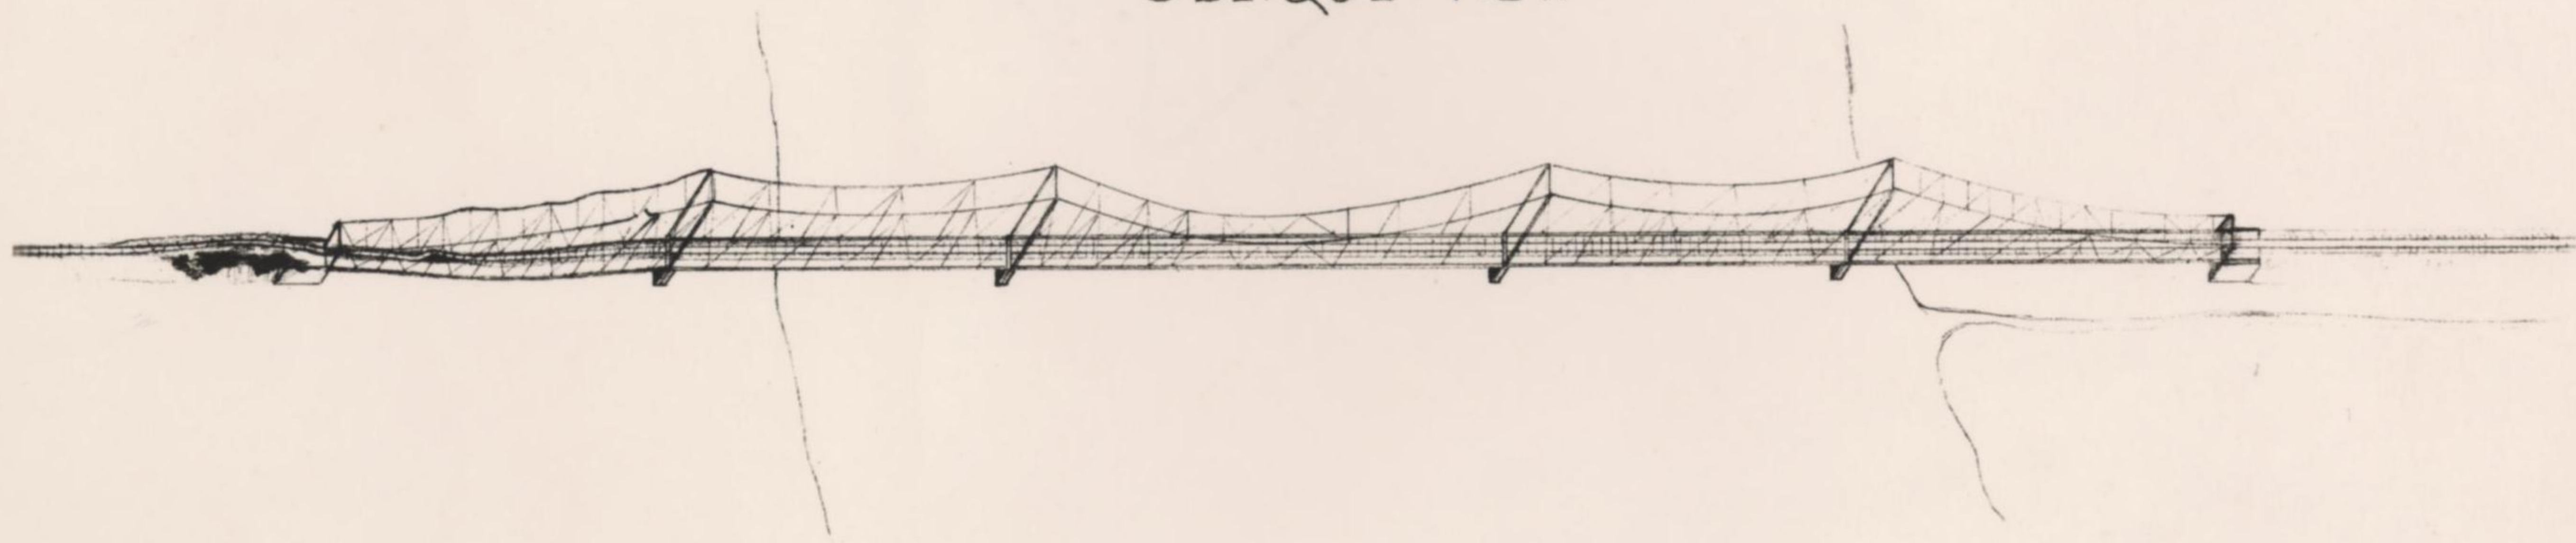
ARTISTS CONCEPTION OF  
DAMAGE TO RAMA VI BRIDGE,  
XX BOMBER COMMAND ATTACK  
OF 2 JANUARY, 1944.

- (1) A section of the west top chord of the northern approach approach span has been destroyed and part of the lateral bracing has been damaged. Shadow study clearly shows a definite sag in the northernmost span. In addition the railway platform and the east top chord have sustained damage and are seen to be buckled.

SIDE VIEW

OBLIQUE VIEW

A section of the west top chord of the northern approach span has been destroyed and part of the lateral bracing has been damaged. Shadow study clearly shows a definite sag in the span. In addition the railway platform and the east top chord have sustained damage and are seen to be buckled.

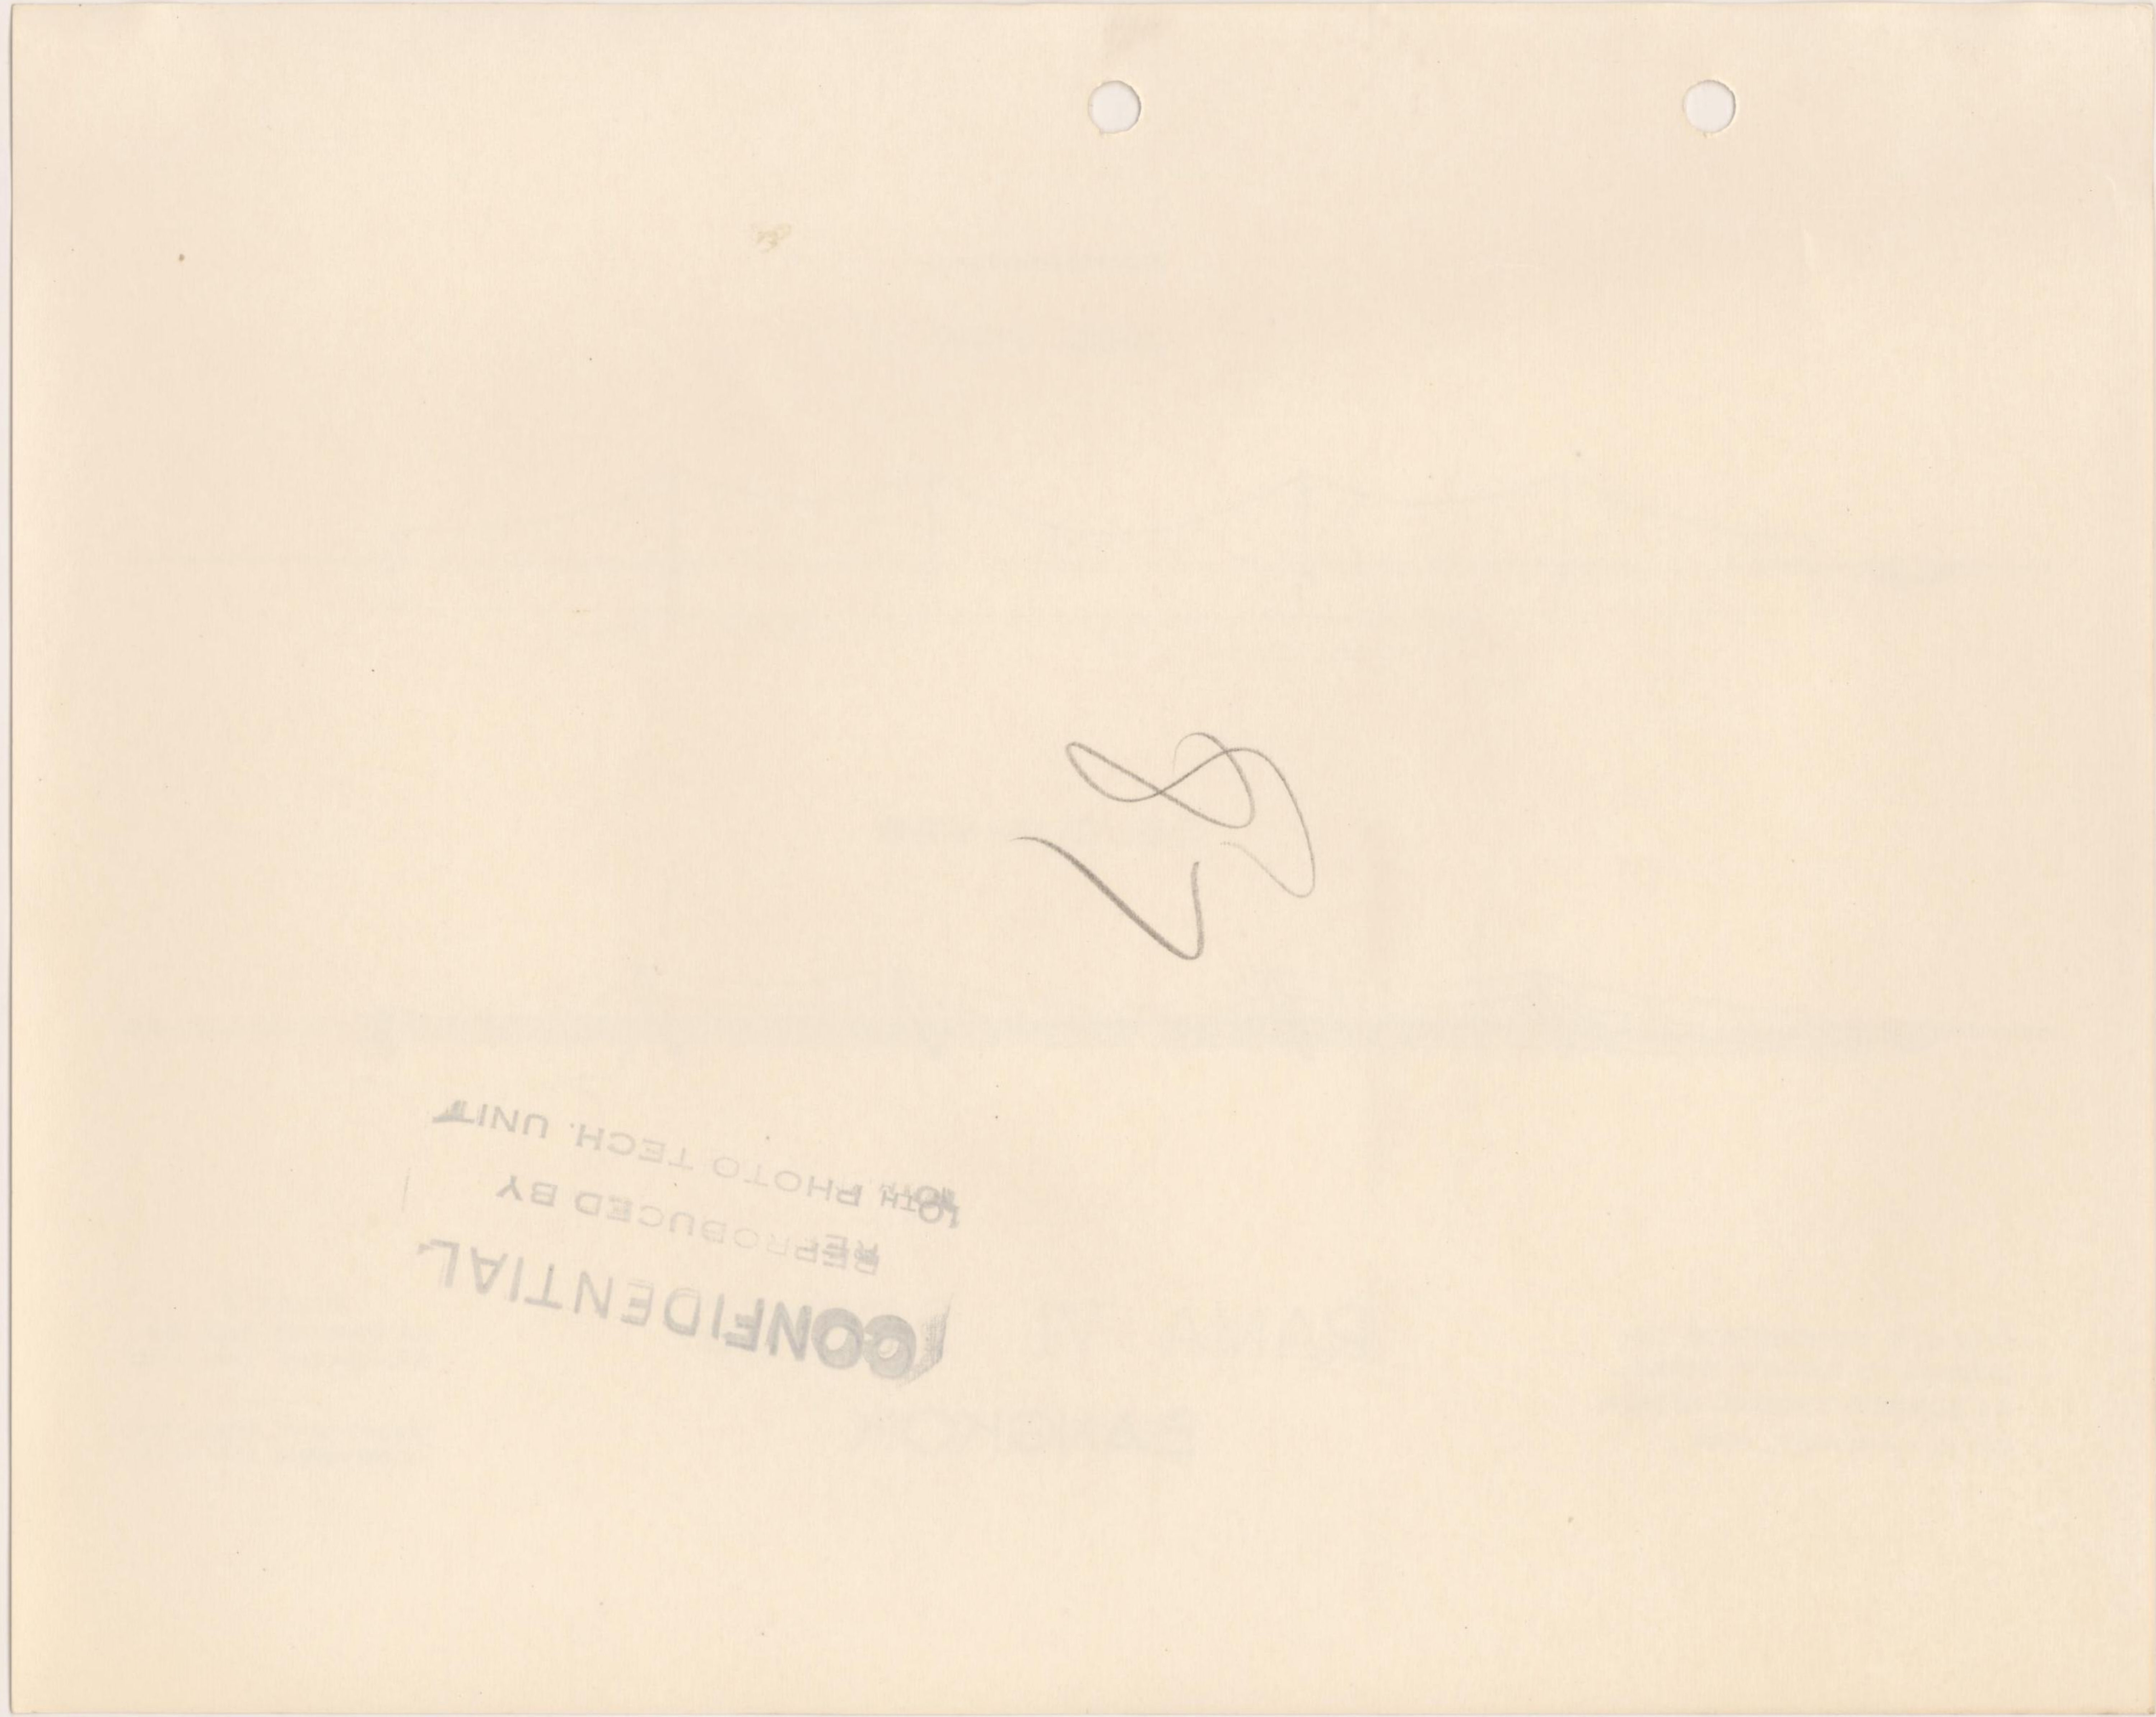
ANNEX 2  
DA REPORT NO. 34  
BANGKOK THAILAND

- (2) The northern approach embankment took at least four hits or near misses which probably severed the rail line.
- (3) A large sawtooth-roof factory type building was severely damaged by three direct hits.

- (4) Bombs falling east of the bridge destroyed at least 32 small buildings, largest 75' x 120', and damaged 10 others.
- (5) The 800' x 40' railway siding shed, damaged by a previous attack, was being dismantled. Additional hits destroyed the remainder of the building. Four nearby buildings averaging 30' x 30' were destroyed and three others were damaged.

- (6) A previously wrecked complex of small buildings just west of the bridge took additional hits and is now virtually obliterated.
- (7) Four small buildings, largest 115' x 45', sustained additional damage from near misses.

# RAMA VI BRIDGE BANGKOK
