RMS Titanic: Why the disaster happen Unfortunate engineering and safety decisions Two structural failure theories Fractured steel hull theory Charpy impact tests Brittle-ductile transition temperature Ultrasound imaging: No large gash 6 narrow slits at collision site Titanic broke up in half: FEA Large deformation of hull plates **Missing rivets** Fractured wrought-iron rivet theory Slag, size, distribution, orientation Experiments, compare to recovered rivets Safety lesson Prescient novel

Titanic, the "Unsinkable", sank on 14 Apr 1912, in less than 3 hours

Two structural failure theories

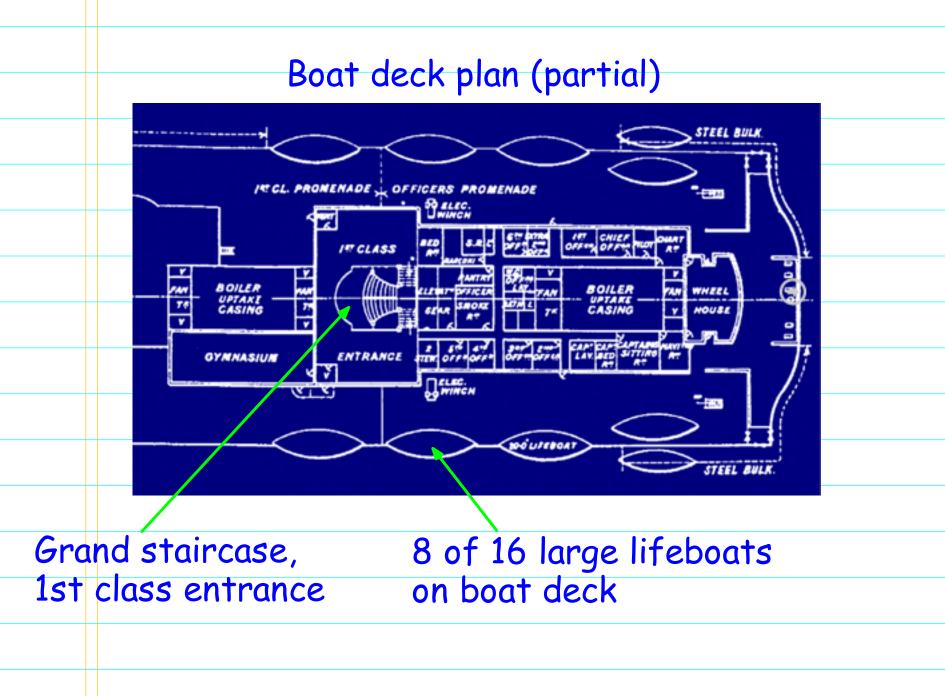
Bulkheads were lowered, just 10 feet above waterline, to allow for the grand staircases to be grander.

Bulkheads are to create watertight compartments (cells) in the ship hull. The higher the bulkheads, the safer the ship, since water can be contained in any damaged compartment.

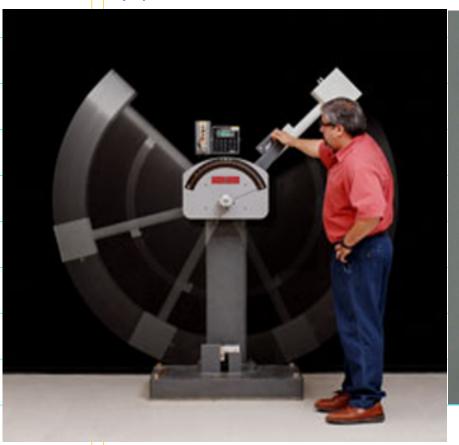
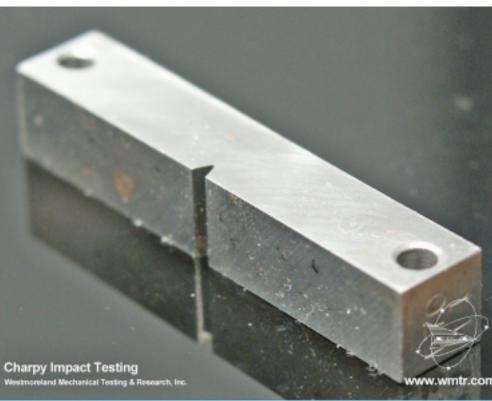
Charpy impact tests Charpy test machine

Notched specimen

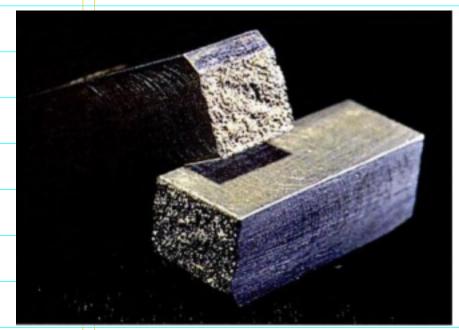
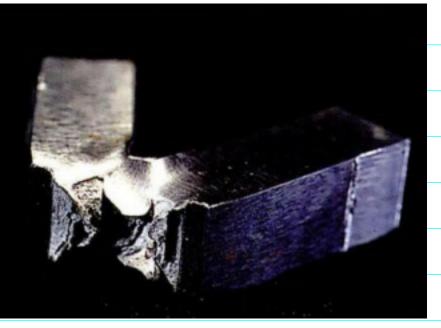
Brittle fracture Titanic steel

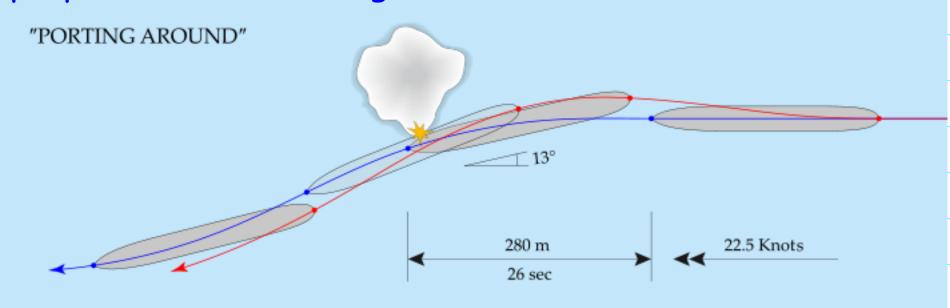
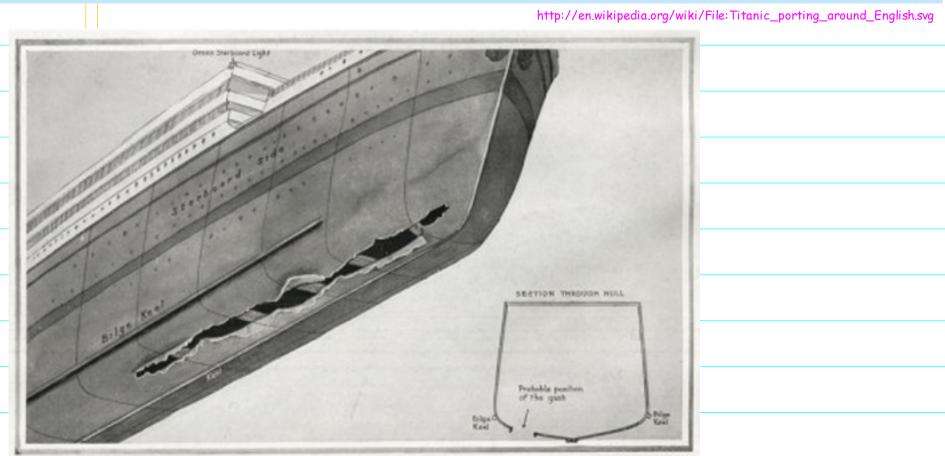
Titanic veered to portside, glancing blow with iceberg on starboard side, veered to starboard side to protect its propellers from iceberg

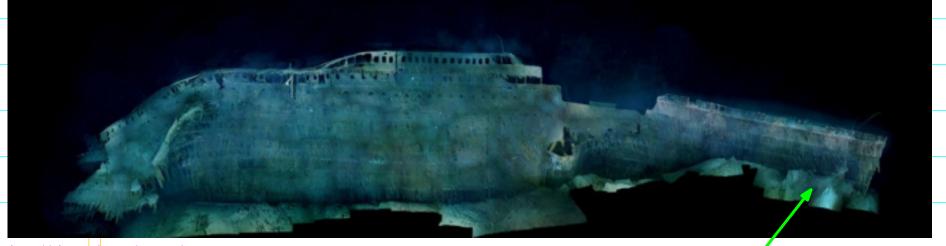
Titanic's bow 90-meter (300-ft) gash by iceberg collision, spreading over 6 compartments, as widely believed since the British inquiry in 1912.

Titanic forward section on ocean floor, side view

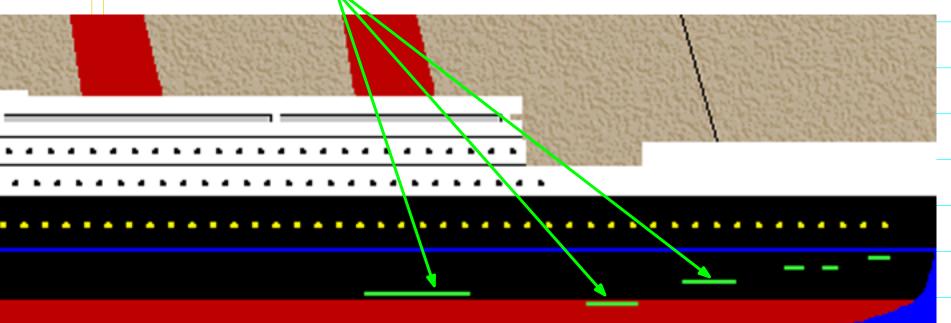
Collision site under 55 ft of mud

- 1997 French expedition
 - Ultrasound imaging
 - No 90-meter (300-ft) gash
 - 6 narrow slits, with width of a finger, totalling about 12 square feet

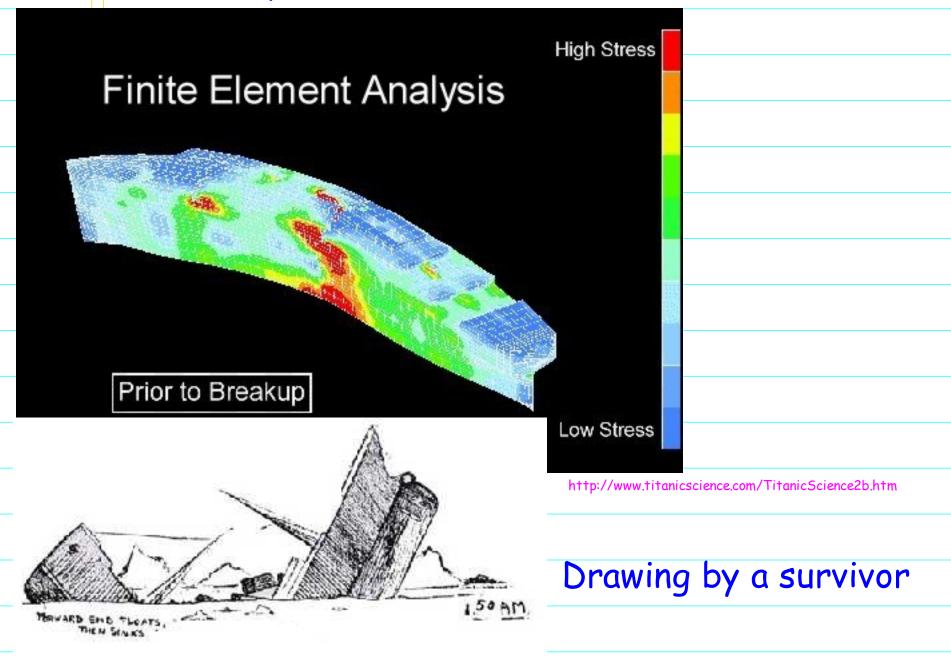
Titanic broke up in half at the surface

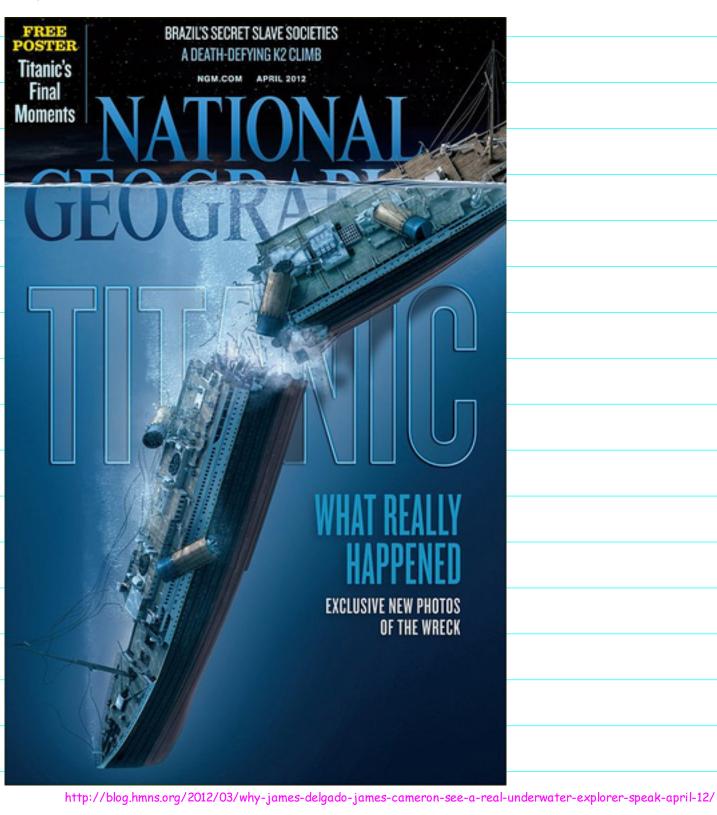
Titanic broke up in half at the surface

Titanic debris field: Patched sonar image

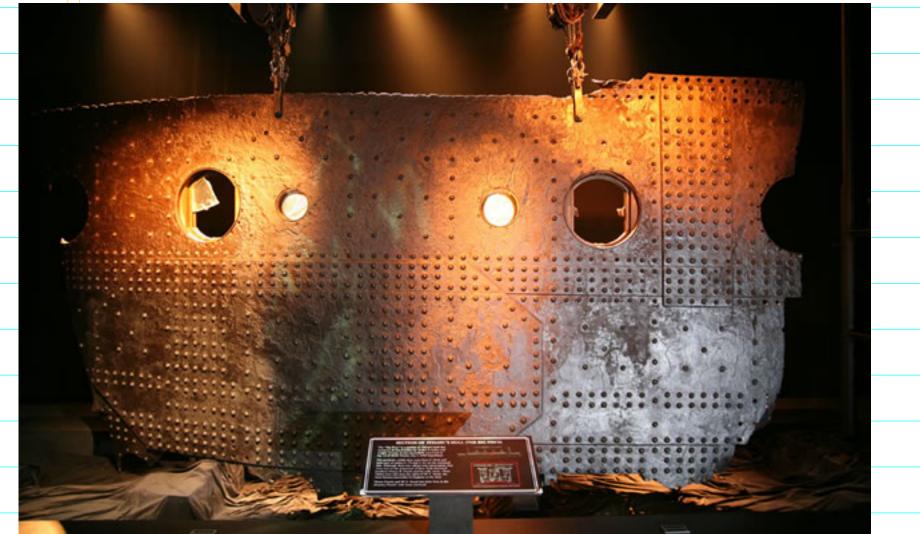
Titanic had 2000 steel plates, each 1 in thick, held together by 3 millions steel and wrought-iron rivets.

Recovered broken steel hull

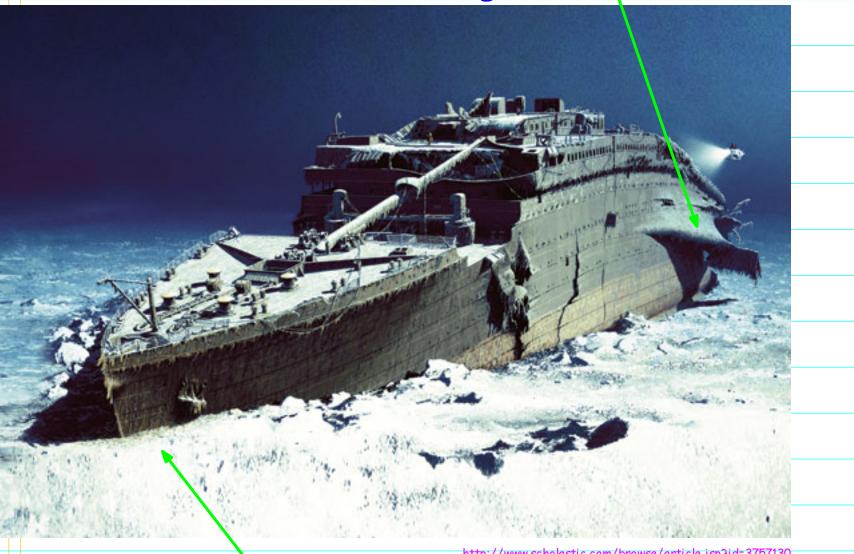
Titanic-hull steel could take on large plastic deformation with no brittle fractures like glass

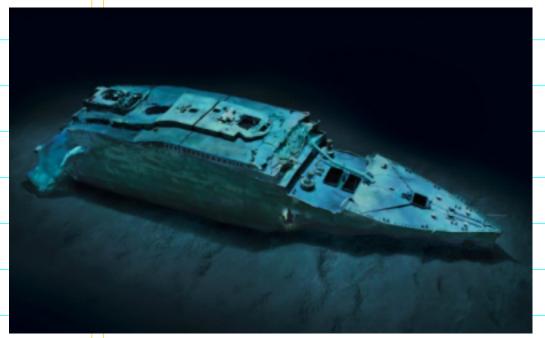
Bow bottom under 55 feet of mud

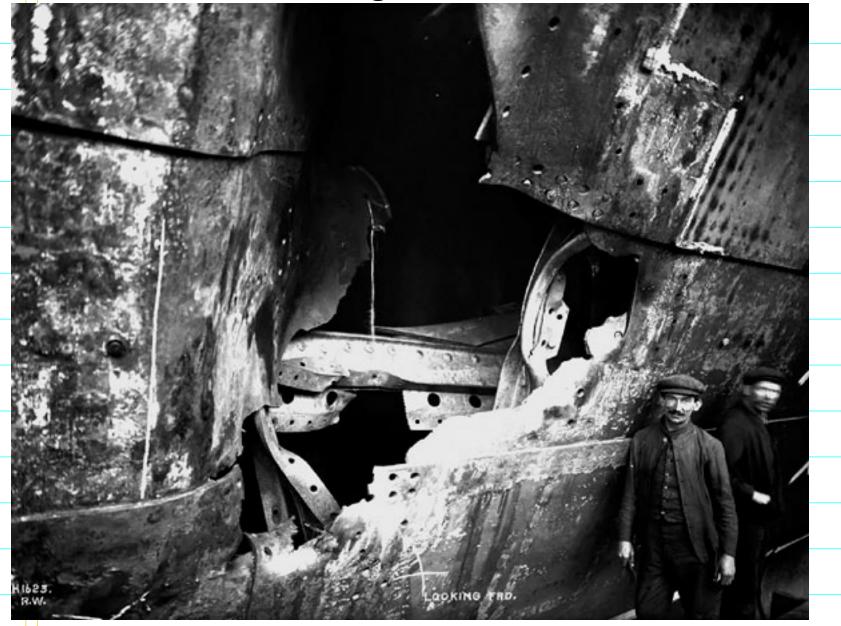
RMS Olympic, sister ship of RMS Titanic, collided with HMS Hawke in 1911: Damage

Plastic deformation in steel hull-plates: Bending and twisting

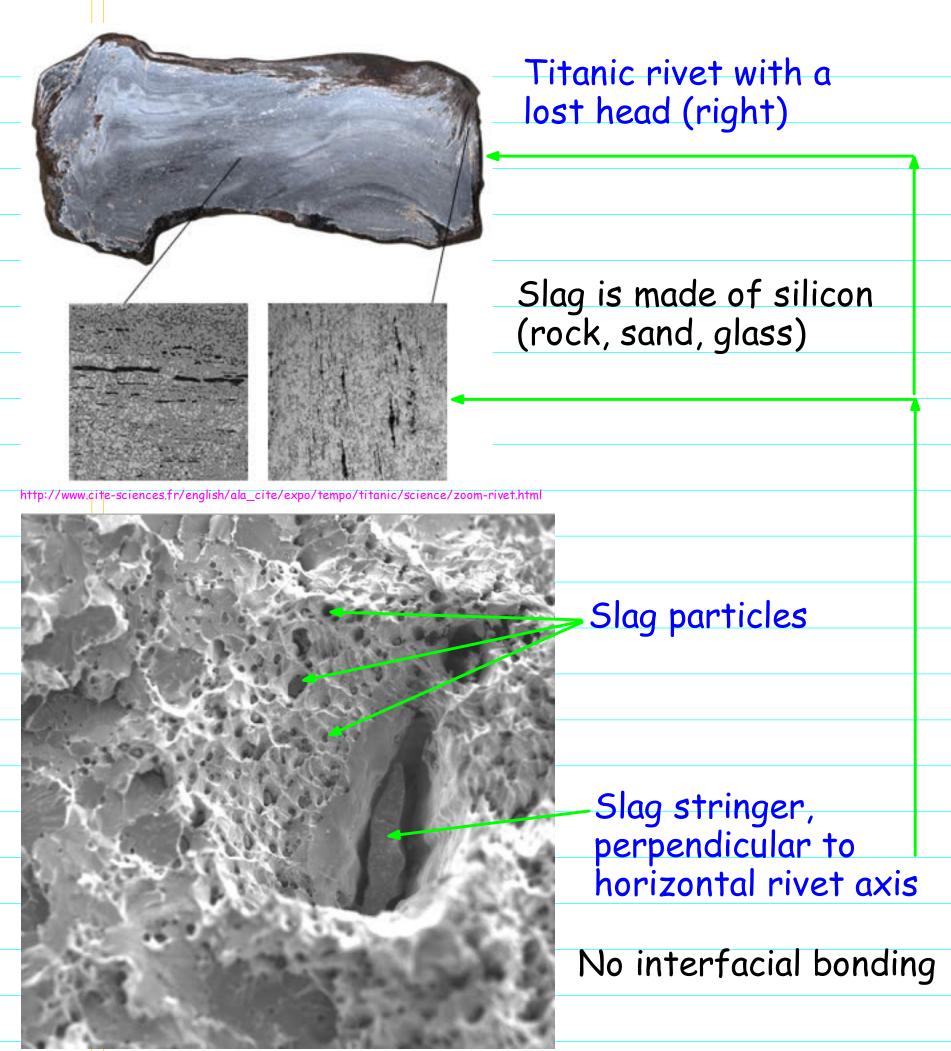
Missing rivets

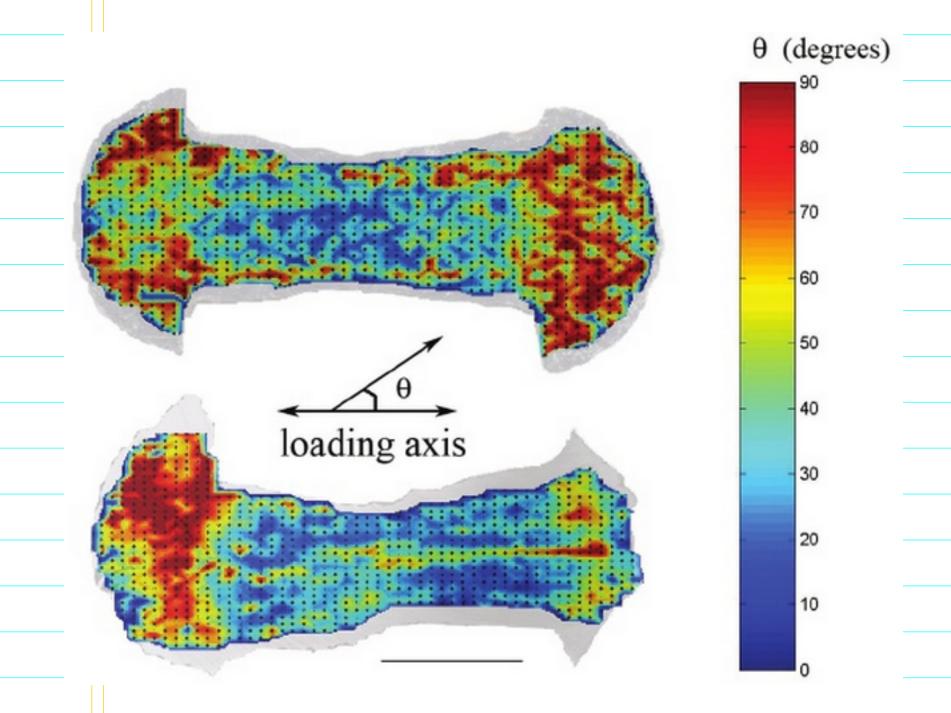
Titanic rivets: Slag stringer orientation

Slag stringers in rivet heads are oriented 90 deg (perpendicular) to rivet shaft axis; weakness against tension, leading to loss of rivet heads and opening of 6 slits in the seams of the ship hull.

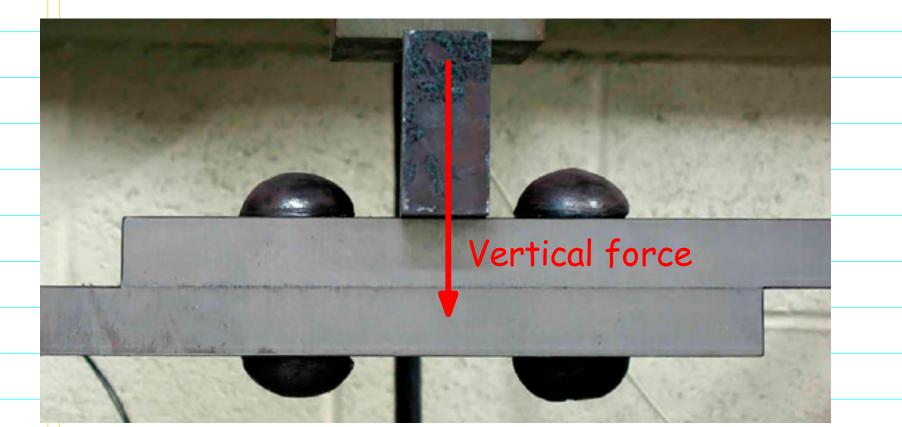
Testing rivets made identical to those of the Titanic

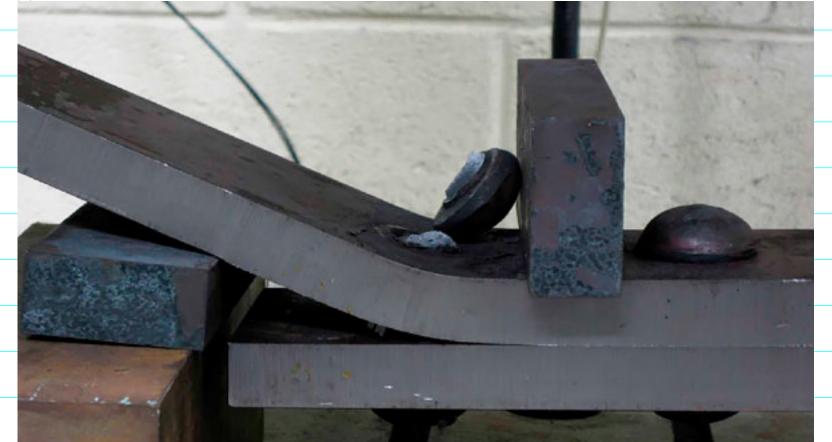
Rivet head popped off at 60% of ultimate force on good rivets

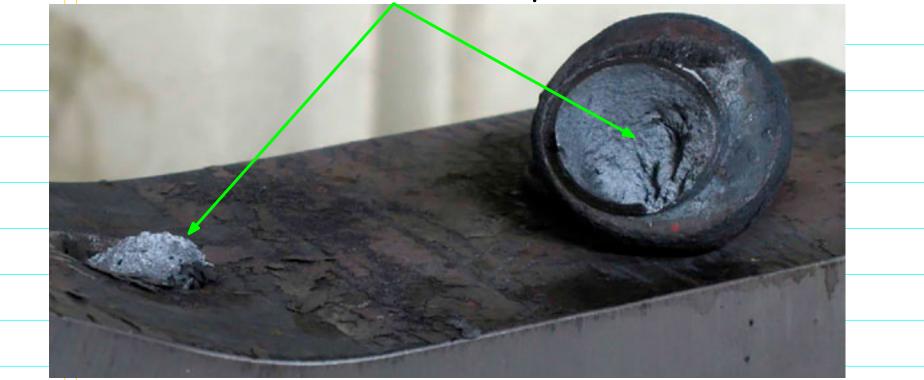
Small button inside rivet head similar to those recovered from the Titanic site (p.51-13)
